# THE DETECTION AND TRACKING OF STACK EFFLUENT WITH A FORWARD LOOKING INFRARED IMAGING SENSOR

NSWC/DL TECHNICAL REPORT TR-3313  
June 1975

Electro-Optics Branch  
Advanced Systems Department

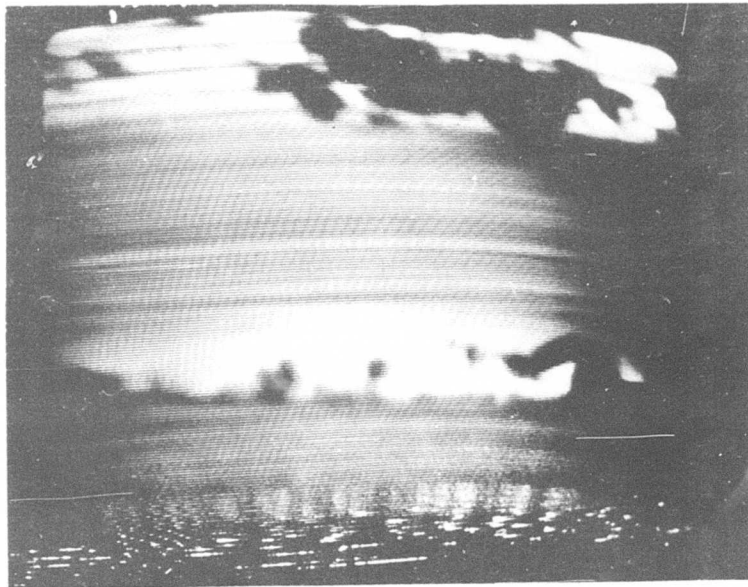
3. The test on 28 January 1975 was conducted during a period when the spray dryer plume was subjected to aerodynamic downwash (D stability and surface winds greater than 10 mph). Figures 10 through 12 show typical FLIR imagery from this condition. The plume was non-uniformly dispersed by the high gusty winds and slammed toward the ground. The FLIR and mobile sampler recorded the same grid position for this test. Figure 10 shows FLIR imagery from grid site 2.9/3.7 of the plume being bent over. (Note the high apparent temperature of the low clouds above the plume--black = hot on the photographs.) Figure 11 is a FLIR image from grid point 3.7/1.4 with the FLIR in its narrow FOV. The figure clearly shows the plume being torn apart by the gusty wind, which is blowing directly toward the FLIR unit. Figure 12 shows the image from site 3.7/1.4 in wide FOV. The plume is bent over, with a small tuft just below the main body of the plume. The arrow is pointed at the mobile sampler.

Figure 10. FLIR Imagery from 2.9/3.7 of Plume  
in Aerodynamic Downwash

Figure 11. FLIR Imagery from 3.7/1.4 of Plume in Aerodynamic Downwash (Narrow FOV)

Figure 12. FLIR Imagery from 3.7/1.4 of Plume in Aerodynamic Downwash (Wide FOV)

28 Jan 1975	1835-1916	3.7/1.5	Heavy turbulence and downwash due to high winds. The main body was blown to the ground near the stack close to the mobile sampler. The top of the plume was usually below 100 ft. The conditions continued throughout the test.
29 Jan 1975	1912-2050	2.9/3.7	The test began with very little turbulence or mixing evident. By the middle of the period, there was virtually none. The rise rate was low but steady. This resulted in a retention of plume integrity and insured that no part of the plume reached the ground. In the early tests, the plume passed 150 ft over E St

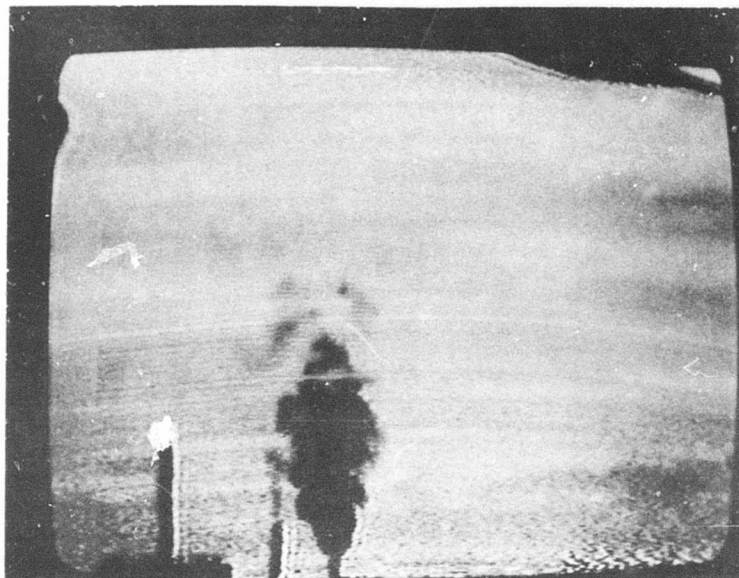
4. The test on 29 January 1975 was conducted during F stability (winds less than 3 mph). The spray dryer plume slowly climbed and bent in the wind direction. The FLIR unit located at grid position 2.9/3.7 observed an SF<sub>6</sub> burst for several minutes. It appeared to remain compact and airborne for the duration of the FLIR tracking (Figure 13) sequence. The FLIR units were used on several occasions during this test to estimate the ground plume location and provided the same approximate independent results each time. The mobile sampler, because of hazardous terrain, was unable to arrive at the FLIR predicted location. However, even when it was within a few hundred ft of the location it detected no sulfur, indicating that little or no plume was dispersed to the ground. This agreed with the FLIR imagery. Figure 14 shows the SF<sub>6</sub> leaving the stack from the FLIR at 3.7/1.4. Figures 15 through 18 show unique plume formations as seen from 3.7/1.4 during F stability when the wind speed was nearly zero.

Figure 13. FLIR Imagery from 2.9/3.7 of Plume in F Stability Conditions

Figure 14. FLIR Imagery from 3.7/1.4 of Plume in F Stability Conditions

Figure 15. FLIR Imagery from 3.7/1.4 of the Plume Without SF<sub>6</sub> Added During Evening of F Stability Conditions

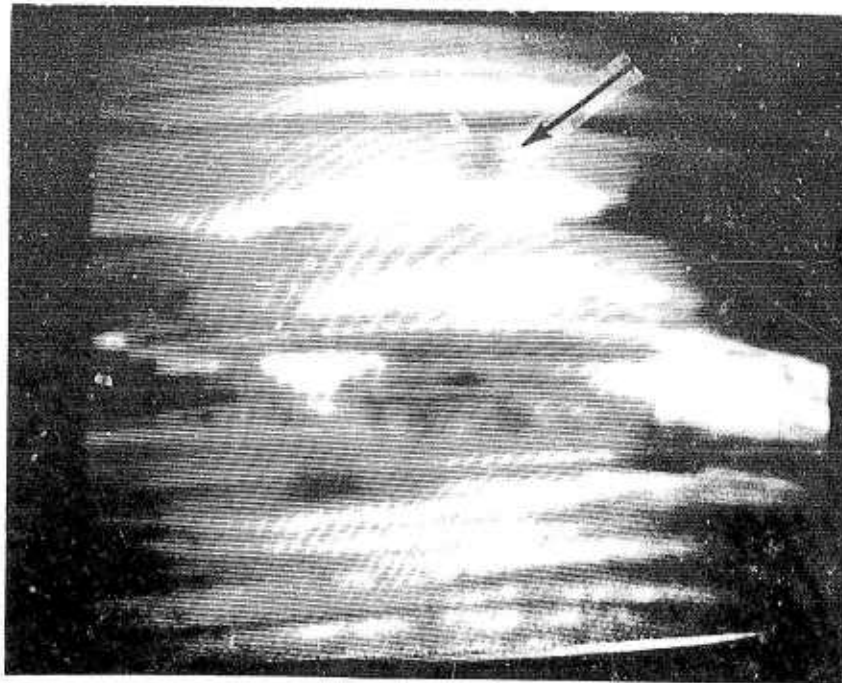
5. Figure 19 shows imagery from 23 January 1975. This was typical of the tests during D and E stability. With the SF<sub>6</sub> bursts, the predicted position of FLIR was along the ridge line at position 3.7/2.3.

Figure 19. FLIR Imagery from 2.9/3.7 of Plume on 23 January 1975

The test on 23 January 1975 demonstrated the effect of the shifting wind. The mobile sampler detected the plume at position 3.9/2.8 which was confirmed by FLIR. However, when the sampling commenced, the wind shifted so that the ground plume was several hundred yards from the sampling position.

6. Near the end of the test on 23 January 1975, resulted in a unique plume composed of sawtooth-shaped puffs due to the atmospheric instability. Figures 19 and 20 show imagery from 23 January 1975. This was typical of the tests during D and E stability. Figure 19 shows the beginning of the SF<sub>6</sub> burst from grid point 2.9/3.7. The leading edge of the plume reached a mean altitude of about 100 ft with the main body remaining at a 50-75 ft height above ground. Figure 20 is FLIR imagery from 3.7/1.4 of the same event. Figure 20 shows the SF<sub>6</sub> shortly after release, and the dispersal of the SF<sub>6</sub> burst as indicated by the inserted arrows.

Figure 20. FLIR Imagery from 3.7/1.4 of Plume on 23 January 1975
