AMMRC CTR 76-12 ✓

BRITTLE MATERIALS DESIGN,  
HIGH TEMPERATURE GAS TURBINE

Arthur F. McLean, Ford Motor Company, Dearborn, Michigan 48121  
Robert R. Baker, Ford Motor Company, Dearborn, Michigan 48121  
Raymond J. Bratton, Westinghouse Electric Corporation, Pittsburgh, Pennsylvania 15235  
Donald G. Miller, Westinghouse Electric Corporation, Pittsburgh, Pennsylvania 15235

Interim Report Number 9, July 1, 1975 to December 31, 1975

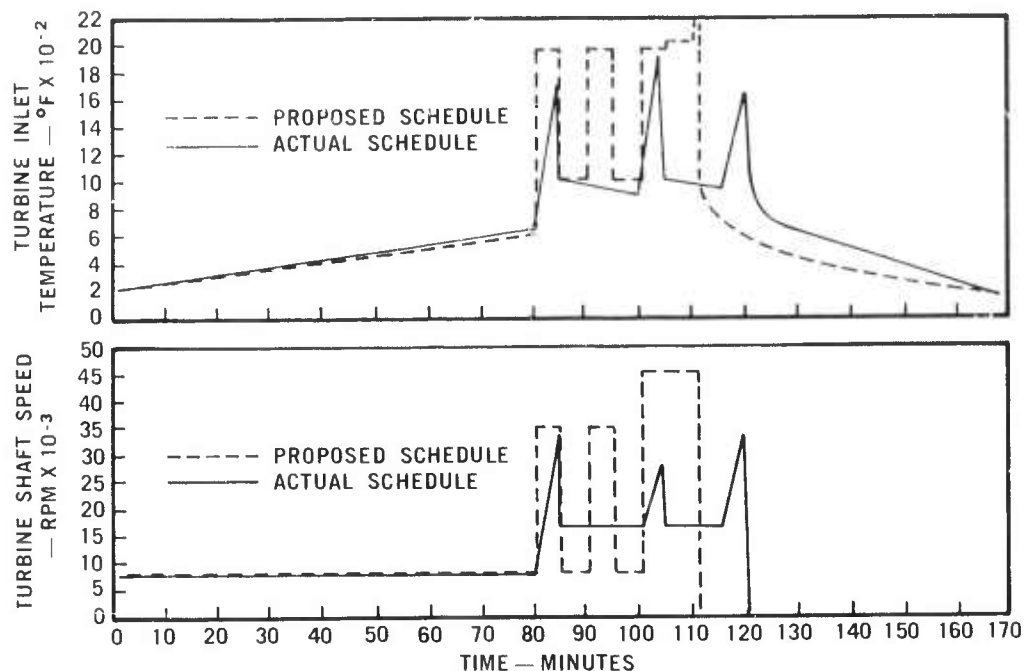
Figure 3.16 Proposed and Actual Speed and Temperature Schedules

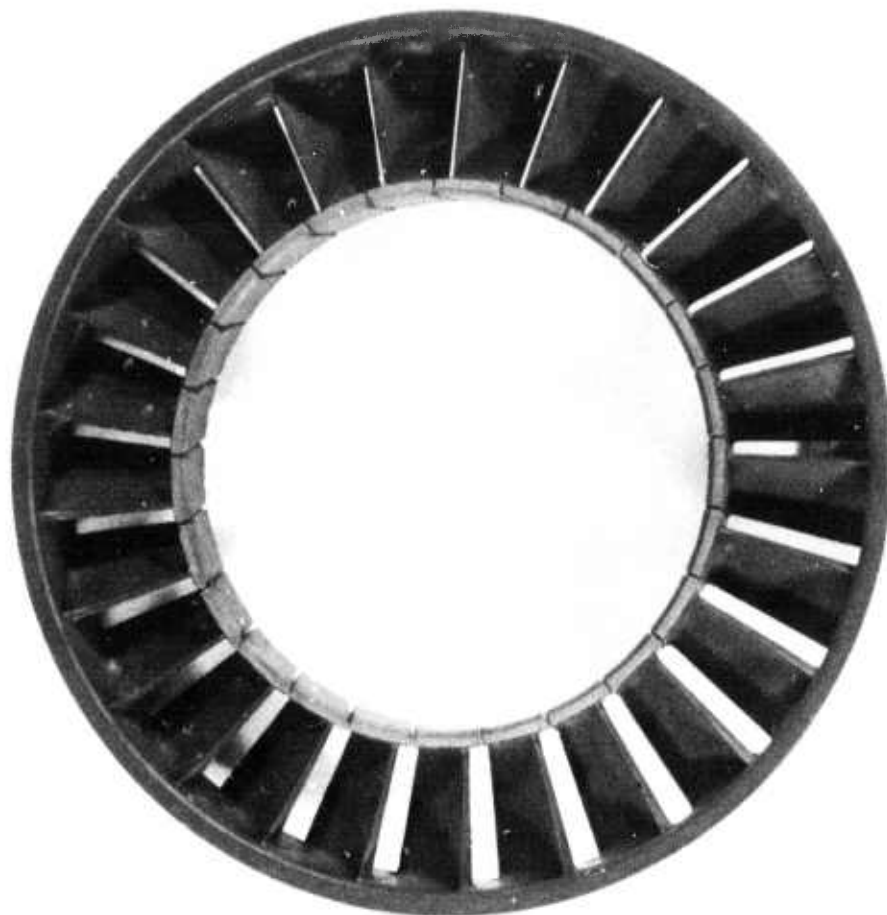
Figure 3.22 Silicon Nitride Stator After 175 Hours of Durability Testing

This problem has been corrected and in addition, a nitriding cycle change has been incorporated. Using these changes three stators were made for testing. Unfortunately during finish grinding of two of these stators some chipping of the outer shrouds occurred. All three stators were tested. Two failed after 5 and 32 hours, believed due to stresses caused by the poor finish machining. However, the third stator, which had good finish grinding, was tested for 175 hours and is in excellent condition as shown in Figure 3.22. Further stators from this system will be evaluated.

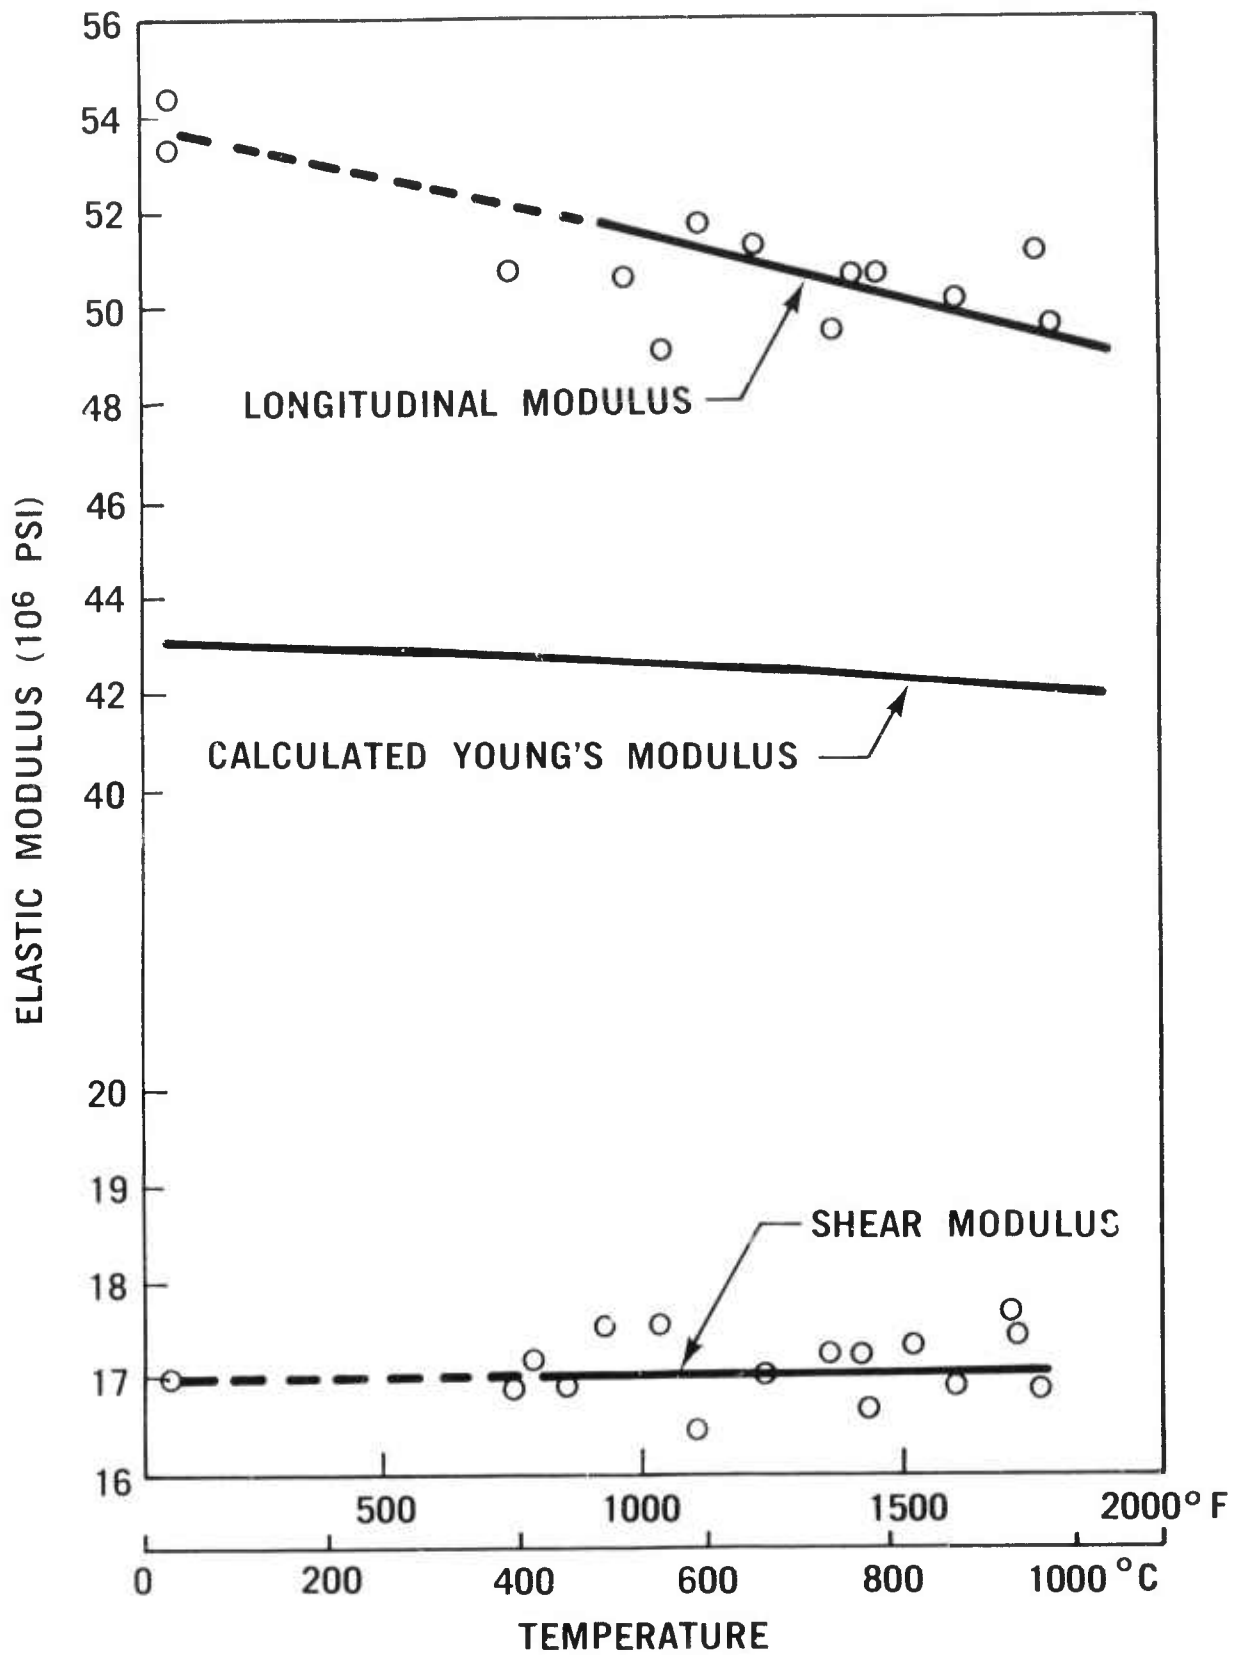
Figure 4.3 Elastic Moduli vs Temperature for Press-Bonded, 5% MgO Si<sub>3</sub>N<sub>4</sub>

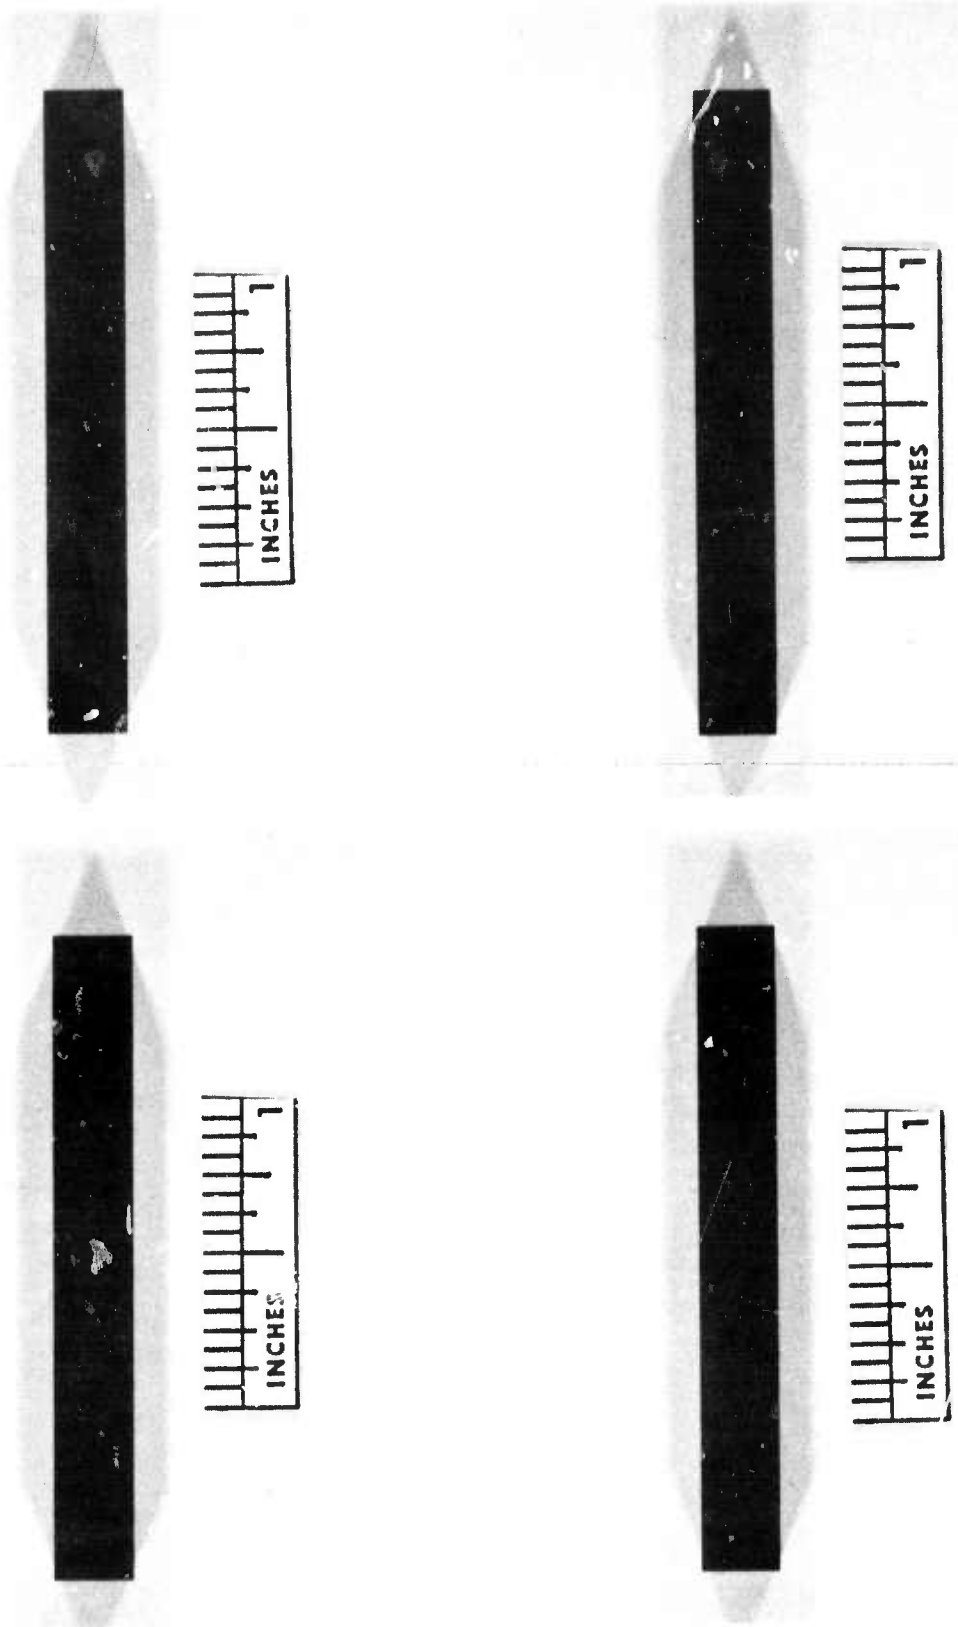
Figure 4.12 Surface Appearance of Four Sides of Norton HS-130 Hot-Pressed  $\text{Si}_3\text{N}_4$ , Specimen 2

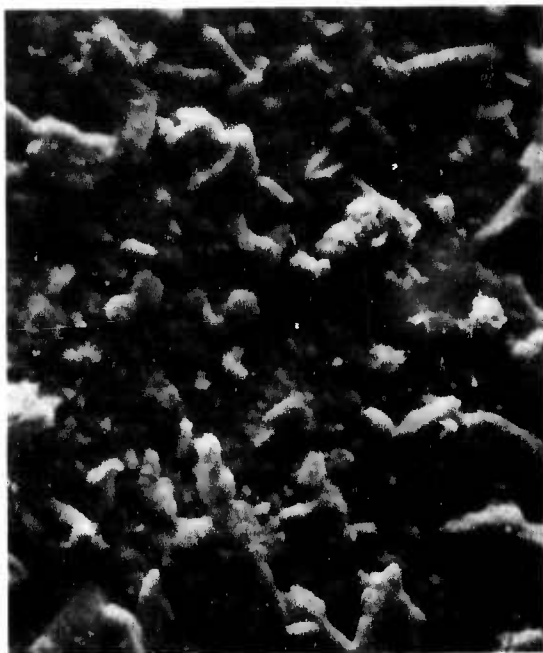
Figure 4.20 SEM of Upstream Surface of Sample 1 Norton NC 203 SiC (1000x)

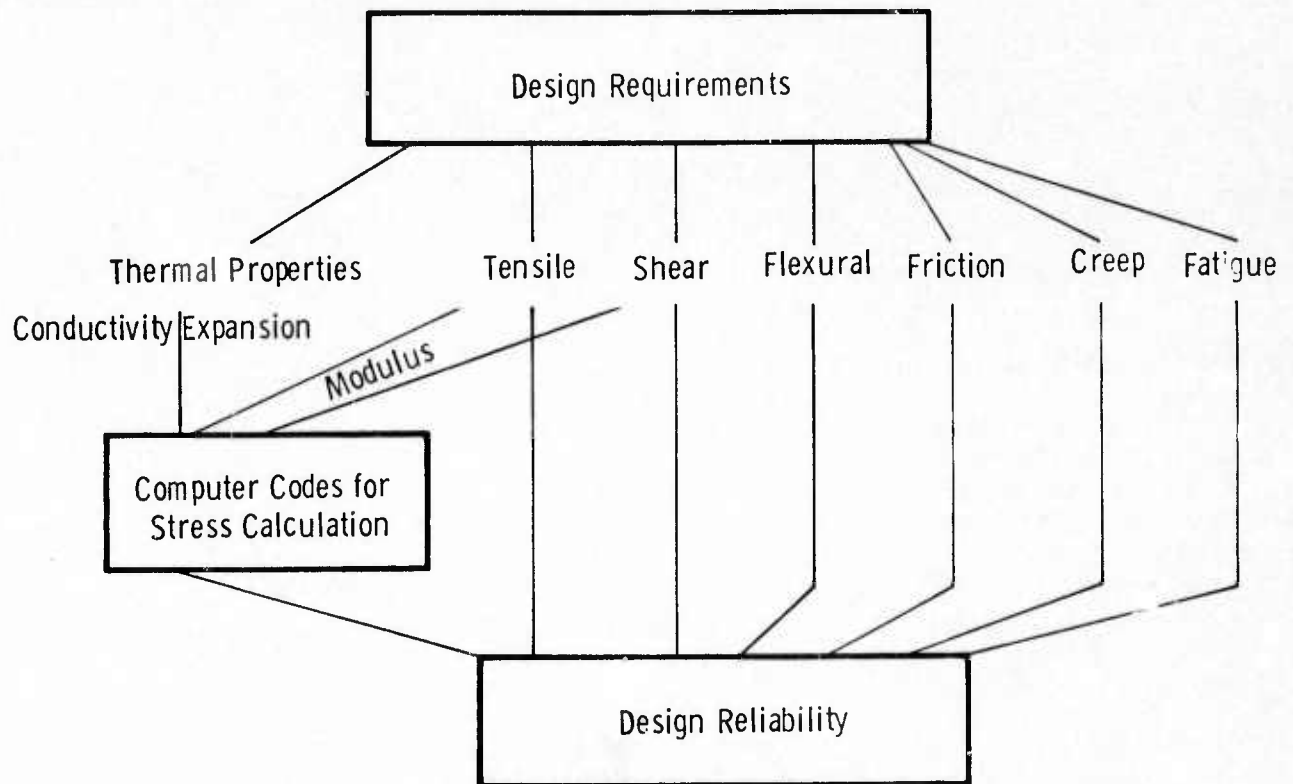
Figure 5.5 The Interactions between Material Properties and Design

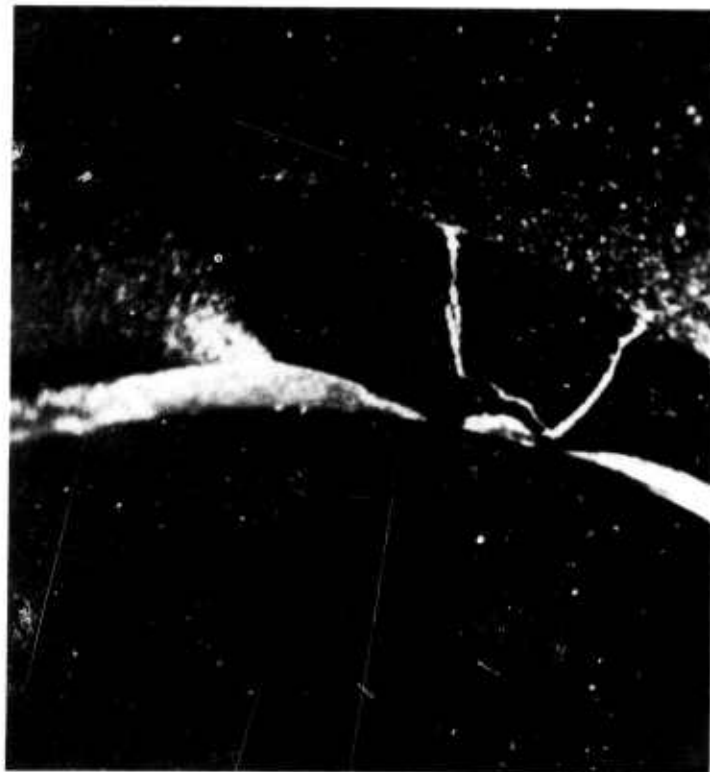
Figure 6.18 Typical Example of Chipping at the Inner End Cap-Airfoil Tenon Interface (Cycles 1-25 Static Rig Test at 2500°F)

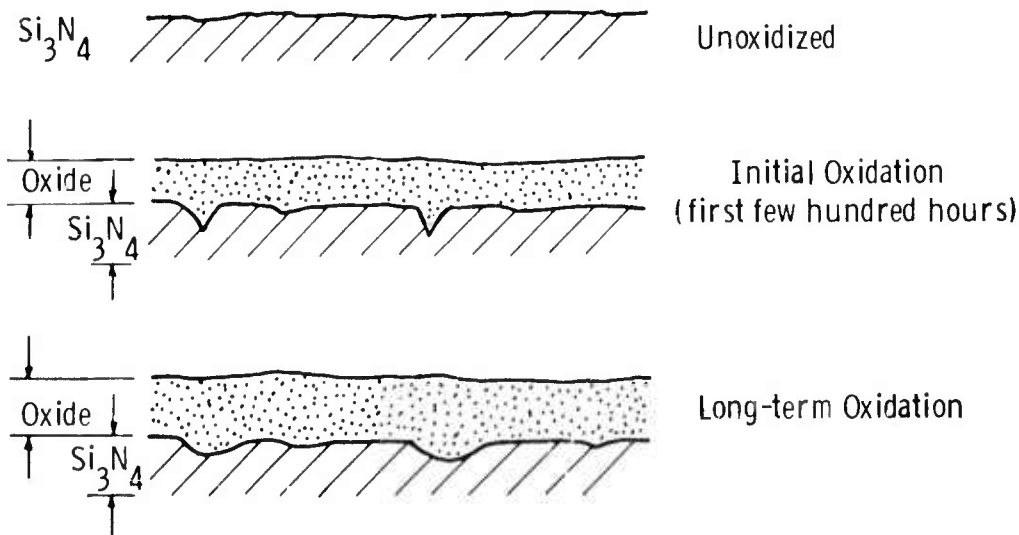
Figure 7.18 Schematic Representation of Surface Oxidation of Hot-Pressed  $\text{Si}_3\text{N}_4$
