RADC-TR-77-236  
In-House Report  
July 1977

TEST AND EVALUATION OF US ARMY RESTRAINT PANEL  
(BROOKS AND PERKINS MECHANICAL RESTRAINT SYSTEM B)

| REPORT DOCUMENTATION PAGE | | READ INSTRUCTIONS<br>BEFORE COMPLETING FORM |
|---|---|---|
| 20. ABSTRACT (Continue on reverse side if necessary and identify by block number)<br><br>This report presents the results of static and dynamic deflection testing of<br>the Type "B" (Brooks & Perkins) Mechanical Dunnage System Kit, designed to<br>structurally upgrade commercial 20 foot International Standard Organization<br>Containers (ISO) for transportation of hazardous material (ammunition) in<br>International Commerce. | | |

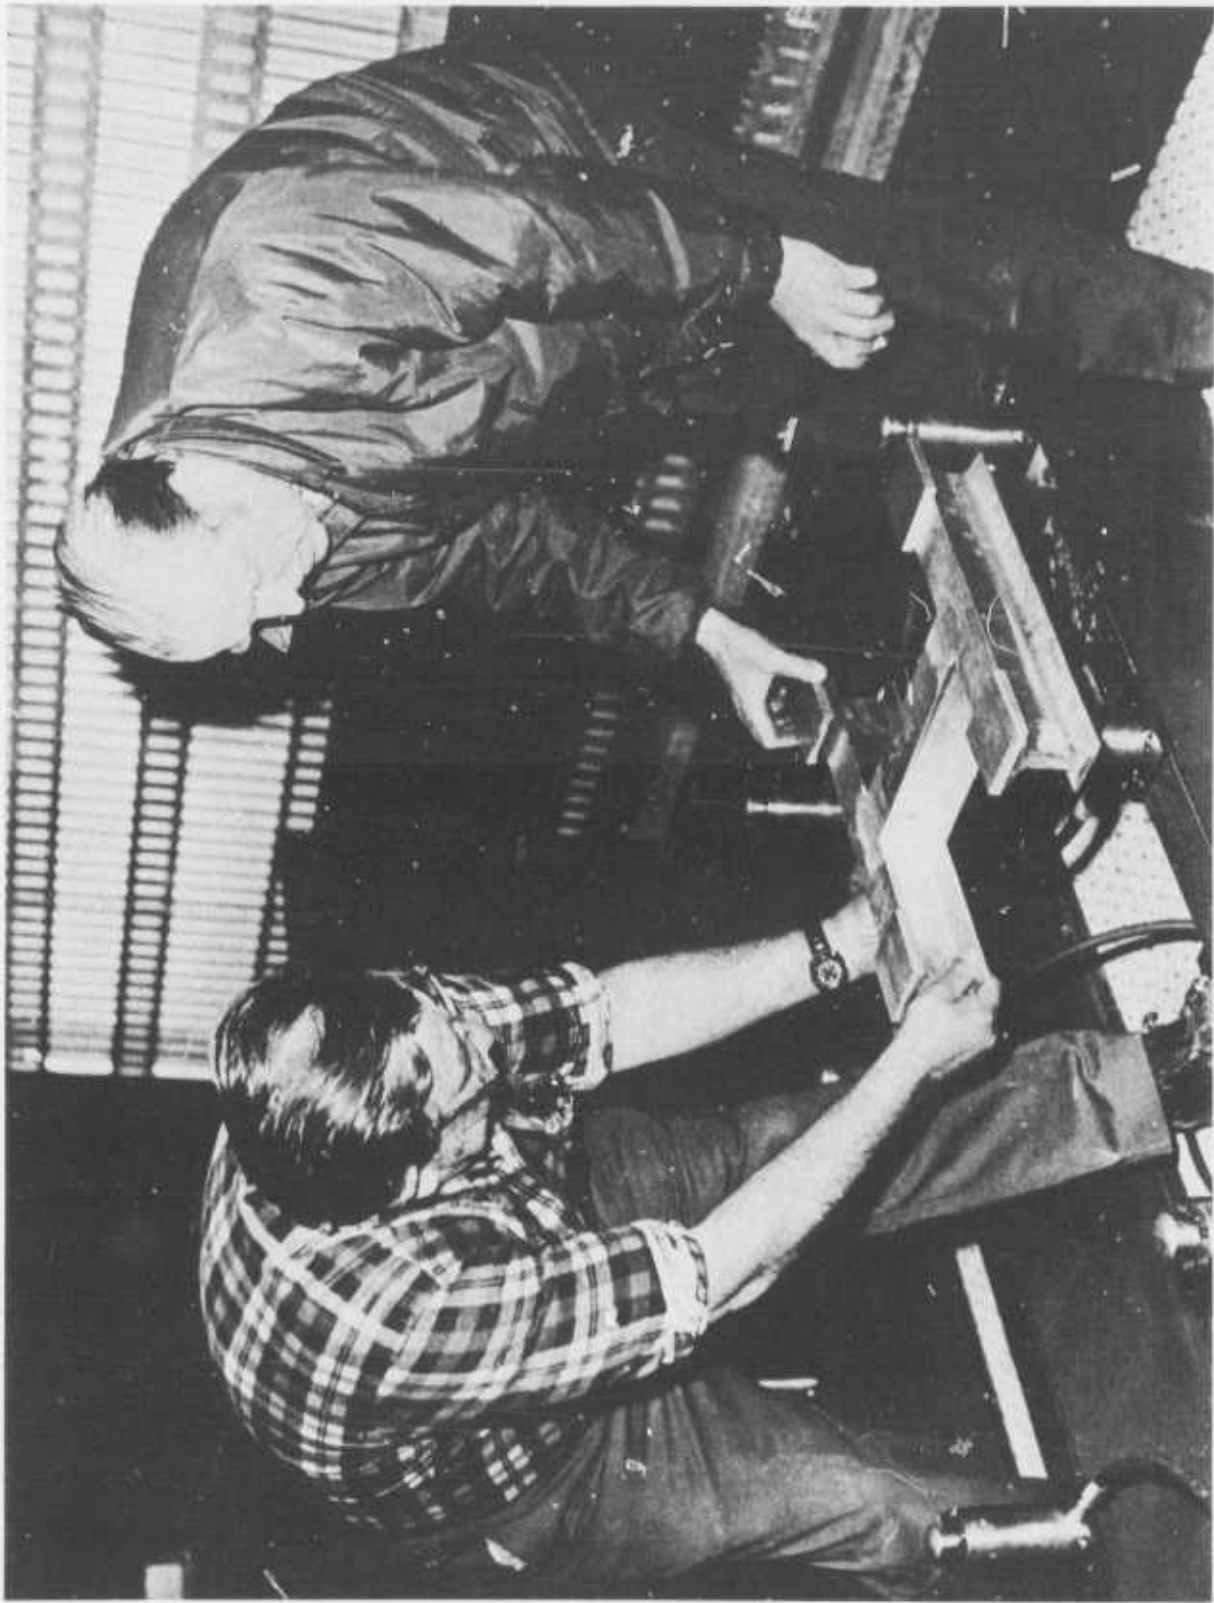
FIGURE 4 LOAD SPREADER ON CYLINDER

The force produced by the cylinder is distributed into the panel through a 4-point load spreader (Figures 3 & 4). Thus, the forces can be distributed linearly or uniformly as needed. The linear load is produced by using two

pads, one placed at each end of the adjoining beam of the load spreader. The uniform load uses four pads placed at the corners of the spreader arms.
