MTMC REPORT OA 77-2

**ANALYSIS  
OF MTMC PARTICIPATION  
IN THE  
REFORGER 77 EXERCISE**

FEBRUARY 1978

**MILITARY TRAFFIC MANAGEMENT COMMAND  
TRANSPORTATION ENGINEERING AGENCY  
NEWPORT NEWS, VIRGINIA 23606**

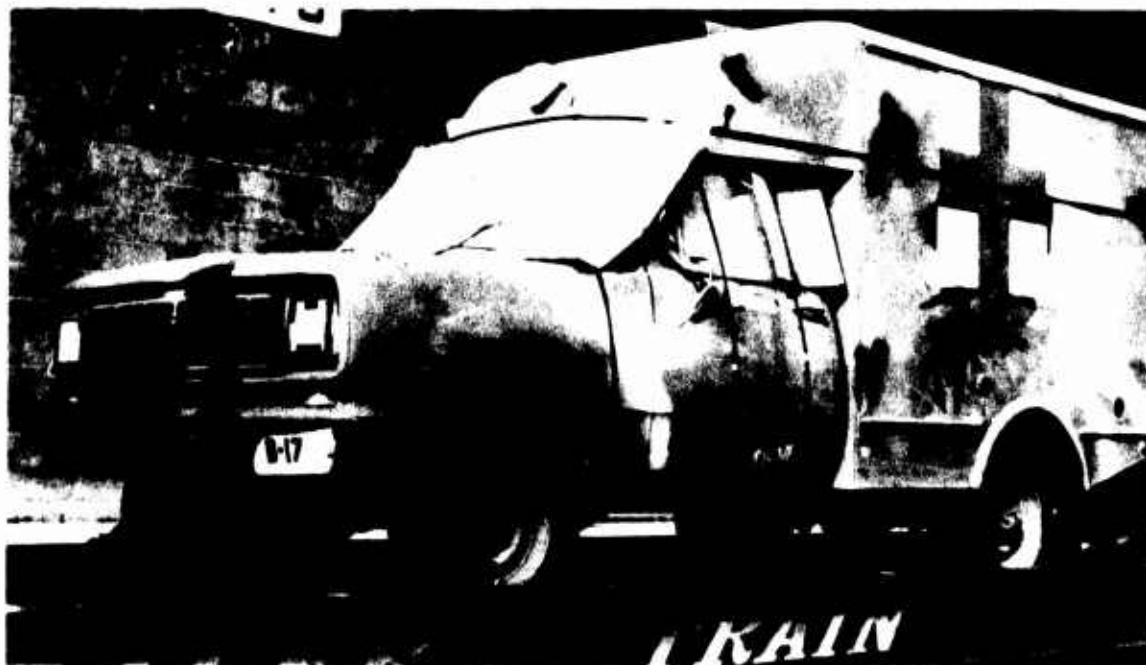
(5) Vehicles in most cases were overprotected. Taping and padding of headlights, boxing of windshields, and other overprotective measures were unnecessary (figs 6-26 through 6-28). (AR 220-10 and FORSCOM Reg 55-1.)

Figure 6-26. M-886 windows and headlights protected.

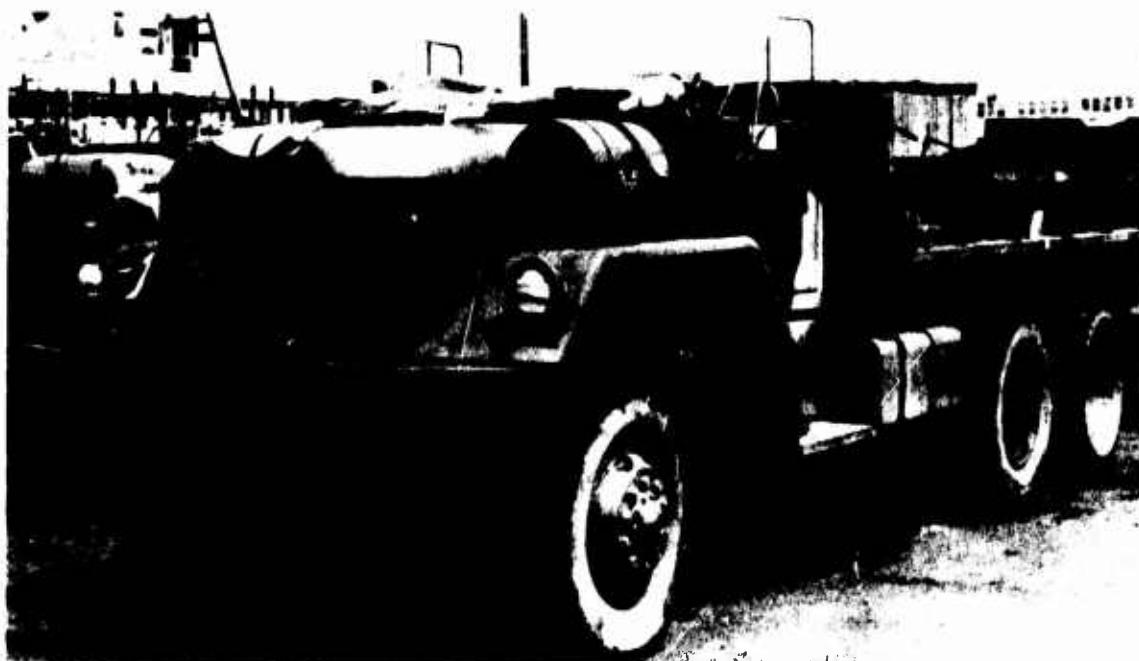
Figure 6-28. M-813 windshield and headlights protected.

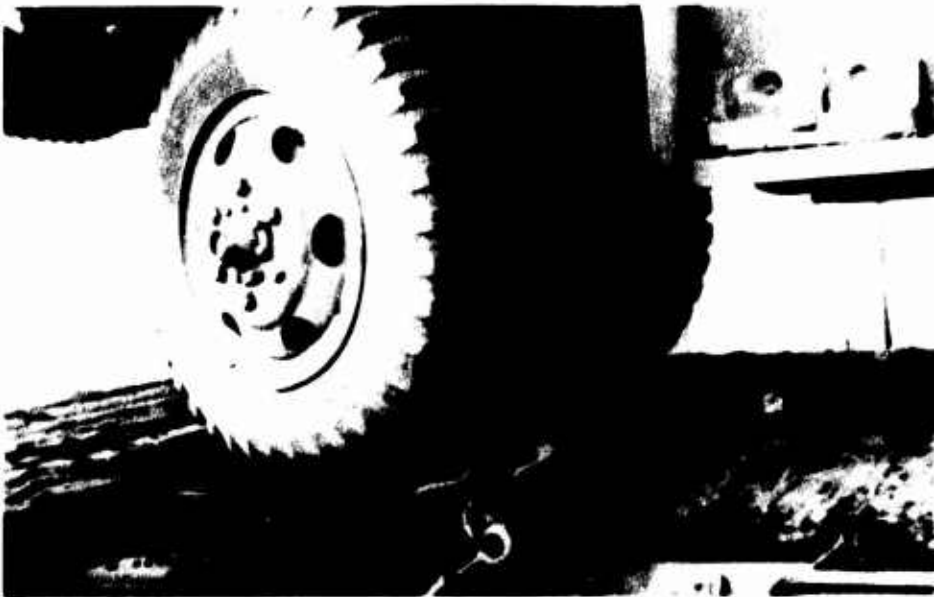
Figure 8-14. Unhooked and missing chain tiedowns.

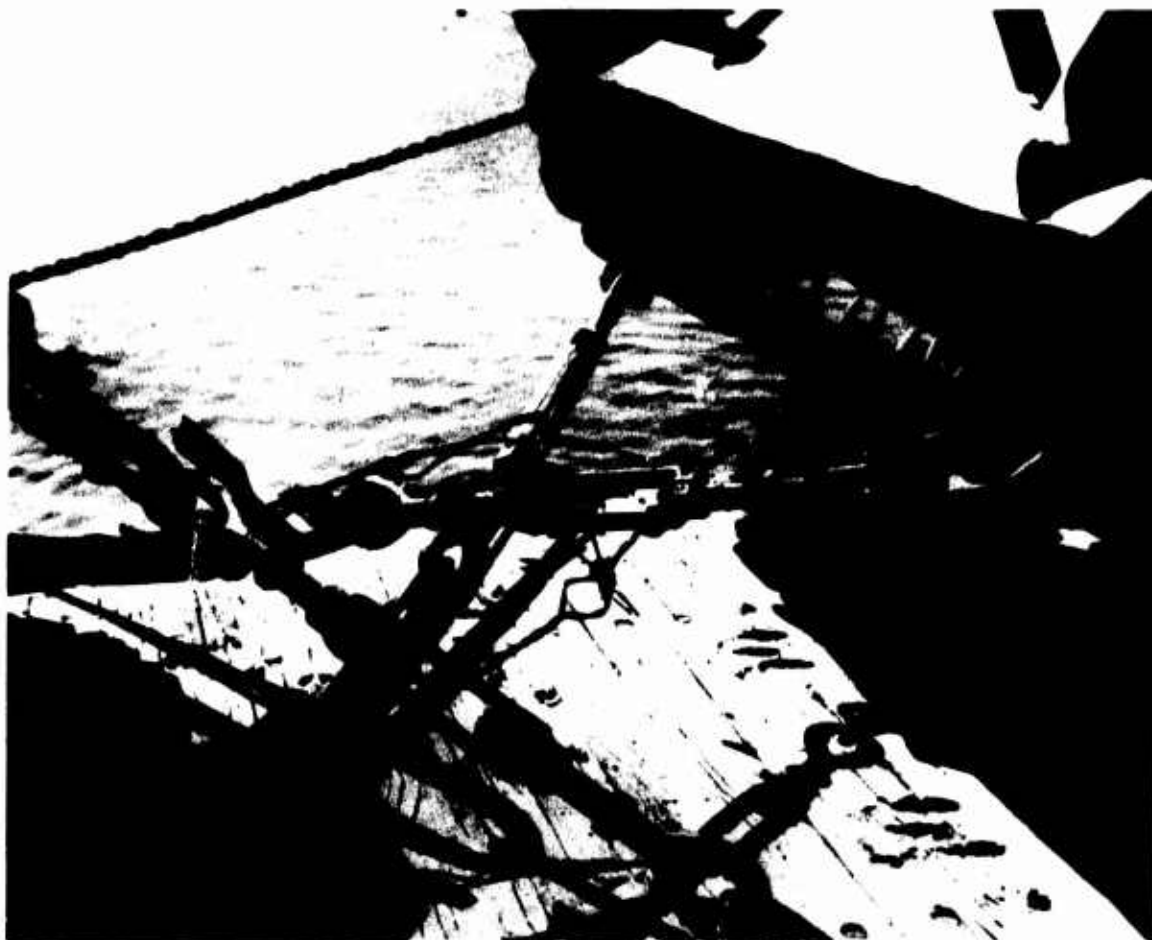
Figure 13-7. Wired turnbuckles.

transit. As a result, the turnbuckles and tiedowns loosened slightly; however, no damage occurred as a result. (Wiring turnbuckles together at the point where they cross will preclude this problem.) Note: This procedure was employed on the Beaumont to Carson train (Figure 13-7).
