AFATL-TR-76-64

**THE EFFECTS OF HIGH INTENSITY IMPULSE
LOADING ON REINFORCED CONCRETE BEAMS**

**OKLAHOMA STATE UNIVERSITY
SCHOOL OF CIVIL ENGINEERING
STILLWATER, OKLAHOMA**

**FINAL REPORT FOR PERIOD
JANUARY 1973-MAY 1976**

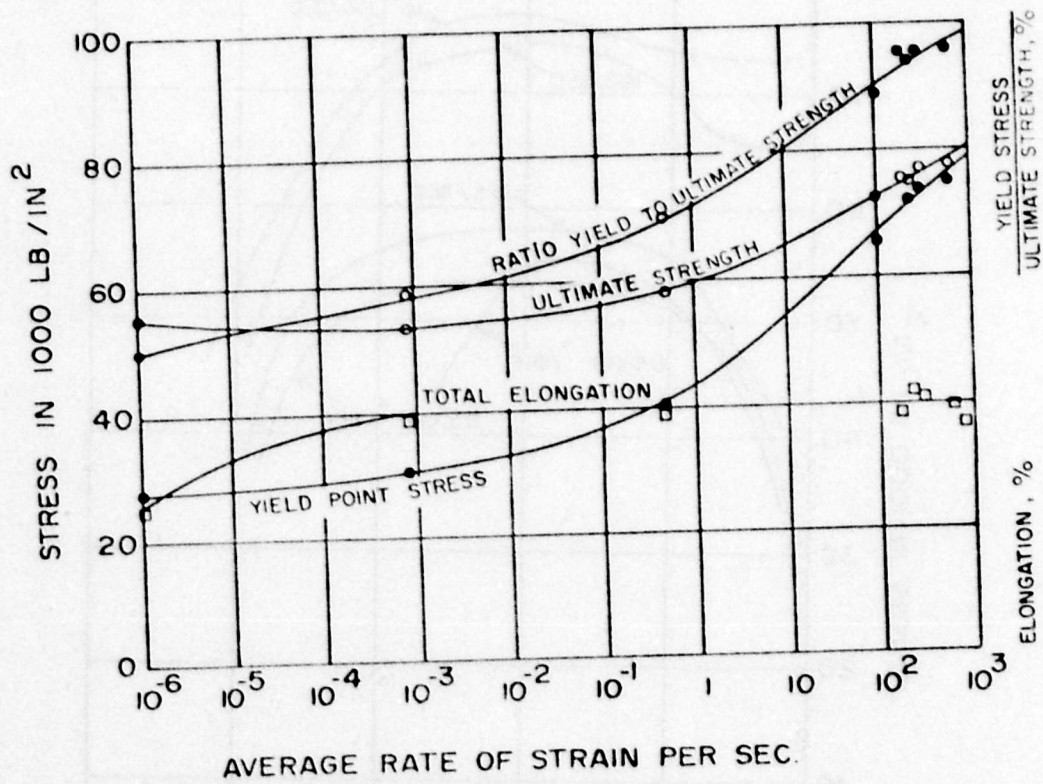
Figure 2. Influence of Strain Rate on Mild Steel Tensile Properties (From Reference 4)

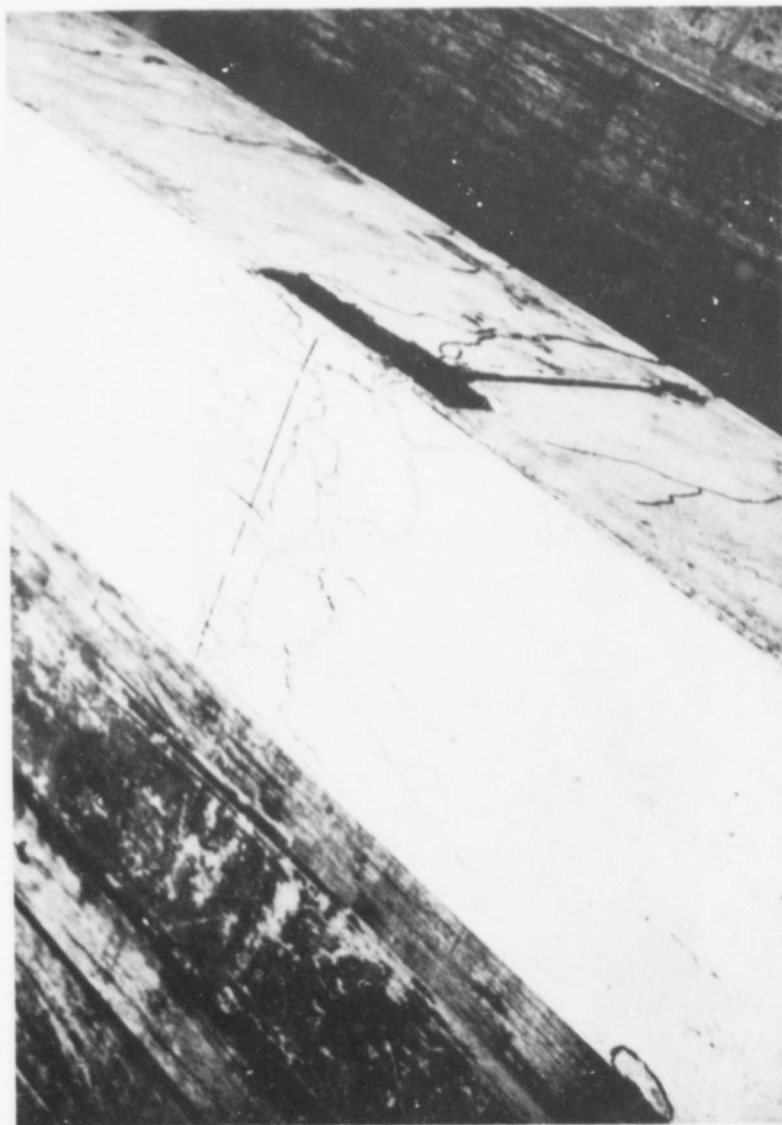
Figure 22. Center Section of Beam 10 After Test No. 3

The beams suffered little damage in the first two tests. A vertical crack ran through the beams to their top surface as shown in Figure 21. These cracks were clean, straight tensile fractures on the top surface and appeared to have resulted from beam rebound. Longitudinal hairline cracks were noted on the sides of these two beams about 1/2 inch below the top surface for 3 to 4 inches on either side of the centerline. These cracks appeared to be the beginning of spalling of the top layer. In later tests, with smaller charge standoff distances, the top layer (1/2 to 3/4 inch thick) exhibited crushing damage 6 to 8 inches on either side of the centerline. In Figure 22 the extent of damage indicates a massive spalling was

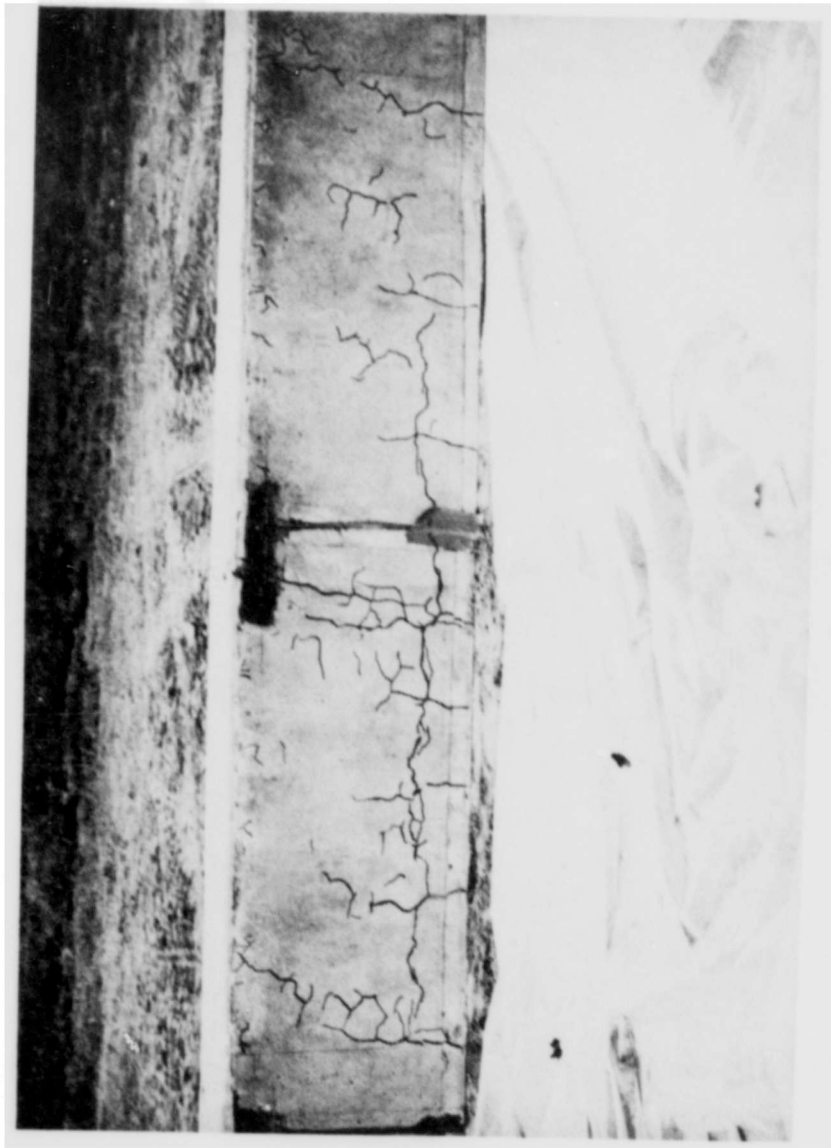
Figure 28. Side View of Beam 3 After Test No. 4

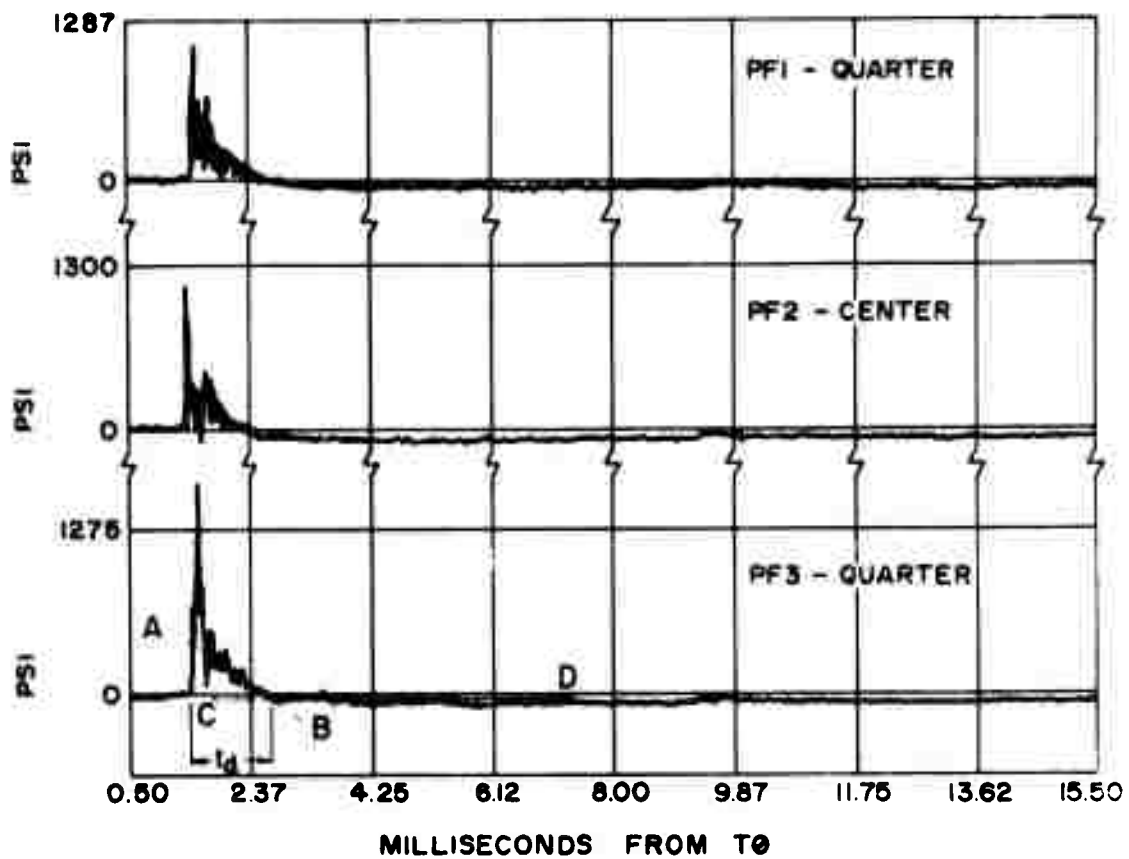
Figure 30. Plots of Typical Pressure Data From Test No. 4

approximately 1.25 ms. The construction shown on PF3 of Figure 30 illustrates the evaluation of the positive pressure duration, t_d . The value of impulse at 1.25 ms is recorded as I in Table X. Future reference to impulse will refer to the value related to 1.25 ms.
