MTMC REPORT OA 78-7b-8  
**ANALYSIS  
OF MTMC PARTICIPATION  
IN THE  
REFORGER 79 EXERCISE**

MAY 1979

**MILITARY TRAFFIC MANAGEMENT COMMAND  
TRANSPORTATION ENGINEERING AGENCY  
NEWPORT NEWS, VIRGINIA 23606**

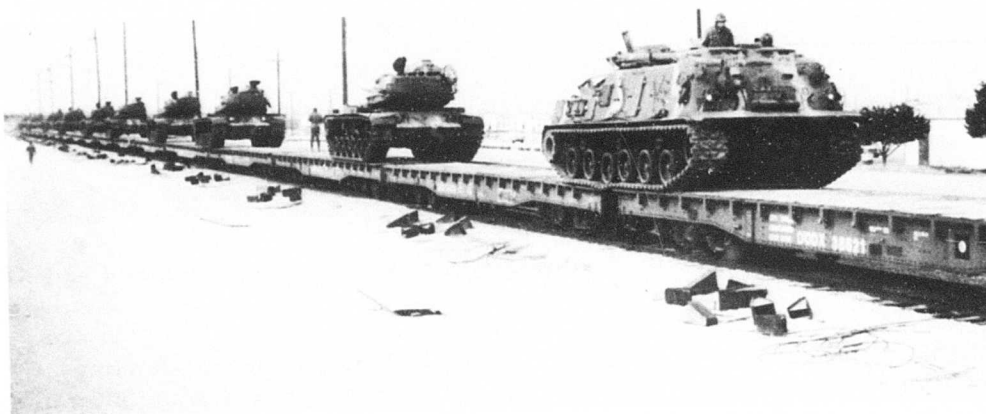
Figure 4-11. Circus-style rail loading of M88's and tanks.

the tracks and two bogey chocks on each side of each vehicle. MTMC has recommended and the AAR has adopted this securement method as standard for tank movement on unit trains during readiness exercises and/or emergencies.

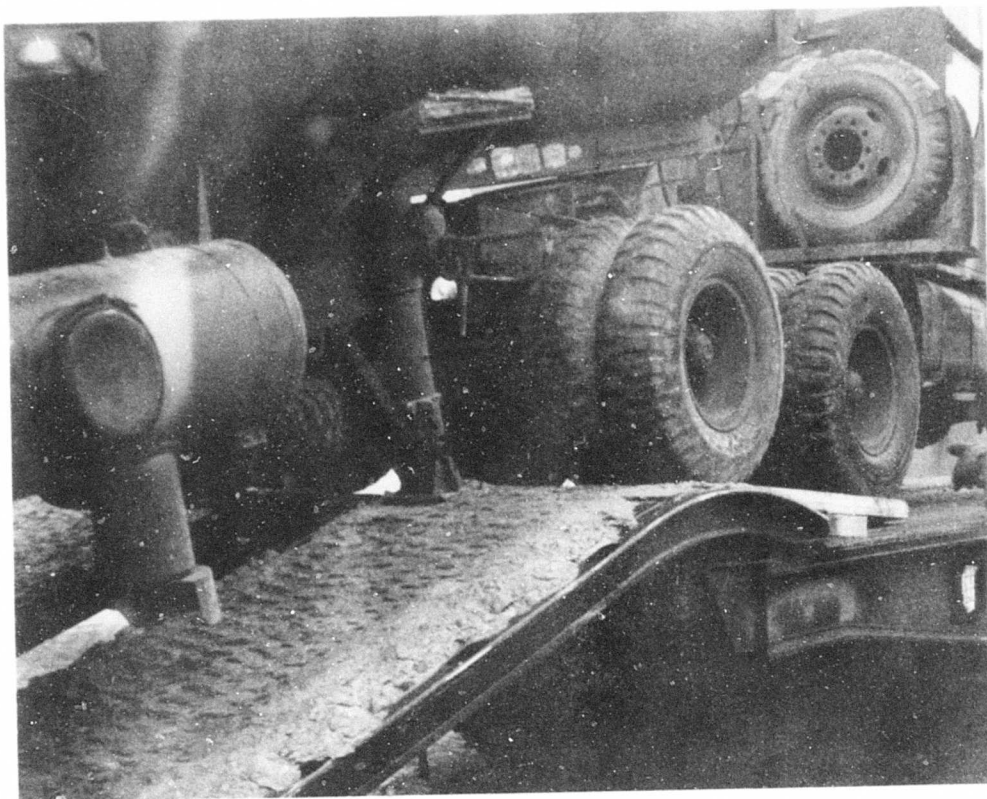
Rather than lift these tractor-trailers onto railcars and create similar problems during rail unloading, 12 vehicles were convoyed, on 25 January, to Zolder, Belgium, to link up with the last convoy from Haasdonk, Belgium, to Boeblingen, Germany. Although many of the railcars were lashed and blocked in the port area (fig 7-6) to alleviate congestion on the quay, some were moved to railcar holding areas to complete securing.

Figure 7-5. Mobile Netherlands Army ramp would not accommodate tractor-trailer combinations.

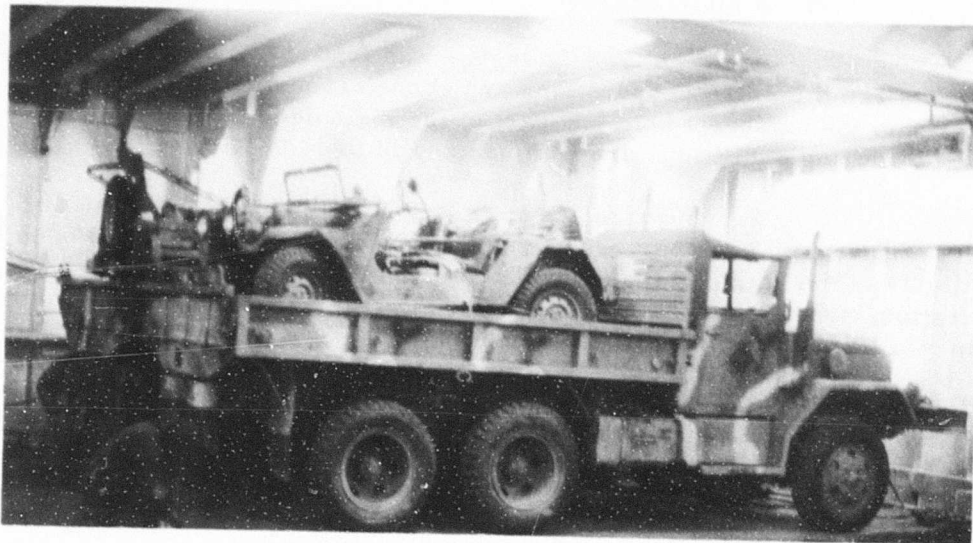
4. Since the USNS Meteor was the final ship to be loaded, equipment was consolidated at the port to insure that loading space aboard the ship would accommodate all available cargo (fig 9-15). Cargo consolidation operations proved difficult as most cargo beds contained quantities of unsecured cargo.

Figure 9-15. To insure adequate space aboard USNS Meteor, vehicles were consolidated.
