AFWAL-TR-81-4020

EXPERIMENTAL EVALUATION OF F-16 POLYCARBONATE CANOPY MATERIAL

Kenneth I. Clayton  
John F. Milholland  
Gregory J. Stenger

April 1981  
Final Report for Period September 1978 - November 1980

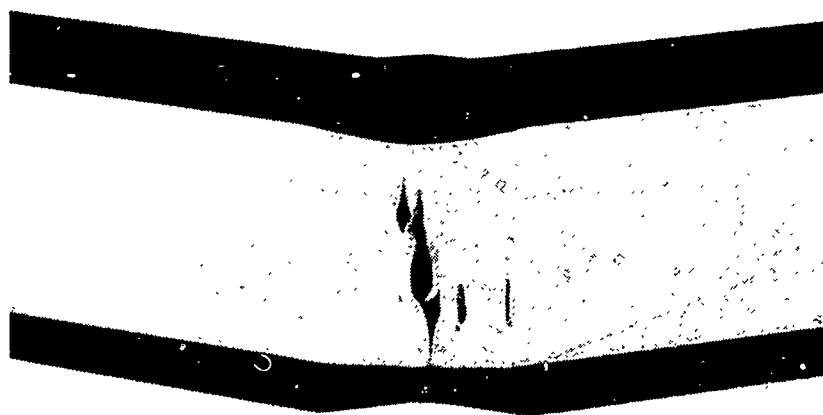
Figure 39. Typical Failed Falling Weight Beam.
