Contractor Report ARLCD-CR-84039

**ENGINEERING DEVELOPMENT OF THE XM261 MULTIPURPOSE  
SUBMUNITION WARHEAD AND THE XM267  
SUBMUNITION TRAINING WARHEAD**

**William S. Marks  
BEI Defense Systems Company, Inc.  
11312 South Pipeline Road  
Euless, Texas 76039**

JANUARY 1985

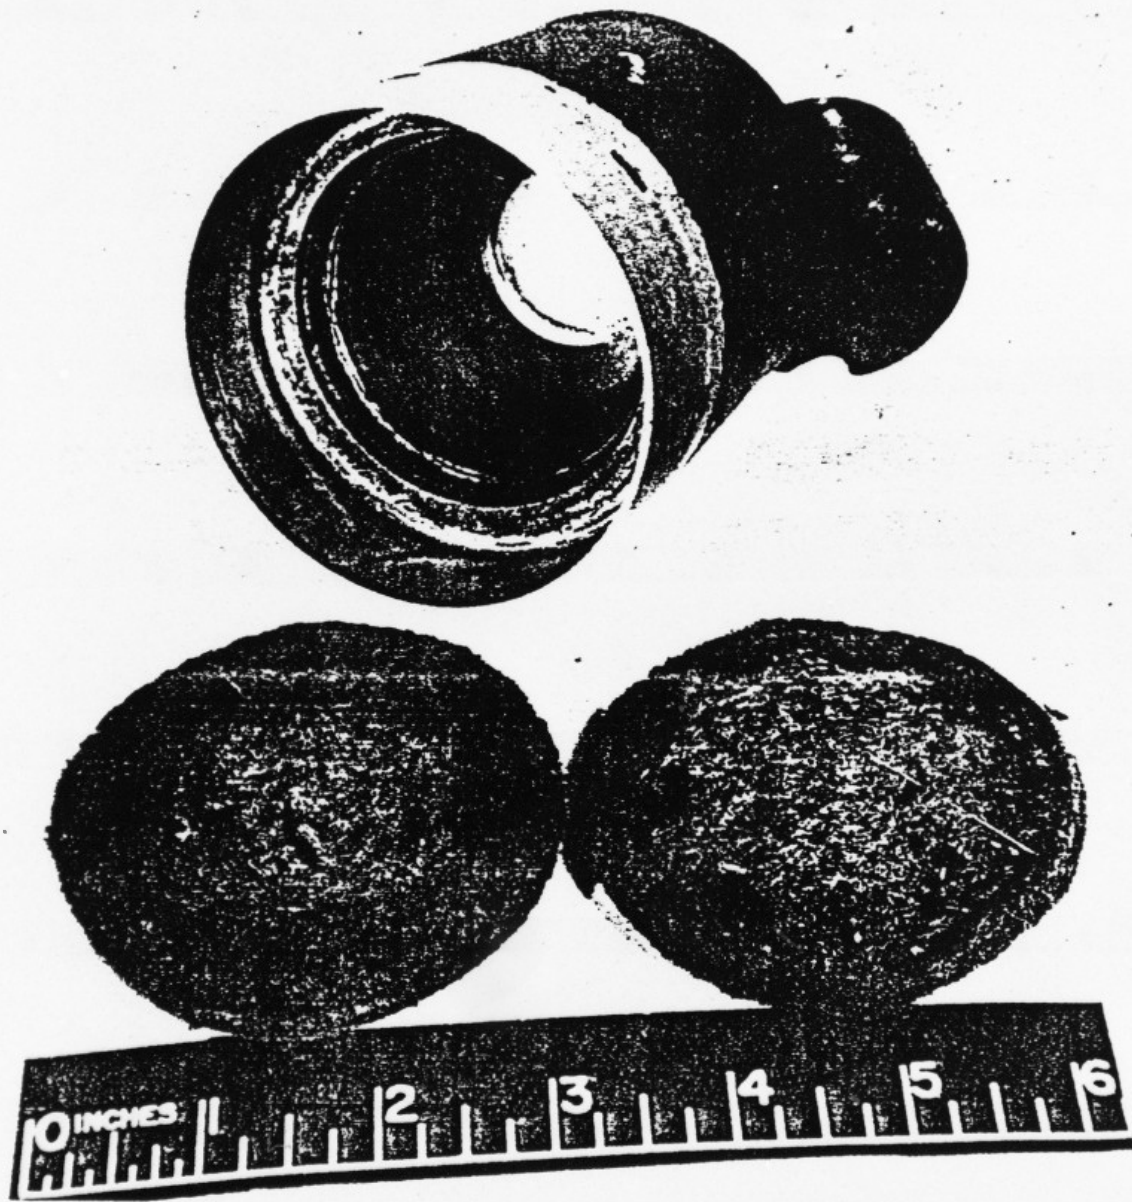
Figure 1. Copper cones scored by rotation RAD assembly (top);  
felt pad crushed (bottom)

| Discrepancies | Round no. | | | |
|---|---|---|---|---|
| 14. The copper cones of the cone and ring assembly, AMRON drawing No. 00022-009, were scored. Each cone was damaged by the rotation of the RAD assembly (fig. 1 (top)). | x | x | x | x |

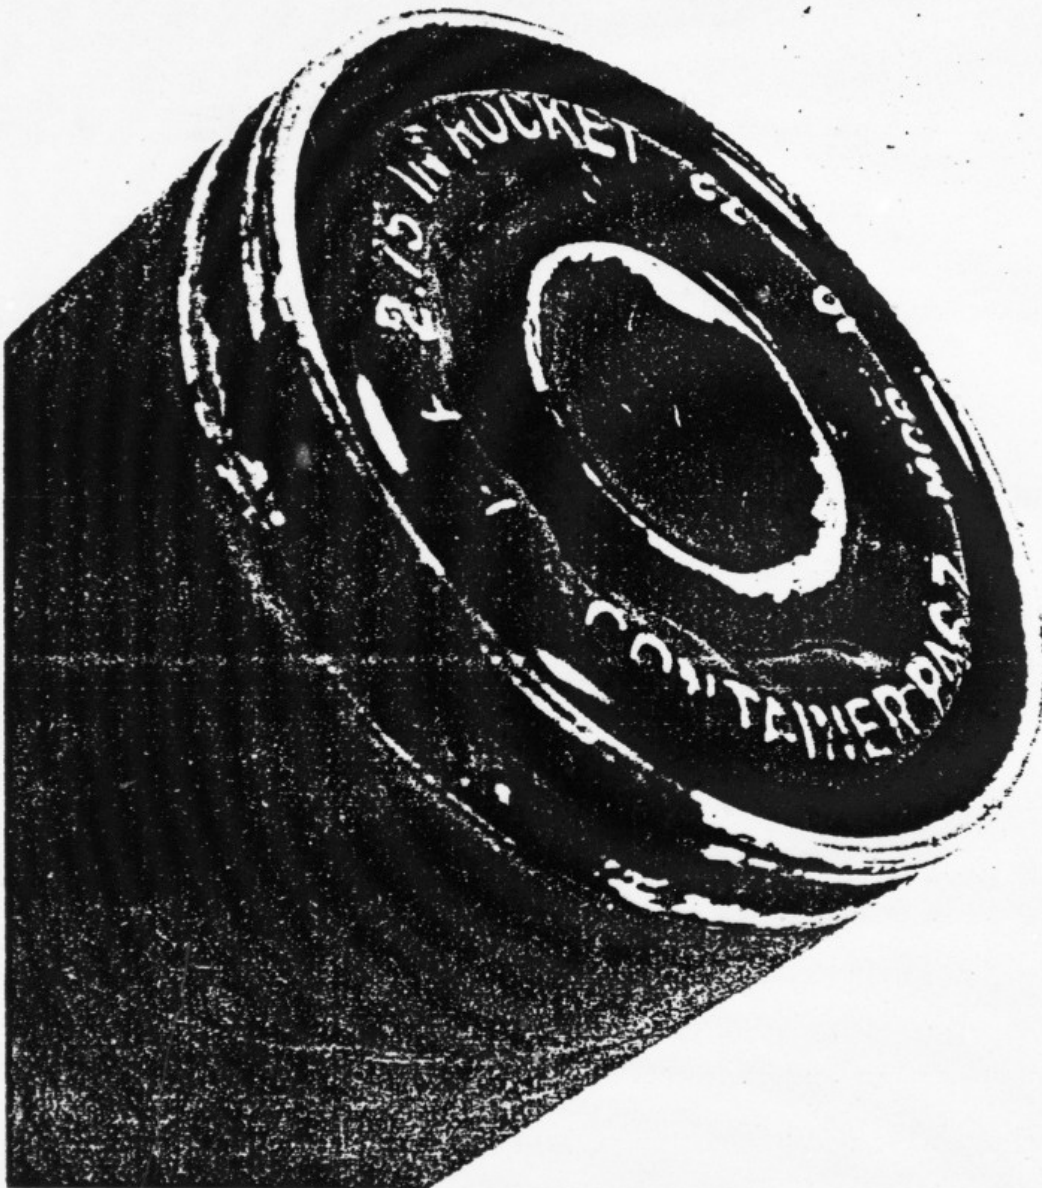
Figure 2. Pushed in metal end cap of cover tube

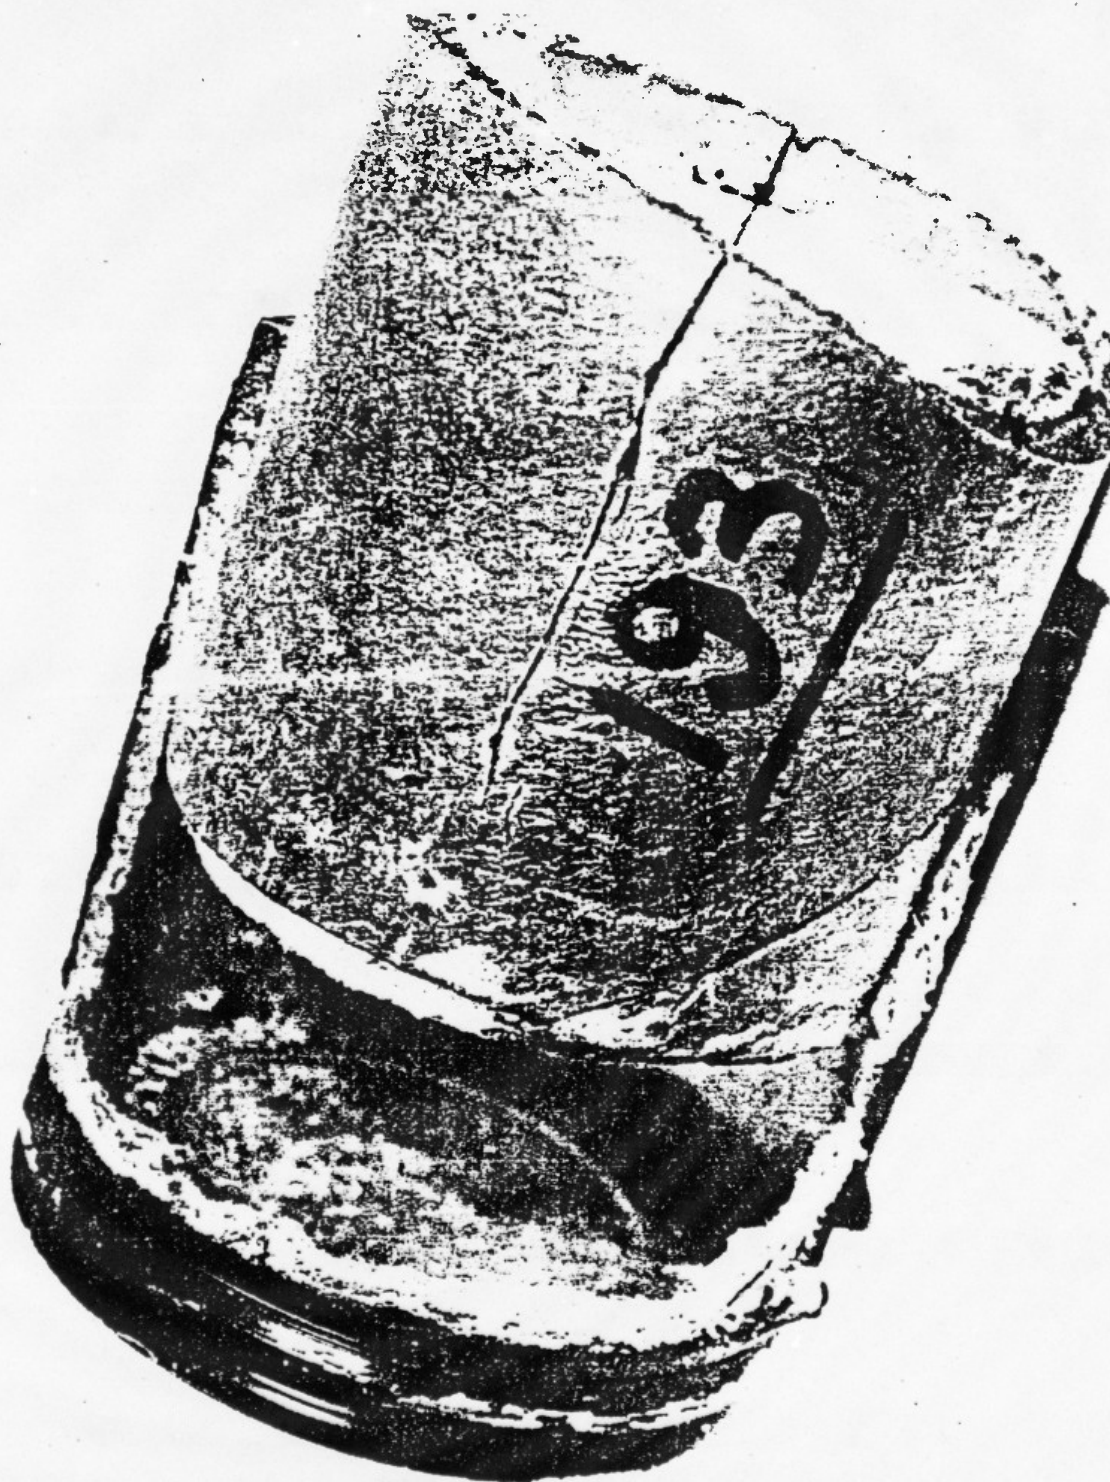
Figure 3. Cushion of nose cushion assembly compressed 1/4 inch

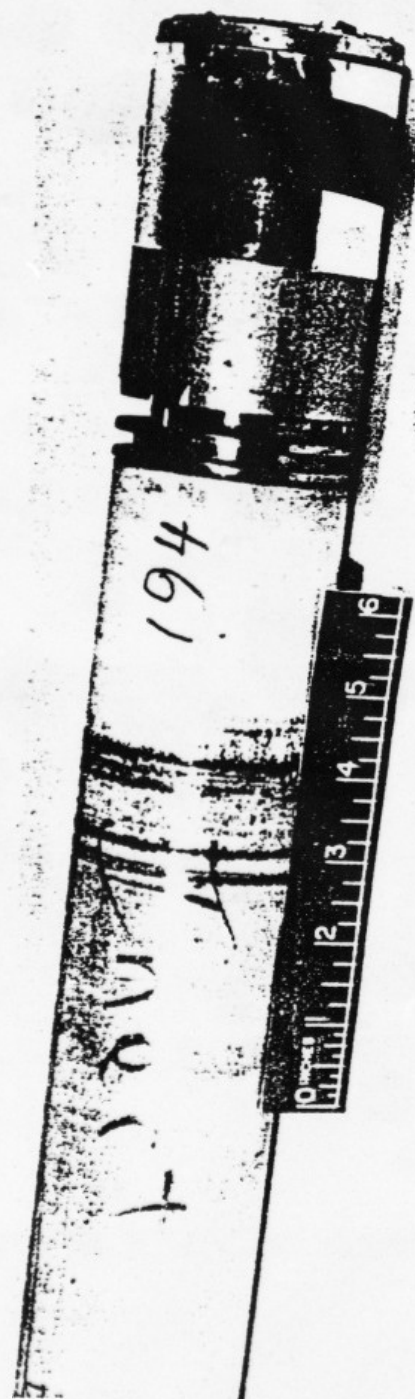
Figure 4. 1-inch neck ring signature on rocket motor case assembly showing longitudinal movement within the M67 fiber container

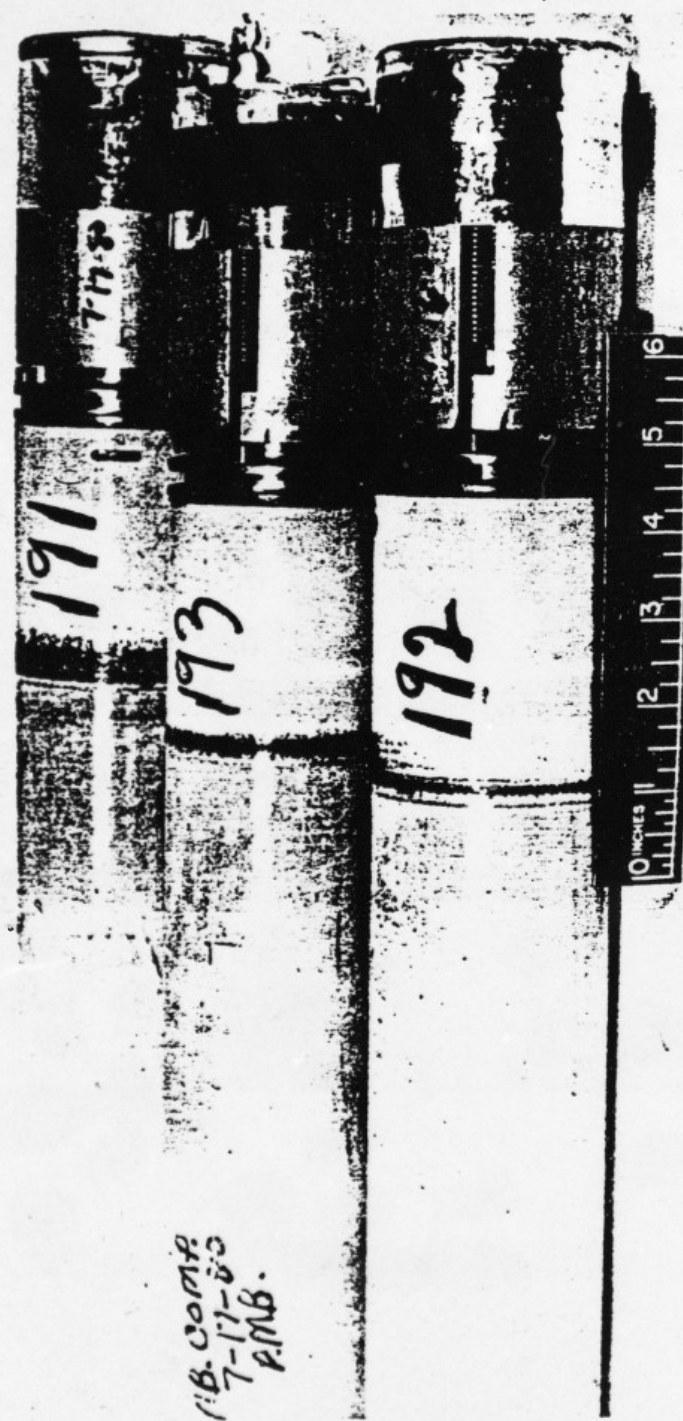
Figure 5. 1/8 to 1/4-inch neck ring signature on rocket motor case assembly showing longitudinal movement within the M67 fiber container

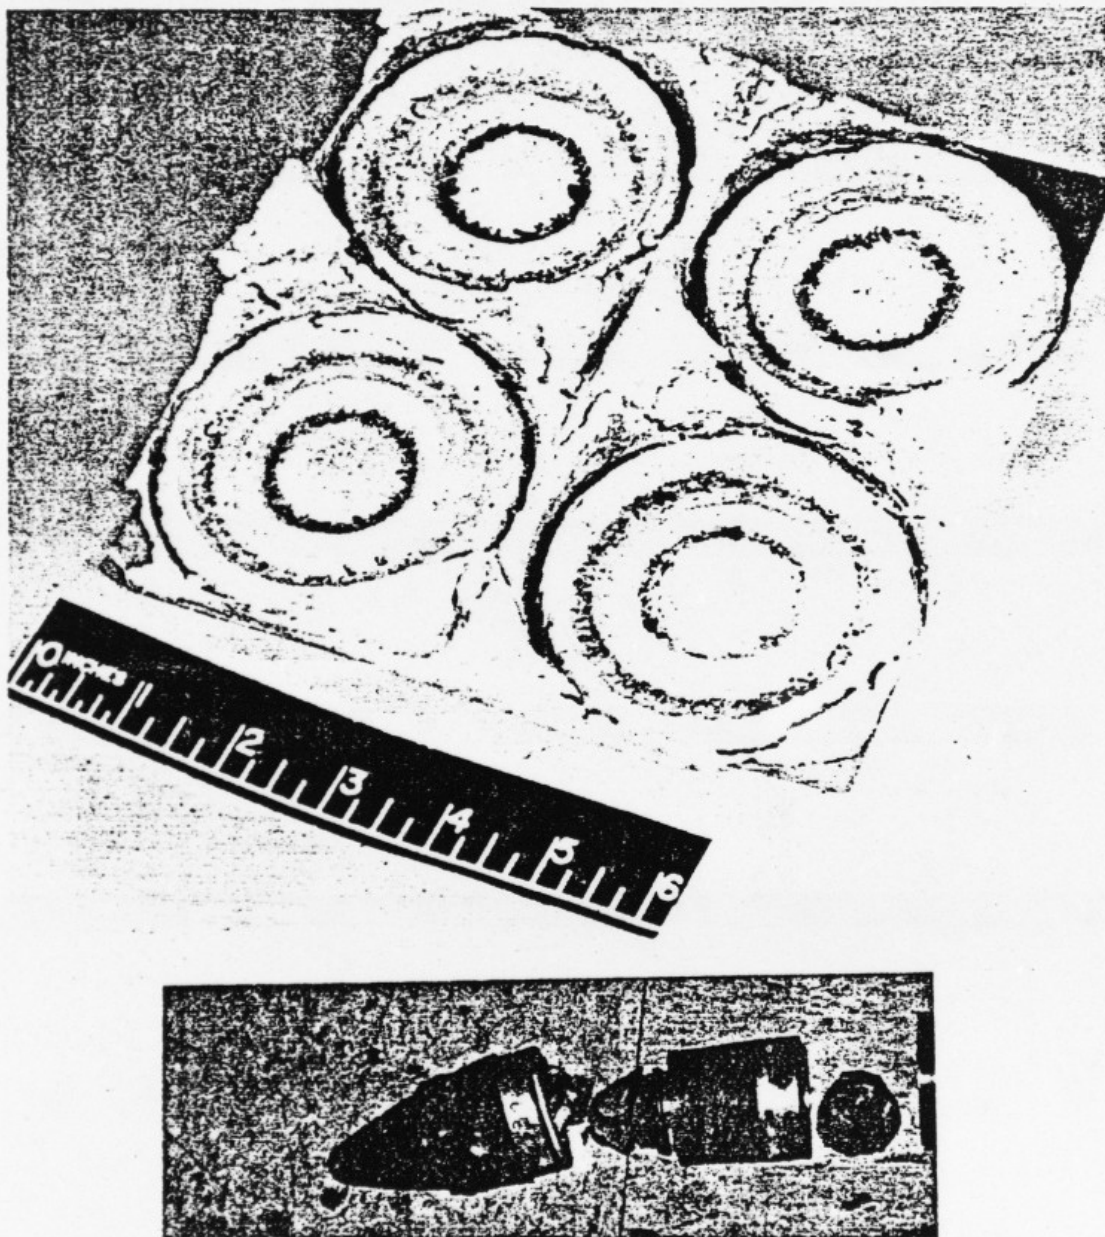
Figure 6. Motor end packaging crushed (top).  
Nose cone assembly (rd 194) completely  
separated from warhead assembly (bottom)

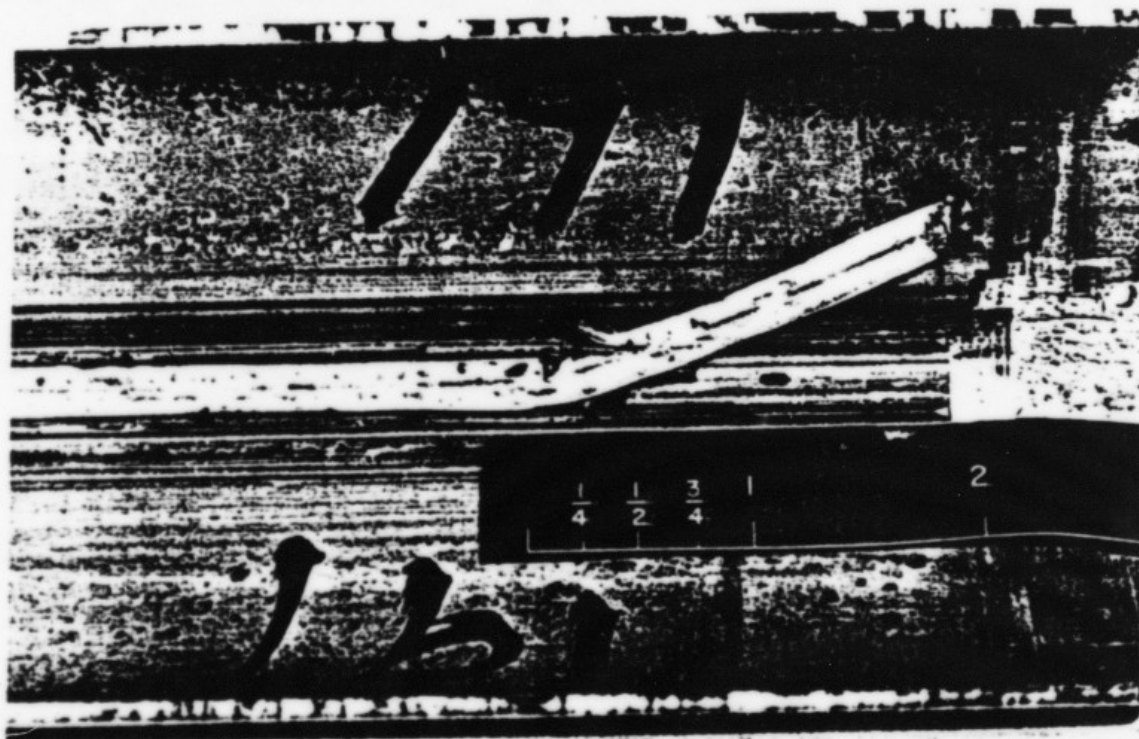
Figure 8. Fuze connector cable cut at mouth of warhead case assembly

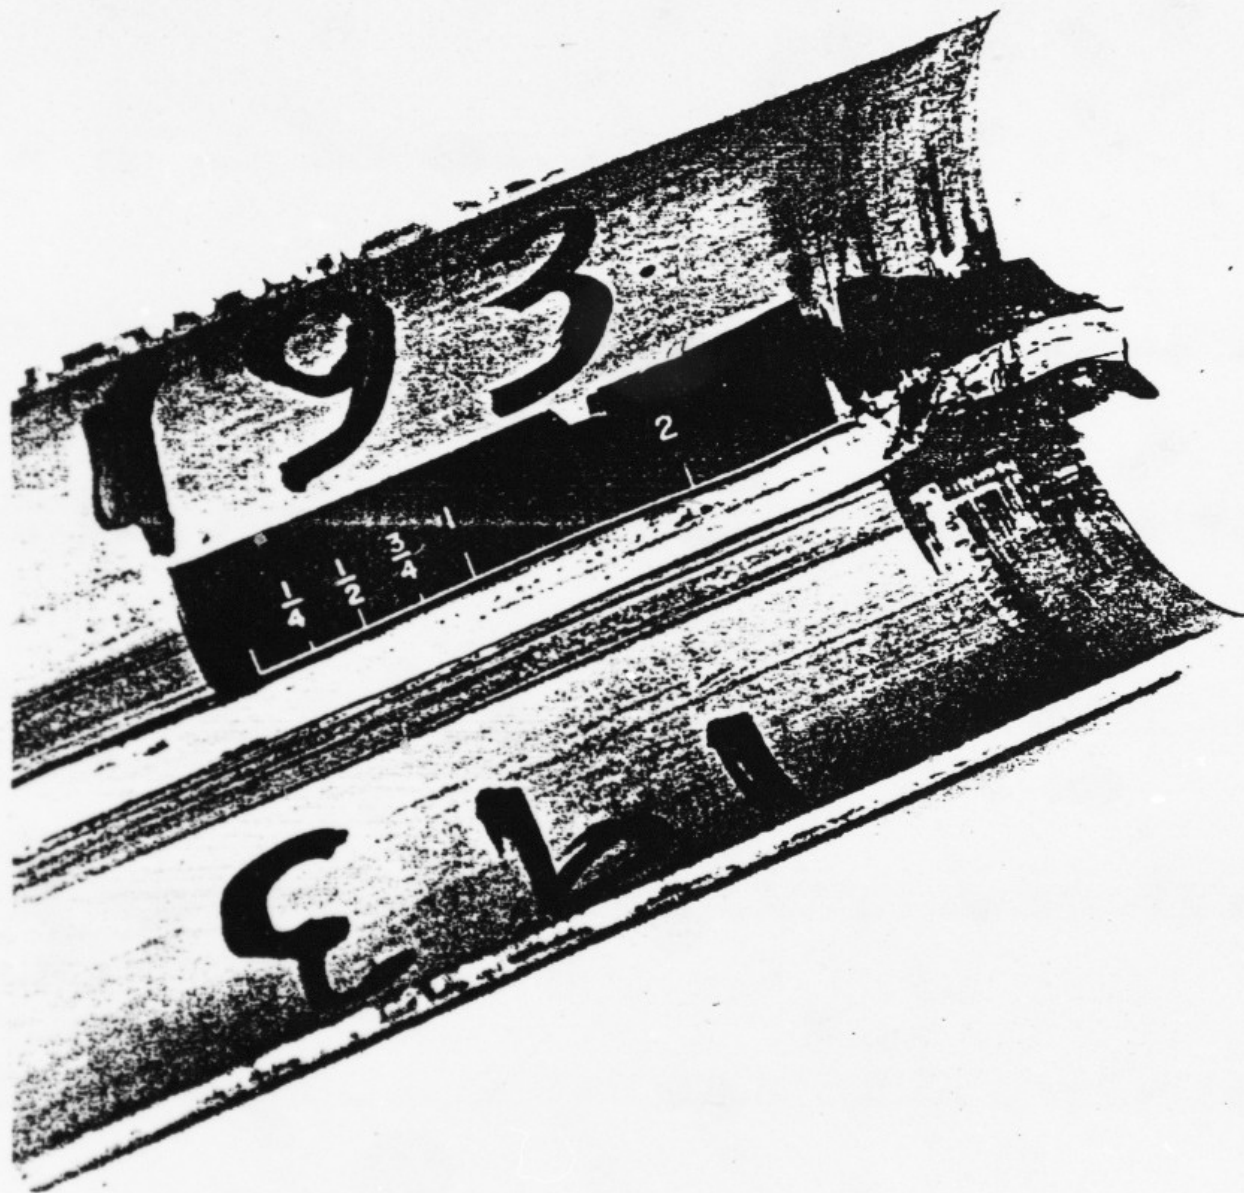
Figure 9. Fuze connector cable cut at mouth of warhead case assembly

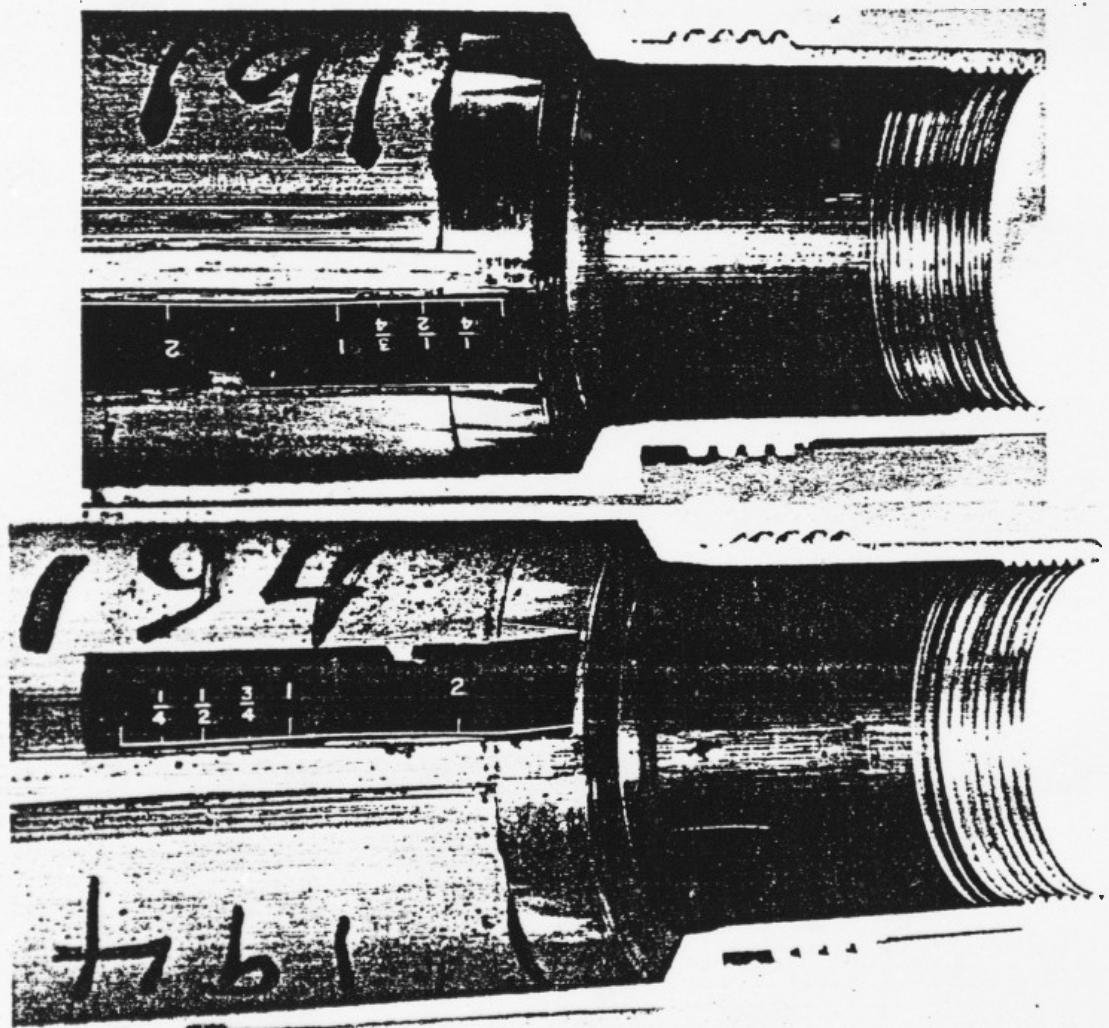
Figure 10. Fuze connector cable severed at fuze support

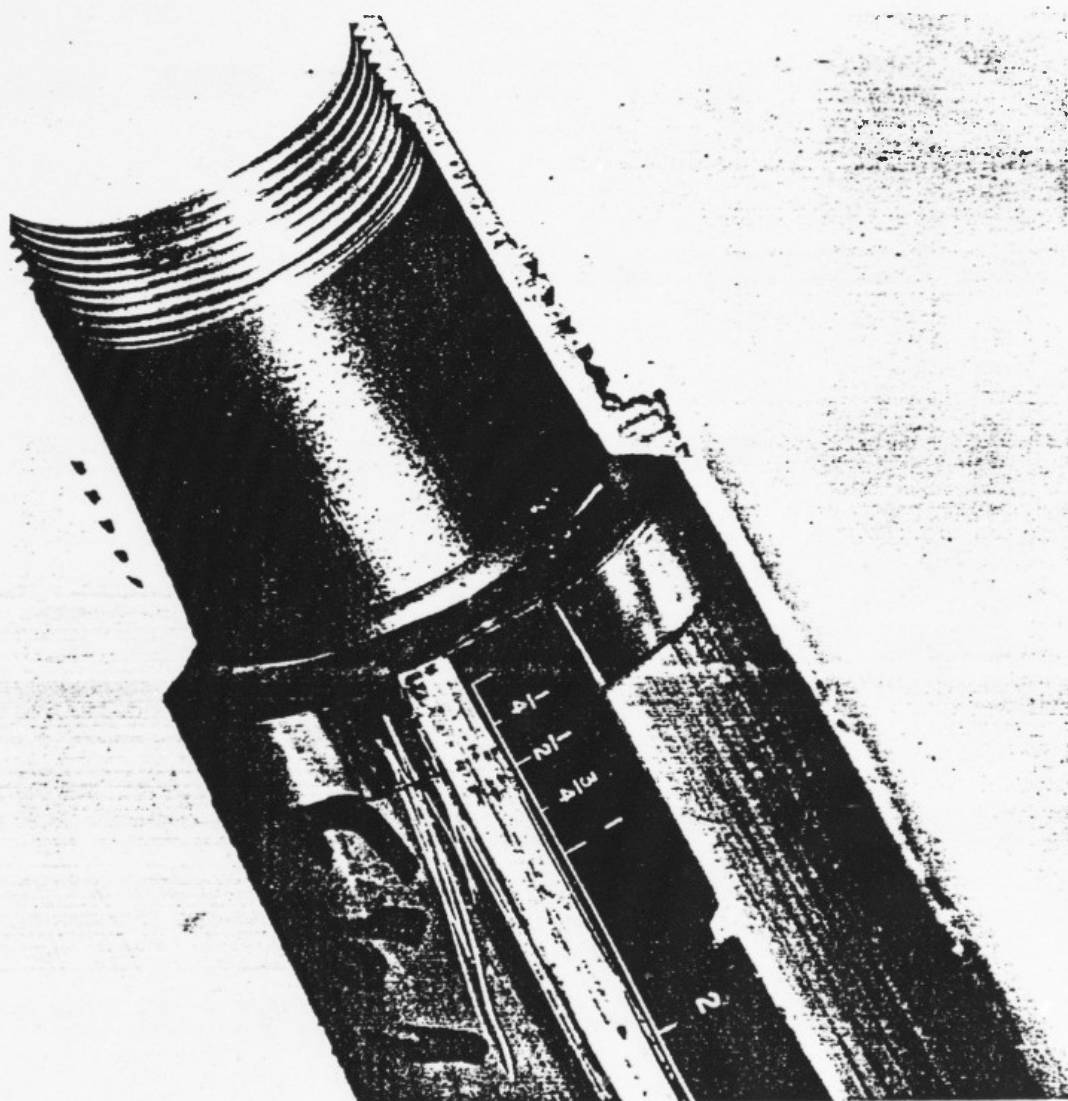
Figure 11. Fuze connector cable severed at fuze support

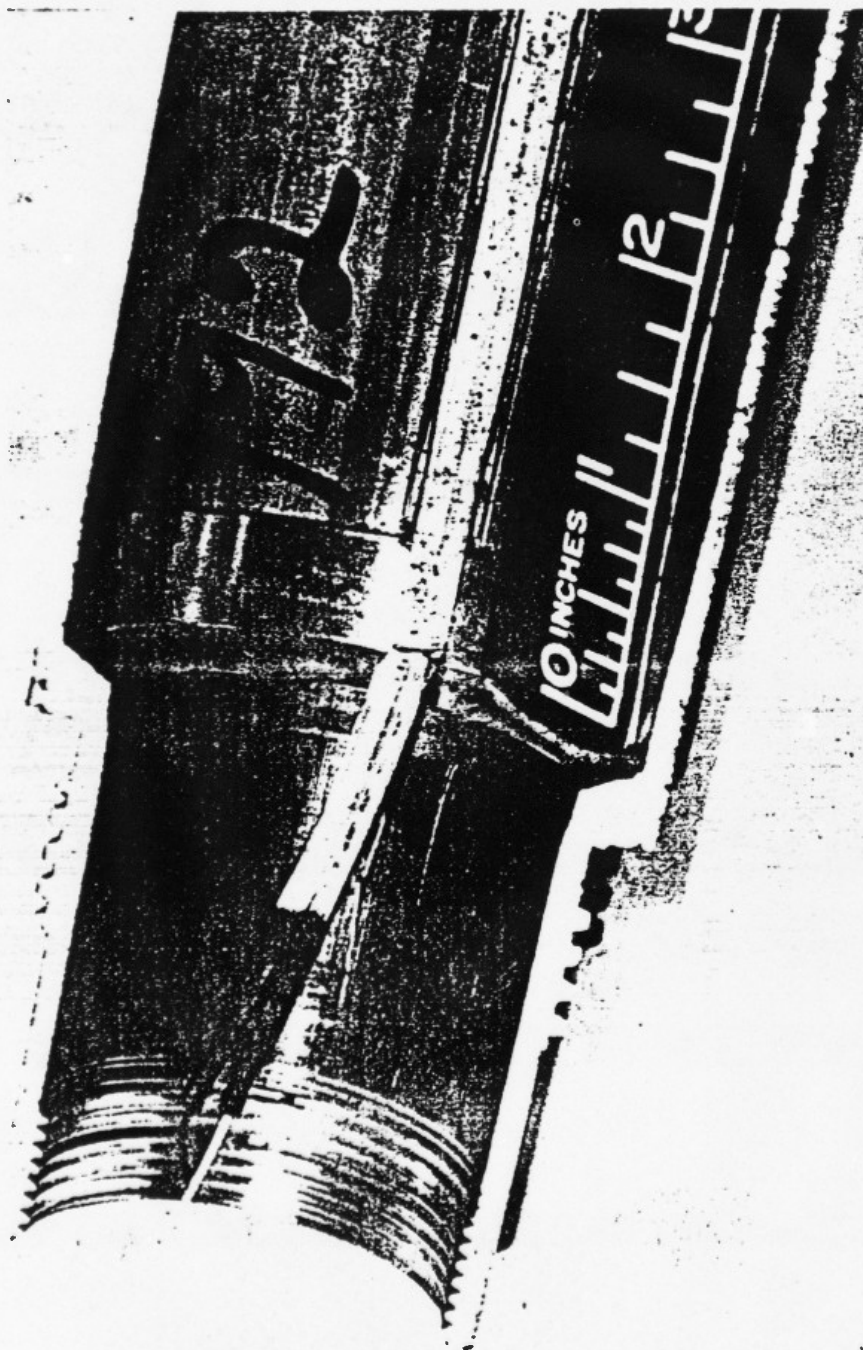
Figure 12. Fuze connector cable partially severed at fuze support

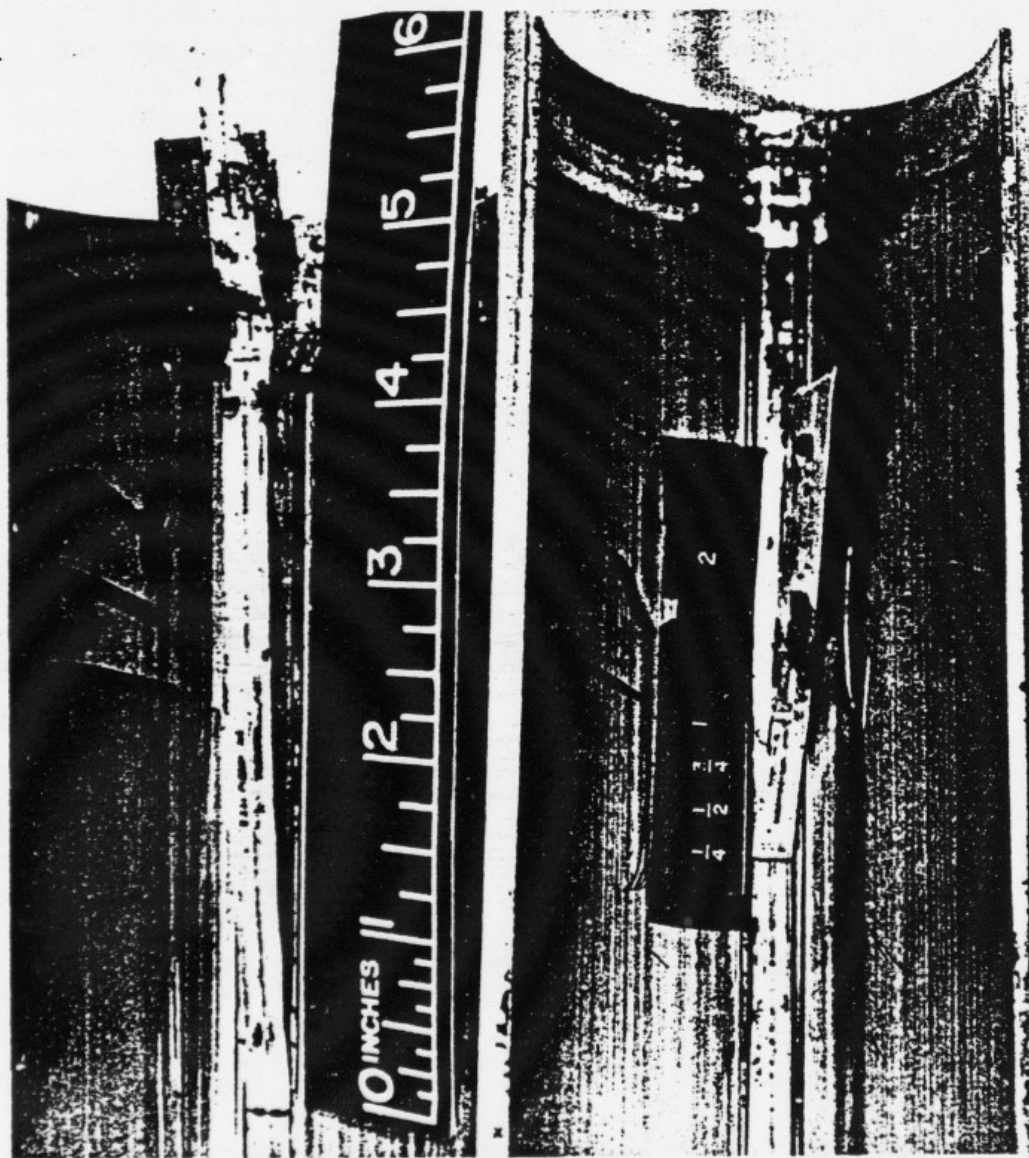
Figure 13. Fuze connector cable pulled out of connector cable groove

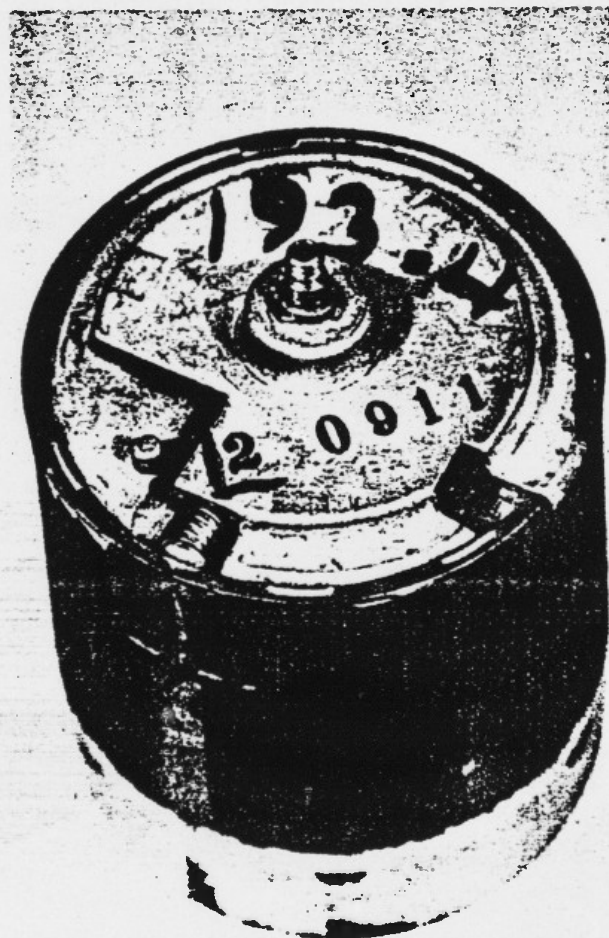
| Discrepancies | Round no. | | | |
|---|---|---|---|---|
| 16. Firing pin cap stake failed on submunition 193-4 (fig. 14). | Sat | Sat | x | Sat |

Figure 14. Firing pin stake failed

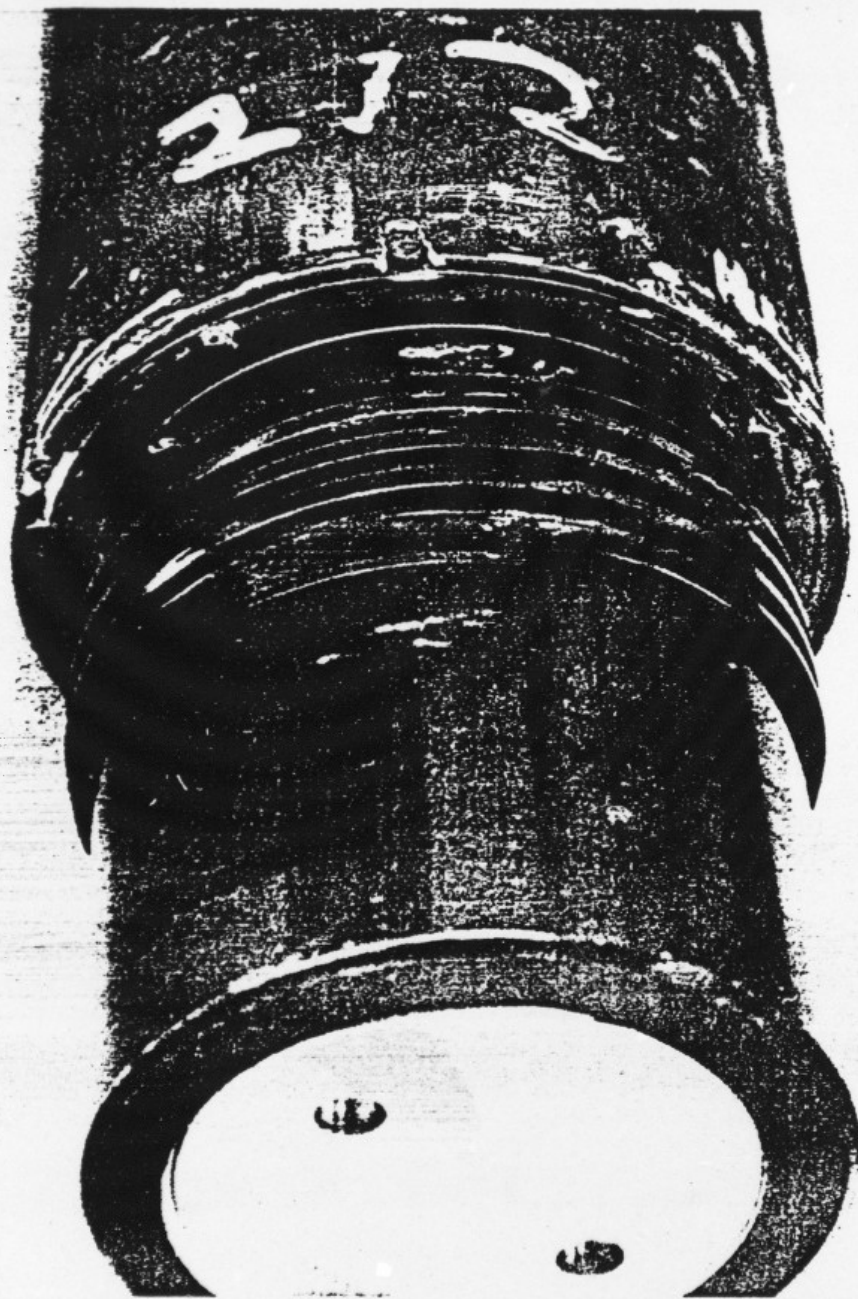
Figure 15. Rd. No. 212. Warhead case pins or rivets sheared and elongated the pinholes in the warhead case assembly after nose down and 45° to nose drops.

WARHEAD MARKED INCORRECTLY: CORRECT S/A 211

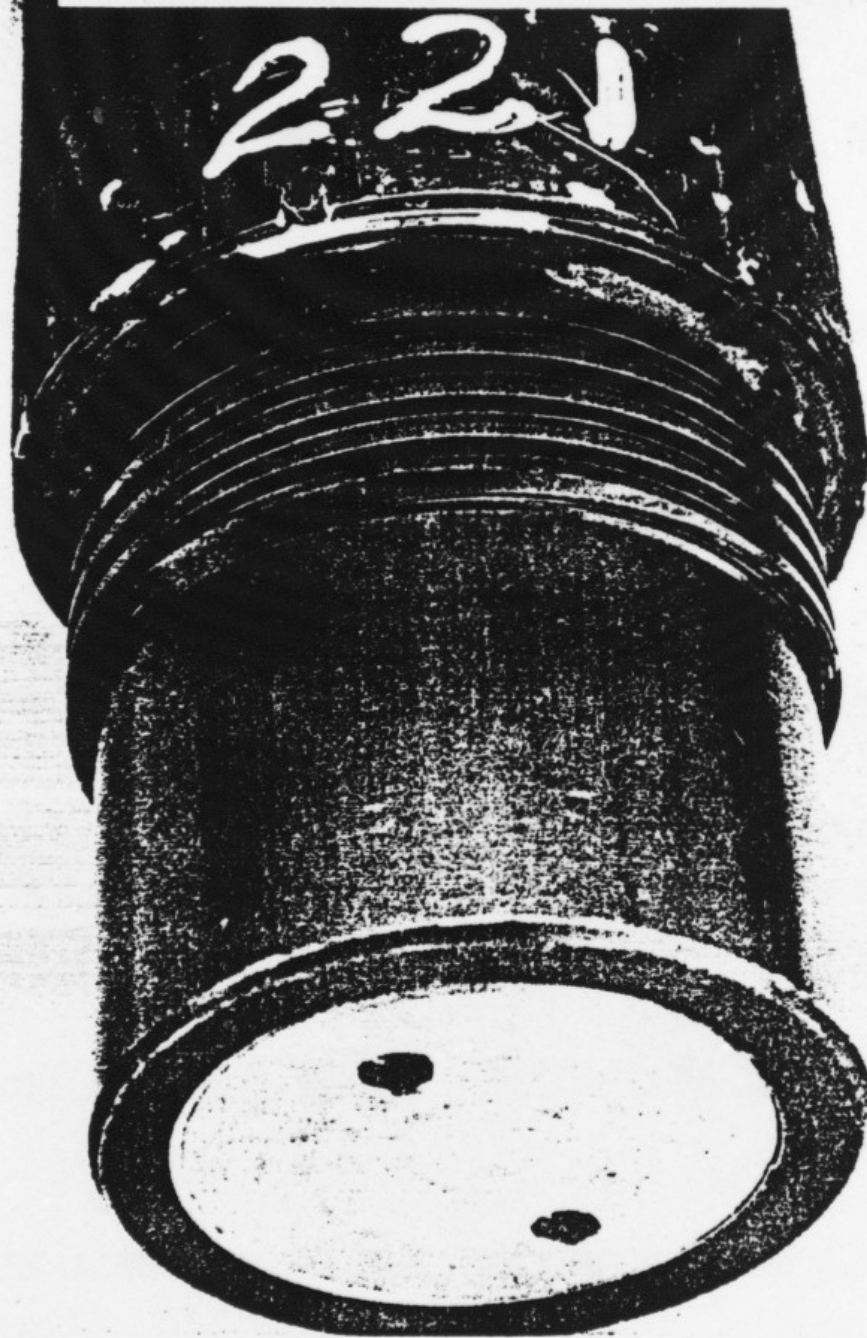
Figure 16. Rd. No. 211 Warhead case pins or rivets sheared and elongated the pinholes in the warhead case assembly after the nose down and 45° to nose drops

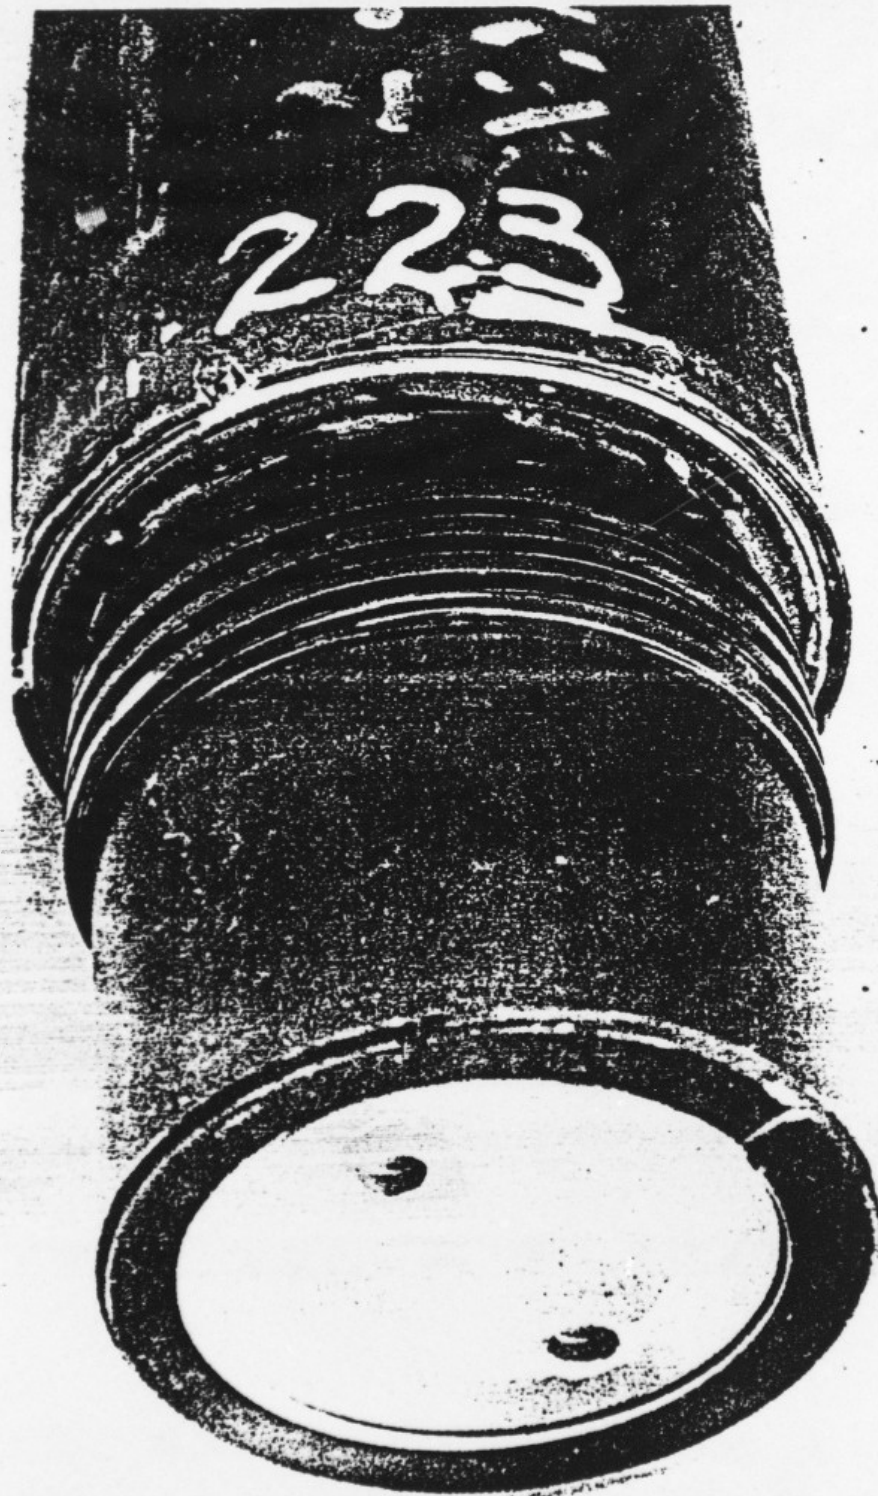
Twenty XM261 HE warheads were packed in 5 boxes and subjected to the 7-foot packaged drop (17 February 1981). The PA89 fiber ammunition container for the XM261/XM267 rocket warhead failed to protect the rocket round satisfactorily. The warheads in box 2 that were temperature conditioned to 145°F (63°C) received severe nose cone damage. The warhead casepins or rivets sheared and/or elongated the rivet holes in the warhead case assembly (part no. 9334131), ARRADCOM Dwg. No. 9334097 (figs. 15 and 16). The warheads in boxes 4 and 5 that were temperature conditioned to -60°F (-51°C) were damaged during the 7-foot packaged drop. The warhead case assemblies were damaged by rivet hole elongation (figs. 17, 18 and 19).

Figure 17. Rd. No. 223. Warhead case pins or rivets sheared and elongated the pinholes in the warhead case assembly after 45° to nose and 45° to base drops.

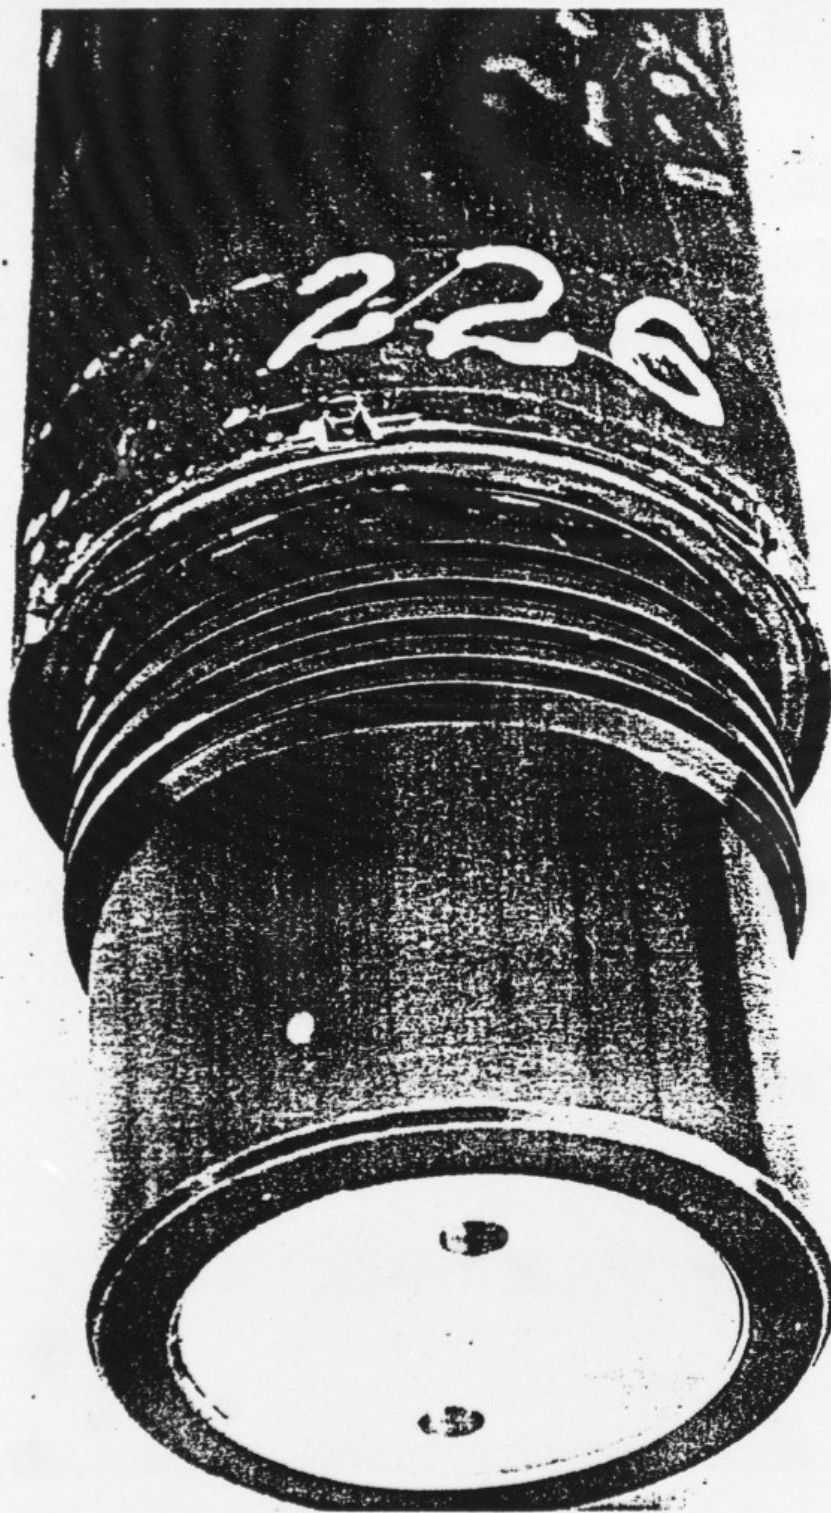
Figure 18. Rd. No. 226. Warhead case pins or rivets sheared and elongated the pinholes in the warhead case assembly after 45° to nose and 45° to base drops.

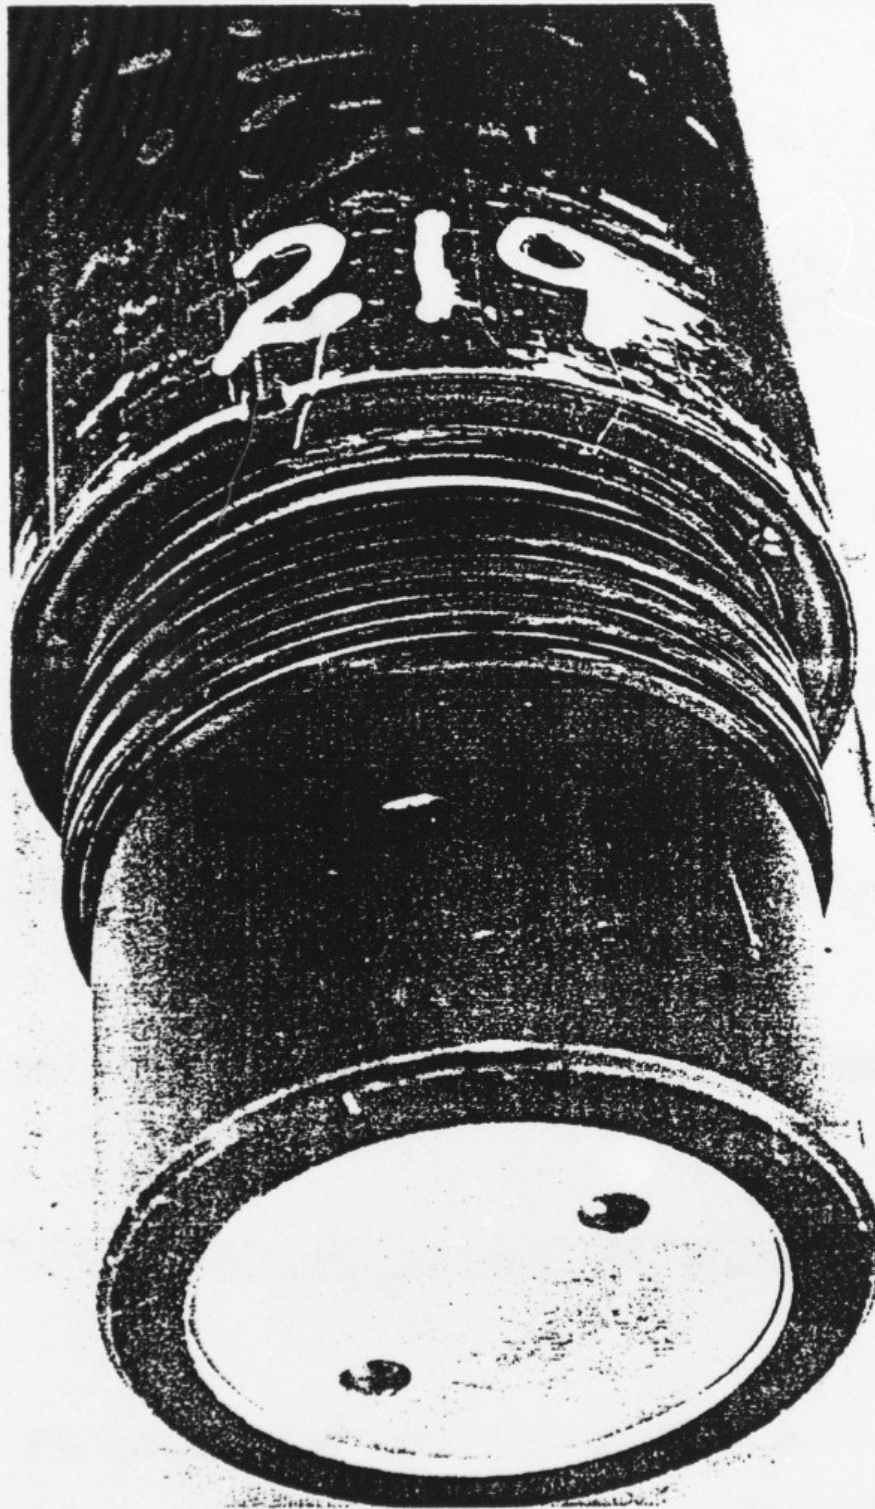
Figure 19. Rd. No. 219. Warhead case pins or rivets sheared and elongated the pinholes in the warhead case assembly after the base down and 45° to nose drops.

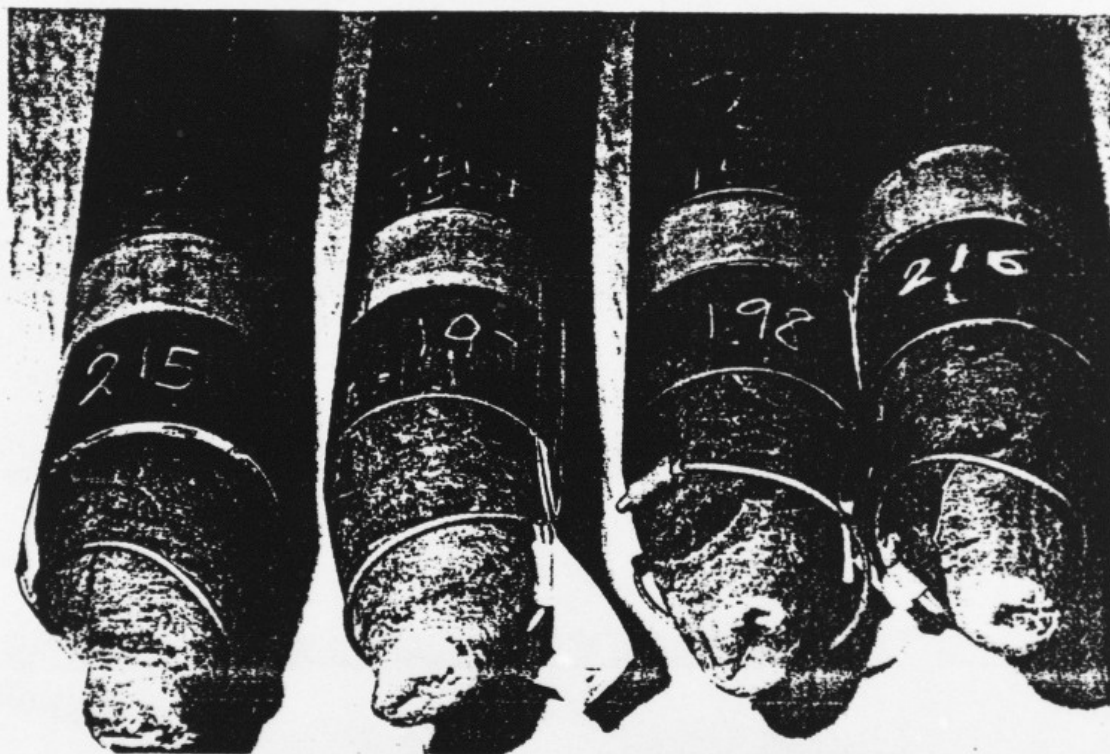
The XM261 HE warheads were dropped on 9 April 1981 and were again damaged in the 7-foot packaged drop. Four warheads had damaged nose cone assemblies (figs. 20 and 21). Seven warheads had elongated rivet holes in the warhead case assemblies (figs. 22 and 23). The fiber filler disc of three rocket rounds was cut by rocket motor nozzle assembly (fig. 24). The fiber ammunition packing containers proved inadequate for the rough handling 7-foot packaged drop.

Figure 20. Box 2, 150°F, rd. No. 197, 198, 215, 216. Nose cone assembly (PN9334119), ARRADCOM Dwg. No. 9334097, flattened 7/8 to 1 inch after nose down and 45° to base drops.
