Contractor Report ARLCD-CR-84039

**ENGINEERING DEVELOPMENT OF THE XM261 MULTIPURPOSE  
SUBMUNITION WARHEAD AND THE XM267  
SUBMUNITION TRAINING WARHEAD**

**William S. Marks  
BEI Defense Systems Company, Inc.  
11312 South Pipeline Road  
Euless, Texas 76039**

JANUARY 1985

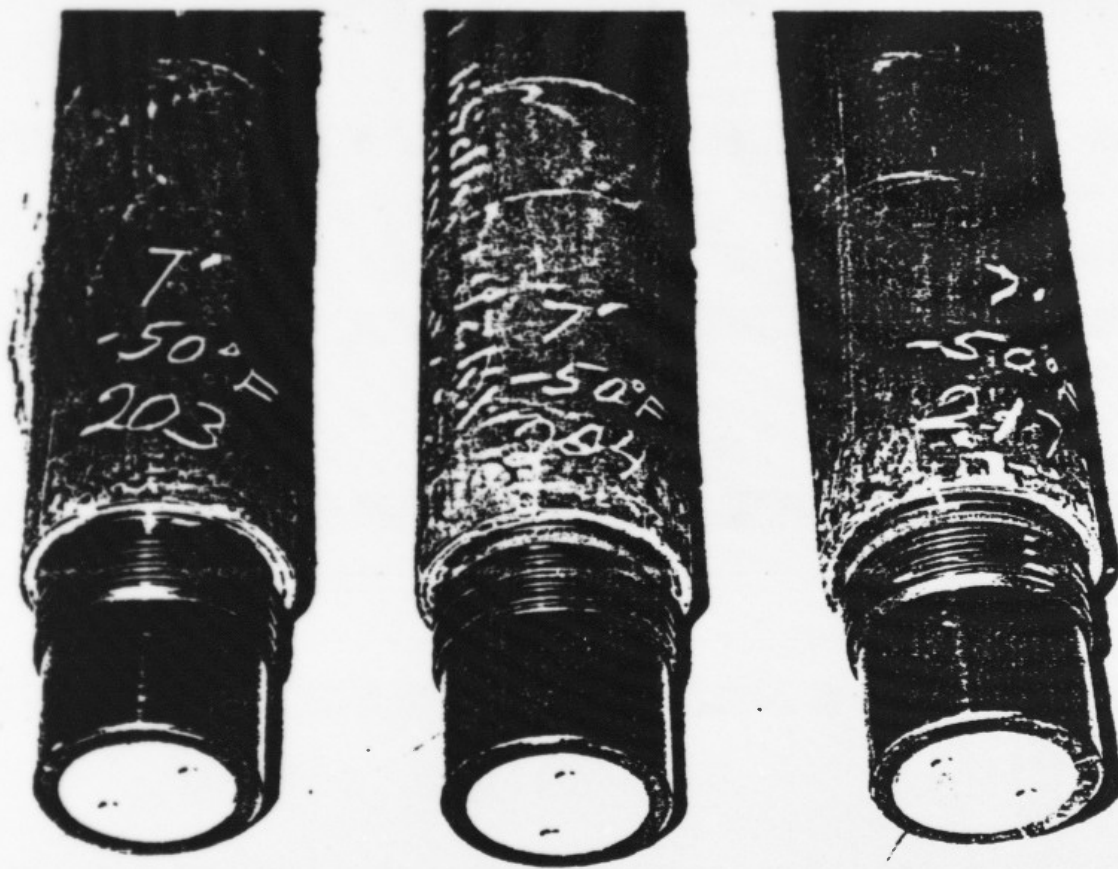
Figure 22. Box 4, -50°F, rd. No. 203, 204, 217. Warhead case pins or rivets sheared and/or elongated the pinholes in the warhead case assembly (PN 9334131) after the base (motor end) and 45° to nose drops.

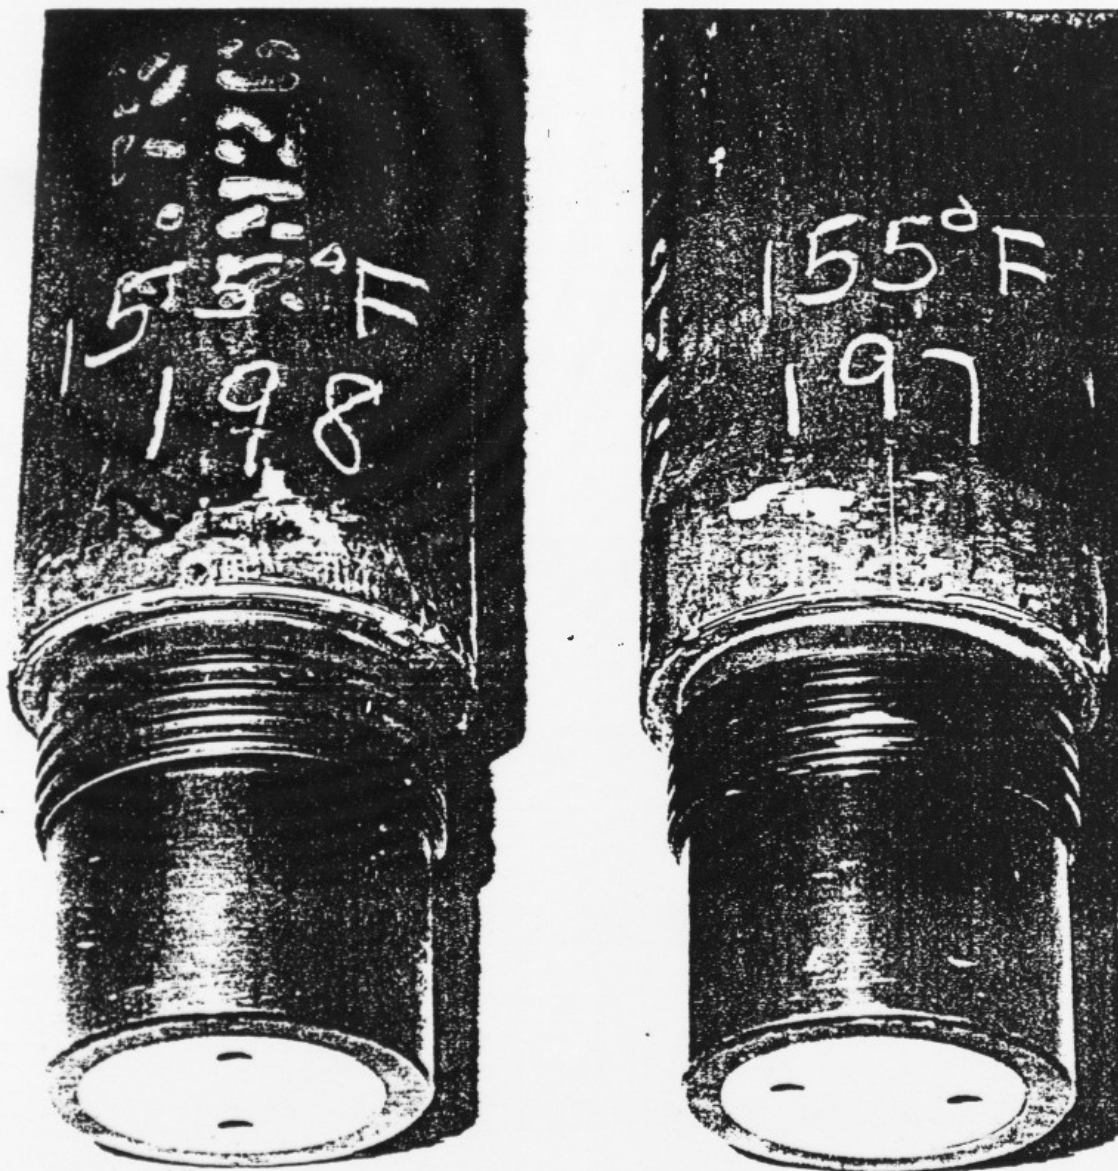
Figure 23. Box 2, 150°F, rd. no. 197 and 198. Warhead case pins or rivets sheared and/or elongated the pinholes in the warhead case assembly (PN 9334131) after the nose down and 45° to base down drops.

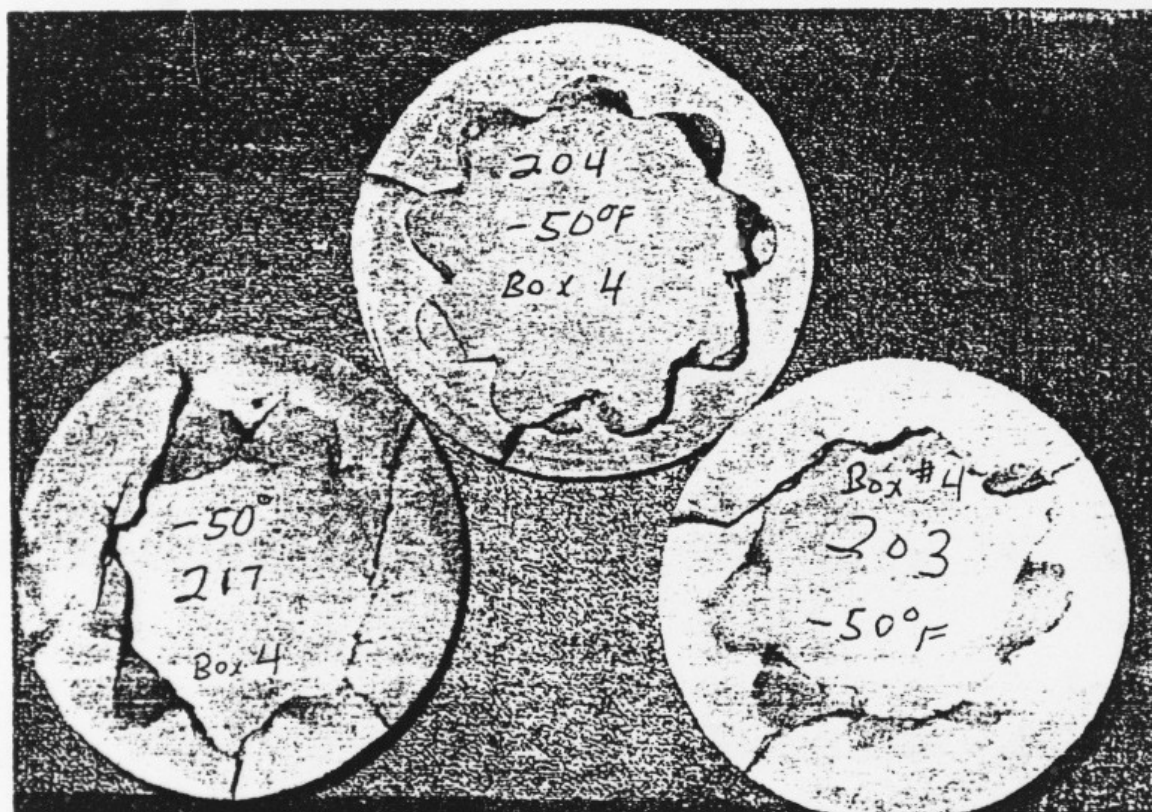
Figure 24. Box 4, -50°F, rd. No. 203, 204, 217. Fiber filler discs cut by rocket motor nozzle assembly.
