**SACRAMENTO RIVER FLOOD CONTROL PROJECT,  
CALIFORNIA  
MID-VALLEY AREA, PHASE III**

**DESIGN MEMORANDUM  
VOLUME I OF II**

**US Army Corps  
of Engineers**

**June 1996**

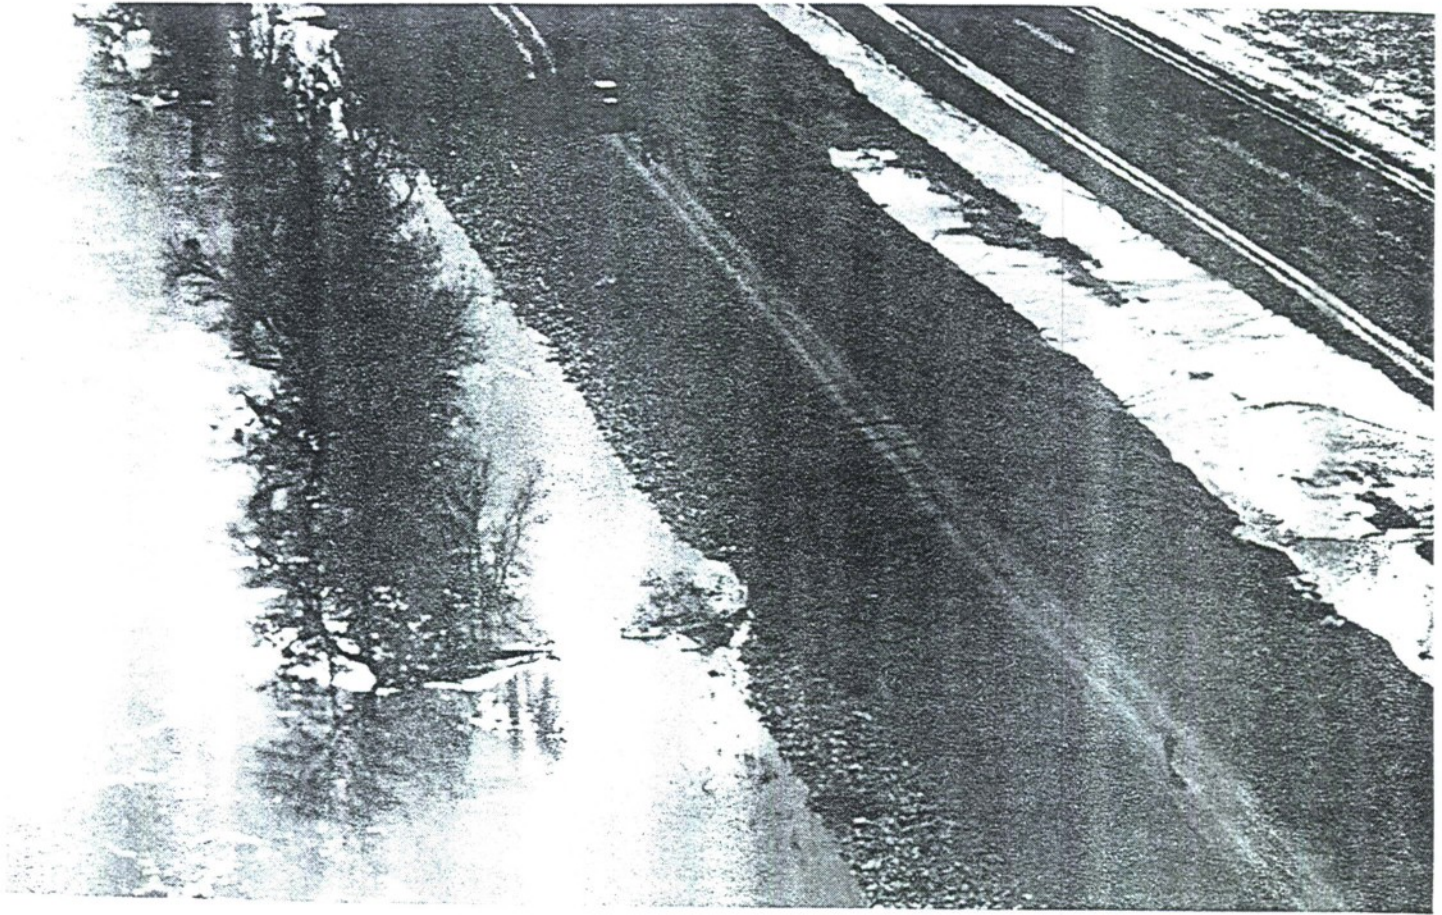
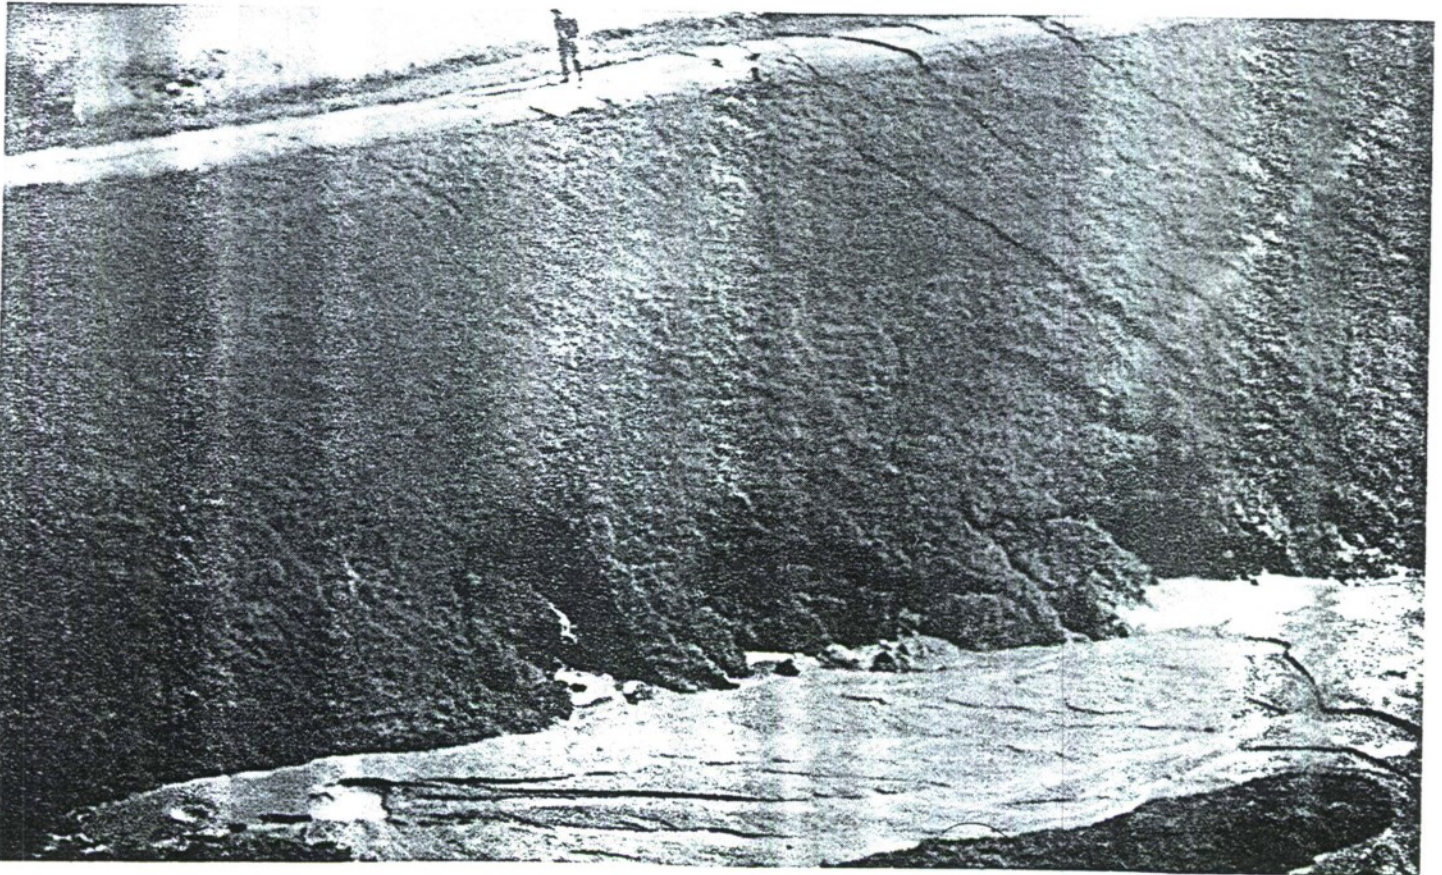
At 8:00 a.m. on February 22, levee patrols of Sutter County's R.D. 1500 discovered a 500-foot-long slump, up to 4 feet deep, on the west levee of the Sutter Bypass near Robbins (see Figure 1). High flows in the bypass had caused boils and

LEVEE EMBANKMENT SLUMP ON WEST LEVEE SUTTER BYPASS  
DURING FEBRUARY 1986 FLOOD.

extensive piping damage. The Robbins fire chief ordered the community of nearly 400 residents evacuated at 8:15 a.m., and evacuation was completed within an hour. Emergency flood fight efforts by the Corps of Engineers (see Figure 2) reinforced the sagging levee and probably prevented a levee break. To stabilize the levee and prevent total failure, sand and gravel were dumped on the waterside slope, creating a waterside berm about 50 feet wide and 300 feet long. Cost of the flood fight was about \$290,000. Complete levee failure was averted, but extensive damages resulted, including slumping of the levee crown, landside slope cracking, and large holes at the landside levee toe.

In May 1986, Wahler Associates prepared a report indicating that the levee was constructed mainly of clayey soils with occasional layers of clean or silty sand and that damage to the levee was the result of piping due to the sustained high water and the presence of nearly continuous layers of highly pervious and erodible sands and silts within the levee embankment and foundation.

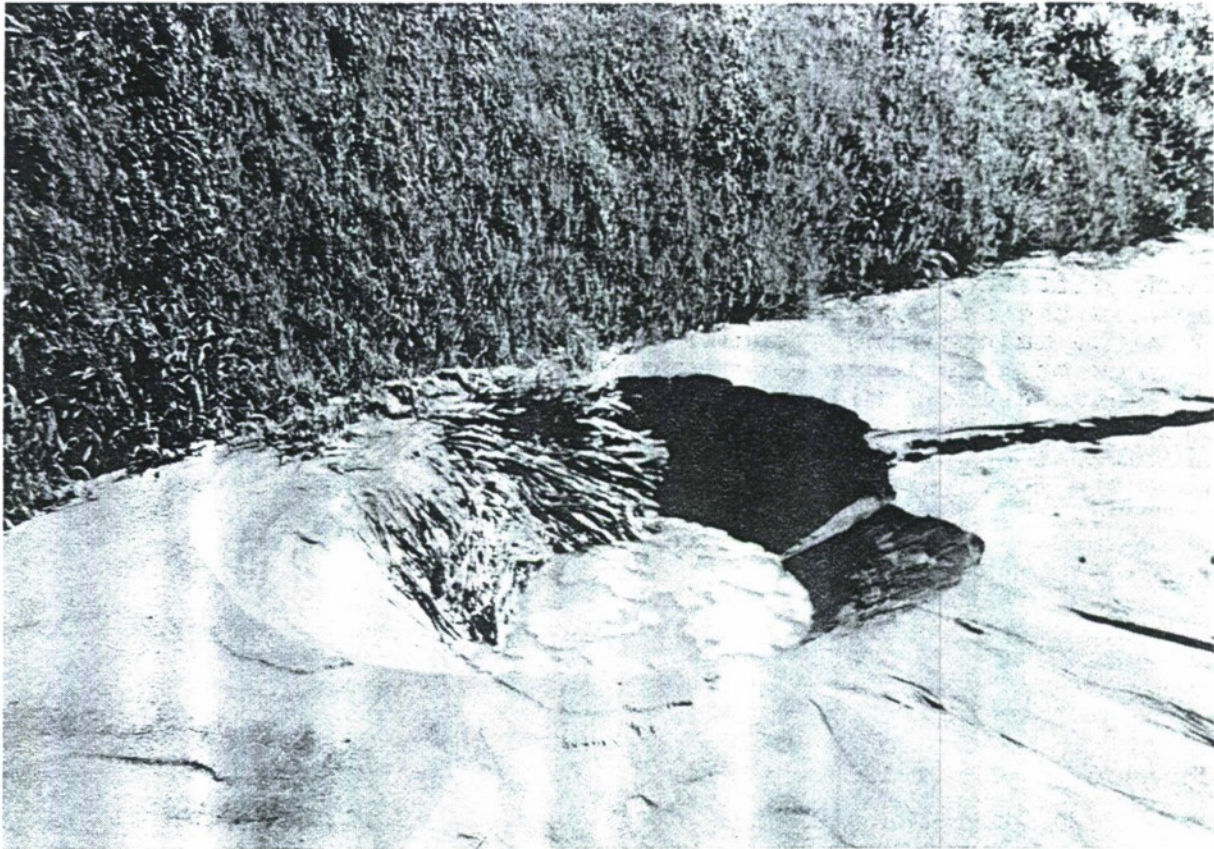
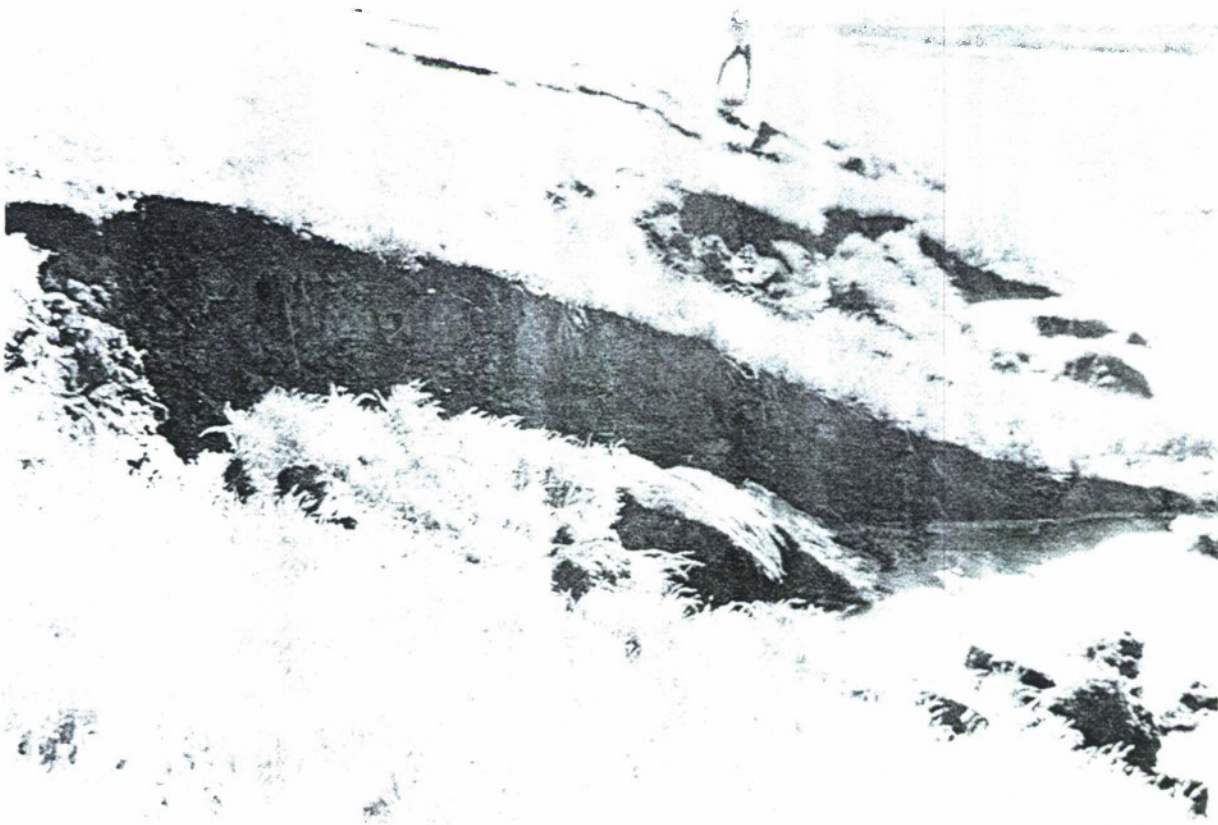
Sutter Bypass. - The west levee of Sutter Bypass just east of Robbins was the site of significant seepage and settlement in February 1986 (see Figures 1, 2, and 3). The problem began suddenly as a blowout of levee embankment toe material. Erosion of the landside levee toe continued until the levee embankment subsided at the site. Seepage water then appeared immediately downstream, eroding levee material until this too was stopped by settlement of the levee. The process continued downstream for about 200 feet. Emergency flood fight efforts (see Figure 2) were initiated by the Corps of Engineers to stabilize the levee embankment. A temporary waterside berm about 50 feet wide and 300 feet long was constructed of sand and gravel at a cost of about \$290,000. Upstream from this site (in the vicinity of Highway 113), numerous clear water boils have occurred along about 1 mile of levee during past high flows. Two of these boils, identified as boil numbers 12 and 16, have occurred regularly enough to have acquired numbers

LEVEE EMBANKMENT PROBLEM AREAS ON WEST LEVEE SUTTER BYPASS  
DURING FEBRUARY 1986 FLOOD.

(numbered staffs at each boil). One of these boils has a permanently installed corrugated metal standpipe to control flow. On the east side of Sutter Bypass, seepage waters appear landward of the levee during high flood stages from the Natomas Cross Canal upstream along about 8 miles of levee. Significant seepage and small boils have occurred along this levee just upstream from the cross canal. The levee embankment also failed in this same area (see Plate 3 for location) in the past.

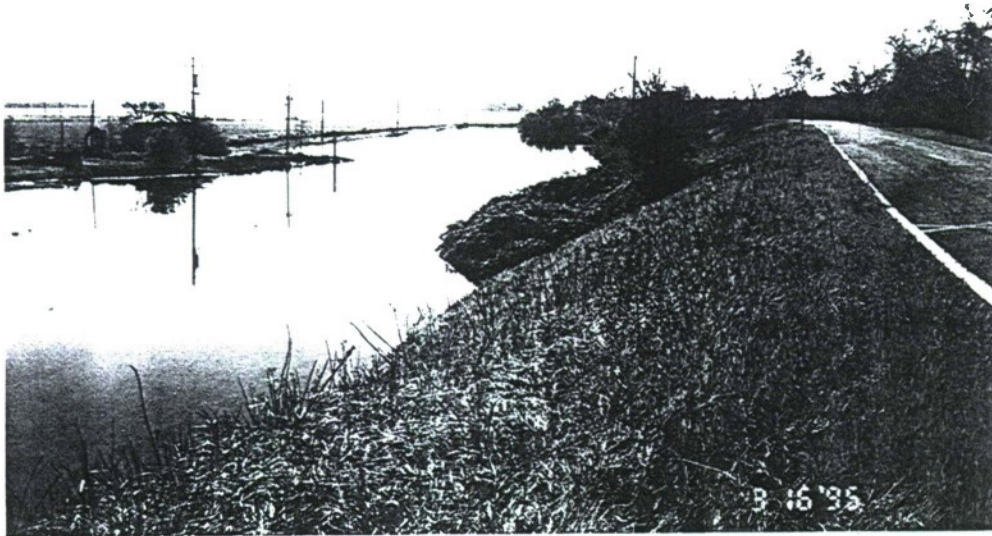
IN 1995, POND CREATED FROM EXTENSIVE SEEPAGE ALONG  
LEVEE TOE AT SITE 18, FEATHER RIVER/YOLO BYPASS.  
LAST TIME WATER PONDED HERE WAS IN 1985.

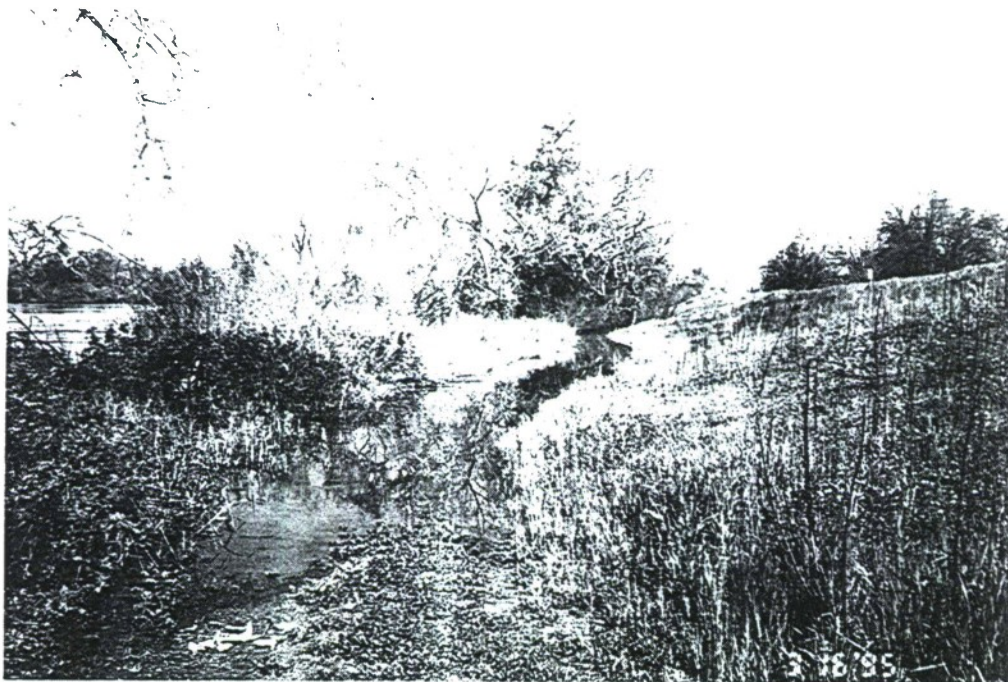
SITE 17 WATERSIDE VIEW MARCH 16, 1995  
OPPOSITE OLD LEVEE BREAK POND.

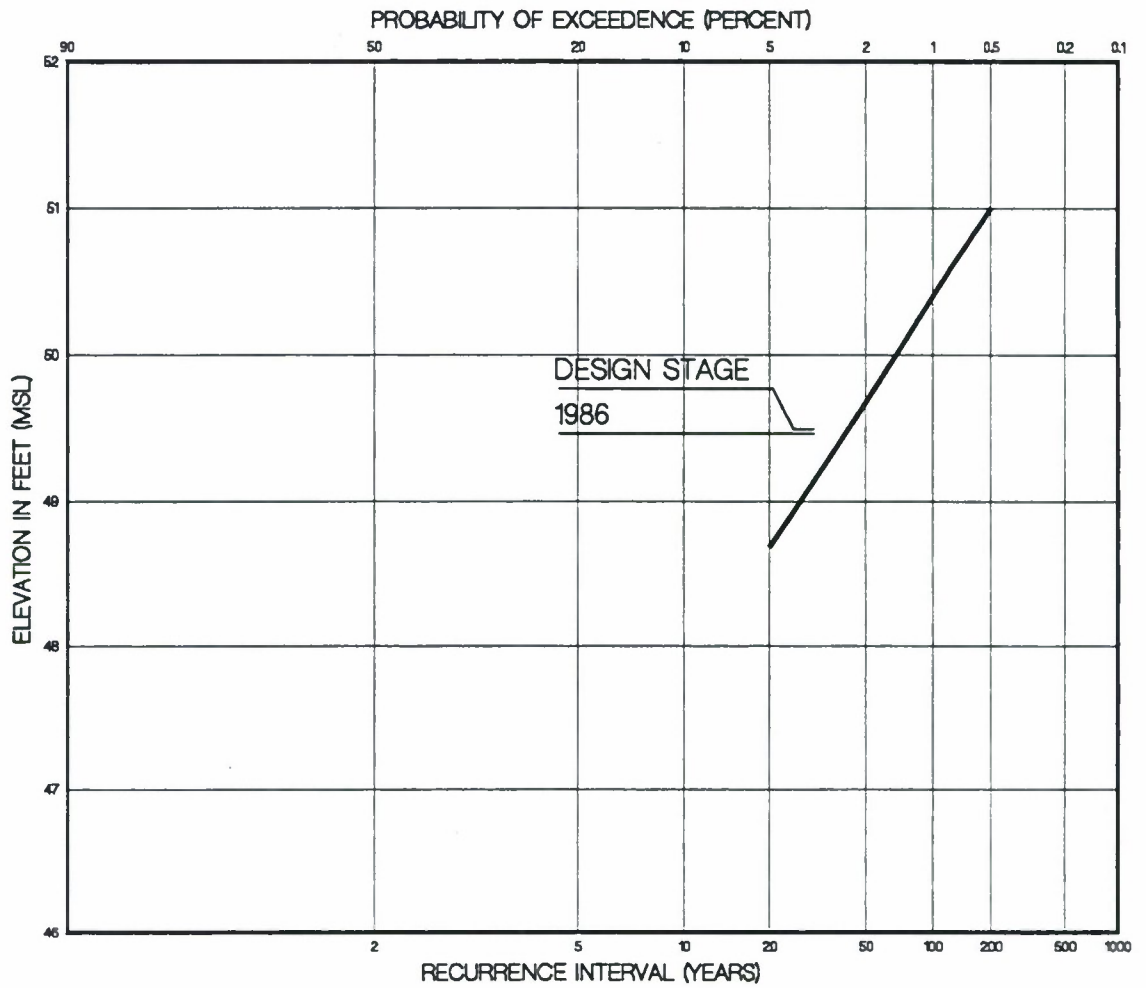
**Figure 5**

NOTE: Present condition (peak stage) stage-frequency relationship developed for this study, July 1990.

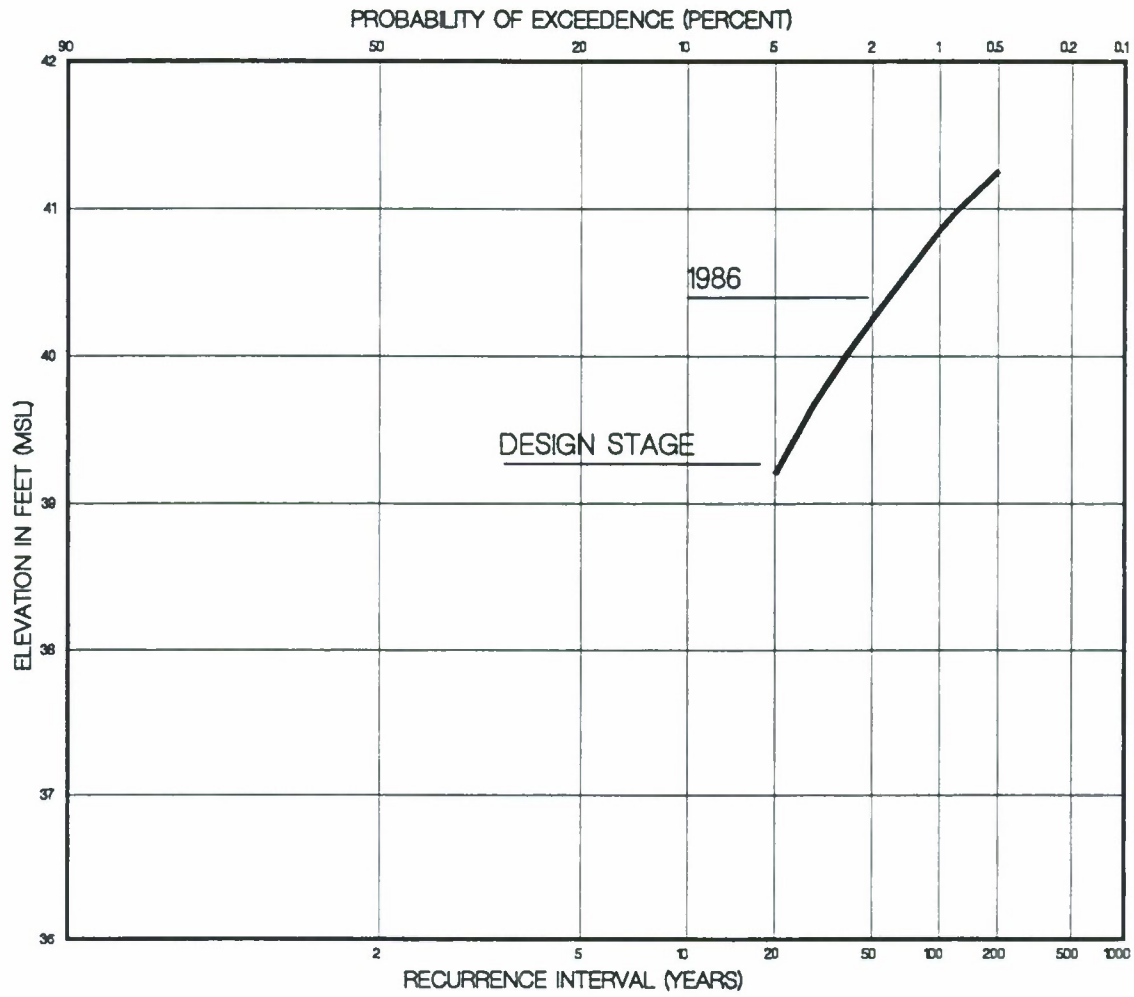
**Figure 6**

NOTE: Present condition (peak stage) stage-frequency relationship developed for this study, July 1990.

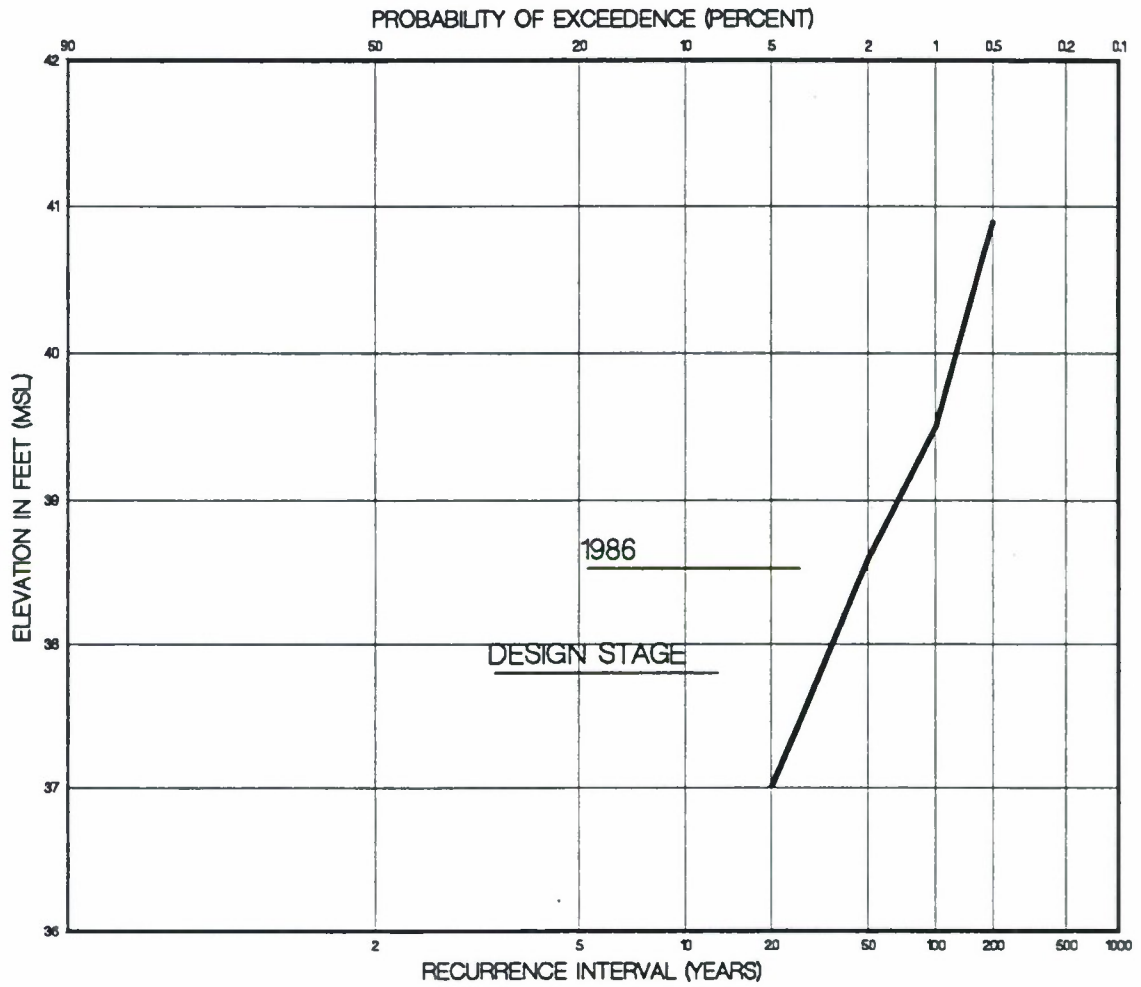
Figure 7

NOTE: Present condition (peak stage) stage-frequency relationship prepared during American River Investigation.

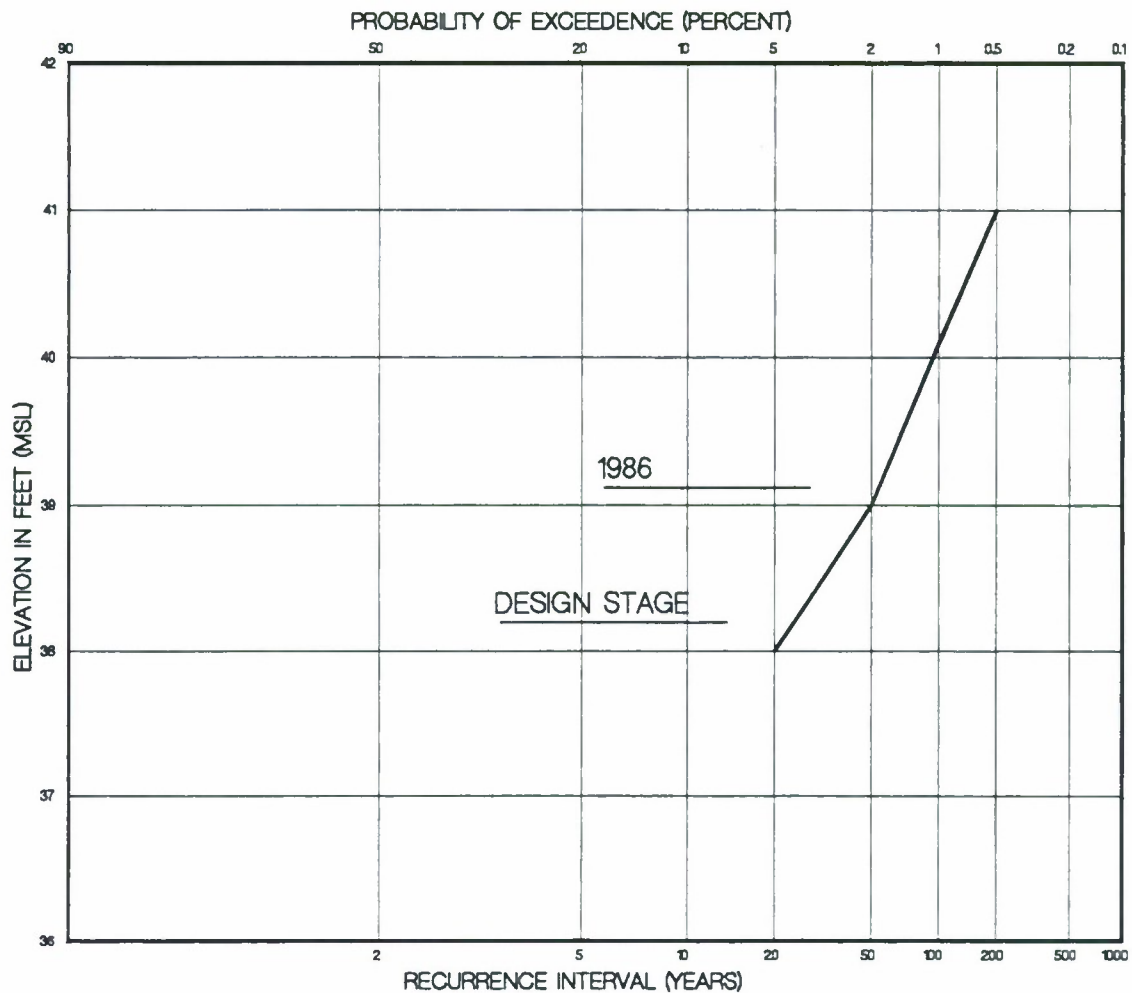
**Figure 8**

NOTE: Present condition (peak stage) stage-frequency relationship prepared during American River Investigation.

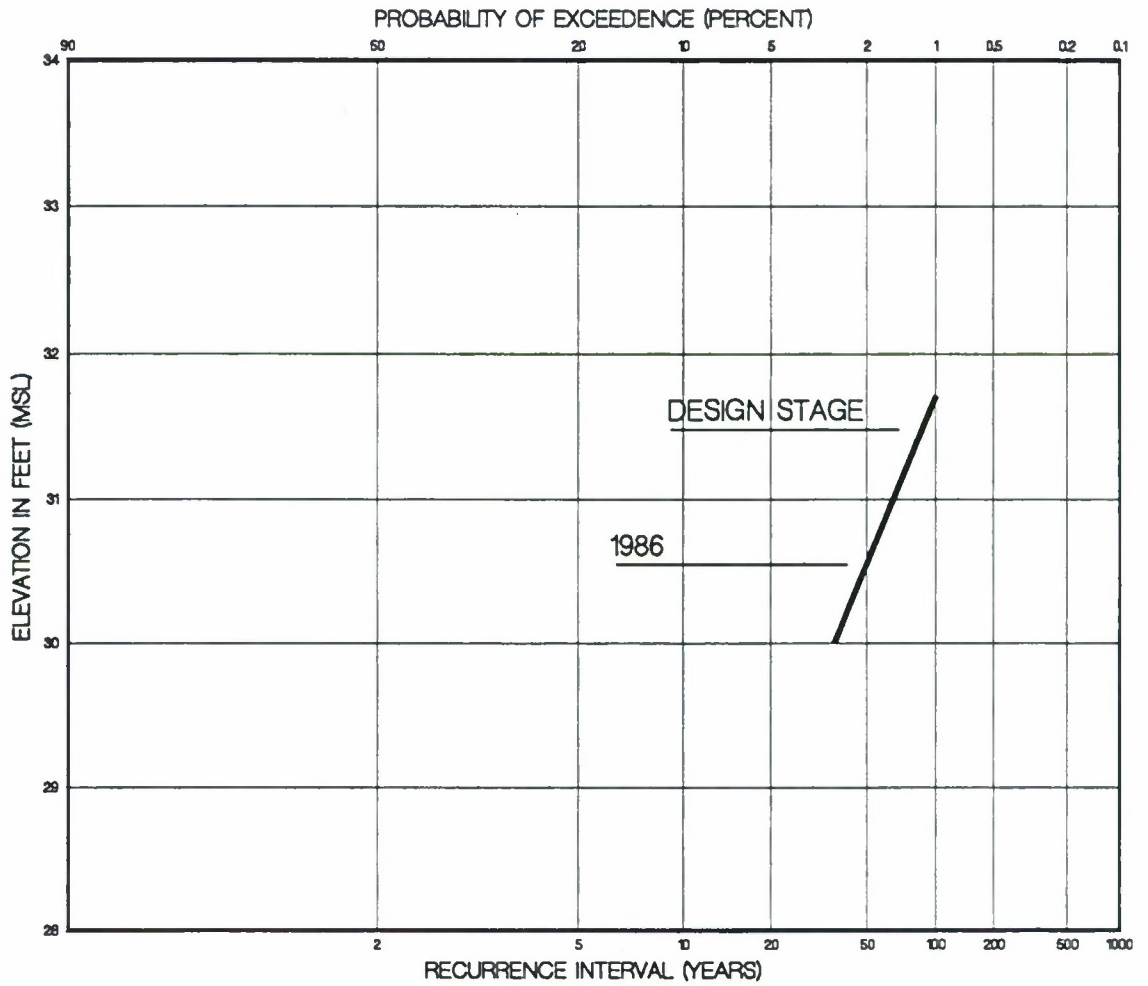
**Figure 9**

NOTE: Present condition (peak stage) for the 100-year recurrence interval taken from the Hydrology Office Report, "American River and Sacramento Metro Investigations, California," Corps of Engineers, January 1990. The recurrence interval for the 1986 peak flood stage estimated based on correlations with stage-frequency curves developed in the area.

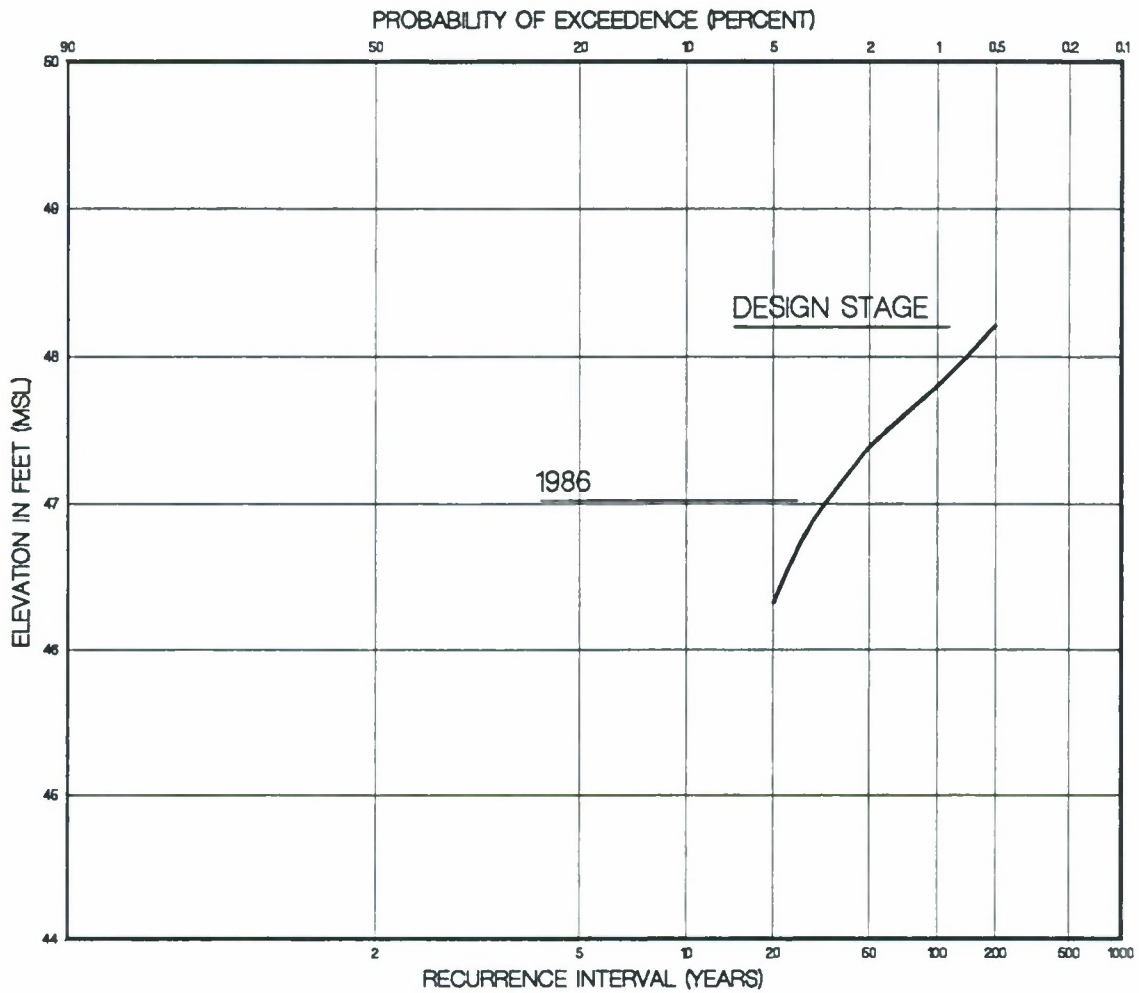
**Figure 10**

NOTE: Present condition (peak stage) stage-frequency relationship developed for this study, July 1990.

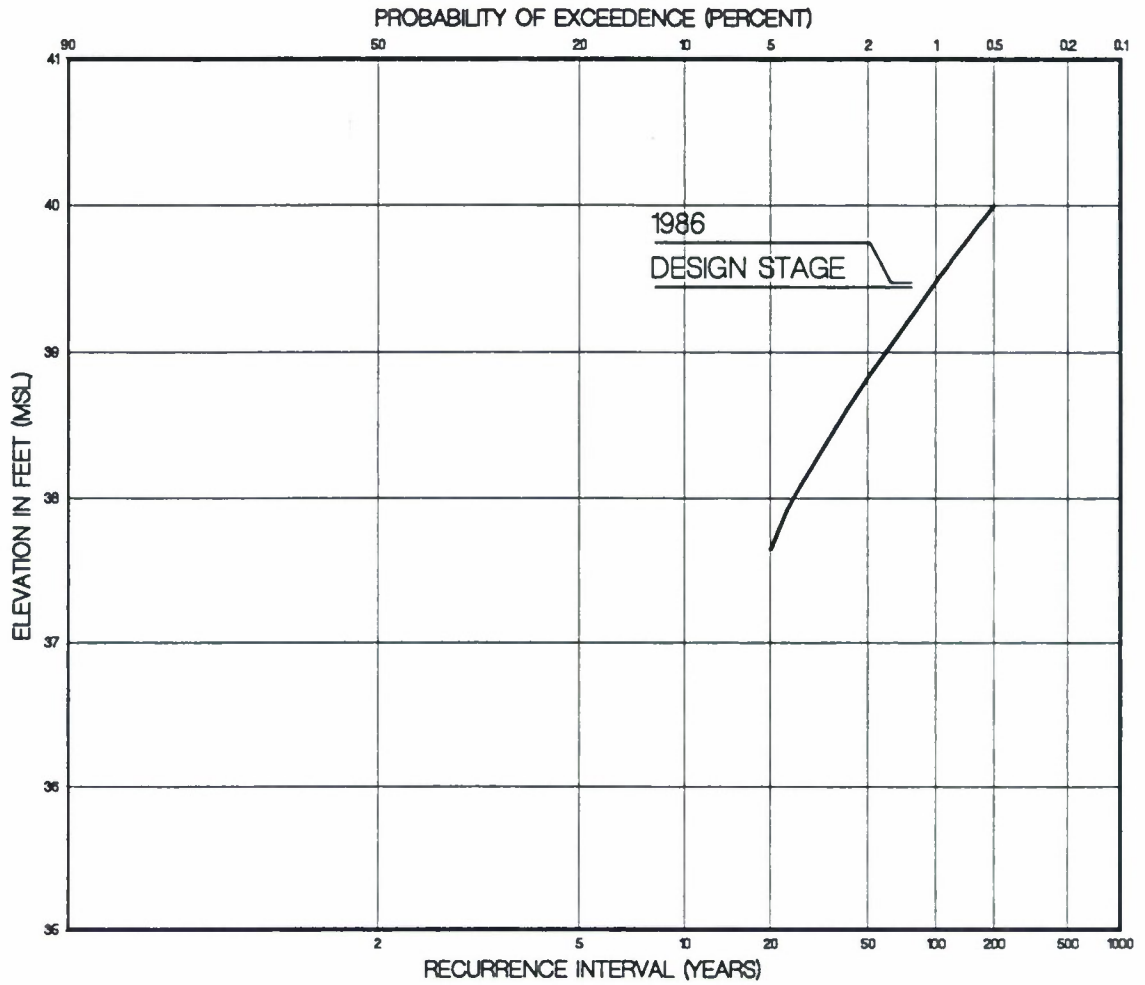
**Figure 11**

NOTE: Present condition (peak stage) stage-frequency relationship developed for this study, July 1990.

The existing condition stage-frequency relationships indicate that the 1986 water surface elevations (the static water surface elevations plus wind setup) represent about a 40-year recurrence interval on the Sacramento River below Wilkins Slough (Figure 5), a 60-year recurrence interval on the Sacramento River near Knights Landing (Figure 6), a 50-year recurrence interval on the Sacramento River at Fremont Weir (Figure 7), a 60-year recurrence interval on the Sacramento River near the Natomas Cross Canal (Figure 8), a 50-year recurrence interval on the Sacramento River near Sacramento Bypass (Figure 9), a 30-year recurrence interval on the Sutter Bypass near Tisdale Bypass (Figure 10), a 100-year recurrence interval on the Sutter Bypass just upstream from the

Sacramento River (Figure 11), and a 55-year recurrence interval on the Yolo Bypass just downstream from Cache Creek (Figure 14).

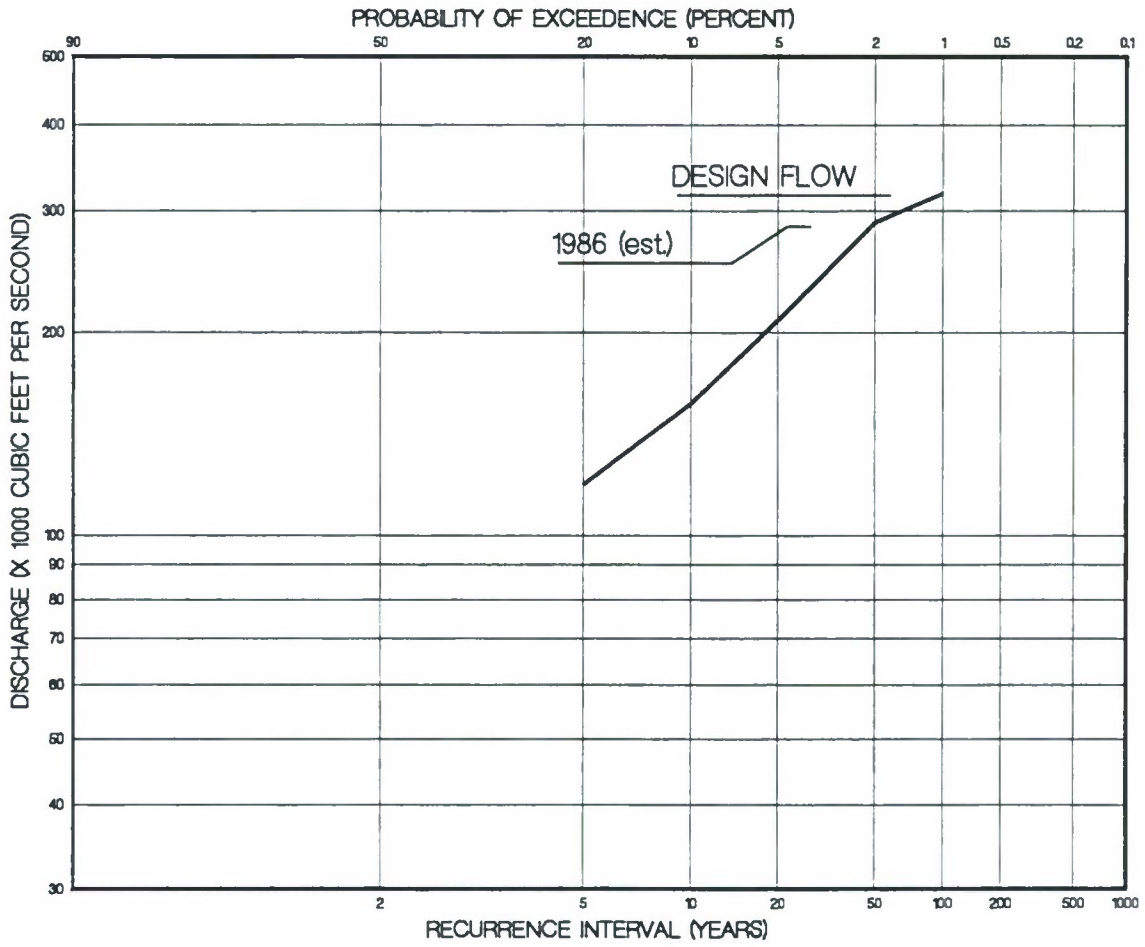
Figure 12

NOTE: Present condition (peak flow) discharge-frequency relationship taken from "Sacramento River Flood Control Project, Hydrology, Office Report," dated October 1993.

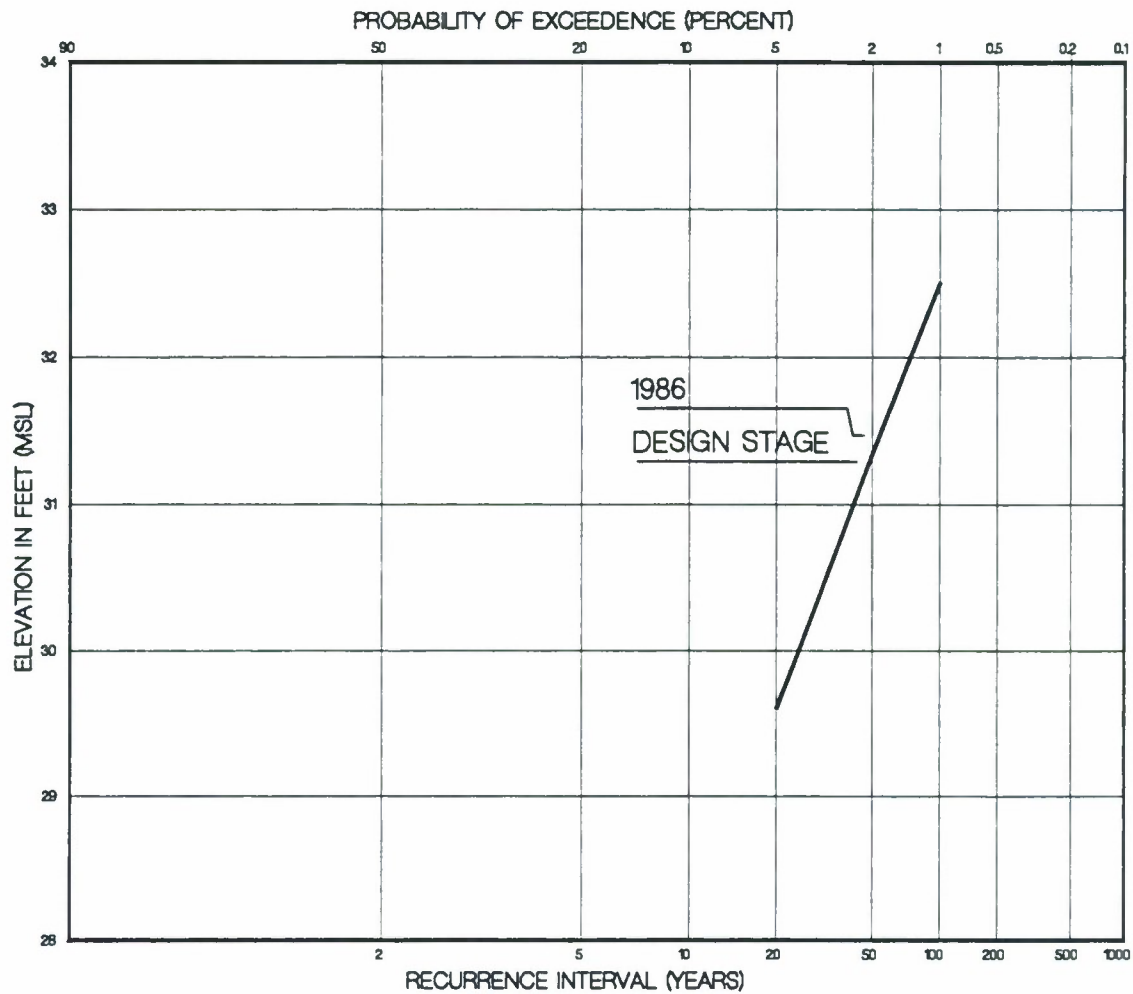
Figure 14

NOTE: Present condition (peak stage) stage-frequency relationship taken from the Hydrology Office Report, "American River and Sacramento Metro Investigations, California," Corps of Engineers, January 1990.

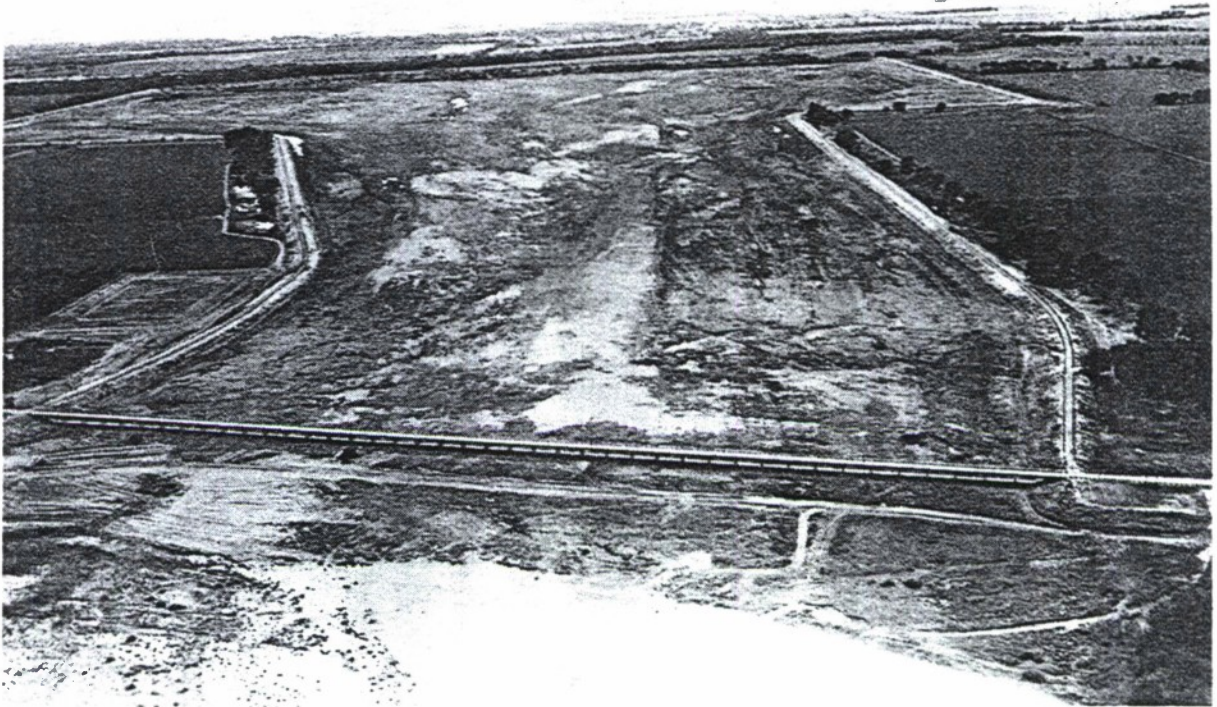
RIVER MILE 146 - ENTRANCE TO THE COLUSA WEIR AND THE COLUSA BYPASS  
15 JULY 1982

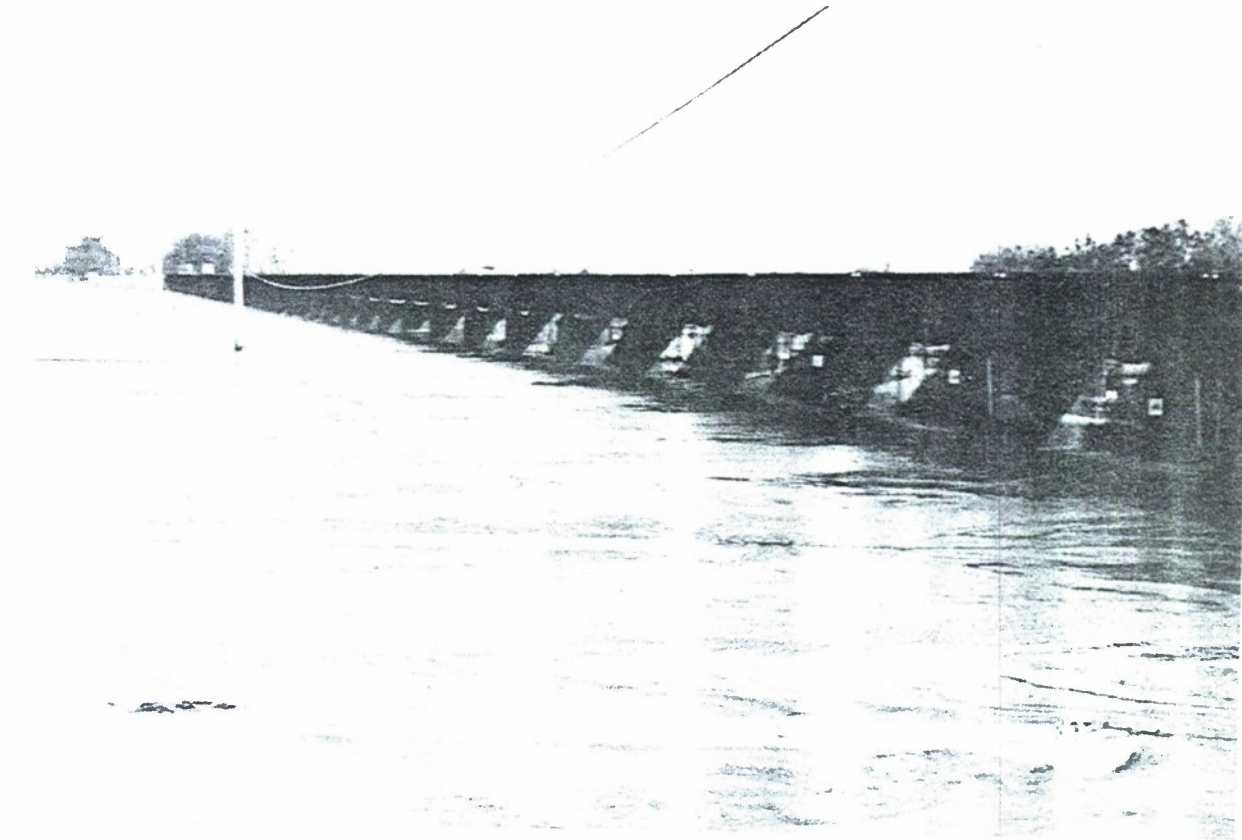
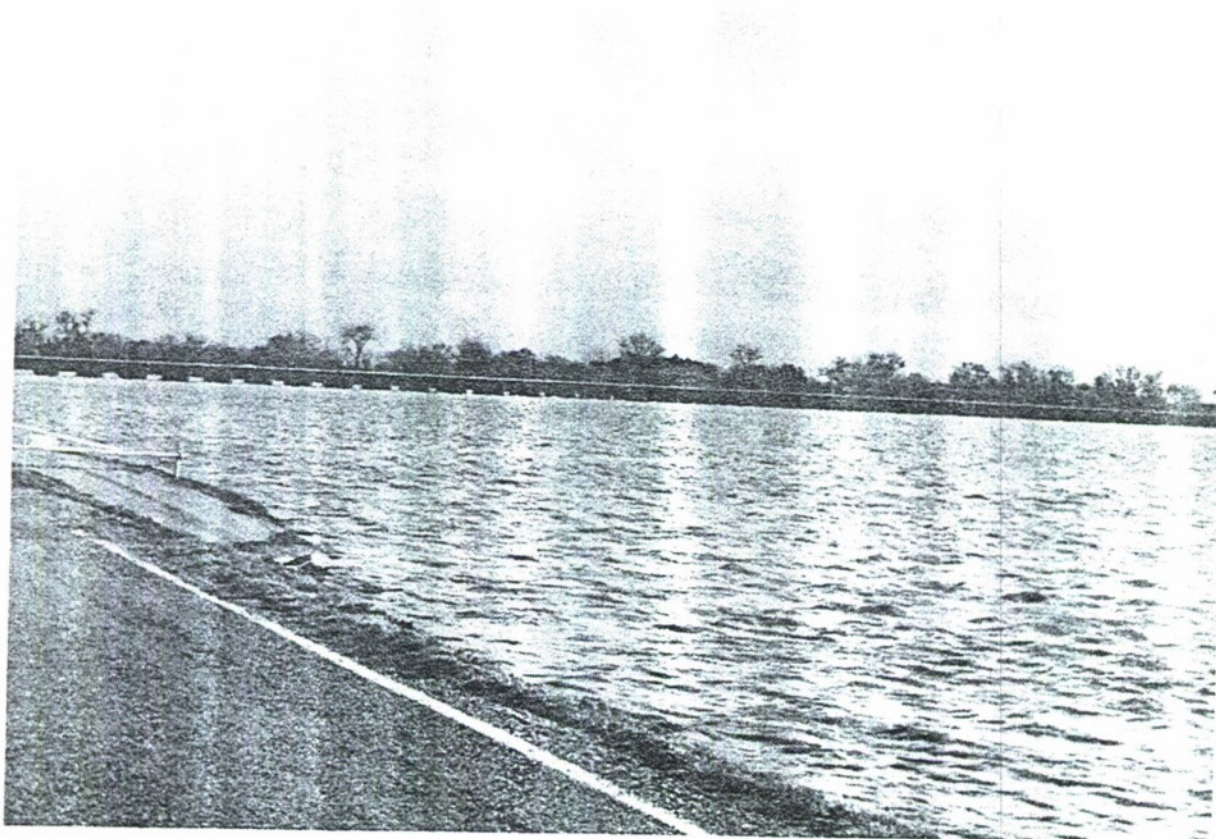
FEBRUARY 1986 FLOODFLOWS EXCEEDED DESIGN CONDITIONS  
FOR SACRAMENTO WEIR AND BYPASS.

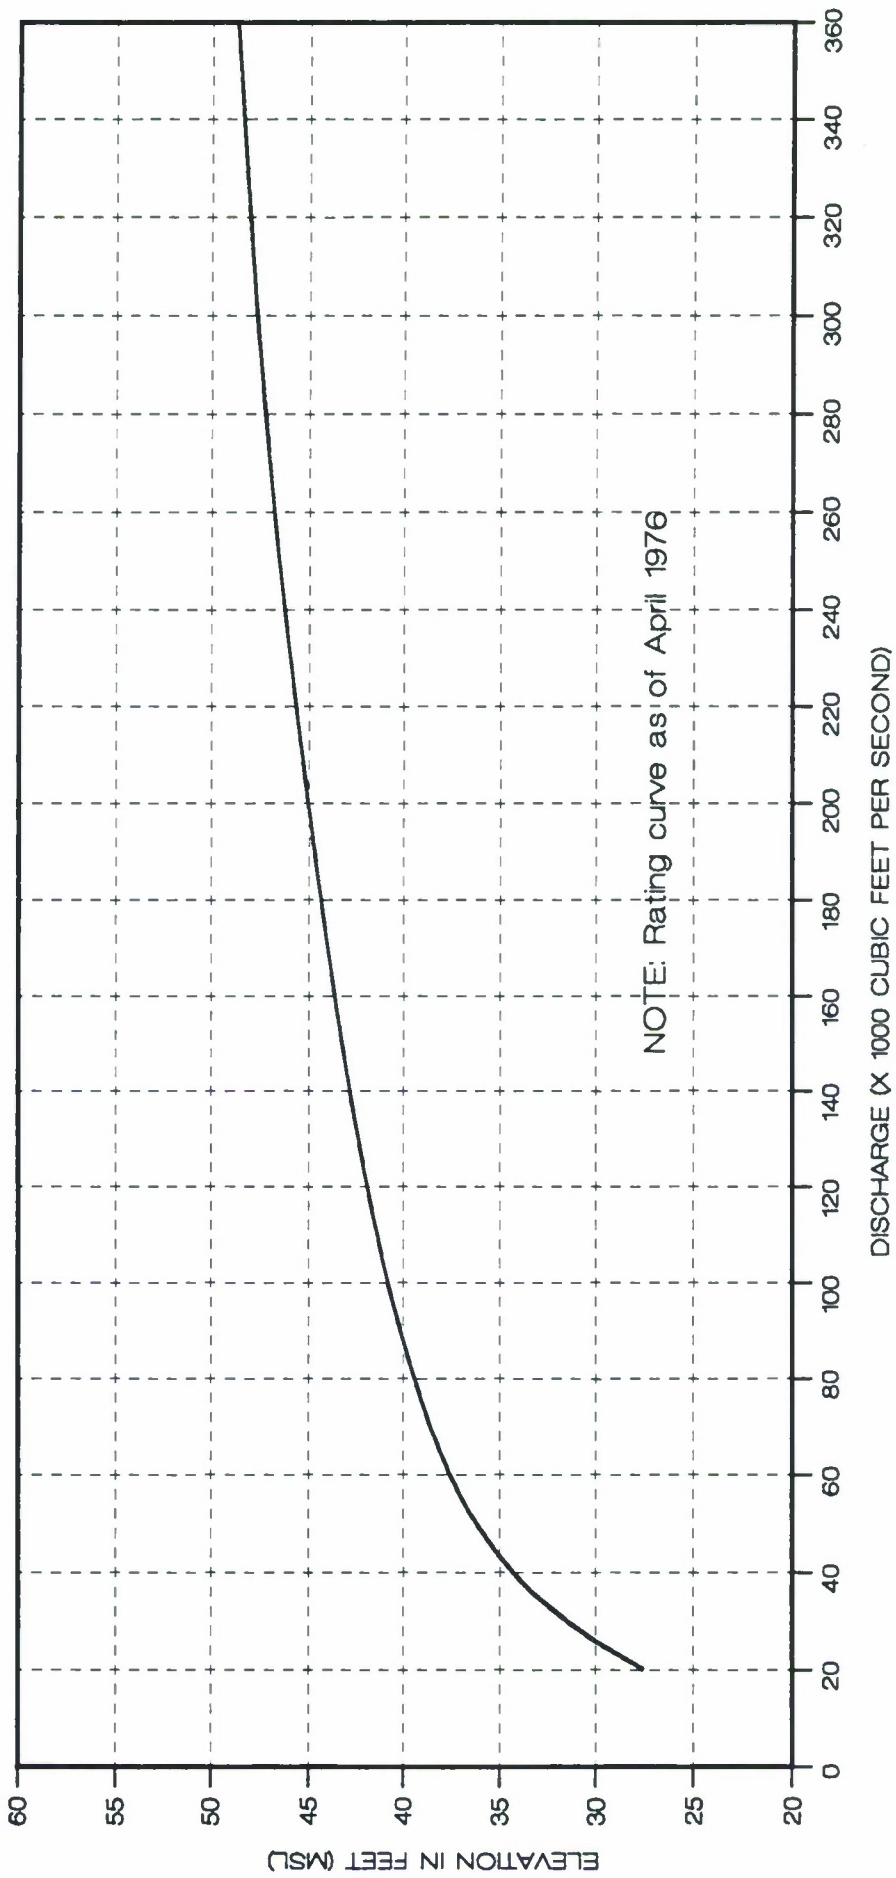
**RATING CURVE  
FEATHER RIVER AT NICOLAUS**
