**SACRAMENTO RIVER FLOOD CONTROL PROJECT,  
CALIFORNIA  
MID-VALLEY AREA, PHASE III**

**DESIGN MEMORANDUM  
VOLUME I OF II**

**US Army Corps  
of Engineers**

**June 1996**

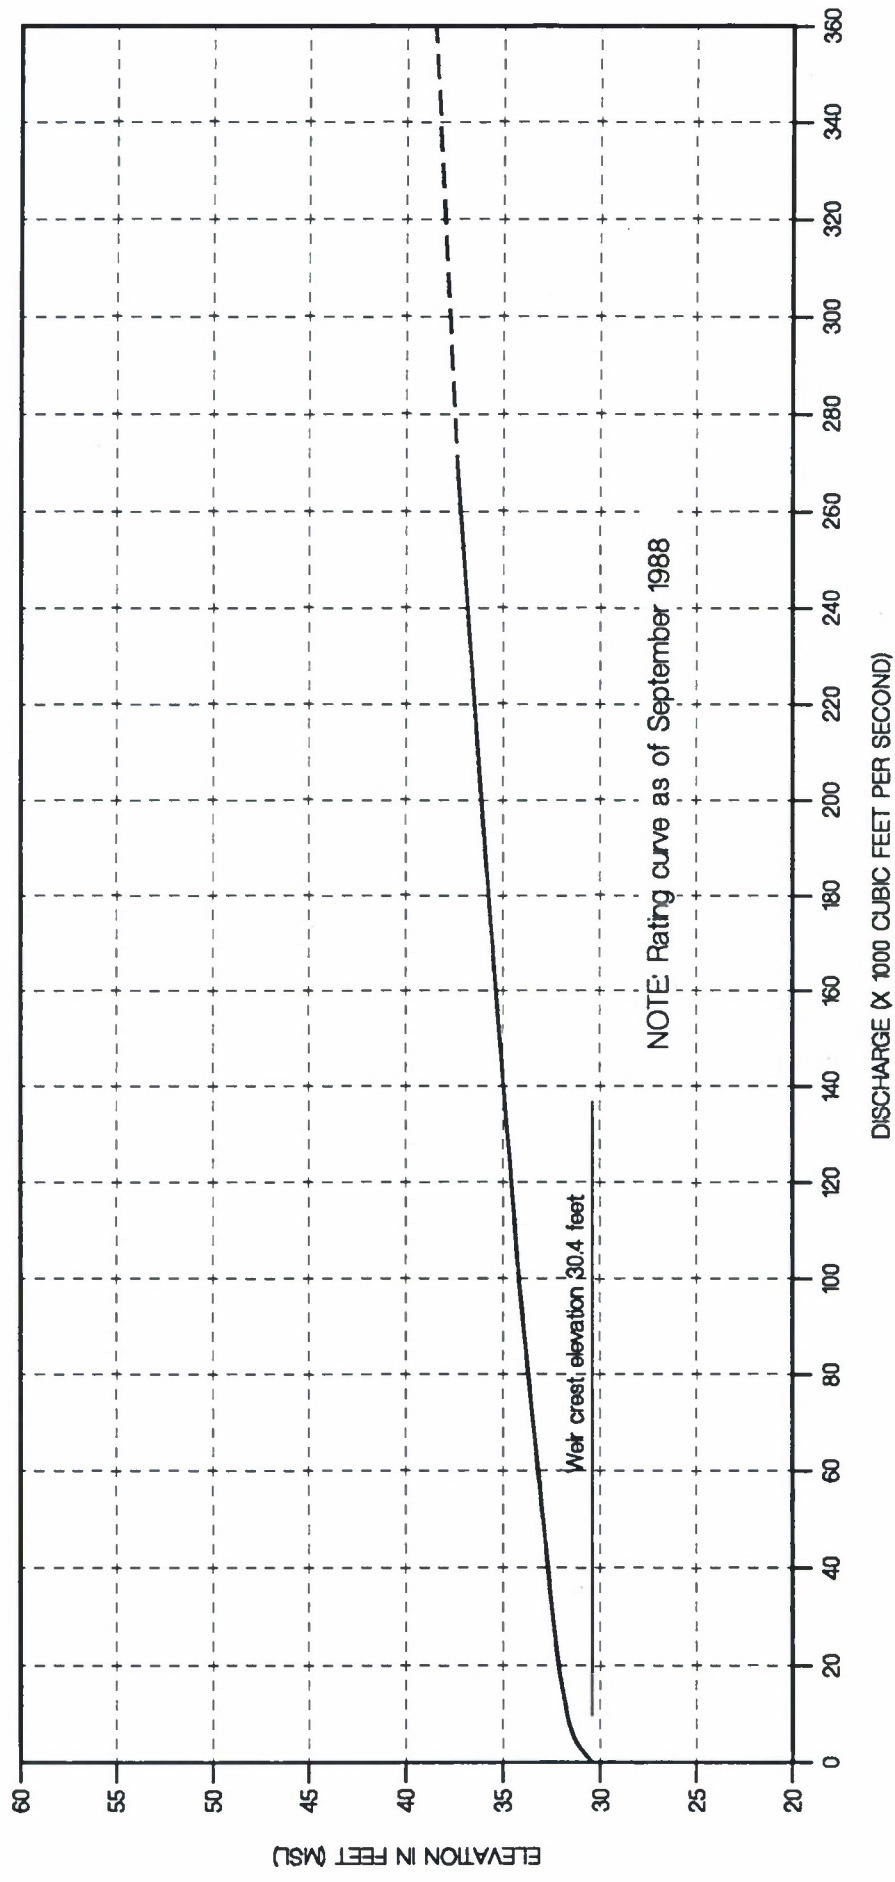
NOTE: Elevation recorded at Gage located 500 feet Upstream of West Abutment of Weir Structure.

NOTE: Rating curve as of September 1988

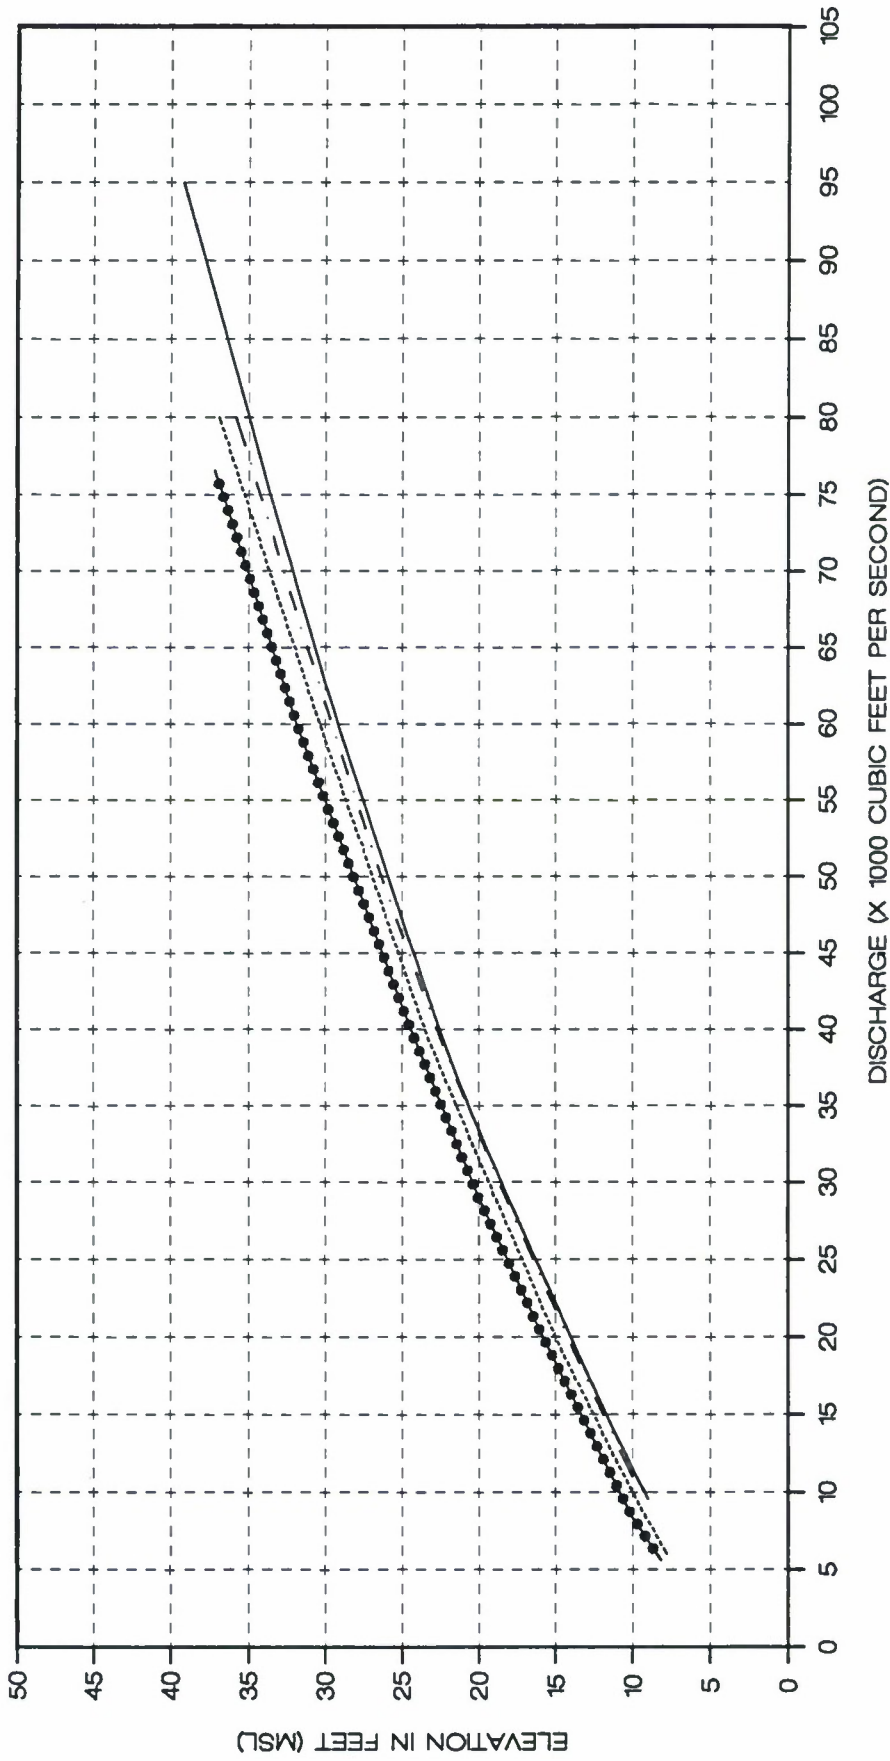
**HISTORIC RATING CURVES  
 SACRAMENTO RIVER AT VERONA**

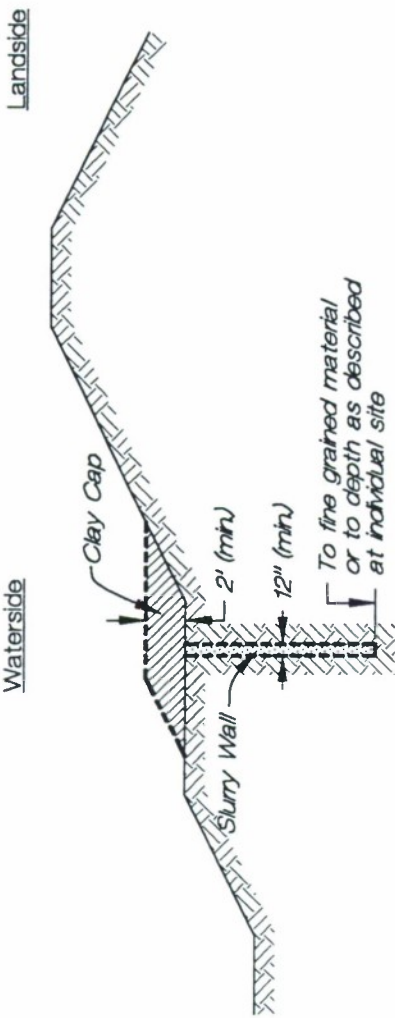
**SLURRY WALL - TYPE 1B**

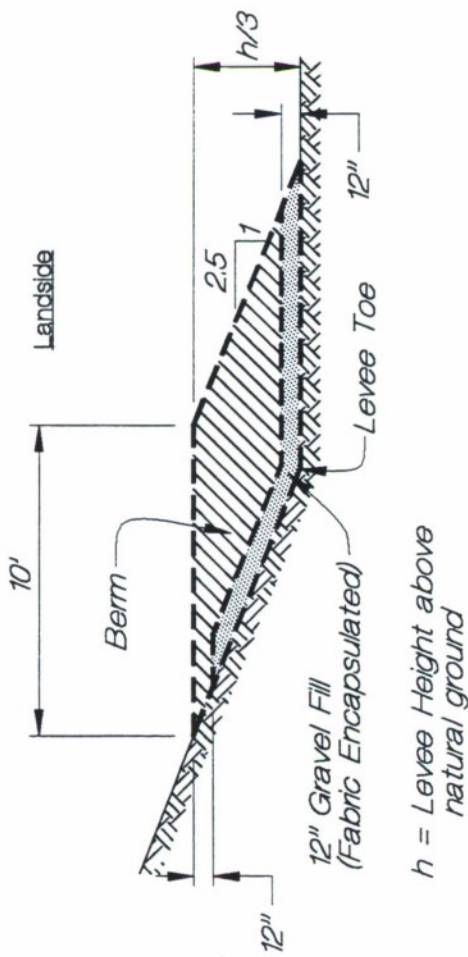
**SEEPAGE/STABILITY BERM - TYPE IIA**

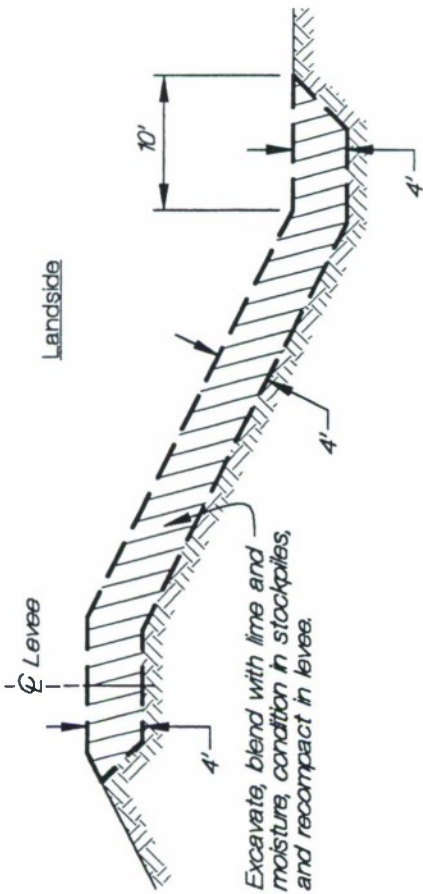
**LIME STABILIZATION OF LANDSIDE SLOPE AND CROWN - TYPE IVA**

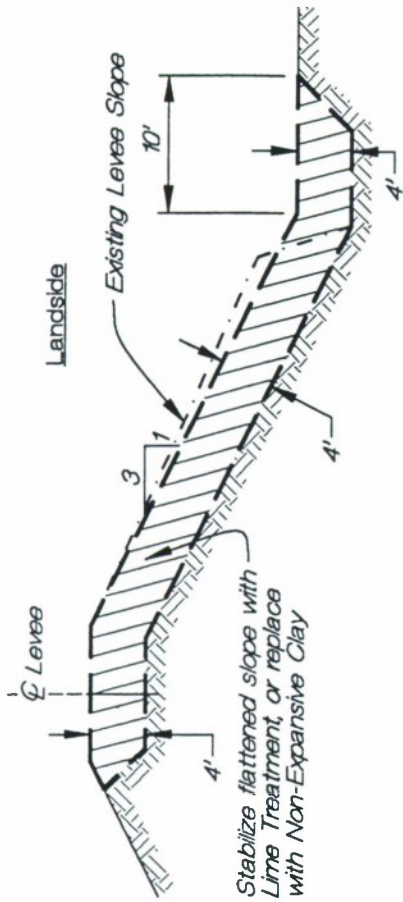
**STABILIZATION OF LANDSIDE SLOPE AND CROWN BY REPLACEMENT W/NON-EXPANSIVE CLAY - TYPE IVB**
