- *Title:* Technology Showcase: Integrated Monitoring, Diagnostics and Failure Prevention.  
Proceedings of a Joint Conference, Mobile, Alabama, April 22-26, 1996.

## **POOR SURFACES AND INTERSECTIONS OF SURFACES STILL CAUSE TROUBLE JUST LIKE THEY USED TO DO**

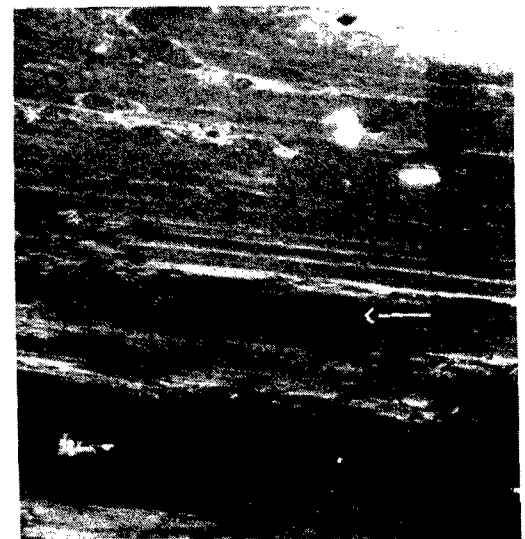
**CASE HISTORIES:** First, a trunion shaft approximately 4" diameter that failed in fatigue starting from origins on the inner surface. Figure 1 shows the fracture with two arrows pointing to origins on the rubbed (post fracture) surface. Figure 2 shows the step-like fracture progression so typical of fatigue, and Figure 3, with an arrow pointing to a tiny crack just starting, shows the roughly machined inner surface in which the origins were found. Surfaces machined inadequately for the service that the component must endure are a major source of failures of load-bearing and rotating components. Poor surface preparation can include simple roughness, tears, gouges, and chatter.

Figure 3. Crack (arrow) starting in machining groove. Mag: 85x

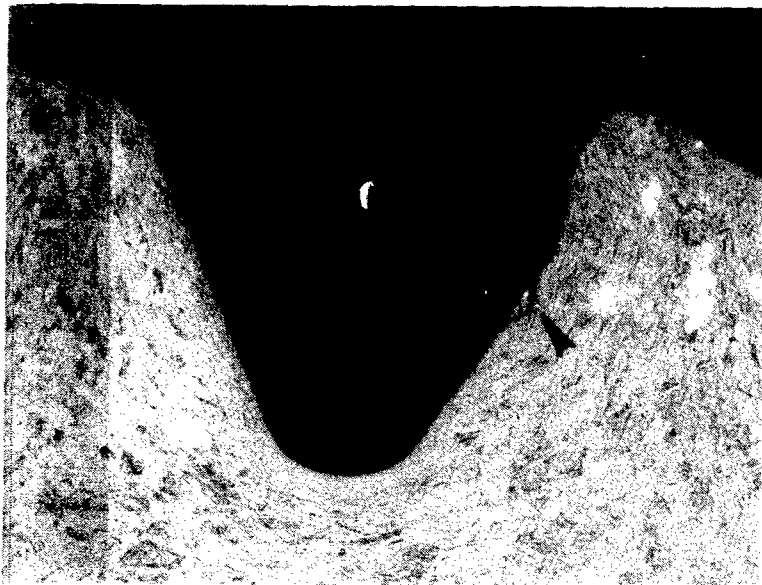
Another example of poor surface is in Figures 4 and 5. Thread rolling laps caused nuts to be loosely tightened on bolts; and the looseness ultimately allowed vibration and fatigue failure. The looseness was due to surface finish of threads: slivers (laps) of steel were able to tear free from the rolled threads during tightening and cause galling between nuts and bolts. This led to the nuts appearing to be adequately fastened when actually they were not.

Figure 5. Cross section shows lap re-entering surface. Mag: 64x
