TITLE: Occurrence of Corrosion in Airframes

TITLE: Aging Aircraft Fleets: Structural and  
Other Subsystem Aspects [le Vieillissement des  
flottes d'avions militaires : aspects structures  
et autres sous-systemes]

# Occurrence of Corrosion in Airframes

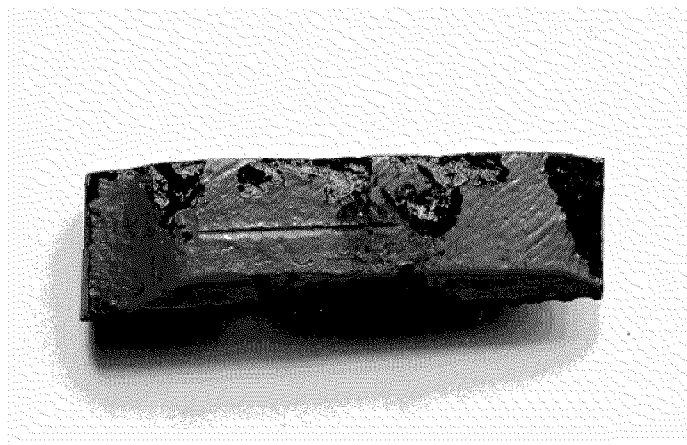
**Fig. 7 – Pitting Corrosion on MB-326 Balance Tabs**

Here following (Fig. 6 and 7) some cases occurred in the recent past are shown.

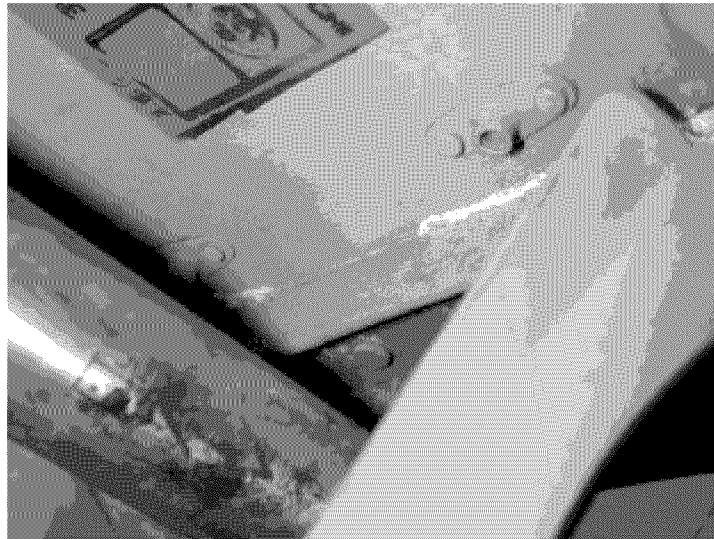
**Fig. 11 – Galvanic Corrosion on the MB-339 Attach Fitting**

Looking at the galvanic series it's easy to realize that magnesium alloys are very susceptible to suffer galvanic attack when used in junction with any other metal (Fig. 9-11).
