TITLE: Russell Road Landfill Virginia's First Subtitle C Landfill Closure

RUSSELL ROAD LANDFILL  
VIRGINIA'S FIRST SUBTITLE C LANDFILL CLOSURE

James R. Faison, Jr. Author and Kenneth J. Davis, P.E. Coauthor  
OHM Remediation Services Corp.  
Trenton, New Jersey 08690, USA  
609/584-8900  
609/588-6300

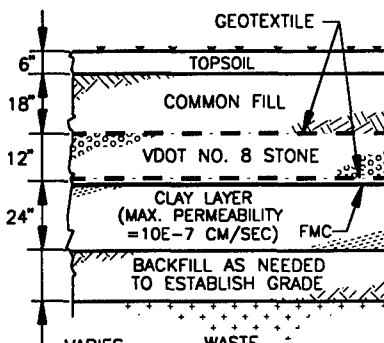
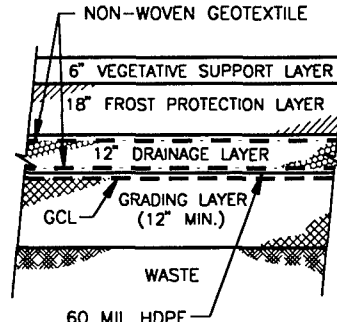
## NEW CAP CROSS-SECTION

| ORIGINAL DESIGN | MODIFIED DESIGN | BENEFITS TO CHANGE |
|---|---|---|
| <p>Diagram of the original cap cross-section showing layers from top to bottom: GEOTEXTILE (6"), TOPSOIL (18"), COMMON FILL (12"), VDOT NO. 8 STONE (24"), CLAY LAYER (MAX. PERMEABILITY = 10E-7 CM/SEC) FMC, and BACKFILL AS NEEDED TO ESTABLISH GRADE. The bottom layer is labeled 'VARIES' and 'WASTE'.</p> | <p>Diagram of the modified cap cross-section showing layers from top to bottom: NON-WOVEN GEOTEXTILE, 6" VEGETATIVE SUPPORT LAYER, 18" FROST PROTECTION LAYER, 12" DRAINAGE LAYER, GRADING LAYER (12" MIN.), GCL, and 60 MIL HDPE. The bottom layer is labeled 'WASTE'.</p> | <ol style="list-style-type: none"> <li>1) 10 oz. fabric was replaced with 8 oz. fabric. The fabric functions as a separation layer and filter layer. The materials are lower priced and are adequate for their function.</li> <li>2) 10 oz. fabric was replaced with 16 oz. fabric. Heavy fabric was needed to withstand construction loads and to protect the liner.</li> <li>3) 40 mil VLDPE was not available. The switch to 60 mil HDPE was motivated by questions of regulatory acceptance of 40 mil.</li> </ol> |

Once it was determined that the incorporation of these changes would require a resubmission of the Closure Plan, the project team embarked on a complete and comprehensive modification to the design package. Significant changes made were: the replacement of 60-mil HDPE for 40-mil VLDPE; the replacement of two concrete leachate sumps with one double-walled HDPE leachate sump, a revision to the tie-in detail between the leachate trench liner and the cap liner; the replacement of 10-ounce geotextiles above and below the stone drainage layer, with 8- and 16-ounce, respectively; redesign of the leachate collection system; and perhaps most significantly, the identification of seven areas where, after waste would be removed from outside the proposed leachate trench and verification samples were returned, "clean closure" certification would be sought. Table 1 highlights the changes made and the benefits gained. Table 2 shows the design considerations necessitated by the changes.

During discussions with VADEQ, interest was expressed in the use of alternate products that would improve cap performance and save the government money. The VADEQ enthusiastically supported a proposal to substitute GCL for off-site clay. Potential savings were now quite significant since the search for an on-site source of clay was not successful. An equivalency review was performed to verify that the proposed GCL would meet all of the requirements of the clay. Additionally, a testing program was undertaken to determine strength parameters of the GCL and between each layer of the composite cap.

In addition to the movement of waste from outside the cap to within the landfill, waste was relocated within the landfill. The landfill was reshaped to an average 3% grade. Over 60,000 cubic yards of waste were moved within the landfill to achieve final waste grade. Above the regraded waste, a 12-inch grading layer will be applied as final subgrade. The final 6 inches of subgrade will be screened to insure that no soils in excess of 2 inches in diameter would be placed. This was a measure taken to ensure that the GCL would not be subject to puncture stresses.

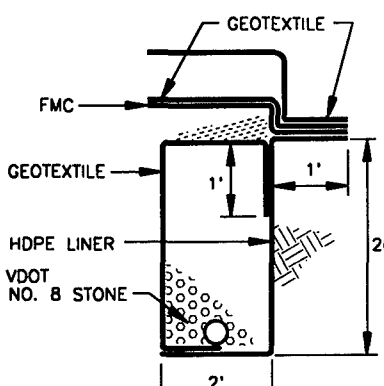
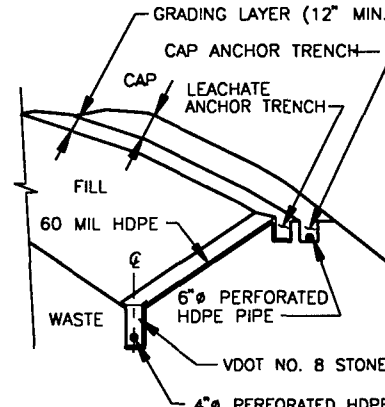
## NEW LEACHATE TRENCH CROSS-SECTION

| ORIGINAL DESIGN | MODIFIED DESIGN | BENEFITS TO CHANGE |
|---|---|---|
| <p>Diagram of the original leachate trench cross-section showing a trench with a 2' width and 20' depth. The trench is lined with HDPE LINER and VDOT NO. 8 STONE. The trench is surrounded by GEOTEXTILE and FMC. The bottom of the trench is labeled '1' and '2'.</p> | <p>Diagram of the modified leachate trench cross-section showing a trench with a 2' width and 20' depth. The trench is lined with 60 MIL HDPE and VDOT NO. 8 STONE. The trench is surrounded by GRADING LAYER (12" MIN.), CAP ANCHOR TRENCH, LEACHATE ANCHOR TRENCH, FILL, and WASTE. The bottom of the trench is labeled '6" PERFORATED HDPE PIPE' and '4" PERFORATED HDPE'.</p> | <ol style="list-style-type: none"> <li>1) Liner trench separated to facilitate staged construction.</li> <li>2) The excavation was benched to facilitate installation of the trench materials and for safety reasons.</li> <li>3) Cleanouts were installed at 400 foot centers to allow for removal of any plugs within the collection system.</li> <li>4) Placement of geotextile to prevent binding/clogging of the drainage.</li> <li>5) The trench was redesigned to ease construction.</li> </ol> |

The results of test pits provided insight into the actual depth of waste within the landfill, as well as its lateral extent. It became apparent that the proposed grades for the leachate collection system would have to be modified to allow for the leachate collection system to function as originally designed. Additionally, concerns over the constructability of trench configuration were raised. It would be nearly impossible to construct a 24-inch-wide trench to a depth of 20 feet, place a HDPE geomembrane on one wall and a geotextile on the other wall, and then place a perforated HDPE pipe and backfill the excavation. There was no way to seam the HDPE liner sheets together to create the impermeable barrier that was intended in the design. With these concerns in mind, the trench was redesigned.

The most significant impact of the new design was the ability to successfully weld the HDPE liner sheets together. During the excavation of the trench, additional waste that was encountered within the excavation was relocated to within the footprint of the landfill, thereby removing any potential contamination from outside of the landfill.

Leachate trench construction was initiated along the east border of the site. The final configuration of the trench was shown in Table 1. Included in the Closure Plan were four scenarios under which the leachate trench installation would progress for the possible subsurface conditions. For instance, provisions were made for cases where waste was encountered outside or below the designed leachate pipe invert.

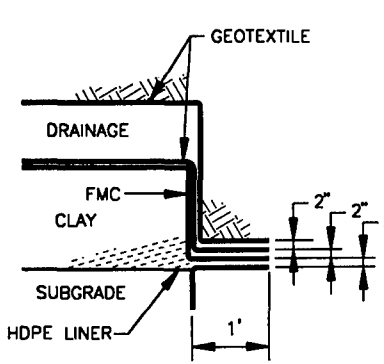
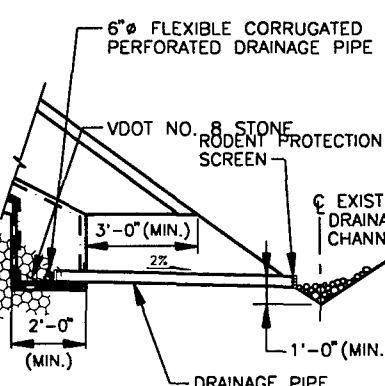
## NEW ANCHOR TRENCH CROSS-SECTION

| ORIGINAL DESIGN | MODIFIED DESIGN | BENEFITS TO CHANGE |
|---|---|---|
| <p>Diagram of the original anchor trench cross-section showing a trench with a 1' width and 2' depth. The trench is lined with HDPE LINER and FMC. The trench is surrounded by GEOTEXTILE and DRAINAGE. The bottom of the trench is labeled 'SUBGRADE'.</p> | <p>Diagram of the modified anchor trench cross-section showing a trench with a 2'-0" (MIN.) width and 2'-0" (MIN.) depth. The trench is lined with 6" FLEXIBLE CORRUGATED PERFORATED DRAINAGE PIPE. The trench is surrounded by VDOT NO. 8 STONE, RODENT PROTECTION SCREEN, EXISTING DRAINAGE CHANNEL, and DRAINAGE PIPE. The bottom of the trench is labeled '3'-0" (MIN.)' and '2'-0" (MIN.)'.</p> | <ol style="list-style-type: none"> <li>1) The drainage layer was keyed into the cap anchor trench.</li> <li>2) Placement of lateral drains prevent blowouts of the trench.</li> <li>3) Placement of geotextile to create a filter for the drainage stone, to prevent clogging.</li> <li>4) Enhances long term stormwater management.</li> </ol> |

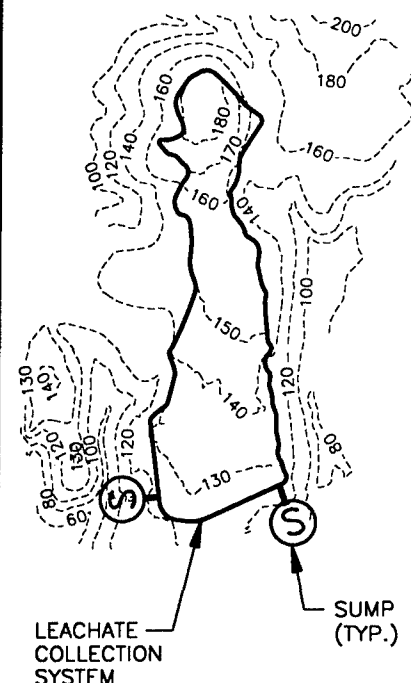
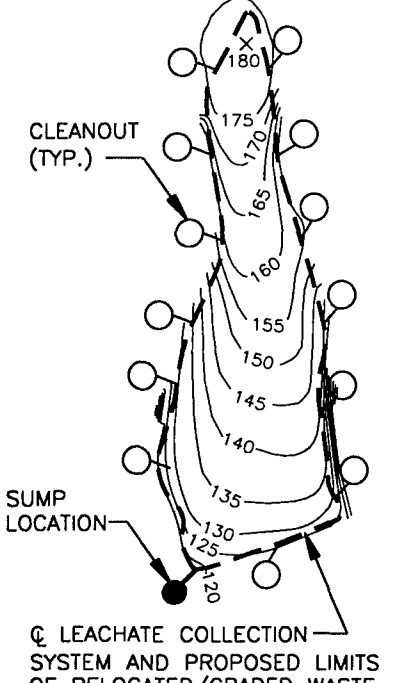
| NEW LEACHATE TRENCH CROSS-SECTION | | |
|---|---|---|
| <p>LEACHATE COLLECTION SYSTEM</p> <p>SUMP (TYP.)</p> | <p>CLEANOUT (TYP.)</p> <p>SUMP LOCATION</p> <p>Q LEACHATE COLLECTION SYSTEM AND PROPOSED LIMITS OF RELOCATED/GRADED WASTE</p> | <ol style="list-style-type: none"> <li>1) Elimination of one sump. Single discharge/alarm. Elimination of one potential spill point. Placed to allow for easy access from paved road.</li> <li>2) A concrete sump was replaced by a prefabricated HDPE sump. HDPE is a less expensive material and is more resistant to leachate breakdown.</li> <li>3) Relocation of waste saved costs associated with extending the cap to encompass all of the waste fingers.</li> <li>4) Cleanouts added.</li> </ol> |

During redesign of the leachate collection system, engineers proposed the elimination of one of the two leachate sumps. This proposal was based on a number of considerations. First, the regulations do not require any specific storage capacity for leachate collection. Second, the placement of a second sump was nearly impossible, due to the topography of the southeastern side of the landfill. Lastly, during the development of the trench profile, engineers were able to convey all collected leachate to a single collection point in the southwest corner of the landfill. This location was ideal because of its proximity to the site access way (facilitating maintenance) and its distance from other construction activity.

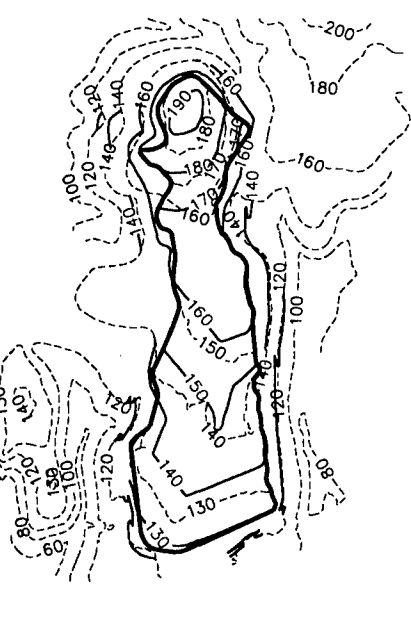
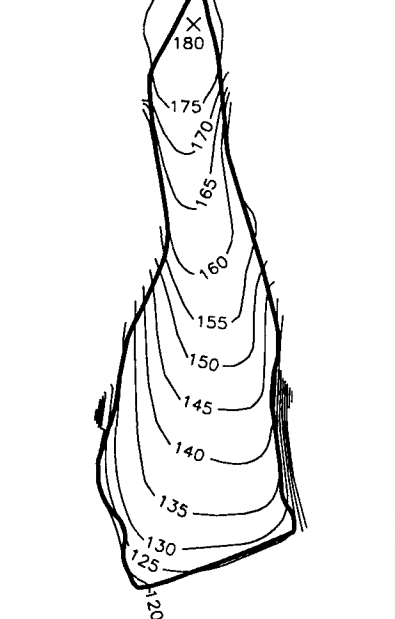
| NEW LEACHATE TRENCH CROSS-SECTION | | |
|---|---|---|
| | | <ol style="list-style-type: none"> <li>1) Flow paths were shortened by regrading the landfill. Shortened flow paths minimize potential blowouts in the cap anchor trench.</li> <li>2) Increase in grade hastens the discharge of water and reduces the potential for infiltration, which could help induce a cap failure.</li> <li>3) Grade adjustments allowed for better stormwater management, due to more water reaching the perimeter drainage channels, which then would be conveyed to the sediment control structures for final removal from the site.</li> </ol> |
