K_c Tests of Welds in Ti-13V-11Cr-3Al Alloy Sheets

from Company A and K_c Tests of Age-Strengthened

Base Metal and of Welds in Ti-6Al-4V and

NWL Report No. 1798

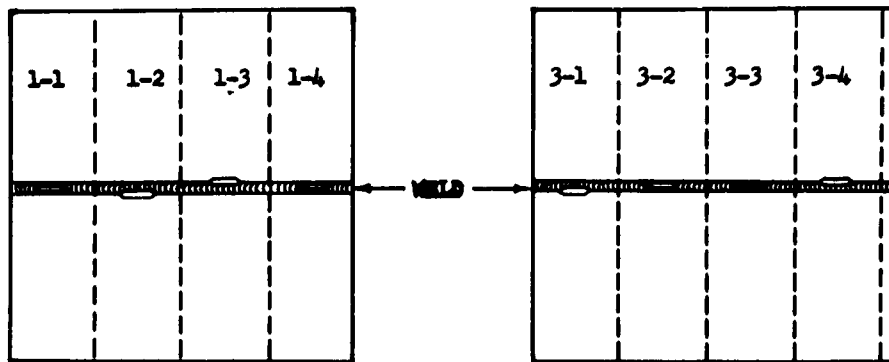
A. SOLUTION TREATED, WELDED, THEN AGED 72 HOURS AT 900°F
PLUS 5 MINUTES AT 1050°F

Etched cross sections of the welds after K_c test fracture are shown in Figures 2, 3 and 4. All welds were single pass and the melt grain size was about average. A dendritic structure pattern was brought out only in the case of aging after welding (Figure 2).

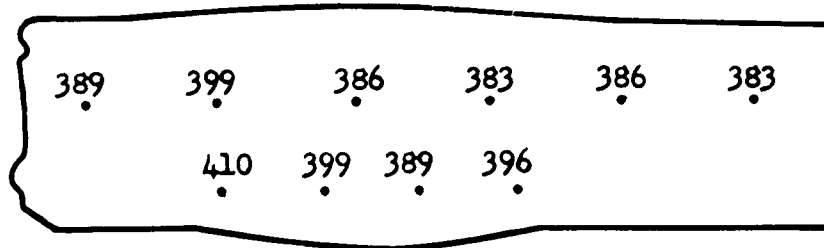
PHD-56414-9-61   FIGURE 4

(A) Specimen 6-2, notch at edge of weld, G_c fast
fracture on left end. Small
spherical cavity (arrow)

The welding practice was a special technique and the best available to Company A at the time (November 1960). Some spherical cavities like the one visible in Figure 4A were observed in the supplier's radiographic inspection. The cavities were small and probably could be classed as acceptable scattered porosity by soundness requirements for steel welds (MIL-R-11468(ORD)). Notch locations were chosen to minimize the presence of cavities in the fracture zone and no adverse effect on $\mathcal{W}_c$ was detected. The welds on these small plates were experimental; production welding presumably would overcome the cavity problem.

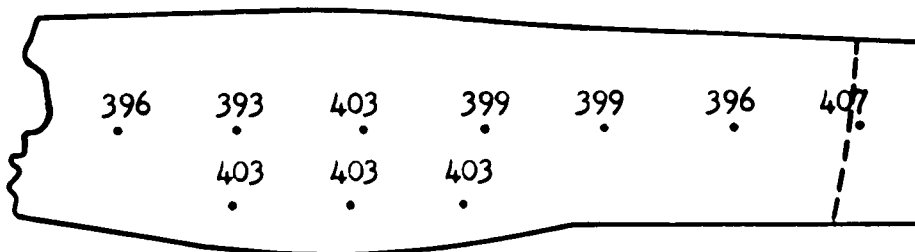
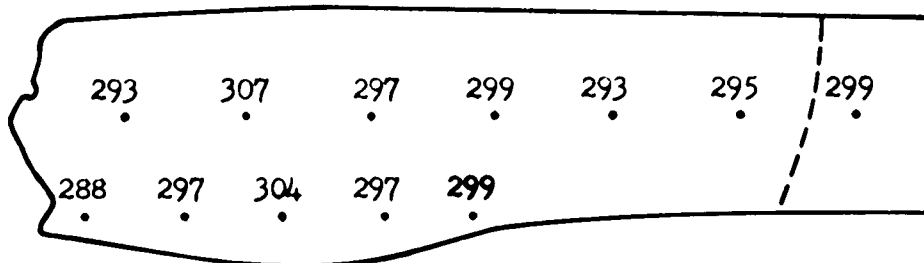
FIGURE 5

The hardness of weld cross sections in Figures 5 and 6 could be related to heat treatment based on approximate values of 300 DPH for annealed and 400 DPH for aged conditions. In panels 1 and 3 both weld and base metal had the aged hardness. Corresponding zones in panels 2 and 4 were in the soft annealed condition. In panels 6 and 7 (Figure 6, B and C), the base

(A) Specimen 1-3. Solution treated, welded,
then aged 72 hours at 900°F plus 5 minutes
at 1050°F. (Photo, Figure 2A)

(B) Specimen 3-4. Same heat treatment as
(A) above. (Photo, Figure 2B)

(C) Specimen 2-3. Solution treated and
welded. (Photo, Figure 3A)

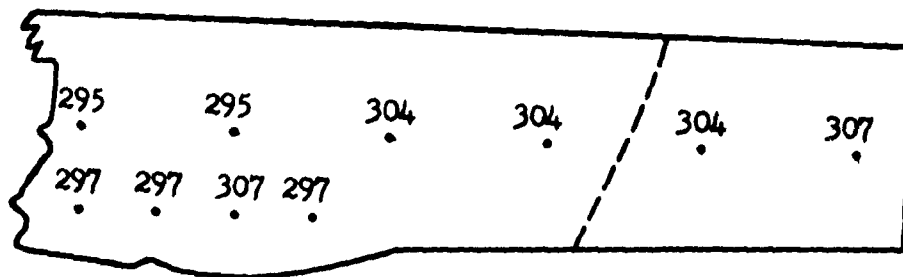
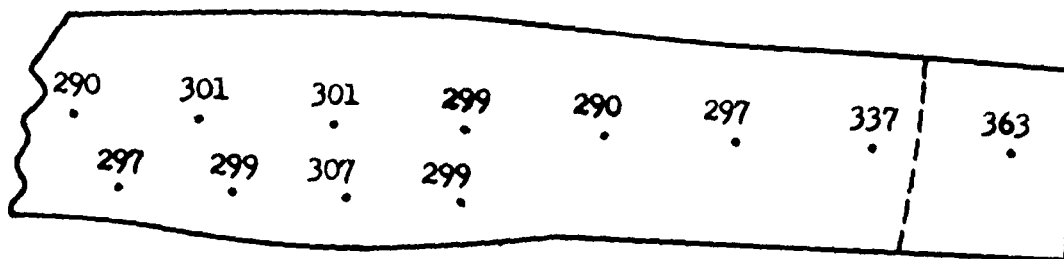
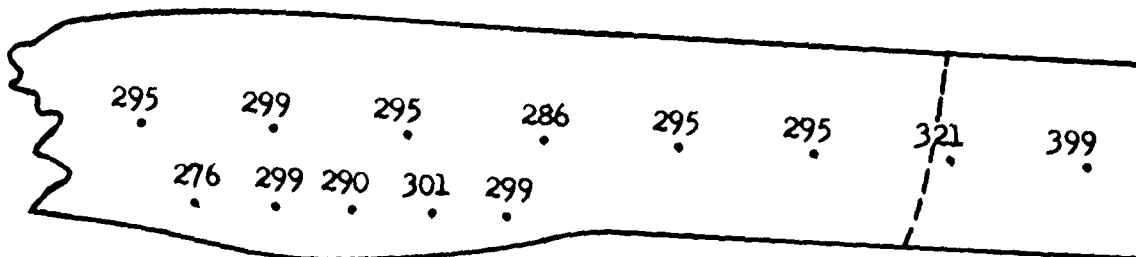
FIGURE 6

metal had been aged before welding and the weld was in the annealed condition. Hardness patterns across the welds in panels 6 and 7 were used to estimate probable yield strengths at weld edge and weld center for $\mathfrak{K}_c$ calculations.

(A) Specimen 4-3. Solution treated and welded.
(Photo, Figure 3B)

(B) Specimen 6-2. Solution treated, aged 72 hours
at 900°F then welded. (Photo, Figure 4A)

(C) Specimen 7-2. Same heat treatment as (B) above.
(Photo, Figure 4B)

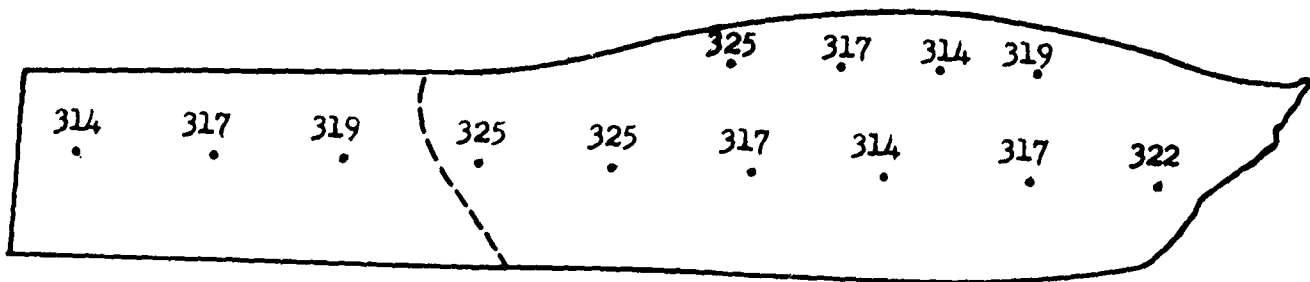
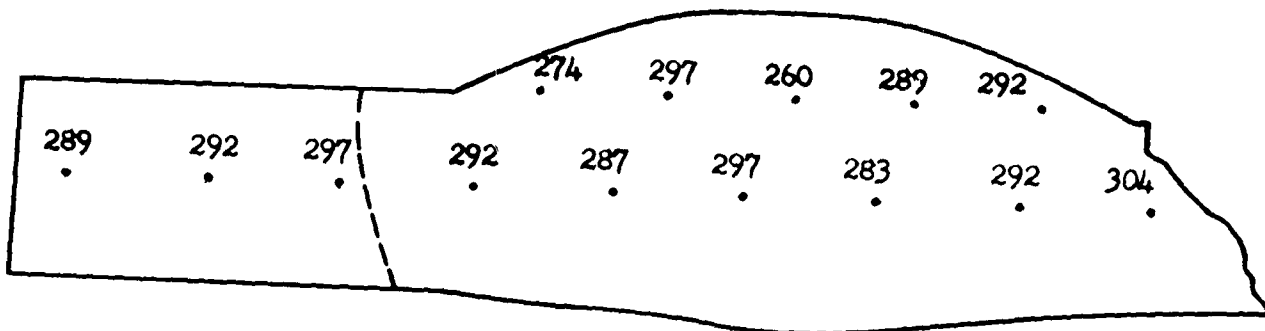
FIGURE 10

Weld macrostructures of the alloys in the as-welded (annealed) condition are illustrated in Figure 9. The weld grain size was large in Ti-6Al-4V metal but this is known to have little effect on fracture toughness of welds in this alloy. The Ti-13V-11Cr-3Al weld had a moderately fine grain structure. The weld hardness patterns (Figure 10) confirmed the expected annealed conditions of weld and base metal in both alloys.

(A)   Ti-6Al-4V alloy, specimen W-4.   (Photo, Figure 9A)

(B) Ti-13V-11Cr-3Al alloy, specimen W-4.   (Photo, Figure 9B)

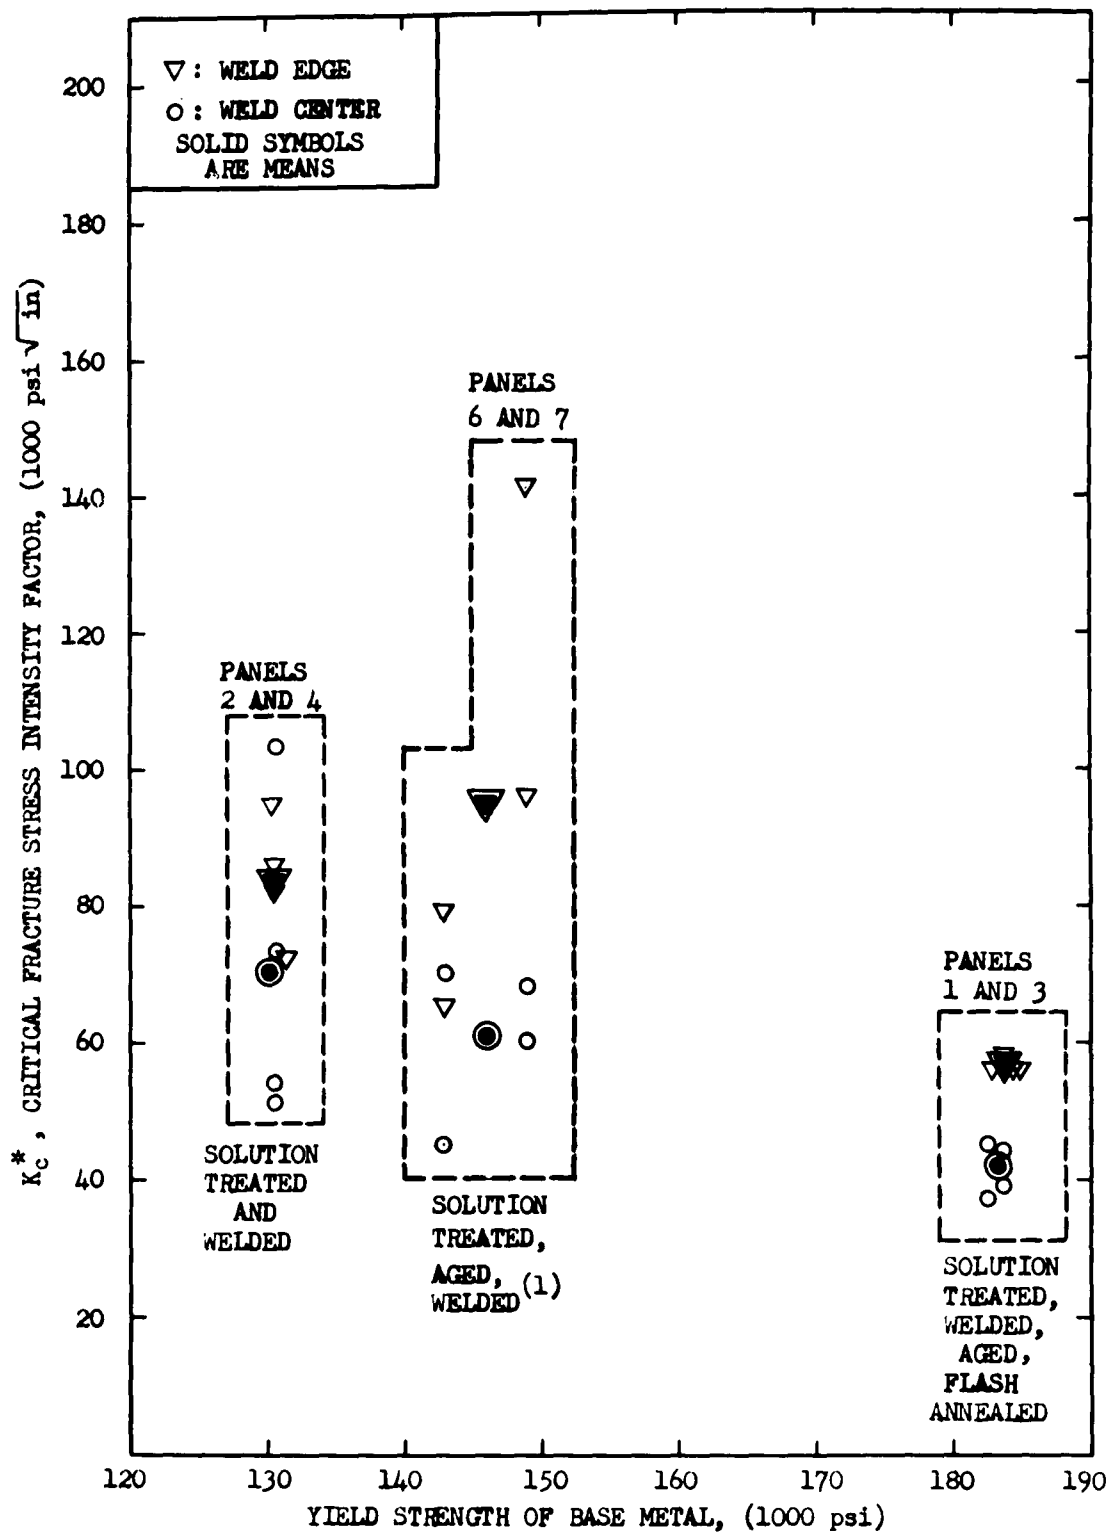
FIGURE 11

Results on Ti-13V-11Cr-3Al Samples from Company A. The crit-
ical fracture stress intensities (K_c^*) for crack propagation were
plotted in Figure 11. When welding was the final operation so
that a soft annealed metal (about 130,000 psi yield strength) was
obtained in the joint, fracture toughness properties within the
weld zone were practically independent of whether the base metal
had been in a soft solution-treated or in an age-strengthened
condition. If the panel was given a final aging treatment after
welding (panels 1 and 3), poor fracture toughness properties were
obtained. The latter tests represented an experimental treatment
since aged welds of this alloy ordinarily are not used.

K_c^* CRITICAL FRACTURE STRESS INTENSITY FACTORS FOR WELDS OF
Ti-13V-11Cr-3Al TITANIUM ALLOY SHEET, 0.125 INCH NOMINAL THICKNESS
WITH INDICATED TREATMENTS, SAMPLES FROM COMPANY A

(1) Yield strengths were referred to hardness indications
at the edge of the annealed weld rather than the
yield strength of the aged base metal.

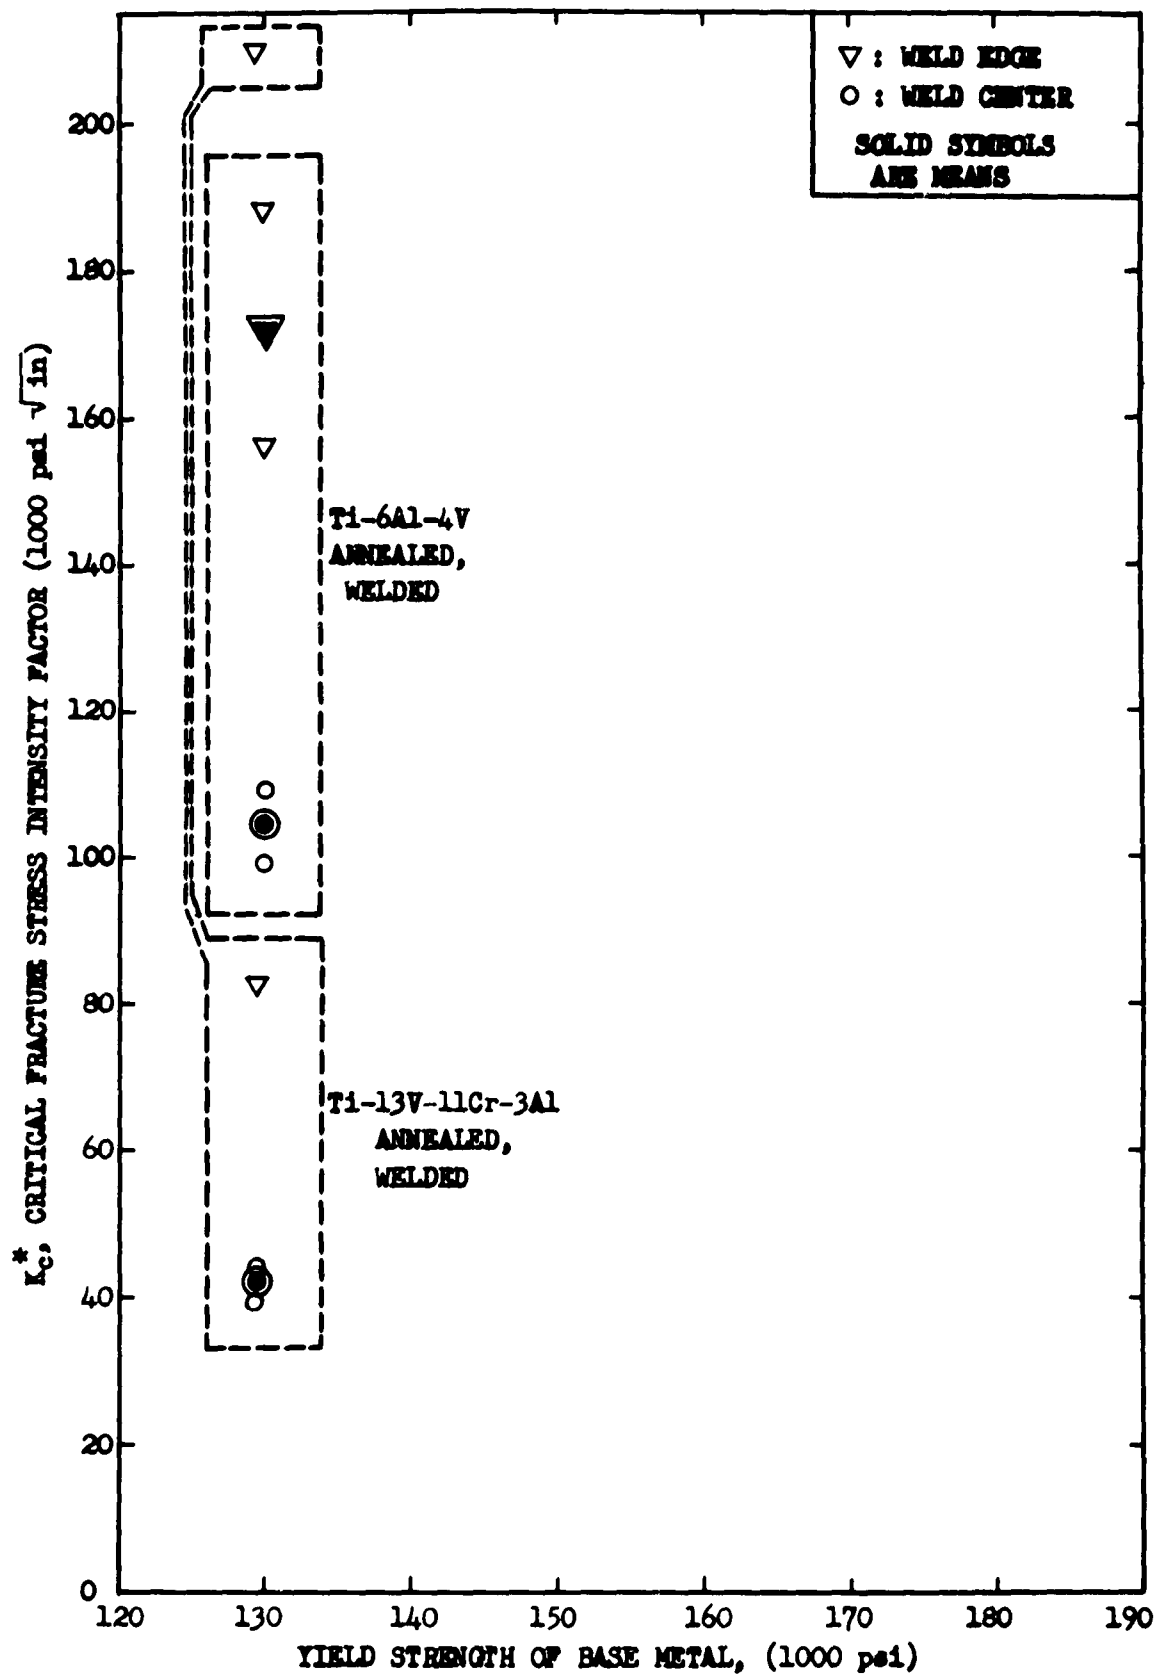
FIGURE 12

K_c* fracture toughness values in the weld zone of annealed base metal for both alloys from Company F are plotted in Figure 12. The Ti-6Al-4V panel showed consistently high toughness values in the center and edge of the weld. This was confirmed by shear values of 100 percent in the fast fracture (Table 5).

The weld centers in Ti-13V-11Cr-3Al alloy gave typical low results. The weld edge values were better and an extremely high value was found in specimen W-4. As shown in Figure 13, the cause was traced to a sharply-angled juncture of heat-affected weld zone with unaffected base metal which enabled the tough base metal to reinforce the weld edge at the point of fracture.

K_c^* CRITICAL FRACTURE STRESS INTENSITY FACTORS FOR WELDS OF Ti-6Al-4V
AND Ti-13V-11Cr-3Al TITANIUM ALLOYS, 0.125 INCH NOMINAL THICKNESS,
ANNEALED BASE METAL AS WELDED, SAMPLES FROM COMPANY F

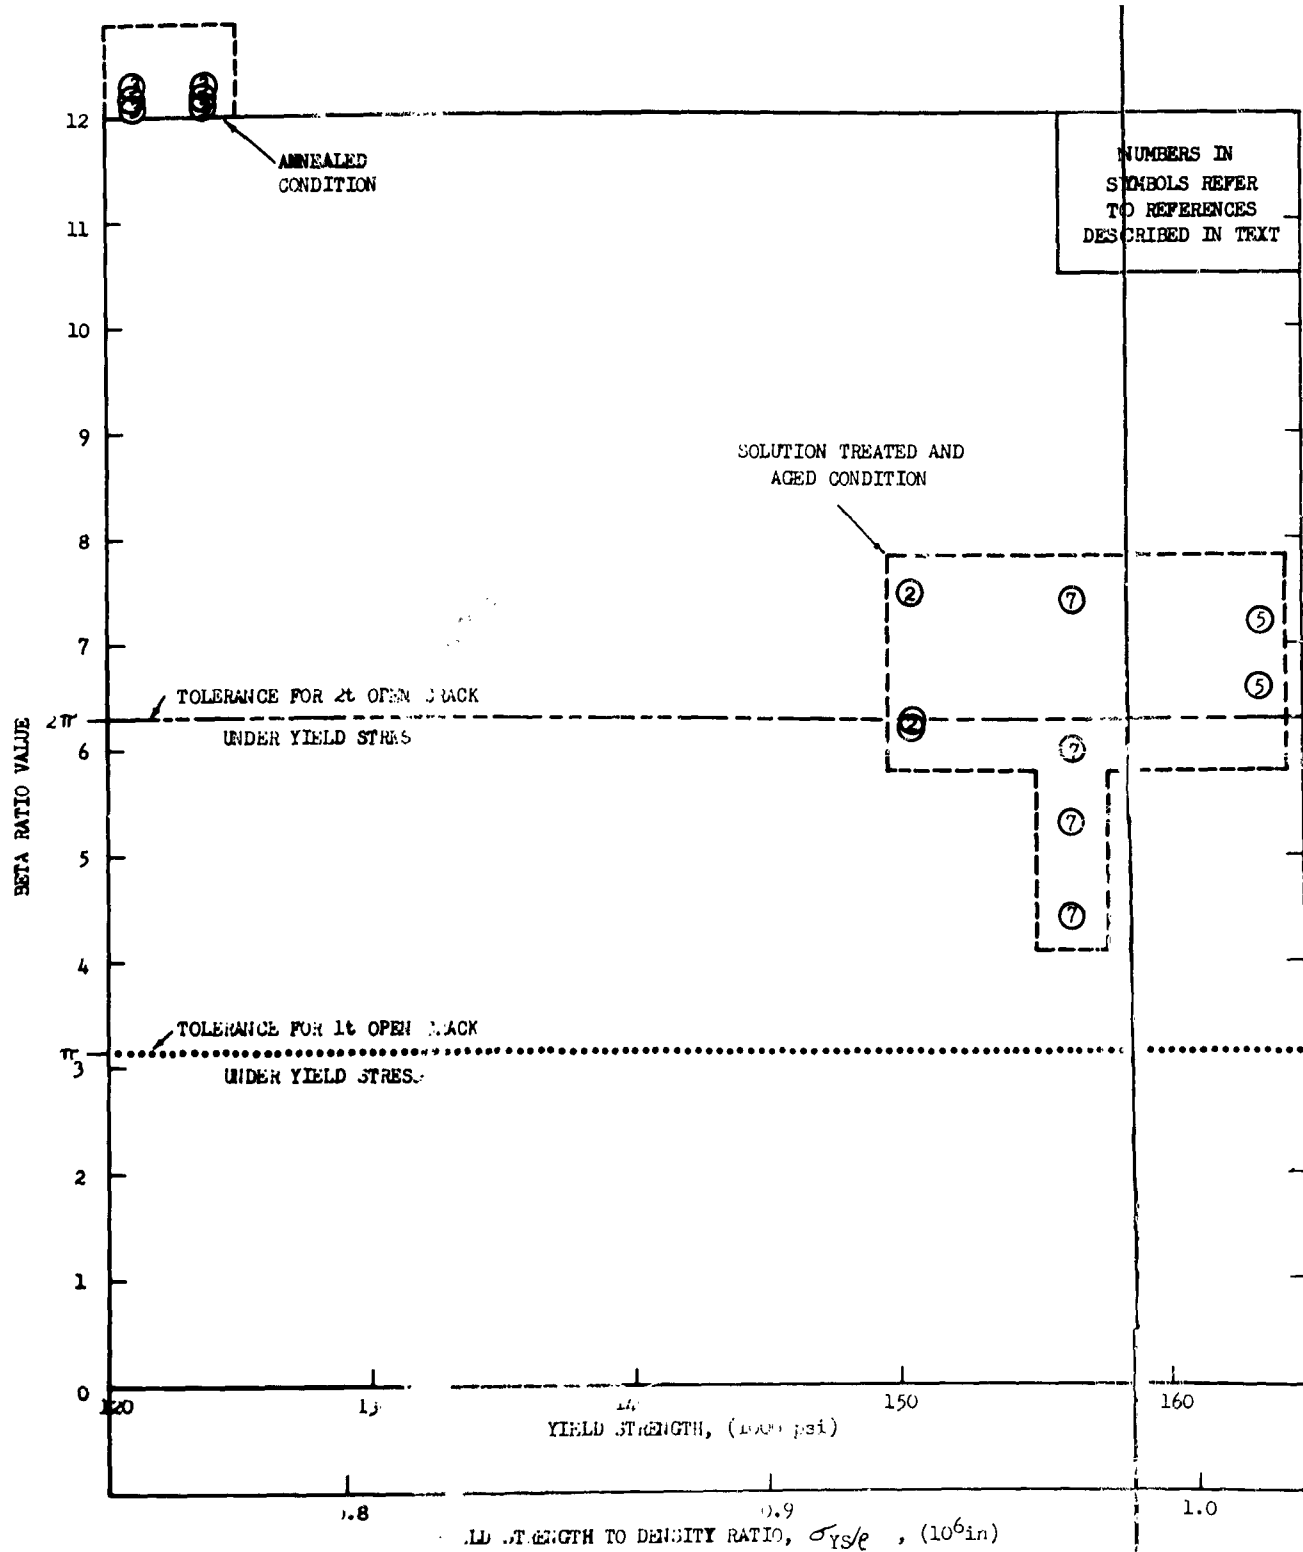
FIGURE 14

Fracture toughness results on Ti-6Al-4V sheet are summarized in Figure 14. With a low σ_{YS}/ρ of about 0.75×10^6 inches, the annealed condition is not of much interest even though crack tolerance is large. In the solution-treated and aged condition, the improved strength resulted in strength-weight ratios approximating the desired value of one million inches. A beta ratio of about 2π in the high strength condition indicated a crack length tolerance close to 2t corresponding to an optimum balance between toughness and yield strength (reference (c)). This alloy, therefore, appears to have both a strength-weight ratio and an optimum resistance to crack propagation suitable for wall construction in lightweight chambers for solid propellant rockets. The rocket casings probably would be made by machining ring-rolled heavy cylinders. A water quench is a necessary part of the heat treatment. Weld toughness will be discussed later.

RET.   .UE F OM G_c TESTS OF Ti-6Al-4V TITANIUM ALLOY SHEETS,
       .. 9 TO 0.12 INCH THICK, FROM ALL SOURCES

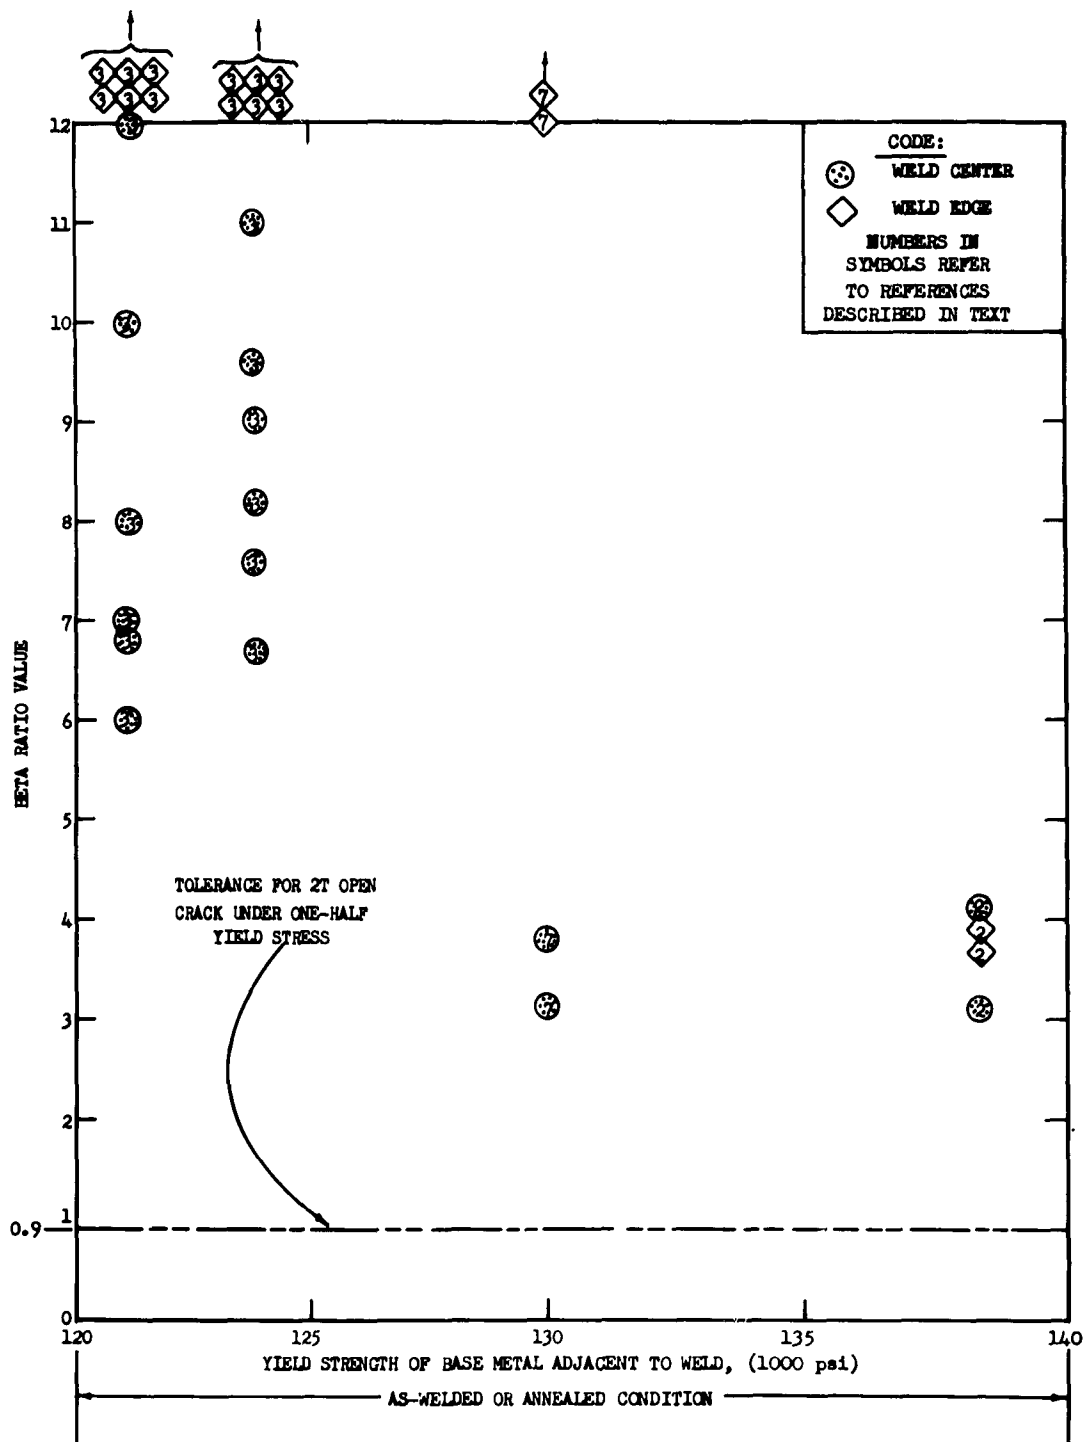
FIGURE 16

As shown in Figure 16, $\mathcal{H}_c$ tests of Ti-6Al-4V welds from
three sources indicated considerably more than the minimum crack
length tolerance. Provided that welds are made by ordinary good
practice for titanium, fracture toughness of girth welds appar-
ently is not a problem in the use of this alloy for rocket chambers.

BETA VALUES FROM G$_c$ TESTS ON WELDS IN Ti-6Al-4V SHEET, APPROXIMATELY 0.125 INCH THICK, FROM ALL SOURCES

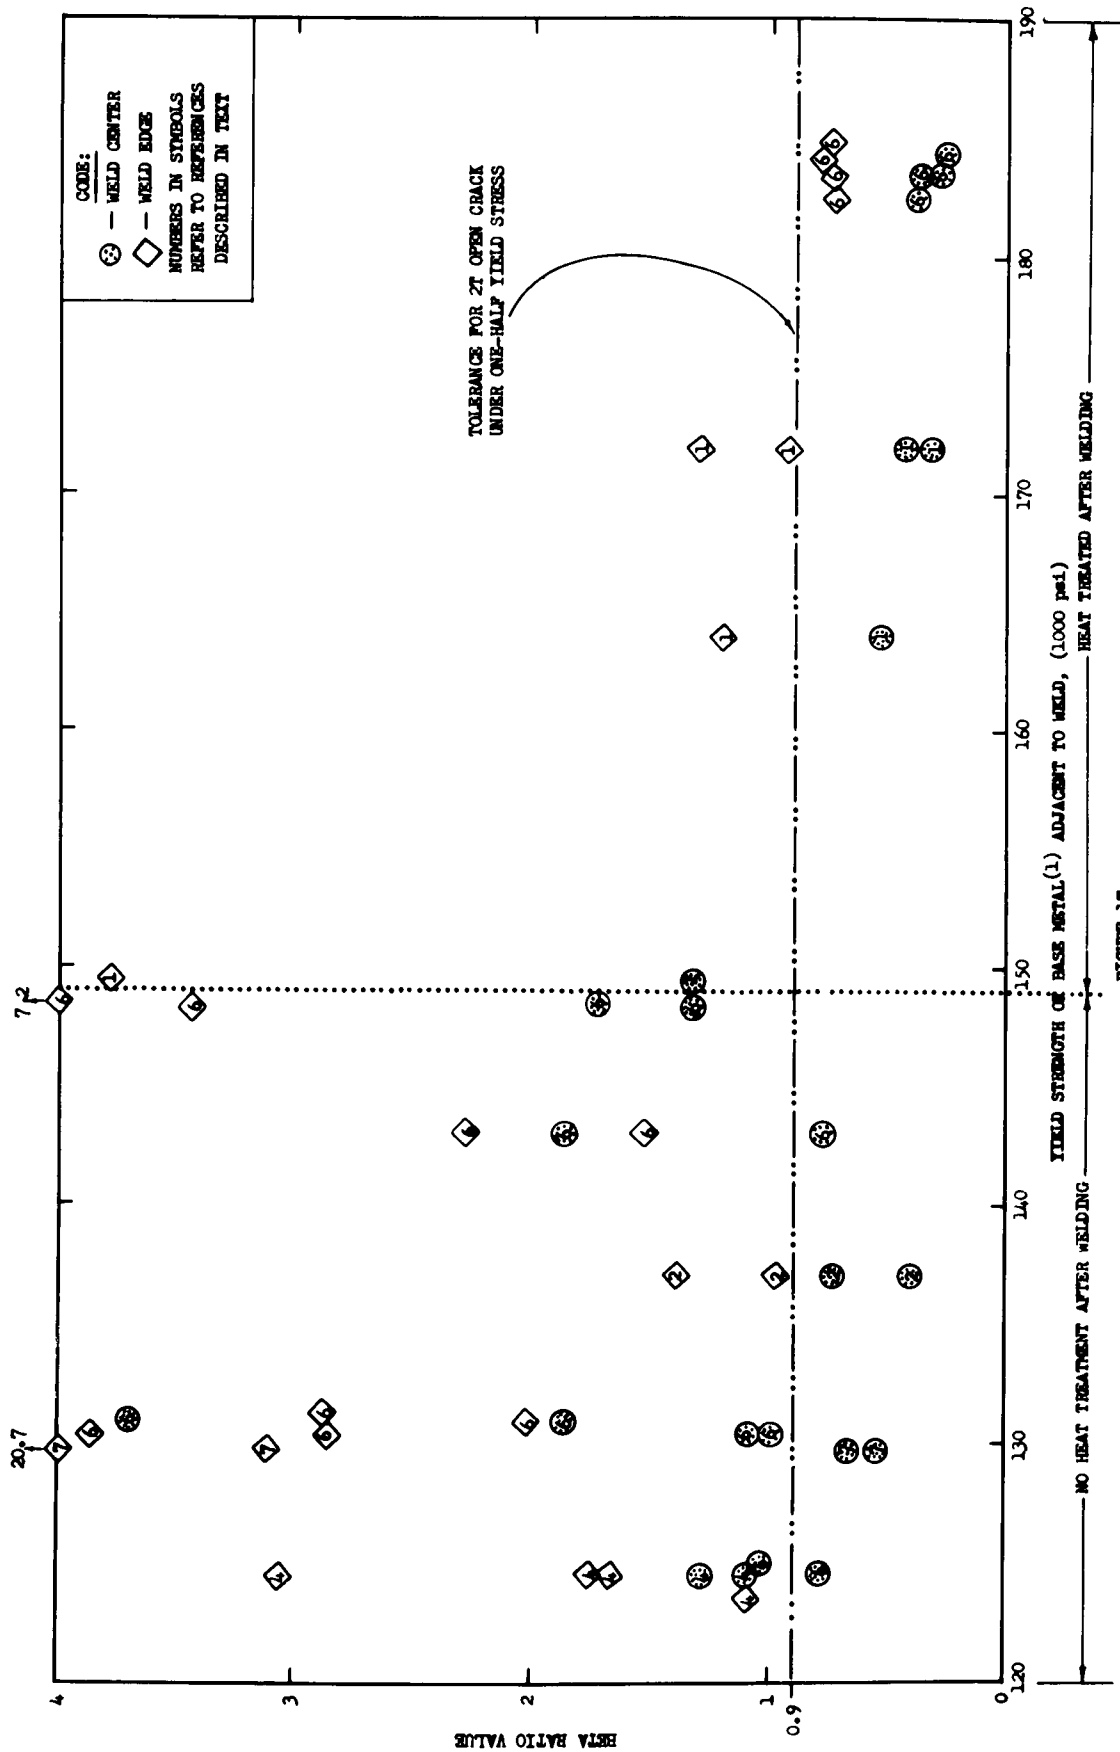
FIGURE 17

The fracture toughness results in girth welds of all-beta
Ti-13V-11Cr-3Al alloy are illustrated in Figure 17 based on
samples from five sources. The beta value of 0.9 required for
a 2t crack tolerance in these welds was not exceeded consistently
at any part of the yield strength range covered by the chart.
Aging heat treatment after welding to yield strength levels above
160,000 psi was obviously harmful to toughness since all of the
weld centers in this region were relatively brittle. This effect
of aging is not serious since unaged (annealed) yield strengths
are considered satisfactory with the practice of joining thick-
ened edges. Based on beta values in annealed welds, several
apparently satisfactory individual welding practices were indi-
cated. The brief sampling plan did not lead to definition of

optimum welding conditions. The general characteristics of all-beta welds have been discussed in other reports (reference (j)). Flaw content of the weld center obviously ought to be kept low since there is little excess of toughness above the minimum requirement. With fracture toughness tests to establish and control a selected welding practice, it would seem that satis-factory welds could be made in all-beta alloy.

BETA VALUES FROM G_c TESTS ON WELDS IN Ti-13V-11Cr-3Al SHEET, APPROXIMATELY 0.125 INCH THICK, FROM ALL SOURCES
