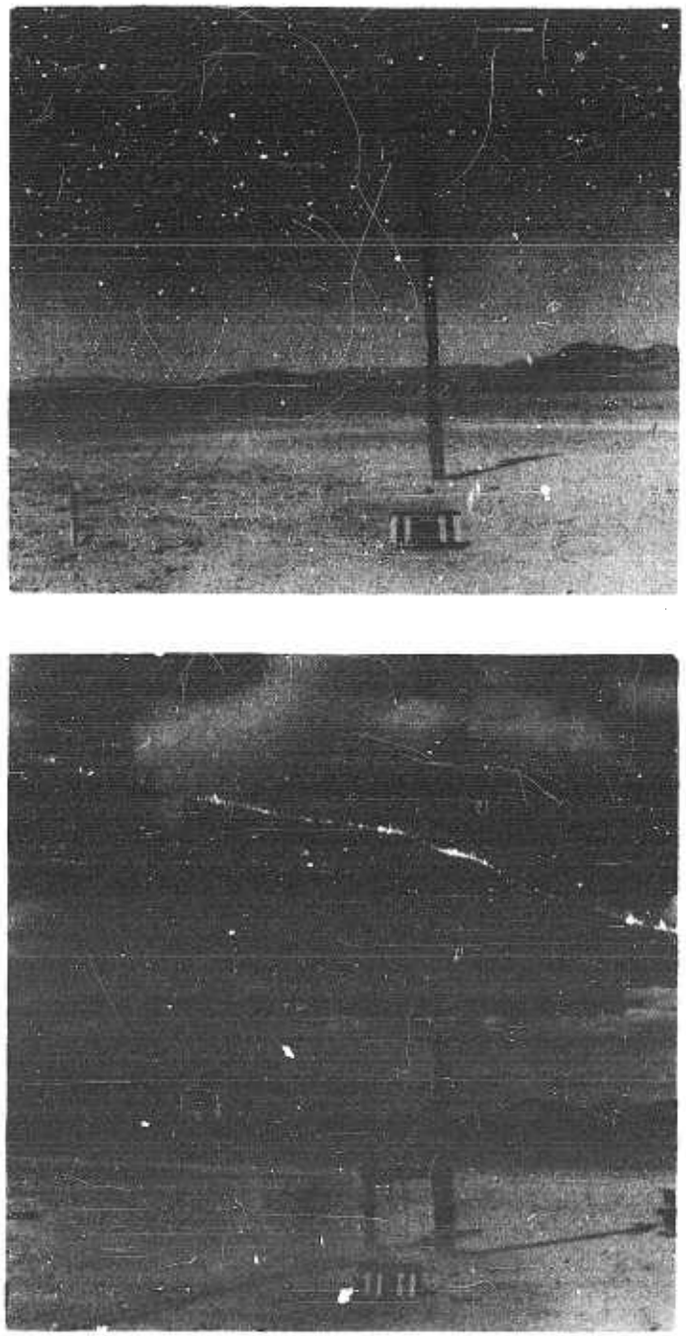
Fig. 3.1 Shot 9, Test Group 1, Radial Pole Line, Pole D-1 (Top-before, Bottom-after) (EE-8 Field Telephones in Bottom View were Installed Prior to Shot 9.) 9080 ft, 8 cal, 3 psi

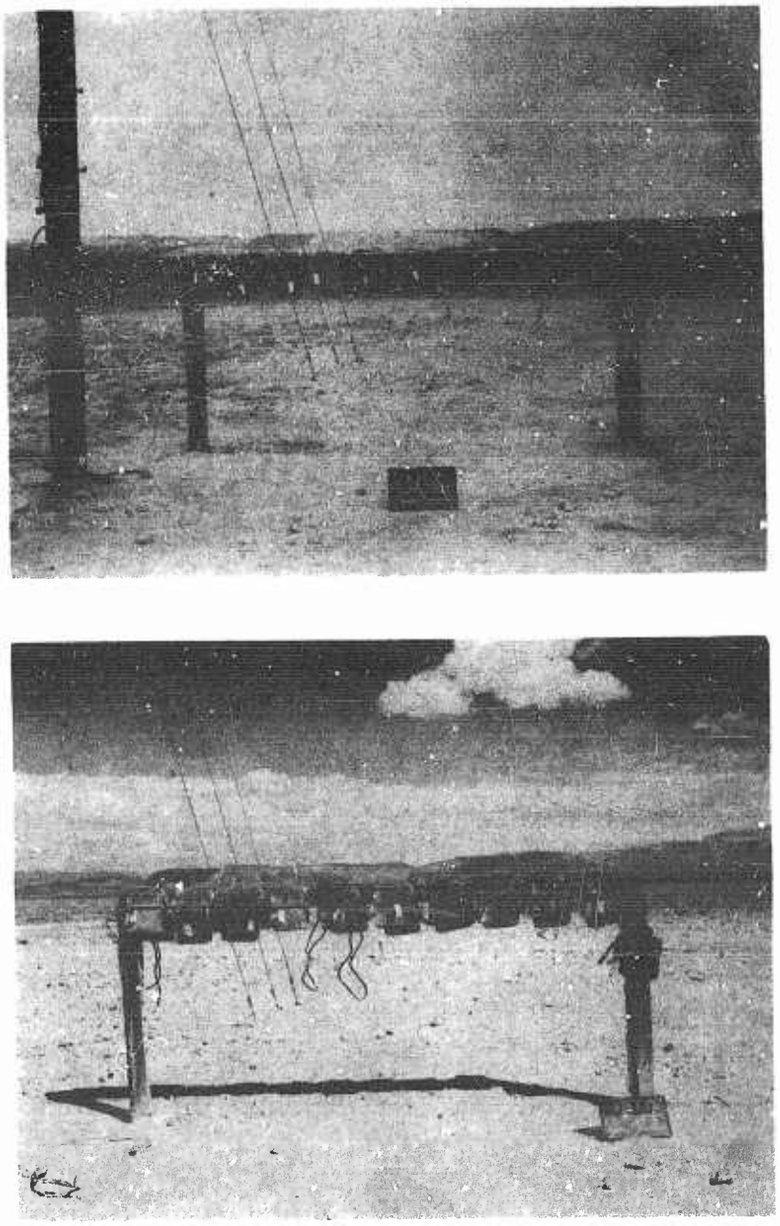
Fig. 3.2 Shot 9, Test Group 1, 1-1/2 Mile Pole Line, Pole D-1 and EE-8 Field Telephones used to Test Circuits. (Top-before, Bottom-after) 9080 ft, 8 cal, 3 psi

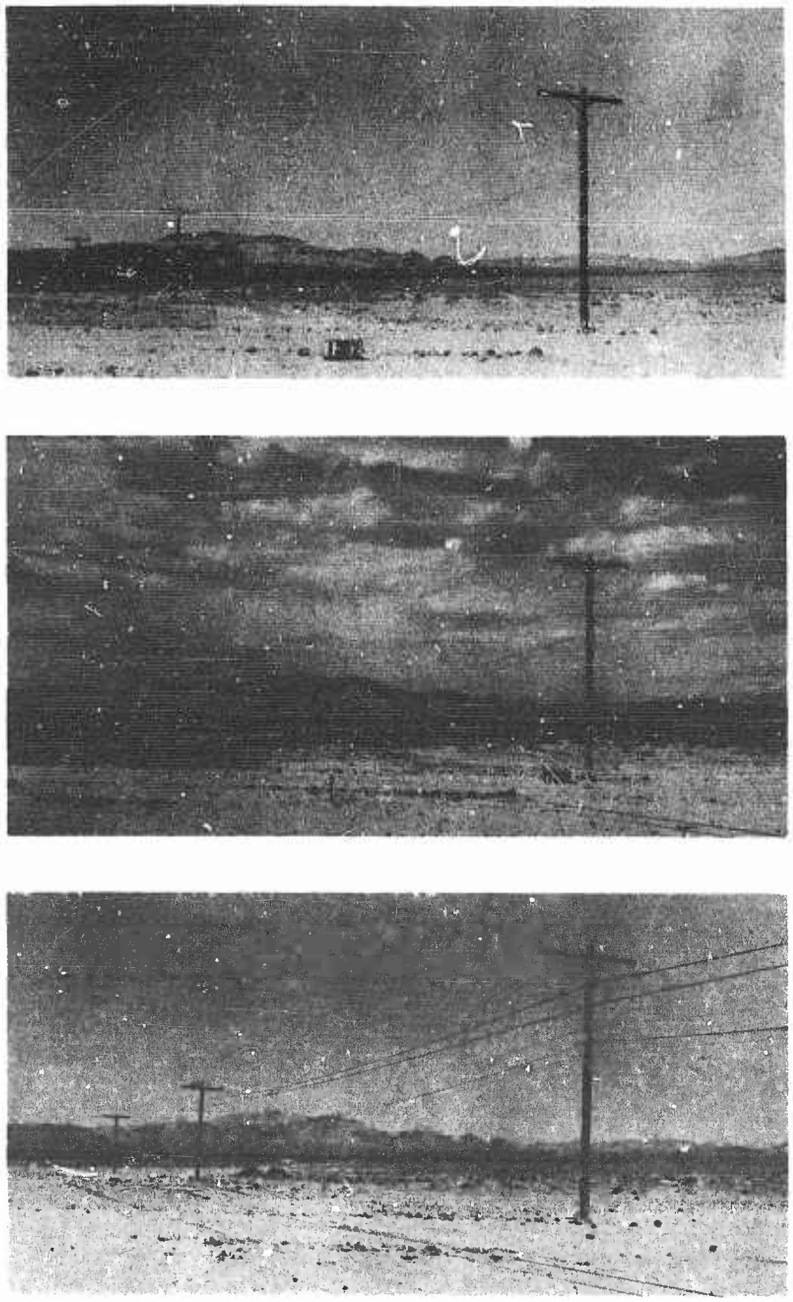
Fig. 3.3 Shots 9 and 10, Test Groups 1 and 1A, Radial Pole Line, Poles D-1 through D-4. D-4 in Foreground. (Top-before 9, Center-after 9, Bottom-after 10) Shot 9 - 9080-8450 ft, 8-10 cal, 3-3.1 psi. Shot 10 - 8350-7850 ft, 5.5-6.5 cal, 1-1 psi

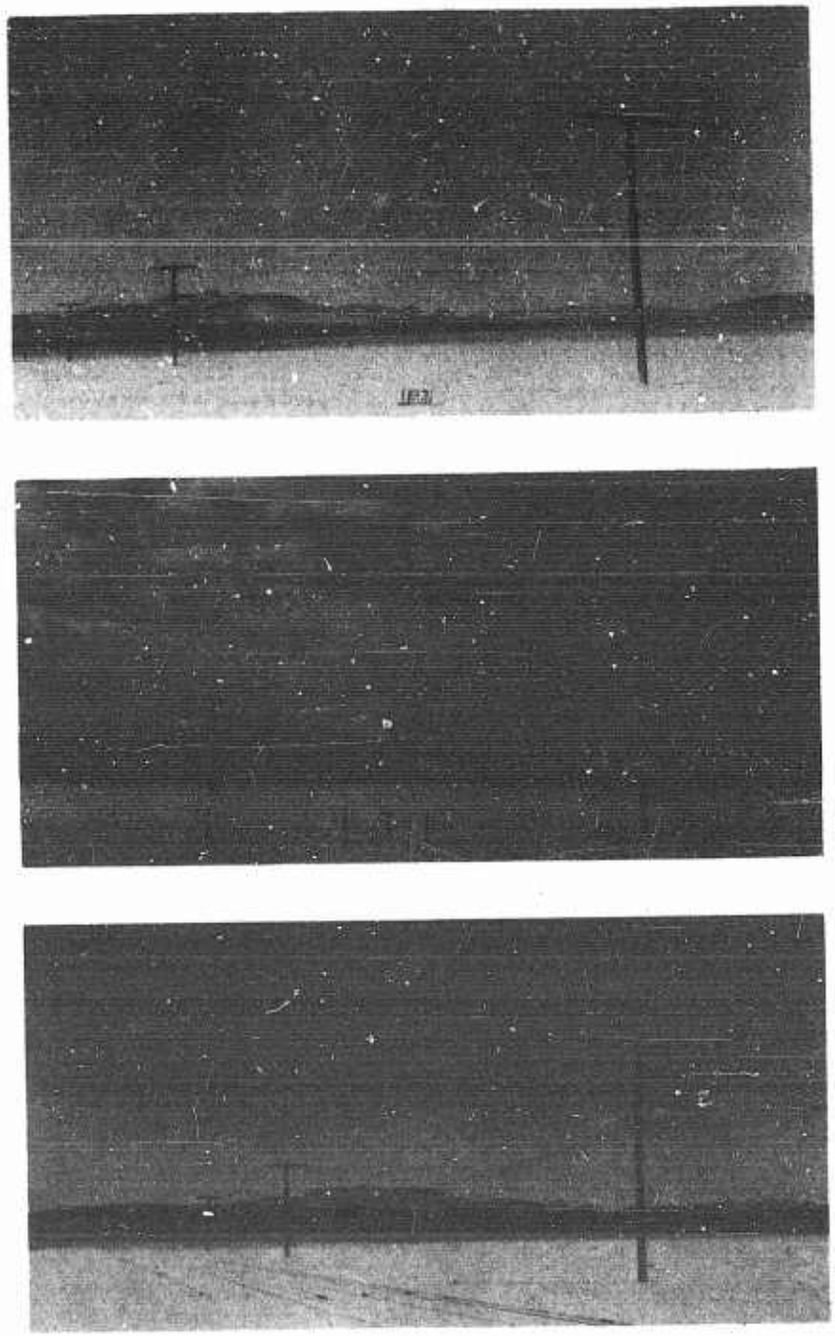
Fig. 3.4 Shots 9 and 10, Test Groups 1 and 1A, Radial Pole Line, Poles D-3 through D-7. D-7 in Foreground. (Top-before 9, Center-after 9, Bottom-after 10) Shot 9 - 8750-8050 ft, 9.5-11.5 cal, 3-3.4 psi. Shot 10 - 8000-7425 ft, 6-7.5 cal, 1-1 psi.

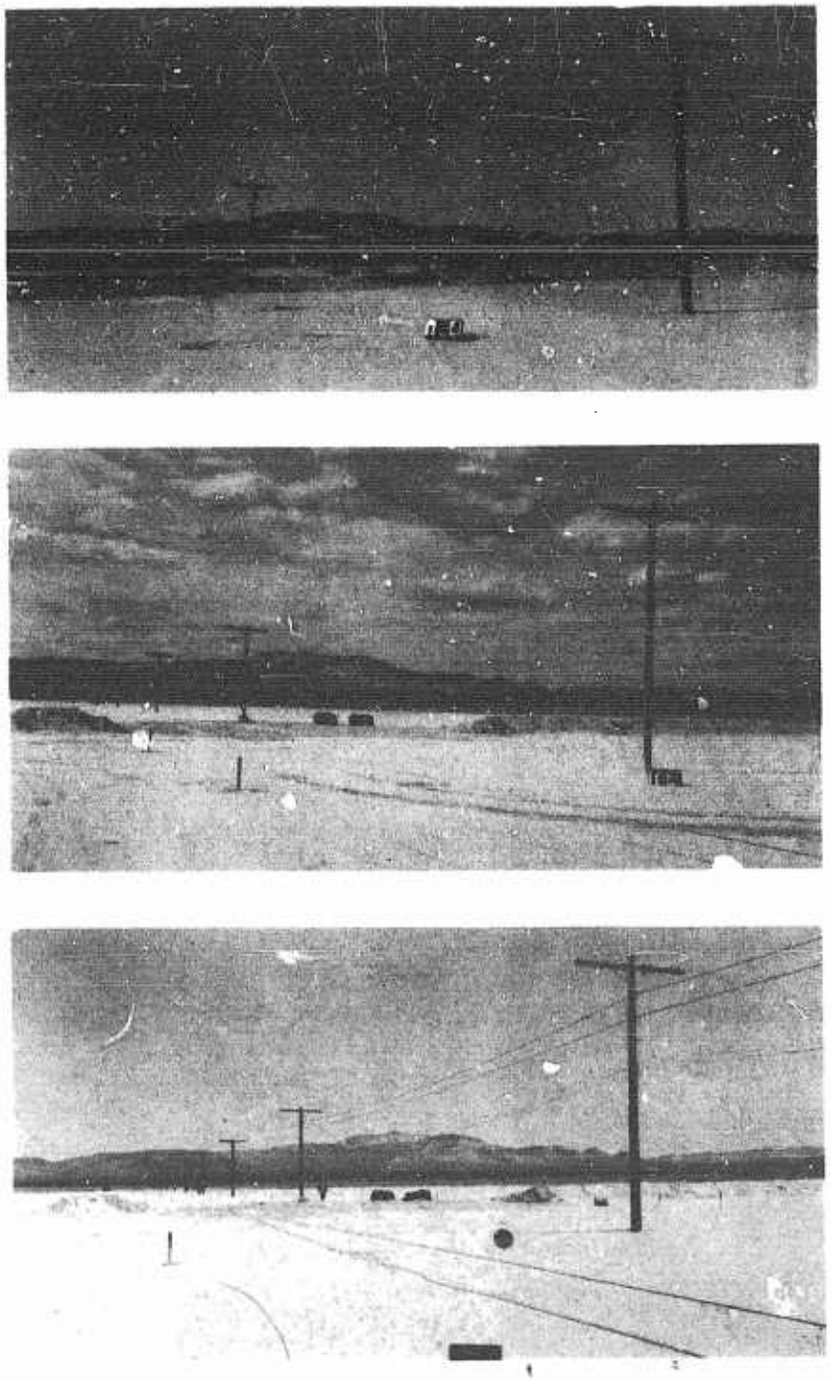
Fig. 3.5 Shots 9 and 10, Test Groups 1 and 1A, Radial Pole Line, Poles D-1 through D-10. D-10 in Foreground. (Top-before 9, Center-after 9, Bottom-after 10)
Shot 9 - 9080-7550 ft, 8-13 cal, 3-3.6 psi.
Shot 10 - 8350-6950 ft, 5.5-8.5 cal, 1-1 psi.

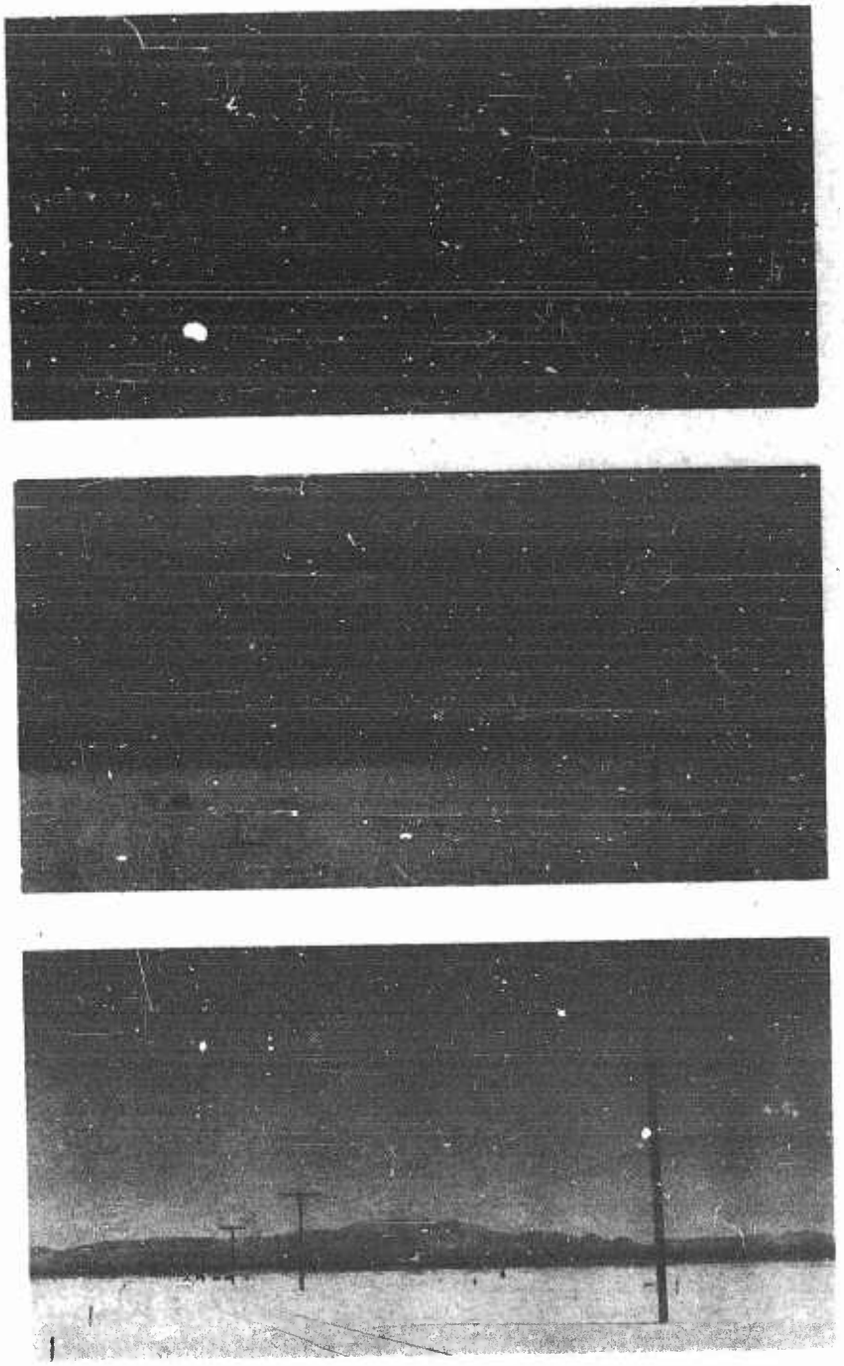
Fig. 3.6 Shots 9 and 10, Test Groups 1 and 1A, Radial Pole Line, Poles D-1 through D-13. D-13 in Foreground. (Top-before 9, Center-after 9, Bottom-after 10)
Shot 9 - 9080 ft, 8-15 cal, 3-4.1 psi.
Shot 10 - 8350-6480 ft, 5.5-10.5 cal, 1-2 psi.

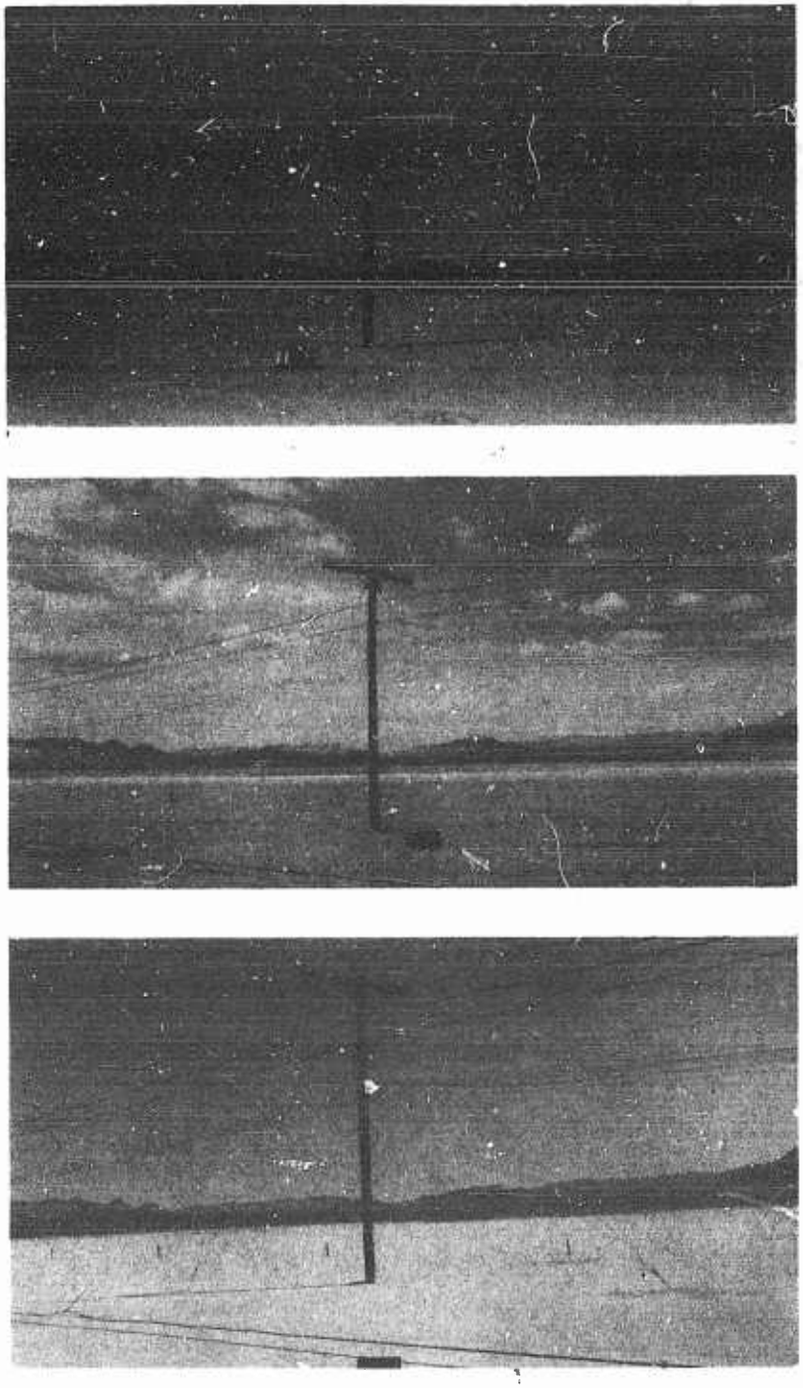
Fig. 3.7 Shots 9 and 10, Test Groups 1 and 1A, Radial Pole Line, Pole D-14. (Top-before 9, Center-after 9, Bottom-after 10)
Shot 9 - 6950 ft, 16 cal, 4.2 psi.
Shot 10 - 6350 ft, 10.5 cal, 2 psi.

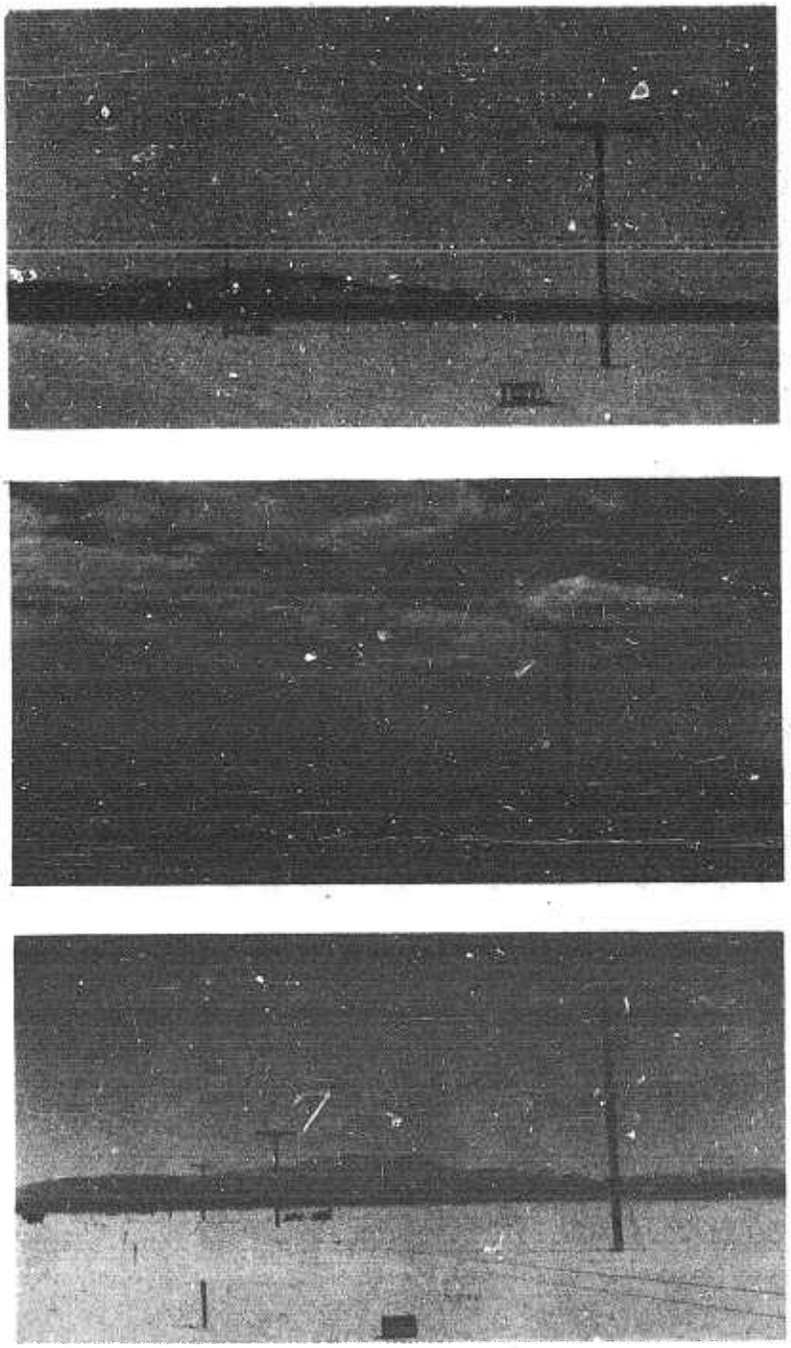
Fig. 3.8 Shots 9 and 10, Test Groups 1 and 1A, Radial Pole Line, Poles D-1 through D-17. D-17 in Foreground. (Top-before 9, Center-after 9, Bottom-after 10)
Shot 9 - 9080-6500 ft, 8-18.5 cal, 3-4.6 psi.
Shot 10 - 8350-5860 ft, 5.5-12.5 cal, 1-2 psi.

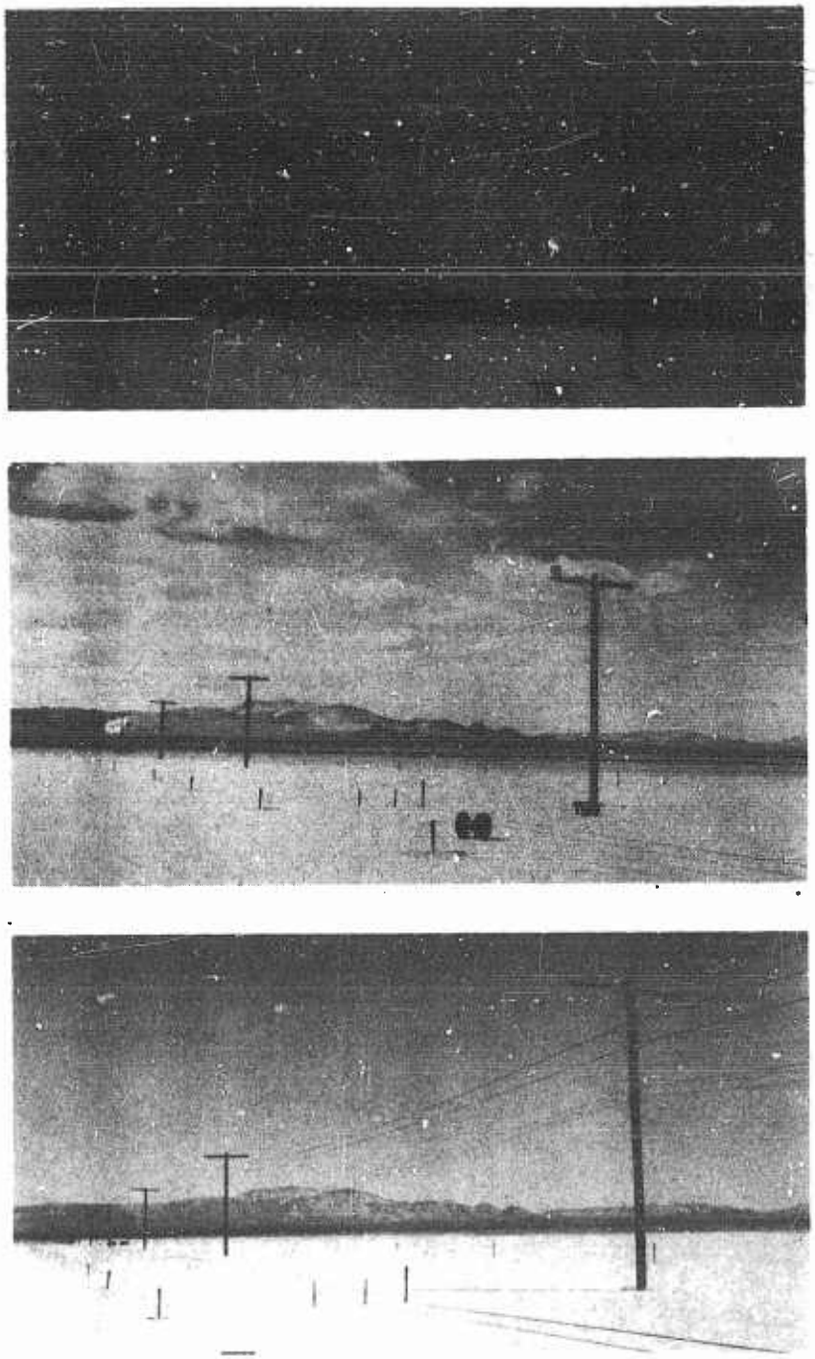
Fig. 3.9 Shots 9 and 10, Test Groups 1 and 1A, Radial Pole Line, Poles D-1 through D-20. D-20 in Foreground.
(Top-before 9, Center-after 9, Bottom-after 10)
Shot 9 - 9080-6050 ft, 8-22 cal, 3-5 psi.
Shot 10 - 8350-5440 ft, 5.5-14.5 cal, 1-2 psi.

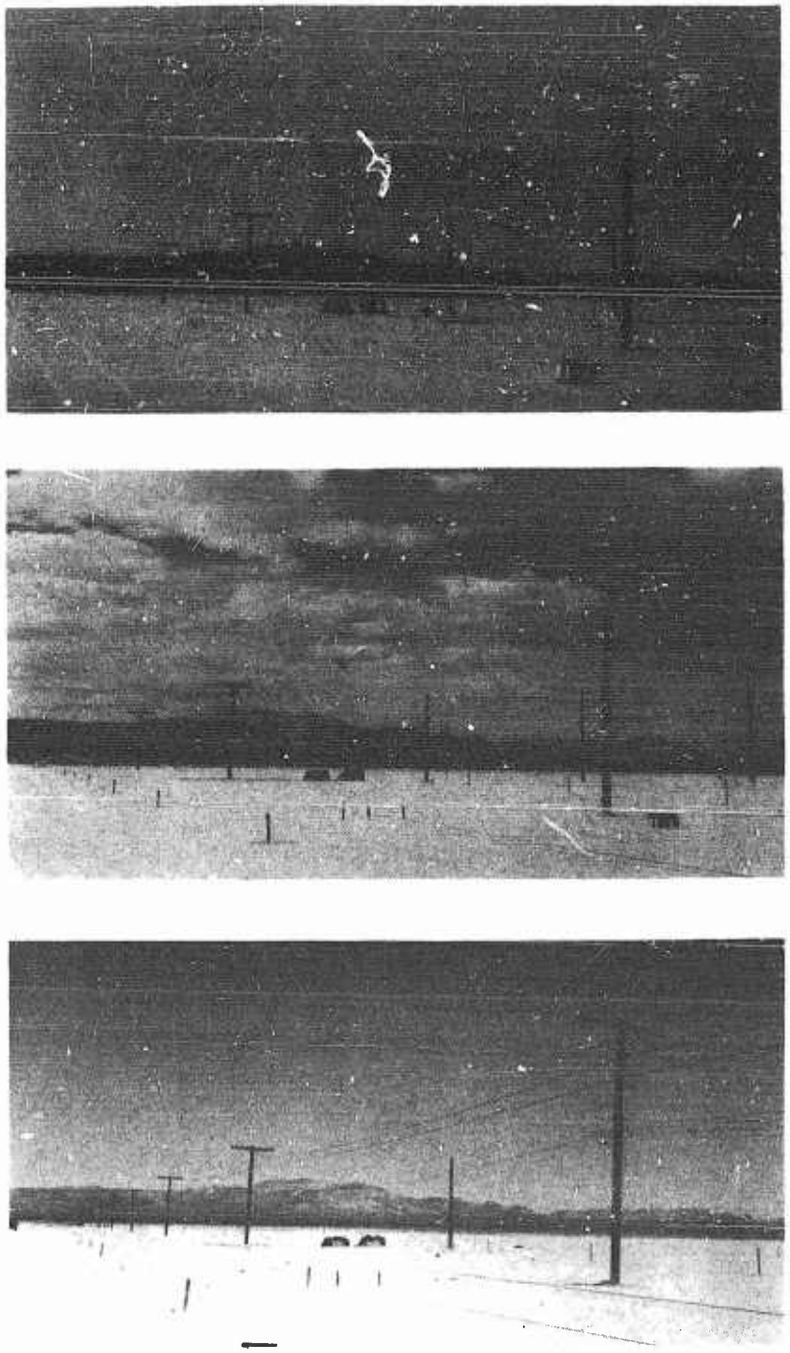
Fig. 3.10 Shots 9 and 10, Test Groups 1 and 1A, Radial Pole Line, Poles D-1 through D-23. D-23 in Foreground. (Top-before 9, Center-after 9, Bottom-after 10) Shot 9 - 9080-5600 ft, 8-24.5 cal, 3-5.4 psi. Shot 10 - 8350-4975 ft, 5.5-17.5 cal, 1-3.5 psi.

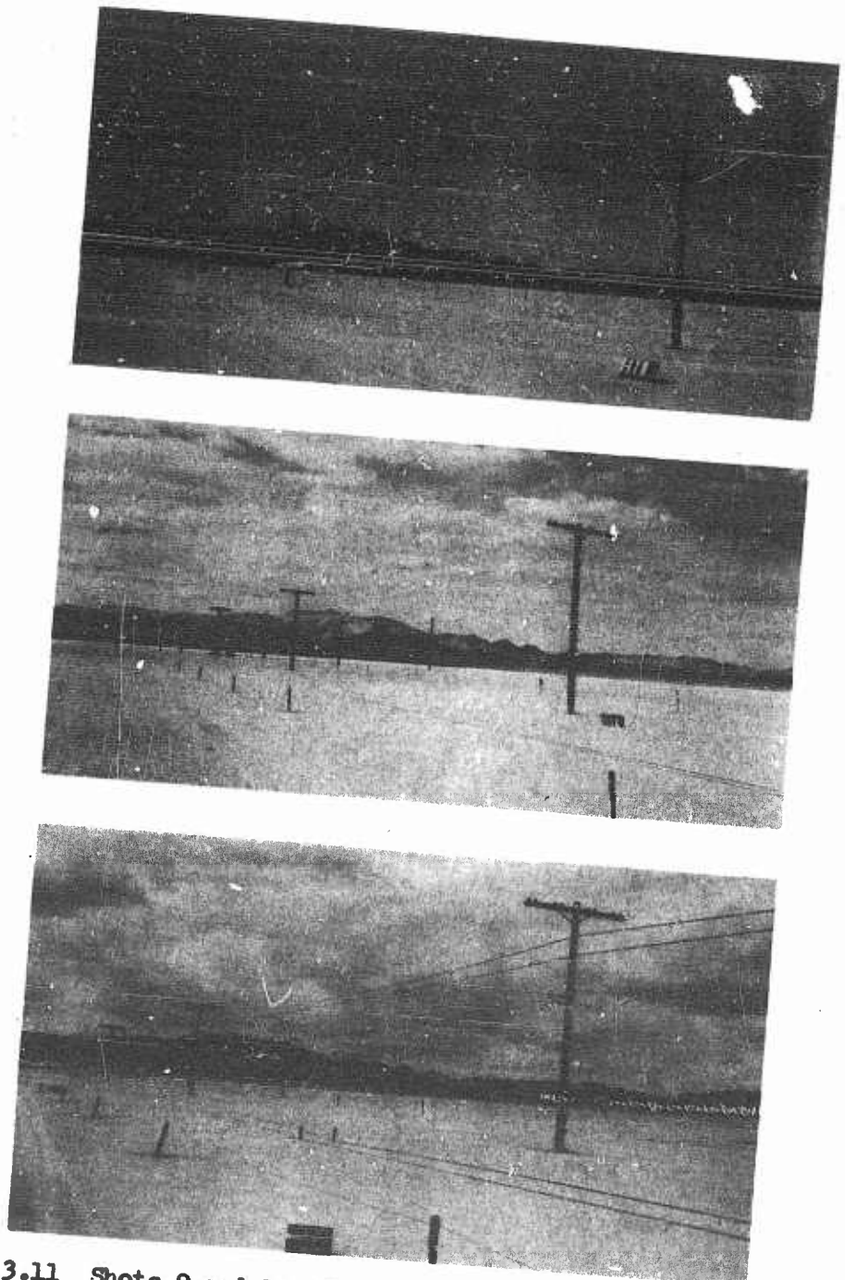
Fig. 3.11 Shots 9 and 10, Test Groups 1 and 1A, Radial Pole Line, Poles D-1 through D-26. D-26 in Foreground. (Top-before 9, Center-after 9, Bottom-after 10)
Shot 9 - 9080-5150 ft, 8-27.5 cal, 3-5.8 psi.
Shot 10 - 8350-4500 ft, 5.5-21 cal, 1-4 psi.

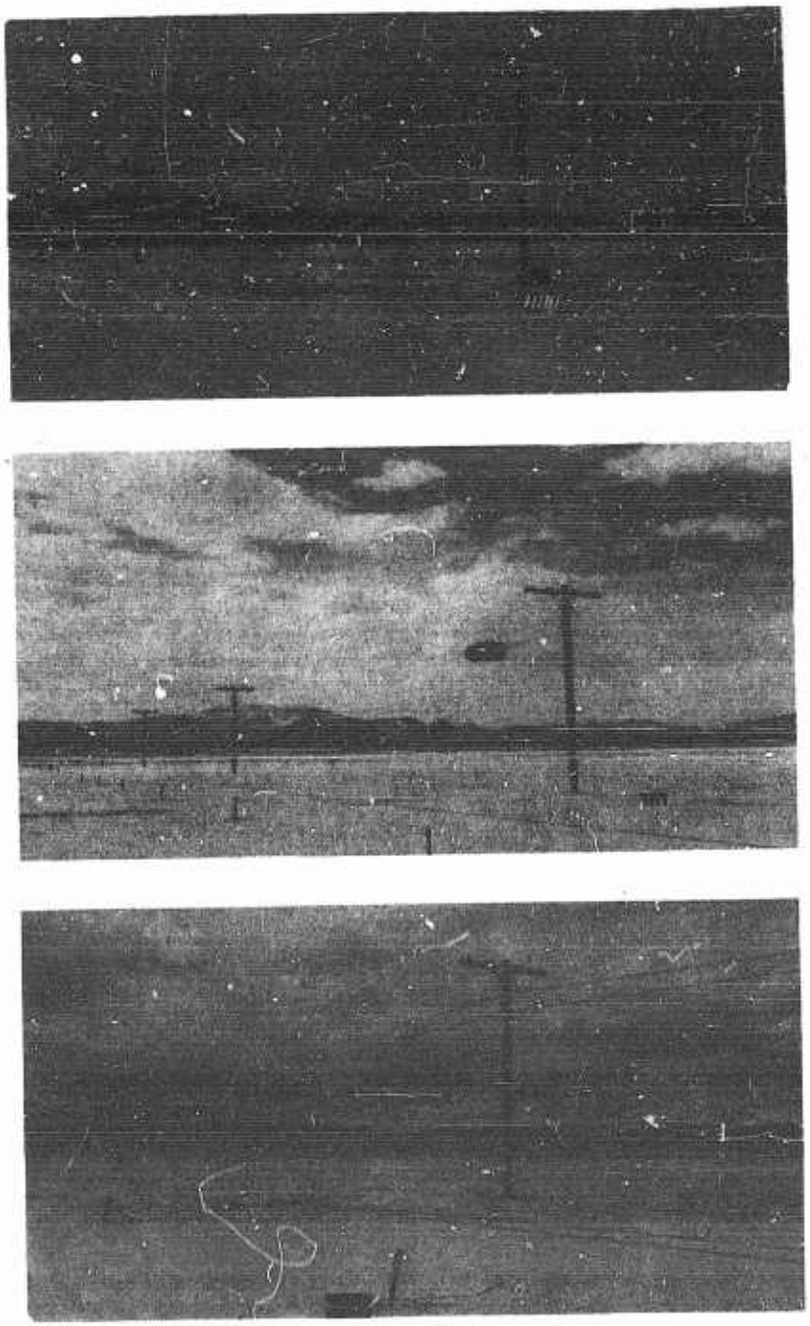
Fig. 3.12 Shots 9 and 10, Test Groups 1 and 1A, Radial Pole Line, Poles D-25 through D-28. D-28 in Foreground. (Top-before 9, Center-after 9, Bottom-after 10) Shot 9 - 5280-4750 ft, 26.5-31 cal, 5.7-6.6 psi. Shot 10 - 4670-4150 ft, 20.5-24.5 cal, 4-4 psi.

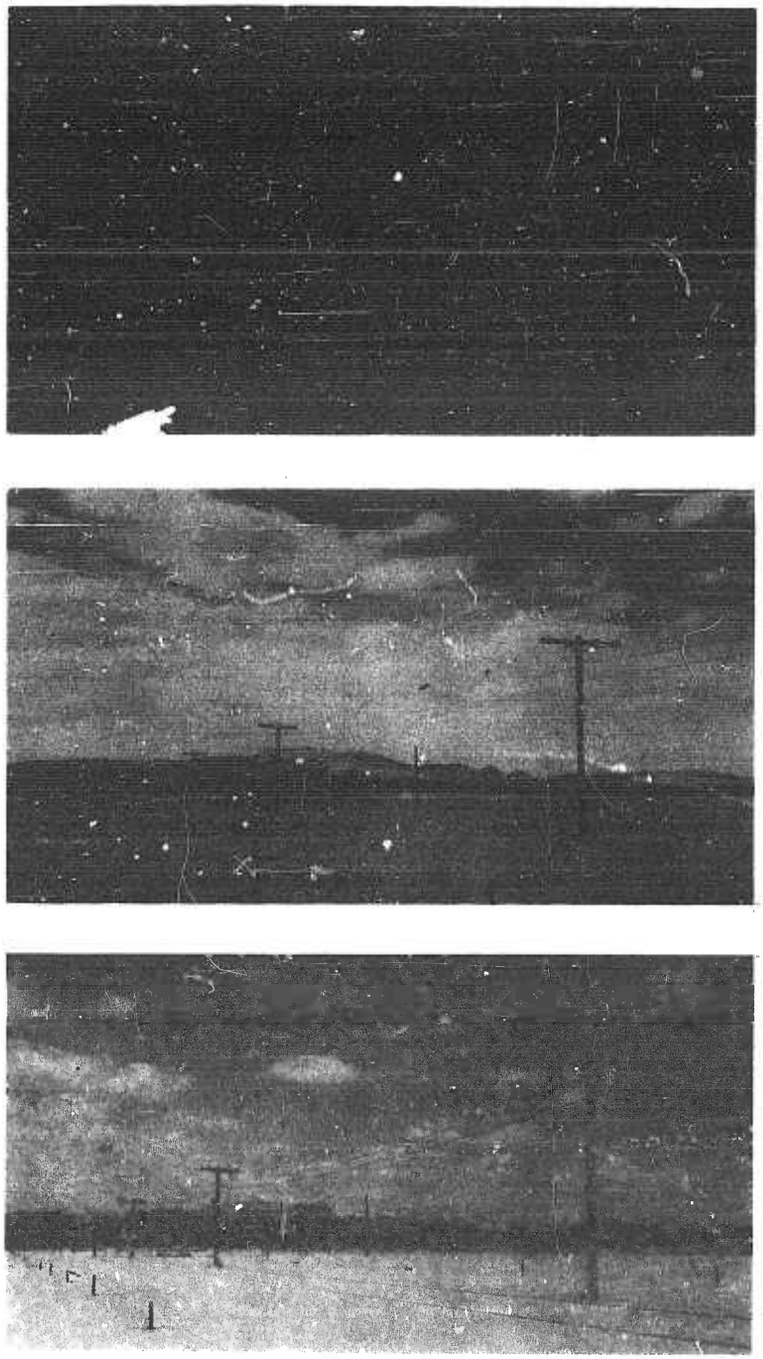
Fig. 3.13 Shots 9 and 10, Test Groups 1 and 1A, Radial Pole Line, Poles D-1 through D-31. D-31 in Foreground. (Top-before 9, Center-after 9, Bottom-after 10)
Shot 9 - 9080-4380 ft, 8-35 cal, 3-7.2 psi.
Shot 10 - 8350-3750 ft, 5.5-27 cal, 1-4 psi.

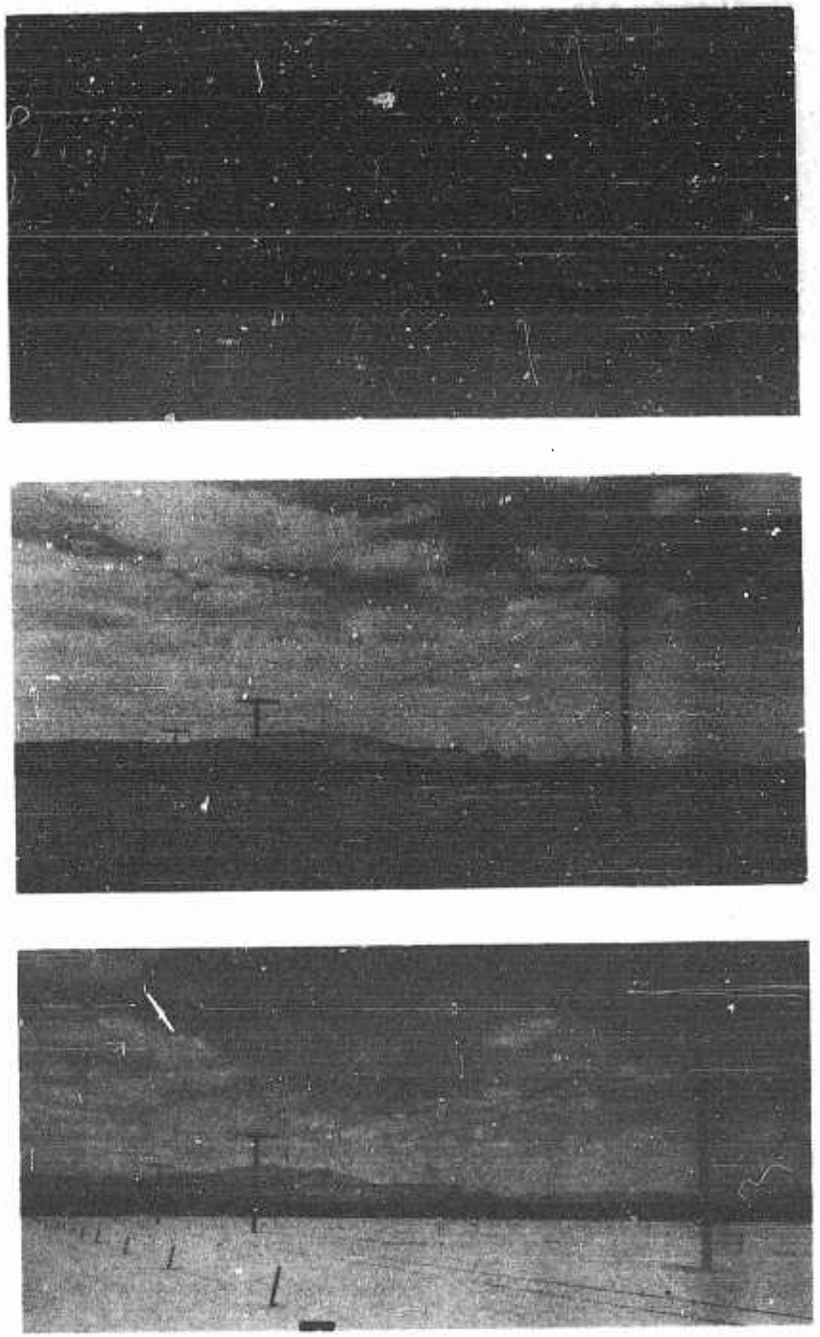
Fig. 3.14 Shots 9 and 10, Test Groups 1 and 1A, Radial Pole Line, Poles D-1 through D-34. D-34 in Foreground. (Top-before 9, Center-after 9, Bottom-after 10)
Shot 9 - 9080-3900 ft, 8-42.5 cal, 3-8.4 psi.
Shot 10 - 8350-3300 ft, 5.5-37.5 cal, 1-5 psi.

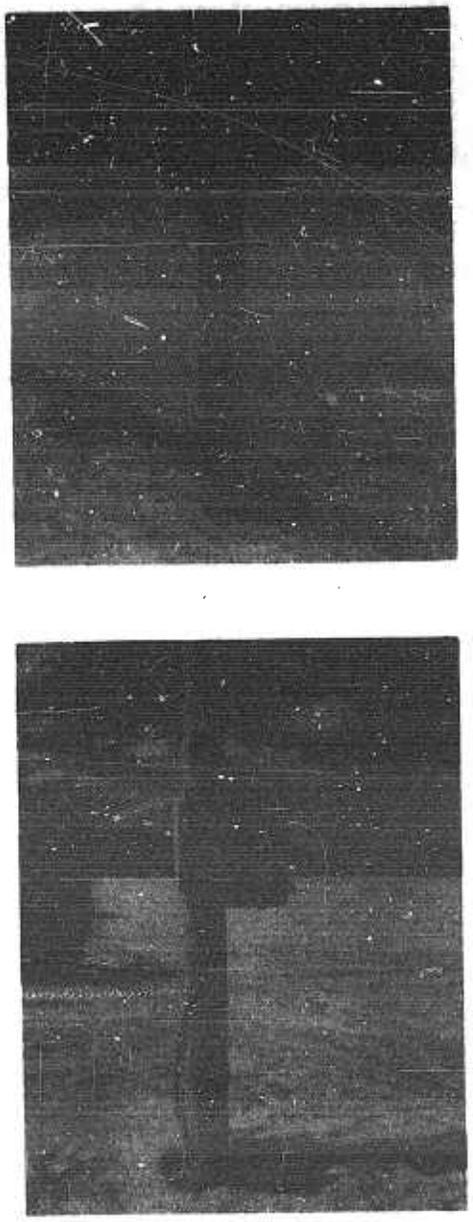
Fig. 3.15 Shot 9, Test Group 1, Radial Pole Line, Cable Transfer Relay on Pole D-35. (Top-before, Bottom-after) 3750 ft, 44.5 cal, 8.8 psi.

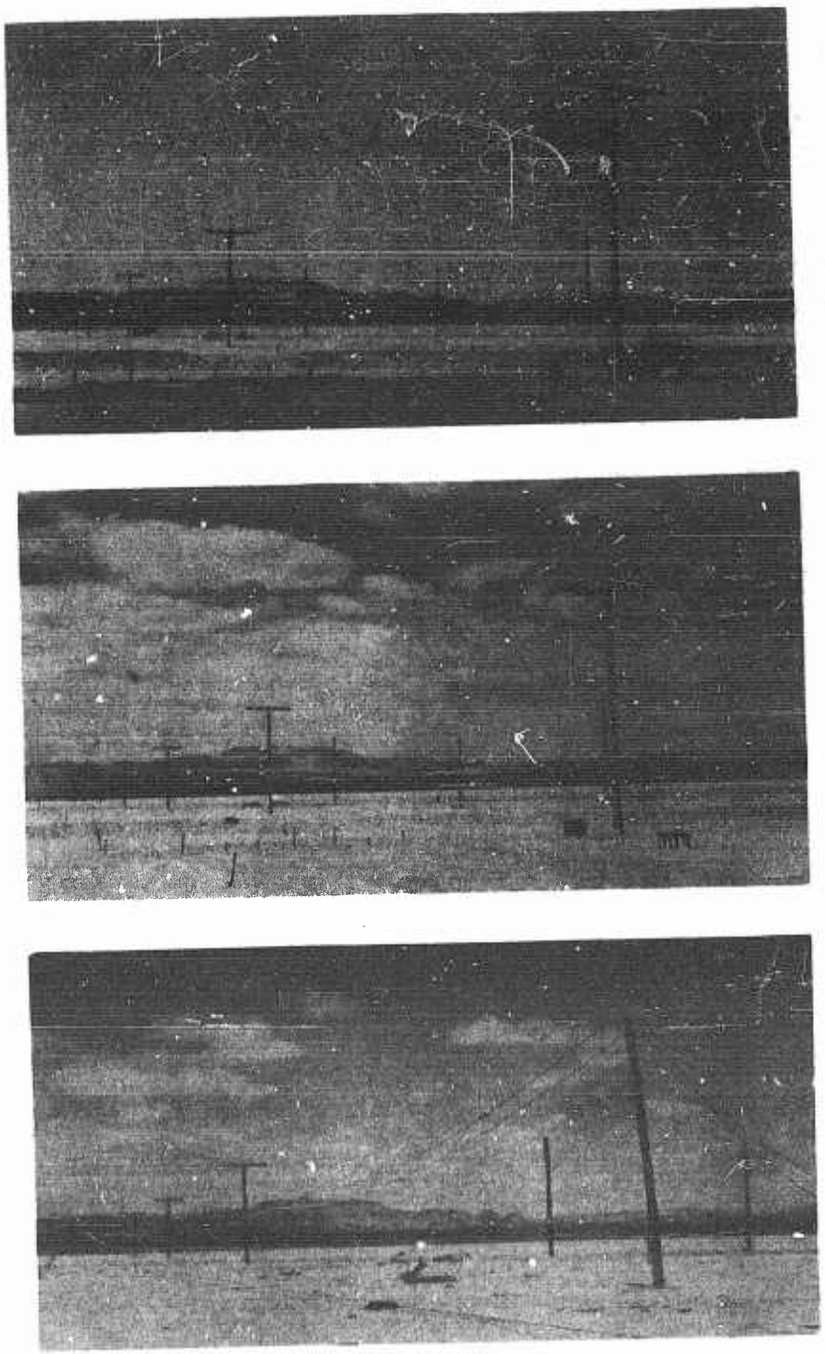
Fig. 3.16 Shots 9 and 10, Test Groups 1 and 1A, Radial Pole Line (Top-before 9, Poles D-1 through D-37; Center-after 9, Poles D-1 through 37; Bottom-after 10, Poles D-1 through D-36) (D-37 through D-52 Not Shown in this Photo were Destroyed in Shot 10) Shot 9 - 9080-3500 ft, 8-49 cal, 3-9.4 psi. Shot 10 - 8350-2900 ft, 5.5-47.5 cal, 1-5 psi.

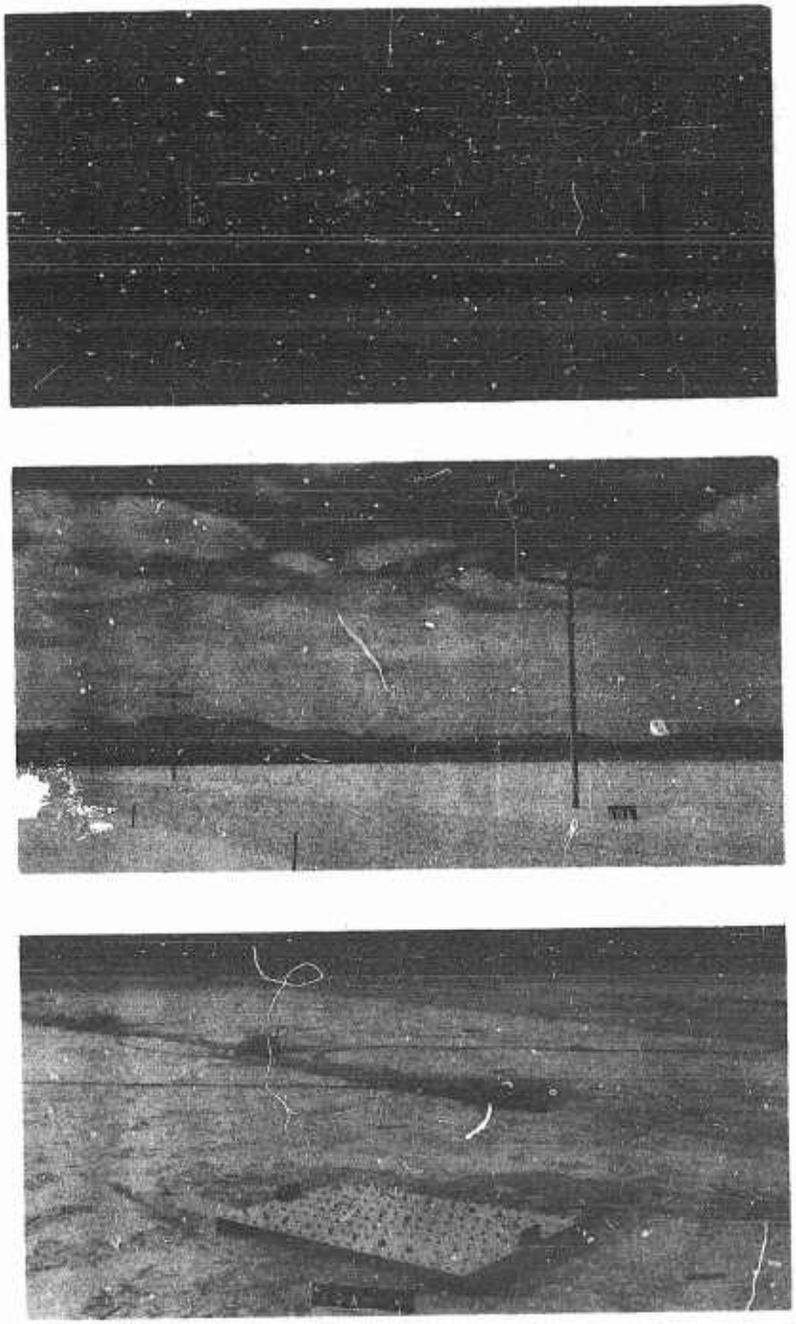
Fig. 3.17 Shots 9 and 10, Test Groups 1 and 1A, Radial Pole Line, Poles D-1 through 40, Top and Center Views. D-40 in Foreground; D-1 through D-40 in Bottom View; D-36 in Background. Poles D-37 through D-52 were Destroyed in Shot 10. (Top-before 9, Center-after 9, Bottom-after 10) Shot 9 - 9080-3050 ft, 8-57.5 cal, 3-10.4 psi. Shot 10 - 8350-2425 ft, 8- over 65 cal, 1-6 psi.

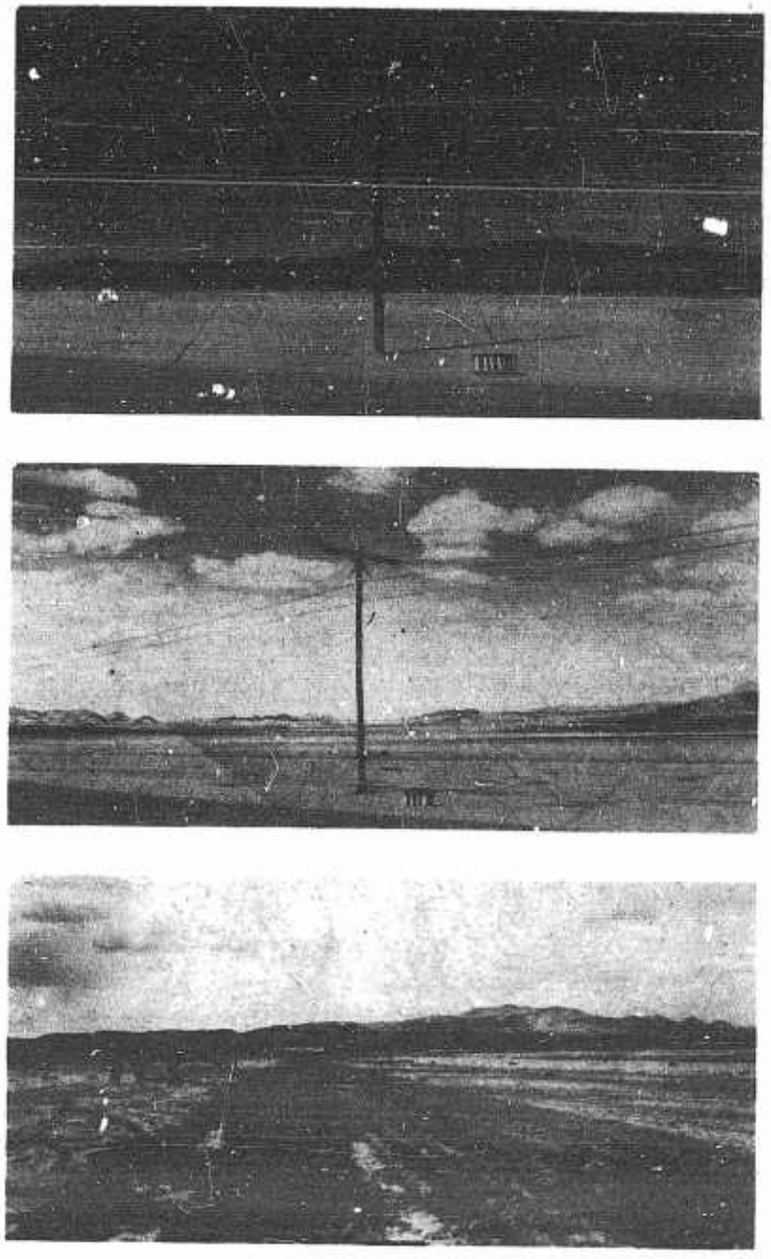
Fig. 3.18 Shots 9 and 10, Test Groups 1 and 1A, Radial Pole Line, Pole D-41. In Bottom View Poles D-37 through D-52 Destroyed in Shot 10. (Top-before 9, Center-after 9, Bottom-after 10)
Shot 9 - 2900 ft, 60 cal, 10.6 psi.
Shot 10 - 2250 ft, 65 cal, 7 psi.

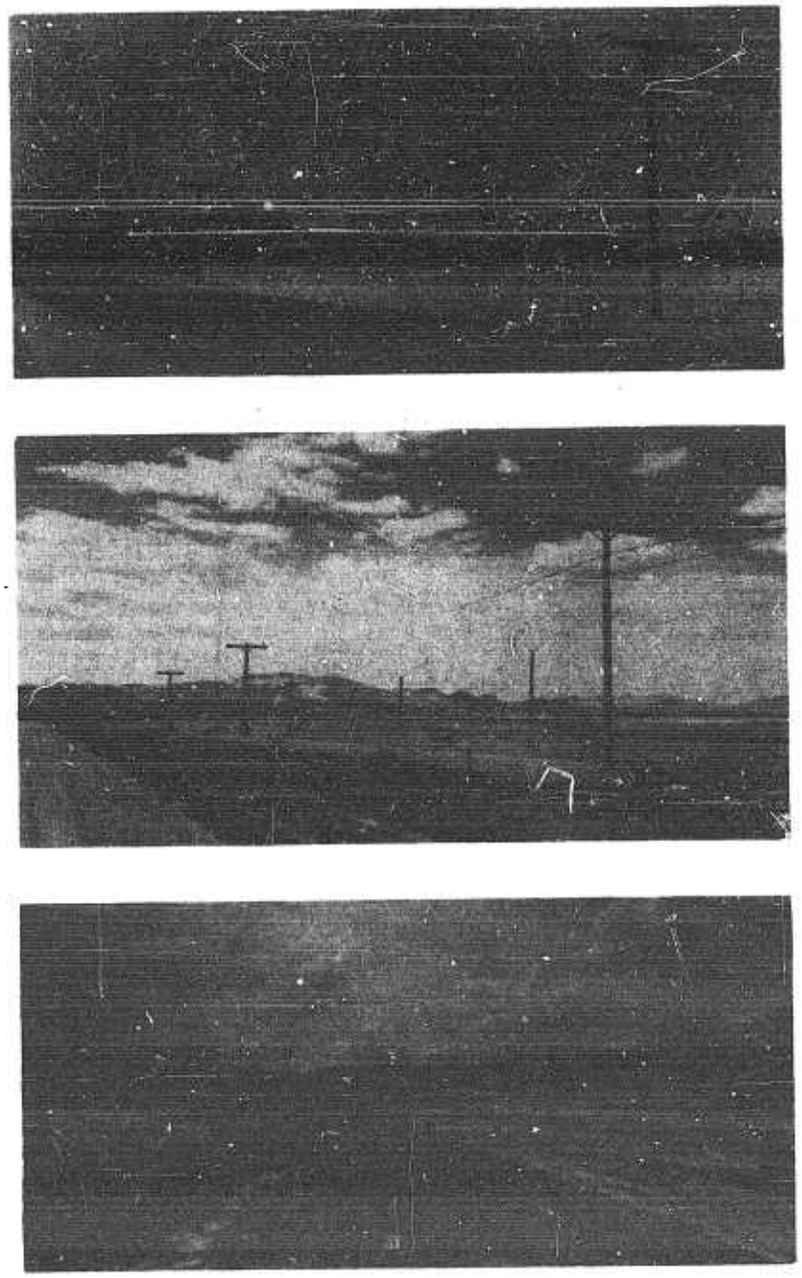
Fig. 3.19 Shots 9 and 10, Test Groups 1 and 1A, Radial Pole Line, Poles D-1 through D-44. D-44 in Foreground in Top and Center Views. In Bottom View Poles D-37 through D-52 have been destroyed in Shot 10. (Top-before 9, Center-after 9, Bottom-after 10)
Shot 9 - 9080-2450 ft, 8-69 cal, 3-11.2 psi.
Shot 10 - 8350-1820 ft, 5- over 65 cal, 1-9 psi.

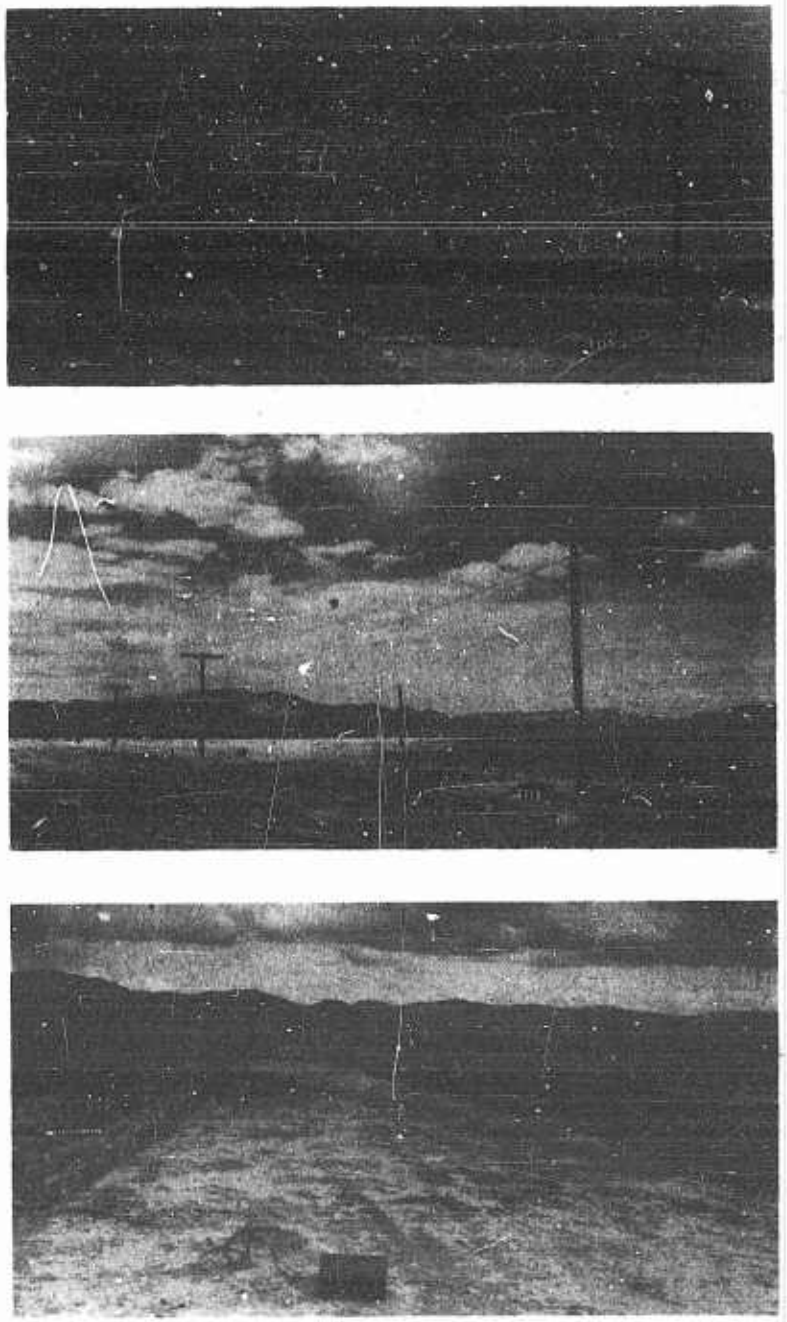
Fig. 3.20 Shots 9 and 10, Test Groups 1 and 1A, Radial Pole Line, Poles D-1 through D-47. D-47 in Foreground in Top and Center Views. In Bottom View Poles D-37 through D-52 have been Destroyed, D-41 Position in Foreground. (Top-before 9, Center-after 9, Bottom-after 10) Shot 9 - 9080-2000 ft, 8-82 cal, 3-12.6 psi. Shot 10 - 8350-1350 ft, 5.5-over 65 cal, 1-20 psi.

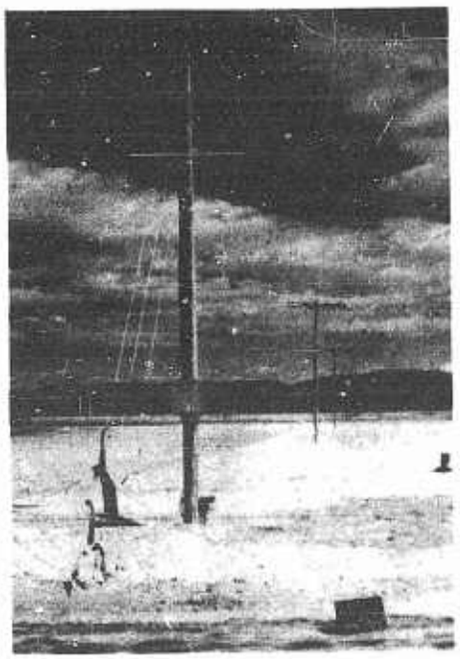
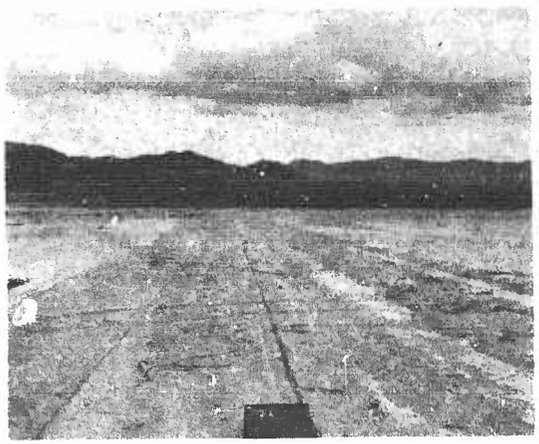
Fig. 3.22 Shots 9 and 10, Test Groups 1 and 1A, Radial Pole Line, Poles D-52 through D-50 in Top View, D-52 in Foreground; Poles D-52 through D-1 in Bottom Left View, D-52 in Foreground; Poles D-52 through D-36 Bottom Right View Destroyed in Shot 10. (Top-before 9, Bottom Left-after 9, Bottom Right-after 10)
Shot 9 - 1550-1250 ft, 98-113 cal, 14.16.6 psi.
Shot 10 - 2250-600 ft, over 65 cal, 7.0-over 115 psi.
