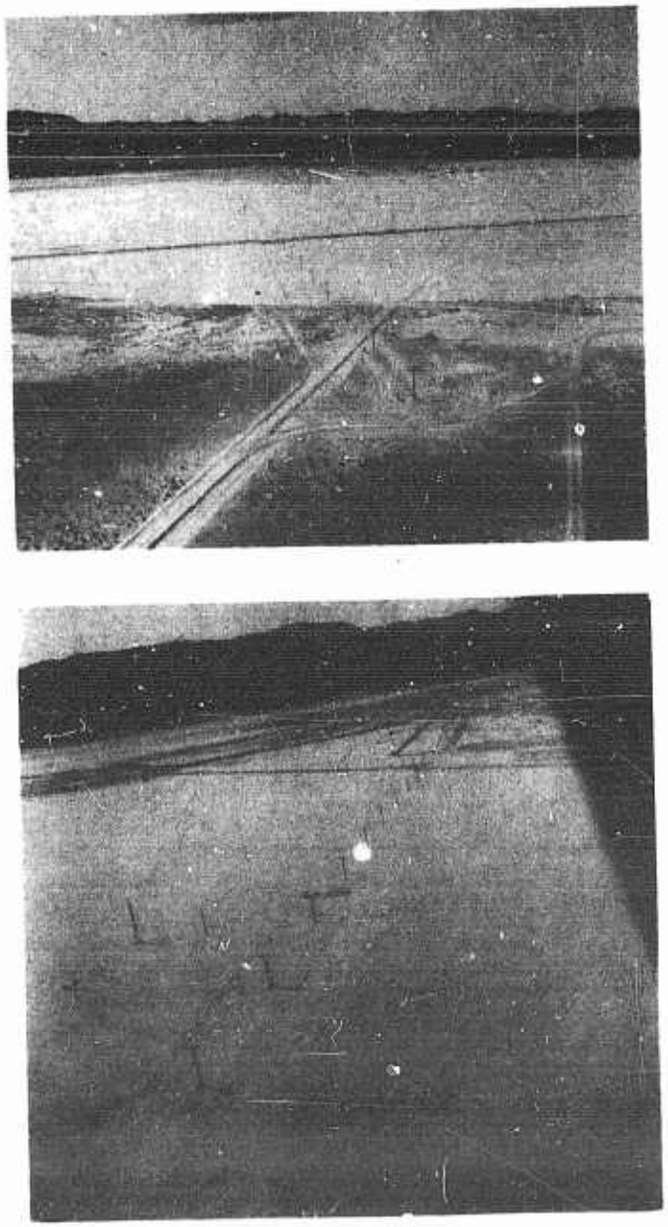
Fig. 3.23 Shot 10, Miscellaneous Aerial Views, Test Group 1A, Radial Pole Line. All Views after Shot 10. (Top-entire Pole Line from Poles D-1 through D-52, D-1 in Foreground; Bottom-poles D-27 through D-37; Note All Poles Down, D-36 through D-52.

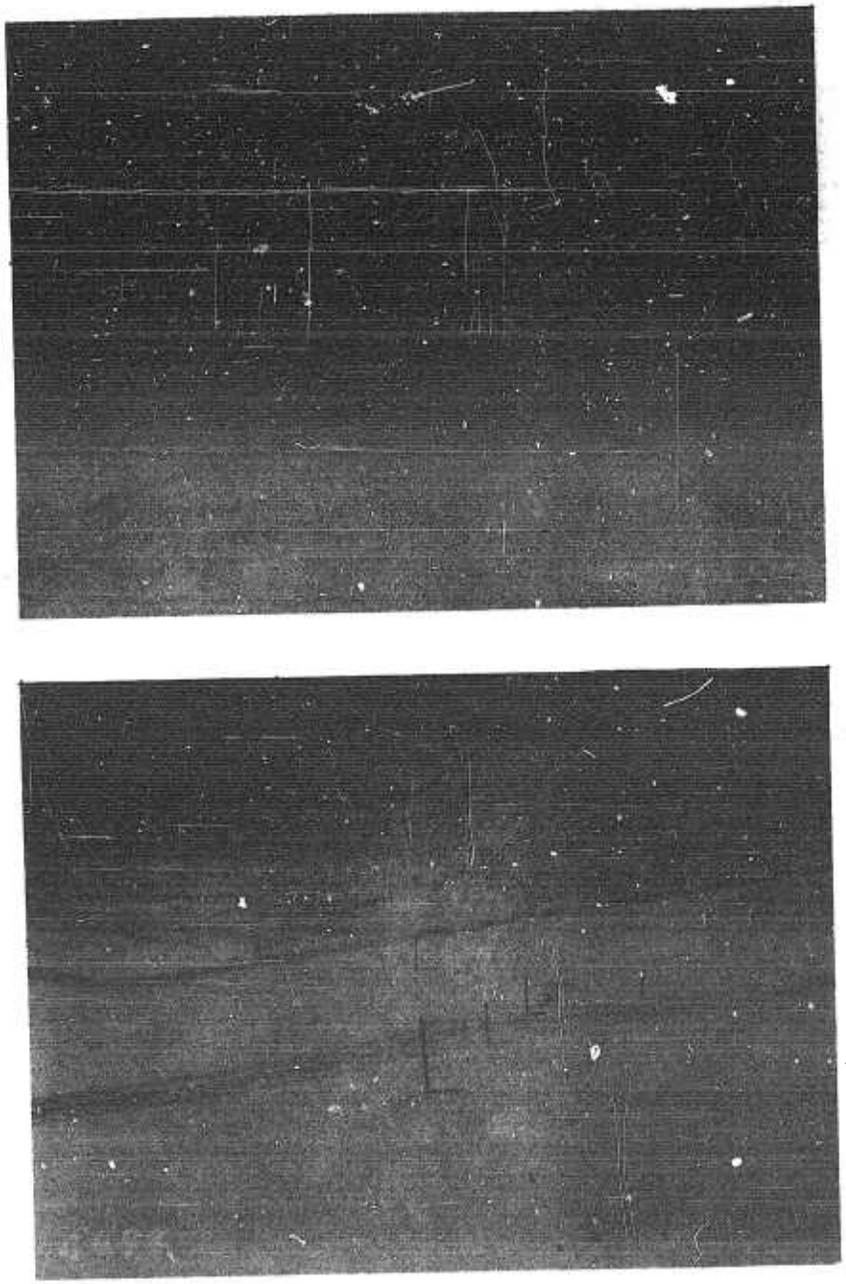
Fig. 3.24 Shot 10, Miscellaneous Aerial Views Test Group 1A, Radial Pole Line. All Views after Shot 10. (Top-from Left to Right Poles D-39 through D-21. Note that Poles D-39 through D-37 are Broken and on the Ground. Also Note that Test Group 6A, 3 Separate Poles (Top Left) are Broken whereas in Test Group 7A (To the Right of Pole D-35) Remained Standing and Received Negligible Damage. Bottom-close up of Poles D-39 through D-35 and Test Group 7A)

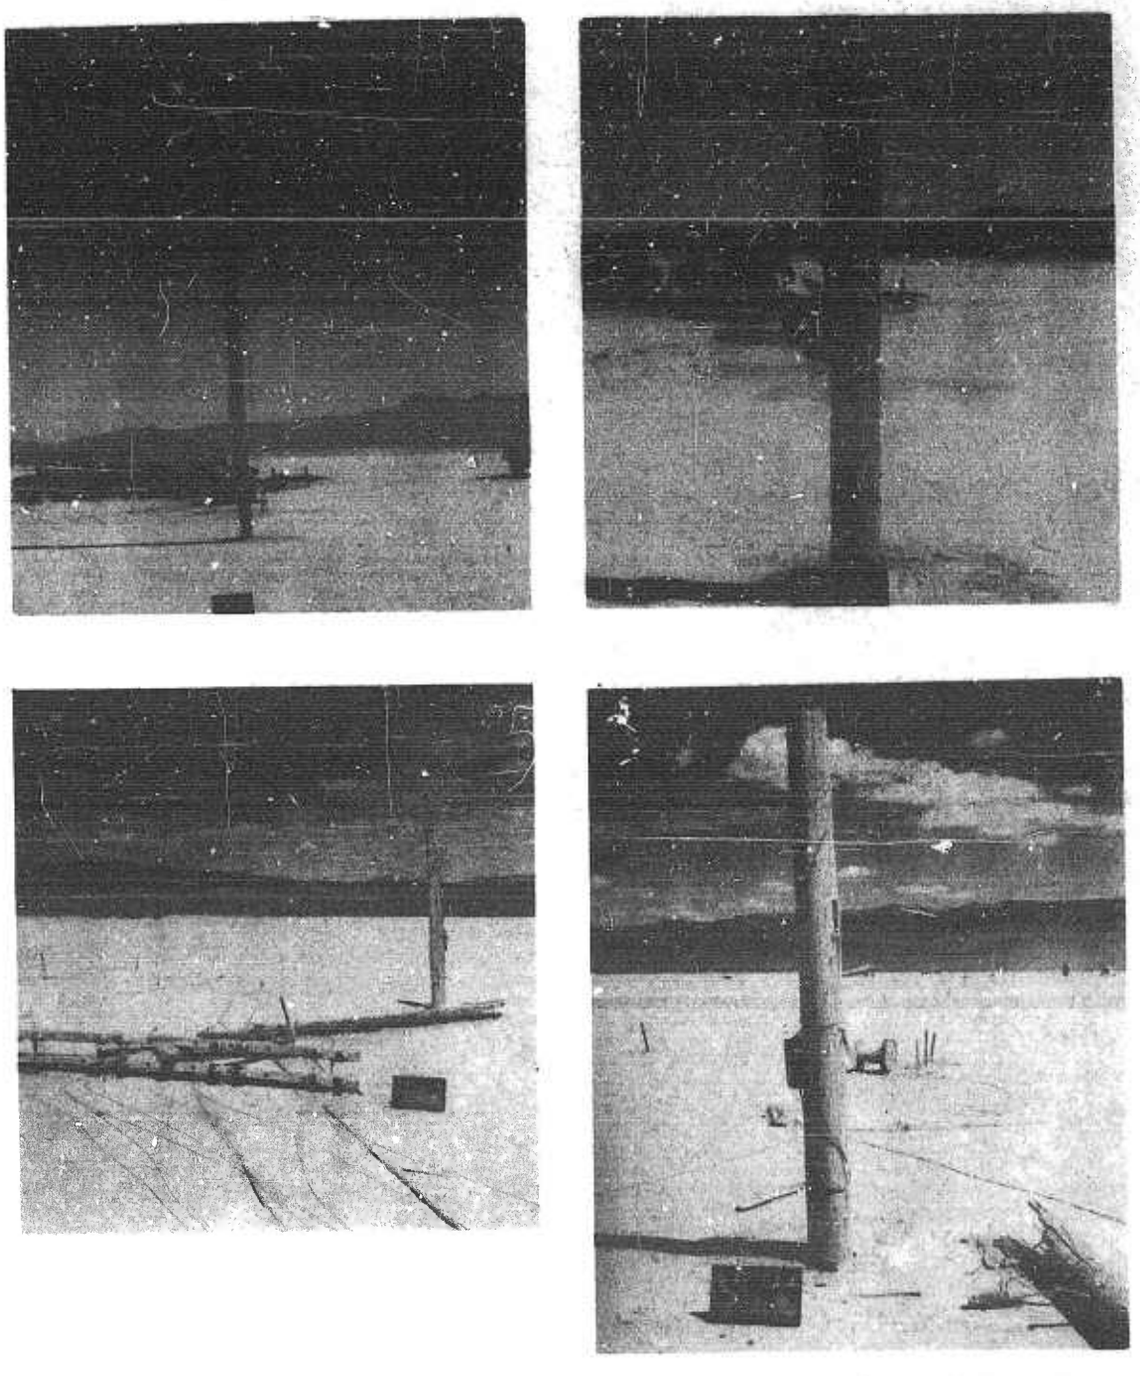
(4) GLASS INSULATORS: Several of the glass insulators were broken. Those not broken were serviceable.

Fig. 3.25 Shot 9, Test Group 24, Transverse Pole Line, Pole C-1. (Top-before, Bottom-after). Close ups of same Pole (Top-before, Bottom-after). 3425 ft, 50 cal, 9.6 psi.

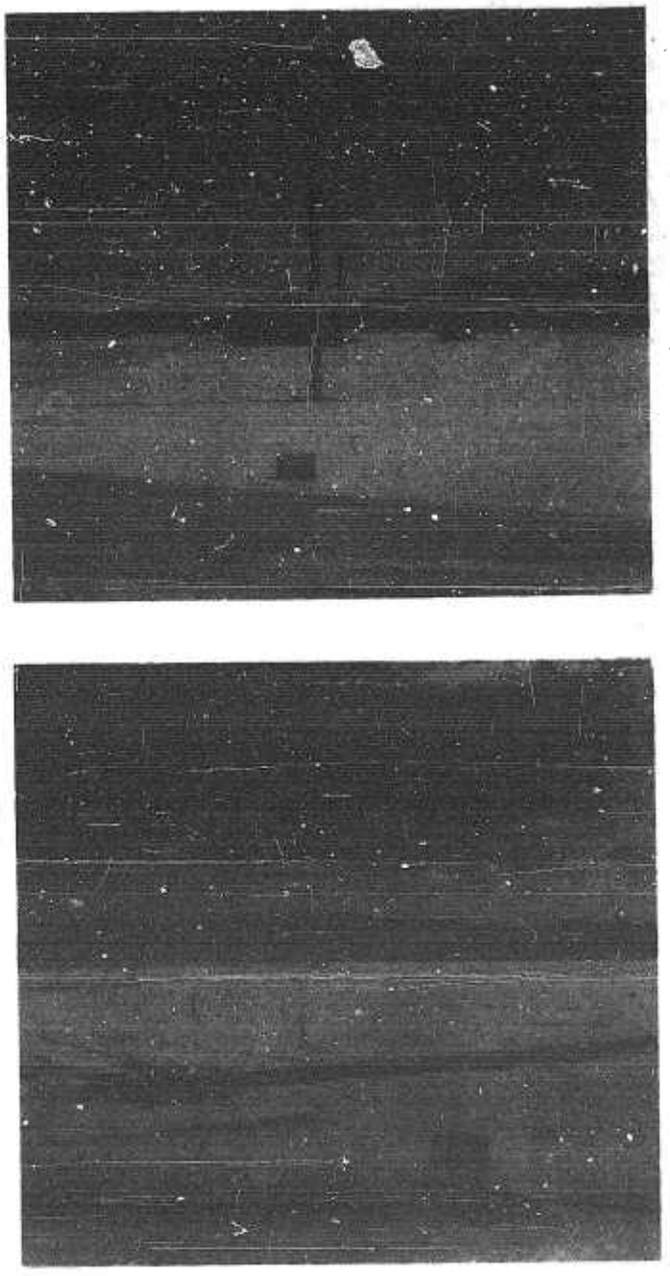
Fig. 3.27 Shot 9, Test Group 24, Transverse Pole Line, Poles C-1 through C-2, C-2 in Foreground. (Top-before, Bottom-after) 3425 ft, 50 cal, 9.6 psi.

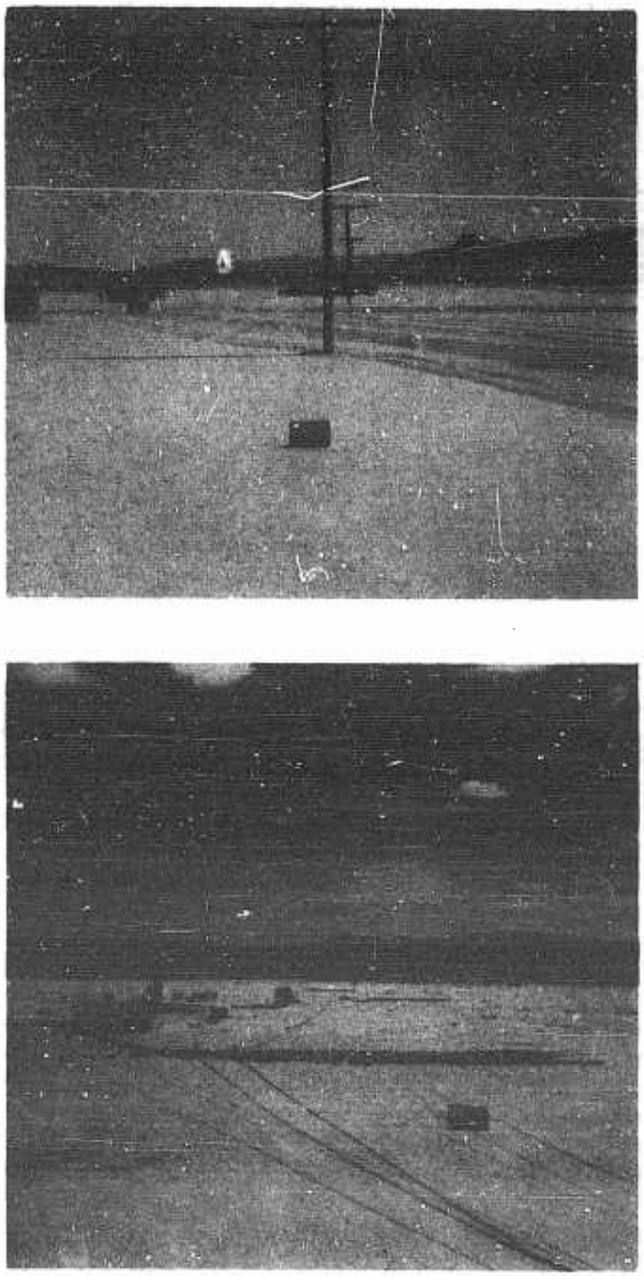
Fig. 3.28 Shot 9, Test Group 24, Transverse Pole Line, Poles C-1 through C-3, C-3 in Foreground. (Top-before, Bottom-after) 3425 ft, 50 cal, 9.6 psi.

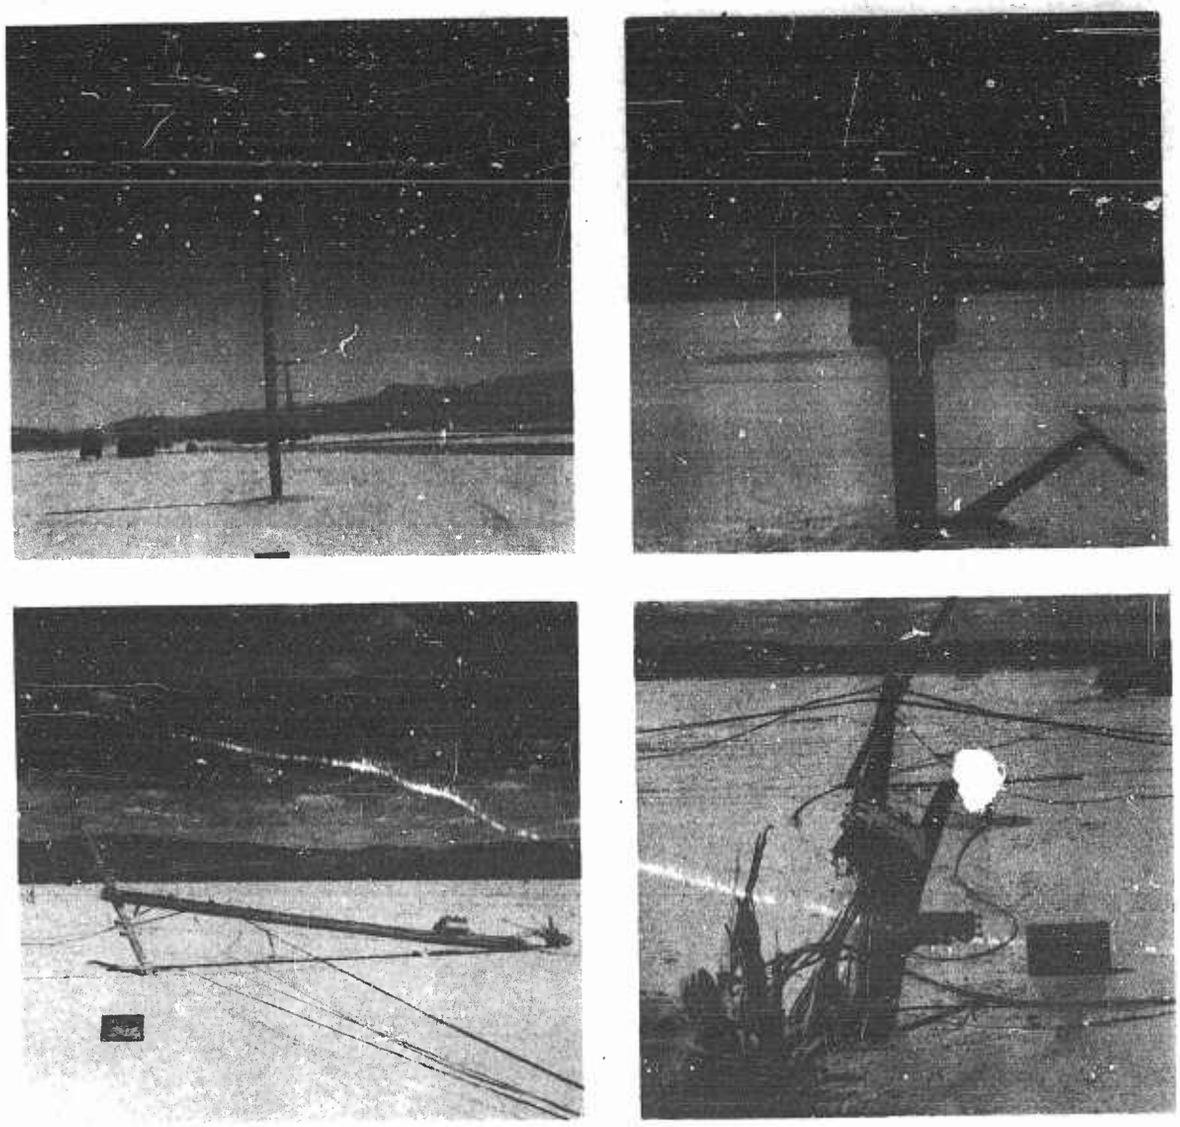
Fig. 3.29 Shot 9, Test Group 24, Transverse Pole Line, Poles C-1 through C-4, C-4 in Foreground. (Top left-before, Bottom left-after, Top right-before, Bottom left-after) Close-ups of Cable Transfer Relay on Pole C-4 (Right). 3425 ft, 50 cal, 9.6 psi.

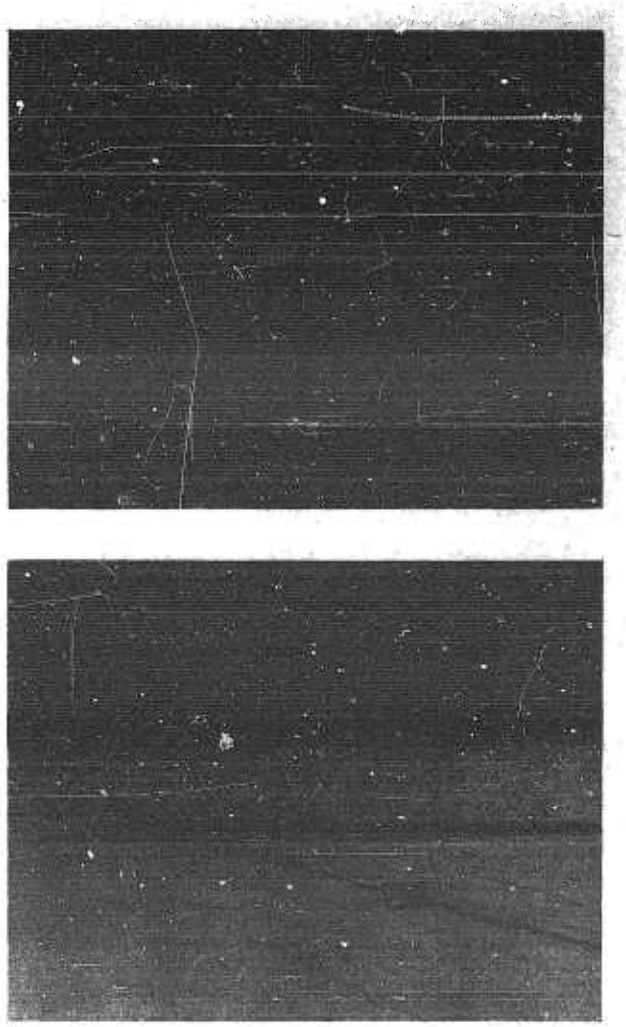
Fig. 3.31 Shot 9, Test Group 24, Transverse Pole Line, Poles C-1 through C-6, C-6 in Foreground. (Top-before, Bottom-after) 3425 ft, 50 cal, 9.6 psi.

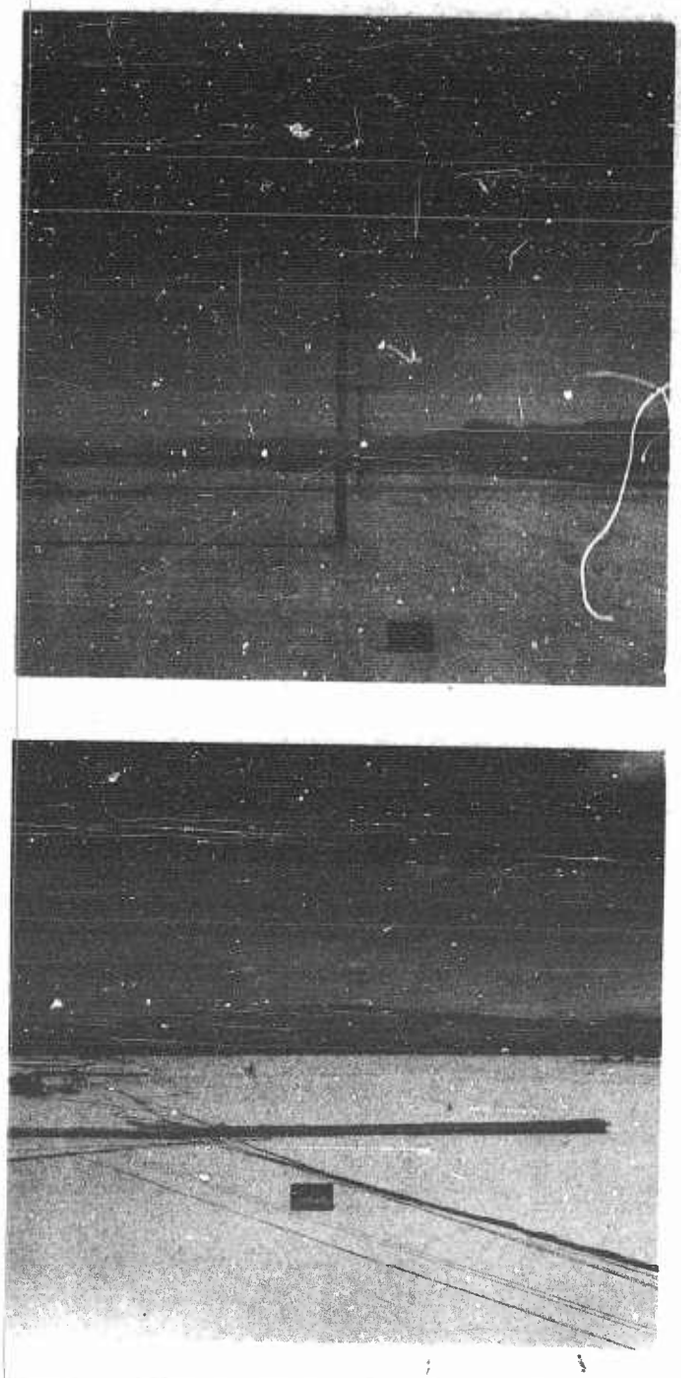
Fig. 3.32 Shot 9, Test Group 24, Transverse Pole Line, Poles C-1 through C-7, C-7 in Foreground. (Top-before, Bottom-after) 3425 ft, 50 cal, 9.6 psi.

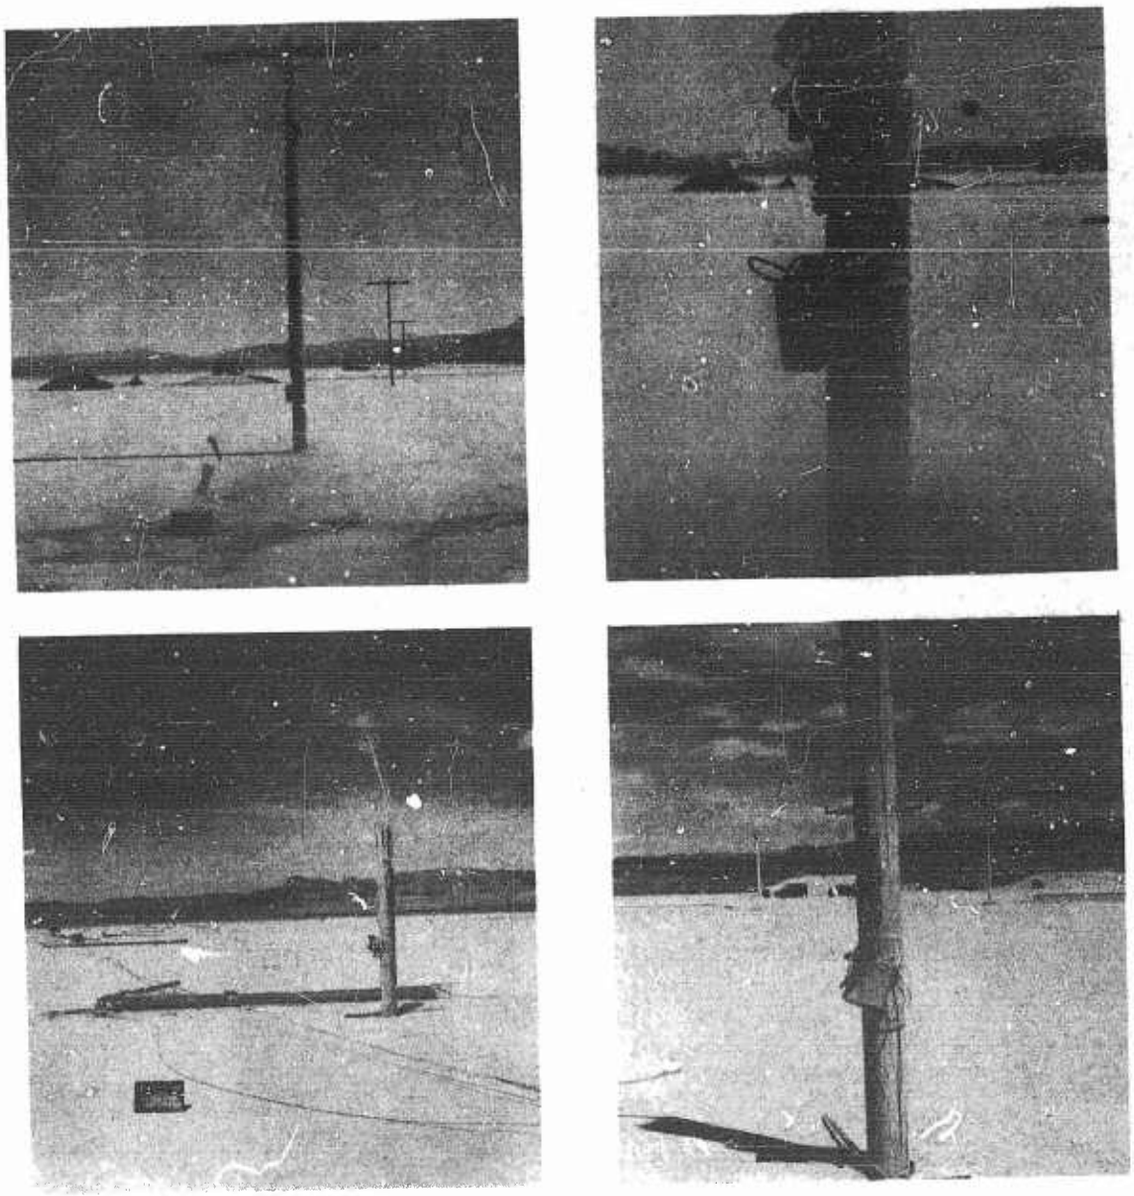
Fig. 3.33 Shot 9, Test Group 24, Transverse Pole Line, Poles C-1 through C-8, C-8 in Foreground. Right Shows Close-ups of EE-8 Telephone and TM-184 Terminal Strip on Shielded Side of Pole C-8. (Top left-before, Bottom left-after, Top right-before, Bottom right-after) 3425 ft, 50 cal, 9.6 psi.

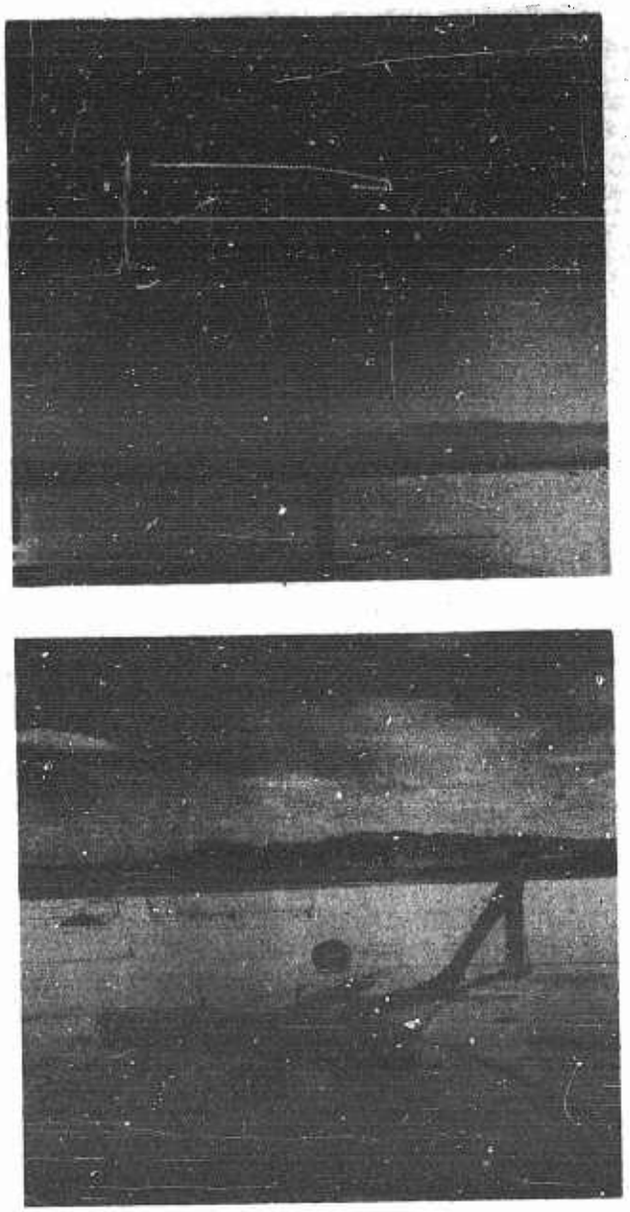
Fig. 3.34 Shot 9, Test Group 27, Transverse Pole Line, Pole B-1. (Top-before, Bottom-after)
4450 ft, 35 cal, 7 psi.

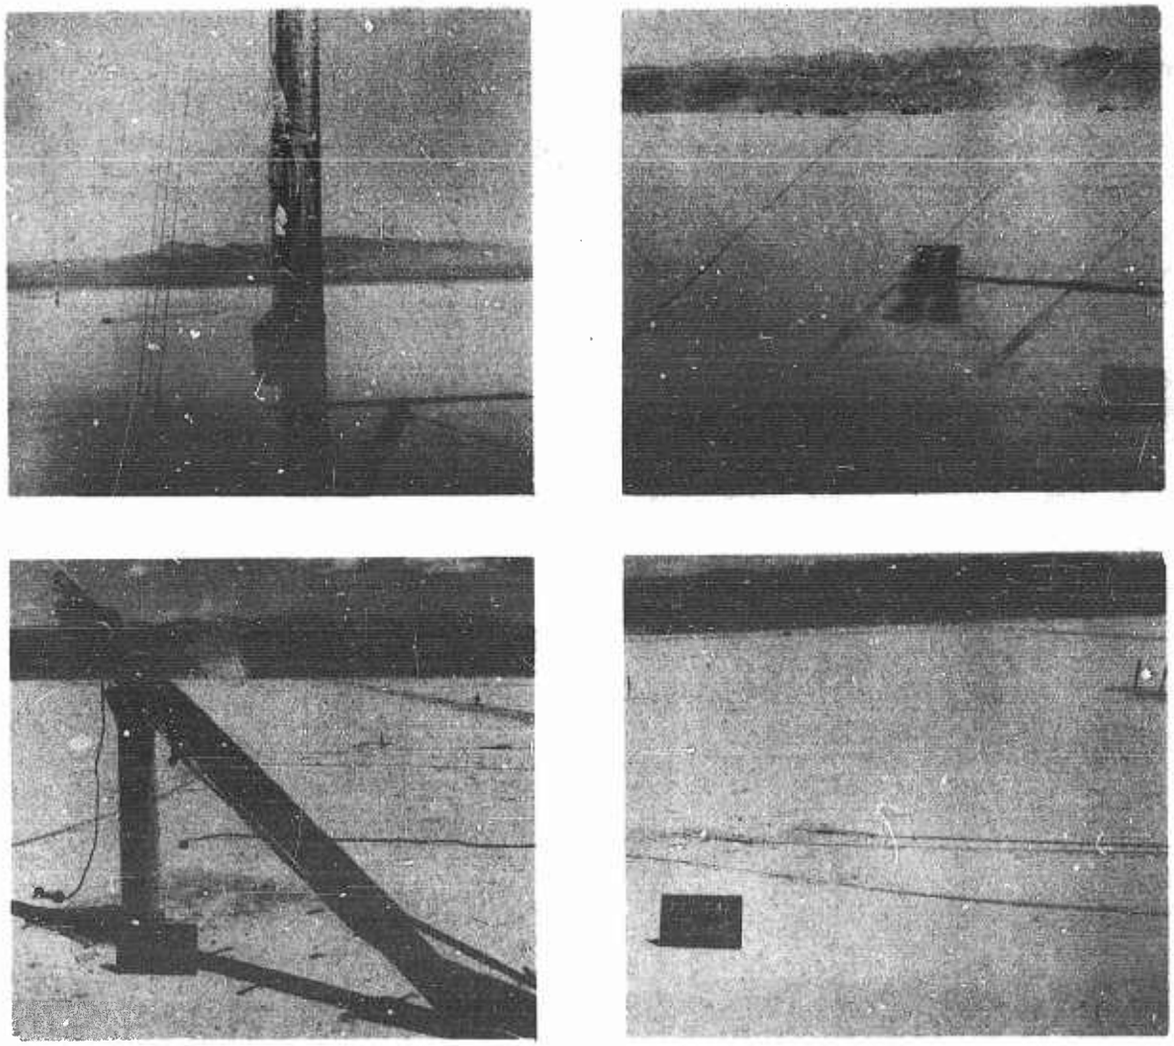
Fig. 3.35 Shot 9, Test Group 27, Transverse Pole Line, Close-up of Pole B-1. (Top-before, Bottom-after) 4450 ft, 35 cal, 7 psi. Right - Close-ups of Triple guys on Pole B-1. (Top-before, Bottom-after)

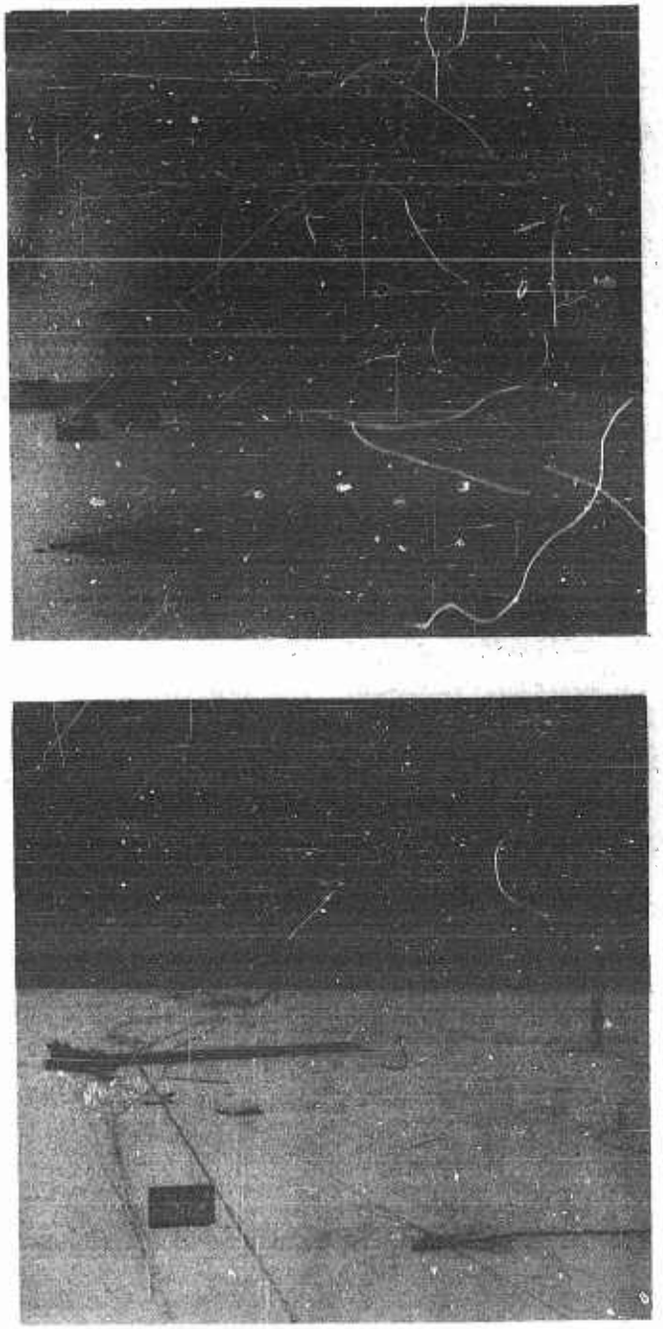
Fig. 3.36 Shot 9, Test Group 27, Transverse Pole Line, Poles B-1 through B-2, B-2 in Foreground. (Top-before, Bottom-after) 4450 ft, 35 cal, 7 psi.

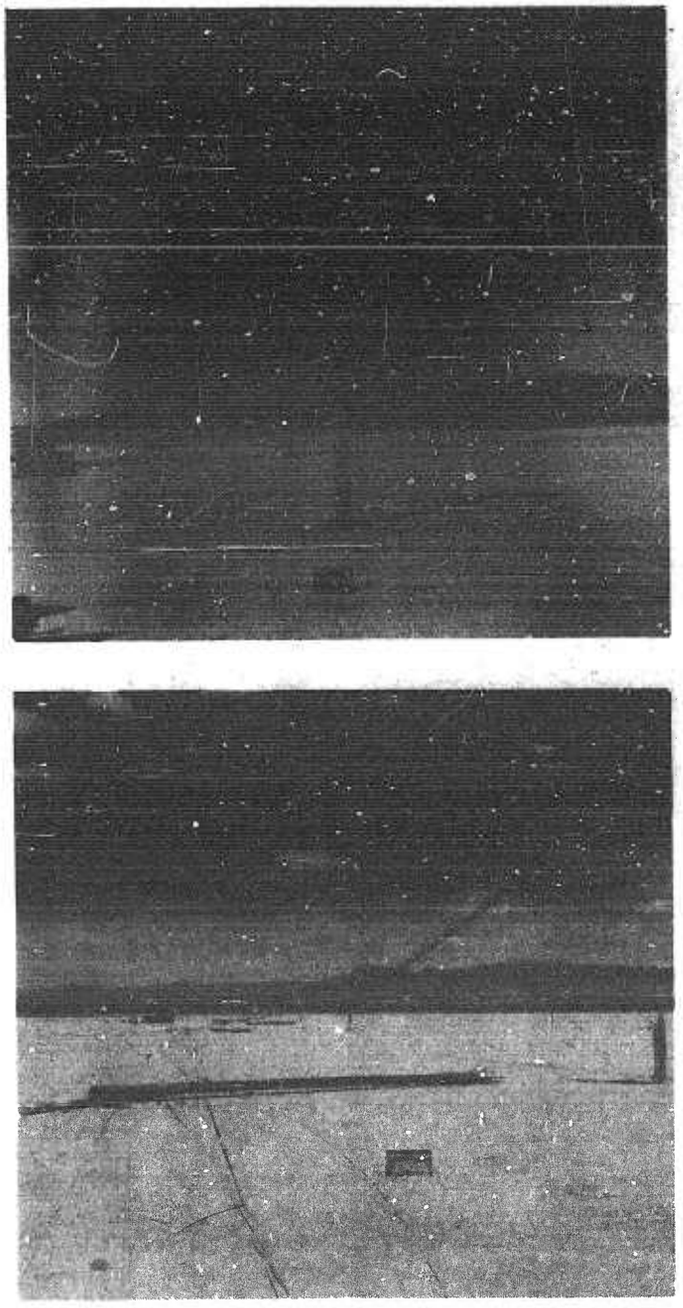
Fig. 3.39 Shot 9, Test Group 27, Transverse Pole Line, Poles B-1 through B-5, B-5 in Foreground. (Top-before, Bottom-after) 4450 ft, 35 cal, 7 psi.

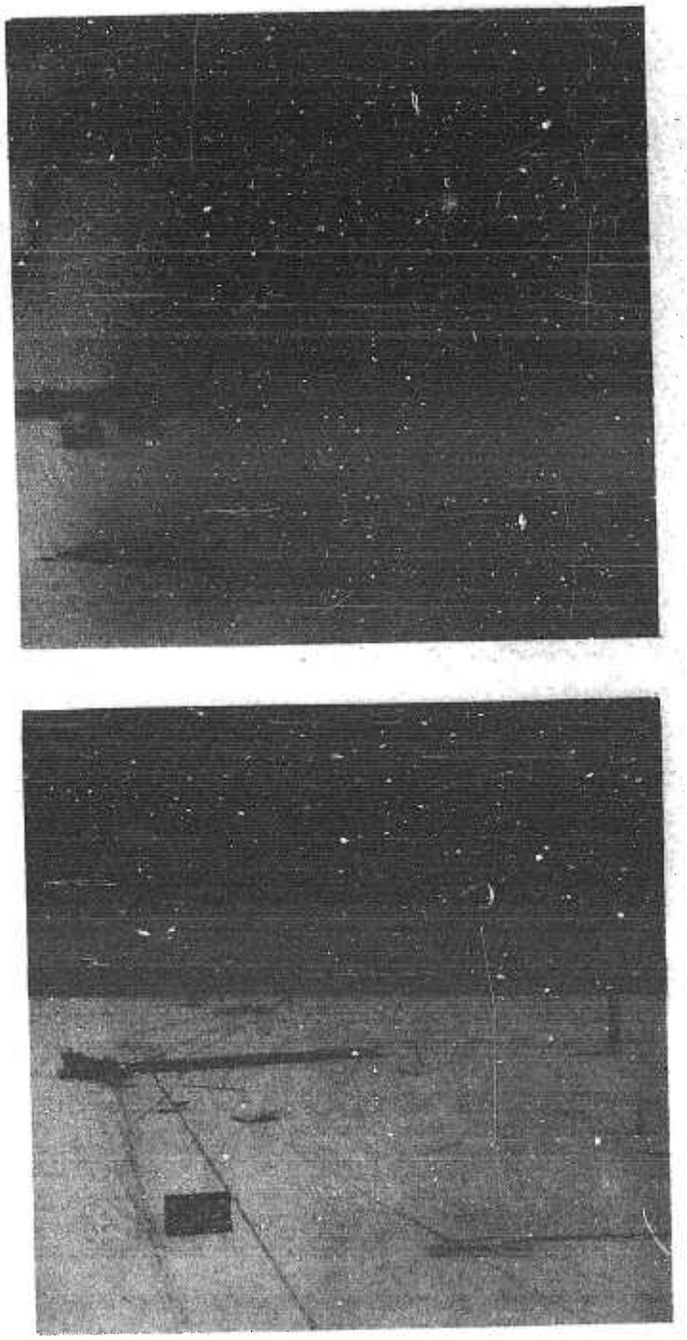
Fig. 3.36 Shot 9, Test Group 27, Transverse Pole Line, Poles B-1 through B-2, B-2 in Foreground. (Top-before, Bottom-after) 4450 ft, 35 cal, 7 psi.

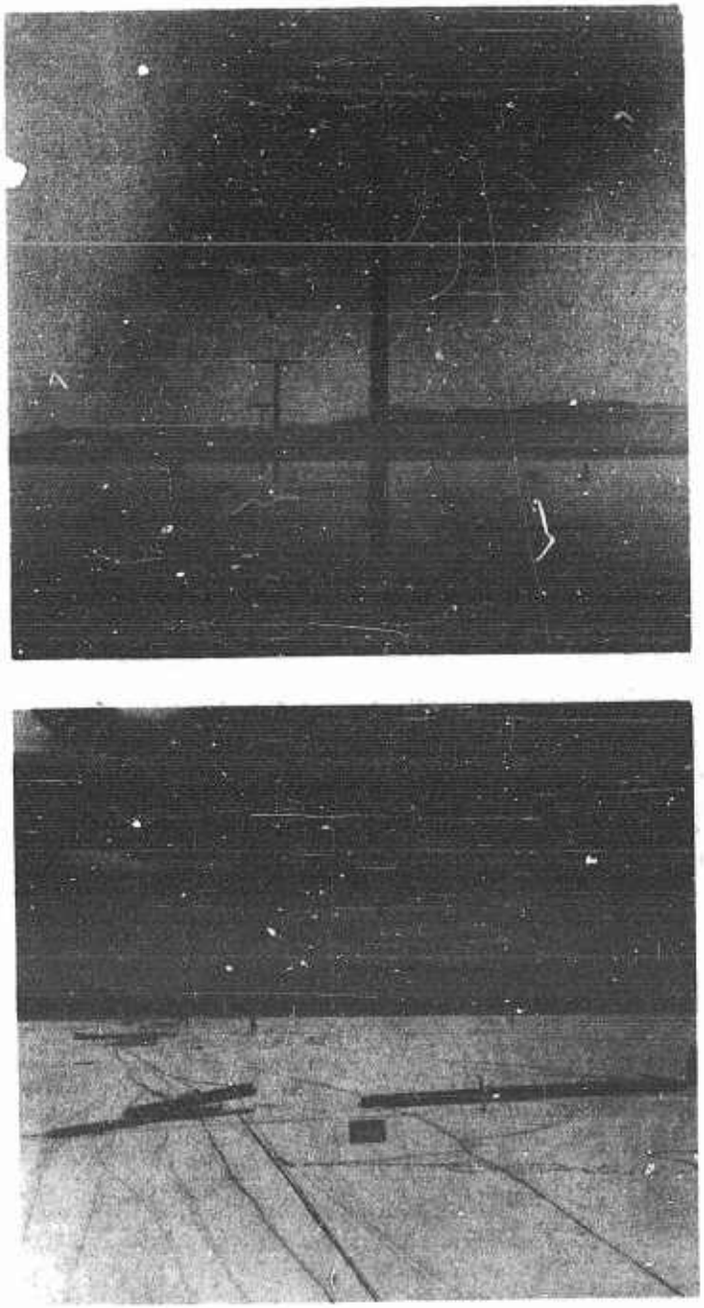
Fig. 3.37 Shot 9, Test Group 27, Transverse Pole Line, Poles B-1 through B-3, B-3 in Foreground. (Top-before, Bottom-after) 4450 ft, 35 cal, 7 psi.

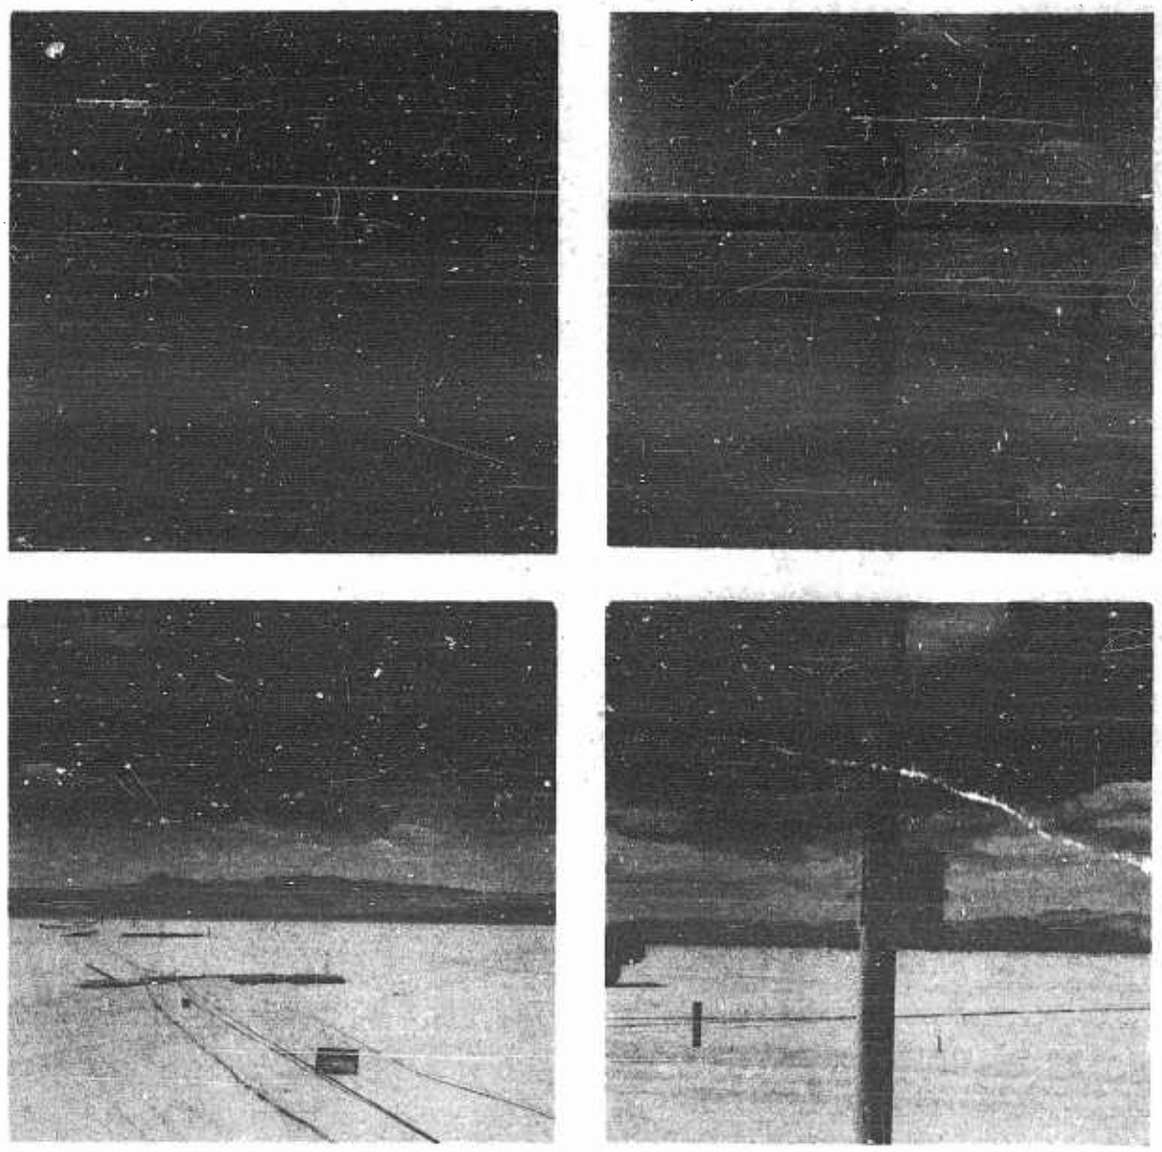
Fig. 3.38 Shot 9, Test Group 27, Transverse Pole Line, Poles B-1 through B-4, B-4 in Foreground. Right Shows Close-ups of Cable Transfer Relay on Pole B-4. (Top left-before, Bottom left-after, Top right-before, Bottom right-after) 4450 ft, 35 cal, 7 psi.

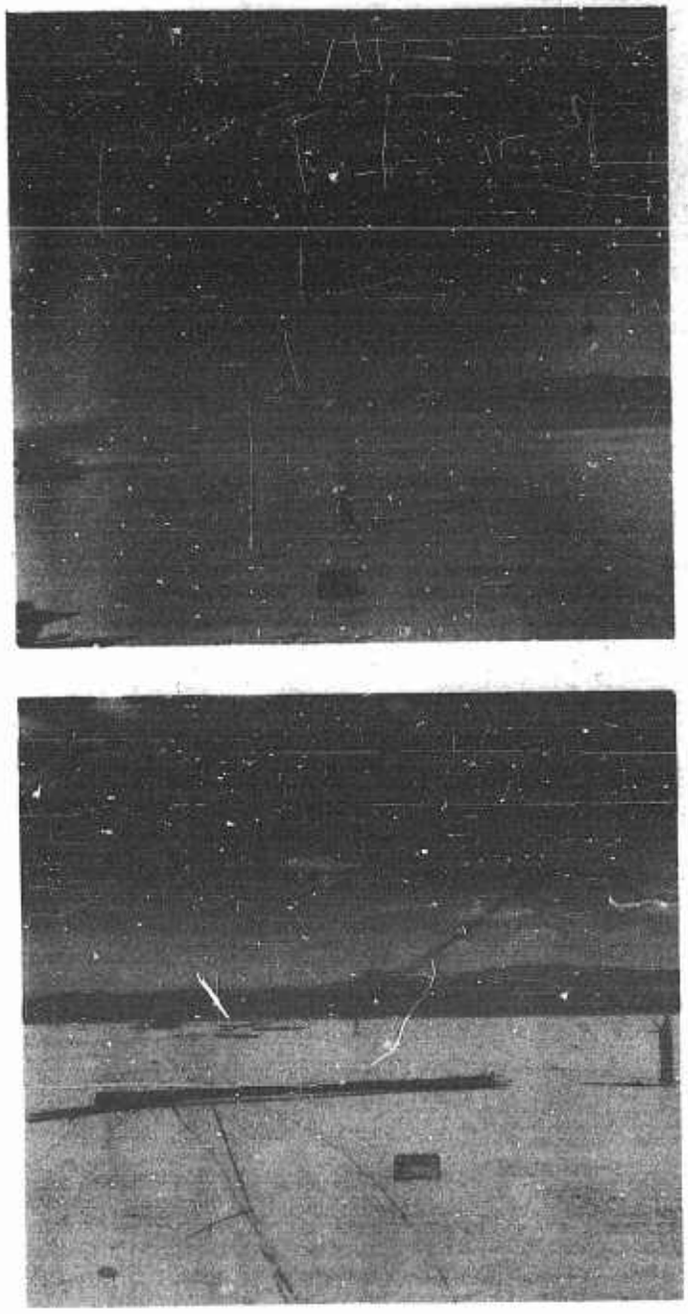
Fig. 3.39 Shot 9, Test Group 27, Transverse Pole Line, Poles B-1 through B-5, B-5 in Foreground. (Top-before, Bottom-after) 4450 ft, 35 cal, 7 psi.

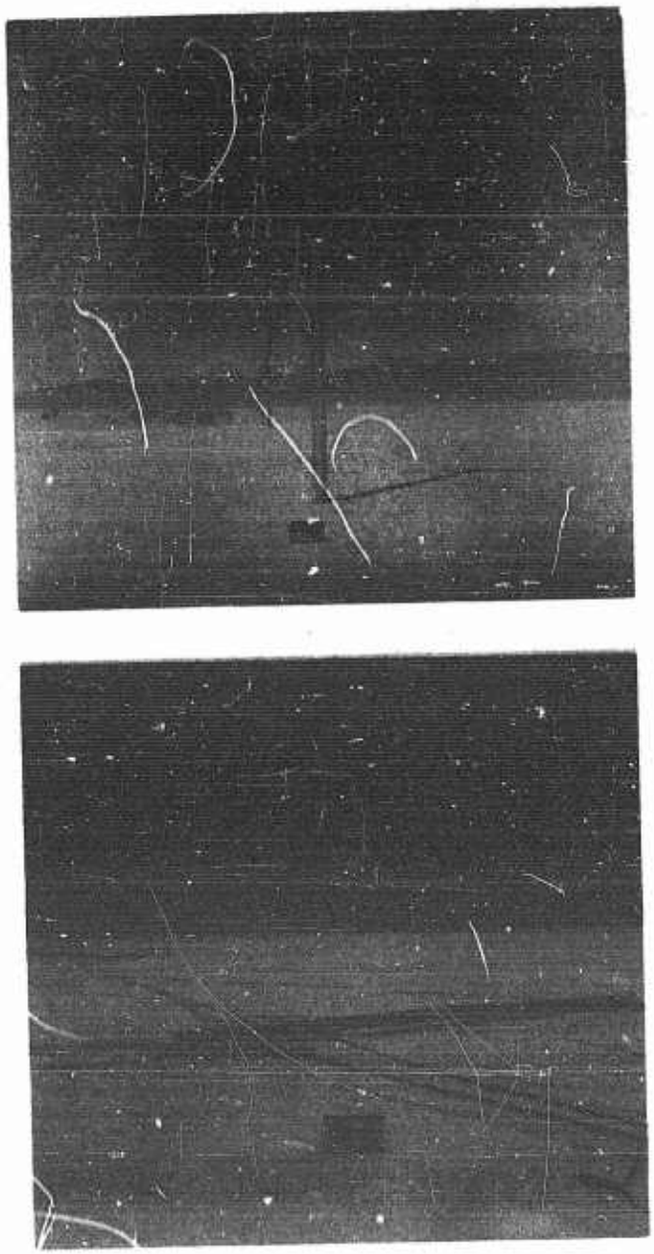
Fig. 3.41 Shot 9, Test Group 27, Transverse Pole Line, Poles B-1 through B-7, B-7 in Foreground. (Top-before, Bottom-after) 4450 ft, 35 cal, 7 psi.

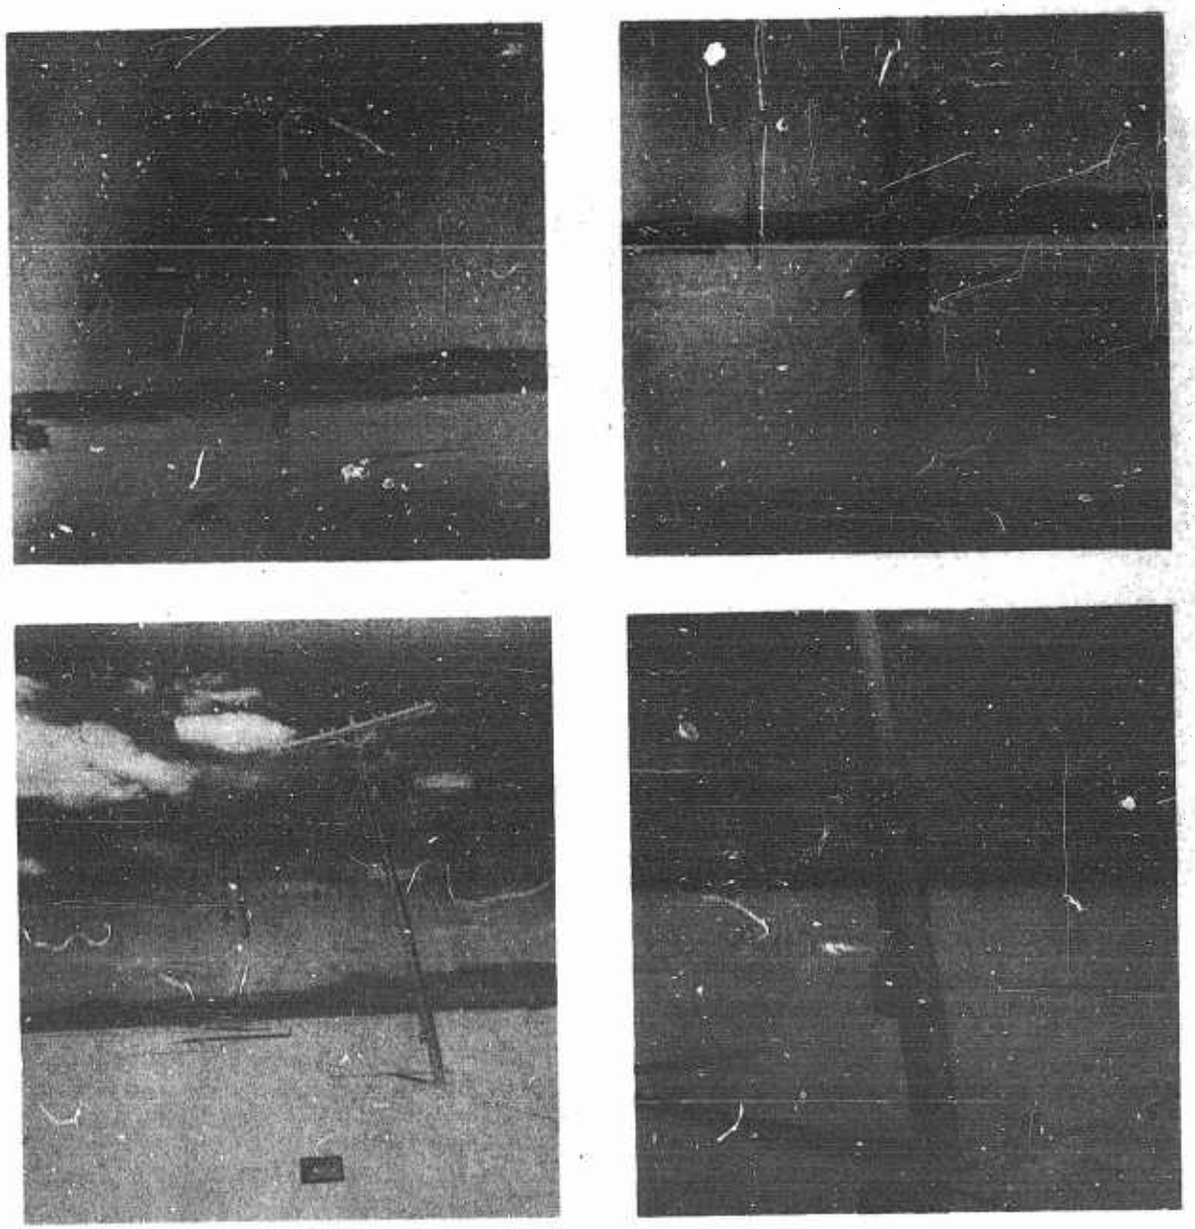
Fig. 3.42 Shot 9, Test Group 27, Transverse Pole Line, Poles B-1 through B-8, B-8 in Foreground. Right Shows Close-ups of EE-8 Telephone and TM-184 Terminal Strip on Shielded Side of Pole B-8. (Top left-before, Bottom left-after, Top right-before, Bottom right-after) 4450 ft, 35 cal, 7 psi.

(11) JUNCTION BOXES AND TERMINAL STRIPS: These items received no significant thermal or blast damage.

(12) FIELD TELEPHONES: These items on poles B-1 and B-8 were shielded from the thermal flux and received no significant thermal or blast damage.

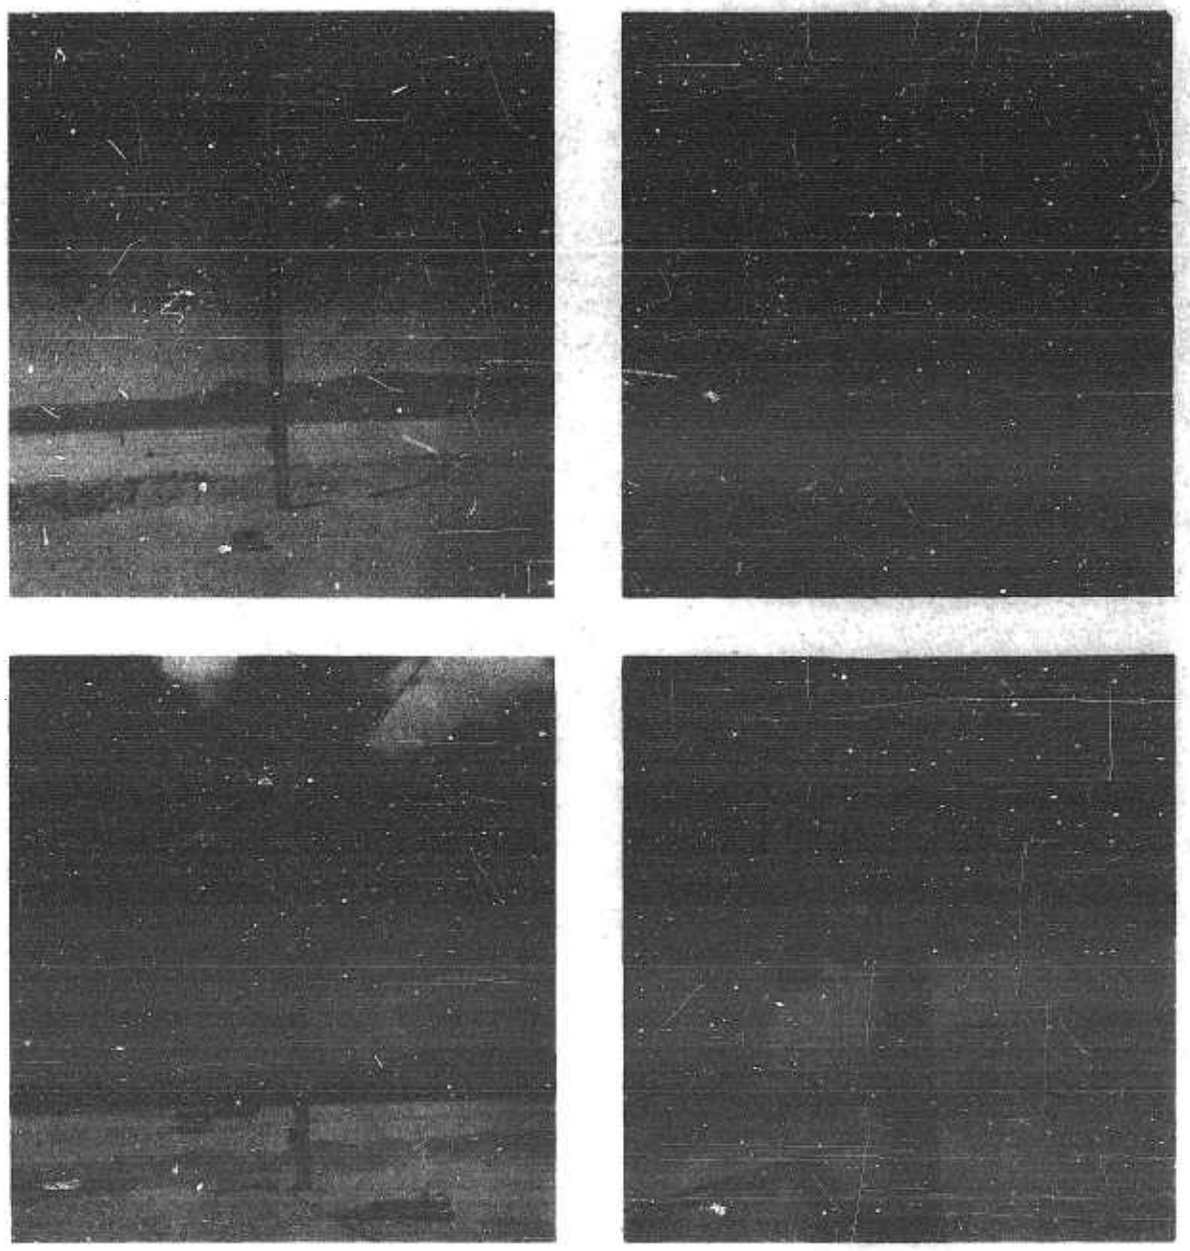
Fig. 3.43 Shot 9, Test Group 30, Transverse Pole Line, Pole A-1. (Top left-before, Bottom left-after) Close-ups of EE-8 Telephone and TM-184 Terminal Strip on Shielded Side of Pole A-1. (Top right-before, Bottom right-after) 5425 ft, 25.5 cal, 5.6 psi.

(13) EE-8 FIELD TELEPHONES: These telephones mounted on poles A-1 and A-8 were shielded from the thermal energy and received no thermal or blast damage.
