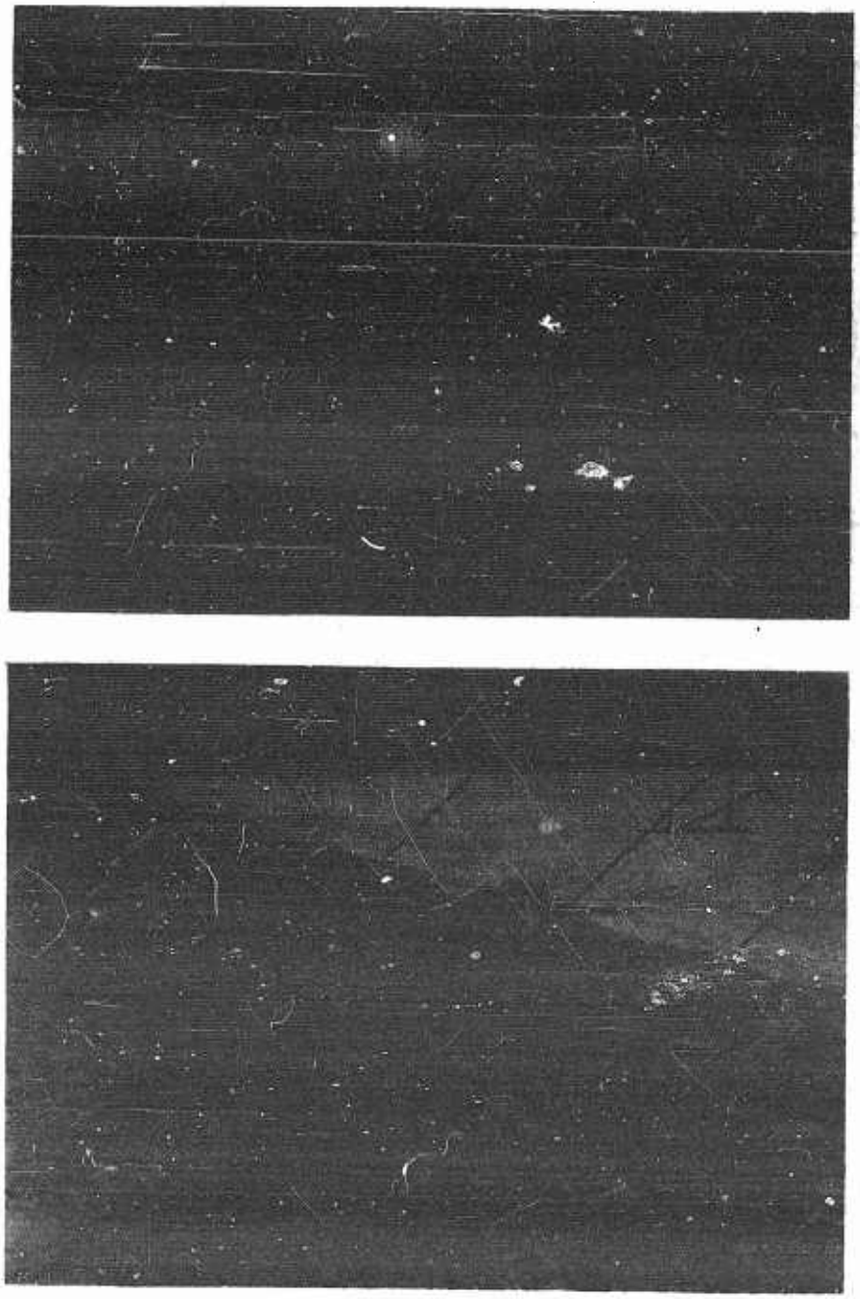
Fig. 3.44 Shot 9, Test Group 30, Transverse Pole Line, Triple Guys and Anchors on Pole A-1. (Top-before, Bottom-after) 5425 ft, 25.5 cal, 5.6 psi.

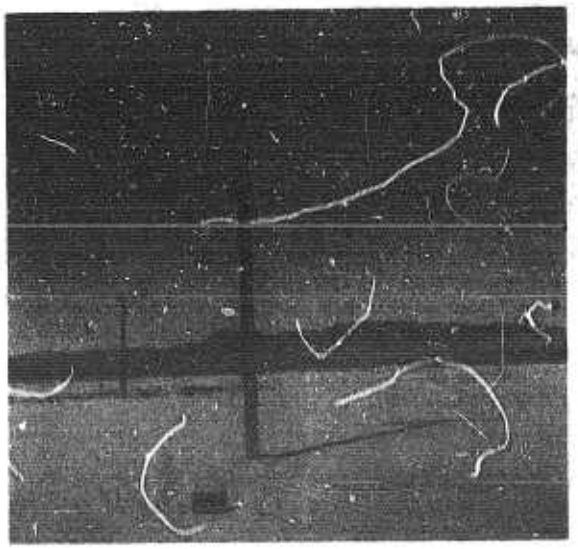
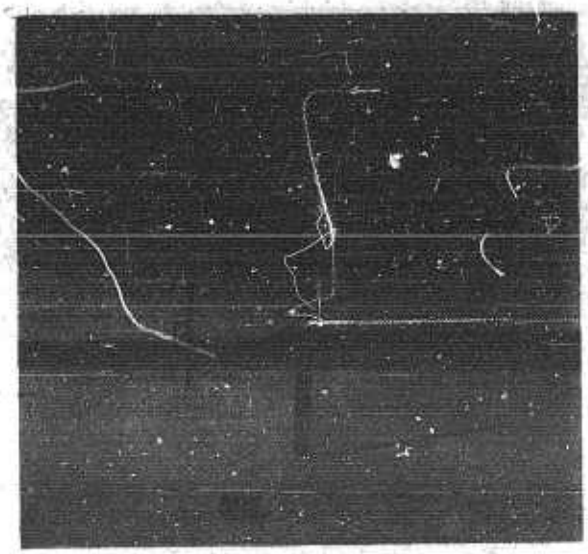
Fig. 3.45 Shot 9, Test Group 30, Transverse Pole Line, Poles A-1 through A-2, A-2 in Foreground. (Top-before, Bottom-after) 5425 ft, 25.5 cal, 5.6 psi.

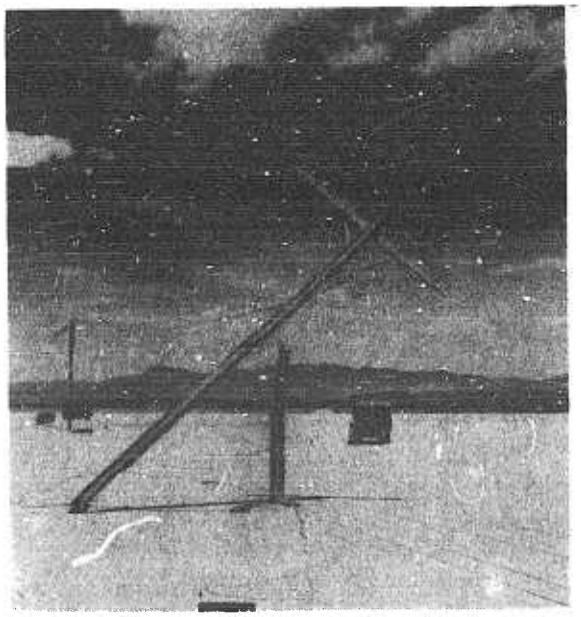
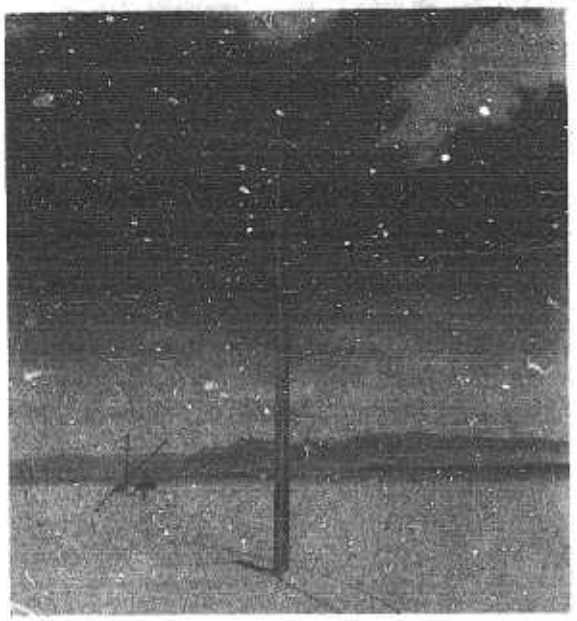
Fig. 3.46 Shot 9, Test Group 30, Transverse Pole Line, Poles A-1 through A-3, A-3 in Foreground. (Top-before, Bottom-after) 5425 ft, 25.5 cal, 5.6 psi.

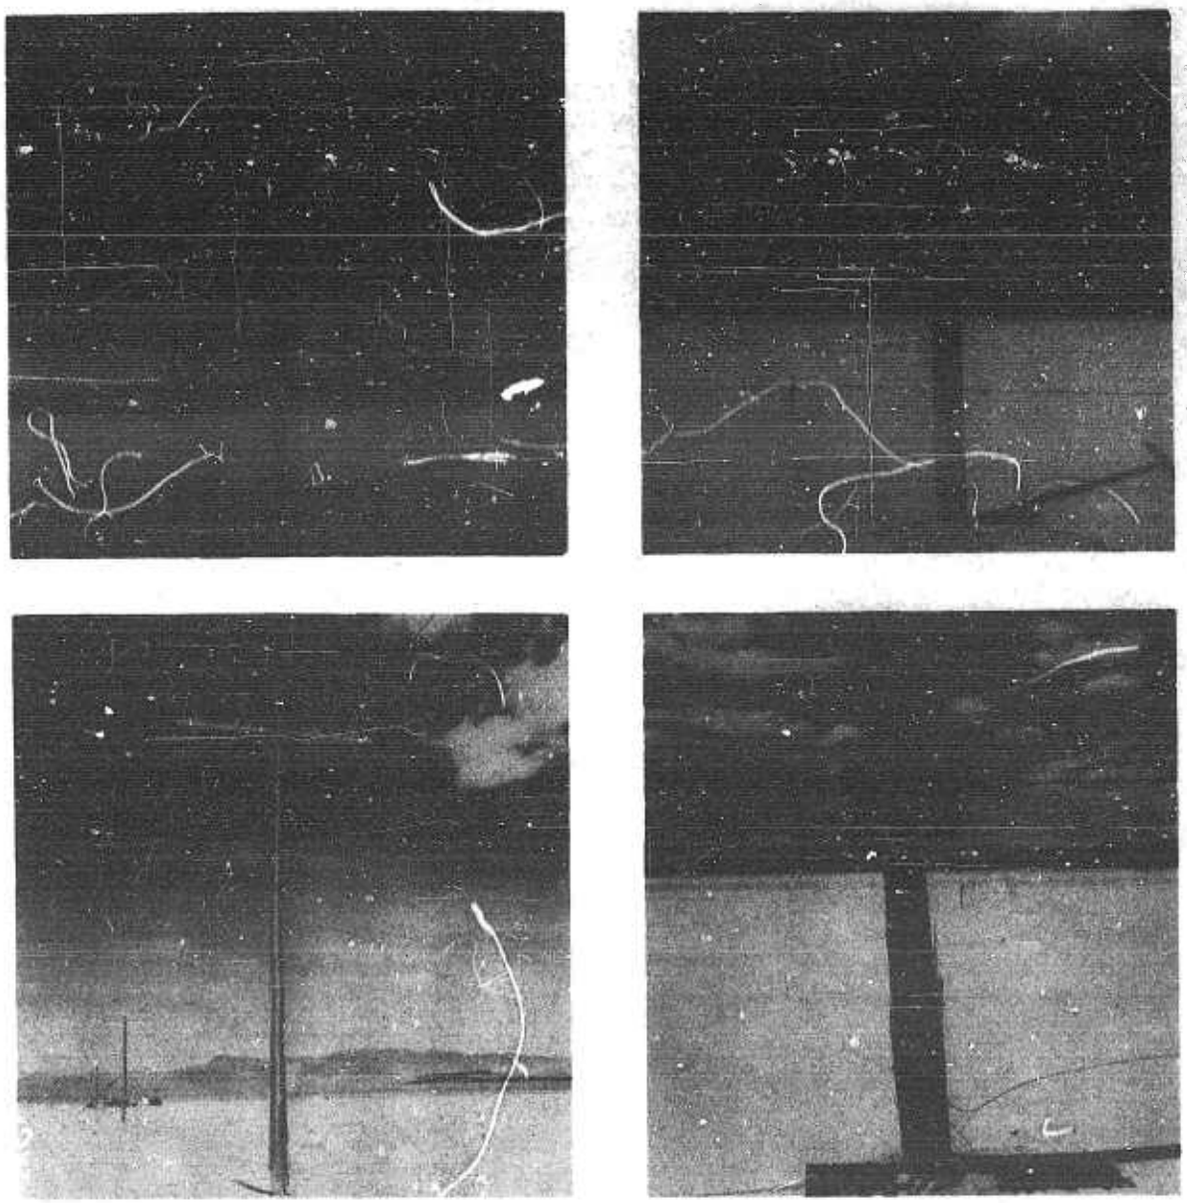
(11) CABLE TRANSFER RELAY: This relay on pole A-4 received no visible damage. A laboratory analysis indicates that this relay received no electrical or structural damage and it would have been serviceable.

Fig. 3.47 Shot 9, Test Group 30, Transverse Pole Line, Poles A-1 through A-4, A-4 in Foreground. (Top-before, Bottom-after) Right - Close-ups of Cable Transfer Relay on Pole A-4. (Top-before, Bottom-after) 5425 ft, 25.5 cal, 5.6 psi.

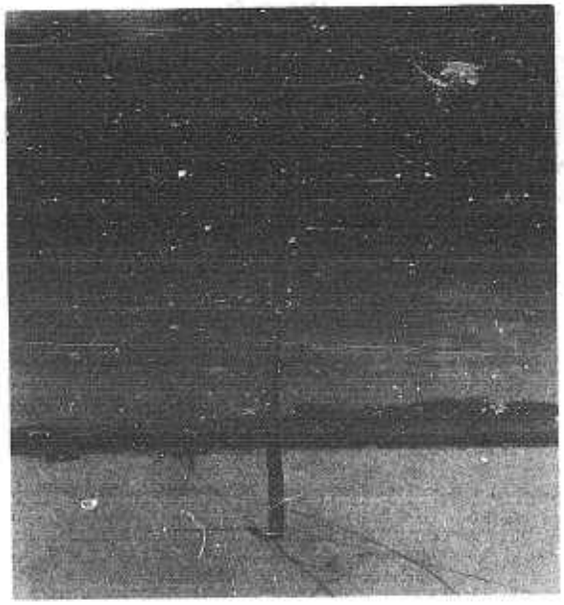
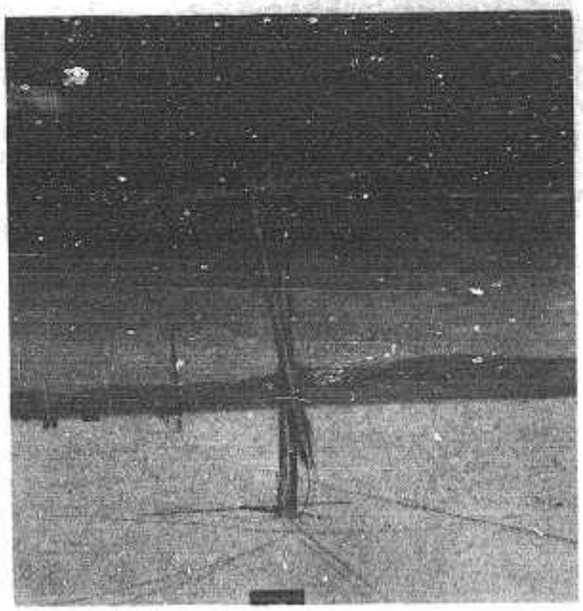
Fig. 3.48 Shot 9, Test Group 30, Transverse Pole Line, Poles A-1 through A-6, A-6 in Foreground. (Top-before, Bottom-after) 5425 ft, 25.5 cal, 5.6 psi.

Fig. 3.49 Shot 9, Test Group 30, Transverse Pole Line, Poles A-1 through A-7, A-7 in Foreground. (Top-before, Bottom-after) 5425 ft, 25.5 cal, 5.6 psi.

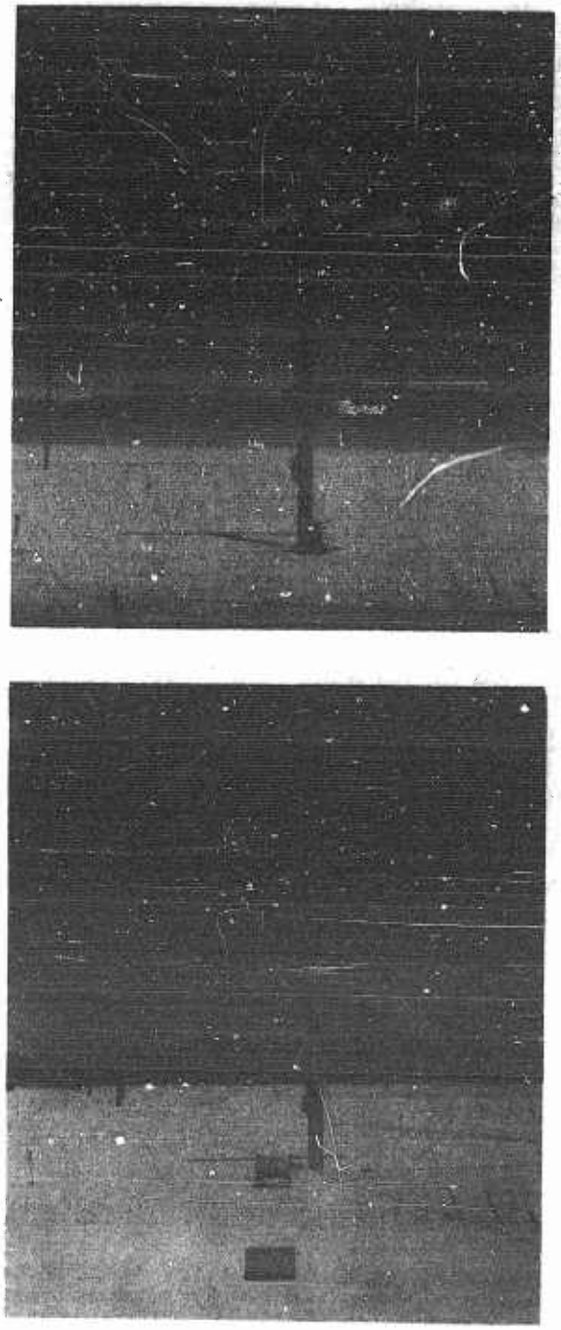
Fig. 3.50 Shot 9, Test Group 30, Transverse Pole Line, Poles A-1 through A-8, A-8 in Foreground. (Top-before, Bottom-after) 5425 ft, 25.5 cal, 5.6 psi.

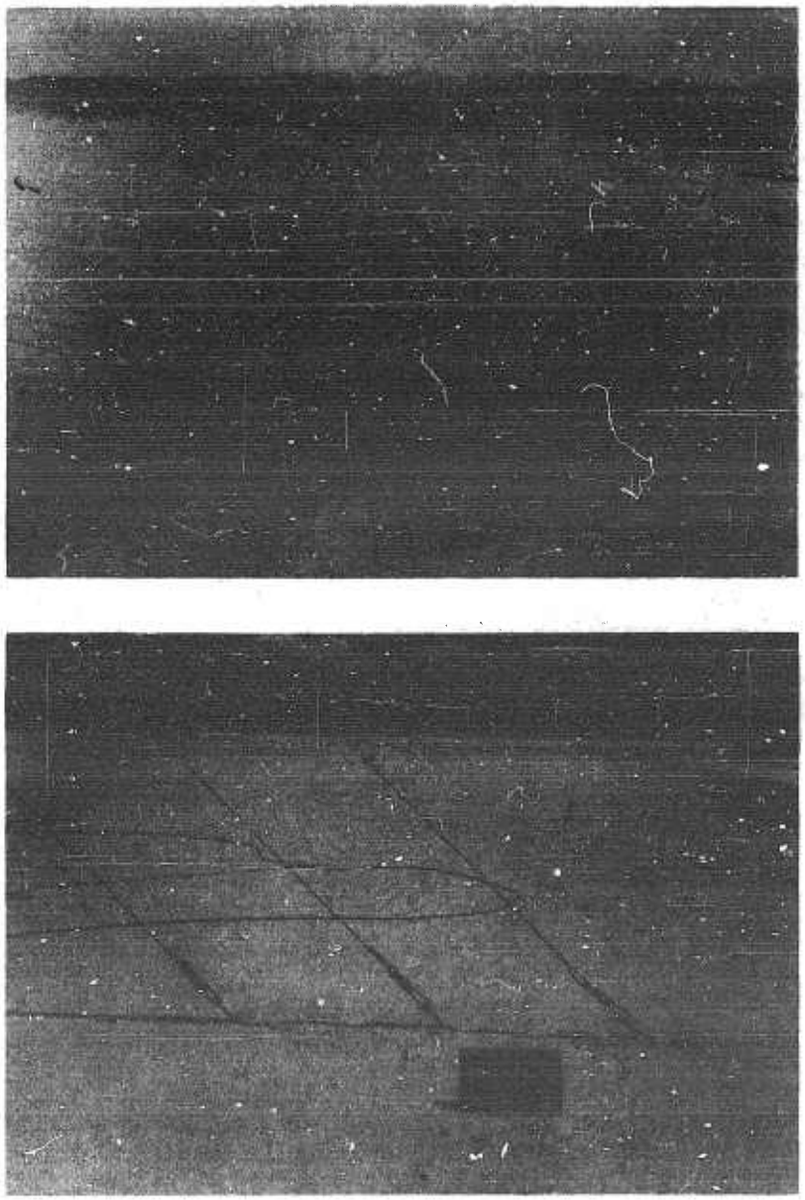
Fig. 3.51 Shot 9, Test Group 30, Transverse Pole Line, Triple Guys and Anchors on Pole A-8. (Top-before, Bottom-after) 5425 ft, 25.5 cal, 5.6 psi.

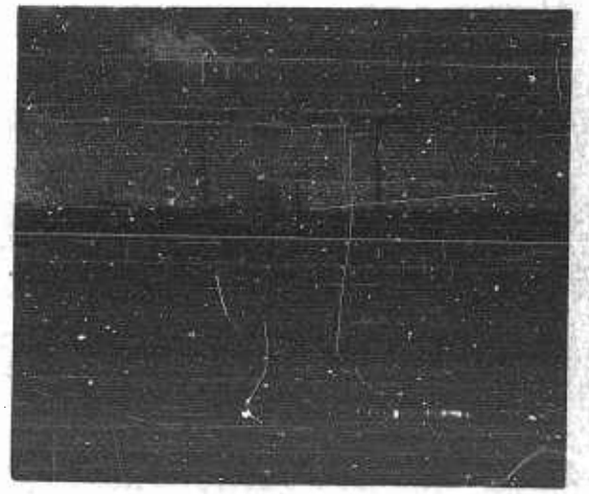
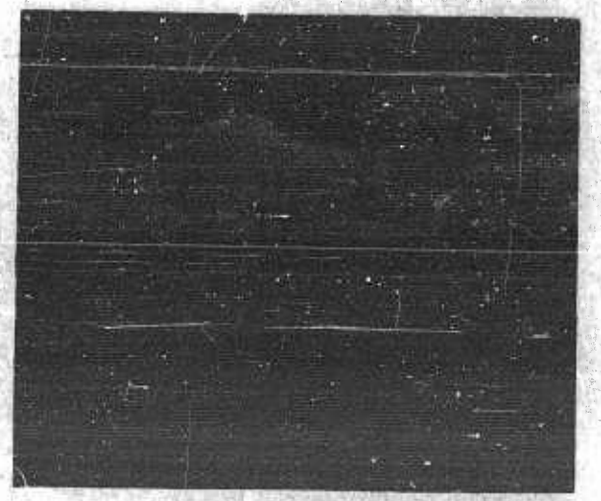
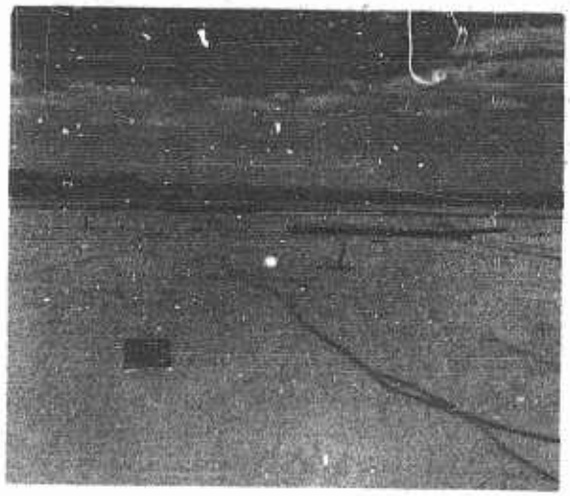
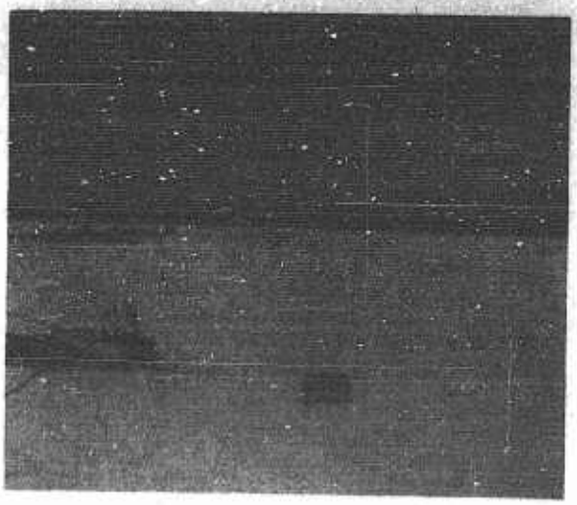
b. RESULTS: The five pair rubber-covered cable and the spiral four cable received no thermal or blast damage. The WD-1/TT field wire received severe thermal and blast damage (3400 ft, 50.0 cal, 9.6 psi).

Fig. 3.53 Shot 9, Test Group 25, Surface Laid Wire and Cable Along Transverse Pole Line. Photos Taken from Center of Lays Looking West. (Top-before, Bottom-after) 3400 ft, 50 cal, 9.6 psi.

Fig. 3.54 Shot 9, Test Group 25, Surface Laid Wire and Cable Along Transverse Pole Line. Photos Taken from Center of Lays Looking East. (Top-before, Bottom-after) 3400 ft, 50 cal, 9.6 psi.

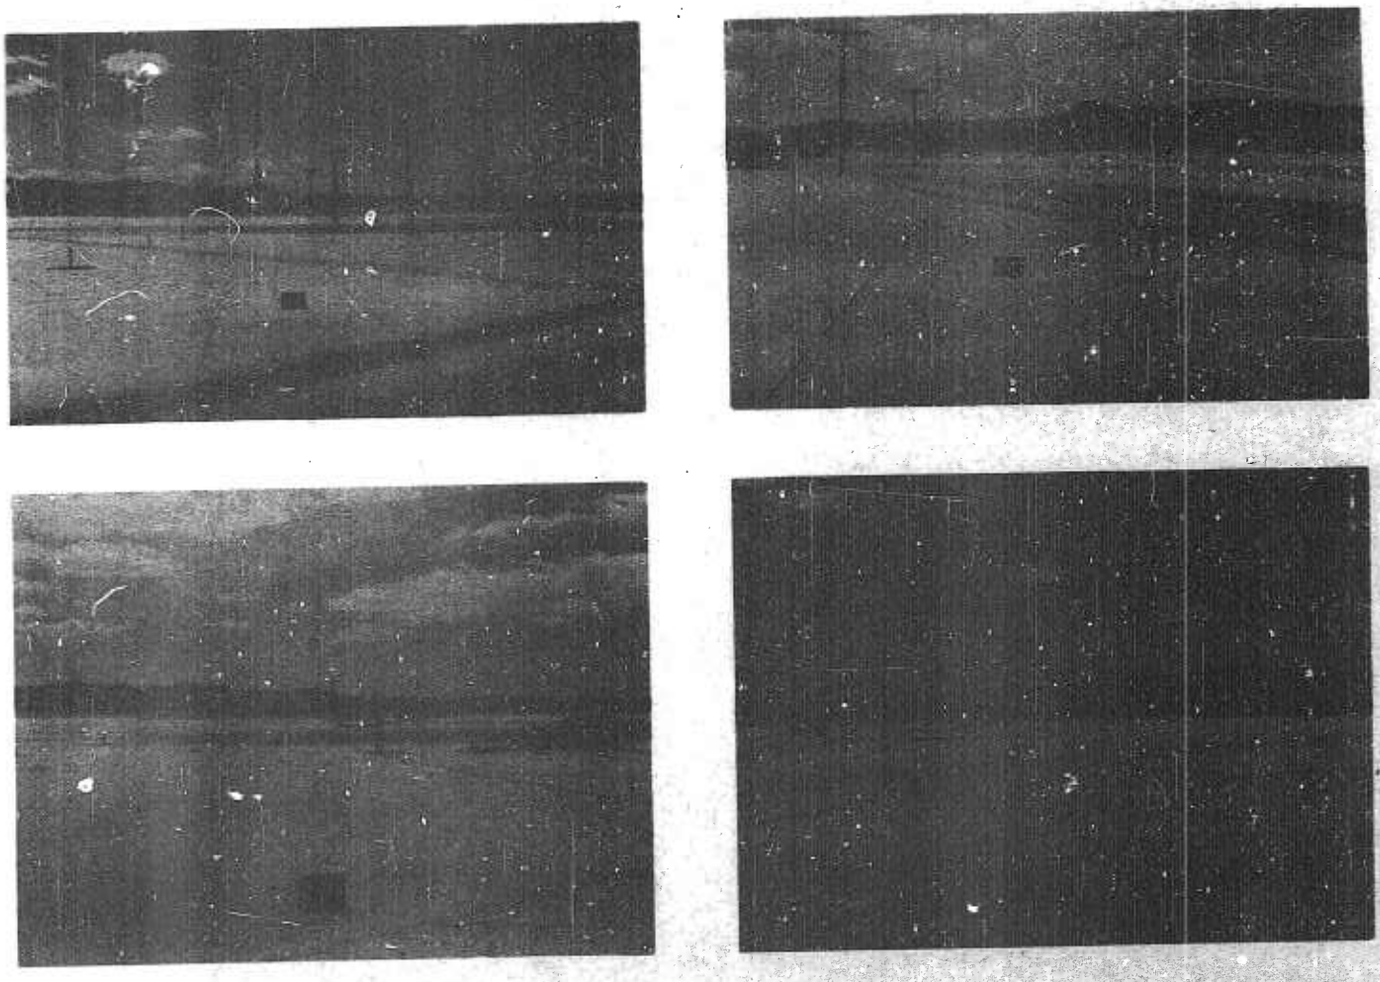
b. RESULTS: The five pair rubber covered cable and the spiral four cable received no thermal or blast damage. The WD-1/TT field wire received severe blast and thermal damage (4425 ft, 35 cal, 7.0 psi).

Fig. 3.55 Shot 9, Test Group 28, Surface Laid Wire and Cable along Transverse Pole Line. Photos Taken from Center of Lays Facing West. (Top left-before, Bottom left-after) Photos Taken from Center of Lays Facing East. (Top right-before, Bottom right-after) 4425 ft, 35 cal, 7 psi.

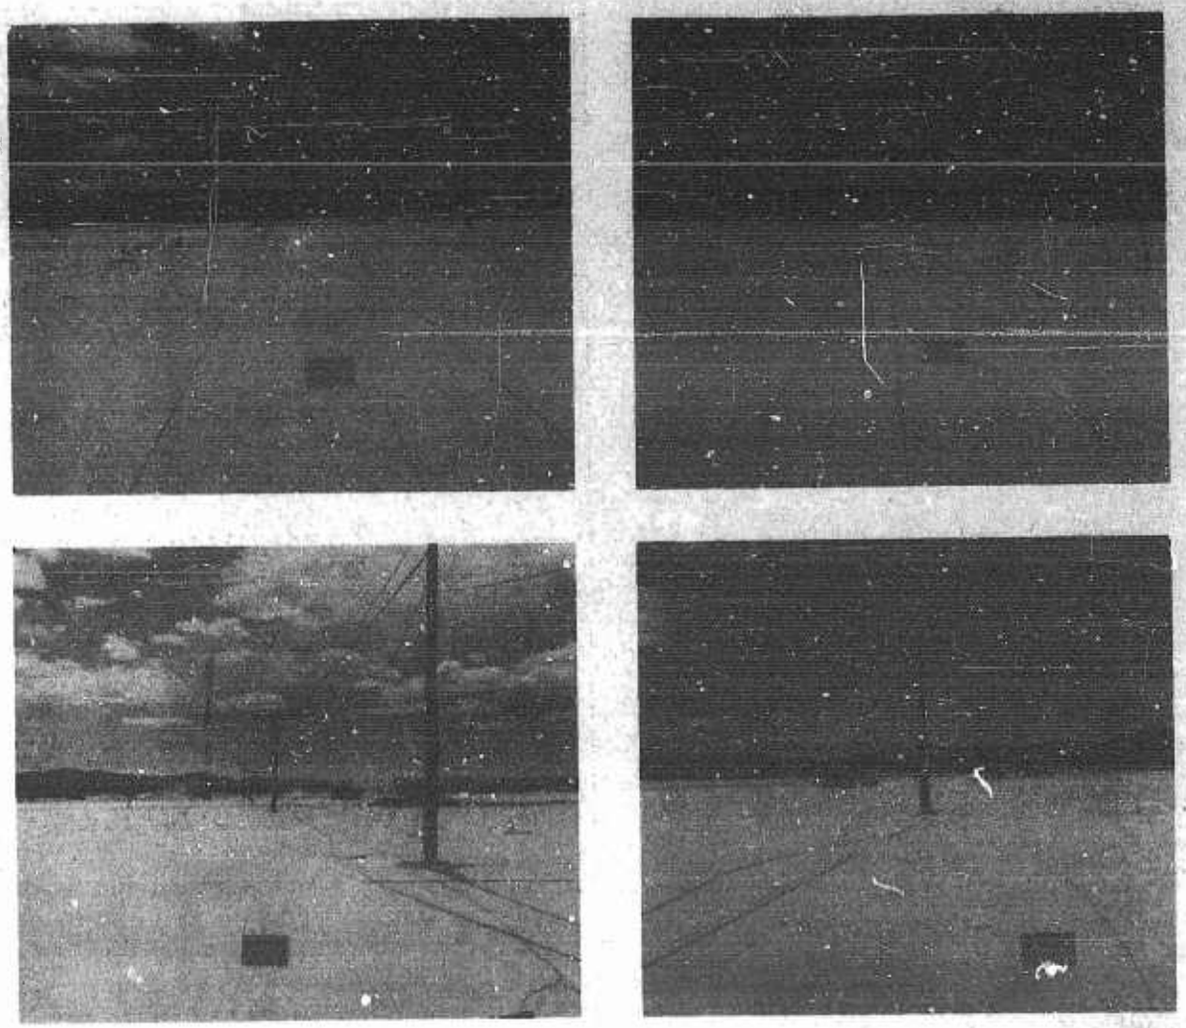
b. RESULTS: The five pair rubber covered cable and the spiral four cable received no thermal or blast damage. The WD-1/TT field wire received moderate thermal damage and severe blast damage (5400 ft, 25.5 cal, 5.6 psi).

Fig. 3.56 Shot 9, Test Group 31, Surface Laid Wire and Cable Along Transverse Pole Line. Photos taken from Center of Lays Facing West. (Top-before, Bottom-after) Photos taken from Center of Lays Facing East. (Top right-before, Bottom right-after) 5400 ft, 25.5 cal, 5.6 psi.

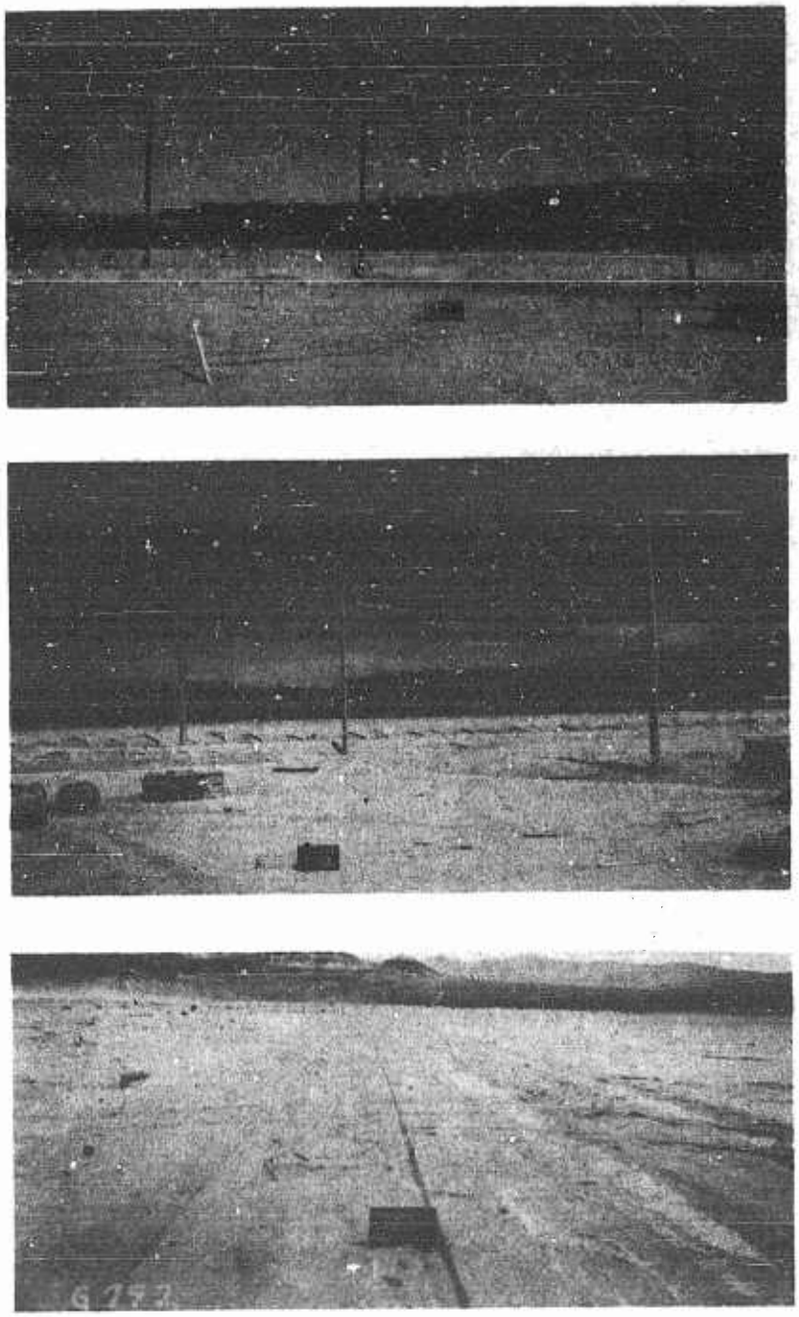
Fig. 3.58 Shots 9 and 10, Test Groups 4 and 4A, Separate Poles. (Top-before 9, Center-after 9, Bottom-after 10) (In Bottom View Note the Foxhole on Left Hand Side of Photo - Test Group 4A was about 1000 ft forward and 25 ft to the Left of this Foxhole. The Three Poles were Disintegrated in Shot 10) Shot 9 - 1850 ft, 85 cal, 13.2 psi. Shot 10 - 1120 ft, over 60 cal, 32 psi.

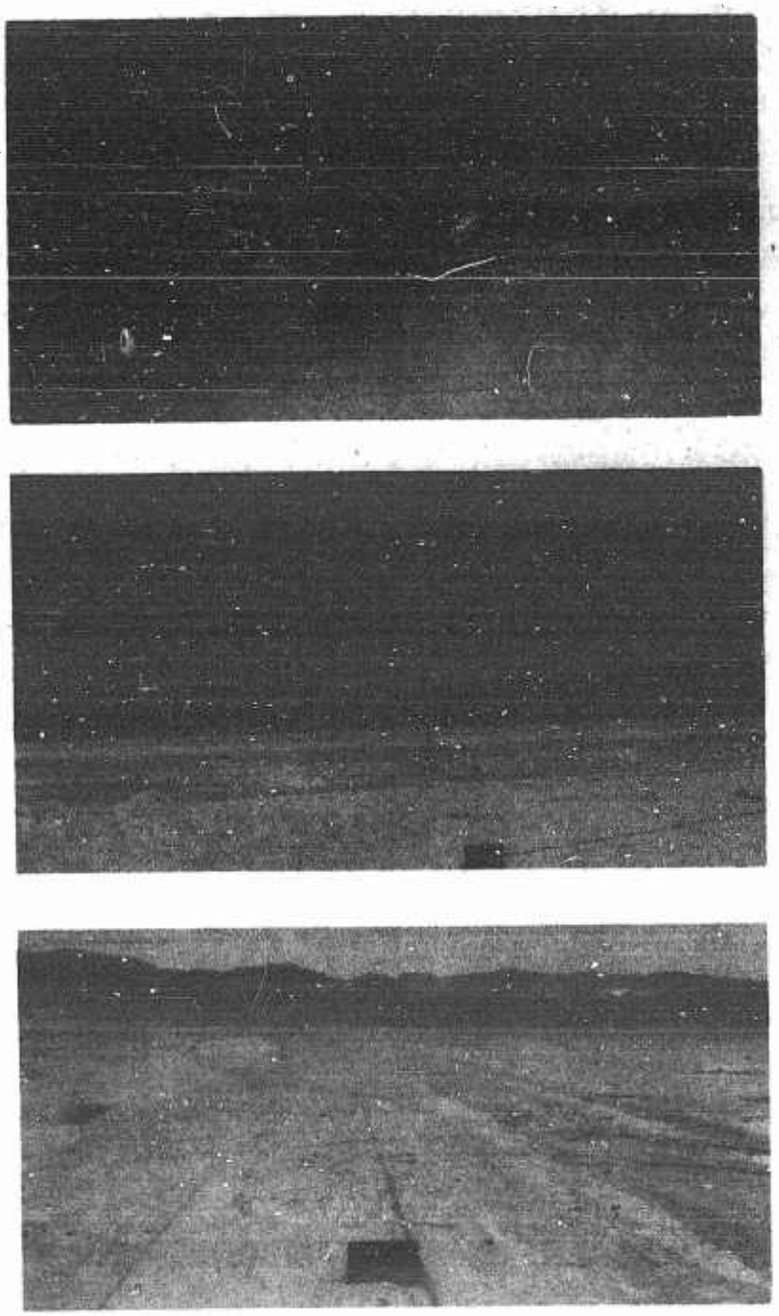
Fig. 3.59 Shots 9 and 10, Test Groups 5 and 5A, Separate Poles. (Top-before 9, Center-after 9, Bottom-after 10) (In Bottom View Note the Foxhole on Left Hand Side of Photo - Test Group 5A was Located about 500 ft forward and 50 ft to the Left of this Foxhole. The Pole was Disintegrated.)

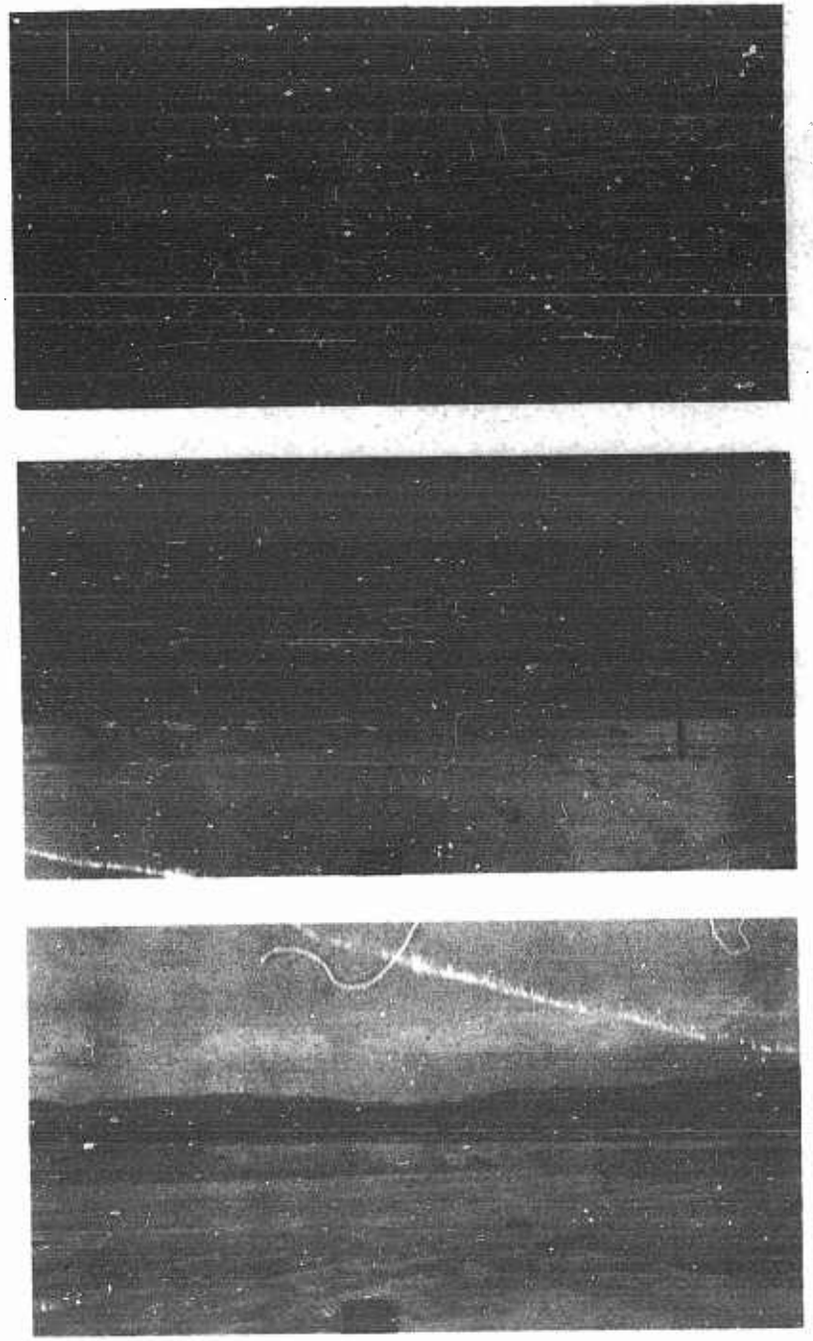
Fig. 3.60 Shots 9 and 10, Test Groups 6 and 6A, Separate Poles. (Top-before 9, Bottom-after 10) (In Bottom View the Splintered Stubs of the Three Poles can be Seen Diagonally Across the Photo from Right to Left) Shot 9 - 2825 ft, 61.5 cal, 10.8 psi. Shot 10 - 2125 ft, over 60 cal, 7 psi.

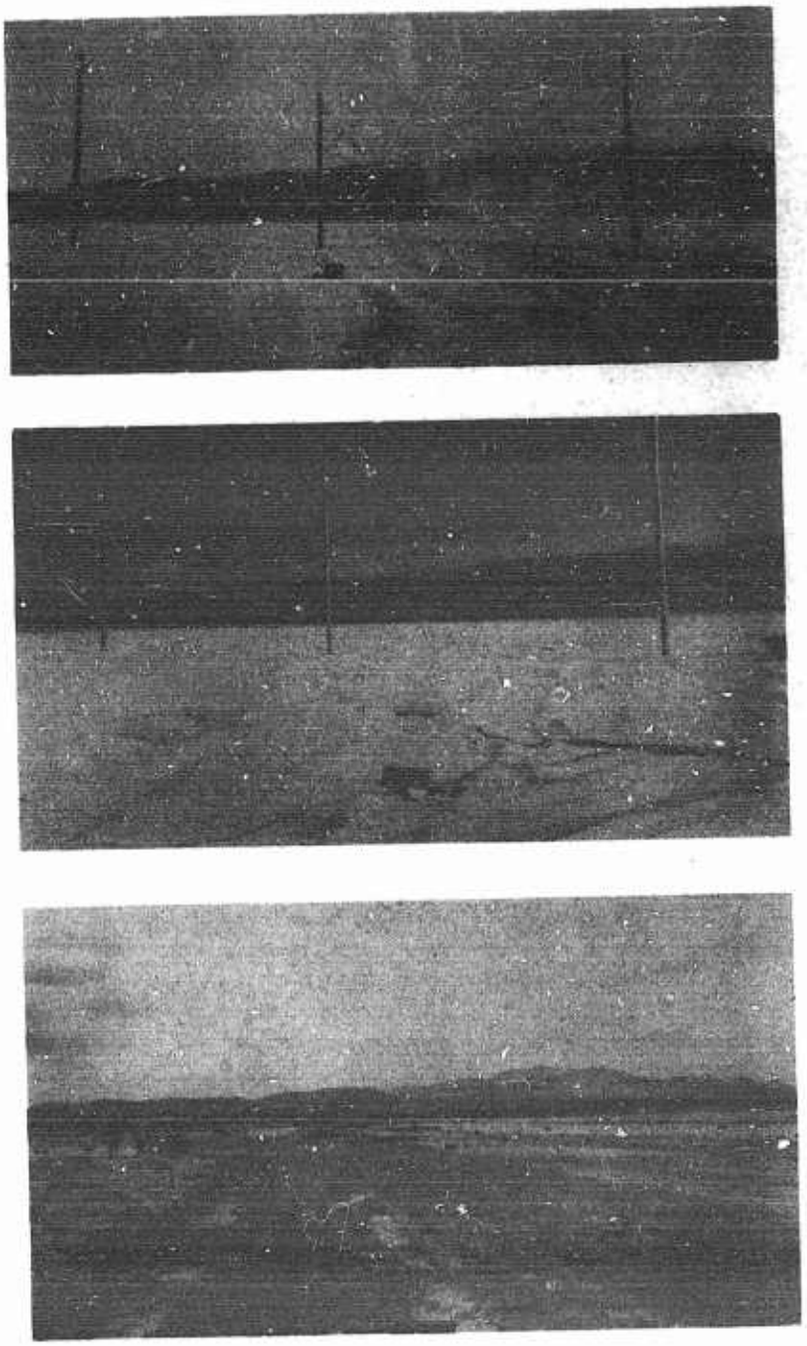
Fig. 3.61 Shots 9 and 10, Test Groups 7 and 7A, Separate Poles. (Top-before 9, Center-after 9, Bottom-after 10) (In Bottom View Test Group 7A, 3 Separate Poles can be seen to the Right of Pole D-36. Test Group 7A is the First of the Separate Poles which Remained Standing after Shot 10) Shot 9 - 3825 ft, 43.5 cal, 8.6 psi. Shot 10 - 3125 ft, 41 cal, 5 psi.

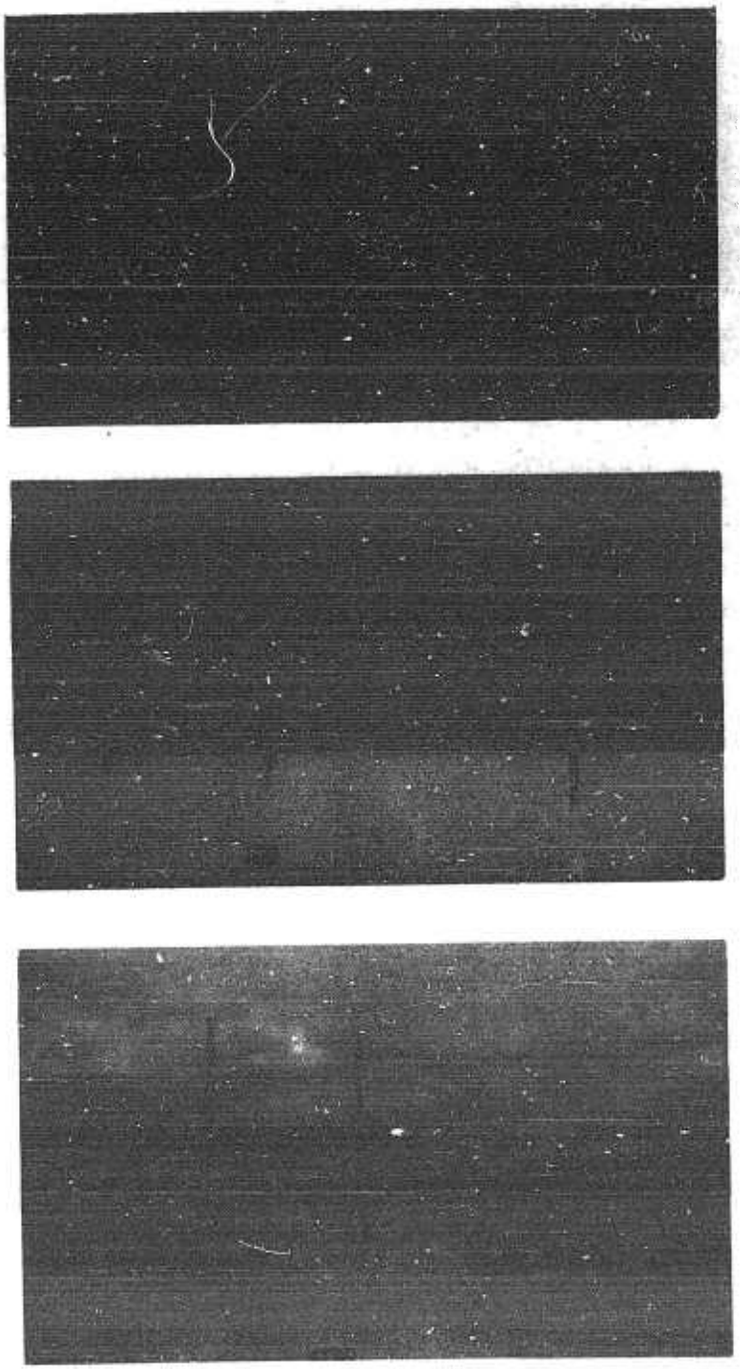
Fig. 3.62 Shots 9 and 10, Test Groups 8 and 8A, Separate Poles. (Top-before 9, Center-after 9, Bottom-after 10) (Pole on Bottom Right was Removed for other use prior to Shot 10.)
Shot 9 - 4875 ft, 30.5 cal, 6.2 psi.
Shot 10 - 4200 ft, 24 cal, 4 psi.

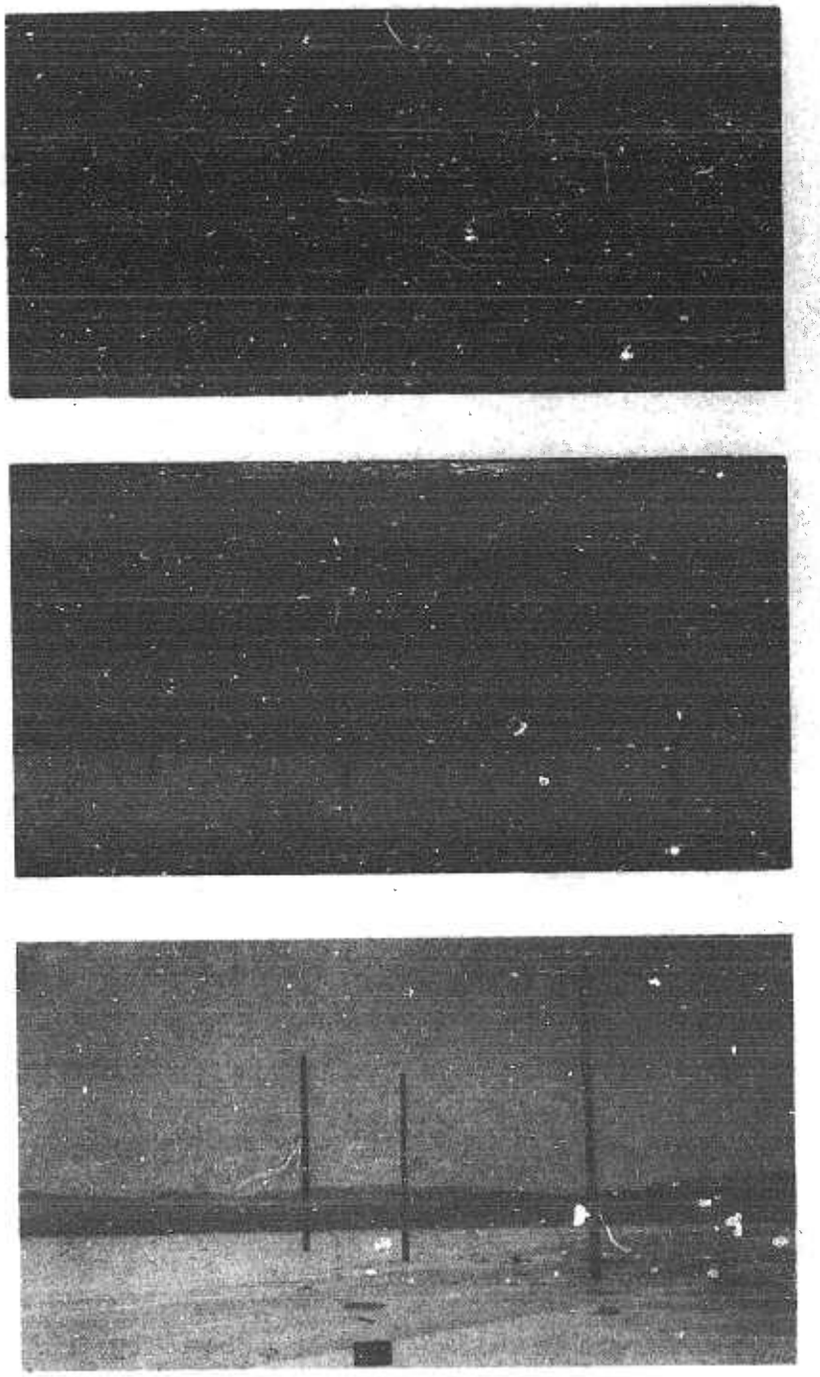
Fig. 3.63 Shots 9 and 10, Test Groups 9 and 9A, Separate Poles. (Top-before 9, Center-after 9, Bottom-after 10)
Shot 9 - 5800 ft, 23.5 cal, 5.2 psi.
Shot 10 - 5125 ft, 16 cal, 3 psi.

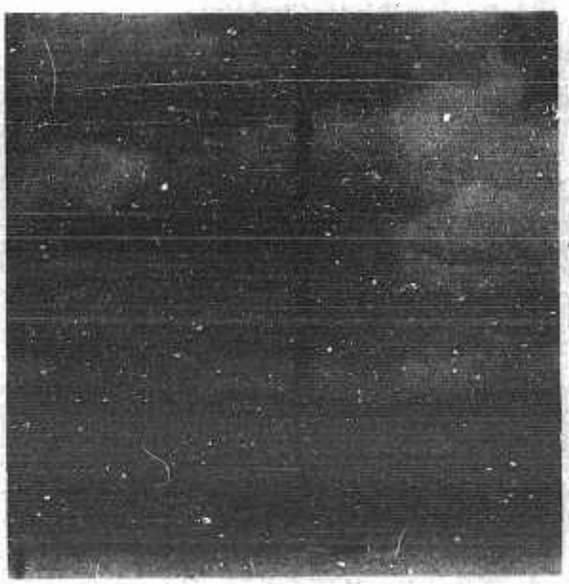
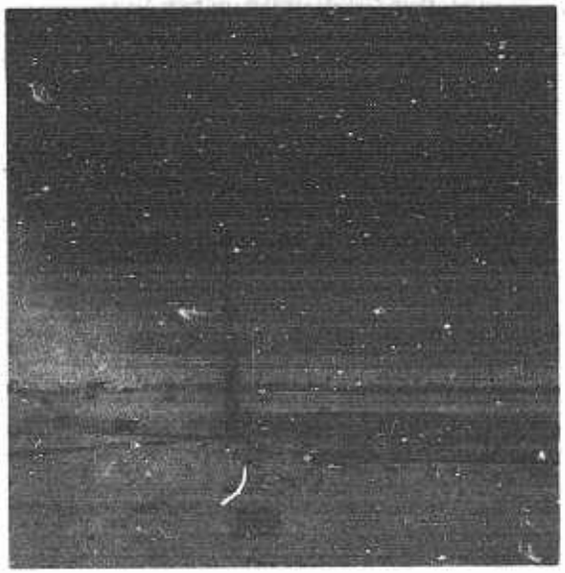
b. RESULTS: These poles received no significant damage in Shot 9.

Fig. 3.64 Shot 9, Test Group 83. SigC Items in Med. C. Installations, Separate Pole. (Top-before, Bottom-after) 4125 ft, 39.5 cal, 8 psi.

Fig. 3.65 Shot 9, Test Group 84. SigC Items in Med.C. Installations, Separate Pole (Top-before, Bottom-after) 9000 ft, 8.5 cal, 3 psi.

NOTE: Wire and Attachments Removed from Pole after Shot 9 but Prior to Taking the Bottom Photo. They were not damaged.

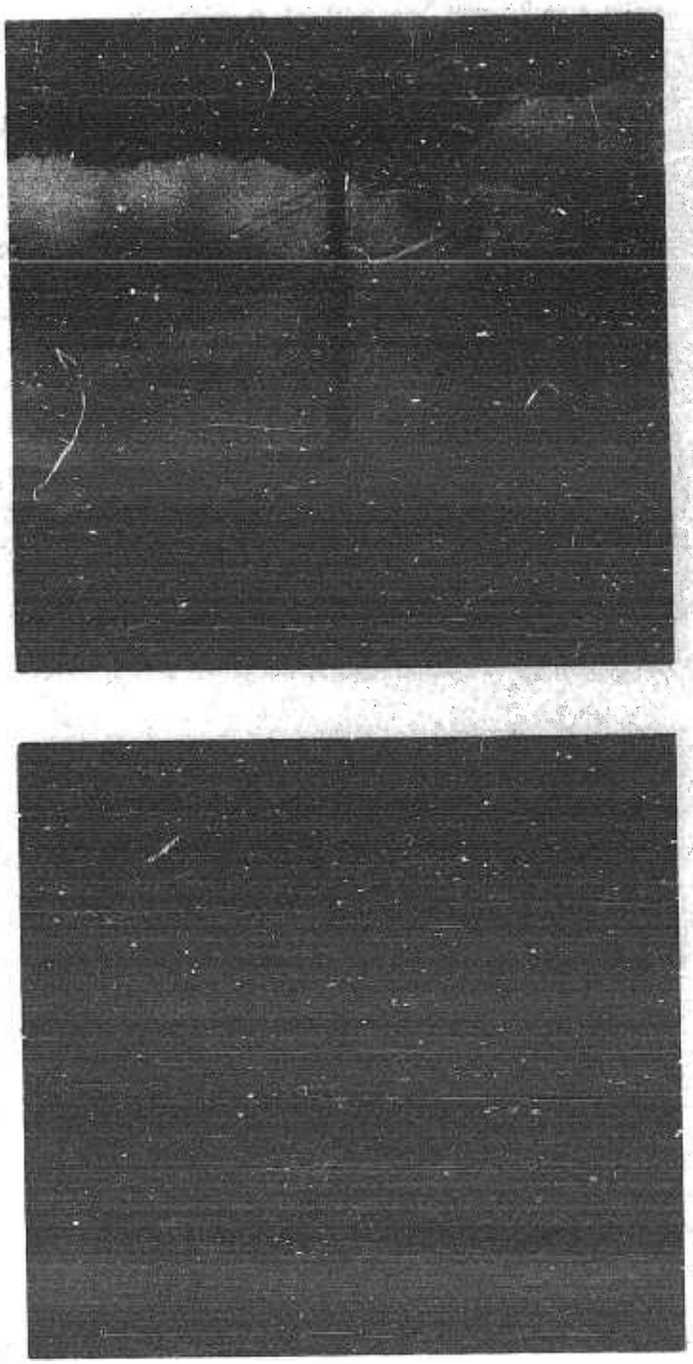
Fig. 3.66 Shot 9, Test Group 85, SigC Items in Med.C Installations, Separate Pole. (Top-before, Bottom-after) 1500 ft, less than 1 cal, less than 1 psi.

NOTE: Wire and Attachments Removed from Pole after Shot 9 but prior to taking this photo. They were not damaged.

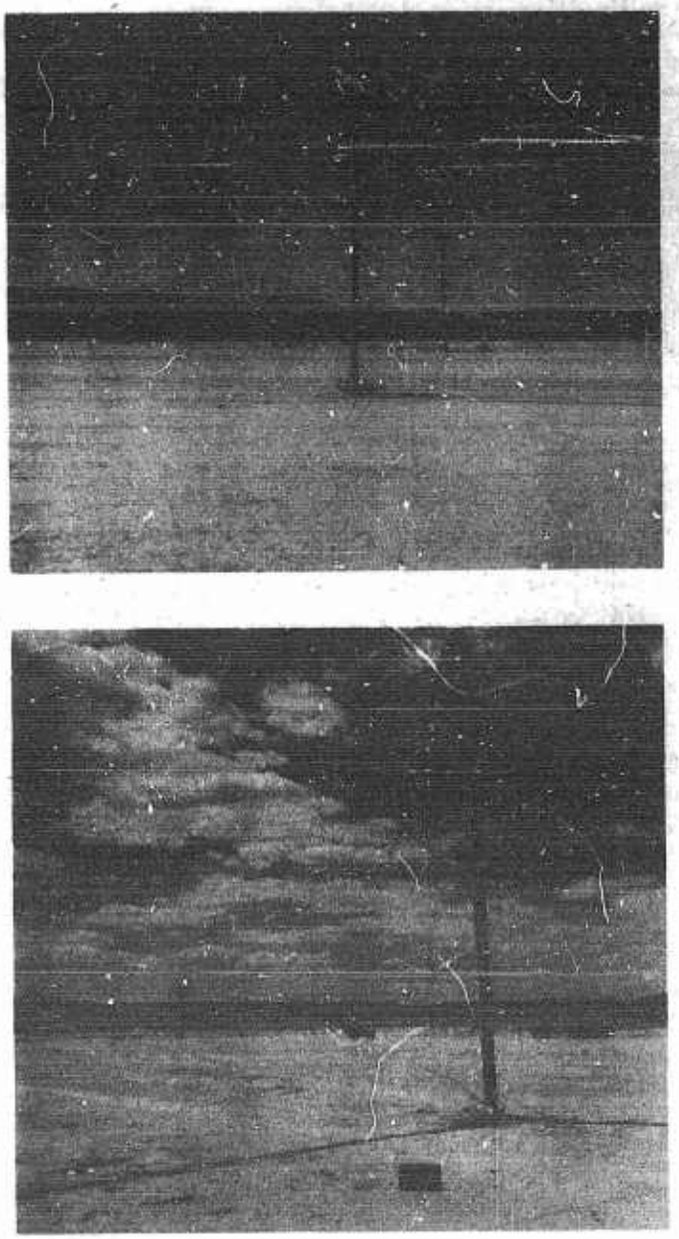
Fig. 3.67 Shots 9 and 10, Test Groups 103 and 103A, Seperate Pole.
(Top-before 9, Center-after 9, Bottom-after 10)
Shot 9 - 1150 ft, 120 cal, 17.8 psi.
Shot 10 - 500 ft, over 60 cal, over 115 psi.

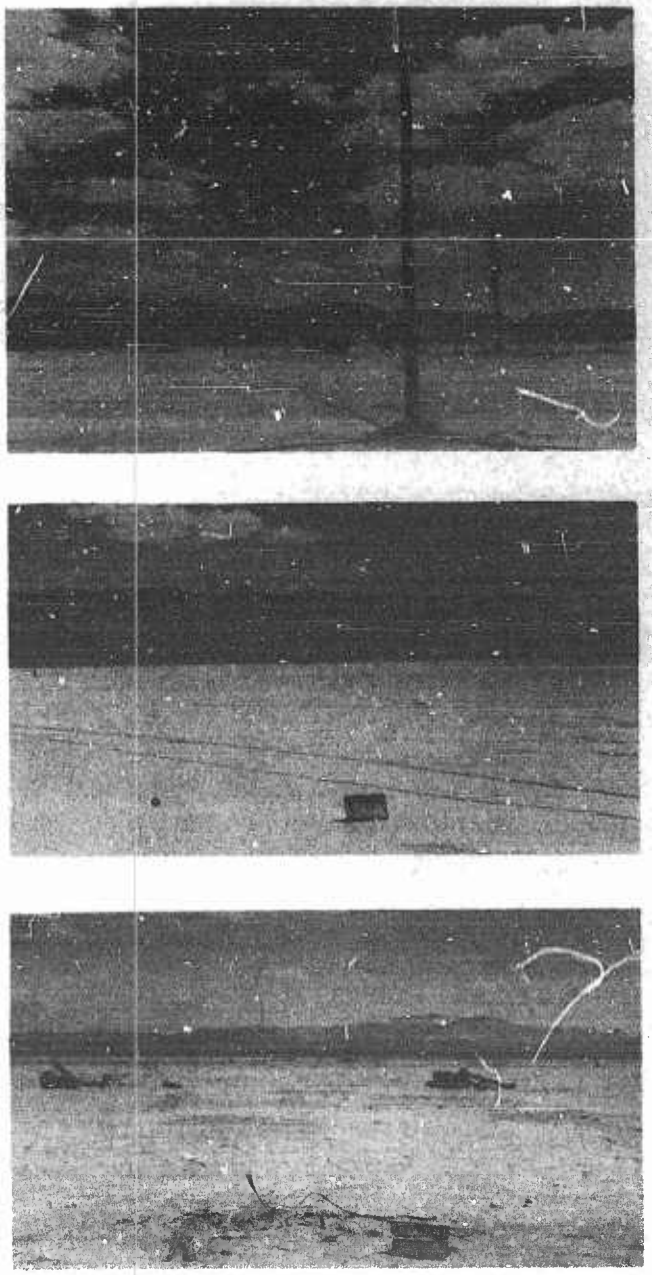
Fig. 3.68 Shots 9 and 10, Test Groups 104 and 104A, Separate Pole. (Top-before 9, Center-after 9, Bottom-after 10) (In Center View Test Group 104 is the First Pole from Left to Right in the Background. In Bottom View Test Group 104A was 900 ft forward of Test Group 105A, about where the Pole Stub can be seen in Upper Righthand Side of Bottom Photo. Shot 9 - 850 ft, over 120 cal, over 21 psi. Shot 10 - 300 ft, over 60 cal, over 115 psi.

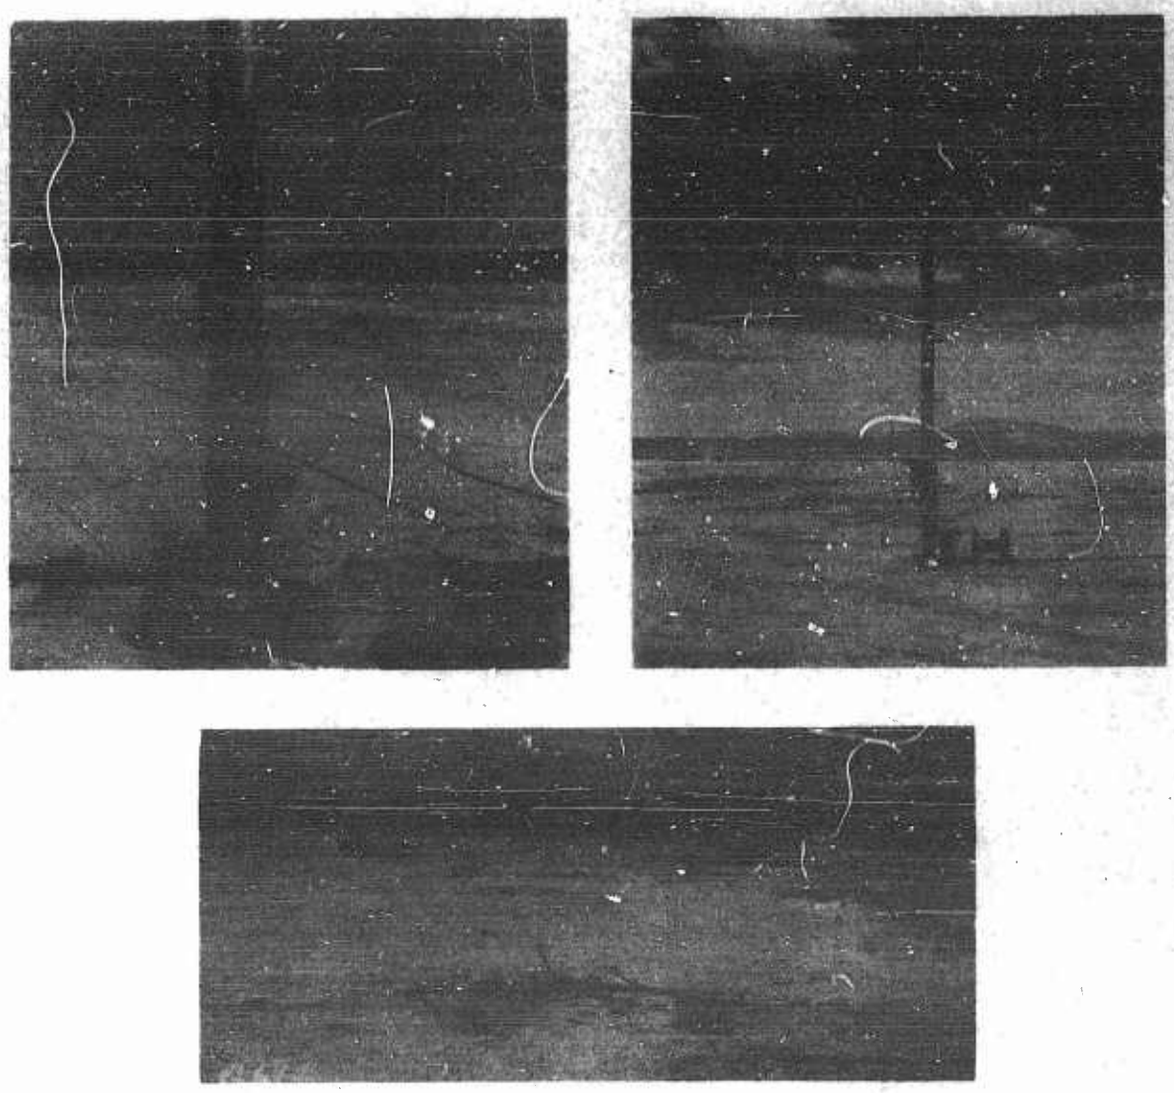
Fig. 3.69 Shots 9 and 10, Test Groups 105 and 105A, Separate Pole.
(Top-before 9, Right-after 9, Bottom-after 10)
Shot 9, 175 ft, over 120 cal, over 21 psi.
Shot 10 - 800 ft, over 60 cal, over 90 psi
