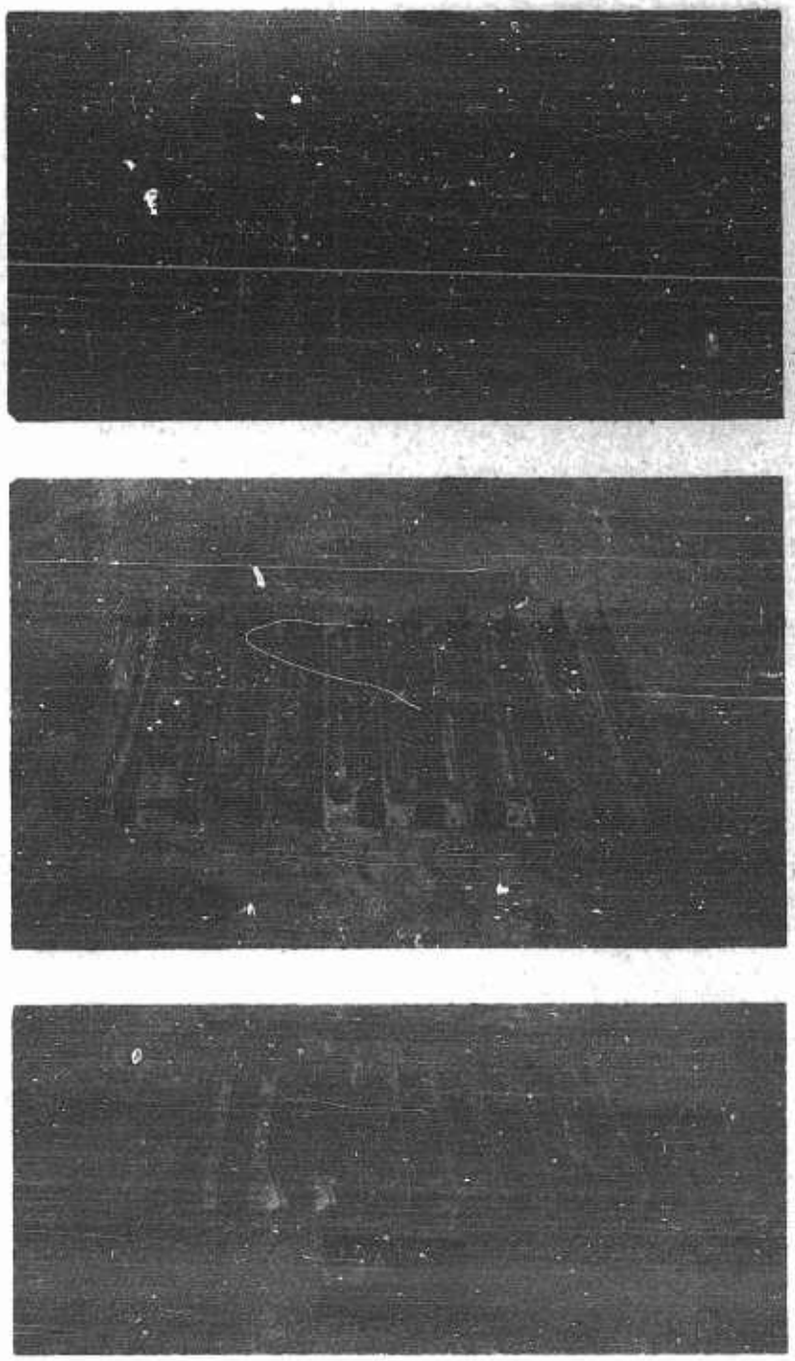
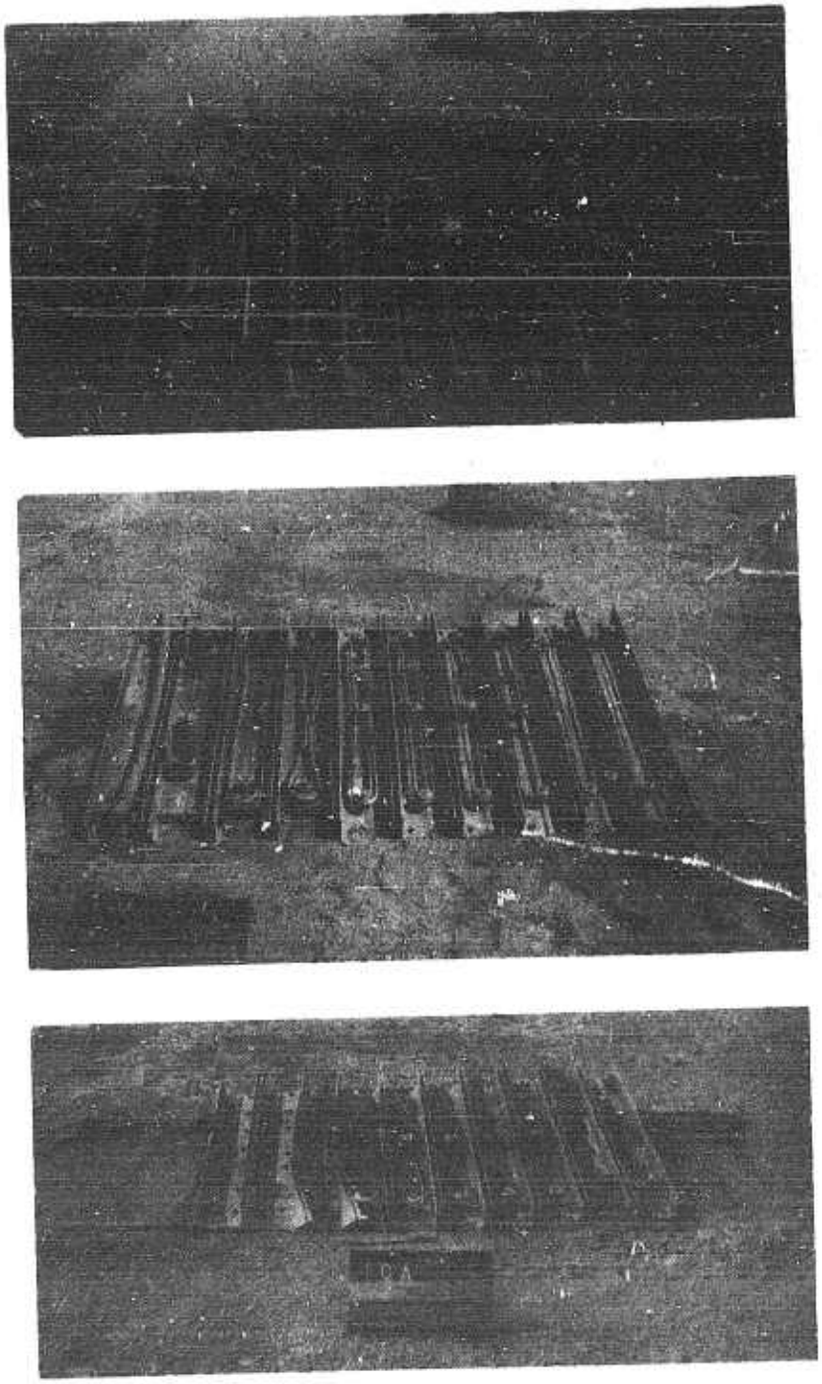
Fig. 3.70 Shots 9 and 10, Test Groups 10 and 10A, Exposure Boards. (Top-before 9, Center-after 9, Bottom-after 10) (A new Exposure Board was Positioned for Shot 10.) Shot 9 - Shot 9 - 1825 ft, 88 cal, 13.2 psi.
Shot 10 - 1125 ft, over 60 cal, 32 psi.

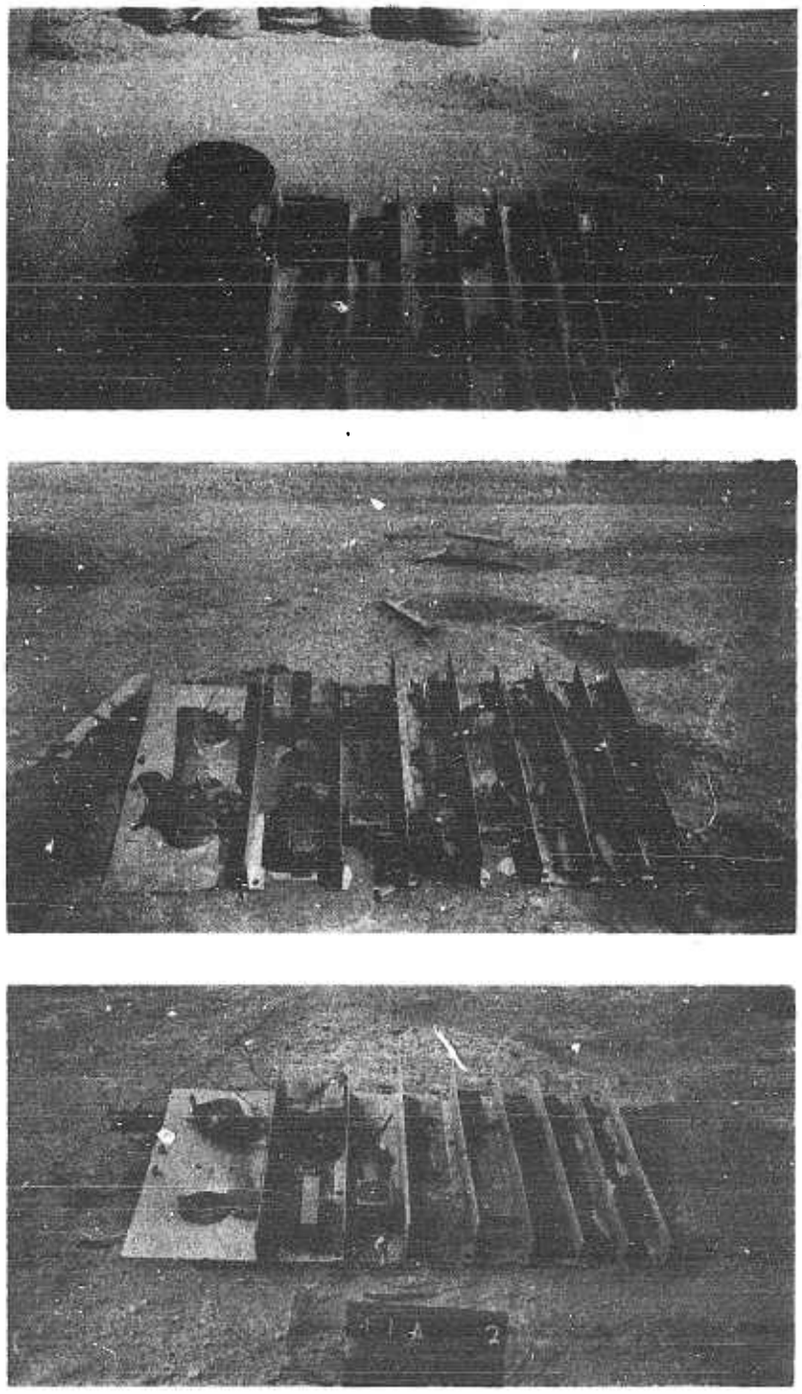
Fig. 3.71 Shots 9 and 10, Test Groups 11 and 11A, Exposure Boards, (Top-before 9, Center-after 9, Bottom-after 10) (A new Exposure Board was Positioned for Shot 10.) Shot 9 - 1825 ft 88 cal, 13.2 psi. Shot 10 - 1125 ft, over 60 cal, 32 psi.

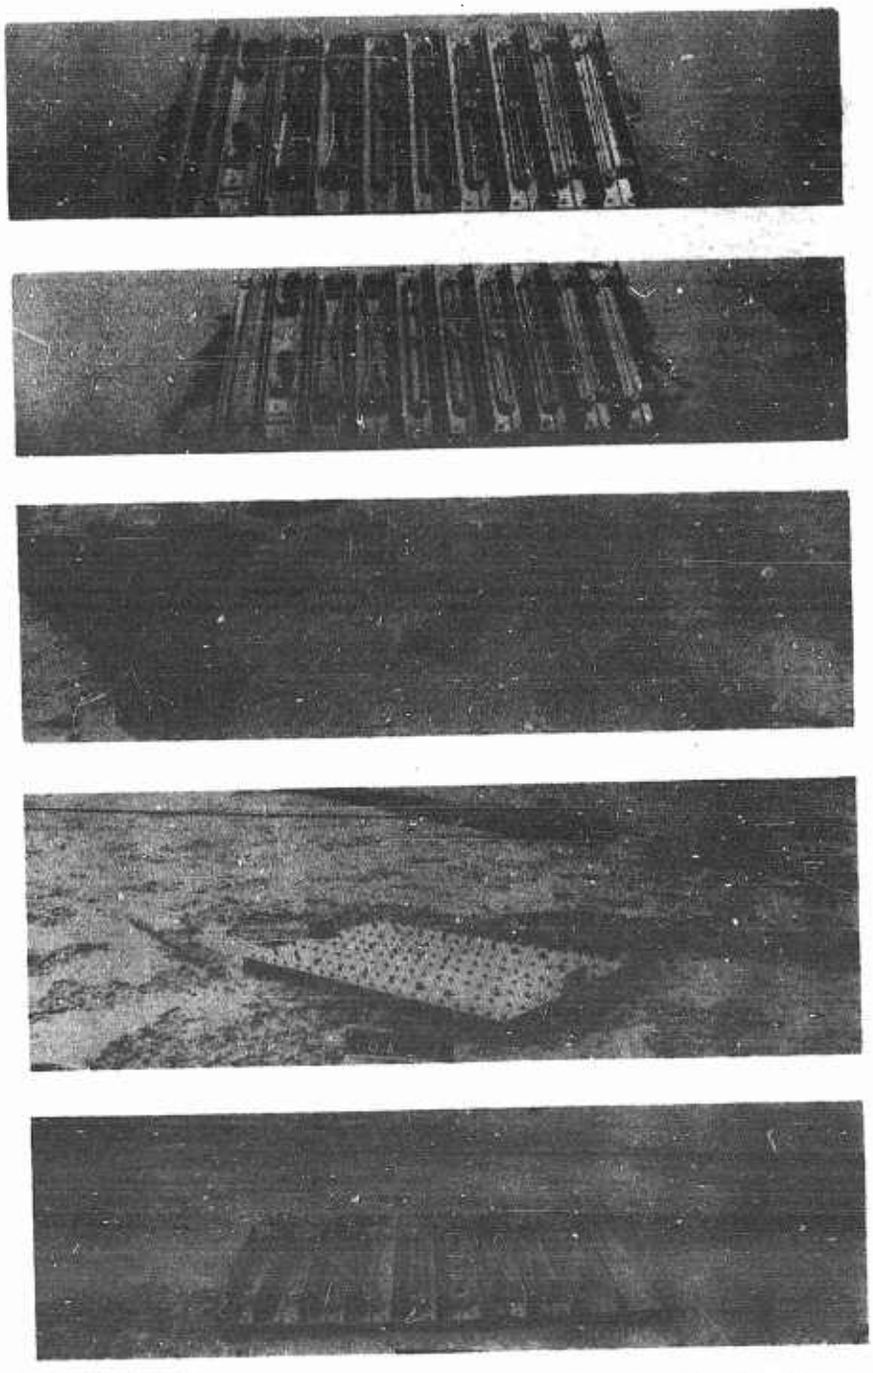
Fig. 3.72 Shots 9 and 10, Test Groups 12 and 12A, Exposure Boards. (Top-before 9, Second-after 9, Third-after 10, Fourth-Position of Board 12A, 450 ft from Original Position, Bottom-Appearance of Board after it was Turned Over.) Shot 9 - 2800 ft, 62 cal, 10.8 psi. Shot 10 - 2125 ft, over 60 cal, 7 psi.

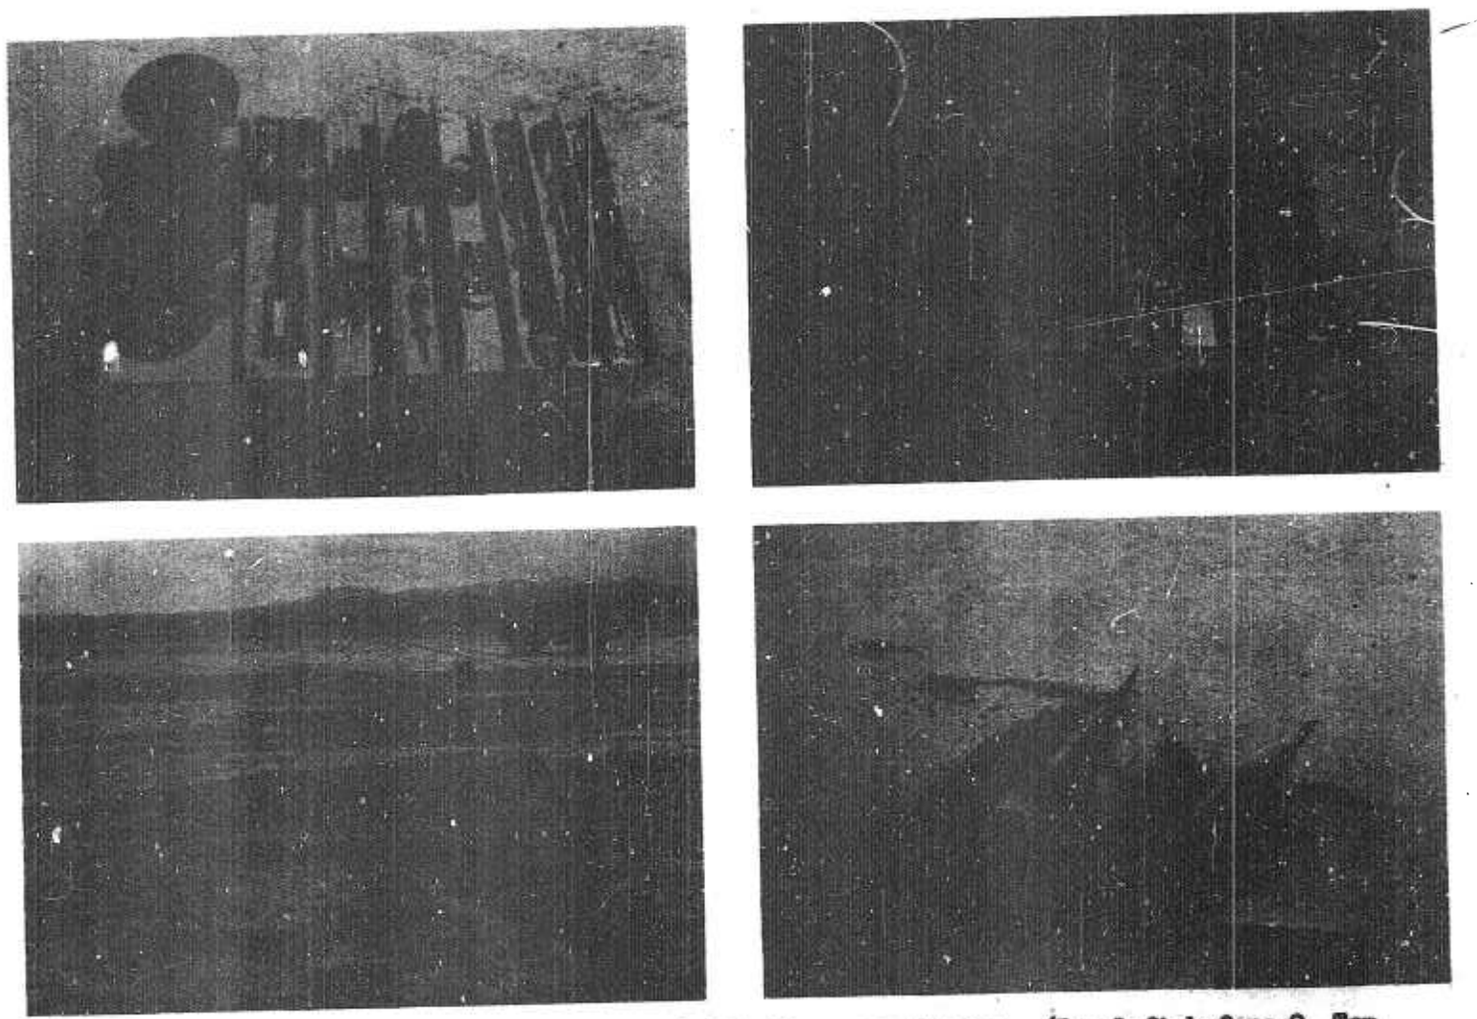
Fig. 3.73 Shots 9 and 10, Test Groups 13 and 13A, Exposure Boards. (Top left-before 9, Top right-after 9, Bottom-after 10) A New Exposure Board was Positioned for Shot 10. Bottom right-Landing Position of Board 13A, 450 ft from Original Position in Shot 10. Shot 9 - 2800 ft, 62 cal, 10.8 psi. Shot 10 - 2125 ft, over 60 cal, 7 psi.

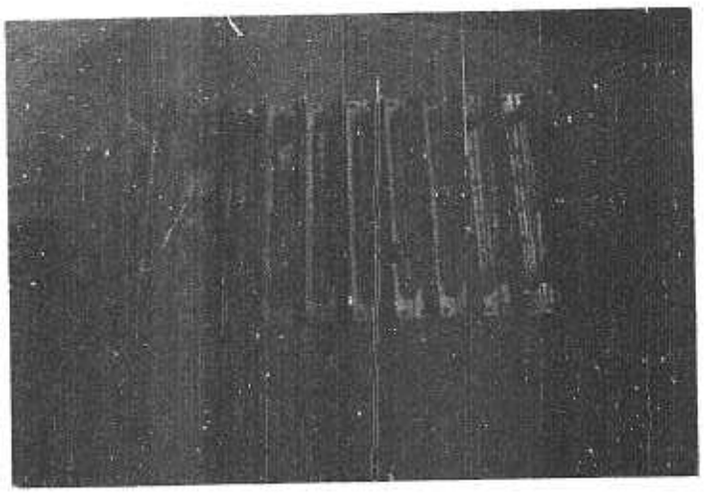
Fig. 3.74 Shot 9, Test Group 14, Exposure Boards.
(Top left-before, Bottom left-after)
3825 ft, 43.5 cal. 8.6 psi.

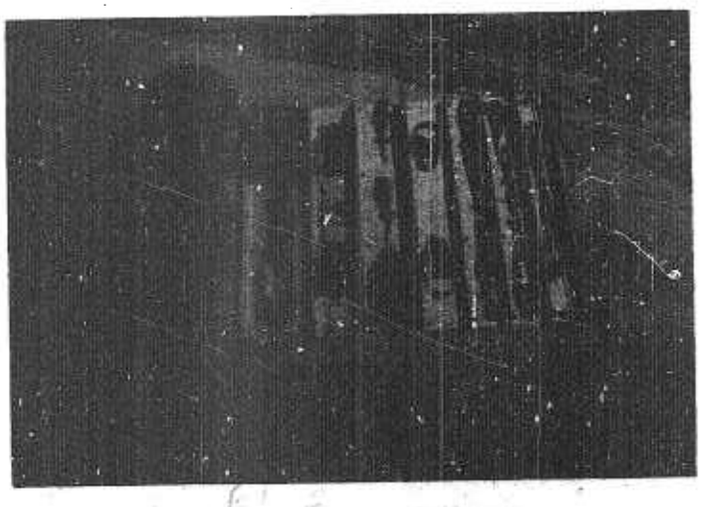
Fig. 3.75 Shot 9, Test Group 15, Exposure Board.
(Top right-before, Bottom right-after)
3825 ft, 43.5 cal, 8.6 psi.

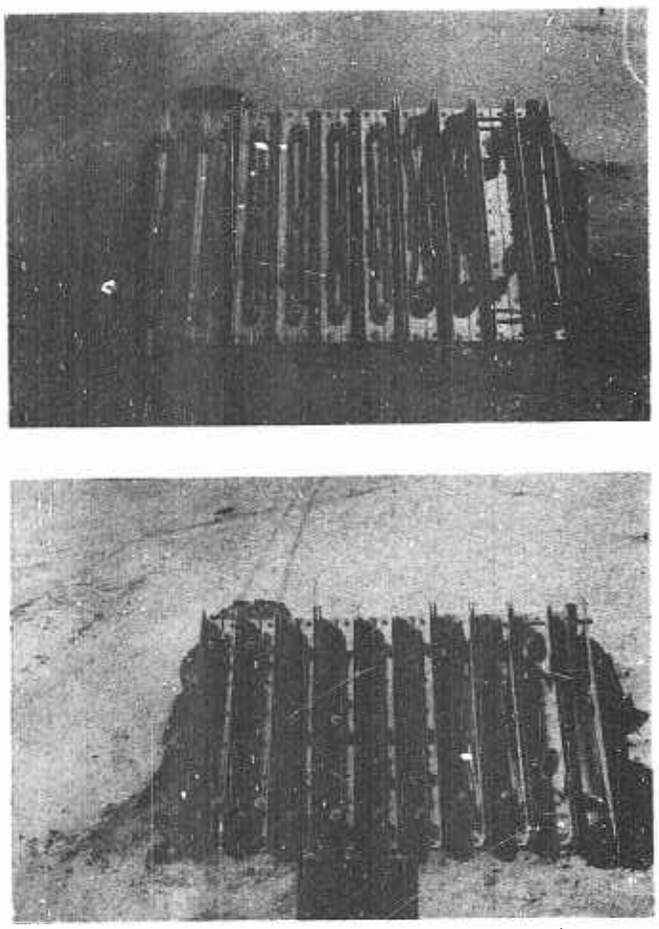
Fig. 3.76 Shot 9, Test Group 16, Exposure Board. (Top-before, Bottom-after) NOTE: The Positions of the Test Items on this Exposure Board were Inadvertently Reversed from Those of Other Exposure Boards. 4800 ft, 30.5 cal, 6.4 psi.

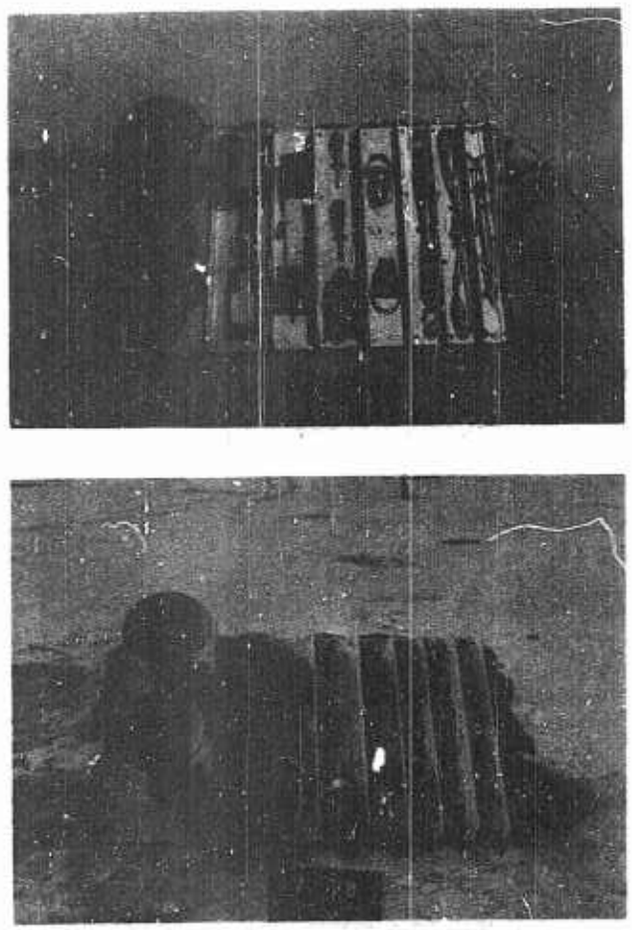
Fig. 3.77 Shot 9, Test Group 17, Exposure Board. (Top-before, Bottom-after) 4800 ft, 30.5 cal, 6.4 psi.

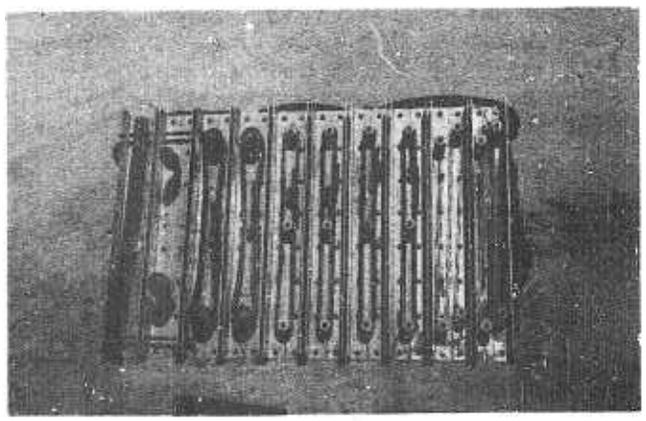
Fig. 3.78 Shot 9, Test Group 18, Exposure Board.
(Top-before, Bottom-after)
5800 ft, 23.5 cal, 7.2 psi.

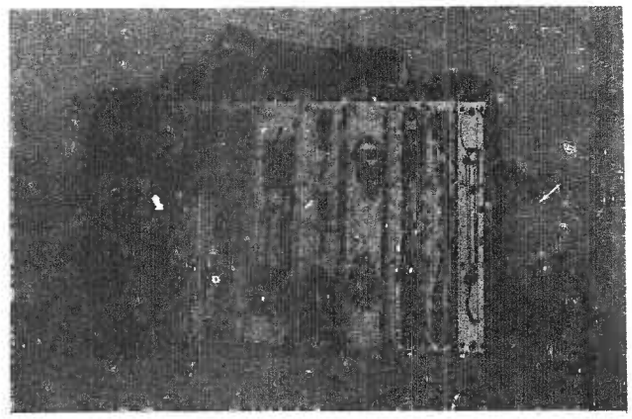
Fig. 3.79 Shot 9, Test Group 19, Exposure Board.
(Top-before, Bottom-after)
5800 ft, 23.5 cal, 7.2 psi.

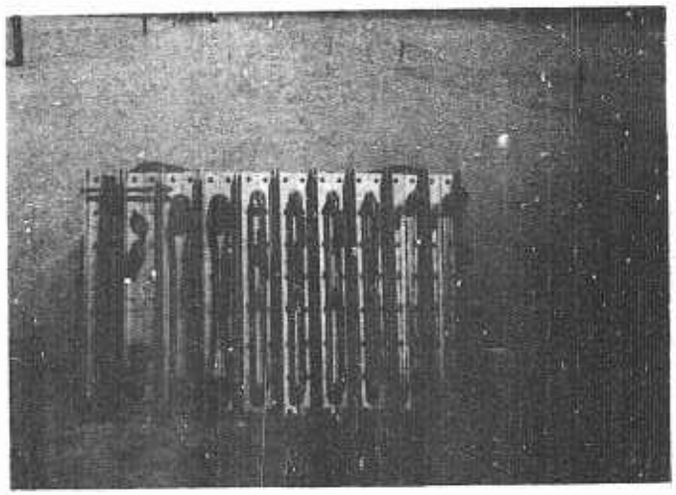
Fig. 3.80 Shot 9, Test Group 20, Exposure Board.
(Top-before, Bottom-after)
6800 ft, 16.5 cal, 4.2 psi.

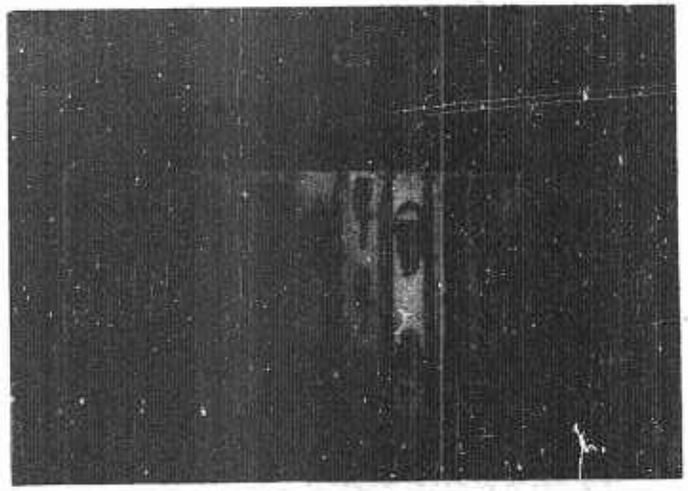
Fig. 3.81 Shot 9, Test Group 21, Exposure Board.
(Top-before, Bottom-after)
6800 ft, 16.5 cal, 4.2 psi.

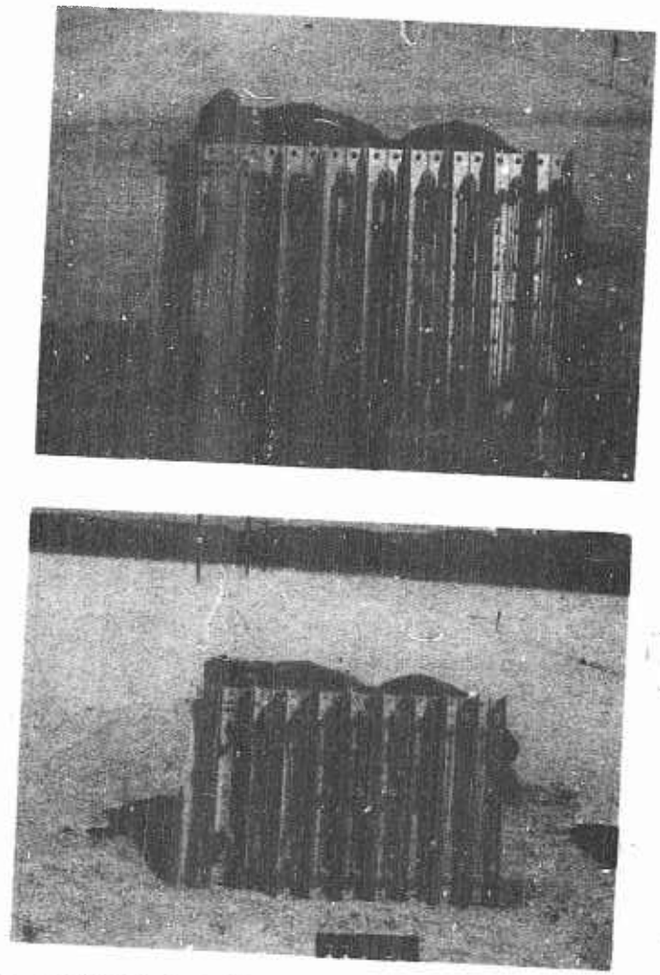
Fig. 3.82 Shot 9, Test Group 22, Exposure Board.
(Top-before, Bottom-after)
7800 ft, 10.8 cal, 3.4 psi.

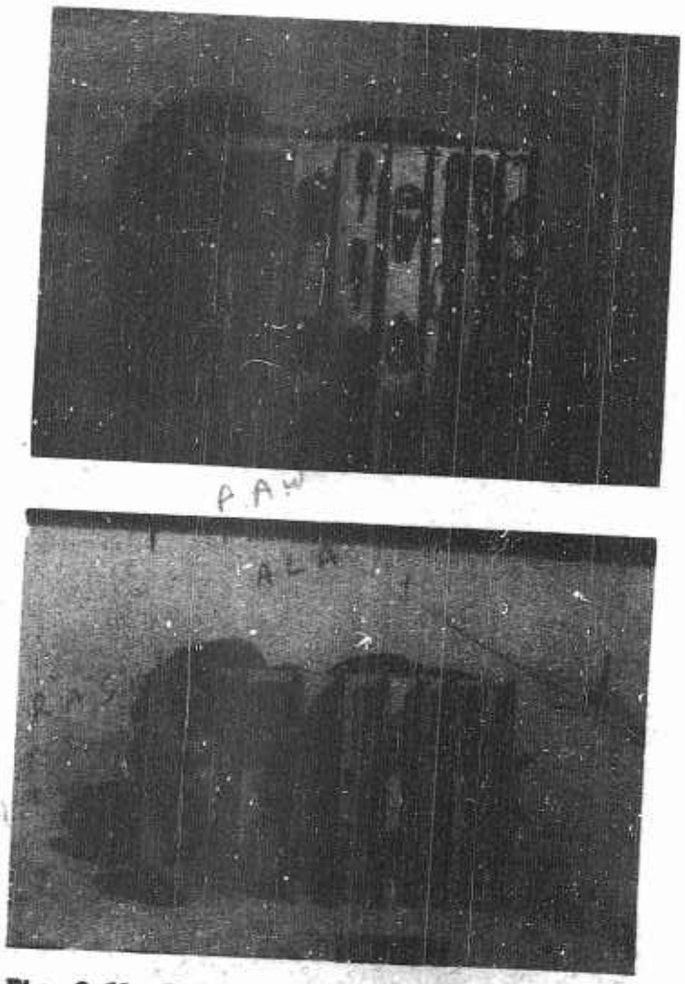
Fig. 3.83 Shot 9, Test Group 23, Exposure Board.
(Top-before, Bottom-after)
7800 ft, 10.8 cal, 3.4 psi.

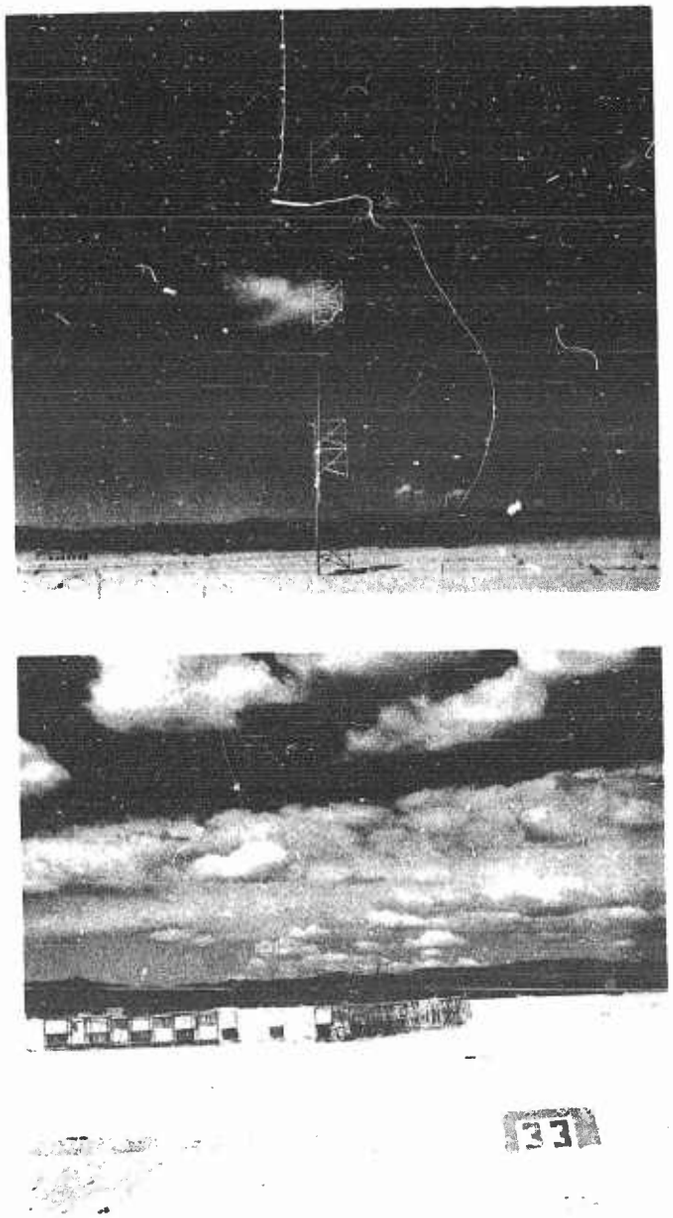
b. RESULTS: Severe damage by blast forces. Tower collapsed. Study of high speed photography indicates that basic tower failure occurred between ground and the first guy level. The base and third section from bottom were demolished. Members were severely bent or broken. Adjustable feet at base section were severed. Examination of individual tower sections revealed that only 5 sections could be reused. Fifteen sections were sufficiently damaged to require replacement. Small diagonals (1 inch diameter tubing) in many of the damaged sections failed in either tension or compression. The tensile failure caused the two rivets to be sheared at either end of the diagonal. The compression

Fig. 3.86 Shot 9, Test Group 33, Tower, 120 ft.
(Top-before, Bottom-after)
3350 ft, 51.5 cal, 9.8 psi.

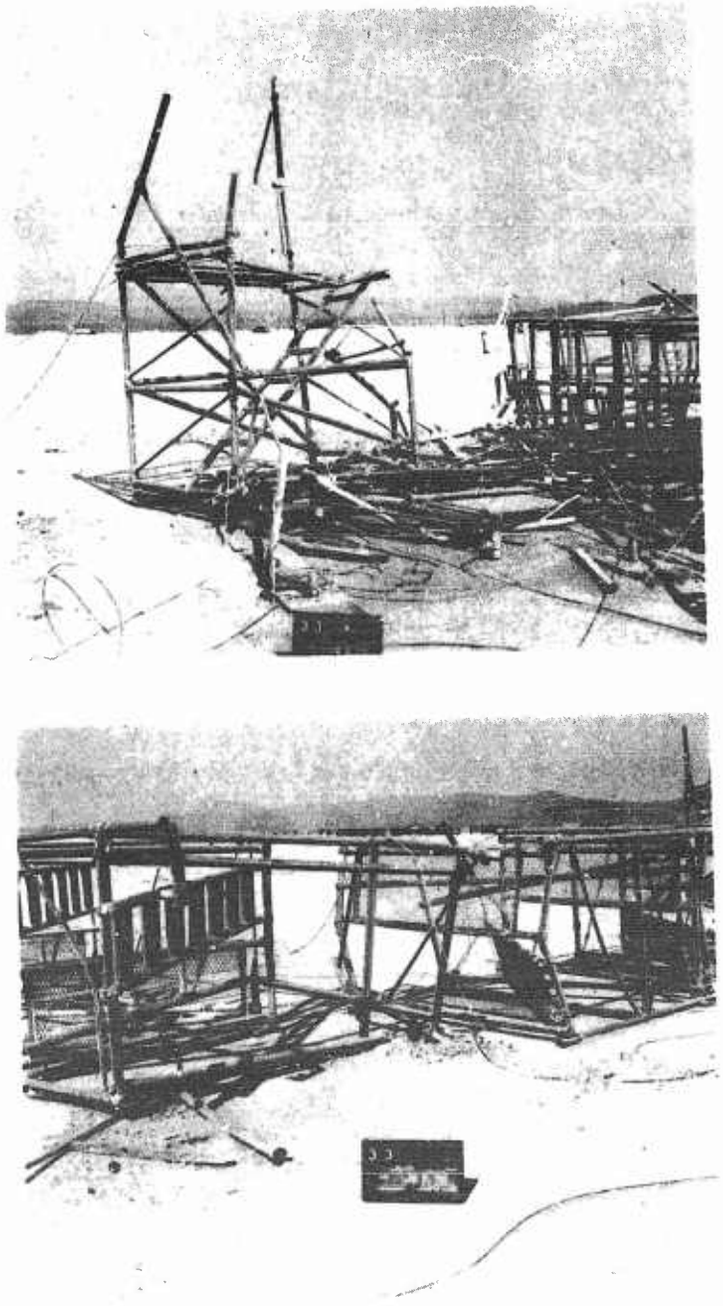
Fig. 3.87 Shot 9, Test Group 33, Tower, 120 ft. (See Fig. 3.129)
(Top-after, Bottom-after) 3350 ft, 51.5 cal, 9.8 psi.

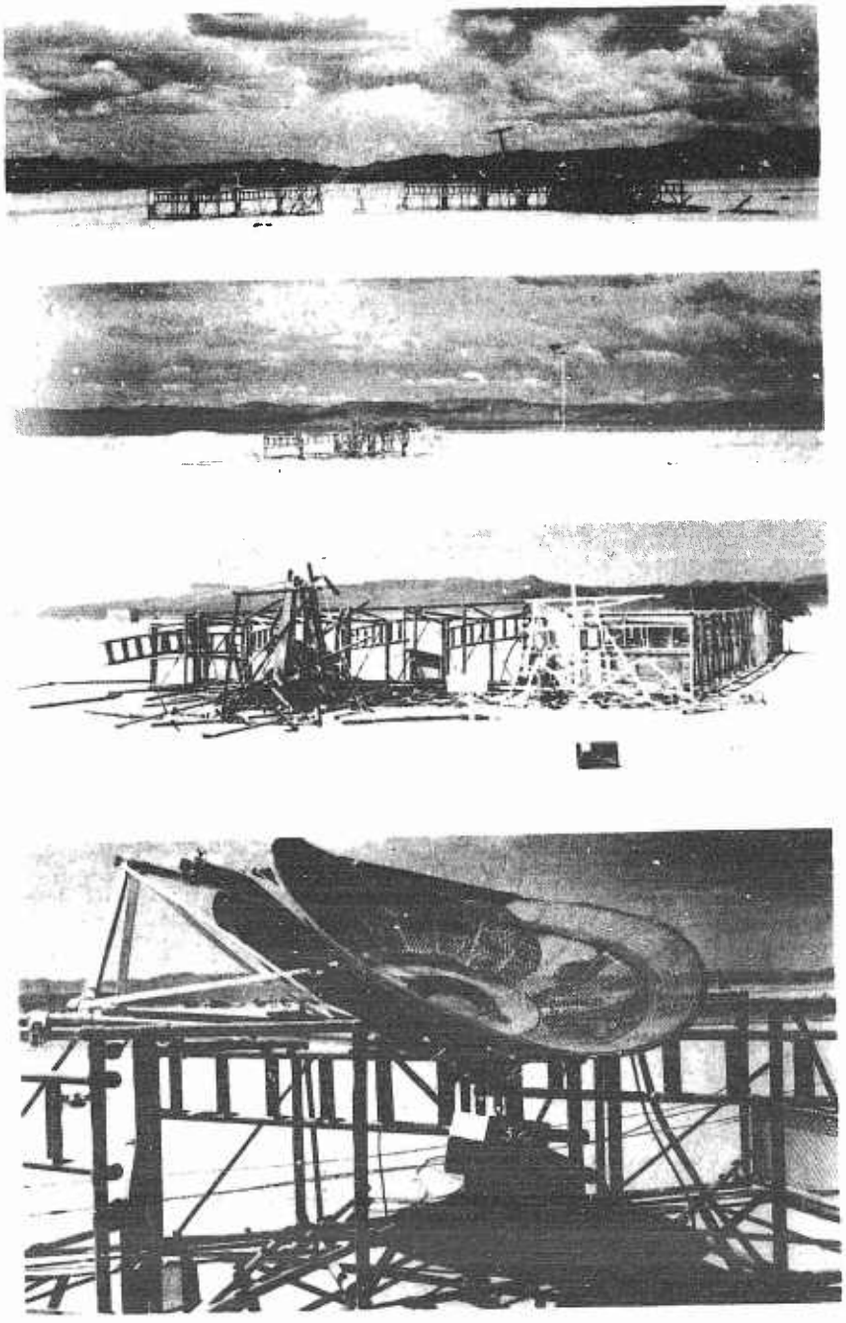
Fig. 3.89 Shot 9, Test Group 34, Tower, 120 ft.
(All after Photos Showing Damage Details.)
4350 ft, 36 cal, 7.2 psi.

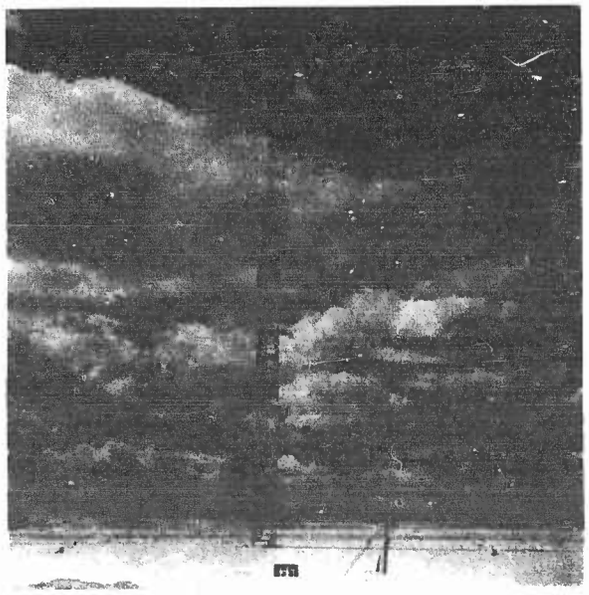
Fig. 3.90 Shot 9, Test Group 35, Tower, 120 ft. (Top-before, Bottom left-Side View Looking West-after; Bottom Right-Side View Looking East-after.) (Note Buckle in Tower.) 5350 ft, 19.5 cal, 4.6 psi.

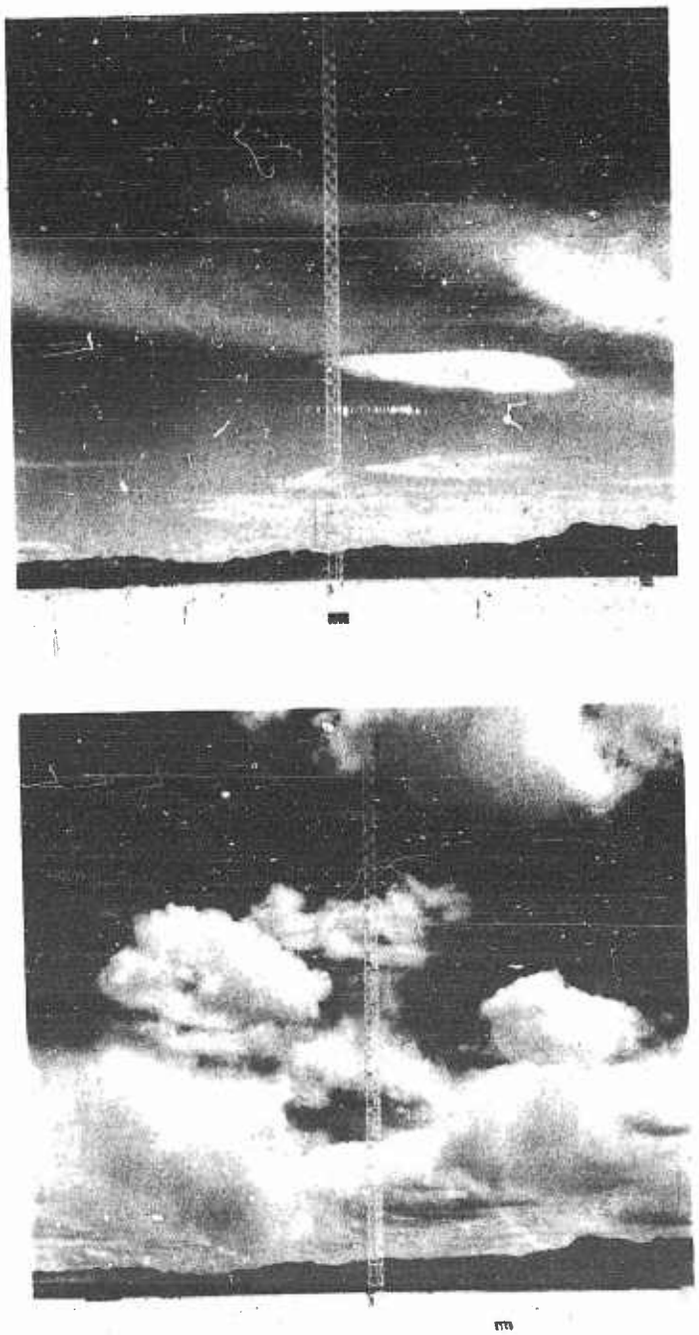
Fig. 3.91 Shot 9, Test Group 36, Tower, 200 ft.
(Top-before, Bottom-after)
6350 ft, 19.5 cal, 4.6 psi.

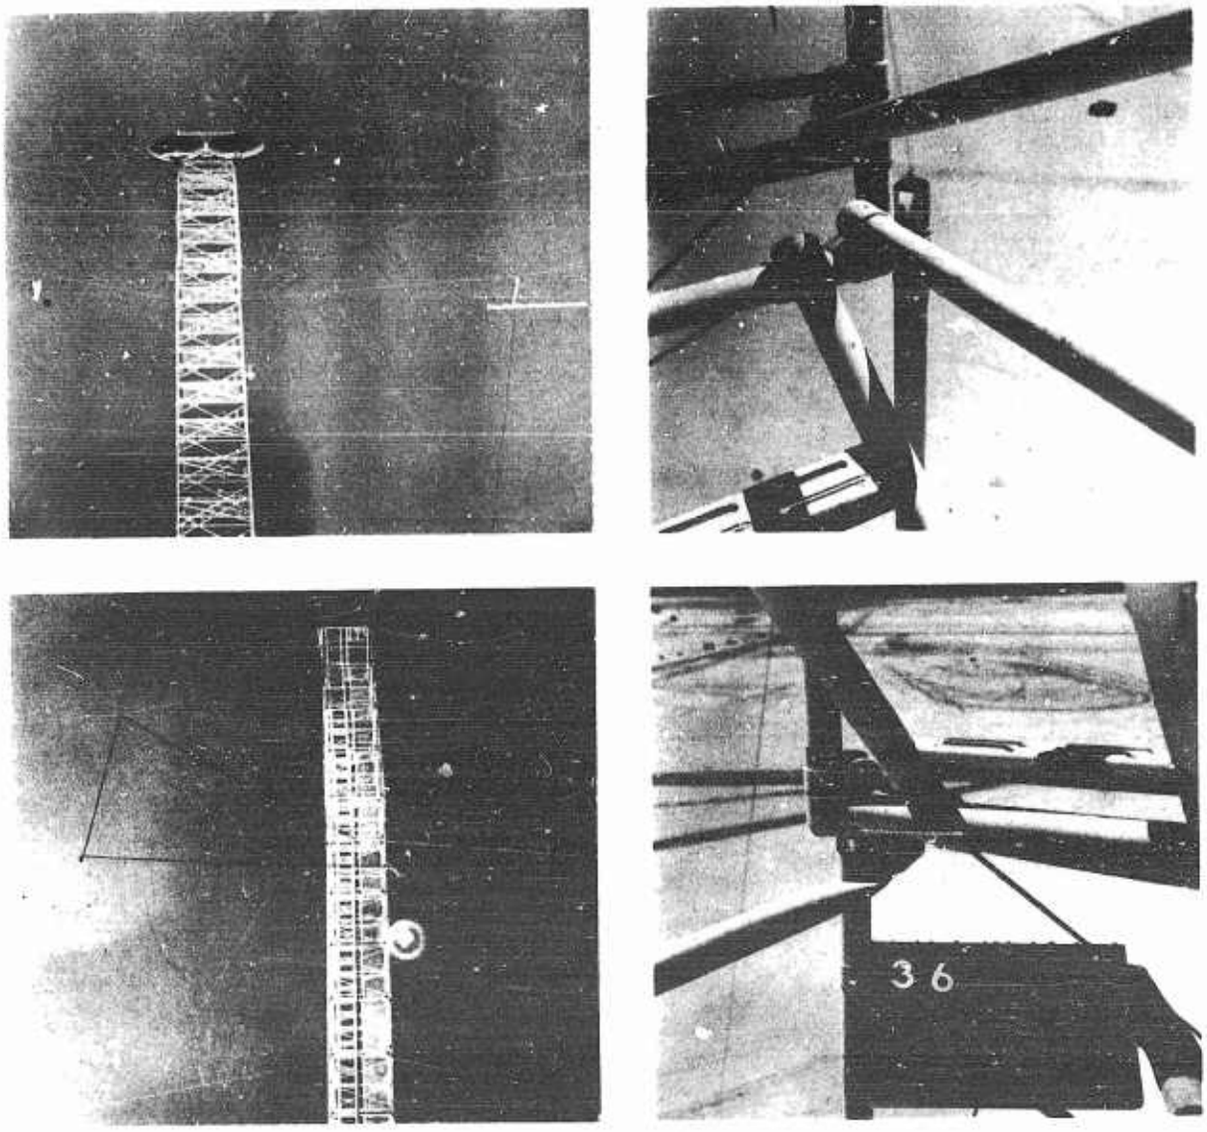
Fig. 3.92 Shot 9, Test Group 36, Tower, 200 ft. After Shot Photos. (Top left-Front View, Bottom left-Side View Looking West - Note the Deformation at Junction of 5th and 6th Tower Sections, Top Right and Bottom Right Show Section Unseated. 6450 ft, 19.5 cal, 4.6 psi.

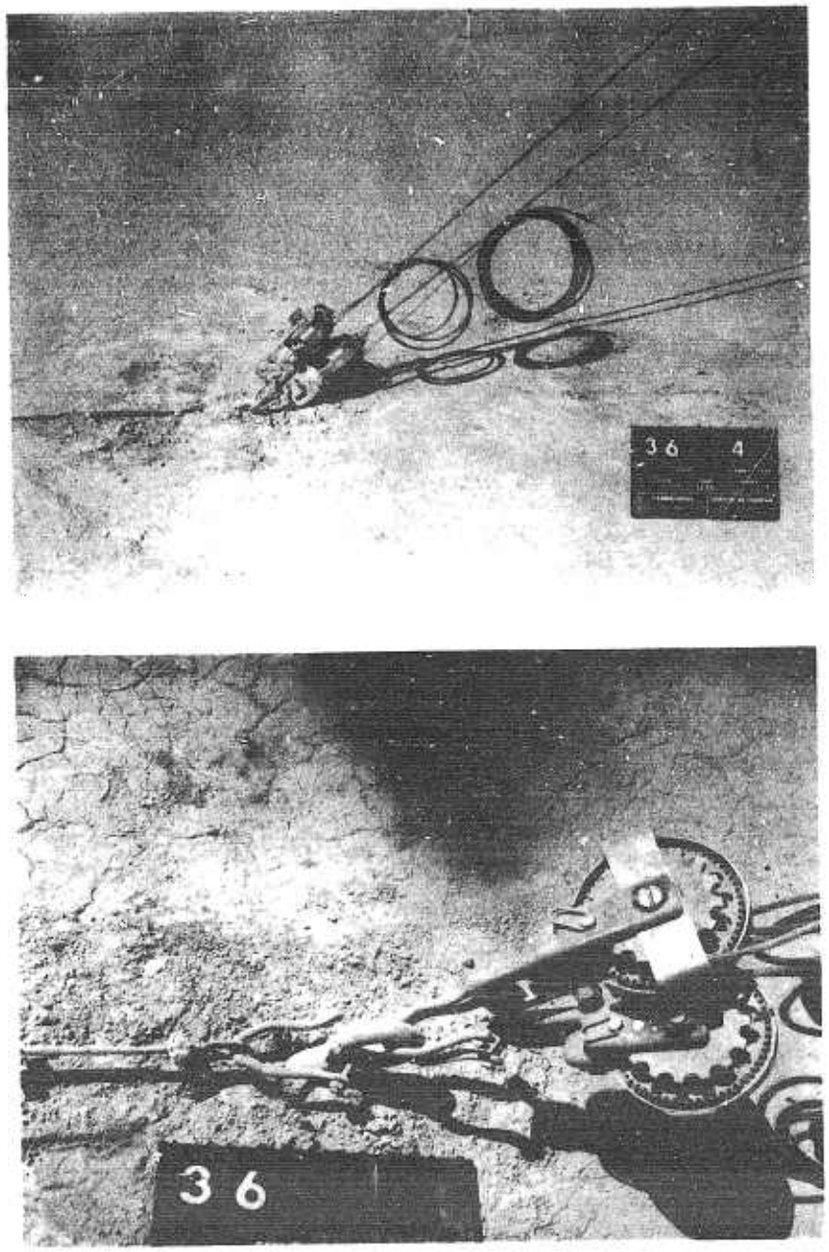
Fig. 3.93 Shot 9, Test Group 36, Tower, 300 ft, Clevice Details. (Top-before, Bottom-after) (Note Strain on Bolts.) 6350 ft, 19.5 cal, 4.6 psi.

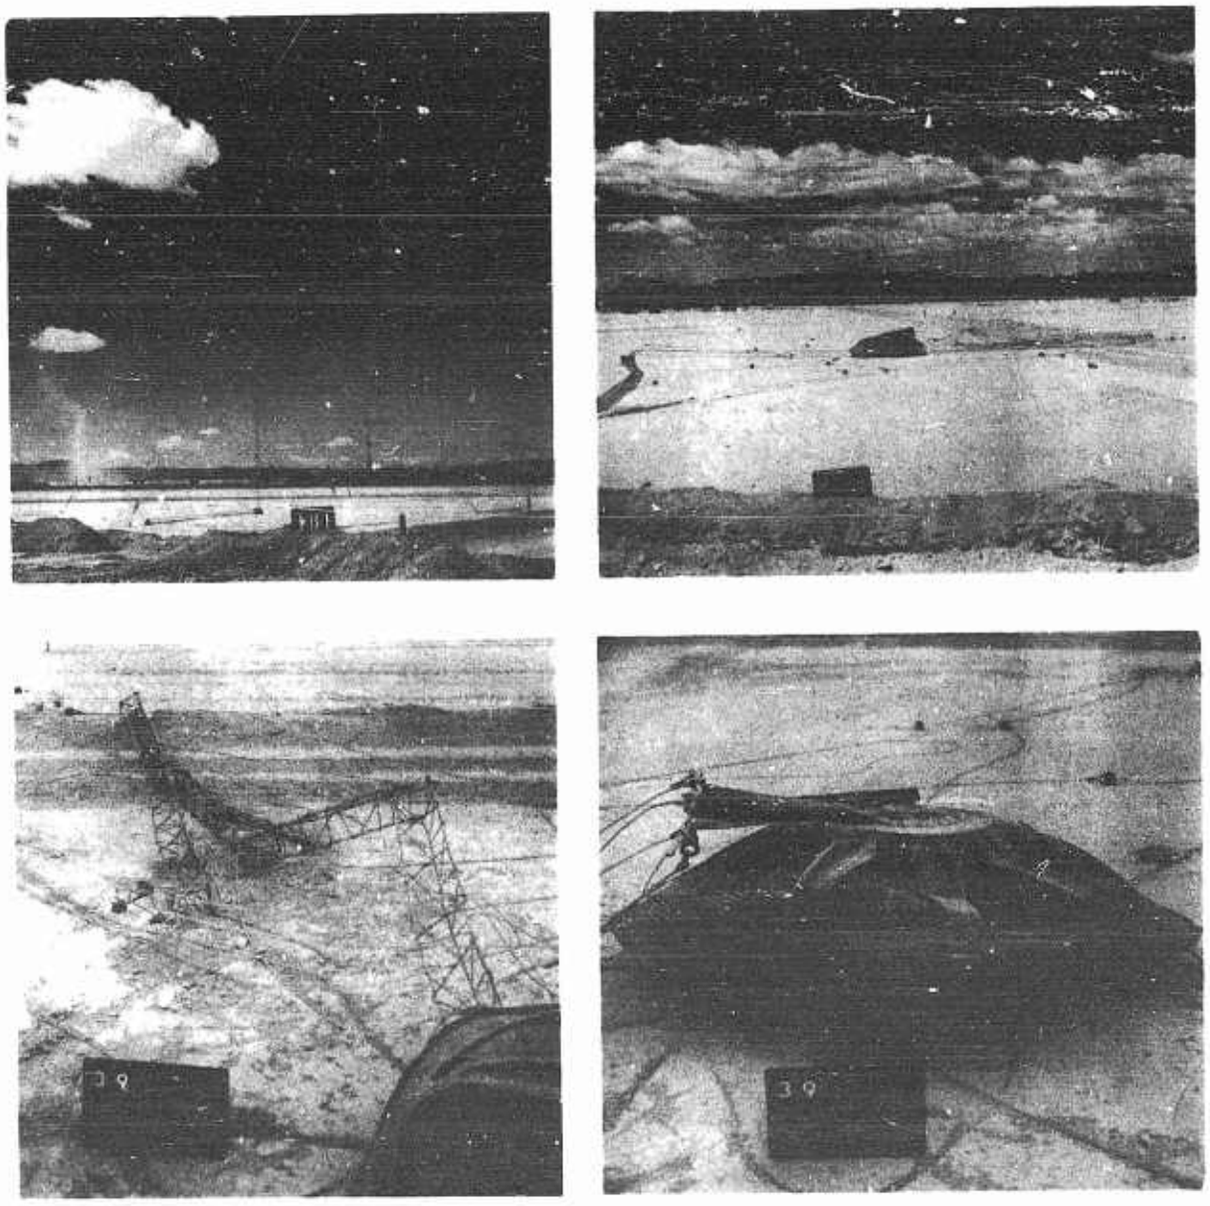
Fig. 3.94 Shot 9, Test Group 39, Antenna Mast AB-26/CR. (Top left-close-up, after; Bottom right-Reflector, after) 4050 ft, 40.5 cal, 8 psi.

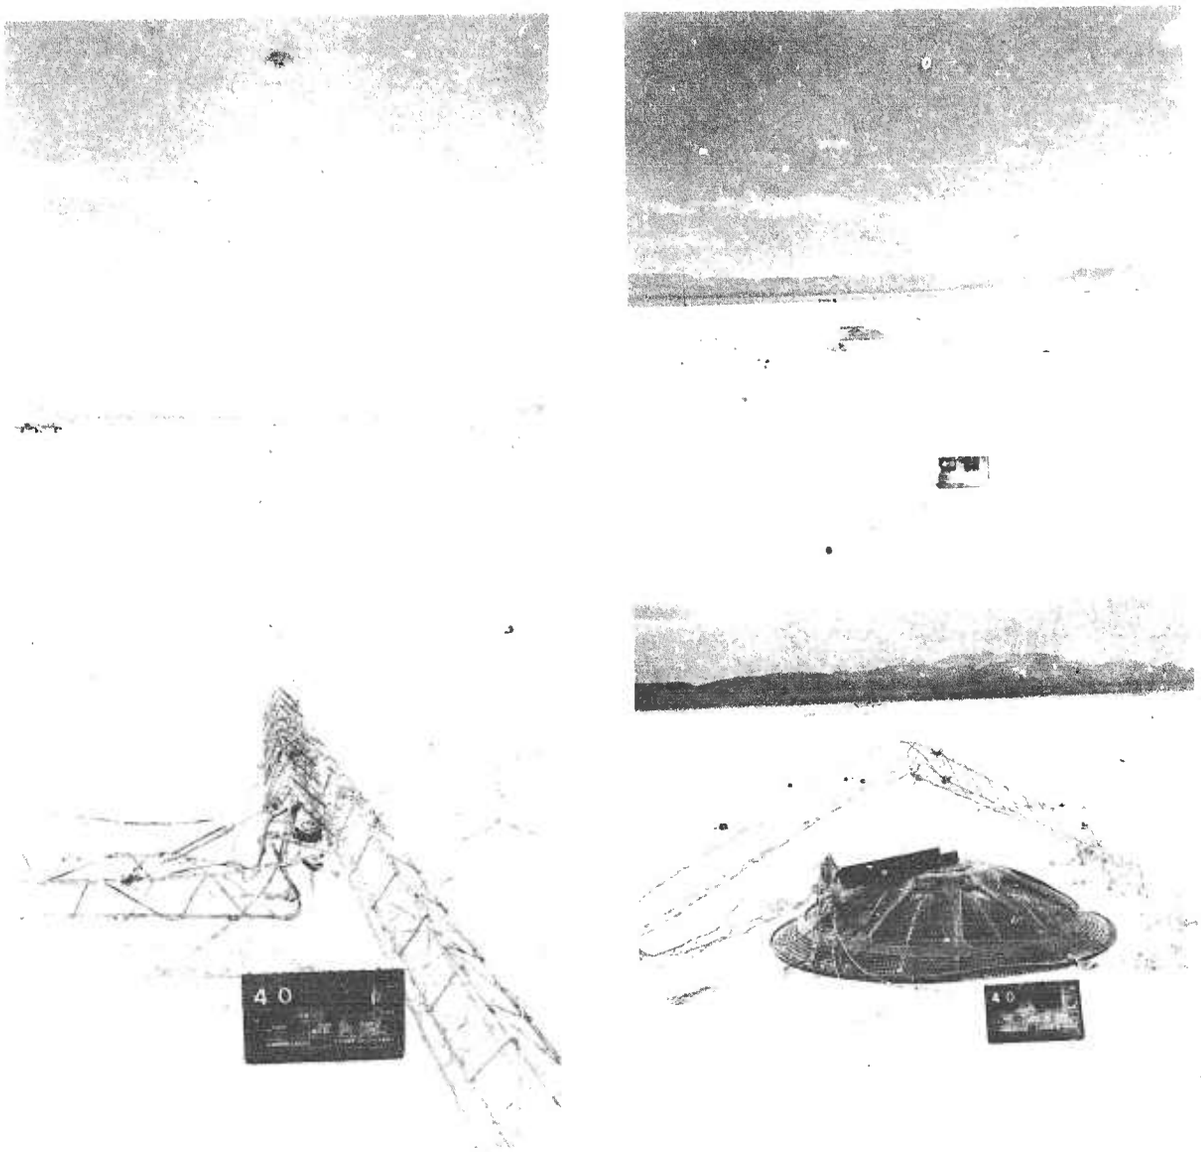
Fig. 3.95 Shot 9, Test Group 40, Antenna Mast AB-26/CR.
(Top Left-before, Top right-after, Bottom left-close-up, after,
Bottom right-Reflector, after) 4600 ft, 32.5 cal, 6.8 psi.

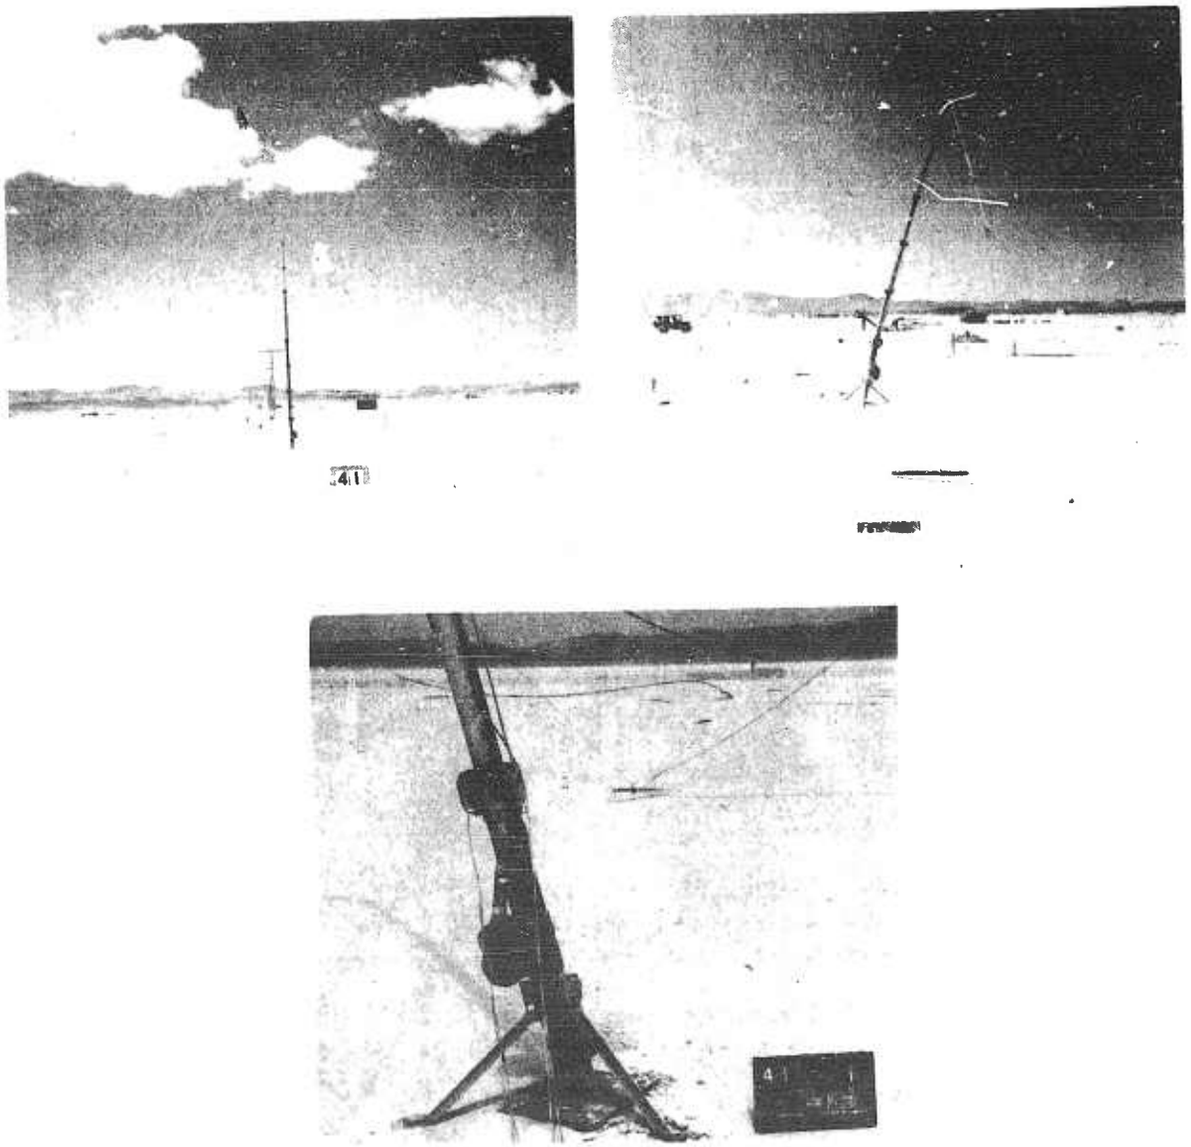
The antenna system received severe damage from the blast forces. The antenna support collapsed. There were no guy failures. The antenna remained attached to the mast. Three of the antenna elements were broken as a result of the fall. The mast base

Fig. 3.96 Shot 9, Test Group 41, Antenna Mast AB-224/U. (Top Left-before, Top right-after; Center Close-up of Antenna Base-after) 4625 ft, 32.5 cal, 6.8 psi.
