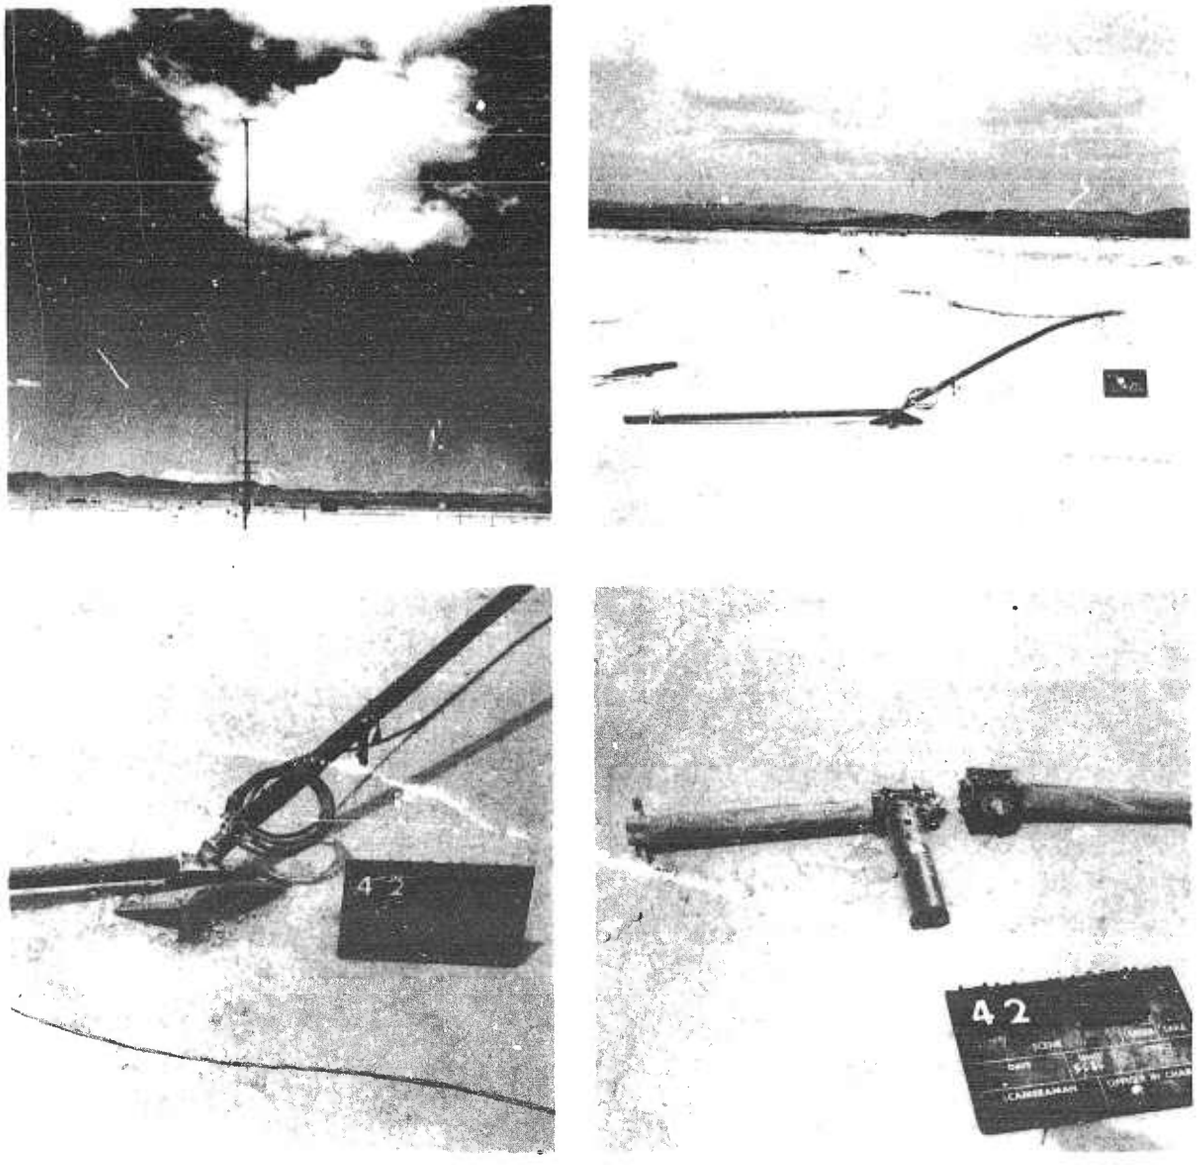
Fig. 3.97 Shot 9, Test Group 42, Antenna System AS-19/TRC-1. (Top left-before, Top right-after; Bottom left, Antenna Base-after; Bottom Right, View of Break at Top of Mast-after.) 4650 ft, 32.5 cal, 6.8 psi.

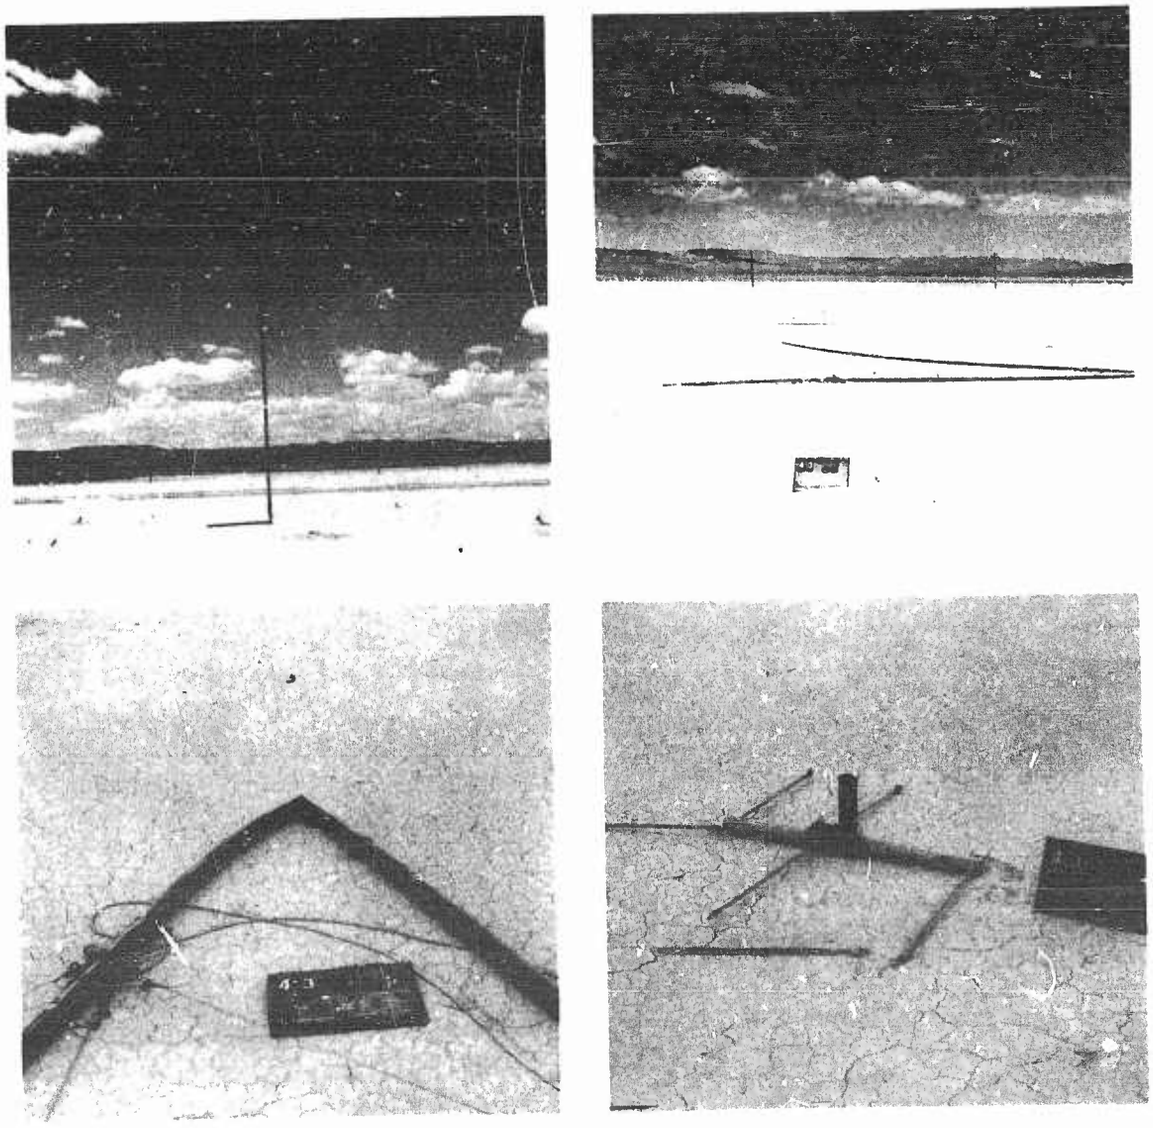
Fig. 3.98 Shot 9, Test Group 43, Antenna System, AS-19/TRC-1.
(Top left-before, Top right-after, Bottom left, bent Mast-after, Bottom Right-Broken Top of Mast)
4900 ft, 29.5 cal, 6.2 psi.

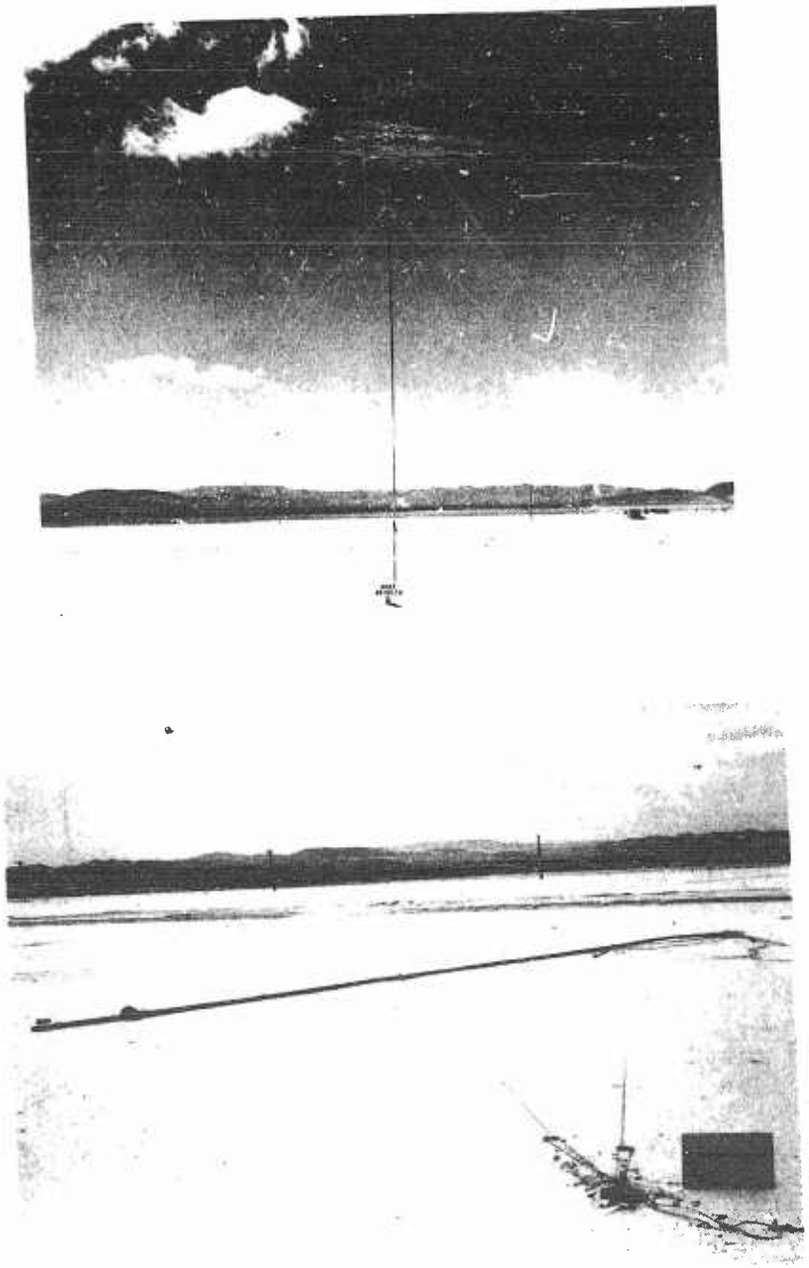
Fig. 3.99 Shot 9, Test Group 44, Antenna Mast AB-155/U.
(Top-before, Bottom-after)
4900 ft, 29.5 cal, 6.2 psi.

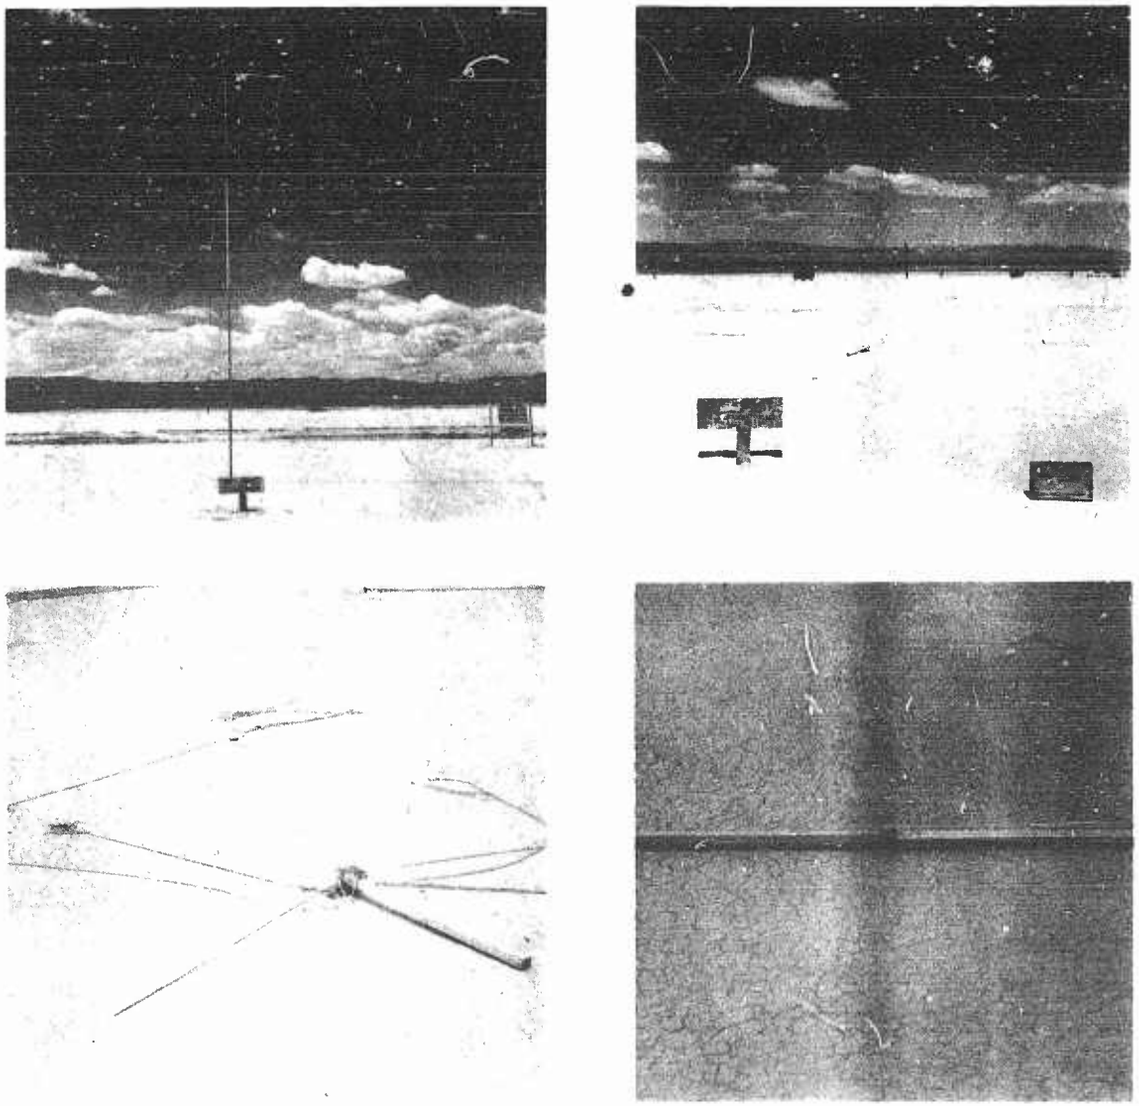
Fig. 3.100 Shot 9, Test Group 45, Magnesium Mast, 30 ft. (Top left-before, Top right-after; Bottom left, Top of Mast-after; Bottom right, Broken Mast Joints-after.) 4925 ft, 29.5 cal, 6.2 psi.

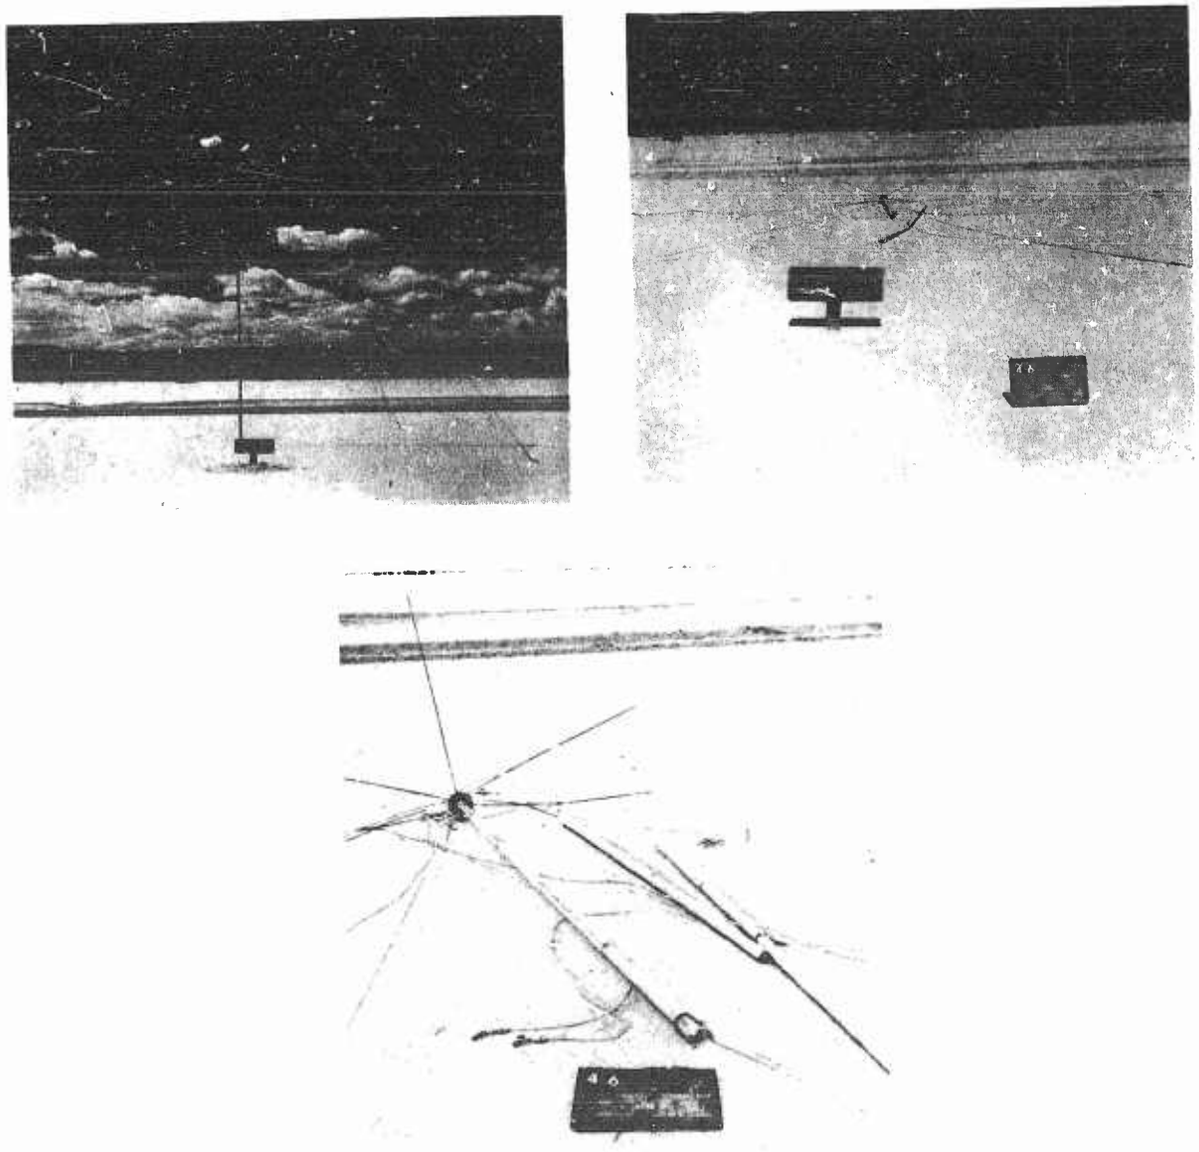
Fig. 3.101 Shot 9, Test Group 46, Magnesium Mast, 30 ft. (Top left-before, Top right-after; Bottom, Broken Mast Sections-after) 4950 ft, 29.5 cal. 6.2 psi.

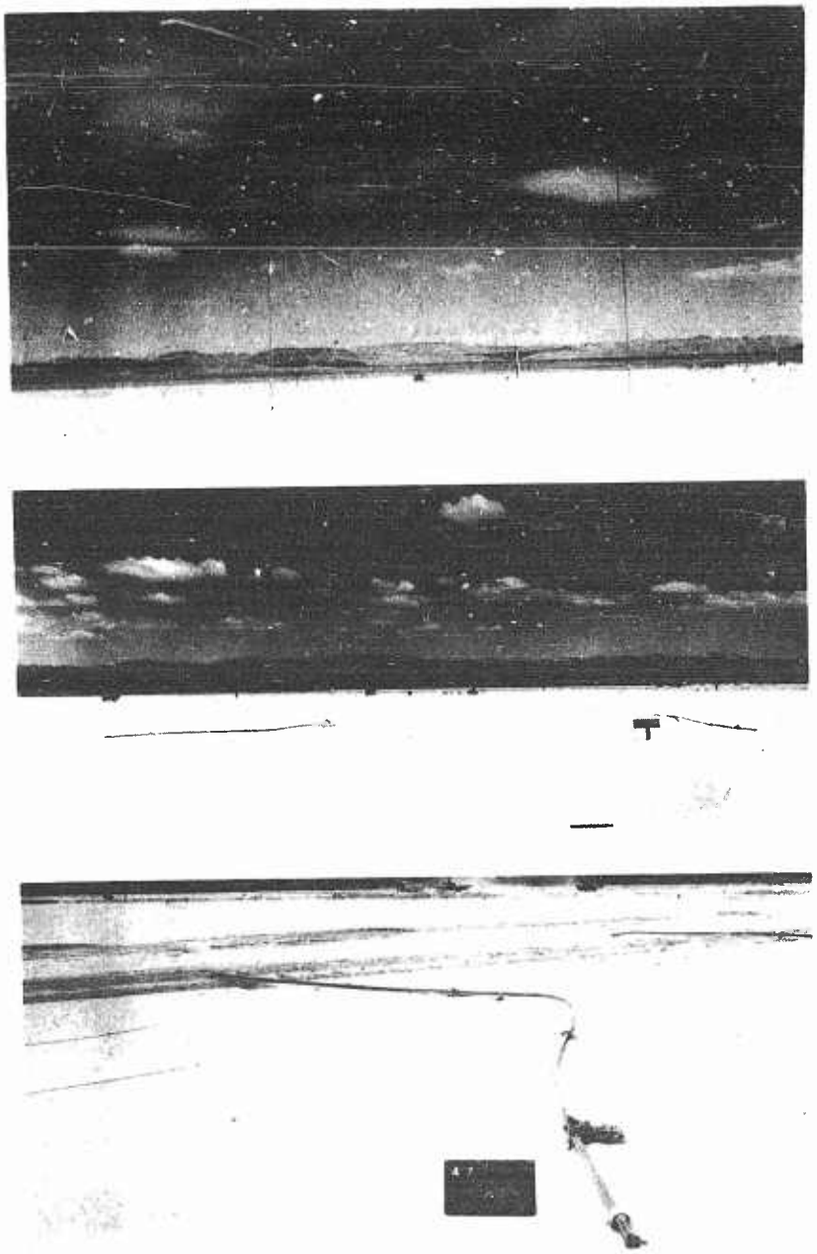
Fig. 3.102 Shot 9, Test Group 47, Antenna System AN-GRA-4.
(Top-before, Center-after, Bottom-after)
5000 ft, 28.5 cal, 6 psi.

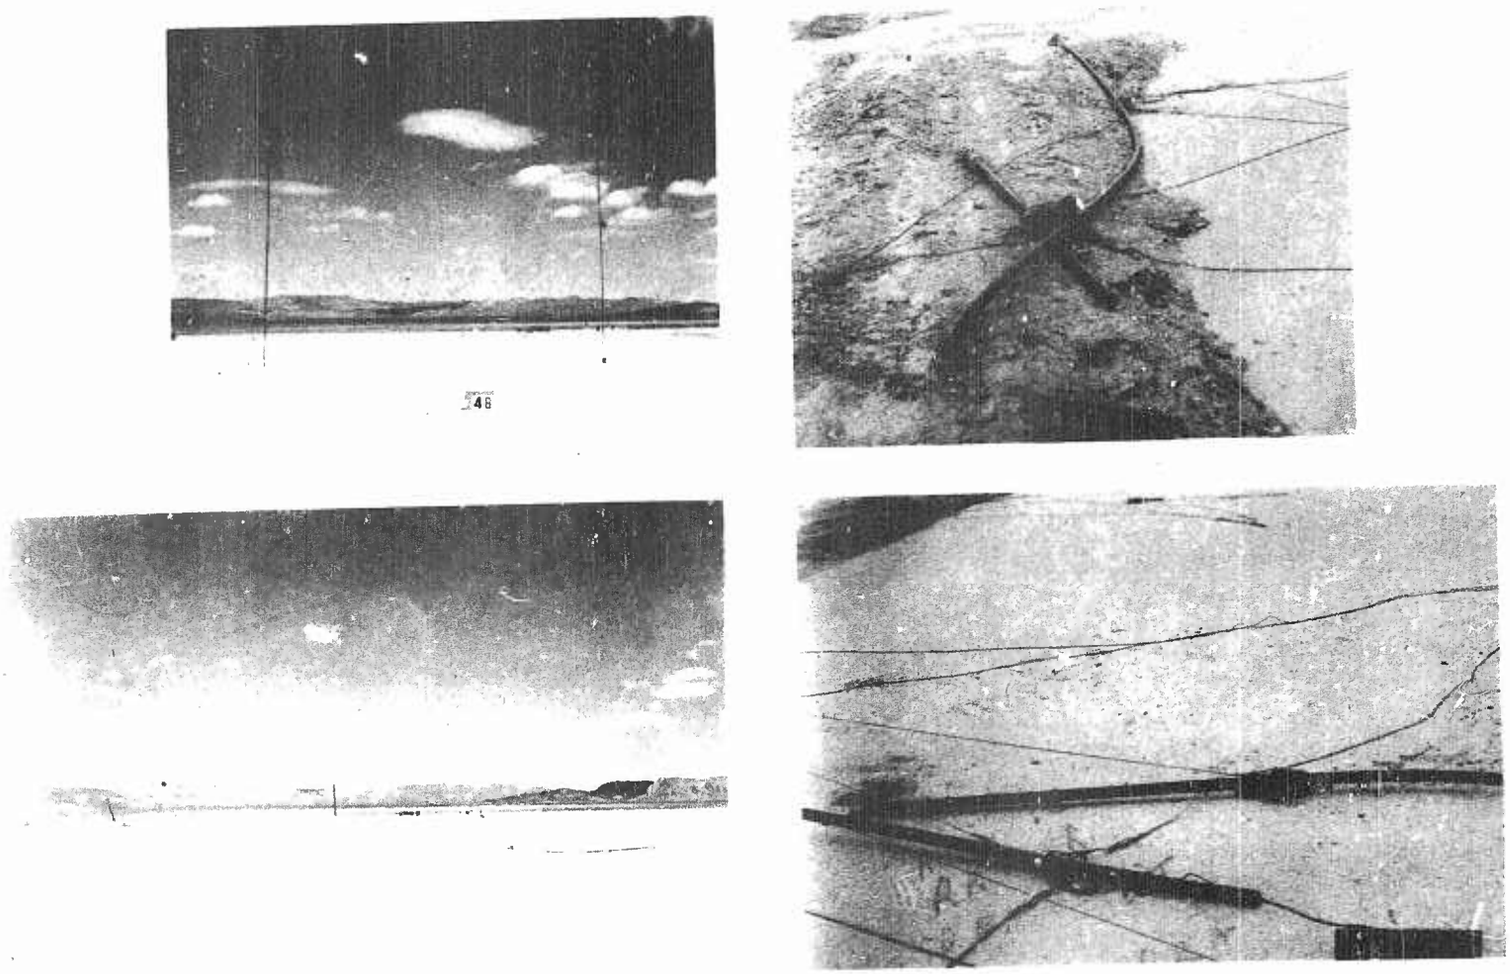
Fig. 3.103 Shot 9, Test Group 48, Antenna System AN/GRA-4. (Top left-before, Top right-after, Bottom left-after, Bottom right-after.) 5000 ft, 28.5 cal, 6 psi.

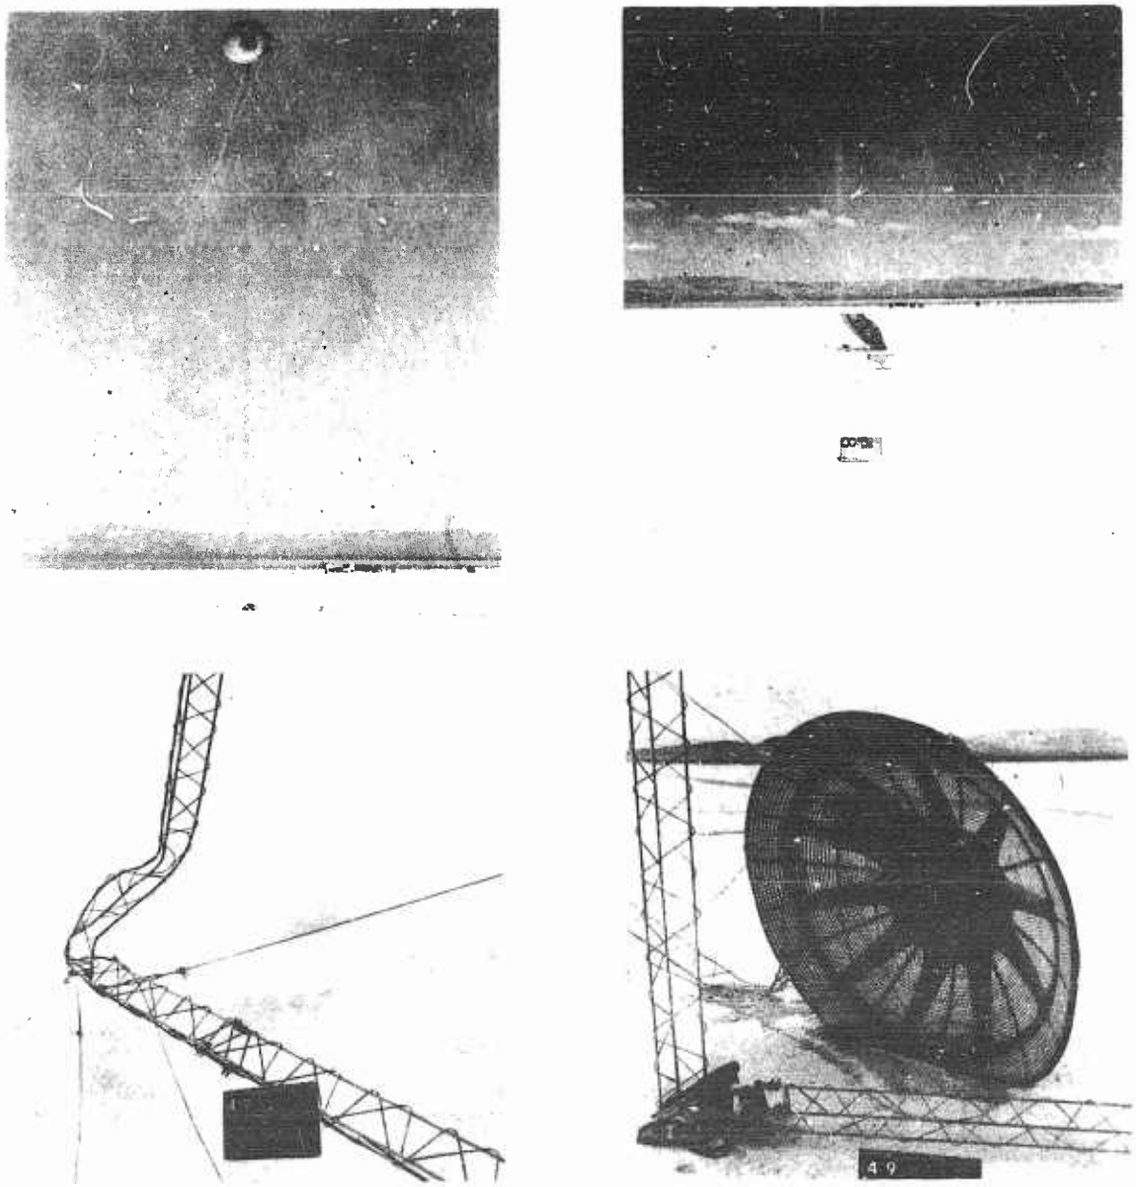
Fig. 3.104 Shot 9, Test Group 49, Antenna Mast AB-26/CR. (Top left-before, Top right-after; Bottom left, Section of Twisted and Broken Mast-after; Bottom right, Reflector-after.) 5550 ft, 25 cal, 5.4 psi.

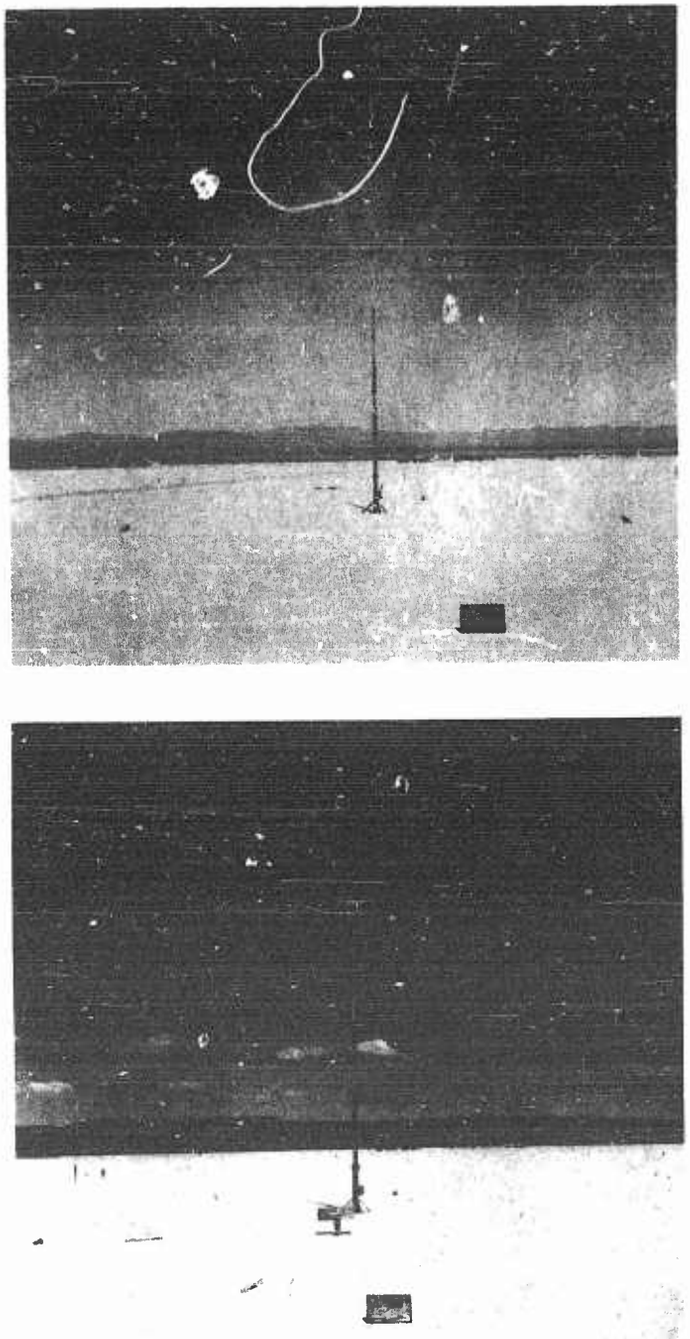
Support was severely damaged by the blast forces. The mast buckled at the joint of the third section from the top. The mast remained upright up to the joint of buckling. Because of the construction it would be necessary to replace the entire unit. Light thermal

Fig. 3.105 Shot 9, Test Group 50, Antenna Mast AB-224/U.
(Top-before, Bottom-after)
5575 ft, 25 cal, 5.4 psi.

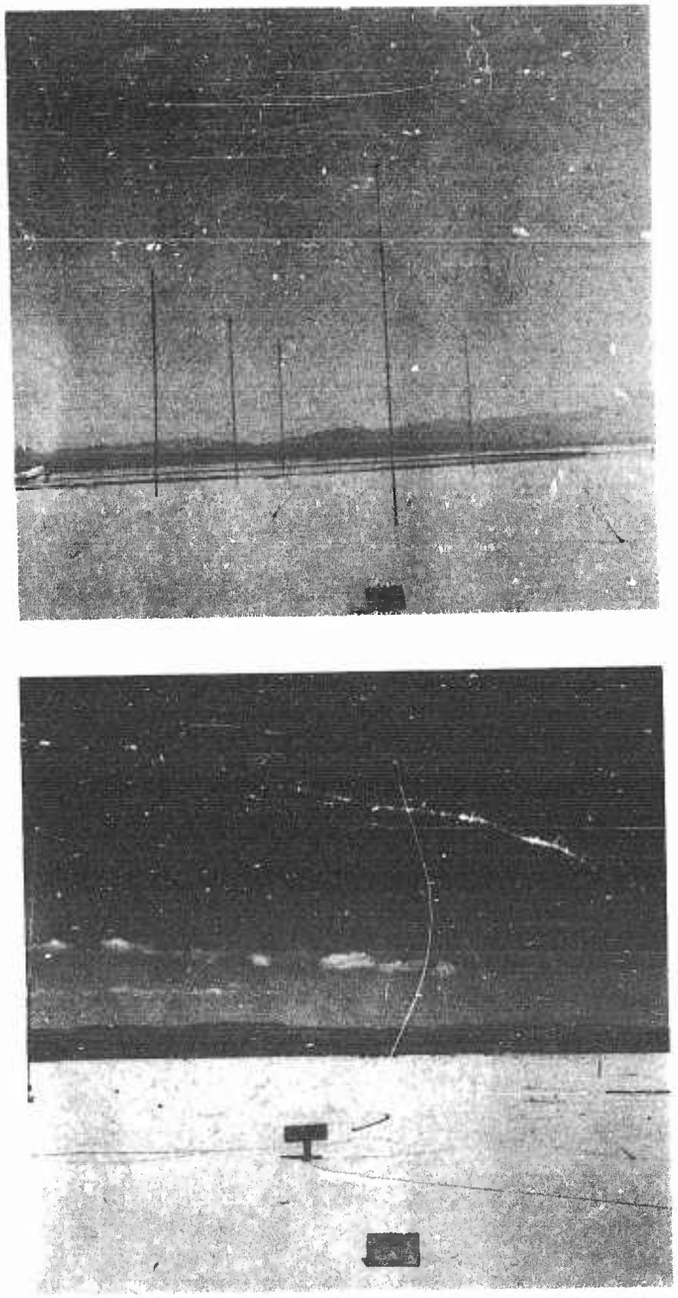
Fig. 3.106 Shot 9, Test Group 51, Antenna mast Magnesium.
(Top-before, Bottom-after)
5550 ft, 25 cal, 5.4 psi.

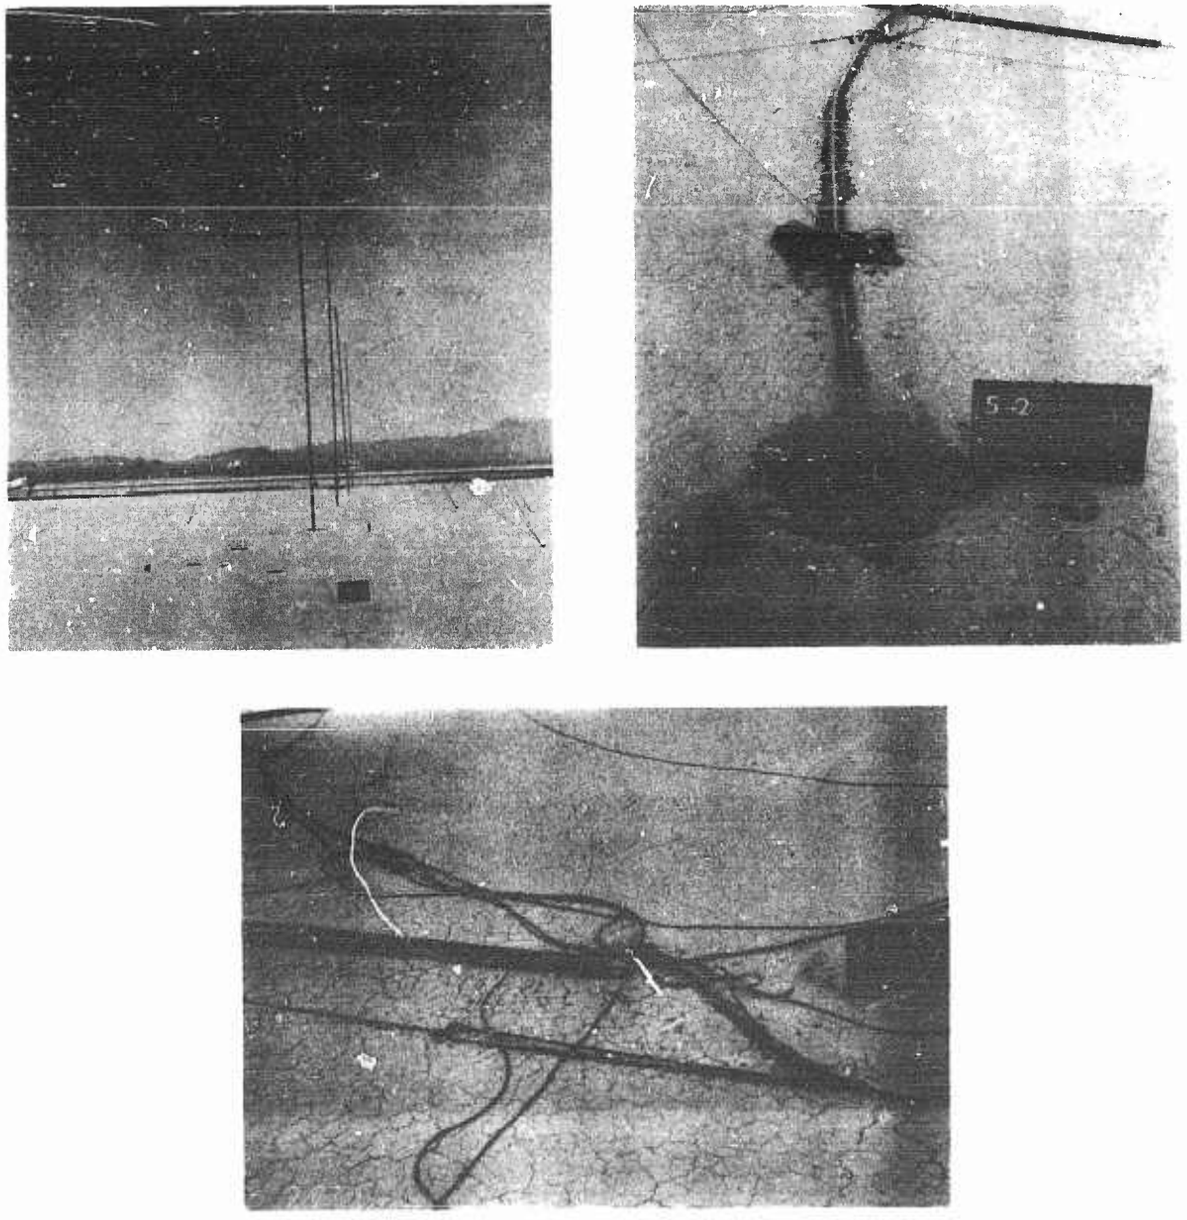
Fig. 3.107 Shot 9, Test Group 52, Antenna Mast AB-155/U. (Top left-before, Test Group 52 in Foreground, Top right-after, Bottom-after) 5625 ft, 24.5 cal, 5.3 psi.

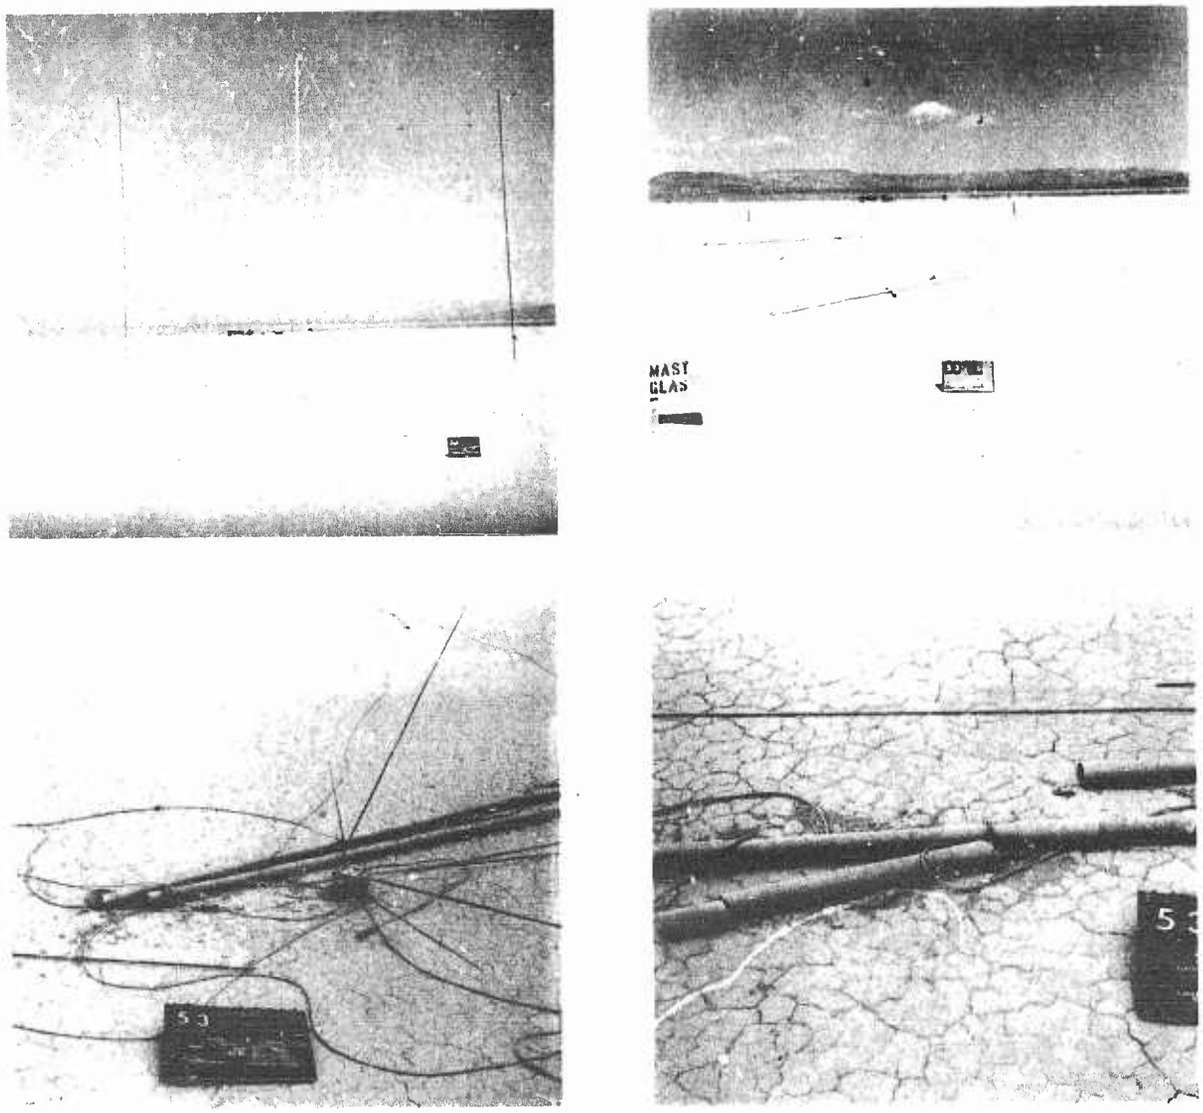
Fig. 3.108 Shot 9, Test Group 53, Antenna Mast, 30 ft, Fiberglass. (Top left-before, Top right-after; Bottom left, Broken Top-after, Bottom right, Broken Mast Section-after.) 5575 ft, 24.5 cal, 5.4 psi.

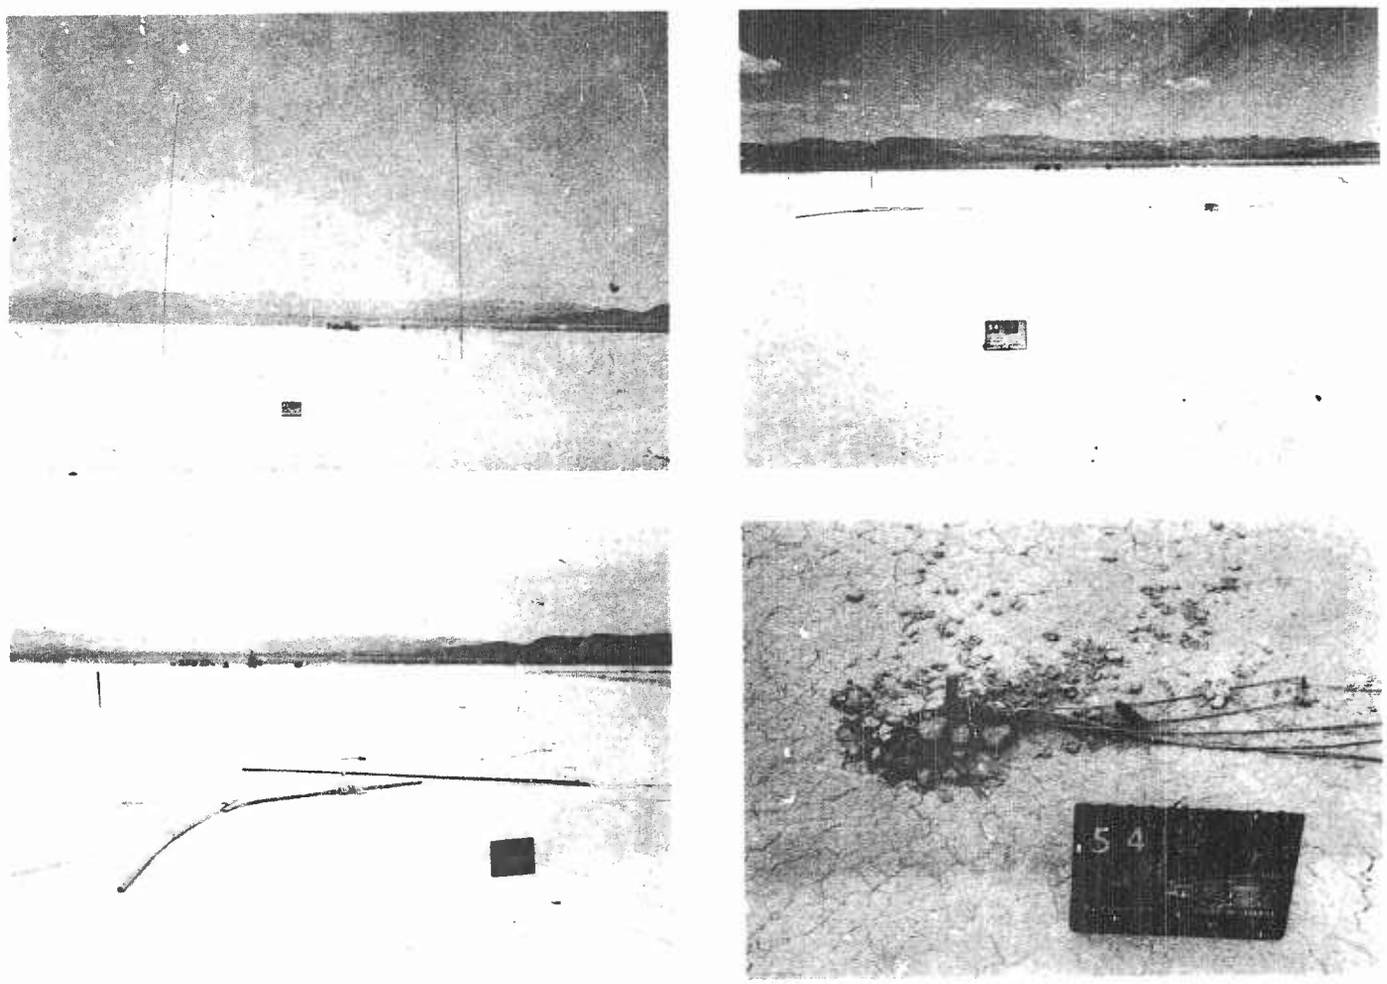
Fig. 3.109 Shot 9, Test Group 54, Antenna Mast AB-155/U. (Top left-before, Top right-after, Bottom right, Guy and Anchor-after.) 5675 ft, 24 cal, 4.6 psi.

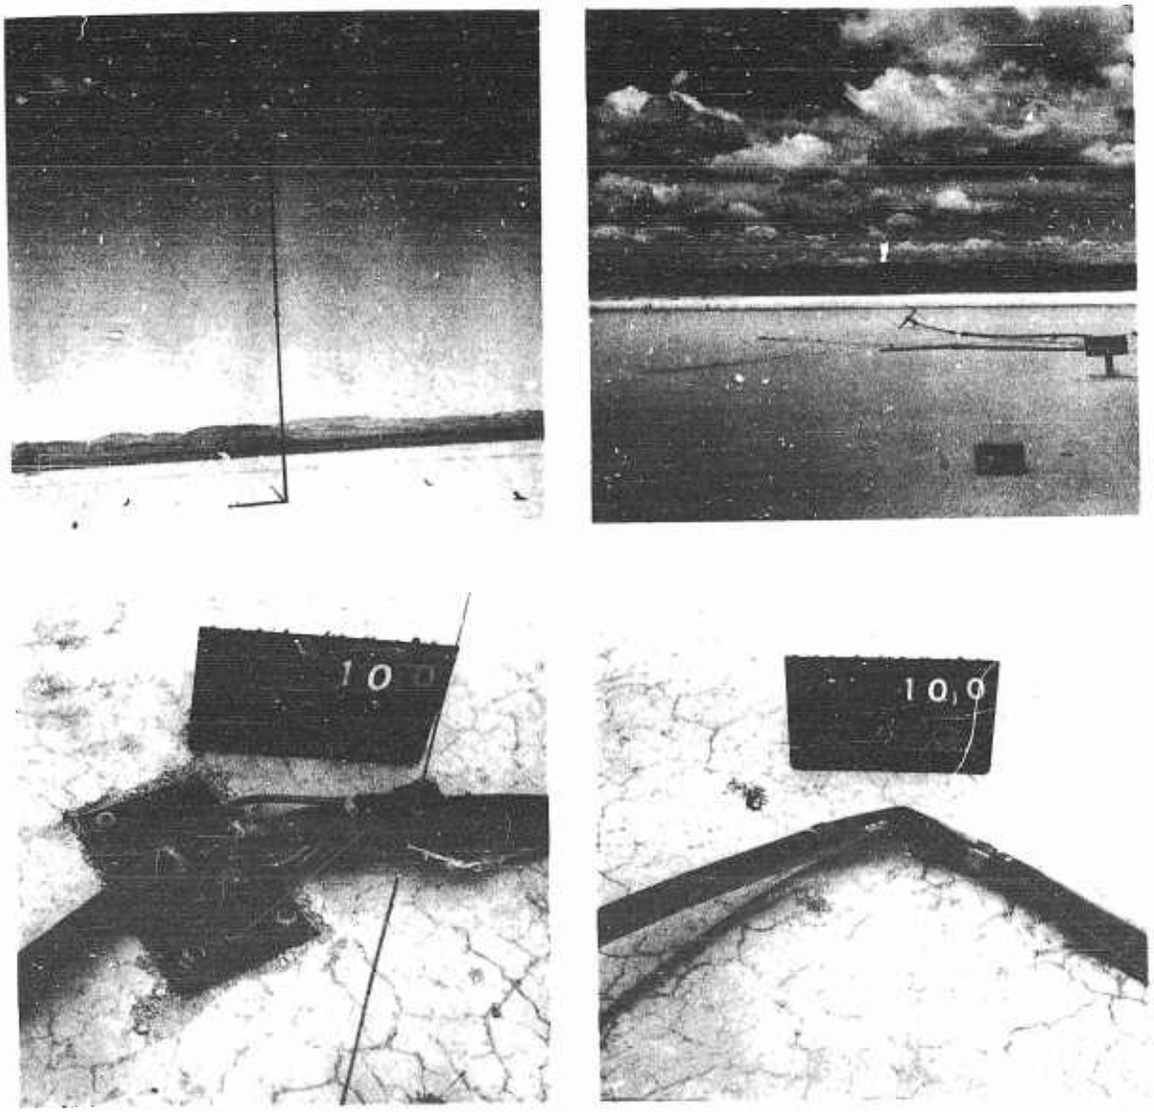
Fig. 3.110 Shot 9, Test Group 100, Antenna System AS-19/TRC-1. (Top left-before, Top right-after; Bottom left, Antenna base-after; Bottom right, Bent Mast Section-after.) 6350 ft, 19.5 cal, 4.6 psi.

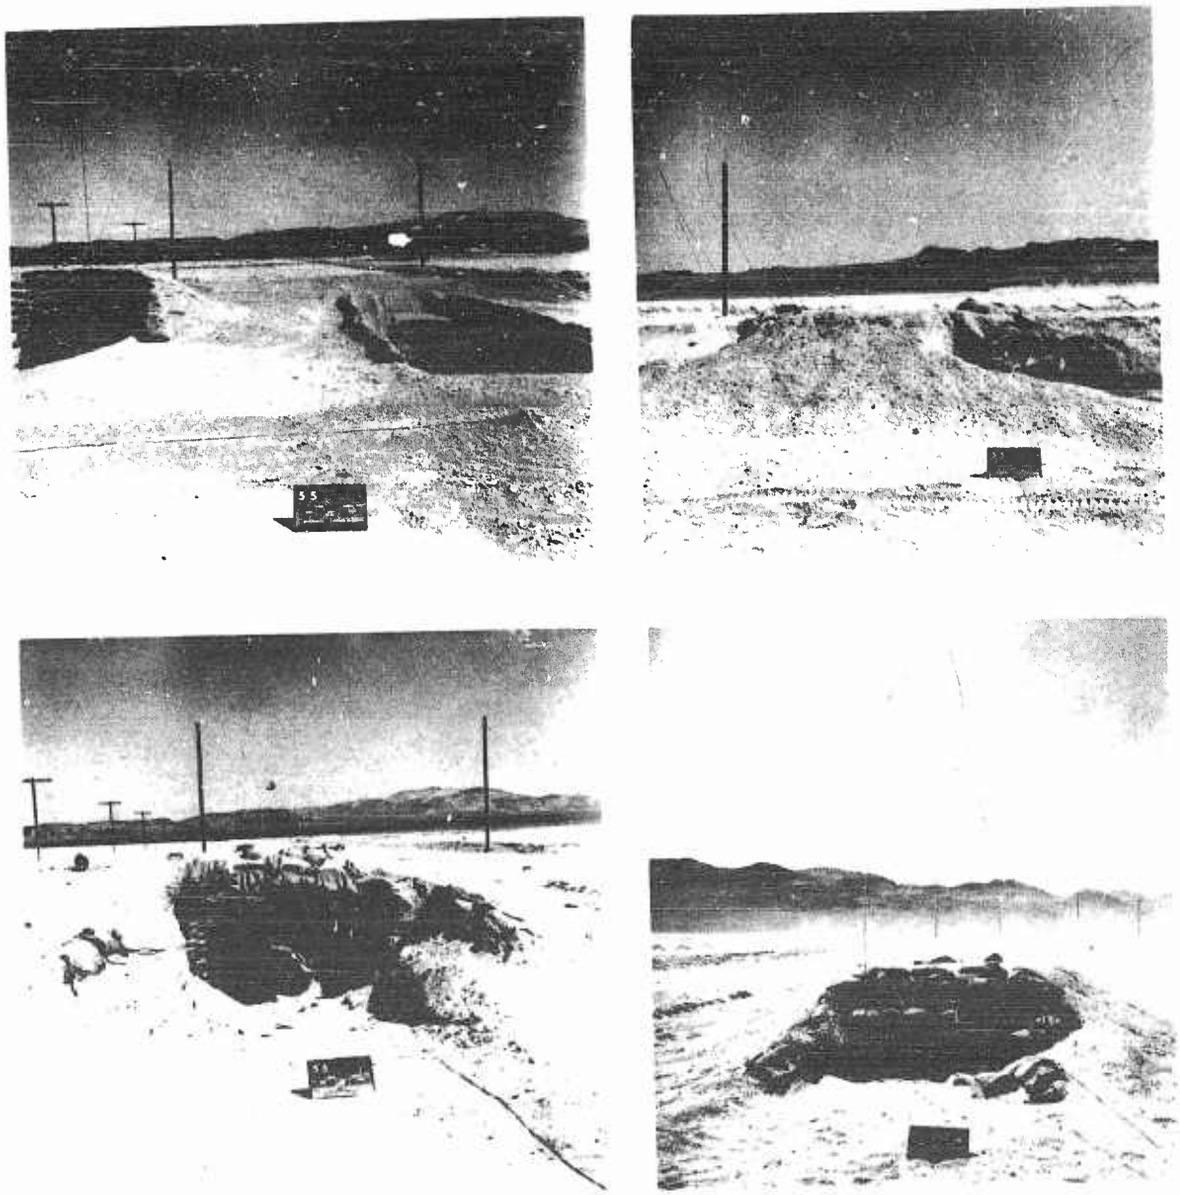
Fig. 3.111 Shot 9, Test Group 55, AN/GRC-26 Radio Set (Revetted). (Top left-before, Bottom left-after, Top right, Side View-after, Bottom right, Rear View-after.) 1700 ft, 91 cal, 13.8 psi, 3600 r at Surface, 572 r in S-56 Shelter.

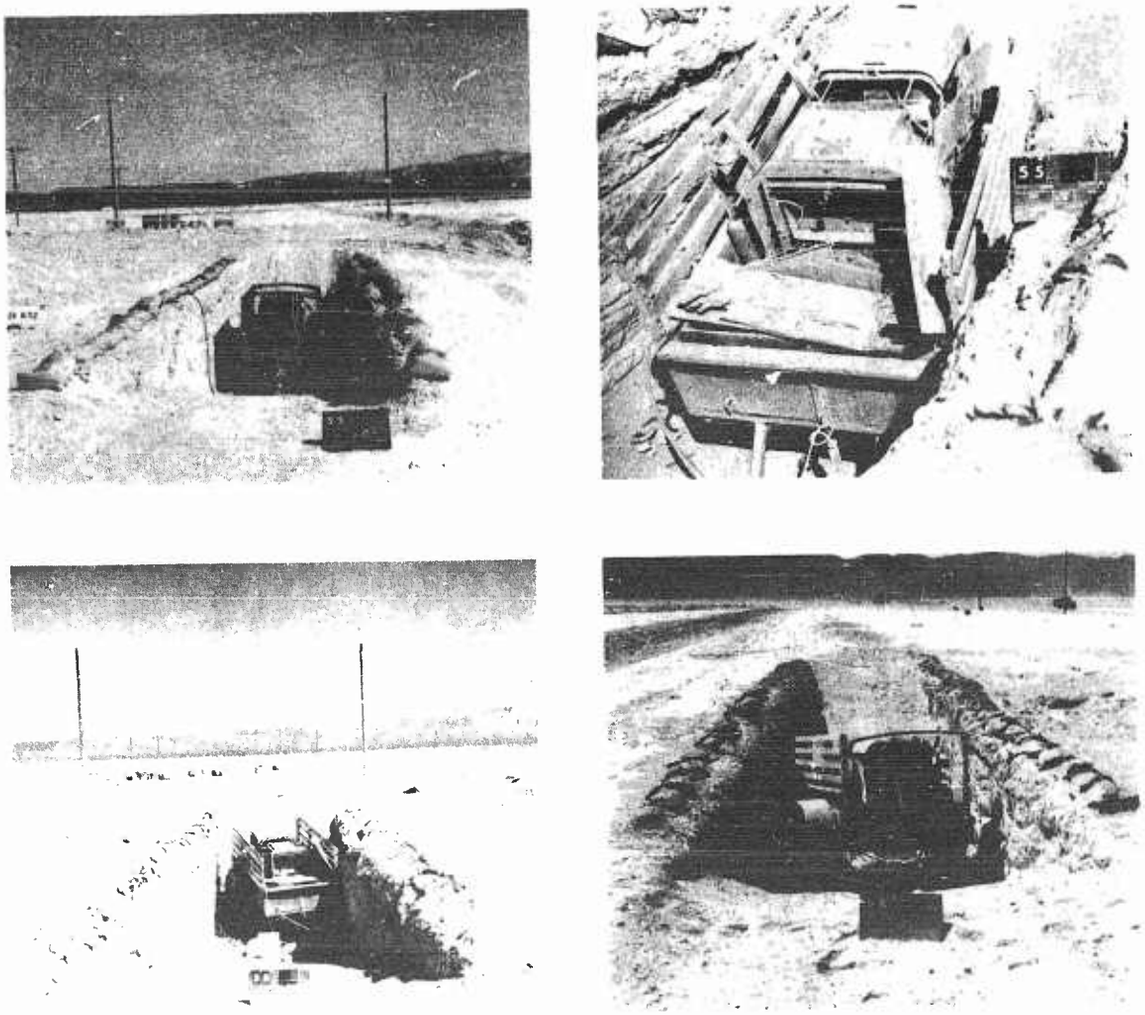
Fig. 3.112 Shot 9, Test Group 55, PE-95 Power Unit, Part of AN/GRC-26 Radio Set. (Top left-before, Bottom left-after, Top right, Front View-after, Bottom right, Rear View-after.) 1700 ft, 91 cal, 13.8 psi.

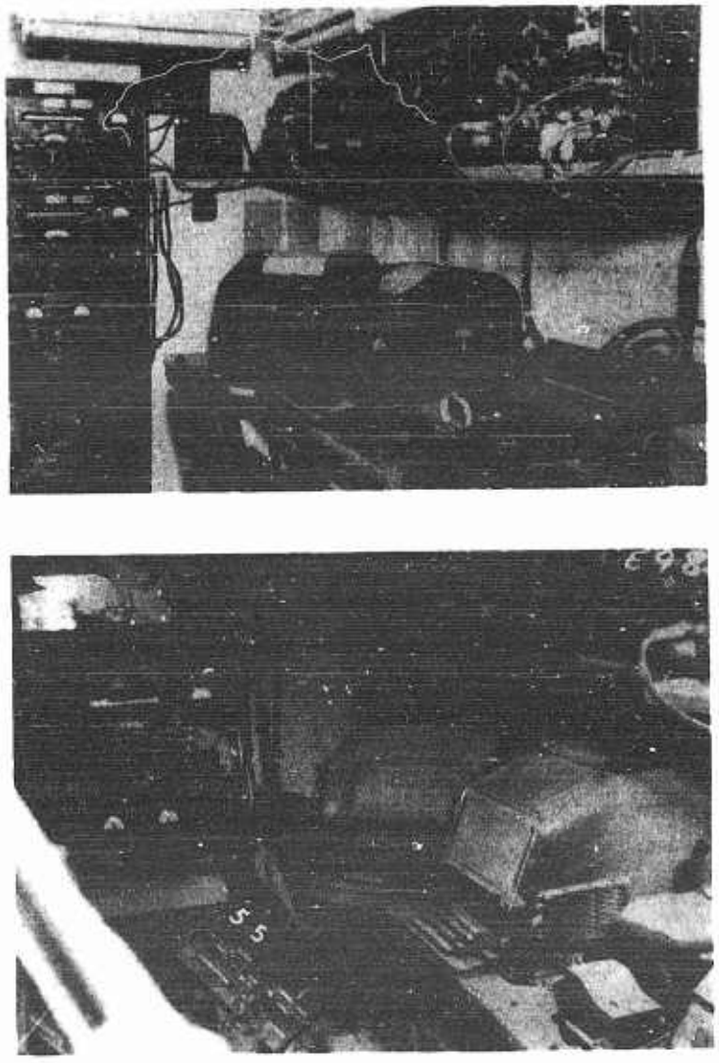
Fig. 3.113 Shot 9, Test Group 55, AN/GRC-26 Radio Set Details. (Top, Interior View before Blast, Bottom, Interior View after Blast.) Radio Receiver Taken out before Picture Taken. 1700 ft, 91 cal, 13.8 psi, 3600 r at Surface, 572 r in Shelter.

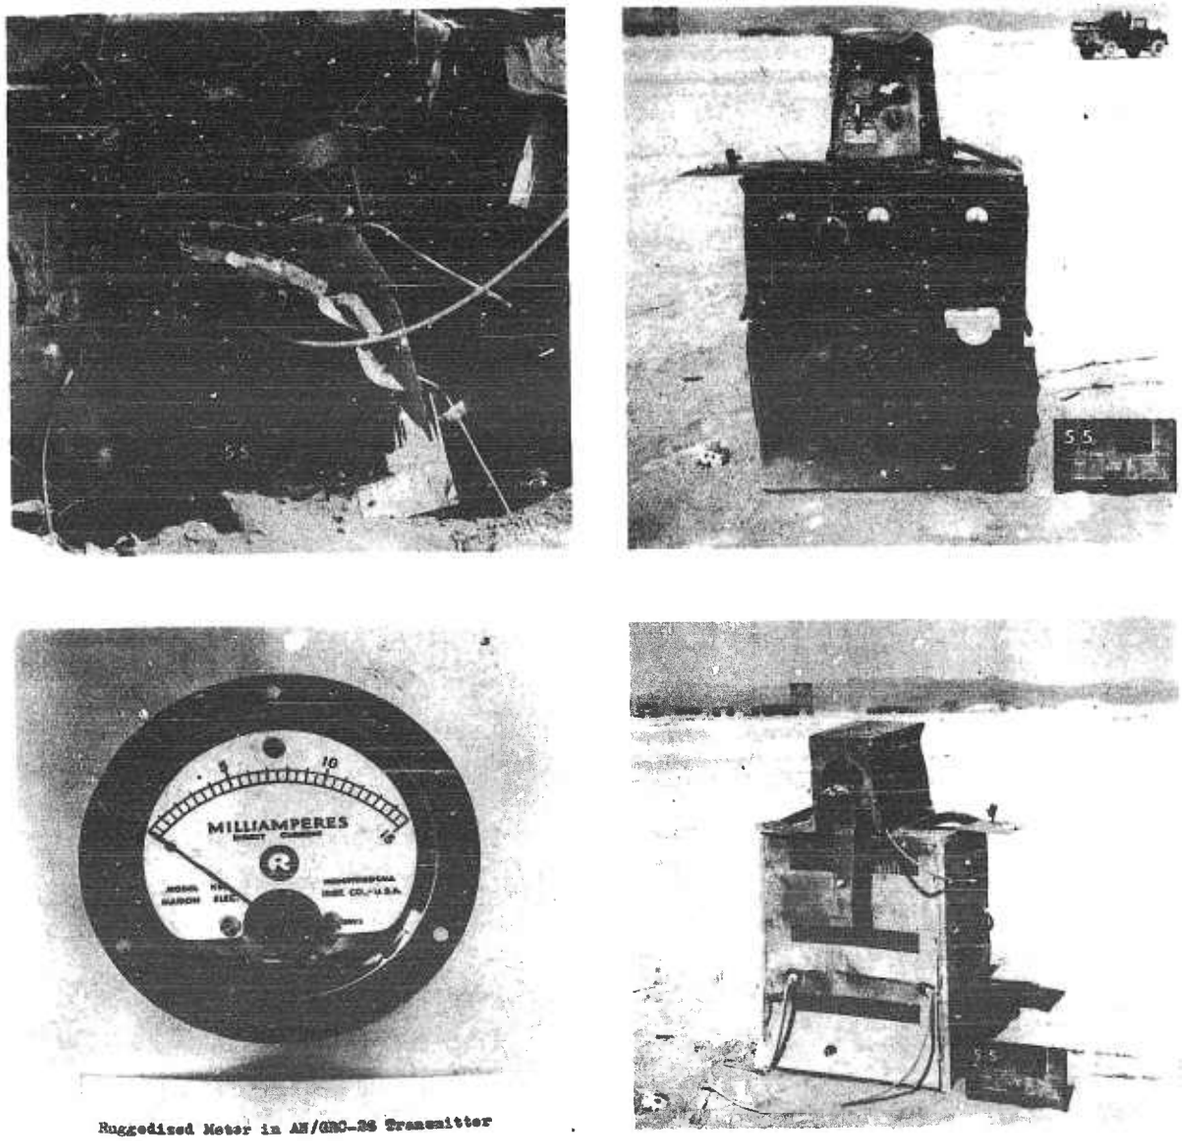
Fig. 3.113A Shot 9, Test Group 55, AN/GRC-26 Radio Set Detail Photos - All Photos after Shot. Top left, interior of S-56 Shelter; Bottom left, ruggedized Milliammeter in BC-610 Transmitter; Top right, BC-610 Transmitter after Removal from S-56 Shelter, Front View. 1700 ft, 91 cal, 13.8 psi.
