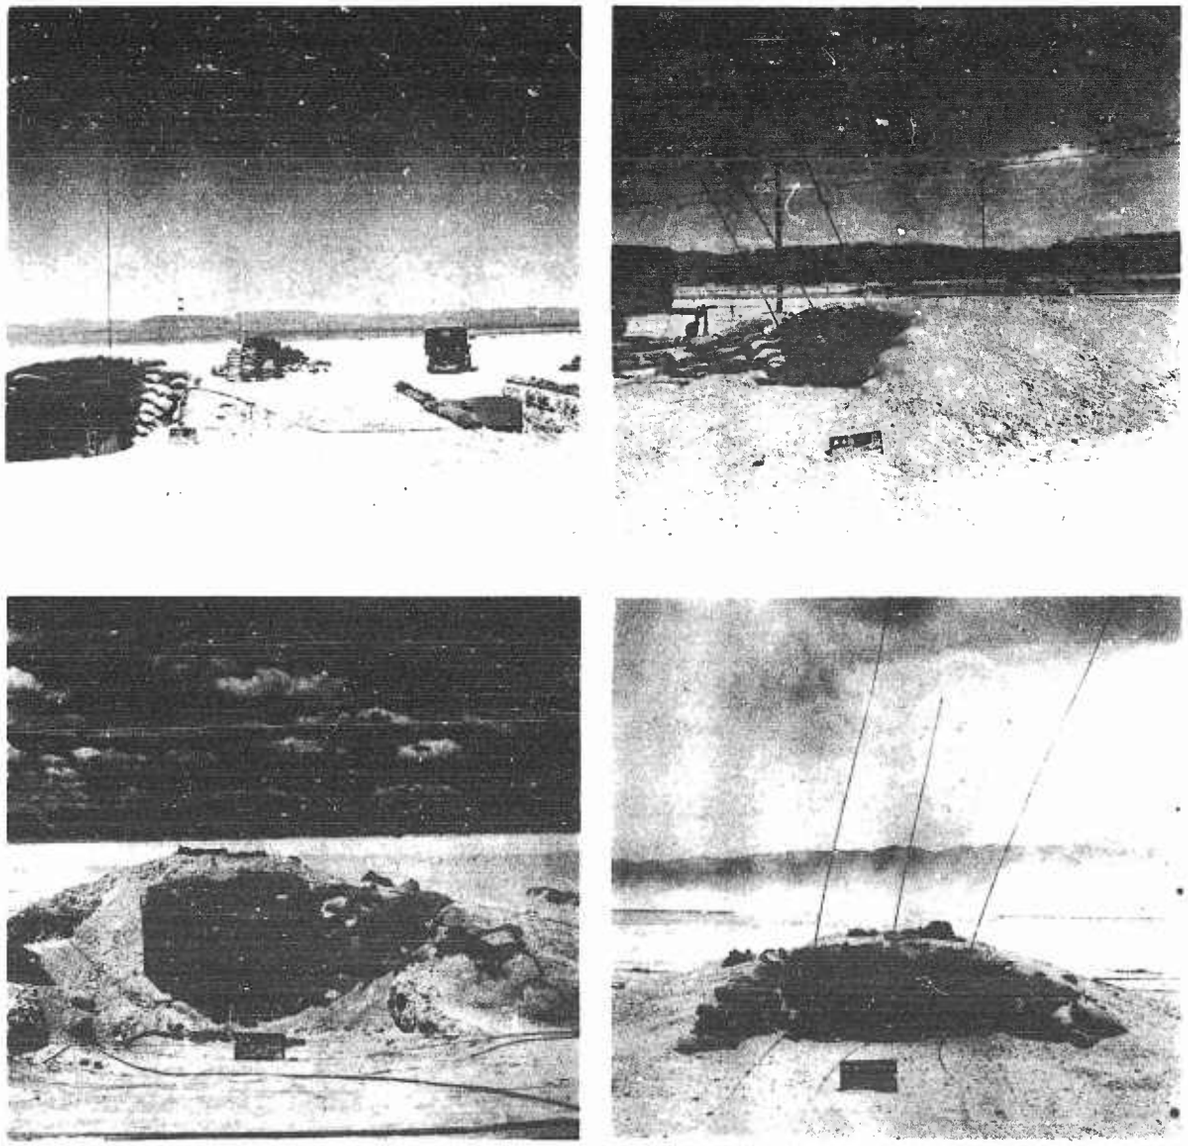
Fig. 3.114 Shot 9, Test Group 56, AN/GRC-26 Radio Set (Revetted). (Top left-before, Bottom left-after, Top right, Rear View-before, Bottom right, Rear View-after.) 3500 ft, 49 cal, 9.4 psi, 840 r at Surface, 316-168 r in S-56 Shelter.

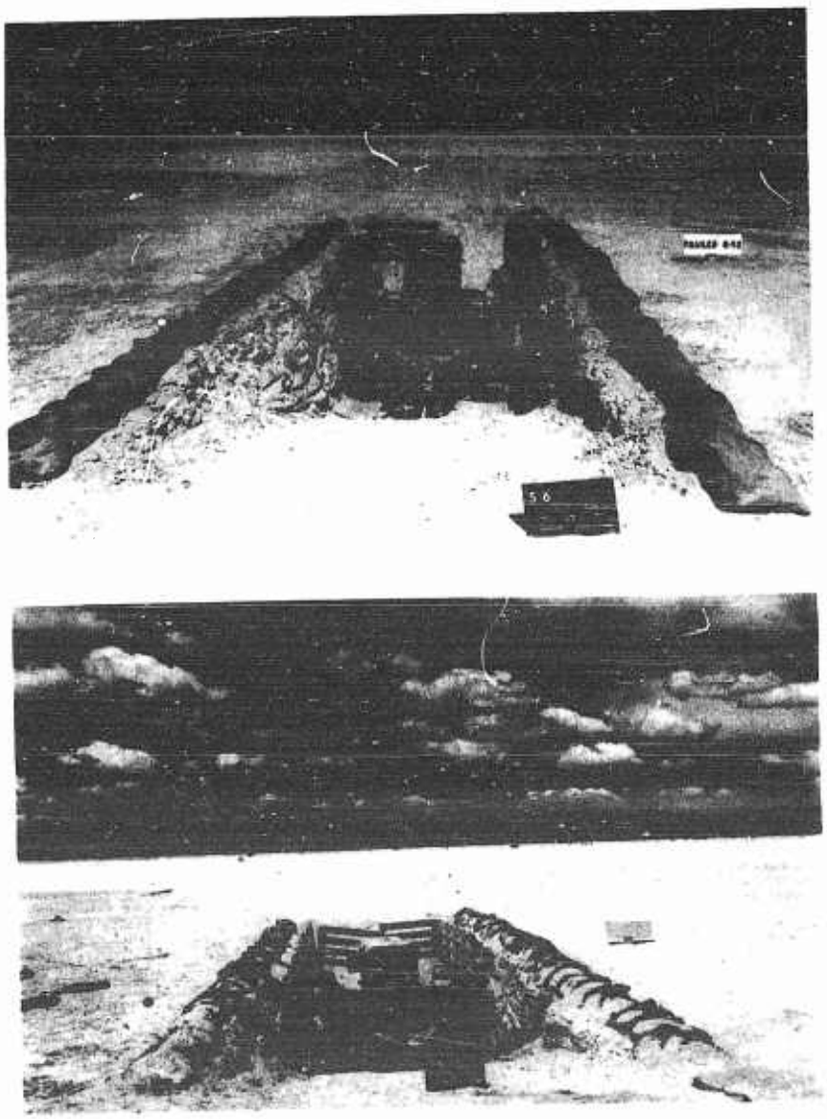
Fig. 3.115 Shot 9, Test Group 56, PE-95 Power Unit, Part of AN/GRC-26 Radio Set (In Open Ended Pit). (Top-before, Bottom-after) 3500 ft, 49 cal, 9.4 psi.

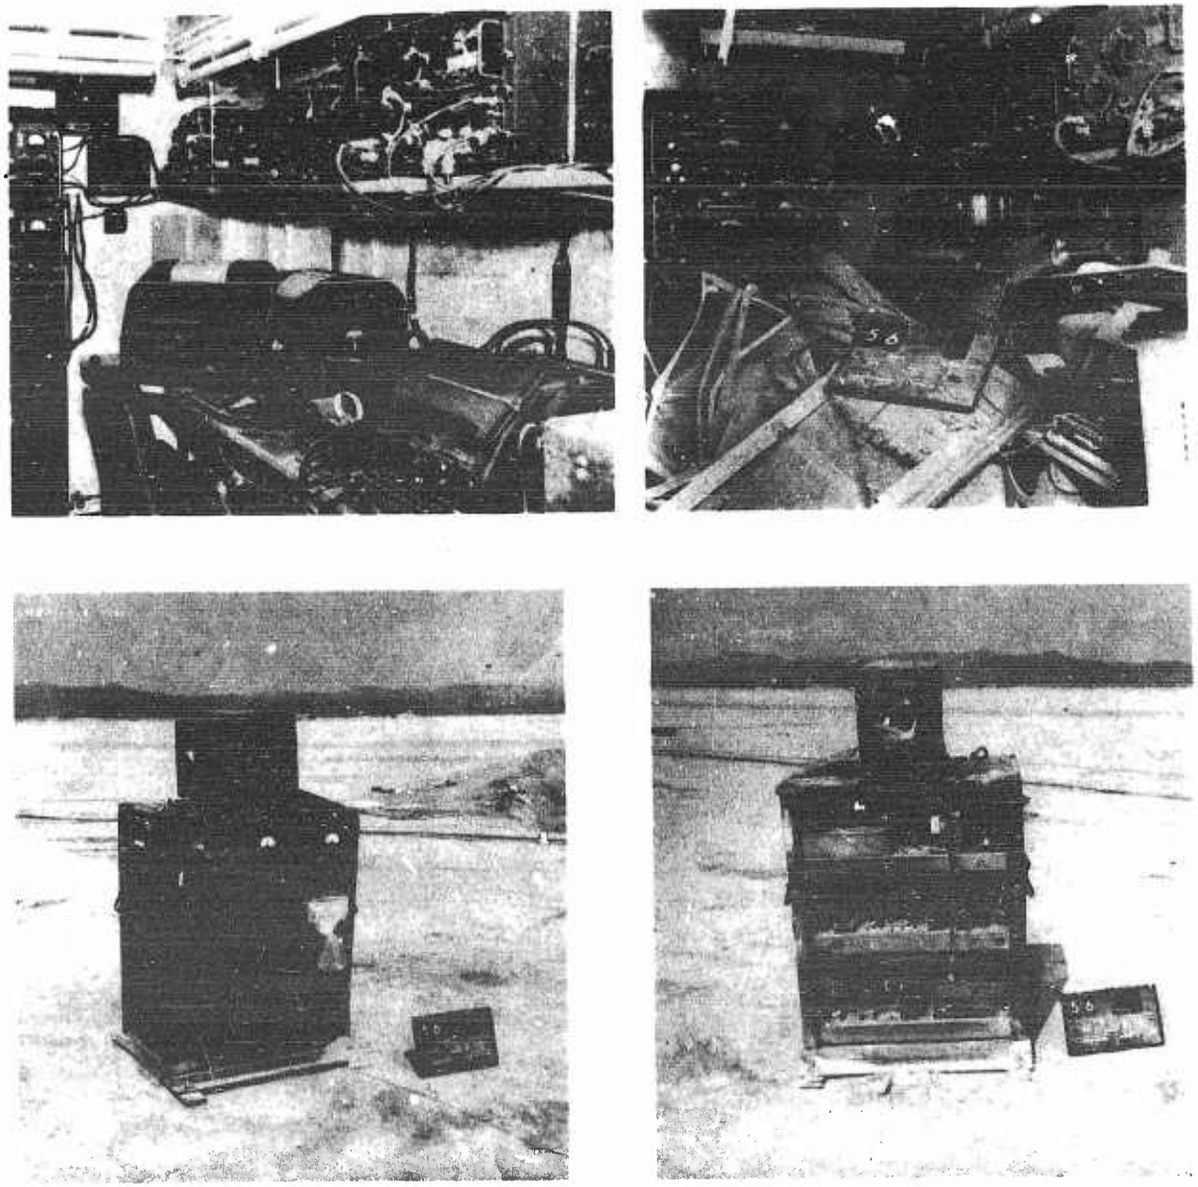
Fig. 3.116 Shot 9, Test Group 56, AN/GRC-26 Radio Set Detail Photos (After). Top left, interior of S-56 Shelter before blast; lower left, BC-610 Transmitter, front view; bottom right, BC-610 Transmitter, rear view, panel removed; top right, shelter interior after blast. 3500 ft, 49 cal, 9.4 psi, 840 r at surface, 316-168 r in shelter.

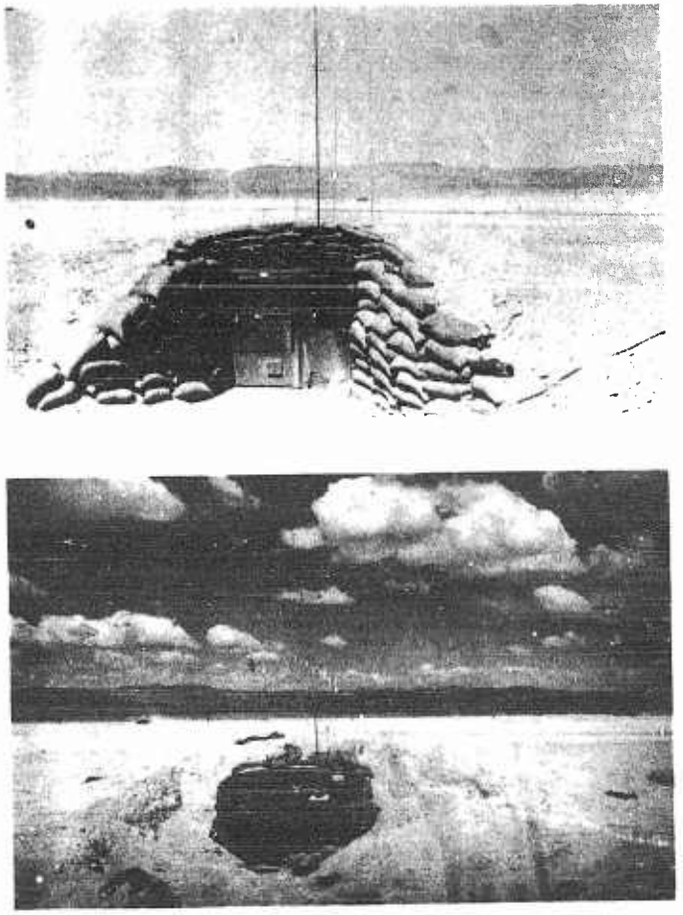
Fig. 3.117 Shot 9, Test Group 57, AN/GRC-26 Radio Set. (Top-before, Center-after, Bottom, Rear View-after) 4500 ft, 34 cal, 7 psi, 200 r at Surface, 96 r in S-56 Shelter.

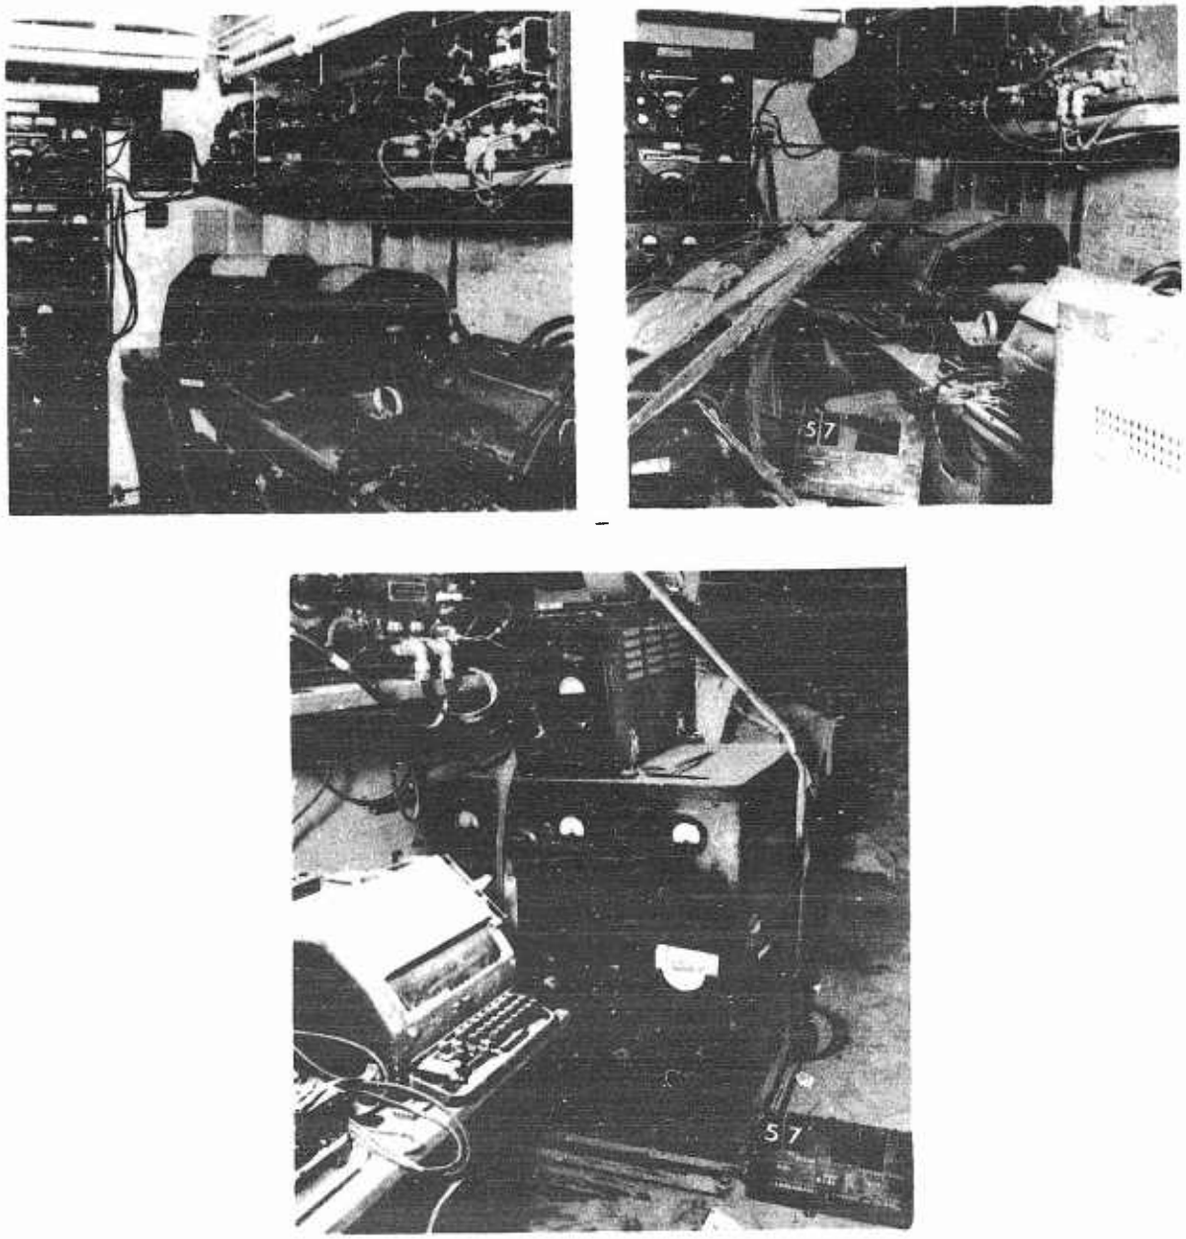
Fig. 3.117A Shot 9, Test Group 57, AN/GRC-26 Details. (Top left-interior View before Blast, Top right and Bottom, Interior View after Blast) 4500 ft, 34 cal, 7 psi, 200 r at Surface, 96 r in Shelter.

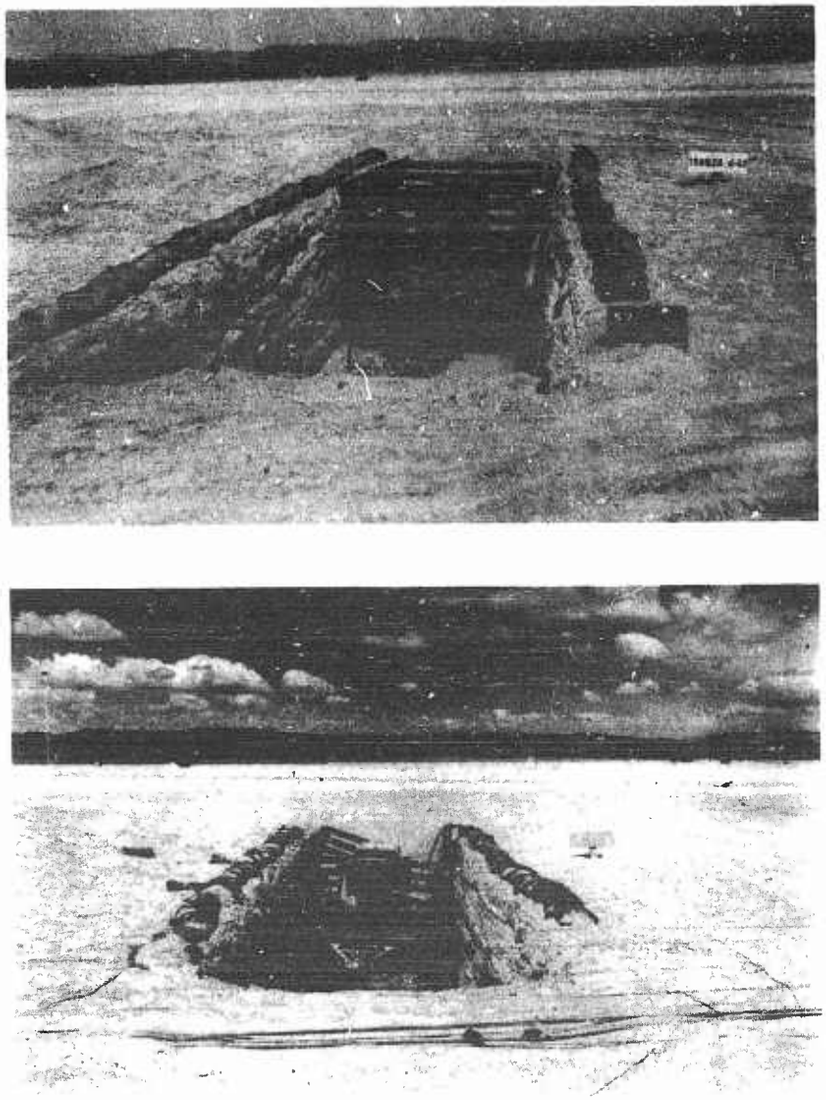
Fig. 3.118 Shot 9, Test Group 57, PE-95 Power Unit in S-56 Shelter. (Top-before, Bottom-after) 4500 ft, 34 cal, 7 psi, 200 r at Surface, 96 r in S-56 Shelter.

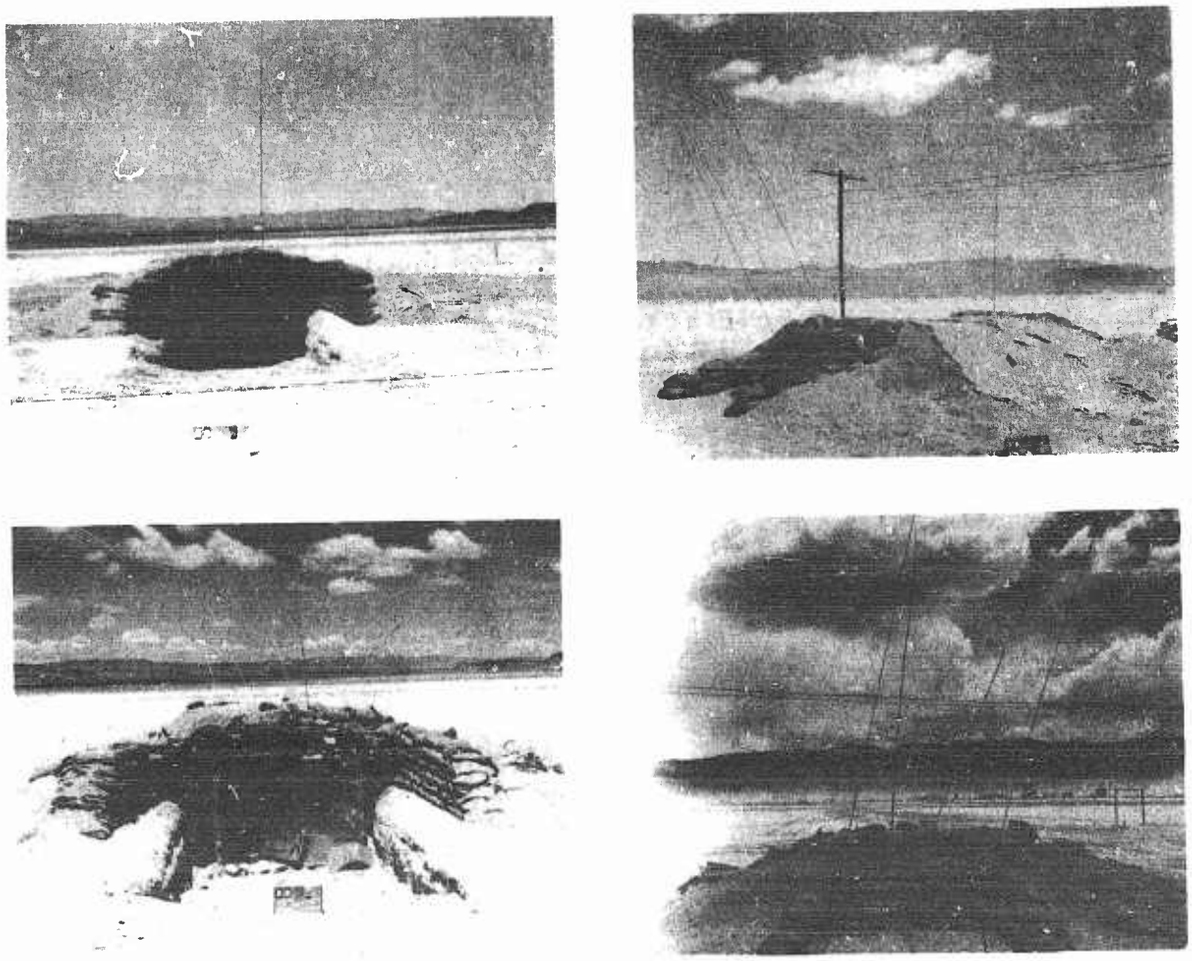
Fig. 3.119 Shot 9, Test Group 58, AN/GRC-26 Radio Set. (Top left-before, Bottom left-after; Top right, rear view-before, Bottom right, rear view-after) 5500 ft, 25 cal, 5.6 psi, 80 r at Surface, 44 r in S-56 Shelter.

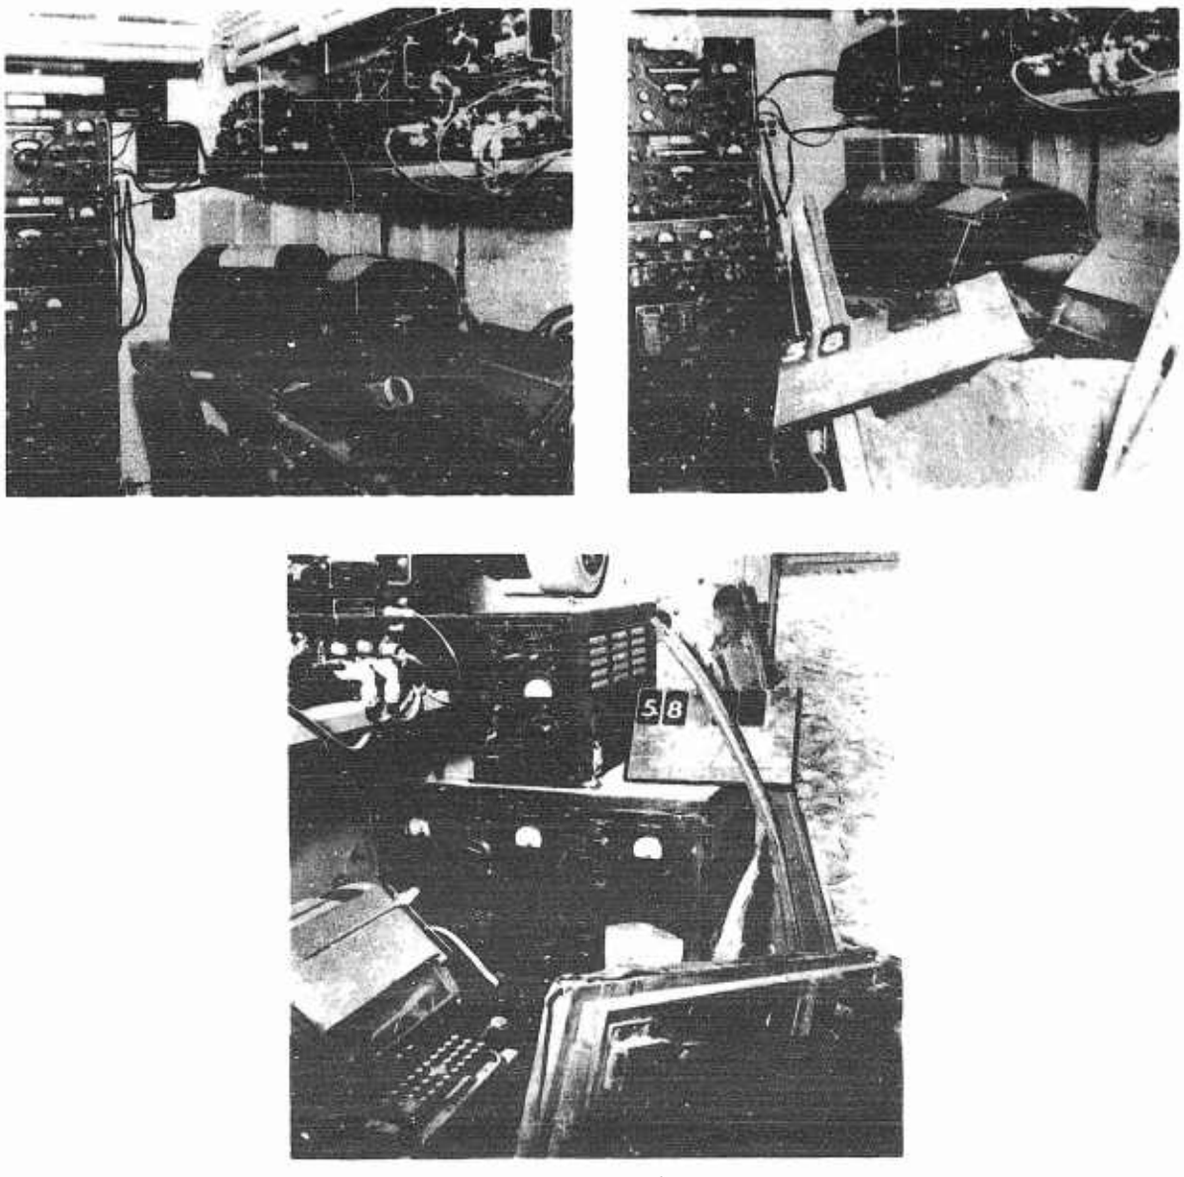
Fig. 3.120 Shot 9, Test Group 58, AN/GRC-26 Radio Set, Detail Photos. (Top left, Interior View before Blast; Top right and Bottom, Interior Views of S-56 Shelter after Blast.) 5000 ft, 25 cal, 5.6 psi, 80 r at Surface, 44 r in S-56 Shelter.

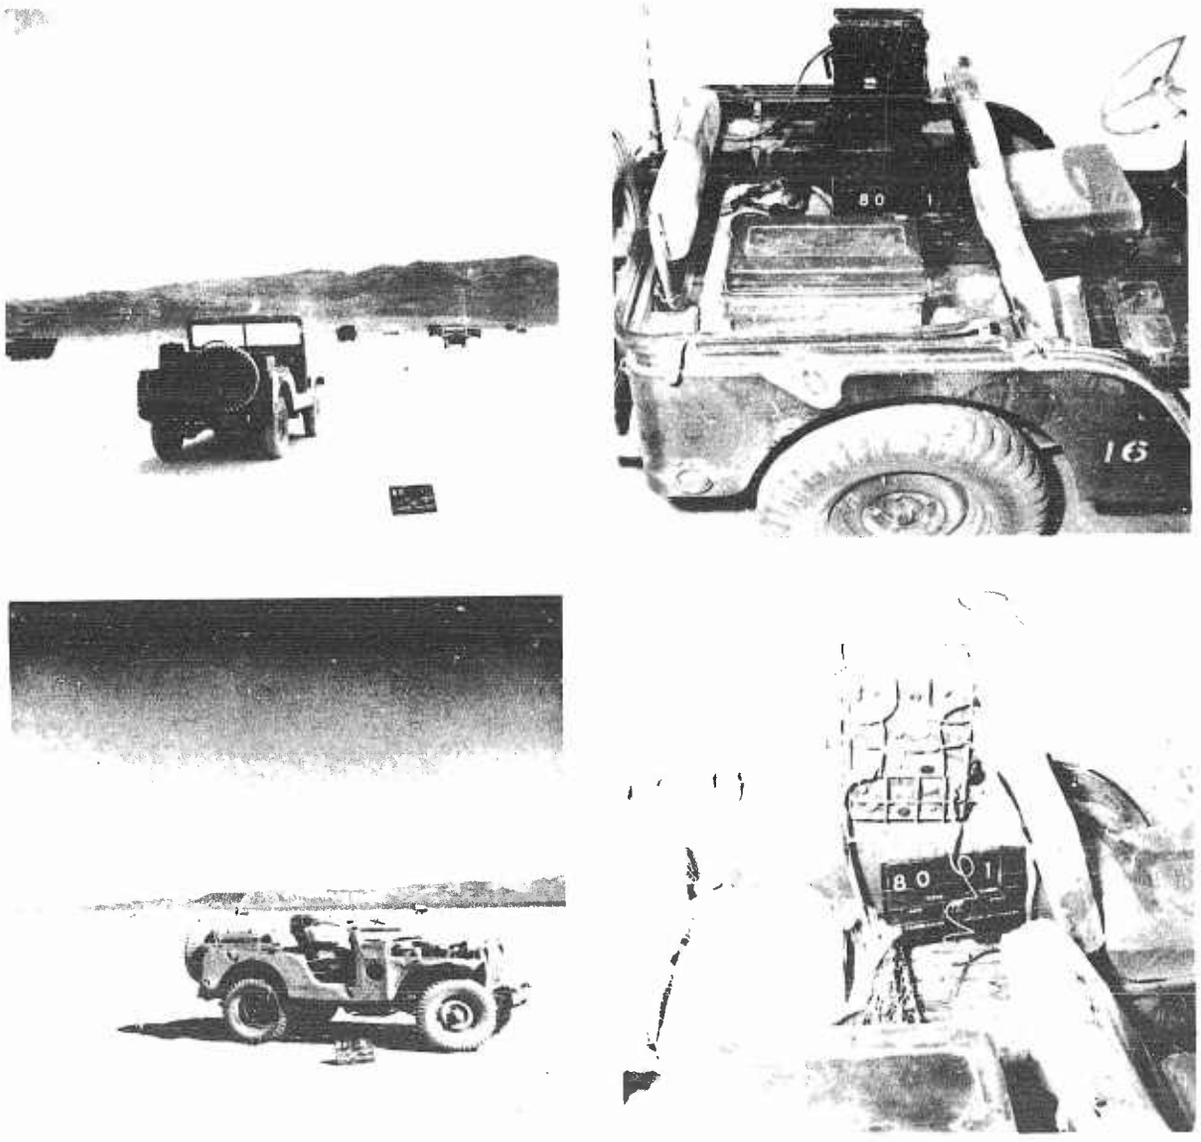
Fig. 3.121 Shot 9, Test Group 80, AN/GRC-9 Radio Set in Ordnance Corps Jeep. (Top left-before, Bottom left-after; Top right-before, Bottom right-after) 1650 ft, 94.5 cal, 14 psi, 368 r at Surface.

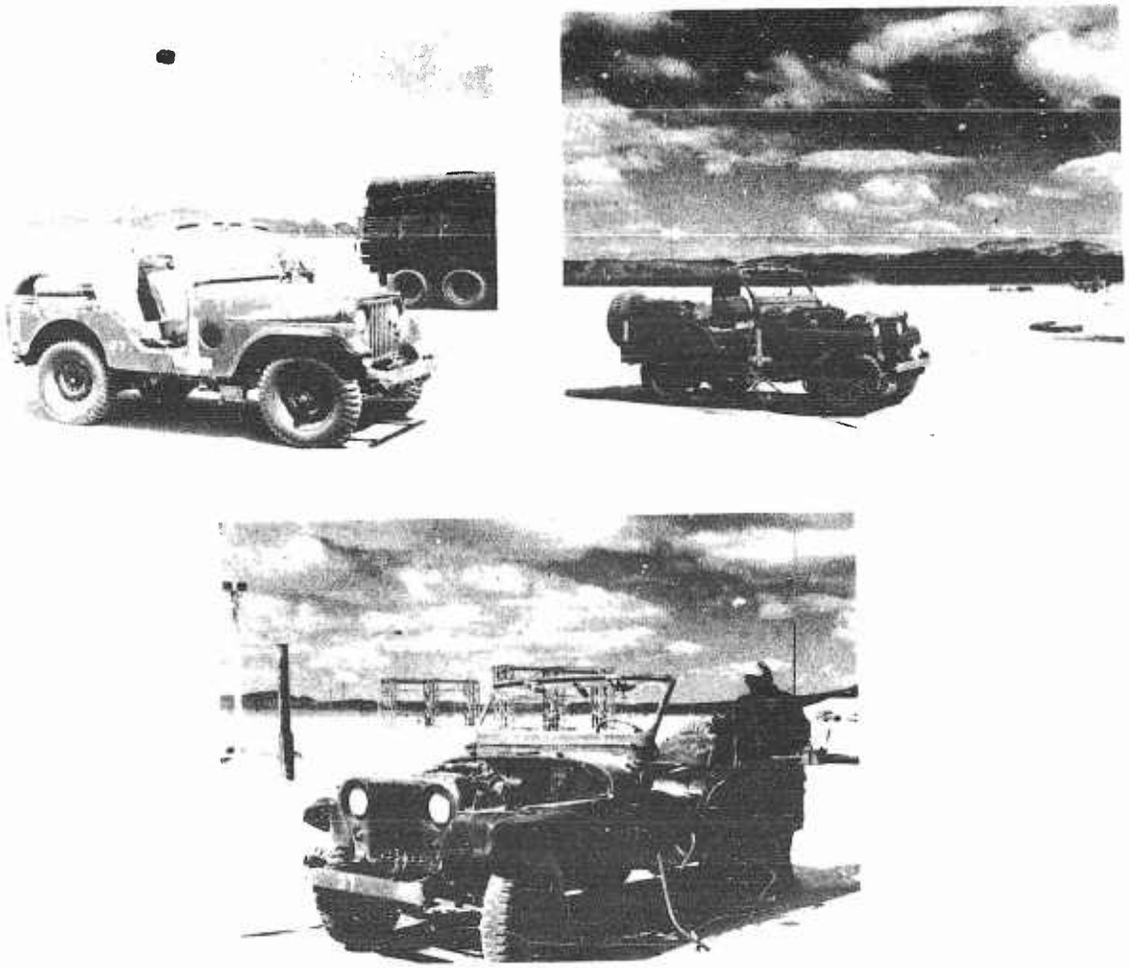
Fig. 3.123 Shot 9, Test Group 81, AN/GRC-9 on Ordnance Corps Jeep. (Top left-before, Top right-after, Bottom, Front View-after) 2425 ft, 58.5 cal, 10.6 psi, 2280 r at Surface.

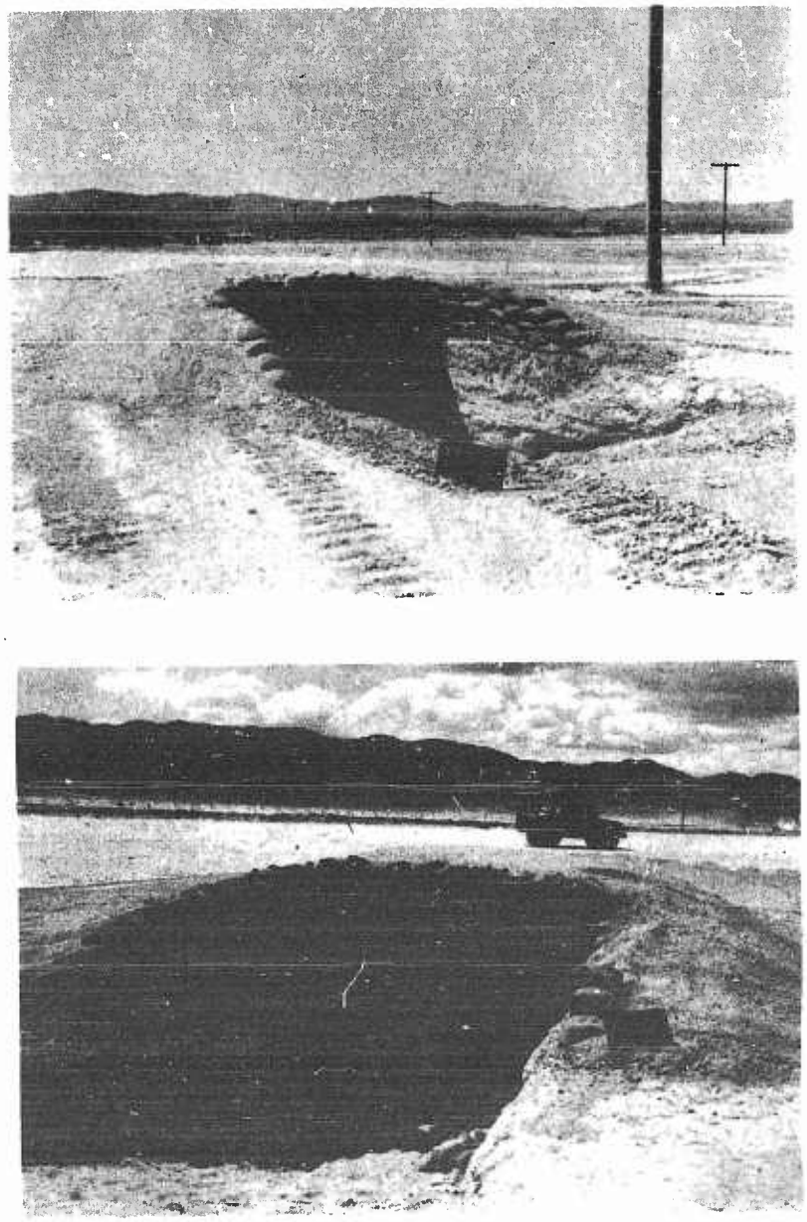
Fig. 3.125 Shot 9, Test Group 59, Shelter S-56 (Revetted) with Front Away from Ground Zero. (Top-before, Bottom-after) 2325 ft, 72 cal, 11.6 psi, 2440 r at Surface.

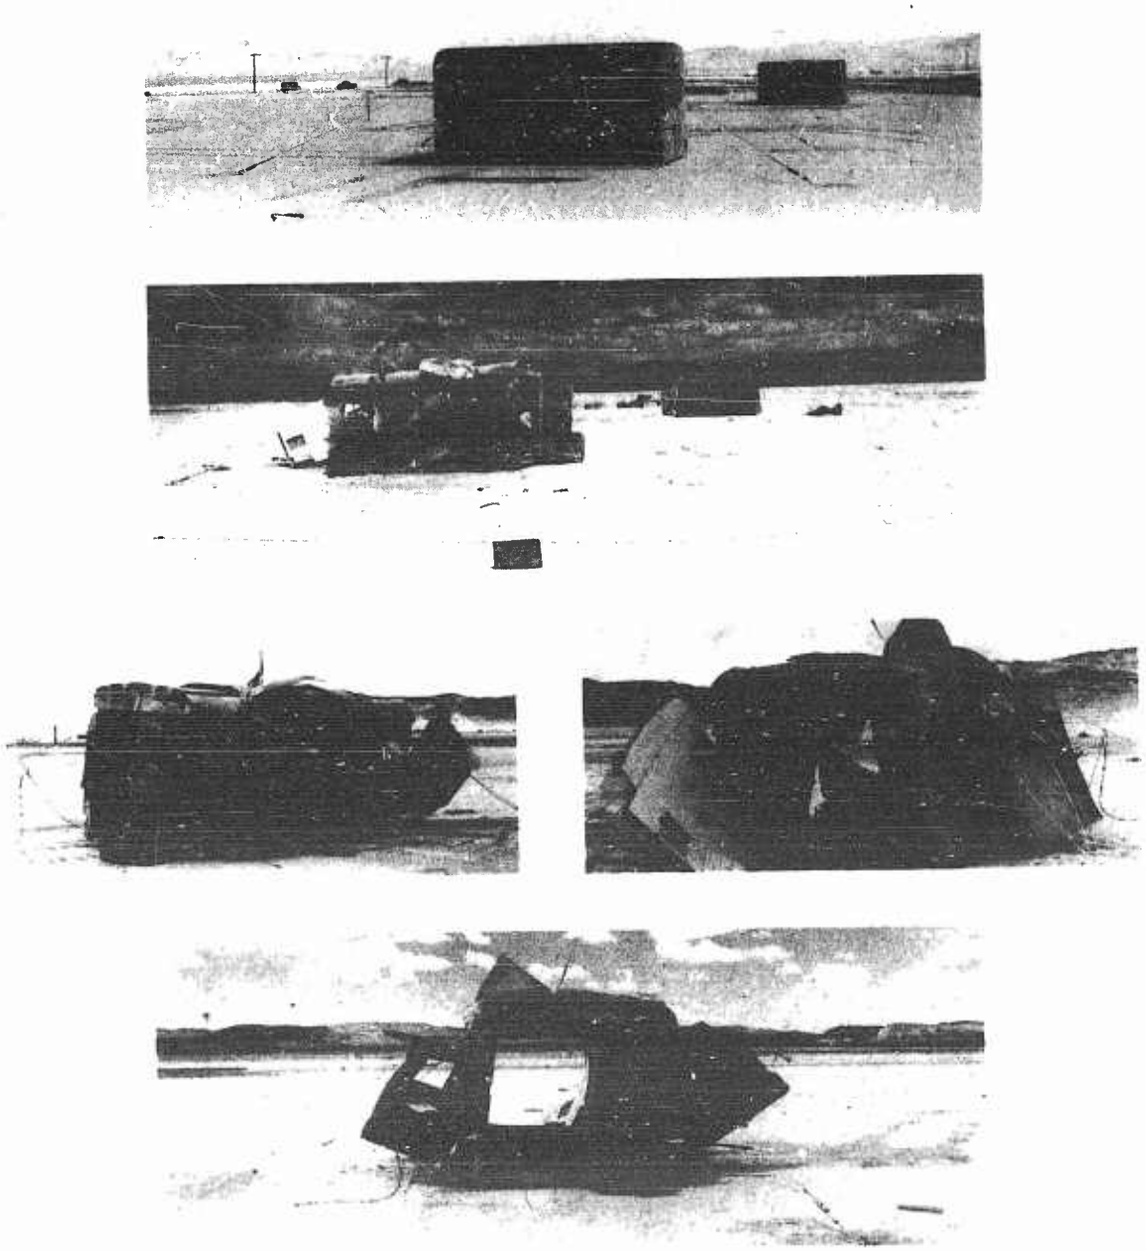
Fig. 3.126 Shot 9, Test Group 60, Shelter S-56 Modified. (Top-before, Second-after, Left, Side-after, Right, Rear-after, Bottom, Front-after) 3050 ft, 57.5 cal, 10.4 psi, 1480 r at Surface.

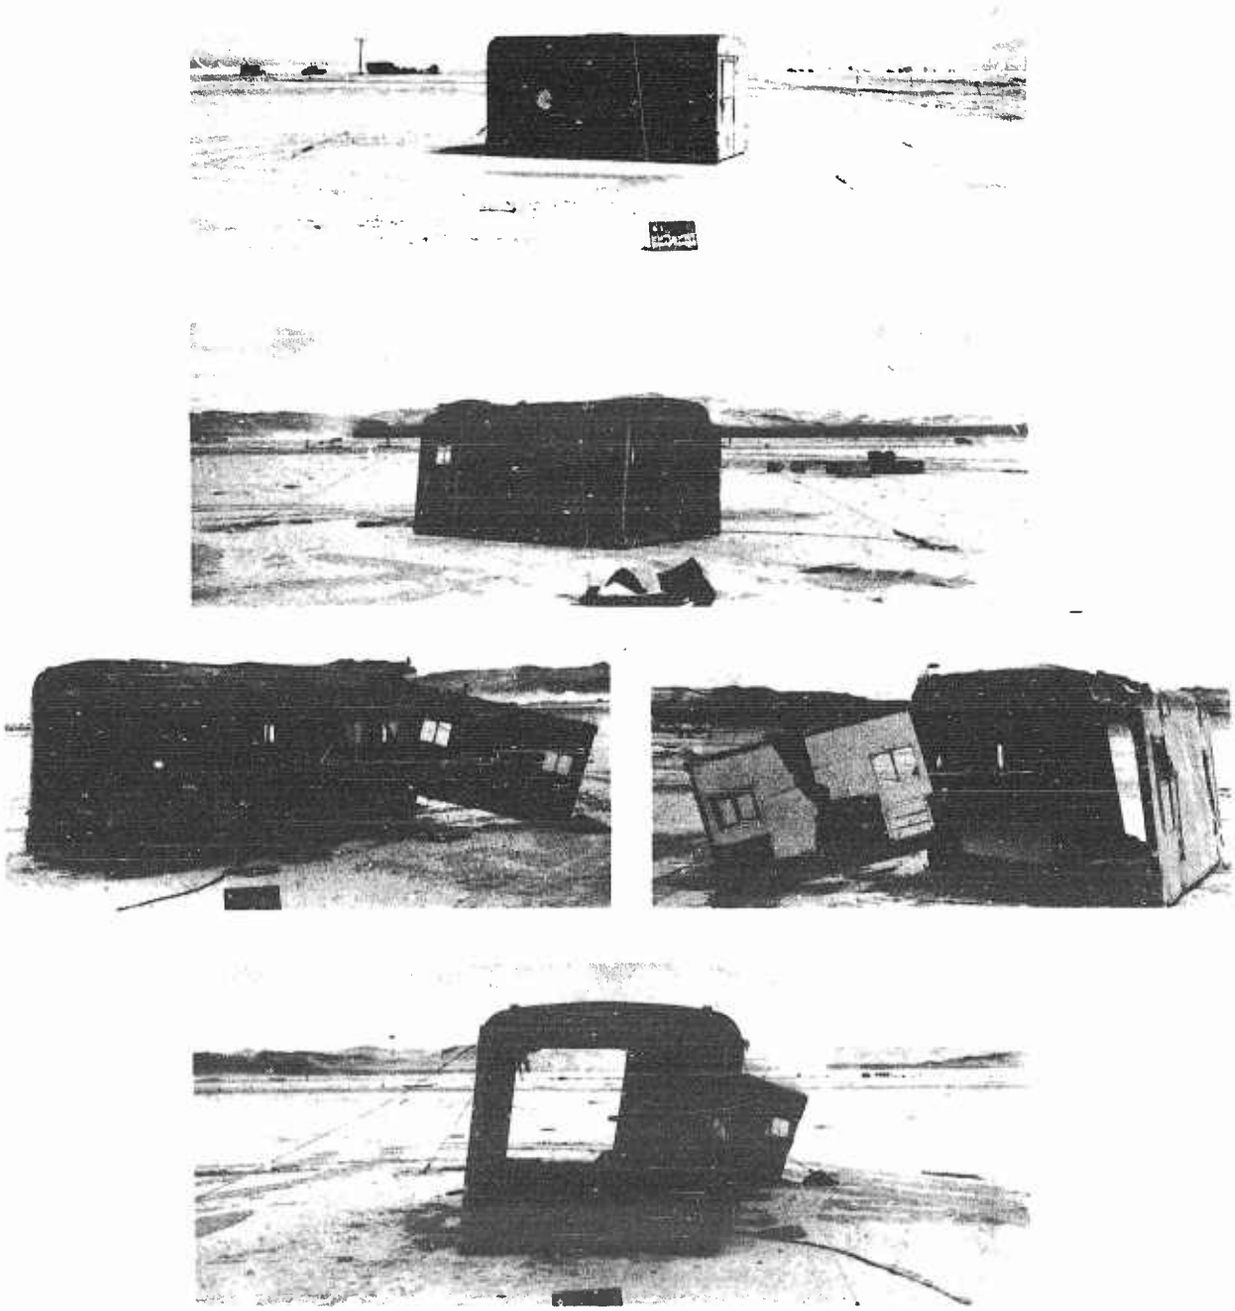
Fig. 3.127 Shot 9, Test Group 61, Shelter S-56 (Standard). (Top-before, Second-after, Left, Side-after, Right, Rear-after, Bottom, Front-after) 3100 ft, 56 cal, 10.4 psi, 1400 r at Surface.

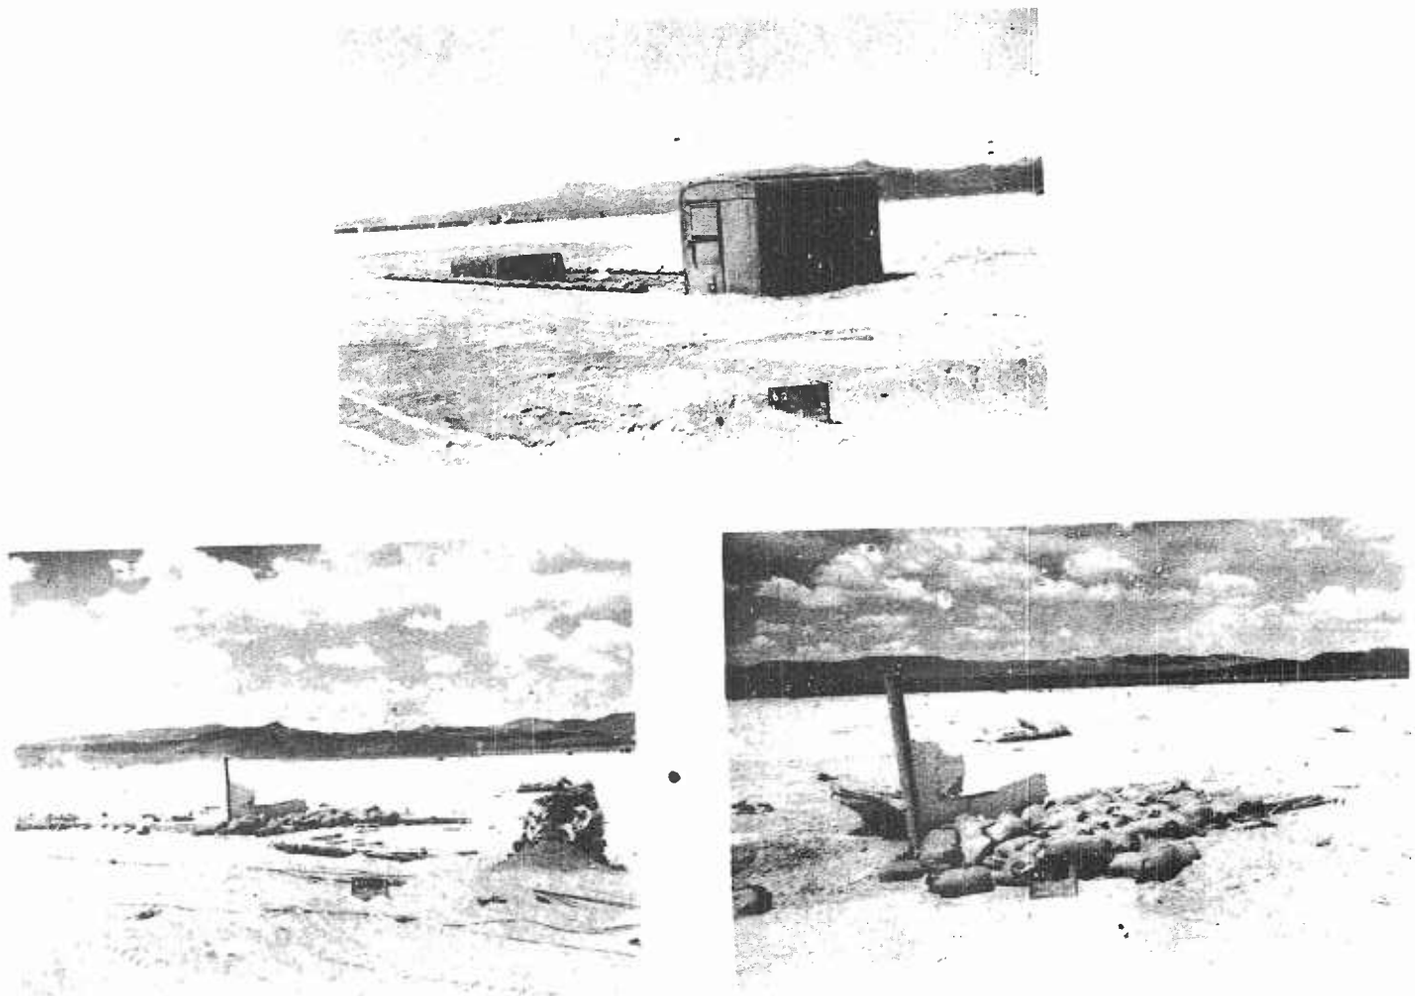
Fig. 3.128 Shot 9, Test Group 62, Shelter S-56.
(Top-before, Left-after, Right-after, Close-up)
3650 ft, 46 cal, 9.0 psi, 720 r at Surface.

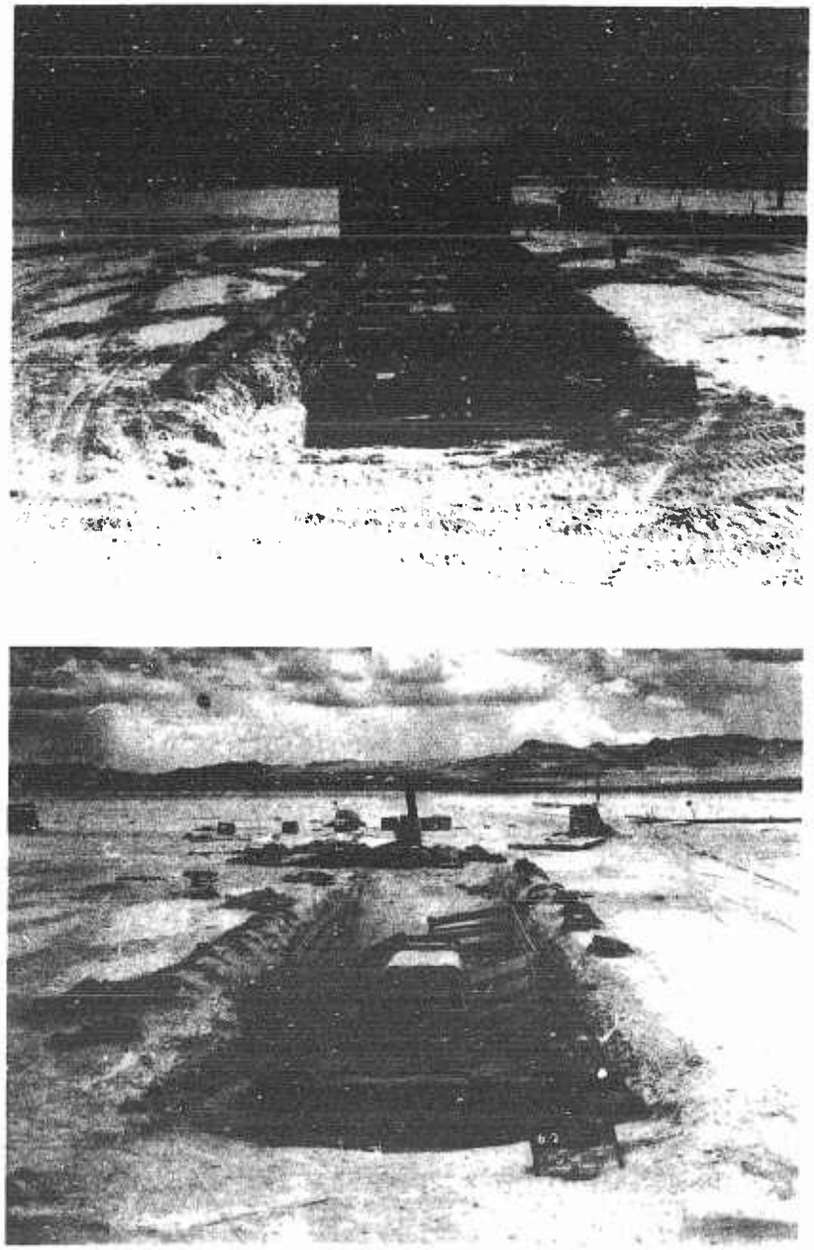
Fig. 3.129 Shot 9, Test Group 62, PE-95 Power Unit in K-52 Trailer in Open Pit Normal to Ground Zero. (Top-before, Bottom-after) 3650 ft, 46 cal, 9.0 psi.

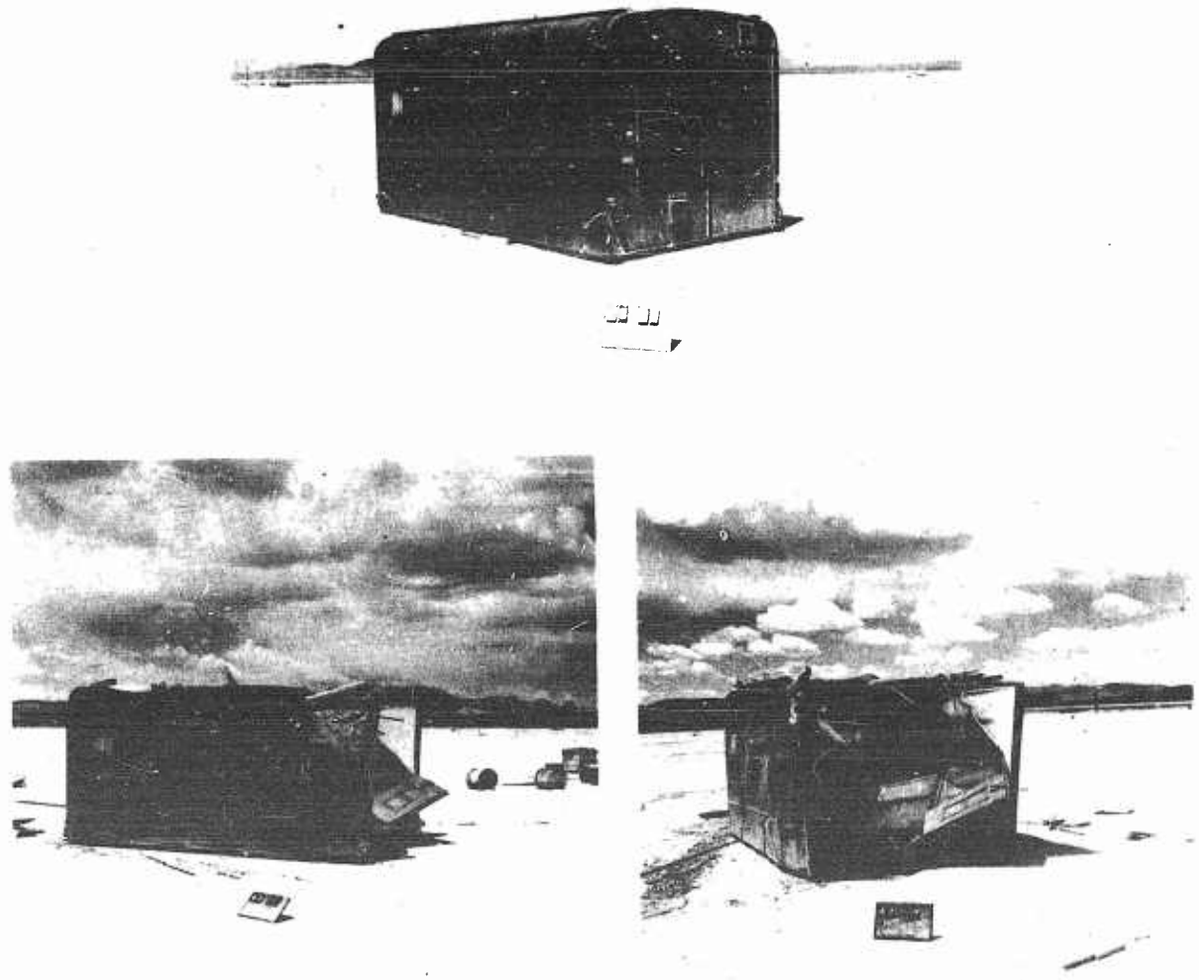
Fig. 3.130 Shot 9, Test Group 63, Shelter S-56. (Top-before, Bottom left-after, Side View, Bottom right-after, Front View) 4650 ft, 32.5 cal, 6.6 psi, 160 r at Surface.

82***	4550	33.5	6.9	200	L	S	Exposed surfaces scorched. Front blown in, top and sides crushed in beyond repair.
63	4650	32.5	6.6	160	N	S	Front blown in, top demolished, sides crushed, beyond repair.
64	5625	24	5.4	80	N	S	Front blown in, top blown in, one side crushed in, one side caved out, blown about 5 ft from original position, beyond repair.

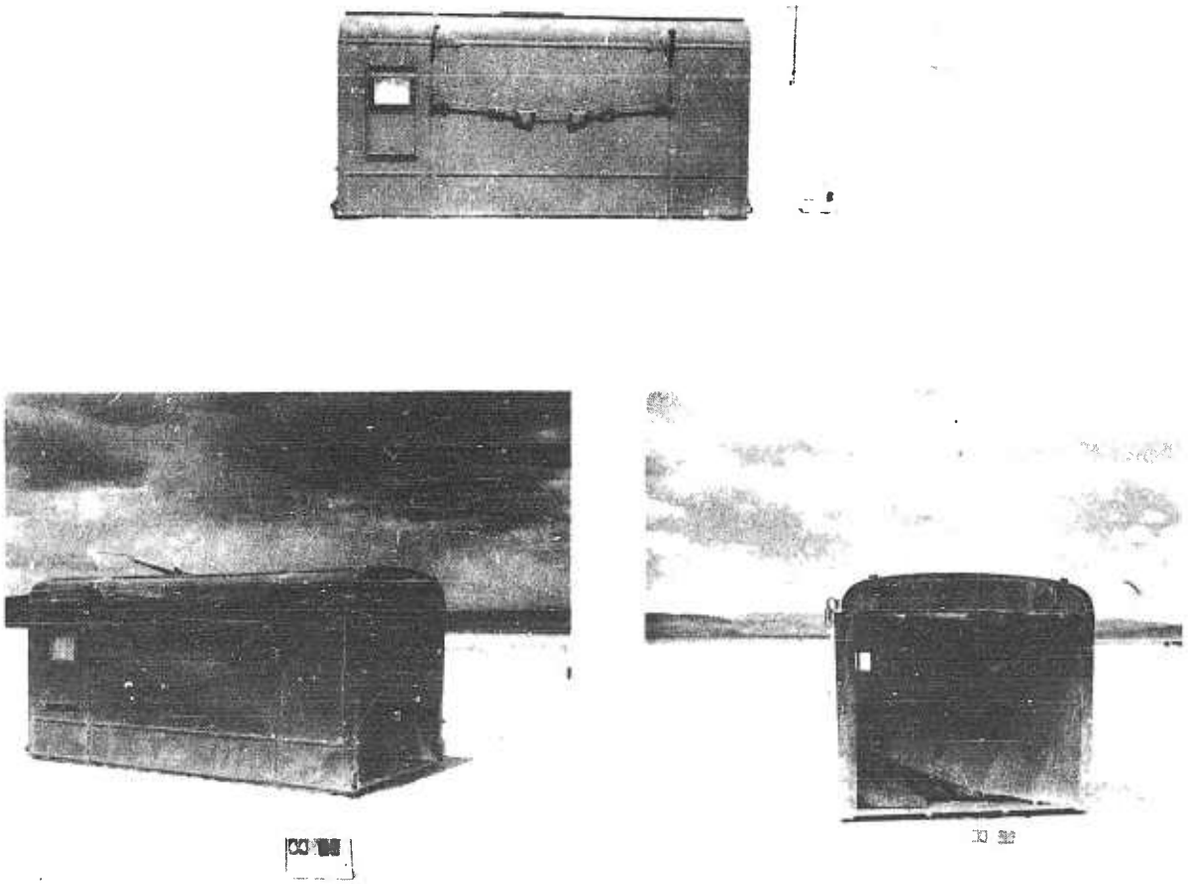
Fig. 3.131 Shot 9, Test Group 64, Shelter S-56. (Top-before, Bottom left-after, Side View, Bottom right-after, Front View) 5625 ft, 24 cal, 5.4 psi, 80 r at Surface.

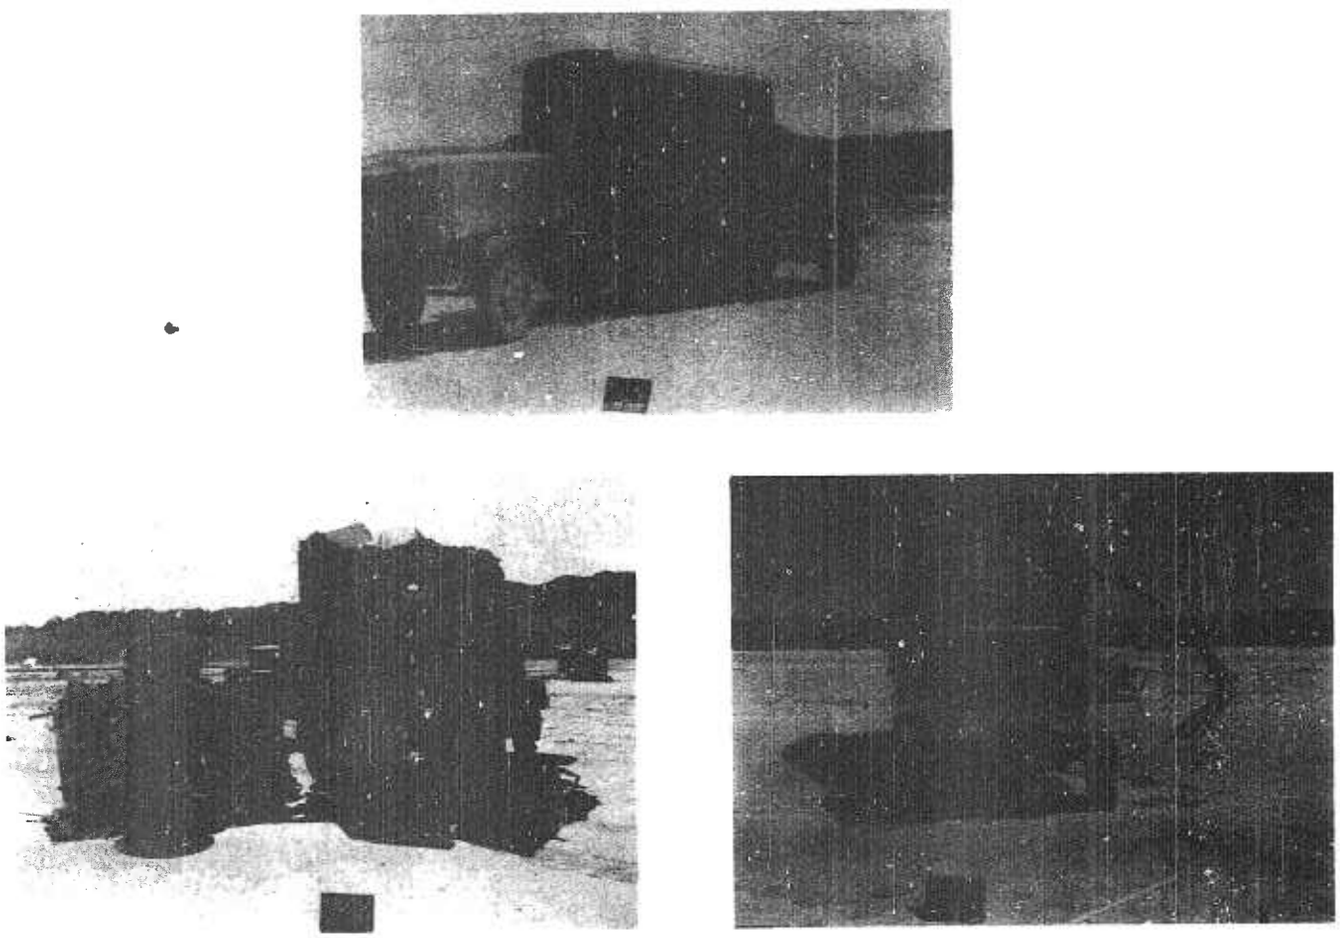
Fig. 3.132 Shot 9, Test Group 80, S-56 Shelter on Ordnance Corps 2-1/2 Ton Truck. (Top-before, Bottom left-after, Bottom right-after, Front View) 1650 ft, 94.5 cal, 14 psi, 3680 r at Surface.

Test Group No.	Ft from GZ	cal	psi	Surface Gamma	DAMAGE		Remarks
					Thermal	Blast	
80*	1650	94.5	14	3680	L	S	Paint scorched on exposed exterior portions of shelter. Front end of shelter and door blown in, frame twisted, damaged beyond repair.
59**	2325	72	11.6	2440	N	S	The earth revetment provided adequate protection from thermal flux. The front end of this shelter was blown in and torn to pieces. The film badge failed and the interior gamma radiation is not known.
60	3050	57.5	10.4	1480	L	S	Exposed surface slightly scorched. Back of shelter blown out, shelter torn apart and beyond repair. The film badge not found and interior gamma radiation not known.
61	3100	56	10.4	1400	L	S	Exposed surfaces slightly scorched. Front and back blown out, sides and top crushed, beyond repair. Film badge not found, interior gamma radiation not known.
62	3650	46	9	720	L	S	Exposed surfaces lightly scorched. Shelter completely demolished.
