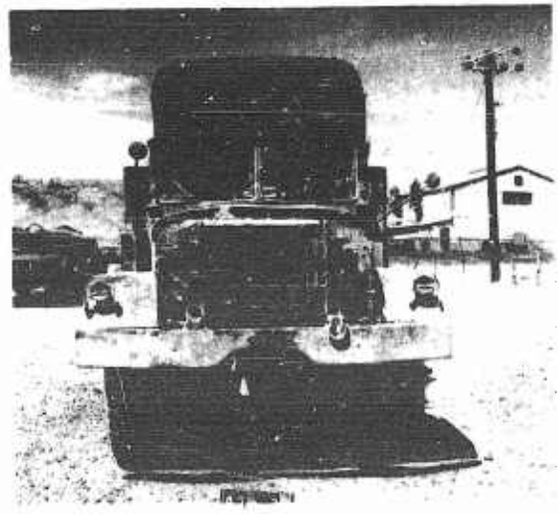
Fig. 3.133 Shot 9, Test Group 82, Shelter S-56 on Ordnance Corps 2-1/2 Ton Truck. (Top-before, Bottom left-after (Side View), Bottom right-after (Front View). Bottom Photos Taken Subsequent to Vehicle Being Moved under Its Own Power from the Test Site.) 4550 ft, 33.5 cal, 6.9 psi, 200 r at Surface.

82***	4550	33.5	6.9	200	L	S	Exposed surfaces scorched. Front blown in, top and sides crushed in beyond repair.
63	4650	32.5	6.6	160	N	S	Front blown in, top demolished, sides crushed, beyond repair.
64	5625	24	5.4	80	N	S	Front blown in, top blown in, one side crushed in, one side caved out, blown about 5 ft from original position, beyond repair.

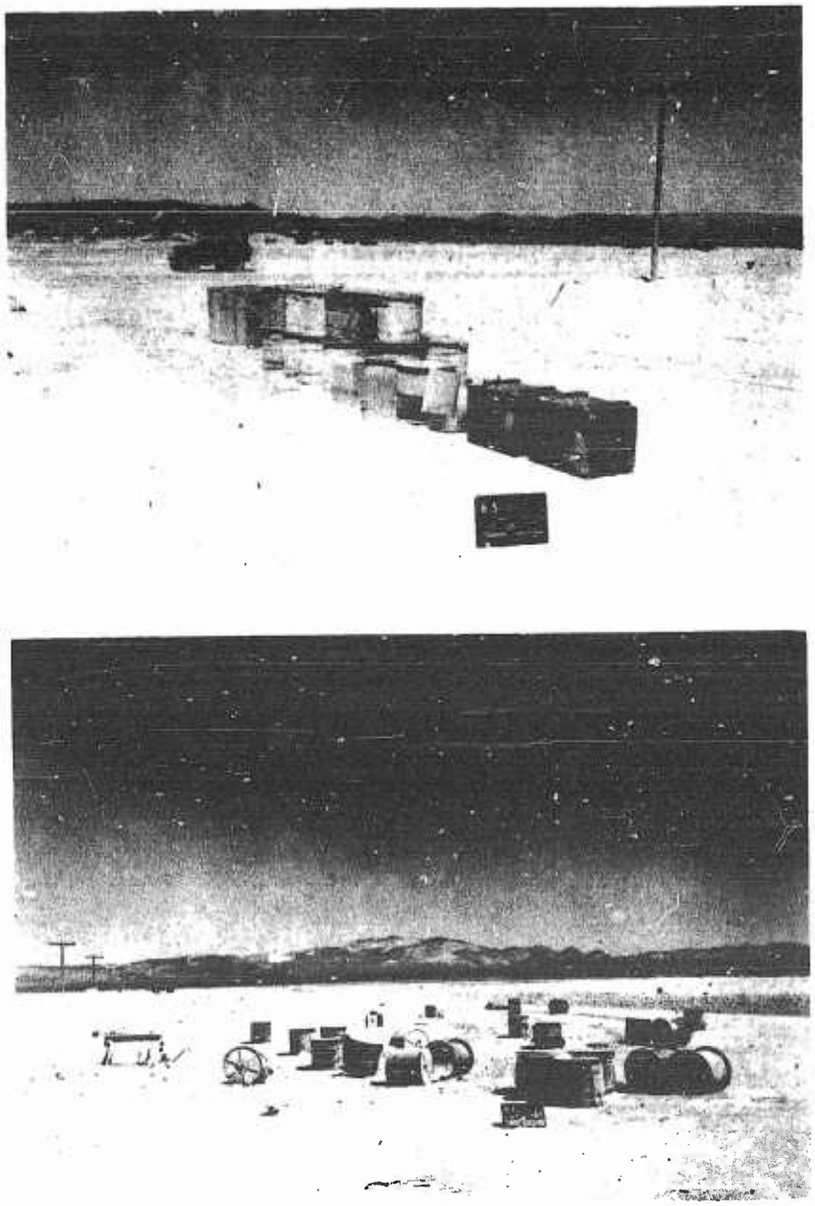
Fig. 3.134 Shot 9, Test Group 65, Signal Supply Point.
(Top-before, Bottom-after)
1900 ft, 88.5 cal, 12.8 psi, 3160 r at Surface.

Test Group No.	Ft from GZ	cal	psi	Gamma*	DAMAGE		Remarks
					Thermal	Blast	
65	1900	88.5	12.8	3160	L	L	2WD-1/TT field wire dispensers lightly scorched on GZ side. Cable reels scattered and blown from 40 to 120 ft from original position. One PE-75 packing crate broken, light damage to PE-75 power unit.
66	3150	55	10.2	1160	S	L	Several wire and cable reels caught fire and burned completely, others burned through several layers of wire on reels. One TRC-1 Transmitter burned up. Several cable reels scattered. PE-75 packing crate broken, light damage to PE-75 power unit.
102**	3150	55	10.2	1160	N	N	No thermal damage. Some of items in the pit covered with dirt, others moved about, no damage.
67	3650	46	9.0	720	N	N	No thermal damage. Reels scattered about, one PE-75 packing case broken, no damage.
68	4675	32	6.6	160	L	N	One reel W-110-B severely burned, slight scorching on other exposed items. Reels and boxes scattered to 30 ft from original positions, no damage.

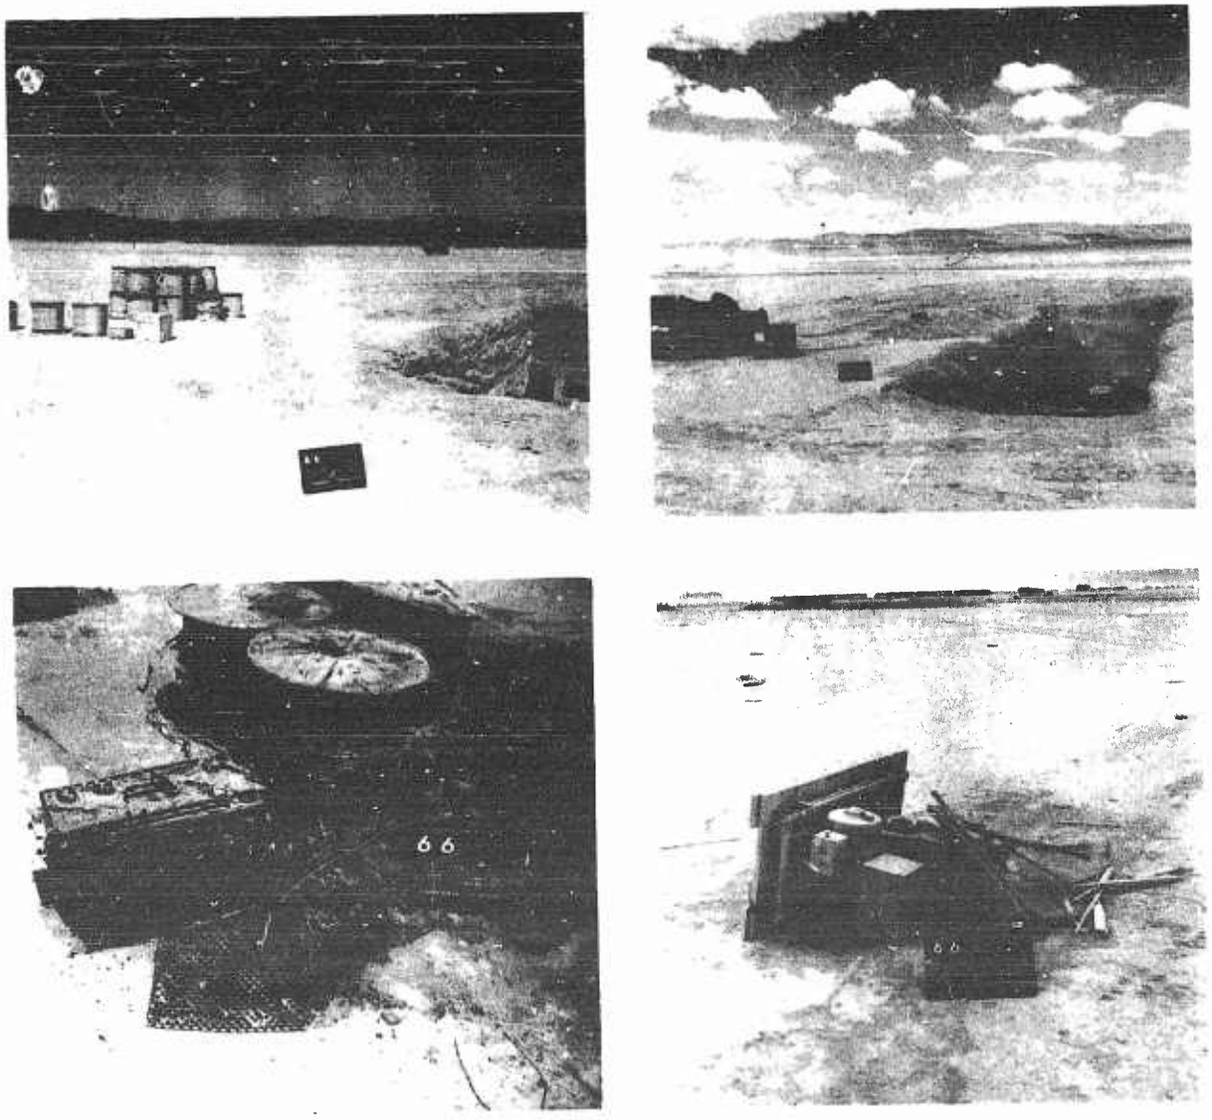
Fig. 3.135 Shot 9, Test Group 66, Signal Supply Point. (Top left-before, Top right-after, Bottom left-Close-up of AN/TRC-1 Transmitter-after, Bottom right-close-up of PE75 Power Unit-after)
NOTE: Signal Supply Point in Open Pit in Top and Center of Photos. 3150 ft, 55 cal, 10.2 psi, 1160 r at Surface.

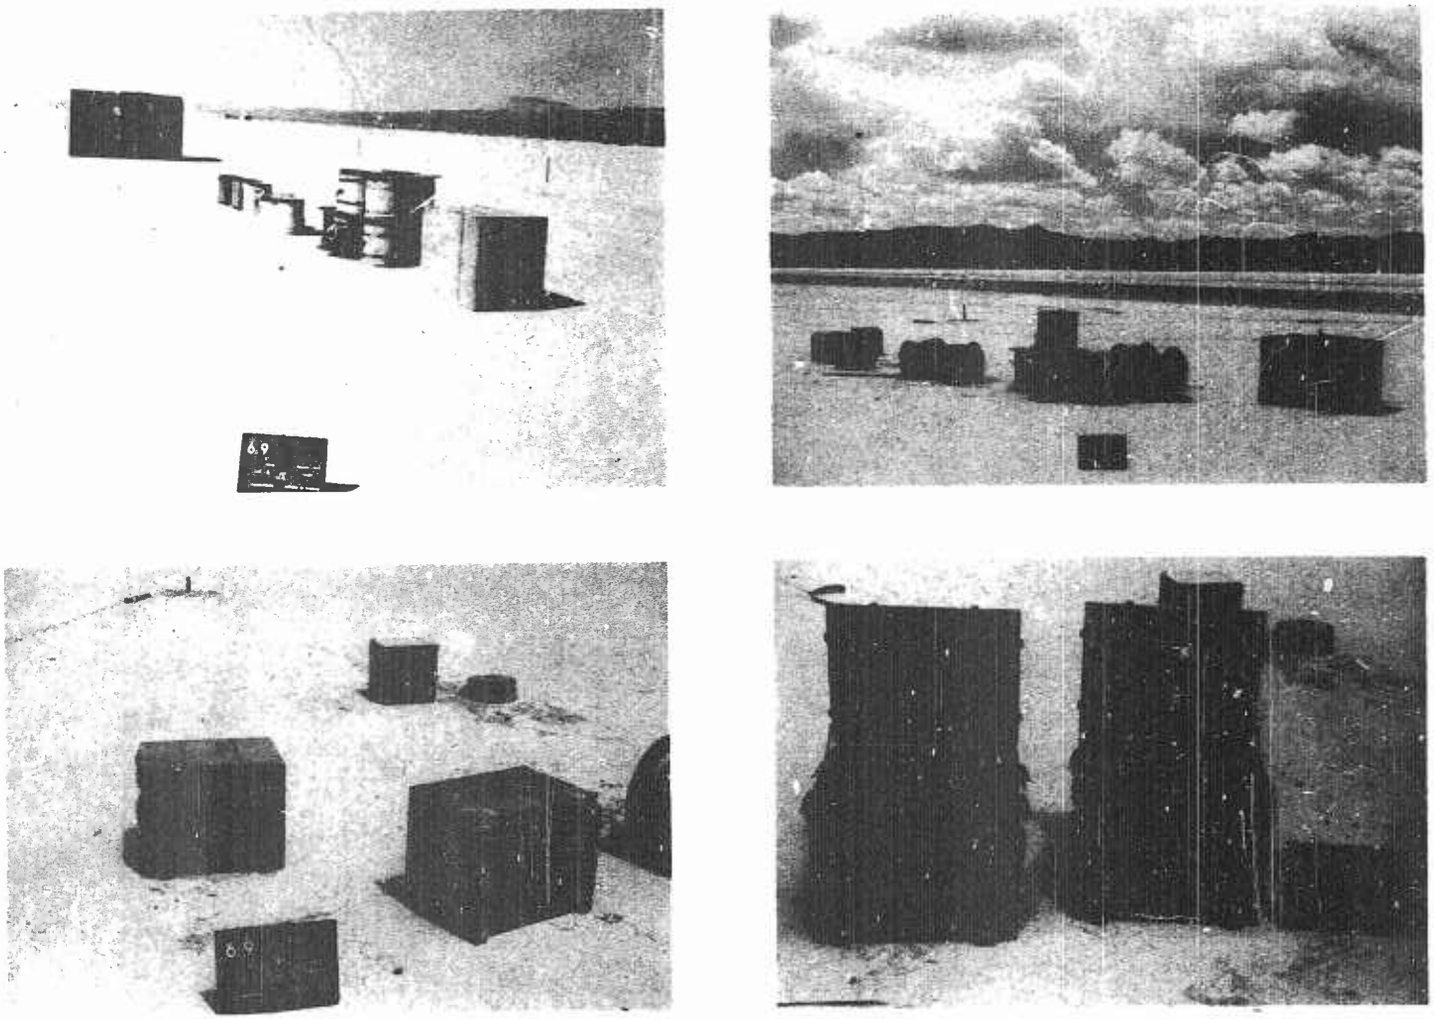
Fig. 3.138 Shot 9, Test Group 69, Signal Supply Point. (Top left-before, Top right-after, Bottom left, close-up of AN/TRC-1 Radio Set in Chests, Bottom right, close-up of AN/TRC-1 Radio Set, Chests open to Show Condition Inside.) 5625 ft, 24.5 cal, 5.4 psi, 80 r at Surface.

69	5625	24.5	5.4	80	L	N	Reel W-110-B burned about 2 in. of wire on outer layer. Wrapping on other reels slightly scorched or burned, no damage to wire under wrappings. Some scattering of reels, no damage.

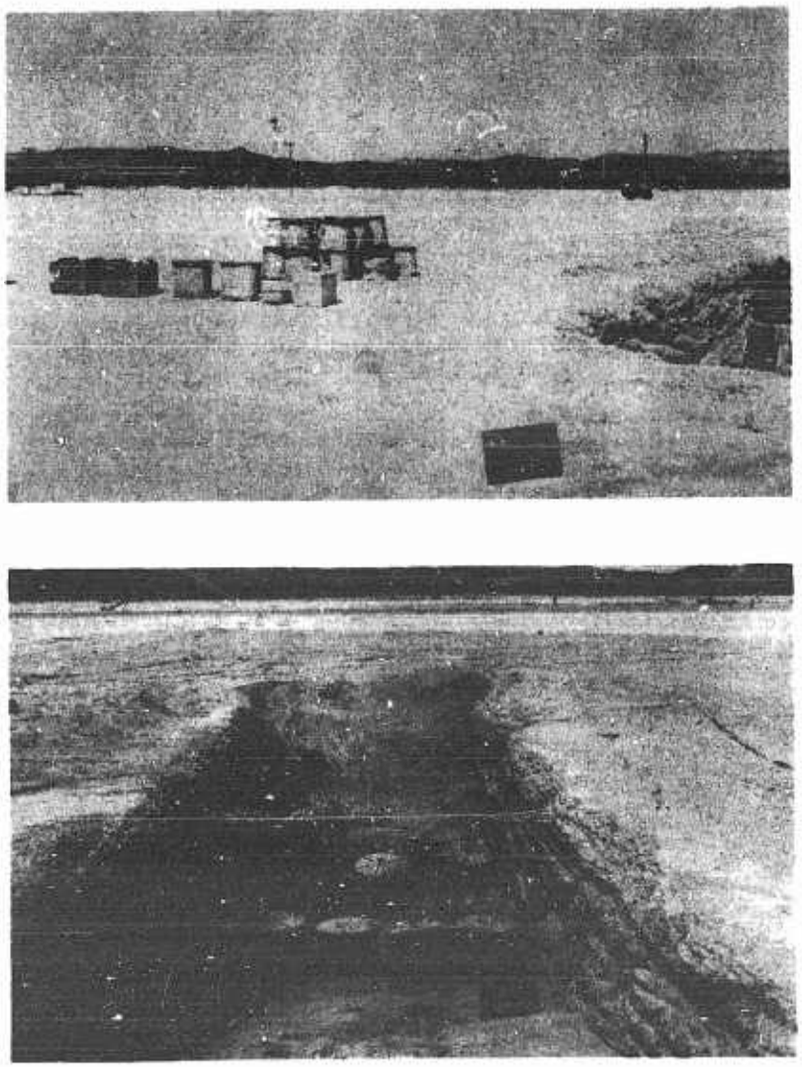
Fig. 3.139 Shot 9, Test Group 102, Signal Supply Point in Open Pit. (Top-before, Bottom-after) In Top View the Open Pit can be Seen to the Right of the Signal Supply Point on the Surface. 3150 ft, 55 cal, 10.2 psi, 1160 r at Surface.

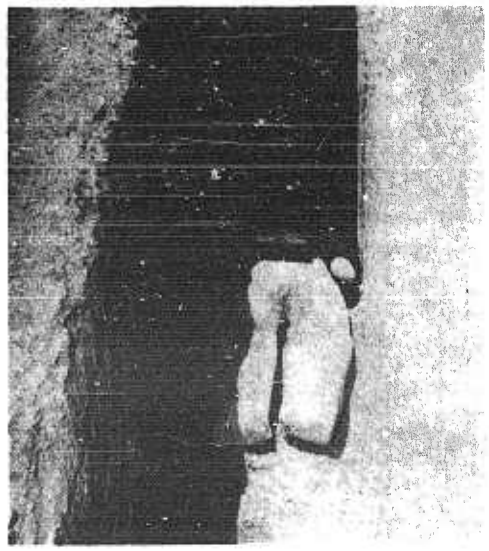
Fig. 3.141 Shot 9, Test Group 70. Foxhole with Radio Set AN/PRC-10 on Dummy. (Top-before, Bottom-after) 1775 ft, 91.5 cal, 13.4 psi, 3400 r at Surface.

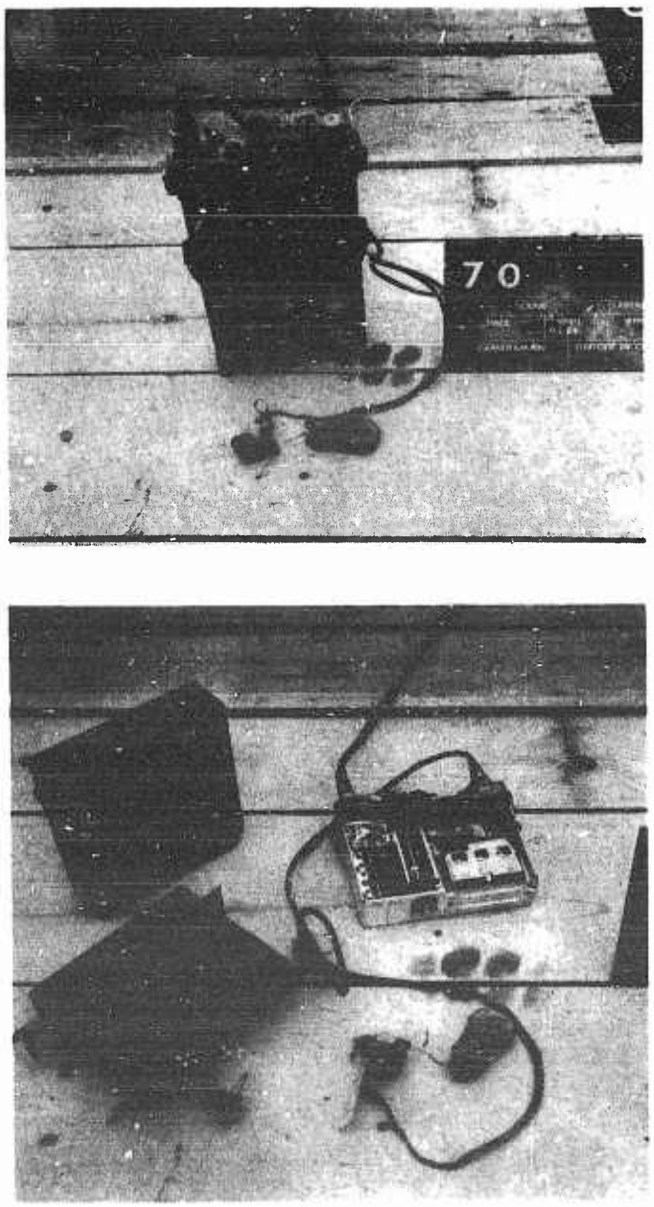
Fig. 3.142 Shot 9, Test Group 70, Radio Set AN/PRC-10 which was on Dummy in Foxhole (Fig 3.113). (Top-exterior, Bottom-Interior) 1775 ft, 91.5 cal, 13.4 psi.

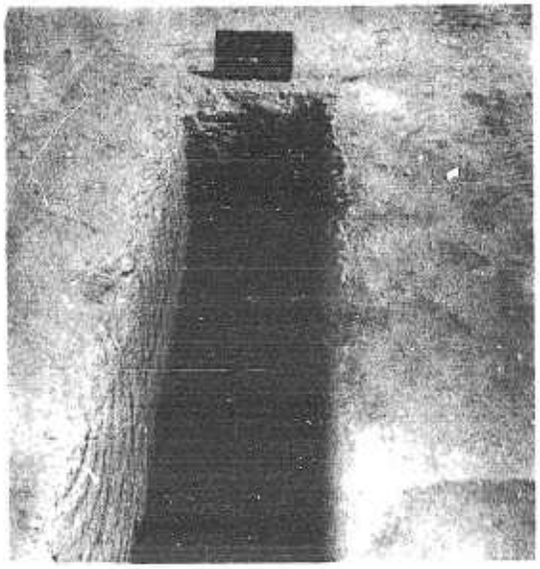
Fig. 3.143 Shot 9, Test Group 71. Foxhole with Radio Set AN/PRC-6 on Dummy. (Top-before, Bottom-after). 2800 ft, 62 cal, 10.8 psi, 1760 r at Surface.

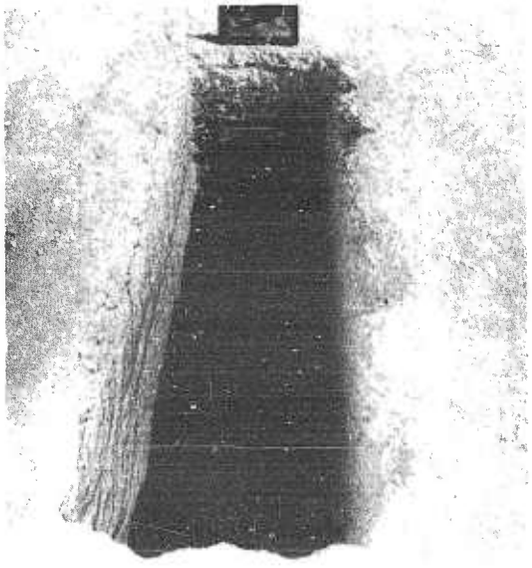
It is of interest to observe that the dummies in foxholes along the radial pole line at 3800 ft, 44 cal, 8.6 psi (Fig. 3.144), and 4800 ft, 30.5 cal, 6.4 psi (Fig. 3.145), did not catch fire and burn. However, the dummy in the foxhole at 5800 ft, 28.5 cal, 5.2 psi (Fig. 3.146), did catch fire and burn. There is no explanation for this phenomenon except that in previous tests the thermal flux has caused no damage at a given ground range from GZ which "skipped" and has caused severe damage beyond the point where no damage occurred. One can also postulate that shielding conditions or the burning point of the materials in this particular dummy (fabric and straw) were such that burned.

Fig. 3.144 Shot 9, Test Group 72. Foxhole with Radio Set AN/PRC-10 on dummy. (Top-before, Bottom-after). 3800 ft, 44 cal, 8.6 psi, 550 r at Surface.

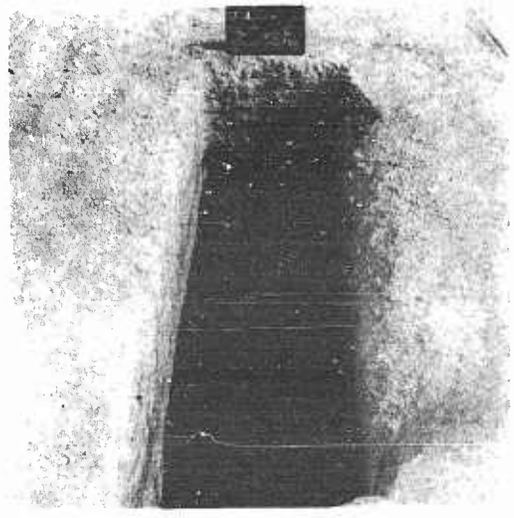
74	5800	28.5	5.2	80	S	N	Dummy caught fire and burned up. One AN/PRC-10 radio set severely burned. One EE-8 field telephone canvas case scorched but telephone not damaged. Some dirt blown in foxhole, no damage.
75	6800	16.5	4.2	20	N	N	Some dirt blown in foxhole, no damage.
76	7800	12	3.5	less than 1	N	N	Some dirt blown in foxhole, no damage.

Fig. 3.146 Shot 9, Test Group 74. Foxhole with Radio Set AN/PRC-10 and Dummy and EE-8 Telephone in Foxhole. (Top-before, Bottom-after) 5800 ft, 28.5 cal, 5.2 psi, 80 r at Surface.

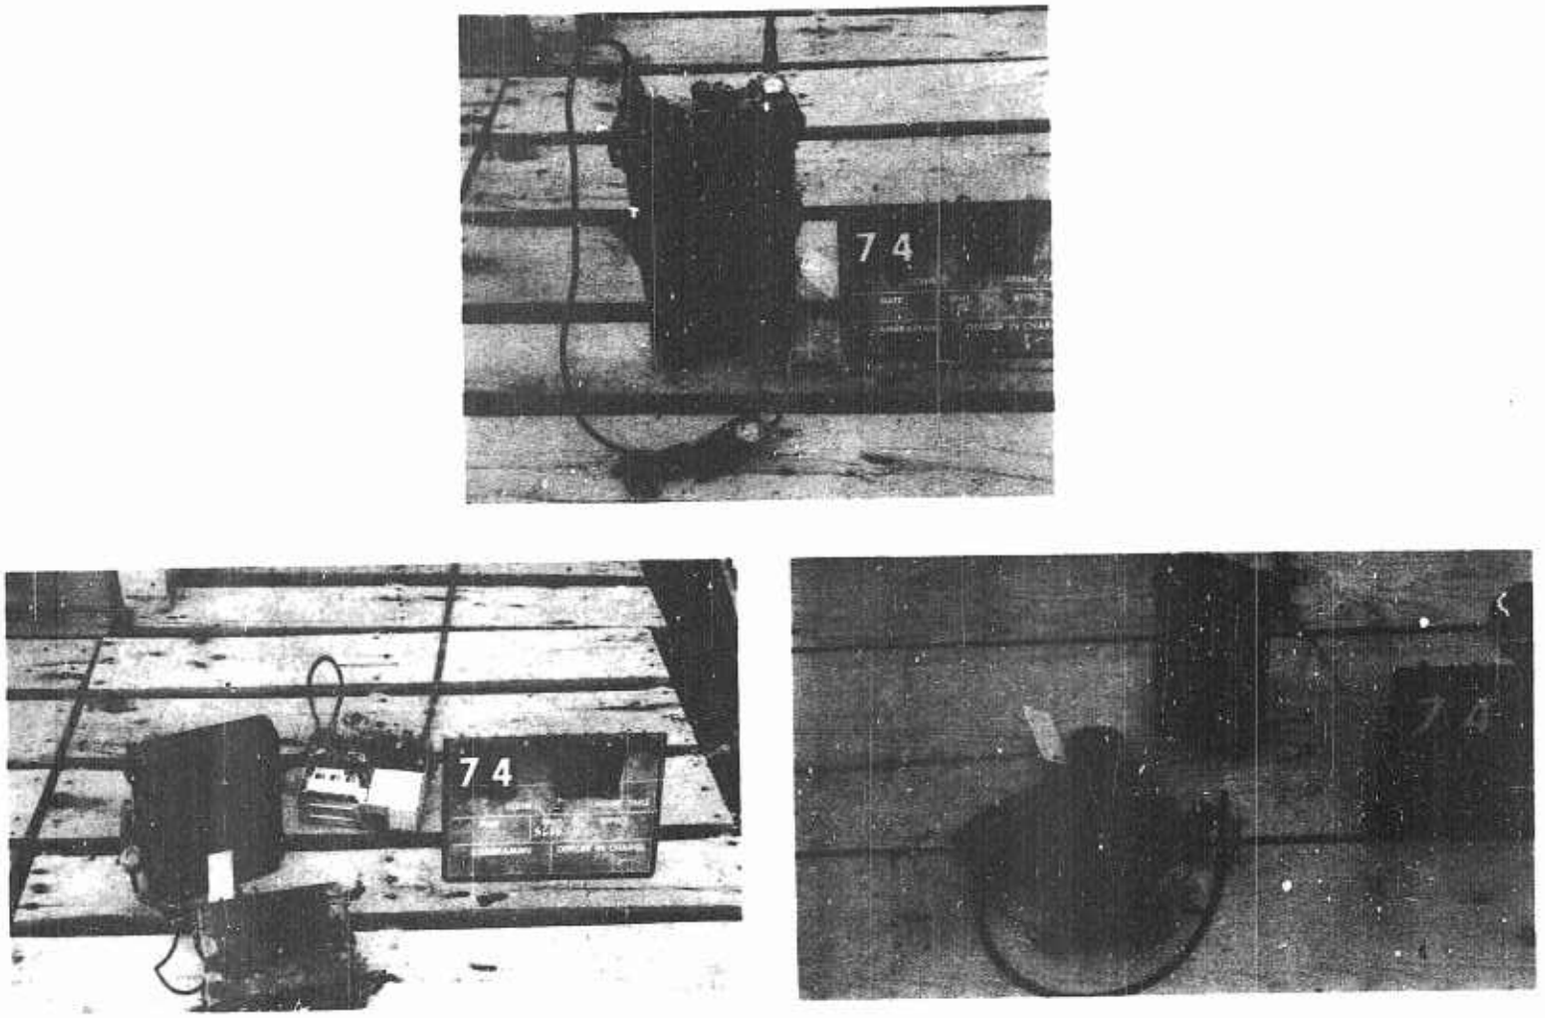
Fig. 3.147 Shot 9, Test Group 74, Radio Set AN/PRC-10 and Telephone Which were in Foxhole (Fig. 3.118). (Top-exterior, Left-interior, Right-EE-8 Telephone) 5800 ft, 28.5 cal, 5.2 psi.

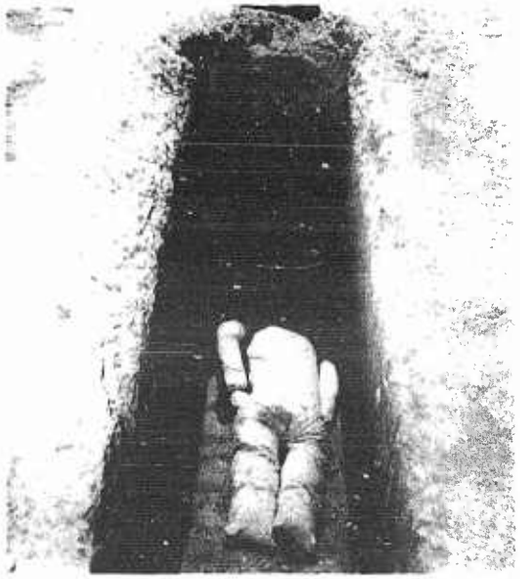
Fig. 3.148 Shot 9, Test Group 75. Foxhole with Radio Set AN/PRC-6 on Dummy and EE-8 Telephone in Foxhole. (Dummy was Moved to Sitting Position Prior to Test.) Top-before, Bottom-after. 6800 ft, 16.5 cal, 4.2 psi, 20 r at Surface.

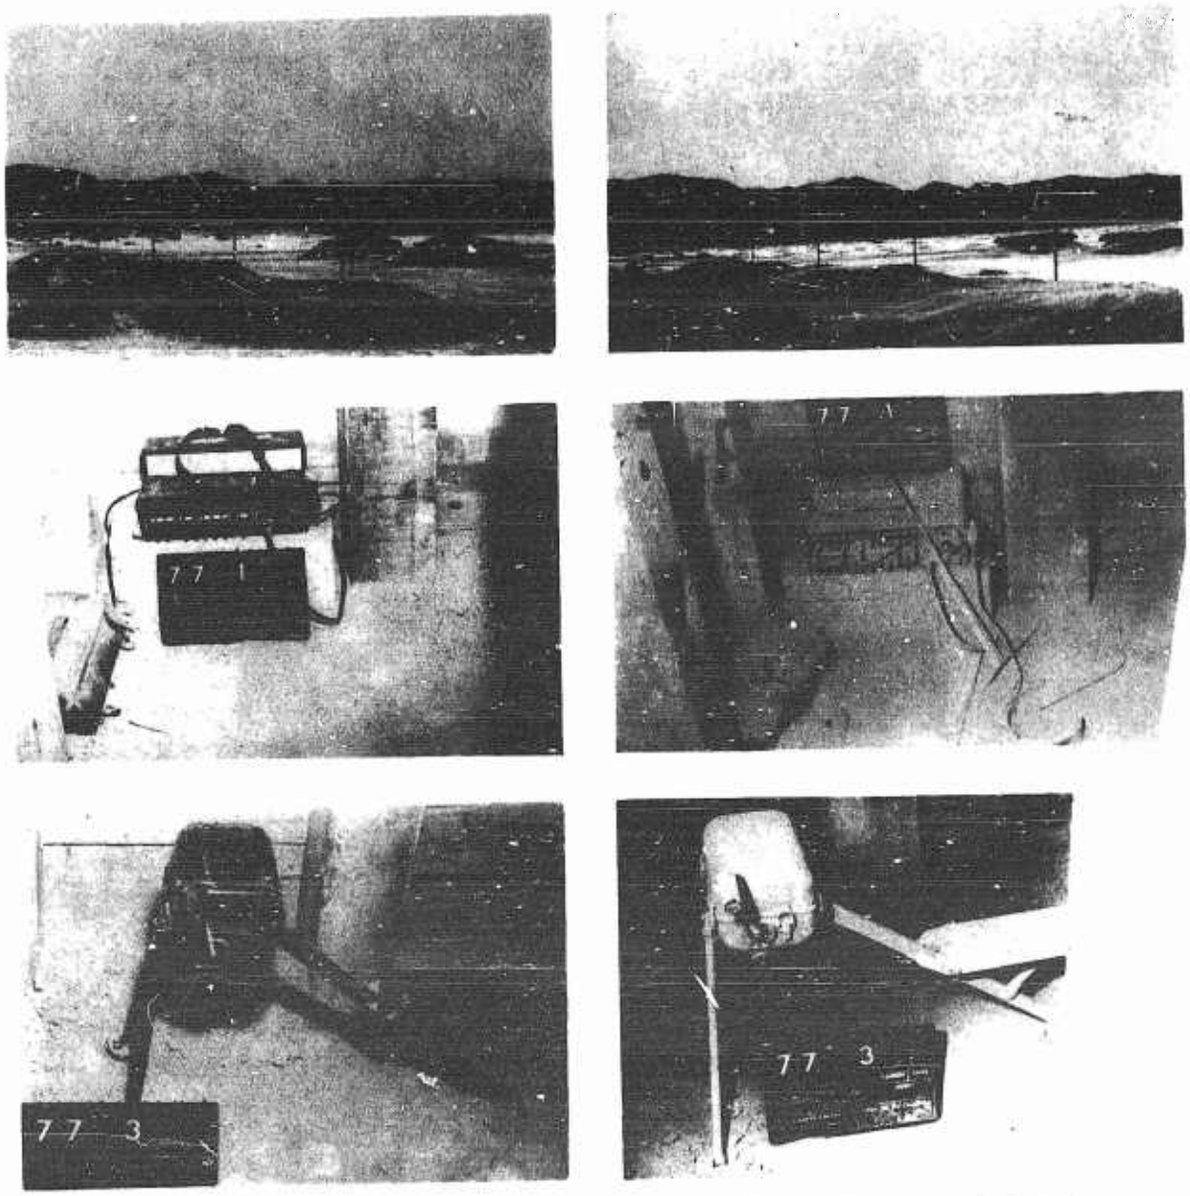
Fig. 3.150 Shot 9, Test Group 77, Signal Corps Items in Corps of Engrs. Installations (CO Type CP). (Top left-before, Top right-after; SB-22 Switchboard, Center left-before, Center right-after; GN-58A Generator, Bottom left-before, Bottom right-after.) 500 ft, over 125 cal, over 21 psi, 6400 r at Surface.

Test Group No.	Ft from GZ	cal	psi	Surface Gamma*	DAMAGE		Remarks
					Thermal	Blast	
77	600	over 125	over 21	6400	N	N	CP shielded from thermal damage. Dust permeated the CP and the equipment, equipment operable.
78	900	over 125	over 21	5400	N	N	CP shielded from thermal damage. Dust permeated CP and the equipment, operable.
79	4000	41	8	400	N	N	CP shielded from thermal damage. Dust permeated CP and the equipment, equipment operable.

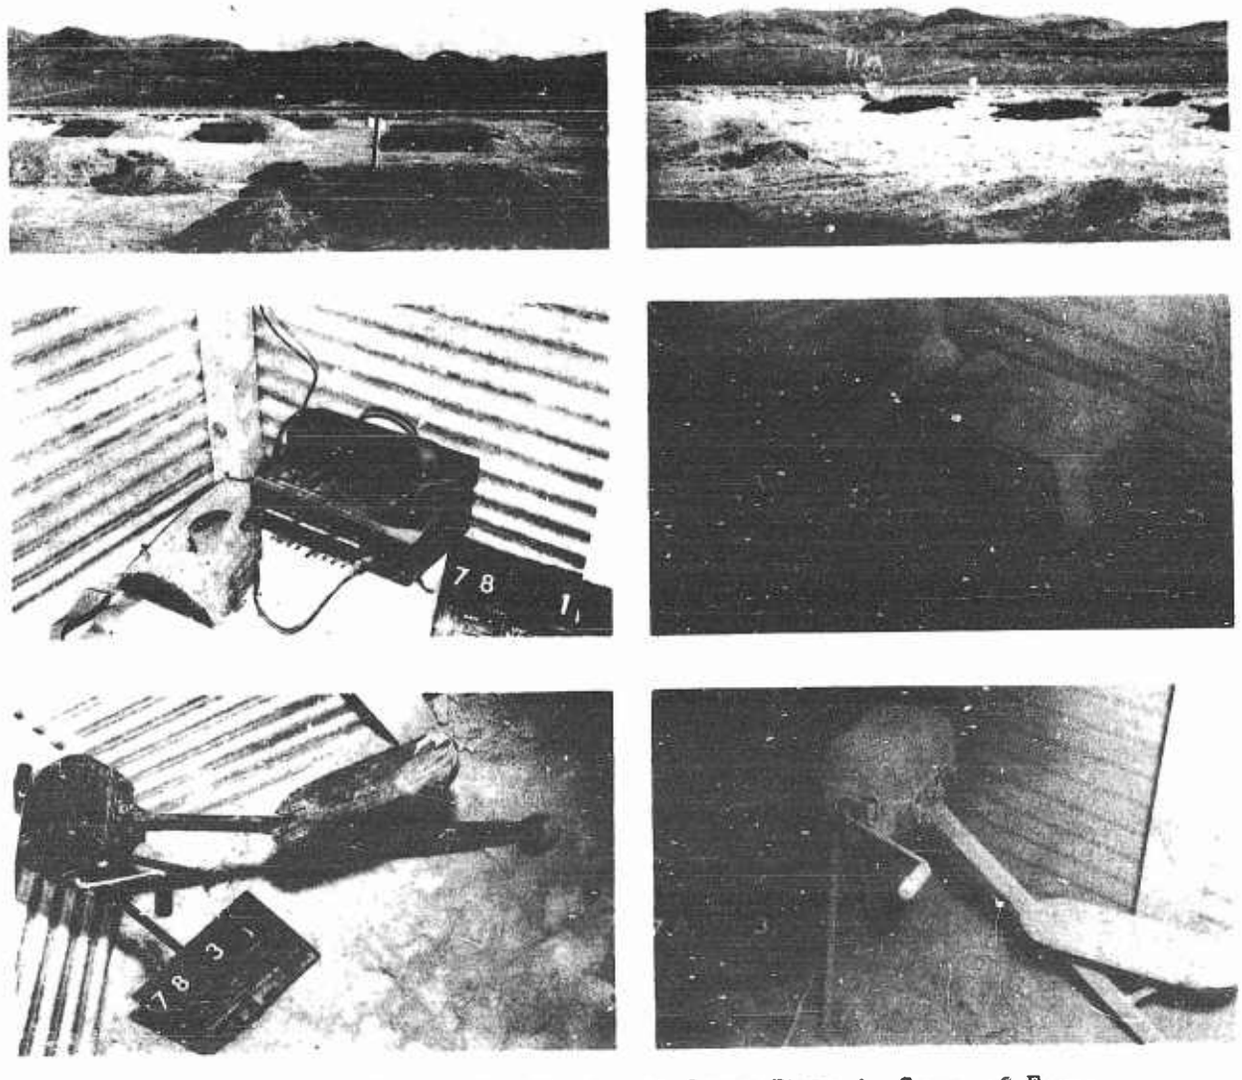
Fig. 3.151 Shot 9, Test Group 78, Signal Corps Items in Corps of Engrs. Installations (CO Type CP). (Top left-before, Top right-after; SB-22 Switchboard, Center left-before, Center right-after; GN-58A Generator, Bottom left-before, Bottom right-after.) 900 ft, over 125 cal, over 21 psi, 5400 r at Surface.

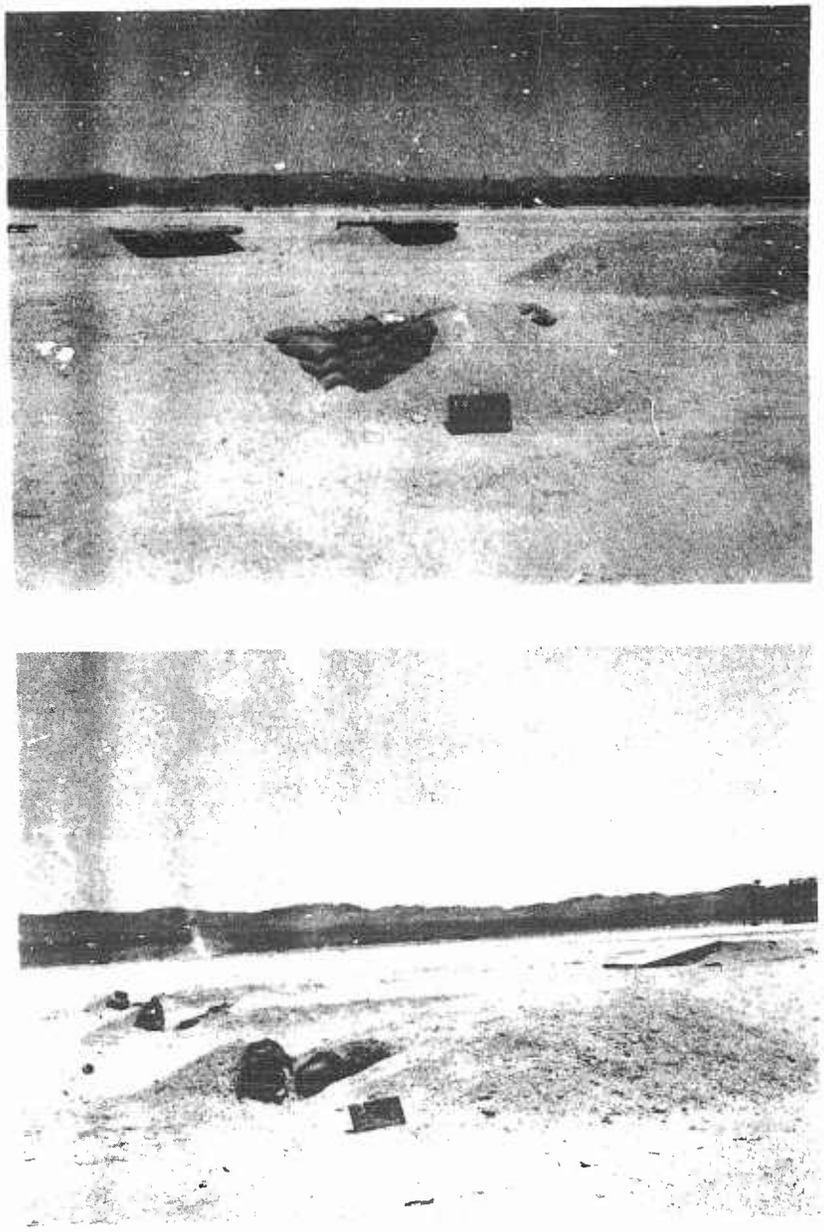
Fig. 3.152 Shot 9, Test Group 79, Signal Corps Items in Corps of Engrs. Installation (CO Type CP). (Top-before, Bottom-after) (See Fig. 3.153 for Equipment.) 4000 ft, 41 cal, 8 psi, 400 r at Surface.

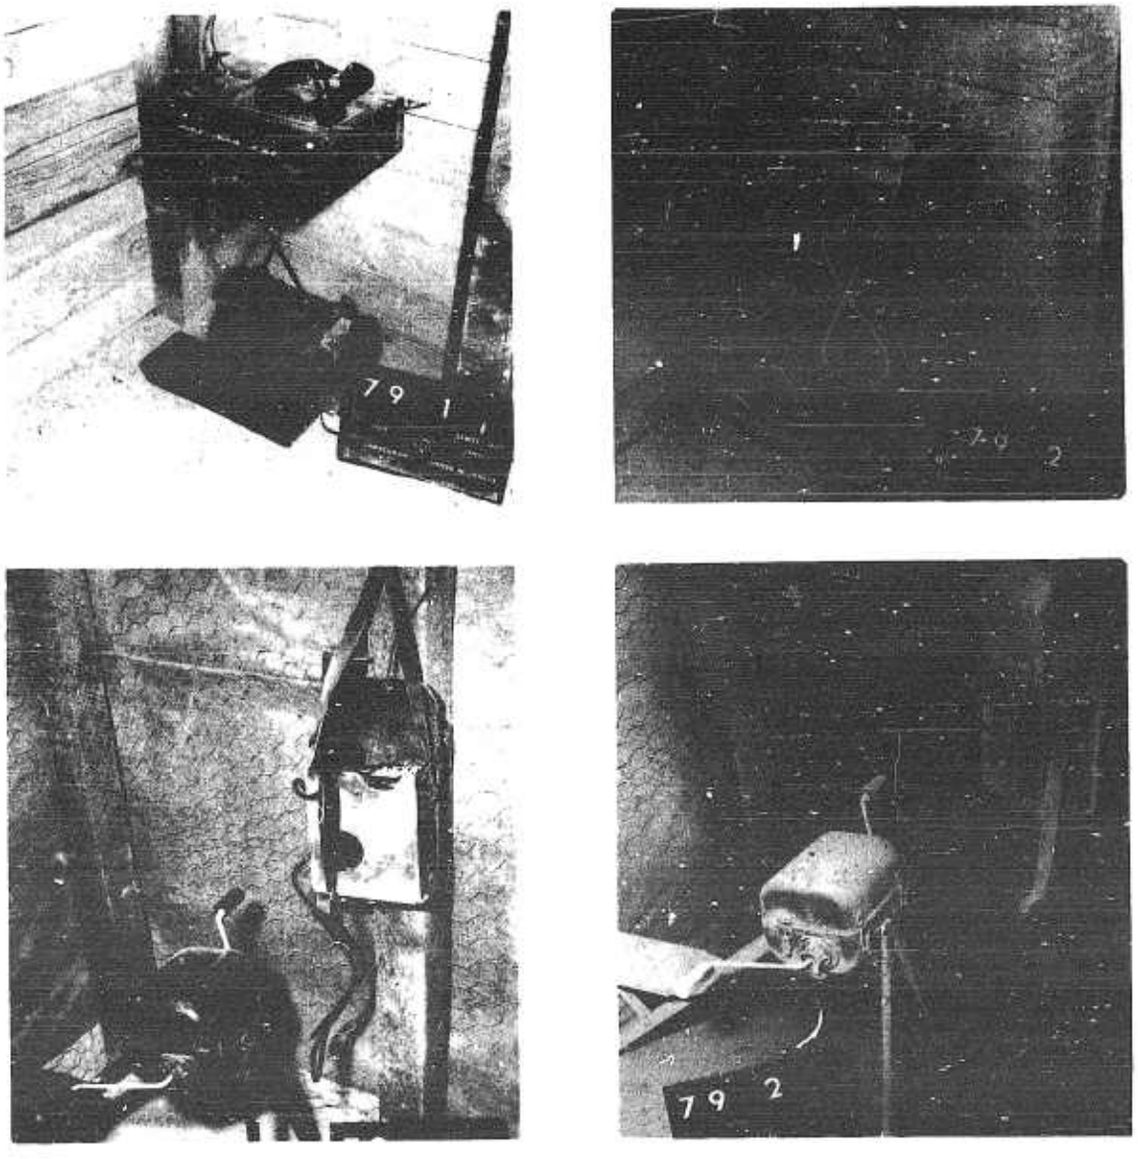
Fig. 3.153 Shot 9, Test Group 79, Signal Corps Items in Corps of Engrs. Installations (CO Type CP-Fig. 3.124). SB-22 Switchboard (Top left-before, Top right-after; GN-94 Generator and EE-8 Telephone (Bottom left-before, Bottom right-after) 4000 ft, 41 cal, 8 psi, 400 r at Surface.

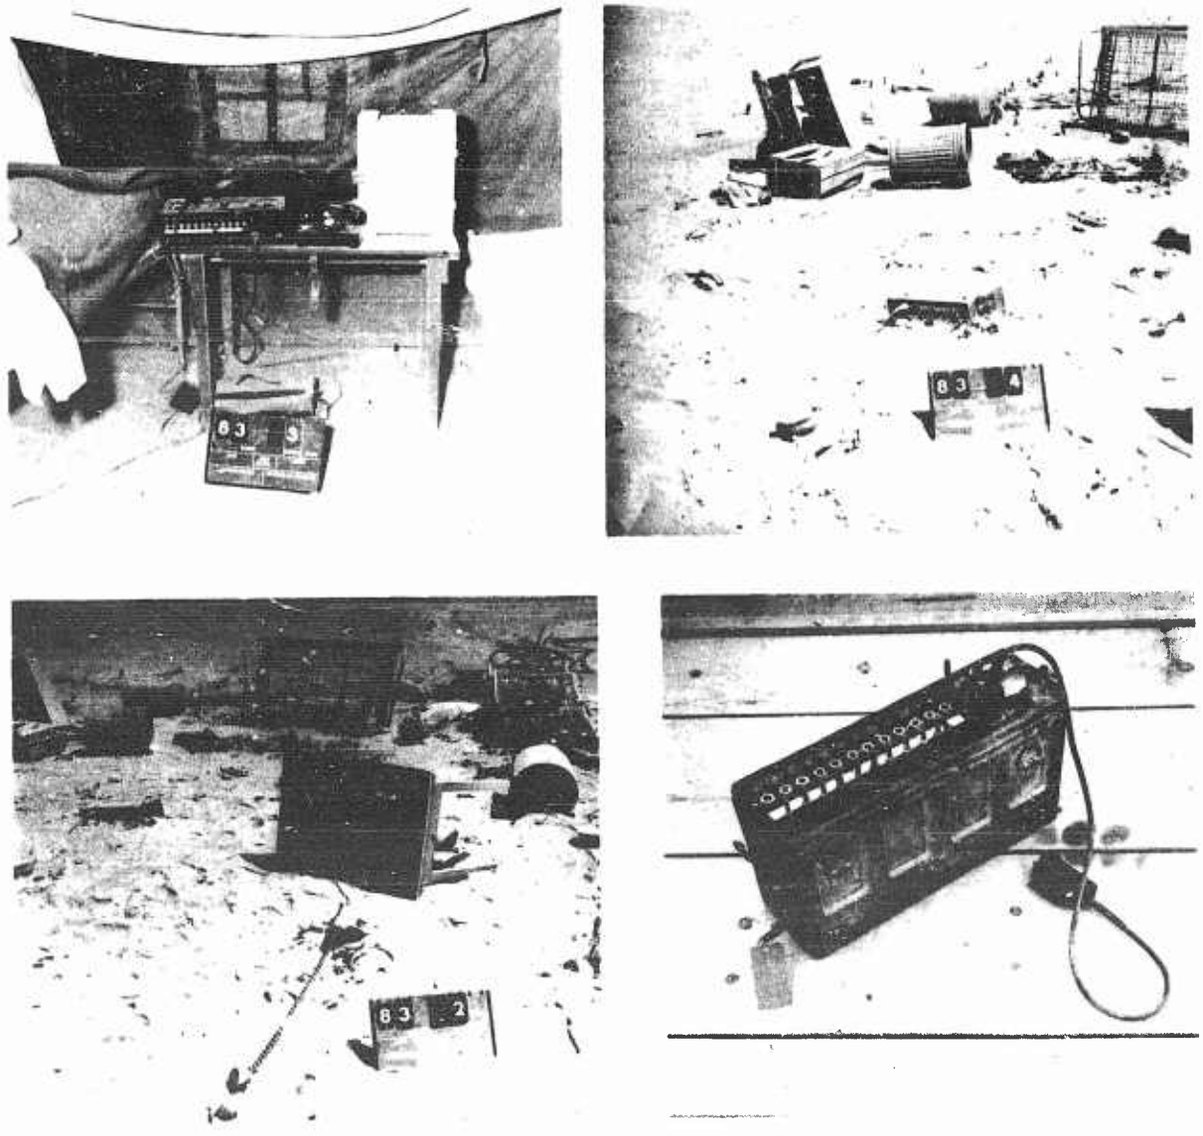
b. RESULTS: The field hospital above and below the surface at 4125 ft, 39.5 cal, 8 psi (Fig. 3.154) caught fire and burned up. An examination of high speed photograph taken during the shot indicates that the heat caused the tent to burn from primary effects. It is extremely doubtful if the telephone equipment in the tent was damaged from primary effects. It is more plausable to believe that the heat from the tent burning caused secondary damage to the telephone equipment. The entire burning cycle is very, very rapid. A damage summary for this test group is shown in Table 3.22.

Fig. 3.154 Shot 9, Test Group 83, Signal Corps Items in Medical Corps Installations. (Field Hospital in Tents at the Surface.) (Top left-before, Bottom left-after; Top right, SB-22 Switchboard-after, Bottom right, close-up of Same Switchboard-after) 4125 ft, 39.5 cal, 8 psi, 320 r at Surface.

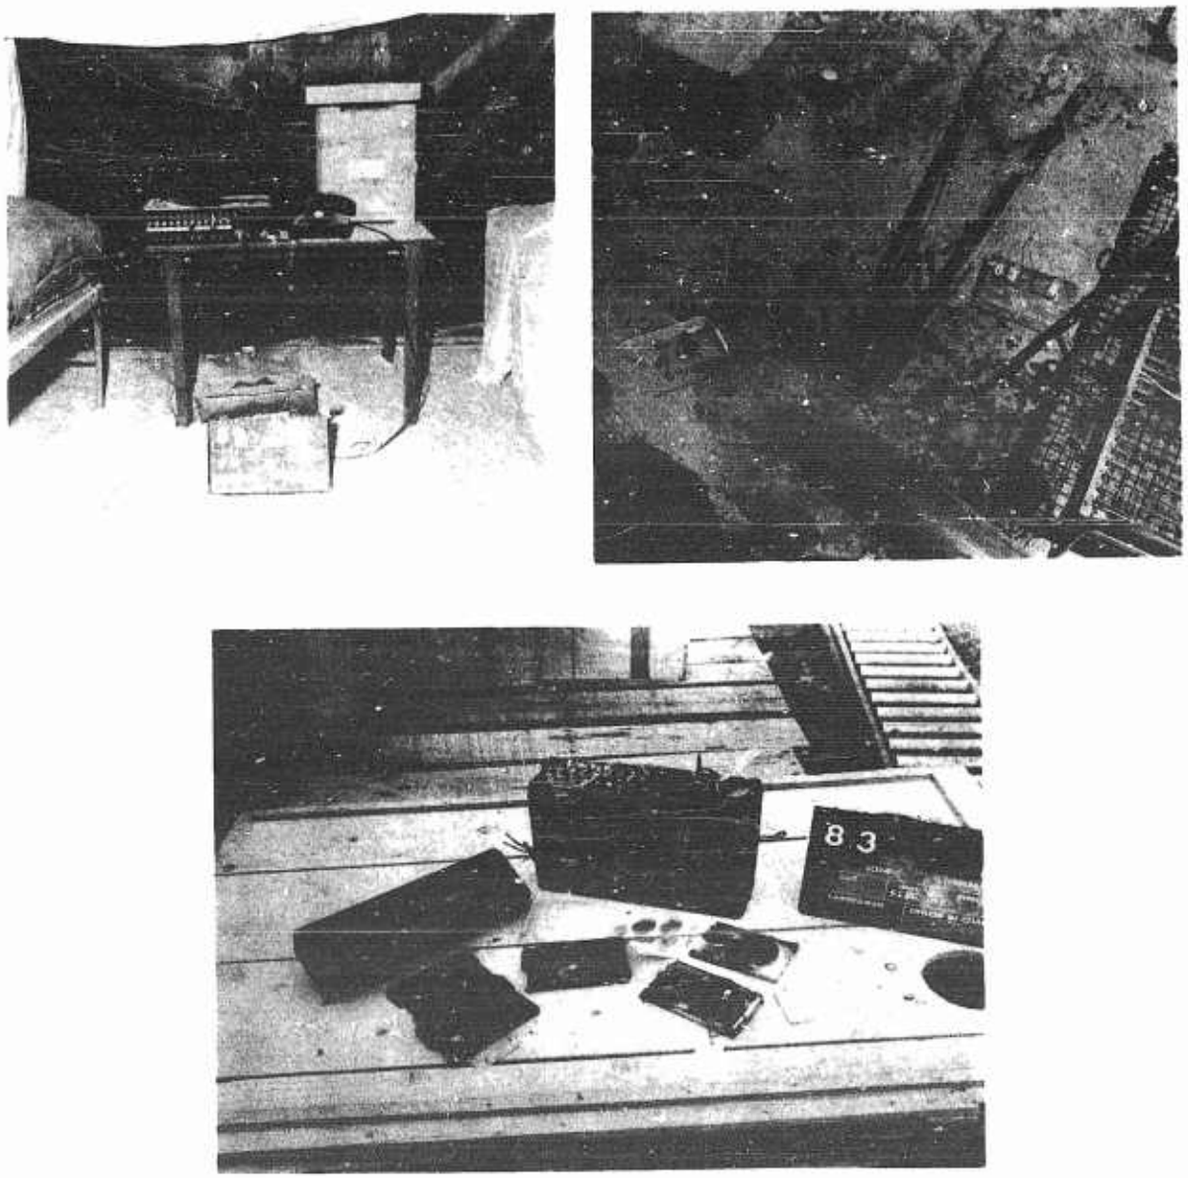
Fig. 3.155 Shot 9, Test Group 83, Signal Corps Items in Medical Corps Installations. (Field Hospital in Tents Revetted below the Surface.) (Top left-before, Top right-after, Bottom, SB-22 Switchboard-after) 4125 ft, 39.5 cal, 8 psi, 320 r at Surface.

Test Item	Ft from GZ	cal	psi	Surface Gamma*	DAMAGE Thermal	DAMAGE Blast	Remarks
IN TENT BELOW THE SURFACE							
SB-22 Switchboard	4125	39.5	8	320	S		Plug melted on bakelite strip, transmitter cord burned up, drop indicators melted. Switchboard thrown to ground.
TP-6 Telephone	4125	39.5	8	320	S	L	Handset, cord, induction coil and condenser completely burned. Telephone thrown to ground.
EE-8 Field Telephone	4125	39.5	8	320	S	L	Handset cord severely burned, terminals button and WD-1/TT wire melted. Telephone thrown to ground.
IN TENT ABOVE THE SURFACE							
SB-22 Switchboard	4125	39.5	8	320	L	L	Spare telephone line circuit severely burned, spare parts kit slightly burned. Thrown 300 ft from original position, one plug slightly damaged, battery case out of sockets. Case slightly damaged near ring back key. Serviceable after minor repairs made.
TP-6 Telephone	4125	39.5	8	320	L	L	Slight
EE-8 Field Telephone	4125	39.5	8	320	L	L	Slight

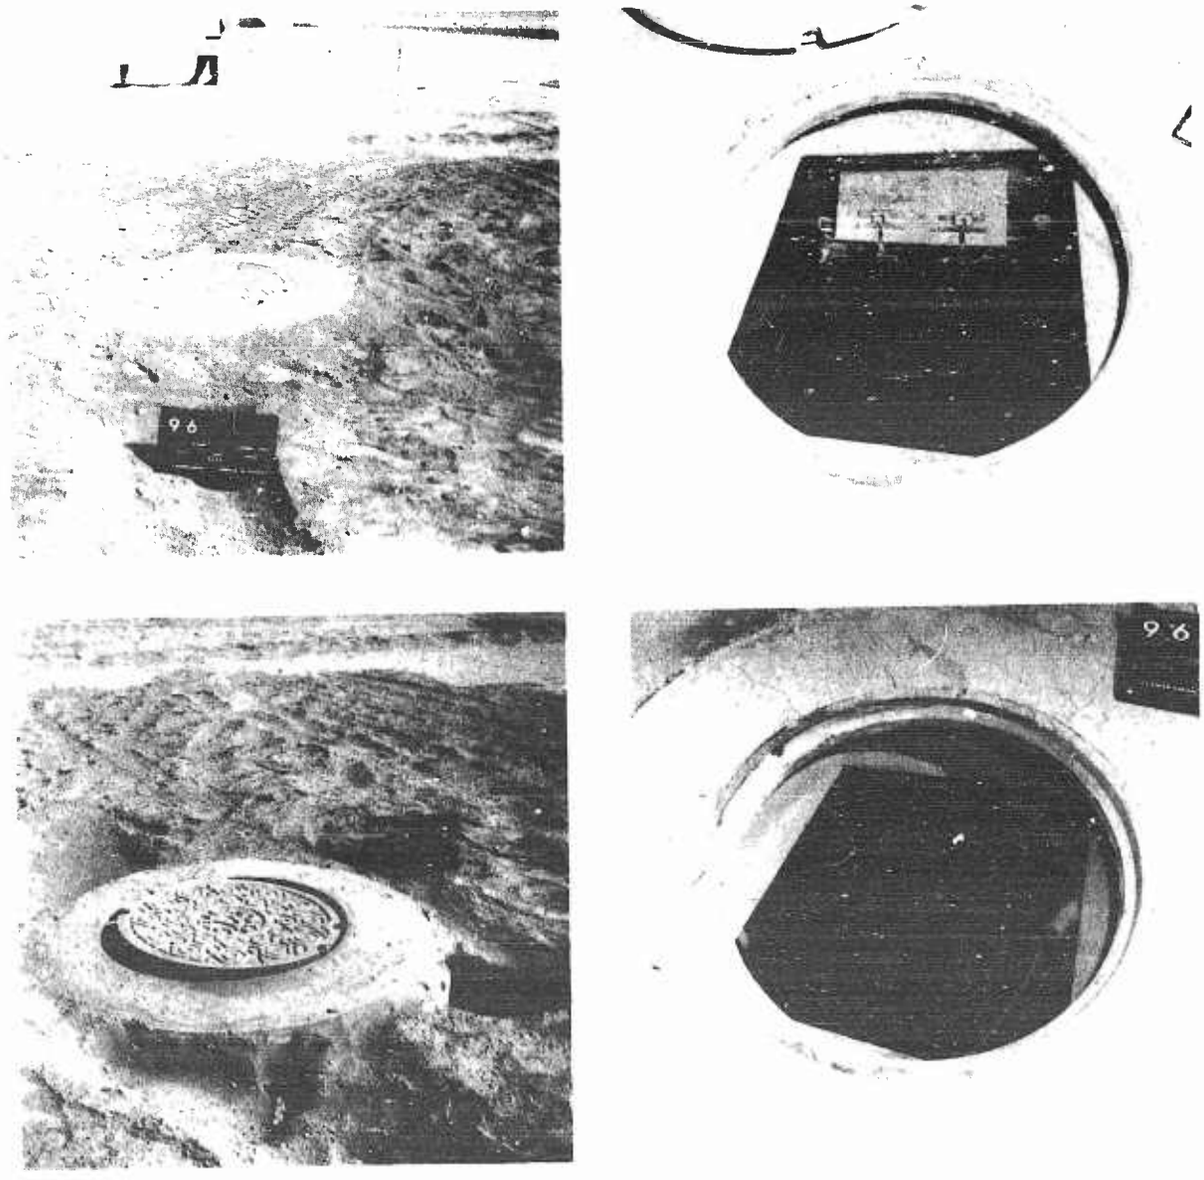
b. RESULTS: The manhole cover in Shot 9 (1250 ft, 113 cal, 16.6 psi), was lifted from its base and moved 1/2 in. There were several

inches of dirt blown into the manhole but there was no apparent damage to the cable transfer relay or cable installed in manhole.

In Shot 10 the manhole cover (600 ft, over 65 cal, over 115 psi), was forced into the manhole and covered with 1-1/2 ft of earth. The manhole (field constructed) was crushed in and filled with 1-1/2 ft

Fig. 3.156 Shots 9 and 10, Test Group 96, Manhole. (Top left-before 9, Bottom left-after 9; Interior of Manhole, Top right-before 9, Bottom right-after 9.) NOTE: The Manhole was destroyed in Shot 10. Shot 9 - 1250 ft, 113 cal, 16.6 psi. Shot 10 - 600 ft, over 65 cal, over 115 psi.

of earth. The concrete tile was intact. There was no cable transfer relay present in the manhole for Shot 10. The cable in the manhole was not damaged.

The manhole used in Shot 9 received no significant damage and was rehabilitated for Shot 10. The cable transfer relay was removed for analysis after Shot 9 and no replacement was available for Shot 10.
