(5) General Dynamics/ Astronautics, San Diego, Calif.

MISSILE 9C FAILURE

(9) FINAL REPORT.

FTA 6182, REVISION A, 22 October 1959

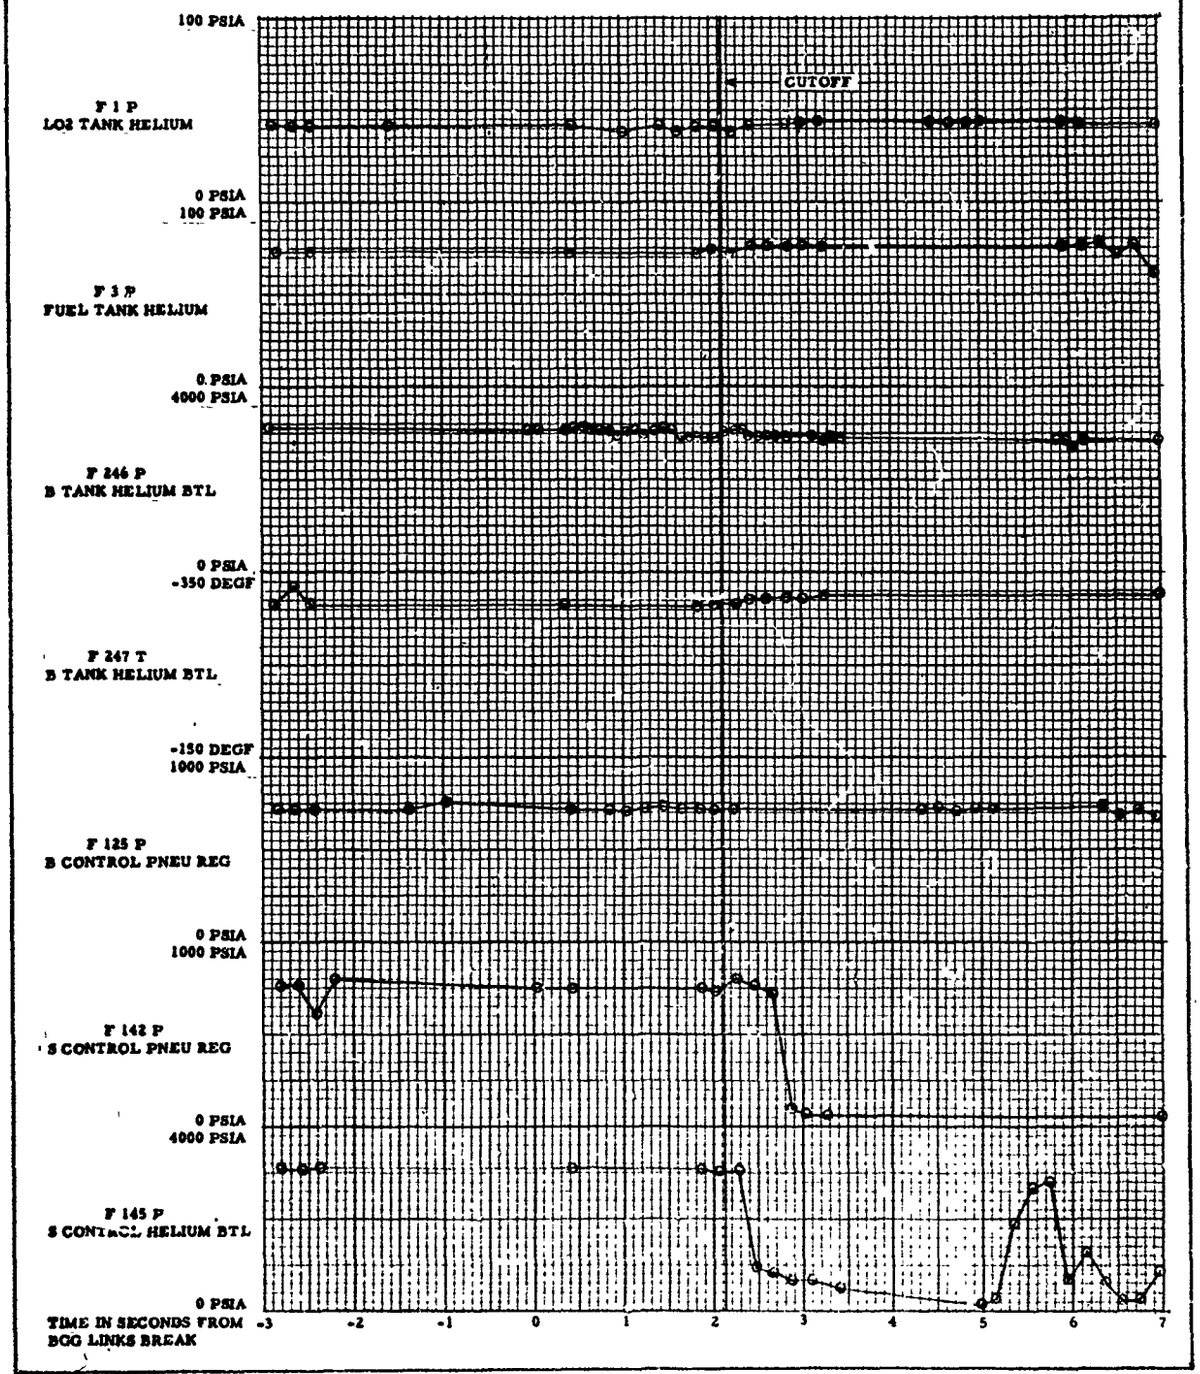
The first recorded indication of damage to the pneumatic system occurred at 2.28 seconds. A review of film coverage indicated an explosion at 2.22 seconds. Beginning at 2.28 seconds sustainer control bottle discharge pressure dropped from 3010 to 900 psig in 0.2 seconds, then decayed to 60 psig by 5 seconds. When the discharge pressure decay reached about 750 psig, satisfactory operation of the sustainer controls pneumatic regulator could not be maintained. By 3.05 seconds regulator discharge pressure had decayed to 60 psig and stabilized. These data indicate the loss of a high pressure helium line downstream of the controls bottle through fire damage in this general area.

The LO_2 and fuel tank pressures during engine firing were adequate at 25.3 and 61.0 psig. With the closure of the propellant valves at sustainer cutoff, the small ullage present in the LO_2 tank was rapidly overpressurized to 30.1 psig before the regulator could respond to the sensed pressure and lock up. This level was maintained until 14.5 seconds when the PCU appeared momentarily to go into emergency, then return to Sequence III with a corresponding drop and surge in LO_2 tank pressure. At 16.1 seconds the PCU went into emergency, initiating decay of LO_2 tank pressure to yield a greater safety margin. (A review of film coverage indicated the boil-off valve to open momentarily at 7.4 seconds then open permanently at 11.5 seconds).

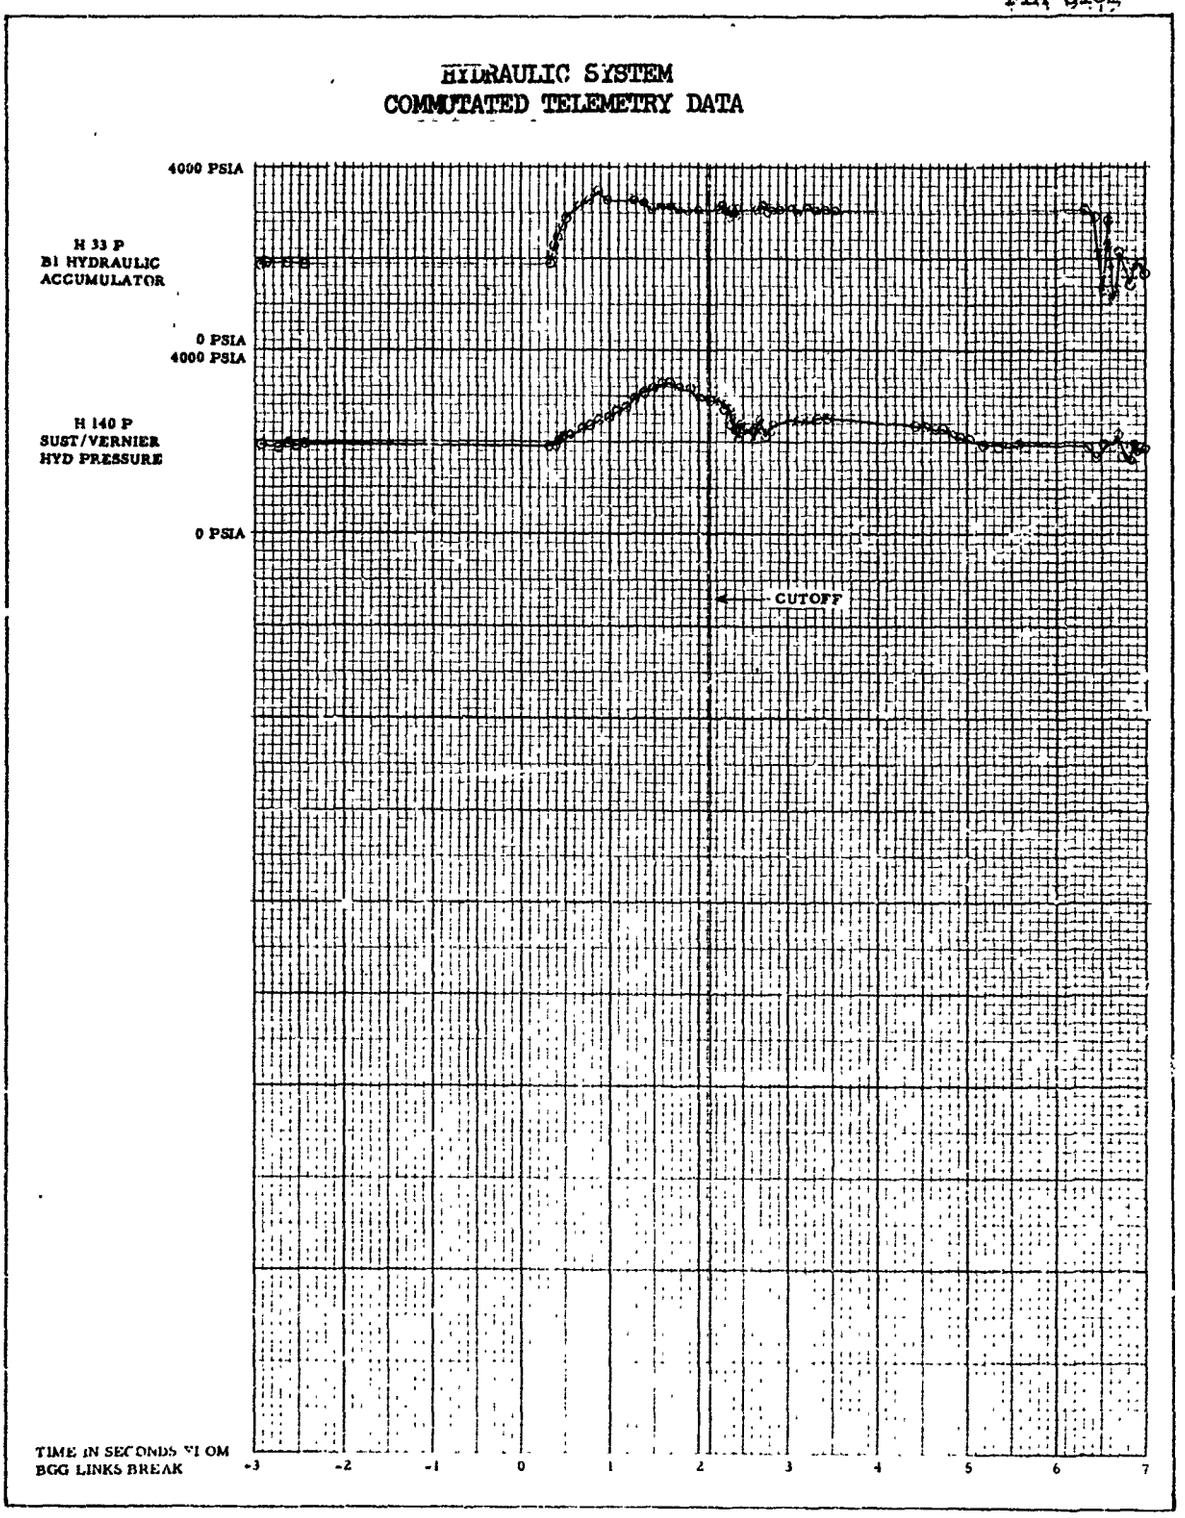
Sustainer hydraulic ground pressure was maintained at a stable 1925 psig until -0.9 seconds when a normal negative 90 psi transient drop in hydraulic pressure was recorded. This pressure transient is the result of hydraulic demands from the head suppression valve. At 0.2 seconds hydraulic pressure began to rise, reaching an airborne system peak of 3320 psig at 1.7 seconds. From 1.7 to 2.0 seconds the pressure decayed normally to 2985 psig where it should have stabilized. From 2.0 to 2.3 seconds, a lesser rate of decay was recorded. Pressure at 2.3 seconds was 2800 psig. By 2.4 seconds it had dropped to 2215 psig. From 2.4 to 9.8 seconds the pressure decayed in steps to 1035 psig, then dropped rapidly to return system pressure of approximately 110 psig when the pre-charge pressure of the vernier solo system accumulators was reached.

The abnormal rapid rate of decay recorded after 2.3 seconds and the inability of the system to maintain pressure at 2000 psig (ground system pressure) indicate the loss of hydraulic oil commencing at approximately 2.3 seconds.

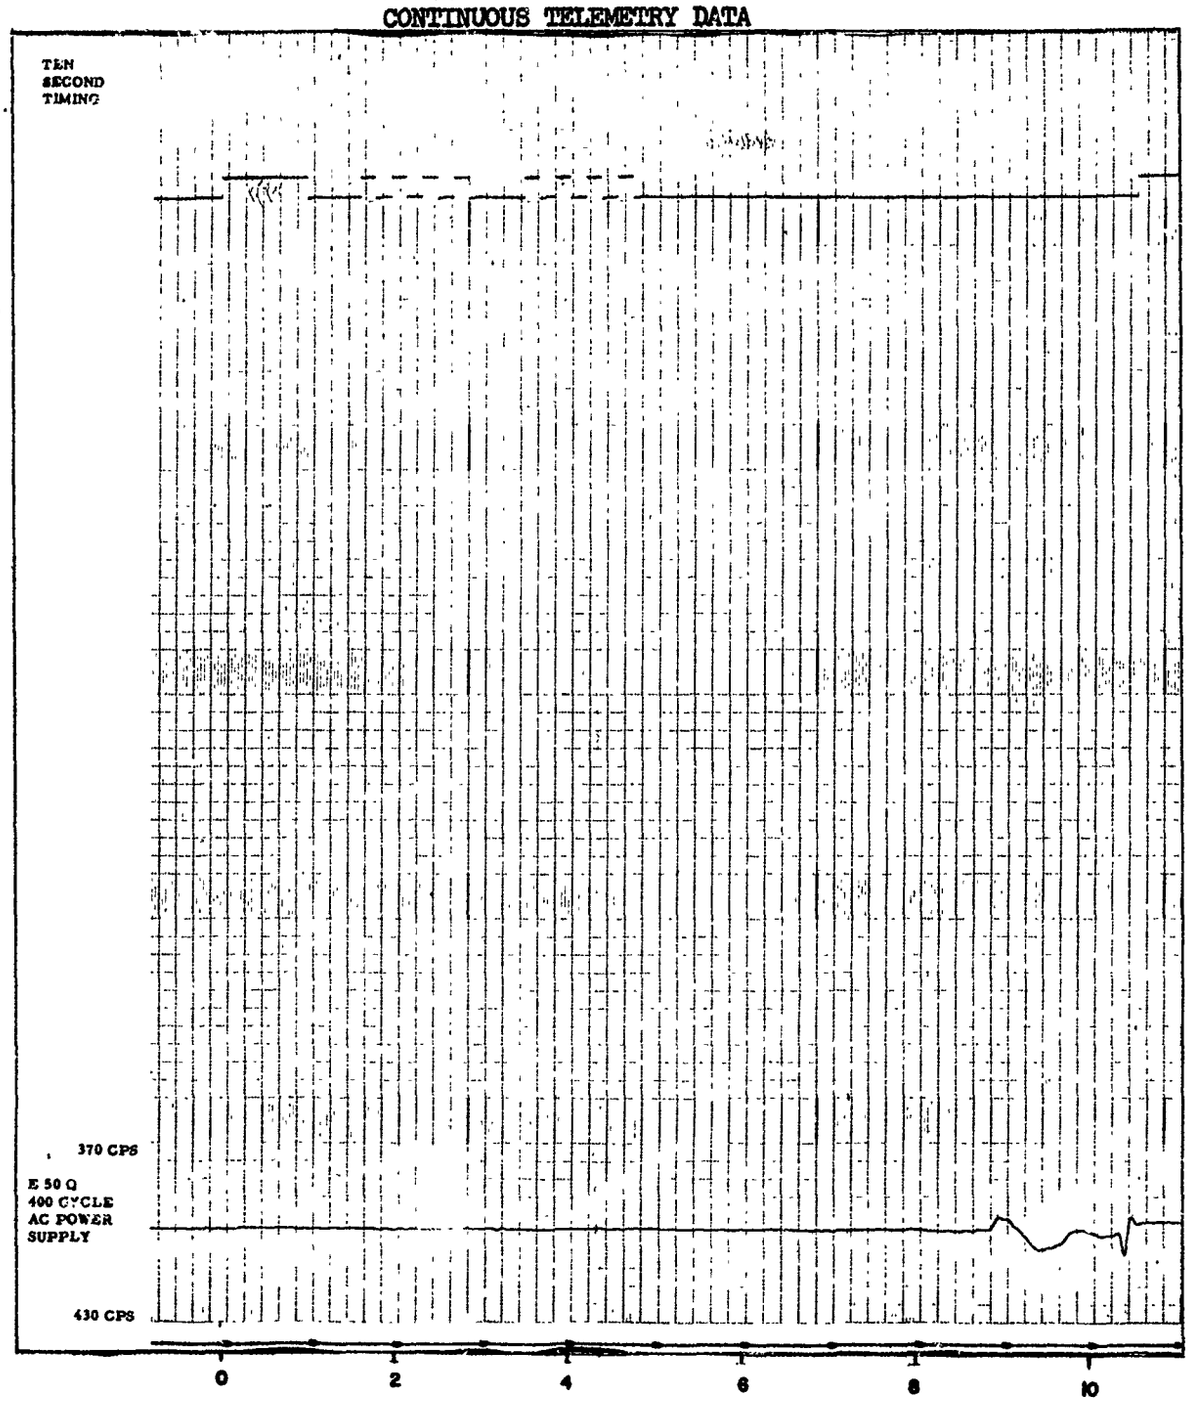
MISSILE ELECTRICAL SYSTEM
CONTINUOUS TELEMETRY DATA

The DC voltage remained at a satisfactory 27.3 volts until changeover to external power at 8.9 seconds. During changeover a transient drop to 15.4 volts was indicated. After 10.6 seconds various transient voltage drops were indicated. The majority of these transients are not reflected in the performance of user systems. The DC voltage, however, did not decay after 10.6 seconds, reaching 23 volts at 31.5 seconds. At this time the voltage dropped abruptly to 9.6 volts, and was lost entirely at 32.9 seconds.

Inverter phase A voltage remained at 114.4 volts until changeover to external power when a change of level to 113 volts occurred. By 30.4 seconds the AC voltage had increased to 114 volts. At this time the loss of phase A voltage was recorded. This loss of voltage is reflected in Azusa, guidance, propellant utilization, and autopilot data at 30.4 seconds.

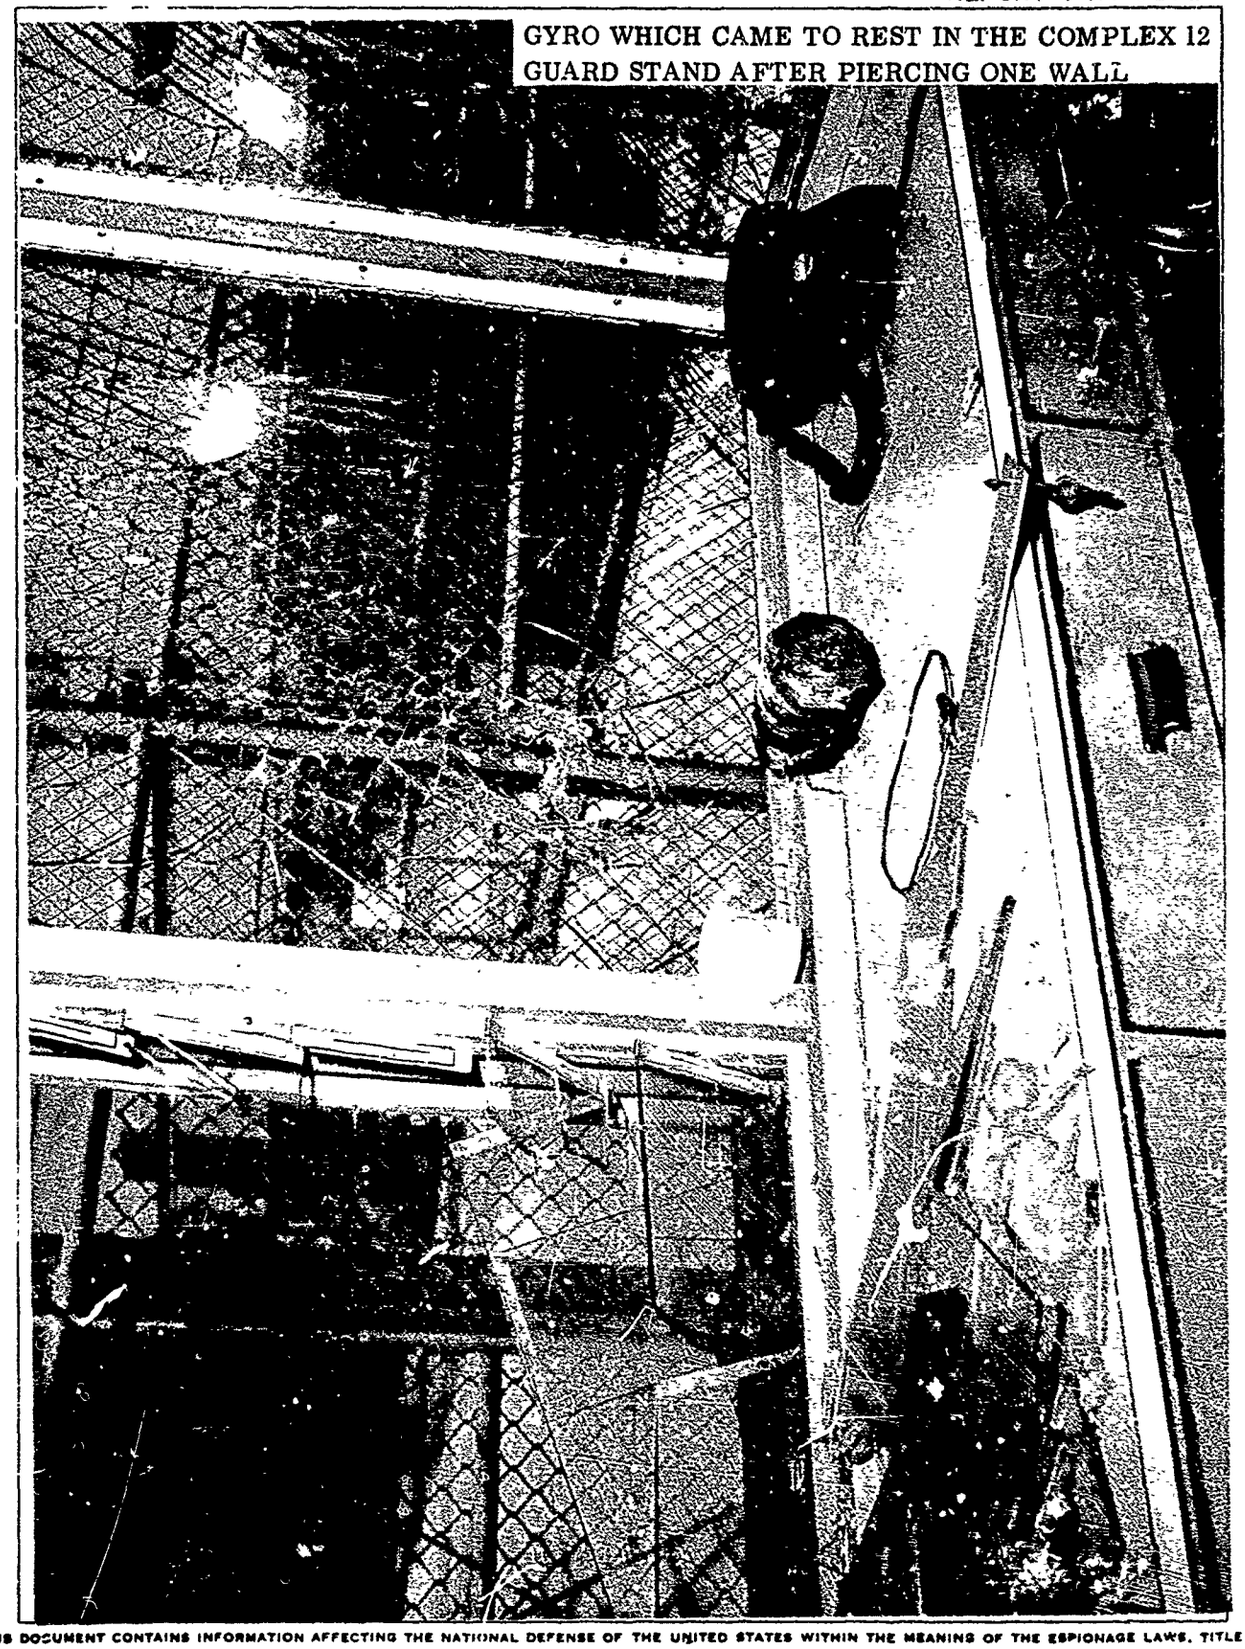
GYRO WHICH CAME TO REST IN THE COMPLEX 12 GUARD STAND AFTER PIERCING ONE WALL

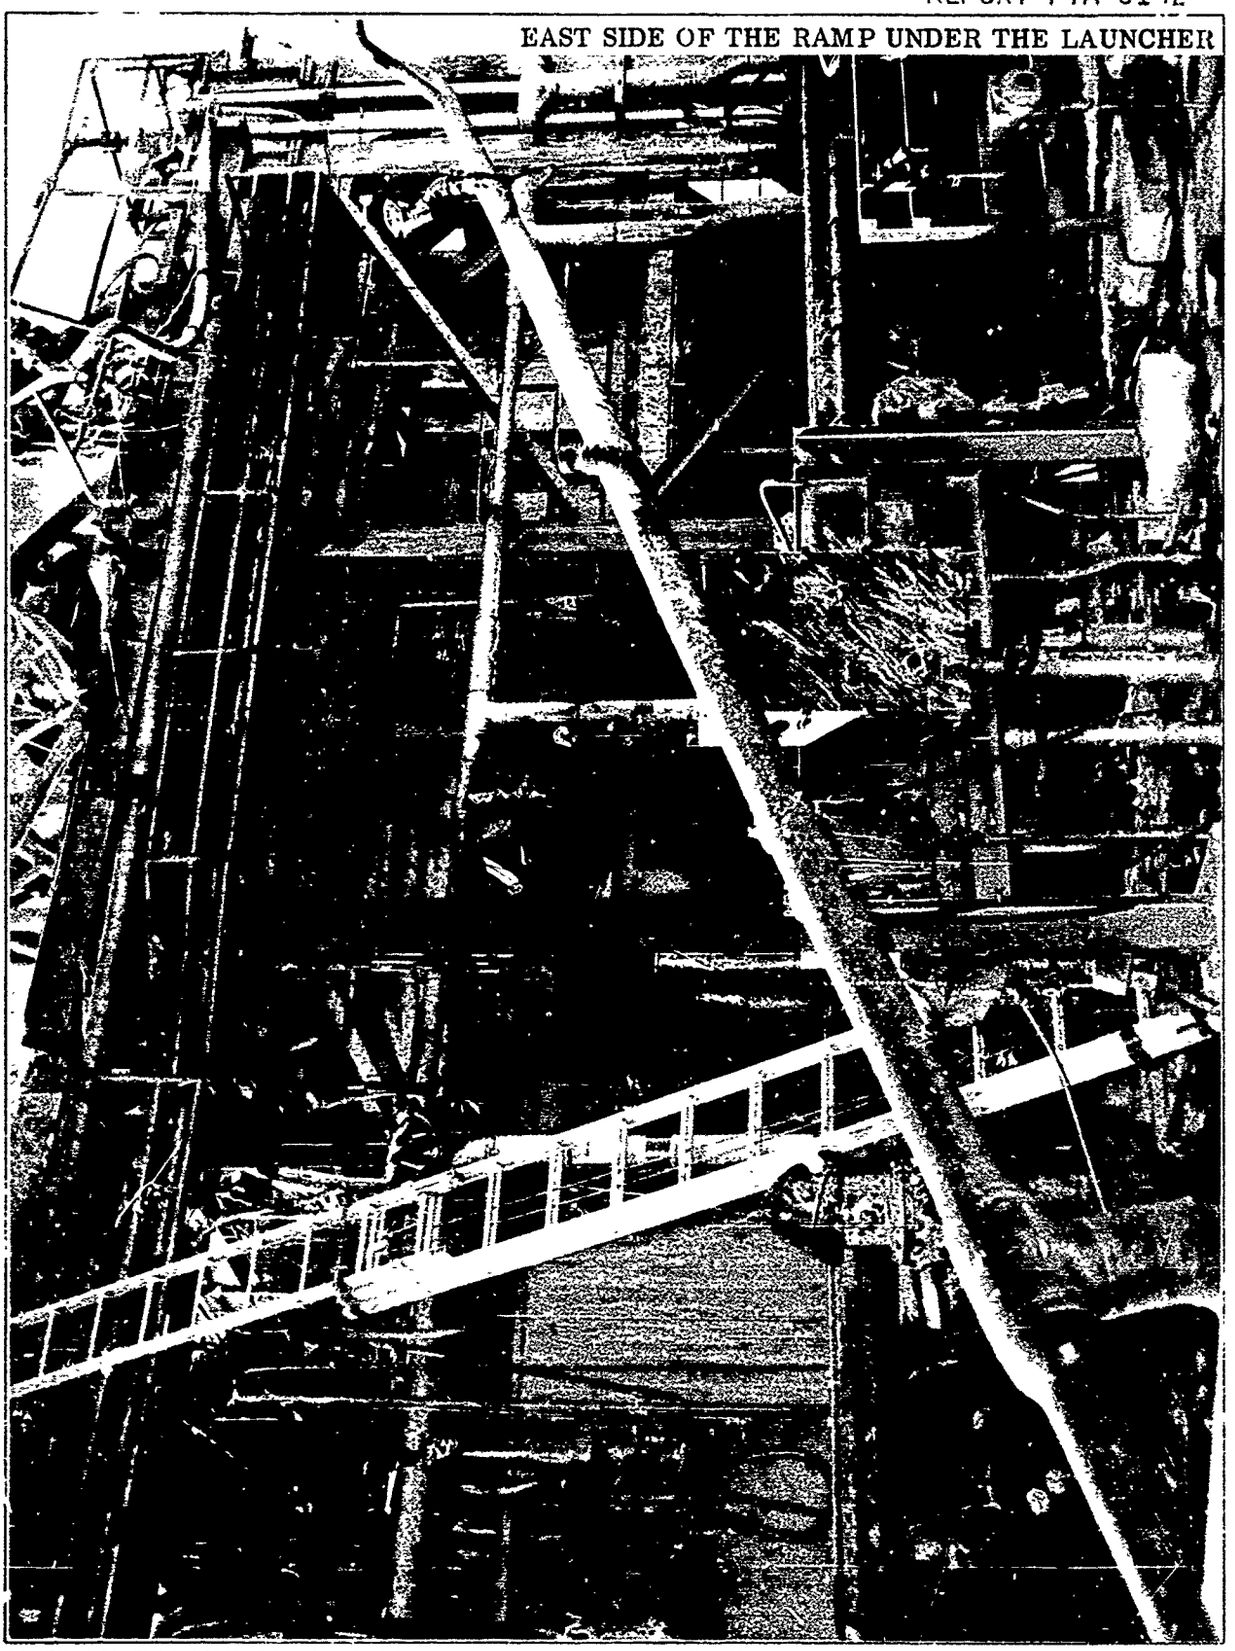
EAST SIDE OF THE RAMP UNDER THE LAUNCHER

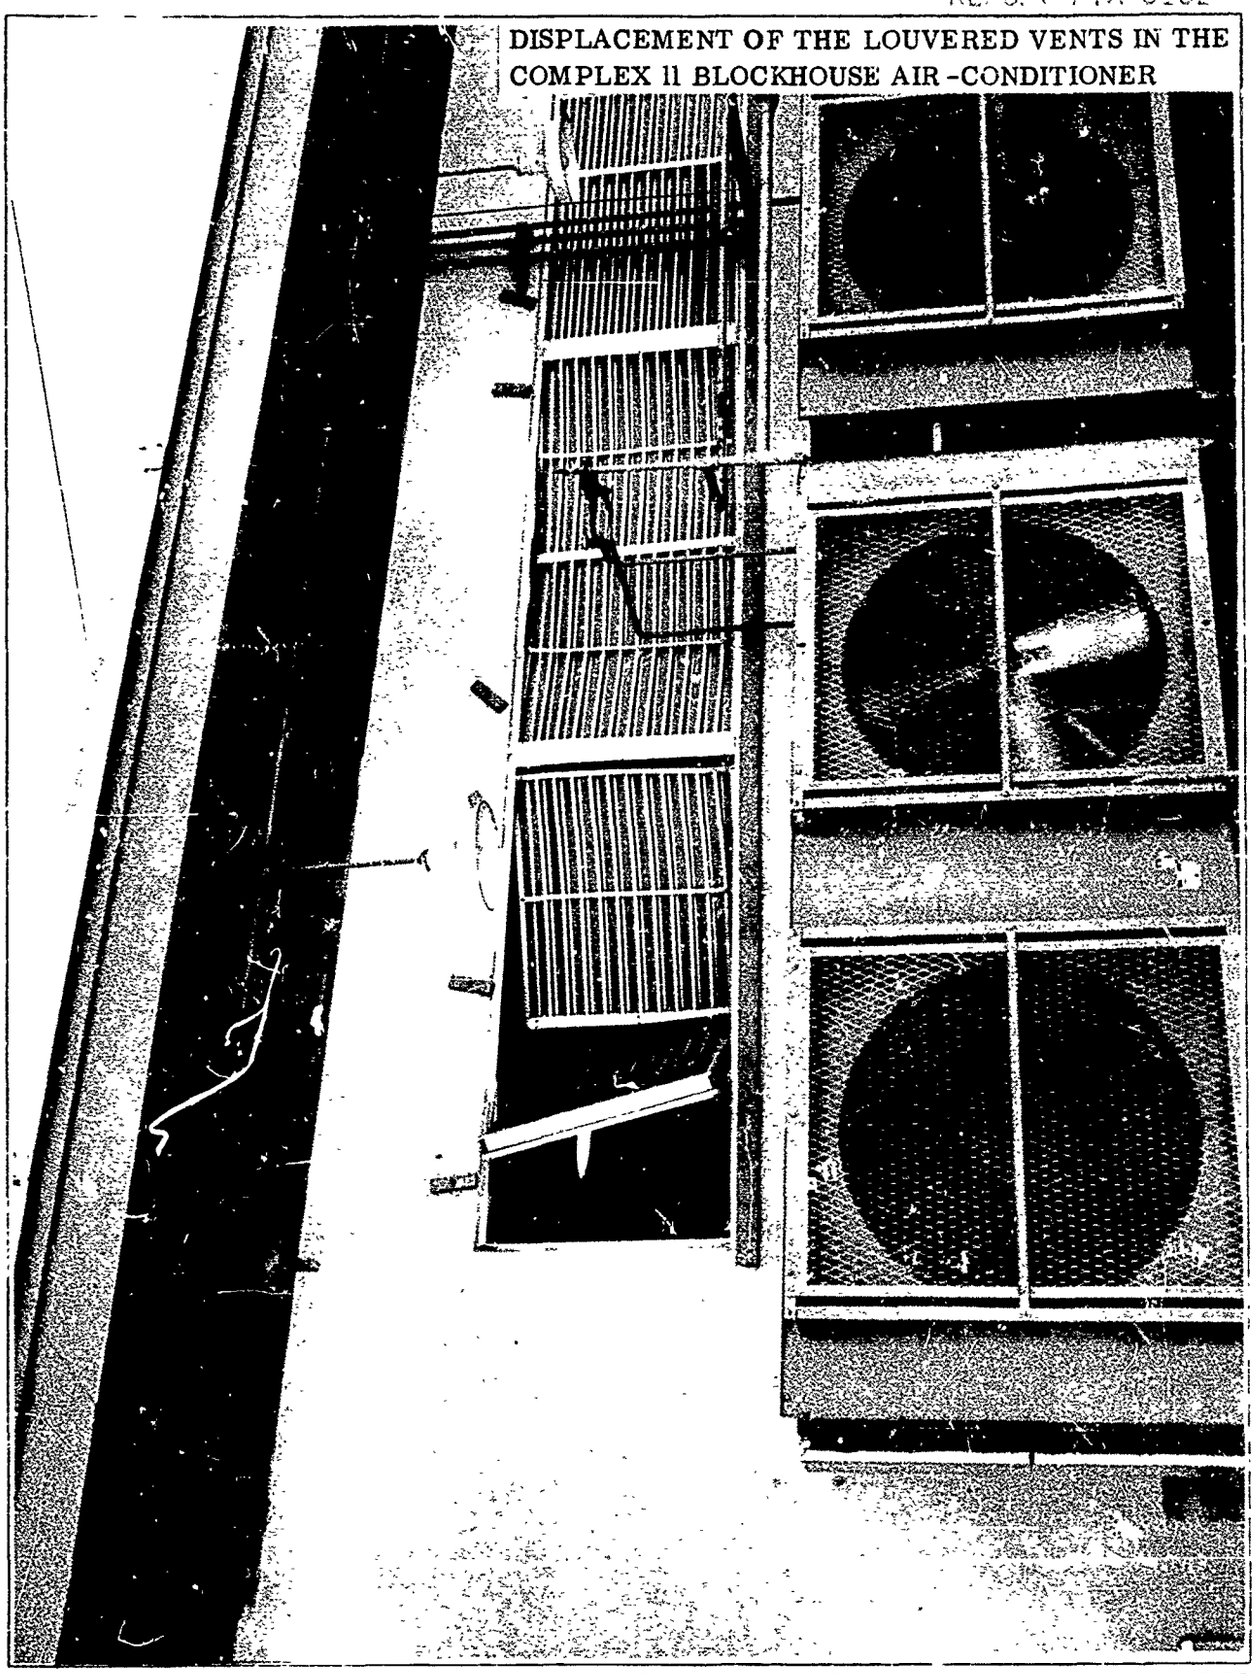
DISPLACEMENT OF THE LOUVERED VENTS IN THE COMPLEX 11 BLOCKHOUSE AIR-CONDITIONER

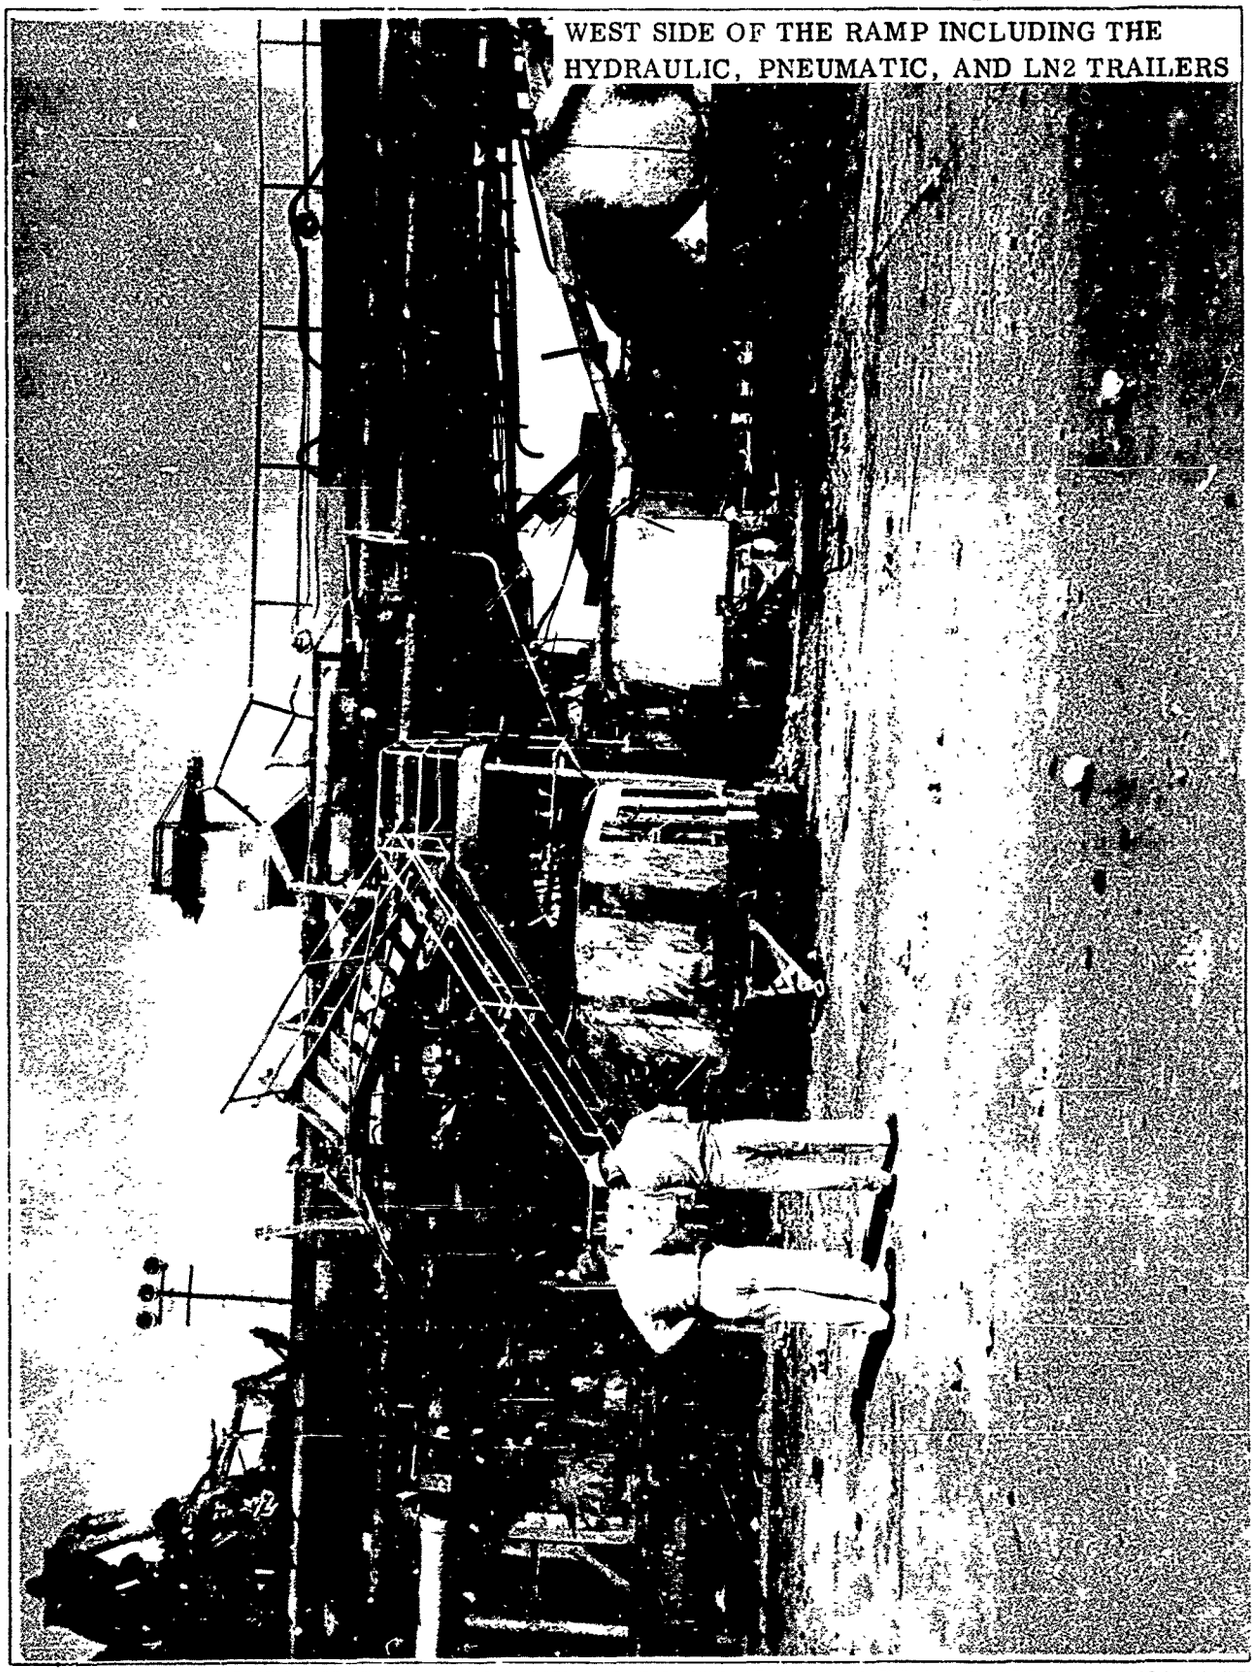
WEST SIDE OF THE RAMP INCLUDING THE HYDRAULIC, PNEUMATIC, AND LN2 TRAILERS

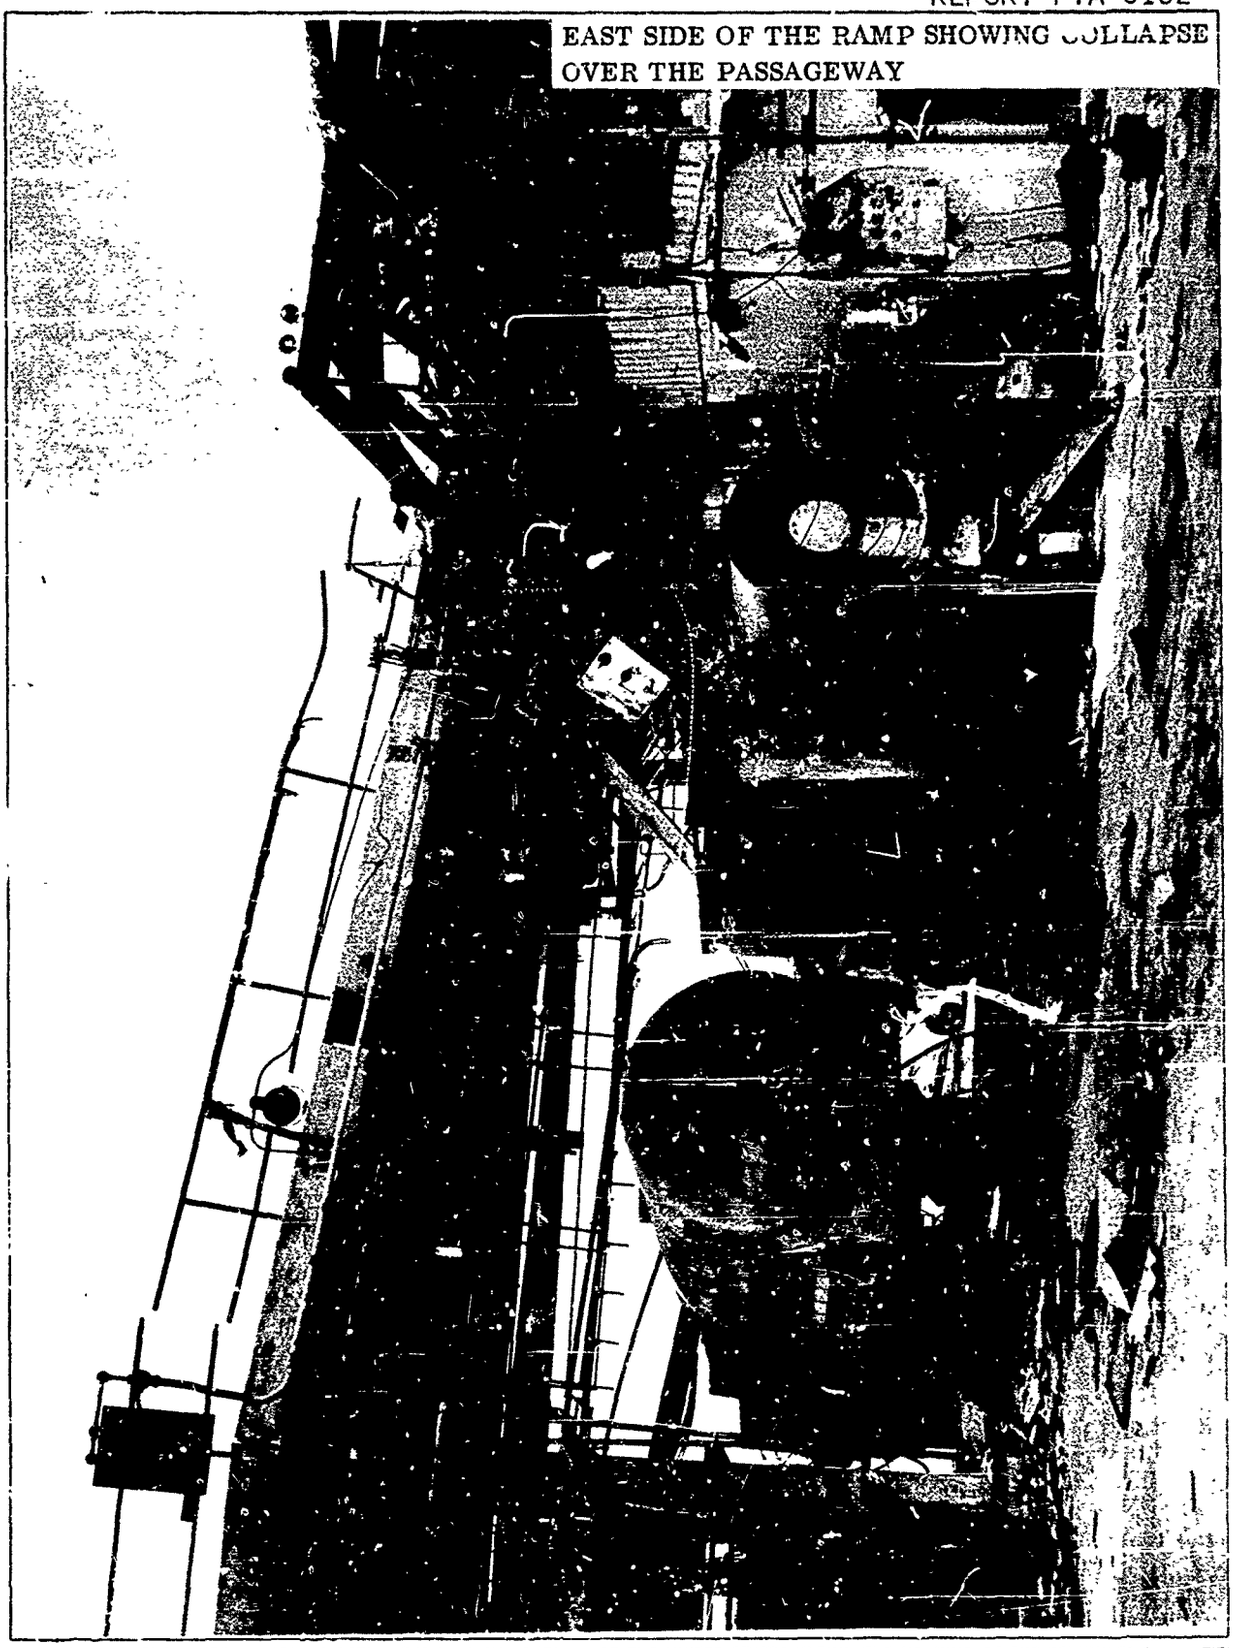
EAST SIDE OF THE RAMP SHOWING COLLAPSE OVER THE PASSAGEWAY

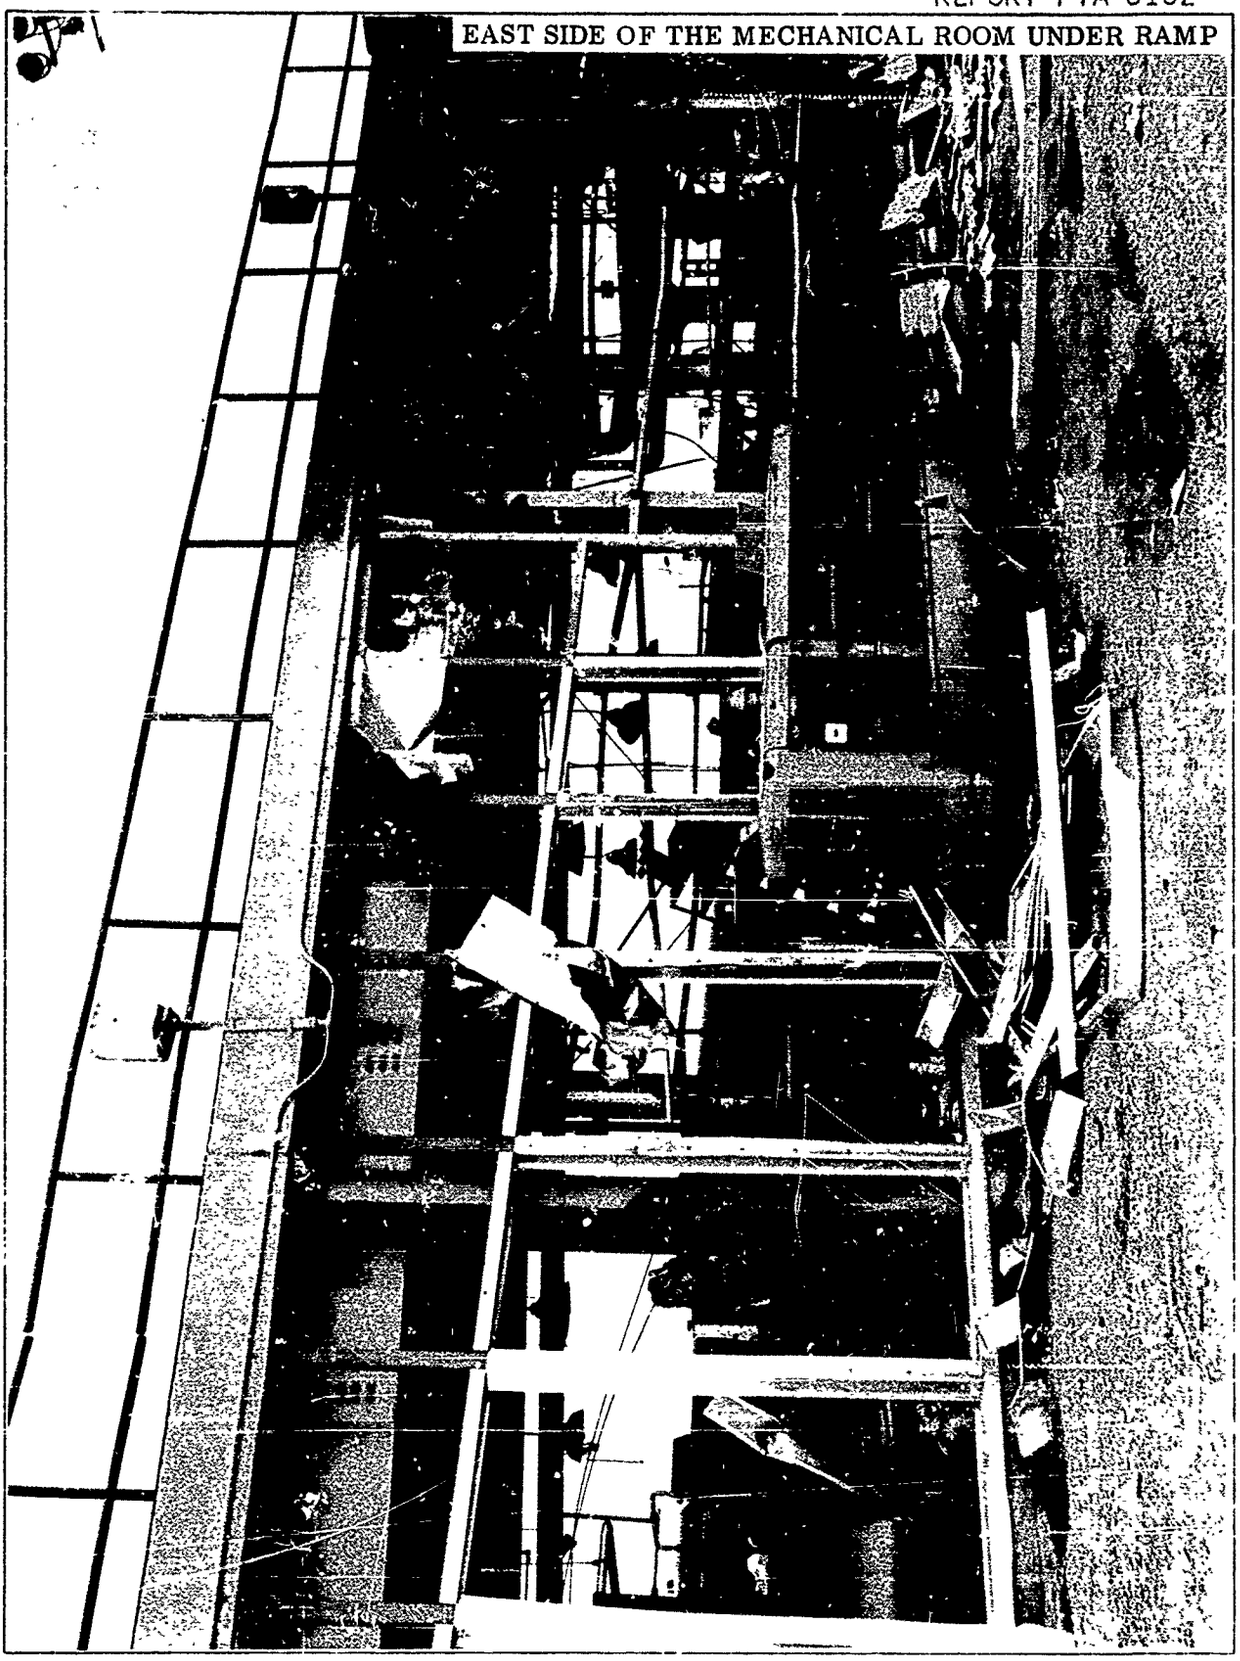
EAST SIDE OF THE MECHANICAL ROOM UNDER RAMP

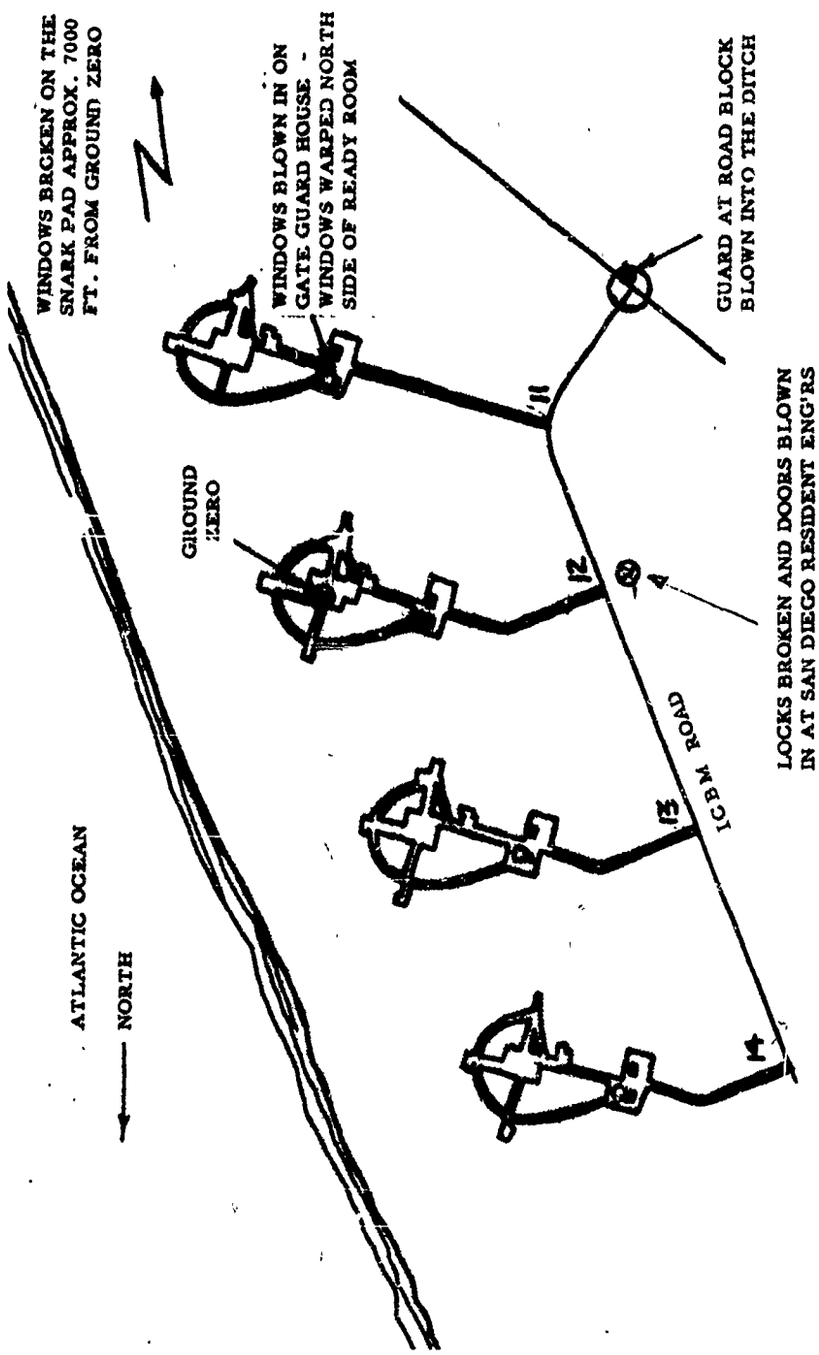
DAMAGE FROM SECONDARY BLAST EFFECTS

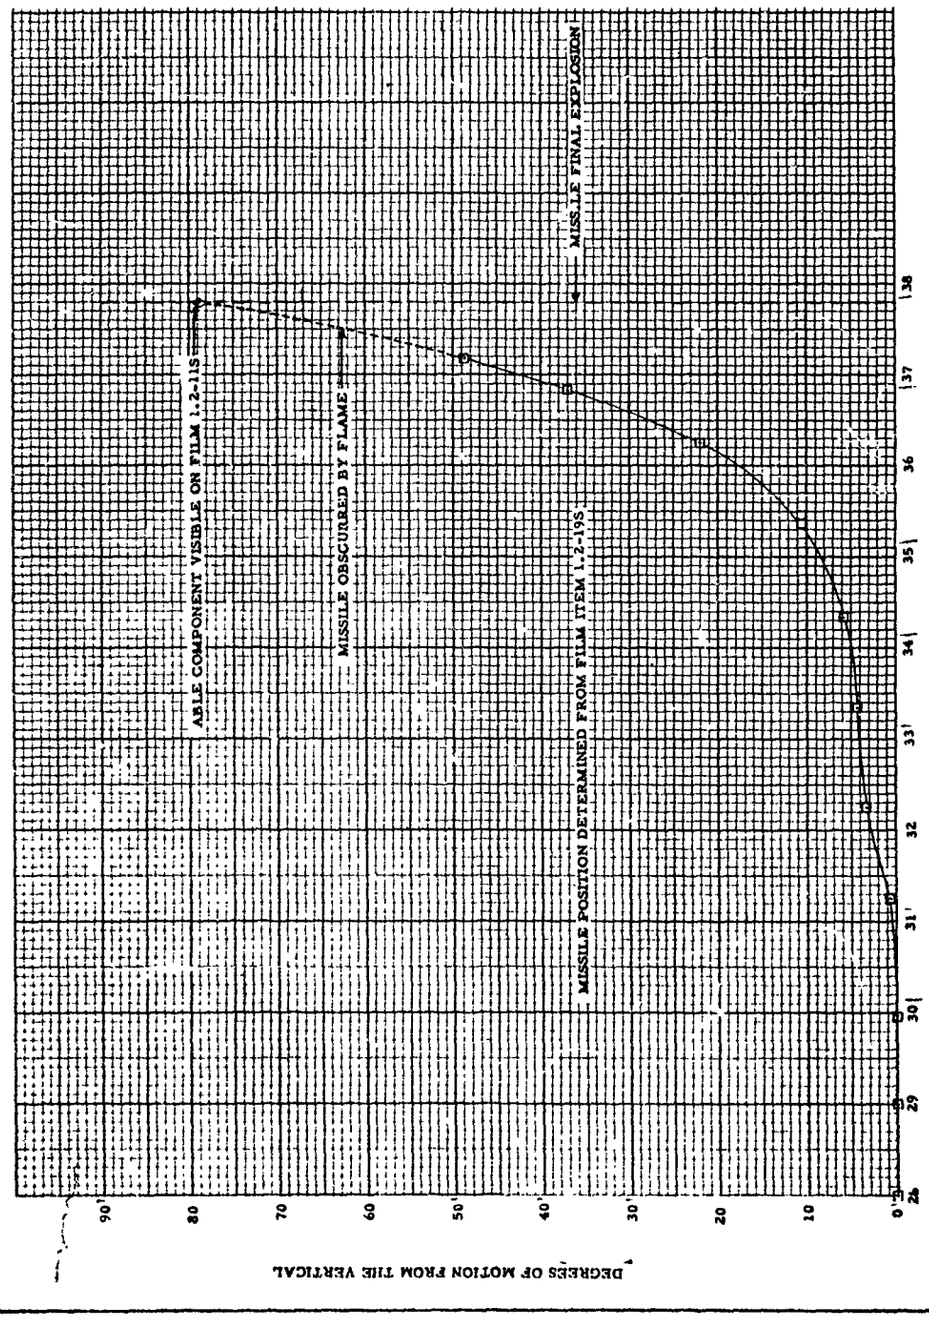
MISSILE ATTITUDE PRIOR TO DESTRUCTION
(from film review)

Event	Time in Secs. From BGG
First visable explosion	2.22
Flame through Quad II skirt	9.53
Flame through Quad III skirt	16.80
Second explosion	19.48
Third explosion	20.10
Fourth explosion	20.25
Fifth explosion	27.94
Msl started to fall	29.56
Final explosion	37.80
