COLLECTION OF REPORTS ON VIBRATION SURVEYS

PUGET SOUND NAVAL SHIPYARD

During 1962

Subj: USS IWO JIMA (LPH2); report of underway vibration trials

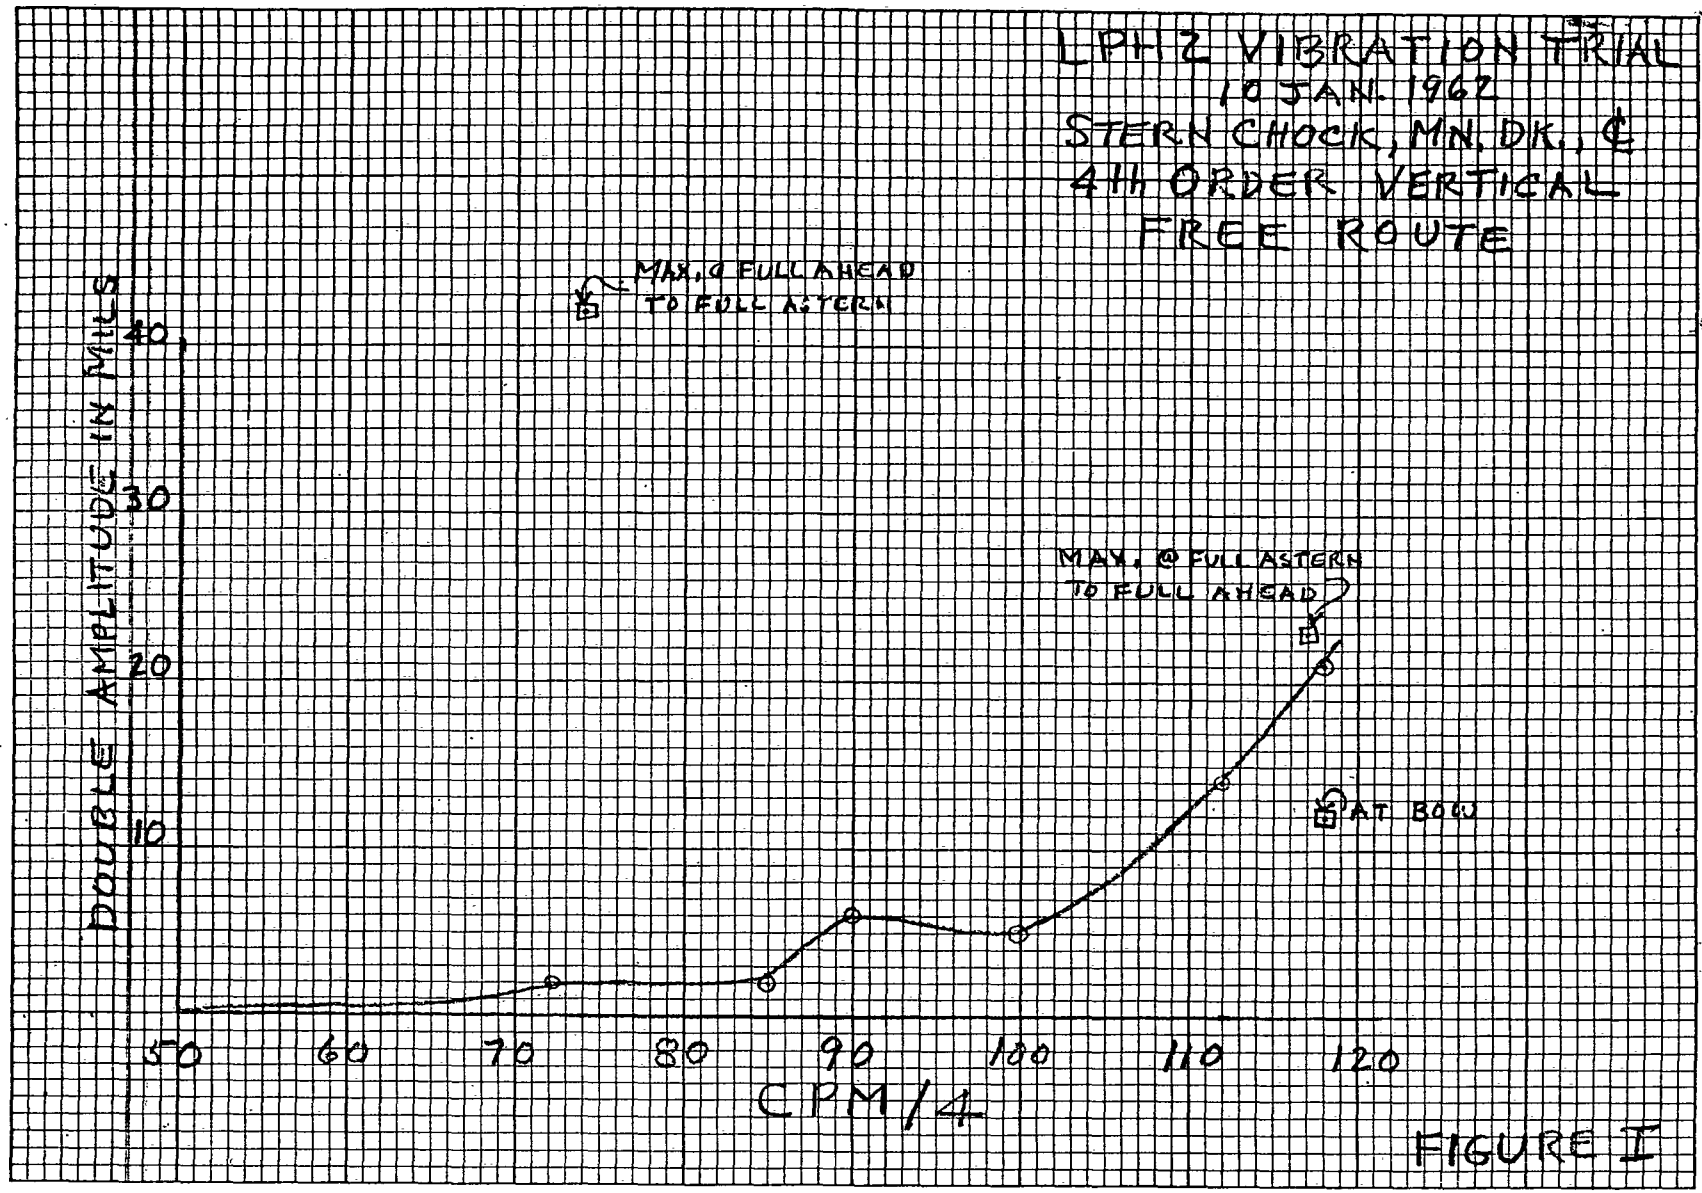
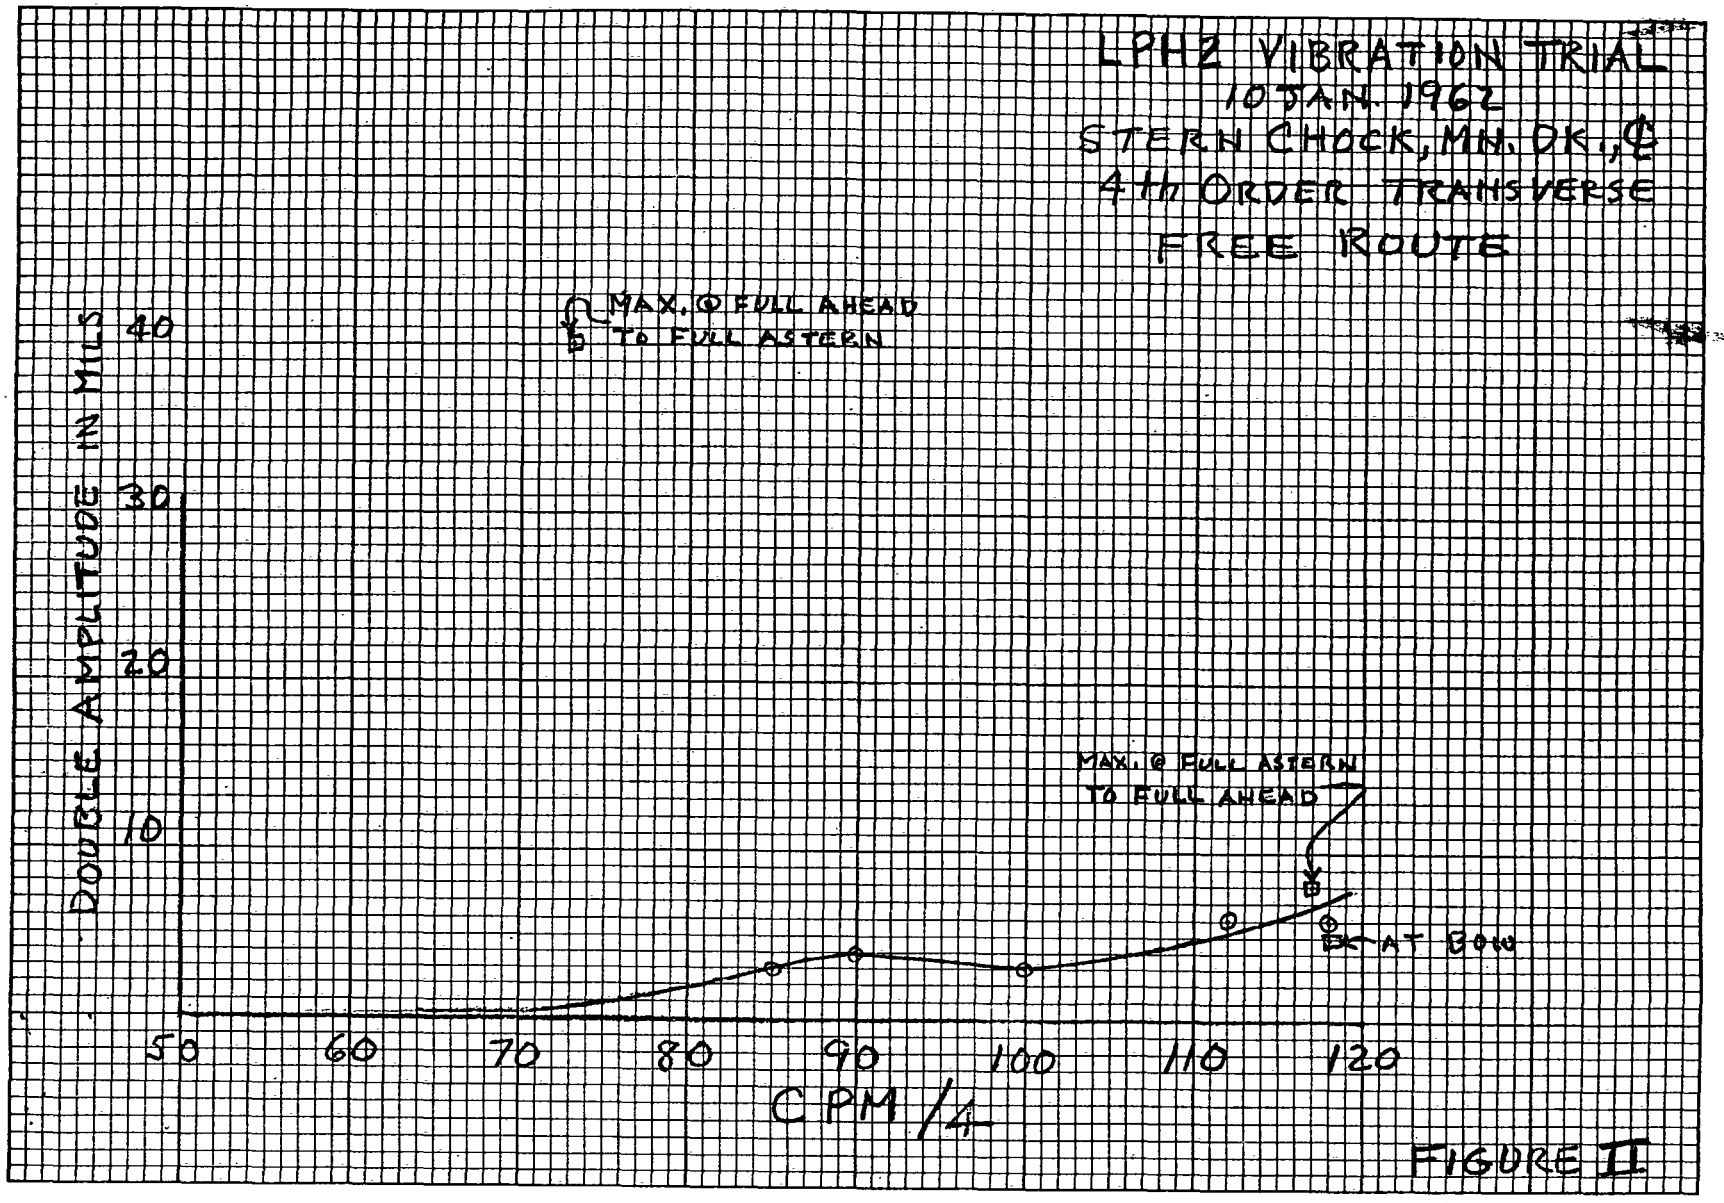
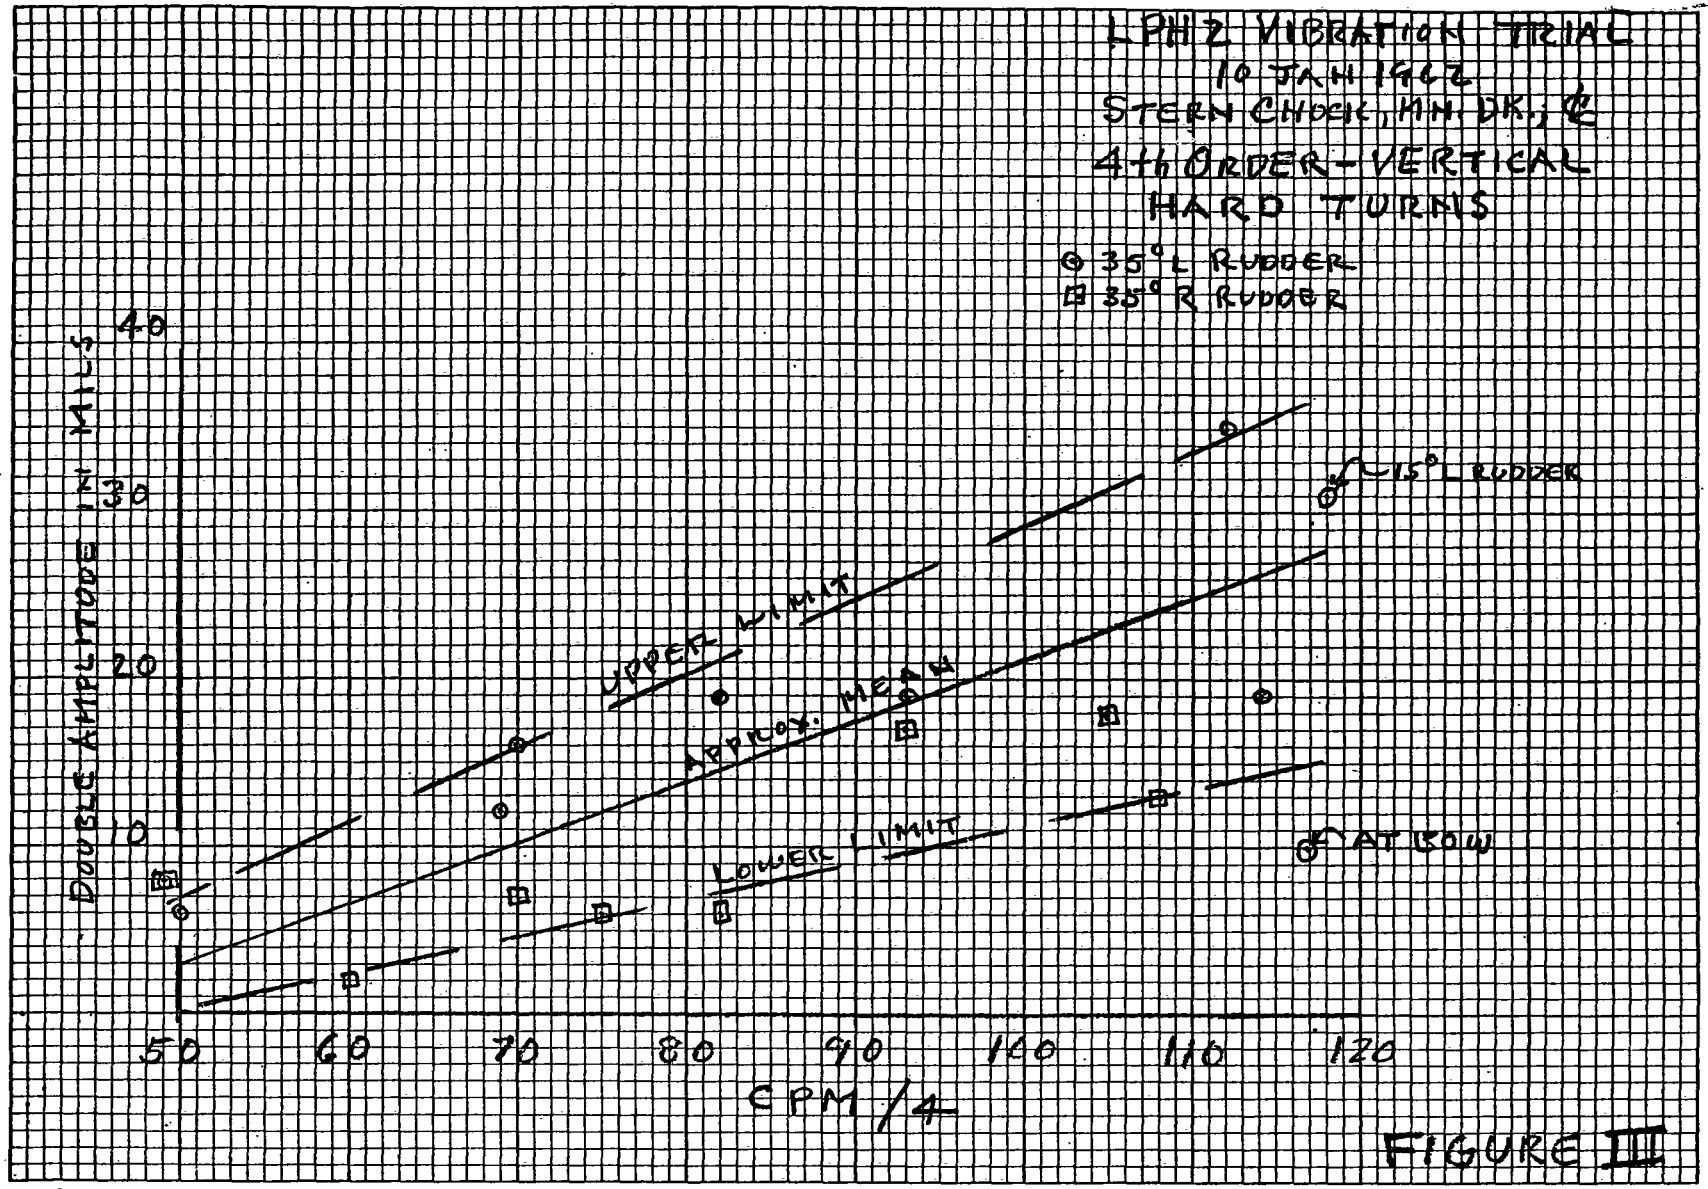
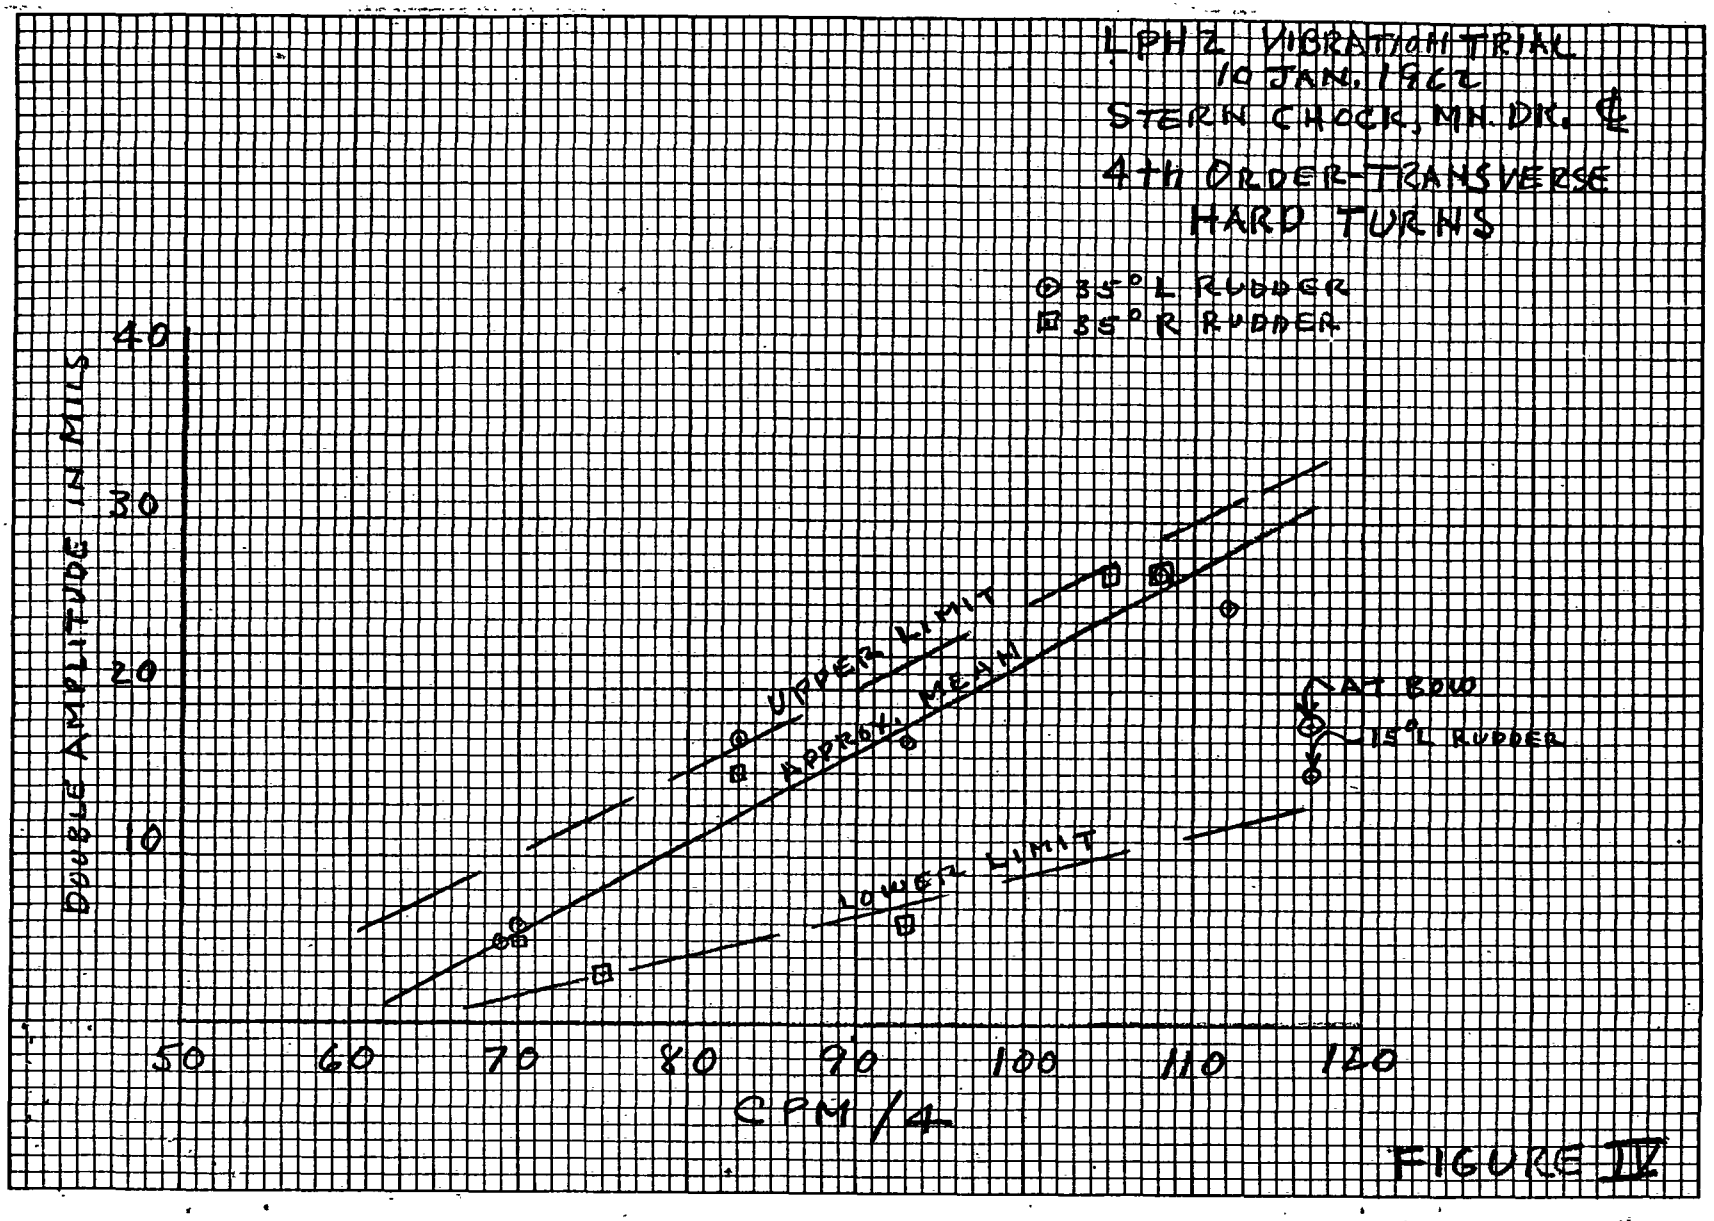
FIGURE I

4. Results of measurements at the stern check during speed build-up are given in Table I, enclosure (2). This data has been plotted on Figures I through IV, enclosure (4). Although various components are present, especially during turns, the major components of interest are at propeller blade frequency, fourth order to SRPM. Since propeller shaft speed varied somewhat from nominal settings, especially during turns, the data is plotted on Figures I through I with recorded CPM 4 as abscissa rather than nominal SRPM. Amplitudes given are, in general, quasi-peaks and are all double amplitude. Original records are furnished for additional review, if desired, as (1) through (20) of enclosure (3). Instrument calibration (either channel) is given in enclosure (6). Chart paper speed was 5 mm/sec for slow (s) operation, 25 mm/sec for medium (m), and 125 mm/sec for fast (f).

5. Evaluation of these data indicates that there is no definite hull resonance condition at speeds 50 SRPM and above. A slight peak is evident in both the vertical and transverse directions at about 90 SRPM. This slight rise could be due, however, to anomaly in the experimental conditions or ship response. During the speed increase from astern to full power ahead there were a few cycles of vibration at increased amplitude at about 6.2 CPS, corresponding to a fourth order at 92 SRPM, which also might indicate a resonant condition. Still, such amplitude increases also occurred at other speeds during this build-up but are not reflected in the curve for incremental speeds. In any event, the resonance, if present, is of no serious consequence. Vibration is mild in free route up to 100 SRPM. Above 100 SRPM, amplitudes increase to a maximum of 21 mils in the vertical direction and to a much smaller degree in the transverse direction. It appears that a hull resonance is approaching in the vertical direction at full speed. Decks and bulkheads in areas throughout the ship responed to both the fourth order excitation and, primarily in the after part of the vessel, to the higher frequency components which are present in the wave form. Most difficulty from such vibration is experienced in the medical spaces where it is difficult to write and perform such duties as reading a microscope under full

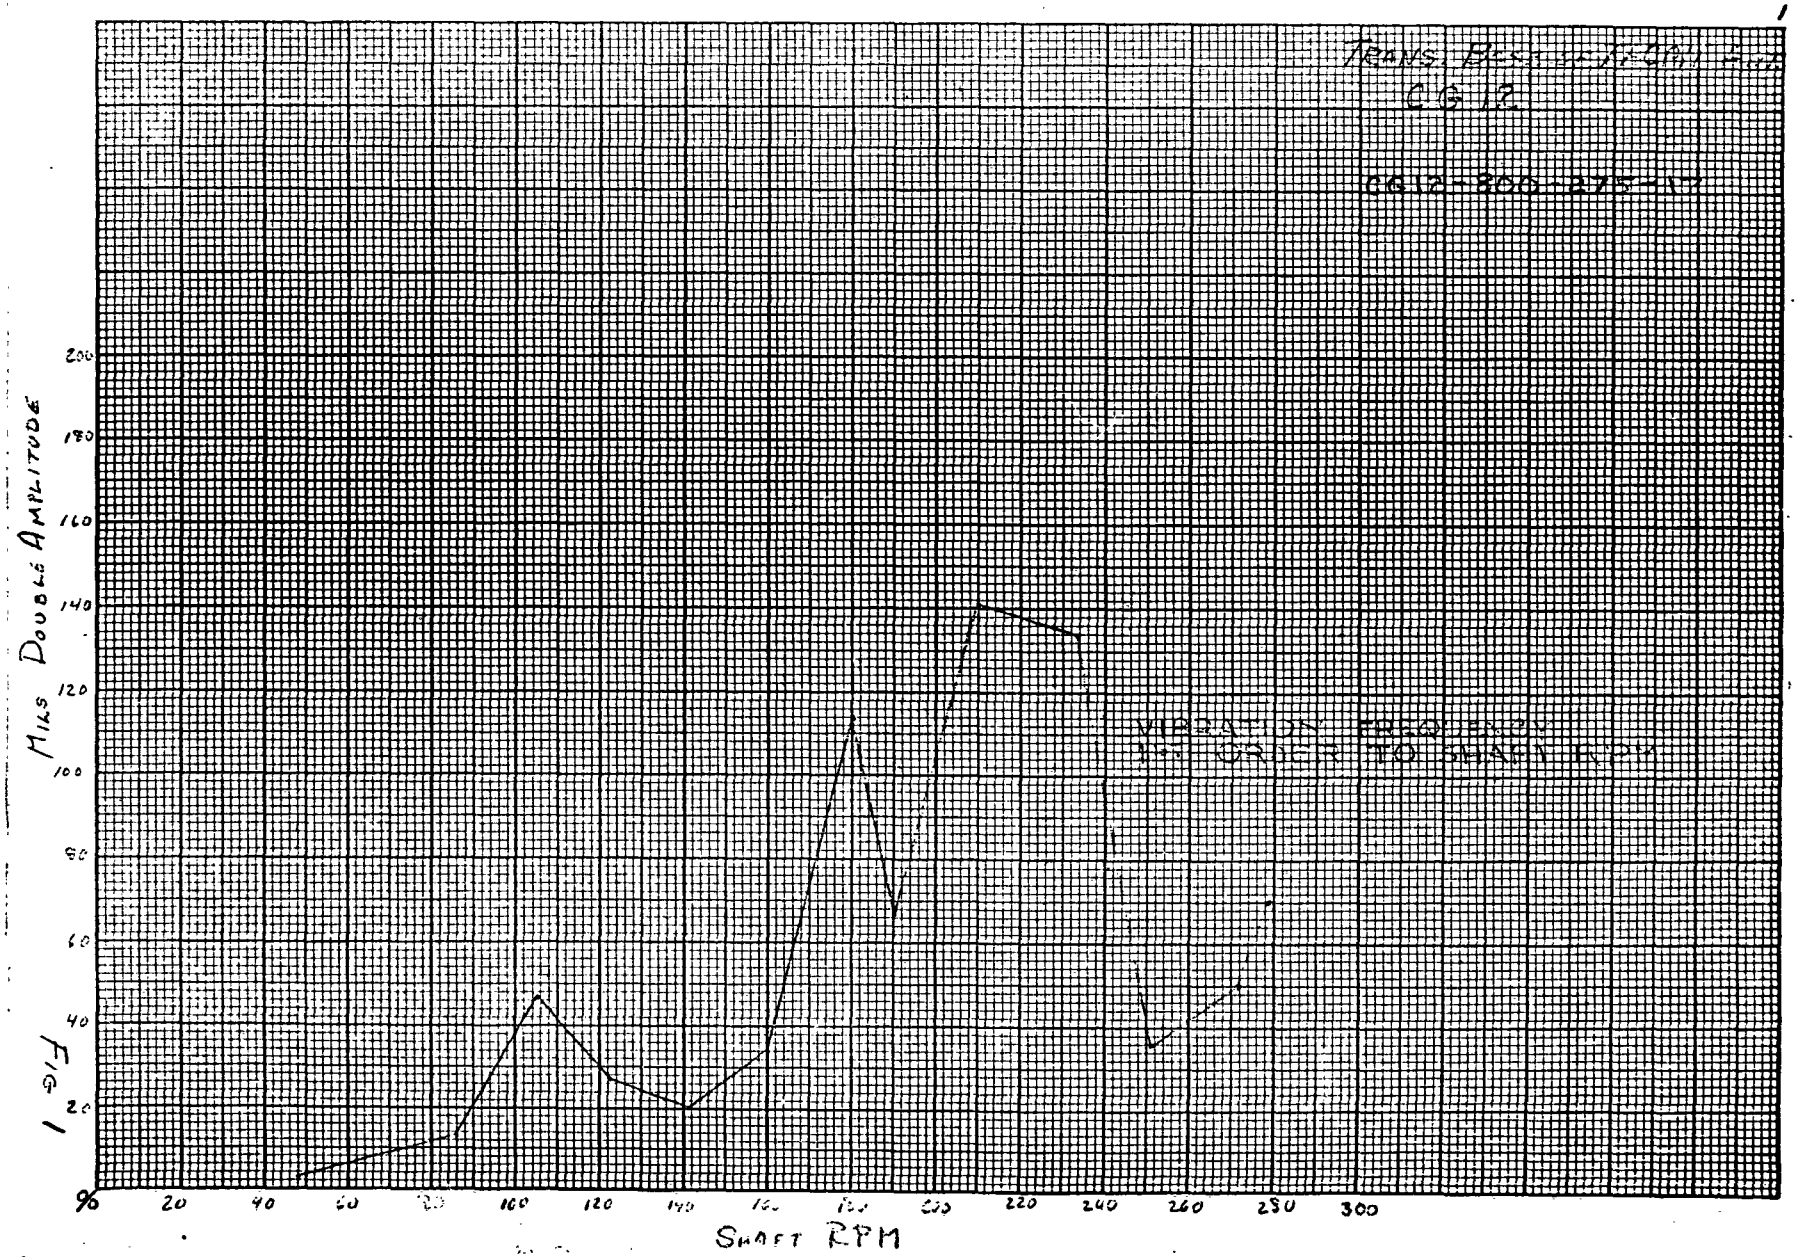
Fig 1

4. Maximum vibration at the base of the TACAN antenna on the top mast of the fwd mack was .205 inches double amplitude (DA) in the longitudinal direction at a ship speed of 20 knots (190 SRPM). The sharply peaked response curve, see figure 1, indicates a natural frequency for longitudinal motion of the top mast at 190 CPM. This information augments that of Ref (a) in which frequencies were not extended low enough to detect the 190 CPM resonance. The maximum athwartship vibration of the top mast was .140 inches DA at 22 knots (210 SRPM).

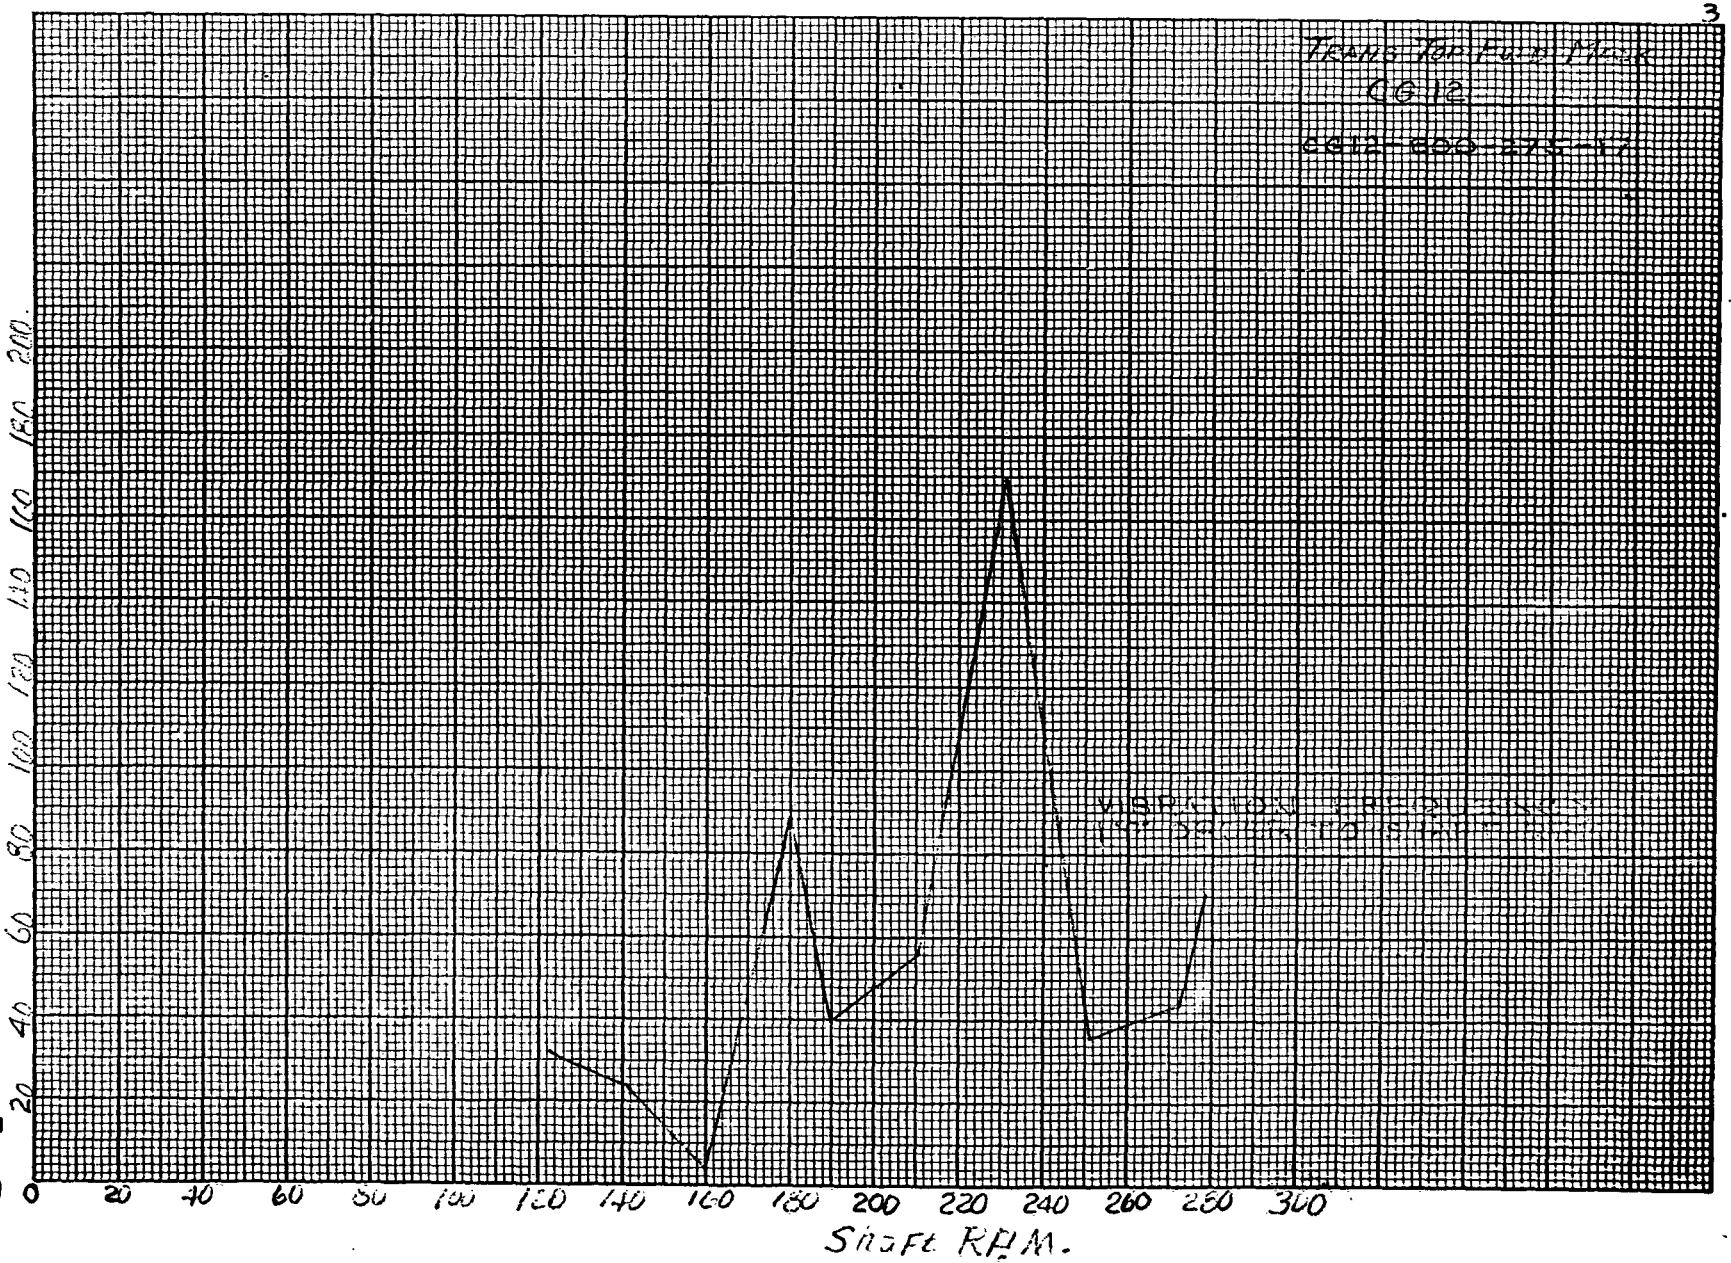
Fig 3

5. The maximum amplitude at the top of the fwd mack was .169 inch DA at 24 knots (23 SRPM). See figure 3. This vibration was in the athwartship direction and its frequency was 231 CPM or 3.9 CPS. The latter does not correlate with reference (a) in which no natural frequency was found above 160 SRPM. Also, this 231 CPM frequency is higher than that stated in reference (b). No appreciable vibration in the longitudinal direction was found in the range of speeds investigated. This agrees with finding of references (a) and (b). The maximum amplitudes on the Aft mack were .087 inches DA at 22 knots (210 CPM) in the athwartship direction and .100 inches DA at 28 knots (272 CPM) in the longitudinal direction. (See figures 4 and 5). The 210 CPM frequency for athwartship vibration agrees
