WT- 728

UPSHOT-KNOTHOLE

Project 3.9

FIELD FORTIFICATIONS

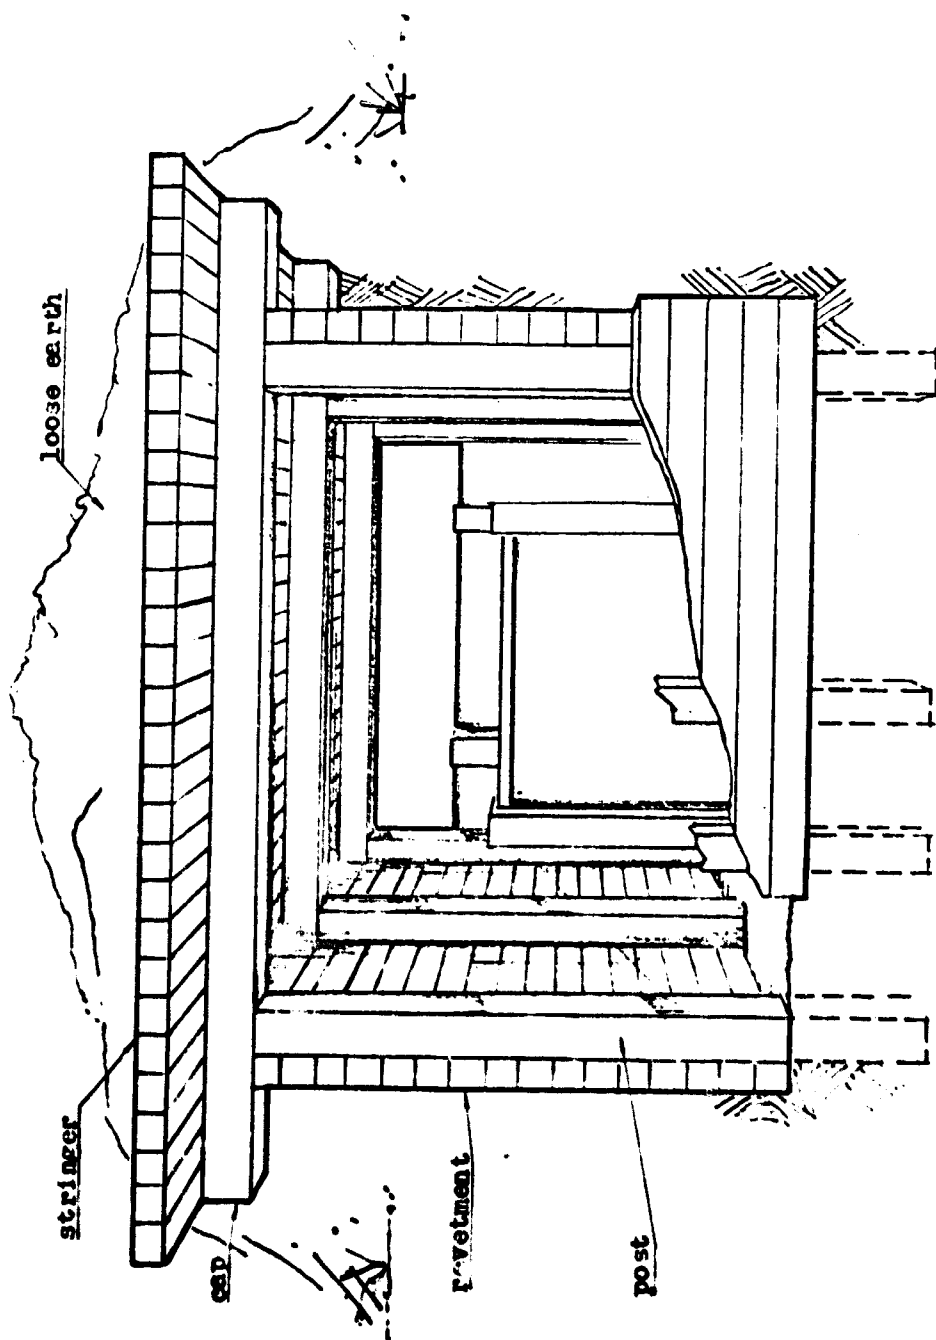
Fig. 2.3 Machine Gun Emplacement with Continuous Stringers

The construction of the machine gun emplacements is shown in Figs. 2.3 and 2.4. The figures show a partially underground rear view, with a portion of the rear wall and posts cut away. The stringers were $1\frac{1}{2}$ ft above grade level, and the overall dimensions of the cover were $8\frac{1}{2}$ ft x 10 ft overlain with about 1 ft of loose earth and sandbags. The overall inside dimensions were $5\frac{1}{2}$ ft long x 7 ft wide x 6 ft tall. The entrance excavation protruded 6 ft from the rear wall and was 2 ft wide and 2 ft deep, leaving a 2 ft step down to the floor of the emplacement. The sizes and spans of the timbers and the various materials used for each component in each machine gun emplacement are included in Table 3.2.

As shown in Table 3.2, most of the damage to structural members was confined to the failure at midspan of the two front 4" x 4" caps. The evaluation of the damage to revetments and top fillers is problematic, because the damage seemed to be as attributable to poor construction as to lack of strength in the materials. In Area 3.9-A where the

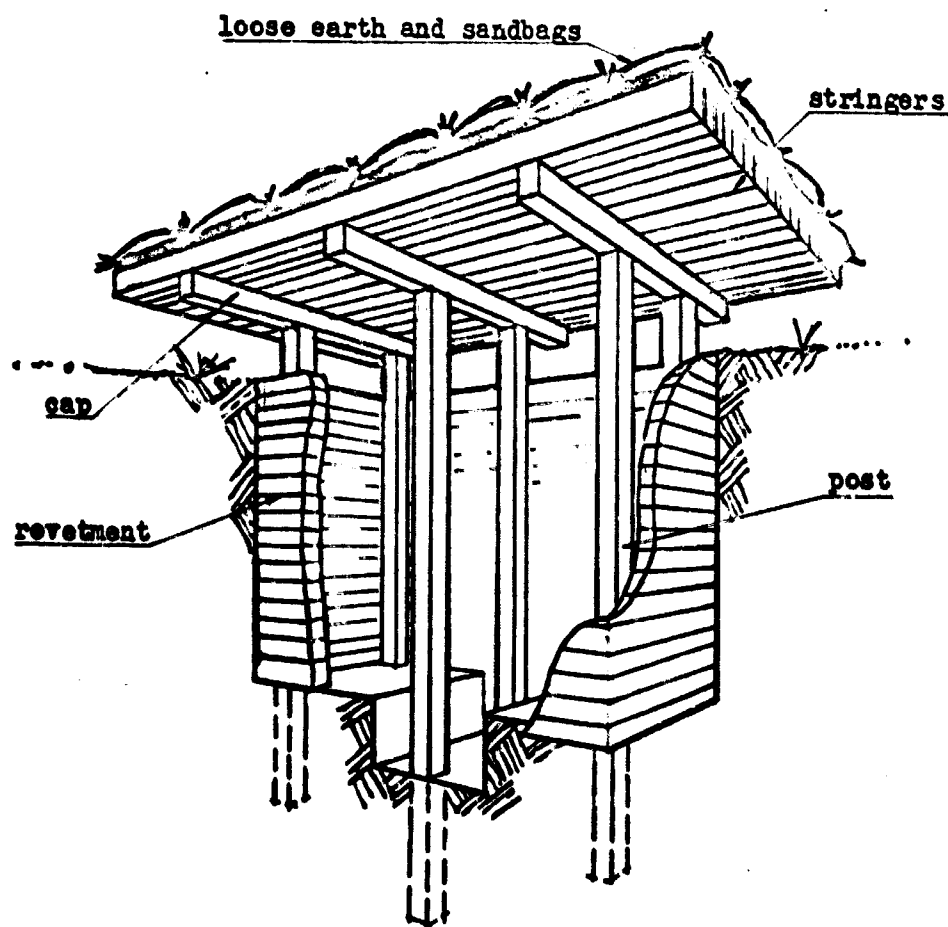
Fig. 2.5 Two-man Foxhole with Continuous Stringers

The construction of the two-man foxholes is shown in Figs. 2.5 and 2.6. The figures show an underground corner view, with portions of the walls cut away. The overall inside dimensions of the foxholes were 2 ft long x 6 ft wide x $5\frac{1}{2}$ ft tall. The stringers were 1 ft above grade level, and the cover had overall dimensions of 5 ft x 9 ft overlain with about $\frac{1}{2}$ ft of loose earth and sandbags. On some of the foxholes, not shown, the cover had no overhang reducing the dimensions to 2 ft x 6 ft. The timber sizes and spans and the materials used in each foxhole are included in Table 3.3.

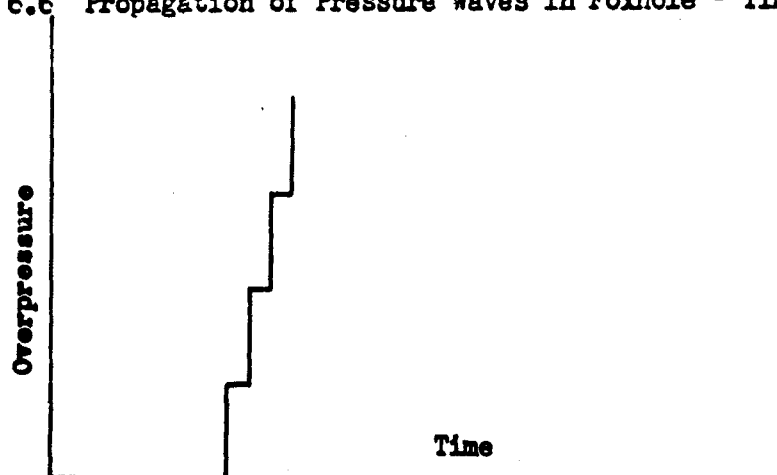
Fig. 6.7 Ideal Time-Overpressure Relationship in Cavity

The magnitude and time of the various steps in Fig. 6.7 depend upon such variables as the angle of incidence, incident overpressure, dimensions and aperture-volume relationship of the cavity, and position of point "A." The various surface irregularities, surfaces which are not perfect reflectors, and the interaction with the sidewalls will also tend to modify the shape of the curve. Because of the dependence of the wave propagation on the above-mentioned factors, the reflections shown in Figs. 6.2 to 6.6 give only an idealized representation of an actual situation.

Ideally, the overpressure build-up in an emplacement should
follow the characteristics shown in Fig. 6.7, showing three and possibly
more distinct "steps" in the process. Examination of the Wiancko gage
traces reveals that the initial build-up is indeed characterized by a
series of "steps." Each trace for both shots for foxholes 1 to 4 (those
that were uncovered) shows at least two of these steps, the presence of
which indicates that method of build-up described in the theory section
of this report is valid, at least to the point where the third or pos-
sibly fourth pressure wave travels past the instrument.

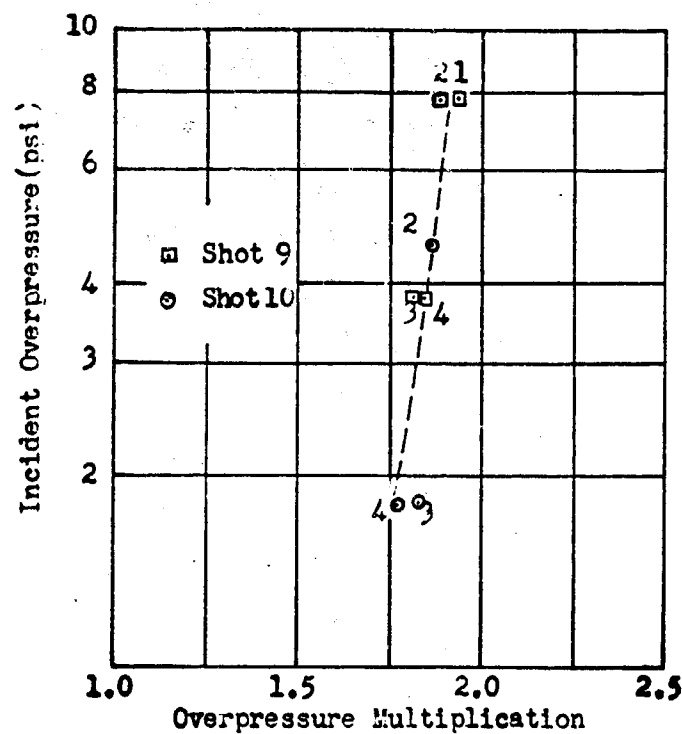
Fig. 9.1 Overpressure Multiplication Plotted as a
Function of Incident Overpressure

Plotting overpressure multiplication as a function of incident overpressure (Fig. 9.1) indicates--at least, in a preliminary nature--that the multiplication will increase with increased incident overpressure. Before a more reliable curve can be established, however, it is necessary to obtain a greater range of points on the graph.

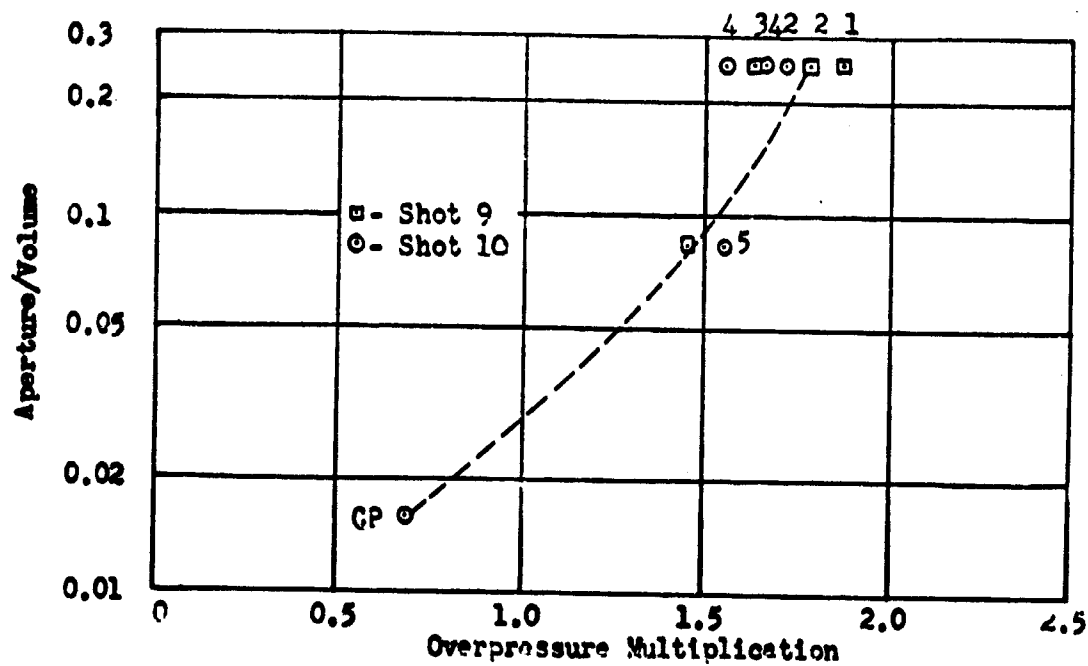
Fig. 9.2 Overpressure Multiplication Plotted as a
Function of Aperture/Volume

Figure 9.2 shows the overpressure multiplication plotted as a function of aperture-to-volume ratio. The points are connected by a dotted line which serves only as an indication of the trend. A more definite relation could not be established; because, as is seen in Fig. 9.1, the overpressure multiplication is also a function of incident overpressure. Had there been more command posts and type 5 (2/3 covered) emplacements placed at various overpressure regions, it may have been possible to draw a series of curves similar to the dotted one shown in Fig. 9.2, each for a different incident overpressure.

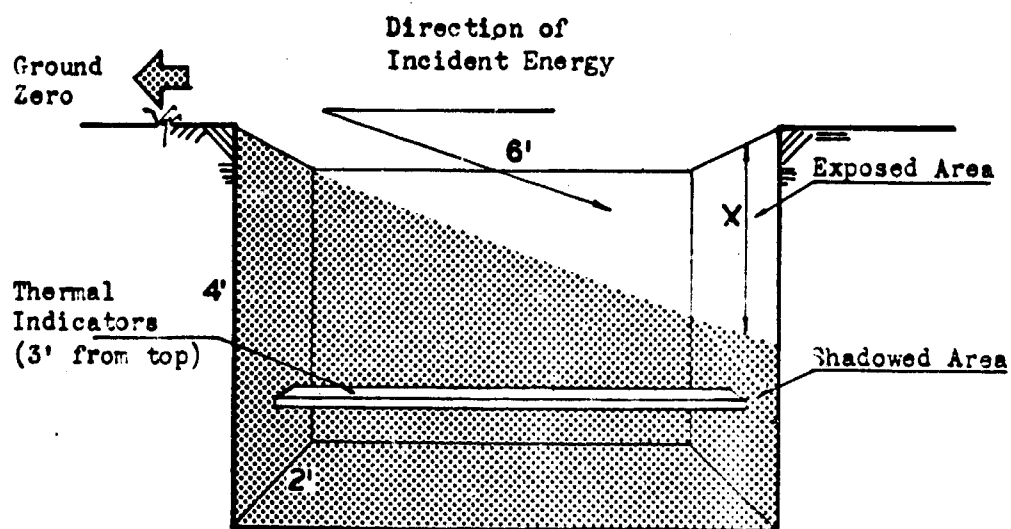
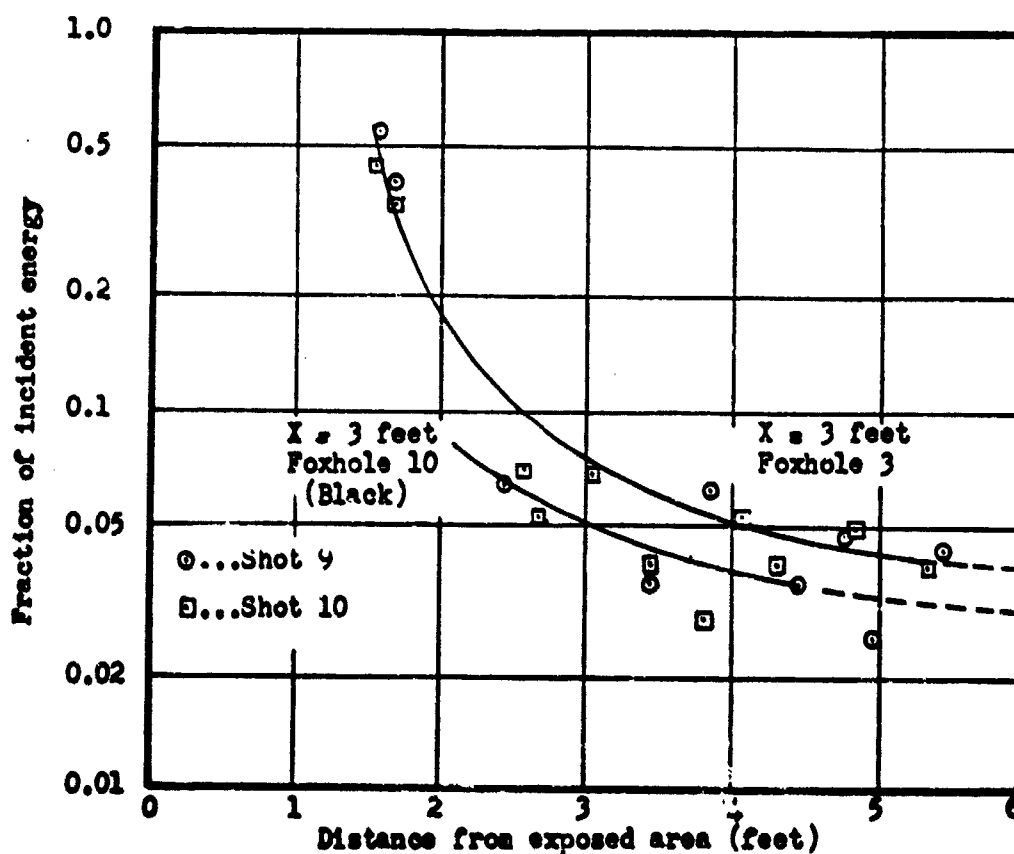
Fig. 13.13 Fraction of Incident Thermal Energy as a Function of Distance from Exposed Wall

Figure 13.13 gives the fraction of incident energy as a function of distance from the directly exposed wall for the 3 ft depth in the foxhole. In this emplacement, all of the walls (except that which was directly exposed) were coated with a low reflectance, flat black paint.

this effect, a foxhole was constructed in which the walls (except the one which was directly exposed to the incident radiation) were coated with a low reflectance, flat black paint. Fig. 13.13 gives the data from this foxhole and for a corresponding aluminum lined foxhole, and shows that the energy received by the black foxhole is lower by a factor of approximately 30 per cent when the receivers are relatively far from the source and is lower by a factor of approximately 40 per cent when the receivers are closer to the directly exposed wall. It must be noted that the data are of limited extent and may not be conclusive for other receiver positions.

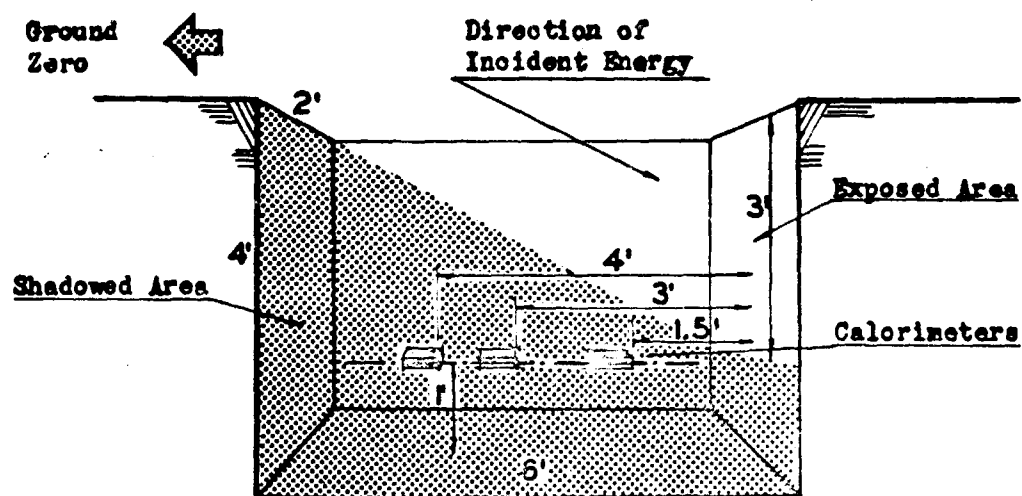
Fig. 13.14 Foxhole Cross Section

TABLE 13.1 - Calorimeter Results

Shot	Distance From		Energy	Fraction	Correction	Corrected
	Top	Exposed Wall			Factor	Fraction
9	3'	1.5'	8.85	.402	1.76	.708
	3'	3.0'	4.04	.183		.322
	3'	4.0'	3.70	.168		.296
	3'	1.5'	5.20	.452	1.64	.741
	3'	3.0'	3.36	.292		.479
	3'	4.0'	2.04	.170		.279

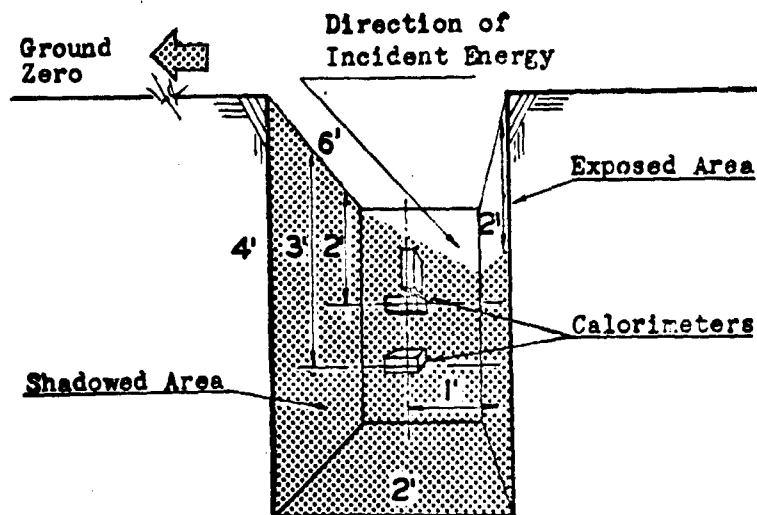
Fig. 13.15 Foxhole Cross Section

TABLE 13.2 - Calorimeter Results

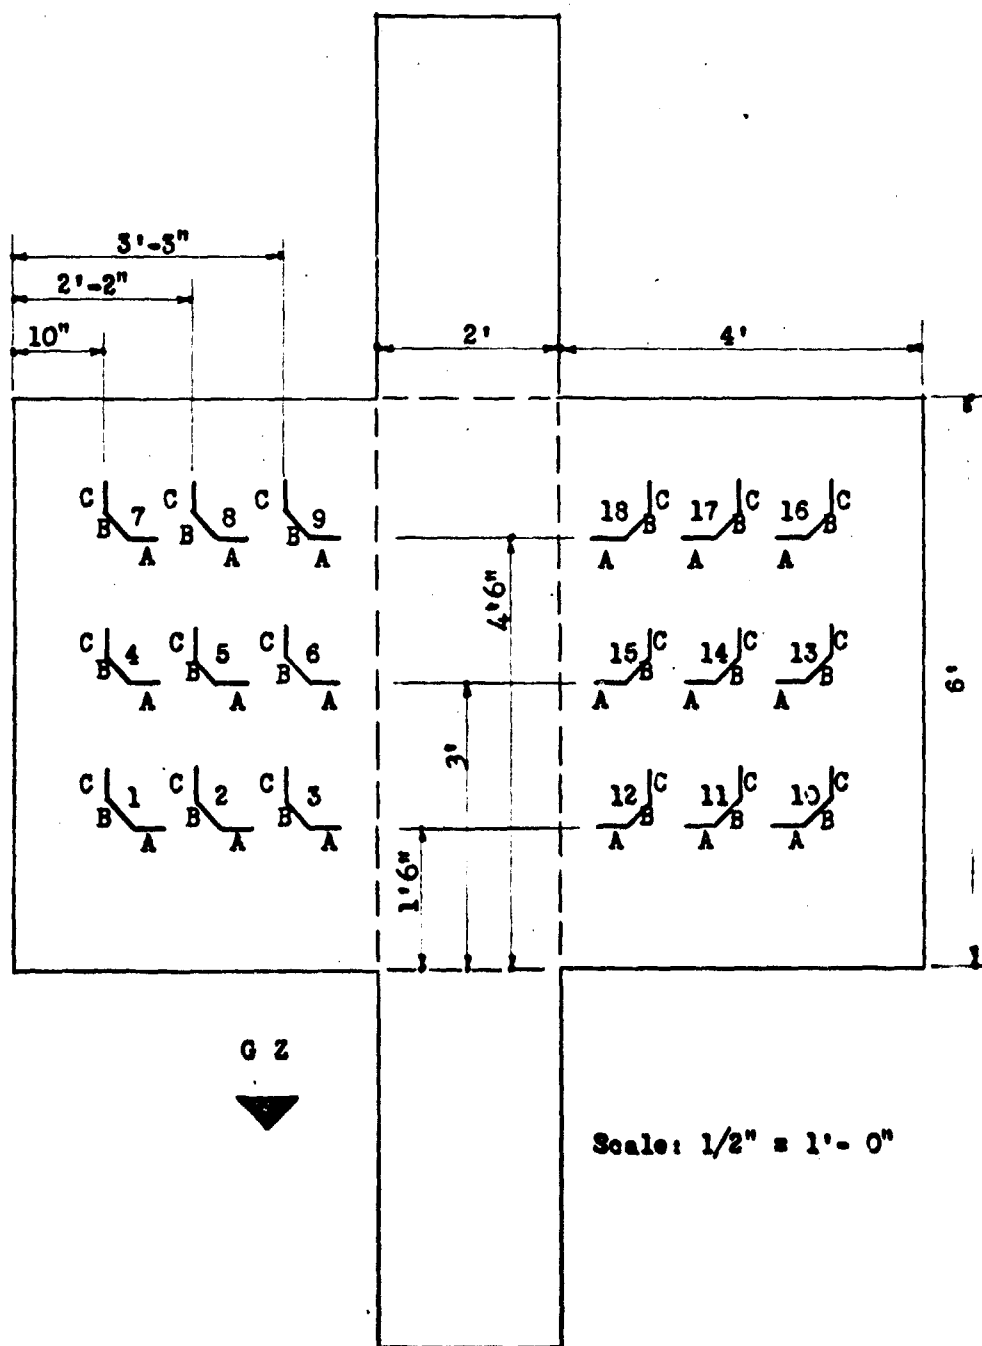
Fig. 17.1 Numbering of Film Badge Locations

One foxhole, 4000 ft from expected ground zero, along the East-West blast line was utilized for this experiment. The film badges were placed, numbered, and oriented as shown in Figs. 17.1 and 17.2.

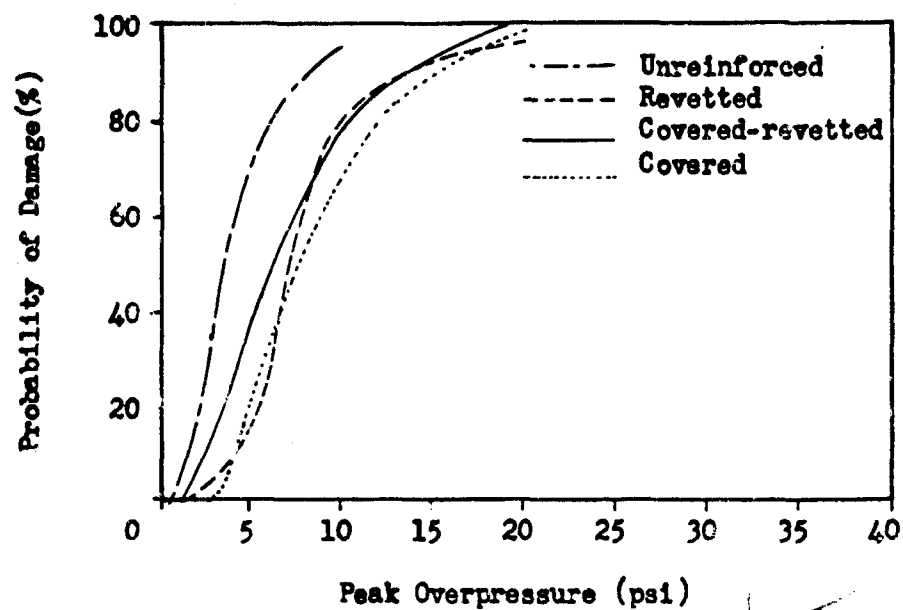
Fig. G.1 Probability of Blast Damage to Field Fortifications vs Peak Overpressure Scaled to 1 KT Based on Desert Rock Data From the Underground, Surface, and Air Bursts.

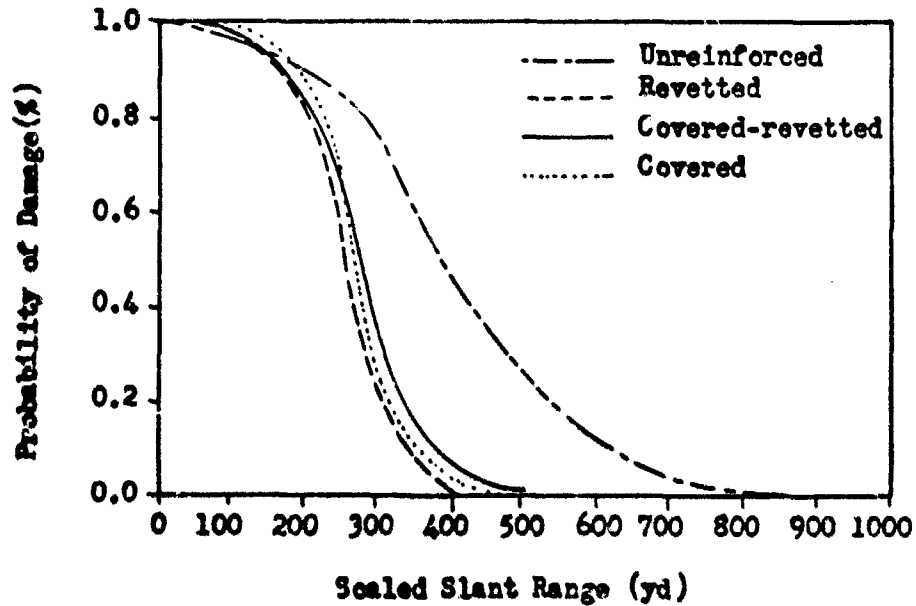
Fig. G.2 Probability of Blast Damage to Field Fortifications vs Slant Range Scaled to 1 KT Based on Desert Rock Data From the Underground, Surface, and Air Bursts.

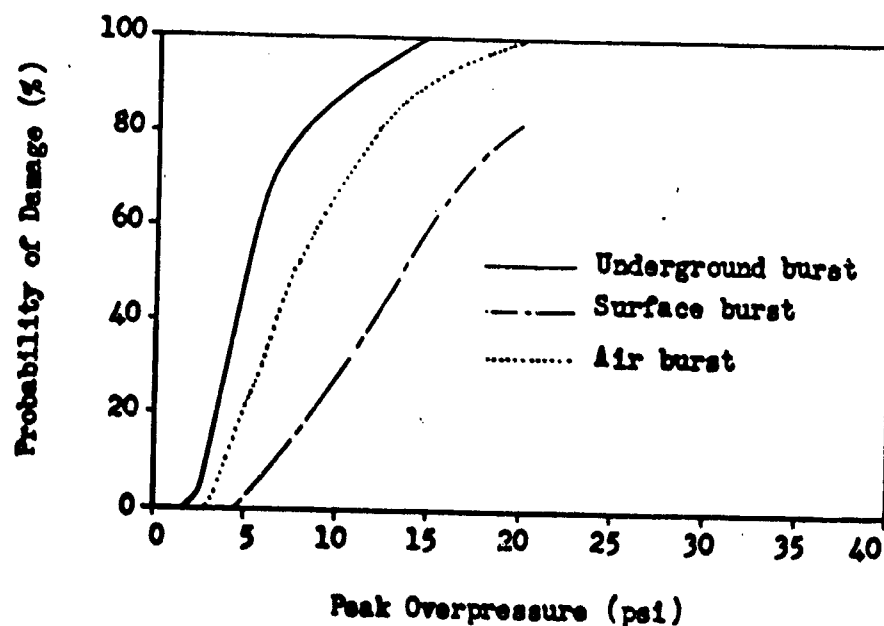
Fig. G.6 Probability of Blast Damage to Reinforced Field Fortifications vs Slant Range Scaled to 1 KT for the Desert Rock Underground, Surface, and Air Bursts.

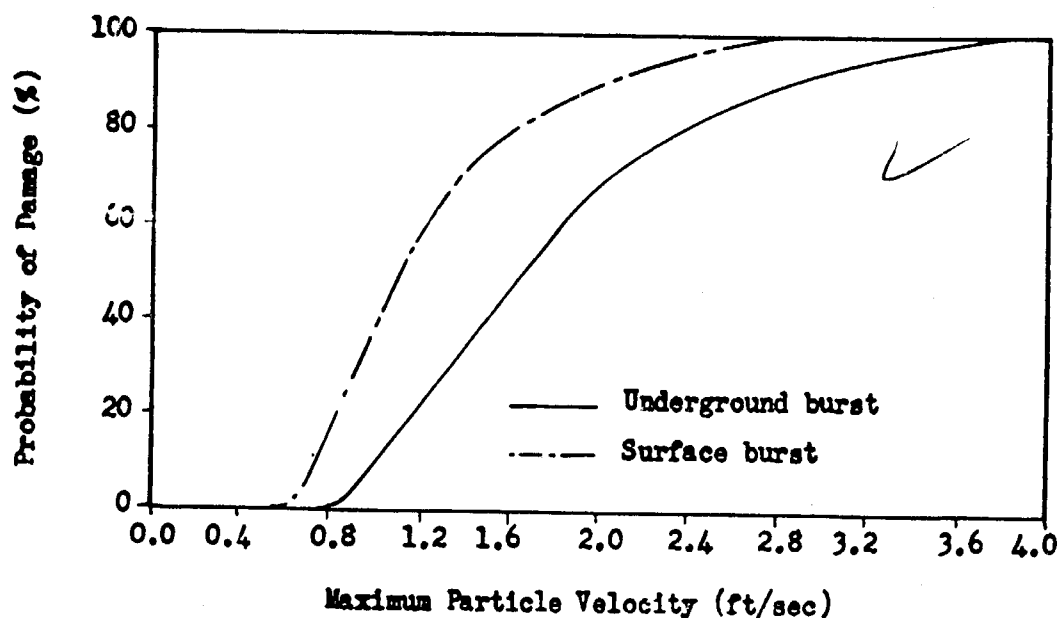
Fig. G.7 Probability of Blast Damage to Unreinforced Field Fortifi-
cations vs Maximum Particle Velocity Scaled to 1 KT for the

Desert Rock Underground and Surface Burst.

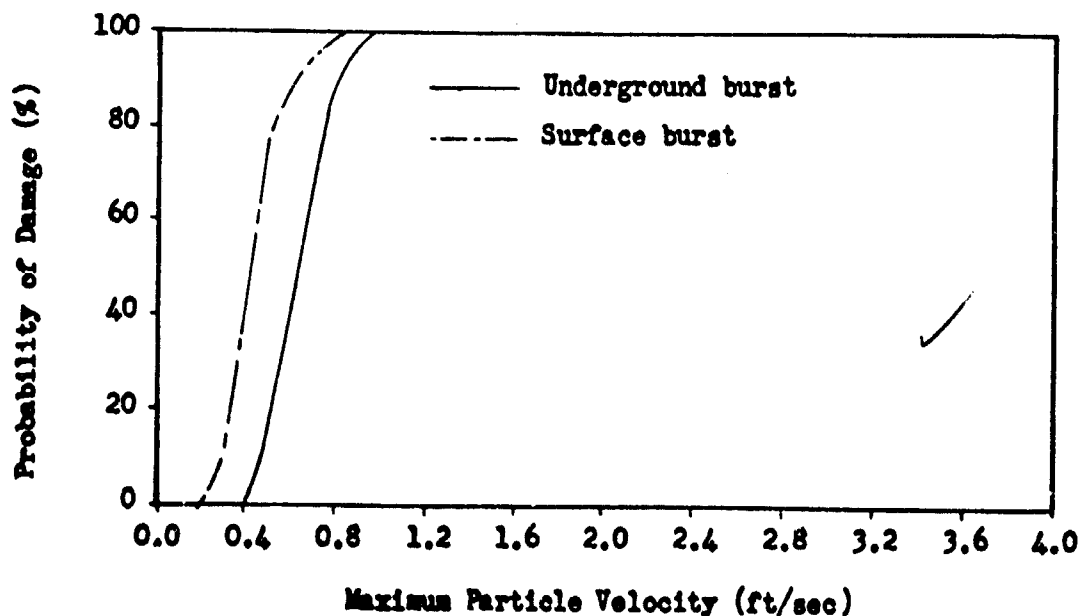
Fig. G.8 Probability of Blast Damage to Reinforced Field Fortifications
vs Maximum Particle Velocity Scaled to 1 KT for the Desert
Rock Underground and Surface Burst.
