AFRPL-TR-68-159-Vol I

# FINAL REPORT
# DEMONSTRATION OF 156 INCH MOTOR WITH SEGMENTED FIBERGLASS CASE AND ABLATIVE NOZZLE

## VOLUME I--MOTOR DESIGN AND FABRICATION (U)

THIOKOL CHEMICAL CORPORATION
WASATCH DIVISION
Brigham City, Utah

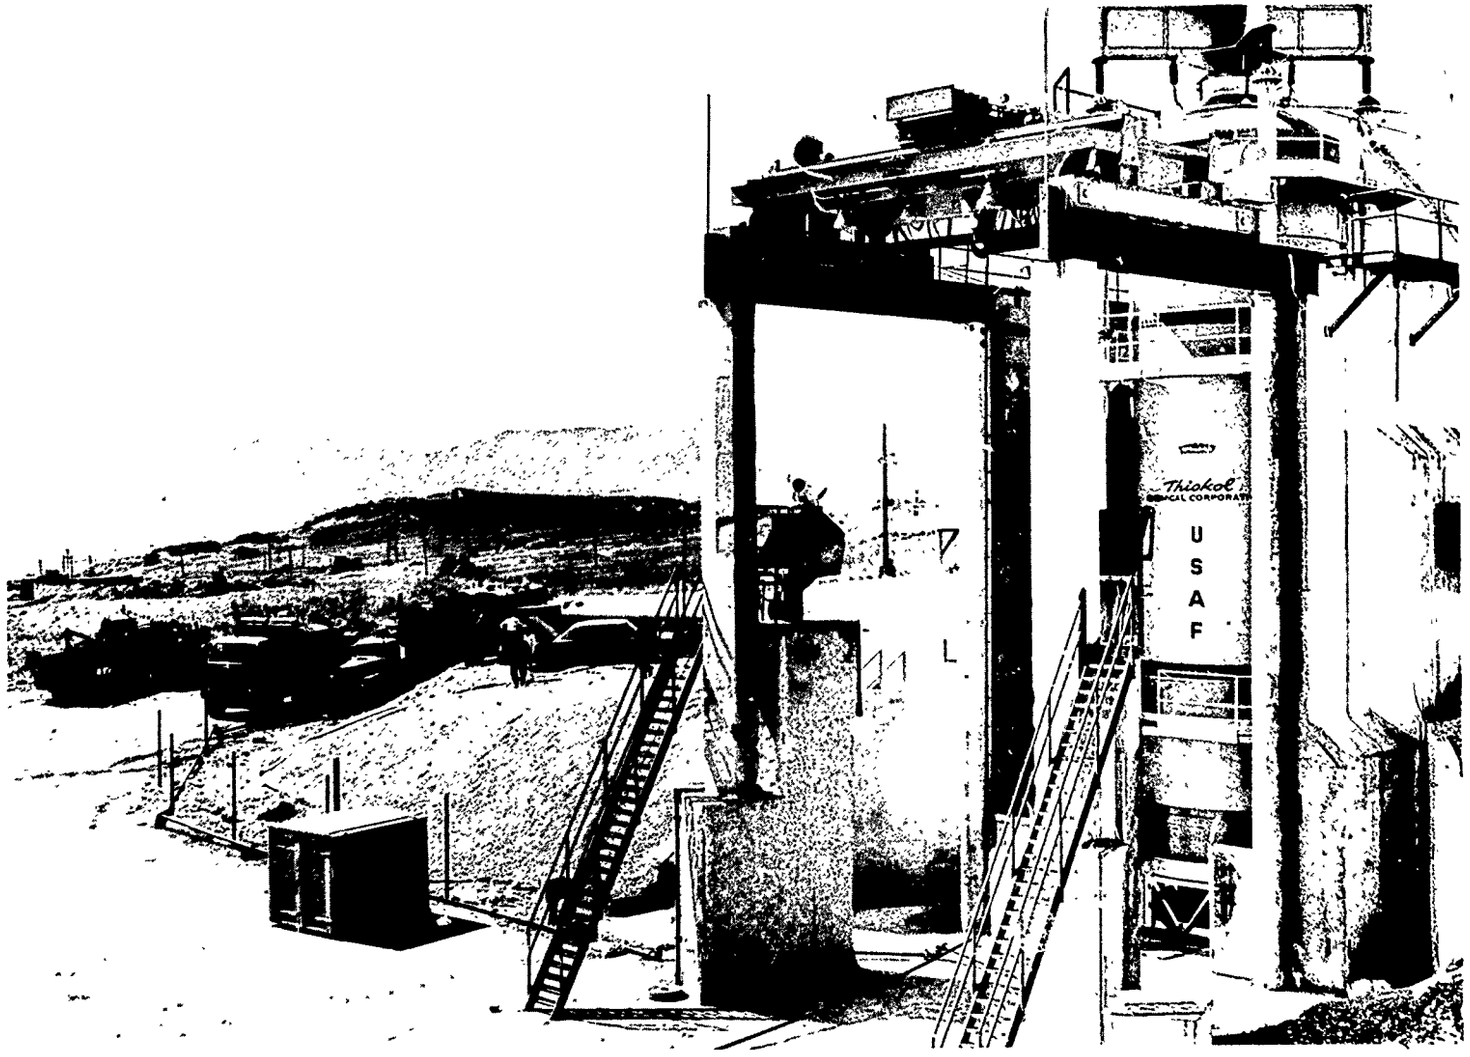
(U) Figure 5. 156-8 Case in Hydrotest Stand, Pressure Pump Trucks in Background

(U) The case performed as expected during the hydrostatic proof test. The replacement skirt transmitted a simulated thrust load of $1.73 \times 10^6$ pounds. The only evidence of damage from the test was loss of a glass cloth patch on the forward segment for retention of previously broken strands and failure of two strands in the aft segment. Both of these discrepancies could be repaired prior to subsequent use of the case.

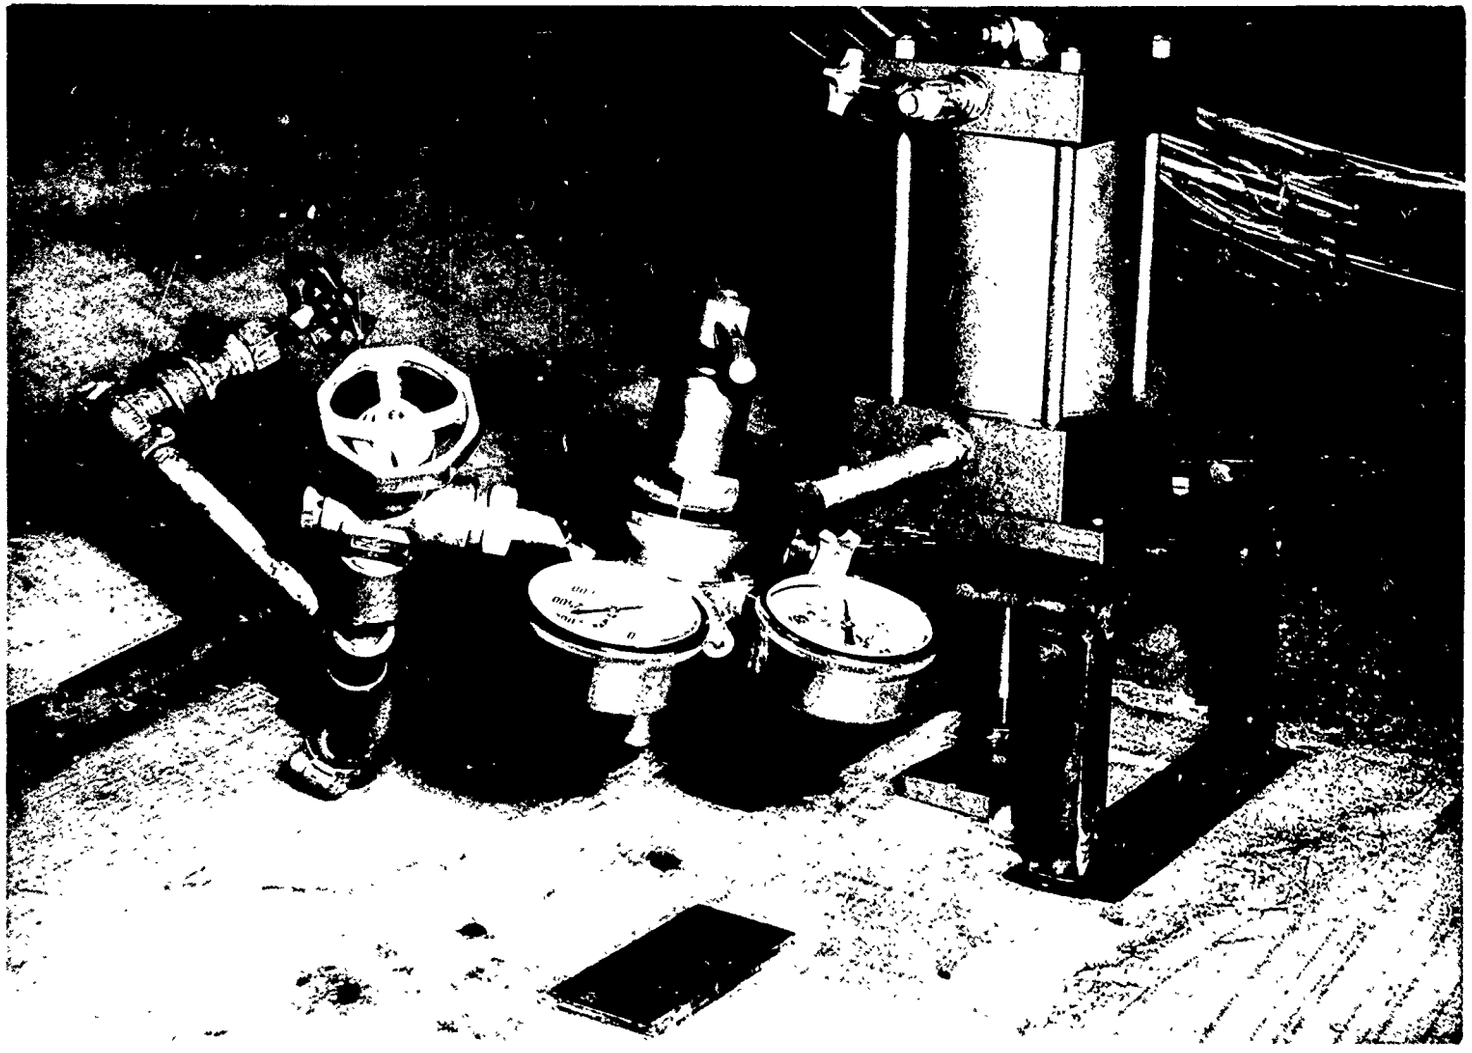
(U) Figure 15. Adhesion Test Arrangement

(U) The other test plate of each formulation was pulled for 1 min at 70 psi. The test arrangement is shown in Figure 15. All test plates passed the tensile adhesion test except the UF-3177 full load test plate in the center segment which failed after 57 sec at 70 psi. Inspection of the failed plate showed an actual bond area of approximately 4 sq in., indicating that failure had actually occurred above bond strength.

The tensile adhesion tests demonstrated that either UF-3119 or UF-3177 were adequate for bonding the replacement bladder into the segments. UF-3119 was selected because of superior working qualities.

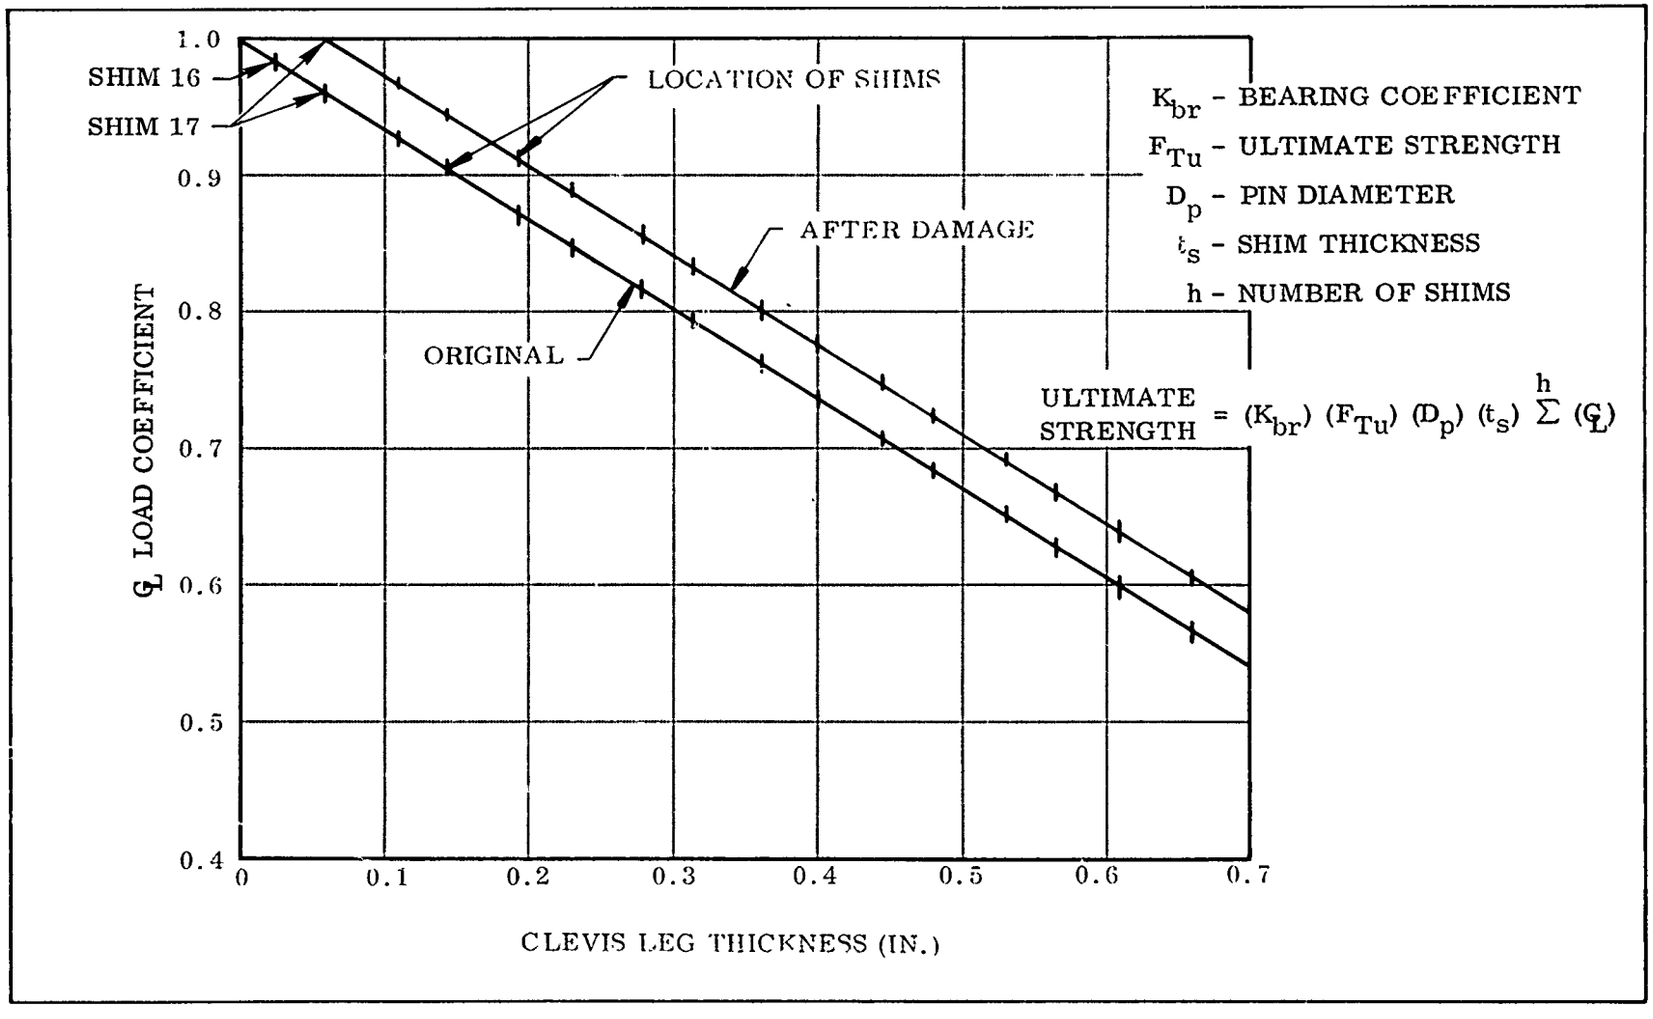
(U) Figure 18. Relative Deflections for Clevis Leg Shims

(U) The clevis joint was originally designed for an ultimate strength of 152,400 lb per clevis leg per pin. The shims next to the clevis gap (the No. 16 and 17 shims) were the most highly loaded shims in each stack, thus the loss of the No. 16 shims shifted the loading coefficient curve (Figure 18) and reduced the ultimate strength to 146,900 lb per leg per pin. Additional shims were removed during case assembly for static test. The minimum margins-of-safety were shown in Table III.

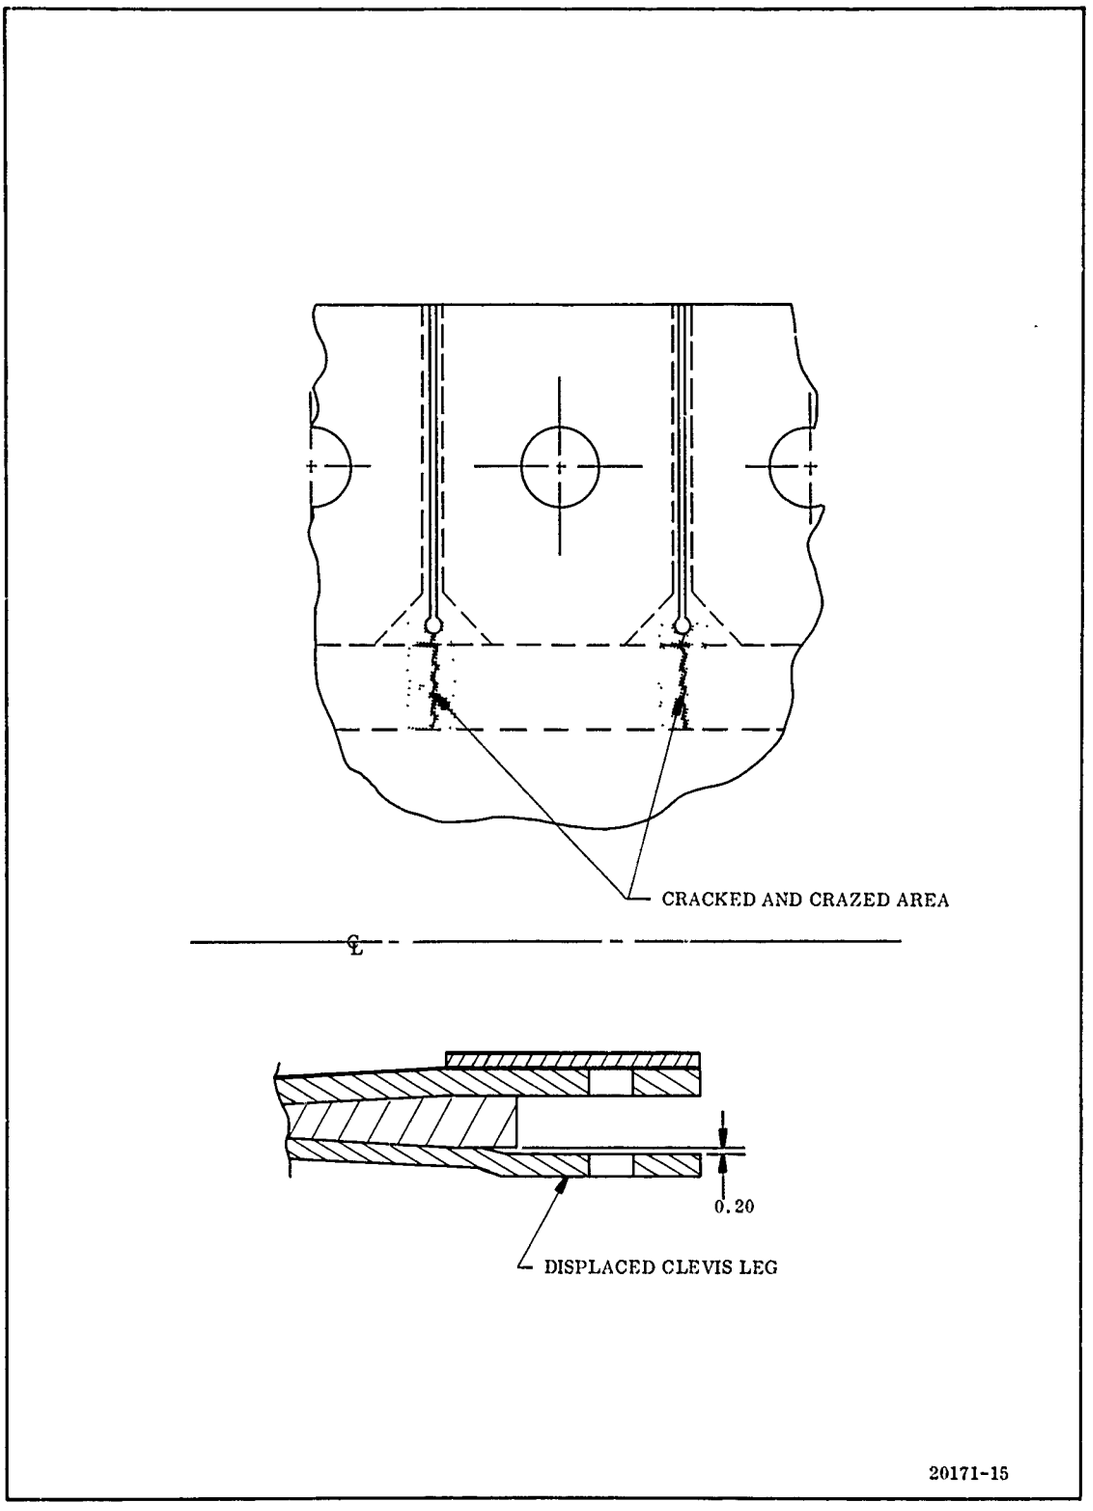
(U) There were three clevis legs on the forward segment that were damaged in the process of handling the case. The worst clevis leg was displaced 0.20 in. radially outward (Figure 19). Cracks progressed axially about 1.5 in. from the hole at the end of the saw cut between shims. The immediate area around the cracks

(U) Figure 19. 156-8 Damaged Clevis Legs

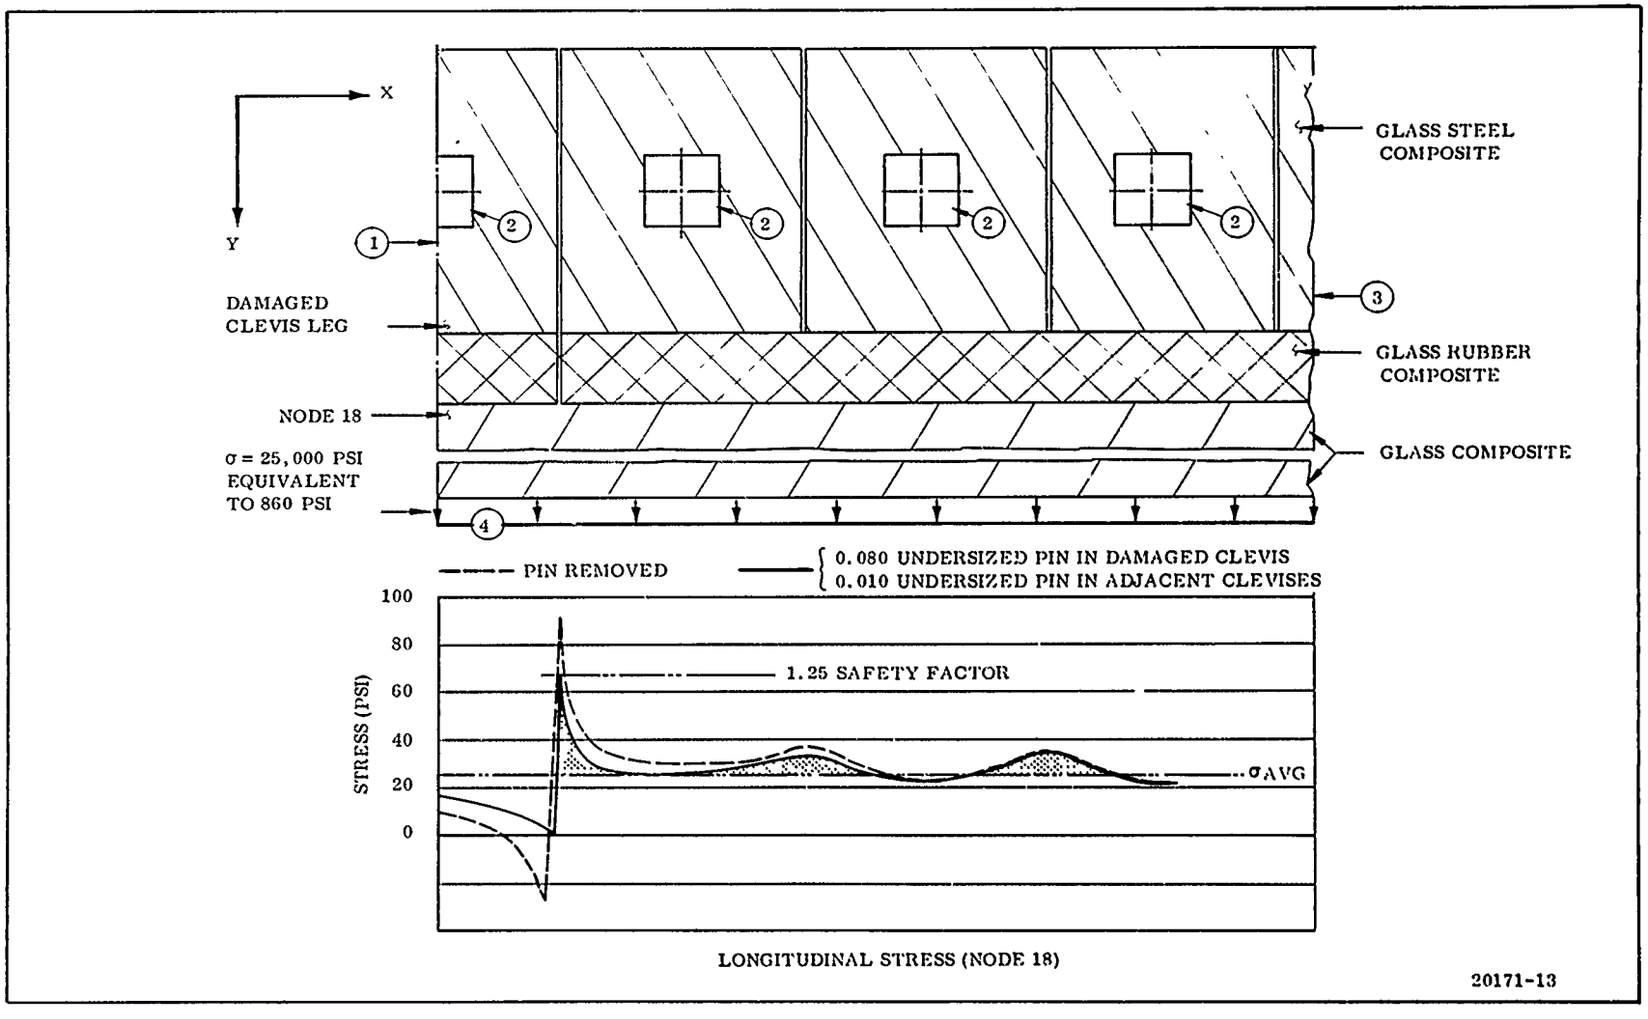
**(U) Figure 20. Results of Finite Element Analysis**

(U) It was felt that the pin should be removed from the damaged clevises because the extent of the fiber damage was not known. An orthotropic finite element analysis was used to analyze the pin removed condition (Figure 20). The input contained material properties in three directions for the glass steel composite, glass rubber composite, and the glass composite. Boundary conditions were the following: side one, free in the Y direction and fixed in X direction; side two in the area of the pins, fixed in the Y direction with a deflection in the X direction equal to the hoop deflection; side three, free in the Y direction with hoop deflection input in the X direction; side four, free in the X direction with a case load of 25,000 psi in the Y direction.

(U) It can be seen from the graph in Figure 20 that a high stress exists at the end of the cracked area. Stresses of that magnitude are unacceptable and, therefore, a pin must be added to the damaged clevis leg. If an undersized pin were inserted, the pin load would be reduced to a level that the damaged clevis could accept.

(U) A finite element analysis was conducted reducing the material properties in the area of the cracks to account for resin crazing. This analysis indicated that it may be possible to accept the load induced by pin removal. Since the amount of damage in the clevis leg was not known, the possibility remained that the damaged clevis might fail during firing. If the clevis did fail, there was a good chance that the joint would accept the static firing load.

(U) Several computer runs were made using different pin boundary conditions. After examining the information, it was felt that the optimum combination would be a 0.080 in. undersized pin in the damaged shim and a 0.010 in. undersized pin in the two adjacent clevises. This would result in 36 percent of the nominal load in the damaged clevis. From Figure 20 it can be seen that the effects of the undersized pins cannot be detected on the fourth clevis on either side of the damaged area. The clevis legs adjacent to the damaged clevis accept 122 percent of the nominal load. This condition did not affect the joint strength as static test pressure was considerably below the design pressure.

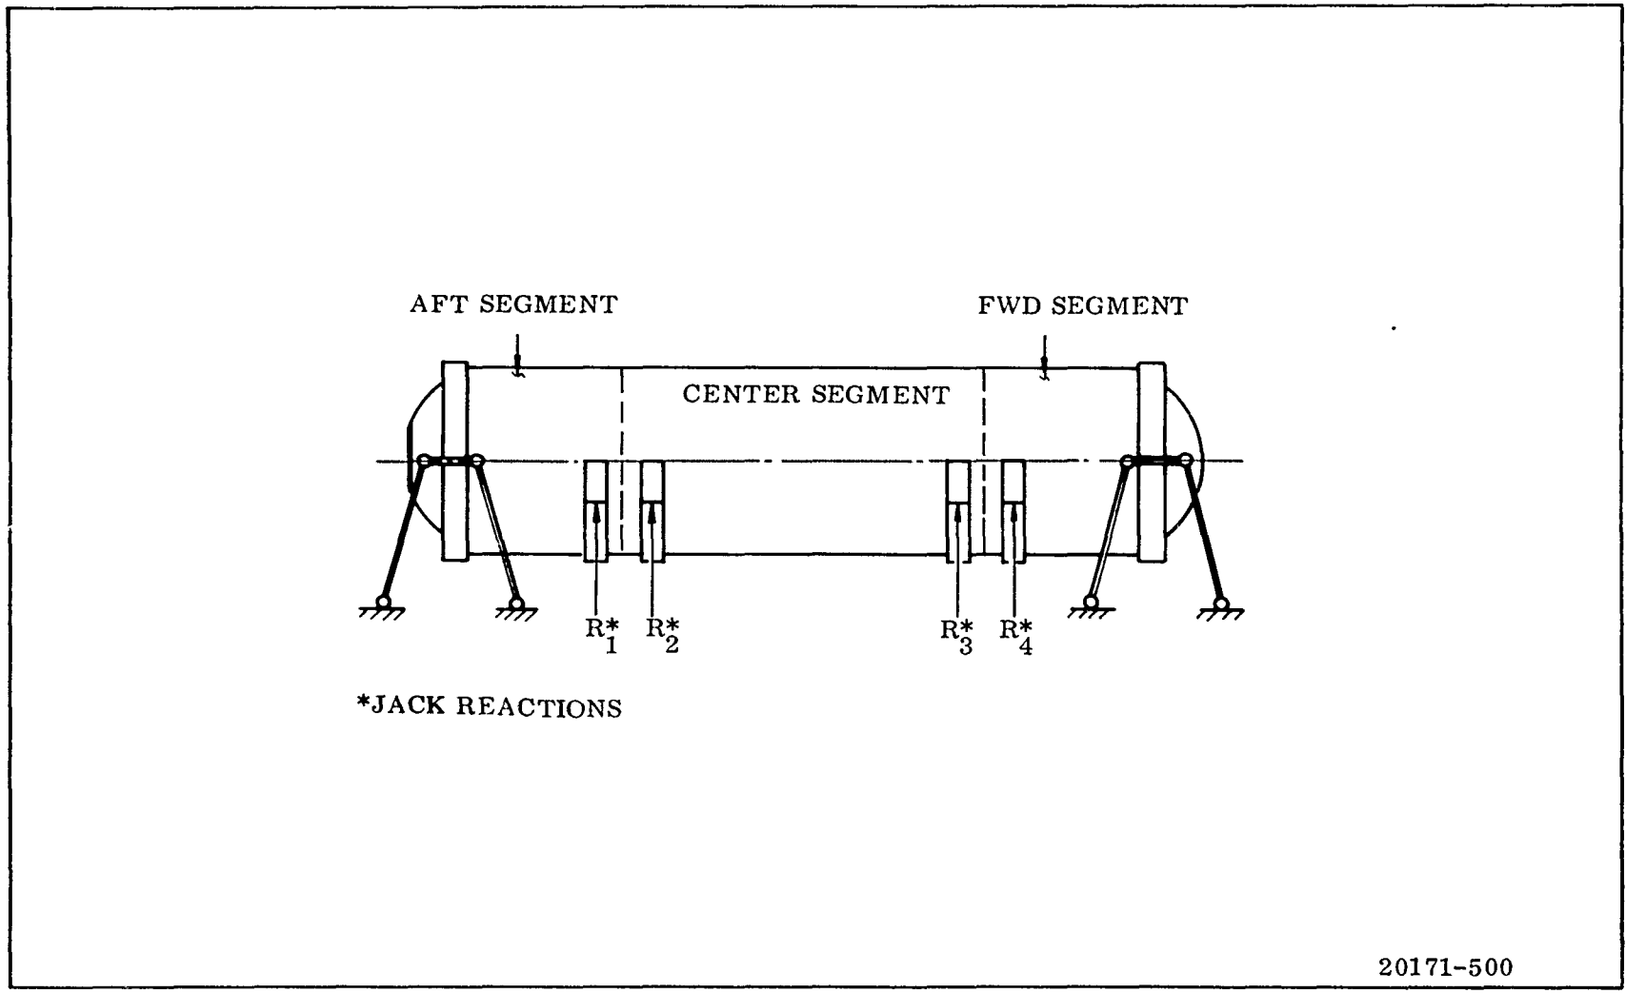
(U) Figure 22. Motor Support Schematic

(U) The aft skirt failed during motor assembly in the test stand. Prior to skirt failure the motor was supported by jacks and fore and aft trunnion supports shown in Figure 22. As the load was removed from the jack supports, the skirt case junction separated as shown in Figure 23. The total load was not removed from the jacks until the amount and cause of the damage could be assessed. After investigating the cause and type of damage, it was apparent that the motor could not be fired without repairing the skirt or supporting the motor in a different manner.

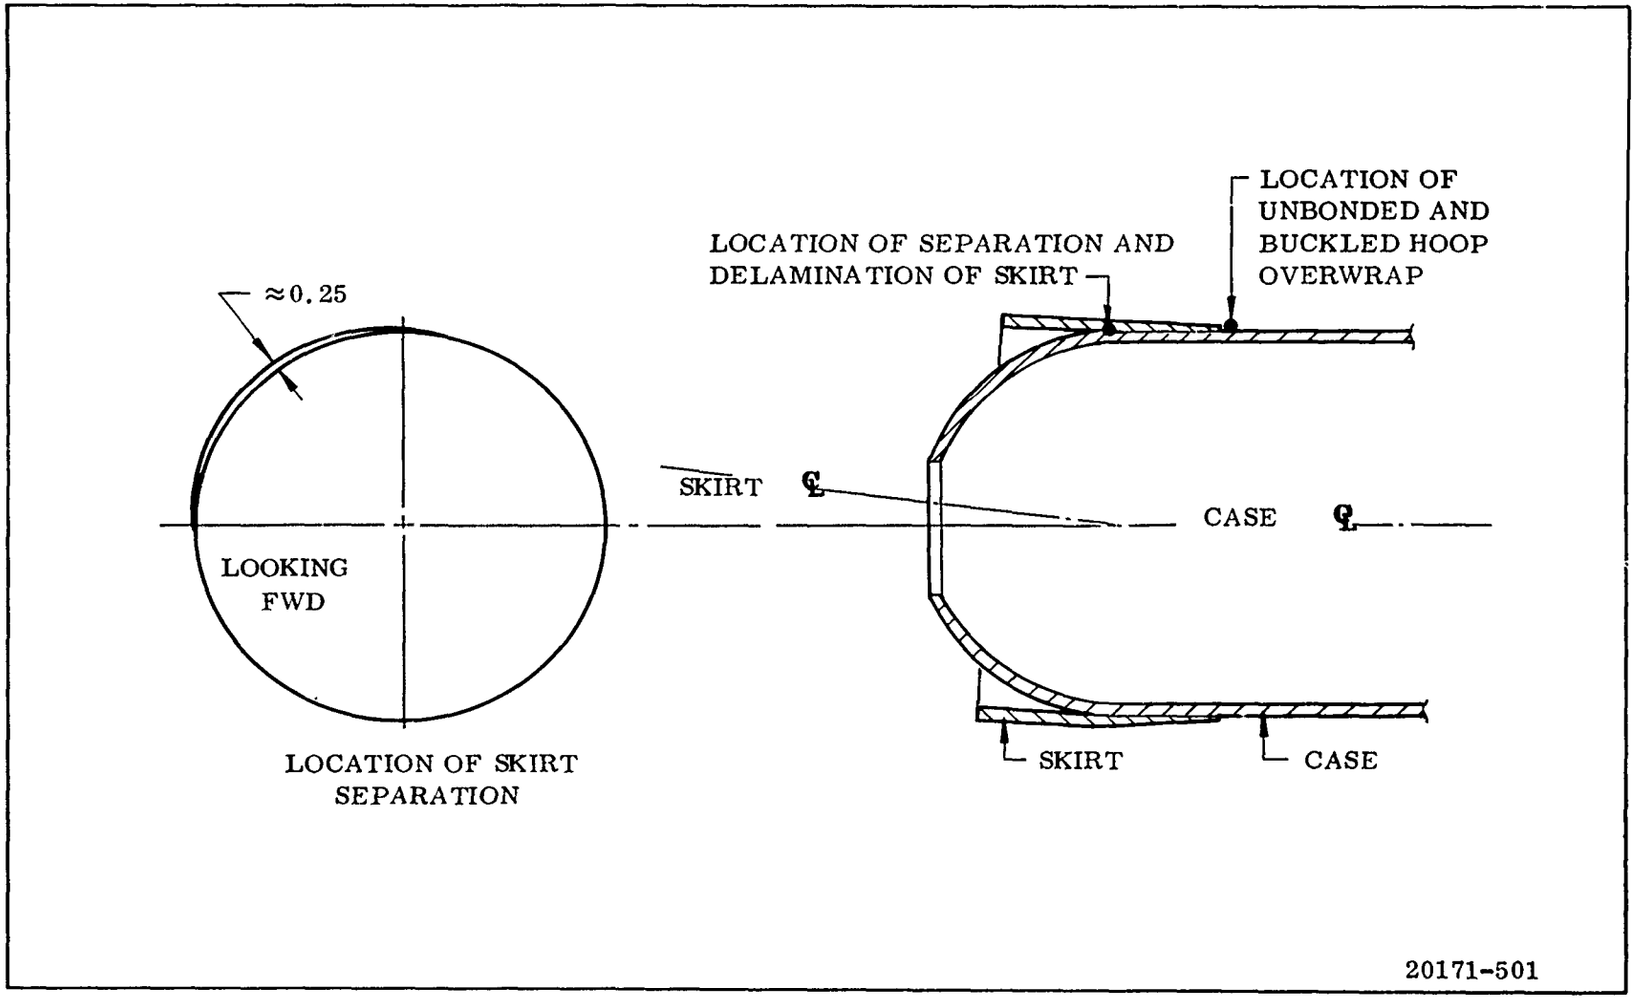
(U) Figure 23. Skirt Unbond Location

(U) The failure occurred in the skirt laminate and not between the laminate and rubber shear ply. Fore and aft movement of the skirt relative to the case was detected on the outer surface of the case. The 2.5 layers of hoop at the forward end of the skirt were buckled and had separated from the skirt in many areas.

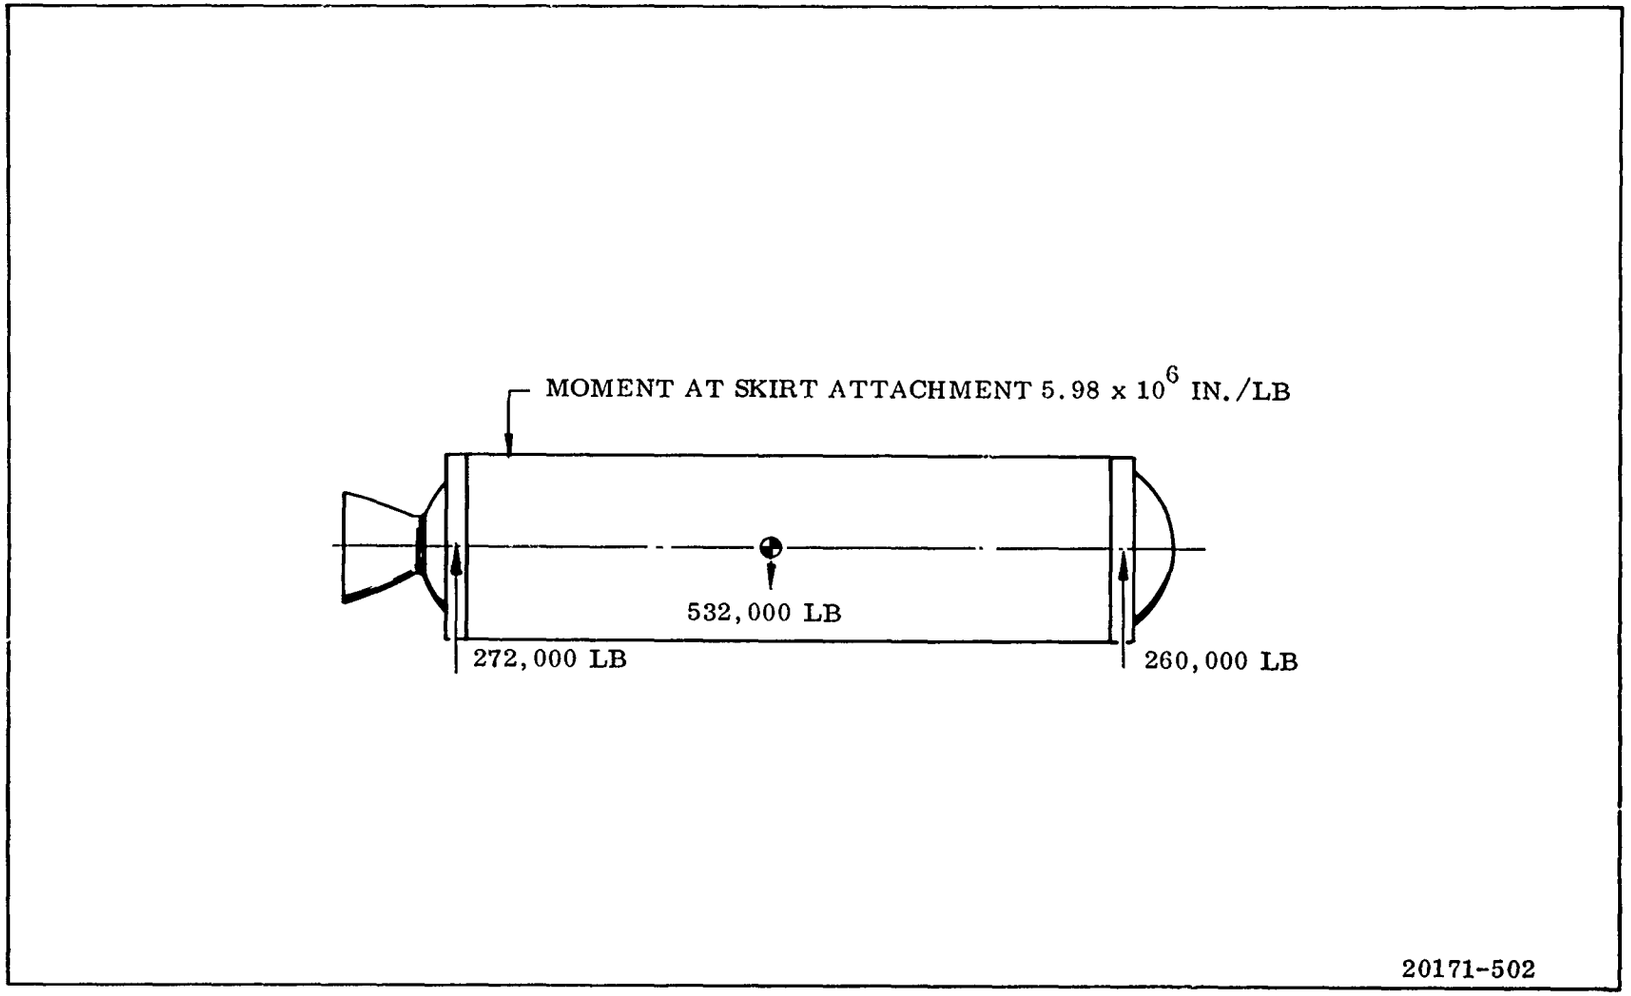
(U) Figure 24. Static Reaction Loads

(U) The failure of the skirt was caused by a combination of compressive loads and interlaminar tension. Figure 24 shows the static reaction loads on the case. The shear load from the case tends to be transferred through the rubber shear ply into the skirt. The shear deformation in the rubber changes the load distribution in the skirt from a pure cosine shear distribution to a cosine normal load distribution supported by shear as shown in Figure 25(A). Taking a section of the skirt as a ring it can be seen that the top 90 deg of the ring is in compression, and has the

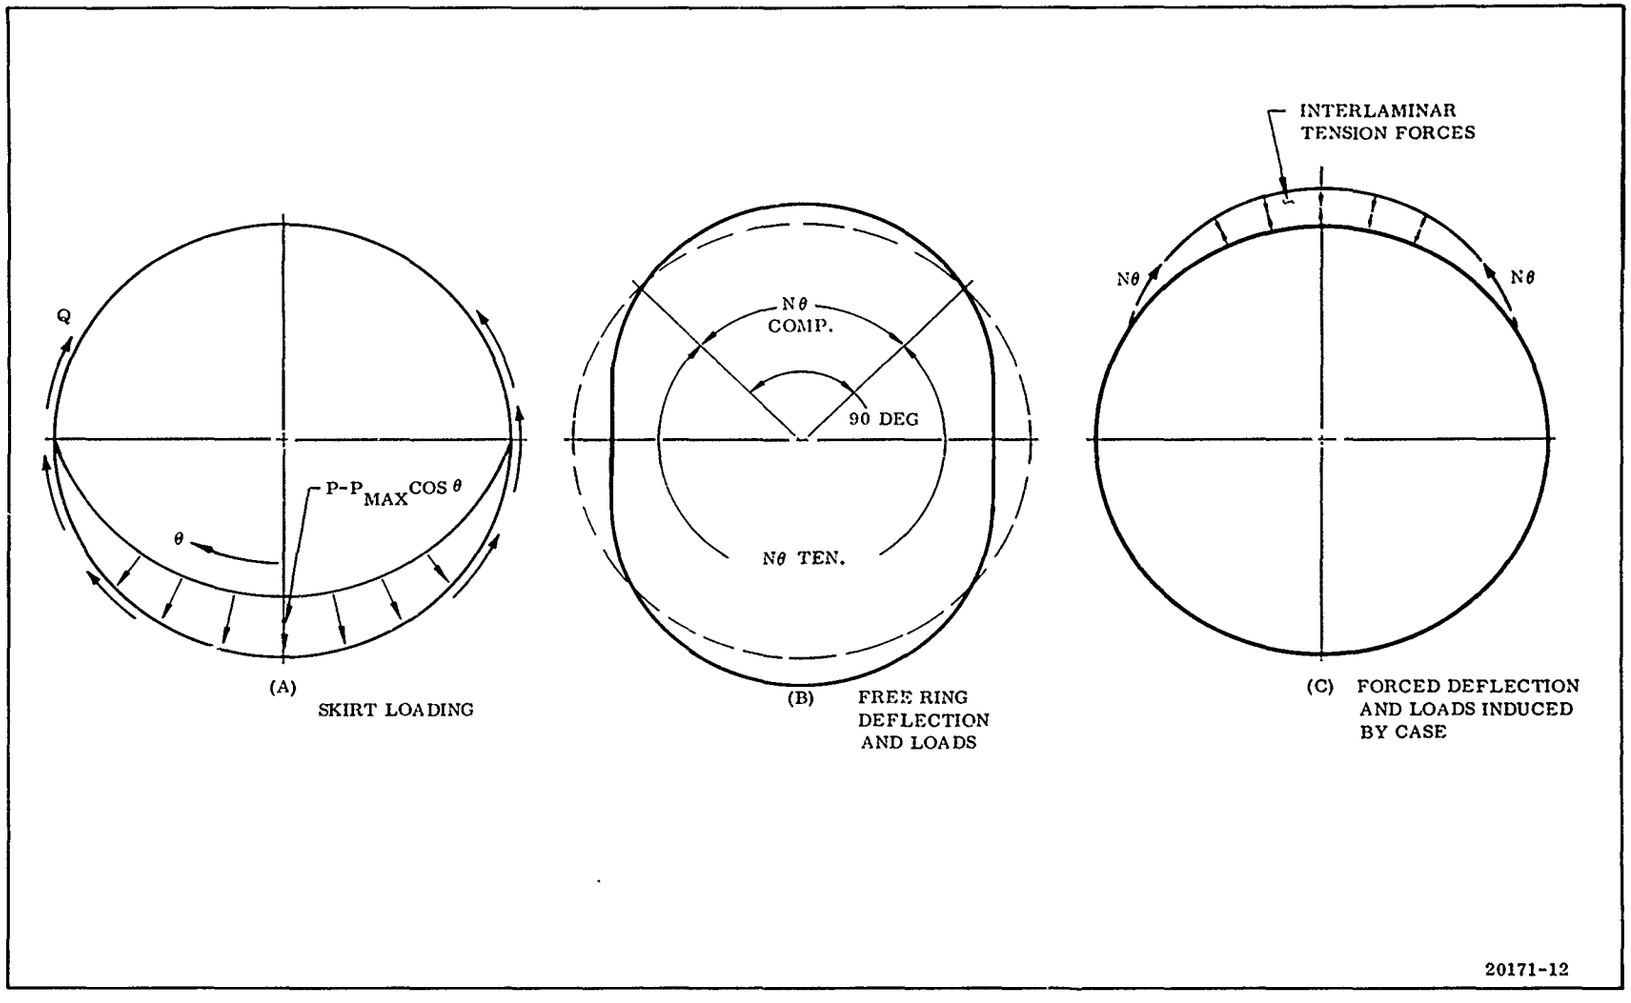
**(U) Figure 25. Deflections and Loads**

free deflection shape shown in Figure 25(B). The case forces the lower half of the ring to remain round with the deflection shape shown in Figure 25(C). The case also tends to force the top of the ring to conform to the case shape, thus inducing tension forces in that area.

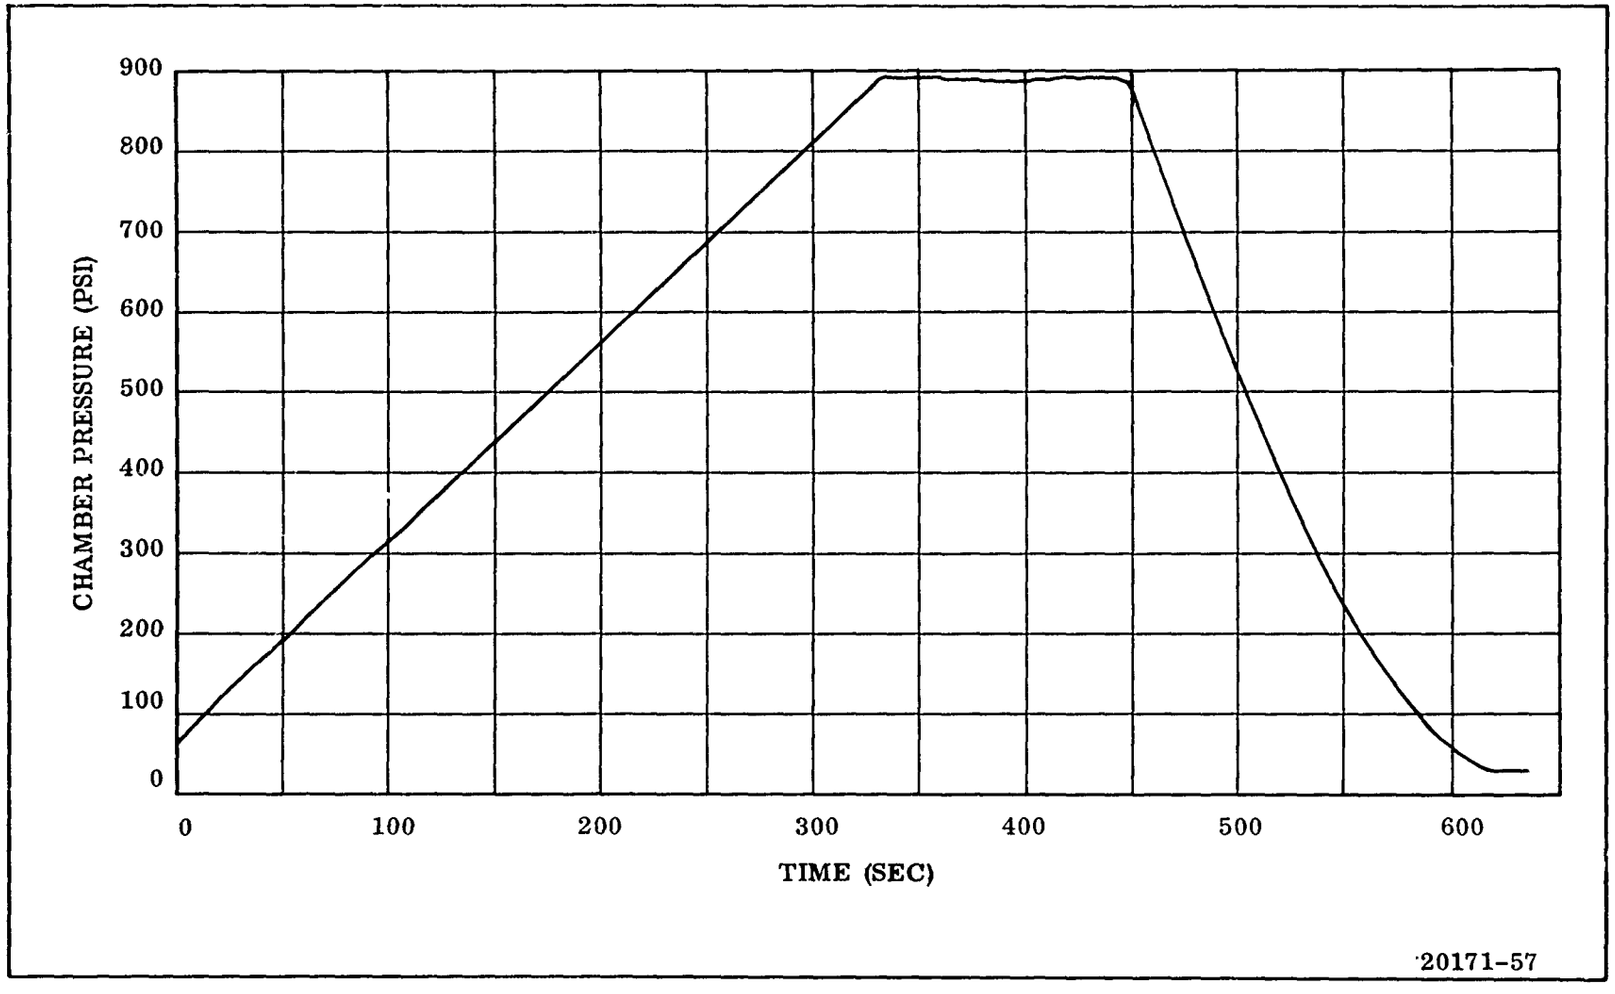
(U) Figure 74. 156-8 Case Hydrotest Pressure Trace

(U) During the hydroproof pressurization, the pressure was gradually increased from 35 psig to 60 psig. At 60 psig, the instrumentation recording systems and slow speed motion movie cameras were started. Pressure was increased at an average rate of 2.3 psi per second to a maximum of 896.8 psig (Figure 74).

High speed cameras were started at 720 psig as the pressure was increased. Pressure was maintained within the 890 (± 10) psig tolerance for 123 sec before being decreased at a rate of approximately 6.3 psi per second to 33 psig.

(U) The case withstood the pressurization cycle with no structural failure and no leakage whatsoever in the joint areas, forward segment dome, center segment, aft segment, and head end cap. Post-test inspection revealed a small amount of seepage from the case wall at the three degree position 42 in. forward of the forward joint in the cylindrical portion of the forward segment.

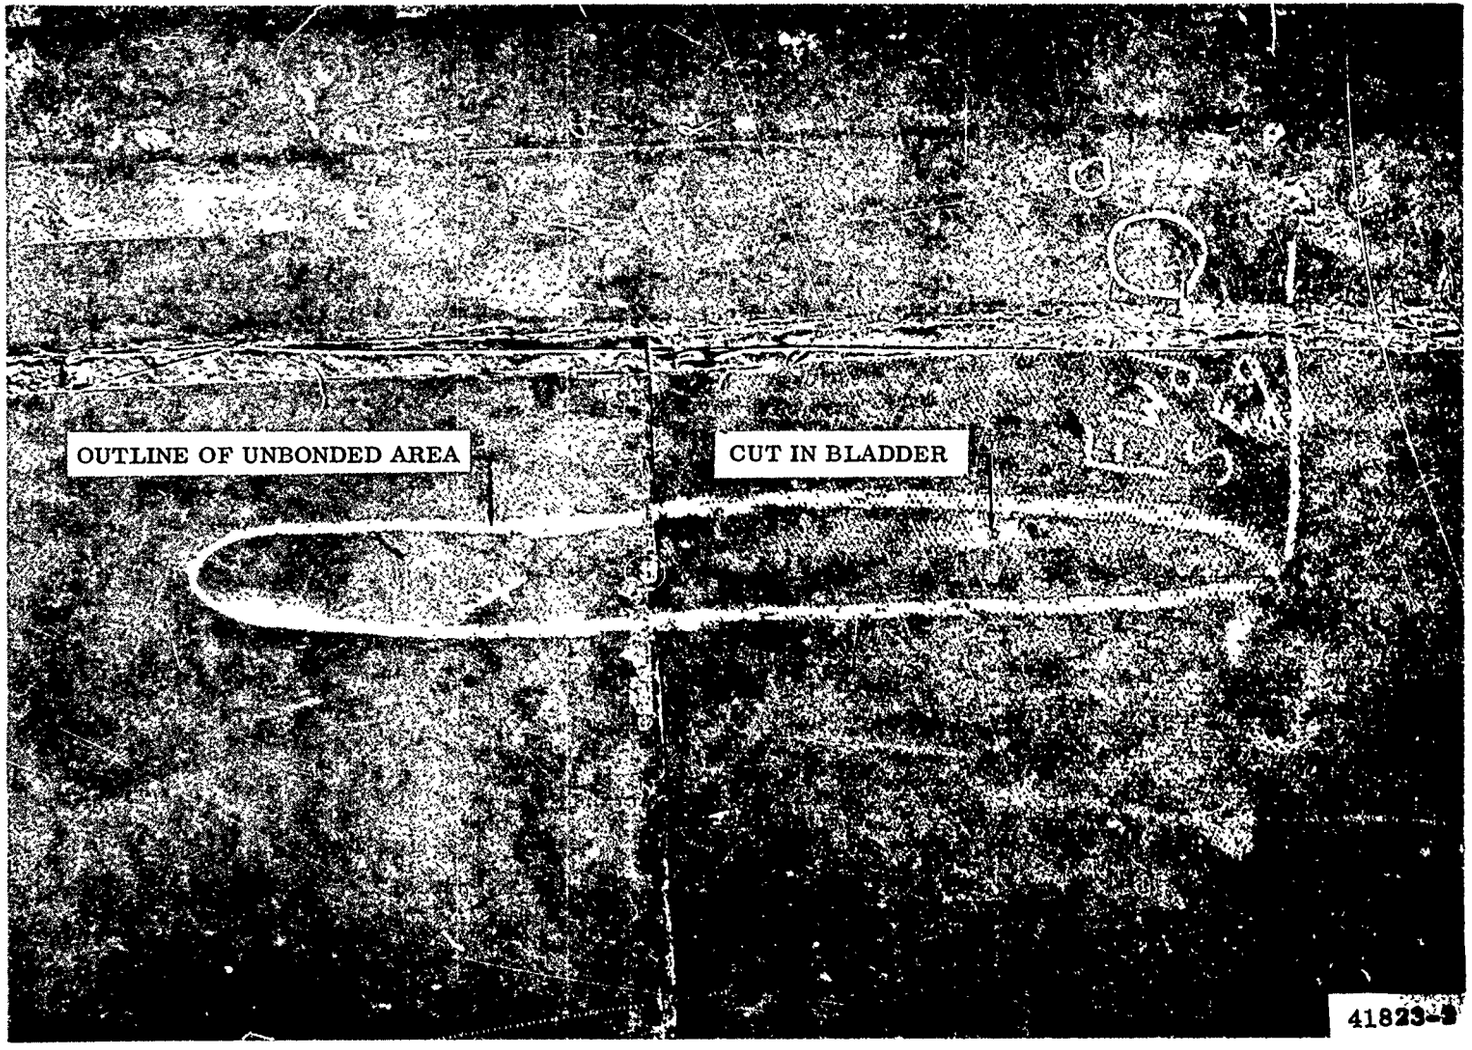
(U) The case withstood the hydrotest with no structural failure and no leakage in the joint areas. There was a small amount of leakage in the forward segment 42 in. from the joint. Post inspection revealed a small cut in the bladder. The cut was repaired by patching with Buna-N prior to loading the segments for static test.

(U) Figure 75. Defect in Bladder

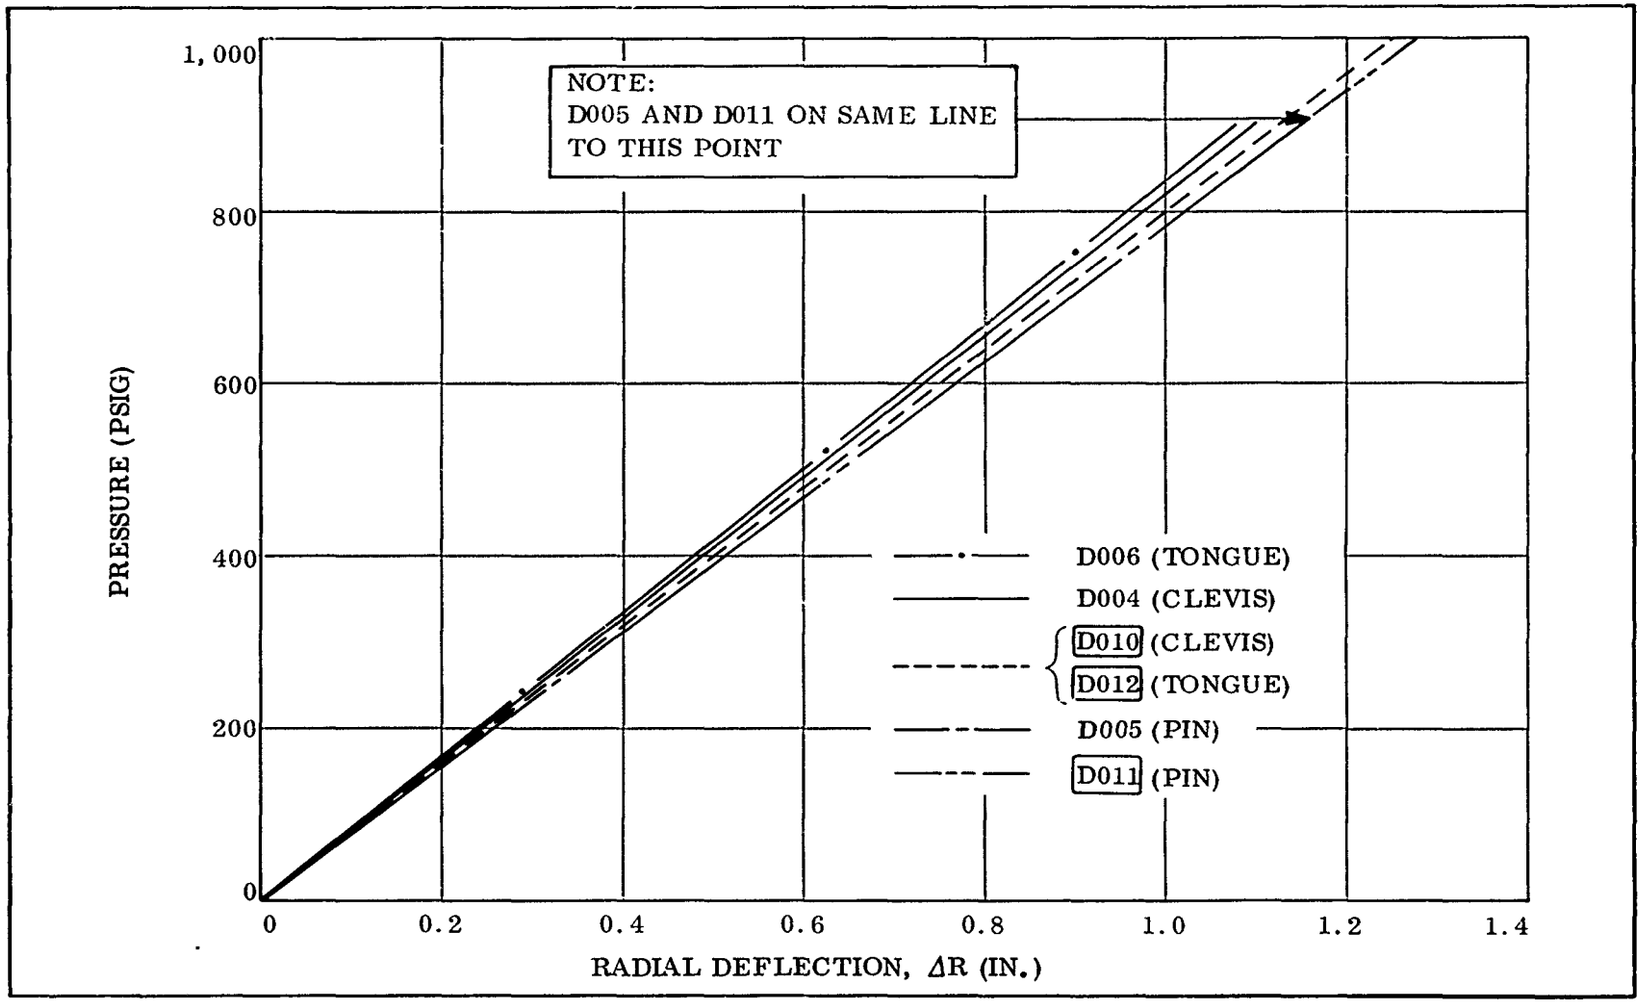
(U) Figure 77. Forward Joint Deflections

Relative gage locations and data separations are shown in Figures 67 and 76. Figures 77 and 78 depict forward and aft joint raidal deflections, respectively, and show excellent correlation of test results and anticipated deflections. Figure 79 shows forward skirt deflections. The 0.1 in. difference between D024 from previous hydrotest and D001 of this hydrotest at 900 psig did not result from any structural change. The difference is within the expected variation due to normal gage location error and normal instrumentation system error.
