AFRPL-TR-68-159-Vol I

# FINAL REPORT
# DEMONSTRATION OF 156 INCH MOTOR WITH SEGMENTED FIBERGLASS CASE AND ABLATIVE NOZZLE

## VOLUME I--MOTOR DESIGN AND FABRICATION (U)

THIOKOL CHEMICAL CORPORATION
WASATCH DIVISION
Brigham City, Utah

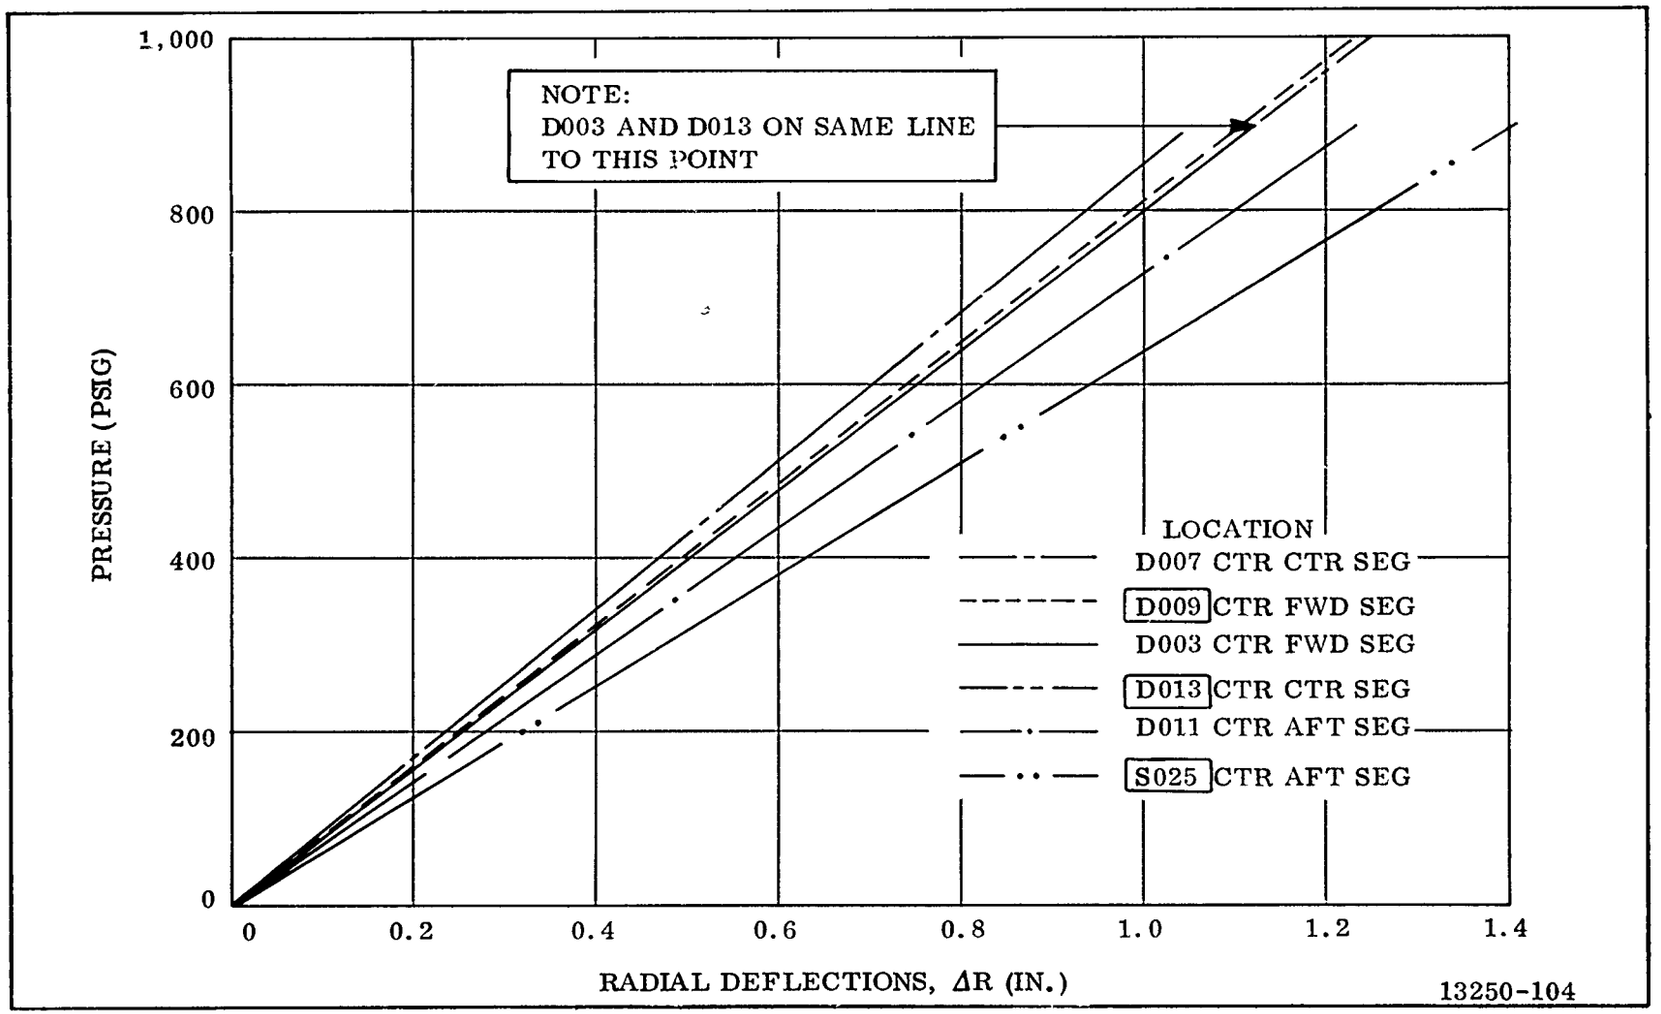
(U) Figure 80. Case Deflections

(U) Figure 80 shows deflection measured at the center of each segment. The greater deflections of the cylinder in this hydrotest when compared to those of

the same location of the previous hydrotest were attributed to the reduction of glass thickness during bladder removal. However, no quantitative conclusion can be reached since the difference again is within the expected range of error due to gage location and instrumentation system data acquisition.

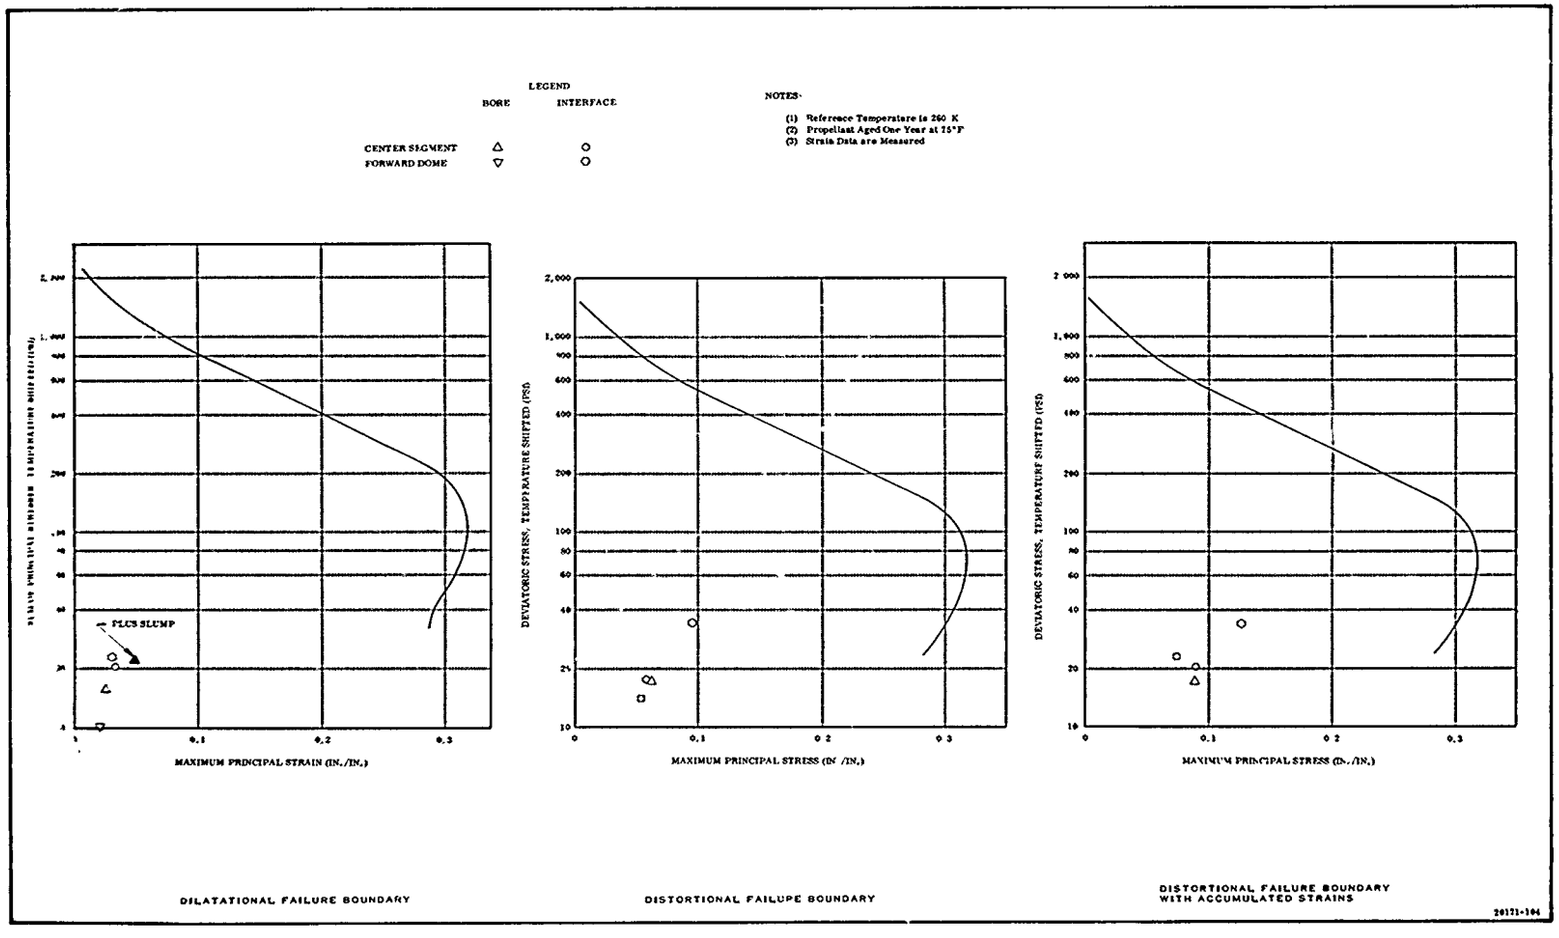
(U) Figure 100. Failure Criteria for 156-8 Grains

(U) Computation of the failure criteria is very straightforward and requires only superposition of the above tabulated stresses and strains on the proper failure boundary. Figure 100 presents the dilatational failure boundary. Since the failure boundary is independent of path, only the end points for each case are shown. As can be seen in Figure 100, dilatational load conditions do not approach the boundary limit. Figure 100 presents the distortional failure boundary, where pressure effects are considered independently of shrinkage effects. Again, no point reaches the boundary. Finally, the distortional and dilatational effects are accumulated and presented in Figure 100.

(U) As has been seen above in Figure 100, the 156-8 grains do not approach the failure boundary for any specific loading conditions. Further, even the accumulated loading effects do not approach the boundary. To illustrate the excellent structural characteristics of the 156-8 grains, margins of safety were compiled for the various loads (Table XXXV). As can be seen, the least margin is greater than 1.79; hence, it must be assumed that no deleterious propellant structural conditions will occur in the 156-8 motor.

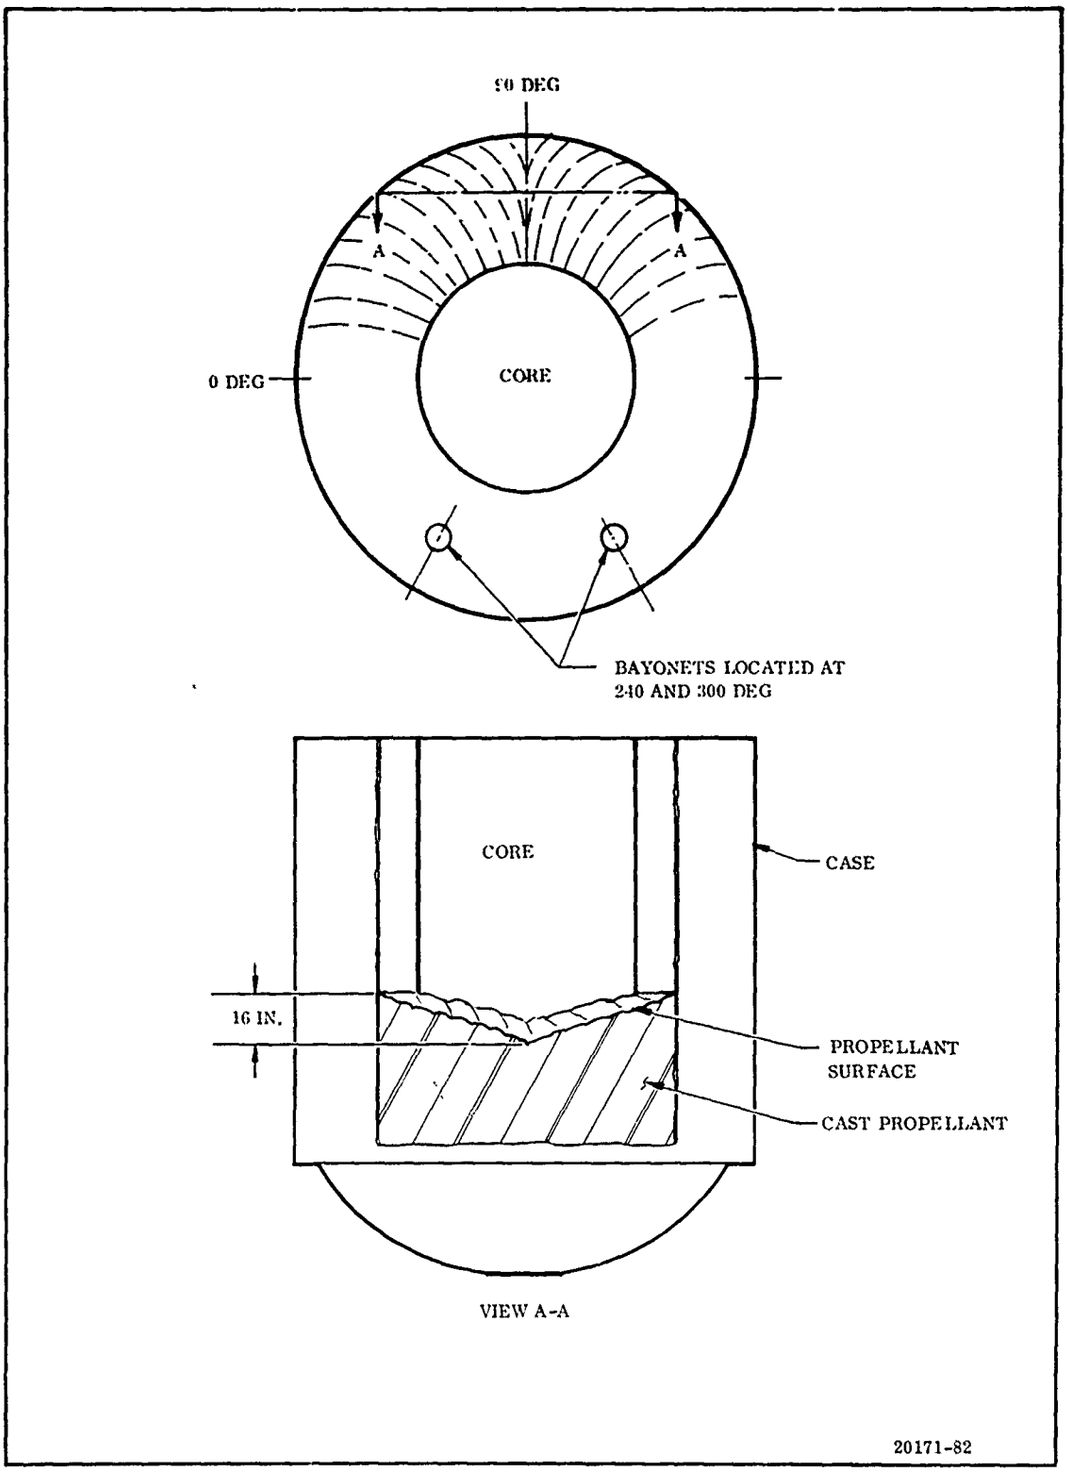
**(U) Figure 111. Schematic of Propellant Folding Condition in Forward Segment**

(U) When the folding condition was noticed, arrangements were immediately made to cast from a single 6 in. bayonet at the 90 deg location. The existing bayonets were raised to the propellant surface in an attempt to allow the propellant flow across the surface rather than down into the cast propellant.

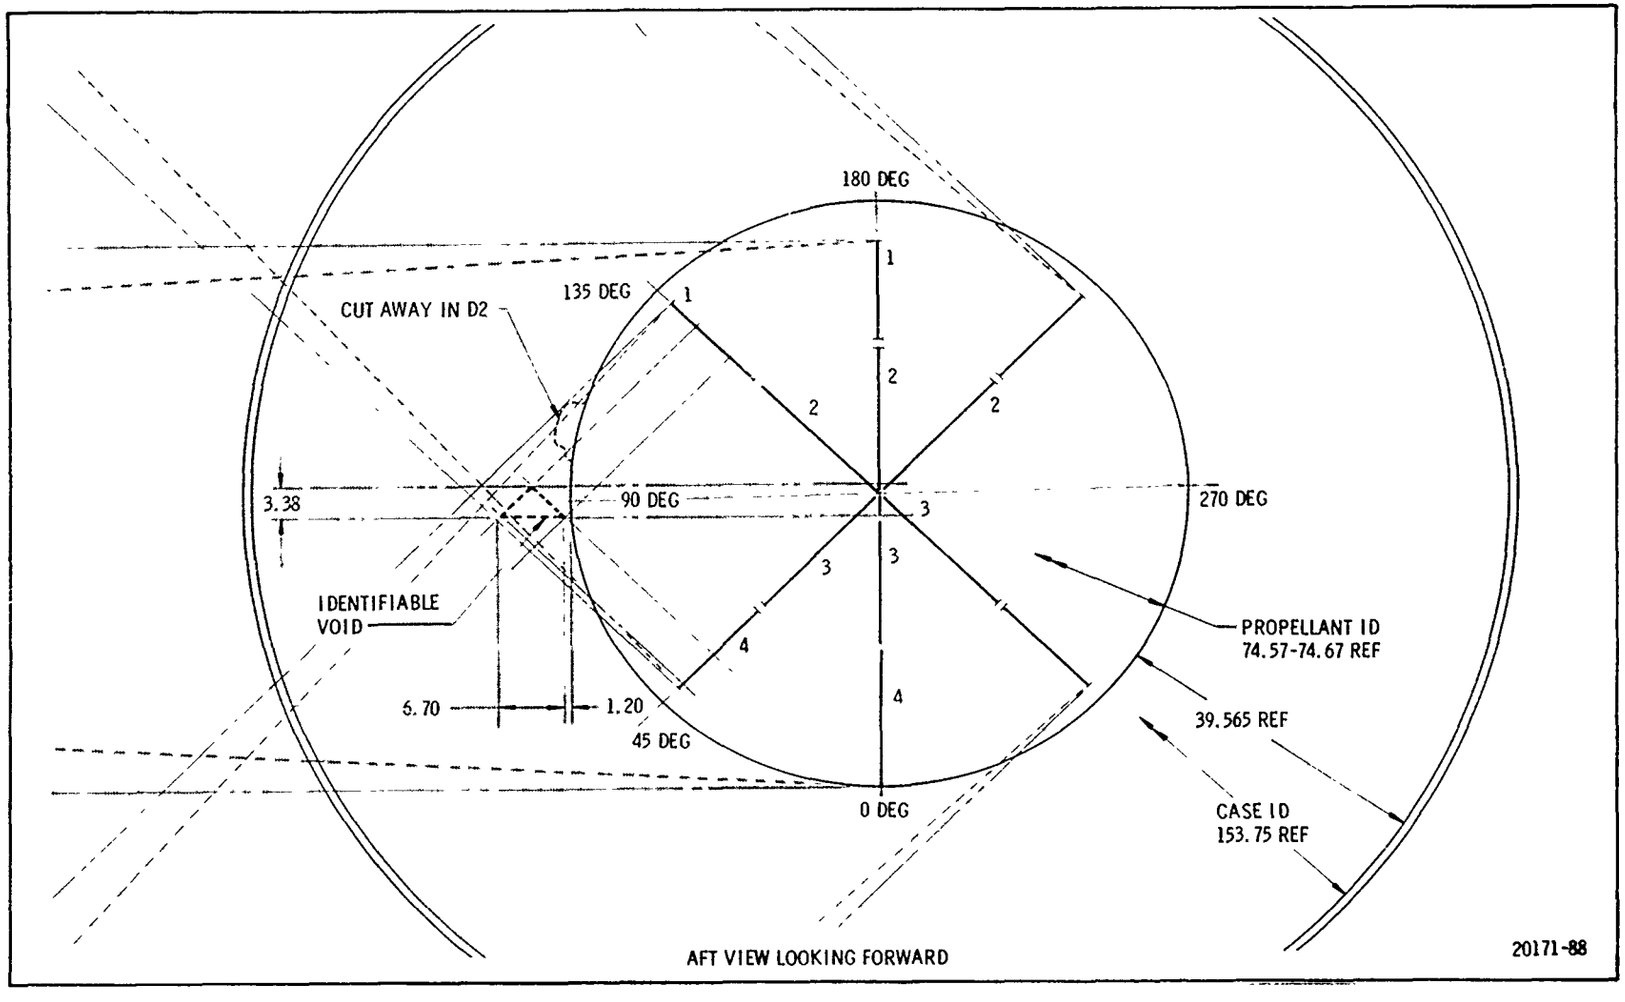
(U) The segment was then inspected in the vertical position, taking shots at 45, 135 and 270 degrees. The X-rays taken at 270 deg revealed only one 1/2 in. diameter circular void; those at 45 and 135 deg substantiated those at 90 degrees. The radiographs also indicated that the voids decreased in number and size in relation to distance from the 90 deg location. Most voids were impossible to triangulate because of the irregular shape of the voids, thickness of propellant, and distance of the source from the film. However, one void was identifiable in two views and is shown in Figure 113.

(U) Figure 113. X-ray Triangulation, 156-8 Forward Segment

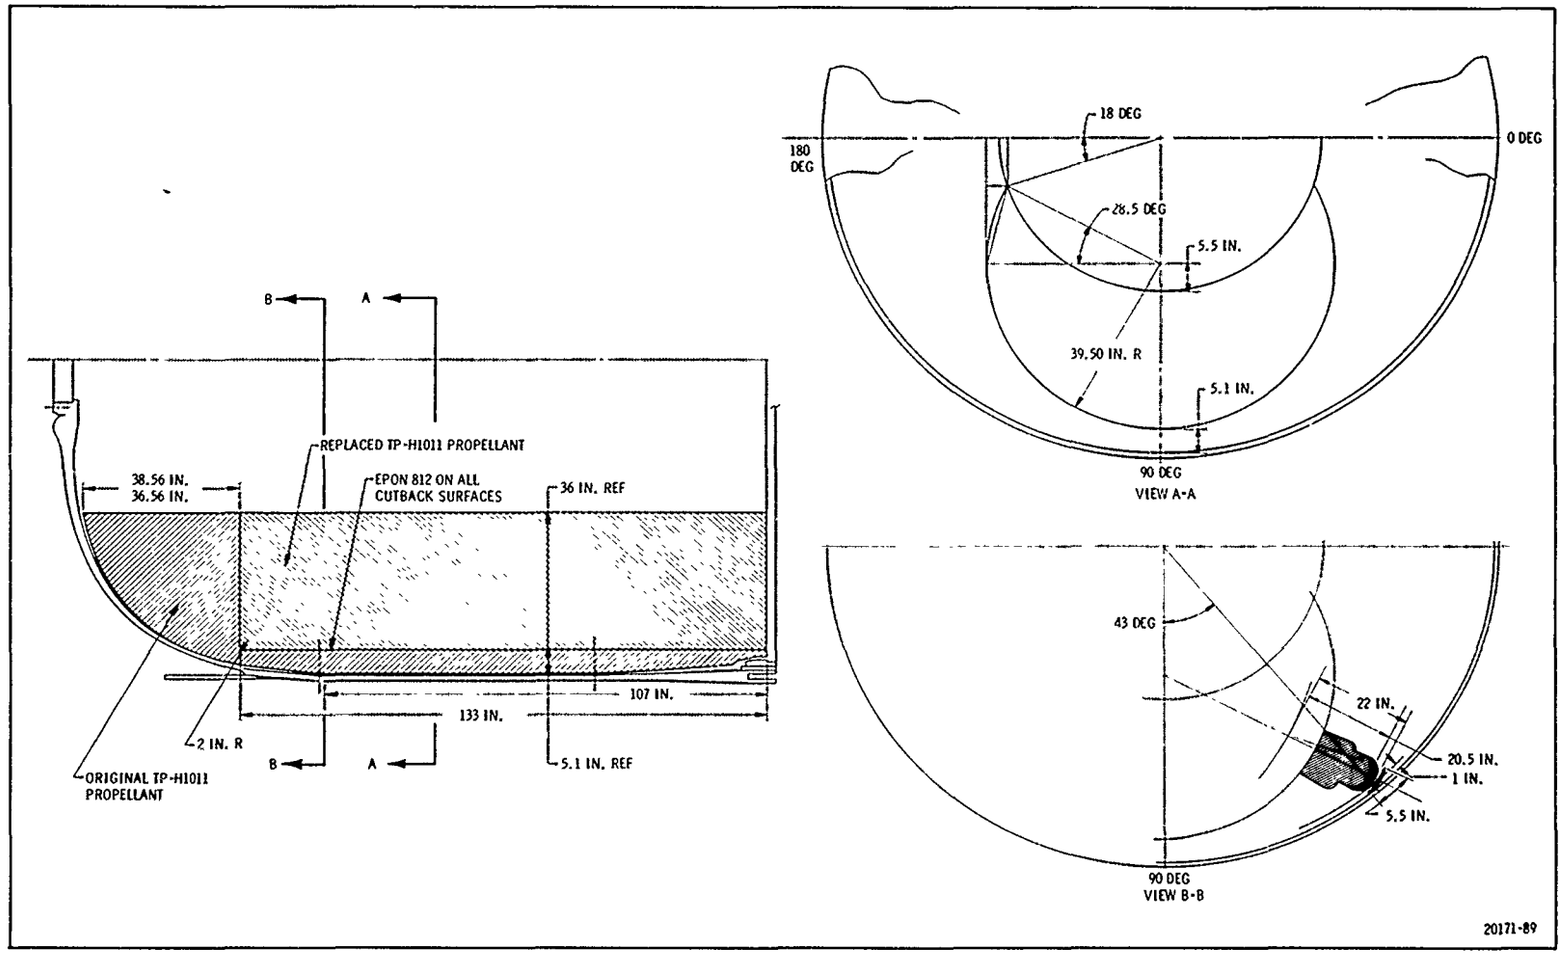
(U) Figure 114. Forward Segment Rework

(U) The propellant was removed by making a circular cut from the aft end of the propellant grain and progressing along the longitudinal axis through the void area in accordance with Figure 114. The longitudinal cut was made with the segment in the vertical position. There were known voids outside of this area next to the case wall. However, these voids would be exposed only at tailoff and would result in only a few seconds premature exposure of the liner and bladder. Machine cutting exactly to the case wall would be risky and very expensive. It was therefore concluded to leave these voids when unexposed.

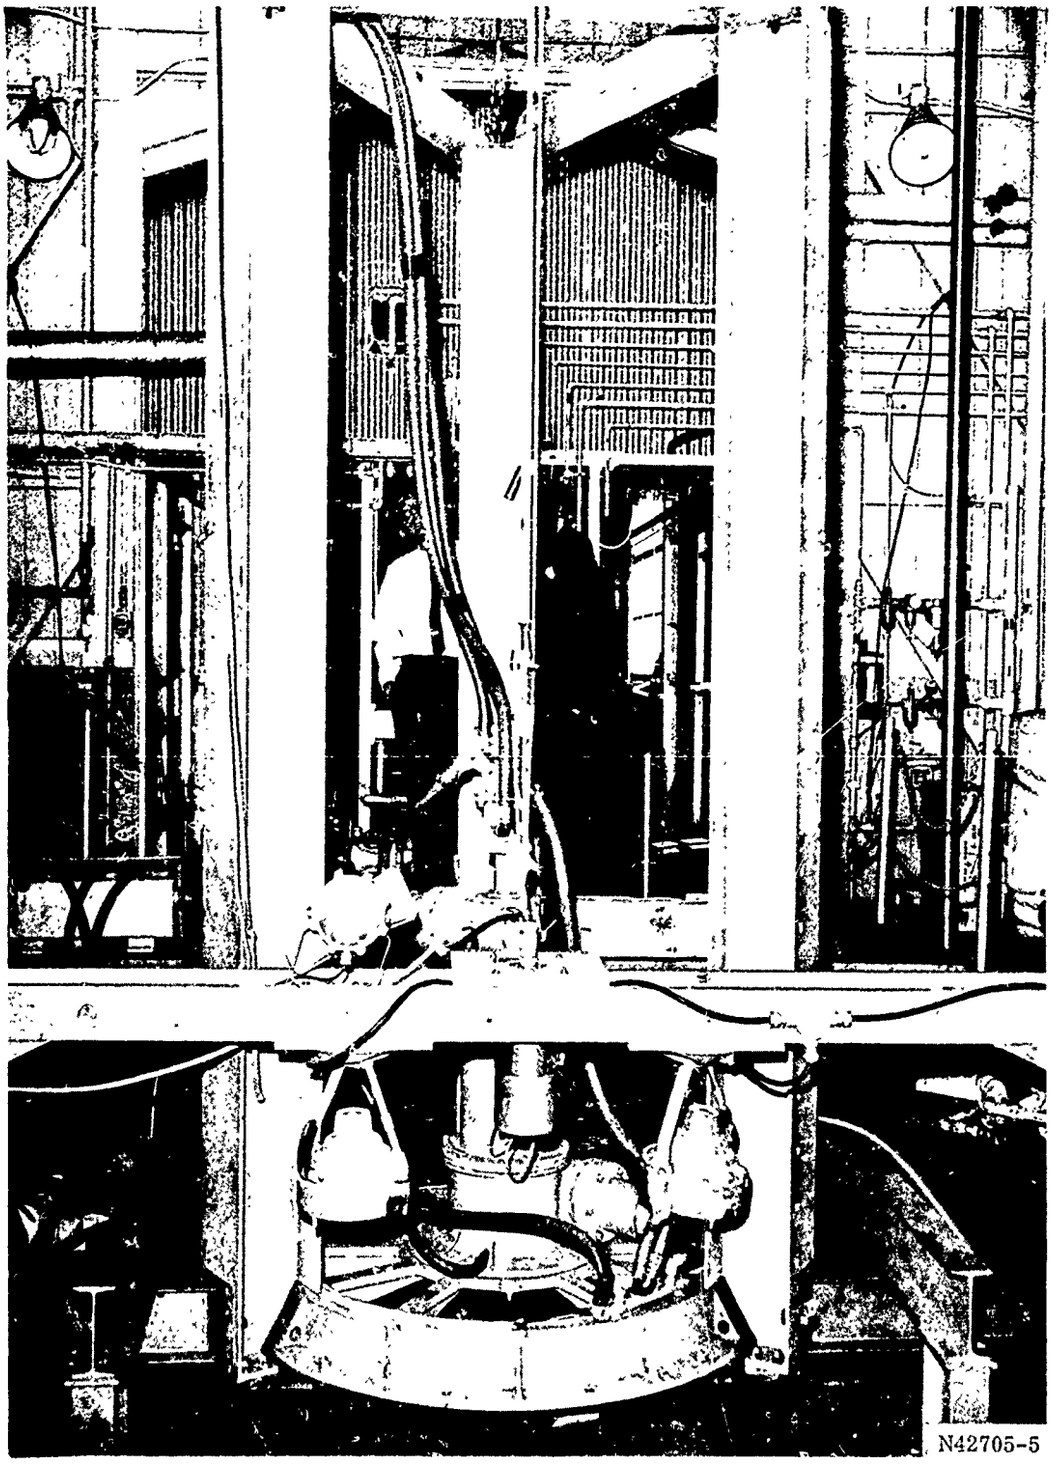
(U) Figure 115. Cutback Machine in Position over Segment

(U) The cut was made with a modified Minuteman cutback machine (WTAB1001) attached to a tripod. The tripod consisted of three "H" beams welded together. The tripod was bolted to a framework arrangement and secured to the aft harness ring in three places. The tripod had bolt holes and could be lowered in 6 in. increments. Figure 115 shows the cutback machine in position prior to starting the cutting operation.

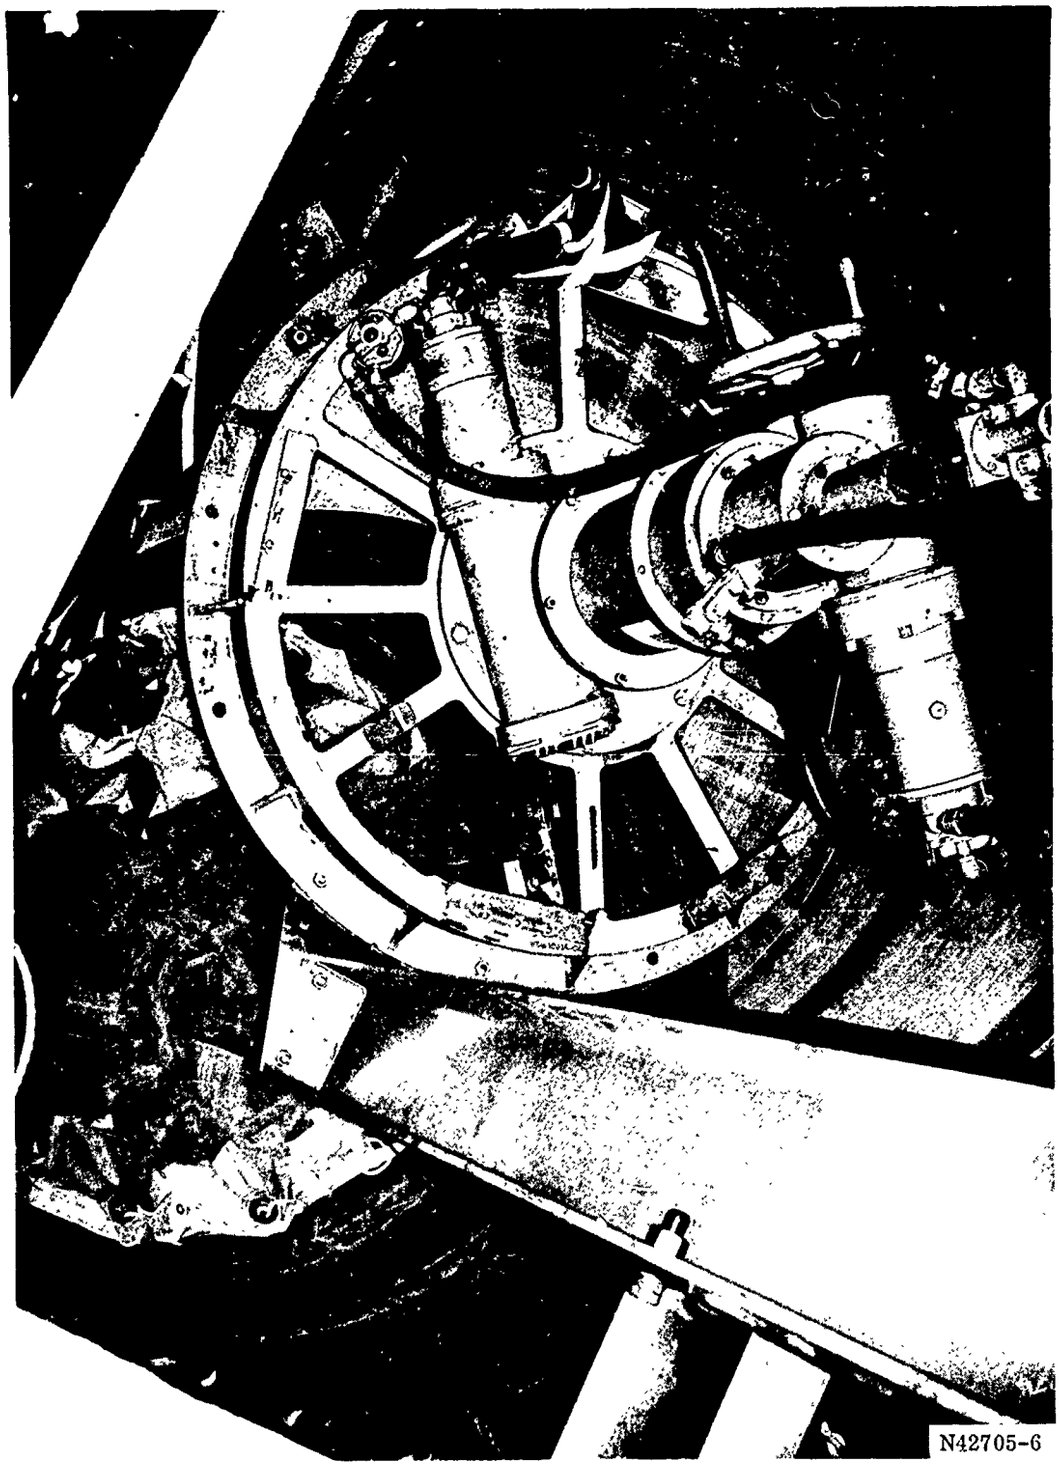
(U) Figure 116. Cutback Machine During Operation (With Scrap Catcher)

(U) The cutting blade had a long arm with a short cutting edge and a short arm with a long cutting edge to balance torque. The trailing edges of the cutting blades had scoops to push the 1/12 in. thick propellant slices into the scrap catcher (Figure 116) in the core cavity. The end of the cutting blade making the outer periphery cut was curved with a 2 in. radius to eliminate the stress rising effect of a sharp corner in the cutout cavity.

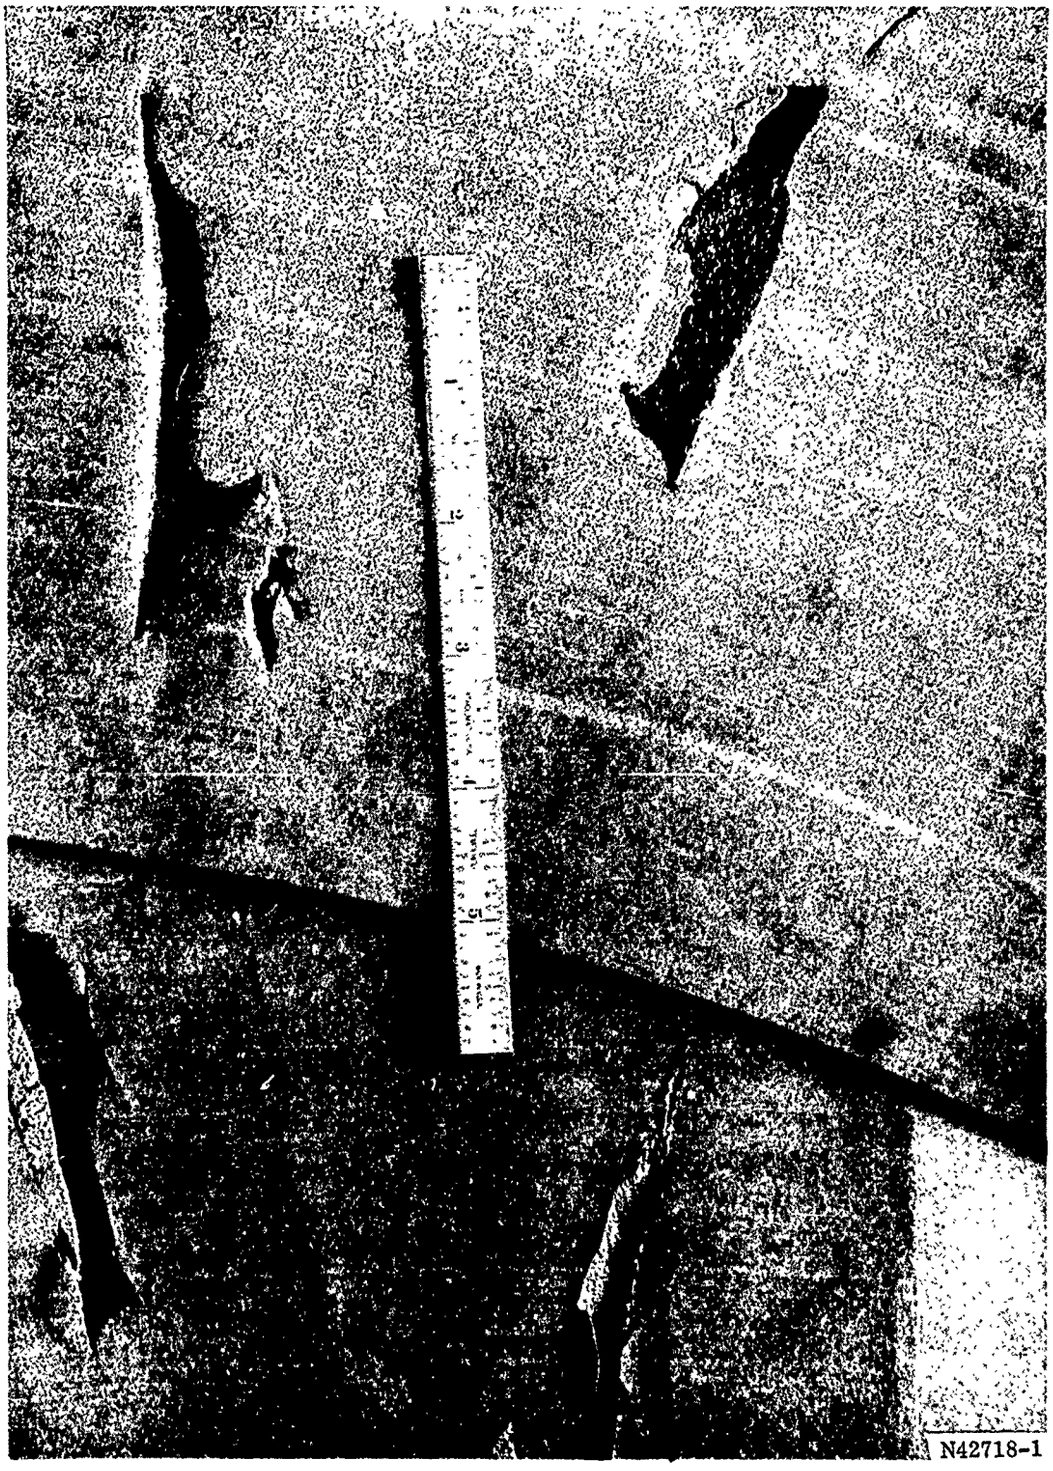
(U) Figure 117. Typical Voids in Propellant Slices Removed from Defect Area (View A)

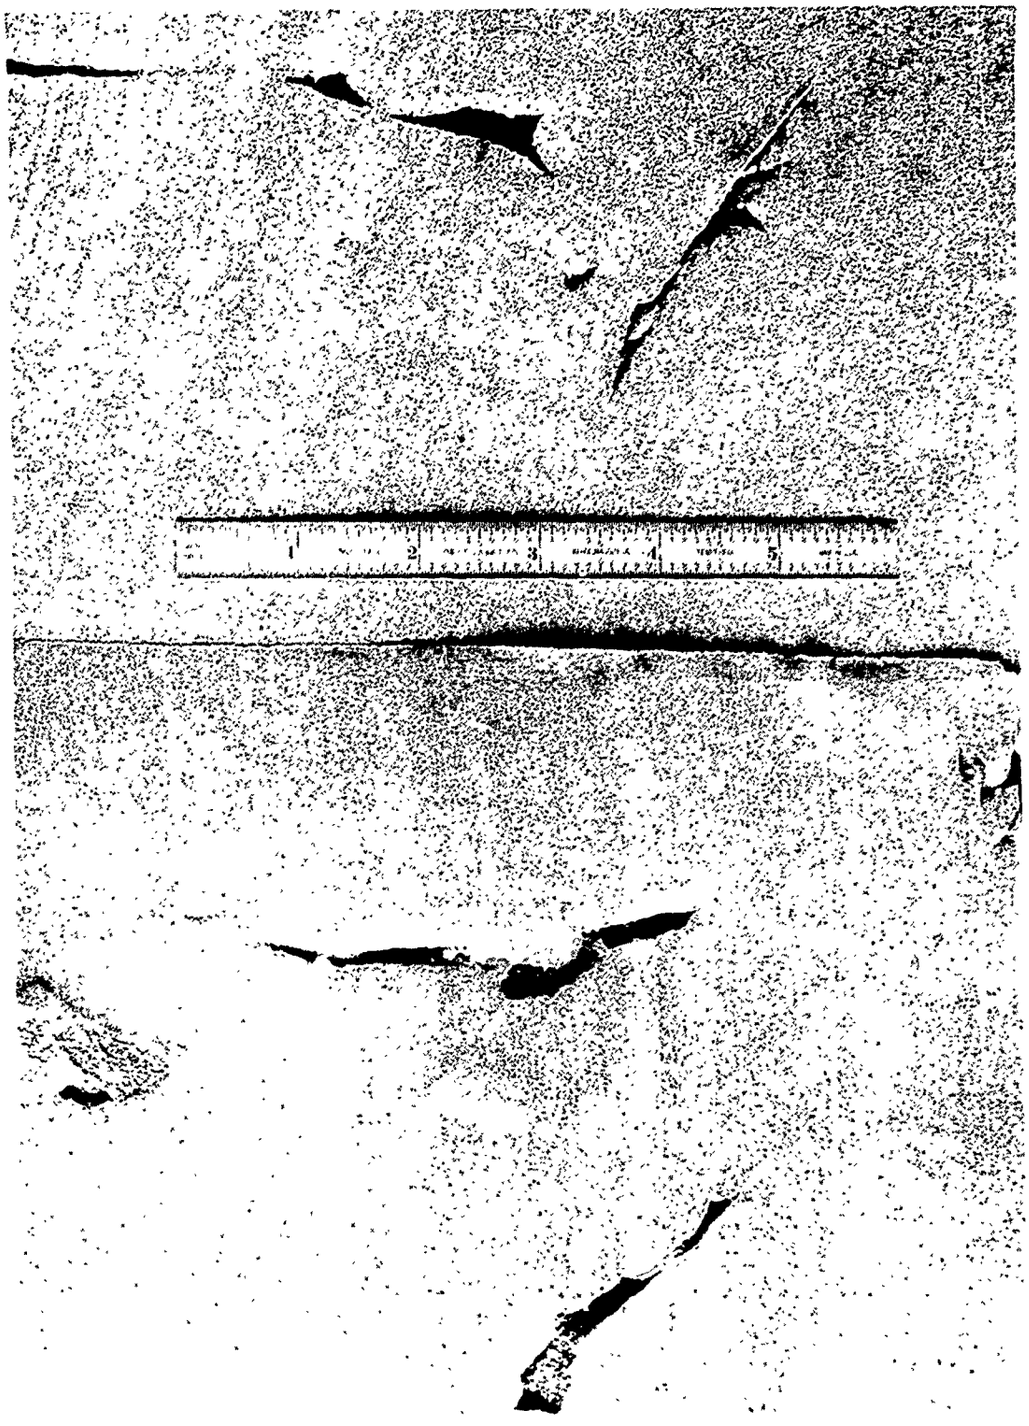
(U) Figure 118. Typical Voids in Propellant Slices Removed from Defect Area (View B)

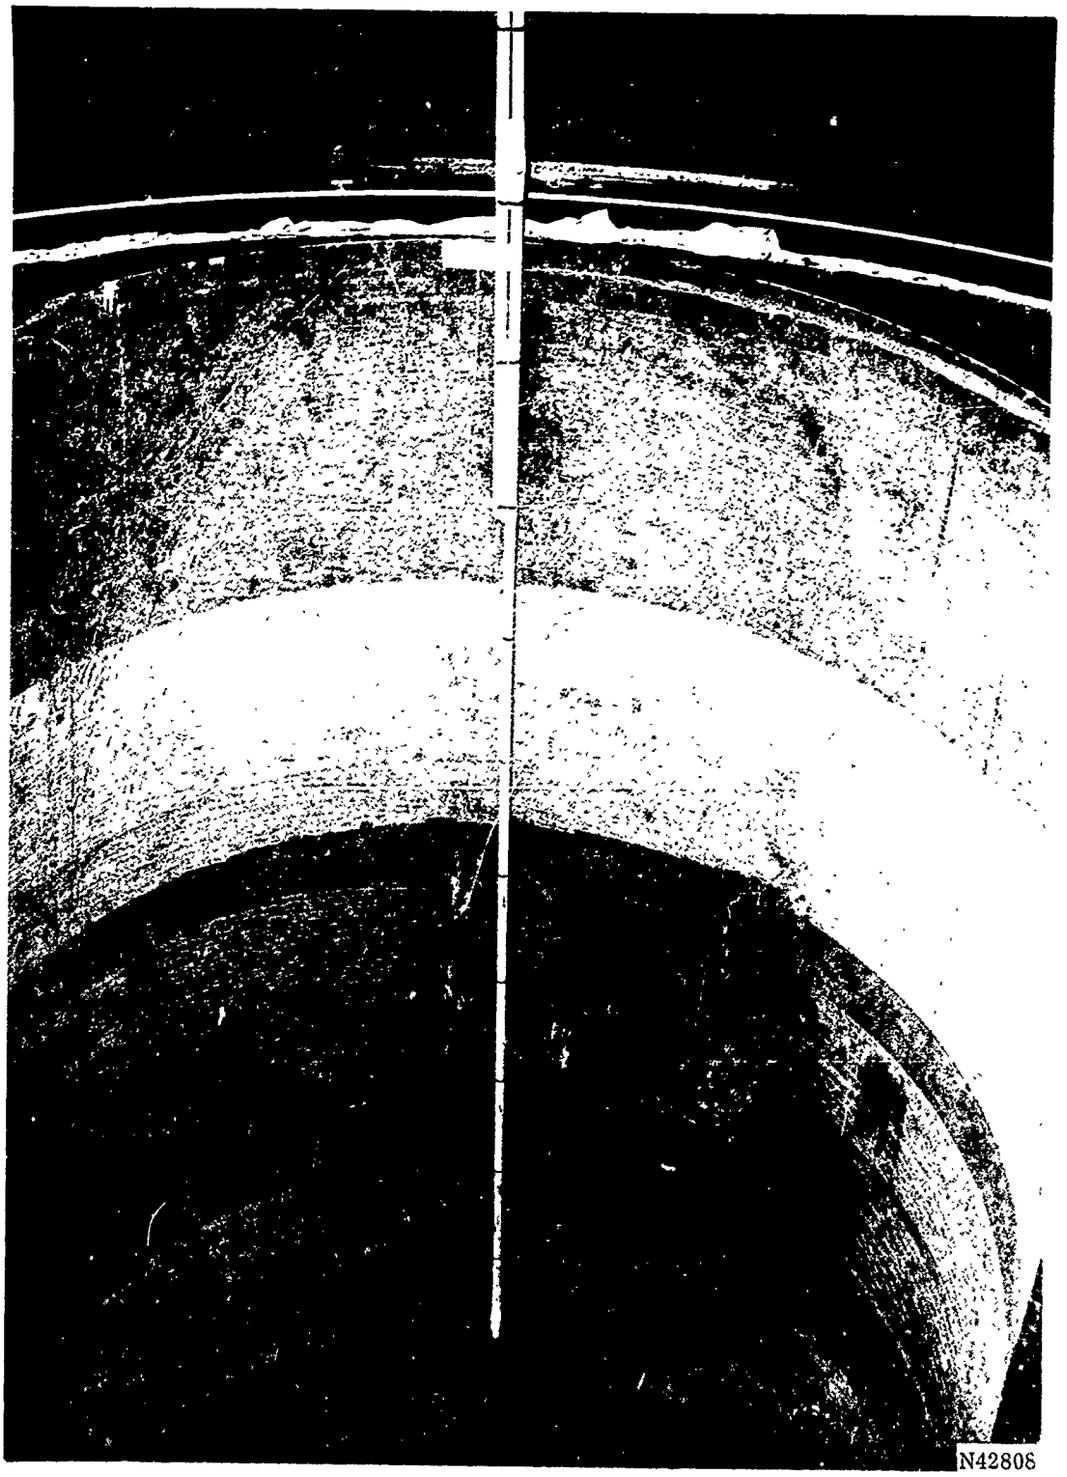
(U) The outer periphery of the cavity exposed several irregular voids. These were hand trimmed until no visible evidence of the void remained (Figure 120). One of these voids extended to the case wall.

(U) Figure 120. Propellant Cavity Surface Showing Hand Blended Voids
