TRECOM TECHNICAL REPORT 64-9

COMPILATION AND ANALYSIS OF TEST DATA ON FIBERGLASS-REINFORCED PLASTICS

March 1964

KAMAN AIRCRAFT CORPORATION
Bloomfield, Connecticut

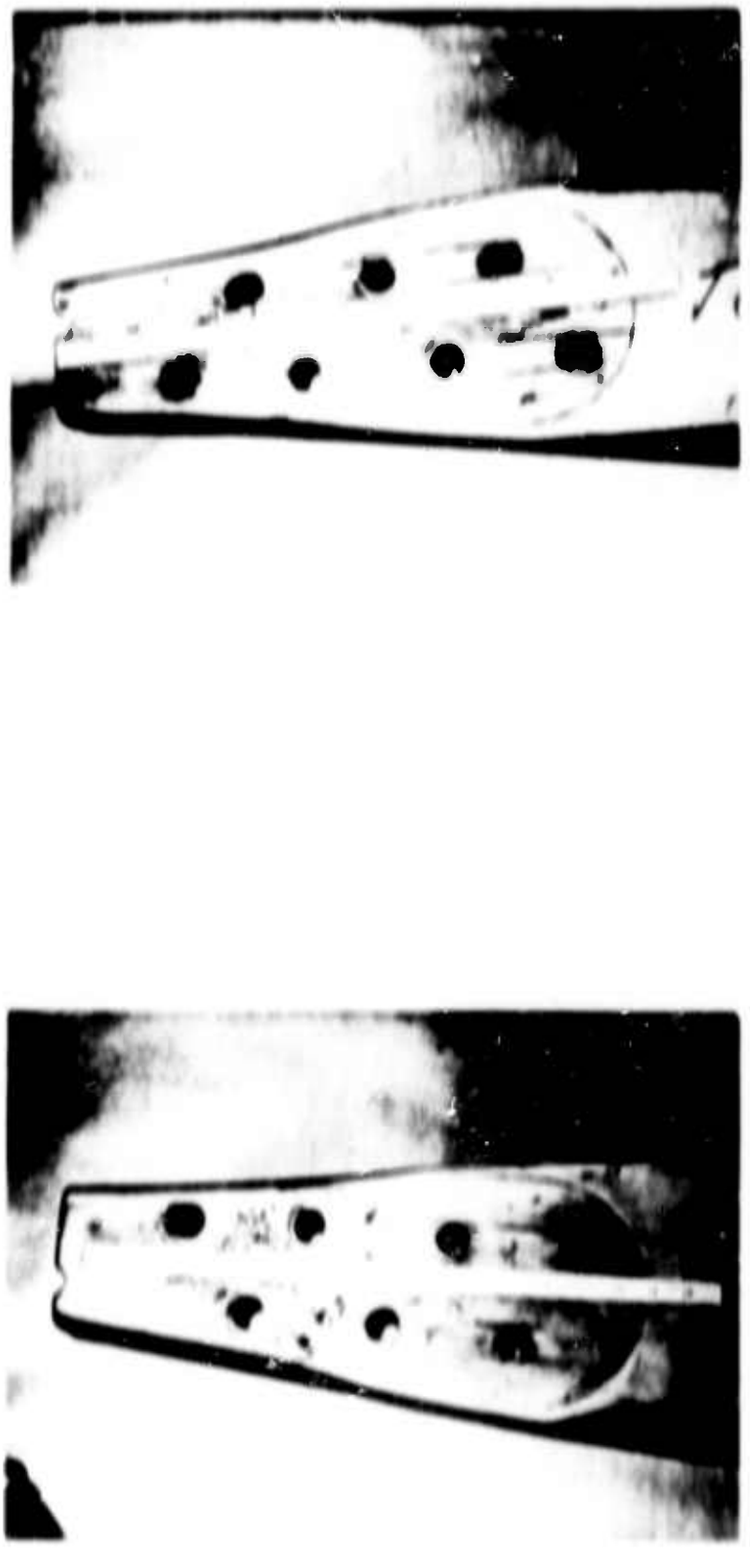
Figure II-43. Spanwise Cracks in Upper and Lower Grip Facings

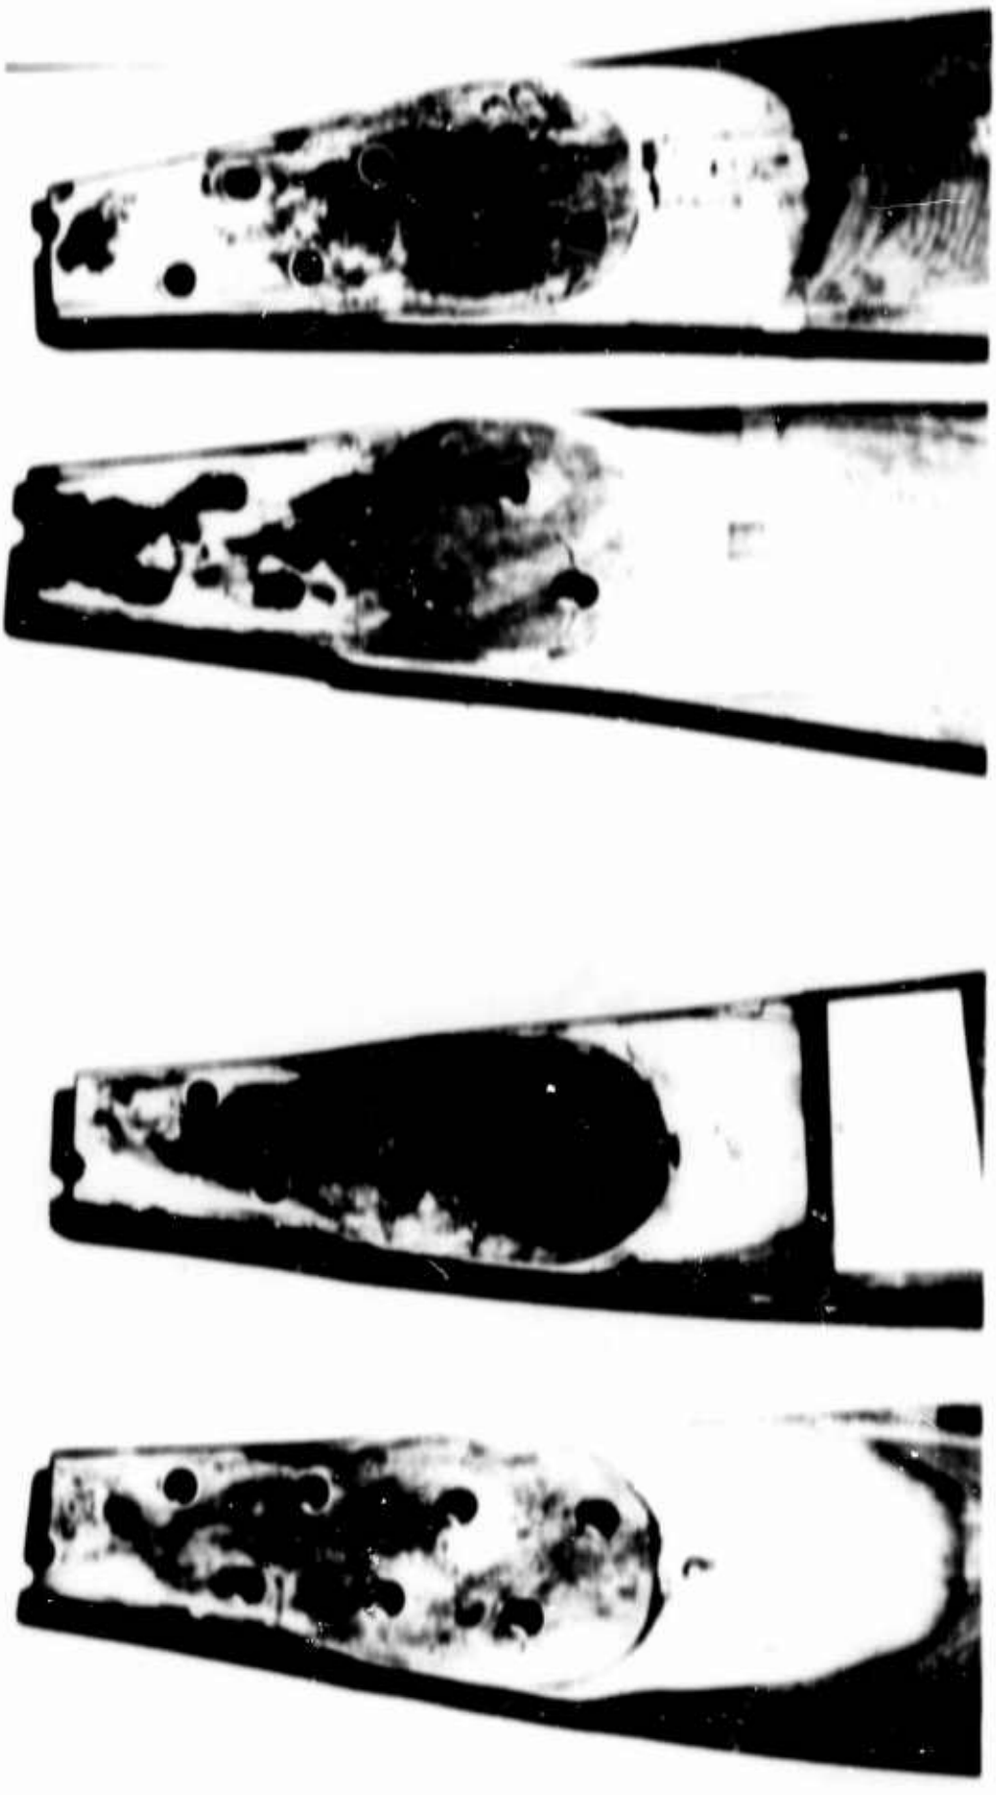
Figure II-45. Blade Root-End Specimen Damage

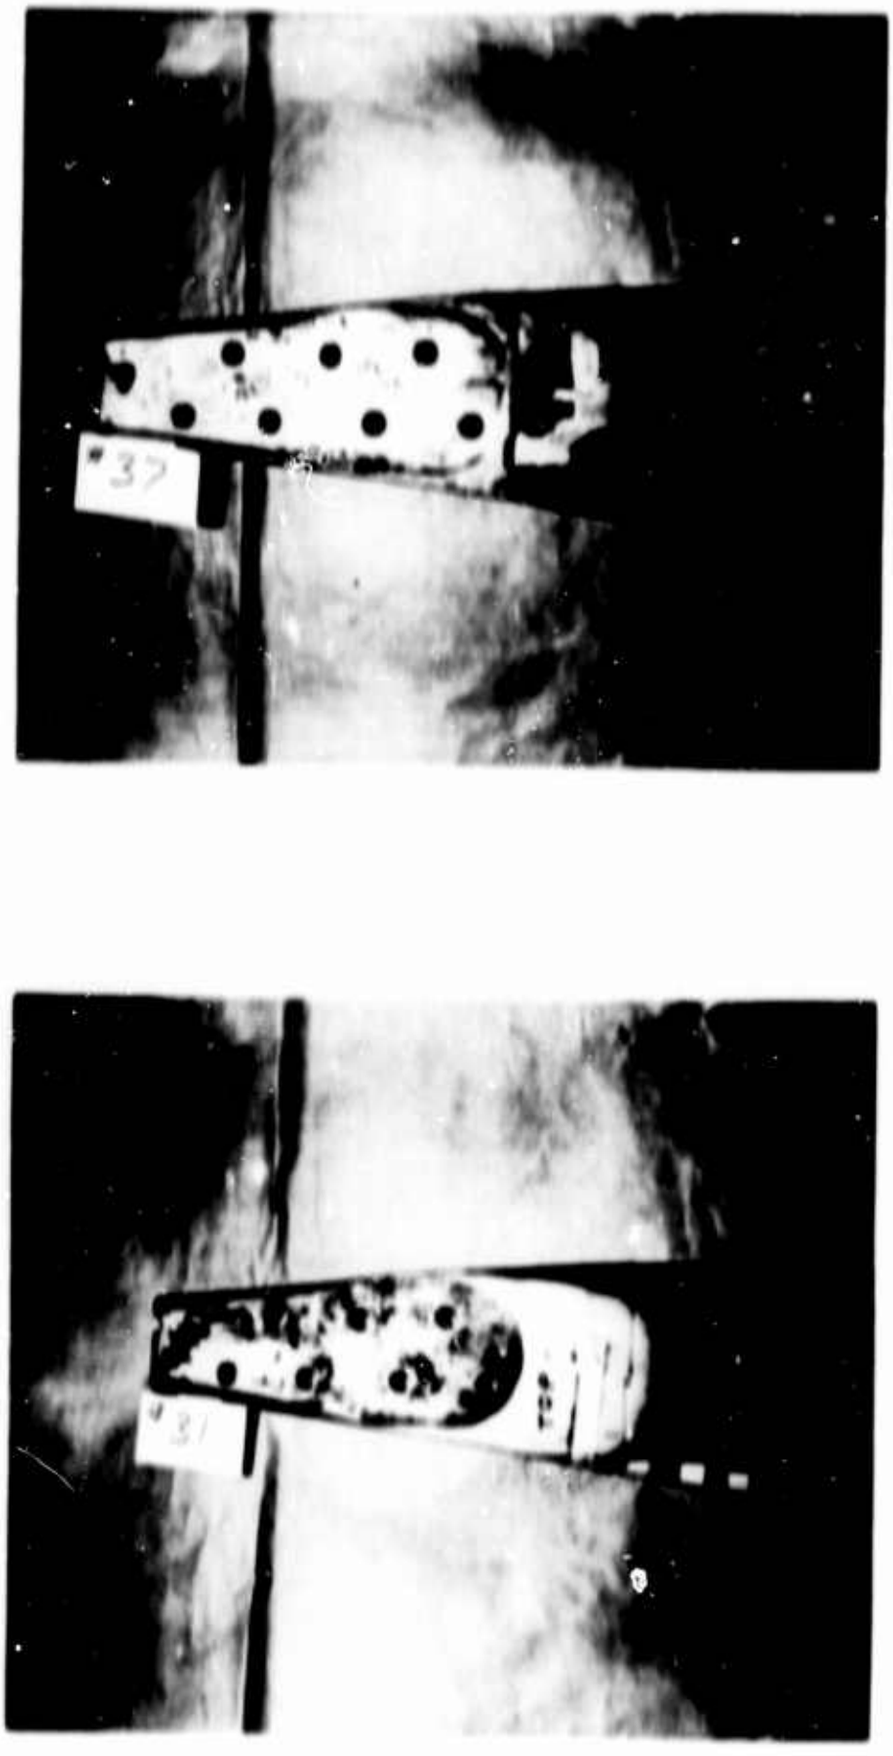
Upon completion of the test, the specimens were inspected and photographed as seen in Figures II-49 and II-50 and then dissected to investigate the internal crack propagation. It was found that no further propagation occurred beyond the resin filled cracks.

Figure II-48. Blade Root-End Spanwise Cracks

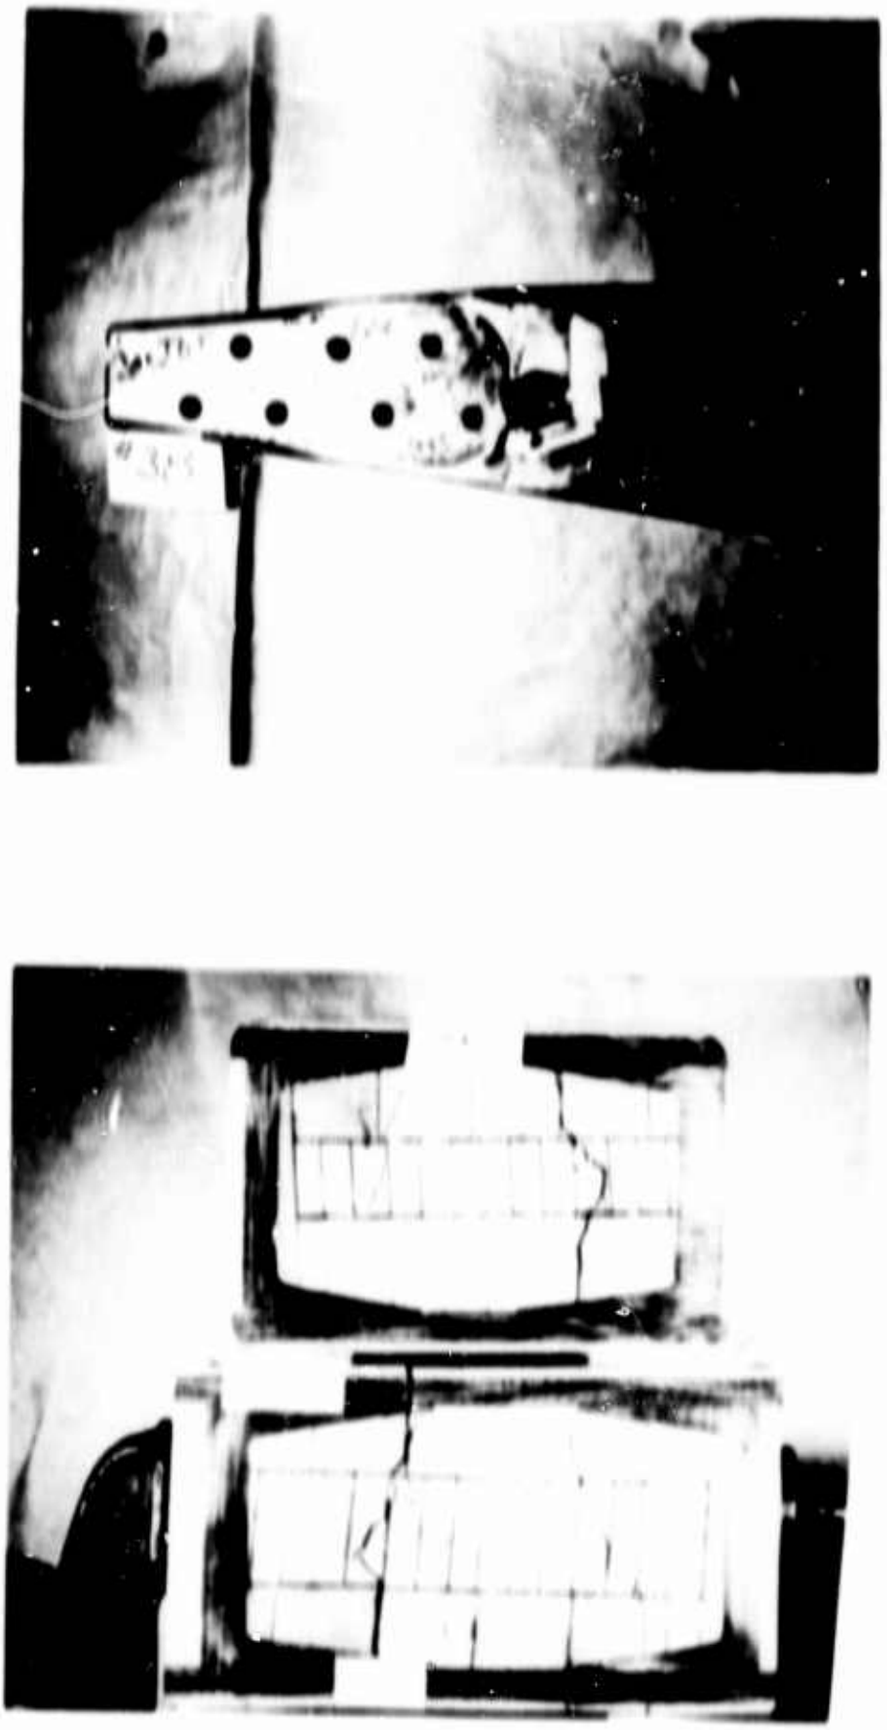
Figure II-46. Blade Root-End Spanwise Cr

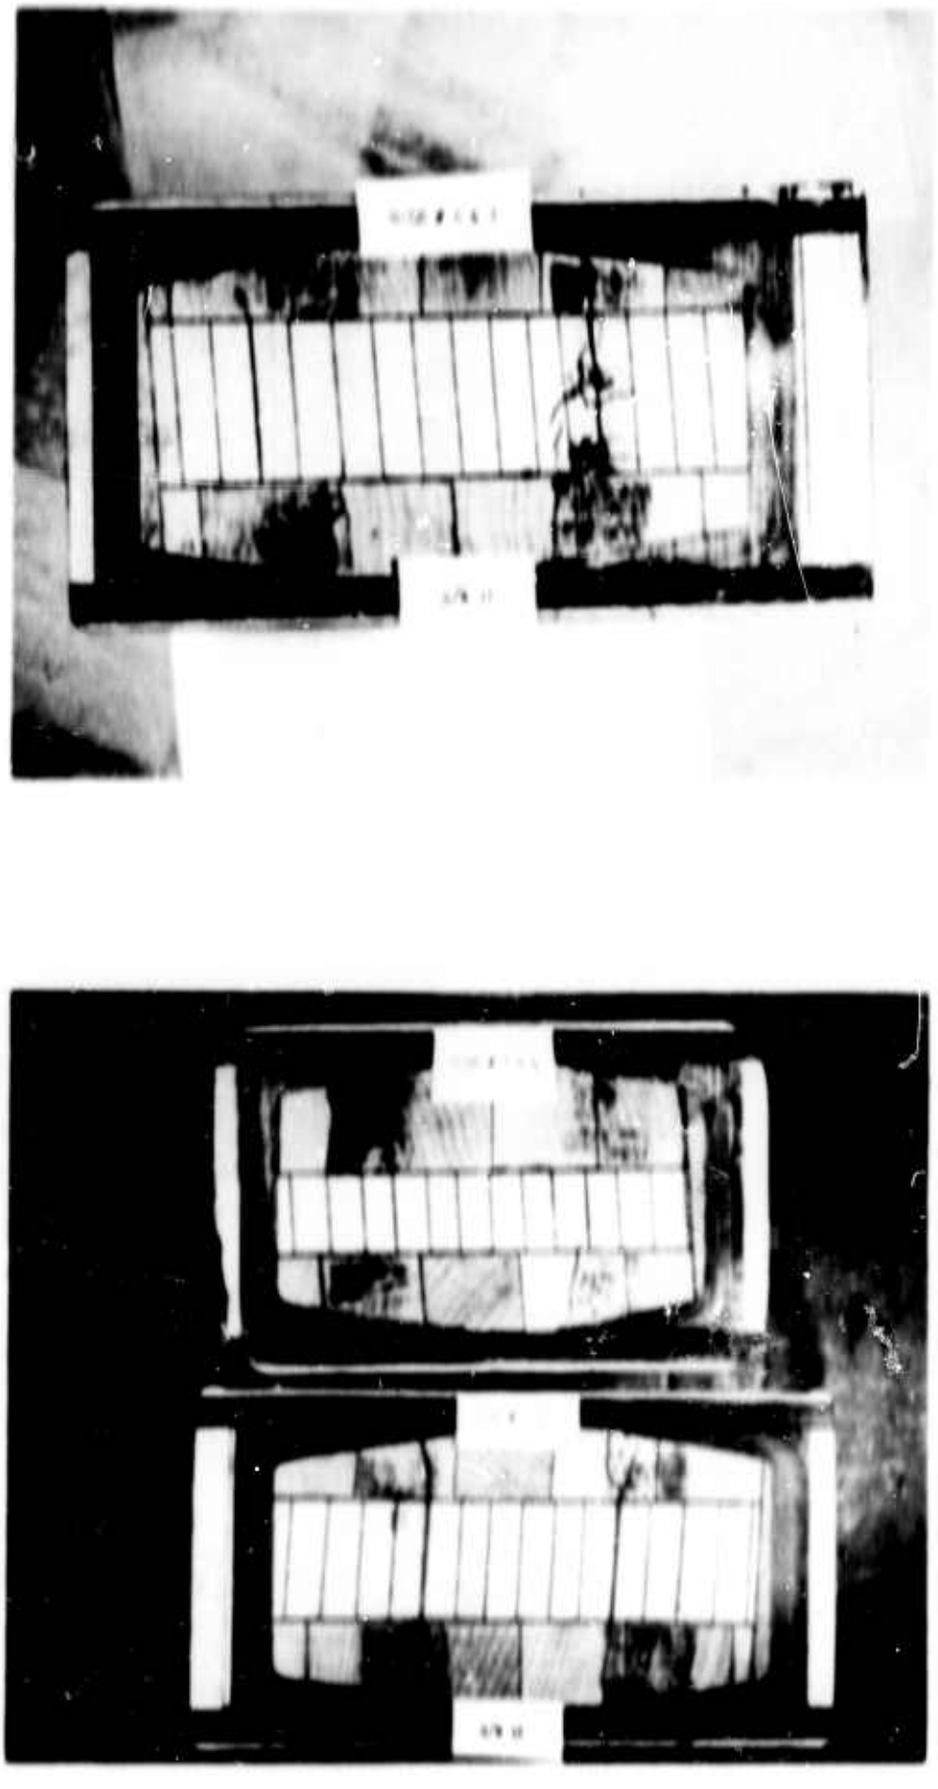
Figure 11-50. Epoxy Filled Spanwise Cracks

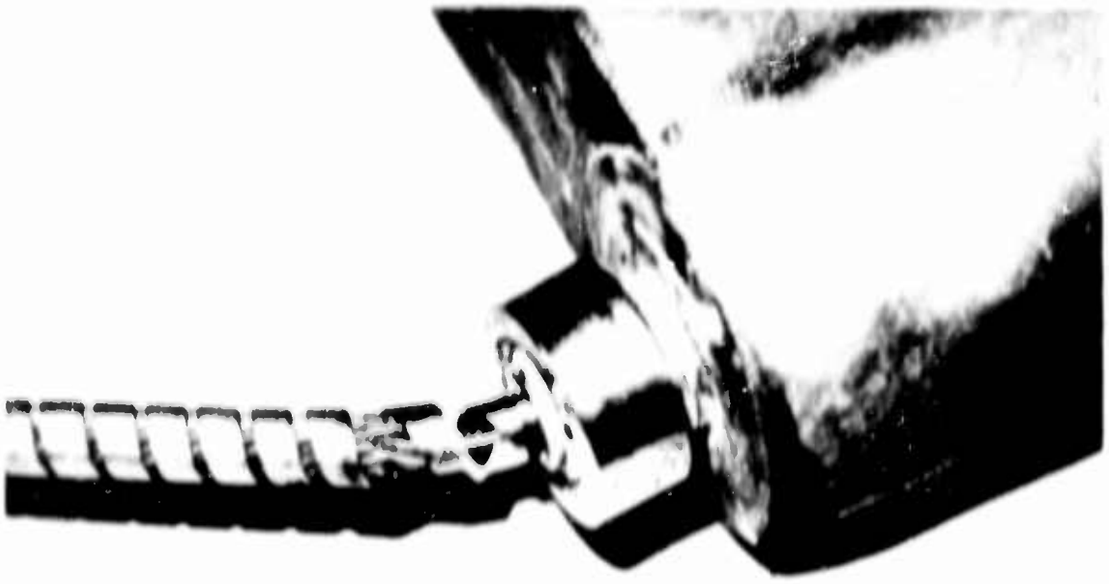
Figure VI-11. View of Flap Cable Failure
