MISCELLANEOUS PAPER S-68-27

MISSILE BASES: DESIGN AND CONSTRUCTION PROBLEMS

W. J. Turnbull

A. J. Hendron, Jr.

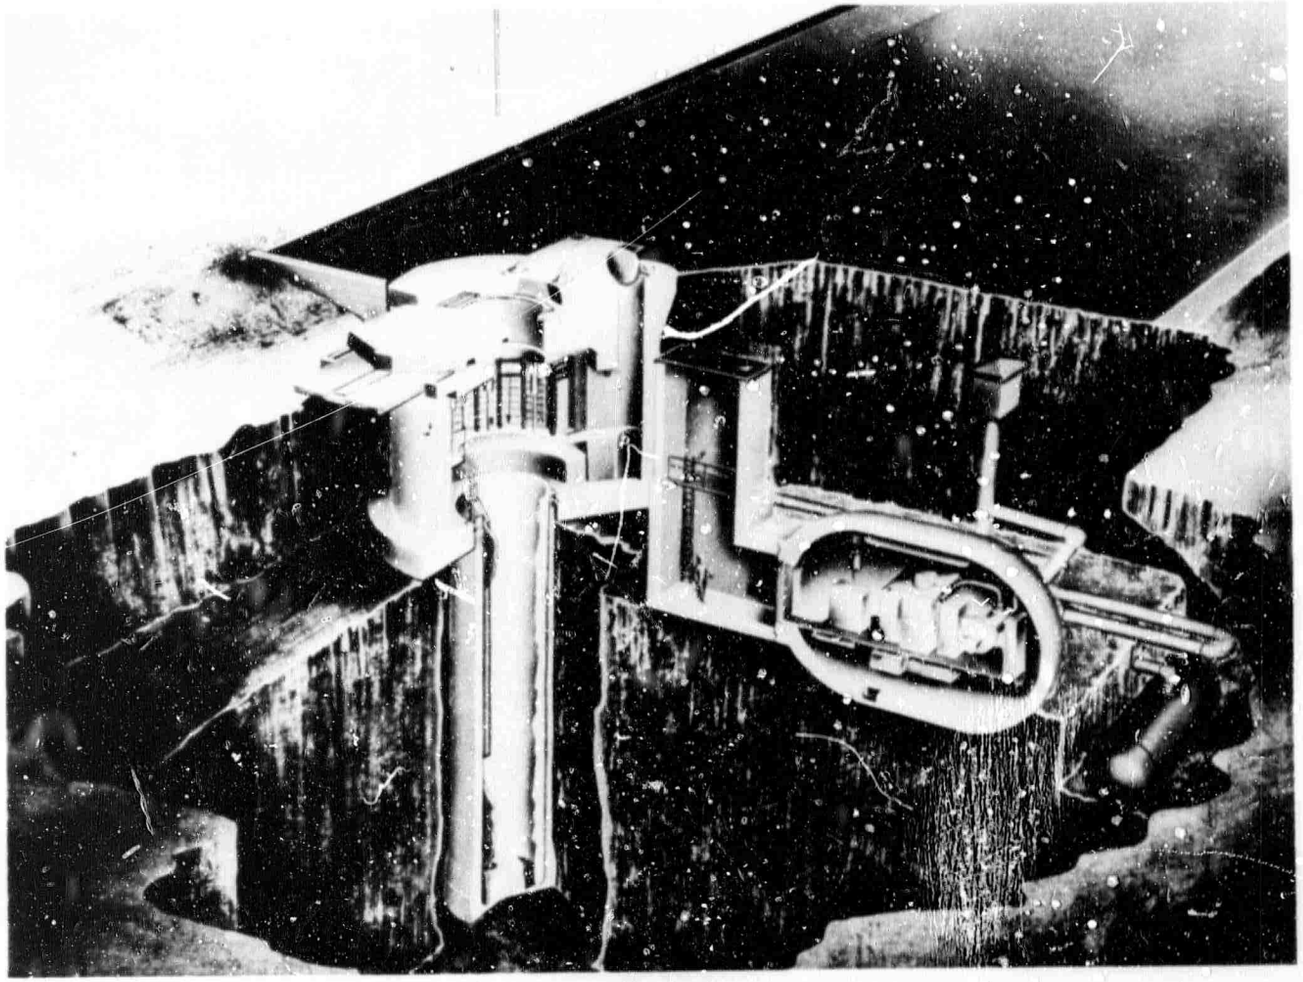
Fig. 2. Atlas F configuration; location of major features of construction with respect to ground surface

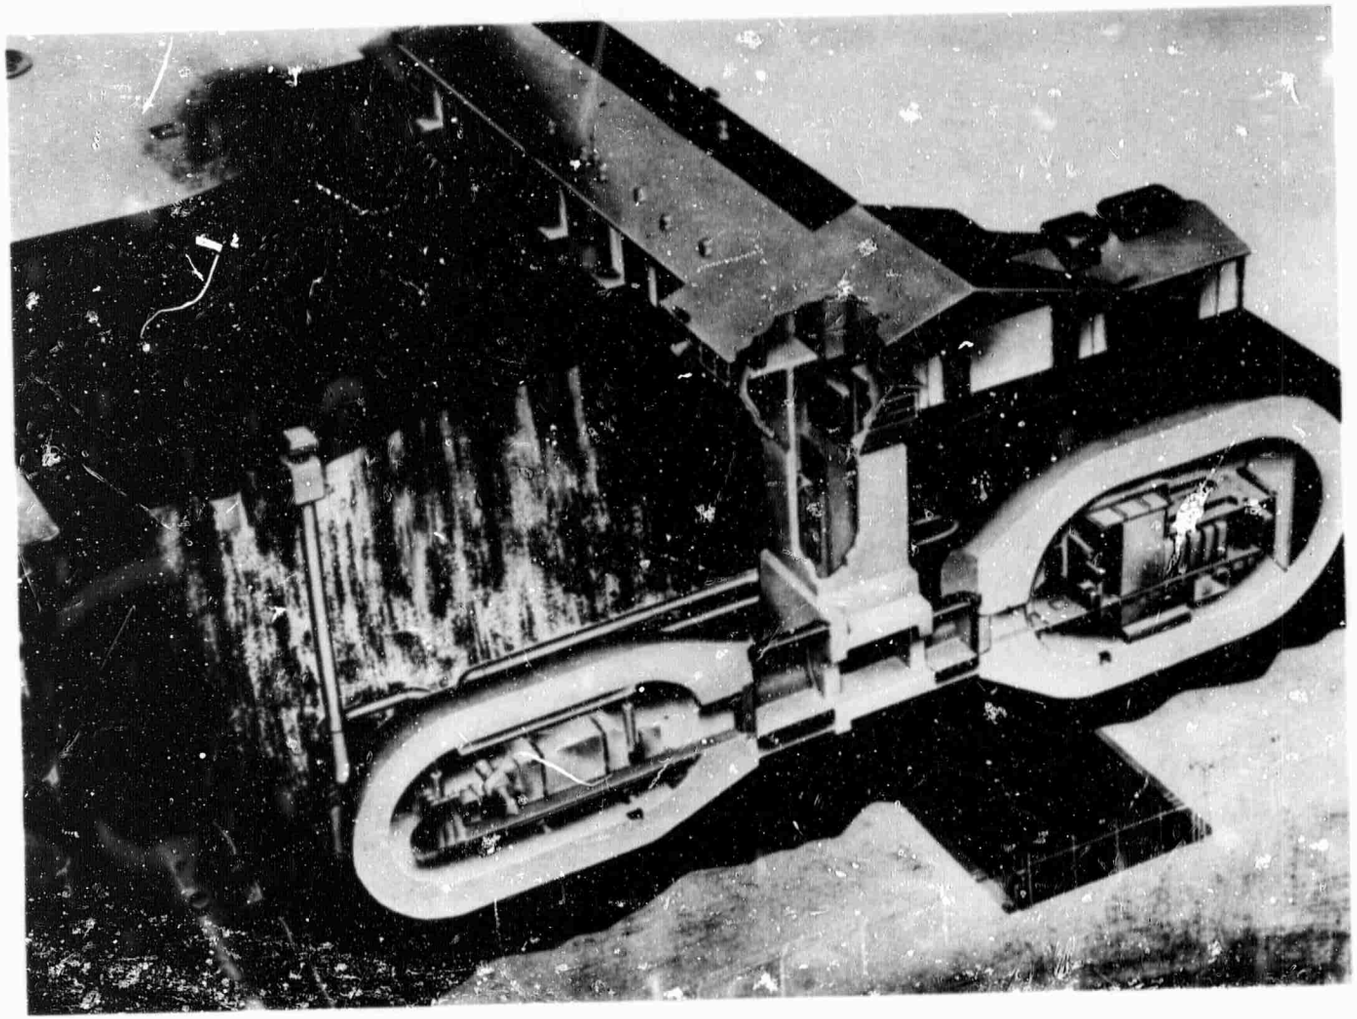
Fig. 3. Minuteman launch facility; relation of launch equipment room, access shaft, and launch equipment building

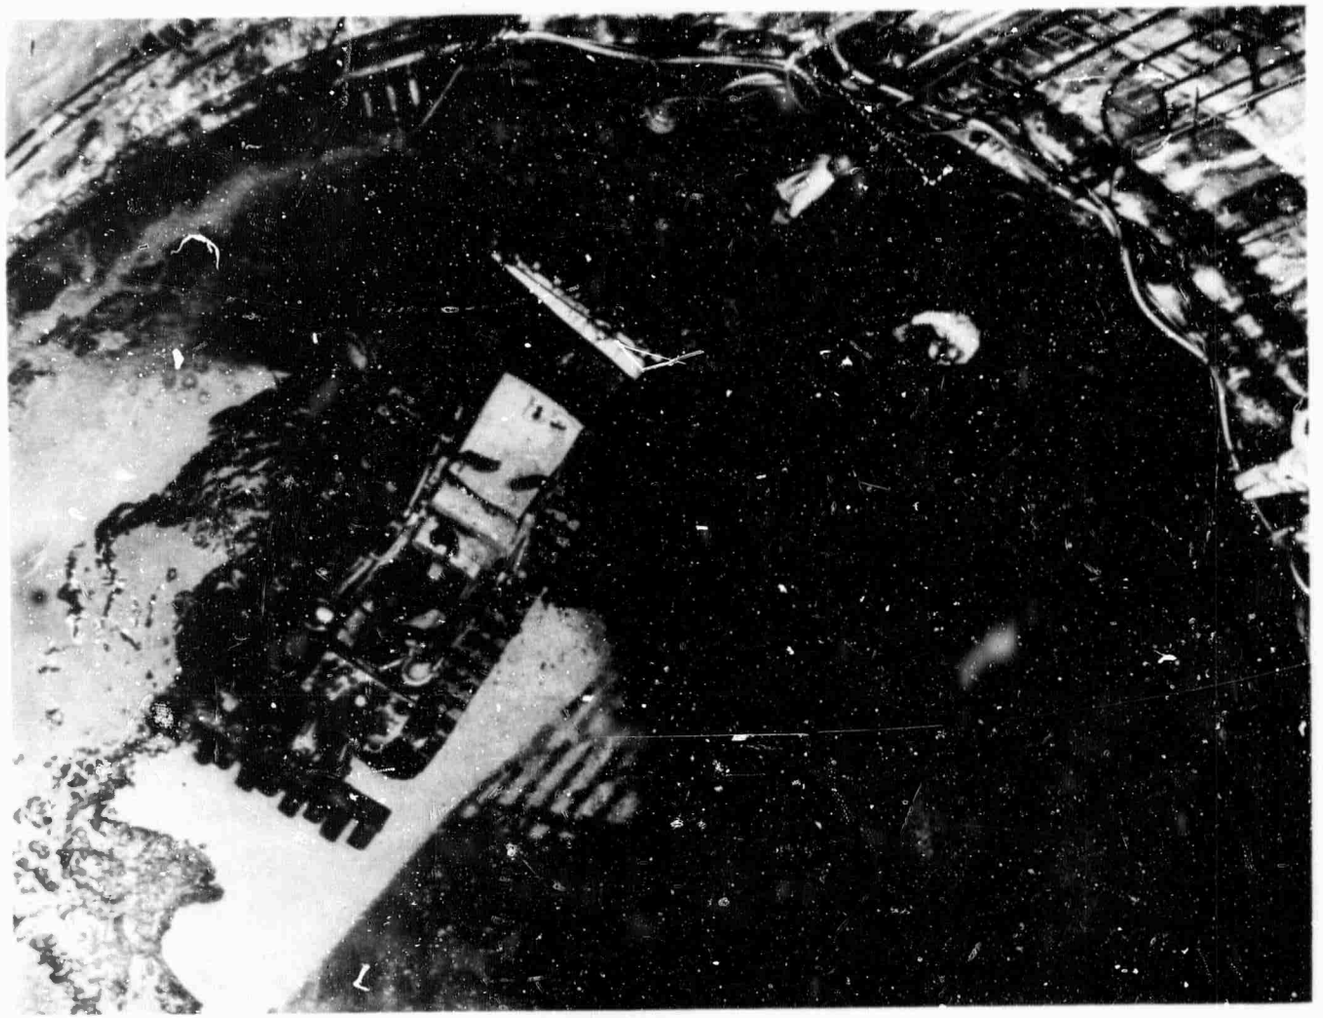
Fig. 7. Excavation to the basic level for an Atlas facility

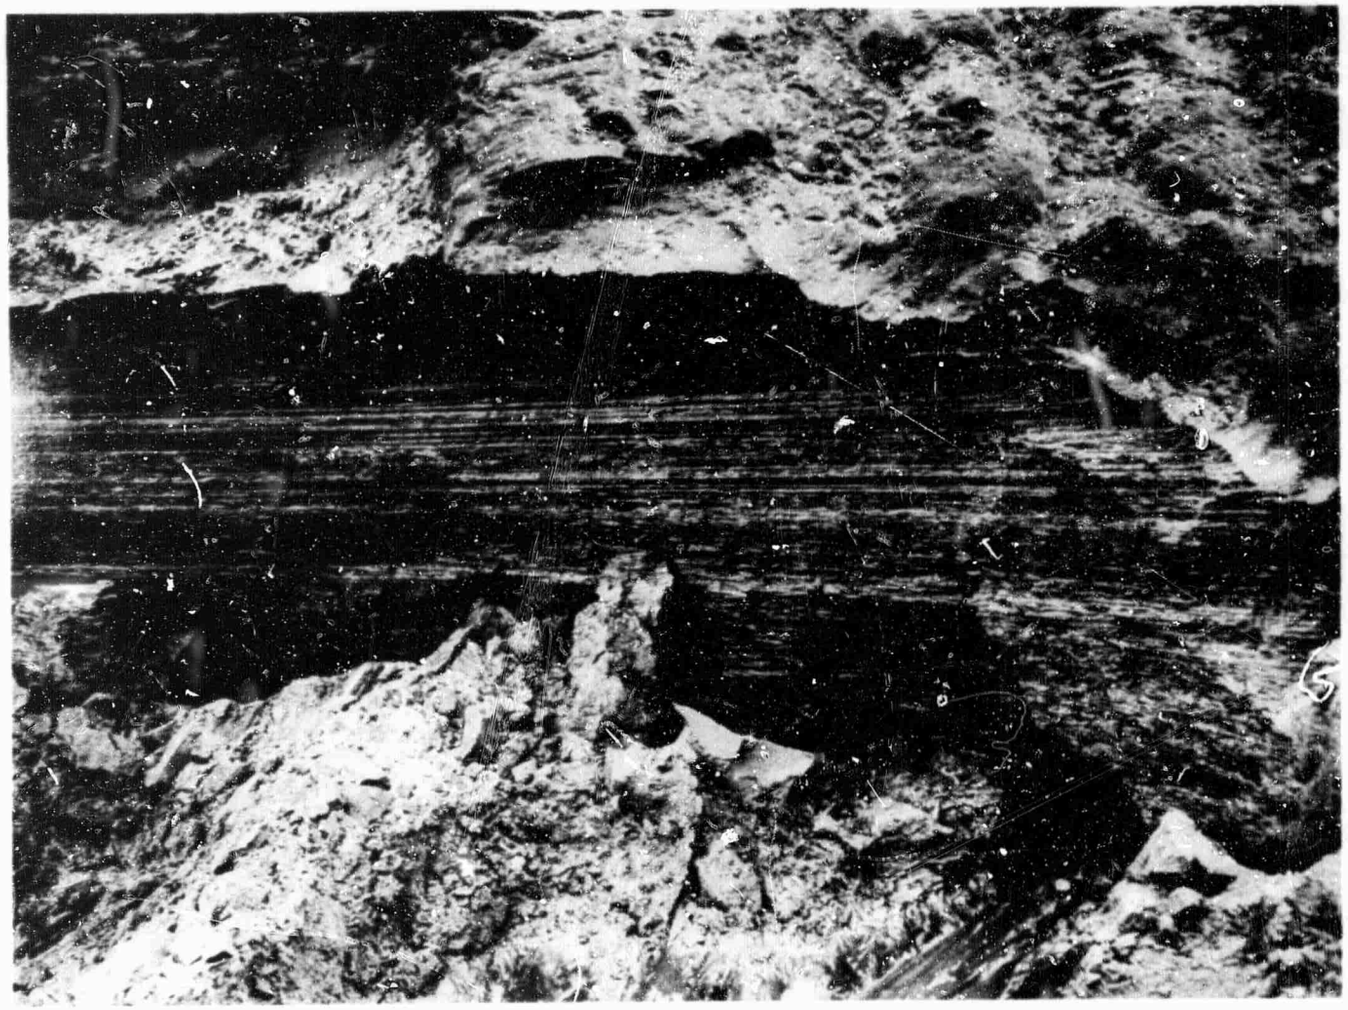
Fig. 9. Minuteman excavation; wet base-level due to seepage from toe of slope

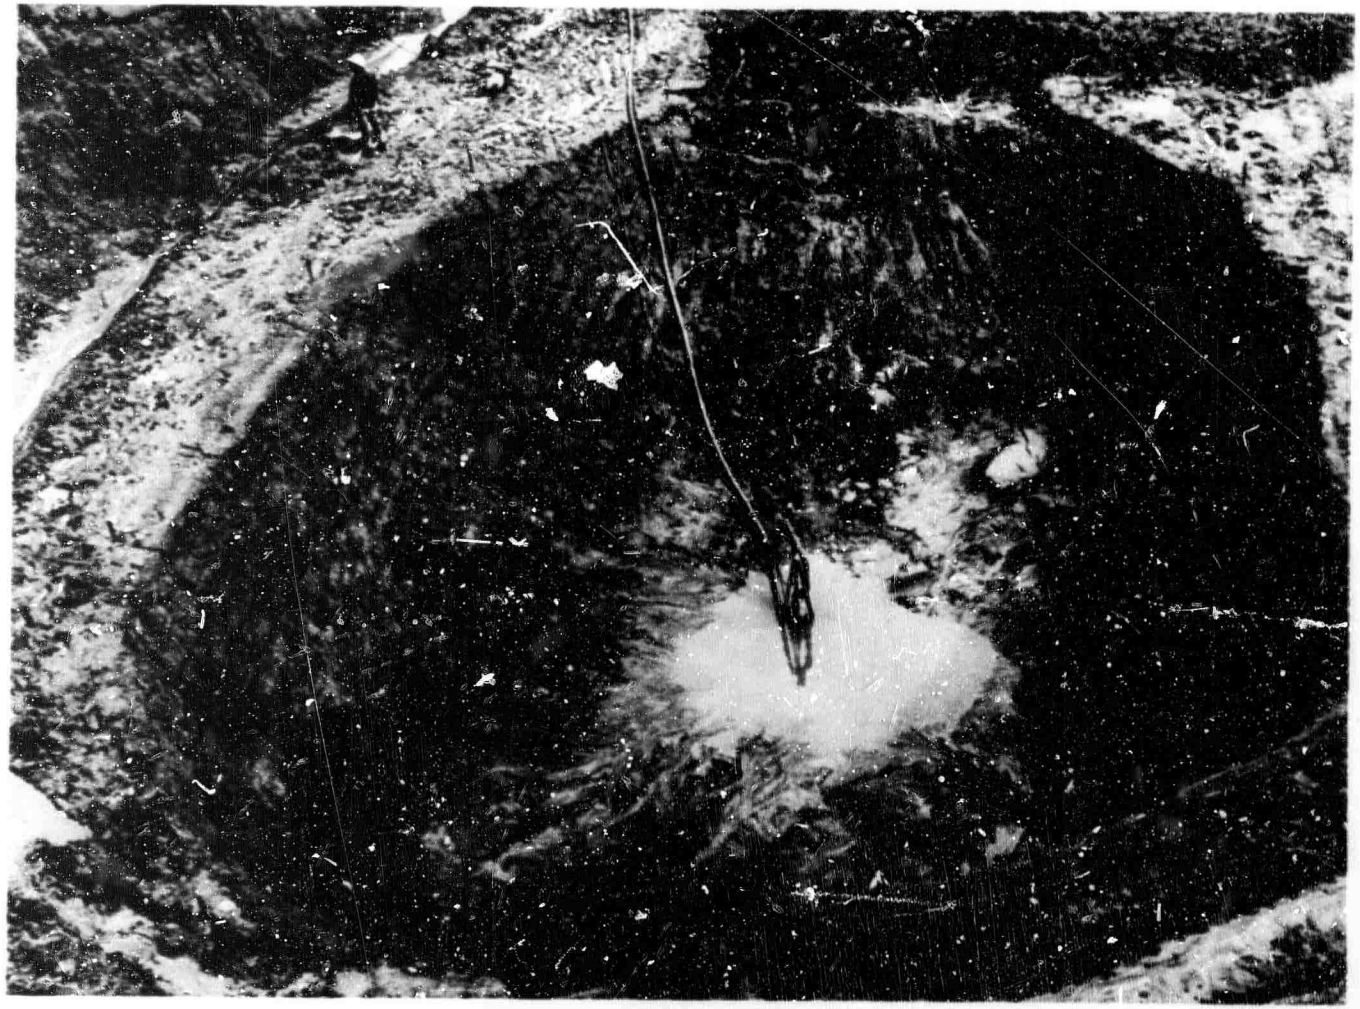
Fig. 10. Minuteman excavation; water piping from toe of excavation and sloughing soil

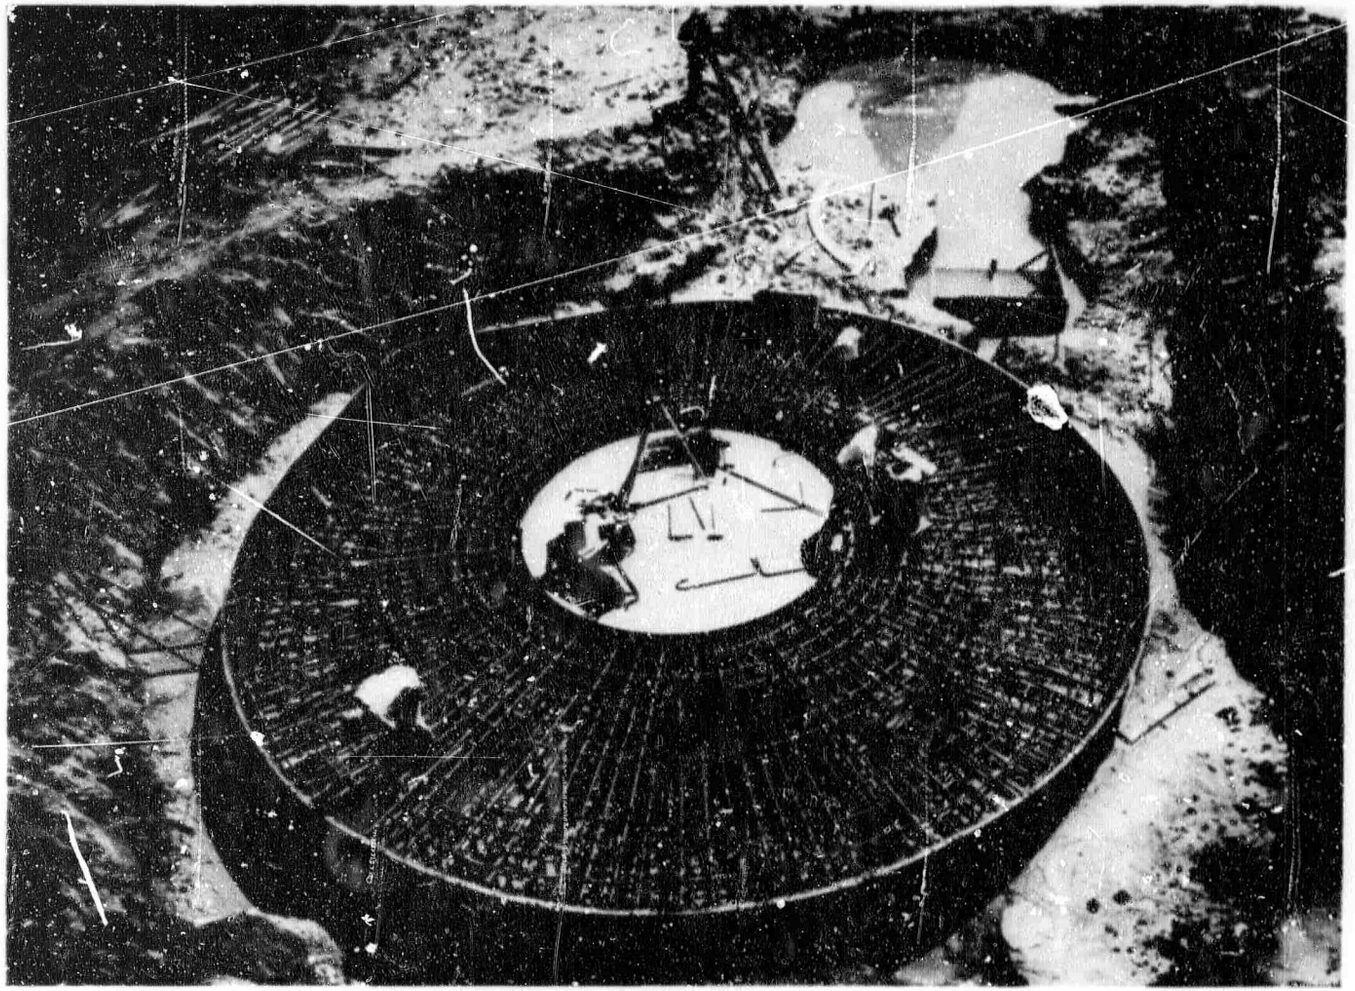
Fig. 11. Completed excavation for Minuteman launch equipment building

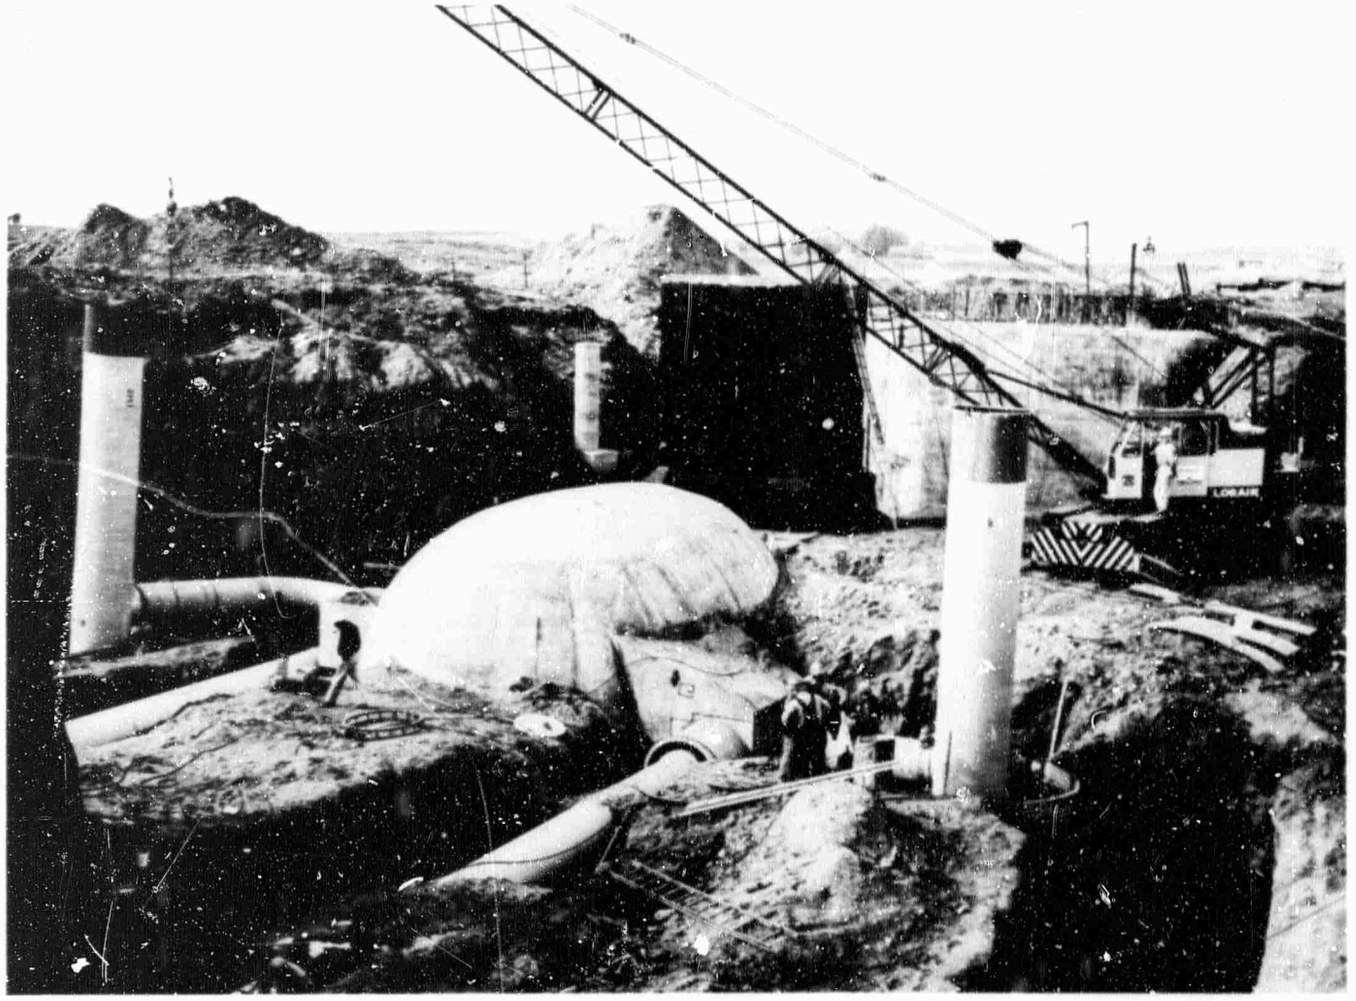
Fig. 14. Restricted backfill area at a Titan II facility

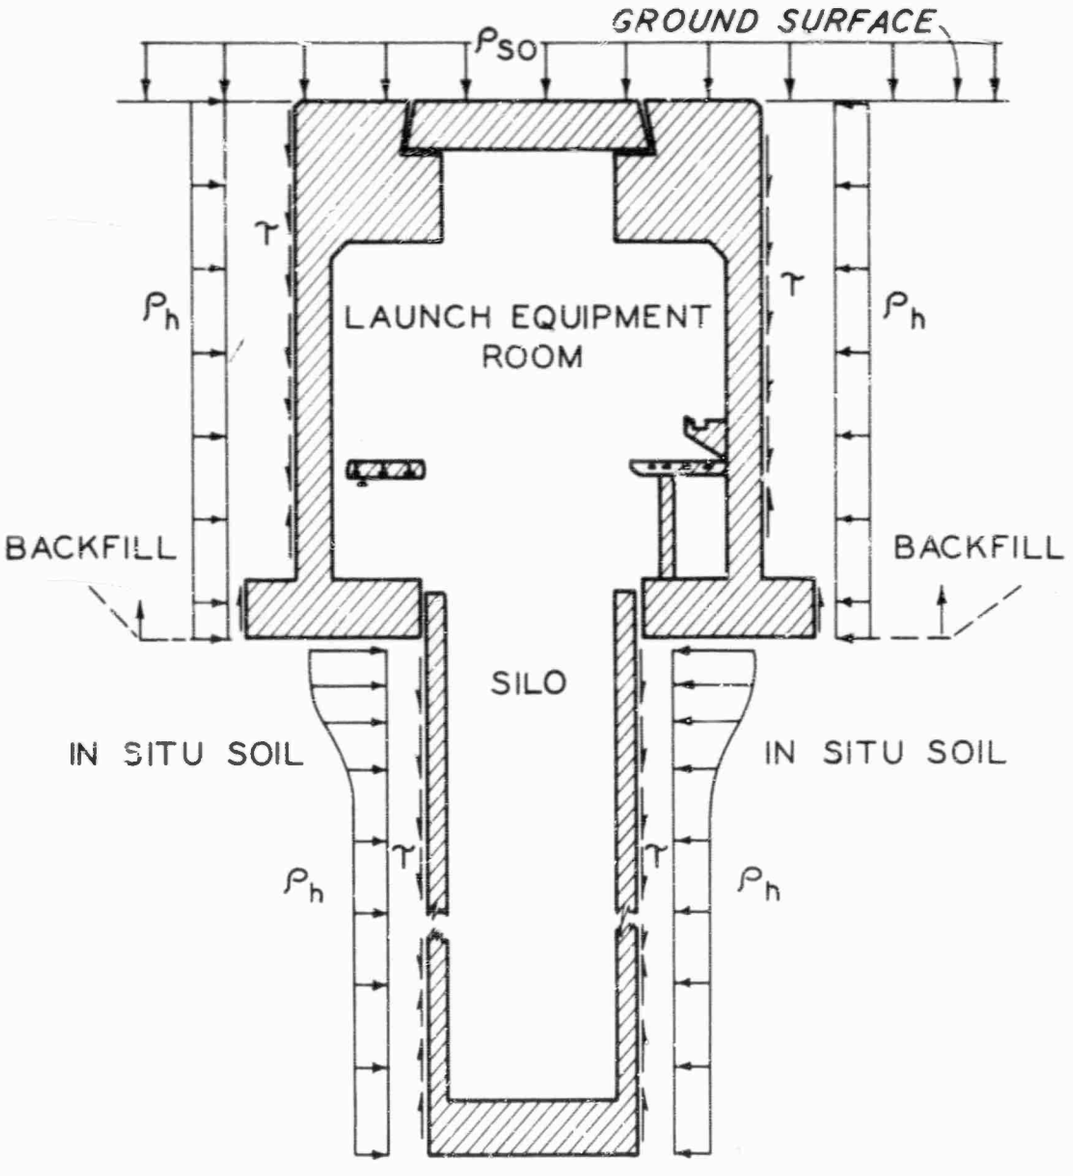
Fig. 15. Constricted areas for backfill at a Minuteman facility
