MISCELLANEOUS PAPER N-71-3

DYNAMIC TESTS OF A MODEL FLEXIBLE-ARCH-TYPE PROTECTIVE SHELTER

April 1971

Conducted by U. S. Army Engineer Waterways Experiment Station, Vicksburg, Mississippi

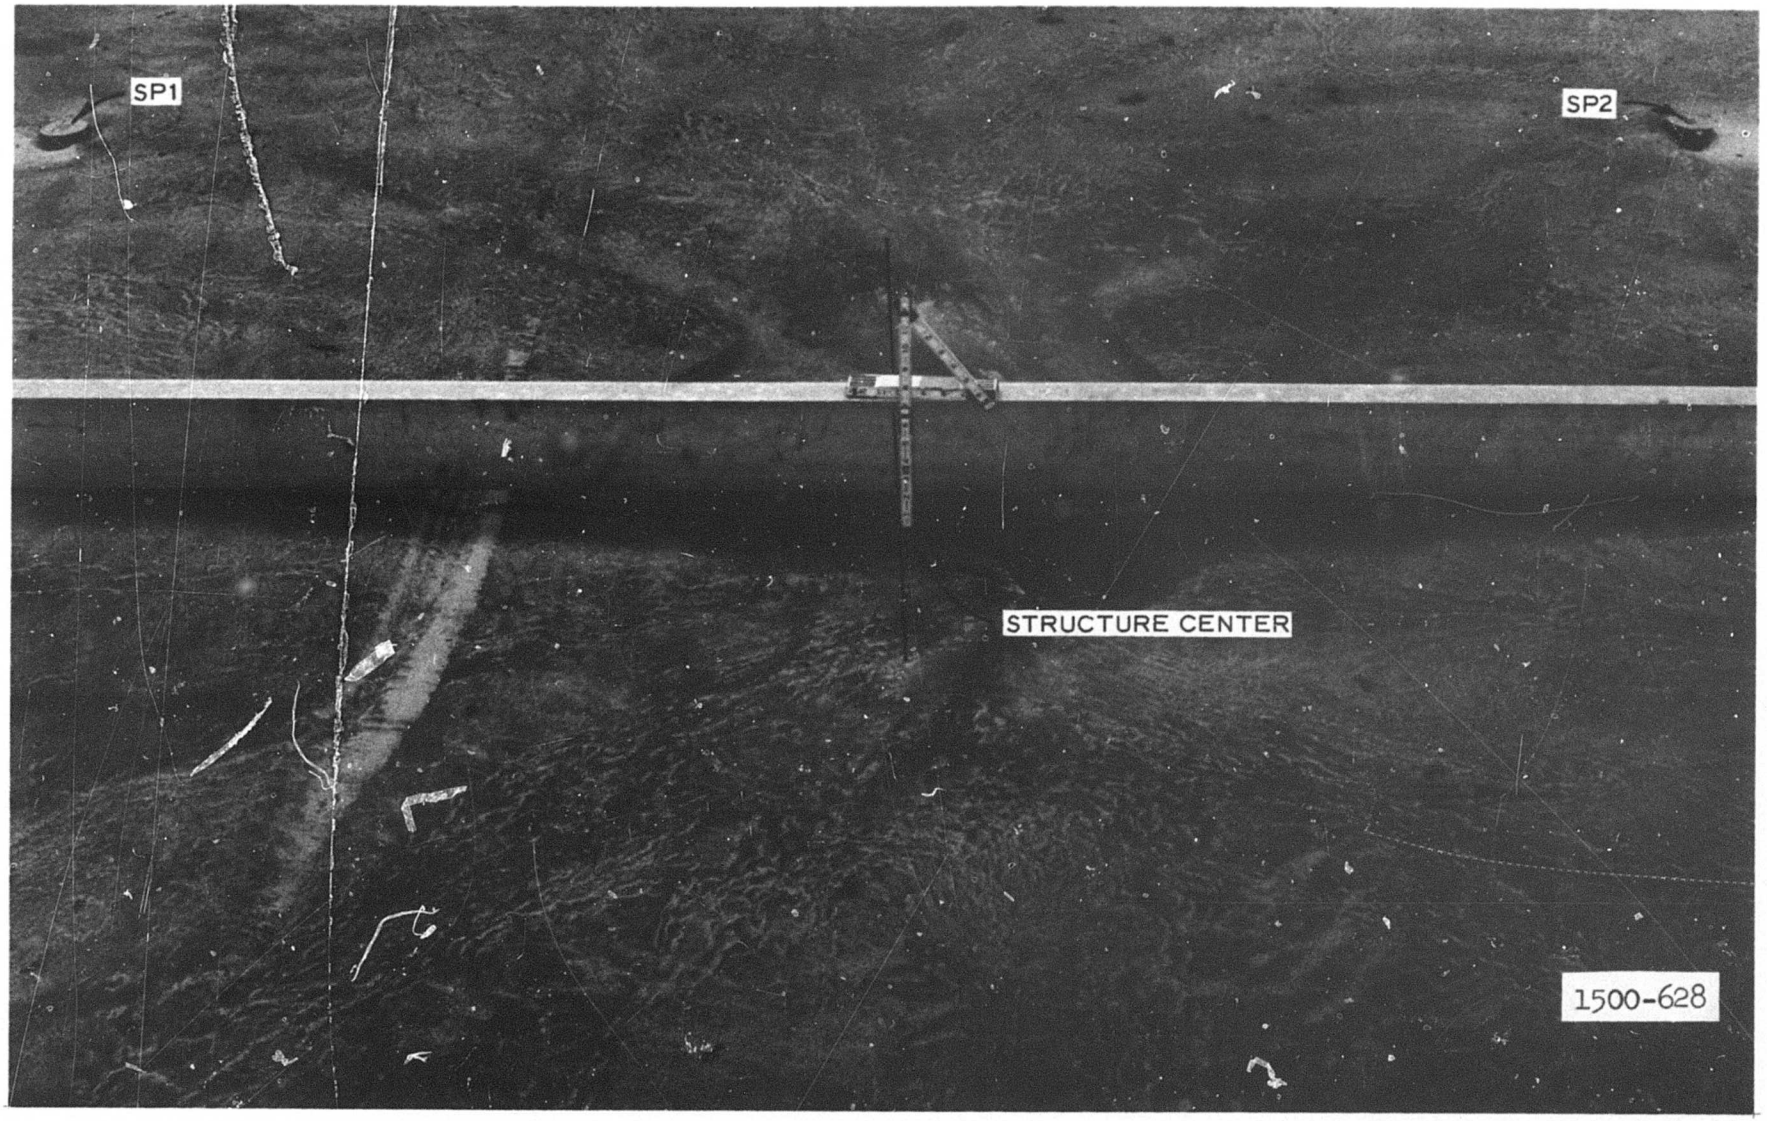
3.2.1 General Gross Motion and Damage. Shots 4 and 5 were the only tests in which the gross motion of the structure was sufficient to create a noticeable depression of the sand surface in the vicinity immediately above the structure (Figure 3.4). It became evident during excavation of the structure that the depression was caused by the vertical deformation of the steel ribs and downward deflection of the footings. While considerable displacement and deformation of the structure were noted after

Figure 3.4 Depression in the sand surface caused by the gross motion of the structure during Shot 4. Note the presence of airblast Gage SP1 in the upper left-hand corner.

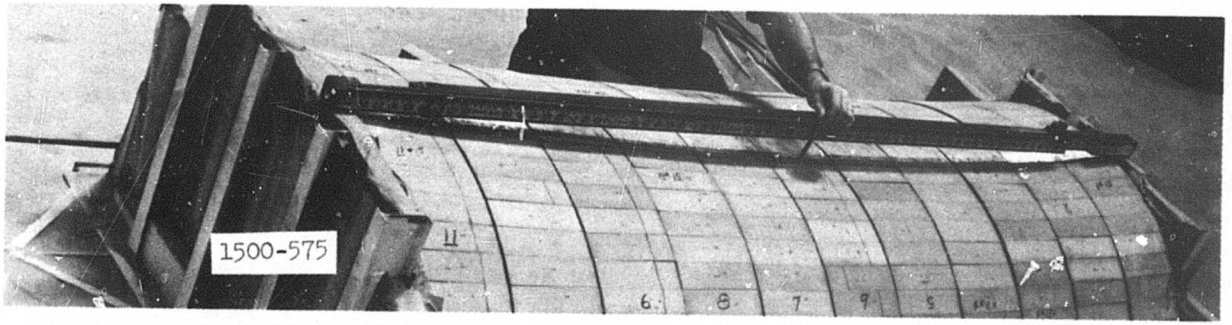
a. Postshot 3.

Shot 3, no definite depression was observed. Shown in Figure 3.5 is a sequence of photographs showing the structure crown curvature after Shots 3, 4, and 5.

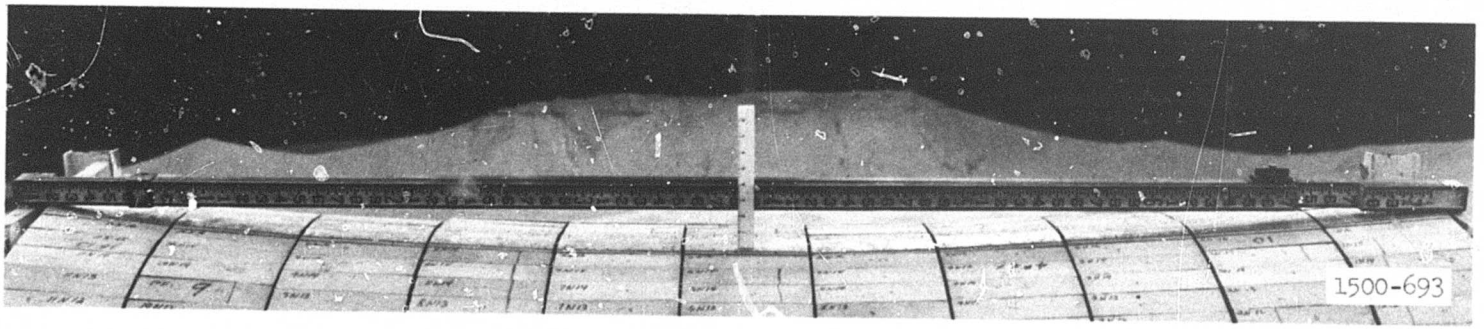
c. Postshot 5.

Figure 3.5 Postshot crown curvature.

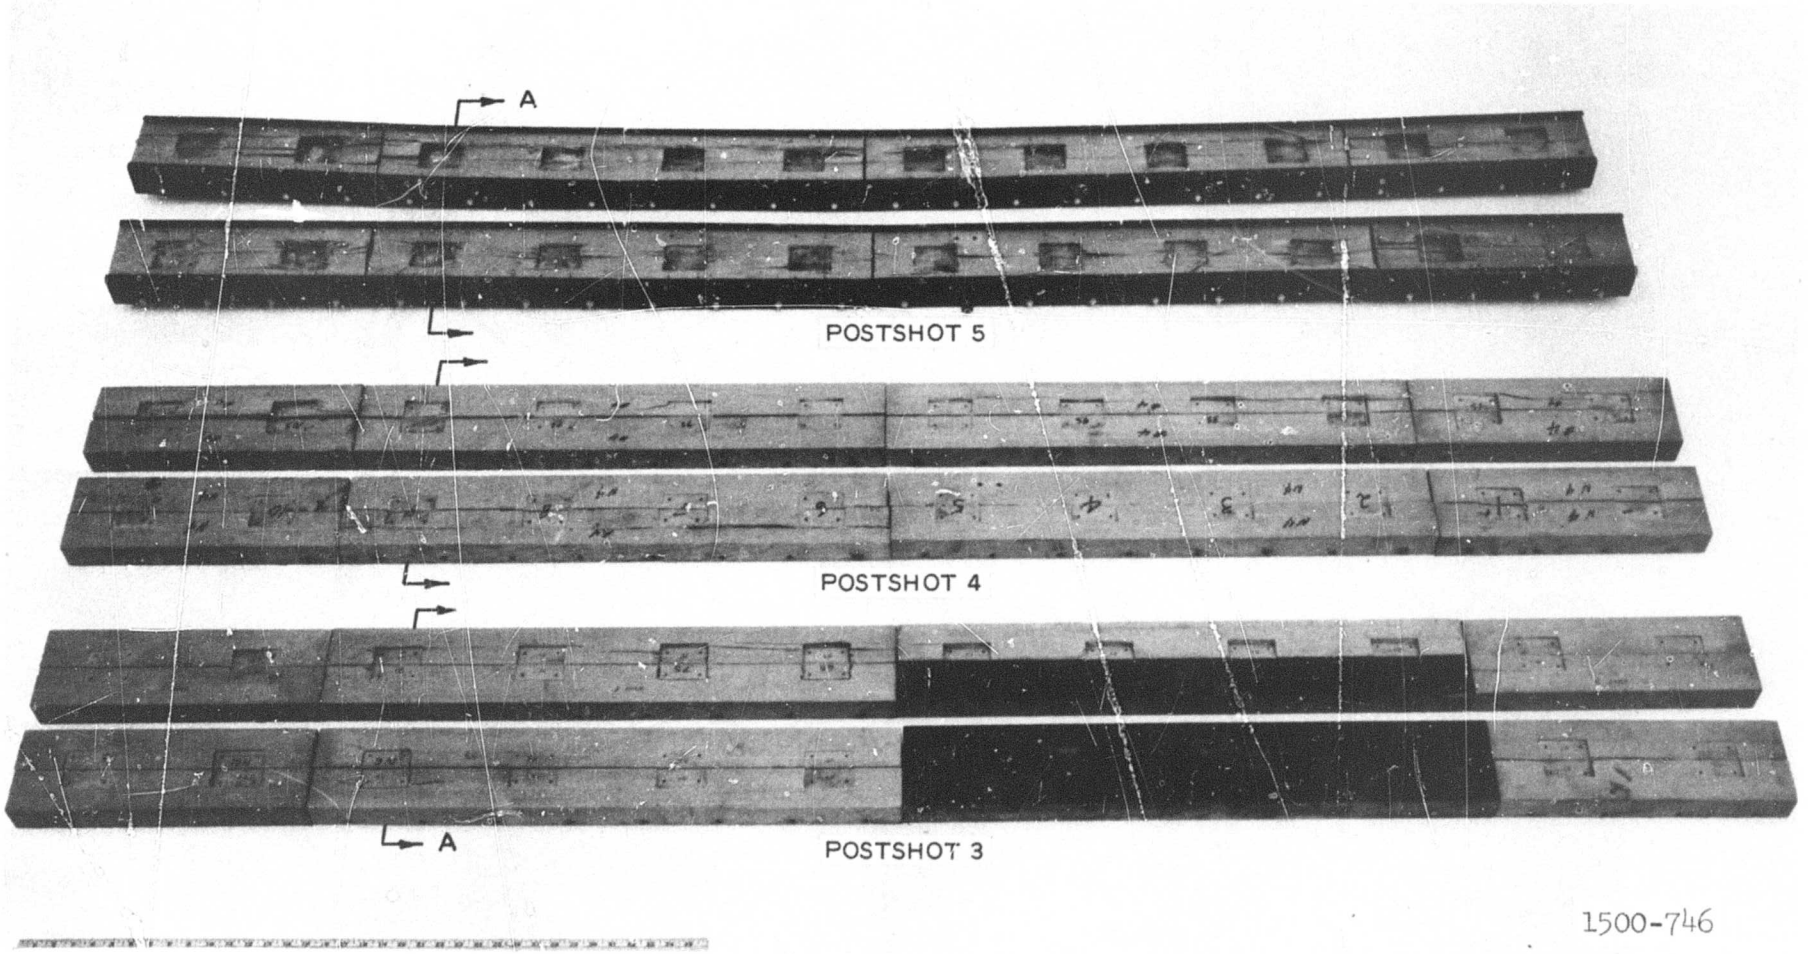
The footings were damaged extensively at the high overpressures, but were only slightly damaged at overpressures below 120 psi. They generally were bent inward and downward in the central region after each shot. This inward deformation can be seen in Figure 3.7 which shows the damage to the three sets of footings from Shots 3 to 5. Parts of the footings for Shot 3 were misplaced and are shown as black dummy sections in the figure. Generally, the damage was greater with increasing overpressure as can be clearly seen in Figure 3.8, a photograph of a section cut through the footing below Rib 9. Also shown in this figure is the deformation of the footing caused by the timber lagging as it was forced into the supporting footing during Shot 5.

Figure 3.7 Postshot view of the damaged footings showing the punching damage. Note also the inward bow of the Shot 5 footings.

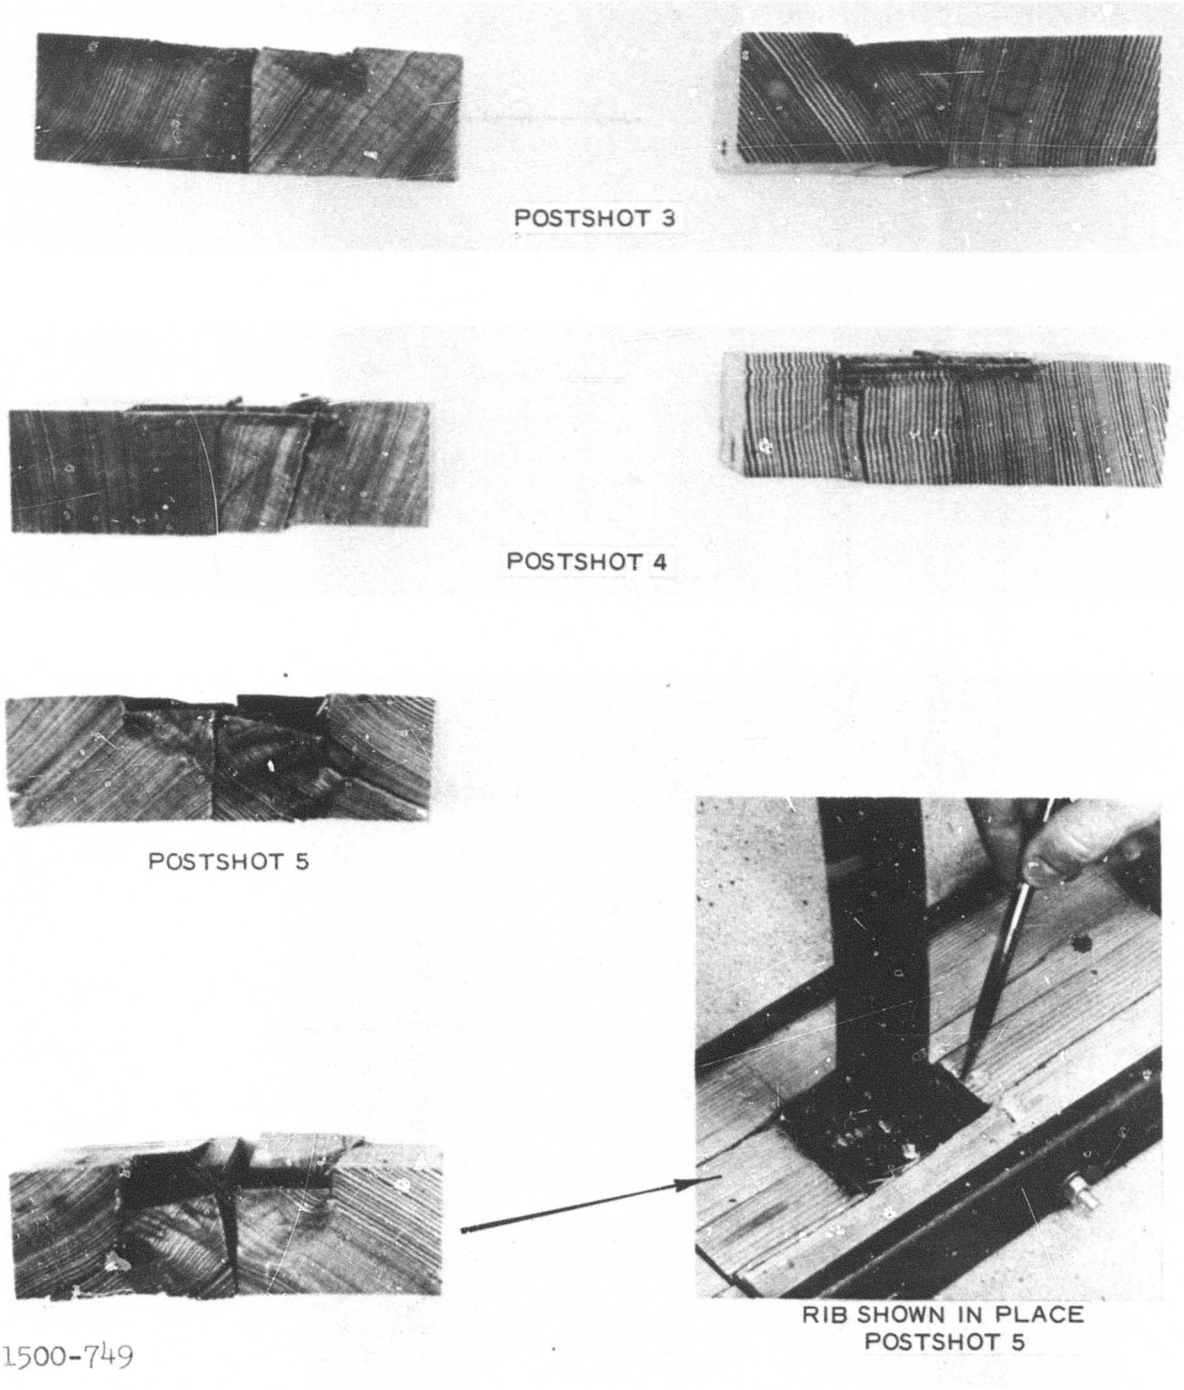
Figure 3.8 Section views of the damage shown in Figure 3.7 to the footings at the section shown (Section AA).

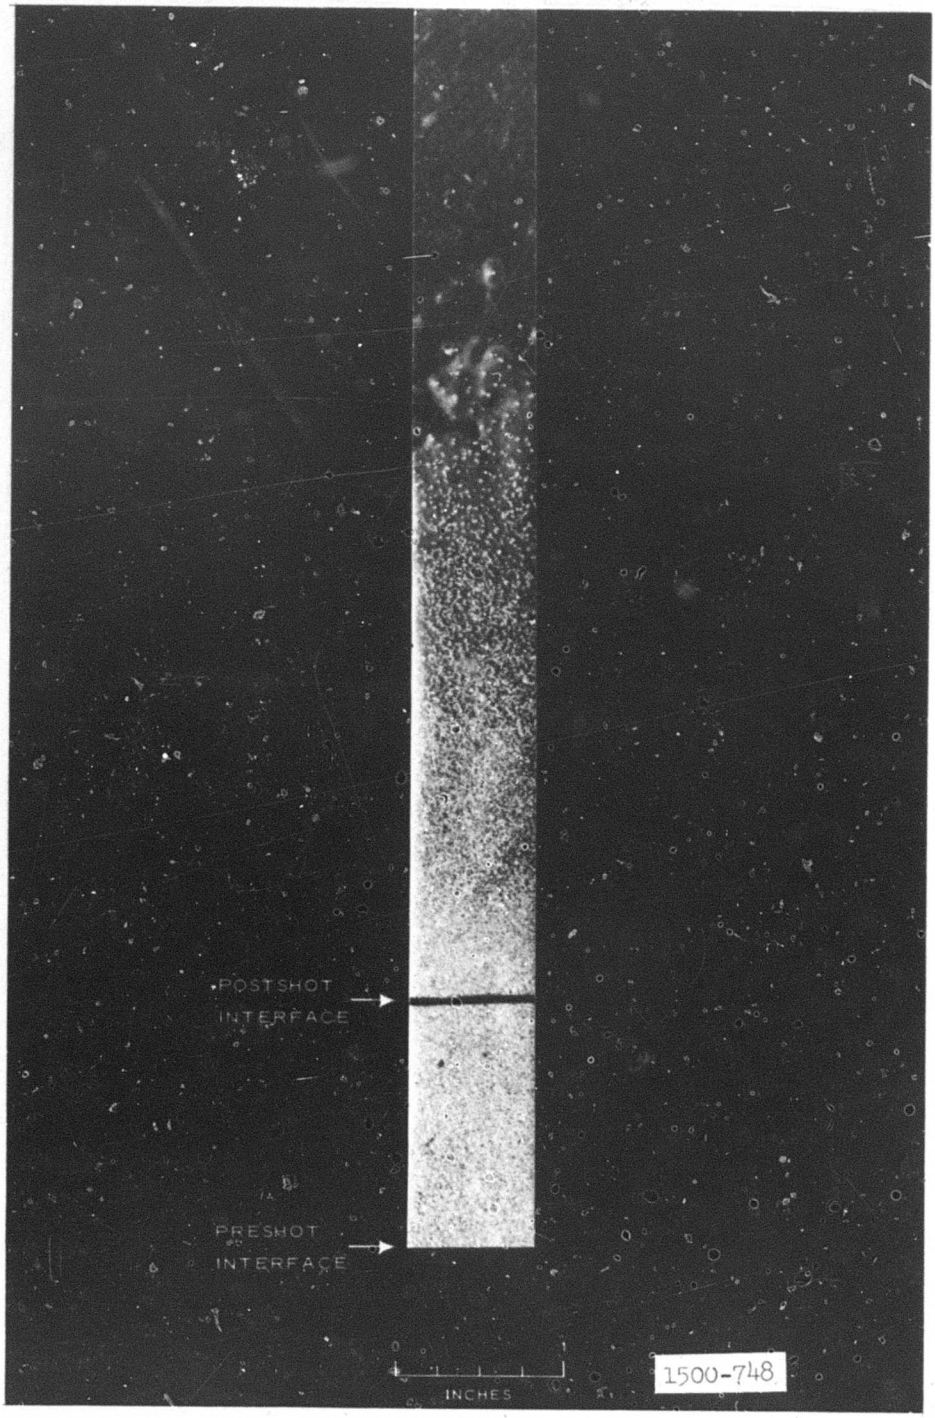
Some attempt was made to determine if a significant amount of spalling and motion of the sand floor occurred during Shots 4 and 5. In these shots a tape strip was placed vertically at about the center of the east side of the structure floor to try to measure the extent the sand surface moved upward. Figure 3.9 shows the sand distribution obtained. This record indicates that the interior floor moved up about 1.45 inches and the sand particles were thrown to a height of about 5.40 inches above the original floor level. The tape for Shot 5 did not yield favorable results. However, the interior floor accelerometer, 51VA, was thrown up and displaced from its preshot location below a sandbag (Figure 3.10). This

Figure 3.9 Sand spall of the interior floor surface during Shot 4.

Limited spalling tests indicate that dust inhalation could be a problem in the prototype, and some means of dust prevention such as oiling the interior floor should be considered.

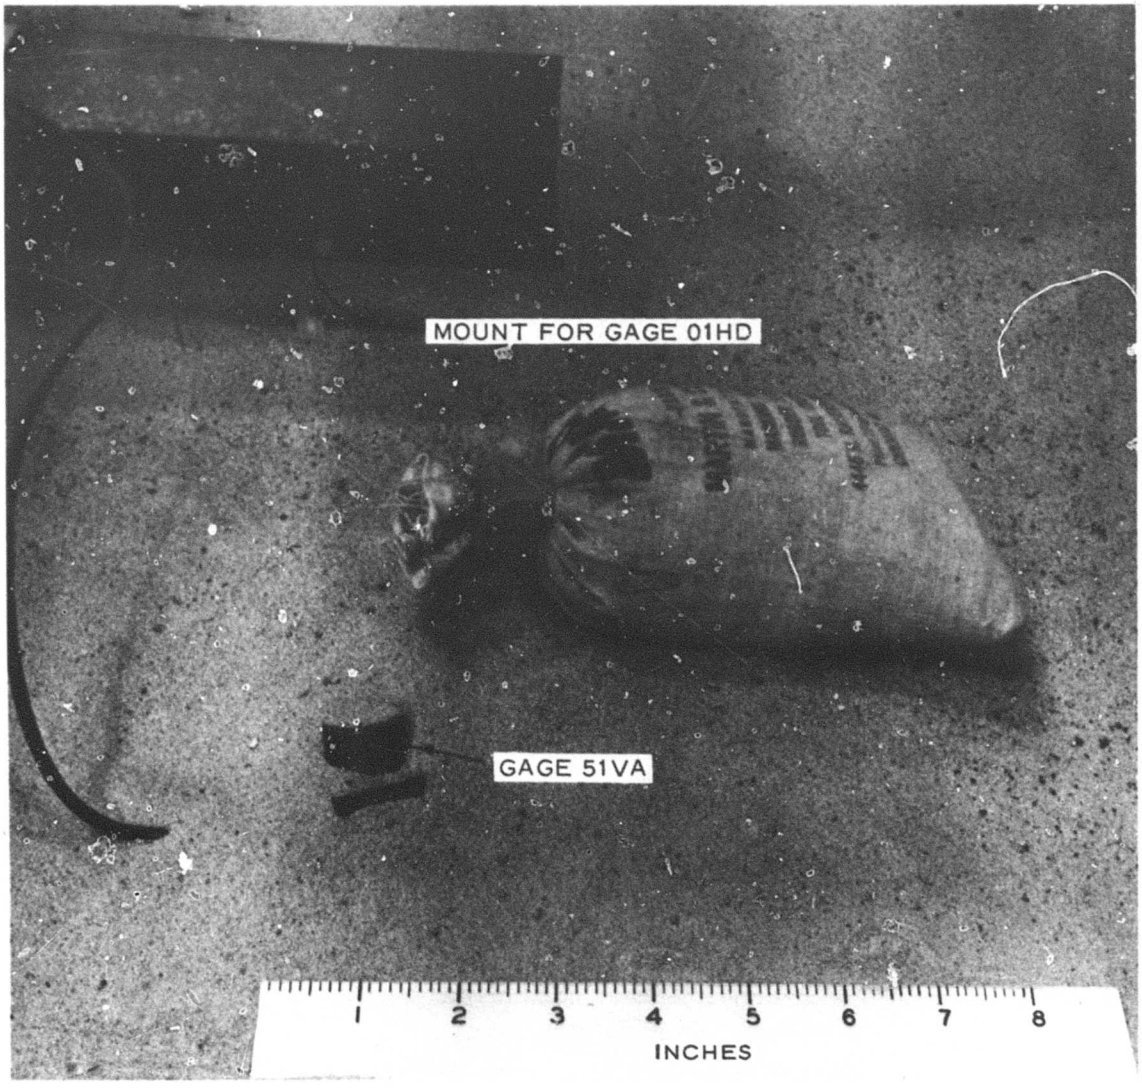
Figure 3.10 Dislocation of Gage 51VA caused by spalling of the interior floor during Shot 5.

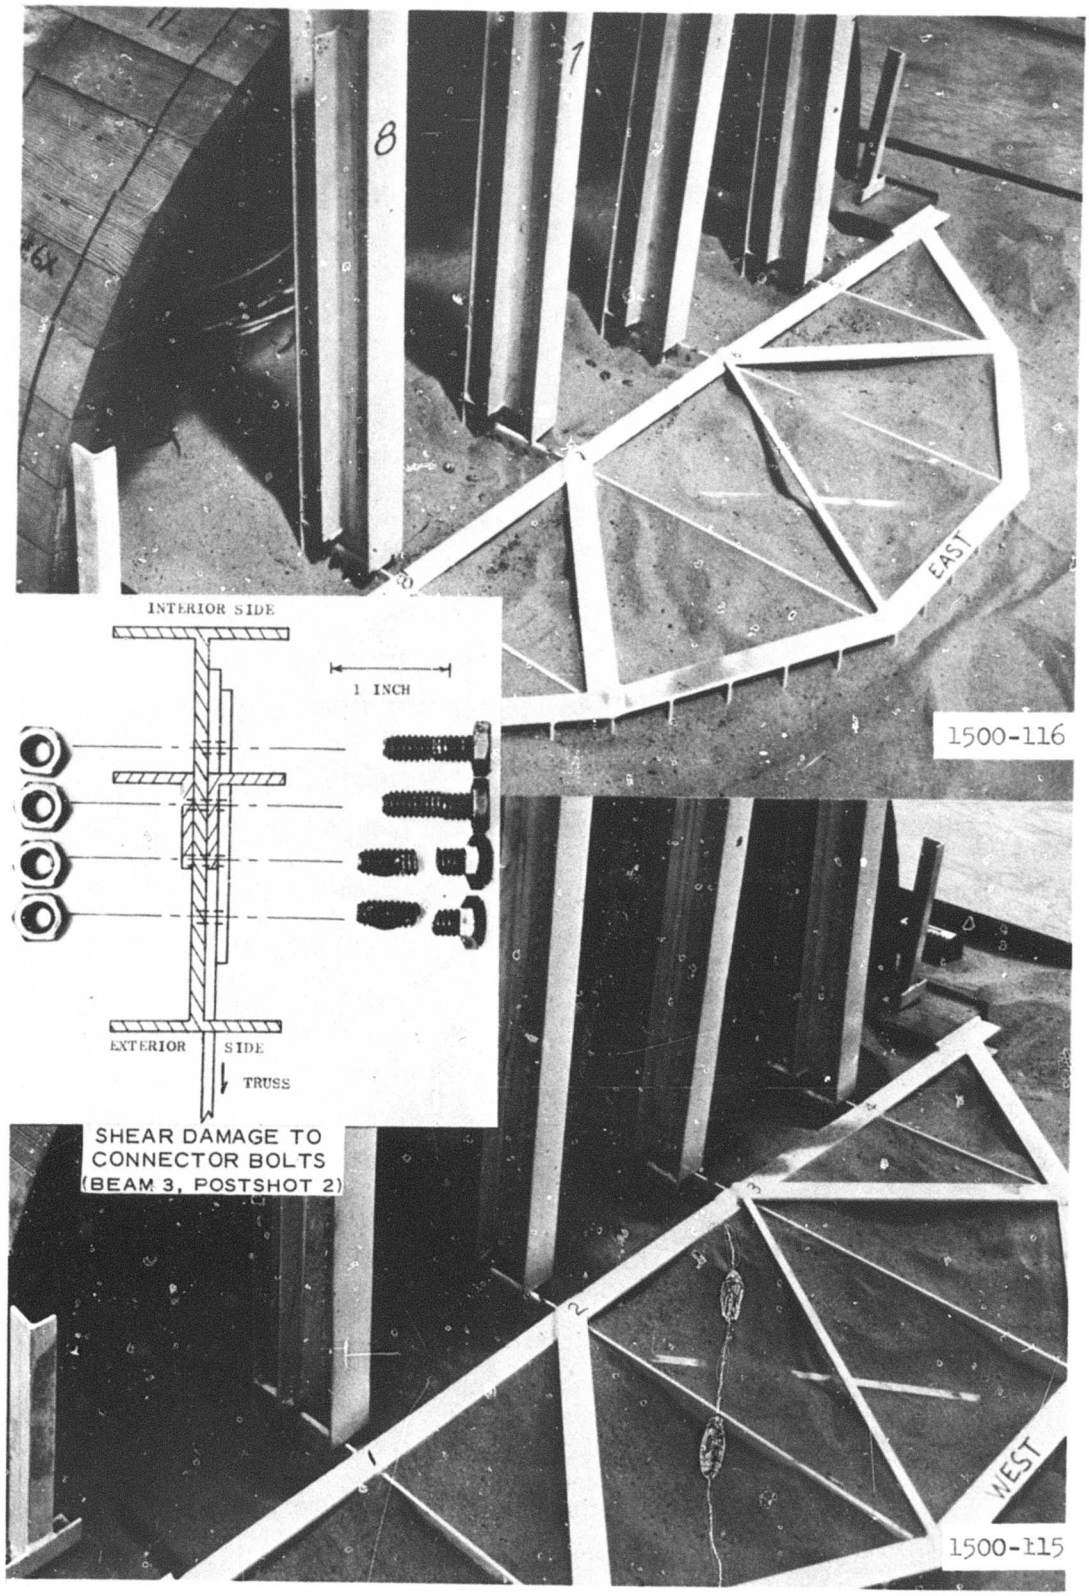
The only serious damage at low overpressure occurred at the connecting bolts between the bulkhead beams and the end trusses. Damage was first noticed here during the pilot test (Figure 3.11), and was initially attributed to insufficient bolt area causing high shearing stresses to occur. Consequently, the bolt sizes for future shots were increased slightly to provide additional shear area. During Shots 1 and 2, the same damage occurred (see inset, Figure 3.11). After closer examination, it was decided that the end truss extending out into the free field acted like a paddle, tending to rotate as the structure moved downward. This rotation occurred about the inner bolt and sheared the bolts off starting with the outer one as shown in the inset of Figure 3.11. A redesign of the connection was made using a pin connector which allows rotation. The redesign used the original shear area of the four bolts as the area of the pin and is detailed in Appendix D. Testing was continued using the modified connectors during Shots 3, 4, and 5. During Shot 3, excessive rotation caused cracks to appear in the tongue between the bulkhead beams and the end truss (Figure 3.12a). Possibly, this distress was due to fatigue since this component had been tested three times previously at lower overpressures. Prior to Shot 4, the end truss tongues were replaced and rotation cracks appeared. Again the tongues were replaced and during Shot 5 complete failure occurred (Figure 3.12b). The fact that complete failure did not occur during Shot 4 seems to indicate that the Shot 3 distress was due in part to fatigue.

Figure 3.11 Shear damage to connector bolts, main photographs showing the post-pilot-test damage.

Based on the laboratory findings, it is recommended that the bulkhead truss connection be redesigned as outlined in Appendix D. This redesign will eliminate problems occurring as a result of truss rotation. With regard to the truss itself, it is recommended that a cheaper configuration be designed. It is possible to use a pair of the arch ribs laid flat and connected to the bulkhead column bases by rods.

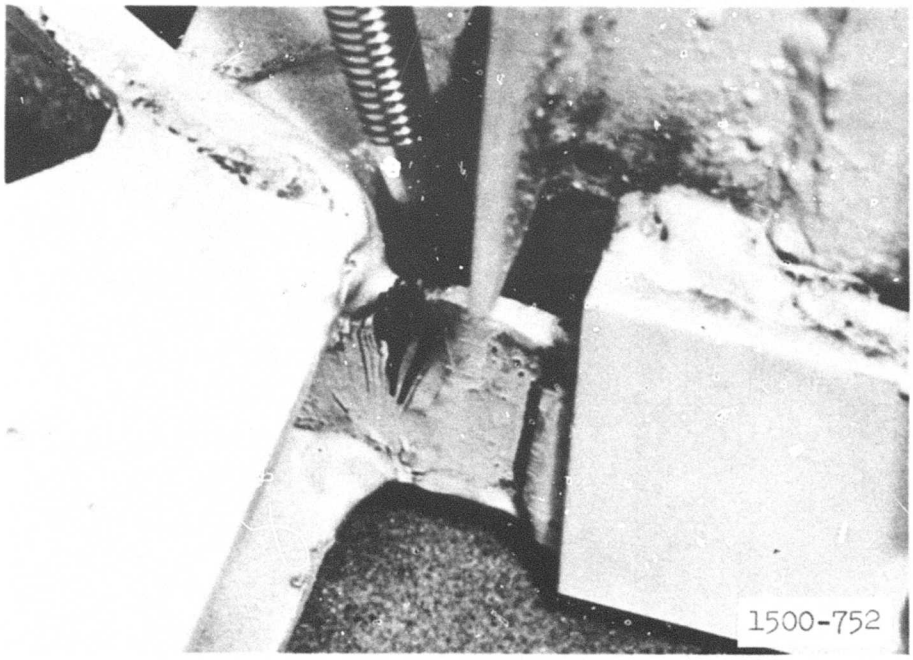
a. Postshot 3. Shear damage to the Beam 2 connector tongue.

Figure 3.12 Damage to the redesigned bulkhead beam-truss connector.

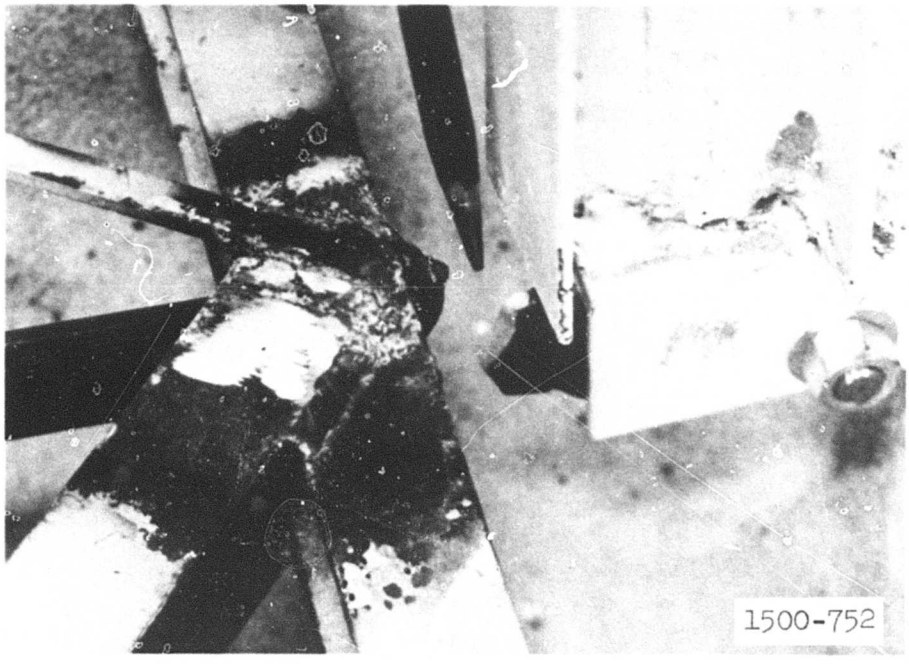
b. Postshot 5. Shear damage to the Beam 2 connector tongue.

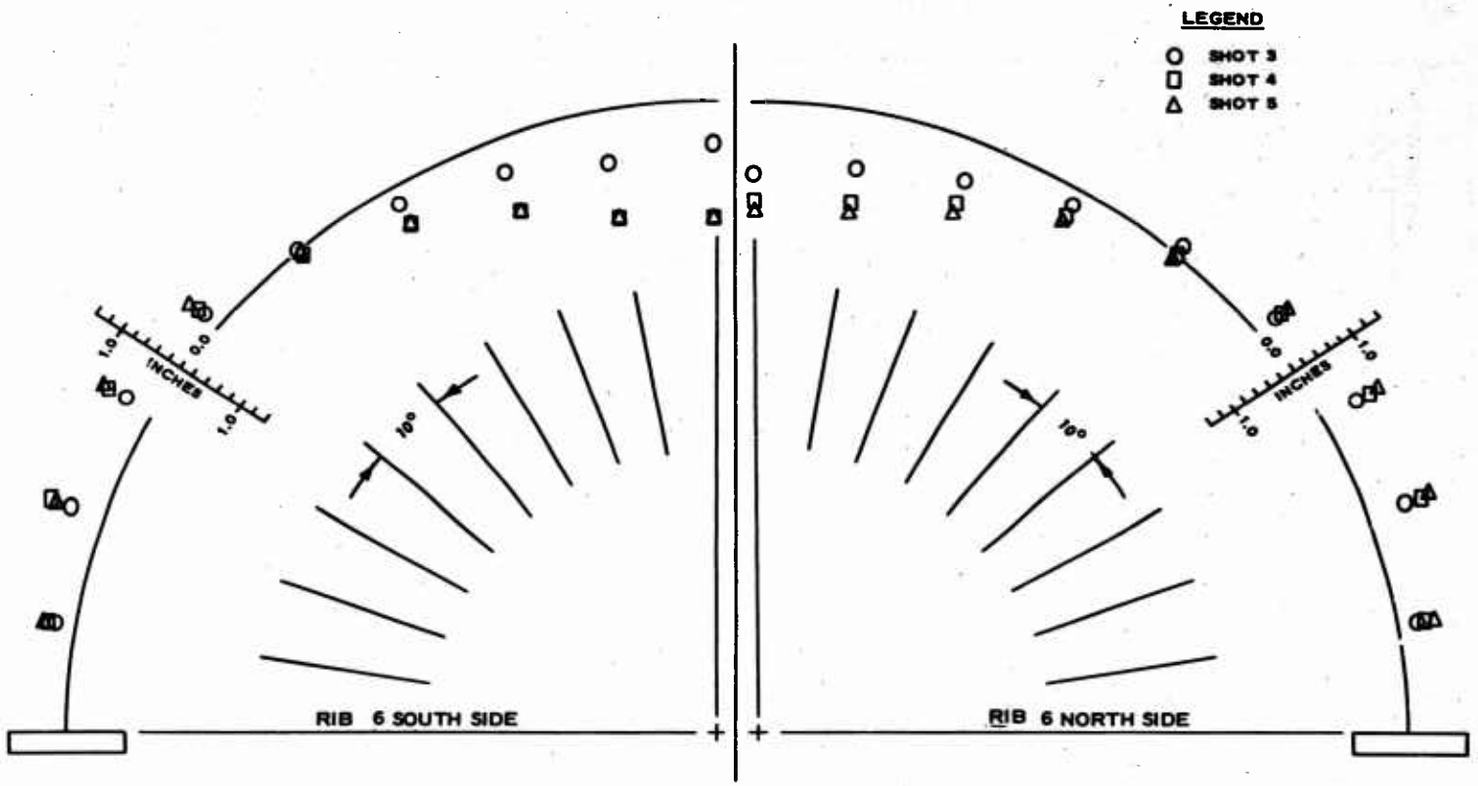
Figure 4.4 Permanent deformation of Rib 6 after Shots 3, 4, and 5.

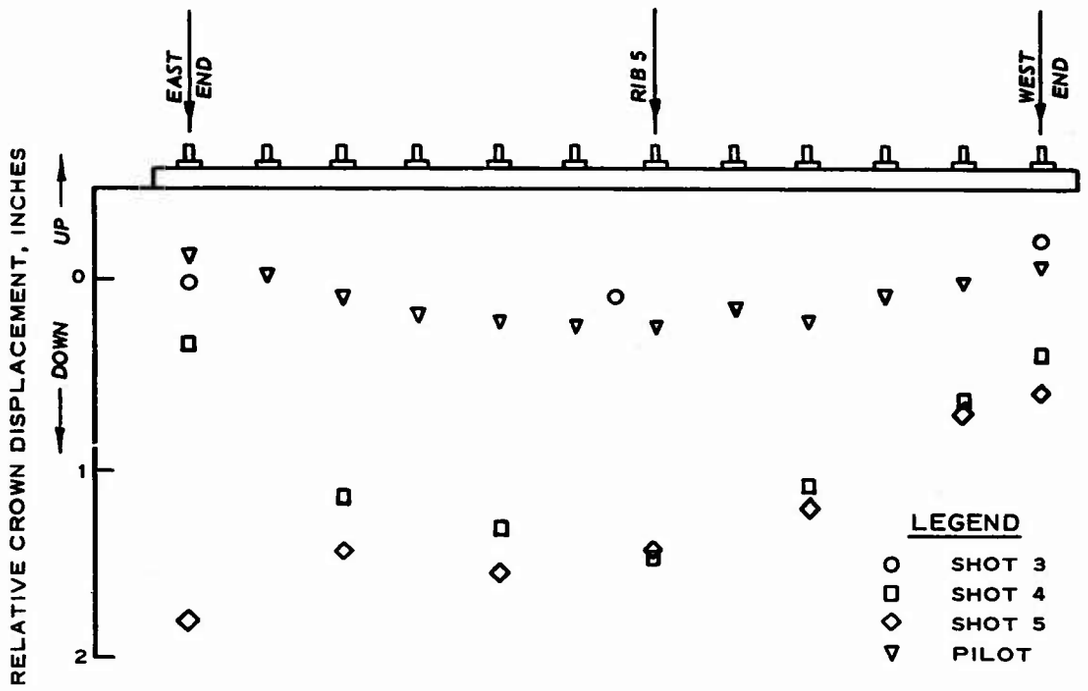
bulkhead did affect to some extent the radial distribution of load on the arch, but probably not in a significant manner. Further evidence of the influence of the bulkheads is shown in Figure 4.6 where it can be observed that the crown deflection was generally less at the bulkheads than in the central area.

Figure 4.6 Level survey, postshot crown deflection with respect to the footings.

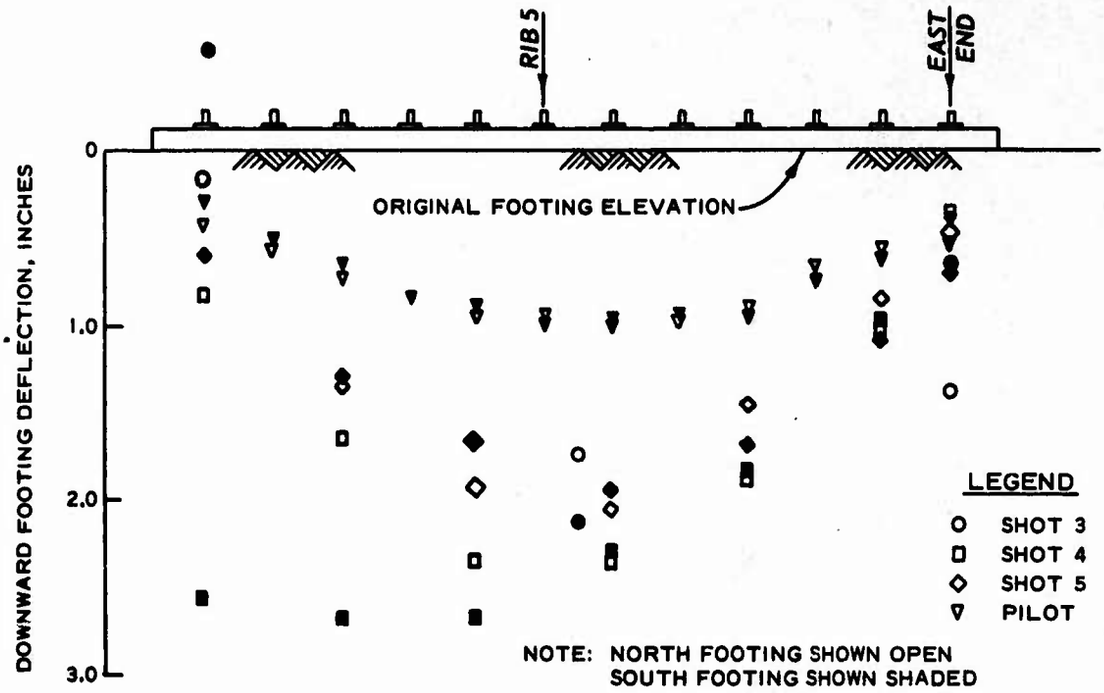
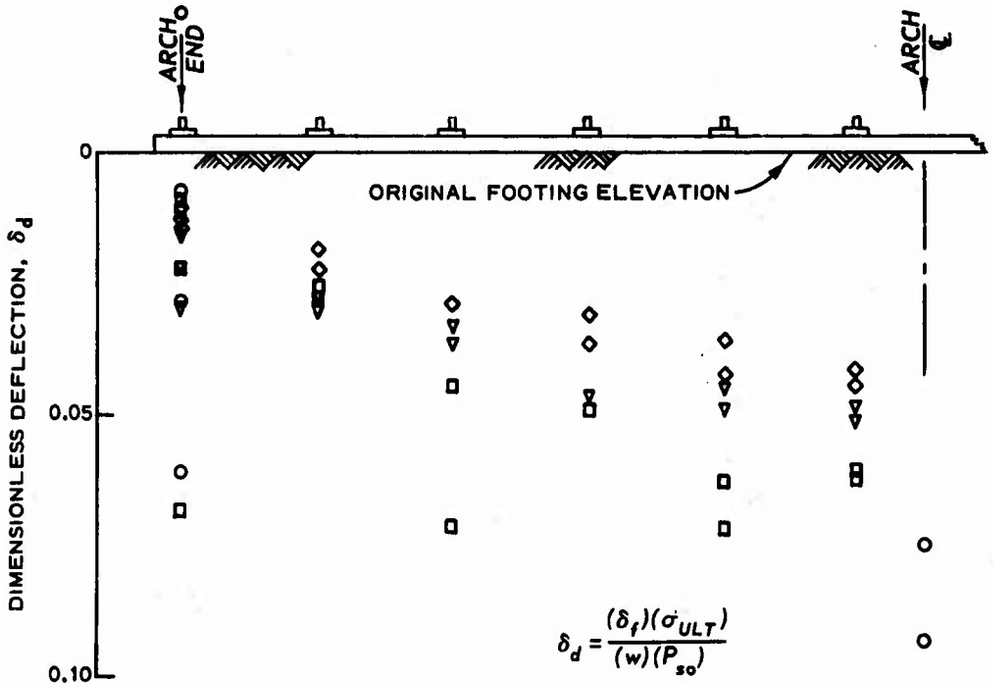
Level survey measurements were made to determine the total movement of the structure after Shots 3, 4, 5, and the pilot test shot. No measurements of this type were made for Shot 2 since it was a repeat loading of the Shot 1 configuration. Figure 4.7a shows the raw footing survey data and Figure 4.7b a plot of dimensionless deflection where

Figure 4.7 Level survey data for footings.

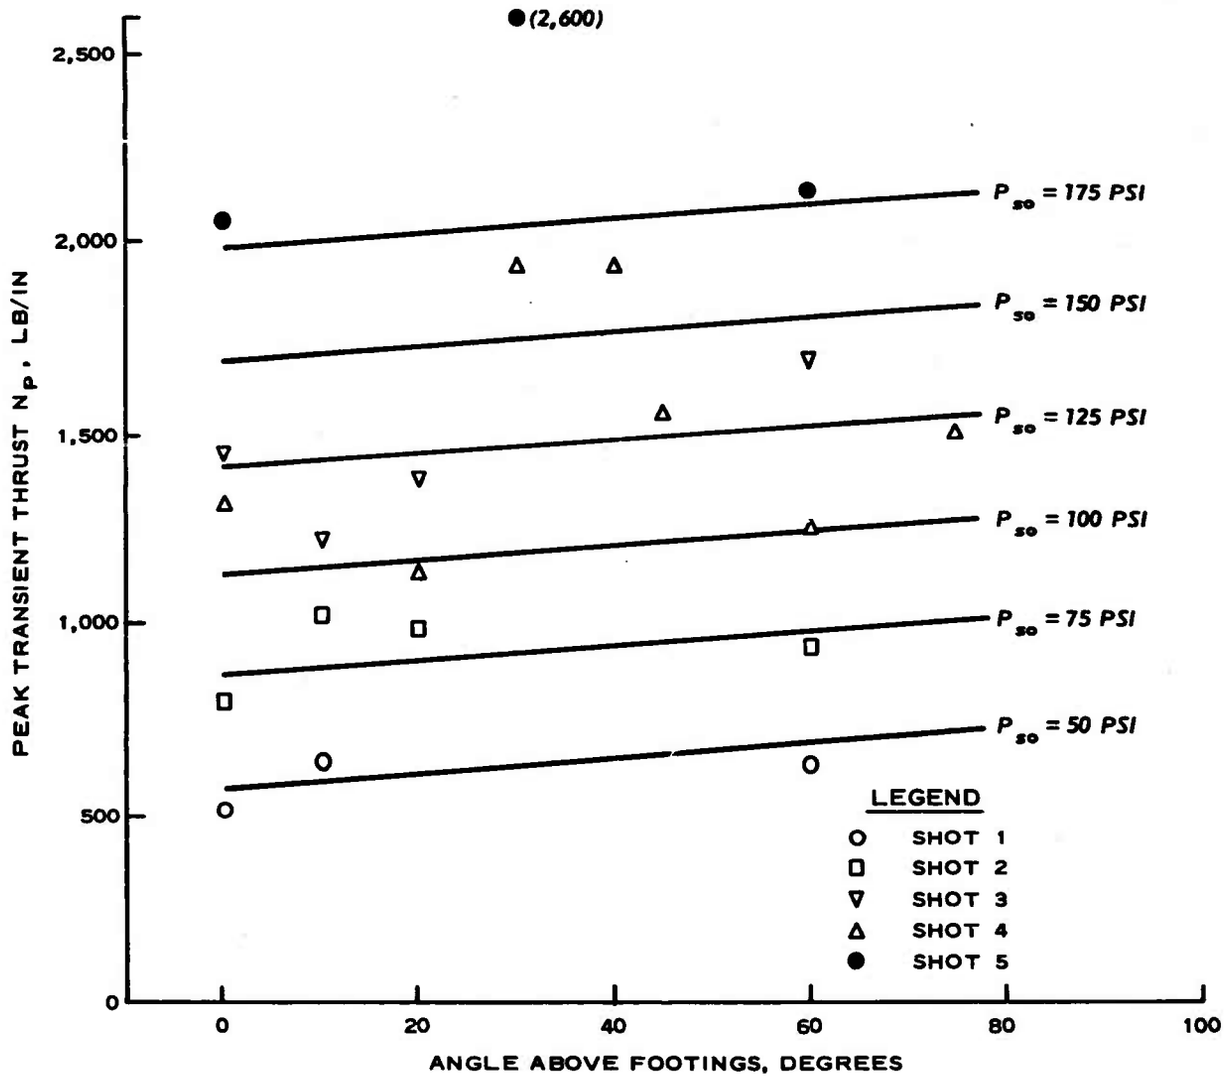
Figure 4.17 Peak transient thrust.

The peak transient thrust data are plotted in Figure 4.17 and show considerable scatter. However, data analysis indicates that the thrust throughout the arch ring is generally uniform with a slight tendency for the thrust to increase as the arch crown is approached. Regression analysis of these data gives the following equation for the peak transient thrust in the arch section in terms of peak overpressure P_{so} and angle above the footing θ .

The lines shown in Figure 4.17 are based on this equation.

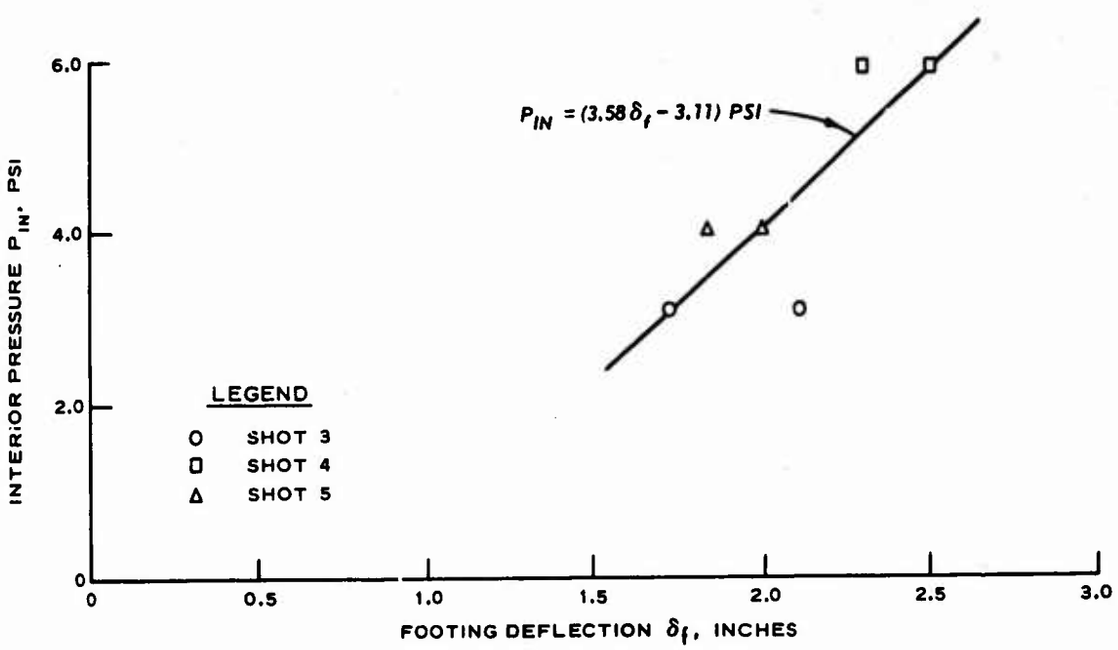
Figure 4.18 Peak interior pressure versus footing deflection.

Two quantities were measured inside the structure, interior pressure and floor acceleration. The peak pressure appears to be directly related to the decrease in interior volume caused by the punching of the footings since no breach occurred which would allow the airblast overpressure to enter the inside of the structure. Peak pressure versus footing punch from the survey data is shown in Figure 4.18 where the footing data are those extrapolated to the Rib 5 location on the north and south footings. Using the equation given, assuming the straight line fit of these data and the normalized data in Figure 4.7b as expressed by Equation 4.2, the interior pressure can be presented as

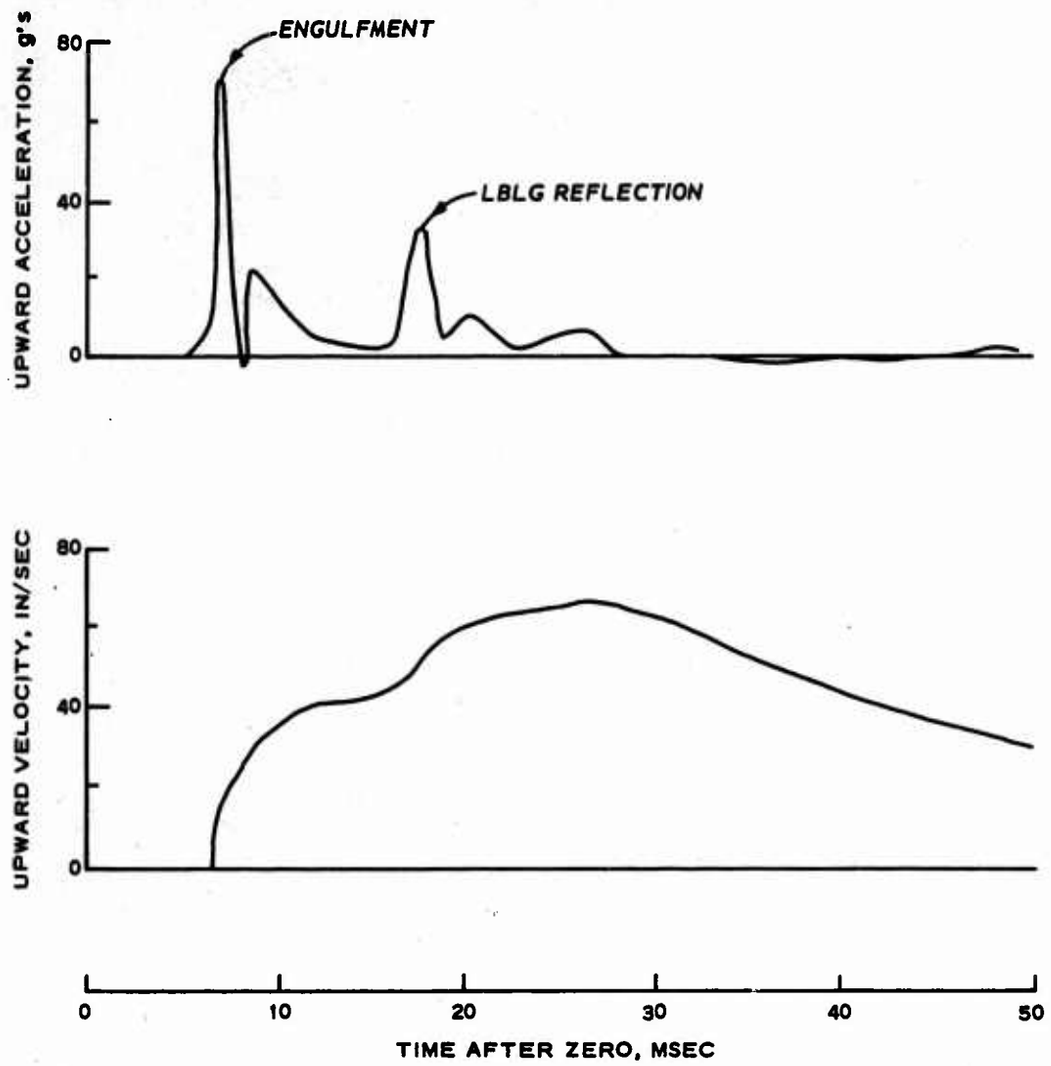
Figure 4.19 Acceleration- and velocity-time histories of the interior floor, Shot 4 (Gage 51VA).

The acceleration measured on the interior floor was characterized by two sharp spikes (Figure 4.19). The first and largest spike was caused by engulfment and punching of the footings and the second spike by the reflection off the base of the LBLG. Double integration of the data gave poor results as far as displacement was concerned, but gave reasonable velocity data. These data are shown as time histories in Appendix C and the peak data are shown in Figure 4.20.

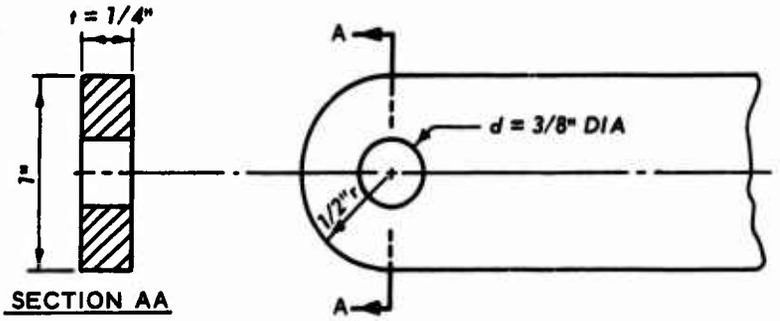
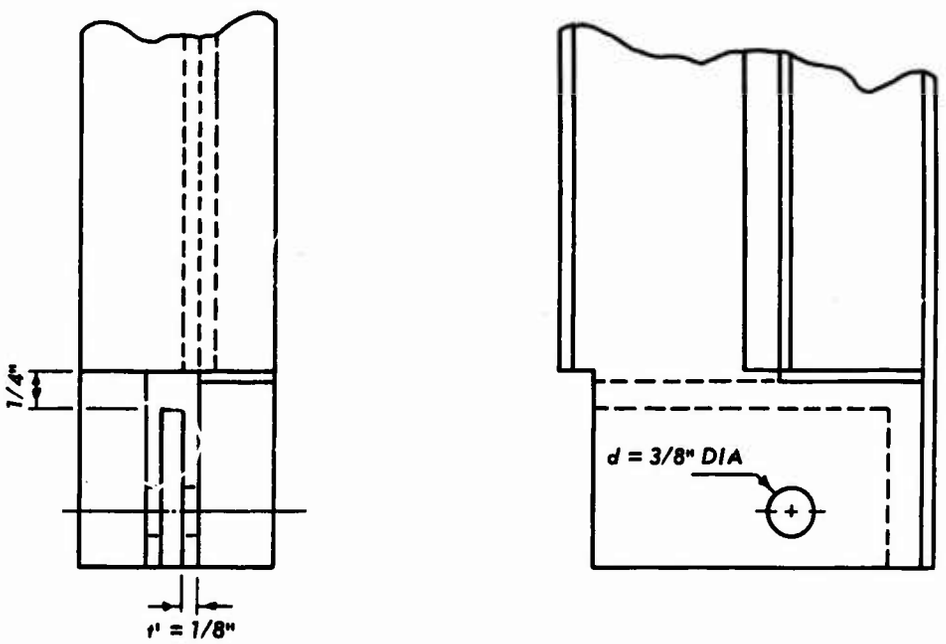
Figure D.2 Detail of the modifications made to the structure column-truss connection.

As discussed in Section 3.2.2, difficulties were encountered at the connection between the bulkhead columns and the end truss. These problems arose because of the rotation of the end truss about the connecting bolts which was caused by the gross motion of the structure. To alleviate this problem it was necessary to redesign the connectors to allow for this rotation. This redesign was done between Shots 2 and 3 and was in use during Shot 3. The new connection was designed as a pinned joint. This appendix details the redesign procedures and the redesign, and uses all of the original assumptions made in Reference 1.

a. TRUSS MODIFICATION

b. COLUMN MODIFICATION
