A FEASIBILITY STUDY FOR THE DEVELOPMENT OF A FATIGUE DAMAGE INDICATOR

ROBERT S. HORNE

LOCKHEED-GEORGIA COMPANY

TECHNICAL REPORT AFFDL-TR-66-113

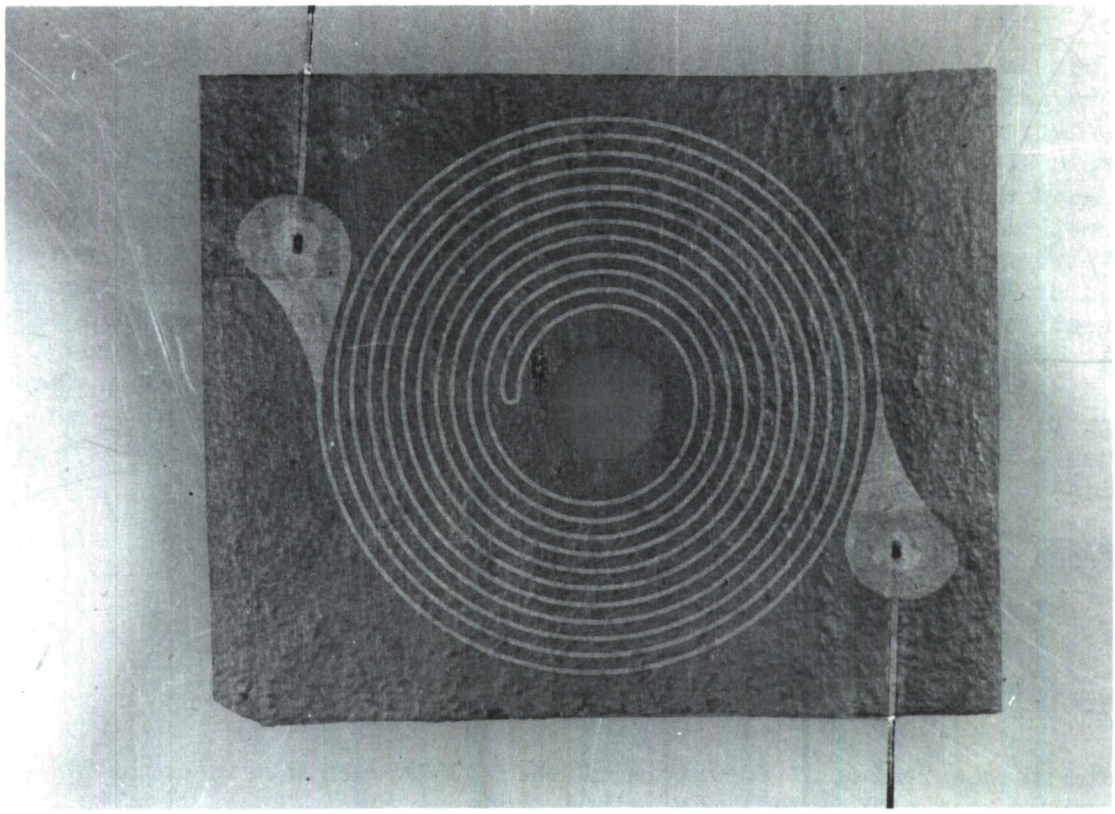
FIGURE 44A BALDWIN SPIRAL GRID FATIGUE SENSOR FOR USE AROUND RIVETS.

The first evaluation of this spiral grid was somewhat disappointing as evidenced by the data from Specimens 6A, 9A, 10A. The size and construction of the sensor as shown in Figure 44A indicates that the design could be improved. It is suspected that the strain pattern on the coupons tested, extended outward from the hole no further than two or three strands of the sensor grid. A review of the strain pattern indicates that the stress gradient around the hole can be pictorially represented as shown below.

The diagram indicates that the stress is relatively high at the hole edge, but quickly reduces to nominal area stress within 2 hole diameters. The revised grid was selected with reduced spacing between the concentric strands so that all strands are within one hole diameter of the hole edge. The 0.325 inch diameter center hole of the grid was selected as a "happy medium" to fit the usual run of rivets, unfilled holes, or spot welds.

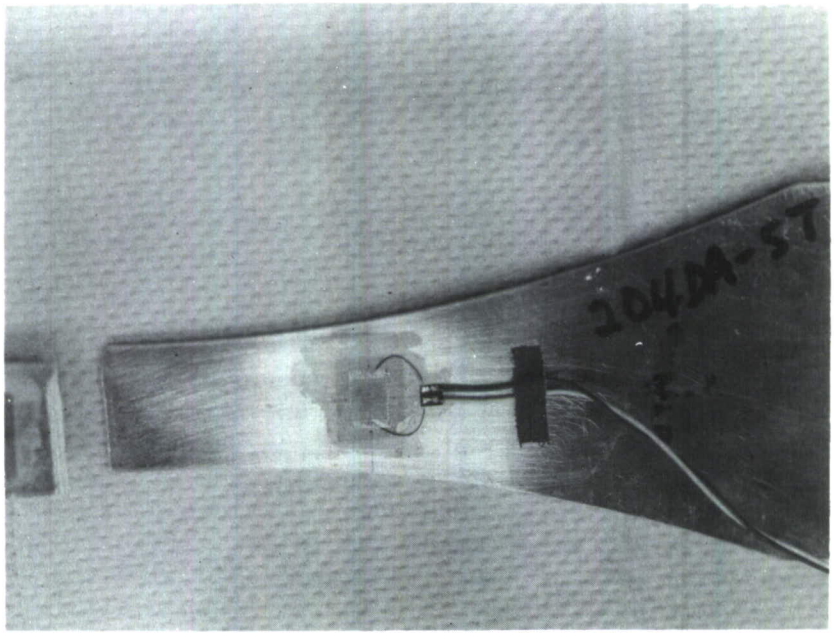
FIGURE 44B TYPICAL SENSOR INSTALLATION ON 7075-T6 ALUMINUM SHOWN AFTER SPECIMEN FAILURE. SENSOR BONDED WITH EPY-150 AND MOISTUREPROOFED WITH GW-1.

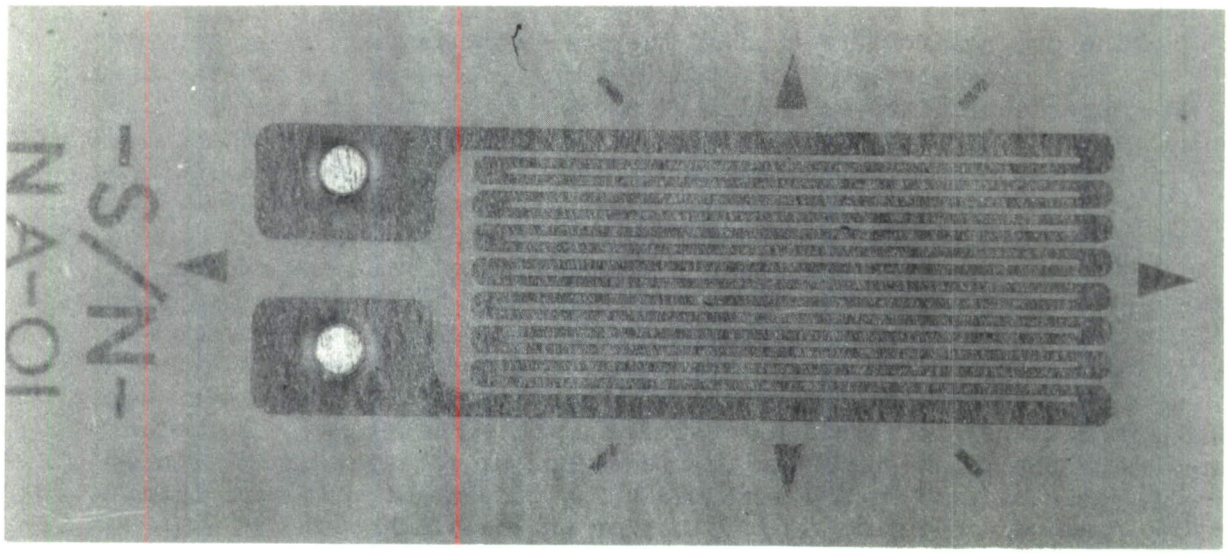
FIGURE 55 TYPICAL ACID ETCHED ANNEALED FOIL GAGE USED AS A FATIGUE SENSOR.

The progressive fracture of the foil strands previously termed "supersensitivity" is a situation controlled by the manufacturer. Supersensitivity is caused by microscopic cracks in the foil strands, starting at the edge of the strand and propagating across. The crack starts and follows along grain boundaries and apparently is accelerated if the strand edge has been exposed to acid. As the number and length of the cracks increase so does the electrical resistance, with any movement of the strands producing a "make and break" circuit across the crack resulting in an erratic resistance change. Microphotos of these fatigue cracks are shown in Figures 62 through 63. The grid strand or strands which had failed were located by using miniature probes and a sensitive wheatstone bridge. The sensor was positioned under a 30X stero-zoom microscope and the resistance of each strand measured. The suspect strands were then examined in detail at 1000X under the metallograph.

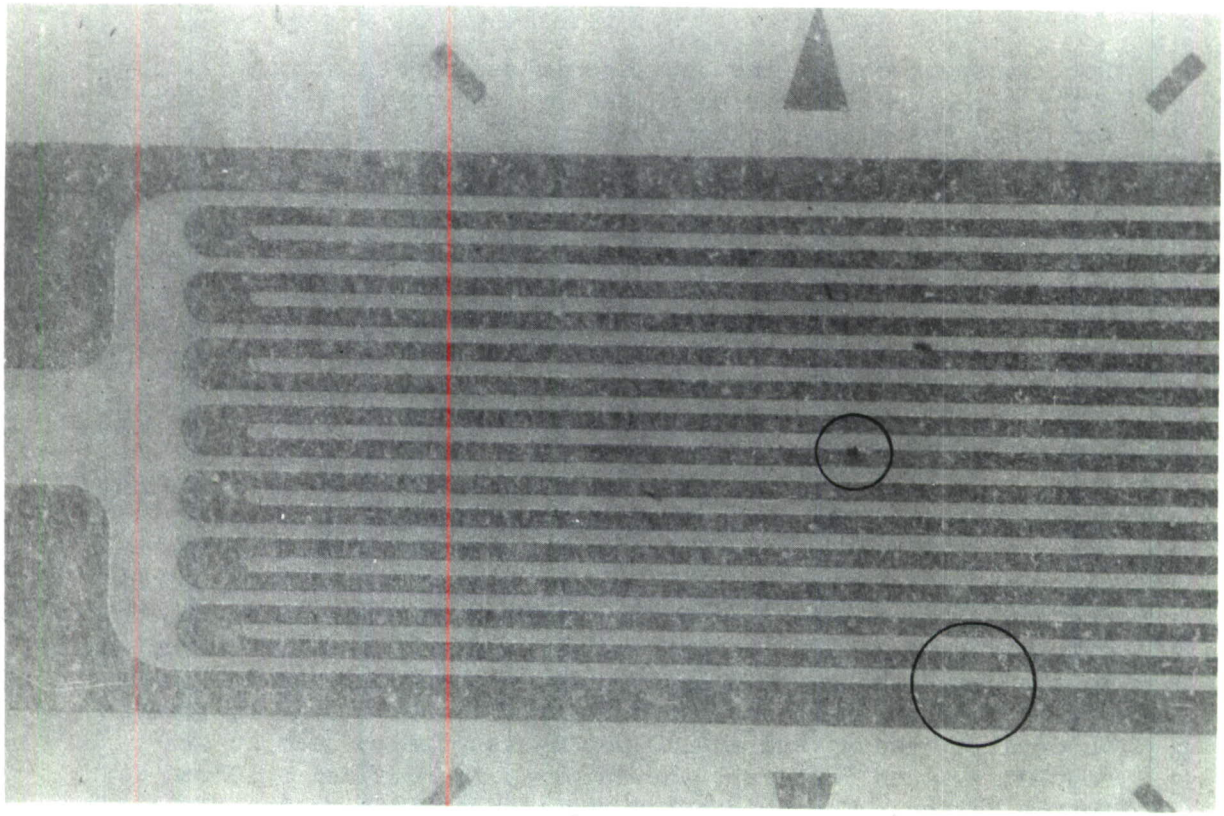
FIGURE 56 CIRCLES INDICATE IRREGULARITIES IN THE FOIL STRANDS PRODUCED BY THE ACID ETCHING PROCESS VISIBLE AT A MAGNIFICATION OF 24X.

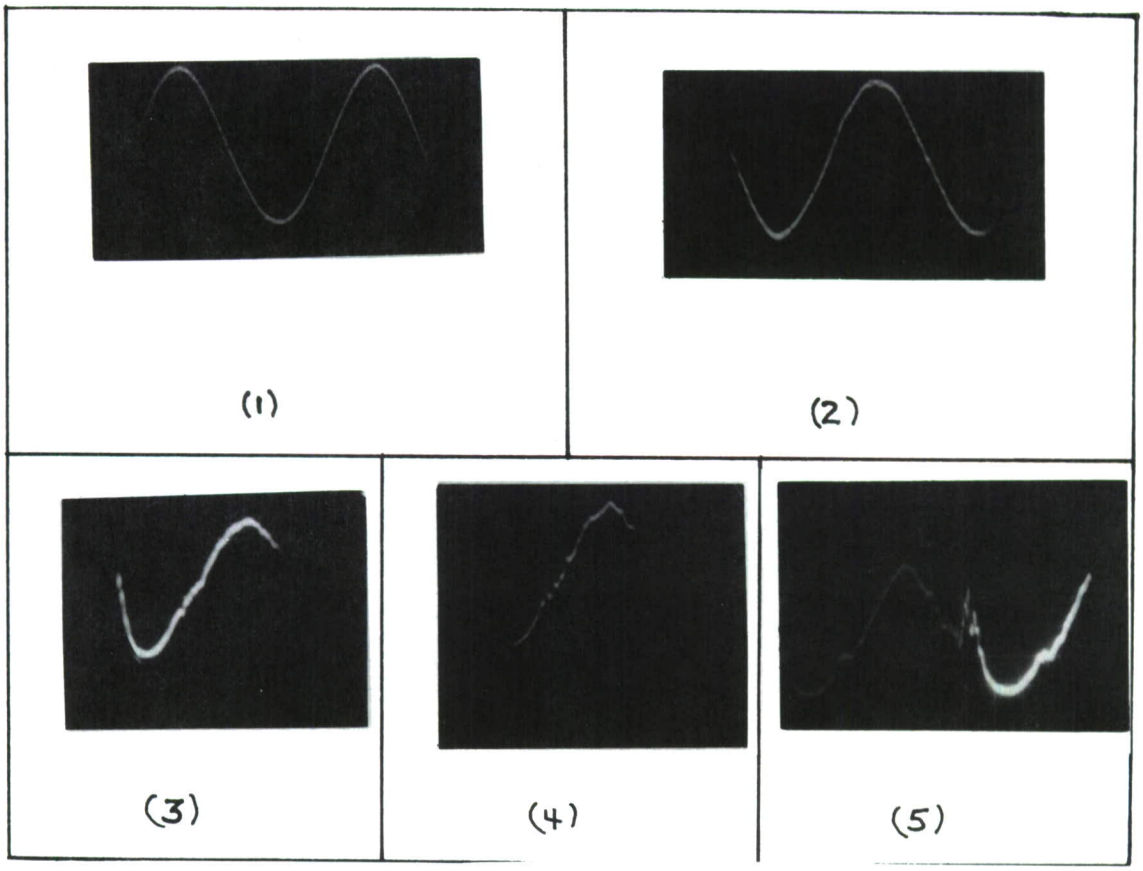
FIGURE 57 SEQUENCE OF OSCILLOSCOPE TRACES SHOWING THE PROGRESSIVE STAGES OF SENSOR GRID FAILURE OF GAGE IN FIGURE 58

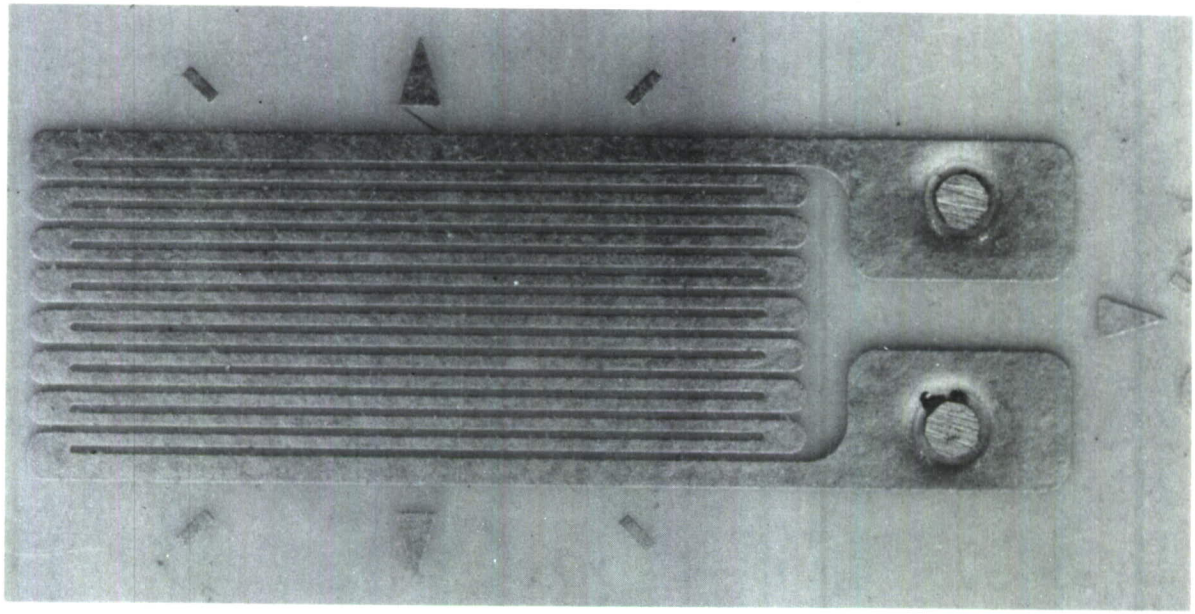
It is felt that irregularities such as sensor 4 on specimen No. 26 must be investigated. This discrepancy was fully investigated by our Chemical Metallurgical group and pinpointed as an inferior connection of the solder button to the foil. This particular type gage (S/N NA-01), makes use of a solder button, note Figure 55, which is apparently fused or otherwise connected to the gage tab by the manufacturer. At approximately 80,000 cycles the button connection had deteriorated enough to present an erratic reading and at 110,000 cycles the connection was completely open, however, the jumper wire remained soldered to the button. The original purpose of evaluating the NA-01 gage was to make a comparison between it and the die cut gage type 204A-ST. However, when failures occur they should be investigated to remove any mystery.

FIGURE 58 S/N NA-01 GAGE AS RECEIVED FROM THE MANUFACTURER PRIOR TO INSTALLATION ON THE CONSTANT STRAIN BEAM OF FIGURE 59

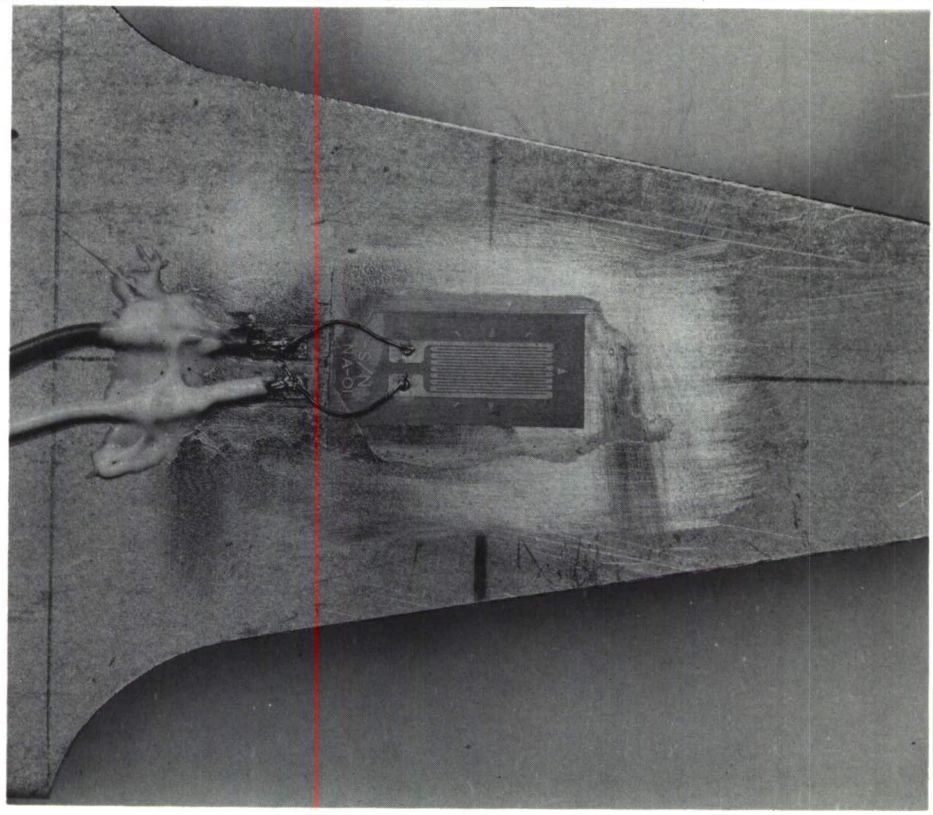
FIGURE 59 S/N GAGE MOUNTED ON BENDING SPECIMEN AND EVALUATED AT ± 1500 MICRO IN/IN UNTIL GAGE FAILURE. PHOTO 2.2 TIMES ACTUAL SIZE.

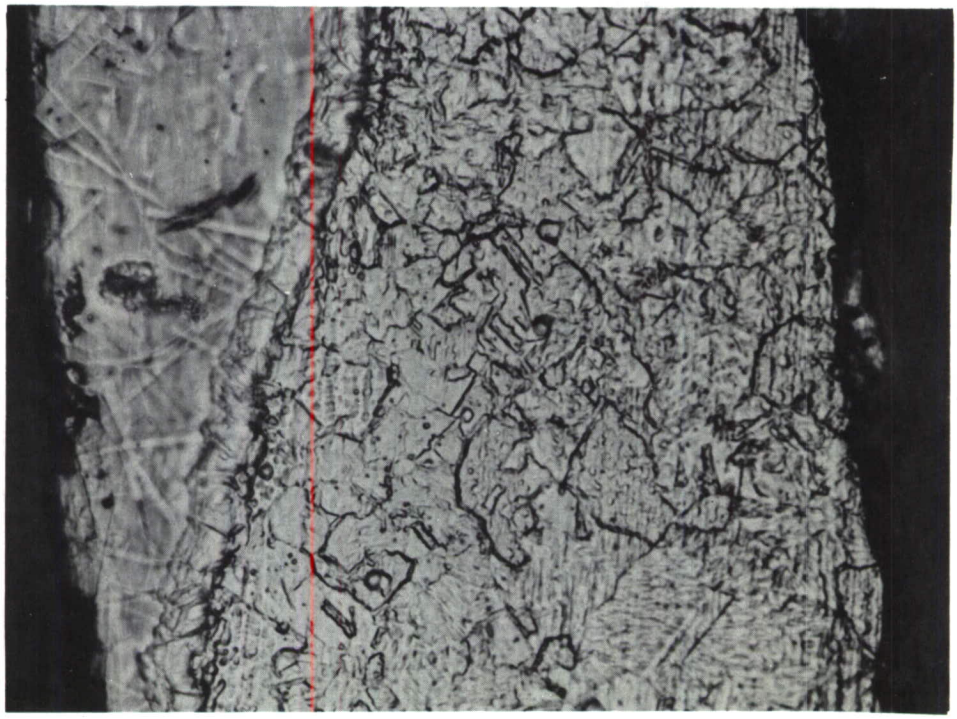
FIGURE 60 S/N NA-01 STRAND AT 1000X AFTER PARTIAL REMOVAL OF EPOXY ENCAPSULATION. ARMSTRONG EPOXY STRIPPER USED FOR REMOVAL OF EPOXY.

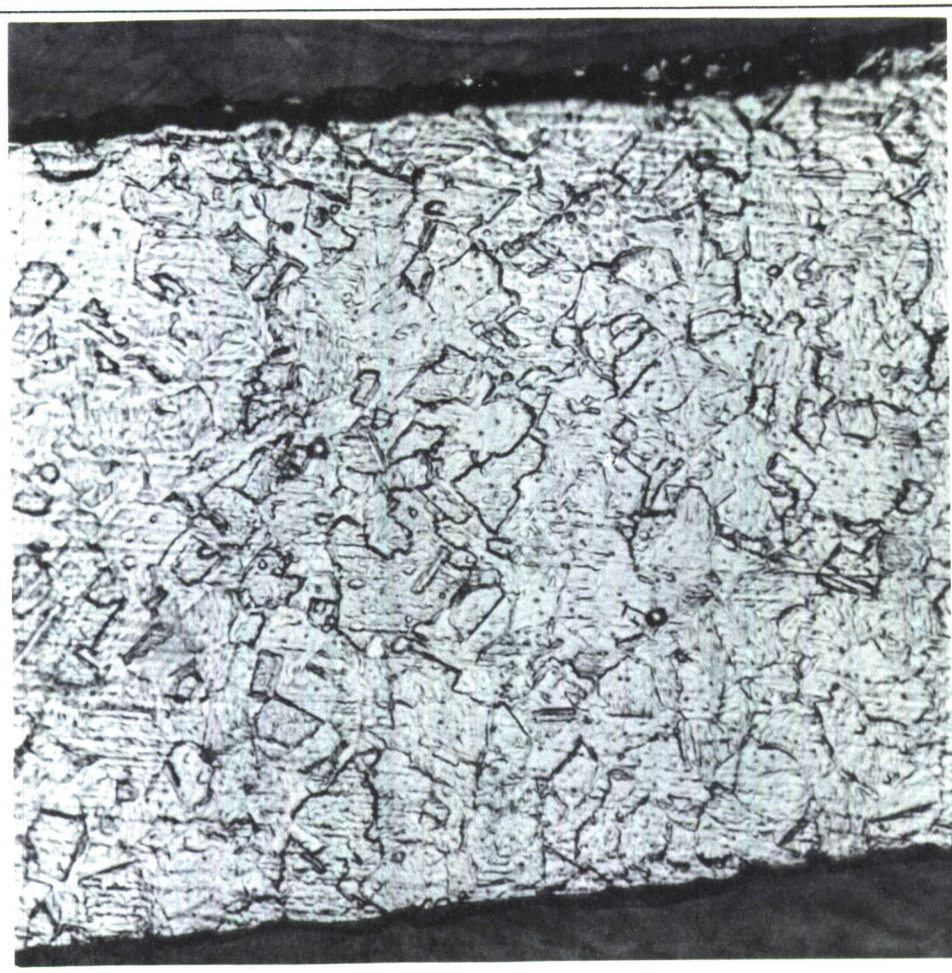
A sampling of some typical photos resulting from grain studies and metallographic examination of both the die cut foil and the acid etch foil are shown in Figures 60 through 72. Figures 65 and 66 show a typical surface and edge condition of the acid etch foil. Although all irregularities can not be definitely identified, it appears that the black spots may be carbonized oil particles, since the foil is often rolled in oil solution while hot and under pressure. The "pock" marks shown in Figure 68 may be due to dirt or other contaminates encountered during the rolling process. The jagged edge shown in Figure 69 is probably the result of the ferric chloride acid preference for grain boundaries, since the masking does not cover the edges of the strand. This strand edge can be compared with that of the die cut gage in Figure 70 since both are shown at a magnification of 500. It should be noted that the acid undercuts the strand edge resulting in a sharp knife like edge as shown in the sectional cut below:

FIGURE 61 A STRAND SECTION OF THE NA-01 S/N GAGE AT A MAGNIFICATION OF 1000X. NOTE THE SEVERITY OF UNDERCUTTING OF STRAND EDGE DUE TO ACID ETCH PROCESS OF FABRICATION.

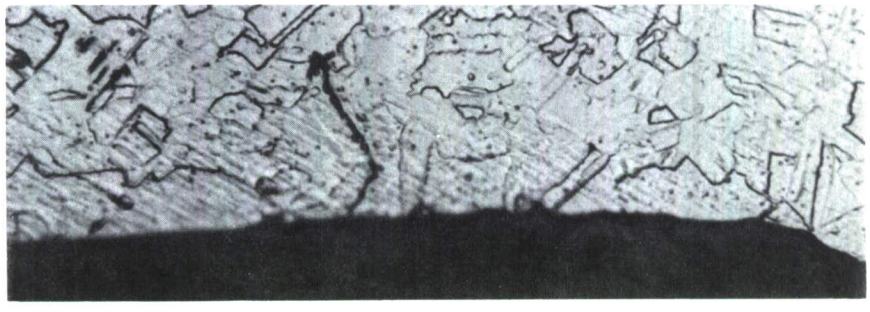
FIGURE 62 A STRAND FAILURE IN THE GAGE SHOWN IN FIGURE 59 NOTE THE MICROSCOPIC CRACK NEAR THE END LOOP. THE SURFACE HAS BEEN SLIGHTLY ETCHED TO HIGHLIGHT THE GRAIN STRUCTURE.

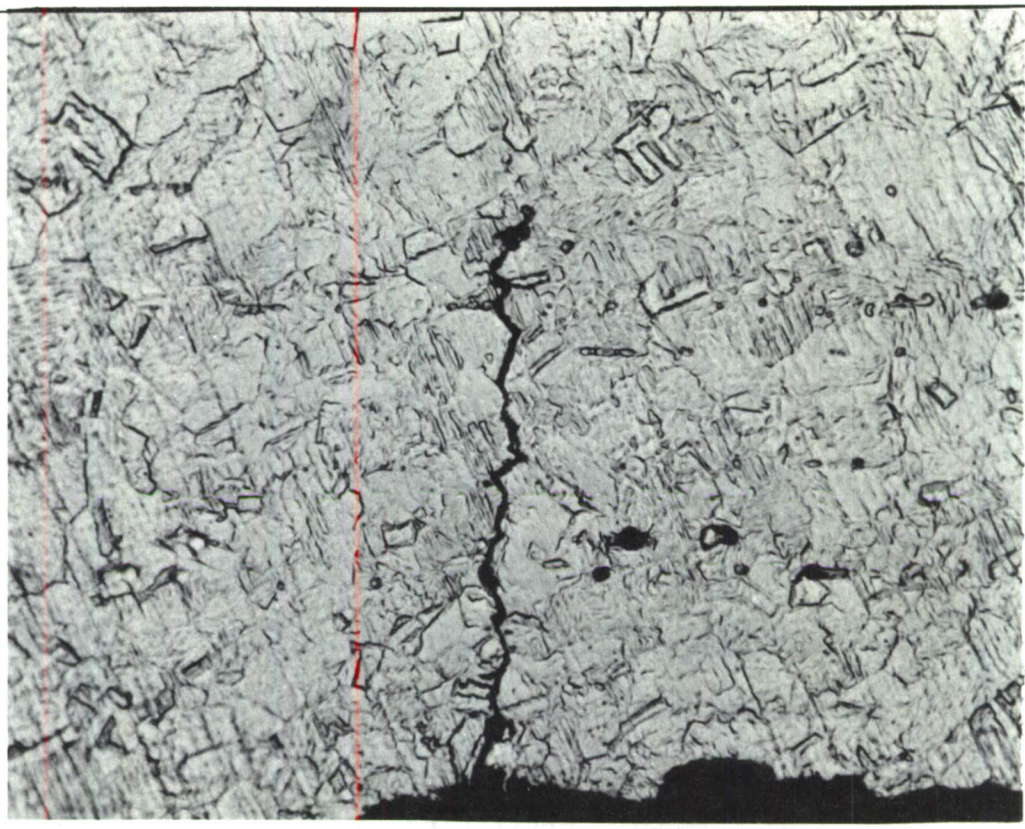
FIGURE 63 MICRO PHOTO AT 1000X OF THE NO. 1 SENSOR USED ON SPECIMEN NO. 47. CRACK APPARENTLY ORIGINATED NEAR END LOOP AND FOLLOWED GRAIN BOUNDARIES.

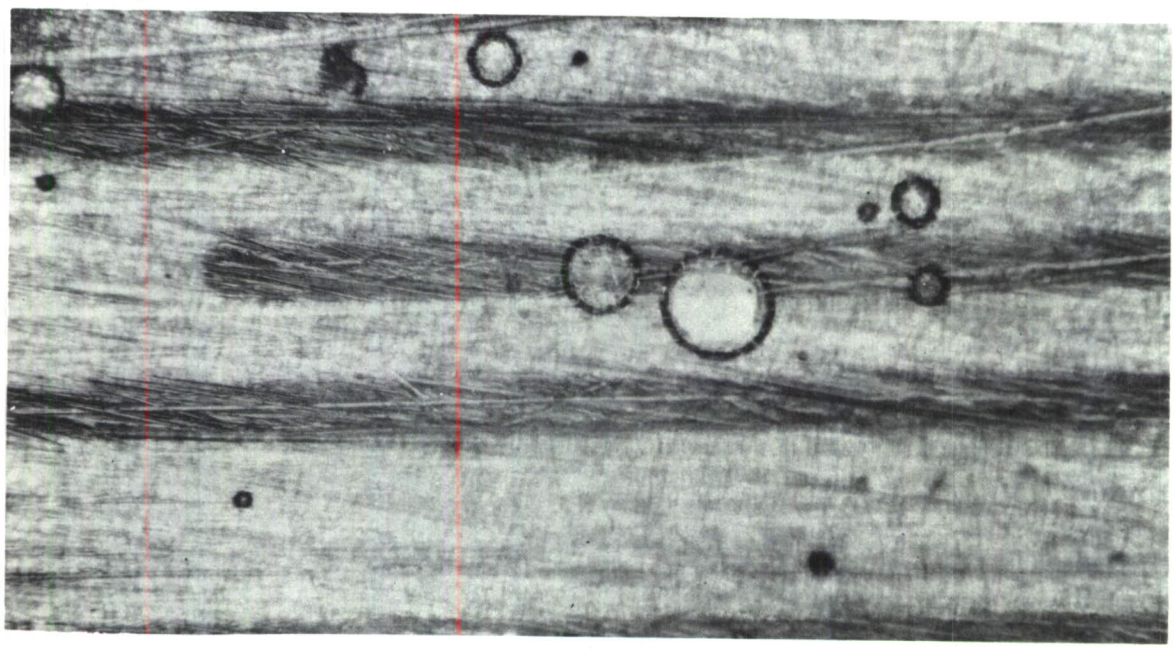
FIGURE 64 S/N GAGE AS RECEIVED FROM THE MANUFACTURER. PHOTO TAKEN AT 100X OF THE BONDING SIDE OF THE GAGE. SHOT WAS TAKEN THROUGH THE EPOXY AND SHOWS BUBBLES IN THE EPOXY AT VARIOUS DEPTHS.

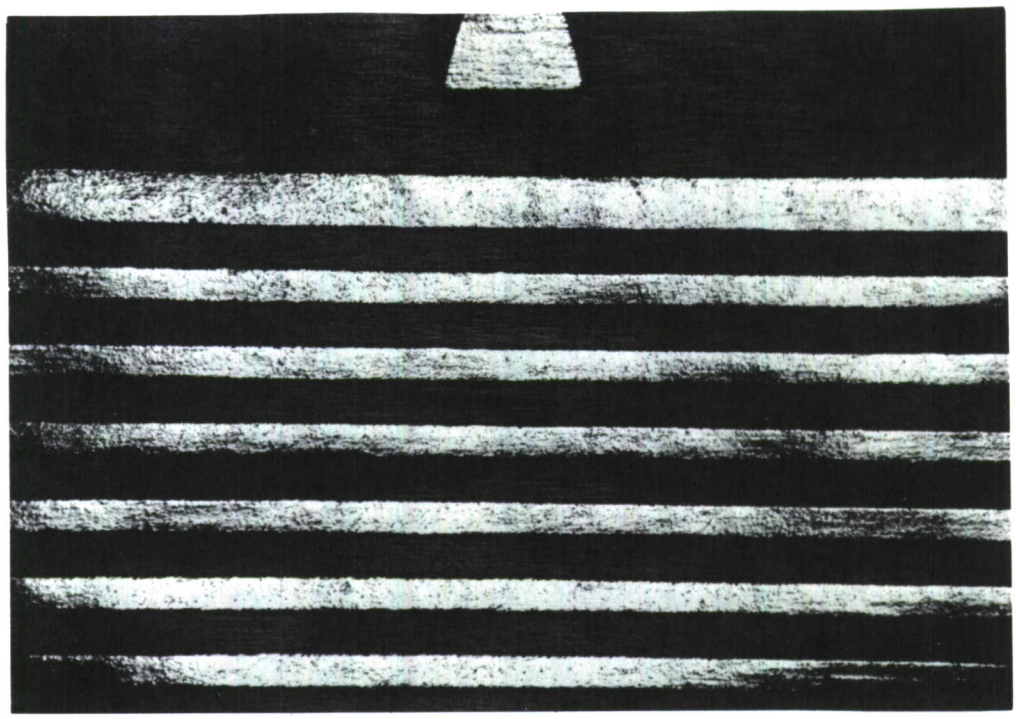
FIGURE 65 VIEW OF UNENCAPSULATED STRANDS OF FATIGUE GAGE AT A MAGNIFICATION OF 50X. OBLIQUE LIGHTING USED TO HIGHLIGHT IRREGULARITIES OF THE SURFACE. GAGE IN AS RECEIVED CONDITION WITHOUT ENCAPSULATION.

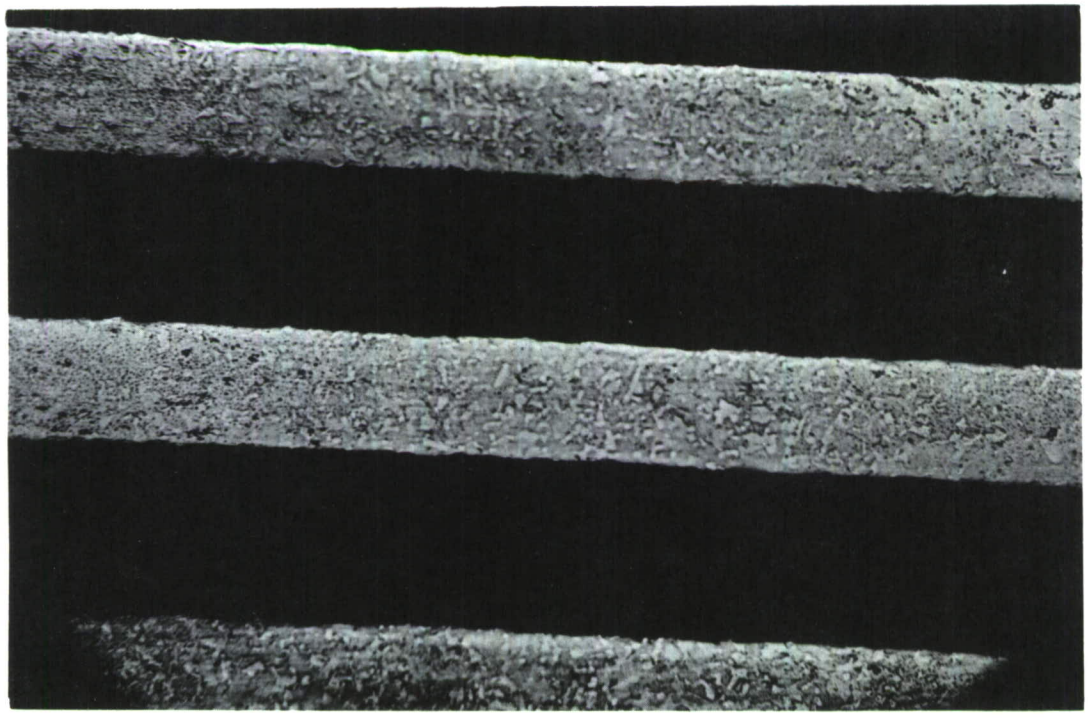
FIGURE 66 VIEW OF SAME GAGE AS ABOVE AT A MAGNIFICATION OF 200X. GAGE IN "AS RECEIVED" CONDITION.

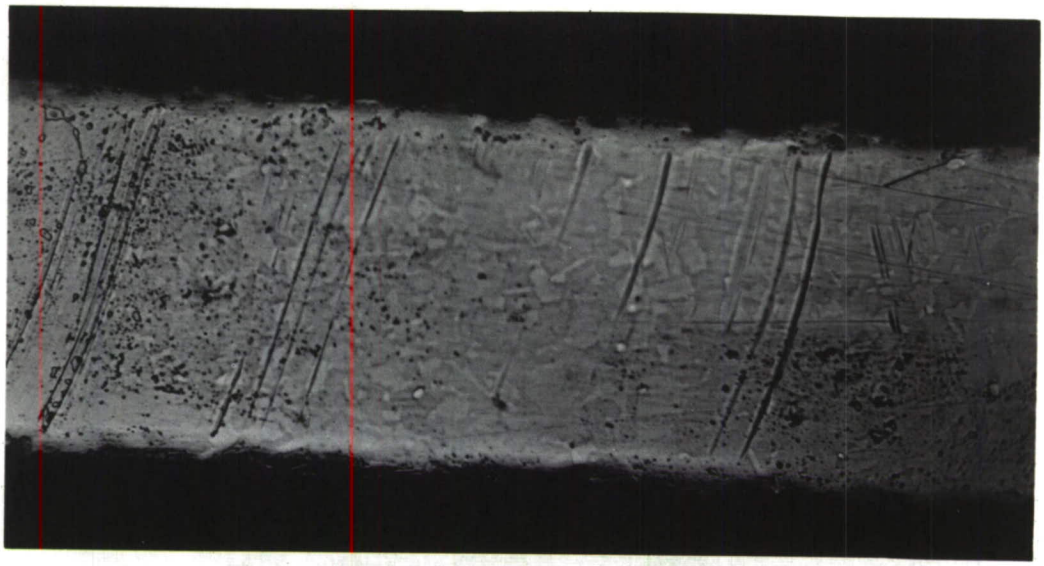
FIGURE 67 STRAND PHOTO AT 500X OF WHAT APPEARS TO BE AN UNDESIRABLE AREA OF THE STRAND CONDUCTOR. THIS STRAND SHOWS A VARIATION IN FOIL THICKNESS, TRANSVERSE SCRATCHES, AND GRAIN EFFECT IN THE FLAT ROLLED SURFACE PLANE.

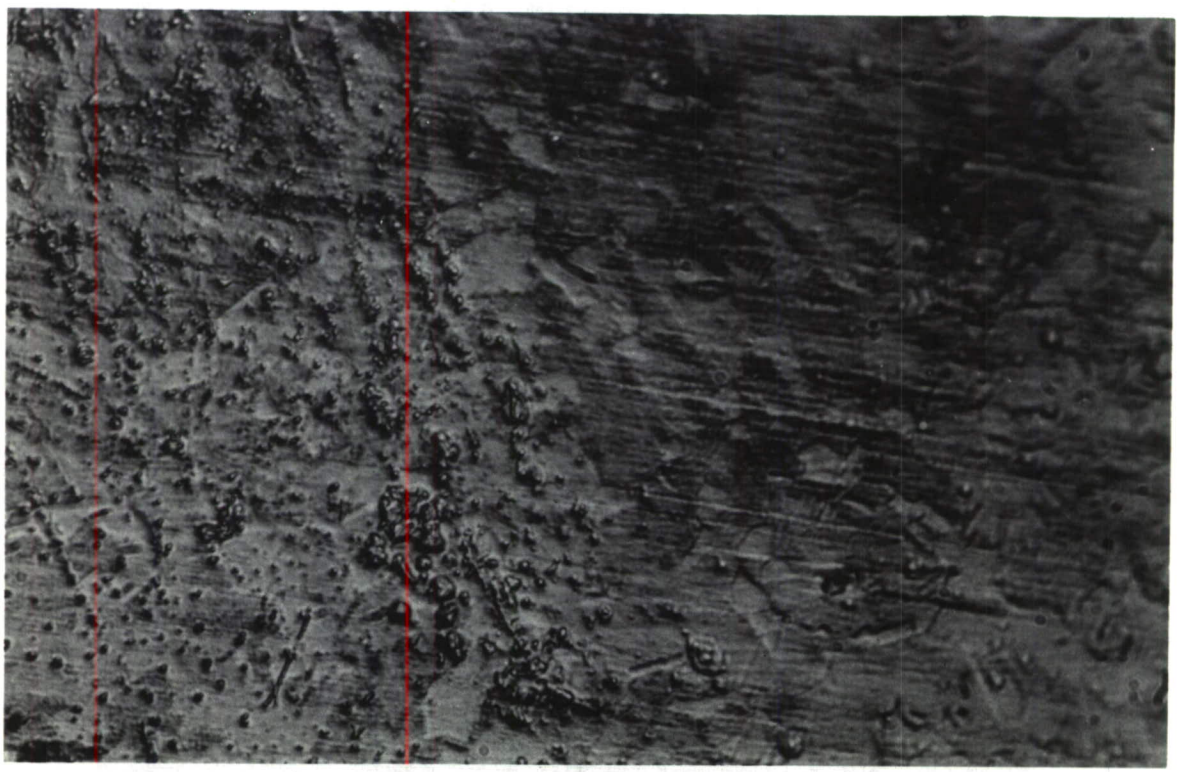
FIGURE 68 VIEW OF THE SAME STRAND AT 1000X. NOTE THE CHANGE IN FOIL THICKNESS. ALSO THE APPEARANCE OF GRAIN EFFECT, ALTHOUGH AN ACID ETCH WAS NOT USED TO HIGHLIGHT THE GRAIN.

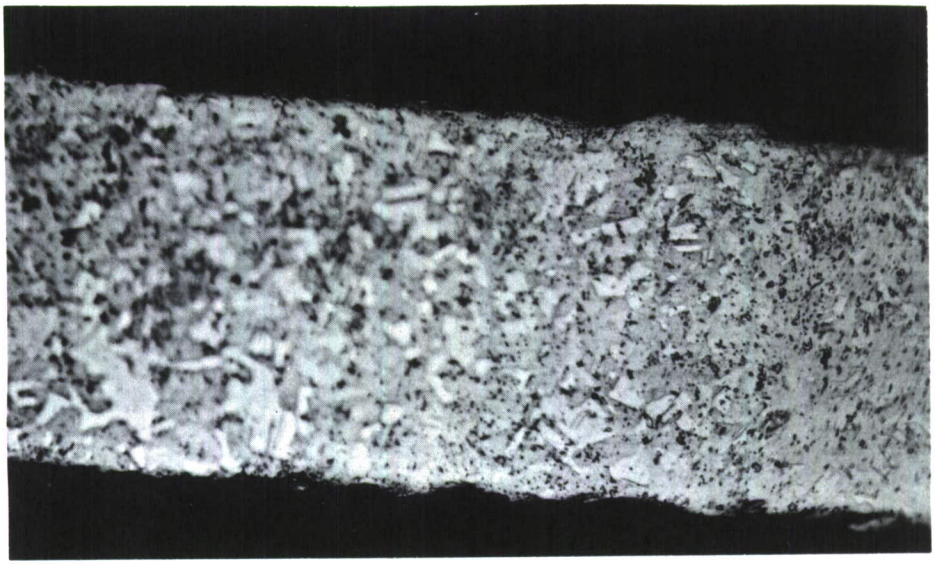
FIGURE 69 PHOTO OF FATIGUE GAGE STRAND AS RECEIVED FROM THE MANUFACTURER. EPOXY ENCAPSULATION REMOVED BY ARMSTRONG EPOXY STRIPPER. BLACK SPOTS MAY BE CARBONIZED OIL, SINCE OIL IS SOMETIMES USED IN THE FOIL ROLLING PROCESS. PHOTO MADE AT 500X.

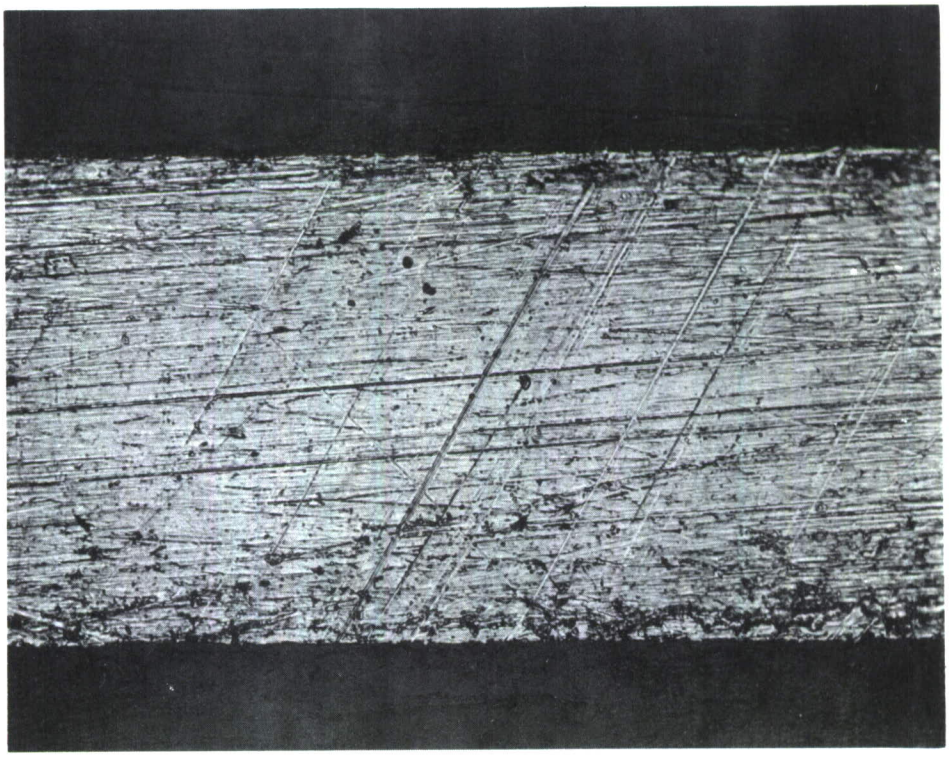
FIGURE 70 VIEW OF AN UNDESIRABLE STRAND SECTION OF A 204DA-ST SENSOR AS RECEIVED FROM THE MANUFACTURER. ALTHOUGH THE 500X MAGNIFICATION SHOWS TRANSVERSE SCRATCHES, IT ALSO INDICATES THE SHARP EDGE POSSIBLE BY DIE CUTTING.

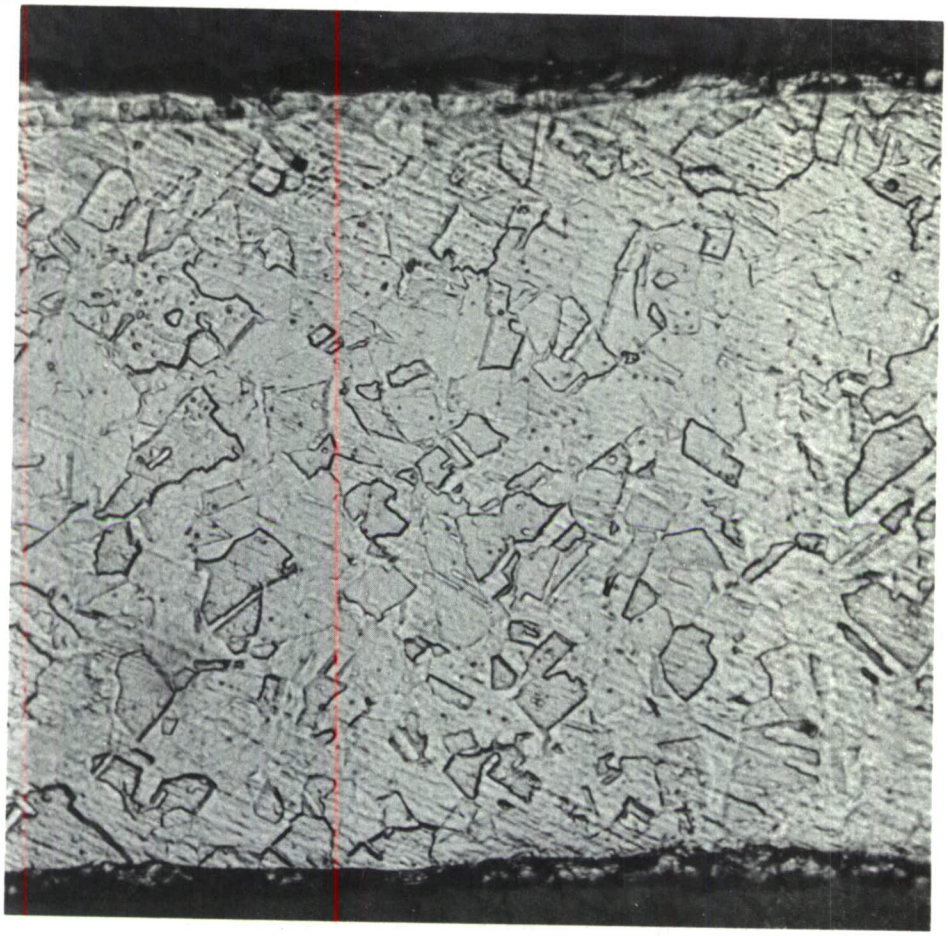
FIGURE 71 PHOTO TAKEN AFTER A FATIGUE INDUCED FAILURE OF AN NA-01 GAGE. POSSIBLE MICROSCOPIC CRACK IN LOWER LEFT CORNER. CARAPELLAS REAGEANT USED TO HIGHLIGHT GRAIN STRUCTURE.

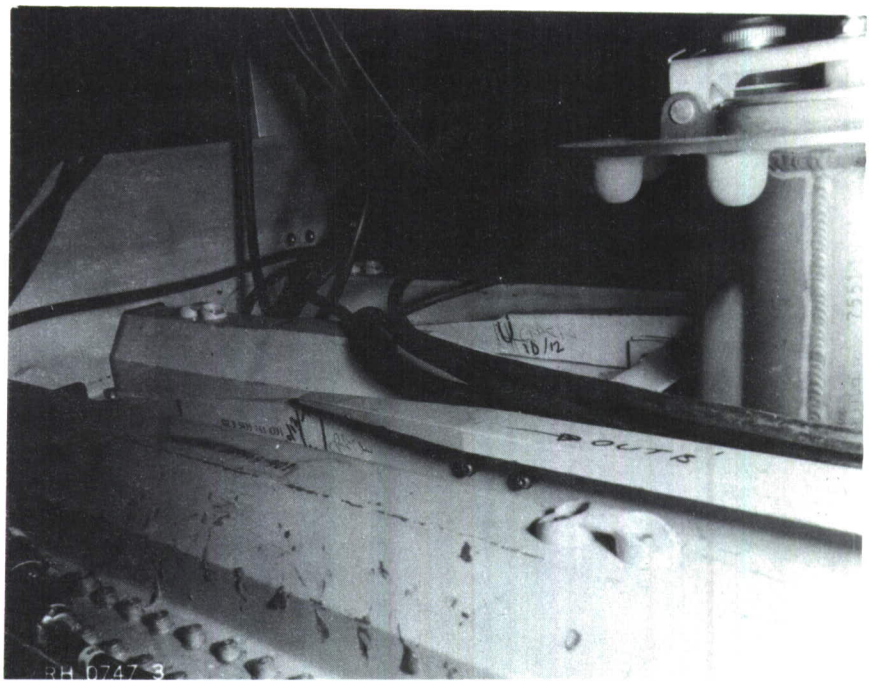
FIGURE 82 REDESIGN C-130E FILLER CAP PANEL SHOWING CRACKS IN THE RISER EXTENSION ADJACENT TO THE FILLER CAP

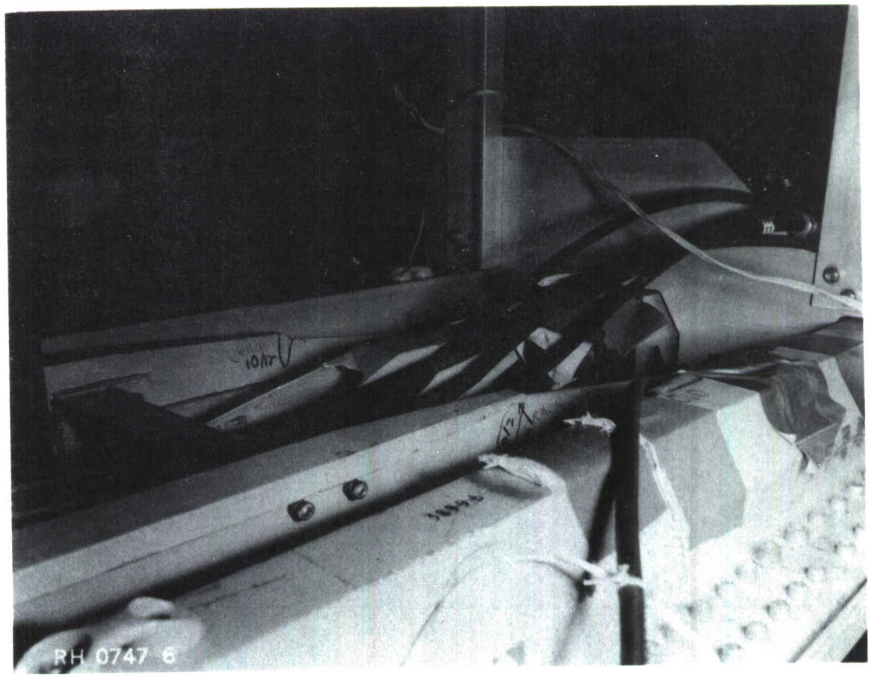
FIGURE 83 OTHER END OF RISER SHOWING CRACKS OF A SIMILAR NATURE

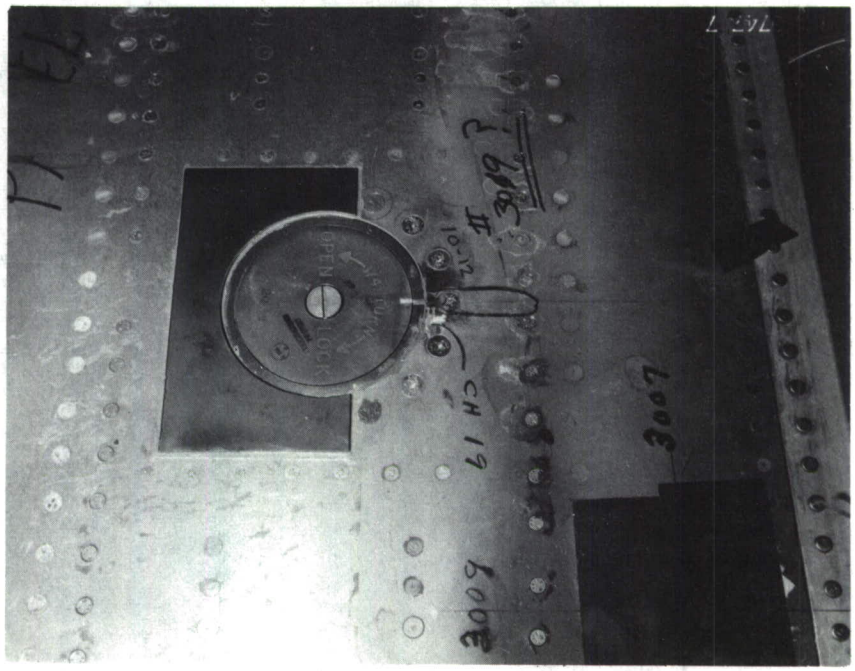
FIGURE 84 REDESIGN C-130E FILLER CAP PANEL SHOWING A CRACK EXTENDING OUT FROM A RIVET

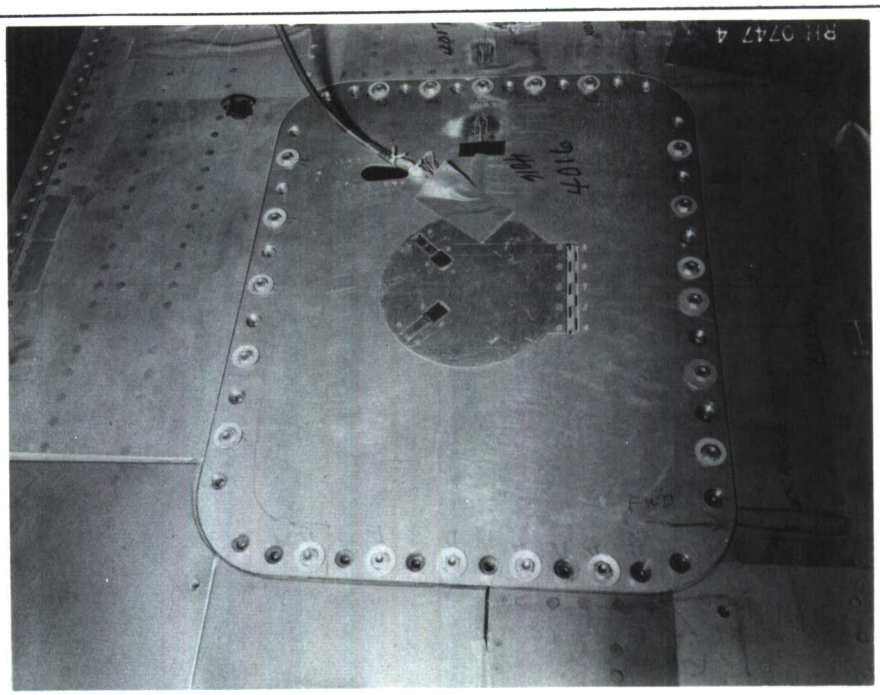
FIGURE 86 REDESIGN C-130E W.S. 1.5 PANEL SHOWING FATIGUE CRACK AT ONE CORNER OF THE ACCESS DOOR

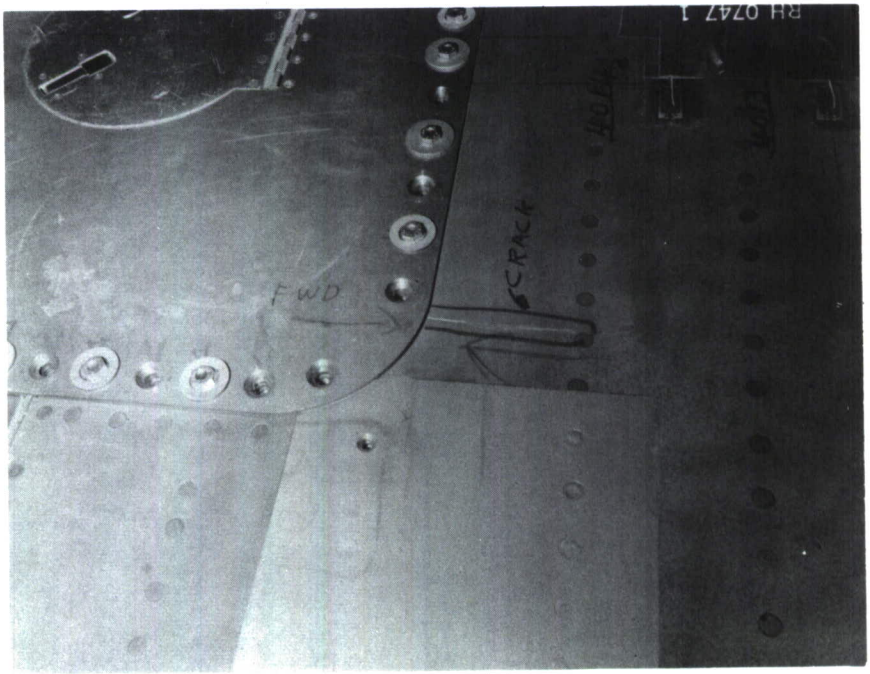
FIGURE 87 CLOSE UP VIEW OF CRACK WHICH RUNS FROM DOOR FASTENER TO THE RIVET
