PROGRAM TITAN IIIM
STANDARD SPACE LAUNCH VEHICLE
DEVELOPMENT REPORT
FOR
STAGE I ENGINE DEMONSTRATION TESTING

Report 9180-941-DR-9 31 March 1969

STAGE I ENGINE DEMONSTRATION TESTING

Aerojet-General Corporation
Liquid Rocket Operations
Sacramento, California
95809

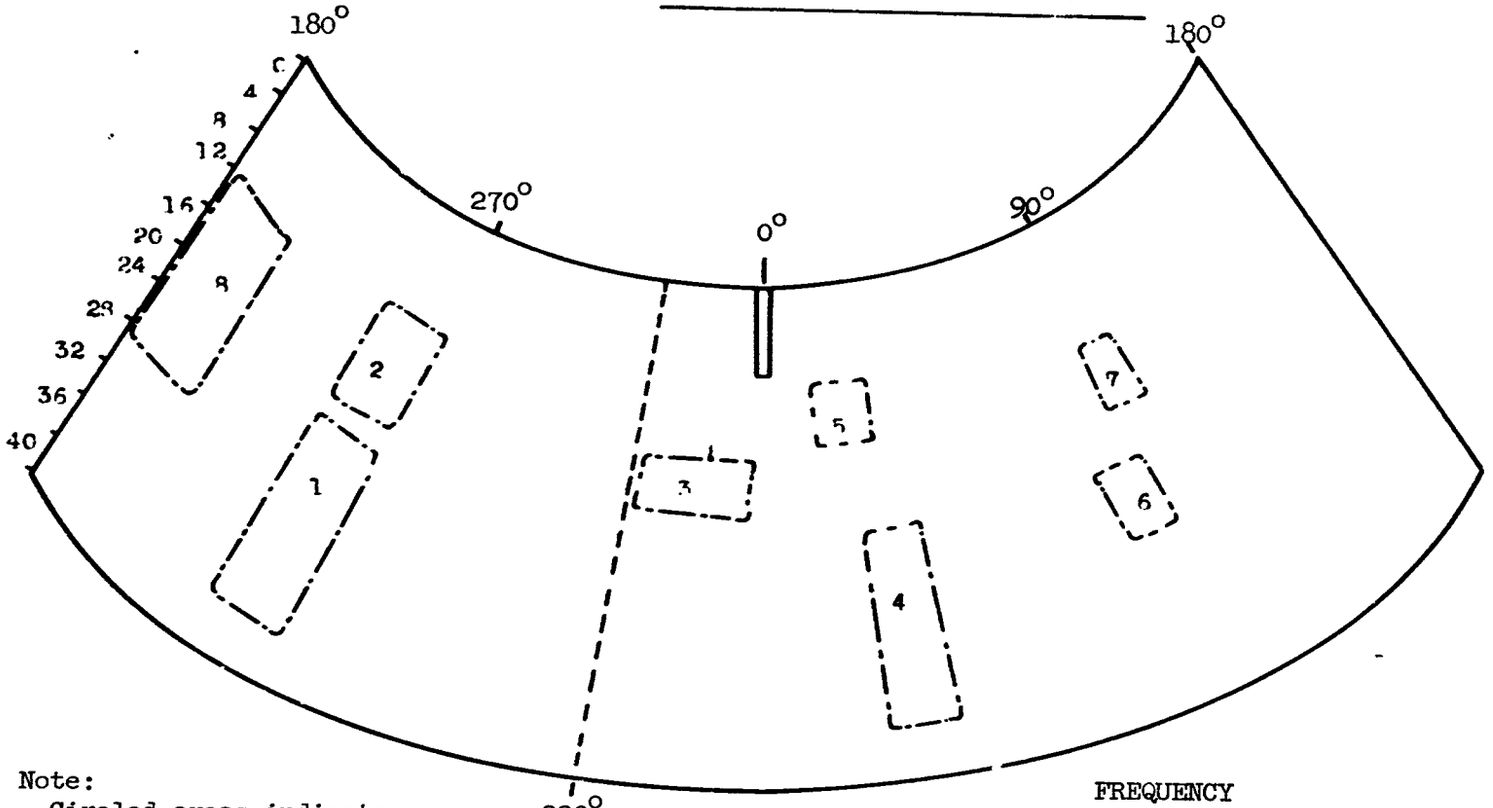
Sonic tests were performed on both nozzles to evaluate the integrity of the honeycomb support structures. The tests indicated that skirt S/N 039 had delamination in eight areas. These areas were detected at 460, 500 and 550 cps ranges (see Figure 43).

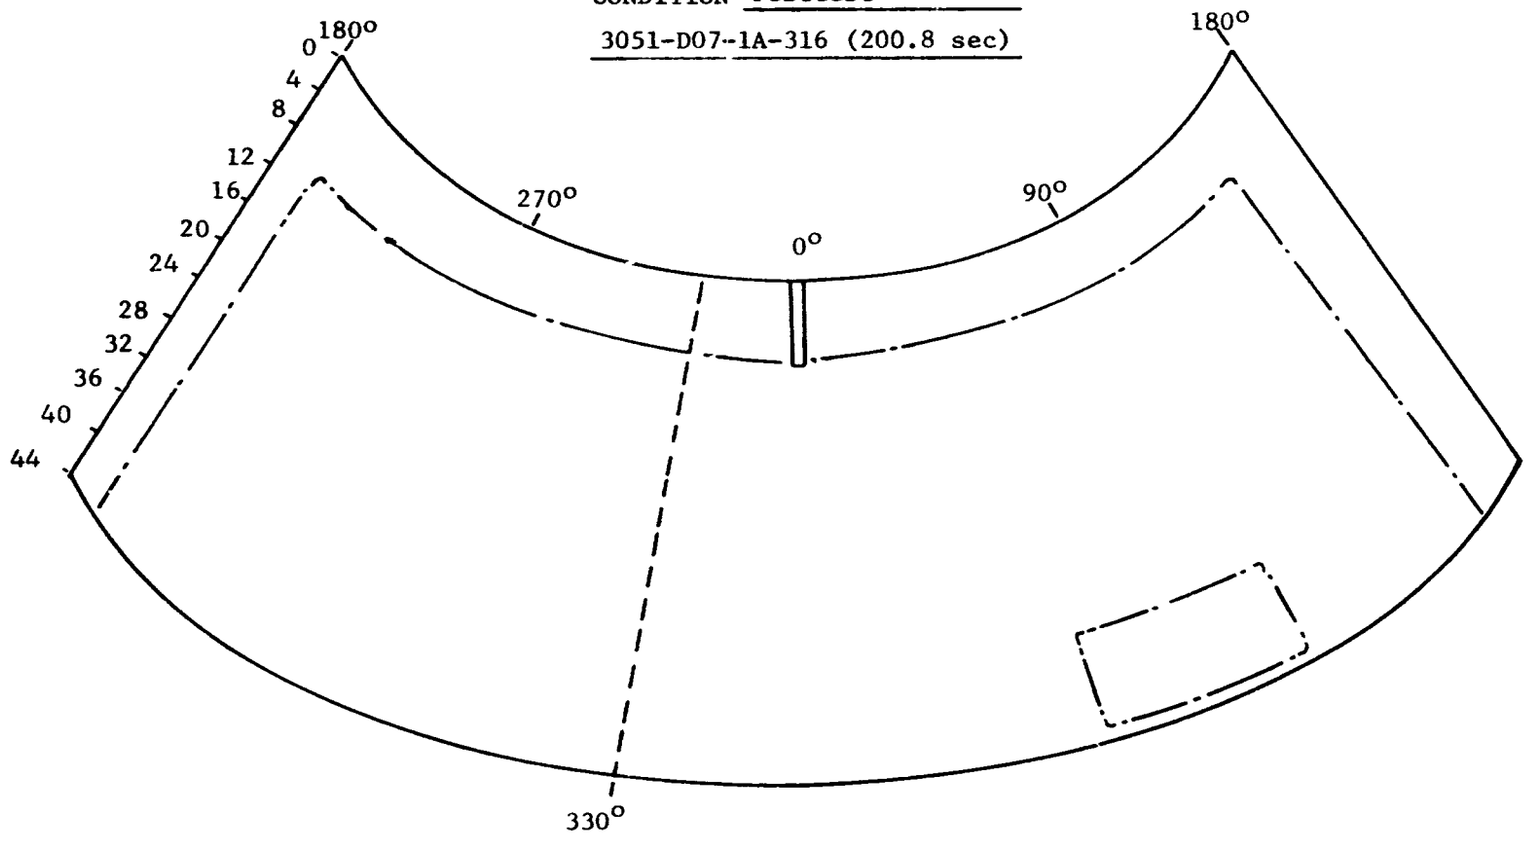
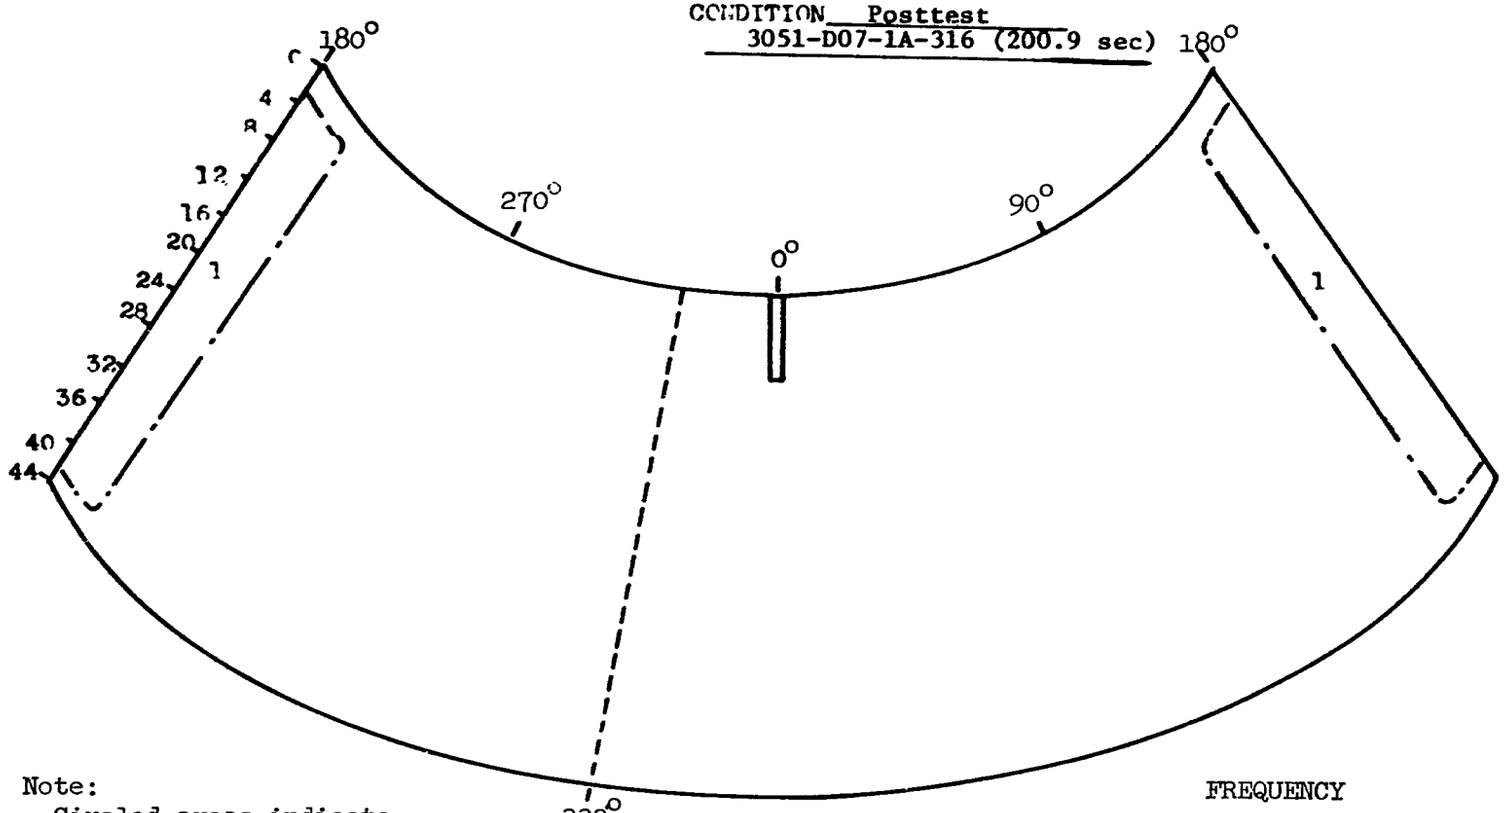
Figure 44 -- Sonic Tap Test, Skirt 040

Skirt S/N 040 showed a single delamination at 180 degrees when tested at the lower frequencies. At frequencies of 4K to 6K cps, the structure appeared to be delaminated peripherally 8-in. below the forward flange (see Figure 44).

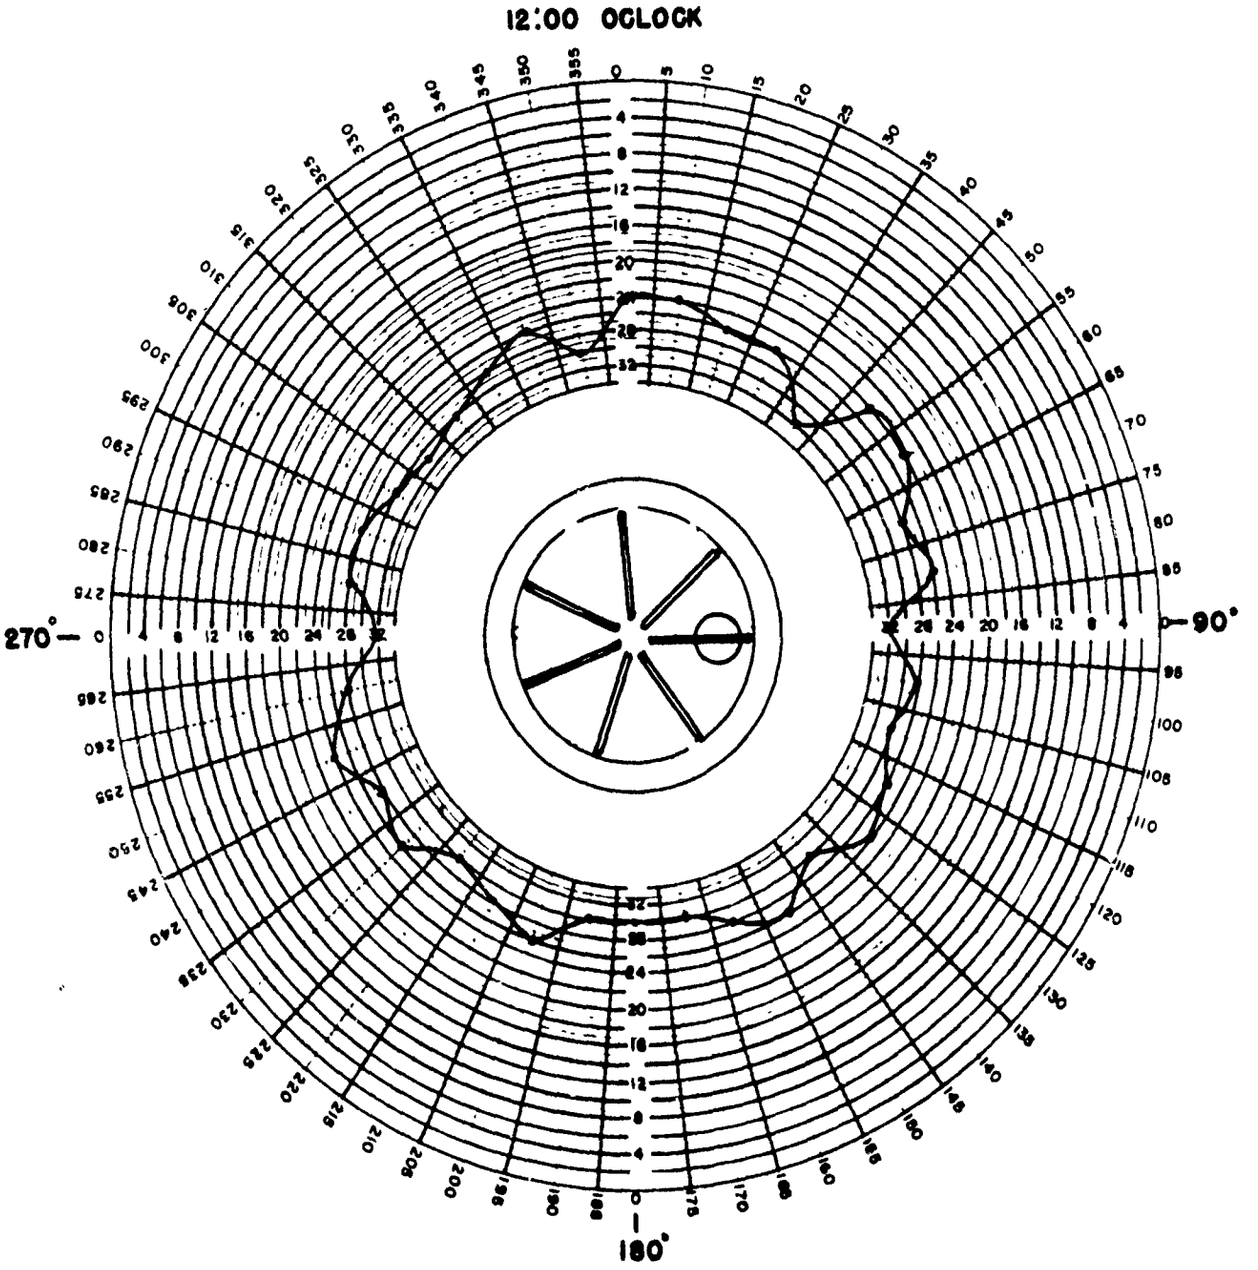
Figure 45 -- Circumferential Char Penetration, Skirt 039

Both skirts were sectioned for the evaluation of structural condition and the measurement of liner char depths. Each skirt was sectioned at six longitudinal stations. The location of these stations, referenced to the injector, and the remaining uncharred thicknesses are presented in Figures 45 and 46. A circumferential cut was made at the midsection of each skirt. This cut was made through the thermocouples located 20 in. from the forward flange on skirts S/N 039 and 22 in. from the forward flange on skirt S/N 040. It was noted that charring was less in areas under the baffle legs than in areas between baffles. The longitudinal linear measurements are presented in Figures 47 and 48.

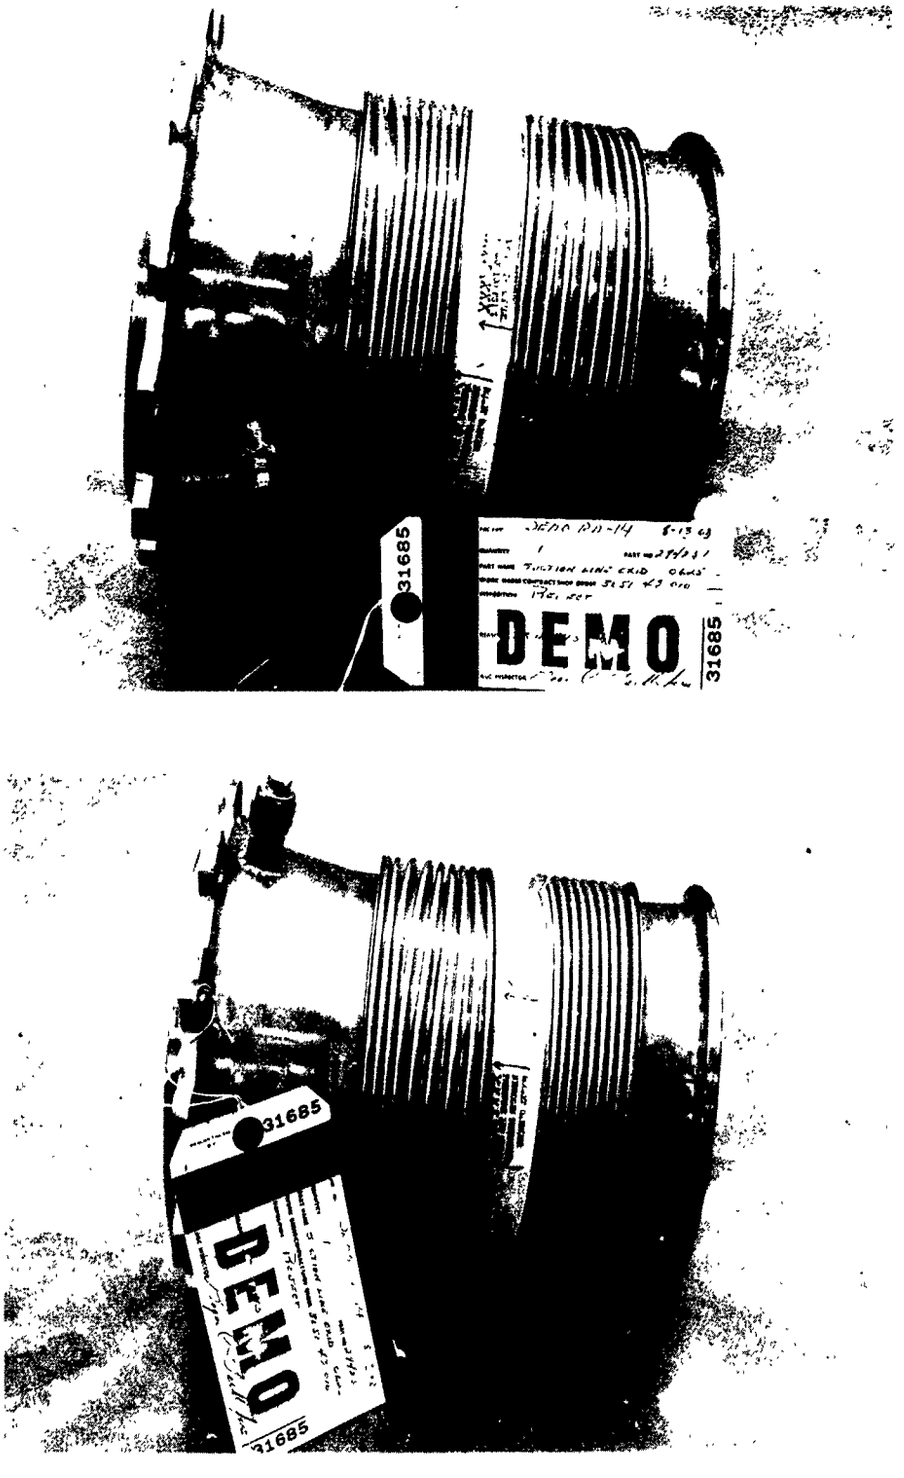
Figure 66 -- Oxidizer Suction Line S/N 625

Excessive bellows distortion was observed on oxidizer suction line S/N 625 after Test No. -214 (see Figure 66). The line had been subjected to 1624 seconds of engine testing while installed on engine S/N 14, Subassembly 1. Oxidizer suction line S/N 628, which replaced S/N 625, was also found to have excessive distortion (See Figure 67). One 200 second test had been conducted with this line installed. The degree of distortion appeared to be similar in both cases. Subsequent to completion of demonstration testing the oxidizer suction lines on both subassemblies of engine S/N 15 and the line installed on Subassembly 2 of engine S/N 14 were found to have normal amount of distortion.

Oxidizer suction pressure spikes and engine interface alignment were reviewed to determine the cause of the discrepancies. The review disclosed that the maximum suction pressure spikes during tests No. -214 and No. -215 were lower in magnitude (395 psia and 410 psia respectively)

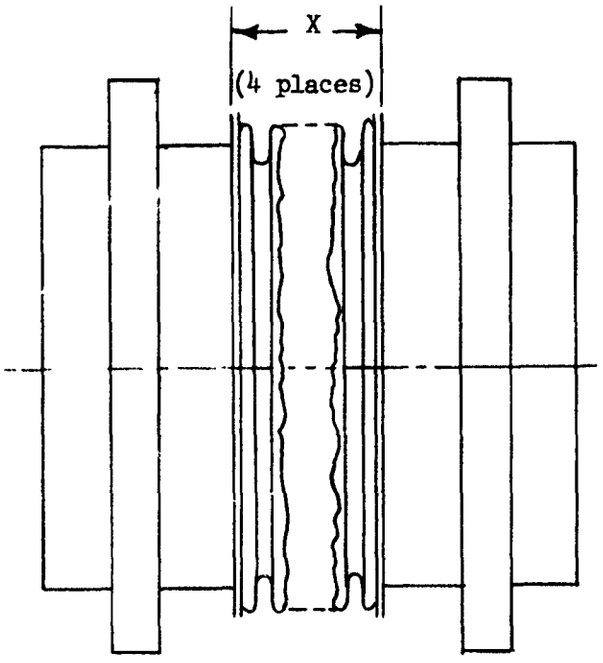
Figure 68--Propellant Discharge Lines Bellows Dimensions

The dimensional criteria associated with these lines (see Figure 68), were established during the basic Titan program to ensure that the structural integrity of the lines was not endangered should a tripod insert become dislocated. Subsequent experience and experimentation has shown this criterion to be very conservative. Therefore, as the anomalous conditions occurred on the Engine S/N 14 lines, the bellows dimensions were documented and the condition accepted "as-is" for retest.

During the first three tests with Engine S/N 14 the oxidizer line bellows measurements exceeded the minimum value of 2.10 in. as much as 0.10 in. and the fuel line bellows exceeded the minimum of 1.95 in. by as much as 0.086 in. Pressurization of the lines (propellant systems) to 50 psig, coupled with manual TCA gimballing, would substantially improve the dimensional discrepancies and frequently restore the bellows lengths above the minimum values. At no time during the tests were any of the inserts completely dislocated or damaged.

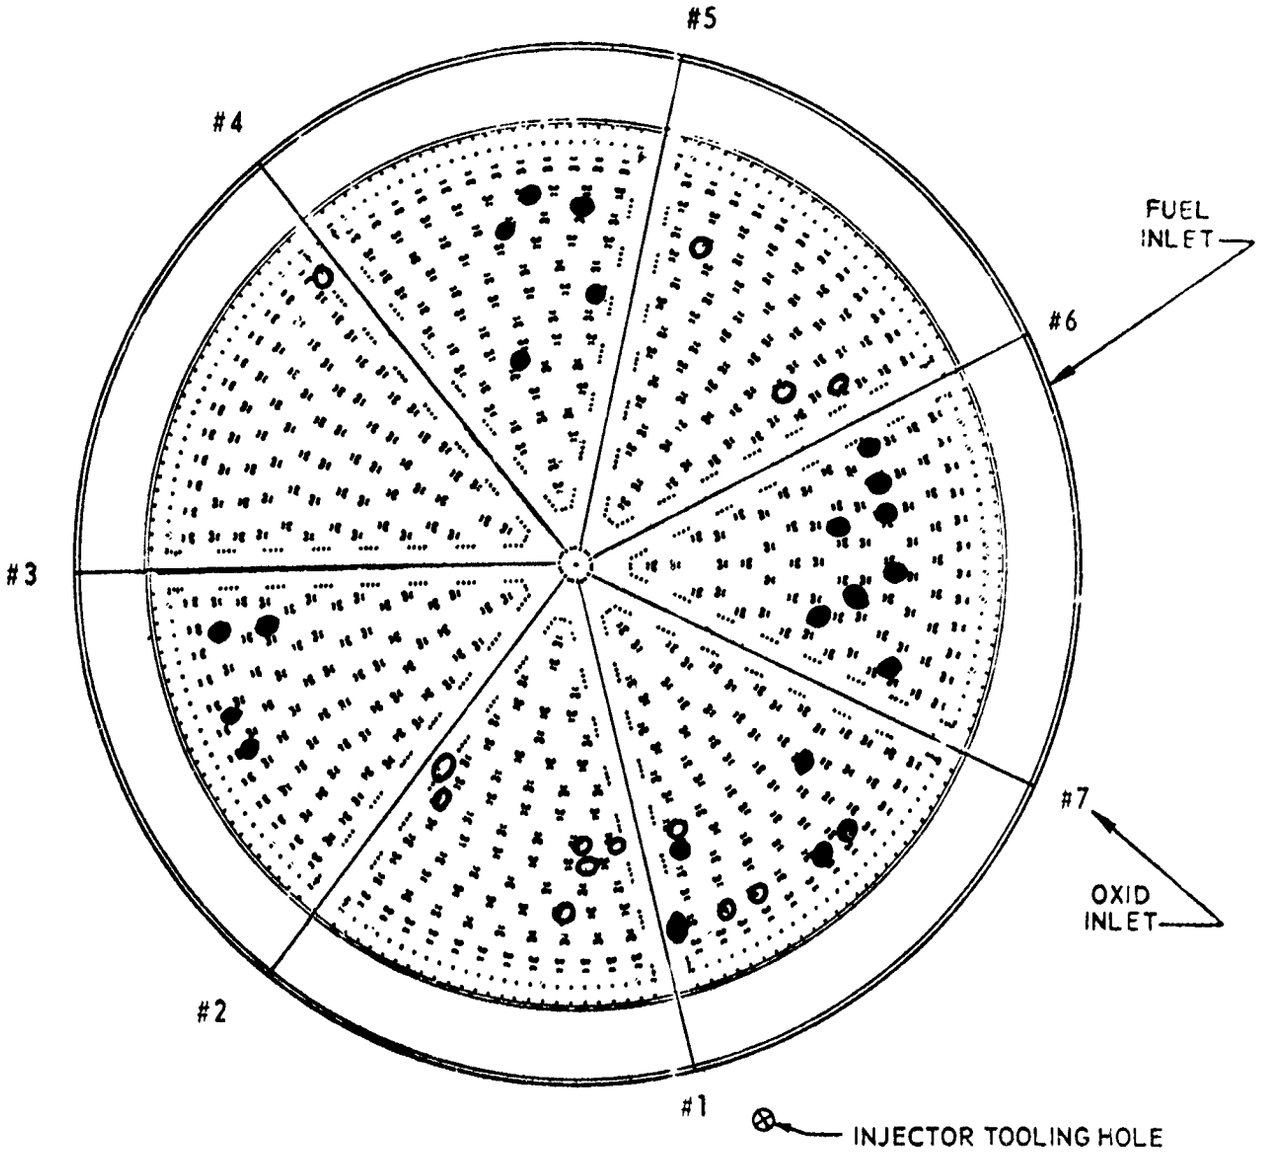
Figure 69--Location of Base Weld Cracks, Injector S/N 696, (1 of 2)

Cracks developed in the base welds of baffles on both injectors during the first five tests. Repairs incorporating the current procedures for preparation and welding were made and eight consecutive tests were conducted before a single small crack appeared in each injector. After each of the three remaining tests the number of base weld cracks were found to have increased

and the previous cracks were longer; however, both injectors were still suitable for continued testing without additional repairs.

Frequent incidents of cracks in the base welds of injector baffles were experienced early in the program. The primary cause for the cracks was the preparation and weld procedures existing at the time that the injectors were originally fabricated. Subsequent repairs using current procedures extended the weld integrity to eight tests before a single crack appeared.

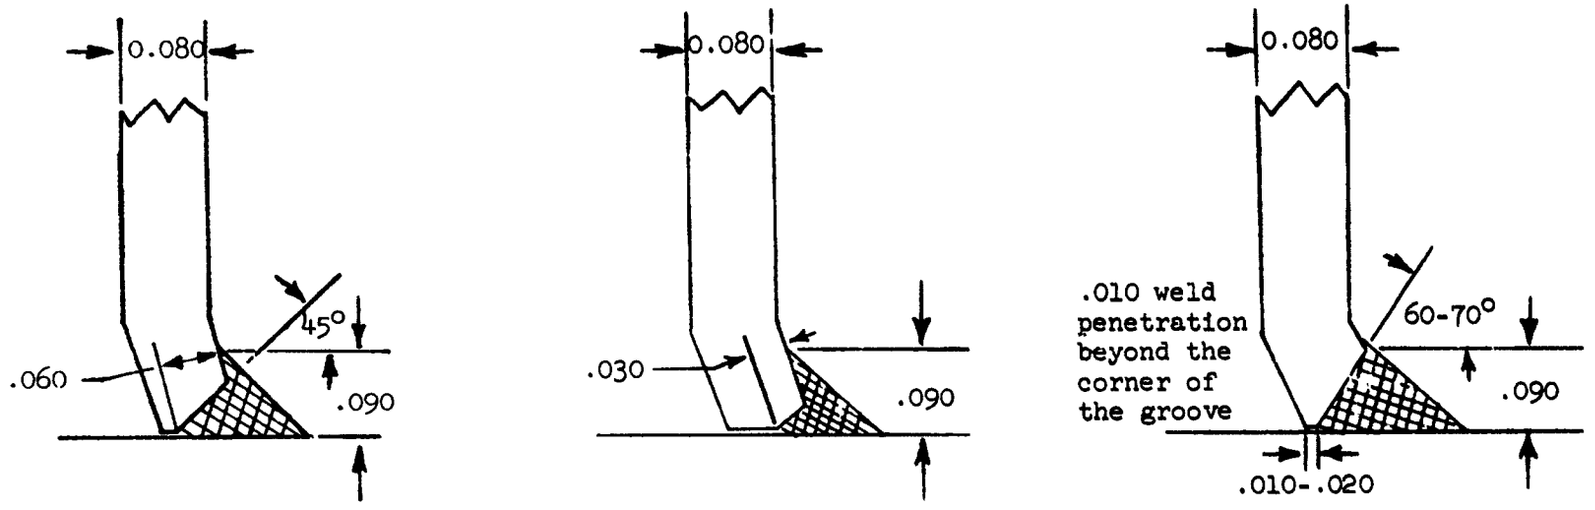
The cause of the weld cracking was determined to be an improper weld preparation and application. The base of the baffle legs was supposed to be beveled at a 45° angle to a depth of 0.060 inches. The fillet weld was supposed to fill this bevel, thereby forming a total fillet thickness greater than the baffle wall thickness. However, the bevel was less than 0.030 inches deep, and the thickness of the resulting fillet weld was slightly less than the thickness of the baffle wall. Also, the lack of weld penetration formed a discontinuity in the transmission of stresses from the baffle to the injector face, thereby increasing the bending stresses in the weld by 50% over what they would be with proper weld penetration. The resulting stress concentration and weak joint led to a premature fatigue failure at the weld joint.

In support of the conclusions, Figure 70 presents both the joint that was required for these units, and the actual configuration that was achieved. The actual weld is clearly inferior, causing a stress concentration that increases the local bending stresses by 50% and forms a minimum cross-sectional area. The failure occurred through fatigue of this joint after stress cycles caused by normal use.

Corrective action was applied to the replacement baffles in the units on engine S/N 15 after Test No. -305 and all subsequent production injectors. The corrective action consisted of clarifying the dimensions of the baffle leg preparation and weld, and increasing the bevel angle to 60-70° for better access. This action provides for greater certainty that a full, penetrating weld is achieved.

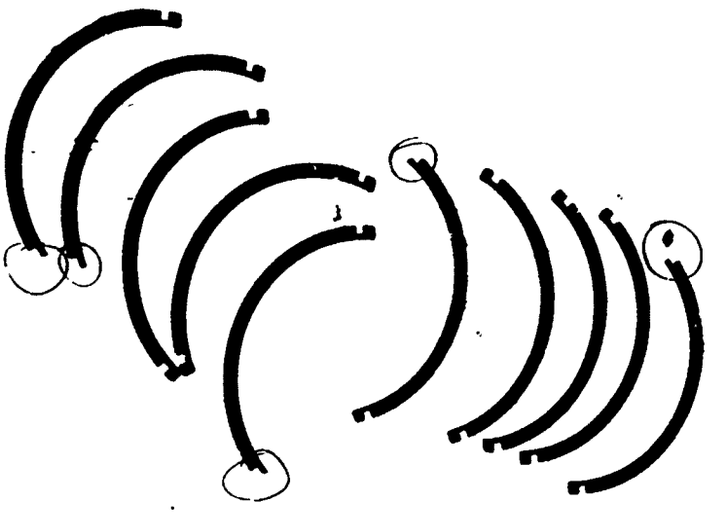
Figure 73 -- Bearing Spacer -- S/N 477

All spacer failures occurred at the corner of the square rod and were tensile type failures (see Figures 73 and 74). A high tensile load on the spacers can only occur when the spacer is restrained from progressing with the rollers. This restraint occurs when rollers become skewed, thereby forcing the spacer against the side of the spacer groove in the inner race. The detached spacer end is contained in the spacer groove by the gimbal lubricant which prevents it from wedging the roller bearings. No redesign activity is recommended at this time.

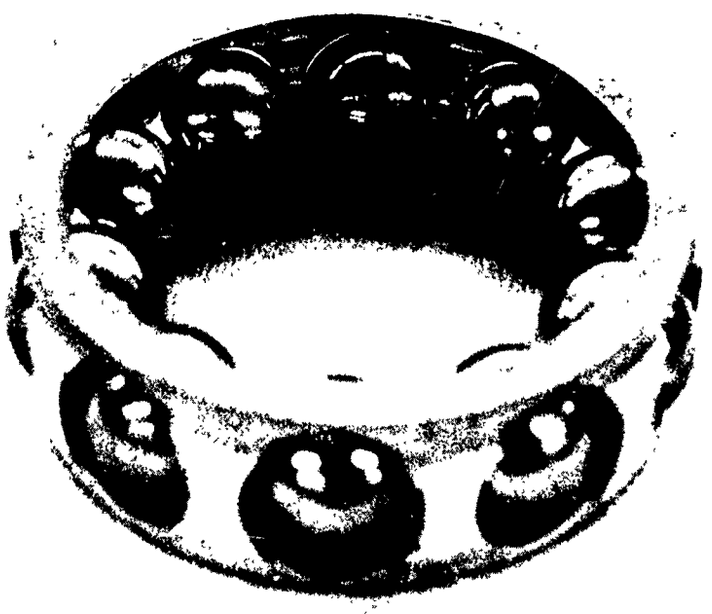
Figure 76 -- Bearing B-10, S/N 1462 -- Balls and Cage

Two corroded bearing assemblies were found in one TPA gearbox during the post program final disassembly. These bearings were on the same fuel pump that seal leakage occurred.

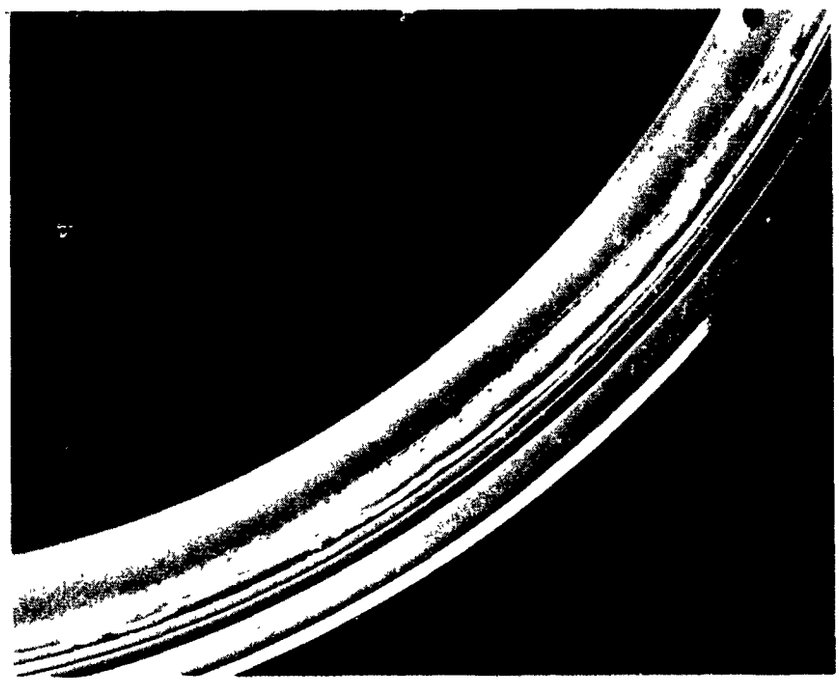
Figure 82 -- Lip Seal -- S/N 0010008

The final disassembly of the thrust chamber valves disclosed cracked lipseals in both oxidizer valves. On one seal approximately 30% of the cracking was all the way through the material, one bearing liner material was loose and there was minor galling on all valve bearings.
