ERDC/CERL TR-17-41

Historic Landscape Inventory for Marietta National Cemetery

November 2017

Under Project 467132, "Cultural Landscape Survey for Marietta National Cemetery, Georgia"

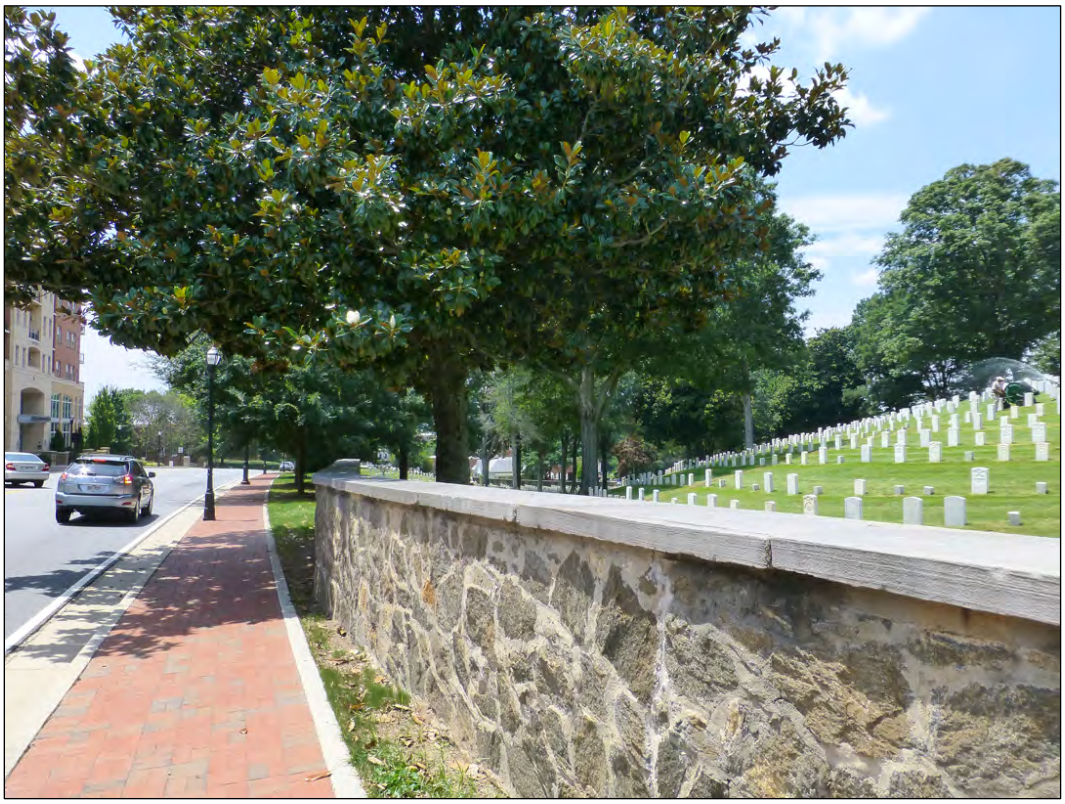
Figure 142. Close-up of the external side of the perimeter wall along Roswell Street, with Section J in the background, 2017 (ERDC-CERL).

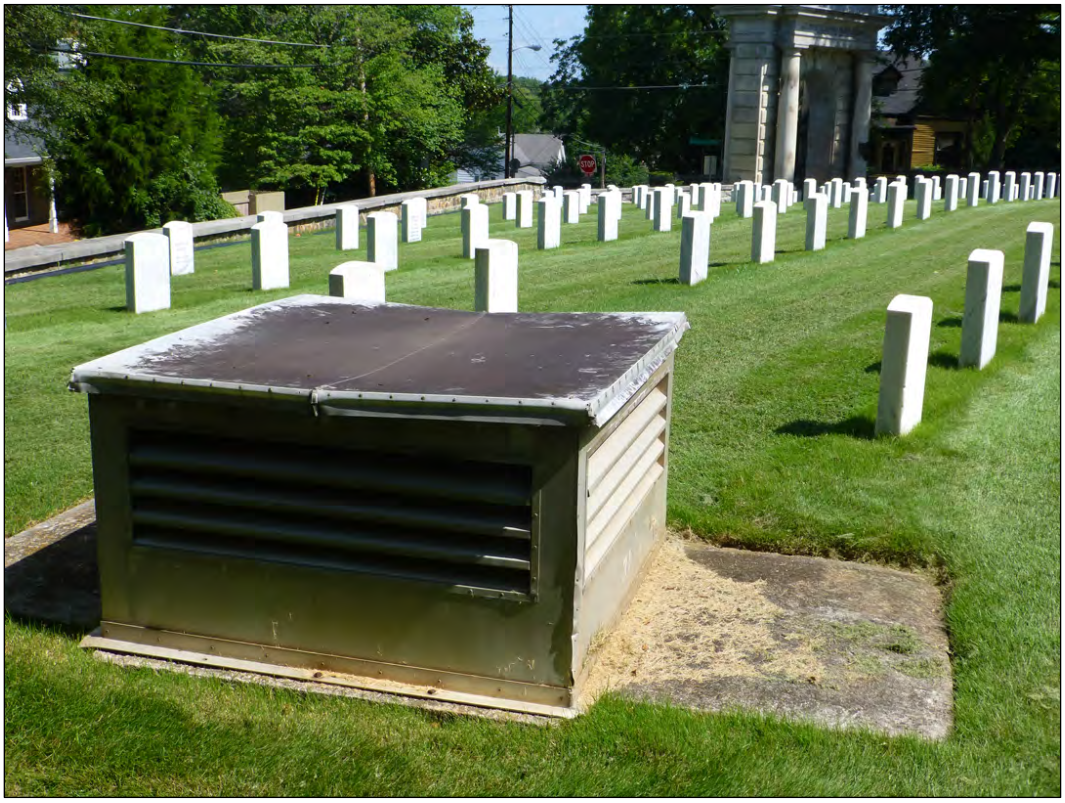
Figure 157. Looking north at the pump house in Section S, 2017 (ERDC-CERL).

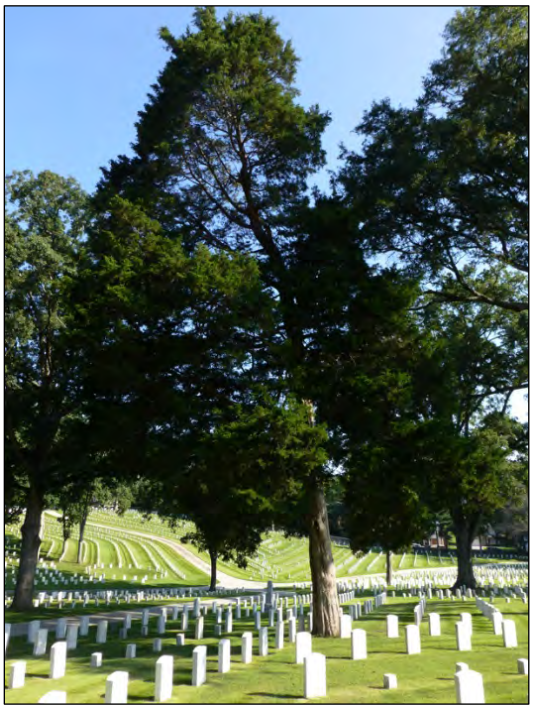
Figure 333. Looking northwest at the northern redcedar tree in Section N, 2017 (ERDC-CERL).

Section N, just like most of the sections in the far eastern portion of the cemetery, has seen almost a complete removal of all trees and shrubs. Also, all the roads and the paths that once separated all the sections have been filled in with burial plots. The center diamond shape of burial headstones has become unreadable within the landscape due to the addition of new burial plots.

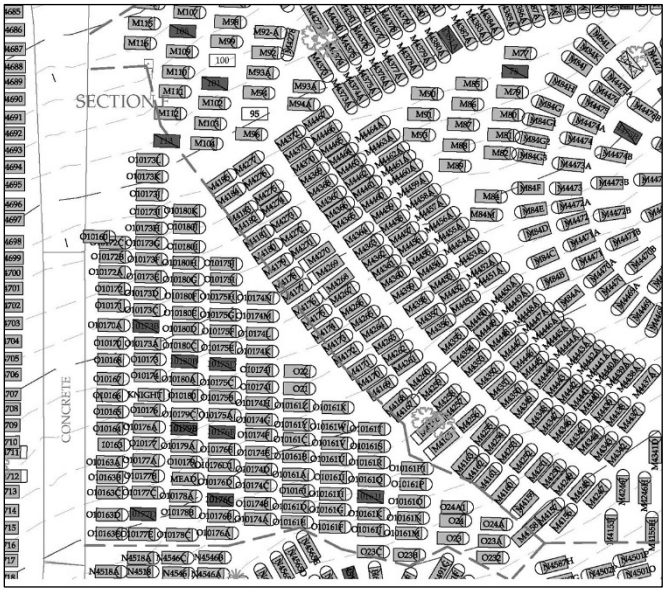
Figure 338. Detail of Section O, 2017 (NCA Archives).

In 2017, no trees or shrubs are extant in Section O (Figure 338).

Section O, like most of the sections in the far eastern portion of the cemetery, has seen almost a complete removal of all trees and shrubs. Also, all the roads and the paths that once separated all the sections have been filled in with burial plots (Figure 339).

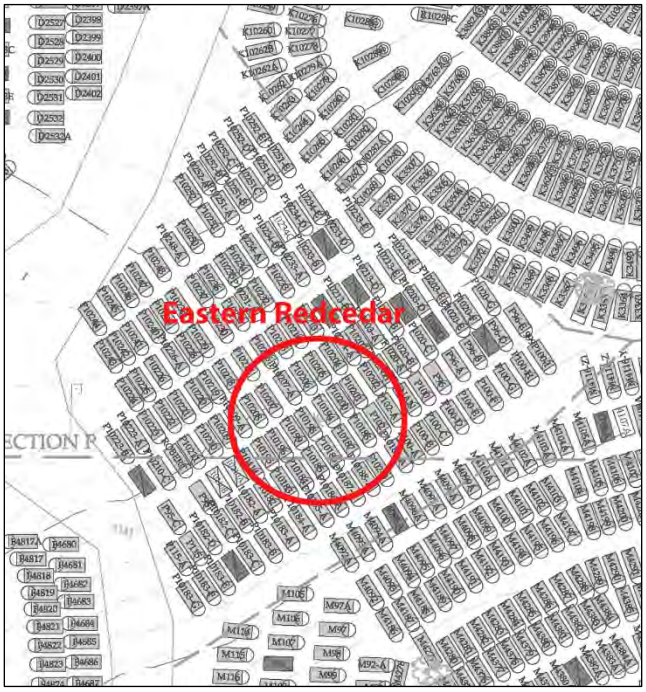
The 1974 planting plan for Section P had the following: 1 common persimmon (*Diospyros virginiana*), 1 eastern redcedar (*Juniperus virginiana*), and 1 willow oak (*Quercus phellos*). In 2017, only the eastern redcedar (*Juniperus virginiana*) is extant (Figure 344 and Figure 345).

Figure 345. Looking east at the base of the eastern redcedar tree in Section P, 2017 (ERDC-CERL).

Section P, like most of the sections in the far eastern portion of the cemetery, has seen almost a complete removal of all trees and shrubs. Also, all the roads and the paths that once separated all the sections have been filled in with burial plots.

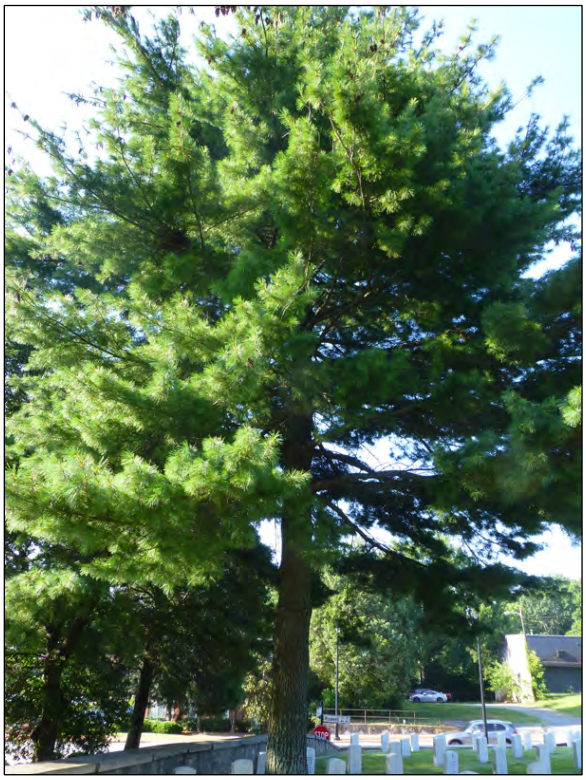
In 2017, Section R (Figure 359) still had 3 eastern redcedar (*Juniperus virginiana*), 2 tuliptree (*Liriodendron tulipifera*), 1 southern magnolia (*Magnolia grandiflora*), and 3 white pine (*Pinus strobus*) (Figure 360 – Figure 362).

Figure 360. A white pine tree in Section R, 2017 (ERDC-CERL).

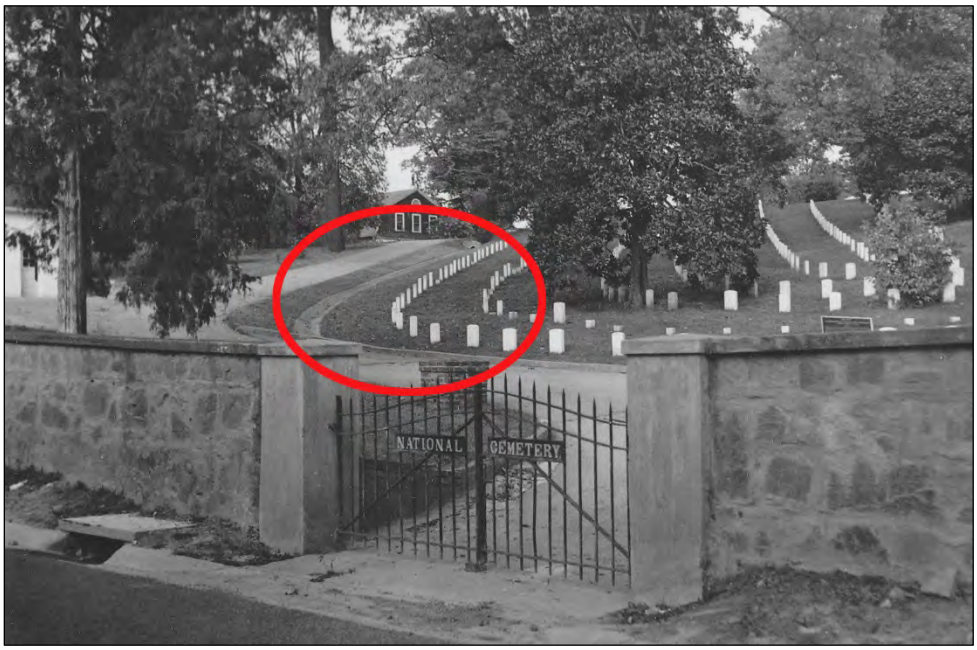
Section S has seen a great many changes over the years, especially with its buildings and structures that have been erected and demolished between the 1920s and 1950s. Additionally, the development of the northern part (location of the first Superintendent's Lodge) for burial plots has changed the feel of the main entrance. While there are trees in the southern portion of the section around the utility building, the removal of the landscaping around the restroom and the removal of all landscaping along the main entrance road has significantly affected the picturesque design of the cemetery (Figure 376 – Figure 381).

Figure 381. Looking northeast over Section S and the service entrance [note concrete gutter marked in red], 1946 (NCA Archives).

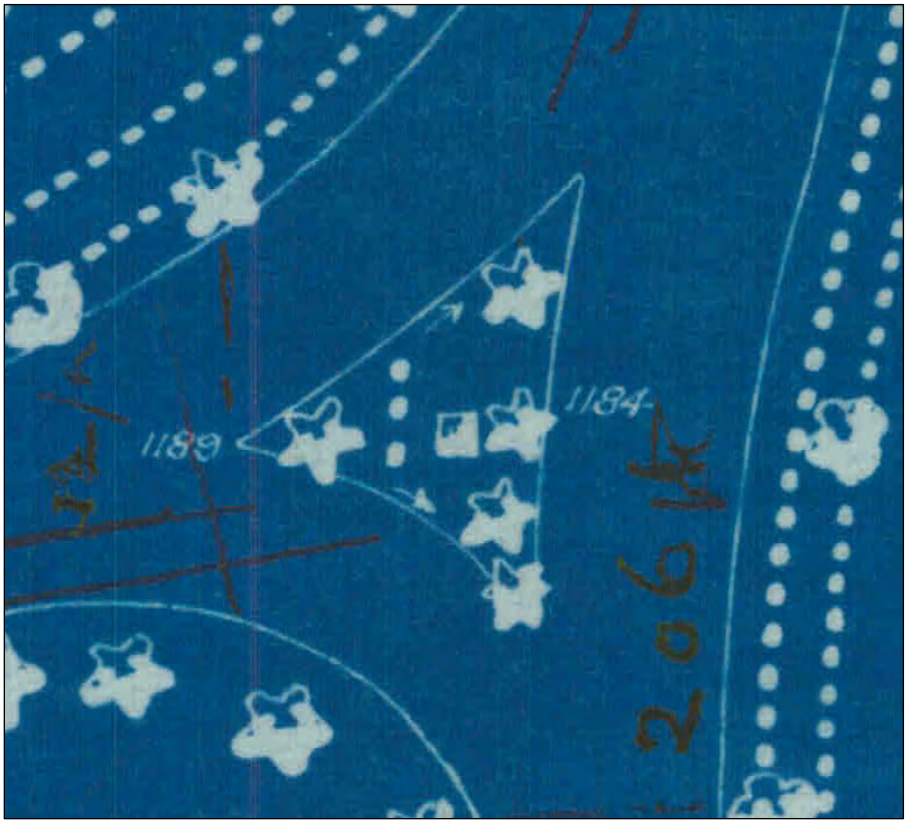
Figure 404. Detail of the Cole Plot, 1893 (NARA College Park).

The Cole Plot was not used for burials in 1866, and it was an "island" between Section C to the north, Section E to the east, and Section G to the south. The roads that surrounded the Cole Plot were gravel in 1893 (Figure 404), and were still gravel in 1933 (Figure 405), but they had concrete gutters. By 1948, the grass roads that surrounded the plot were paved with concrete.

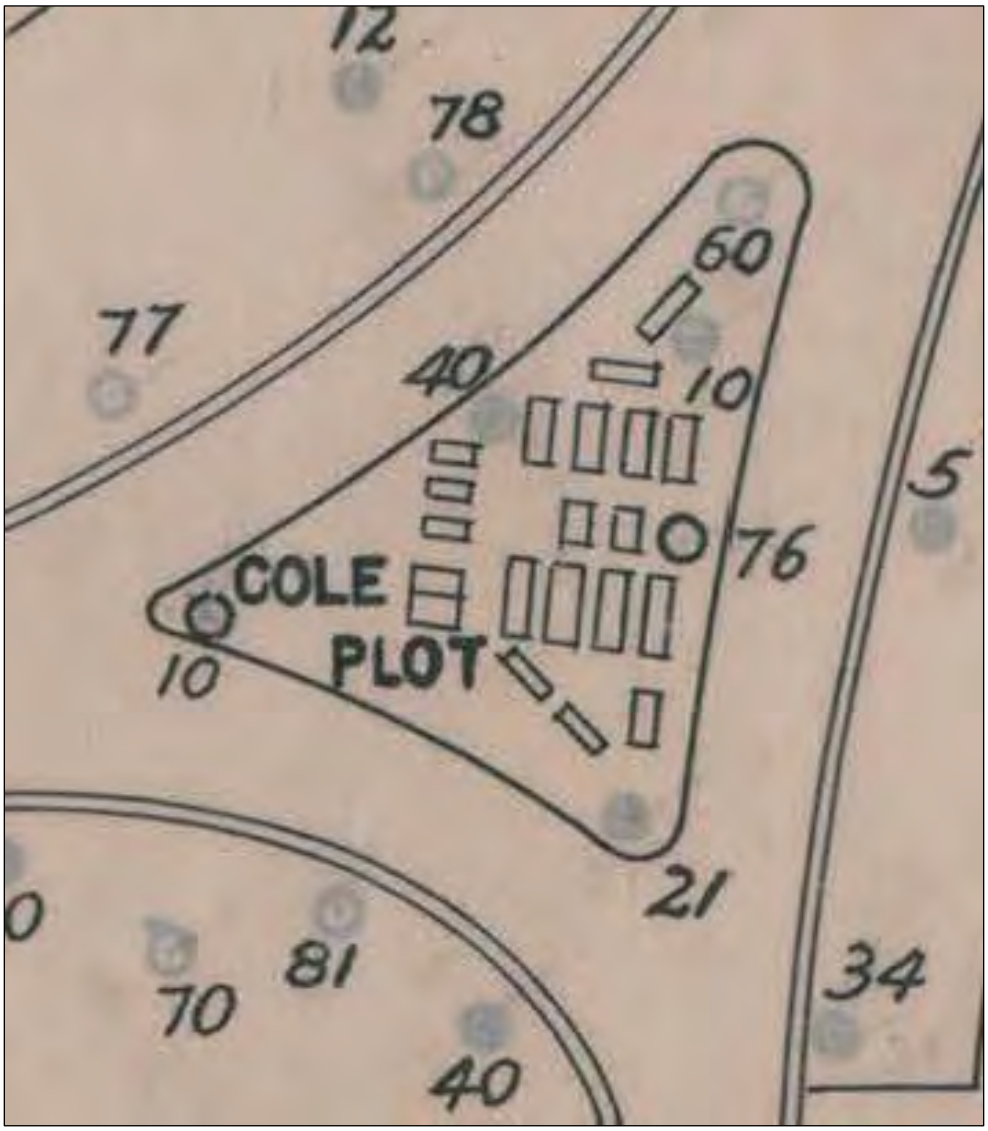
Figure 406. Detail of landscaping in the Cole Plot, 1948 (NCA Archives).

The Cole Plot has been landscaped at least since the 1893 map and by 1948, it had 2 cedar (*Cedrus*), 1 spiny Greek juniper (*Juniperus excels stricta*), 1 euonymus (*Euonymus*), 1 globe cedar *(Thuja occidentalis)*, and roses (Figure 406).

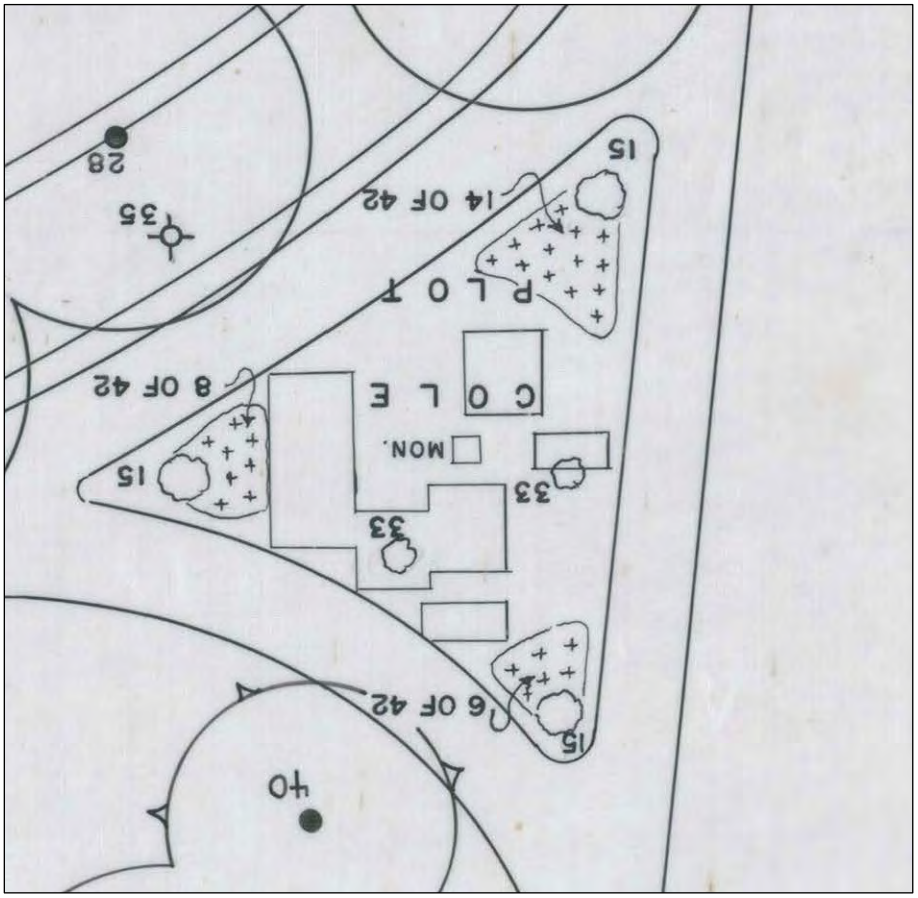
Figure 407. Detail of landscaping in the Cole Plot, 1963 (NCA Archives).

The 1963 planting plan for the Cole Plot (Figure 407) had defined planting beds of Heller Japanese holly (*Ilex crenata (Heller)*) [42 on 1963 map], with 1 Burford Chinese holly (*Ilex Cornuta burfordi*) [15 on 1963 map] at each corner of the triangle, and two rose bushes [33 on 1963 map] in the middle of the plot. The 1974 planting plan for the Cole Plot had 1 Burford Chinese holly (*Ilex cornuta burfordi*) at each of the corners.

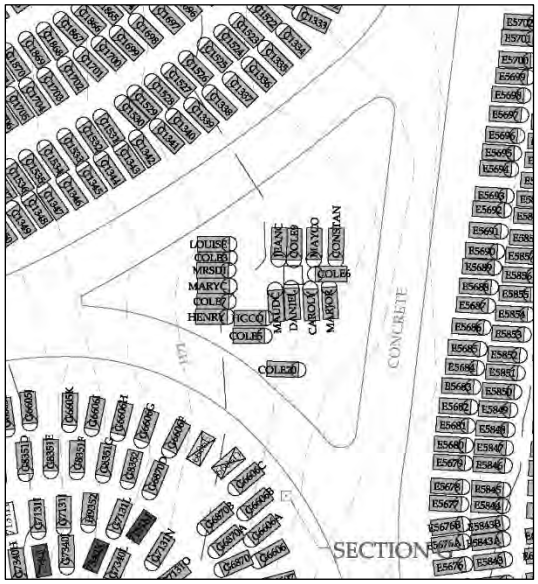
Figure 408. Detail of the Cole Plot, 2017 (NCA Archives).

In 2017, the Cole Plot had no landscaping except for grass (Figure 408).

The Cole Plot was landscaped through at least 1974 with large shrubs at each corner of the triangle and planting beds. The removal of these elements has significantly reduced the elements of the picturesque design of the Cole Plot (Figure 409 – Figure 413).

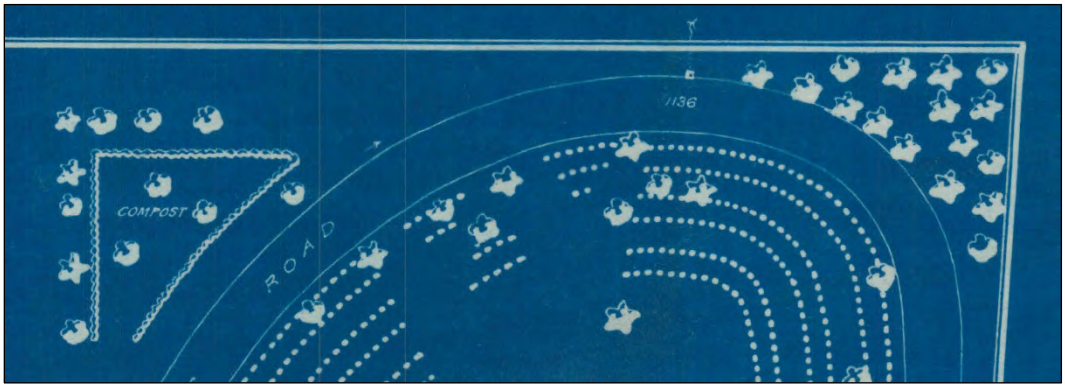
Figure 415. Detail of the Post Section, 1893 (NARA College Park).

The Post Section was not used for burials in 1866. On the 1893 map (Figure 415), it was a landscaped area in the northeast corner that was bounded by the perimeter wall on the north and east, and separated from Section K by a grass road. By 1933 (Figure 416), the northeast portion had burials from the first three decades of the twentieth century. Southwest of this area, between Section D and Section K was a compost pit and landscape service area that is currently part of Section D.

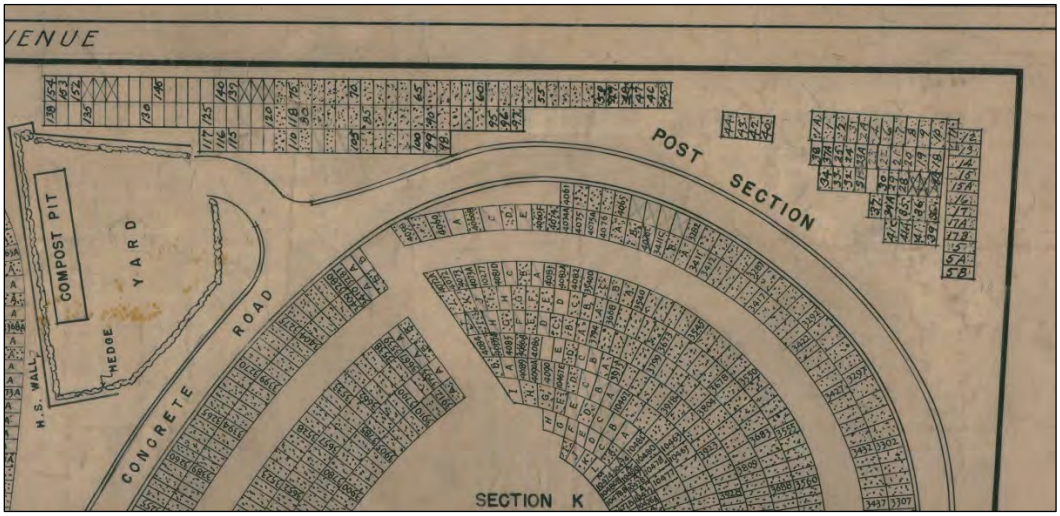
Figure 417. Detail of the Post Section, 1948 (NCA Archives).

In 1948, the Post Section (Figure 417) was planted with the following trees: 2 spiny Greek juniper (*Juniperus excels stricta*), 1 willow oak (*Quercus phellos*), 1 crepe myrtle (*Myrtus lagerstraemia*), 3 eastern redcedar (*Juniperus virginiana*), 2 chestnut oak (*Quercus montana*), 2 Lombardy poplar (*Populus nigra*), 2 pine (*Pinus*), and 2 magnolia (*Magnolia*). The shrubs in the Post Section were 1 boxwood (*Buxus*), 1 spirea (*Spirea*), and 1 Deutzia (*Deutzia*). The area between the road (separating the Post Section from Section K) and the perimeter wall was not landscaped.

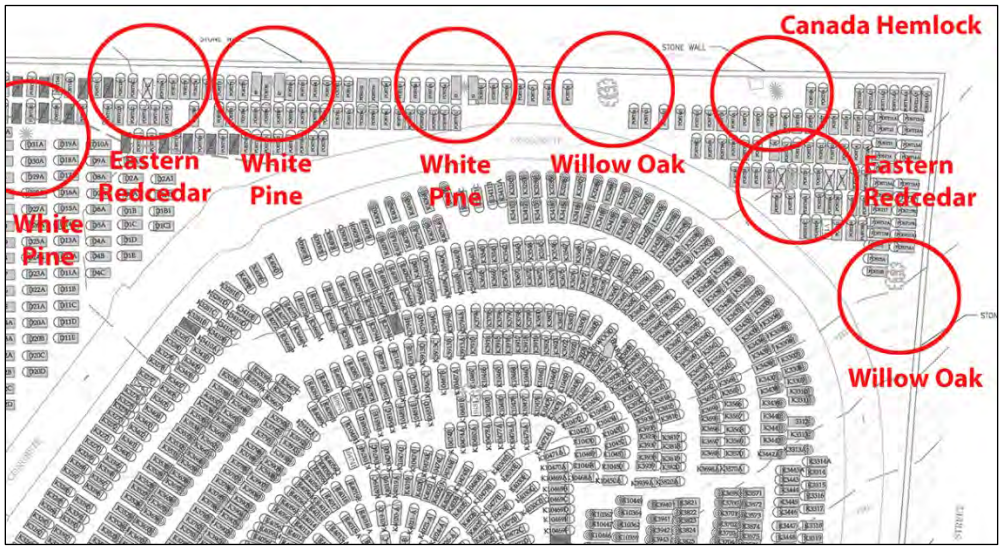
Figure 418. Detail of the Post Section, 2017 (NCA Archives).

In 2017, the Post Section (Figure 418) still had 3 white pine (*Pinus strobus*), 2 eastern redcedar (*Juniperus virginiana*), 2 willow oak (*Quercus phellos*), and 1 Canada hemlock (*Tsuga canadensis*) (Figure 419 – Figure 421).

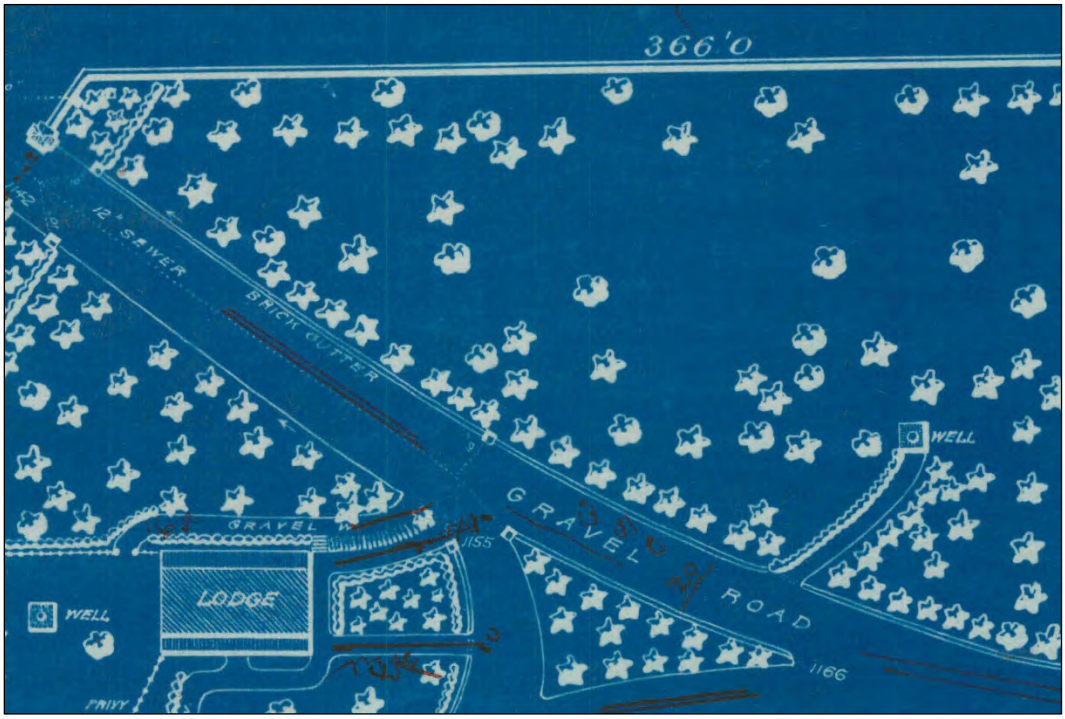
Figure 423. Detail of the Superintendent's Lodge area, 1893 (NARA College Park).

The Superintendent's Lodge area was not used for burials in 1866, and it was landscaped with both deciduous and evergreen trees by 1893 (Figure 423). The area did contain a well and well house that were constructed ca.1880s. In 1921, a new Superintendent's Lodge was constructed northwest of the well house. The 1933 map (Figure 424) shows that a sidewalk led from the road to the front porch, and a second path led from the road past the well house to the backdoor. The main entrance road, which bordered the area to the south in 1893, was paved with gravel and had brick gutters; by 1933, these were replaced with concrete and concrete curbs. The well house was removed in the 1950s, and the path that led to it from the road and continued to the back of the lodge was removed and relocated during the 1960s. A large "island" south of the lodge area, which divided the road up to Section U from the road that went south to the utility building, was reduced in size in 1963 (Figure 425). The path to the rear of the house was removed at some point after 1974, and the concrete pad and committal shelter were added sometime after 1974.

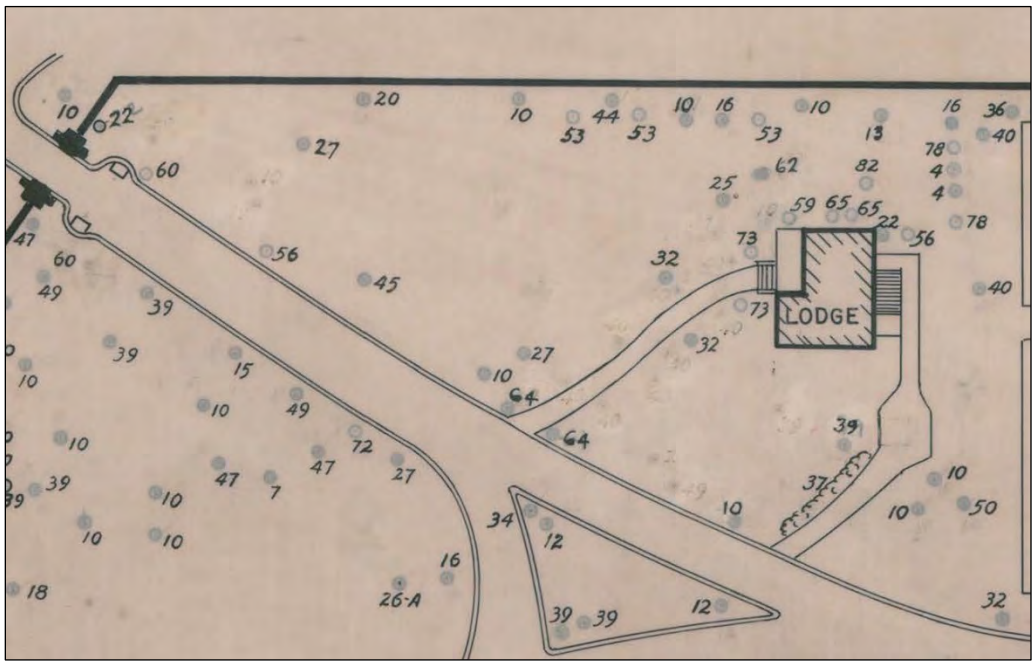
Figure 426. Detail of the Superintendent's Lodge area, 1948 (NCA Archives).

In 1948, the Superintendent's Lodge area (Figure 426) was planted with the following trees: 2 arborvitae Berckman (*Thuja orientalis aurea nana*), 6 cedar (*Cedrus*), 1 Chinaberry (*Azedarach*), 2 crepe myrtle (*Myrtus lagerstraemia*), 1 fig (*Ficus*), 2 hawthorne (*Crataegus*), magnolia (*Magnolia*), 3 pecan (*Carya illinoensis*), 1 post oak (*Quercus stellata*), 1 pussy willow (*Salix discolor*), 1 northern red oak (*Quercus borealis*), 3 spiny Greek juniper (*Juniperus excels stricta*), 1 water oak (*Quercus nigra*), 1 weeping beech (*Fagus sylvatica purpurea*), and 1 yew (*Taxus*). Shrubs in the area were the following: 3 rose of Sharon (*Hibiscus syriacus*), 2 boxwood (*Buxus*), 1 Elaeagnus (*Elaeagnus*), 1 euonymus (*Euonymus*), 1 gardenia (*gardenia*), 2 holly (*Ilex glabra*), 2 honeysuckle (*Lonicera*), 2 nandina (*nandina*), 2 spirea (*Spirea*), and 1 yellow bell (*Allamanda*).

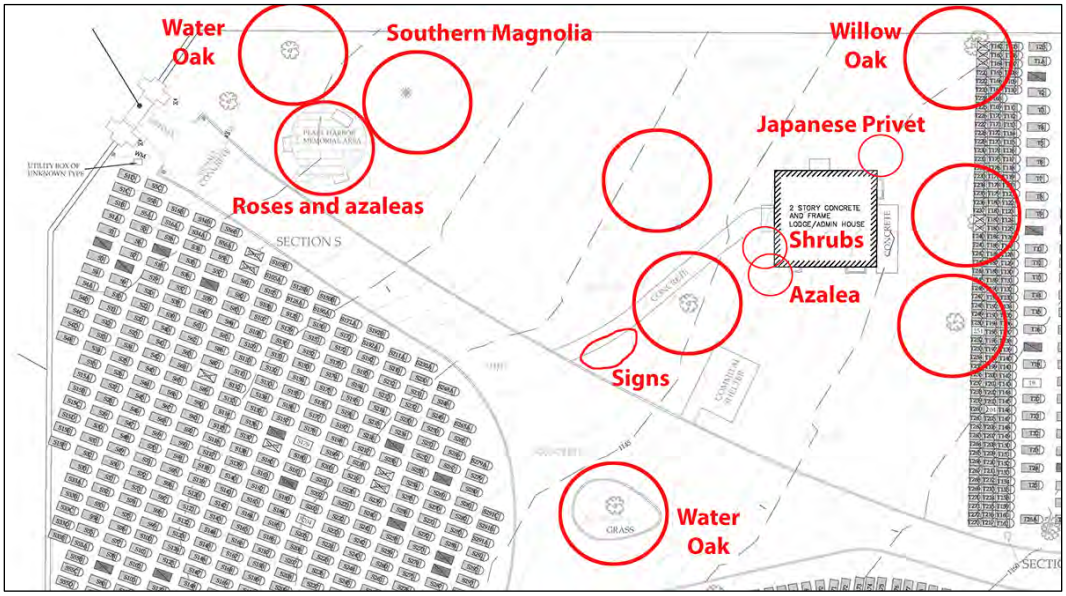
Figure 429. Detail of the Superintendent's Lodge area, 2017 (NCA Archives).

In 2017, the Superintendent's Lodge area (Figure 429) has 1 Japanese privet (*Ligustrum japonicum*), 2 water oak *(Quercus nigra*), 1 southern magnolia (*magnolia grandiflora*), 1 willow oak (*Quercus phellos*) 4 pecan (*Carya illinoensis*), some pink Kurume azalea *(Rhododendron obtusum japonicum*) and 2 unknown shrubs. The Pearl Harbor Survivors Association Monument was laid out in 1996 with pink concrete pavers in a path from the road that leads to a large round area paved with the same concrete pavers, although many of them are inscribed. The paved area is surrounded by various rose and azalea bushes (Figure 430 – Figure 437).

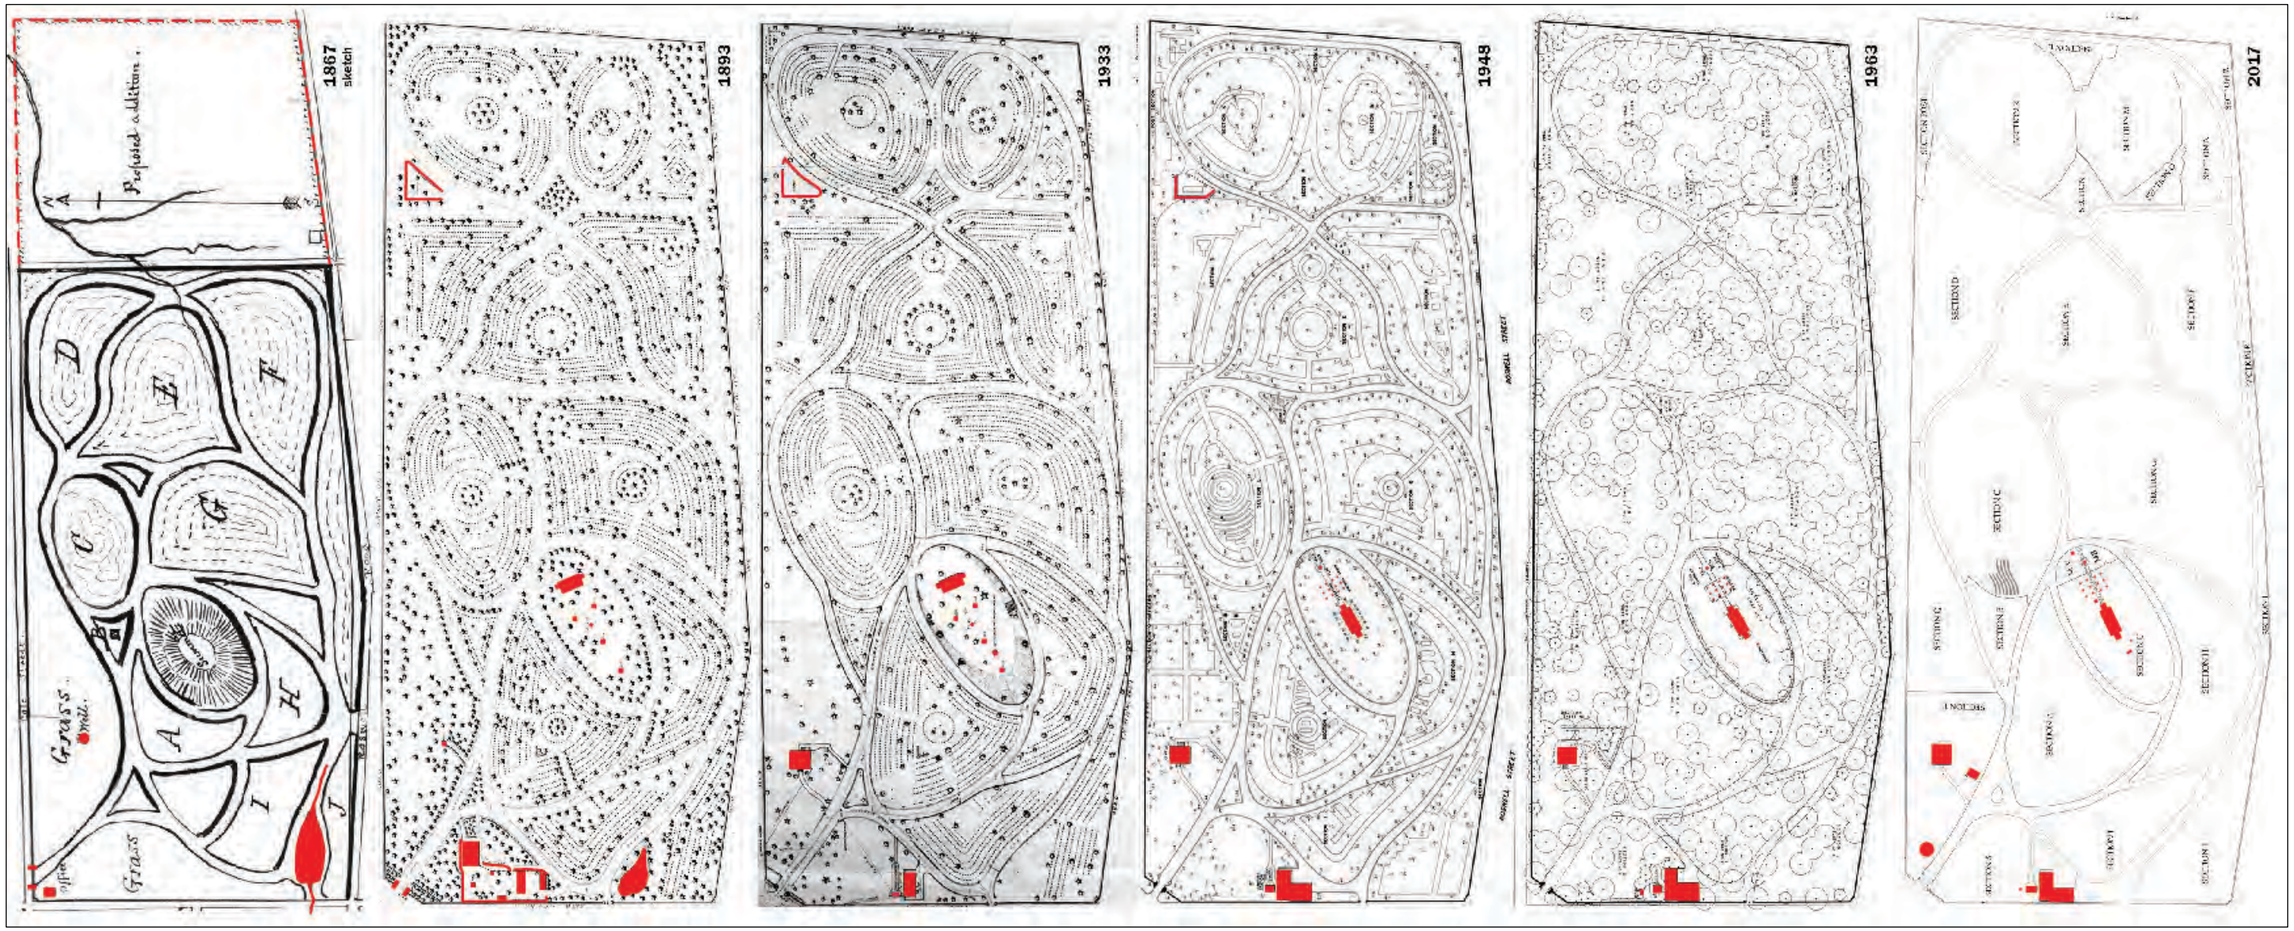
Figure 447. Same-scale map analysis (NCA Archives and ERDC-CERL).

The following figure (Figure 447) provides a comparison of the cemetery through time (1867 to 2017) at the same scale. The maps show the permanence of the layout and road system, the changes to Section U, and the appearance/disappearance of buildings and structures. Most of the maps show tree cover, verifying the loss of tree cover over time.
