ERDC/CERL TR-17-45

Demonstration of Thermoplastic Composite I-Beam Design Bridge at Camp Mackall, NC

Final Report on Projects FY08-16 and FY09-31

December 2017

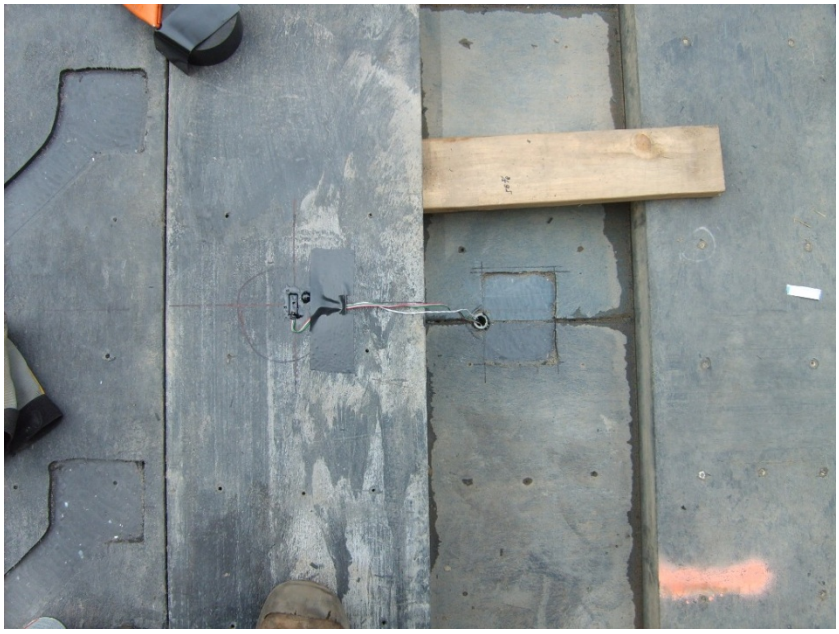
Figure 31. Strain and temperature gauges are visible near center of this photo.

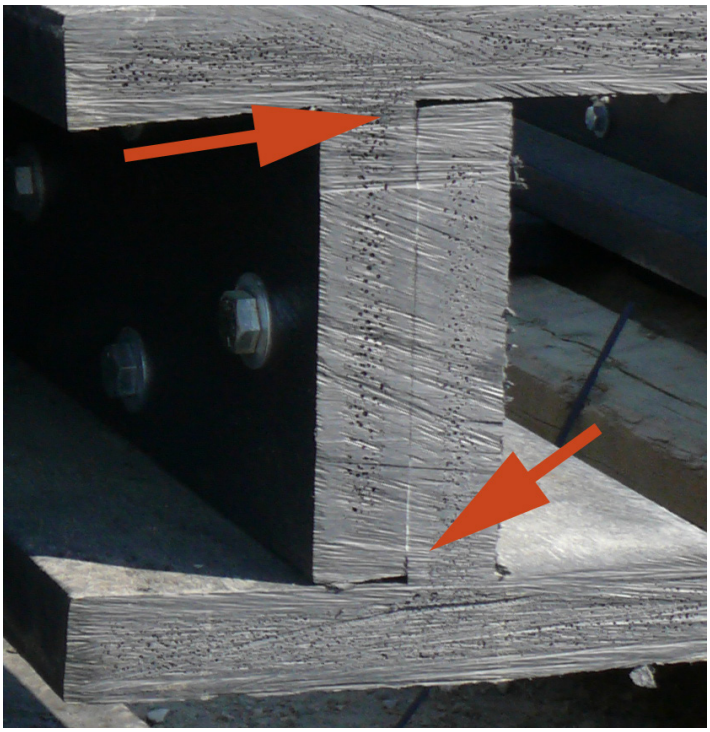
Figure B1. Gaps at the point of contact between the two T-beams.
