NAVAL POSTGRADUATE SCHOOL

THESIS

NPS TERAHERTZ PROJECT: IR HAB FLIGHT TESTING AND INTEGRATION

March 2018

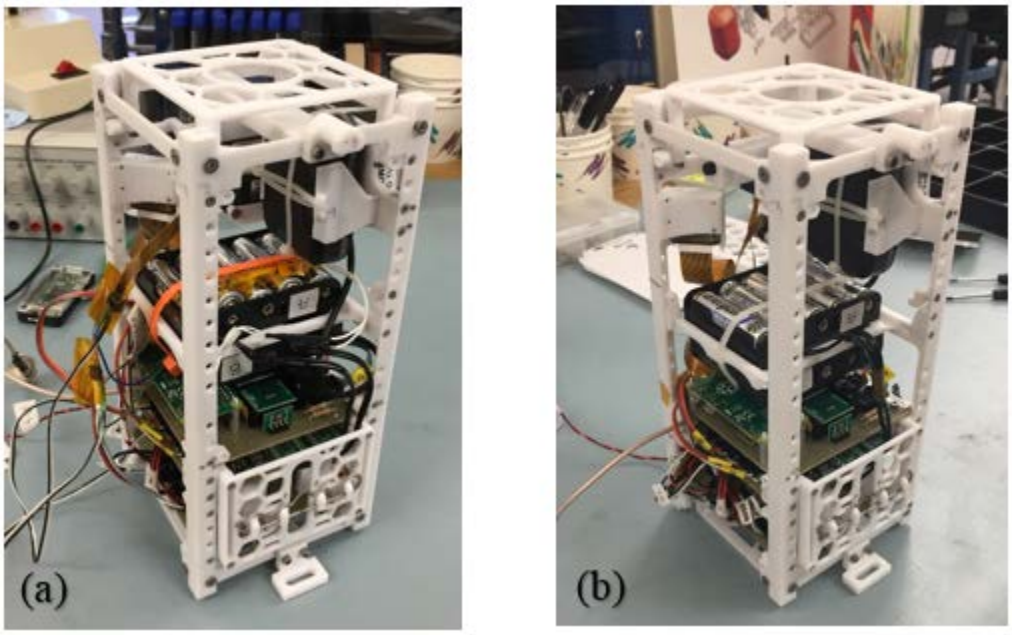
length, bending carefully the cable to avoid broken wires. We noticed improvement on the radio signal by observing that more packages were received on the receiver radio from the HAB payload. In addition, it was easier to access the main bus components (more space to work), which helped with the assembling of the other components and decreased the risk of damage. We can easily see the difference in Figure 32, where the right image is the improvement described.

Figure 32. Difference after taping the wires

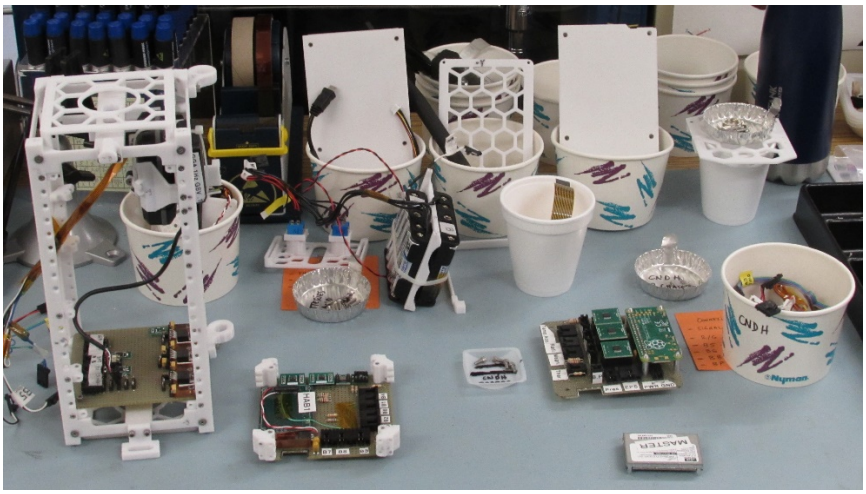
Figure 34. HAB payload disassembled on the last business day before flight

Unfortunately, on the last business day before the flight, we had the HAB payload all disassembled, not working well, and we did not know the reason for that. As planned, we performed the flat test in the early morning, but the test has shown the same behavior as the previous day. Since we were planning to check the radio components, we began with the cable test. We noticed that the cable was transmitting less than 60% of the signal through it. Whereas we suspected that this problem wouldn't cause the described current surge, the cable and the radio were replaced and the tests with these devices were found in acceptable parameters.

Once the current surge problem was fixed, the only concern was the fact that the long duration test was not completely done and we did not have time to start it again because, despite having the entire HAB payload working well, we still had an entire final assembling process to perform (Figures 34 and 35). Besides that, this one should have been very careful, with no chance of any mistake. This procedure was done in about 3 hours.

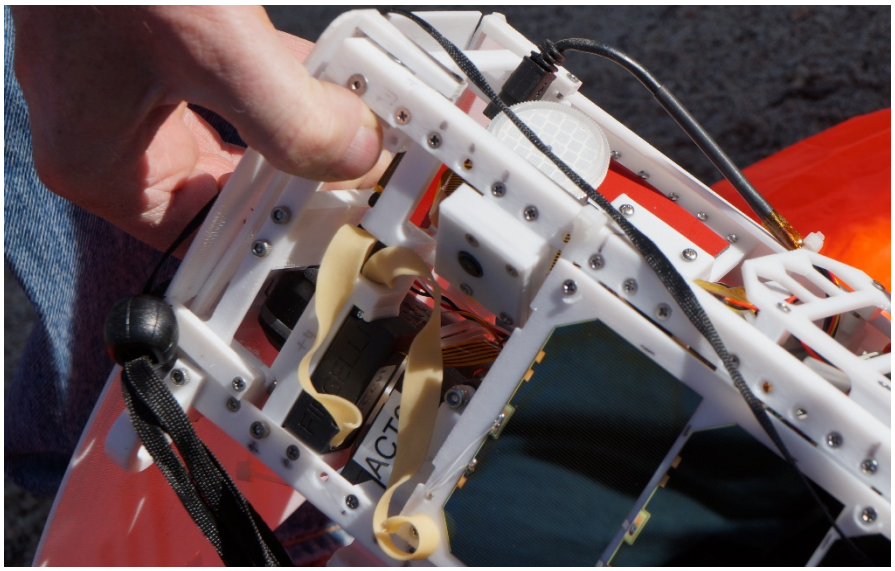
Figure 40. The rubber band grabbed on the actuator

Without a confirmation if the balloon remains were released or not and the altitude going down fast, we decided to command the parachute release because the altitude was less than 5,500 metros and we were concerned that a HAB payload free fall could be worse than a possible fail during the parachute aperture. Again, we did not receive confirmation from the telemetry about the parachute released and we commanded several times. We discovered after recovering the HAB payload that the rubber band used to hold the parachute was grabbed by the actuator pin (Figure 40). That was the reason why the actuator never went to zero.

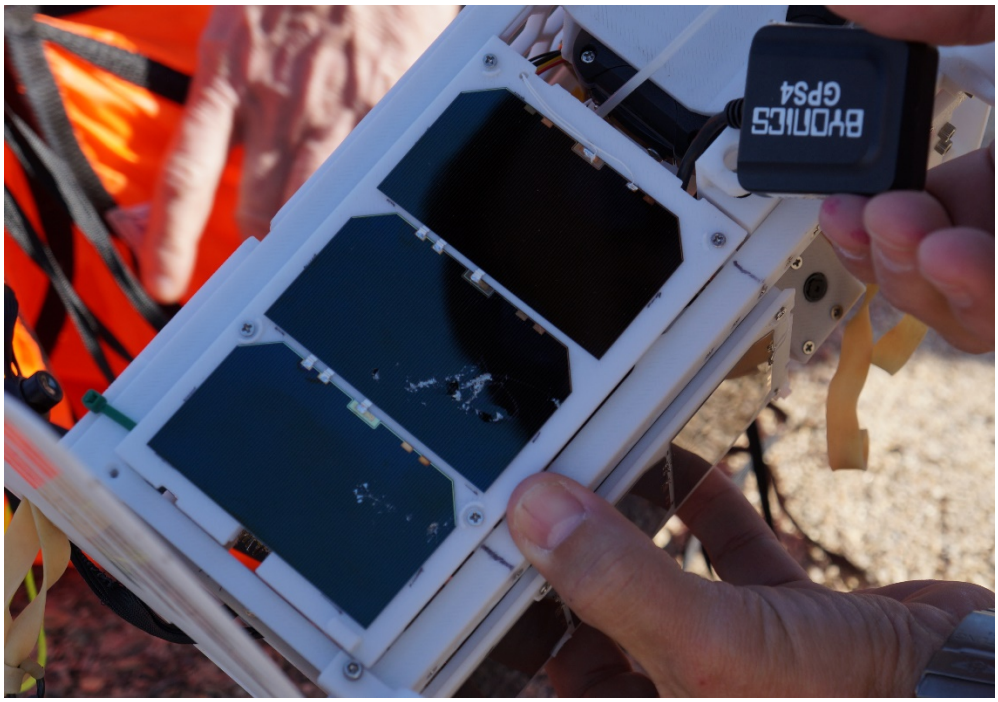
Figure 42. The solar panel damages

The damages found on the HAB payload were minor and basically on the plastic components. The most relevant damage was some cracks on one solar panel, probably caused by the balloon remains (a cord with a metal swivel at the end that connects the balloon to the HAB payload) colliding during the descent. These cracks are shown in Figure 42.

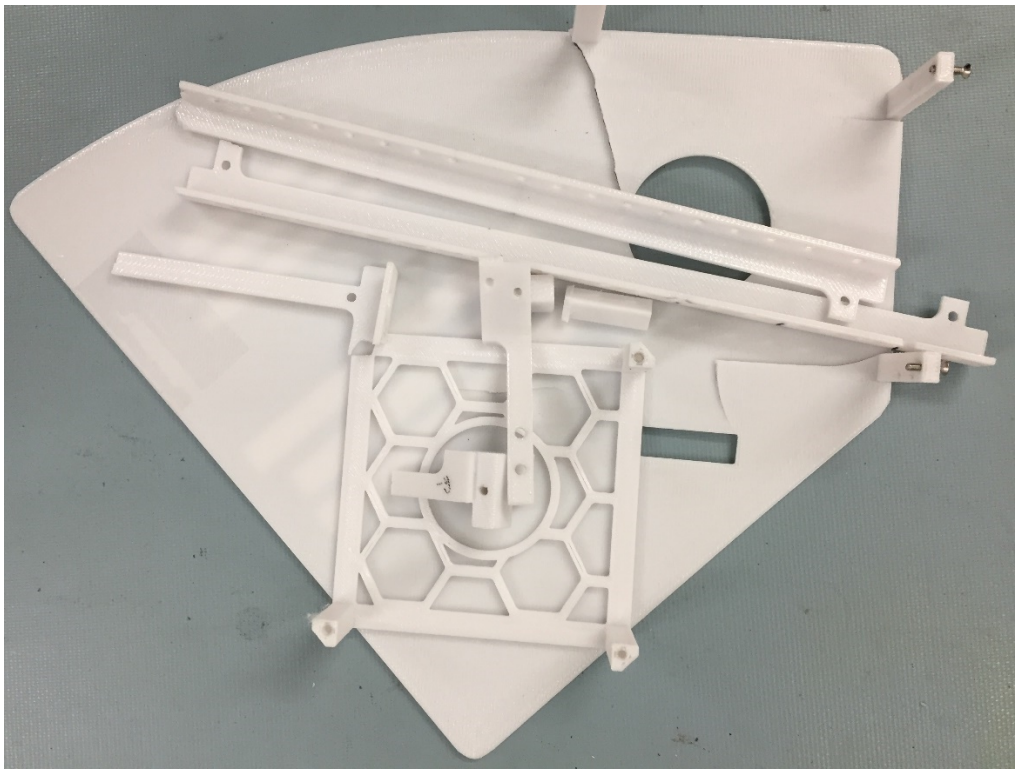
Figure 43. Structural damages

Other minor damages were found on the frame structure but no electronic component was affected by the hard landing. The broken components are displayed in Figure 43.

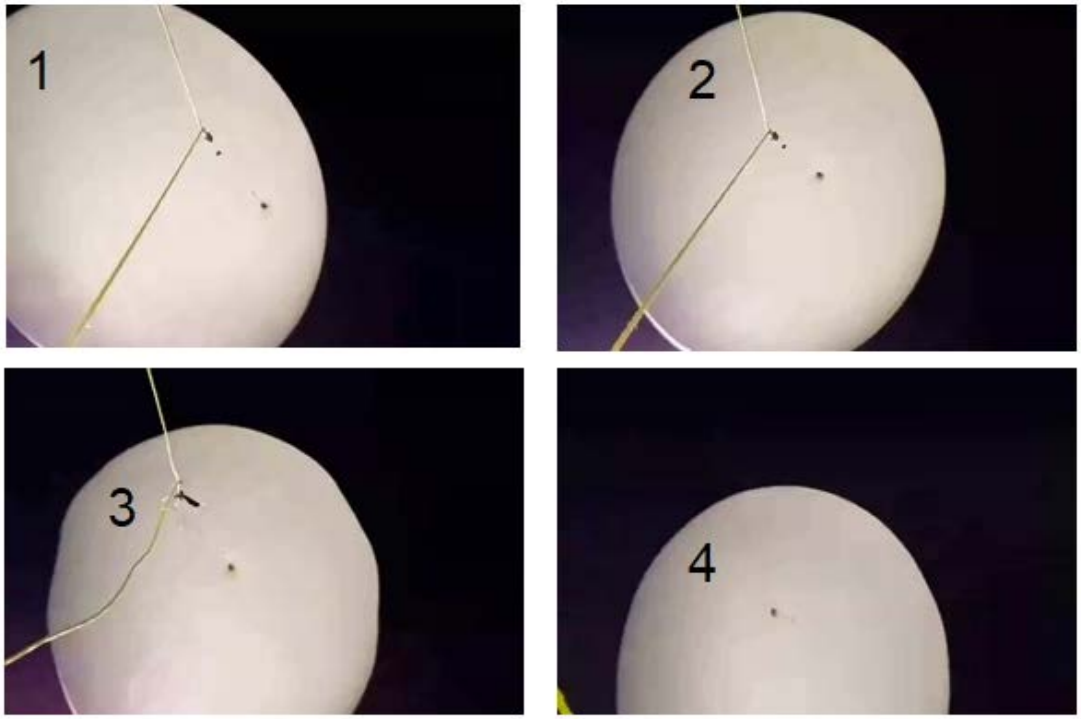
Figure 47. Four snapshots (1 to 4) the balloon detachment moment

As it can be noticed from the video and the images, forces during a rotational movement have broken the hard connection between the balloon and its payload. The most probable explanation is the severity of the jet stream (a narrow belt of high-altitude winds) at the level where the detachment happened. When the HAB flight was exposed to considerable high forces due to the jet stream acceleration, the nylon line broke. According the FAA rules for the HAB flight activity we are not allowed to: "Uses a rope or other device for suspension of the payload that requires an impact force of more than 50 pounds to separate the suspended payload from the balloon" [15]. It is proved to be not strong enough to resist such high accelerations.

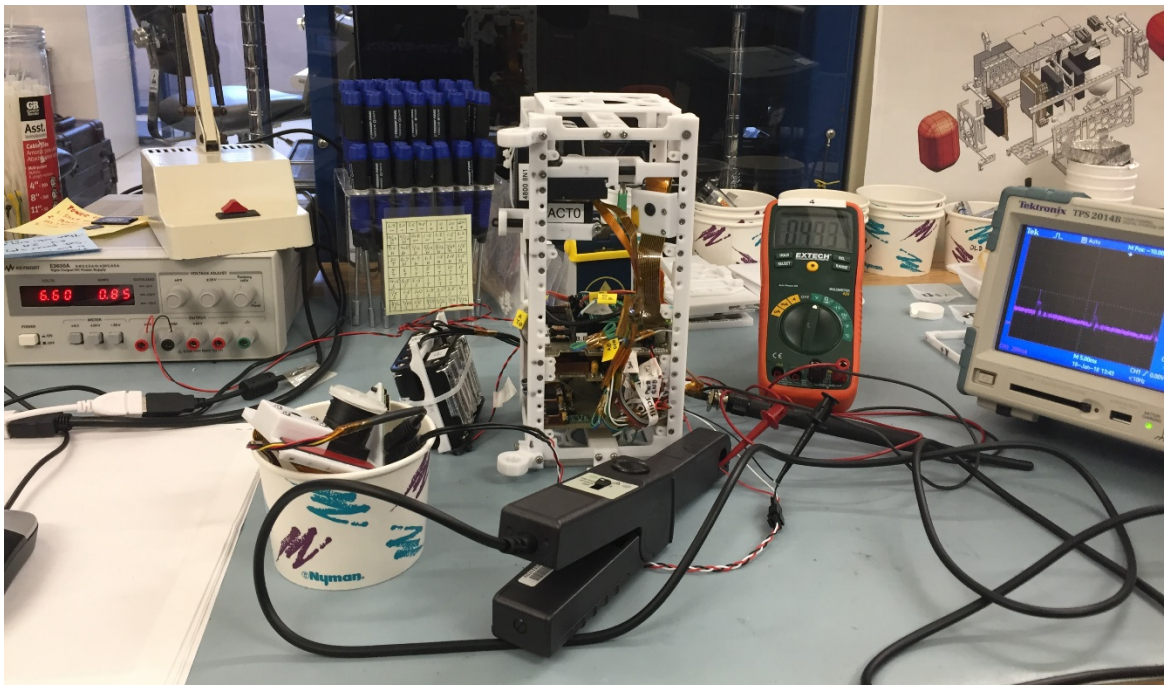
Figure 50. Power supply instrumented test on the HAB payload

It was decided to disassembly the HAB payload to check the condition of all cables and connections first and then check the regulators on the EPS. The overall conditions of the electronic components were classified as well preserved and it led us to the regulator option. We were close to change the regulator responsible for the power line that connects the Pi board, when someone noticed that the voltage selected on the external power supply was incorrect. We were using 5.6 V on that, however, the minimum required during the flight was about 6.6 V.

After we selected the correct value (6.6 V) on the external power supply, we did a long-term and instrumented test on the HAB payload disassembled, as we can see in Figure 50, and no more problems were detected. We still had the bad files made by the IR camera sometimes, but no more stops were noticed. Despite the time spent on those investigations, we noticed that it was the first time we could replicate the failure happened on the first flight.

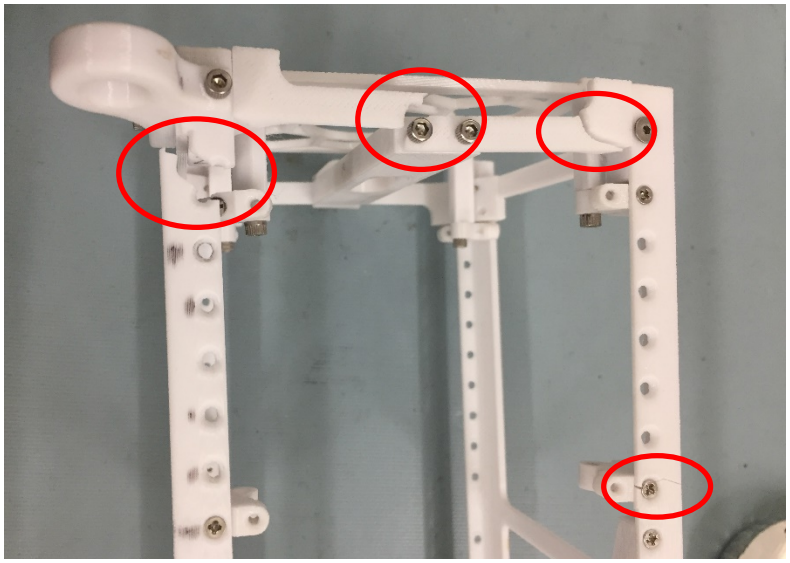
Figure 61. The chassis damage

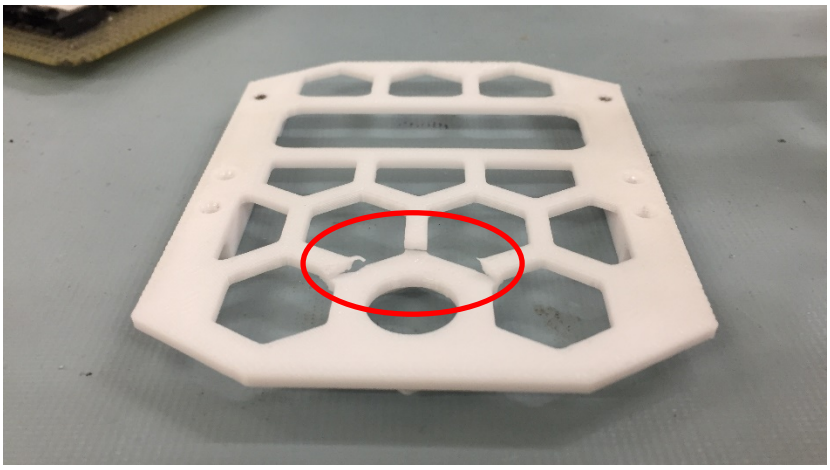
Besides the chassis, only one more broken piece was detected, the antenna's face cover, as shown in Figure 62.

Figure 62. Antenna's face cover damage

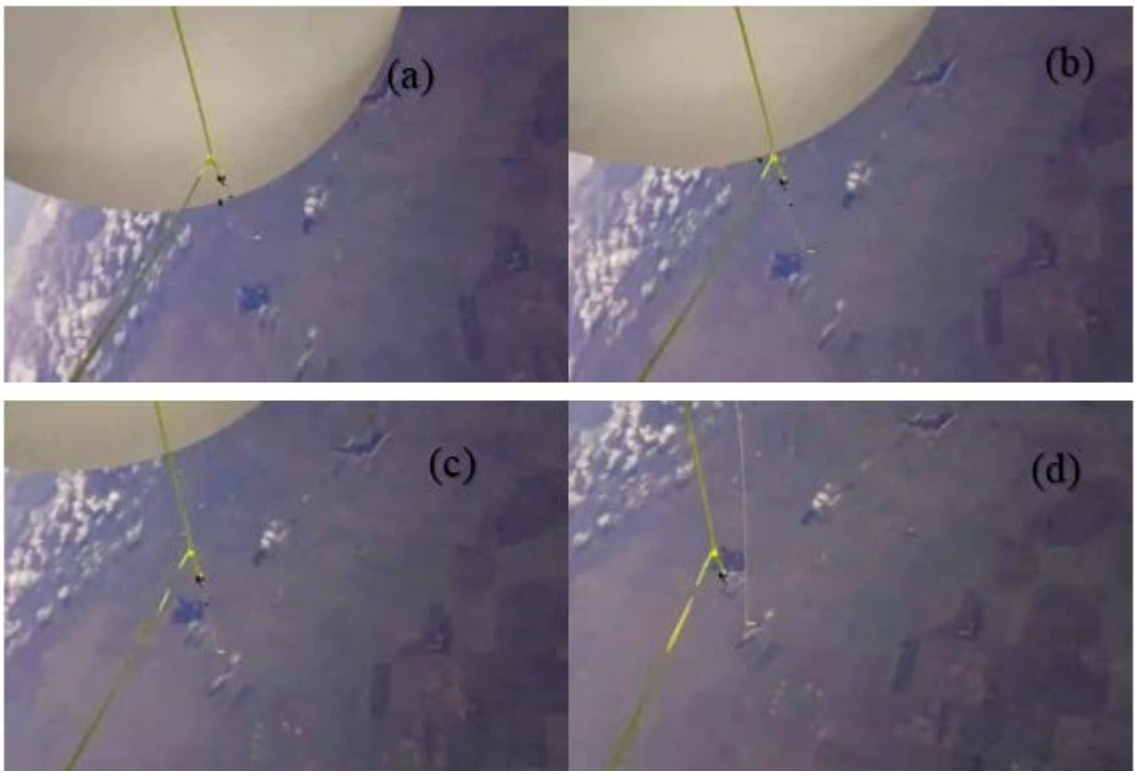
Figure 68. Four snapshots of the 2nd Flight Balloon detachment

As the first flight, this camera was looking to the balloon and was crucial to clarify how the balloon was disconnected during the flight. We concluded that the same fact as the first flight happened again, a very strong turbulence force probably was the reason for the precocious balloon detachment. The jet stream forces were so strong that caused rotational movements and unexpected tensions on the breakable nylon cord. The result was a nylon cord broken and a balloon early detachment that increased in complexity the chasing operation, since we did not have GPS information most part of flight.

On the video of that moment, downloaded from this camera, we could clearly see the nylon cord breaking and the balloon going up faster not carrying the payload as it supposed to be. Besides that, the same video showed the inadvertent backup parachute opening, most likely caused by the same forces. During the after-flight check, we concluded that just the barometric mechanism connection of the parachute was detached and no rubber band broken as we could presume. That means the parachute was removed from its place and the mechanism was open only at the preset altitude (1000 meters). We did a 15 second clip of this moment and posted on YouTube (https://youtu.be/BC-B-F-Kmxg) (Video 3). Four frames snapshots of the moment were also taken and showed in Figure 68.

Another reasonable explanation for the early detachment is related to the backup parachute opening. There is a possibility that the problem with the backup parachute had been the cause for it. The parachute opened would increase instantaneously the drag on the system and thus the tension on the nylon cord, causing it to break.
