title: AIRFIELD PAVEMENT CONDITION SURVEY AND PAVEMENT EVALUATION, USMCAS, EL TORO, CALIF~~ORNIA~~, by

author: L. J. WOLOSZYNSKI

date: DEC~~EMBER~~ 1975.

CIVIL ENGINEERING LABORATORY
NAVAL CONSTRUCTION BATTALION CENTER
Port Hueneme, California 93043

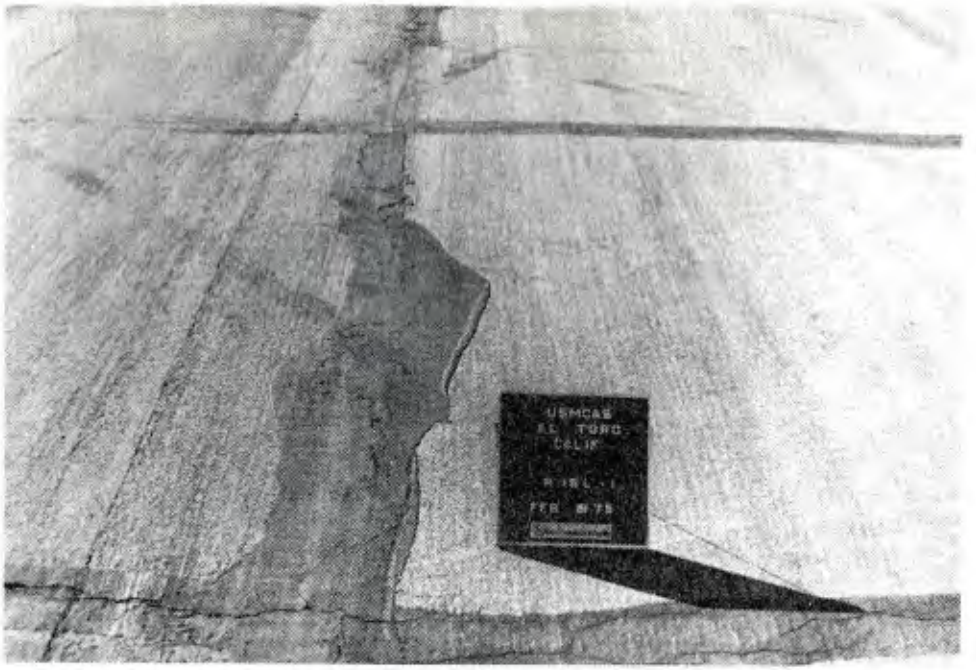
FIGURE 3. SURFACE CONDITION ASPHALTIC CONCRETE, DISCRETE AREA R3-1

Surface aggregate is completely exposed and devoid of bitumen. Cracks have some vegetation growing in them. Raveling was detected in the worst areas where loss of surface fines was noted. Almost the entire area could be considered to be in a state of incipient raveling. See Figure 3.

FIGURE 4. REFLECTION CRACKS, DISCRETE AREA R7R-1

Pattern cracking occurred along reflection cracks. Reflection cracks have been sealed and resealed. There is a large buildup of joint seal material on the pavement surface. See Figure 4.

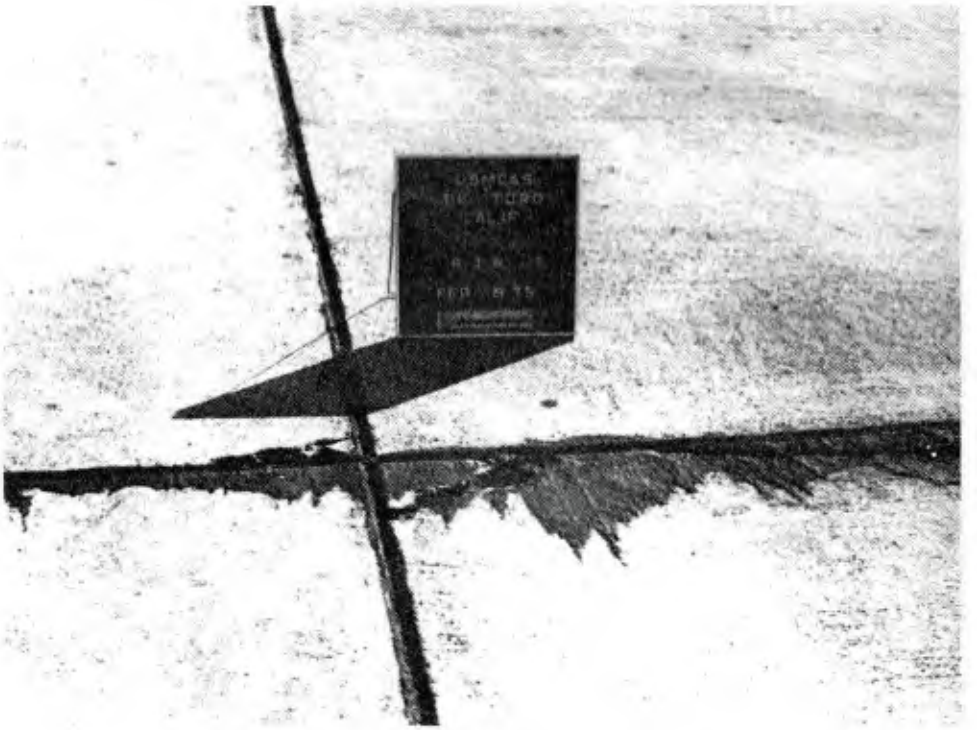
FIGURE 5. REFLECTION CRACKS, DISCRETE AREA R16L-1

Pattern cracking occurs along reflection cracks. See Figure 5.
