R-2093

TESTS OF THE MODEL SF RADAR

Contractor - The Submarine Signal Co.

NAVAL RESEARCH LABORATORY
ANACOSTIA STATION
WASHINGTON, D. C.

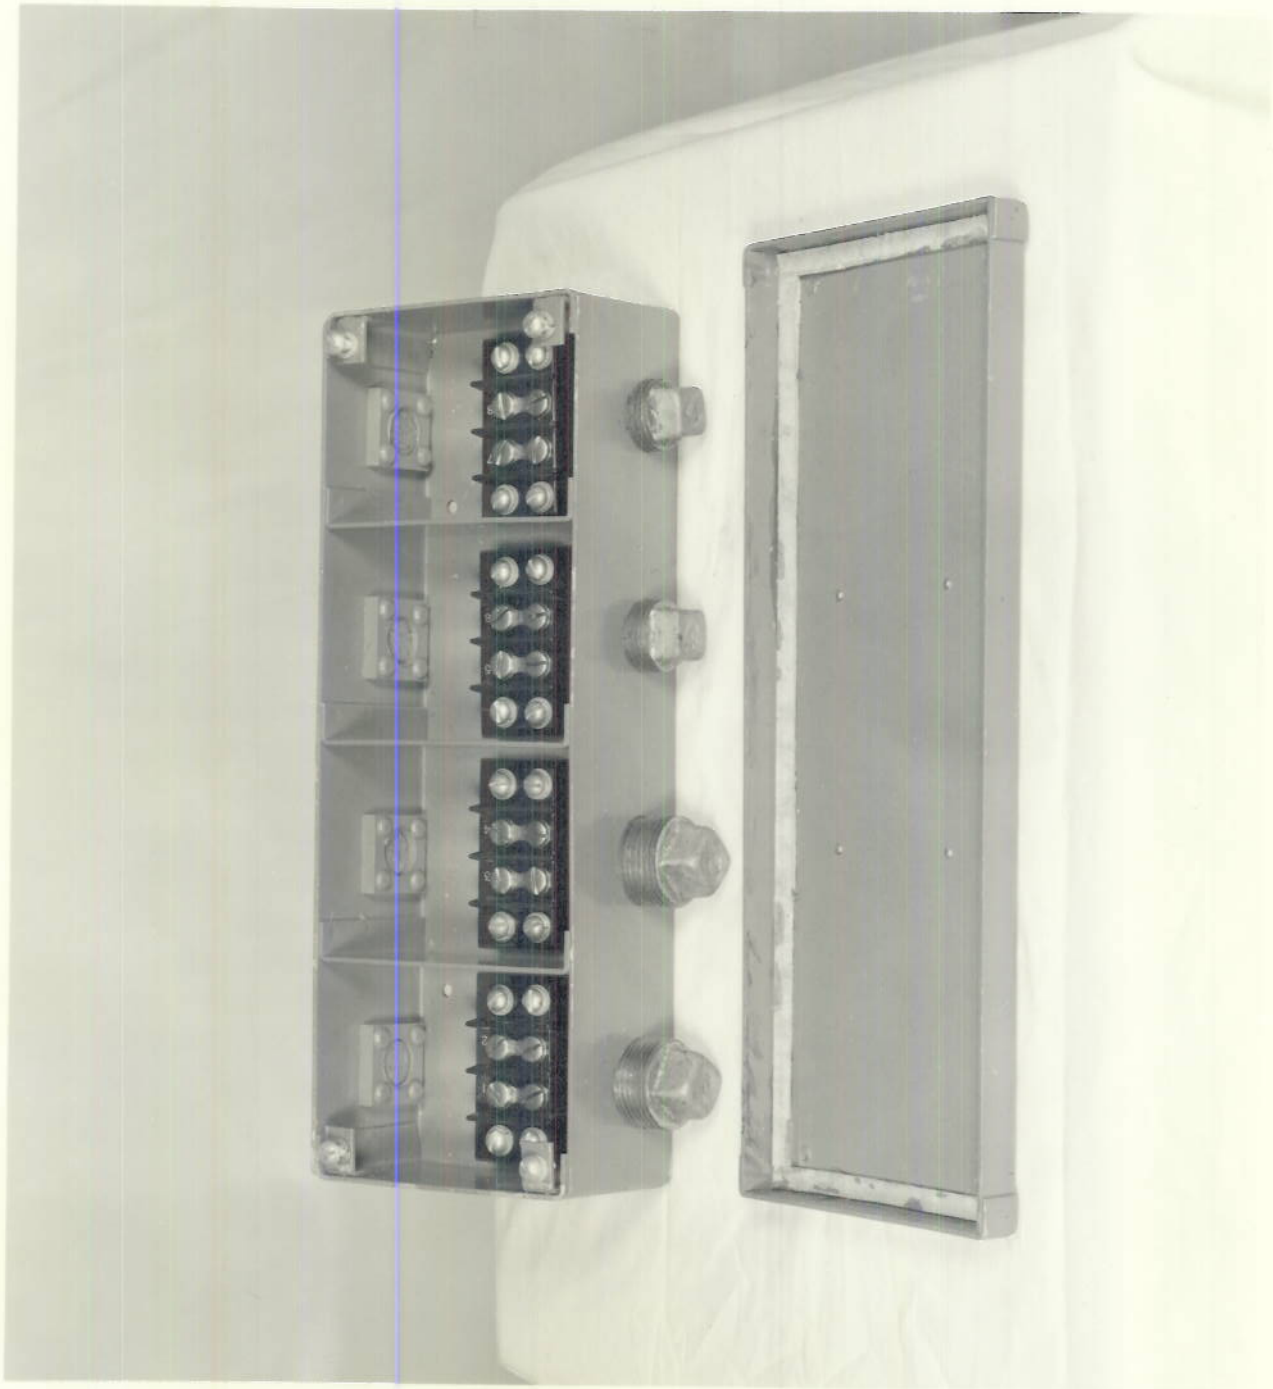
PLATE 32 SEC. 2

2-15-30. The terminal box supplied with the equipment is not moisture proof. (Plate 32)

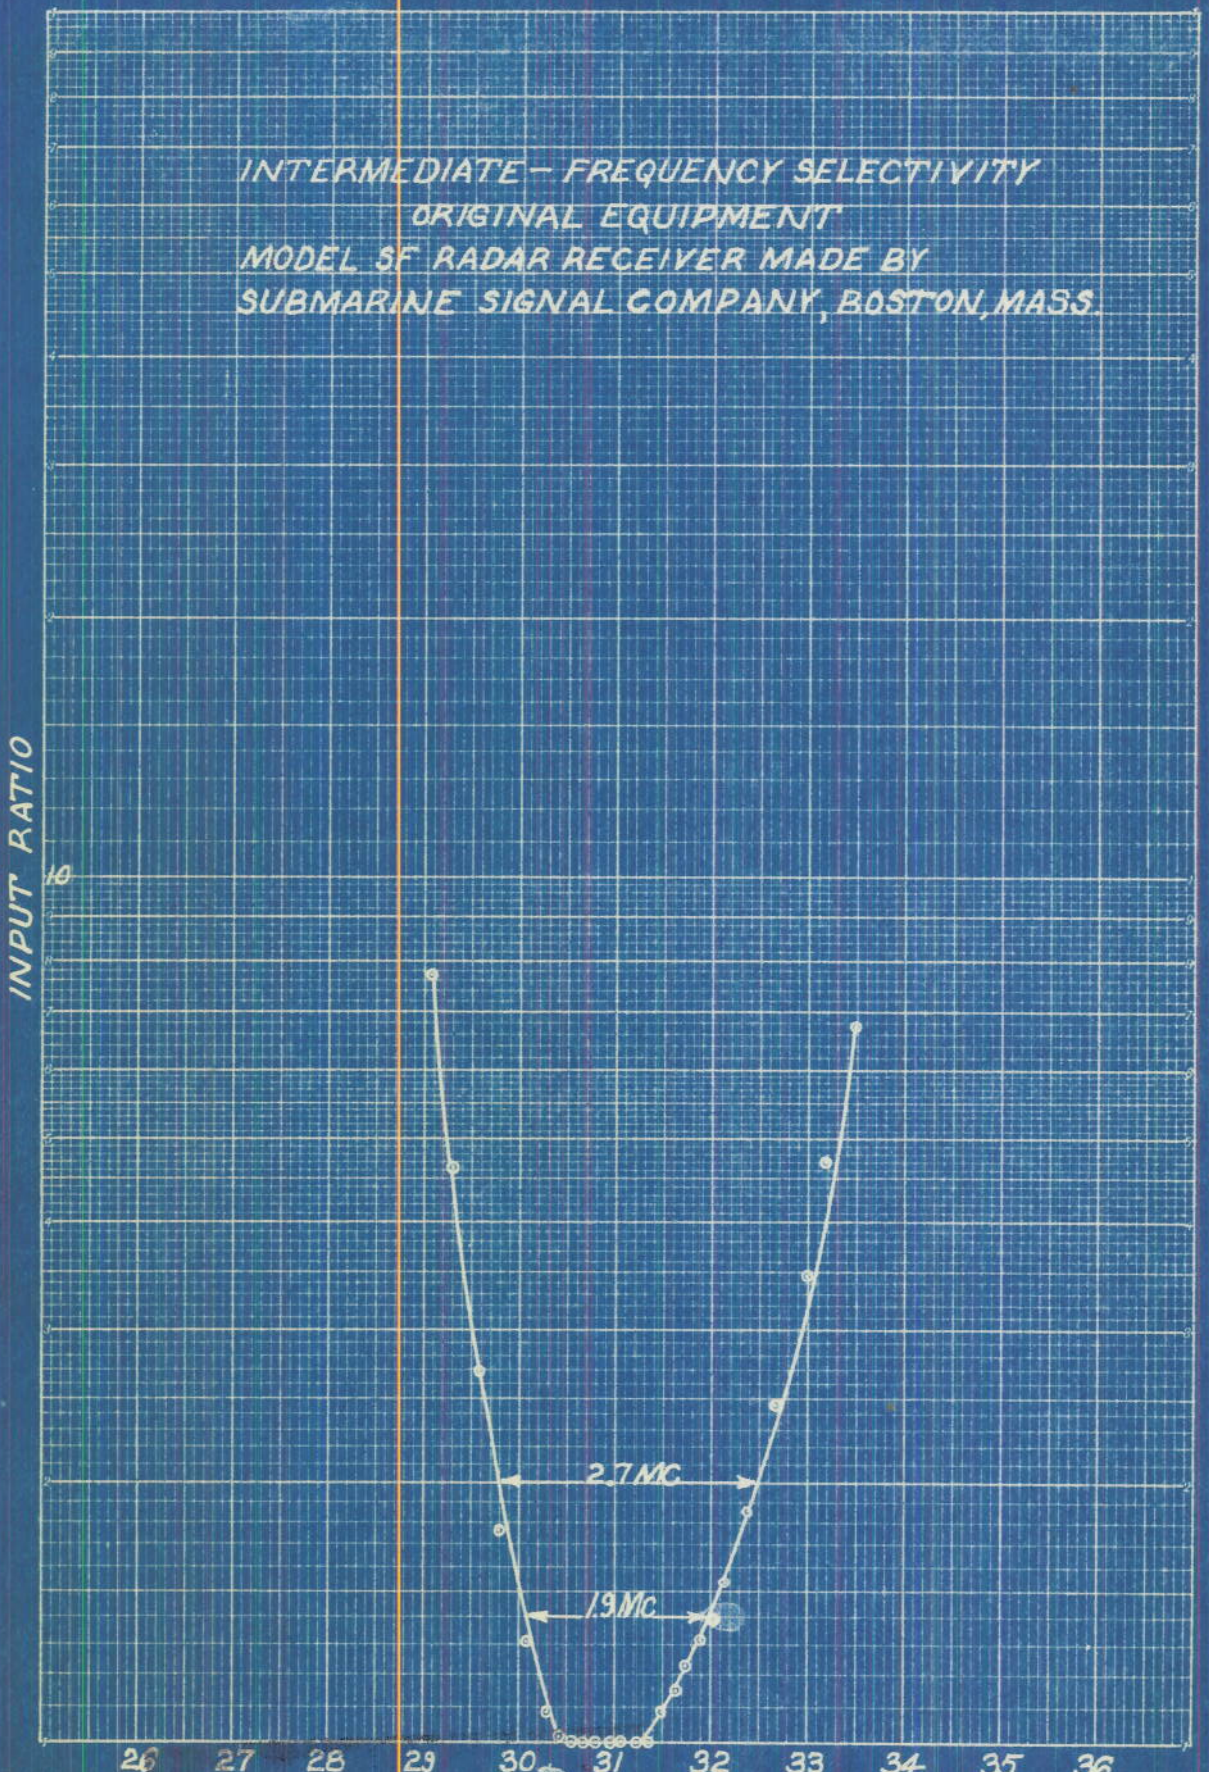
SEC. 3 PLATE 1

3-19-2. The bandwidth at 3.0 decibels down from maximum is 1.9 megacycles and 2.7 megacycles at 6.0 decibels. See plate 1.

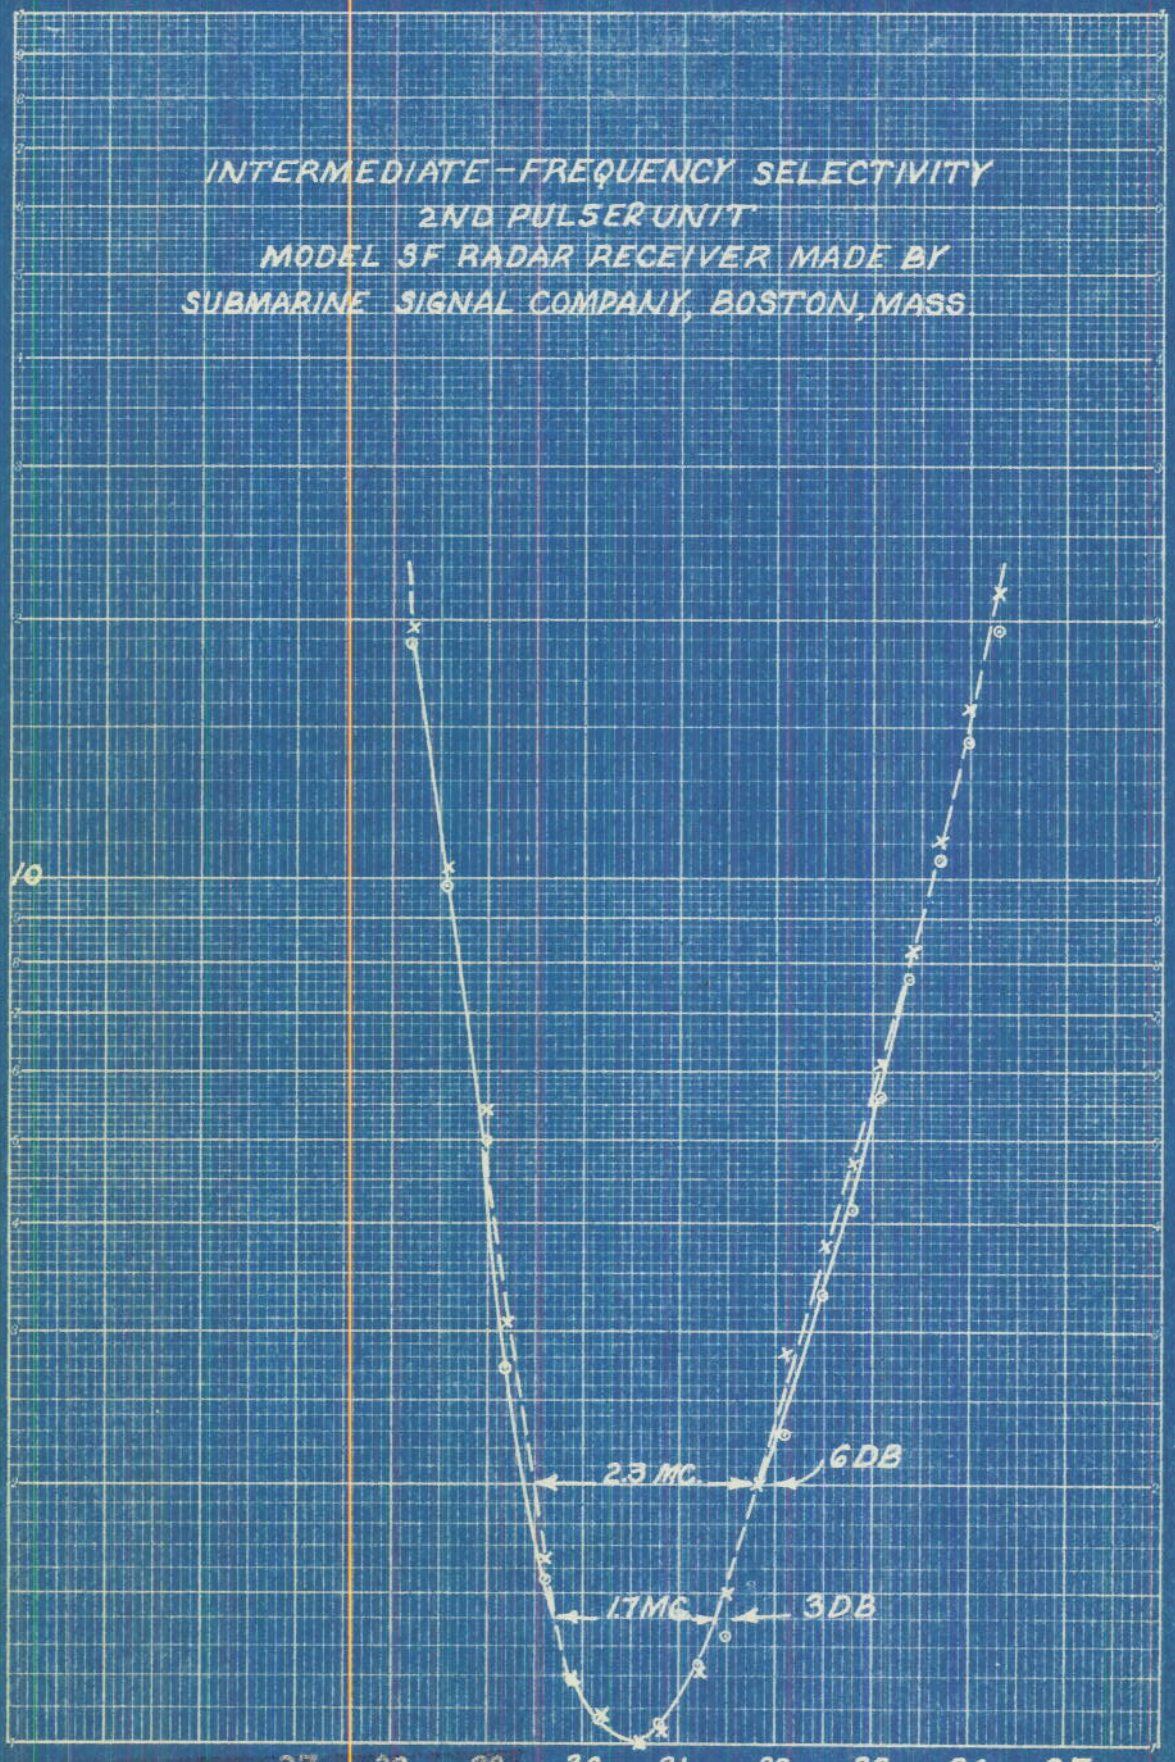
SEC. 3 PLATE 2

3-19-2(a) The bandwidth of the receiver using the mixer and i-f stages of the second pulser unit was 1.7 megacycles at 3.0 decibels down from maximum and 2.3 megacycles at 6 decibels. See plate 2. However, this unit appeared to be somewhat unstable in that, at times two peaks were apparent in the selectivity curve and the bandwidth increased to 2.4 megacycles at 3.0 decibels down from maximum. The cause of this intermittent action was not ascertained.

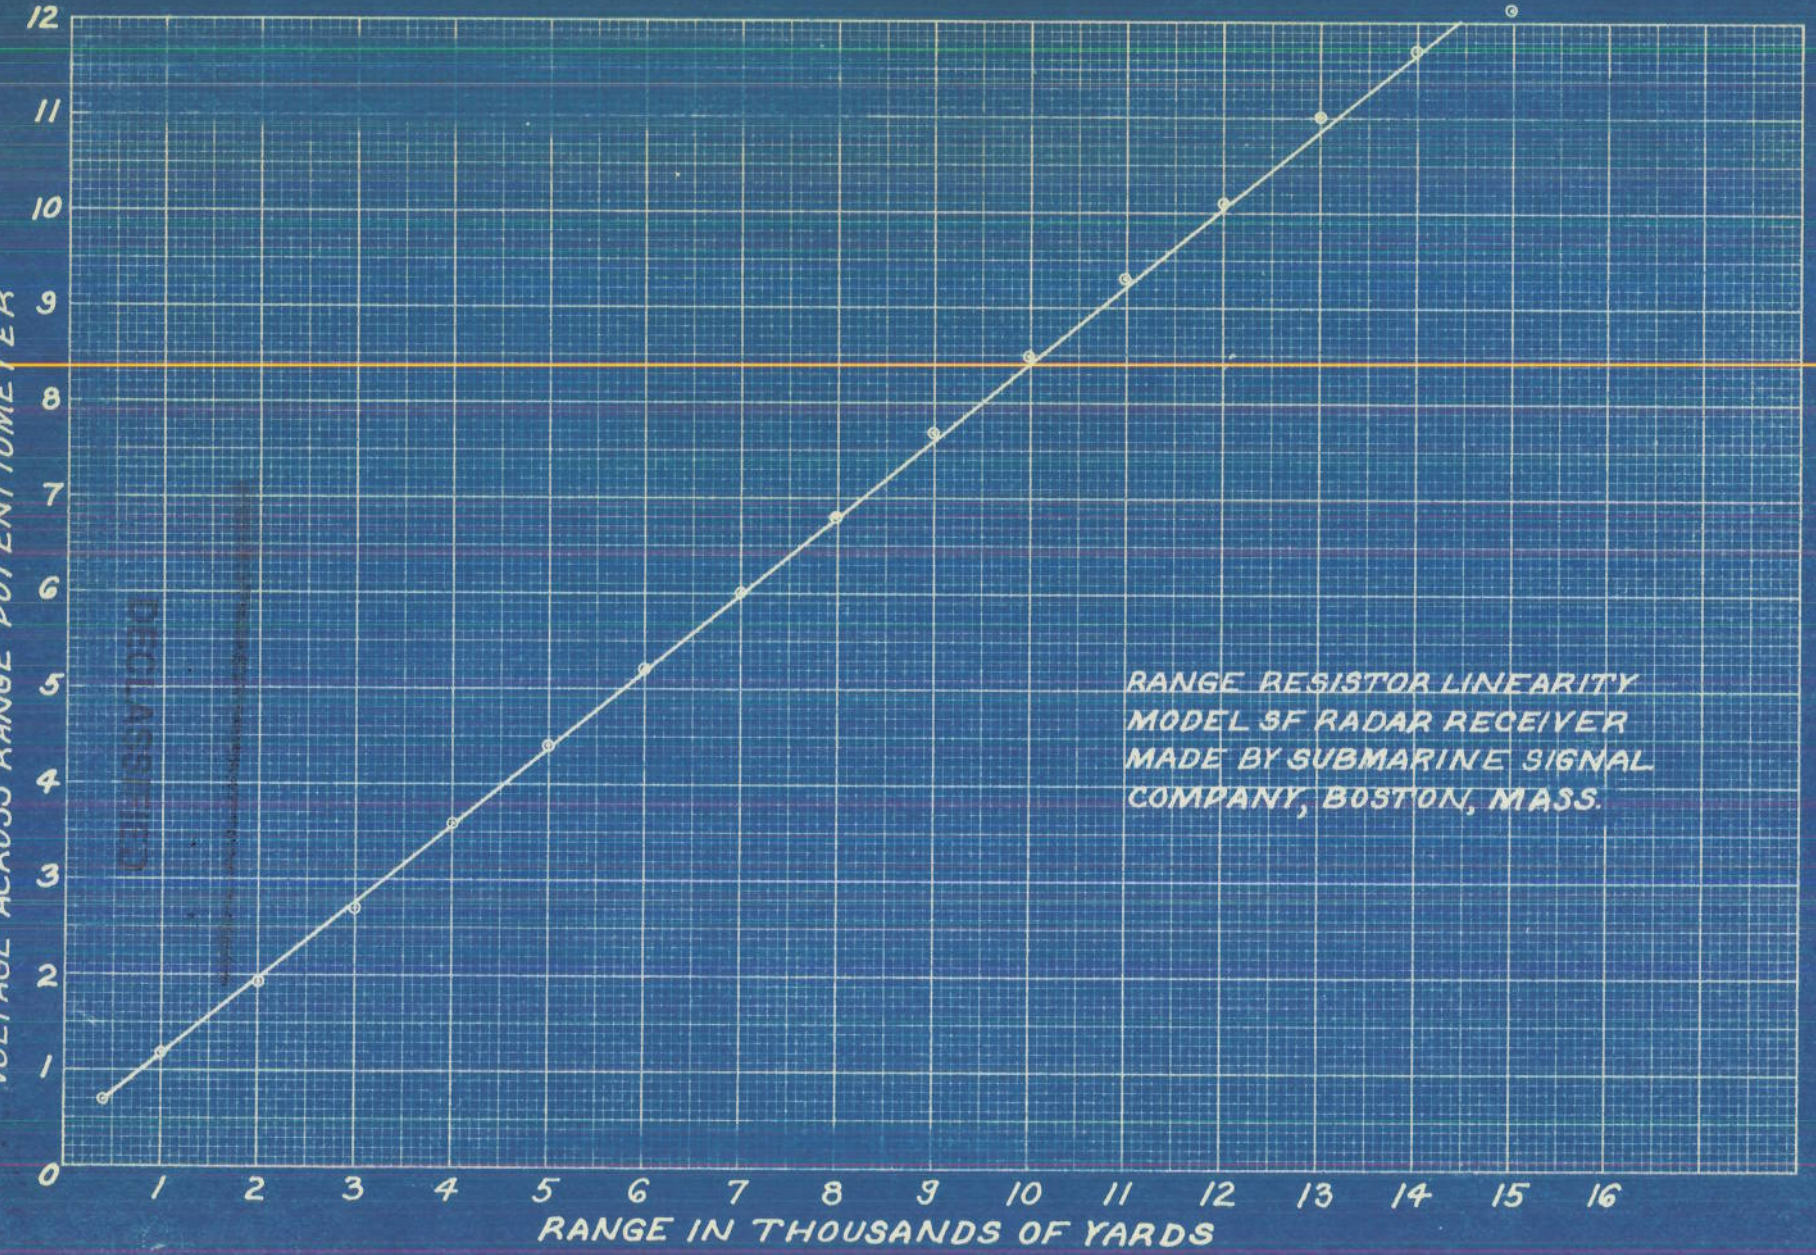
SEC. 3 PLATE 4

The range potentiometer linearity was determined by measuring the voltage above ground at the range resistor as a function of indicated range. The graphical results obtained indicate that this control is linear within probable operational error. See plate 4.

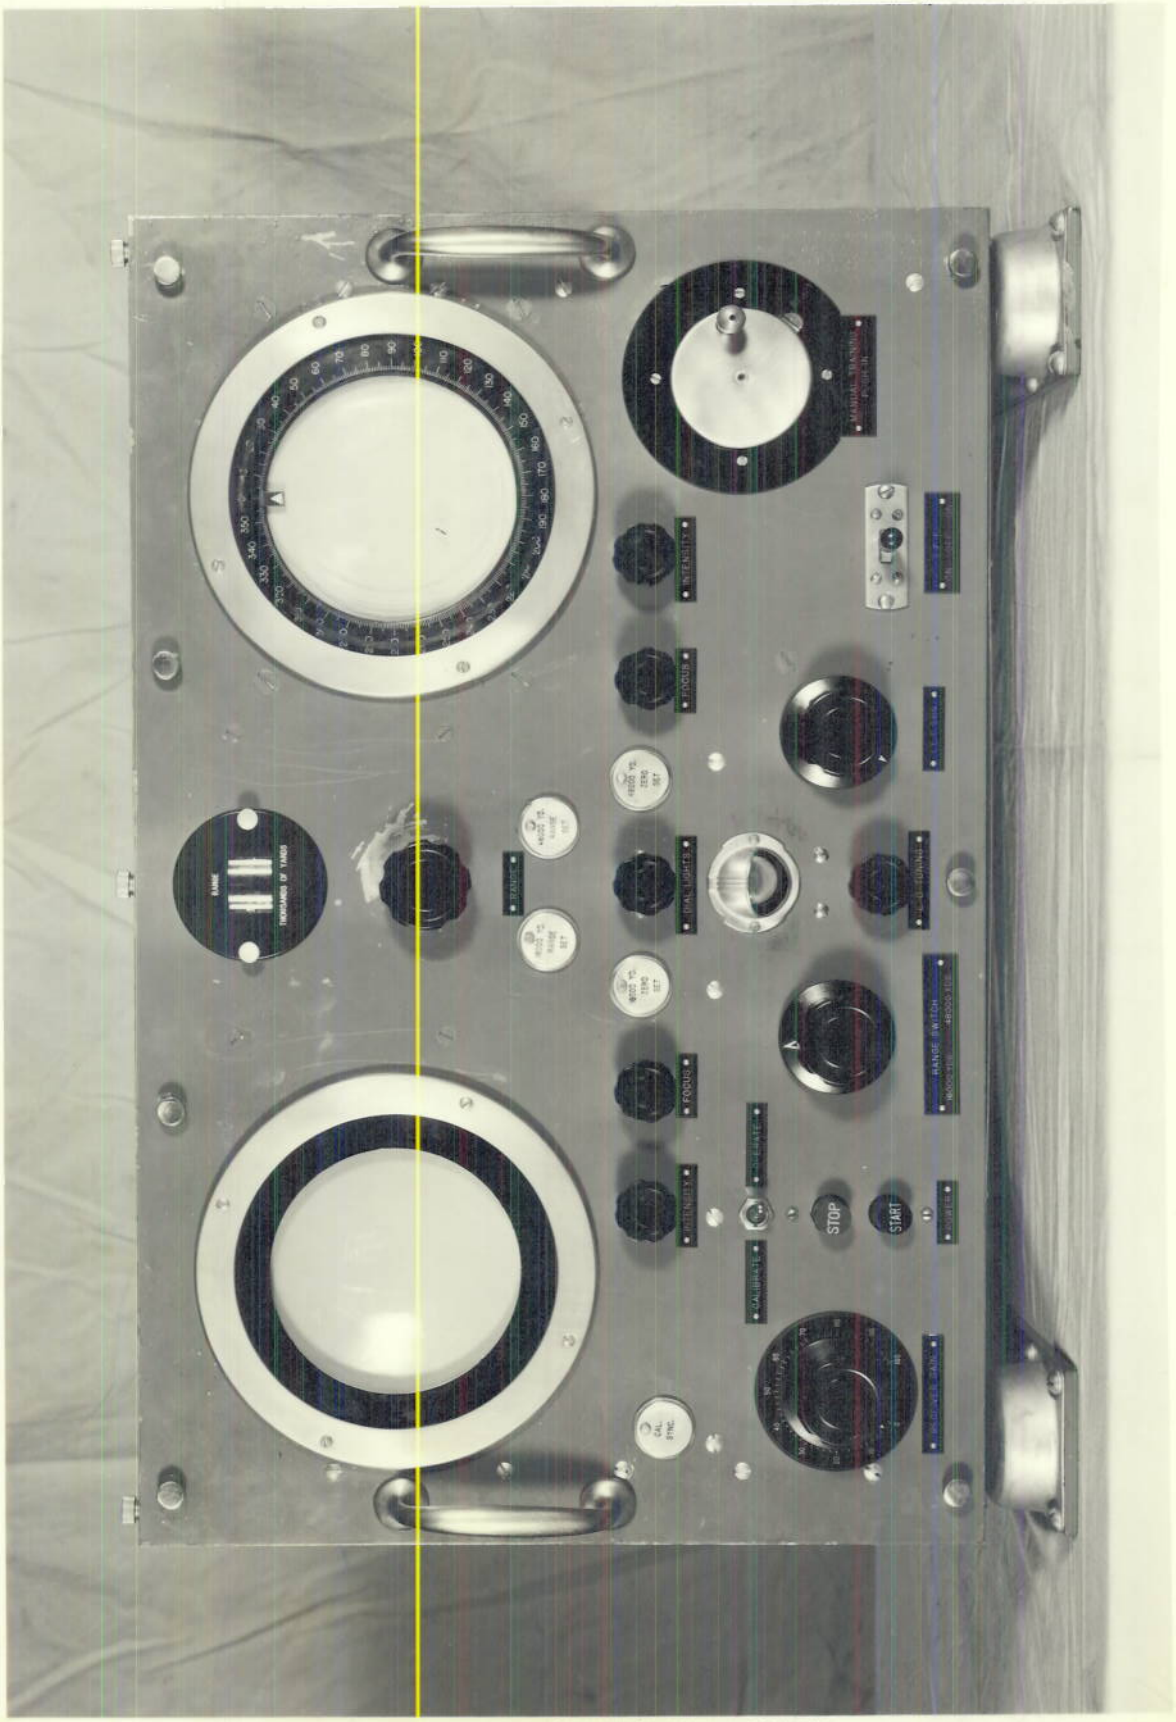
PLATE 101 SEC. 3

The paint finish of this equipment appears to have a primer coating of zinc chromate or similar substance. However, there has been considerable wear and chipping of paint on the receiver-indicator. The paint and rear plating of the front panel developed a large number of blisters. See plates 101, 102 and 104.

3-8-16. The range-switch indicating knob should be attached to its shaft in such a manner that its pointer indicates directly the range scale in use. See plate 101.

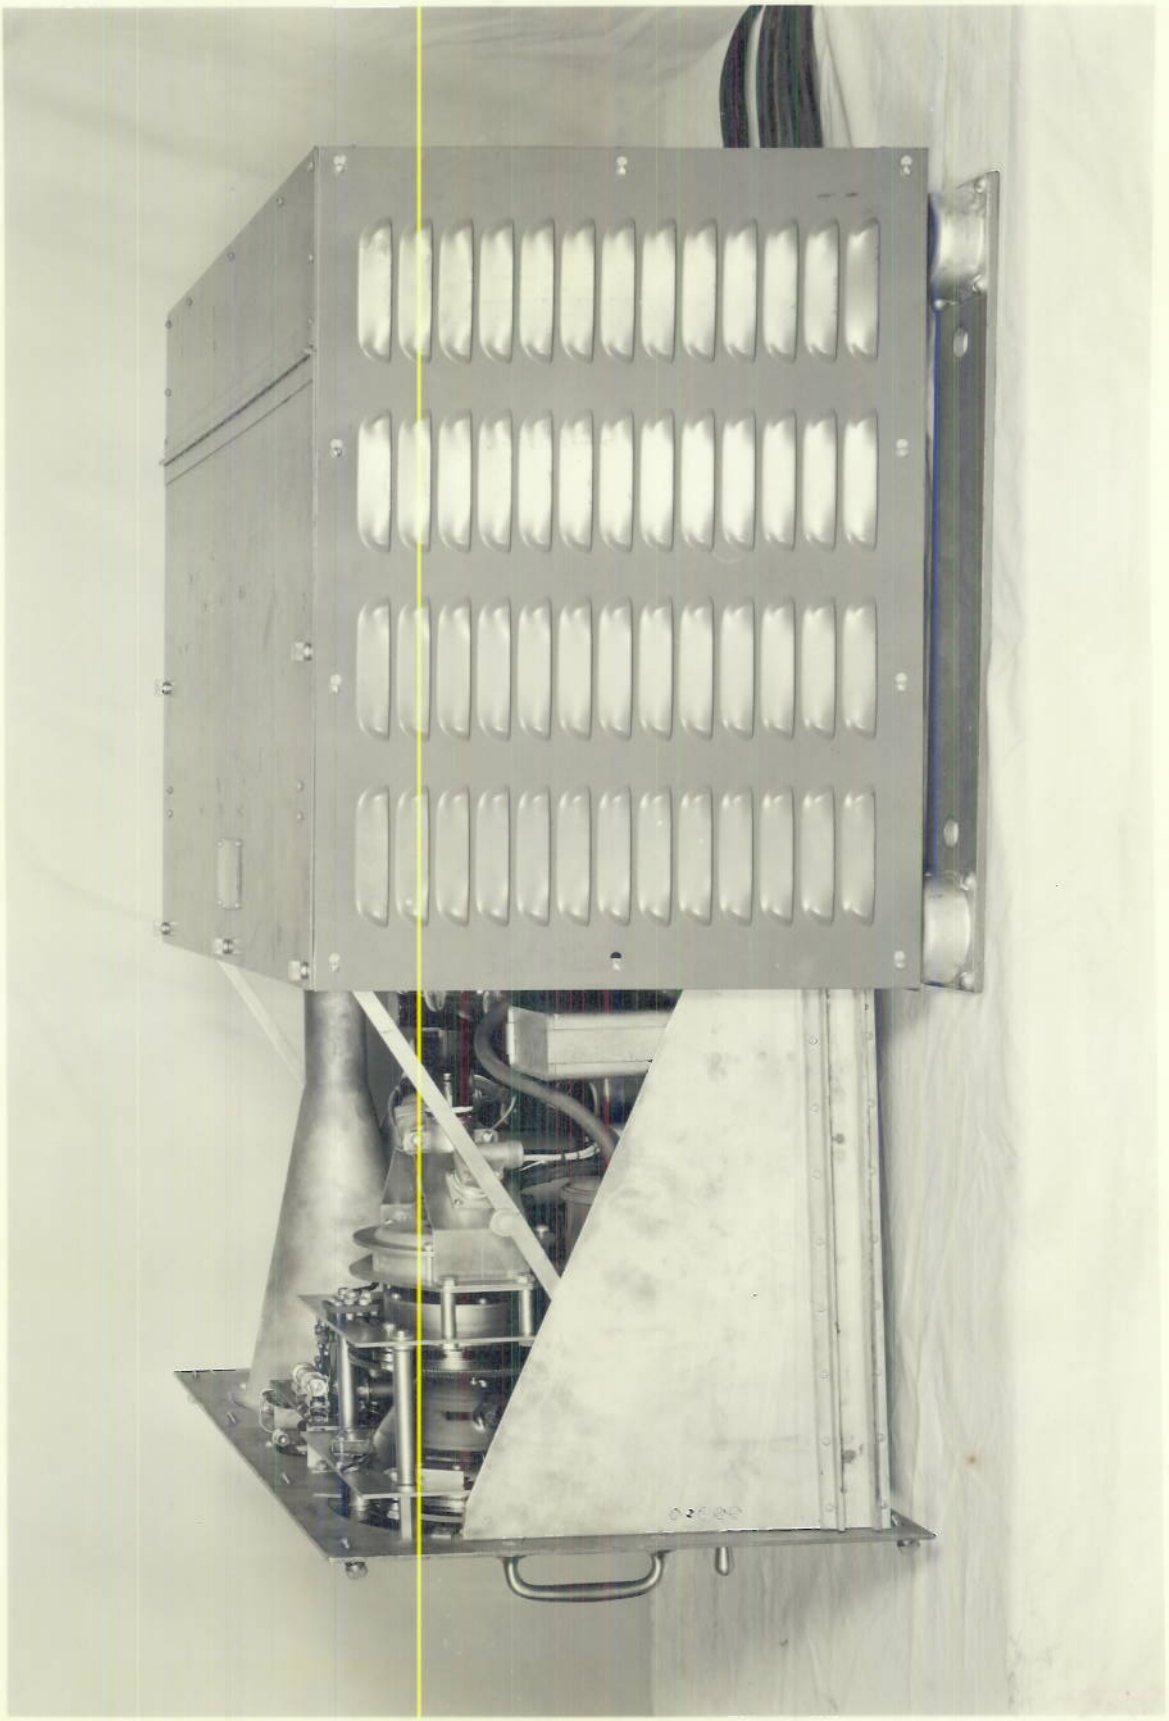
PLATE 103 SEC. 3

The construction of the frame, cabinet and chassis of the receiver-indicator is sturdy. However, the chassis locks of the present equipment will not permit the removal of the chassis by more than four inches. It is necessary to remove a vacuum tube and to spring aside one of the locking arms before the chassis can be pulled out. In this position it is extended three quarters of its total length. However, the i-f sub-chassis and a number of components remain inaccessible. See plate 103.

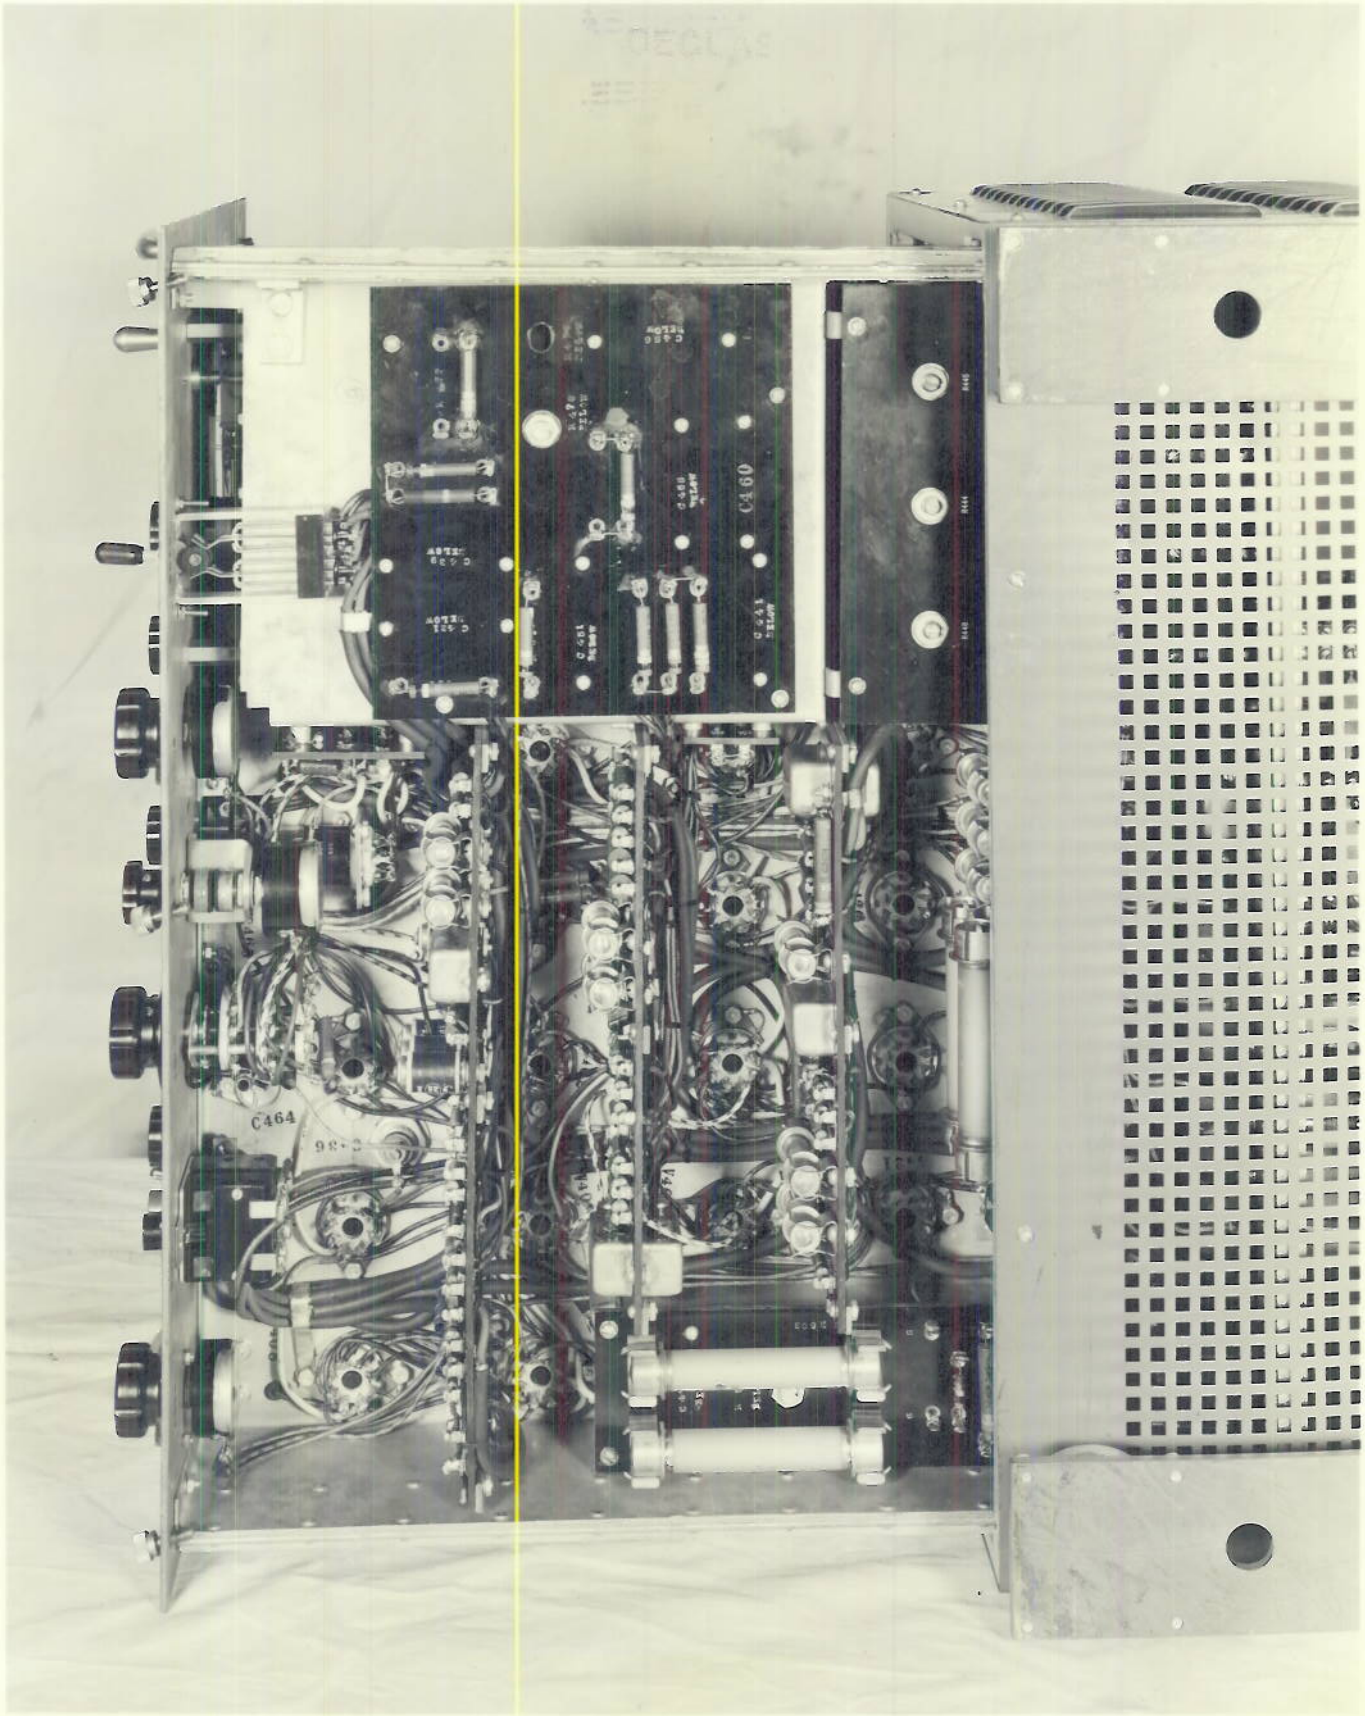
PLATE 106 SEC. 3

3-6-3. Tube and parts designations stamped on the under side of the chassis are generally obscured by the wiring. See plates 106 and 107.

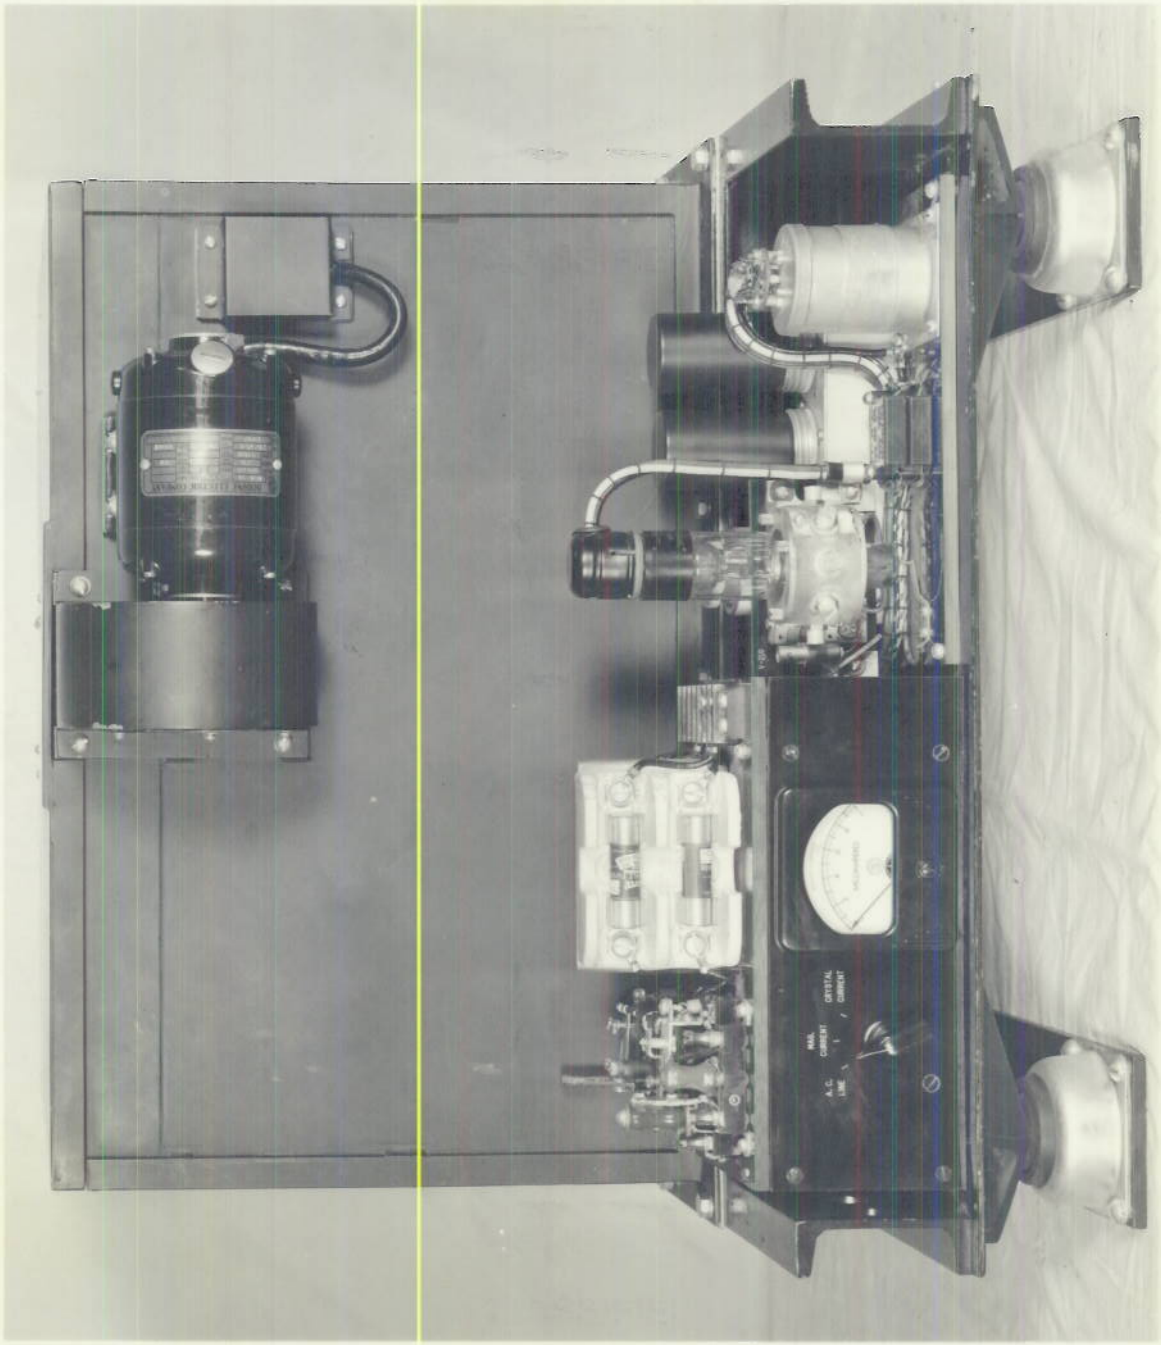
PLATE 109 SEC. 3

3-11-1. The single meter supplied with this equipment is mounted on the pulser unit. See plates 109 and 111. This instrument, upon the manipulation of the meter switch can be made to read the crystal current of the mixer, the magnetron current, or the a-c voltage supplied to the equipment.
