NRL Report No. R-2225
BuShips Prob. S347 T-C
(X-108C)

Report on
TESTS OF MODEL SC-2 RADAR EQUIPMENT

Contractor:
General Electric Company

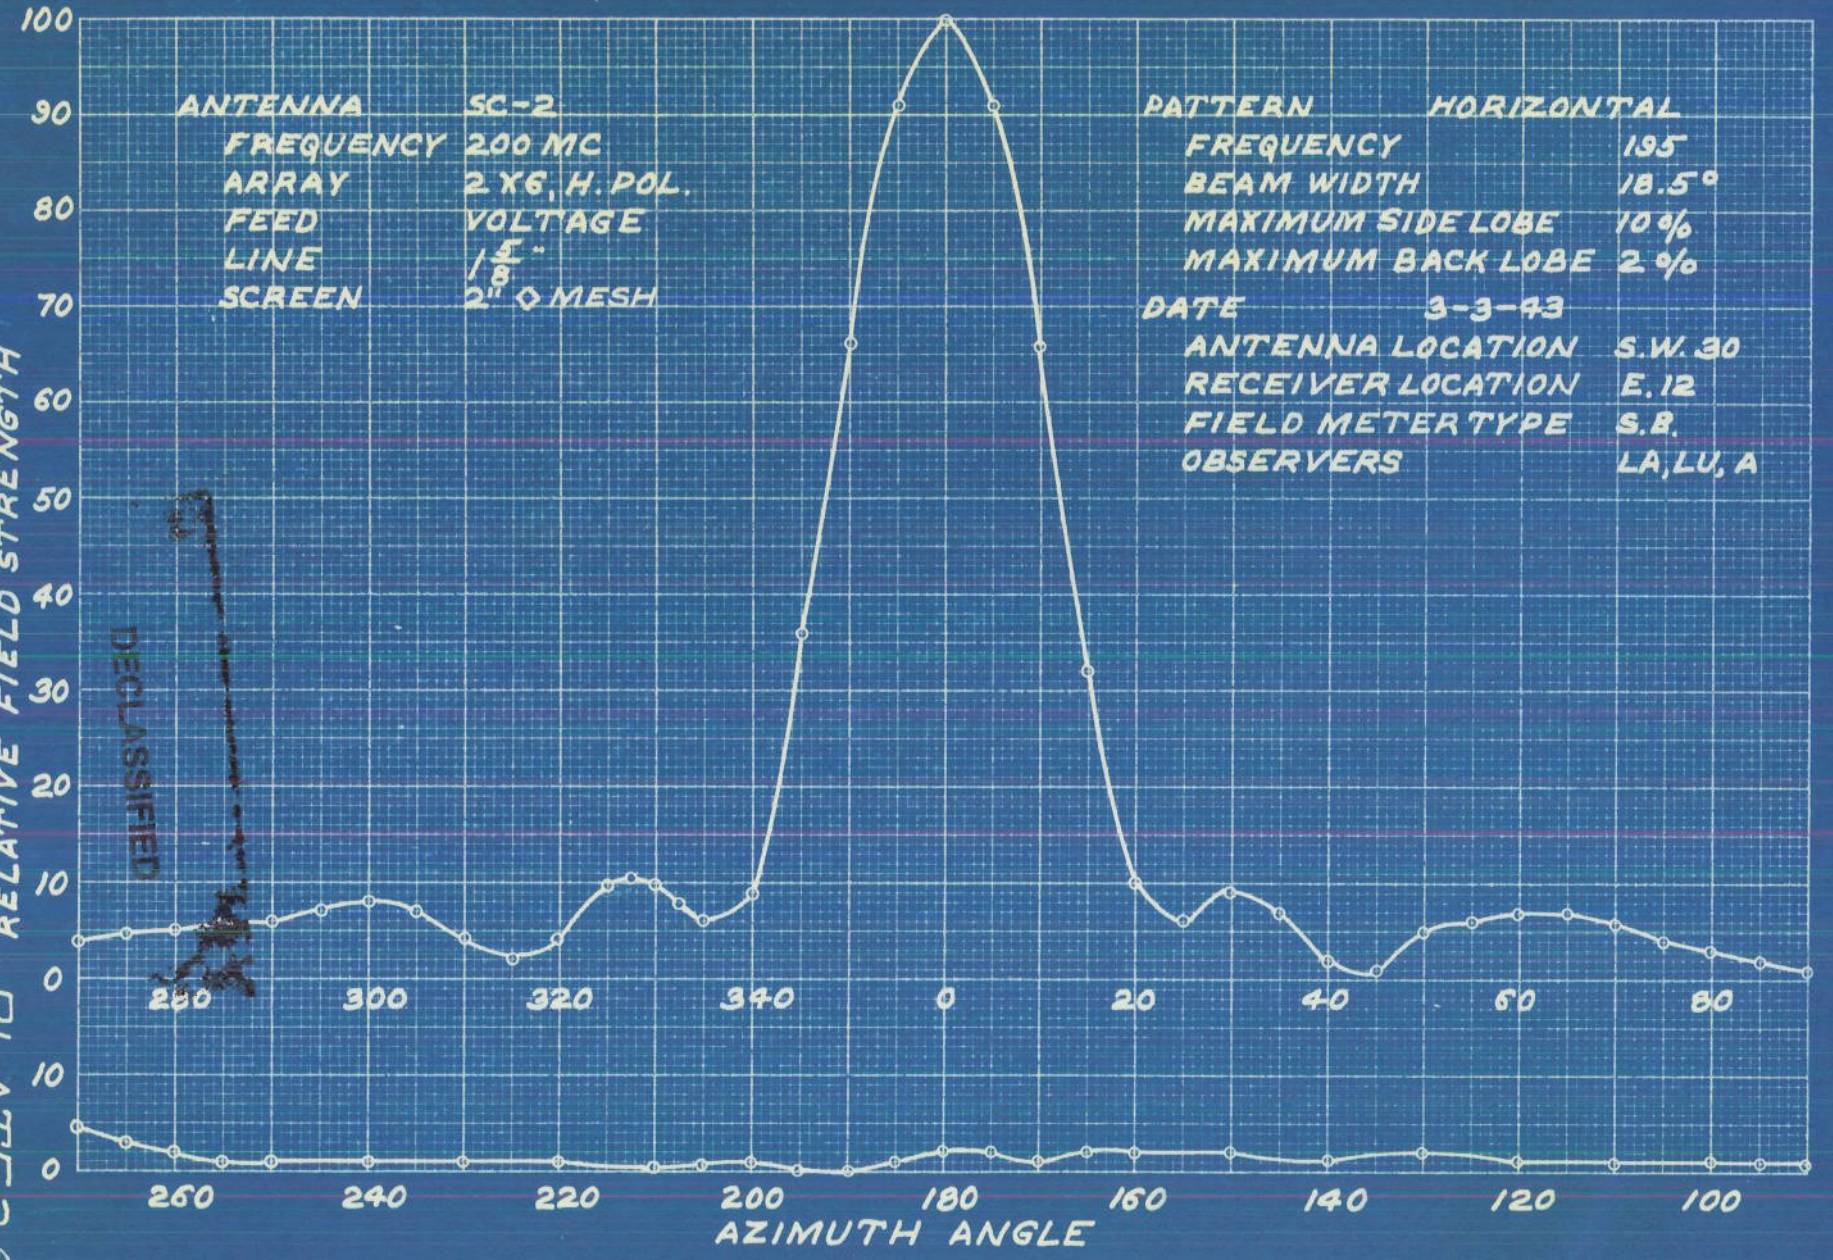
PLATE 3.SEC.1

1-17-2. ELECTRICAL TESTS OF SC-2 ANTENNA. Plates 3, 4, and 5 of Section I are radiation patterns obtained with a slide back type field strength meter at a distance of 120 feet and at frequencies representing the two ends and center of the yellow band. The beam width at half power is 18.5° at 195 mc., 17° at 200 mc., and 16° at 205 mc. Side lobes were observed 30° and 60° on either side of the main beam, with relative field strengths averaging 11 and 8 per cent respectively. Back radiation did not exceed 3 per cent at any of these frequencies. The pattern is considered quite satisfactory for an array of this type. Plate 6 of Section 1 represents the variation of standing wave ratio (i.e., E_{min}/E_{max}) with frequency. It is better than 50% from 195 to 205.5 mc., which is an acceptable band width. This particular antenna is aligned for 203 mc., where the standing wave ratio is 87%. It is interesting to note that it could also be used in the red band, since it matches the line sufficiently well in the region 173 to 190 mc.

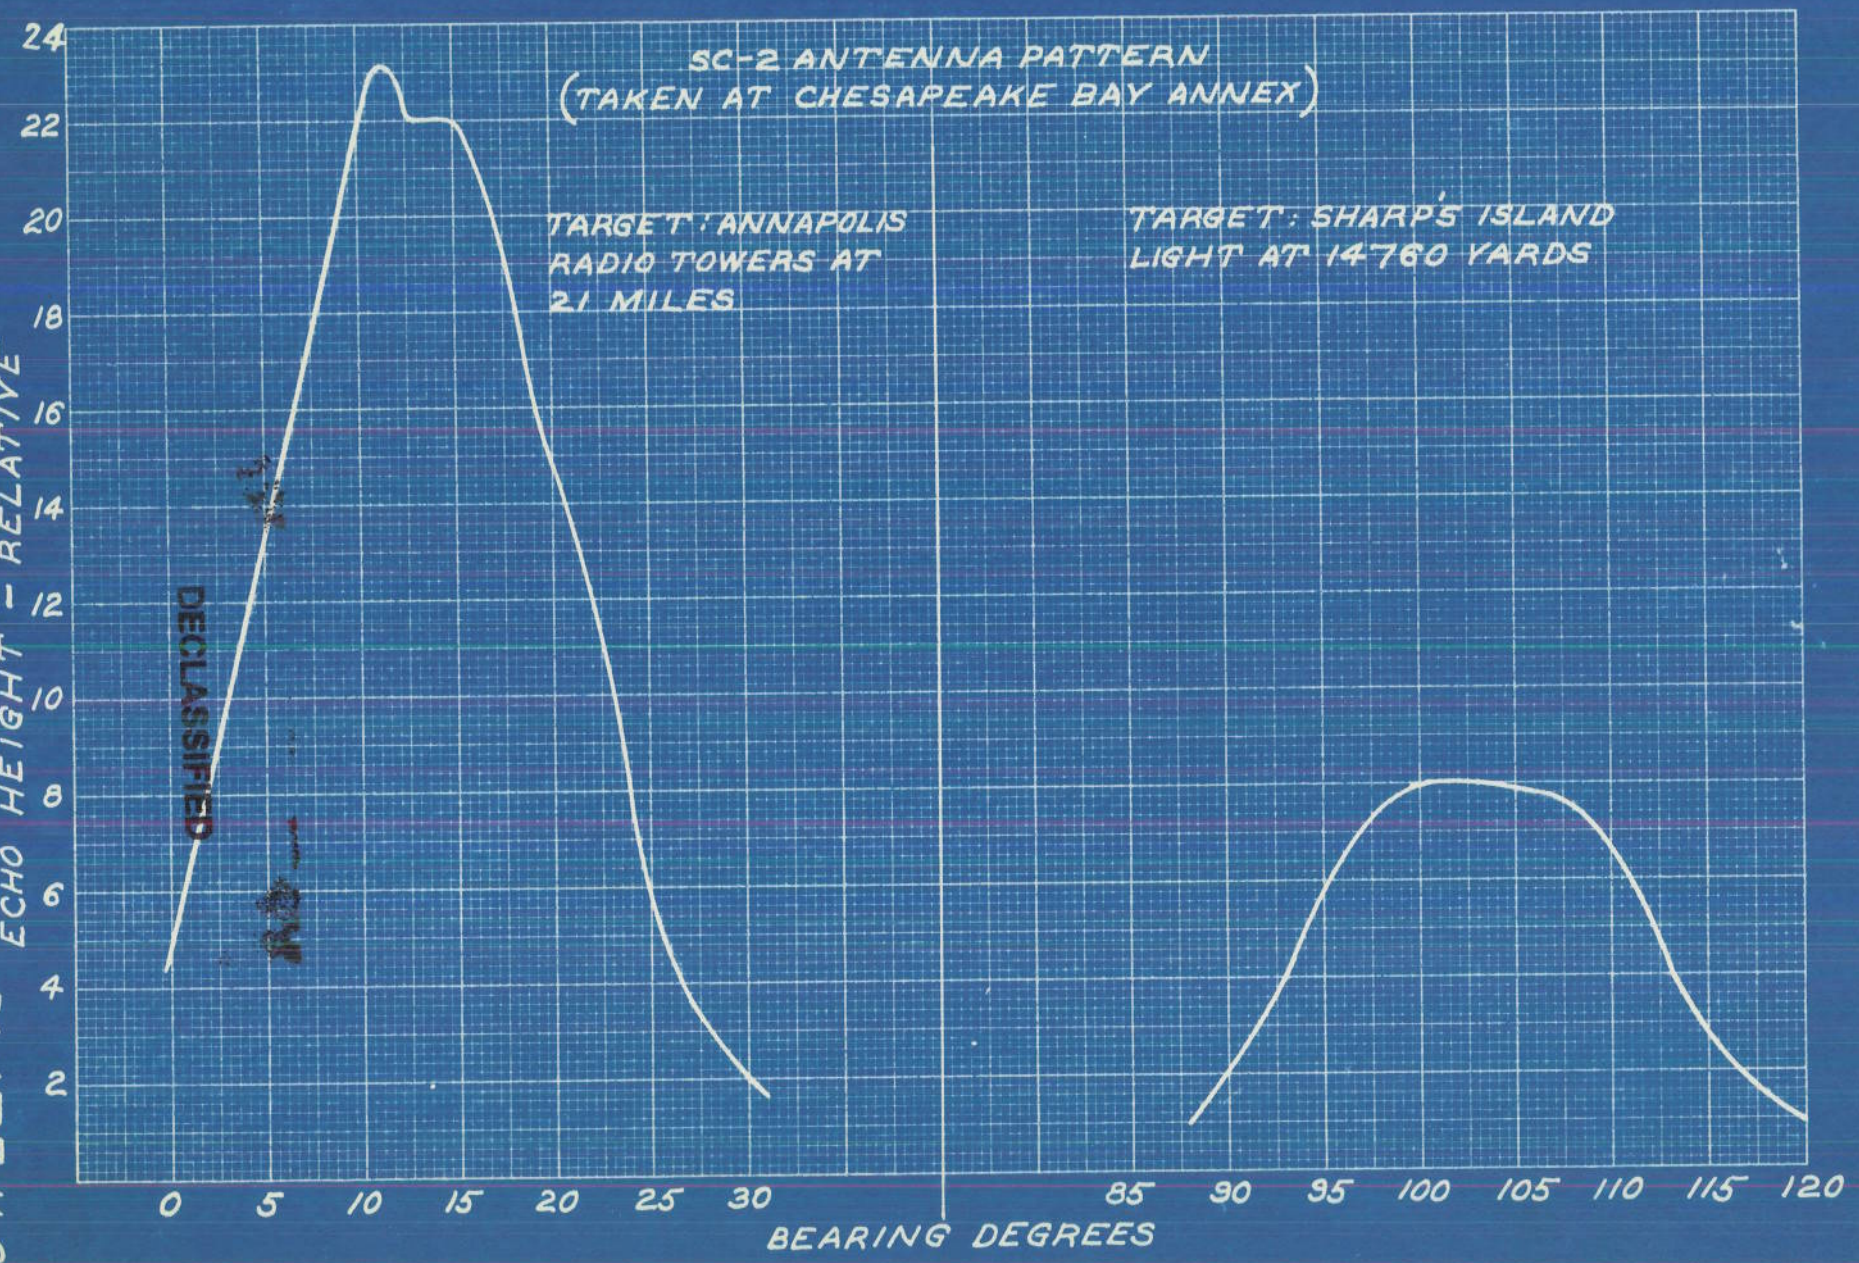
1-17-5. ROUGH ANTENNA PATTERN. During the operational tests, rough antenna patterns were made with the Annapolis Radio Towers and with Sharps Island Light as the targets. Plate 11 of Section I shows the curves which were obtained when relative echo heights were plotted against bearing readings. At the half-maximum points the beam-width was 18.5° for the Annapolis Towers and 20° for Sharps Island Light. As noted in paragraph 1-8, a plane flying at 1,000 feet altitude was followed in to 6,200 yards. This corresponds to an elevation angle of 32°.

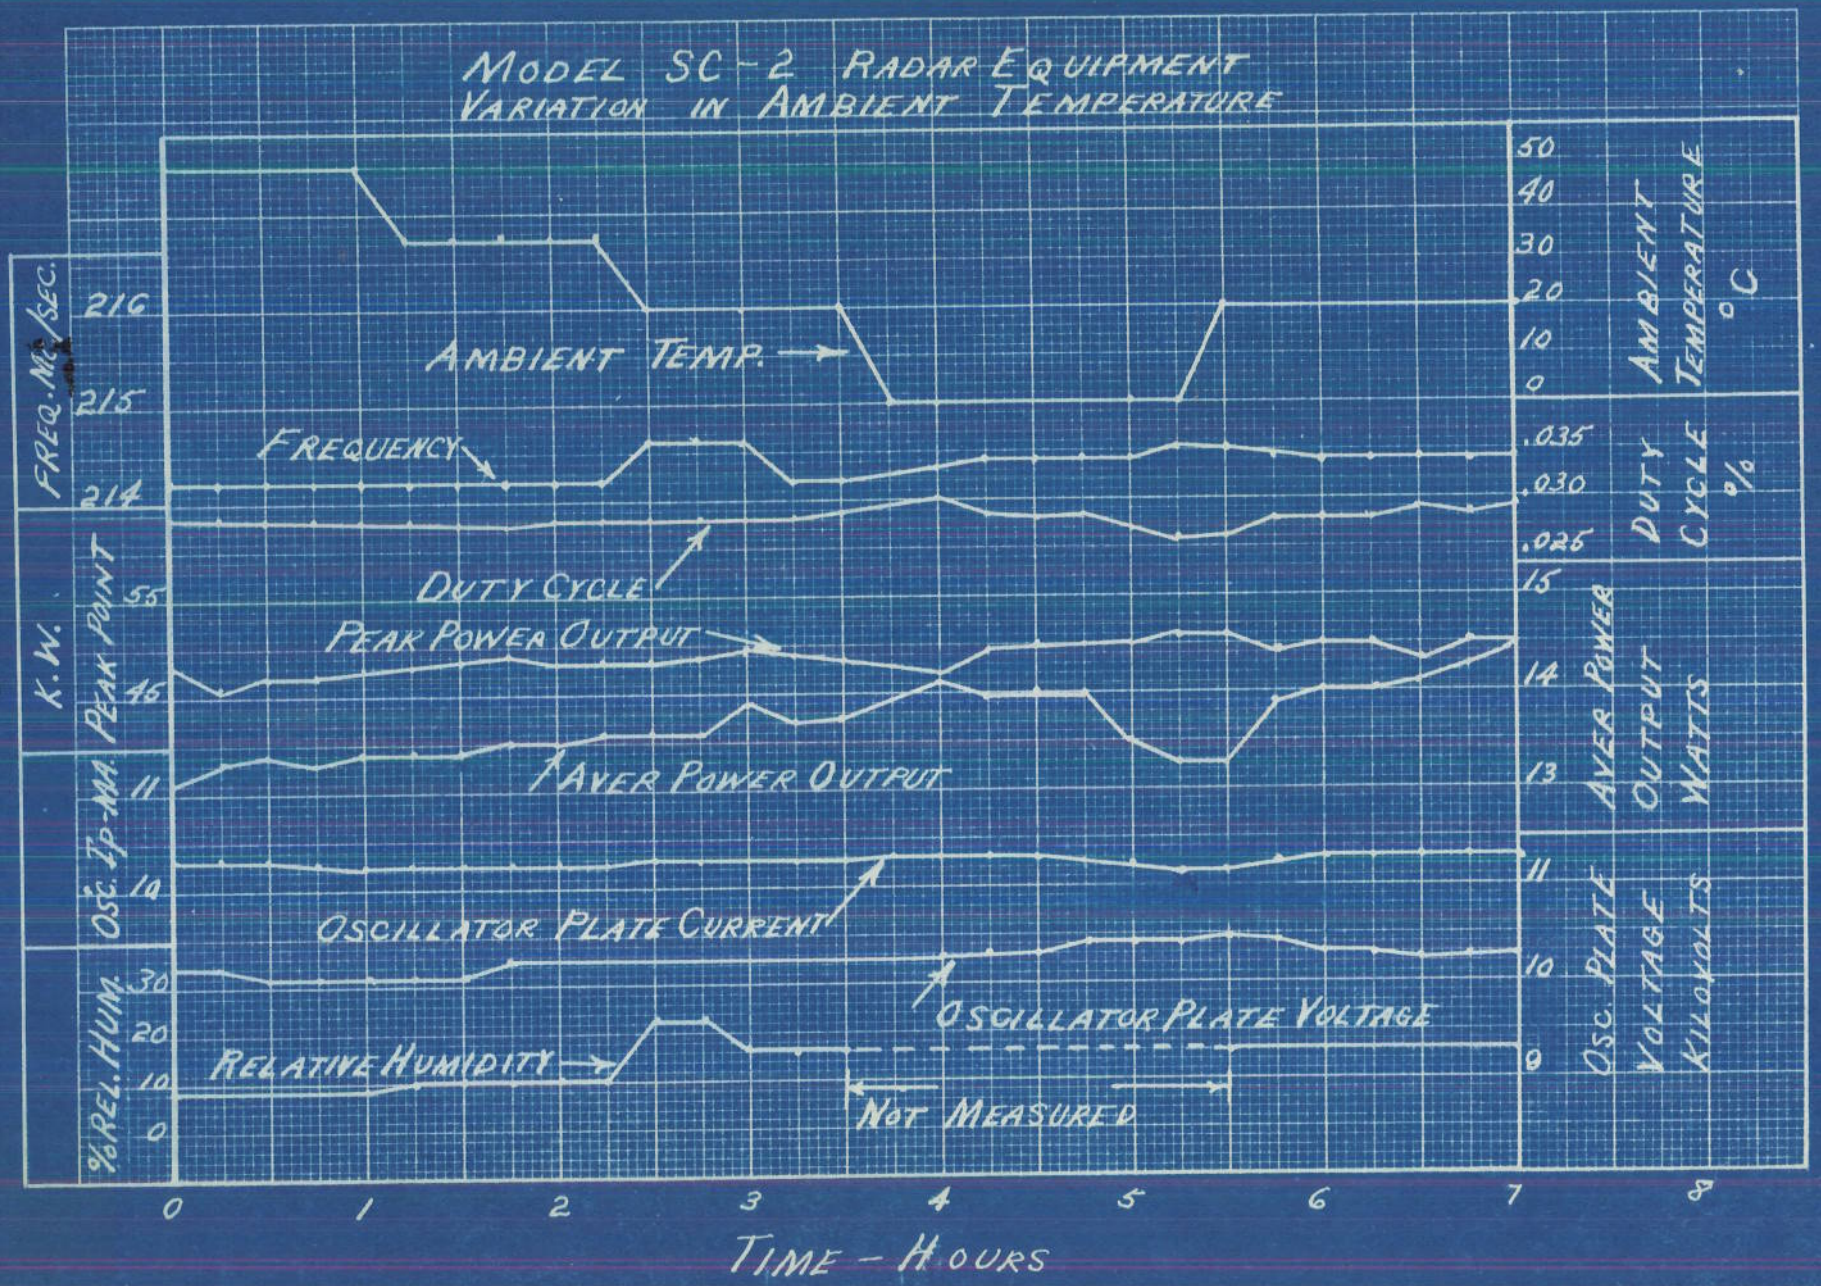
PLATE 1 - SEC. 2

2-2-1. Variation in Ambient Temperature. With the equipment in operation, the ambient temperature was increased to 50°C. This value was maintained for one hour after which the ambient temperature was reduced first to 35°C, then to 20°C and finally to 0°C. Each of these temperatures was maintained for approximately one hour. The data recorded are listed in Table 1 and are presented graphically in Plate 1. The results of the test were as follows:

(a) The frequency of the emitted power varied between the limits 214.2 and 214.6 megacycles during this test. No correlation was obtained between the changes which were made in the ambient temperature and the observed changes in frequency.

changes noted in power output and the changes which were made in ambient temperature. The change in power is not considered excessive.

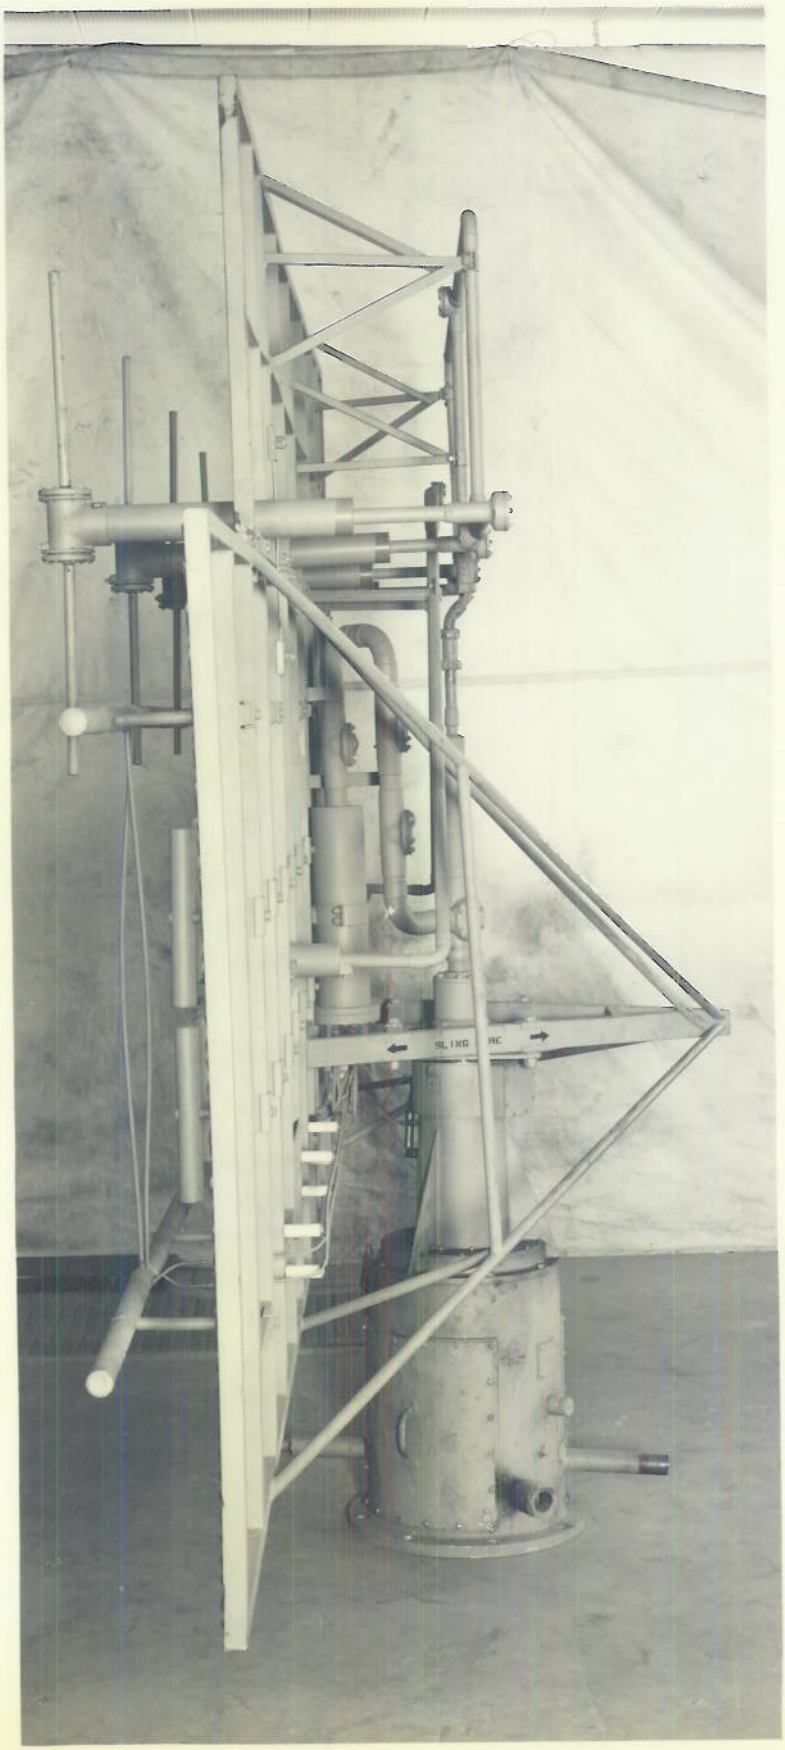
PLATE 19 SEC. 2

The frame at point A on Plates 18 and 21;
The clamp bolt at point B on Plates 19 and 22;
The weld between two struts at point C on Plates 19 and 23;
The weld securing one of the feeder lines to the end of a radiator as shown at point D on Plates 18 and 24;

The outer conductor of the main concentric line at the point at which it connects to the rotating joint as shown at E on Plates 19 and 25;

The threads on the studs at the bottom of one of the matching sections. These threads became stripped. The loss of the threads caused the sleeves which thread on these studs to loosen at F on Plates 19 and 26.
