NRL/6130/FR--2023/2

Isocyanate-Free and Low-VOC Polysiloxane Topcoats for Aircraft and Support Equipment

ERICK B. IEZZI

September 25, 2023

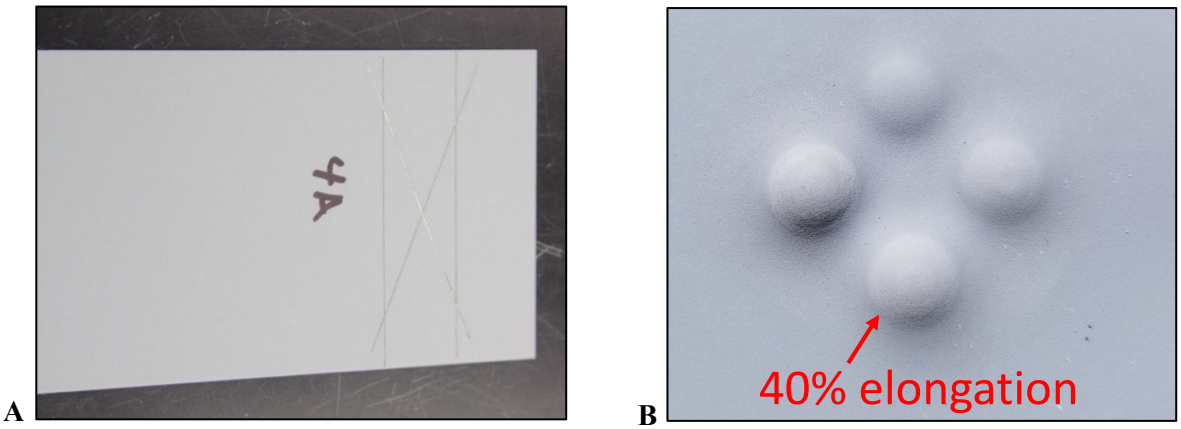
As shown in Table 18, the 1K camouflage gray polysiloxane aircraft topcoat from NCP Coatings met the standard performance requirements for a Navy aircraft topcoat and performed similarly to the qualified 2K camouflage gray polyurethane control. Wet tape adhesion and GE Impact results are shown in Fig. 26A and Fig. 26B, respectively. The 1K polysiloxane met the weatherability requirement for a MIL-PRF-85285, Type IV aircraft topcoat, which is a color change of <1.0 after 3,000 hours of xenon-arc WOM exposure. It is worth restating that the 1K polysiloxane topcoat is isocyanate-free and has a VOC content of <290 g/l, which is ~130 g/l less than a Type IV-qualified 2K camouflage gray polyurethane topcoat.

Fig. 26—A) Wet tape adhesion and B) GE Impact results for 1K camouflage gray polysiloxane topcoat

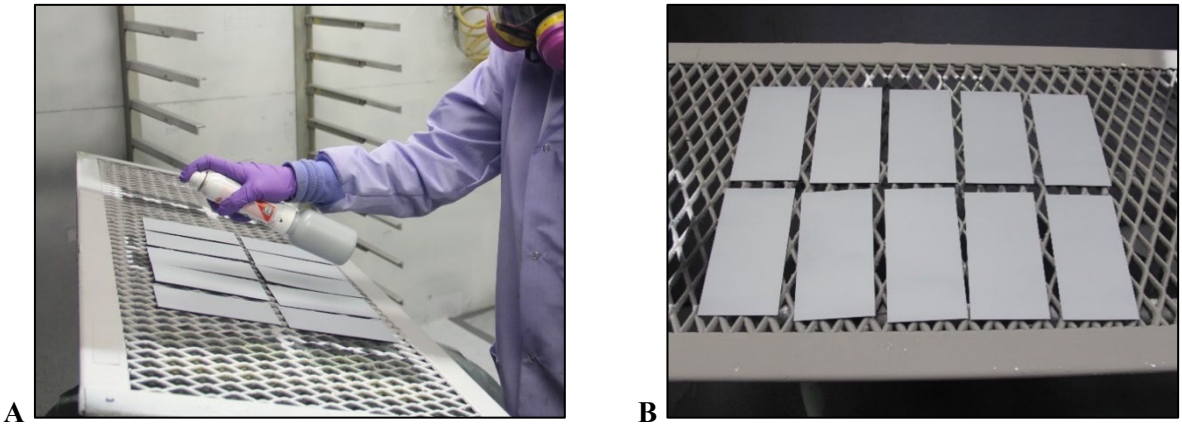
Fig. 27—1K camouflage gray polysiloxane touch-up topcoat: A) application with Preval® spray gun and B) appearance after applied and cured

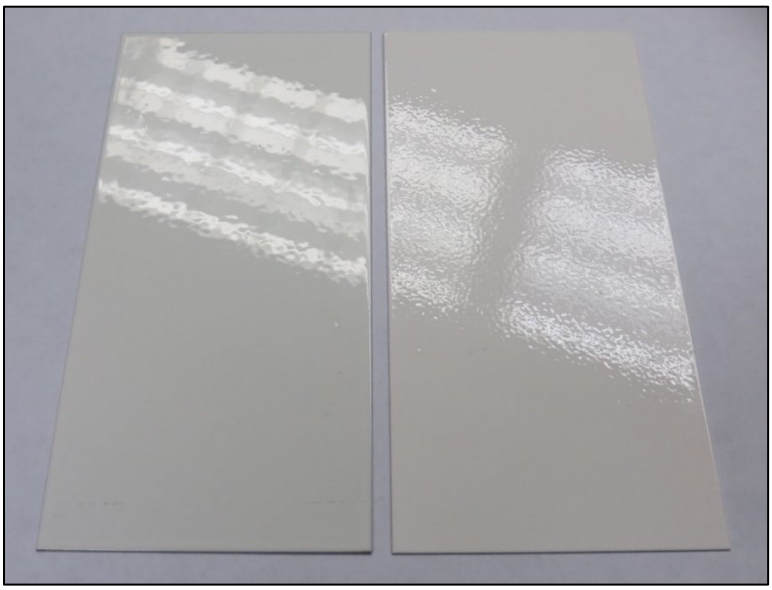
The 2K gloss white polysiloxane topcoat, color matched to #17925 white, was provided to NAWC-AD in gallon kits for testing to standard and extended performance requirements. The topcoat was tested for viscosity and pot life as received, then was applied using HVLP spray equipment to generate stack-ups consisting of a MIL-DTL-53022, Type IV epoxy primer and a MIL-DTL-81706, Type I, Class 1A pretreatment over bare 3-in x 6-in x 0.020-in AA 2024-T3 substrate as shown in Table 12. Topcoat samples for flexibility testing were spray-applied over 3-in x 6-in x 0.020-in chromic acid-anodized AA 2024-0 panels as discussed in Section 5.2.1. A MIL-PRF-85285, Type II-qualified 2K gloss white (#17925) polyurethane topcoat with a VOC content of 336 g/l was applied over the same primer, pretreatment, and AA 2024-0 panels for use as a control. The 2K polysiloxane topcoat has a VOC content of 65 g/l, which is 271 g/l less than the Type II polyurethane topcoat. After curing for 14 days, the DFT of both topcoats was 1.7–2.3 mils (~43–58 microns). As shown in Fig. 28, the 2K gloss white polysiloxane topcoat possessed less orange peel and a glossier finish compared to the Type II polyurethane topcoat.

Fig. 28—(Left) 2K gloss white polysiloxane topcoat and (right) a MIL-PRF-85285, Type II-qualified gloss white polyurethane topcoat

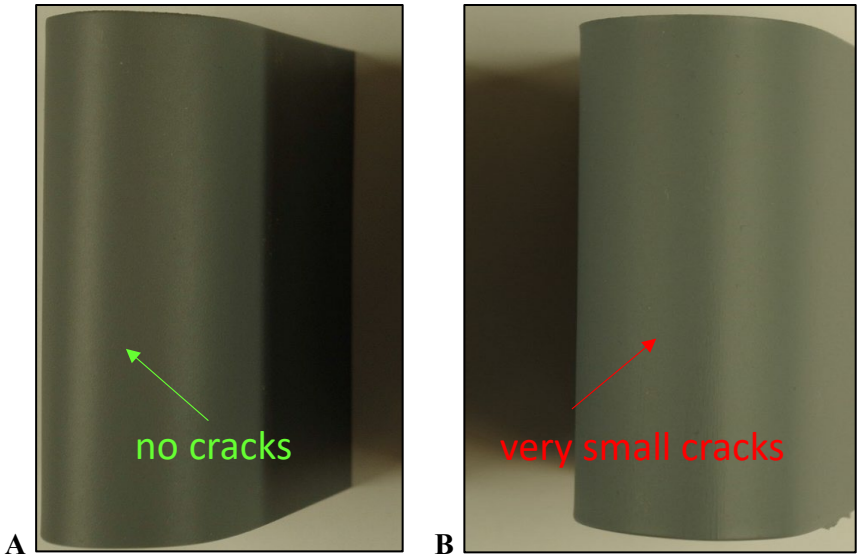
As shown by the results, neither the 1K camouflage gray polysiloxane topcoat system nor the Type IV-qualified 2K camouflage gray polyurethane topcoat system passed all performance requirements. For systems with the magnesium-rich epoxy primer, the 1K polysiloxane topcoat outperformed the 2K polyurethane topcoat. The 1K polysiloxane topcoat only failed the lubricating oil immersion, humidity resistance, cleanability, and Skydrol LD-4 resistance tests, whereas the polyurethane topcoat failed JP-8 and lubricating oil immersion, humidity resistance, cleanability, low-temperature flexibility, and impact resistance after 3,000 hours weatherability. A change in pencil hardness of greater than 2 was the reason the 1K polysiloxane topcoat system failed the lubrication oil immersion and humidity resistance tests, although it did not show blistering or delamination. The 1K polysiloxane topcoat system also demonstrated greater low-temperature flexibility and room temperature flexibility after weathering than the Type IV polyurethane topcoat system (Fig. 29), which is likely because the 1K polysiloxane topcoat bonds differently to the surface of the magnesium-rich primer, thereby enabling slightly greater flexibility.

Fig. 29—A) 1K camouflage gray polysiloxane topcoat over magnesium-rich primer and B) 2K camouflage gray polyurethane topcoat over magnesium-rich primer after low-temperature flexibility test

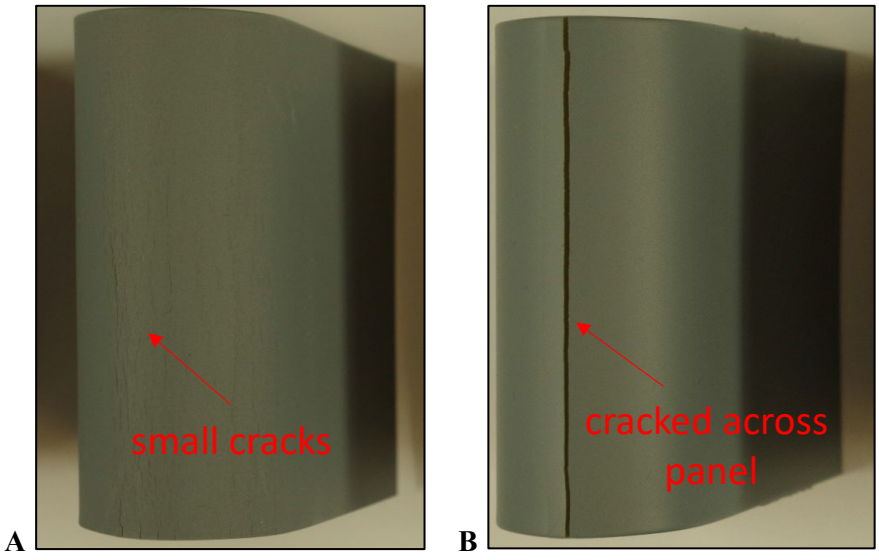
For systems with the chromate-containing epoxy primer, the 1K polysiloxane topcoat performed similarly to the 2K polyurethane control, as both systems failed the low-temperature flexibility, room temperature flexibility after weathering, humidity resistance, cleanability, and Skydrol LD-4 resistance tests. However, although 1K polysiloxane topcoat system failed the low-temperature flexibility test, it still outperformed the polyurethane control system, as the latter cracked the entire way across the panel after bending (Fig. 30).

Fig. 30—A) 1K camouflage gray polysiloxane topcoat over chromate-containing primer and B) 2K camouflage gray polyurethane topcoat over chromate-containing primer after low-temperature flexibility test

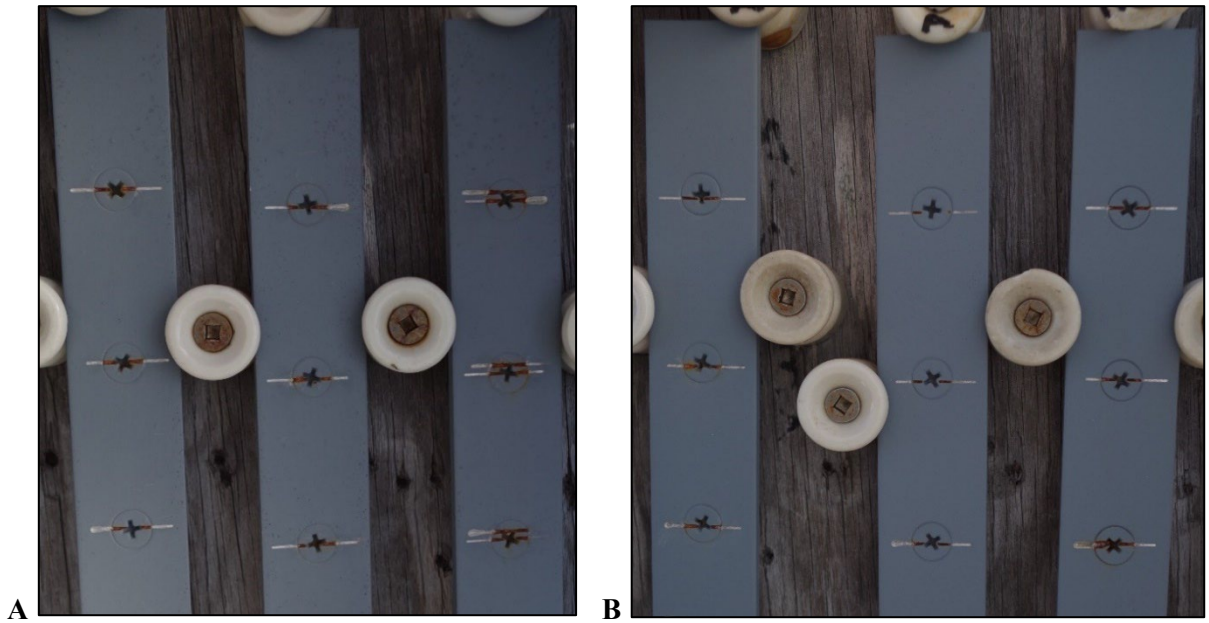
Fig. 31—12-month outdoor corrosion performance for A) 1K camouflage gray polysiloxane topcoat over magnesium-rich primer and B) 2K camouflage gray polyurethane topcoat over magnesium-rich primer. Both sample sets possessed cadmium-plated steel fasteners and AA 2024-T3 substrate with scribes.

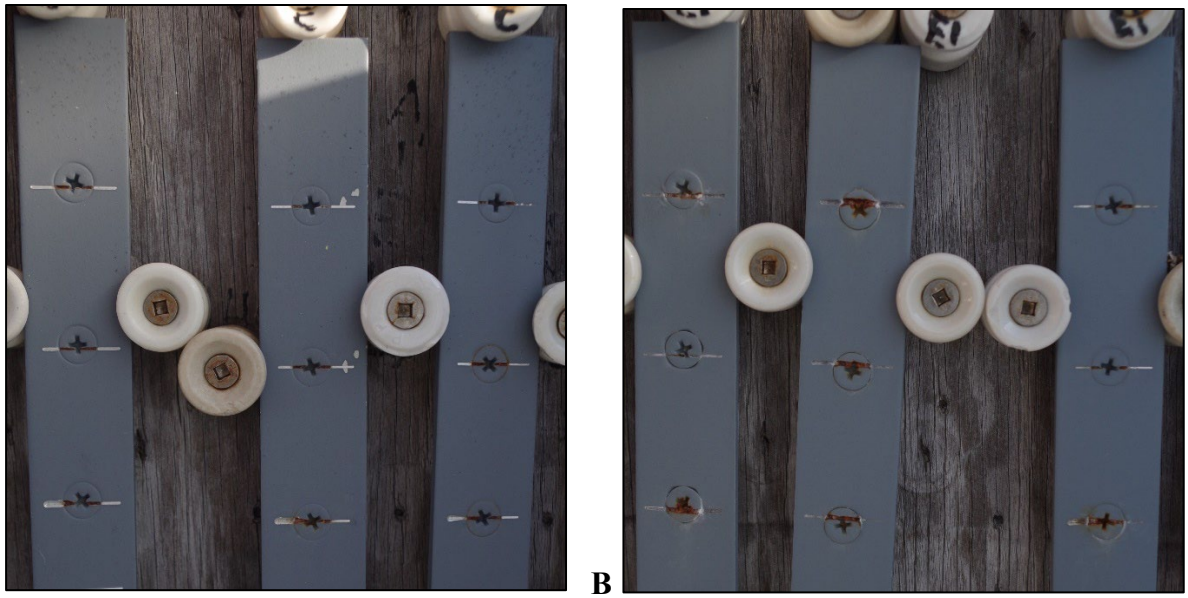
Fig. 32—12-month outdoor corrosion performance for A) 1K camouflage gray polysiloxane topcoat over chromate-containing primer and B) 2K camouflage gray polyurethane topcoat chromate-containing primer. Both sample sets possessed cadmium-plated steel fasteners and AA 2024-T3 substrate with scribes.

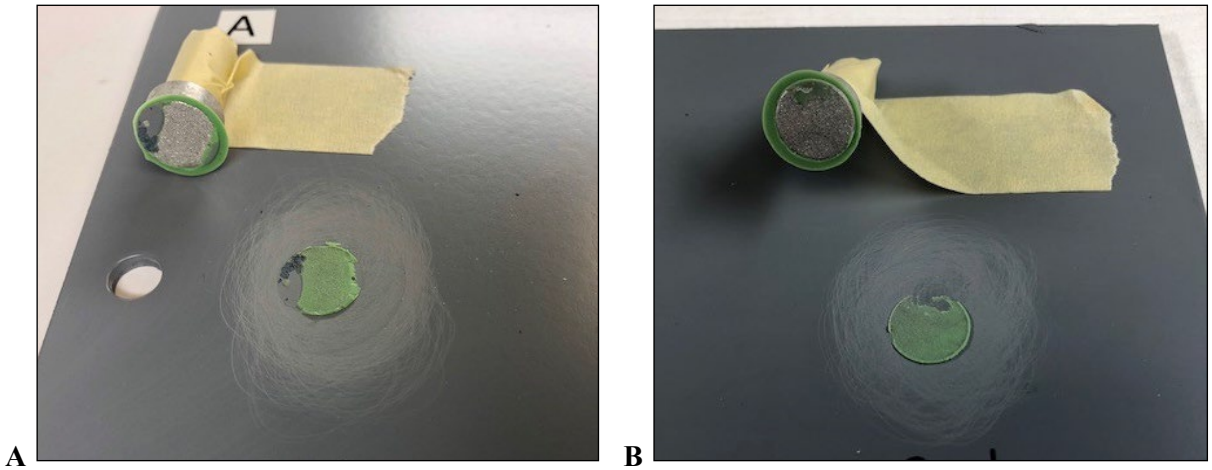
Fig. 33—Photographs of overcoat adhesion for A) 1K semigloss gray polysiloxane topcoat over zinc-rich primer and B) 2K semigloss gray polyurethane topcoat over zinc-rich when second application of both topcoats were applied over sanded and IPA-wiped substrates

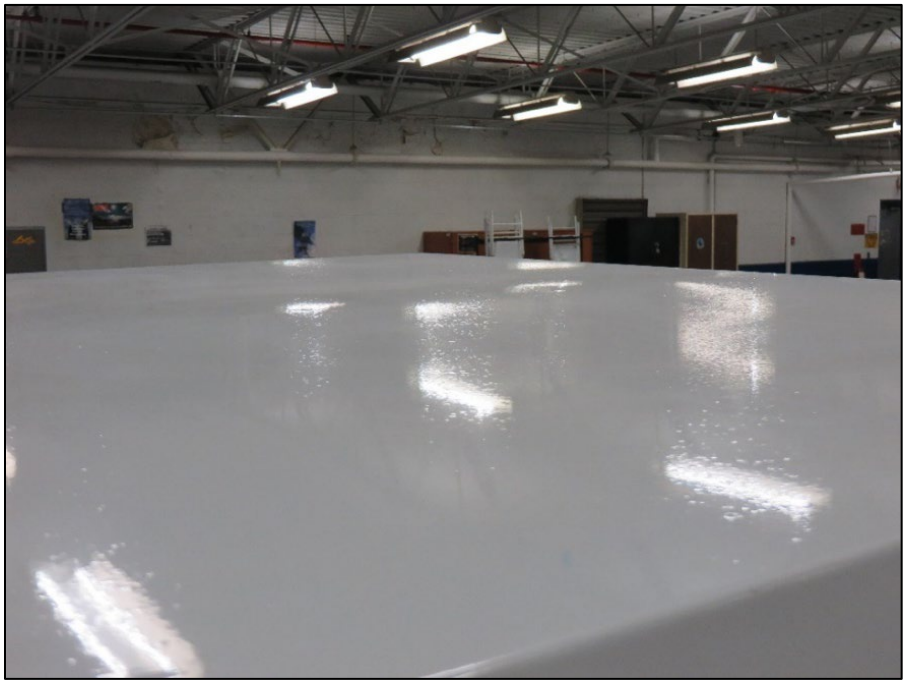
inspected for defects, such as cracking or delamination, then were photographed (Fig. 44–Fig. 48). No issues were observed with either topcoat.

Fig. 44—Roof of cab on MRTT before being placed into service

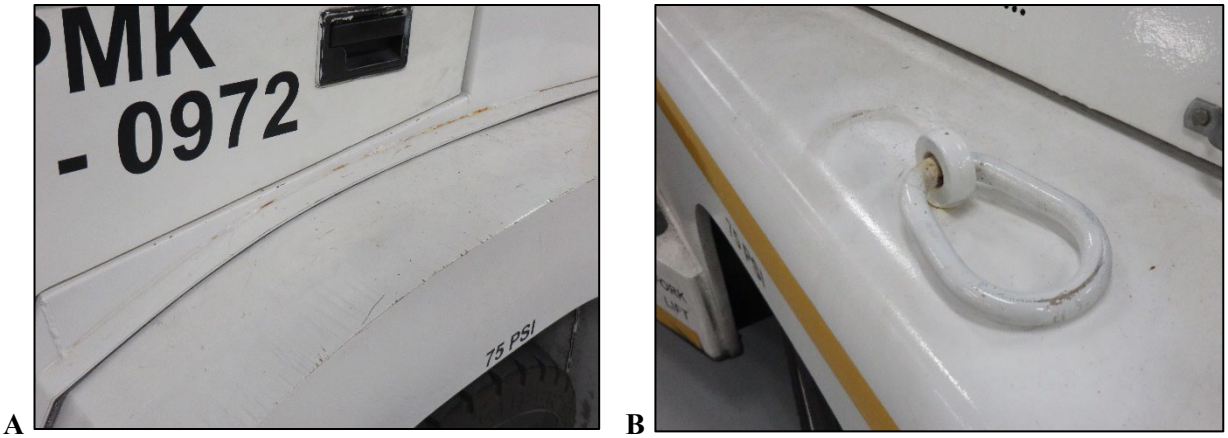
Fig. 49—2K gloss white polysiloxane topcoat showing: A) minor crevice corrosion and B) minor loss of topcoat on tie-down (due to abrasion) after 6 months of field service

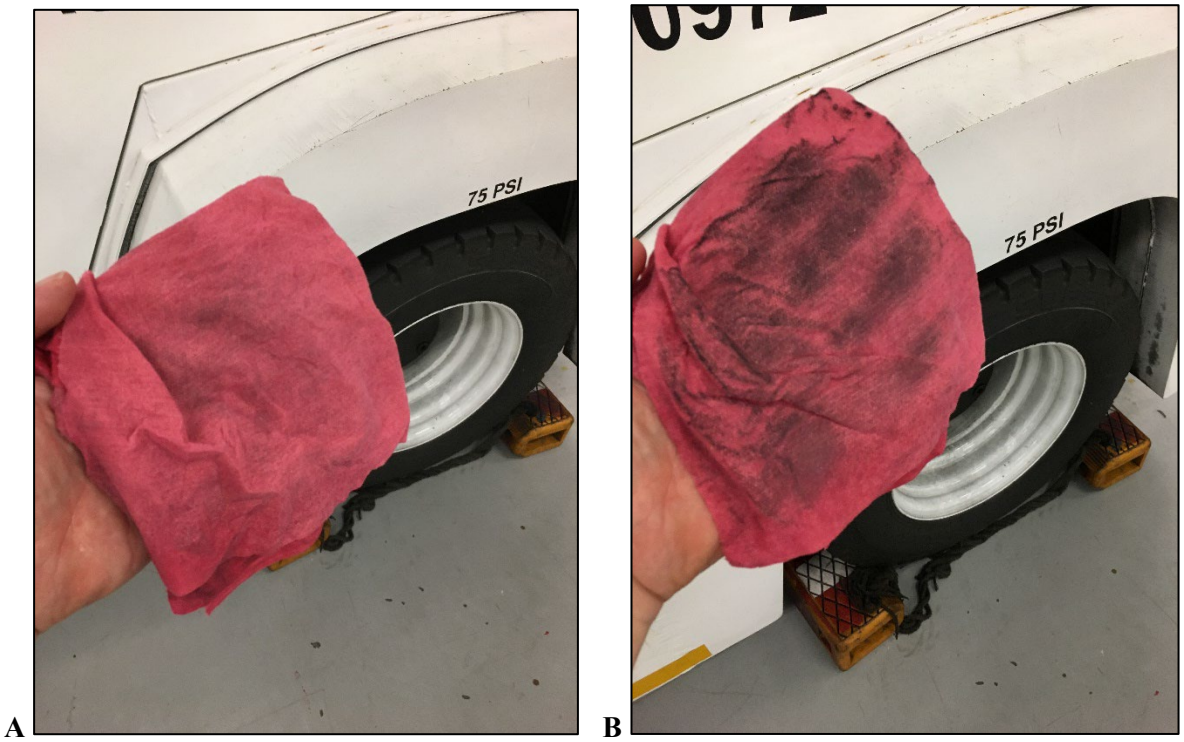
The topcoats on the MRTT were cleaned with warm water and rags, followed by air drying before photographing and collecting color and gloss values. A significant amount of dirt was removed during this process as shown in Fig. 50. Once dry, the MRTT was photographed from several angles to document appearance (Fig. 51–Fig. 55).

Fig. 50—a) Wet rag before wiping and b) wet rag after wiping the chassis of the MRTT

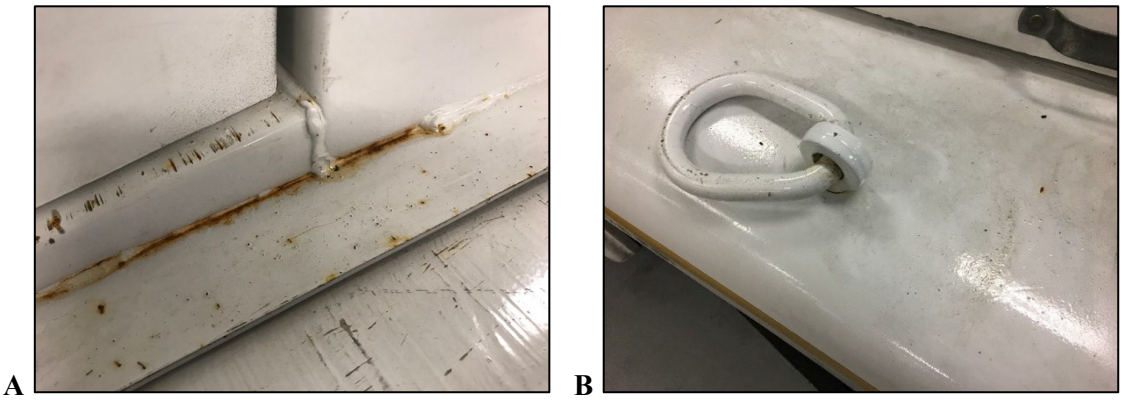
Fig. 56—MRTT after 12 months of field service showing: A) crevice corrosion along edge of cab and B) no cracking, chipping or corrosion on areas around tie-down on chassis

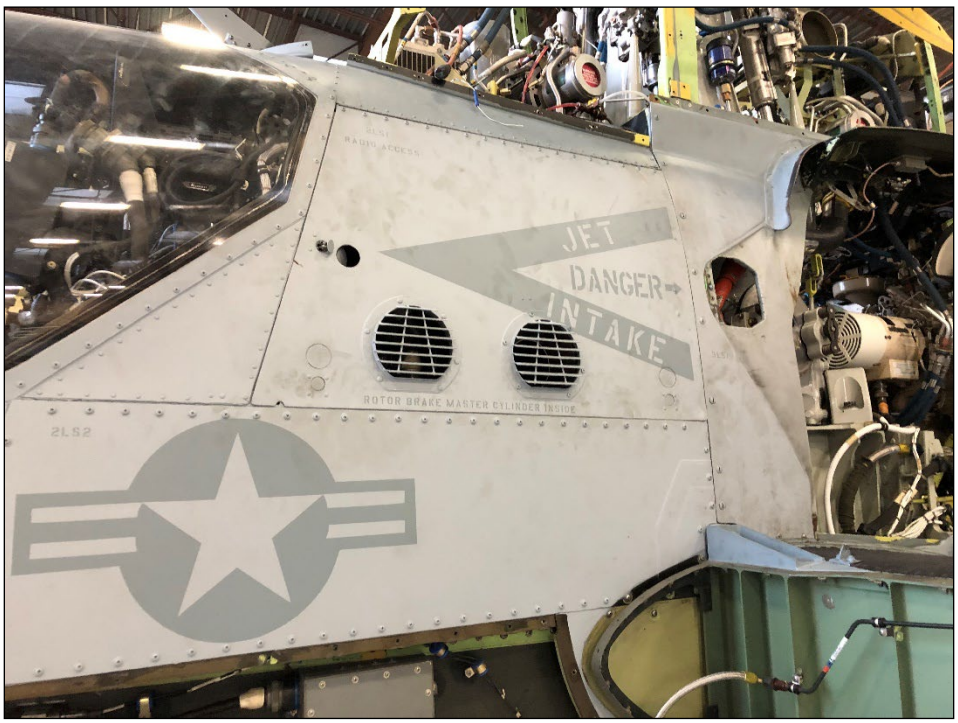
The 1K camouflage gray polysiloxane topcoats on BUNO 168798 were inspected in November 2019 after 8 months of active service at Camp Pendleton (Fig. 80). In general, the topcoats were in excellent condition with no signs of mechanical damage, blistering, cracking, delamination, or facial corrosion. However, the aircraft was extremely dirty/contaminated as shown in Fig. 81 and Fig. 82, and the fuselage below the nacelles was stained with engine oil that was seeping from areas above (Fig. 83). Attempts to remove the dark contamination marks and engine oil with water and rags were unsuccessful.

Fig. 81—1K polysiloxane topcoat on left AFT area of cockpit on BUNO 168798 after 8 months of service

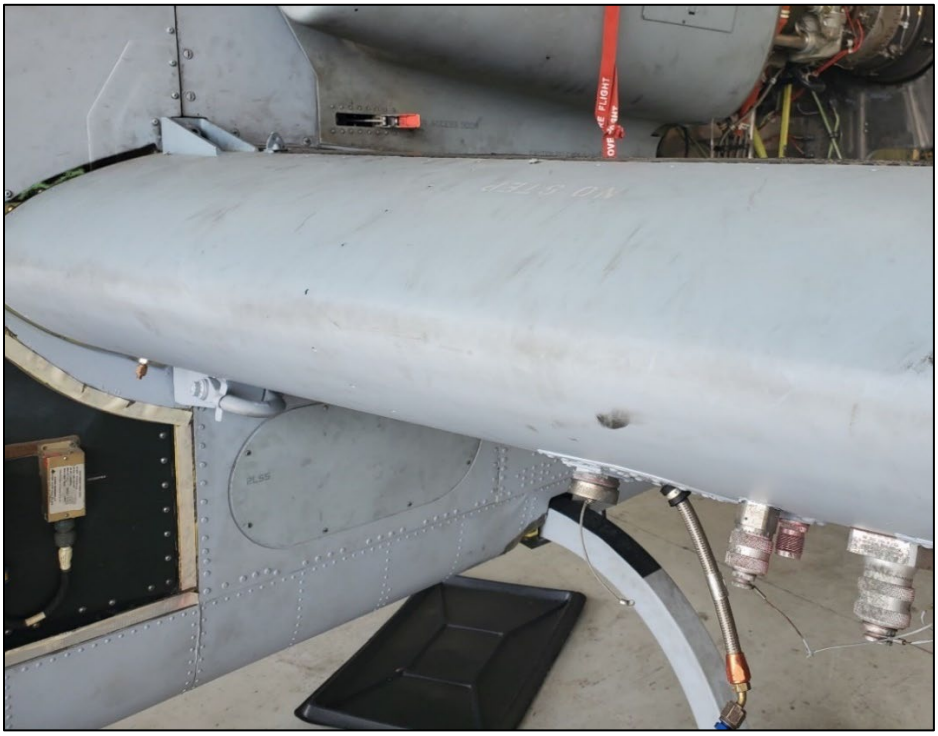
The 1K polysiloxane topcoats on BUNO 168399 were inspected in May 2021 after 25 months of active service at Camp Pendleton (Fig. 110–Fig. 113), and this was the final inspection of this aircraft. After 2 years, the topcoats remained in excellent condition and showed no signs of blistering, cracking, delamination, facial corrosion, or damage due to heat and fluids. However, the aircraft was extremely contaminated with smudge marks due to maintenance activities, and there was a thin layer of soot on the horizontal stabilizes and the top of the tail boom. Cleaning rags and isopropanol (IPA) were used to remove contaminants from the surface because the aircraft was not washed prior to inspection. As shown in Fig. 114, use of the rags and IPA removed a significant amount of contaminants from the surface, thereby providing a clean surface to record color and gloss values. Cleaning of the 1K polysiloxane topcoats was performed on several areas of the aircraft.

Fig. 113—1K polysiloxane topcoat on leading edge of left wing on BUNO 168399 after 25 months of service

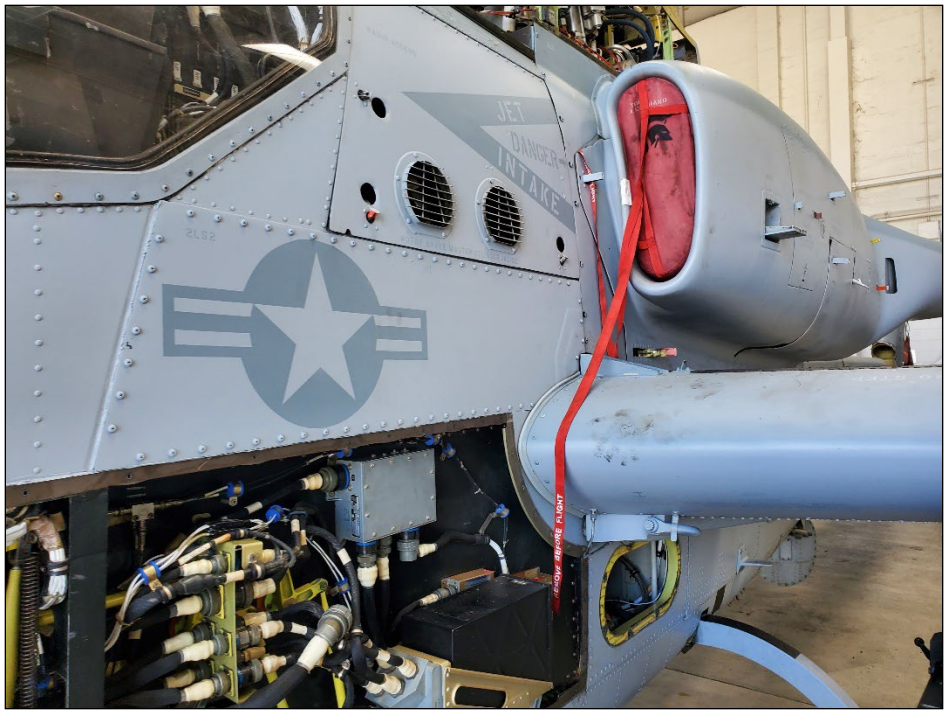
The 1K polysiloxane topcoats on BUNO 168052 were inspected in August 2020 after 15 months of active service at Camp Pendleton (Fig. 120–Fig. 124). In general, the topcoats were in excellent condition with no mechanical damage, staining from fluids, blistering, cracking, delamination, or facial corrosion. Due to mechanical issues, the aircraft was in the hangar where the nose cover, the horizontal stabilizers, and sections of the vertical stabilizer were removed for maintenance purposes. The doors of the fuselage below the cockpit were also opened, thus preventing inspection of the topcoat in this area. The topcoats were contaminated with soot and grease in several areas due to maintenance activities, and the presence of hand and boot prints could be visually observed on the wings. The aircraft was not cleaned prior to inspection.

Fig. 120—1K polysiloxane topcoats on aft cockpit of BUNO 168052 after 15 months of service

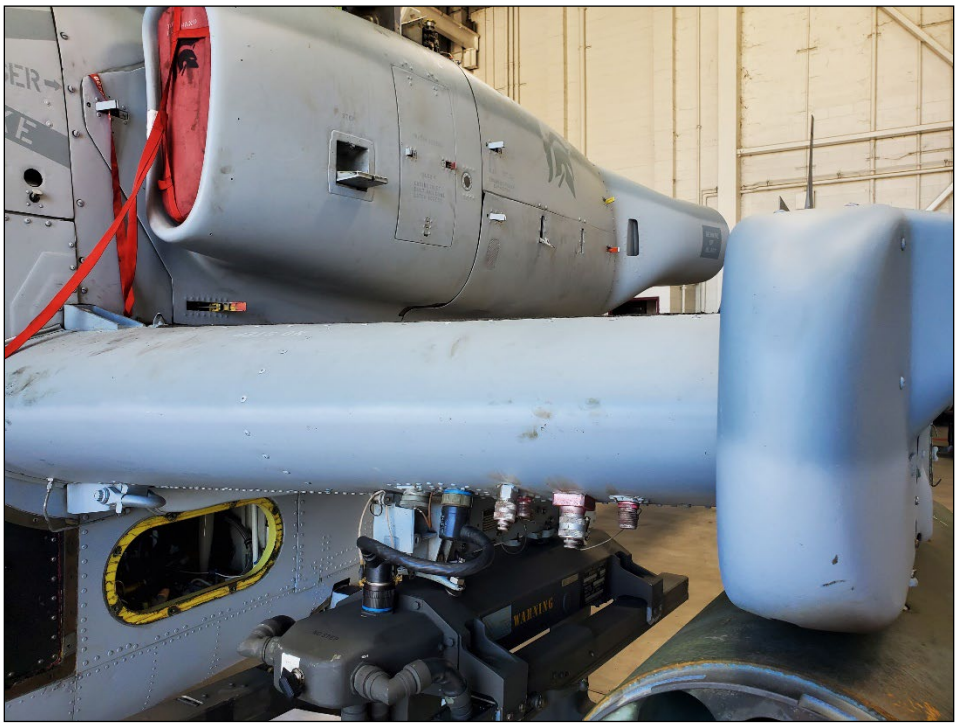
Fig. 121—1K polysiloxane topcoats on left leading edge of wing and nacelle of BUNO 168052 after 15 months of service

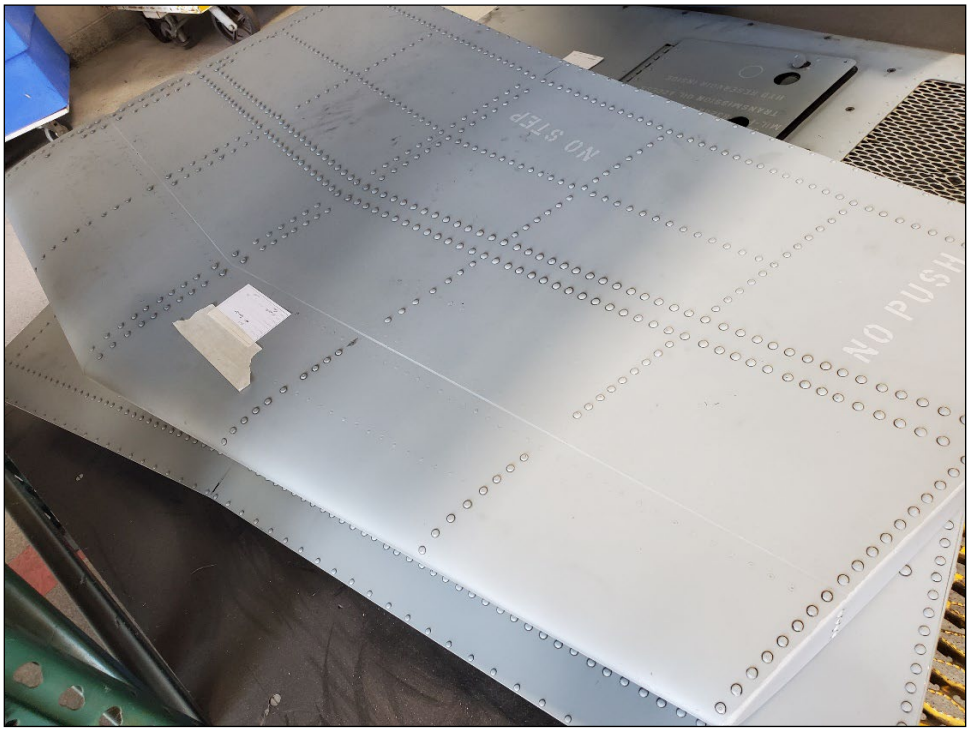
Fig. 123—1K polysiloxane topcoat on horizontal stabilizer (removed) of BUNO 168052 after 15 months of service

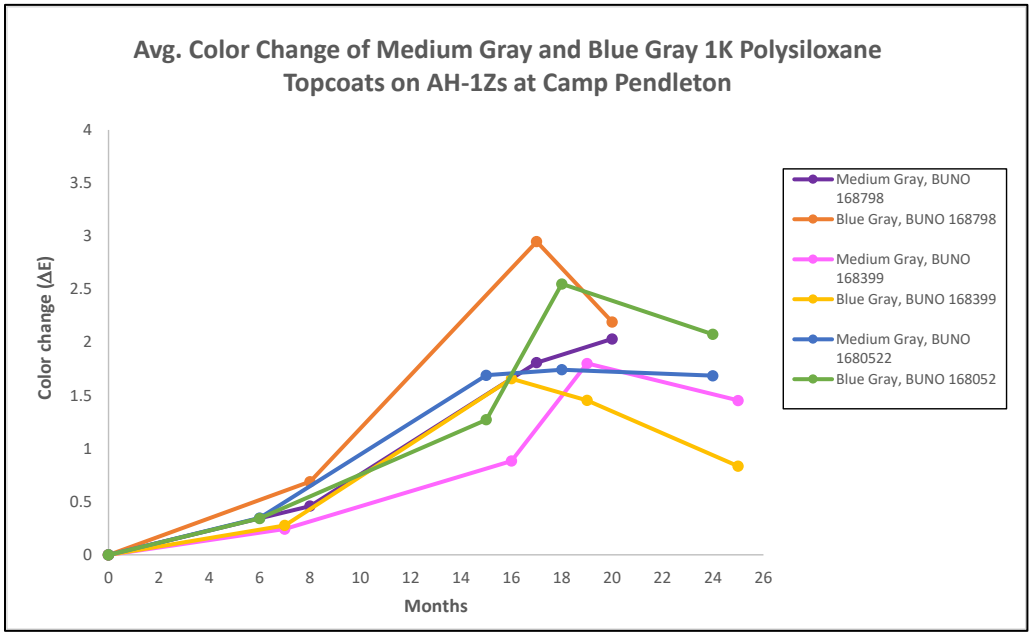
Fig. 136—Average color change of 1K polysiloxane topcoats after approximately 2 years of service on AH-1Zs

The medium gray 1K polysiloxane topcoat on BUNO 168798 demonstrated an average color change of 2.03 after 20 months of service, whereas the same topcoat on BUNOs 168399 and 168052 demonstrated an average color change of 1.45 and 1.69 after 25 and 24 months of service, respectively (Fig. 137). Similarly, the blue gray 1K polysiloxane topcoat on BUNO 168798 demonstrated an average color change of 2.19 after 20 months, whereas the same topcoat on BUNOs 168399 and 168052 demonstrated an average color change of 0.83 and 2.08 after 25 and 24 months of service, respectively. A few of the color change values exceeded 2.0 between the 16- to 18-month inspection periods, although the elevated values can be attributed to contaminants

on the aircraft, which were not removed prior to inspections (see Section 7.2.4). In general, both colors of the 1K polysiloxane topcoat were successful at retaining a ΔE of ≤2.0 after 2 years of service, which met the in-service weathering criteria as shown in Table 10.

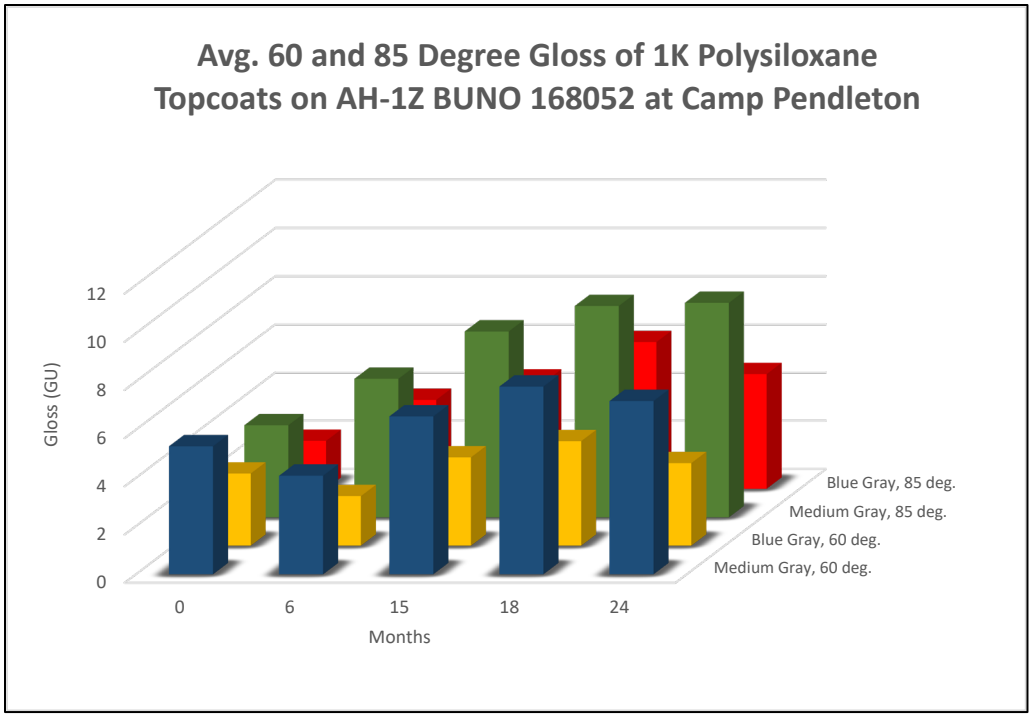
Fig. 137—Average gloss of 1K polysiloxane topcoats after 24 months of service on AH-1Z BUNO 168052

The gloss values of the medium gray and blue gray 1K polysiloxane topcoats were relatively consistent when comparing the initial and final inspection values, whereas periodic inspections demonstrated both increases and decreases in values. The variability during inspections was most likely because the gloss meter was not flush with the surface when values were collected, especially when collecting values on areas of the aircraft with high curvature (e.g., the leading edges of wings, the top of the tail boom). As a result, external light was allowed to enter the meter, altering the values. The aircraft with the most consistent gloss values was BUNO 168052, which possessed an average 60-degree gloss of 7.19 GU and 3.43 GU for the medium gray and blue gray topcoats, respectively, after 24 months, in addition to an average 85-degree gloss of 8.90 GU and 4.76 GU for the medium gray and blue gray topcoats, respectively (Fig. 138). Aside from the average gloss value for the medium gray 1K topcoat at 60 degrees, which was higher due to areas of high curvature, all other values met the NAVAIR requirement of ≤5 GU at 60 degrees and ≤10 GU at 85 degrees, thus meeting the success criteria in Table 10. Furthermore, as stated previously, the gloss on all three aircraft had a flat appearance and was visually similar to other AH-1Z aircraft that were painted with MIL-PRF-85285-qualified 2K camouflage gray polyurethane topcoats.

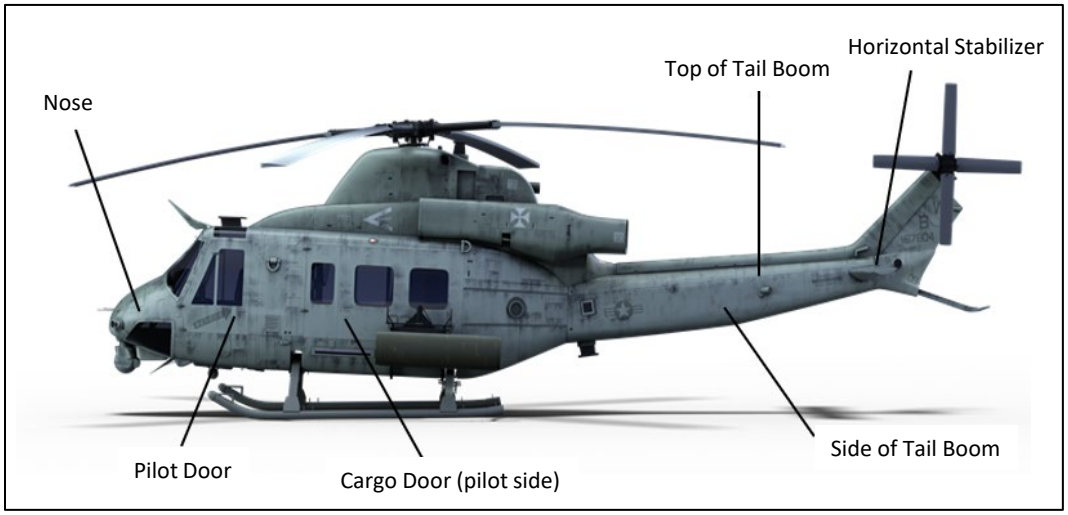
Fig. 145—BUNO 168416 with 1K polysiloxane topcoats after its delivery to the squadron

The initial color values for the medium gray- and blue gray-colored 1K polysiloxane topcoats on BUNO 168416 are shown in Table 115 and Table 116. These topcoats visually matched 2K polyurethanes with #36375 and #35237 colors, and the applicators stated that the polysiloxane topcoats blended well at transition points with

no signs of delamination or peeling between colors. The colors also appeared homogenous across all areas of the aircraft, as shown in Fig. 144 and Fig. 145, and there were zero sags, runs, or other unsightly blemishes.

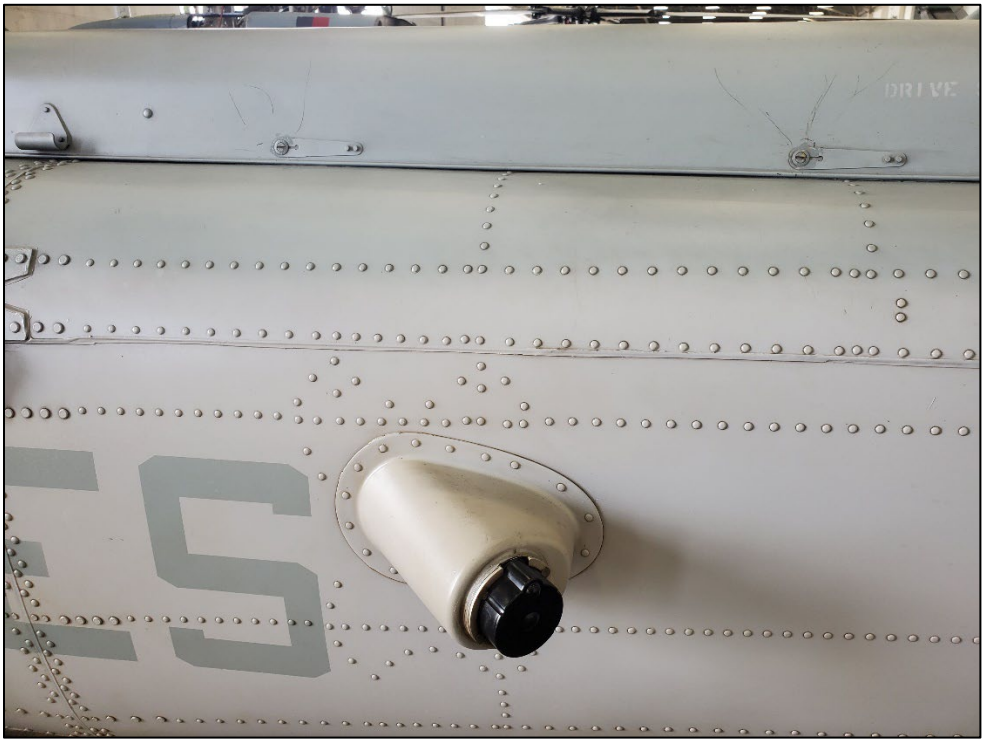
Fig. 158—1K polysiloxane topcoats on left side of tail boom of BUNO 168416 after 21 months of service

The 1K polysiloxane topcoats on BUNO 168416 were inspected in November 2020 after 21 months of active service at MCAS New River (Fig. 156–Fig. 160). In general, the topcoats were in good condition with minimal mechanical damage (e.g., scratches) on the doors, nose, and fasteners due to normal operations. The 1K topcoats showed no signs of blistering, cracking, delamination, or facial corrosion, although minor staining was observed above a cargo door and on the tail boom (Fig. 160). There was minor delamination around a few of the window frames, but maintainers stated this is common for topcoats on these aircraft.

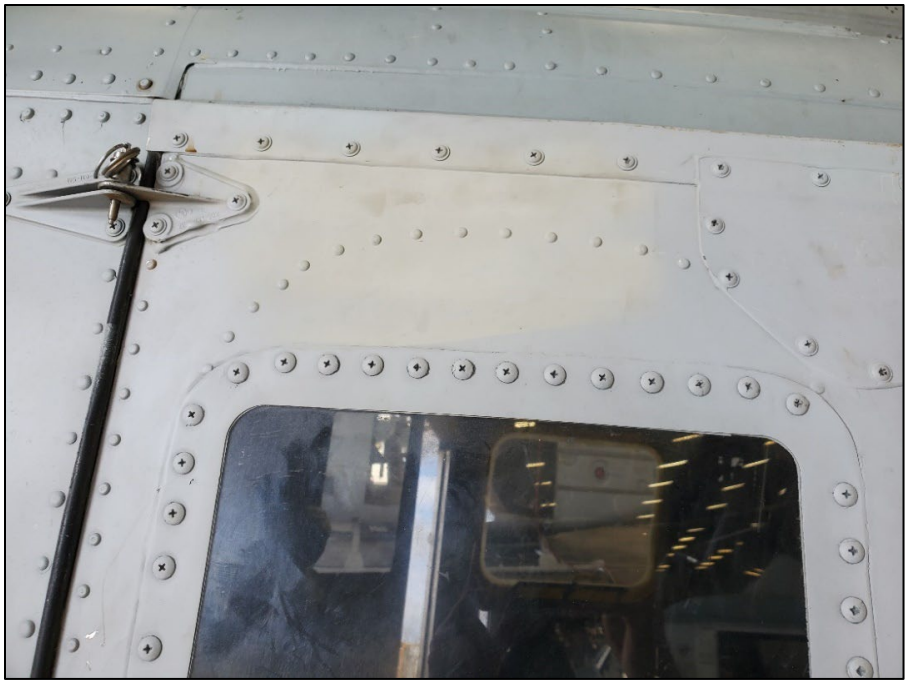
Fig. 159—Stained 1K polysiloxane topcoat above cargo door on BUNO 168416 after 21 months of service

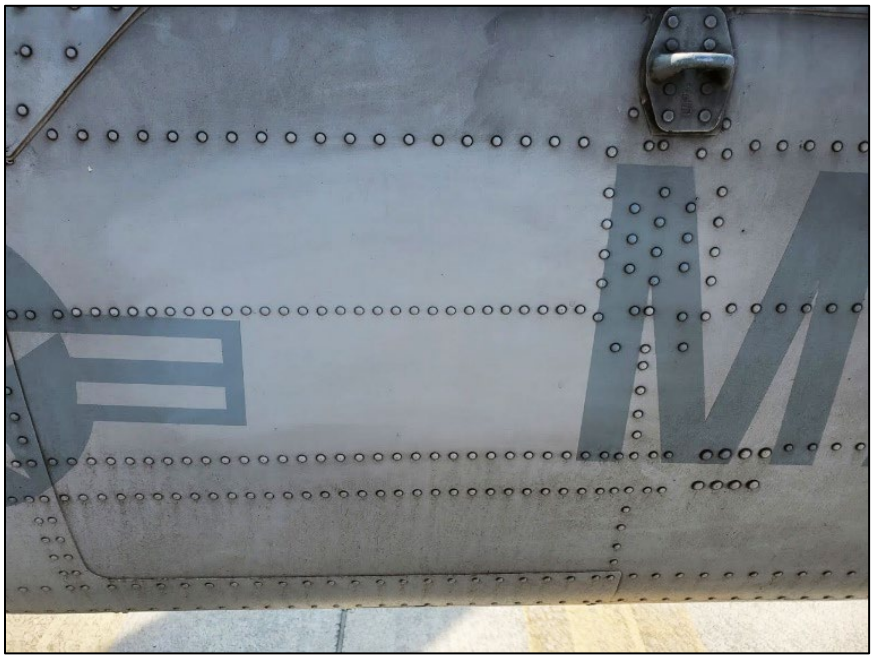
Fig. 168—Removal of dark contaminants from tail boom of BUNO 168416 using rags and IPA

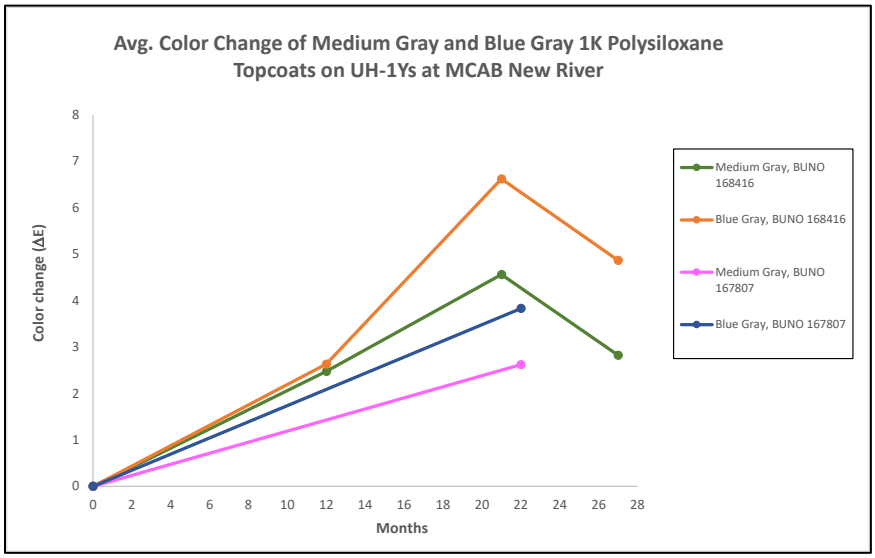
Fig. 178—Average color change of 1K polysiloxane topcoats after 22–27 months of service on UH-1Ys

The medium gray 1K polysiloxane topcoat on BUNOs 167807 and 168416 demonstrated average color changes of 2.62 and 2.82 after 22 and 27 months of service, respectively, whereas the blue gray 1K polysiloxane topcoat on these aircraft demonstrated average color changes of 3.83 and 4.87, respectively, during the same periods (Fig. 179). Elevated color change values on BUNO 168416 were calculated during the 21-month

inspection, although it was determined these increased values resulted from the thin, yellowish film generated by the commercial plastic cleaner. However, the film did not appear to be present on the topcoats during the 27-month inspection. Both 1K topcoats demonstrated an average ΔE of ≥2.0 around the 2-year period, although both aircraft were highly contaminated with soot and grease, and neither aircraft was washed prior to the final inspection. Attempts were made to remove the contaminants, although the extent of removal could not be quantified and the topcoats remained contaminated and darker in color than when initially applied. Thus, the true color of the 1K topcoats was unknown. As a result, per Table 10, the 1K polysiloxane topcoats did not meet the quantitative success criteria for in-service weathering (i.e., ΔE ≤2.0) after 1–2 years of service. However, the 1K polysiloxane topcoats were visually similar in color to UH-1Ys on the fight line that were painted with 2K polyurethane topcoats, and, as mentioned above, the maintainers could not visually discern between the aircraft with different topcoat technologies.

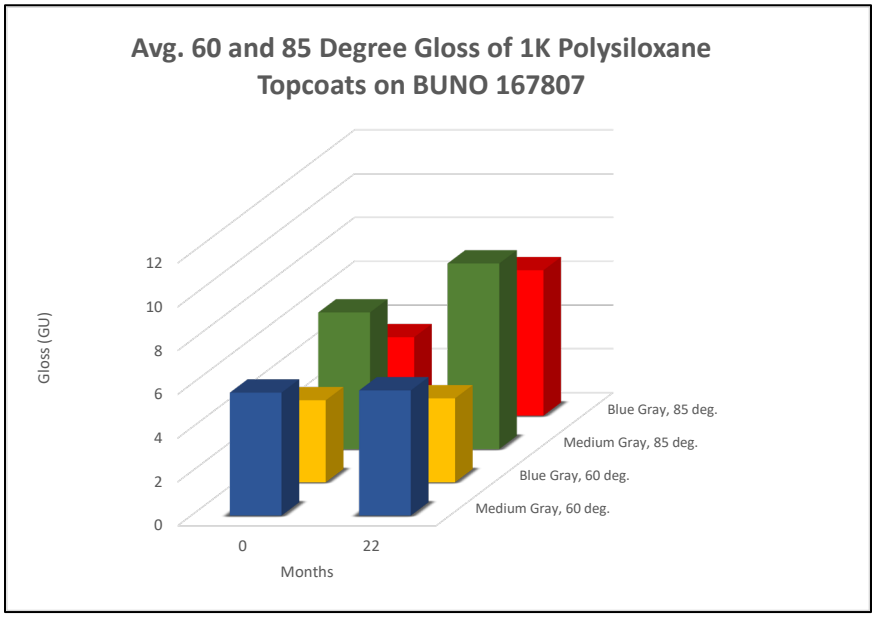
Fig. 179— Average gloss of 1K polysiloxane topcoats after 22 months of service on UH-1Y BUNO 167807

The average gloss values of the medium gray and blue gray 1K polysiloxane topcoats were relatively consistent between the initial and final inspections, whereas periodic inspections on BUNO 168416 demonstrated both increases and decreases in values. The variability during inspections was most likely due to the meter not being flush with the surface, especially when collecting gloss values on areas with substantial curvature (e.g., top of tail boom), thereby allowing external light to enter the meter and providing elevated values. After 22 months, the 60-degree gloss for the medium gray topcoat on BUNO 167807 was an average of 5.72 GU, which was slightly above the NAVAIR requirement of ≤5 GU, although the averages on the pilot's and copilot's door were 5.1 GU and 5.3 GU, respectively, whereas the cargo door on the copilot's side was an average of 4.2 GU. However, the 85-degree value for the medium gray 1K topcoat on BUNO 167807 after 22 months was ≤10 GU, and both the 60-degree and 85-degree values for the blue gray 1K topcoat were ≤5 GU and ≤10 GU, respectively, after 22 months (Fig. 180).

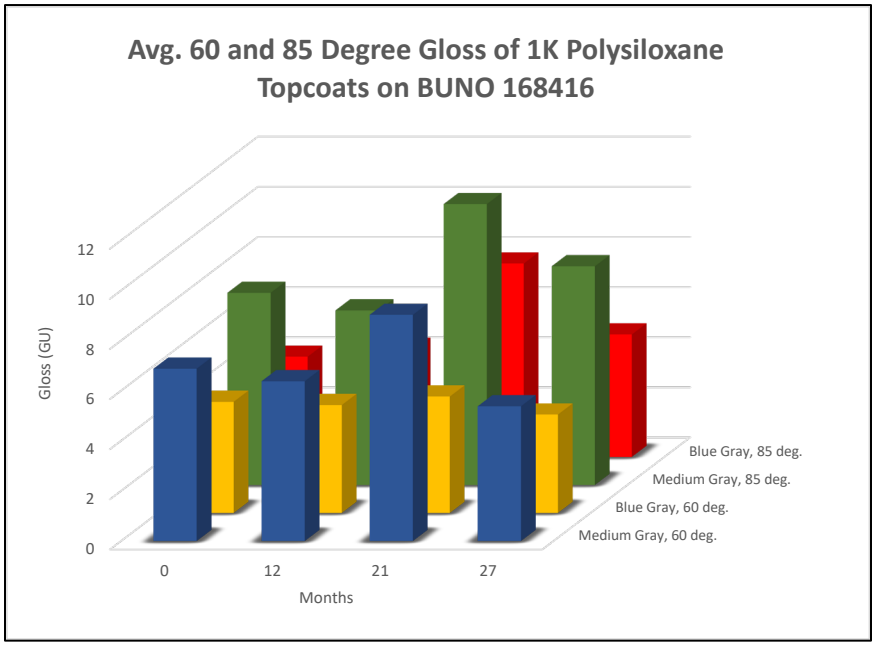
Fig. 180—Average gloss of 1K polysiloxane topcoats after 27 months of service on UH-1Y BUNO 168416

After 27 months of service, the 60-degree gloss for the medium gray topcoat on BUNO 168416 was an average of 5.38 GU, which was slightly above the NAVAIR requirement of ≤5 GU, although the averages on the pilot's door and pilot's cargo door were 4.7 GU and 2.3 GU, respectively, whereas the cargo door on the copilot's side was an average of 4.0 GU. However, the 85-degree value for the medium gray 1K topcoat on BUNO 167807 after 22 months was ≤10 GU, and both the 60-degree and 85-degree values for the blue gray 1K topcoat were ≤5 GU and ≤10 GU, respectively, after 22 months (Fig. 181). This demonstrated that the 1K

camouflage gray polysiloxane topcoats can retain their gloss and meet the NAVAIR requirement of ≤5 GU at 60 degrees and ≤10 GU at 85 degrees after 1–2 years of service, which satisfied the success criteria in Table 10. Furthermore, as stated previously, the gloss on both aircraft had a flat appearance and were visually similar to other UH-1Y aircraft on the flight line that were painted with MIL-PRF-85285-qualified 2K camouflage gray polyurethane topcoats.

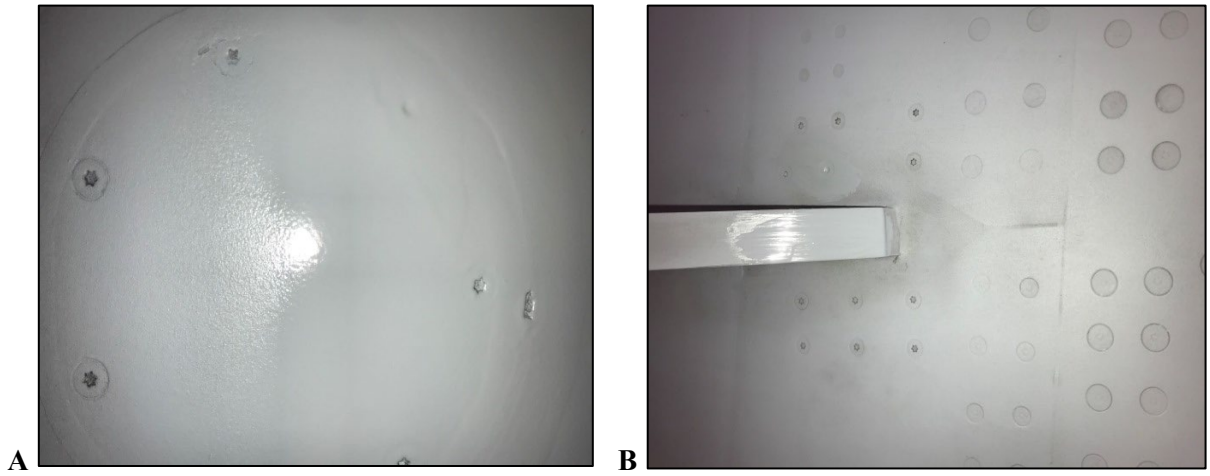
Fig. 183—Application of 1K polysiloxane touch-up topcoat on F/A-18E via A) Preval® spray gun and B) brush

The painter from the squadron stated it was simple to mix the 1K polysiloxane topcoat and methyl acetate reducer in a 1:1 ratio (by volume) and apply with the Preval® spray gun. The paint sprayed and flowed out smoothly in one coat, then blended well with the surrounding polyurethane topcoat as it dried. A photo of the cured 1K polysiloxane topcoat after curing for 24 hours is shown in Fig. 185A. The consistency of the 1K topcoat enabled an easy application with the brush as well, although without the need for solvent reduction. However, the brush left minor strokes in the paint, even though the paint flowed-out and blended well. The brush application after curing for 24 hours is shown in Fig. 185B. Additionally, the painter stated that it required two coats via brushing to fully cover the primer, and he recommended waiting 5 minutes between each coat.

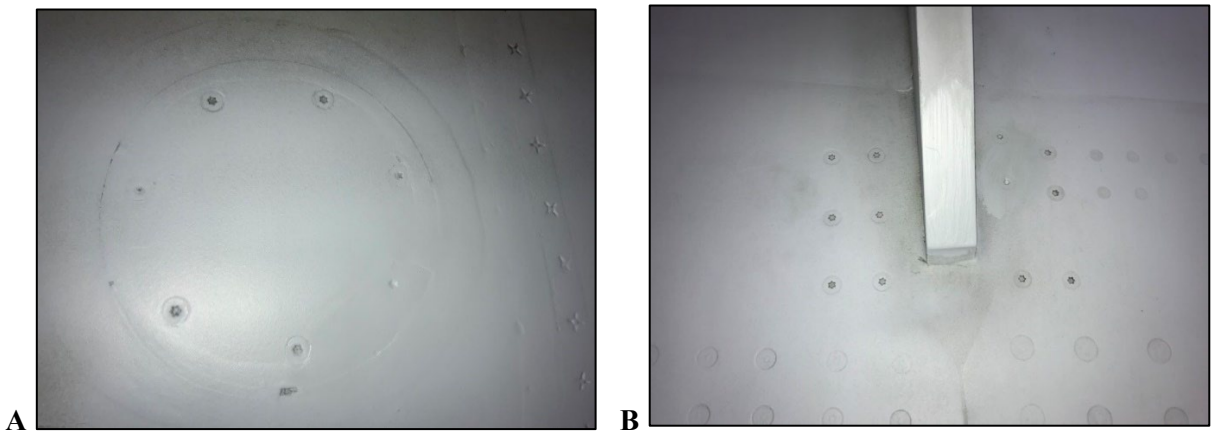
Fig. 184—Appearance of 24-hour-cured 1K polysiloxane touch-up topcoat on F/A-18E resulting from A) Preval® spray gun application and B) brush application

The 1K polysiloxane touch-up topcoat was deemed easy to use and required no training, which met the success criteria shown in Table 9. The time from opening the kit until spraying was only a few minutes, as opposed to metering an mixing a kit of 2K polyurethane topcoat, which can require up to 30 minutes. The 1K topcoat also blended well with the 2K polyurethane topcoat on the aircraft, which met the appearance criteria in Table 9. Furthermore the applicator stated that the 1K polysiloxane touch-up topcoat possessed a more pleasant smell than the 2K polyurethane topcoats currently used by the squadron for touch-up/repair of aircraft.
