NRL/6130/FR--2023/2

Isocyanate-Free and Low-VOC Polysiloxane Topcoats for Aircraft and Support Equipment

ERICK B. IEZZI

September 25, 2023

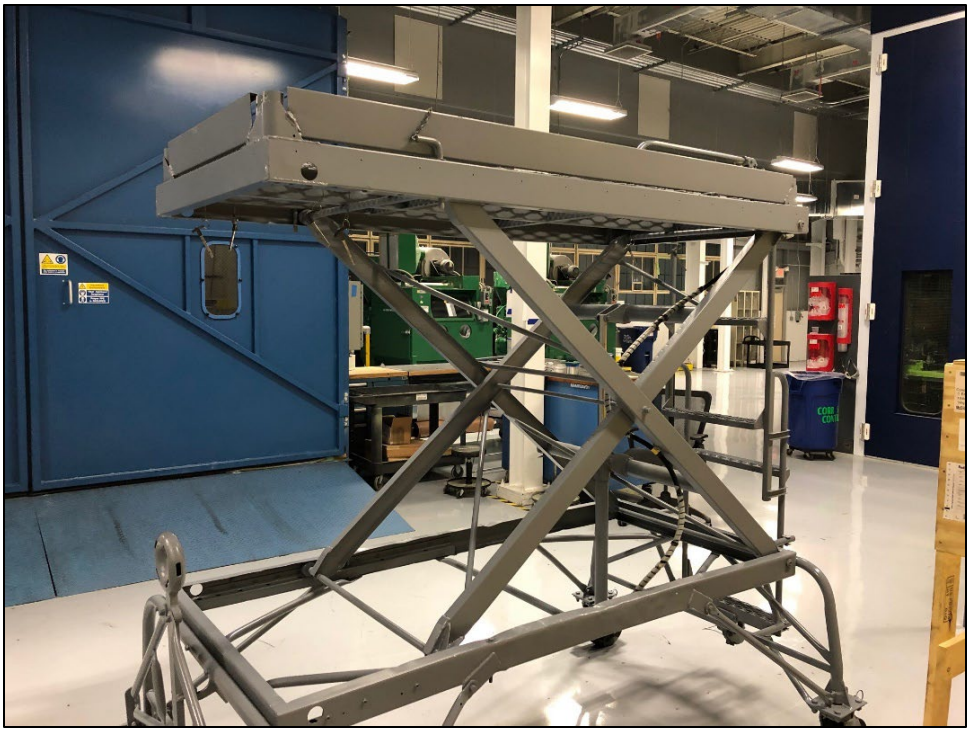
Fig. 185—1K semigloss gray polysiloxane topcoat on B401 maintenance stand after curing for several days

The 1K semigloss gray polysiloxane topcoat was applied on the stands via HVLP spray equipment, although the brand of equipment, the spray gun settings, and the fluid tip size used for the application were not provided to NRL. Per the applicator, the 1K topcoat sprayed well on B401 and flowed out evenly. The topcoat cured overnight and had a better appearance (e.g., less orange peel) than the MIL-PRF-85285, Type I-qualified 2K semigloss gray polyurethane topcoats that are typically applied. The following day, touch-up to minor areas of the stand was performed using a brush and the 1K semigloss topcoat, which smoothed out and blended well with sprayed areas. Painting of the B401 stand consumed 1–1.25 gallons of the 1K topcoat, versus 1.5–2 gallons when applying a 2K polyurethane topcoat. Photos of the B401 maintenance stand after several days of curing are shown in Fig. 186 and Fig. 187. The B407 stand was painted in a similar fashion the following month.

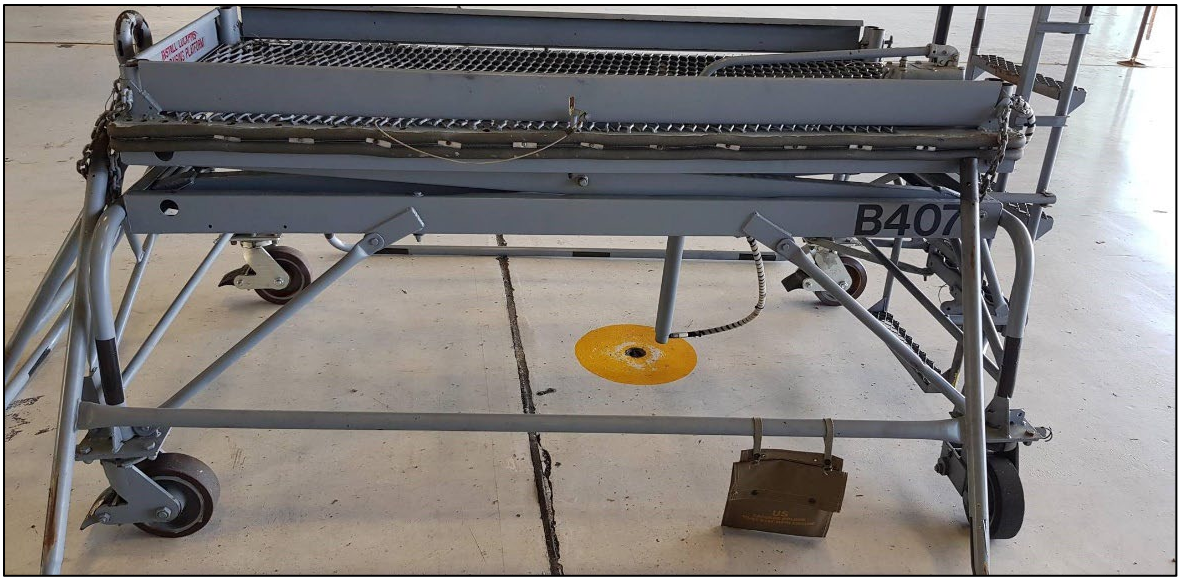
Fig. 192—1K semigloss gray polysiloxane topcoat on B407 maintenance stand after 14 months of service with non-damaged side showing

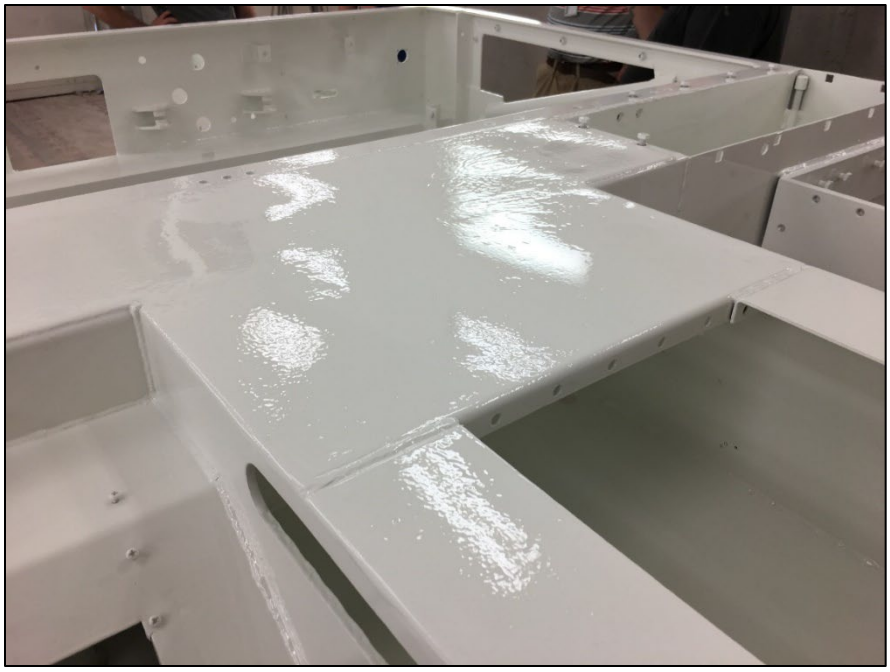
Fig. 196 — 2K gloss white polysiloxane topcoat on frame of spotting dolly immediately after application

The frame and components of the spotting dolly were prepared by removing the old coatings via abrasive blast media and subsequent cleaning (Fig. 194), followed by HVLP spray application of a buff-colored MIL-DTL-53022, Type II epoxy primer (Fig. 195). Once the primer had dried for about 2 hours, the 2K gloss white polysiloxane topcoat was applied using a Binks Mach 1 HVLP spray gun with a 1.7 mm fluid tip (Fig. 196). The spray booth conditions were 82.5–86.3°F ambient temperature and 68.2–82.4% relative humidity. Two successive coats were applied, which required a total of about 40 minutes and consumed more than 1 gallon of paint. No sags, drips, or runs were observed during the application, and one of the painters stated "it was the best paint he has ever sprayed". In some areas, the painters tried to deliberately create runs by applying excess coating, but were unsuccessful. Figure 197 shows the 2K topcoat immediately after the spray application.

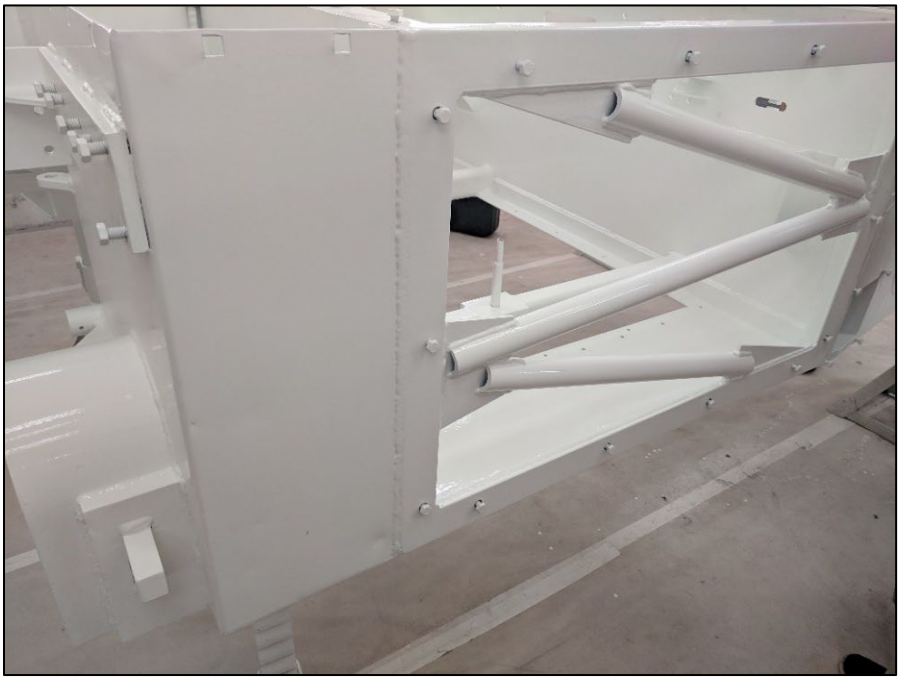
Fig. 197—2K gloss white polysiloxane topcoat on flat and rounded areas of spotting dolly frame the day after application

The 2K gloss white polysiloxane topcoat was inspected the day following the spray application. The topcoat was visually high in gloss with a bright white color as shown in Fig. 198–Fig. 201. No runs or sags were observed, and the topcoat covered well on sharp edges.

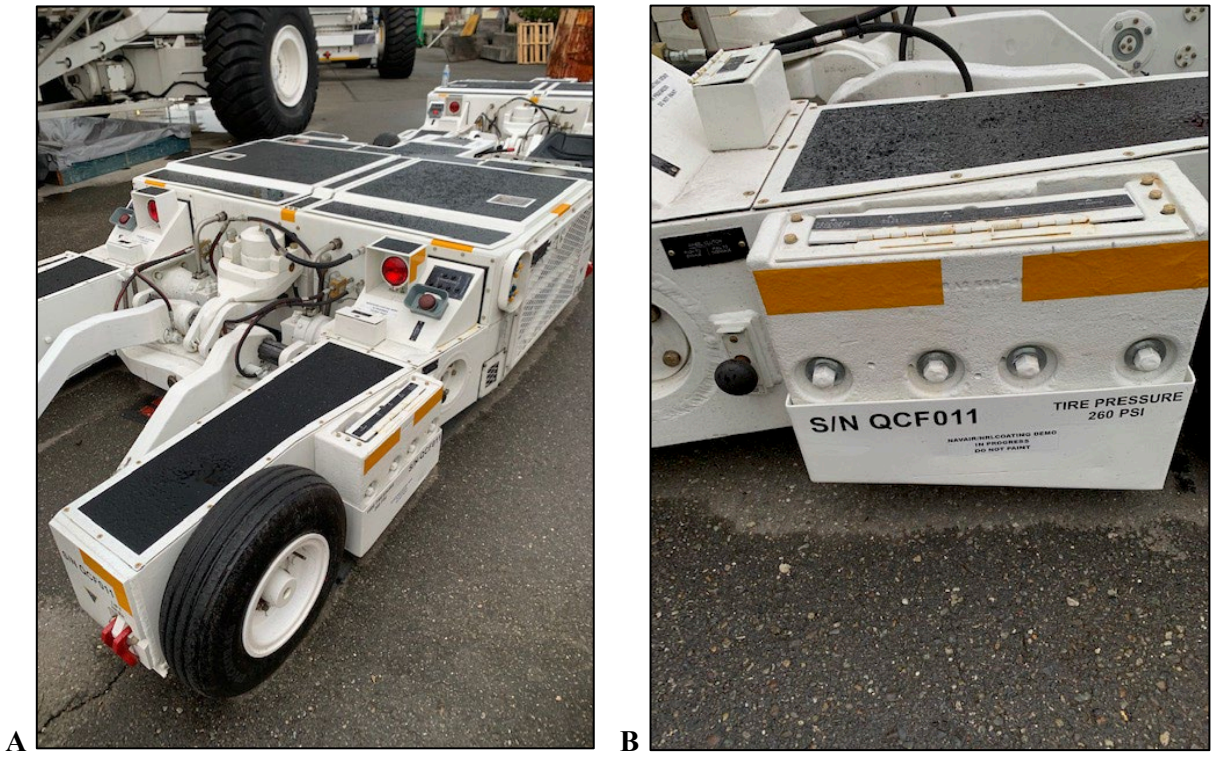
Fig. 201—2K gloss white polysiloxane topcoat on A) front and B) side of spotting dolly after 2 months on the USS Nimitz

The spotting dolly with the 2K gloss white polysiloxane topcoat, S/N QCF011, was visually inspected and photographed by ship's force after 2 months of service aboard the USS Nimitz. During this period, the topcoat showed no signs of blistering, cracking, chipping, delamination, or damage due to heat or fluids, including no facial corrosion (Fig. 202). DFT, gloss, and color values were not determined because the asset was deployed at sea and a representative from NRL or NAWC-AD could not be present to collect metrics. Figure 203 shows the 2K gloss white polyurethane topcoat (control) on a similar spotting dolly, S/N QCF073, during the same period.

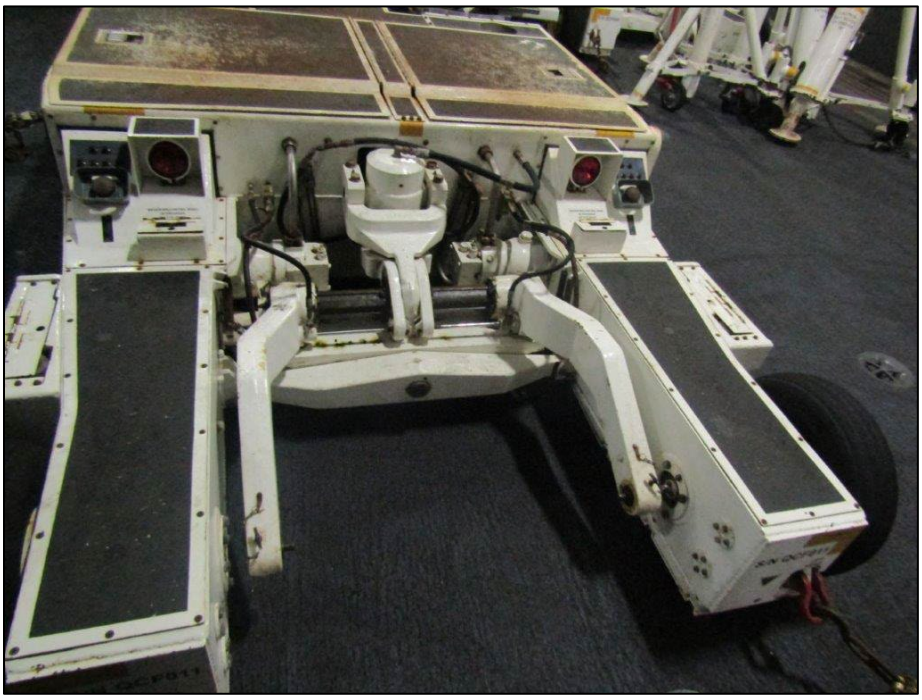
Fig. 203—2K gloss white polysiloxane topcoat on spotting dolly after 18 months on the USS Nimitz

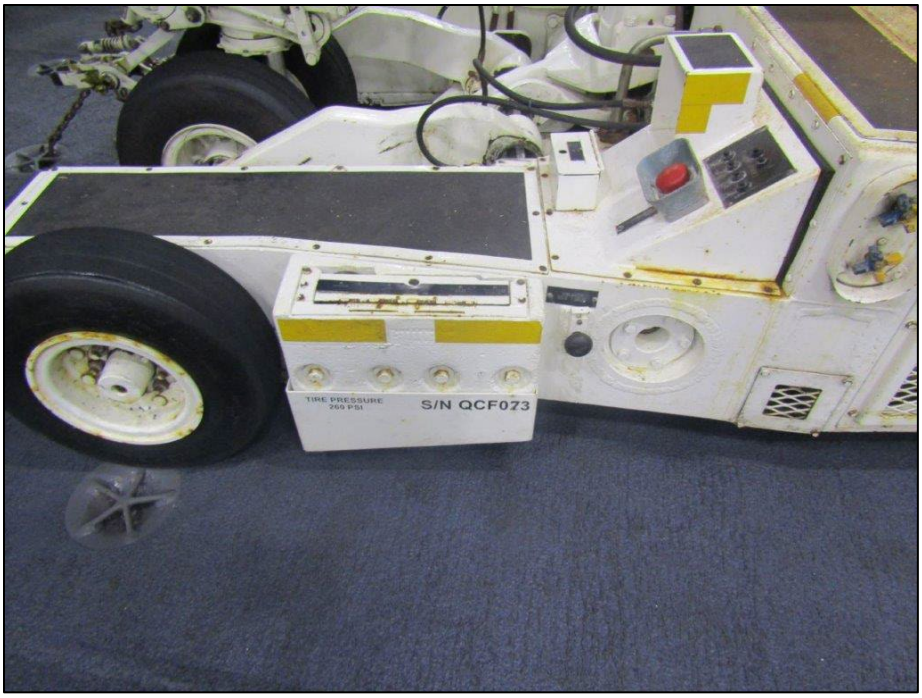
Fig. 204—2K gloss white polyurethane topcoat on spotting dolly after 21 months on the USS Nimitz
