Technical Note N-1450

EXPERIMENTAL POLYURETHANE FOAM ROOFING SYSTEMS

August 1976

CIVIL ENGINEERING LABORATORY
Naval Construction Battalion Center
Port Hueneme, California 93043

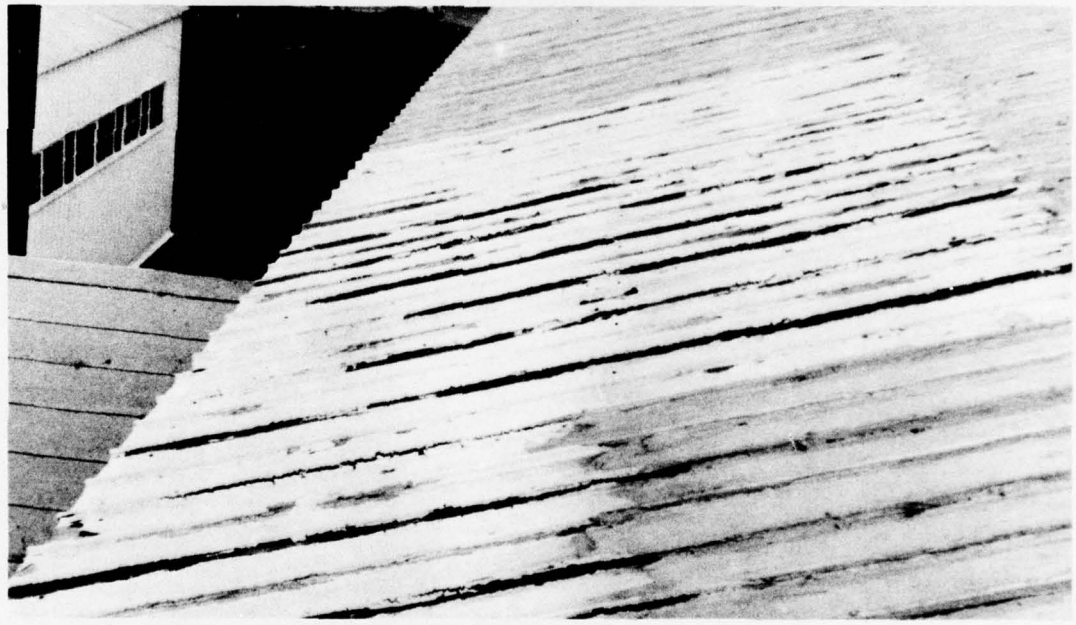
Figure 1. North Building Showing Accumulation of Old Coatings, Before Reroofing

Figure 2. North Building Showing Paint and Bitumen Accumulations, Before Reroofing

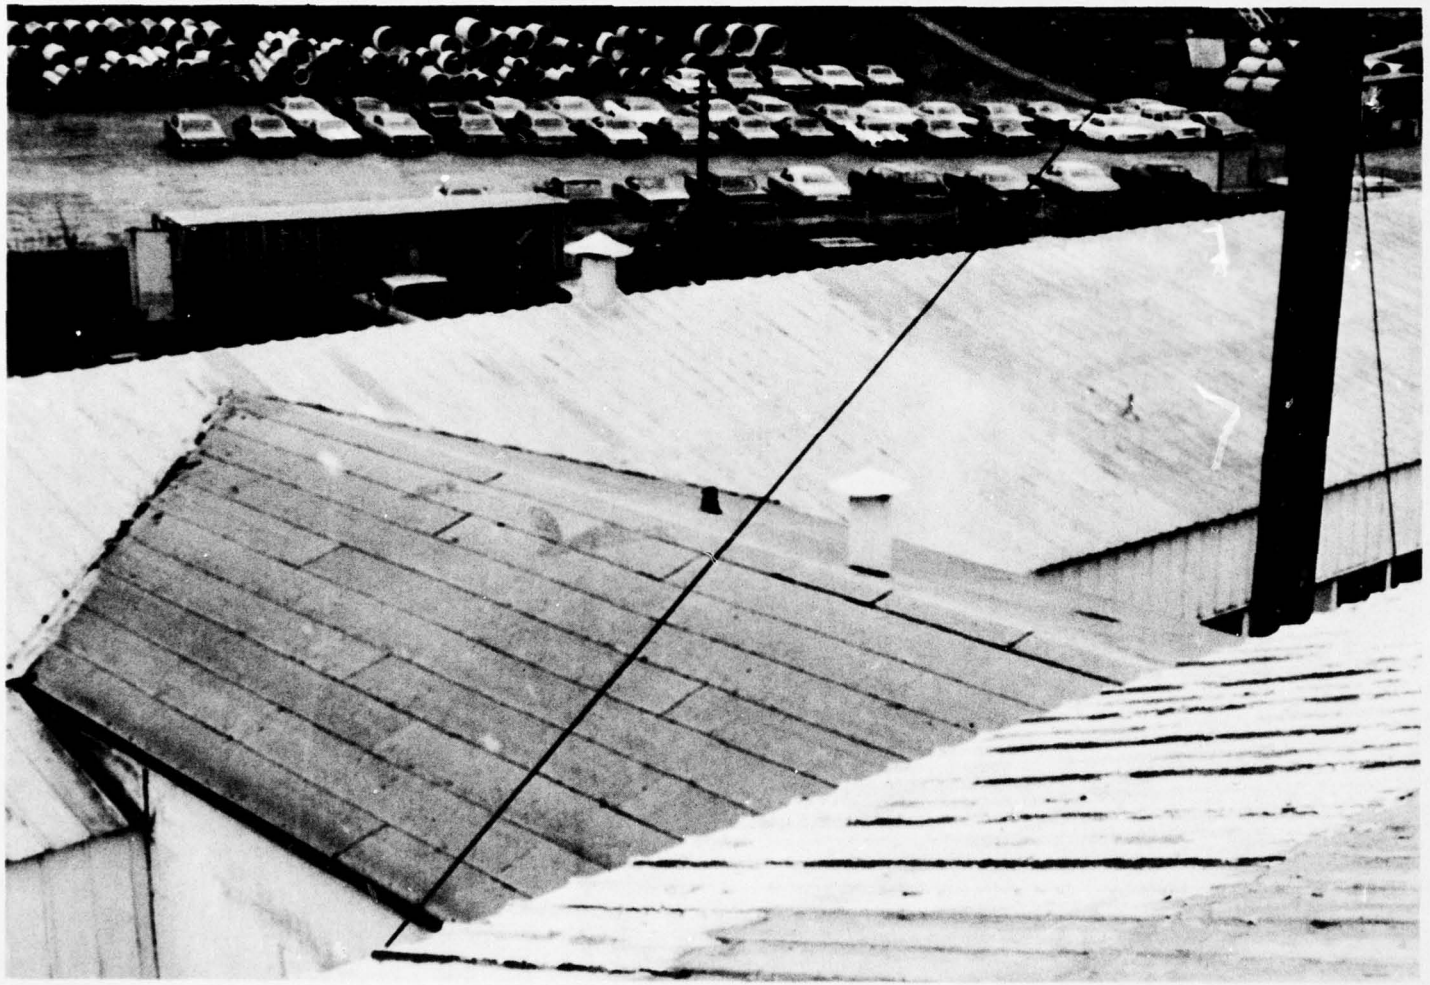
Figure 3. Portions of North Building (Foreground) and South Building and Interconnecting Boiler House, Before Reroofing

Figure 4. Roof Ridge Showing Cracked and Flaked Coatings, Before Reroofing

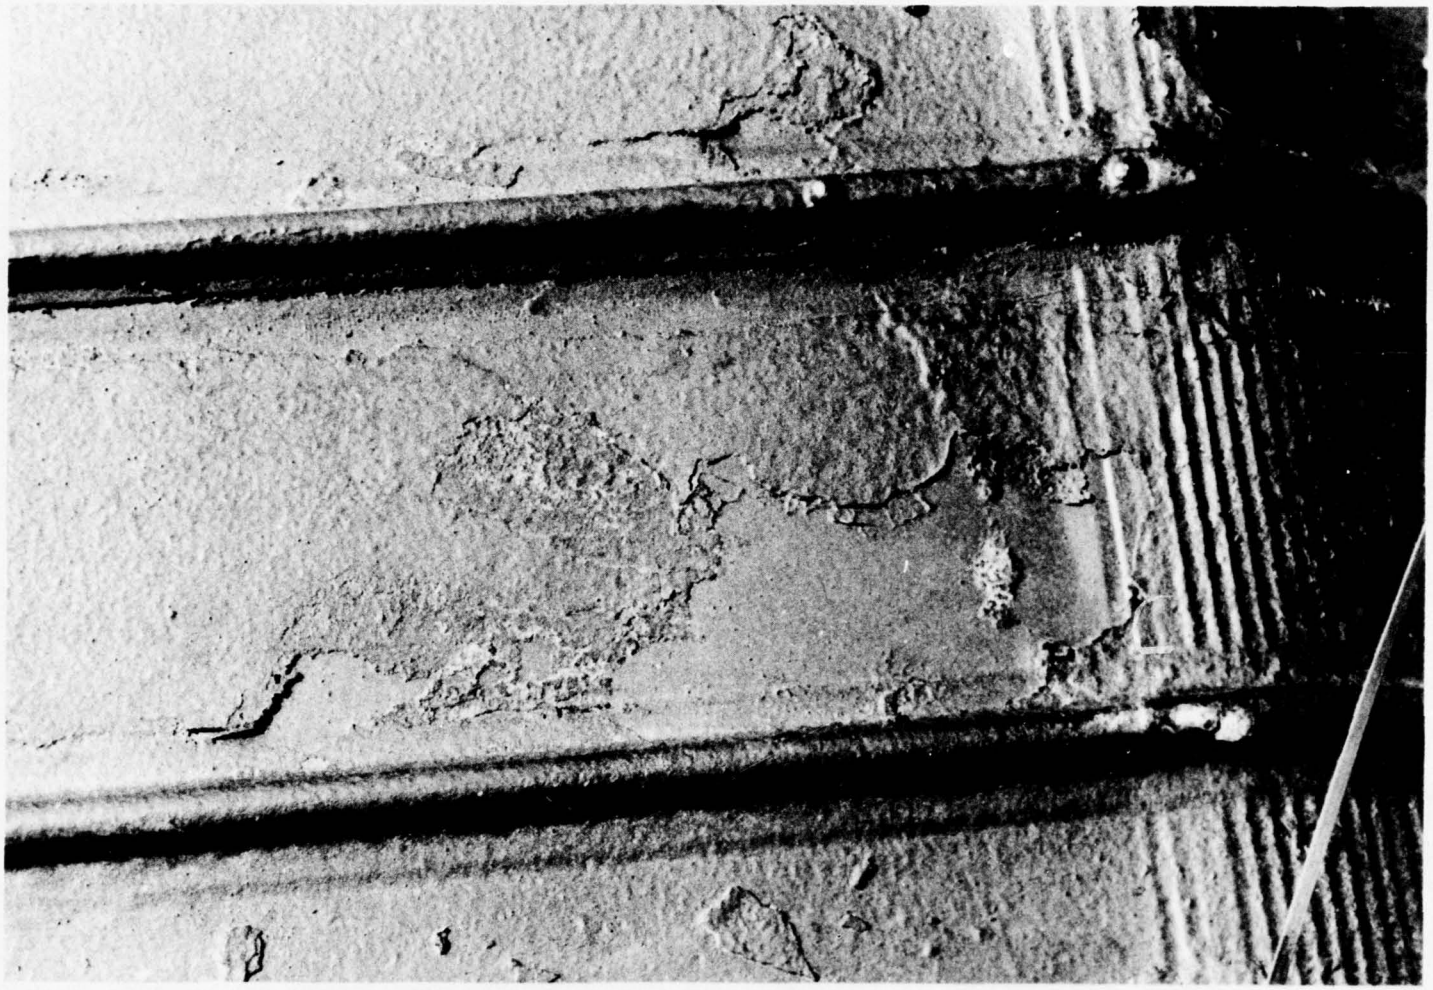
Figure 7. Loose Coating Caused By Asphalt Primer Solvent

Figure 8. Spot-Primed Areas Ready For Foam Application

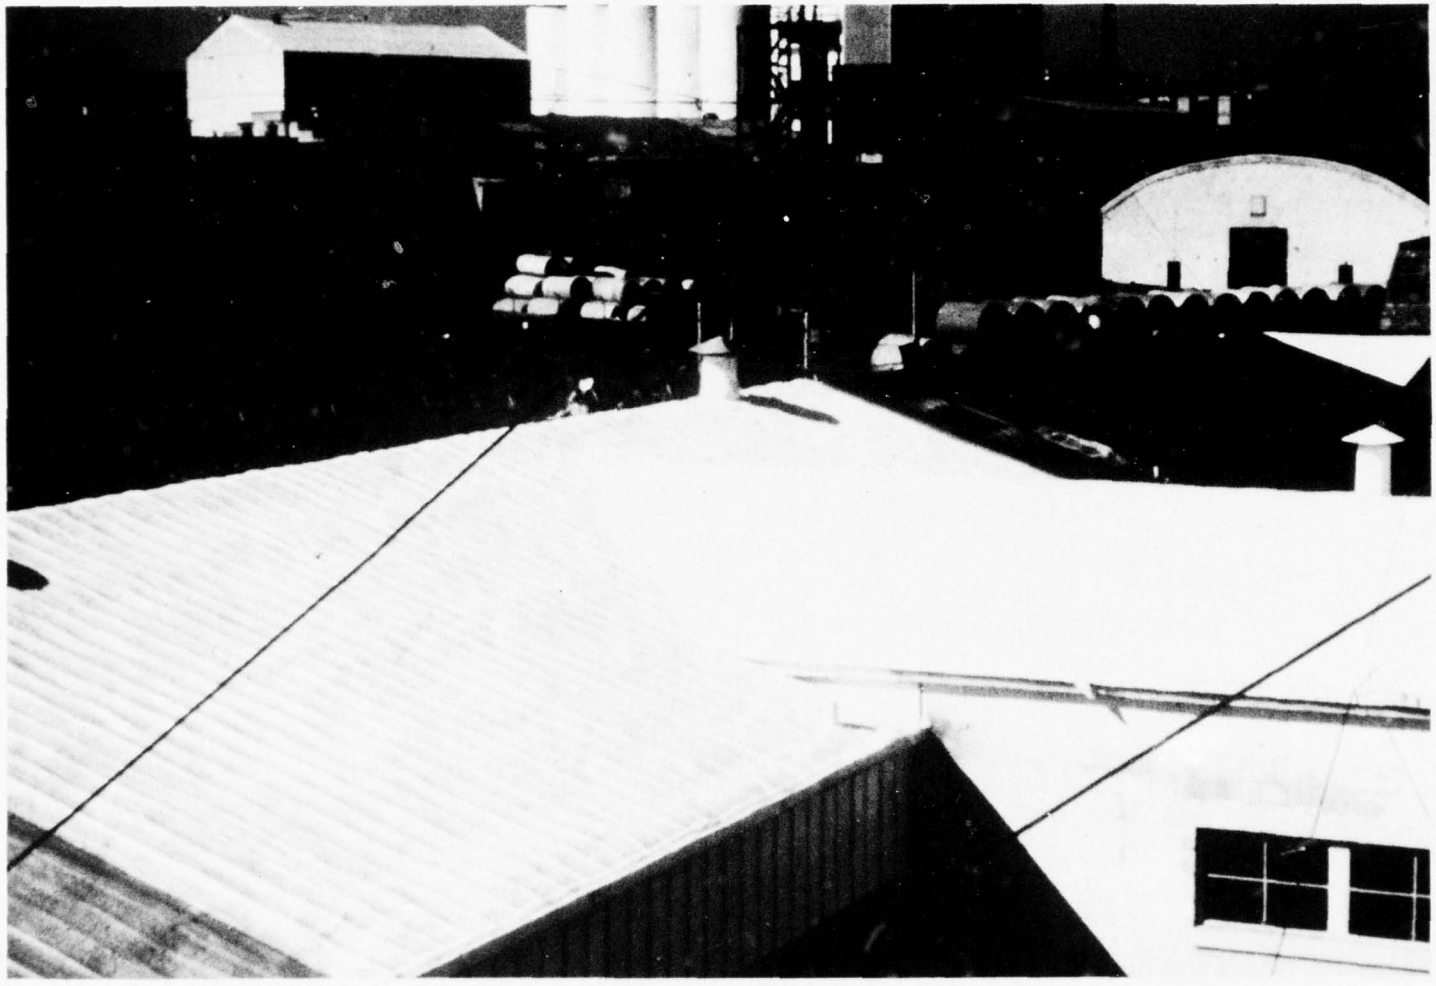
Figure 22. East Side of Junction of Boiler House and South Building

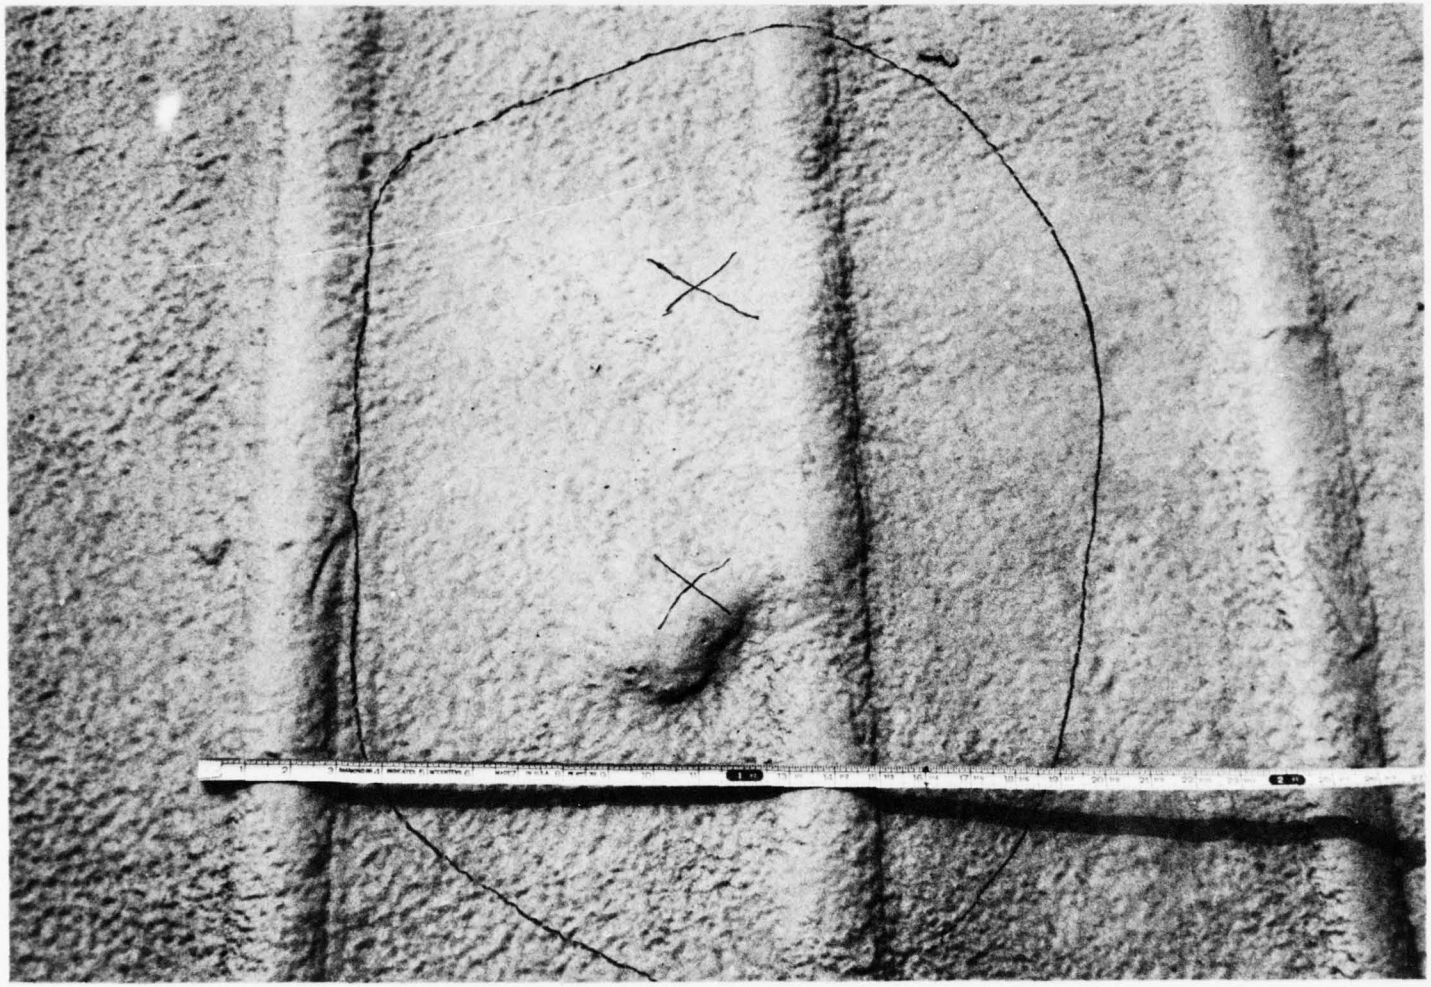
Figure 23. Soft, Spongy Area on North Side of System 1 (Without Granules) After 9 Months Weathering

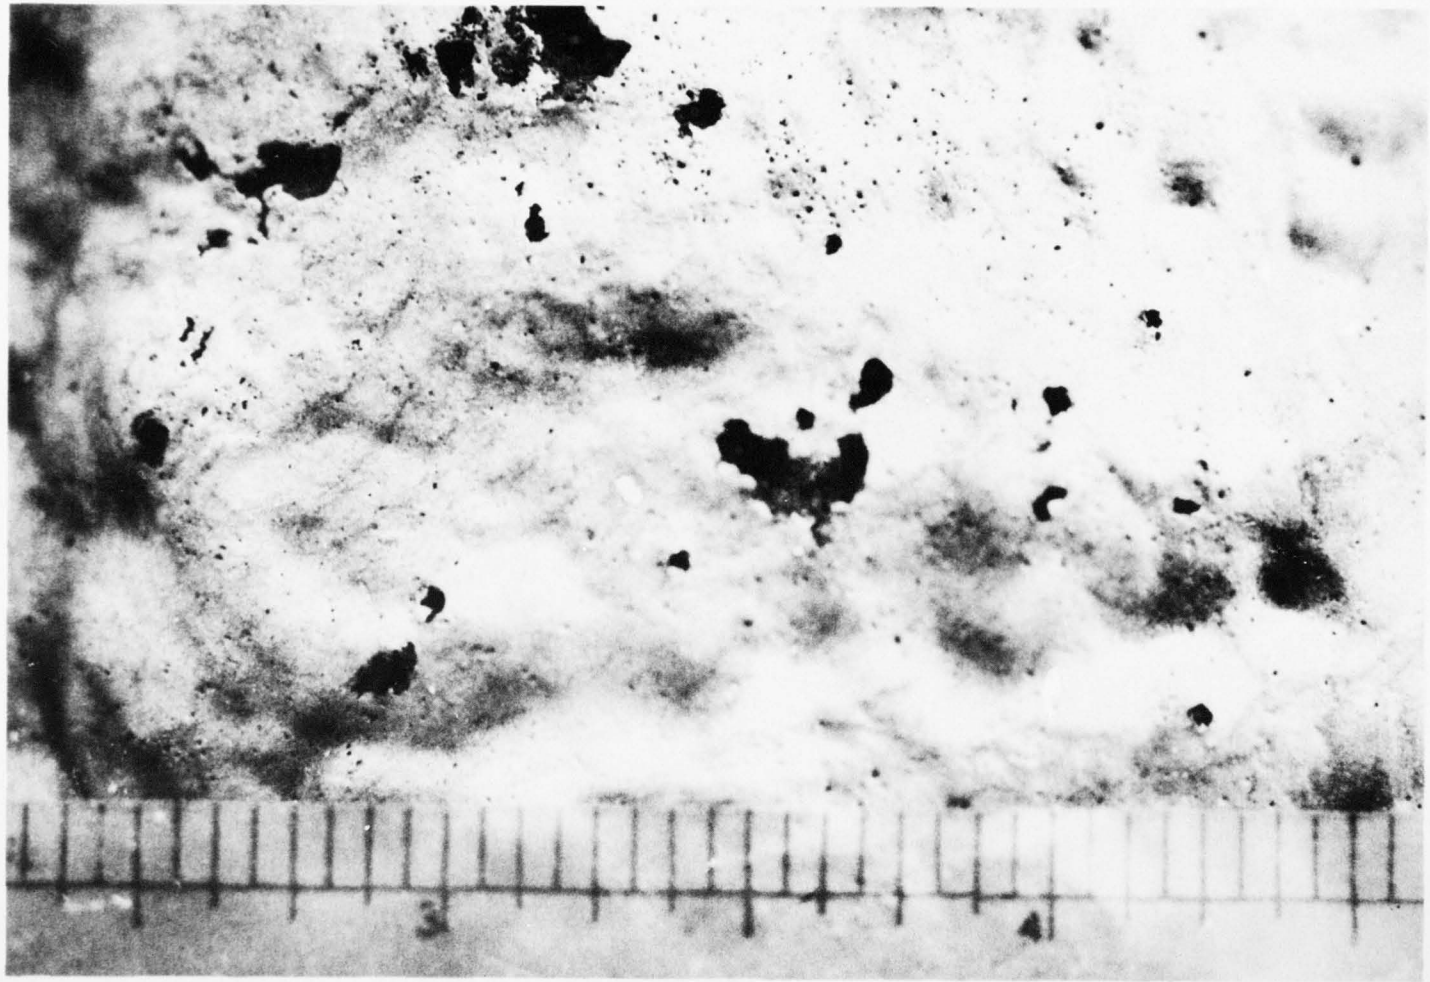
Figure 24. Deteriorating Catalyzed Silicone Rubber Coating Over Replaced Foam 12 Months After Application

Figure 25. Ponded Water Along Gravel Stop in the System 1 Section

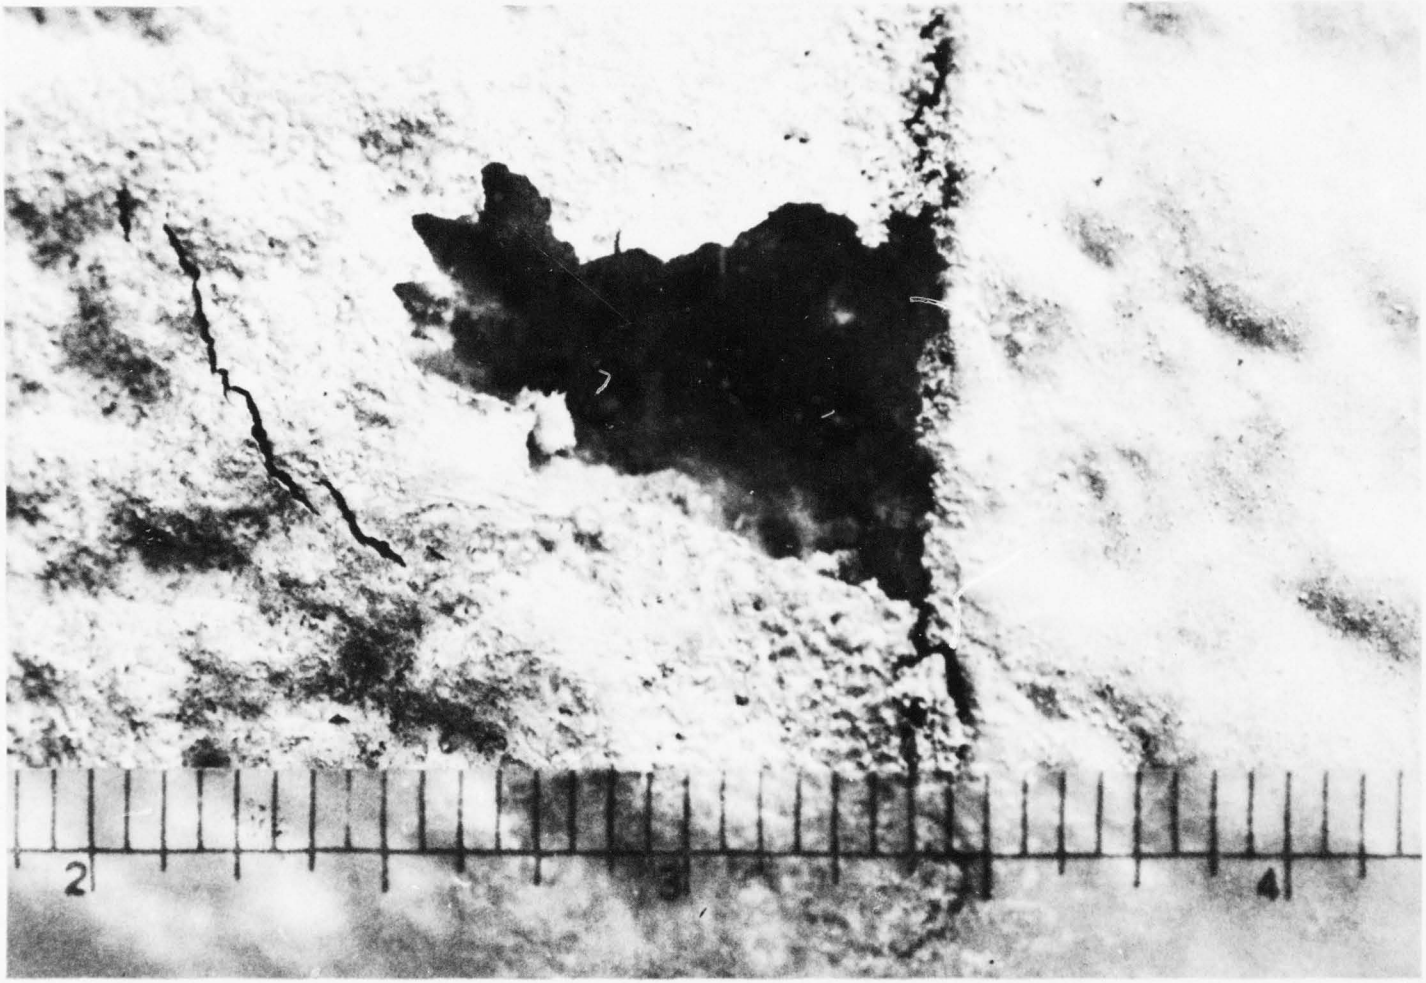
Figure 26. Close-up of Small Area Showing Bird Pecking in System 1 Section After 22 Months of Weathering

Figure 27. Damaged Areas in System 2 Section Caused by Sliding Snow and Ice

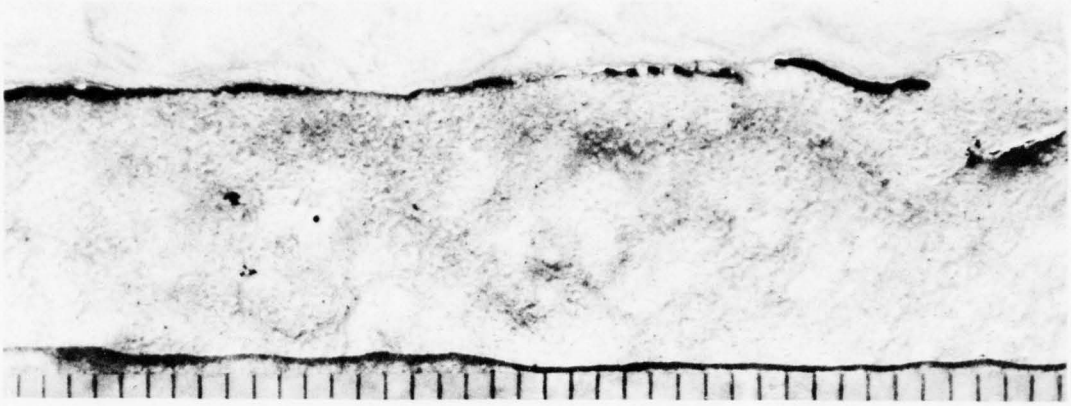
Overall, this moisture-curing silicone rubber coating is performing as well as that portion of the catalyzed silicone coating (System 1) without granules. Several things were observed in this section, however, that should be mentioned. One of these was cracking of the silicone coating in the bottom of the depression along the rib where the coating appeared to be thicker than usual, i.e., where it had run off the higher spots into the depression. This phenomenon, which was noticed during the 9-month inspection, was found in a very few isolated places. An example is illustrated in Figure 28, which shows the same crack in the moisture-curing silicone after 9, 18, and 22 months. The crack shown does not appear to be lengthening with time. This appears also to be true with smaller cracks in dimpled recessed areas. Since the silicones are so hydrophobic, it is doubtful that standing water will cause opening or extension of the cracks to allow water to enter the foam.

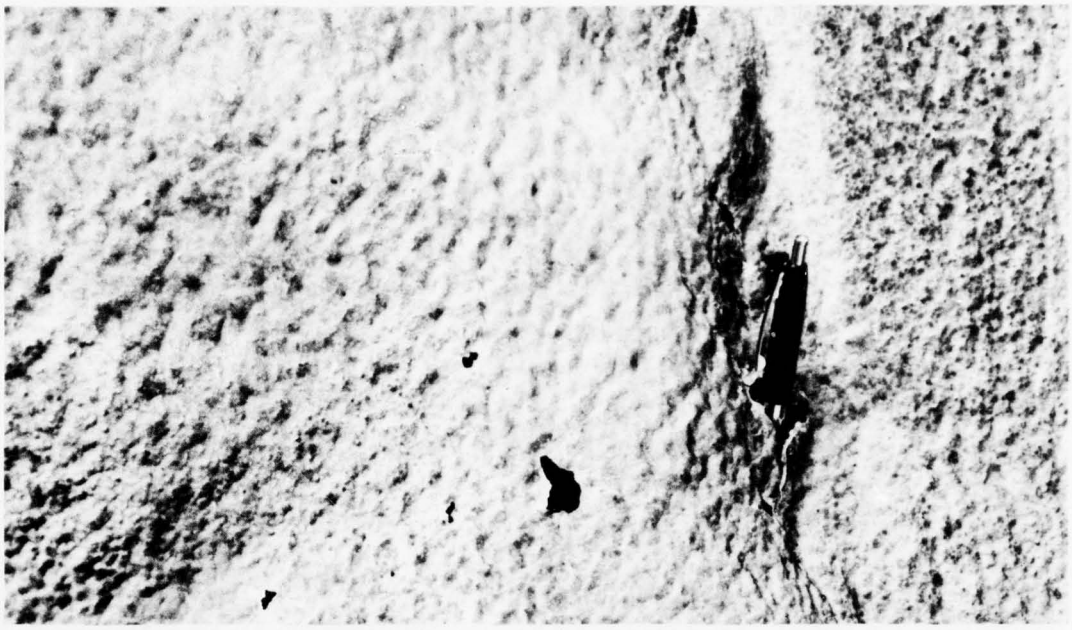
Figure 29. Two Cleaned Spots in System 2 Coating That Show Extent of Dirt Retention by Moisture-Curing Silicone Rubber Coating

By nature, silicone rubber coatings are tacky and, therefore, tend to attract and hold dirt. Thus, while the top coat of System 1 was originally cement gray in color and the top coat of System 2 was white, over a period of 22 months both had become a dirty dark gray. The dirt can be removed by washing with a detergent, as shown in Figure 29.

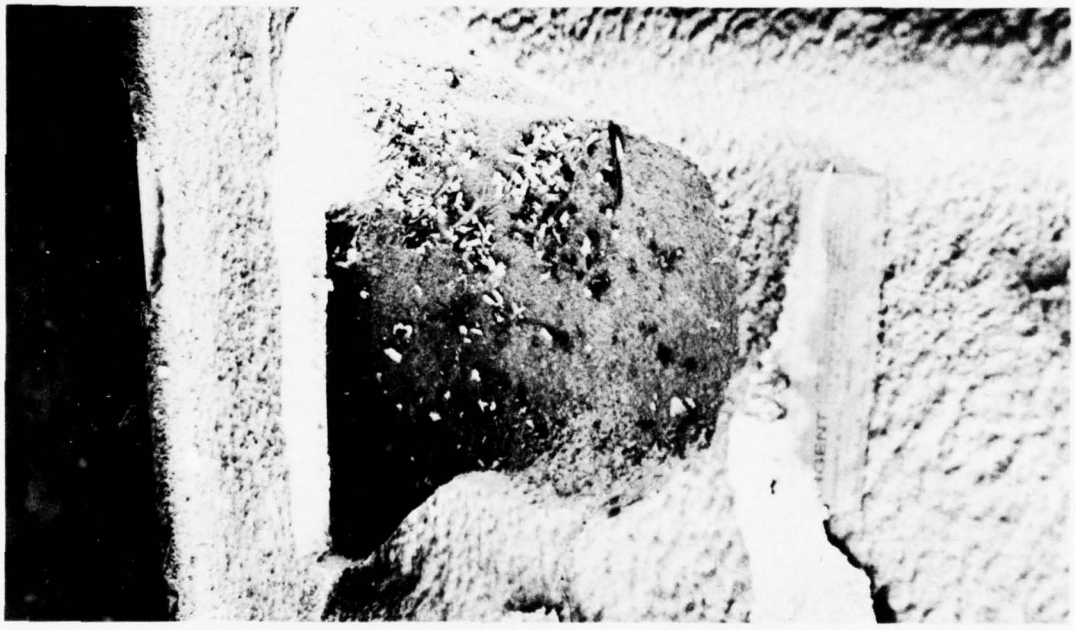
Figure 30. Area in System 2 Section Where Birds Pecked Foam From Beneath Gravel Stop

The largest instance of bird-pecking occurred in the System 2 section in a most unusual manner. Rather than pecking through the coating to reach the foam, the birds attacked the foam from underneath the gravel stop. The larger of two of these pecked areas is shown in Figure 30. Their repair is described in the following section.

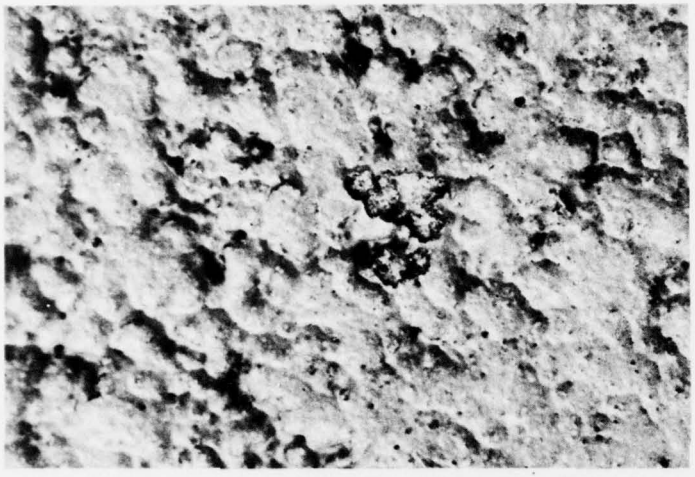
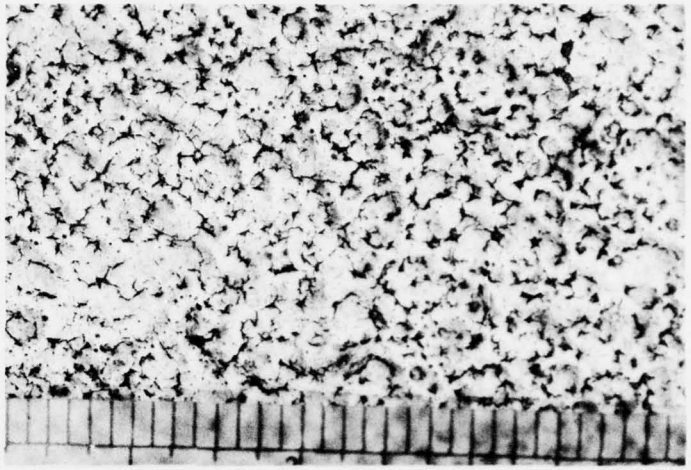
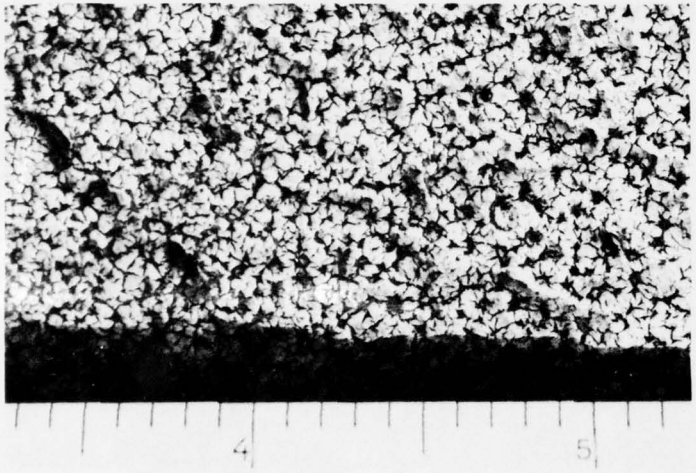
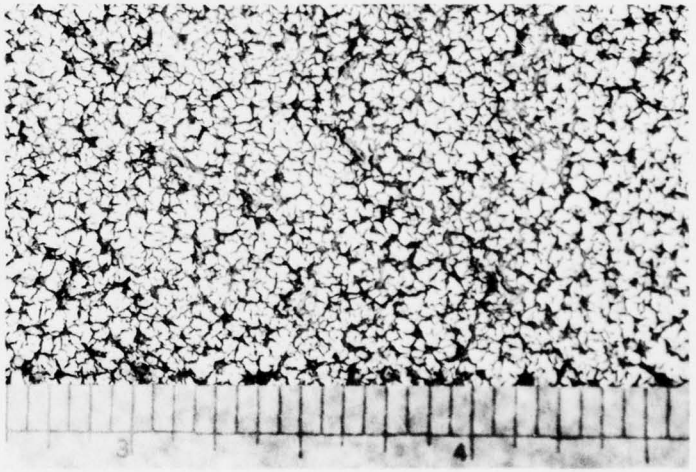
(a) Small Holes in Coating (Note Pen Protruding From Coating).

(b) Void Exposed When Coating Was Removed.

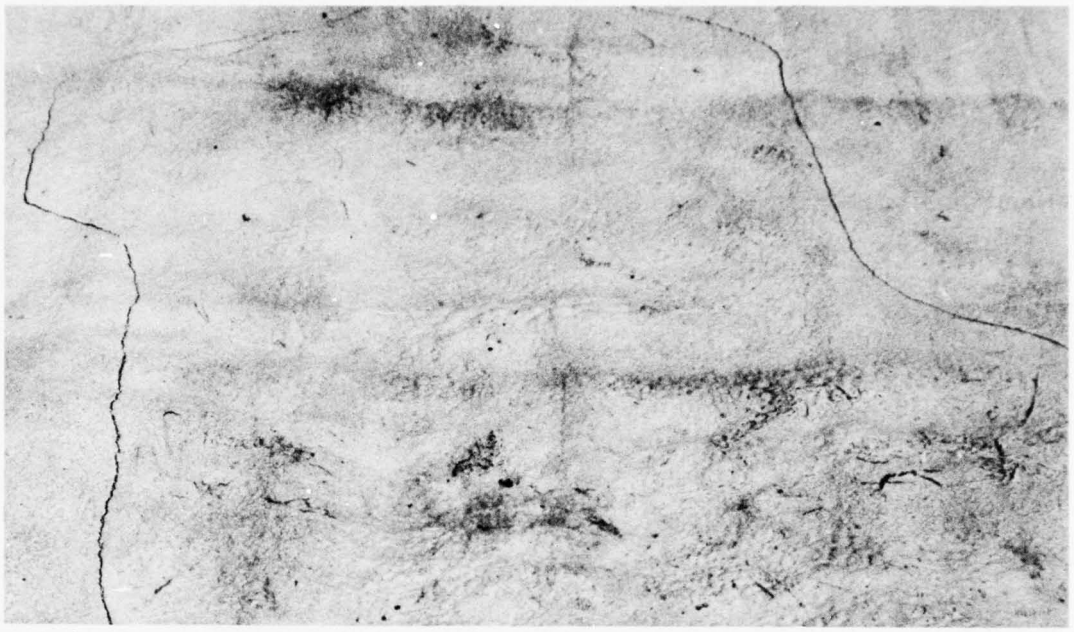
This system also had the largest areas in the experimental roof systems with poor quality foam. These are shown in Figure 32 and Figure 33. Figure 32 shows an area of about 10 square feet of spongy foam, while Figure 33 shows a relatively small area with blistered foam just below the area of spongy foam. In the latter case, the top lift of the foam had blistered from the lift underneath. These areas are believed to have been caused by improper proportioning of components of the foam during application. These areas have also been satisfactorily repaired by the contractor, and their repair is described in a following section.

Figure 32. Area of Spongy Foam on North Side of System 3 Section After 9 Months of Weathering

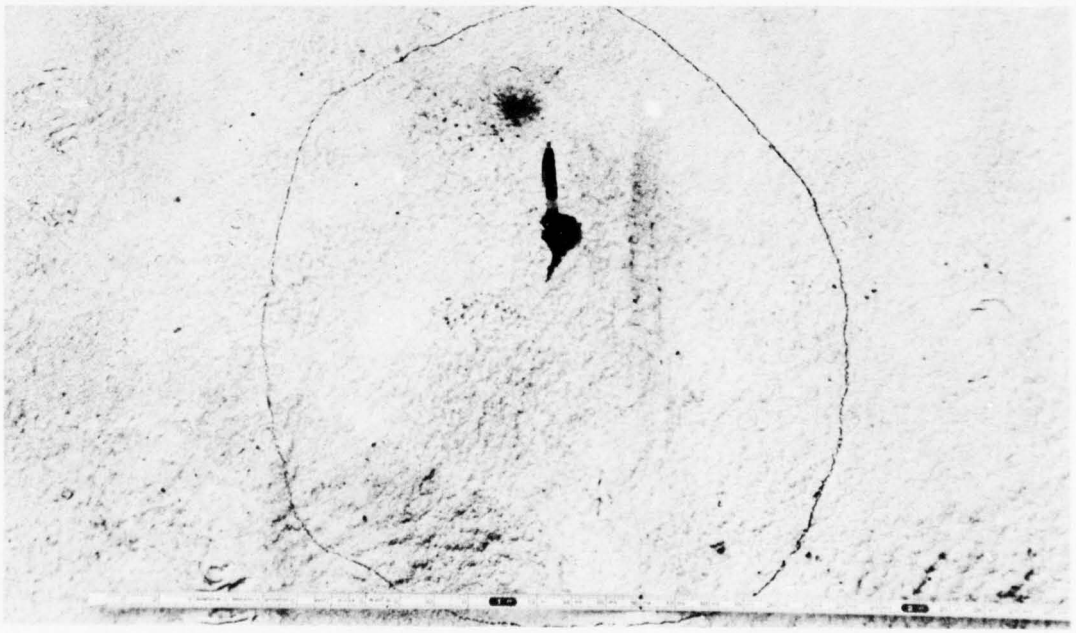
It was mentioned above that the hiding character of the top coat of this system was rather poor. Because of progressive checking, cracking, and eroding, the hiding quality of the top coat has been further reduced as shown in Figure 34.

Figure 33. Area of Blistered Foam on North Side of System 3 Section After 9 Months of Weathering

Figure 34. Overview of South Side of System 3 Section After 18 Months of Weathering

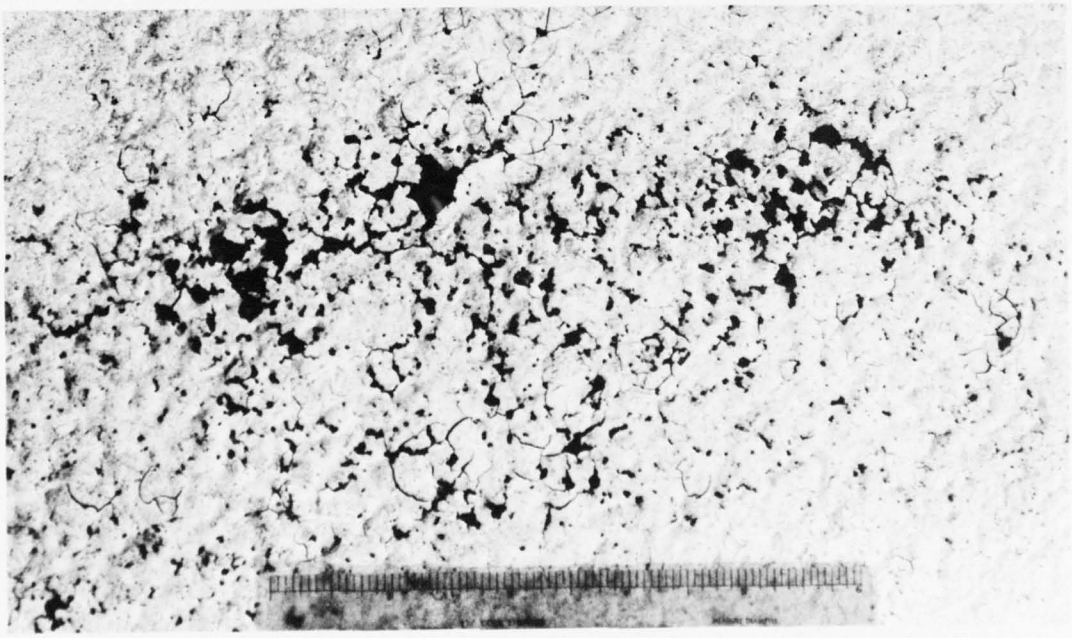
Figure 37. Close-up of Badly Eroded Portion of Hypalon Mastic, (System 4) After 22 Months of Weathering

Figure 38. Cracking of Hypalon Mastic (System 4) in Heelprint After 22 Months of Weathering
