ELECTRO-MECHANICAL LIFT SYSTEM VERSION OF THE DT II TRACK WIDTH MINE PLOW FOR M728 AND M60A1 COMBAT VEHICLES

FINAL TECHNICAL REPORT

June 1976

Chrysler Corporation
Defense Division
P.O. Box 1316
Detroit, Michigan 48231

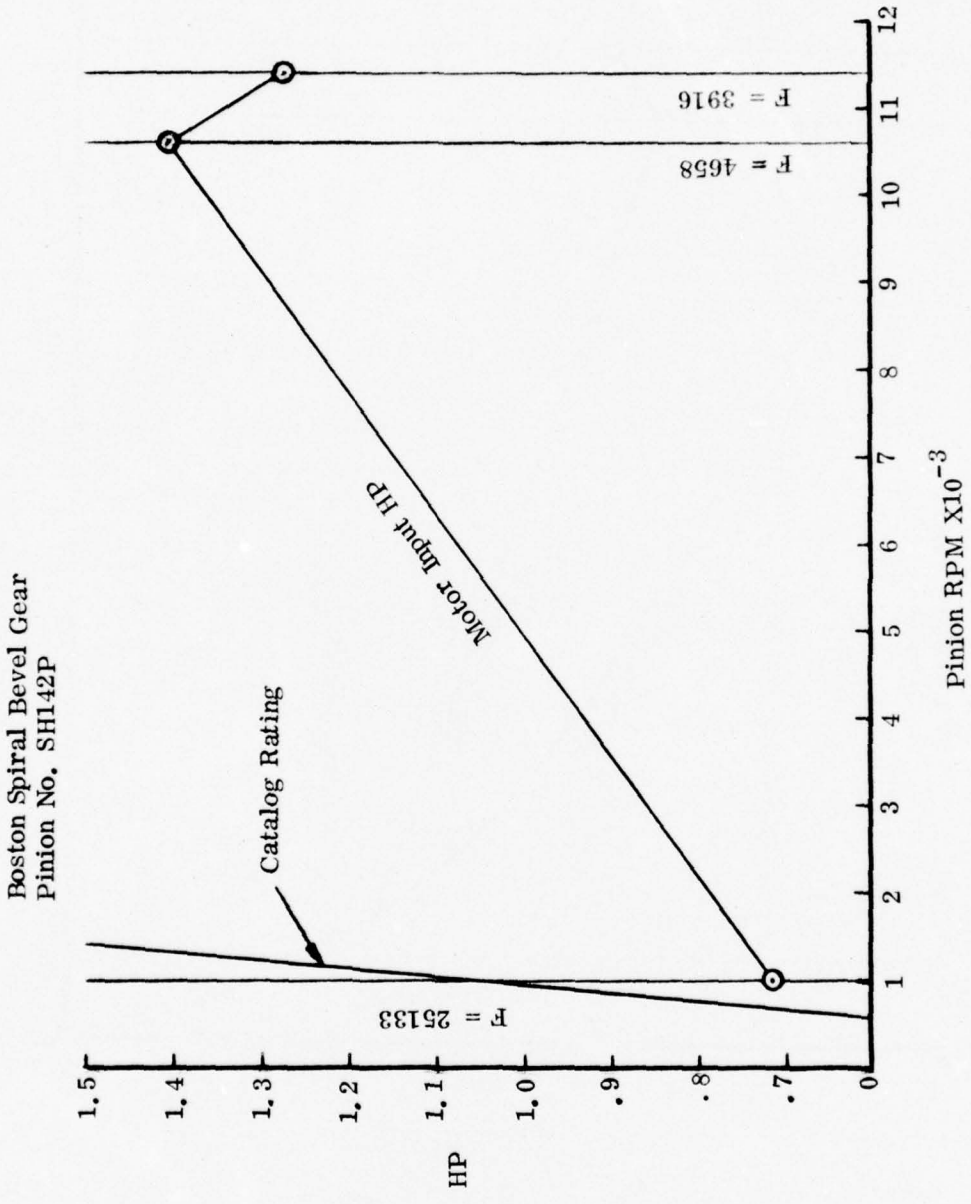
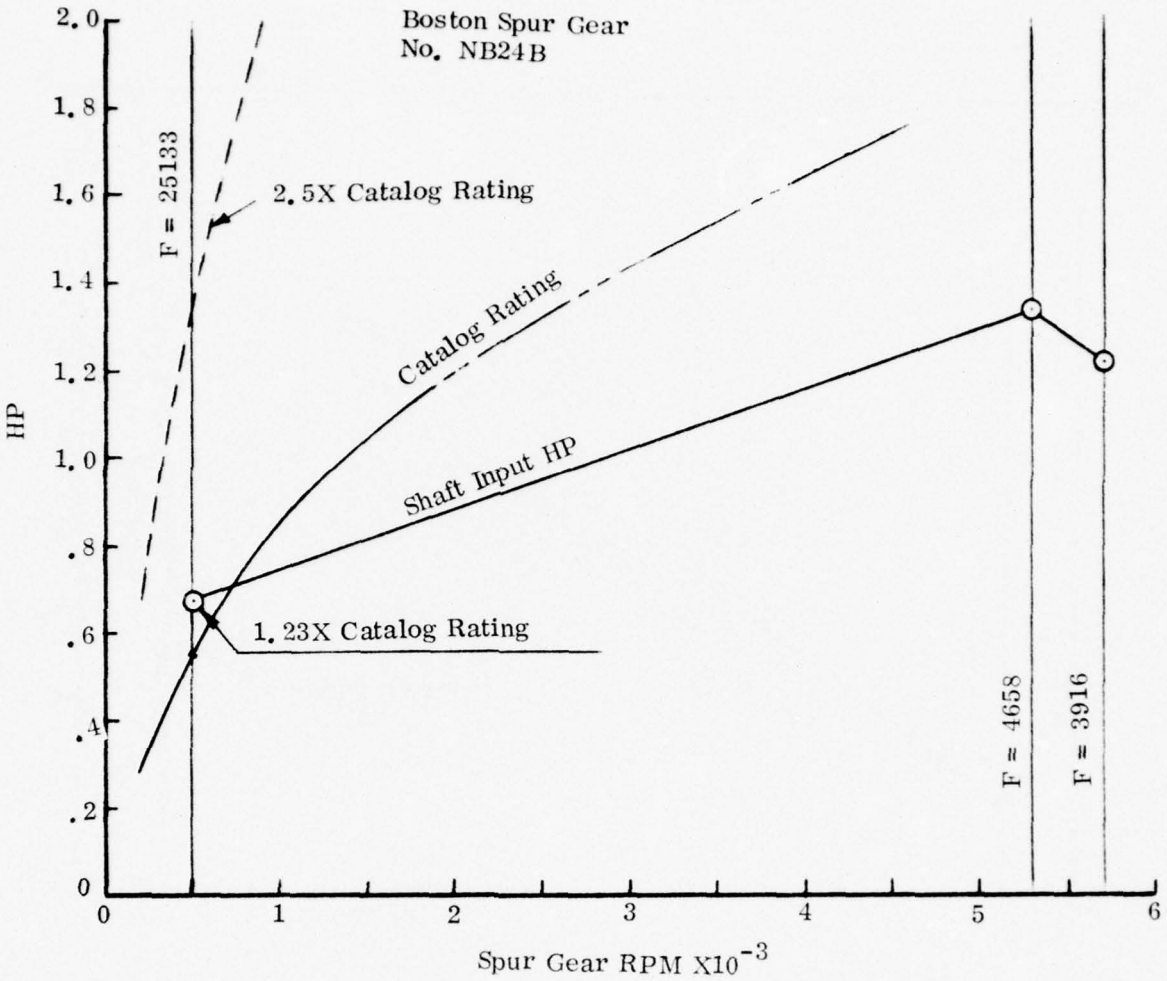
From figure 12 it is seen that the imposed load on the spiral pinion is below the catalog rated curve. Figure 13 shows that there is a 23 percent overload at the maximum dynamic BBSM screw load and then the load falls below the catalog rating shortly after. Figure 14 shows that the worm gear is overloaded throughout the duty cycle, with more overload at the static loading condition. The shape of the rating curve on figure 16 is extrapolated from 1,800 rpm to 5,700 rpm but is considered to be below the 250 percent rating curve since this is the case prior to 1,800 rpm.

Considering that the static load includes an assumed 400 pound dirt load and that the maximum lifting time is approximately 16 seconds (less without the dirt) it is concluded that this overload condition is critical but could function in a controlled test program. In the production design this marginal condition can be avoided if a stronger set of gears is specified.

Figure 12. Spiral Bevel Pinion Gear Loads

Figure 13. Spur Gear Loads

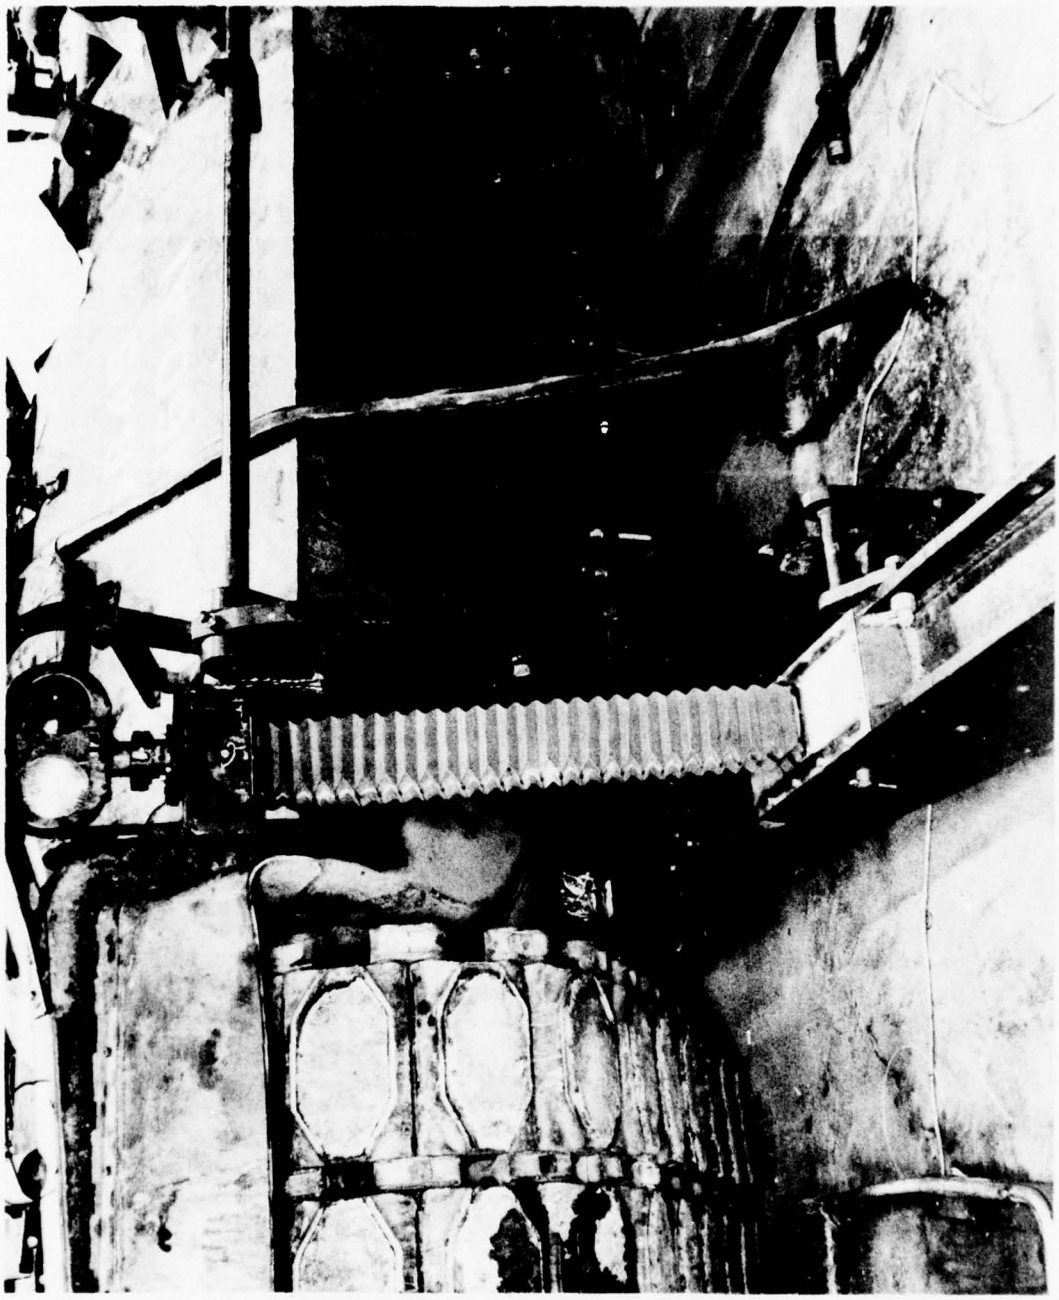
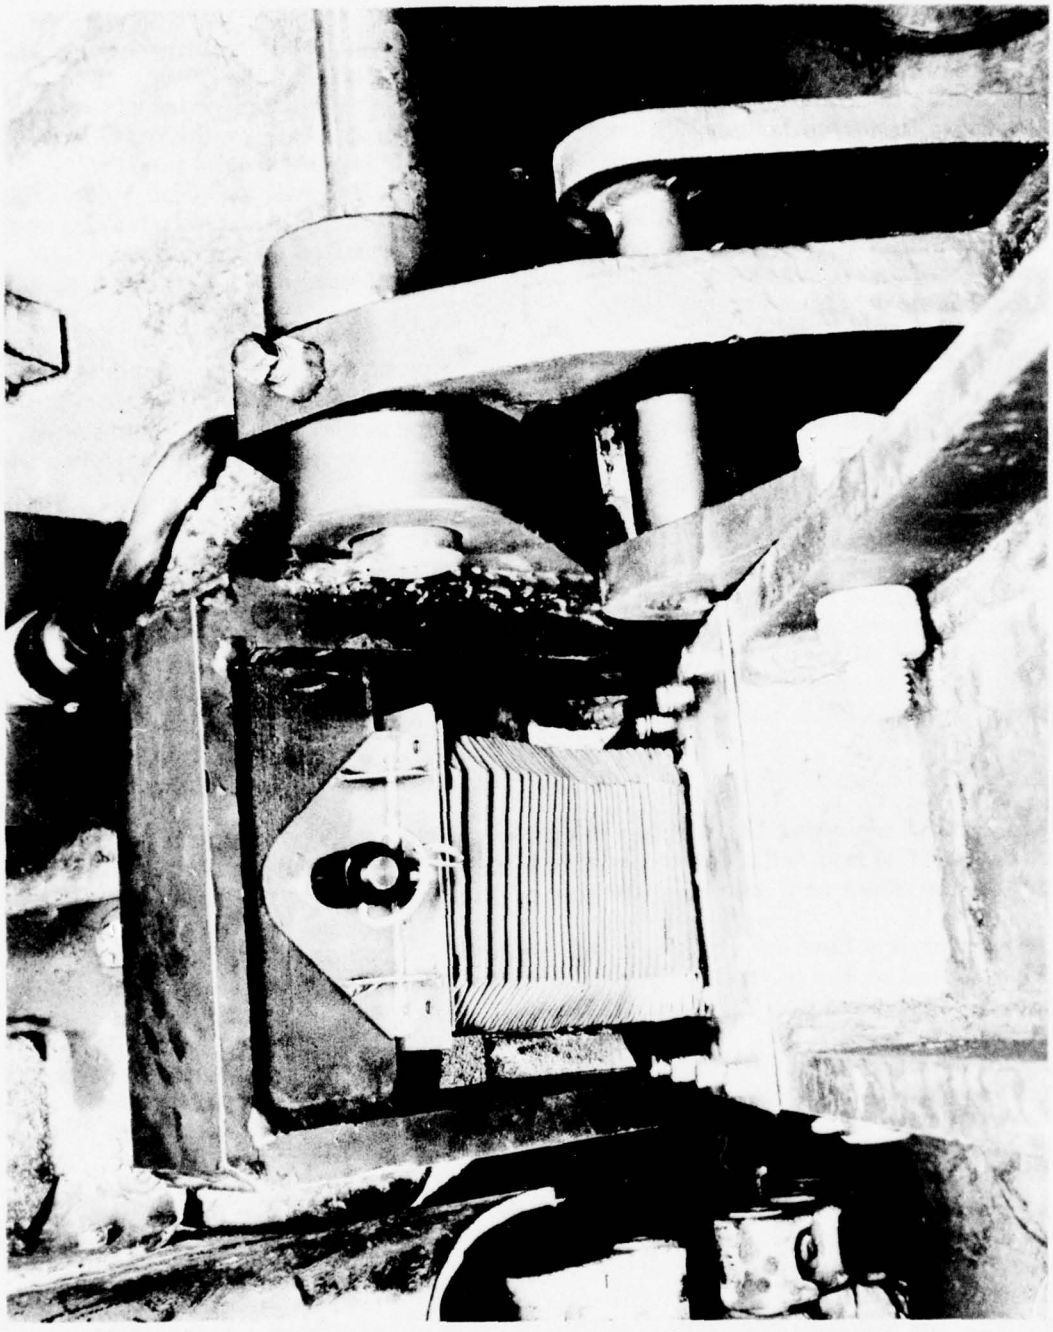
The DT-II EPR's on lift chain failures reveal three problem areas: The chain cannot take lateral flexual loads, the bare carbon steel chain rusts, and the chain leaf link interstices act as carriers to bring mud and debris into the pushbeam cavity. The solution to the lateral load problem was solved by using a pin joint at the upper chain attachment point. The solutions to the rust and debris problem required a survey and evaluation of various concepts and approaches.

An initial chain antirusting approach tried was to clean and degrease, apply a phosphate coat per MIL-P-16232 and finish with a baked-on-solid film lubricant per MIL-L-46010. This was done at Ft. Knox on completely assembled chains. Unfortunately, this process could not protect the metal surfaces at the chain components which touch each other, thus rusting still occurred at these points.

Figure 18. Protective Boot System (Lowered)

Figure 19. Protective Boot System (Raised)

The best approach under the circumstances was to select the protective boot system (figures 18 and 19). This approach presumes that if the present chain, originally greased, is protected from the environment it should not readily rust and the boot itself will prevent mud and debris from entering the pushbeam. Along with this presumption, the pushbeam itself would be reworked in a manner to hinder any mud or debris from entering from other directions.

The boot concept had one major drawback. The boot, when compressed, requires a finite space and this space was not available on the TWMP lift system in the plow up position. Either the upper chain attach point had to be extended to accommodate this compressed boot dimension, or the maximum plow-up position had to be lowered and a longer travel lock hook made to reach the lower positioned plow. The first alternative was selected, primarily so as not to degrade the vehicle's stowed plow mobility. Accordingly, the upper chain mounting point was raised on the mounting bracket with an appropriate weld-on bracket. A quick disconnect pin is used at this upper joint to eliminate the side flexural load on the chain.

The lower end of the boot is attached to a sliding plastic plate to accommodate the change in chain orientation as the pushbeam is raised. This plastic plate moves in a channel bracket which is bolted to the pushbeam. The entire boot assembly can be rapidly replaced in the field by removing this channel bracket and the upper chain pin connection.

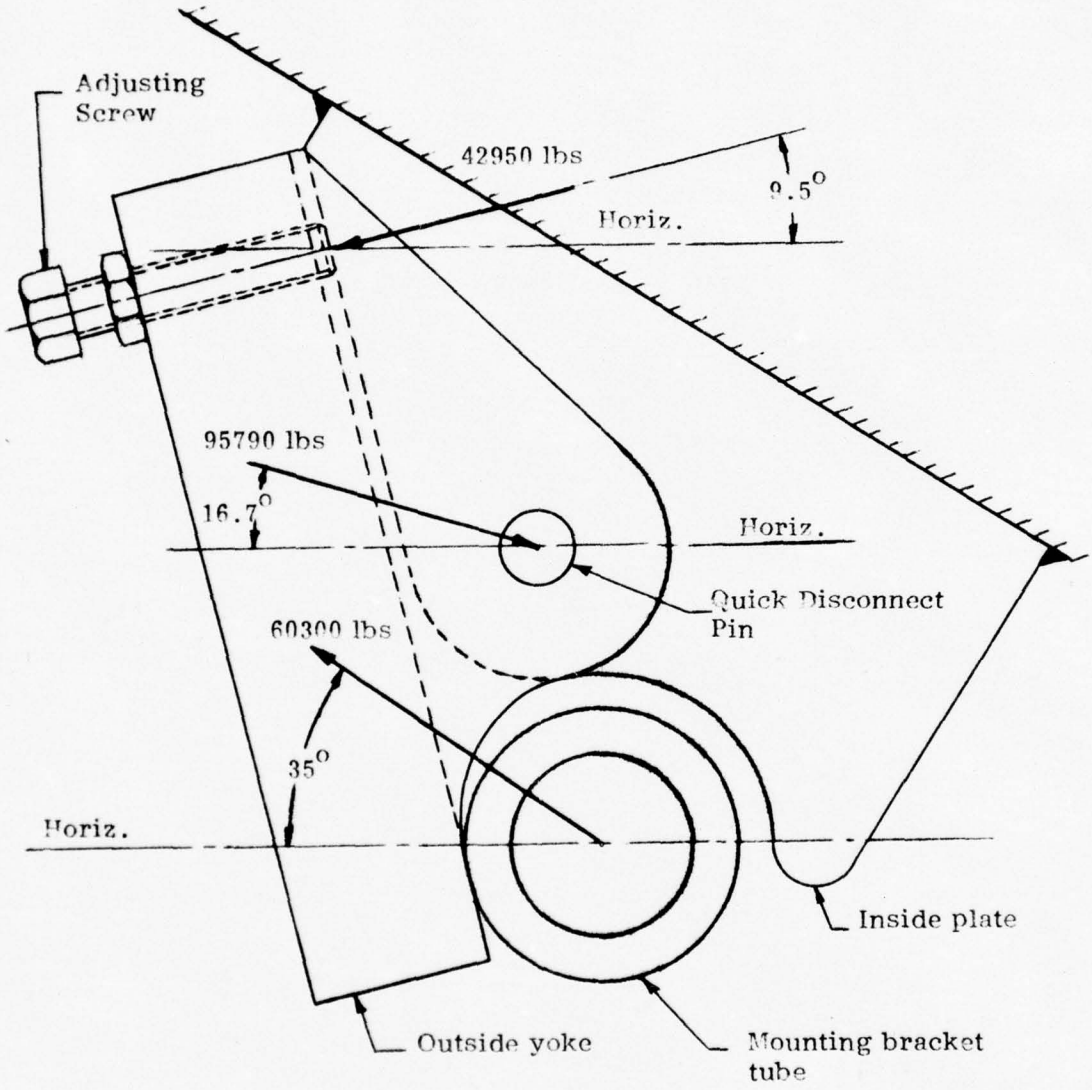
Figure 20. Center Clevis NASTRAN Design Forces

The center clevis concept functioned correctly to prevent tube failures but the unit itself created some undesirable shortcomings, notably the long quick disconnect pin had a tendency to take a permanent bend and made disassembly/assembly very difficult. In addition, the unit was very heavy and the adjustment bolt was difficult to work when it became rusty.

The new center clevis design is very similar to the original design. The unit size and weight have been reduced, the quick release pin was shortened considerably, and the adjustment bolt, with a new jam nut, was arranged for access with a box wrench. This unit was fabricated and shipped to APG along with the TWMP test system.

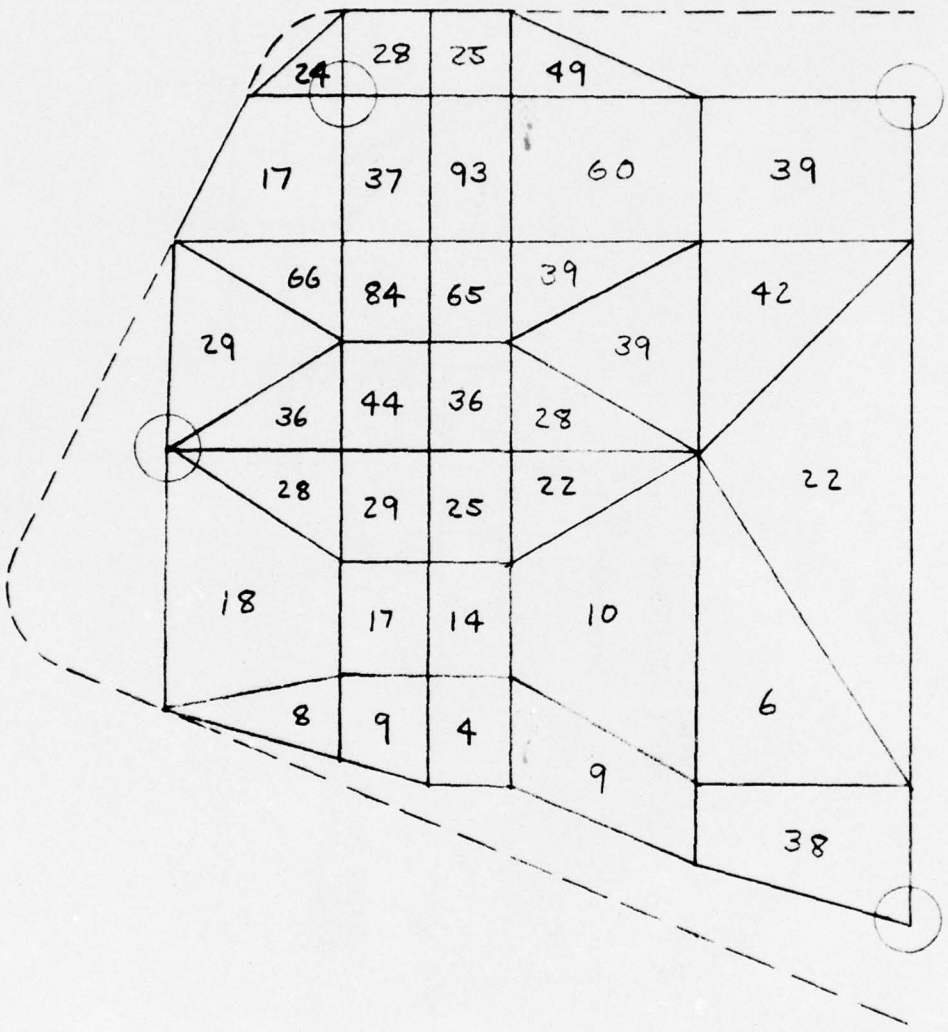
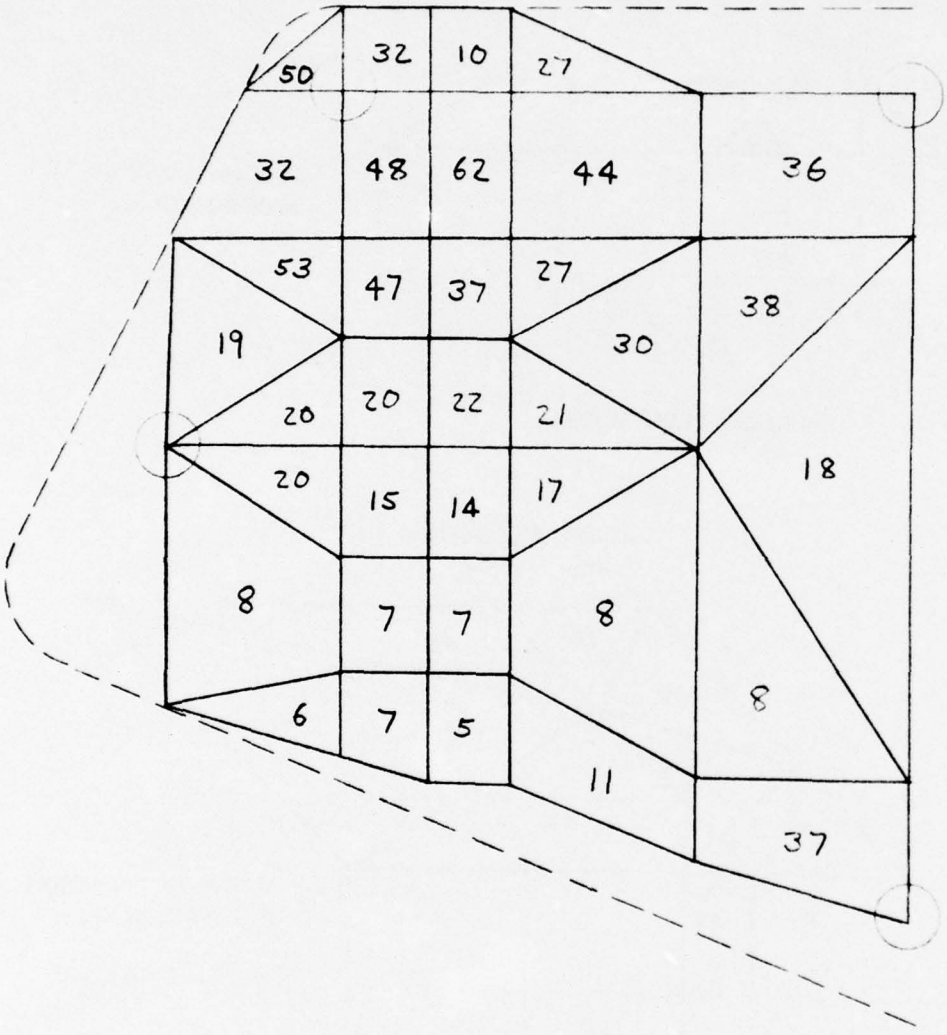
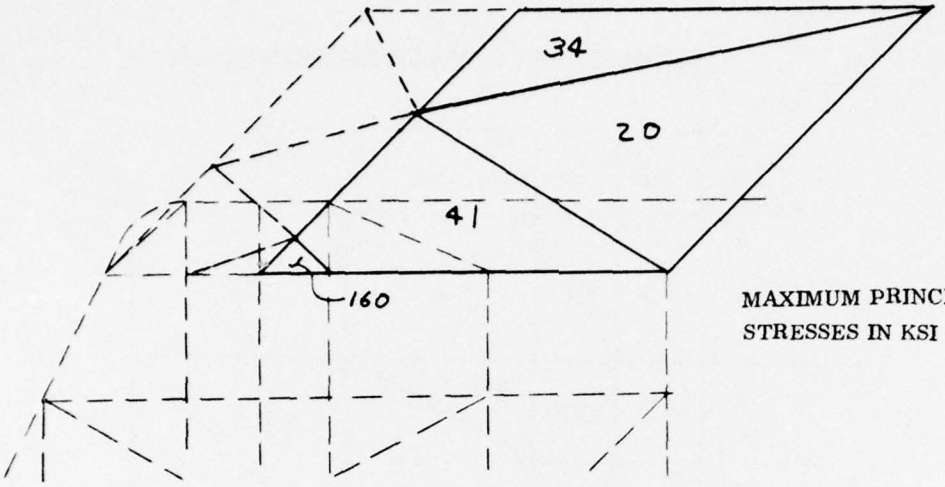
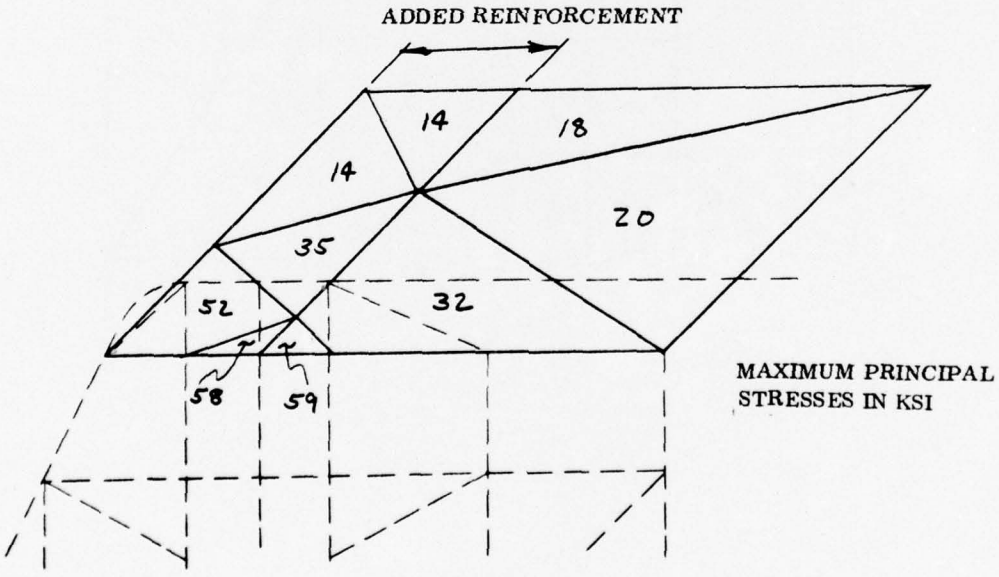
Figure D-8. Comparison of Pushbeam Stresses

Figure D-6. Pushbeam Stresses Baseline Plow Model

Figure D-7. Pushbeam Stresses After Addition of Reinforcement

The changes to the pushbeam include structural modifications to correct DT-II test failures, changes to accommodate the E-MALS actuator unit, and alterations to install the chain/boot attachment bracket. The basic shape and size of the pushbeam was not altered.

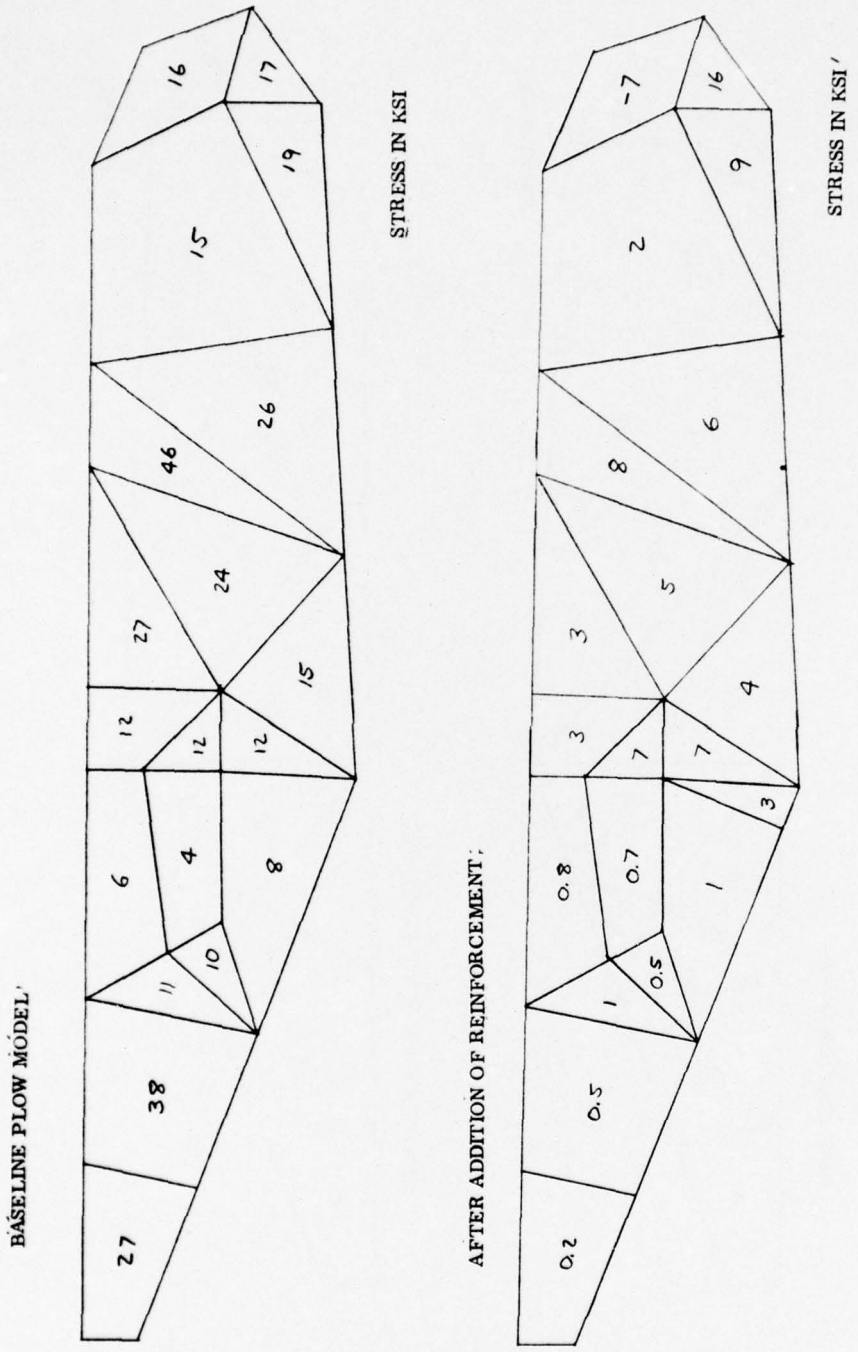
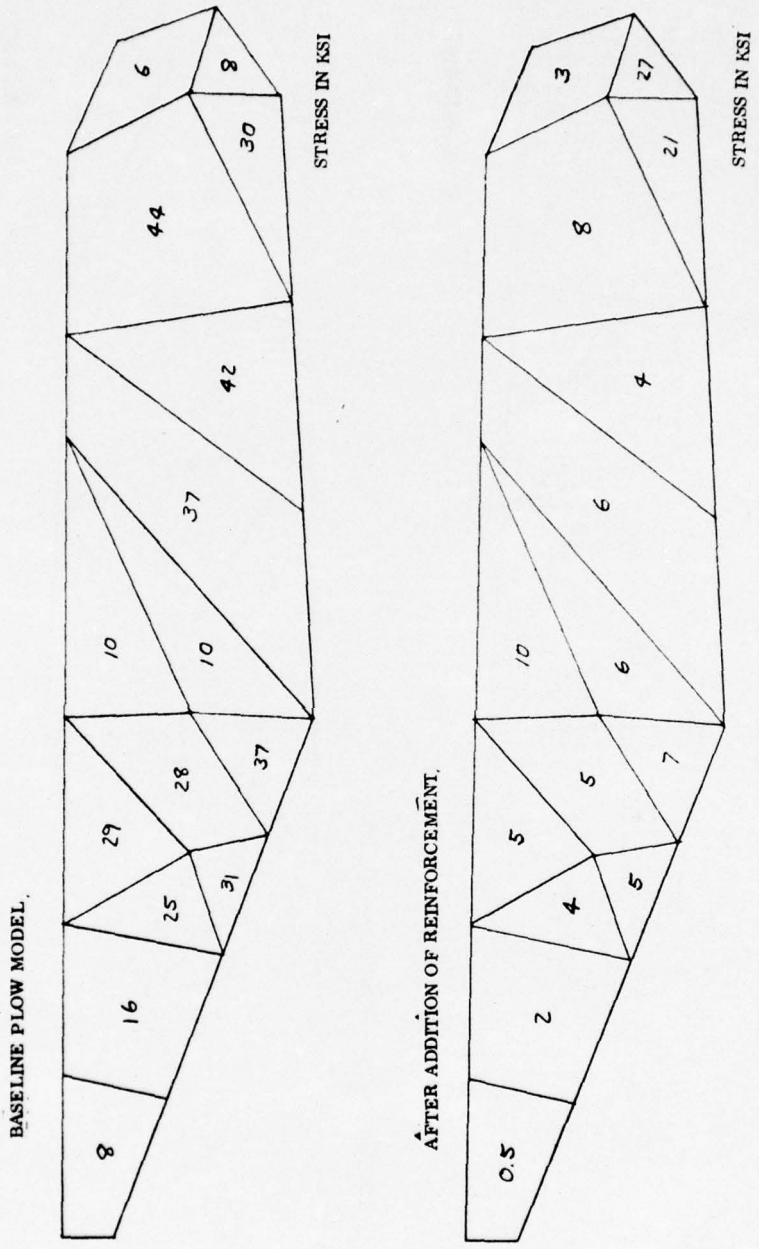
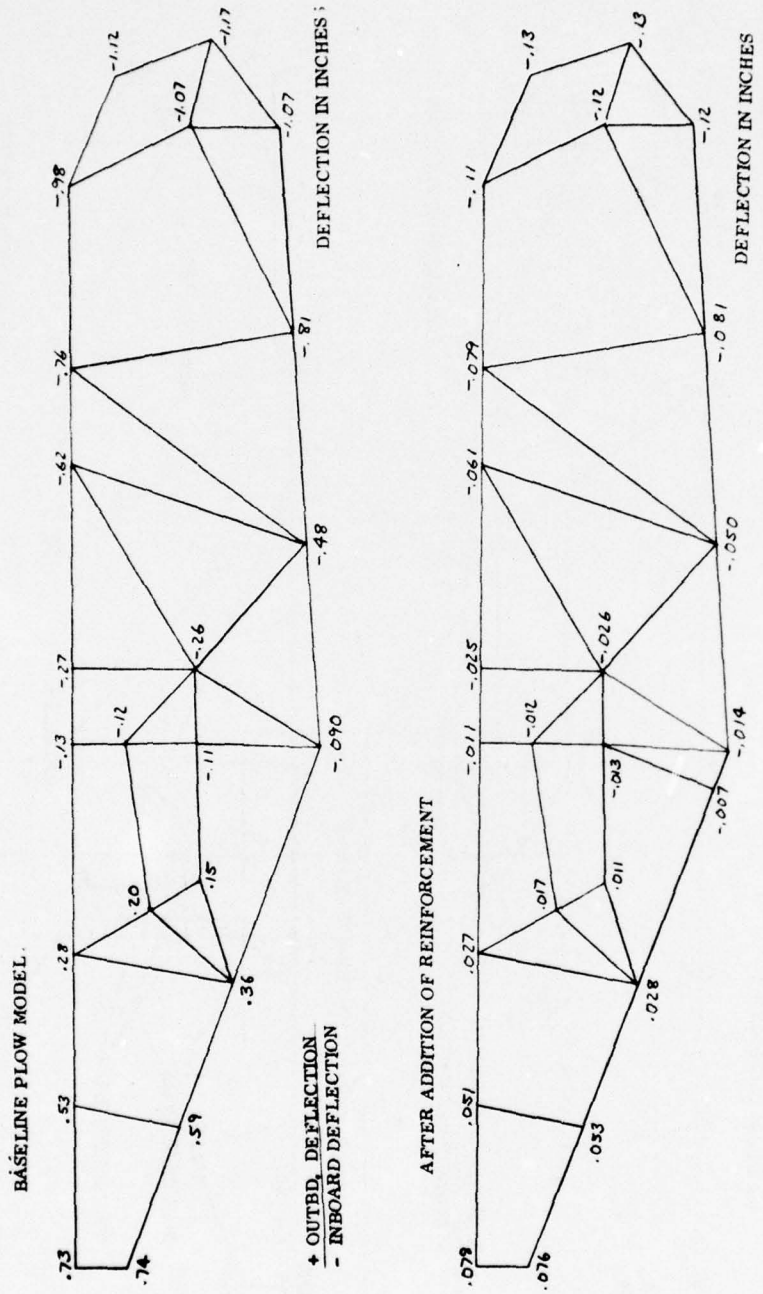
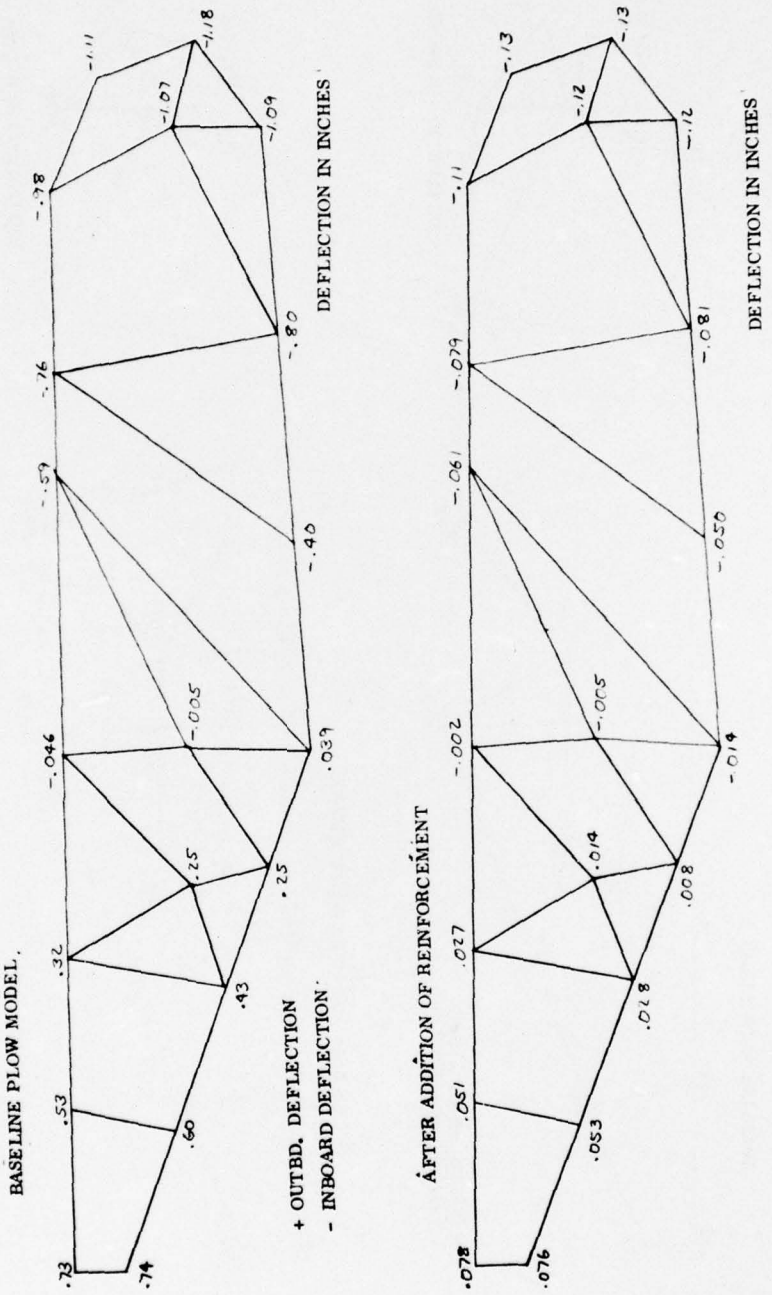
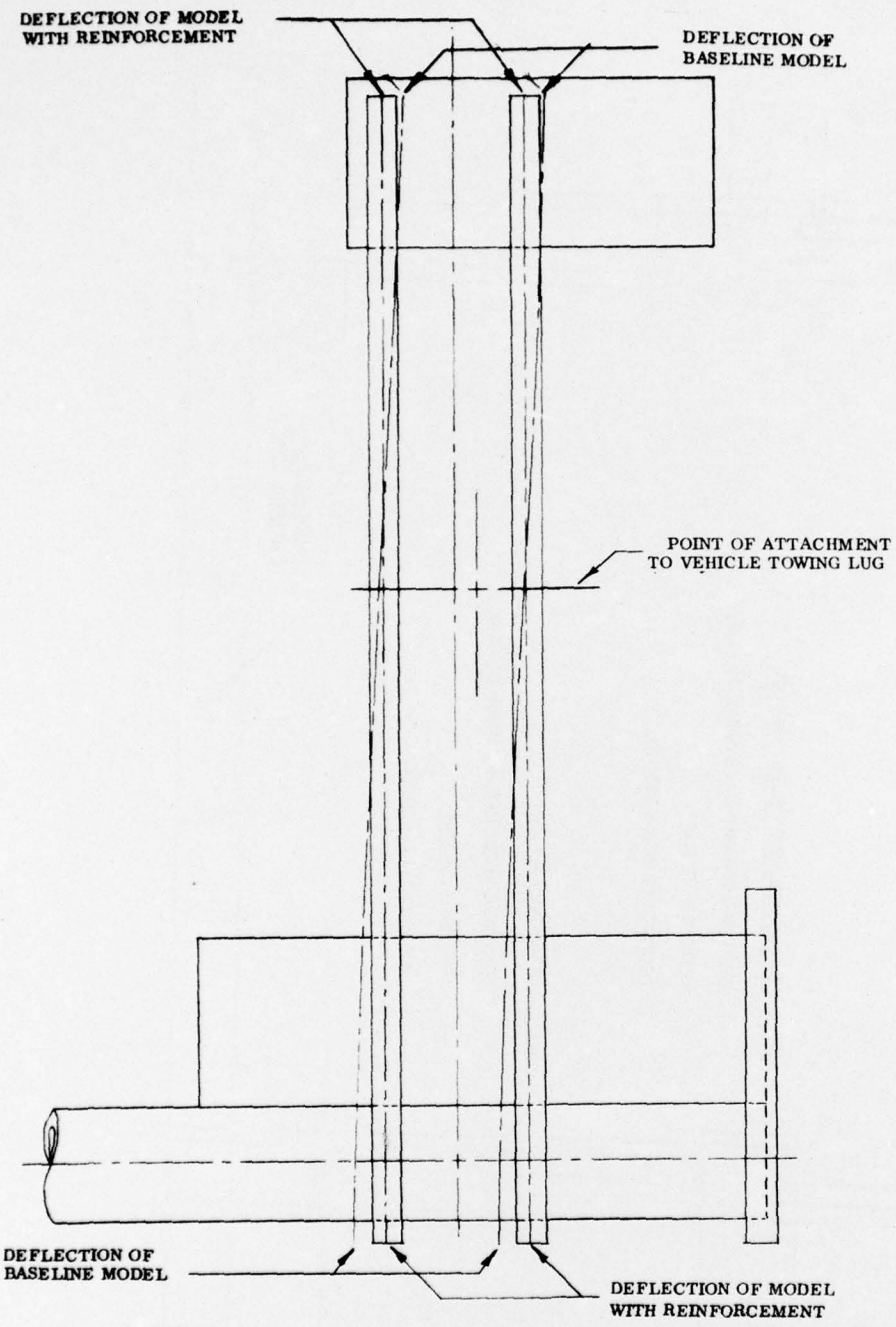
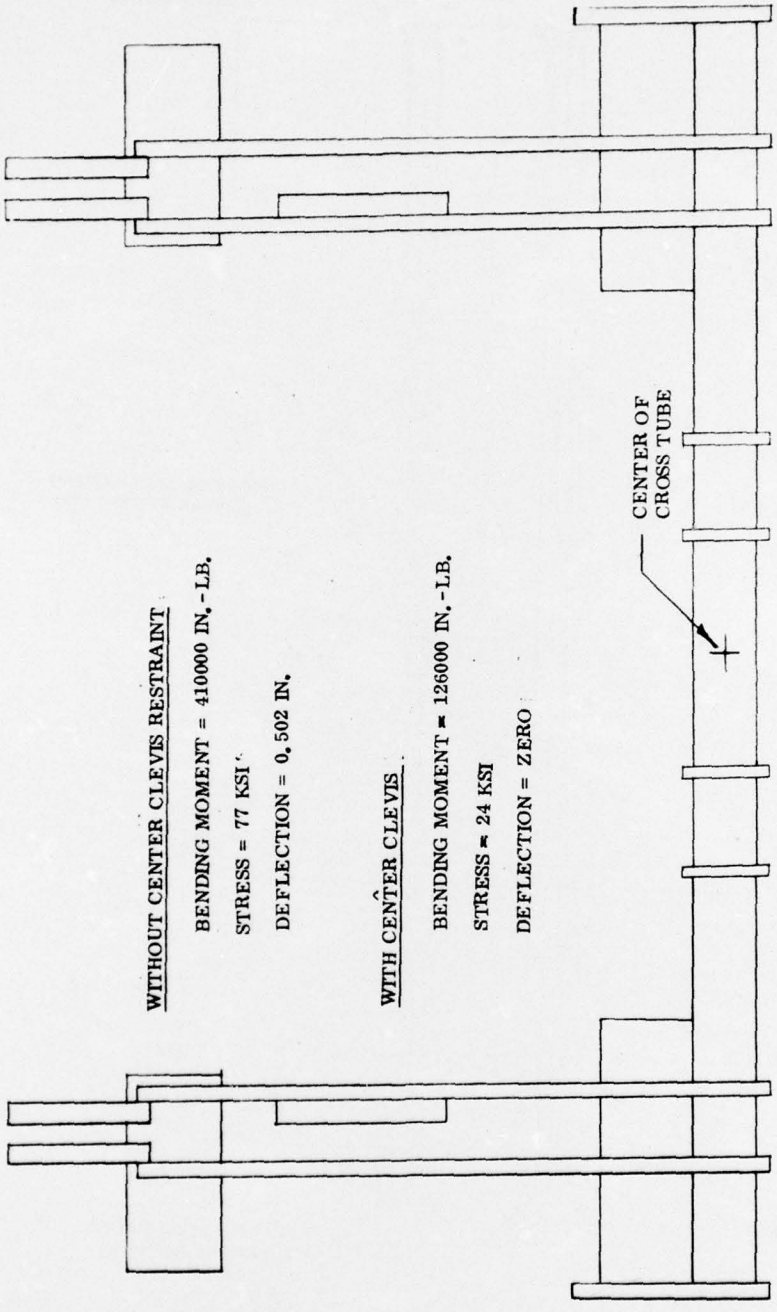
Since the 4-inch tube on the mounting bracket is located too far from the hull for an effective center clevis installation, the tube bending failures were solved by increasing its section modulus. A tee section is welded along its length to provide additional bending resistance in the direction of loading.

Distortion failures of the vertical sides of the mounting brackets are eliminated by the addition of a structural plate along its backside, which essentially results in a channel section. This addition is deemed sufficient to carry the case 1 loads imposed.

Figure D-9. Maximum Principal Stress in Mounting Bracket Inside Piece TD 135932-3

Figure D-10. Maximum Principal Stress in Mounting Bracket Outside Piece TD 135932-4

Figure D-11. Mounting Bracket Grid Point Deflection Normal to Plane of Plate - Inside Piece TD 135932-3

Figure D-12. Mounting Bracket Grid Point Deflection Normal to Plane of Plate - Outside Piece TD 135932-4

Figure D-13. Mounting Bracket Lateral Deflection Based on Nastran Results

Figure D-14. Bending Stress at Center of Lateral Cross Tube

Since plow side load component is transferred to the vehicle at the mounting bracket-vehicle lug interface it is recommended that the large gaps between the lug and bracket sides be filled with shims. Based on the NASTRAN results for the M60A1 plow mounting bracket reinforcement, it is recommended that similar reinforcement be added to the M728 mounting bracket to the extent possible.
