TECHNICAL REPORT H-76-17

SLUICE PRESSURES, GATE VIBRATIONS AND STILLING BASIN WALL PRESSURES LIBBY DAM, KOOTENAI RIVER, MONTANA

October 1976
Final Report

Prepared for U. S. Army Engineer District, Seattle
Seattle, Washington 98124

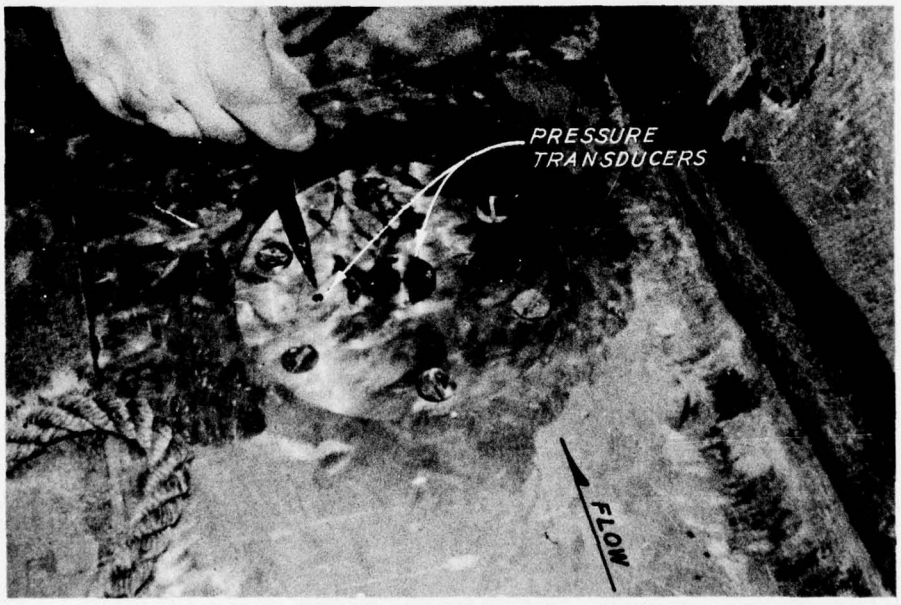
Figure 5. Installed cover plate and pressure transducers in sluice floor

22. The field notes on transducer installation indicate that there was a slight upstream protrusion of transducer plate 2 which could possibly have affected the pressure recordings also. However, transducers installed "smooth" averaged lower pressures, in a number of cases, than those installed with upstream protrusions. For this reason, it is assumed that the installation of the transducer plates was adequate and did not significantly affect flow conditions.

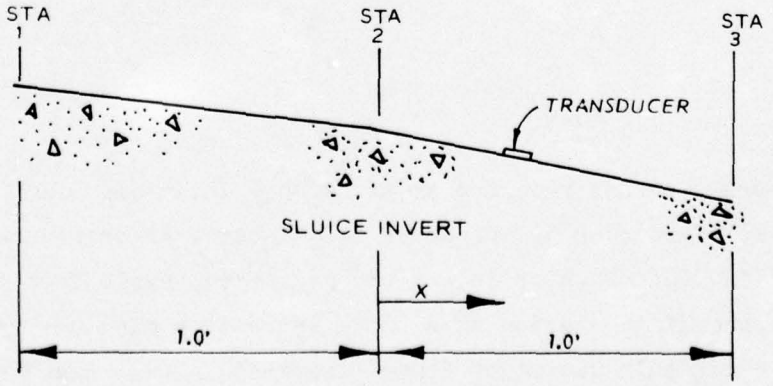
This being the case, it is possible that the recorded pressures were affected by the transducer location with regard to the sudden slope changes of the invert. The following tabulation lists the slopes preceding and at the transducer location and is arranged so that the transducer lies between sta 2 and 3 for each case (see also Figure 10).

Figure 10. Invert slope relative to transducer location

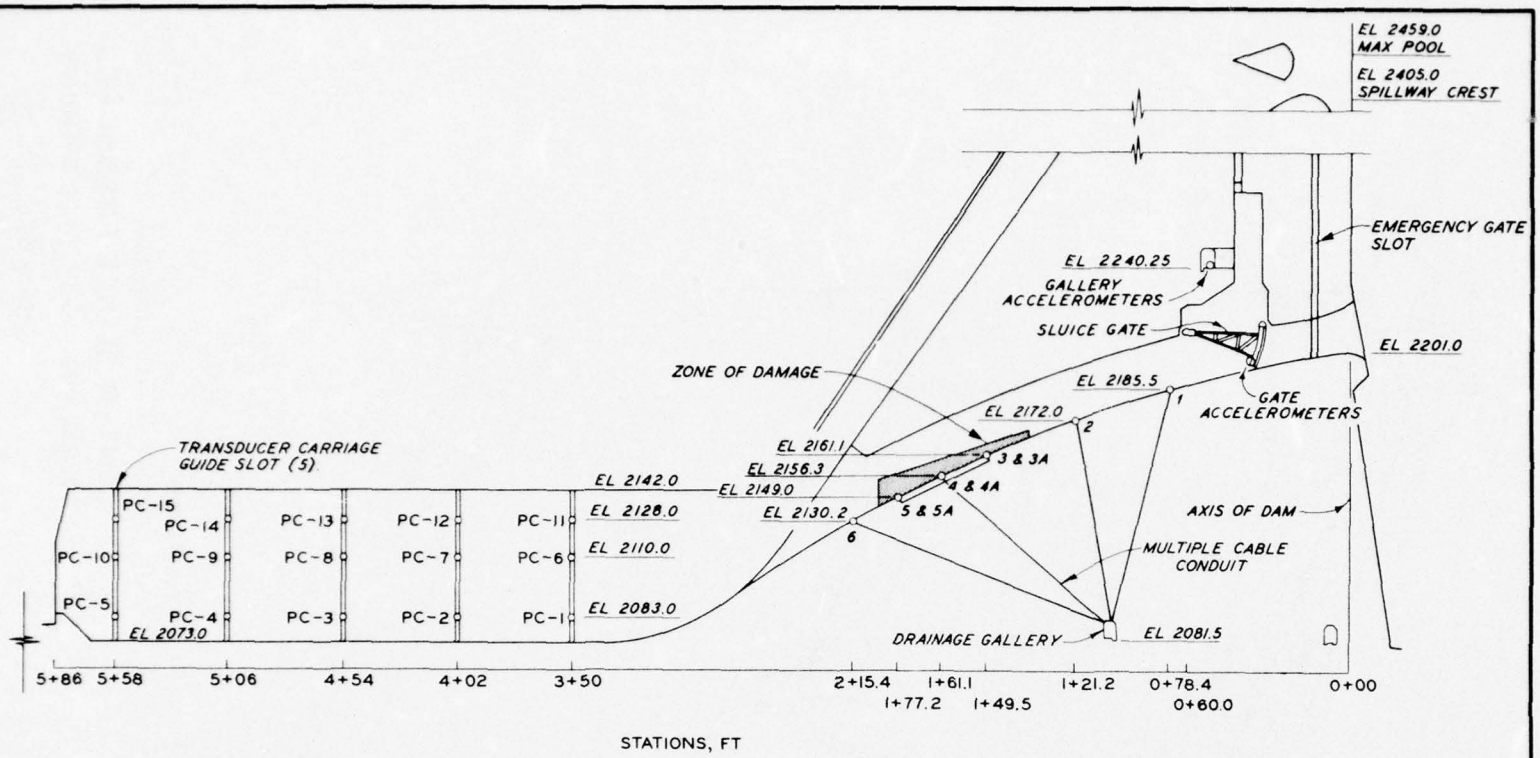
PLATE 1

(Plate 1). It is possible that initial erosion due to the low pressures occurred near the location of transducer 3. This irregularity may have then intensified the cavitation and caused erosion to progress downstream.

34. Negative pressures sufficient to approach or reach vapor pressure were recorded at location PC-1 (Plates 1, 14, and 15 and Table 4) for discharges of 29,000 and 37,000 cfs. This location corresponds to an area where damage has been discovered in an inspection subsequent to the prototype tests. Mean pressures at location PC-3 for all discharges were fairly constant, within ± 2 ft of their collective mean. Also, for all tests conducted with pressure transducers located at el 2083.0, mean pressures were the highest at PC-3.

SECTION THROUGH MONO 29 (CENTER SLUICE)
LIBBY DAM PROTOTYPE TEST - 1974

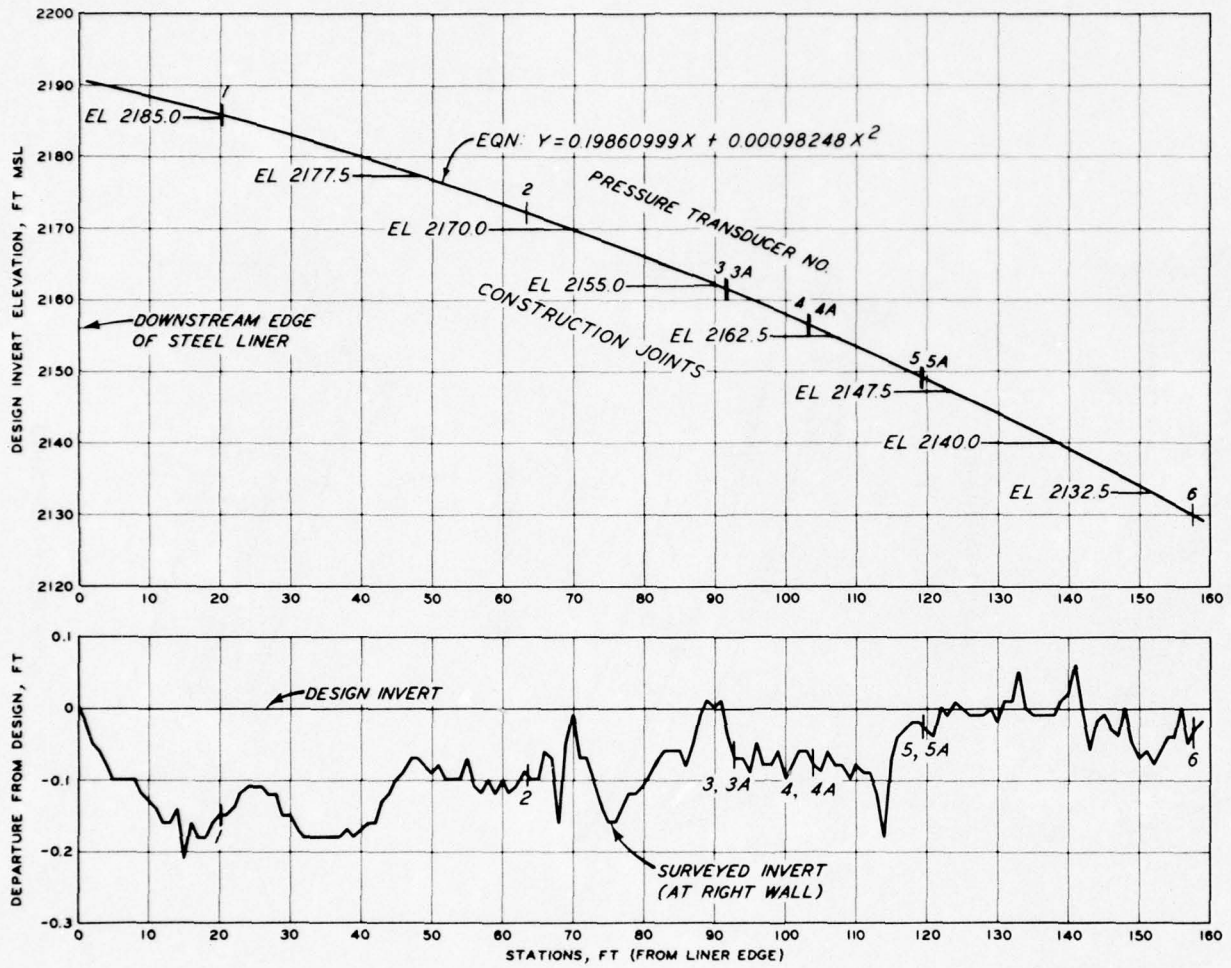
PLATE 8

20. As part of the overall investigation, the sluice invert was surveyed in November 1974 at 1-ft increments along its length and at 2-ft intervals in the transverse direction (Plate 8). The survey confirmed what was observed by visual inspection: the invert did not conform to a smooth parabolic shape, varying by as much as 0.2 ft; rather, it tended to follow a series of chords along the theoretical surface.

21. The worst condition would exist when slope 1-2 was substantially smaller than slope 2-3 and with the transducer located just downstream from sta 2. This combination of conditions is most noticeable at transducer 2. Since other transducers measured, on the average, lower pressures than transducer 2, it cannot be concluded that the invert profile affected the pressure readings. In addition to the irregularities cited above, there appeared to be a chordal effect between horizontal construction joints. The relative positions of the construction joints and the transducers are shown in Plate 8.

CENTER SLUICE INVERT PROFILE

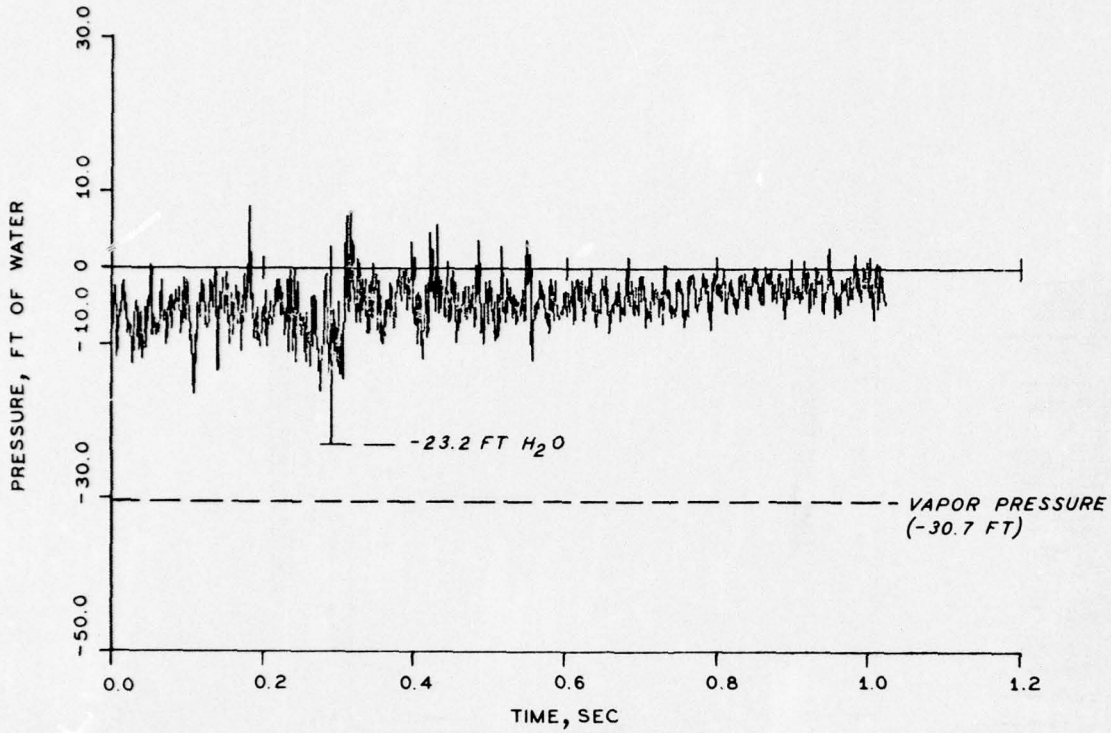
PLATE 9

Vapor pressure was then recorded at transducer locations 3 and 4, and approached at transducer 5. Pressure fluctuations at transducer 3 are illustrated in Plate 9 which is a 1-sec digitized sample from the magnetic tape recording. During this short interval a minimum pressure of -23 ft was recorded. The major damage occurred between sta 3 and 5

CENTER SLUICE PRESSURES
PRESSURE TRANSDUCER 3
DISCHARGE 3800 CFS

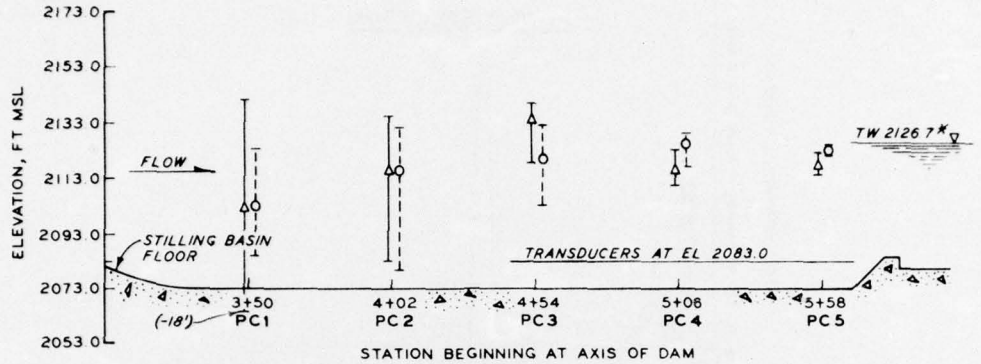
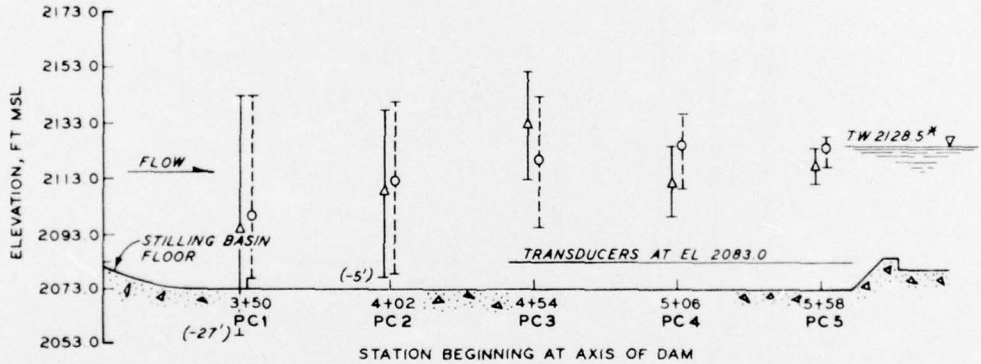
PLATE 14

32. Pressure fluctuation measurements (Plates 14 and 15) by transducers located in the stilling basin wall were described in paragraph 10. The test discharges, as shown in Table 4, were 20,000, 29,000, 37,000, and approximately 47,000 cfs. Considerable damage to the test equipment and railing along the stilling basin wall was experienced at discharges of 37,000 cfs and greater. The test equipment was severely damaged and the railing completely destroyed as the spillway gates were opened in an attempt to reach 50,000 cfs. Because of the damage, the gates were immediately closed and the discharge was estimated to be 47,000 cfs at the time the pressures were recorded. In subsequent tests, the maximum discharge was restricted to 29,000 cfs.

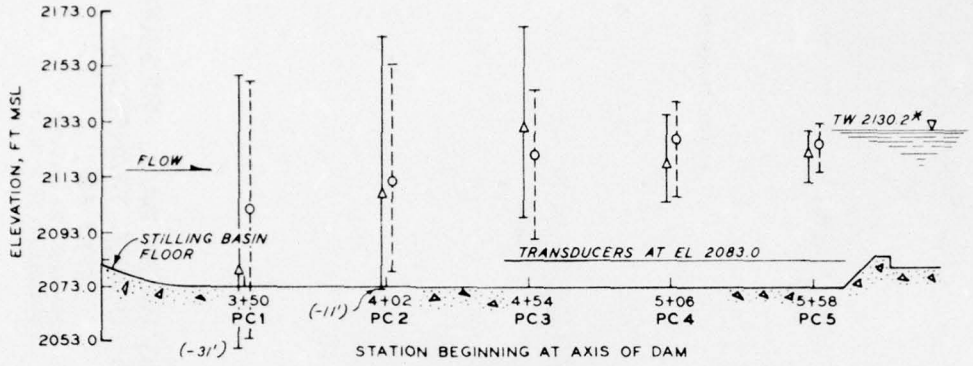
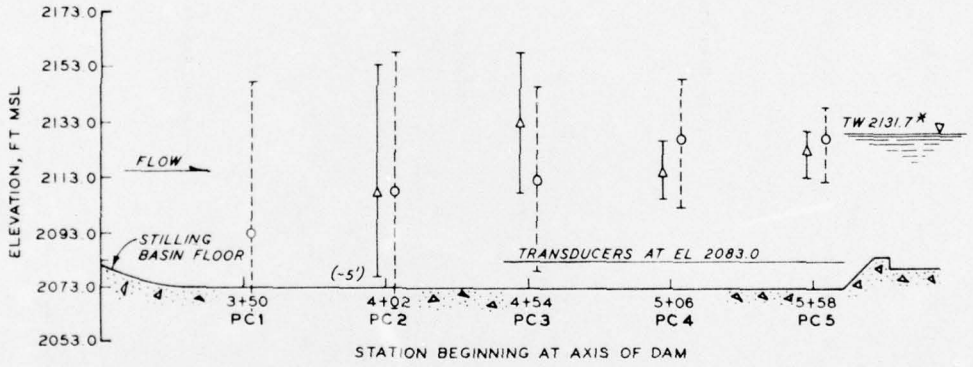
PLATE 15

** DISCHARE APPROXIMATE, TEST HALTED DUE TO HIGH FLOW DAMAGE.

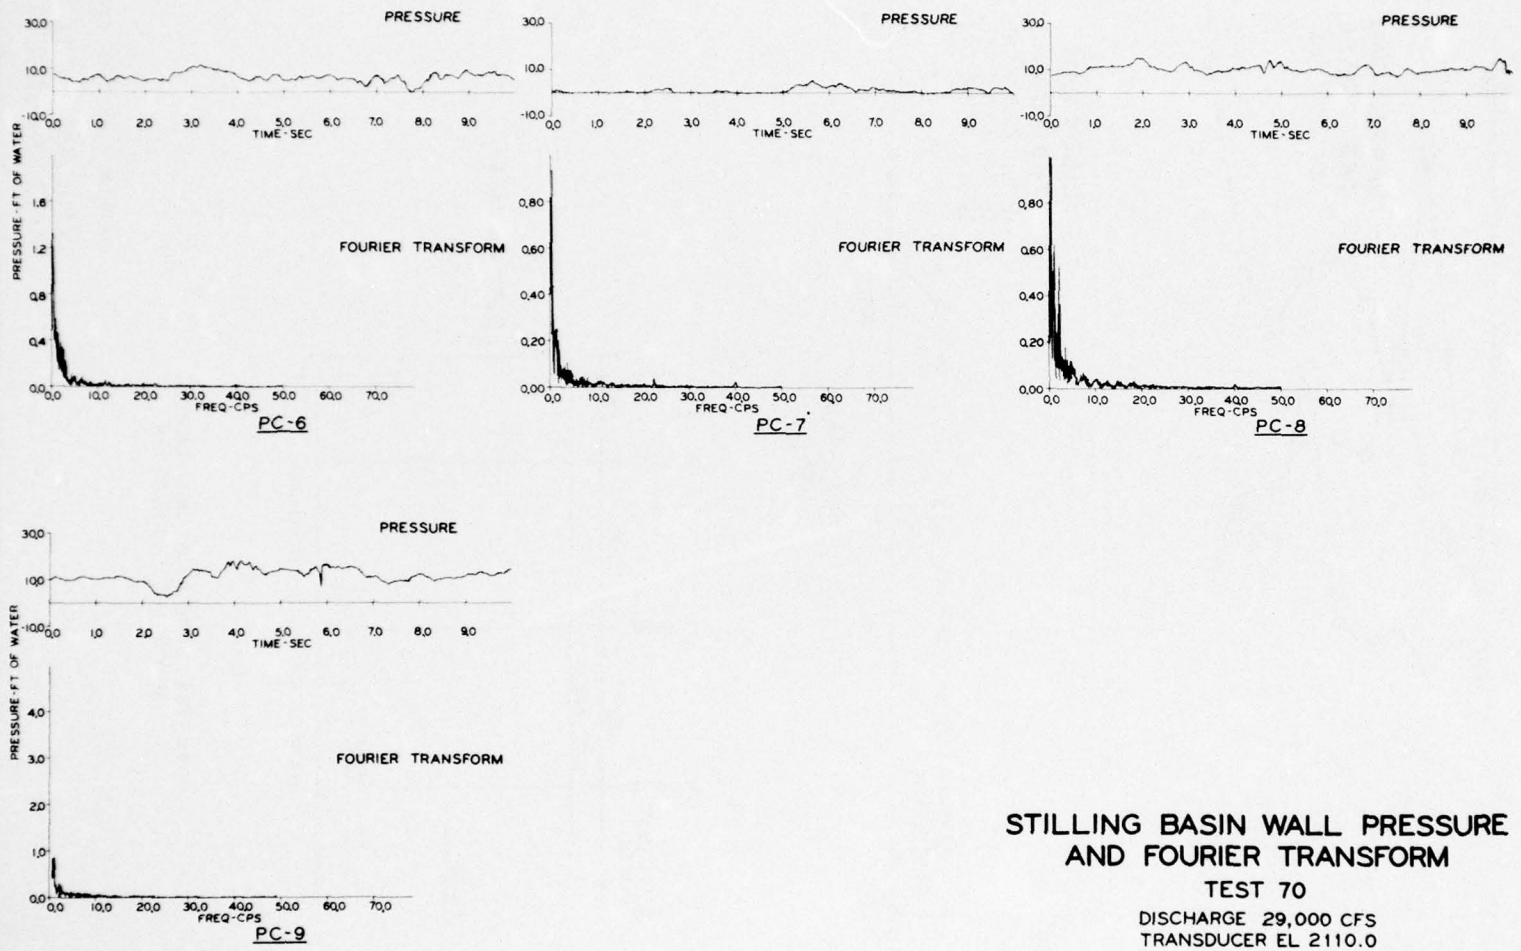
PLATE 21

STILLING BASIN WALL PRESSURE AND FOURIER TRANSFORM

TEST 70

DISCHARGE 29,000 CFS
TRANSDUCER EL 2110.0
