4. TITLE (and Subtitle): APPARENT WASTING INDEX OF EMBANKMENTS,	5. TYPE OF REPORT & PERIOD COVERED
	6. PERFORMING ORG. REPORT NUMBER: Technical Note, No. 149

7. AUTHOR(s): Furudoi, Teruaki / Iguchi, Motoharu	8. CONTRACT OR GRANT NUMBER(s)
9. PERFORMING ORGANIZATION NAME AND ADDRESS: The Port and Harbor Research Institute, Ministry of Transportation, Tokyo, Japan	10. PROGRAM ELEMENT, PROJECT, TASK AREA & WORK UNIT NUMBERS

11. CONTROLLING OFFICE NAME AND ADDRESS: Department of the Army, Coastal Engineering Research Center, Kingman Building, Fort Belvoir, VA 22060	12. REPORT DATE: December 1976

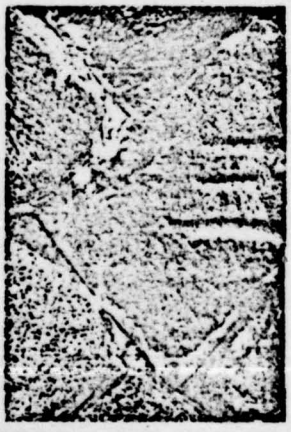
写真 - 5.2 石積の状況(練石積)

Photo 5.2 - Condition of Masonry (scoured masonry)

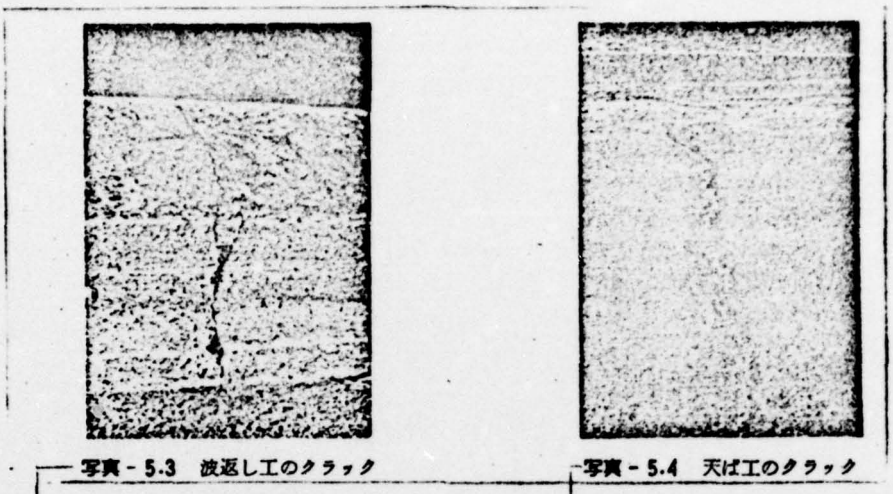
写真 - 5.3 波返し工のクラック

Photo 5.3 - Crack of Wave Deflector

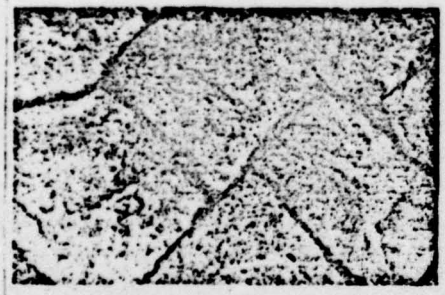
写真 - 5.7 石積のゆるみ

Photo 5.7 - Loosened Masonry

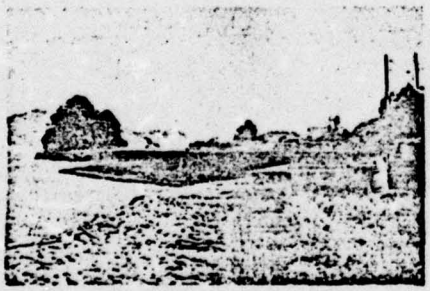
写真 - 5.9 全景（天ば工）

Photo 5.9 - General View (crown)

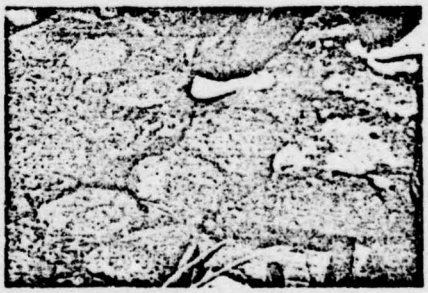
写真 - 5.10 天ば部の状況

Photo 5.10 - Condition of Crown

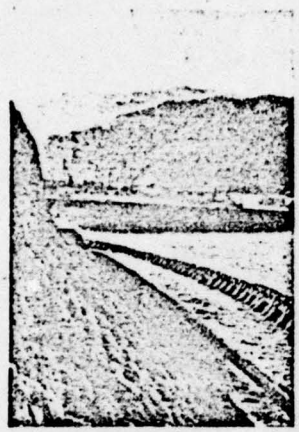
写真 - 5.11　表のり面（石積）

Photo 5.11 - Face Spread (masonry)

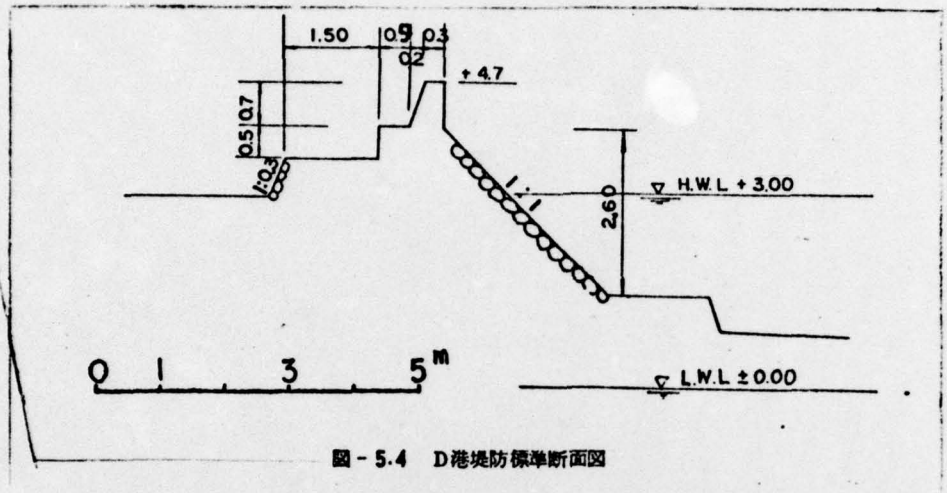
図 - 5.4 D港堤防標準断面図

Embankment located north of Kunisaki peninsula on the south side of Suo Nada; believed no exposure to strong wave action; constructed in 1952 as a subsidized project; face spread, "kanchi" masonry, and crown and rear spread, covered with growing mixed grass; face spread, exposed and shows depression; ground site packed concrete peeled off, showing run off of sea water to indicate possible erosion of embankment earth and sand; angular break of wave deflector's concrete joint; wave deflector shows abrasion; shows normal right angle direction crack.

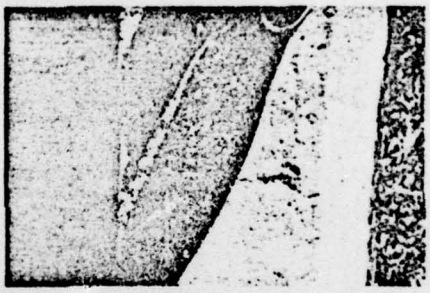
写真 - 5.14 放返し工のクラック（上側）

Photo 5.14 - Wave Deflector Crack (upper side)

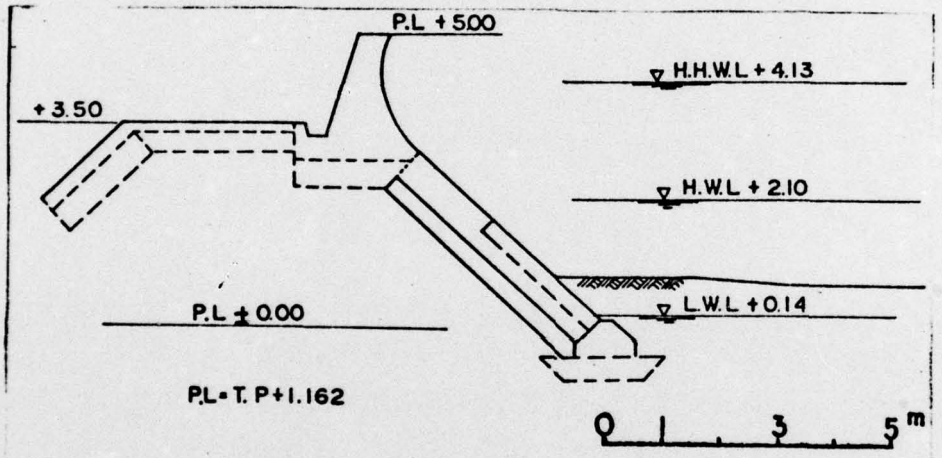
図-5.5 E港護岸標準断面図

Sea wall located on the southwest side of Ise Wan inside an inlet to be free from wave disturbance; depth of water to the front, about 1 m; spread shows crack; farm homes and farmland located to the rear; lower part, "kanchi" block mound showing few abrasions; angular break and damage observable in pile joints of block and concrete and additional breakdown could develop erosion of fill; crack in sectional direction but small so should not develop into big problem; heavy traffic and loads on crown caused sinking; cracking and angular breaks in crown, particularly in corner and at angle.

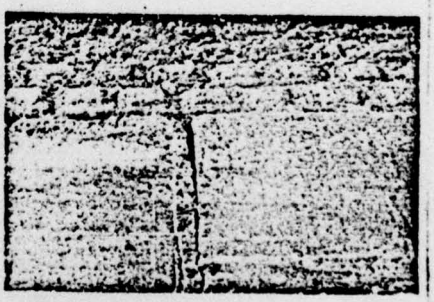
写真-5.17 表のり目地付近の状況

Photo 5.17 - Condition Near Face Spread Ground Site

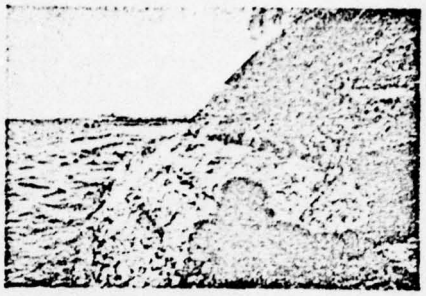
写真 - 5.19　表のり目地付近の状況

Photo 5.19 - Condition Near Face Spread Ground Site

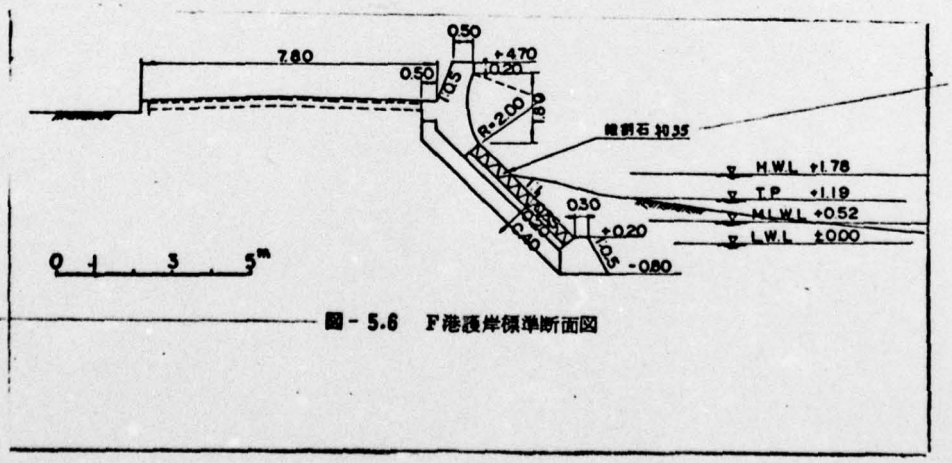
図 - 5.6　F港護岸標準断面図

Sea wall located on the southeast side of Kii peninsula at the innermost site of an inlet ; facing Kumano Nada and thus not exposed to direct wave action but believed to be exposed to heavy diffraction waves; road located to the rear and bottom of sea to the immediate front comprised of small rocks; water level crack at ground site caused by the sinking at 20 m section due to "kanchi" masonry, creating danger of erosion of filled earth and sand; repair plan including the raising of crown and the laying of front concrete layer adopted and scheduled to be implemented soon.

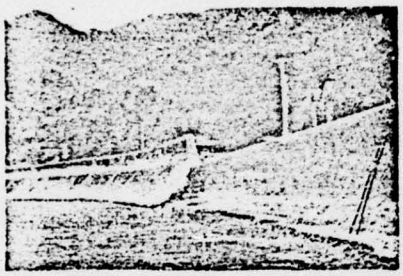
写真 - 5.22　表のりの状況

Photo 5.22 - Condition of Face Surface

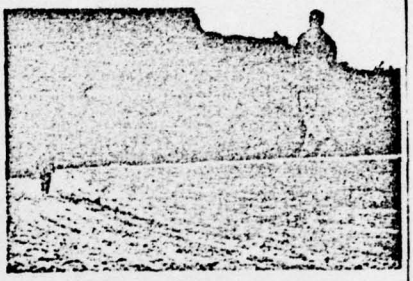
写真 - 5.23　波返し工の背後

Photo 5.23 - Rear of Wave Reflector

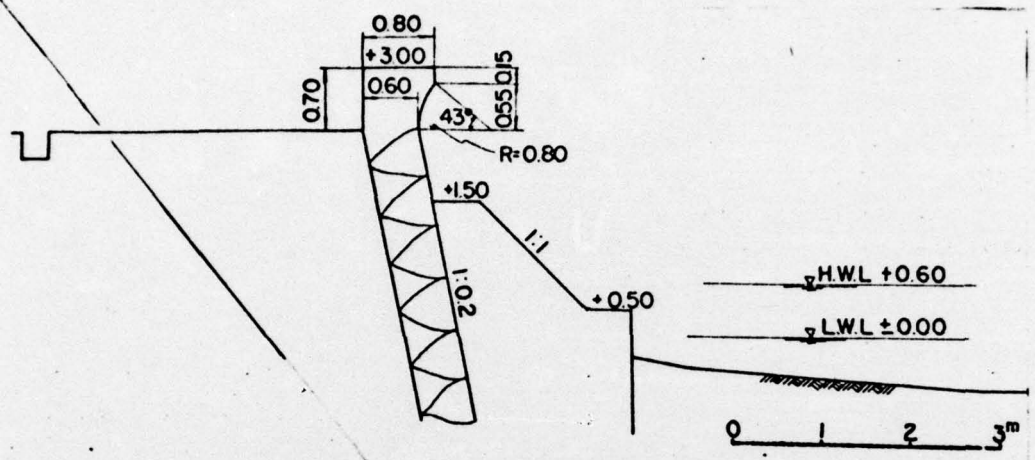
Chart 5.7 - Standard Cross-section Sketch of "G" Harbor Sea Wall

Sea wall located near the eastern part of Noto peninsula; believed to be receiving heavy dosage of waves from Toyama Wan; roadway and dense farm homes located to the rear; constructed in 1930 with "kanchi" masonry, but lower section reinforced with concrete in 1950; severe exposure of structural materials due to concrete abrasion and rubbing between poorly mixed concrete and small front stones; wave reflector cracks per 10 m block but no sign of slippage due to sinking; masonry concrete at ground site peeled off but believed no erosion of fill from ground site nor rock losses.

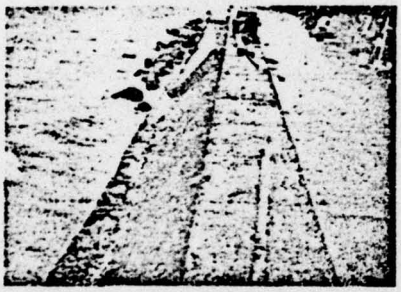
写真 - 5.24 全景

Photo 5.24 - General View

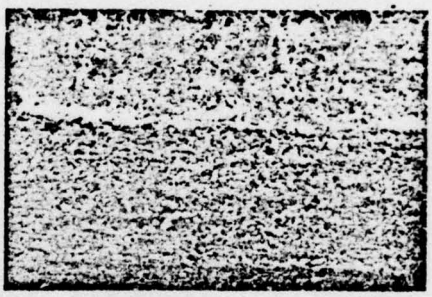
写真 - 5.25 表のり工の摩耗

Photo 5.25 - Abrasion of Face Spread

写真 - 5.26 水叩工の沈下（背後に水たまり）

Photo 5.26 - Sinking of Apron (water puddle to the rear)

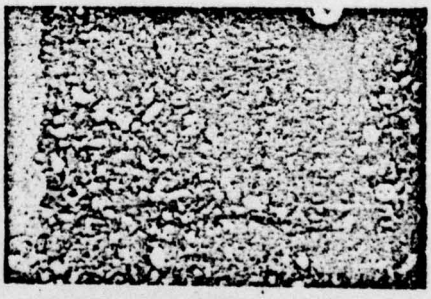
写真 - 5.27 波返し工のクラック

Photo 5.27 - Crack of Wave Reflector

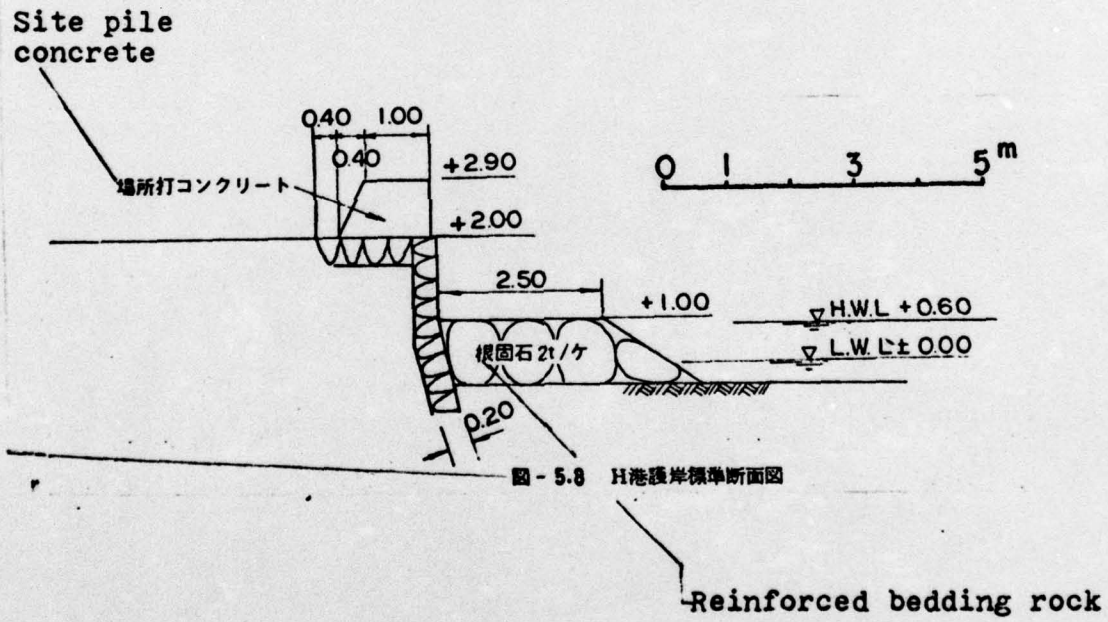
Chart 5.8 - Standard Cross-section Sketch of "H" Harbor Sea Wall

Sea wall located on west side of Noto peninsula; believed facing fairly heavy action of waves due to direct exposure to Japan Sea; part of a roadway and farmland and dense farm homes located to the rear; face spread, "kanchi" masonry; low wall height; wave deflector originally constructed of concrete but repaired with mortar for damage caused by exposure and inferior structural material but still peeling off; shifting of part of the reinforced bedding rocks observed; cave-ins of "kanchi" stones at two spots along the length of ground site due to use of "kanchi" masonry, indicating erosion of fills; no visible surface cave-in of apron observed; serious abrasion and structural material exposure of poorly mixed concrete wave deflector; very uneven crown top due to excessive use of roadway; backside of wave deflector seriously eroded by overtopping waves.

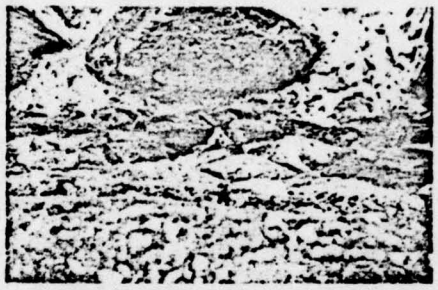
写真 - 5.30　表のり工間知石の抜け出し

Photo 5.30 - Erosion of "Kanchi" Stones of Face Spread

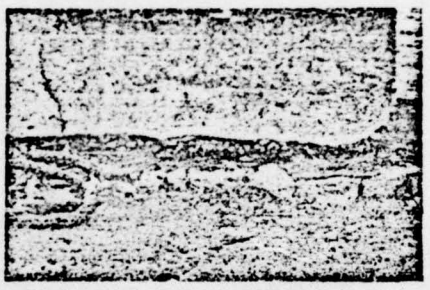
写真 - 5.31　波返し工接続部の損傷

Photo 5.31 - Damage of Wave Deflector Joint

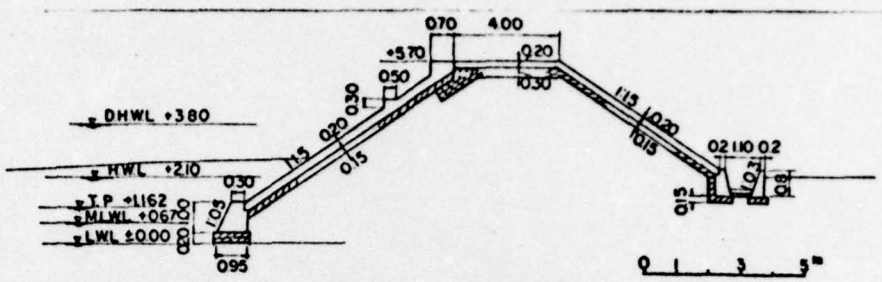
Chart 5.9 - Standard Cross-section Sketch of "I" Harbor Embankment

Embankment located on the west side of Ise Wan; about 200 m of front beach planted with reed, etc., indicating very little wave disturbance; road used by bathers, paddy fields, and farmland located to the rear; embankment constructed of three-layer concrete; face spread provided with small steps; ground site planted with mixed beach grass; structural materials exposed; crack observed in middle of a 10-m block; a 2-3 cm sinking observed in 20-m section of weak base of crown; corner and angular breaks in concrete and large crack in sectional direction; about a 3-cm breach in the berm of rear spread weak base.

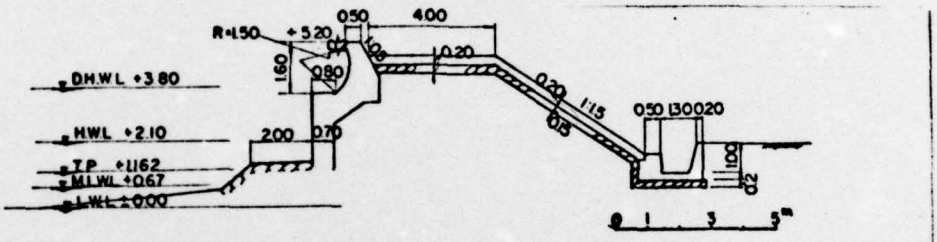
Chart 5.10 - Standard Cross-section Sketch of "J" Embankment

Embankment located on the west side of Ise Wan; little wave disturbance observed but the corner and angular embankment location could mean fairly concentrated action of waves; factories and dense homes located to the rear; vertical front face of embankment, three-layer concrete, but serious abrasion with forward tilting in several spots; crack observed in face spread; about 1-cm sinking as well as slippage of wave deflector; observed abrasion, cracks, and sinking in crown used as roadway.

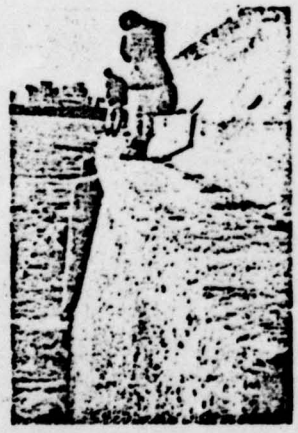
写真-5.37 表のりエの状況

Photo 5.37 - Condition of Face Spread

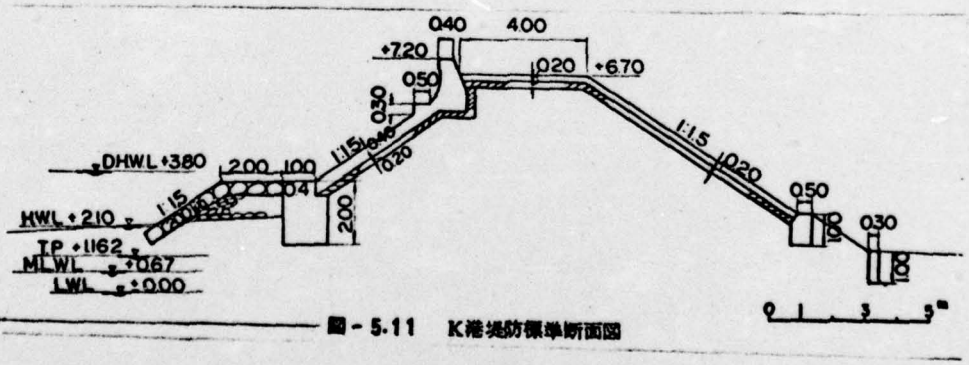
Chart 5.11 - Standard Cross-section Sketch of "K" Harbor Embankment

Embankment located on the west side of Ise Wan; very little wave disturbance; racing boat docks located to the rear; embankment constructed of 3-layer concrete; relatively high embankment with rear spread standing about 5 m high; crack observed in face spread as well as rear spread; pitch of face and rear spreads, both about 3-5 m; both spreads, exposure in several places; sinking of crown, about 1 cm, and ground site, about 3 cm.

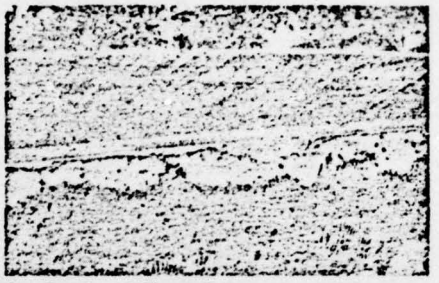
写真 - 5.45 波返し工背後にできた天ば工クラック

Photo 5.45 -
Crown Crack
That Deve-
loped Behind
Wave Deflect-
or

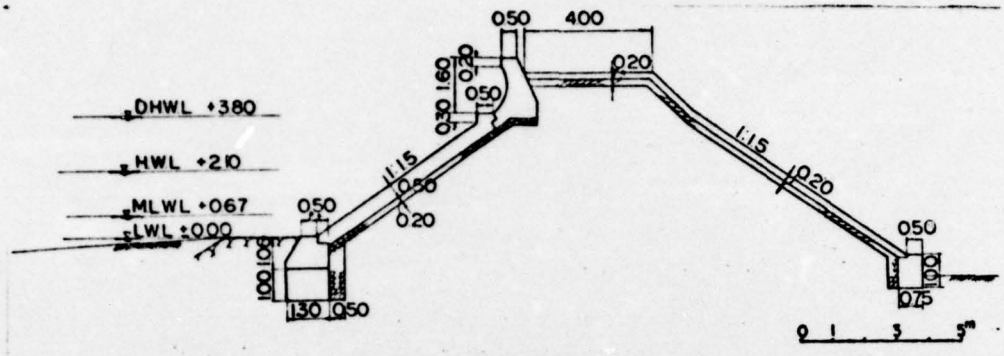
Chart 5.12 - Standard Cross-section Sketch of "L" Harbor Embankment

Embankment located on the southwest side of Ise Wan inside an inlet free of wave disturbance; water depth to the front, about ± 0 m; fish hatchery located to the rear; embankment whole front side, concrete covering; crown and rear spread, asphalt covering; cave-in of bedding anchor front part; ground site cave-in, about 8 cm; water level crack observed about 2 m below the upper part of embankment; wave deflector sinking, about 5 mm; several breaches in wave deflector due to poorly mixed concrete; no conspicuous changes observed for crown or rear spread.

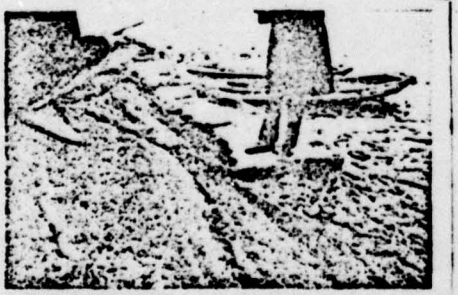
写真 - 5.51　表のり工の沈下によるずれ

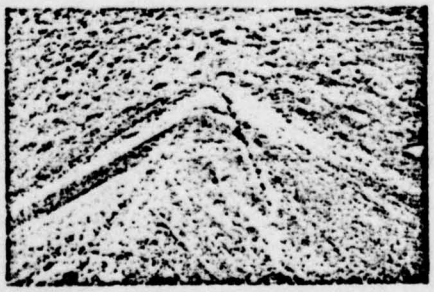
写真 - 5.52　隅角表のり工のクラック

Photo 5.52 - Corner Angular Crack of Face Spread

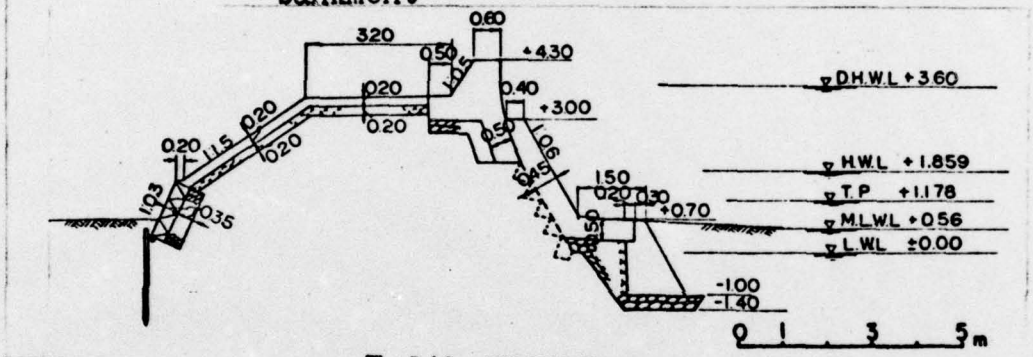
Chart 5.13 - Standard Cross-section Sketch of "M" Harbor Embankment

Embankment located on the southern part of Shima peninsula inside the inner part of a bay that is opened to the south; because of location, only little disturbance from waves; fissure in face spread; road used by bathers and pine forest located to the rear; embankment, a low profile three-layer embankment with sunken weak base but showing no conspicuous uneven sinking; crown crack along 5 m pitch; indications showing ground site breach in several places; crack in wave deflector along 5 m pitch due to its alternate location with face spread; sinking of crown with water puddles in several places; very heavy sinking on the side of the sea with crack along 2-3 m pitch; vulnerable spots believed to be from the time of construction noted in rear spread.

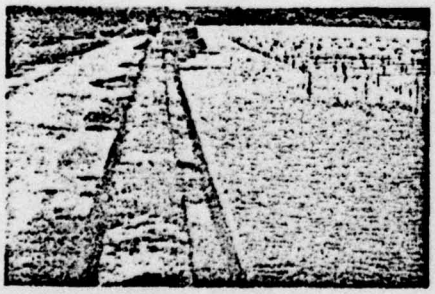
写真 - 5.53 全景

Photo 5.53 - General View

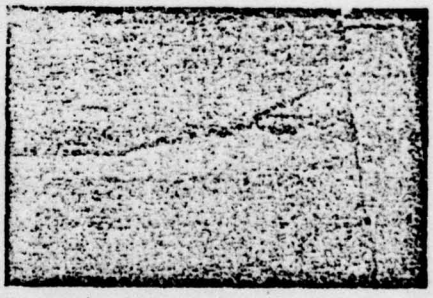
写真 - 5.54 天ば工コンクリートの損傷

Photo 5.54 - Damaged Crown Concrete

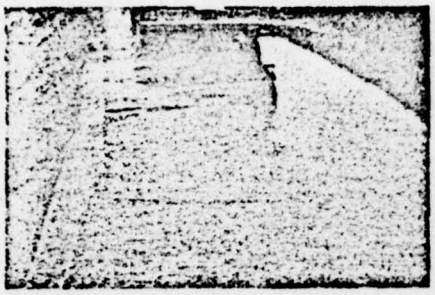
写真-5.55 天ば工の沈下，水溜り

Photo 5.55 - Sinking and Water Puddles of Crown

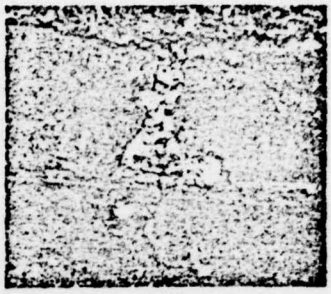
写真-5.56 裏のり工のクラック

Photo 5.56 - Crack of Rear Spread

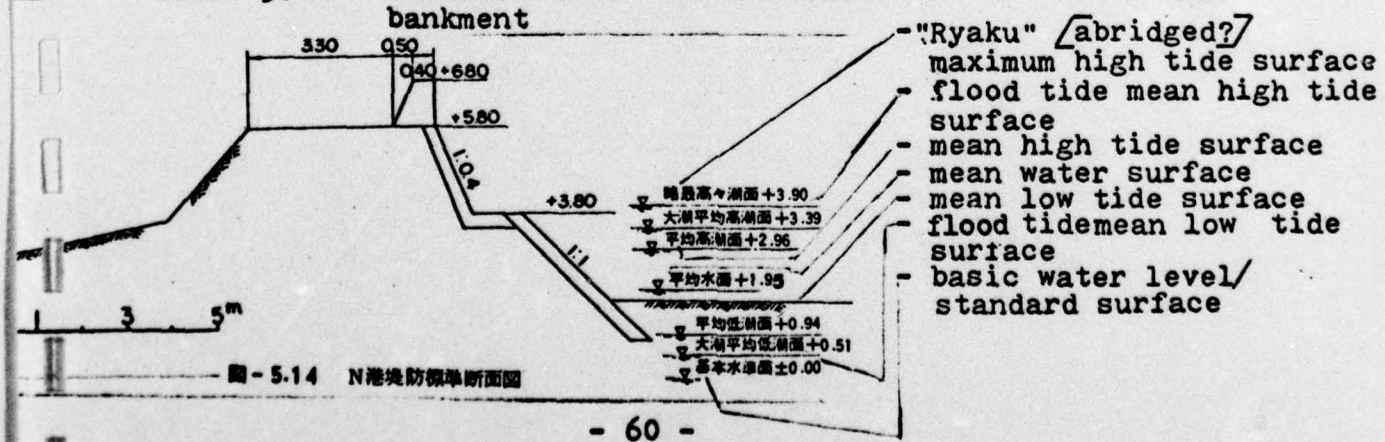
Chart 5.14 - Standard Cross-section Sketch of "N" Harbor Embankment

Embankment located northeast of Minato facing the inner harbor; believe no exposure to wave action; inoperative salt field located to the rear; small steps for reinforced bedding section of face spread; rear spread planted with mixed grass; crack in sunken weak base; sinking fairly deep for border and angular portions of face spread; in 40 m section of reinforced bedding, poor mixing/compostion observed in a number of places; large vertical and horizontal cracks in small steps of reinforced bedding; observed slippage of 2 cm front and back, and vertically for wave deflector; normal right angle direction crack in center of a 10 m long block as well normal direction water level crack in border and angular area; crown sinking, about 4 cm; normal direction crack in crown; cavity more visible than hole in crown; rear spread stable with rich growth of mixed grass.

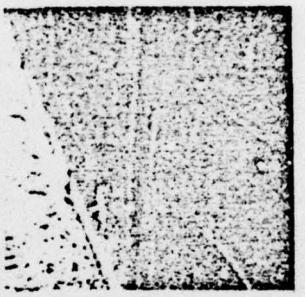
写真 - 5.60
波返し工法線直角方向のずれ

Photo 5.60 - Normal Right Angle Direction Slippage of Wave Deflector

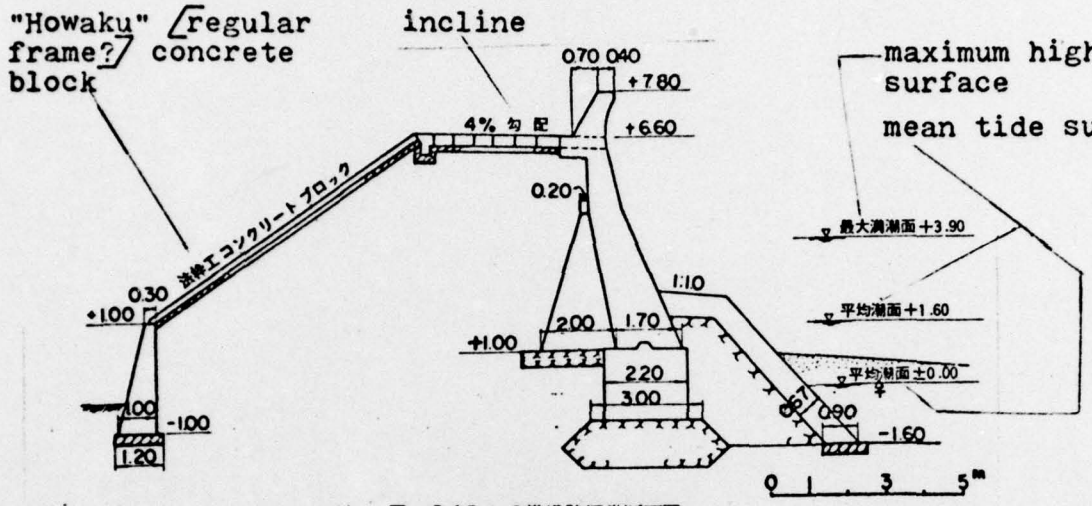
Chart 5.15 - Standard Cross-section Sketch of "O" Harbor Embankment

An embankment in a district [not defined] with its west side adjacent to a river; believed action of waves against it fairly strong; reclaimed embankment with farm homes, paddy fields, and farmland to the rear; steep incline face spread with angular break in lower part; structural materials exposed in many places; many normal direction cracks in reinforced bedding small step section of corner angle section; several large right angle direction cracks in upper part of face spread; wave deflector with a front and rear aberration of 3-4 cm and an oblique crack; crown laid with blocks but cracks in blocks and crown sinkage due to heavy traffic; observed a number of places in corner angle section that had been restored from disaster damages.

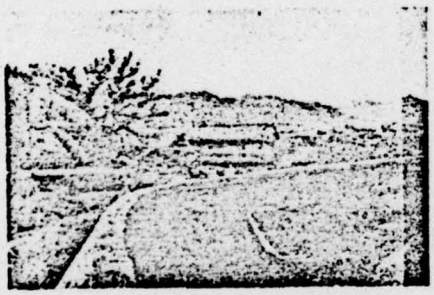
写真 - 5.62　全景

Photo 5.62 - General View

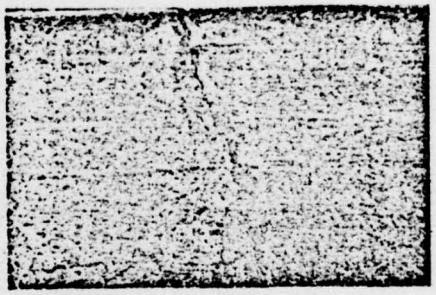
写真 - 5.63　波返し工のクラック

Photo 5.63 - Wave Deflector Crack

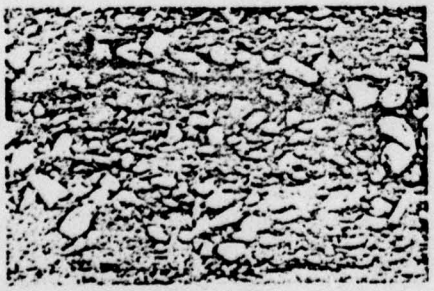
写真 - 5.64　表のり工小段部のコンクリートの損傷

Photo 5.64 - Small Step Section Damage of Face Spread

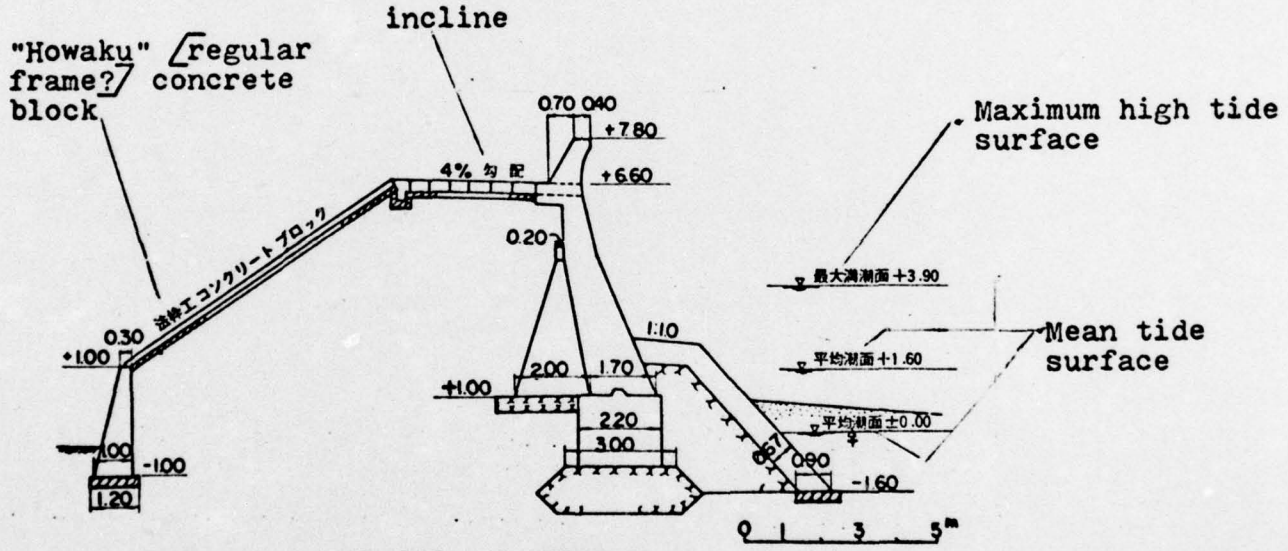
Chart 5.16 - Standard Cross-section Sketch of "P" Harbor Embankment

Embankment located adjacent to "O" harbor coastal embankment; structurally about the same; poorly mixed concrete of face spread very conspicuous; a hole measuring 0.5 m deep, 0.5 m wide, and 2.5 m long observed in small step section of reinforced bedding; a 0.3 m deep hole also visible in upper part of normal surface; large crack in parallel normal line of small step section of reinforced bedding; many cracks in small steps of indented section; 2 cm aberration, both front and back of wave deflector; vertical aberration of about 2 cm for corner angle section; crack in normal right angle direction; sinking and break in blocks laid on crown due to heavy traffic; portion of rear spread block layers exposed and indented in several places.

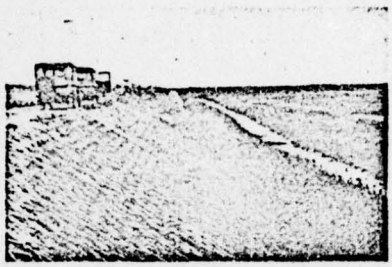
写真 - 5.66　裏のり工の状況（天ば，裏のりの不陸）

Photo 5.66 - Condition of Rear Spread (soil erosion of crown and rear spread)

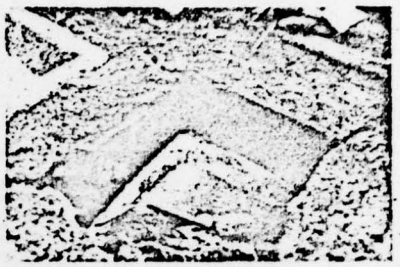
写真 - 5.67　裏のり工の吸出しによるブロック陥没

Photo 5.67 - Block Cave-in Due to Erosion (soil?) of Rear Spread

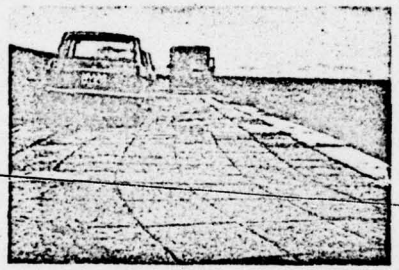
写真 - 5.68　天ばブロックの不陸

Photo 5.68 - Soil Erosion Crown Blocks

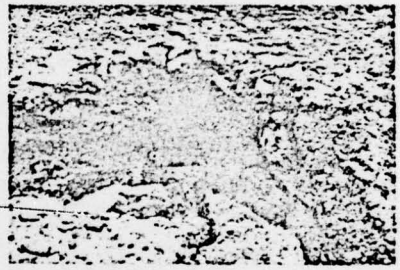
写真 - 5.69　表のり小段部のコンクリートの損傷

Photo 5.69 - Damage of Small Step Section of Face Spread

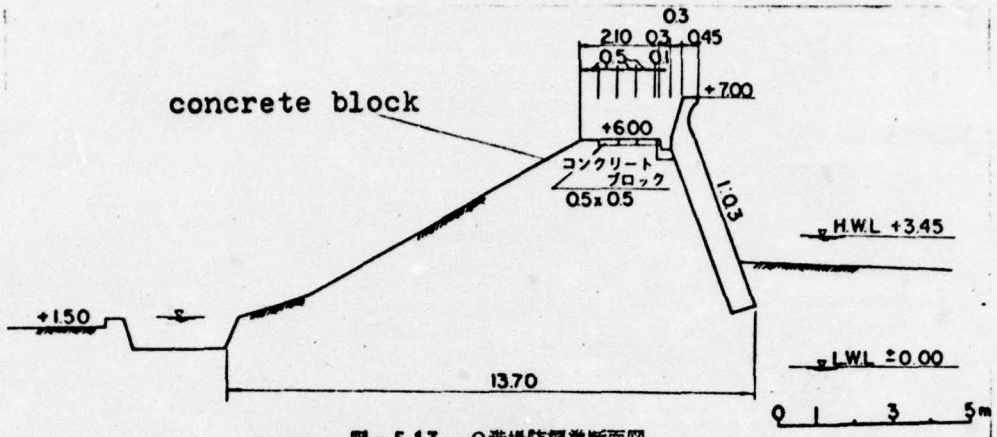
Chart 5.17 - Standard Cross-section Sketch of "Q' Harbor Embankment

Embankment located south of Suo Nada; believed wave disturbance to be very little; reclaimed embankment with paddy fields in the rear; exposed face spread structures but no change in normal line; wave reflector concrete shows wear but no change; normal line right angle crack in corner angle section; block crack and 20 cm sinking of crown blocks due to dump car traffic on crown; rich growing mixed grass on rear spread.

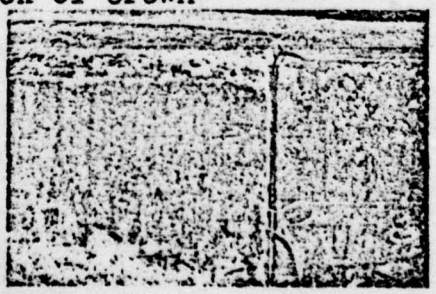
写真 - 5.73 波返し工の目地のかけ

Photo 5.73 - Wave Deflector Ground Site Break

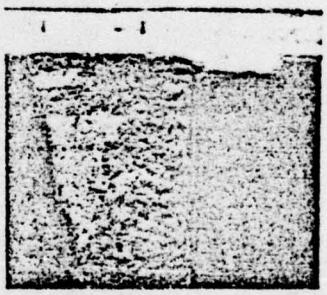
写真 - 5.78 胸壁上端のコンクリートのはがれ

Photo 5.78 - Erosion of Parapet Upper Portion Concrete

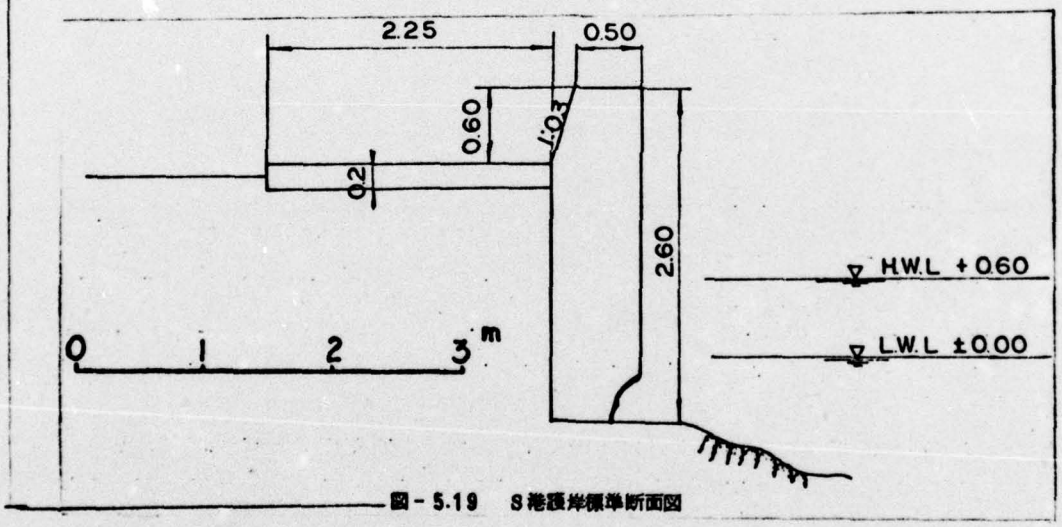
Chart 5.19 - Standard Cross-section Sketch of "S" Harbor Sea Wall

Sea wall located on the bank of Toyama Wan [Bay] in Noto peninsula and inside an inlet with the mouth facing to the south; not sufficient anti-wave provision provided and thus exposed to relatively constant wave action but from the appearance of the rear condition, the strength intensity of the wave action appears fairly mild; fisheries experiment station and farm homes located to the rear; sea wall, a vertical concrete structure; concrete wall installed on rock foundation, but now showing rupture at connecting points; innumerable cracks in wave deflector; constructed in 1937-1938 and shows poor mixture of concrete; portion of crown shows sinking of about 2 cm as well as cracks in several places.

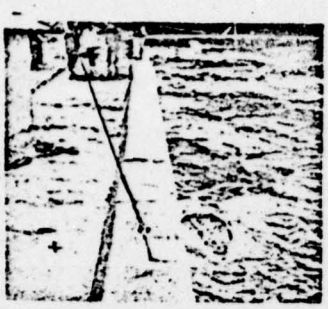
写真 - 5.79 全景

Photo 5.79 - General View

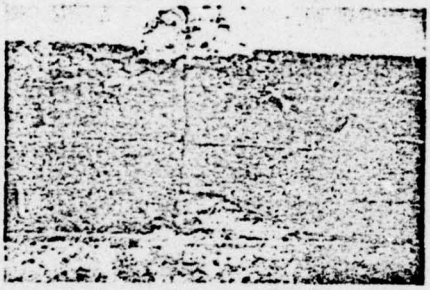
写真 - 5.81 波返し工目地の損傷, クラック

Photo 5.81 - Damage, Cracks of Wave Deflector Ground Site

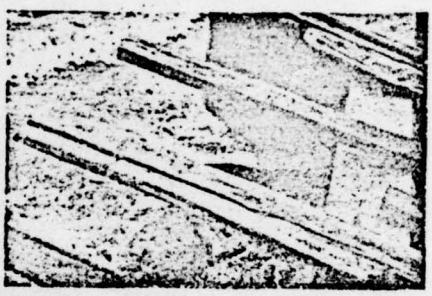
写真 - 5.82 岩盤との接続部の欠け

Photo 5.82 - Breaks and Erosion of Connecting Part with Rock Foundation

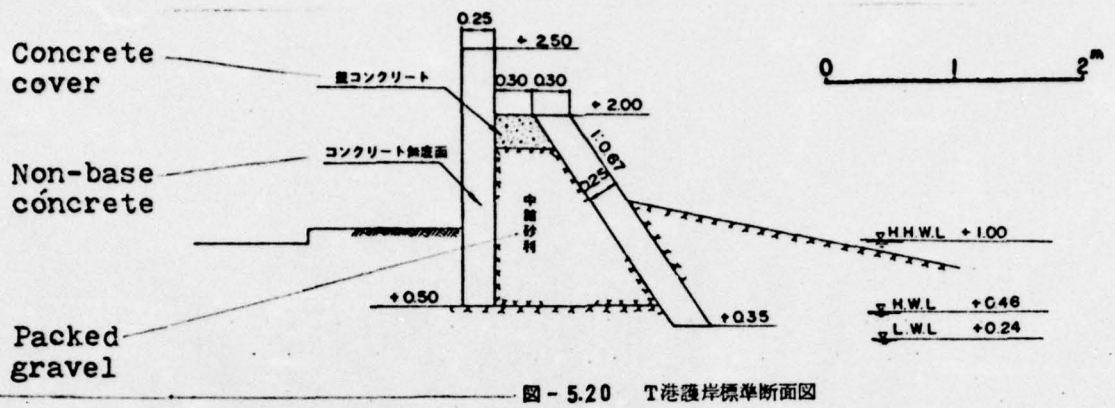
Chart 5.20 - Standard Cross-section Sketch of "T" Harbor Sea Wall

Sea wall located near the eastern part of Toyama Wan (bay); believe relatively heavy wave action being encountered; front beach: relatively steep inclined rocky shore; farmland and farm homes located to the rear; known as Saito-type sea wall of non-base concrete constructed in 1958; normal line aberration of about 2.5 cm and a large breach of about 6.5 cm between ground site and adjoining armor; serious abrasion of concrete that shows vertical and horizontal cracks; about 20 cm on both sides, only remaining structures are embankments.

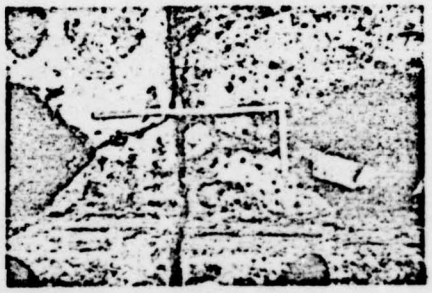
写真 - 5.84 表のり工のクラック

Photo 5.84 - Crack of Wave Deflector

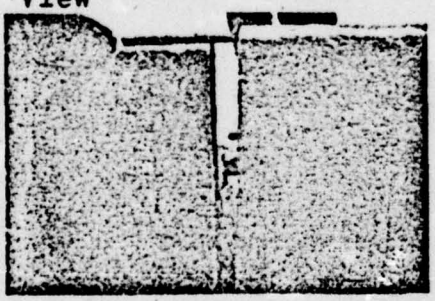
写真 - 5.85 目地のひらき

Photo 5.85 - Breach of Ground Site

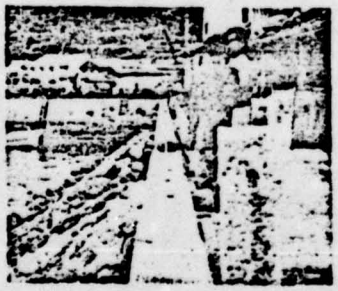
写真 - 5.88 表のり工のクラック

Photo 5.88 - Crack of Face Spread

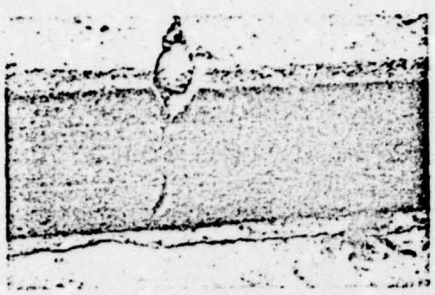
写真 - 5.89 波返し工のクラック，損傷

Photo 5.89 - Crack, Damage of Wave Deflector

Harbor located in Uchinoumi; believe no action of wave against sea wall; paddy fields located to the rear; about 2 cm wide horizontal crack in mid-section of face spread; throughout the length of wave deflector, crack observed around the mid-section (about 7-8 m) of almost every 15-m block; no covering on aprons but no danger of erosion from overtopping waves and thus, could be left without any change.

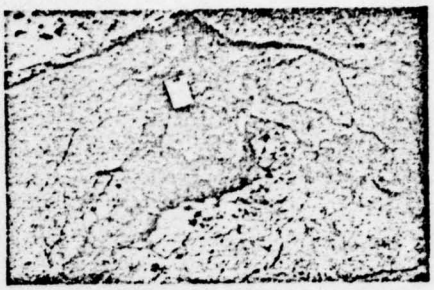
写真 - 5.90 水叩工の沈下，損傷

Photo 5.90 - Sinking, Damage of Apron

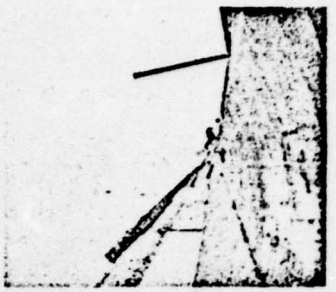
写真 - 5.92 表のり形状（小段部）

Photo 5.92 - Condition of Face Spread (step section)

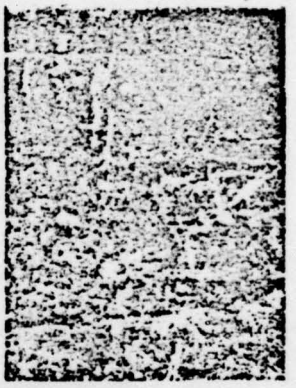
写真 - 5.95 波返し工のクラック

Photo 5.95 - Crack of Wave Deflector

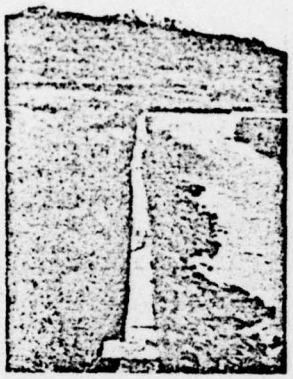
Photo 5.96 - General View (showing normal line indentation)

写真- 5.96　全景（法線の凸凹）

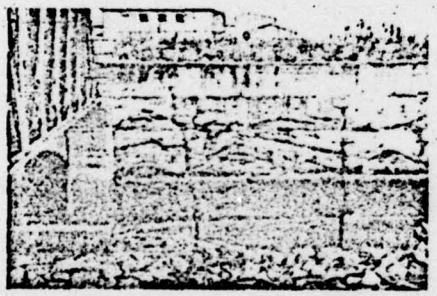
写真 - 5.99　表のり工のクラック

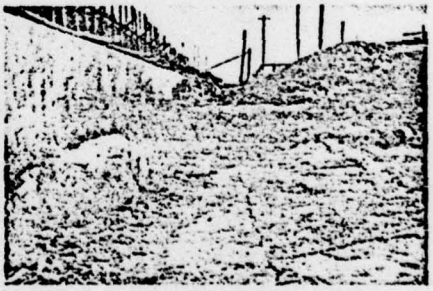
写真 - 5.102 水叩工の沈下, クラック

Photo 5.102 - Sinking, Cracking of Apron

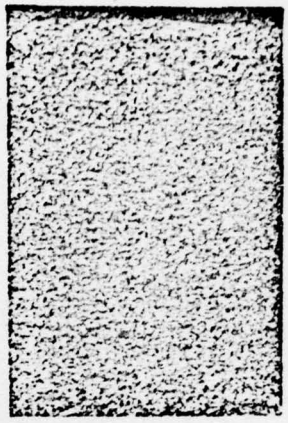
写真 - 5.104 波返し工背面のコンクリートの劣化

Photo 5.104 - Concrete Wasting on the Back Side of Wave Deflector

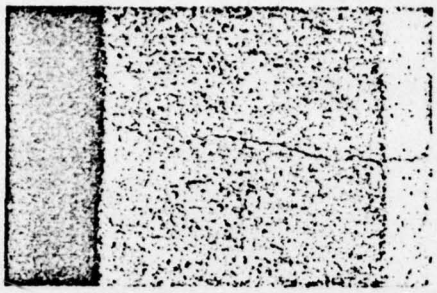
写真 - 5.107 波返し工のクラック（上面）

Photo 5.107 - Crack of Wave Deflector (upper surface)

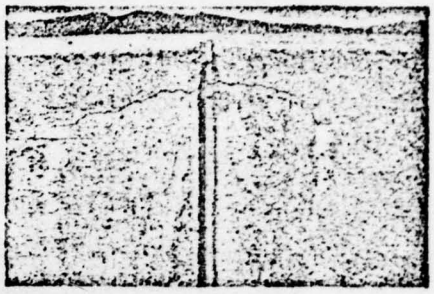
写真 - 5.108 波返し工のクラック（背面）

Photo 5.108 - Crack of Wave Deflector (back surface)

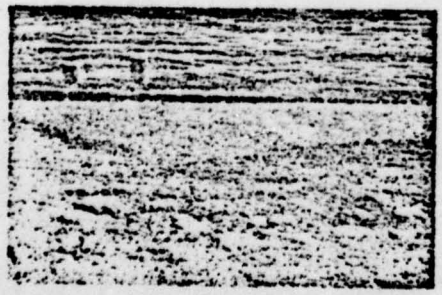
写真 - 5.111 水叩工（路面）の沈下，損傷による水溜り

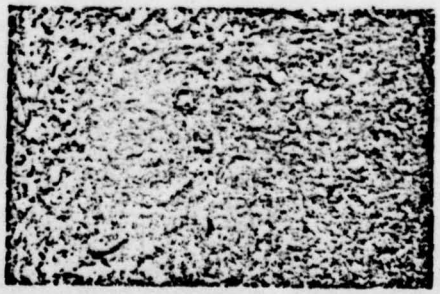
写真 - 5.112 コンクリートの摩耗

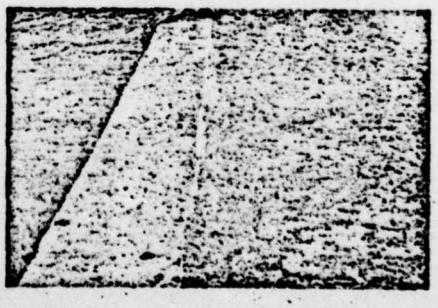
写真 - 5.114 水叩工の沈下

Photo 5.114 - Sinking of Apron

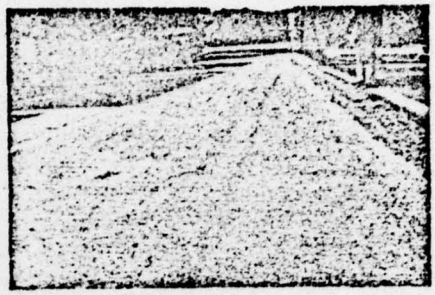
写真－5.115　水叩工（路面）のクラック（法線方向）

Photo 5.115 - Crack of Apron (road surface)(normal line)

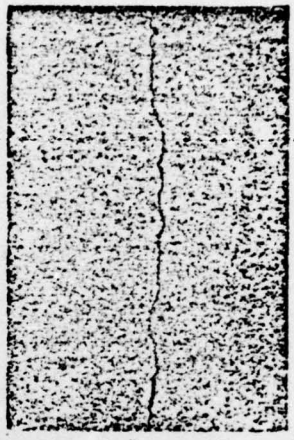
写真 - 5.119 波返し工のクラック

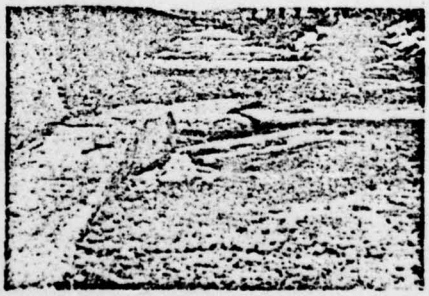
A vanguard sea wall constructed on a reclaimed land [exact position not given]; presumably exposed to action of waves because of its location; area in the rear: factory site; scattering of reinforced bedding rocks and serious abrasion of lower part concrete of face surface; holes and ruptures in face surface; big crack in foundation concrete; 5-8 mm aberration to both front and back of wave deflector; crack in 12-m long block near 3-5 m pitch; sinking of apron to develop water puddles and 20 cm cave-in section causing erosion of fills; breach, angular break, and innumerable cracks in ground site.

写真 - 5.121 裏込の吸出しによる水叩工の陥没

Photo 5.121 - Apron Cave-in From Erosion of Fills

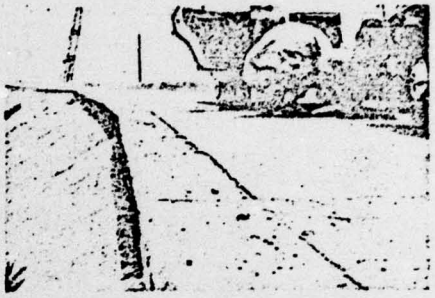
Photo 6.2 - Level Difference Between Crown and Rear Spread at Ground Site

写真 - 6.2 天ば工と裏のり工との目地の段差

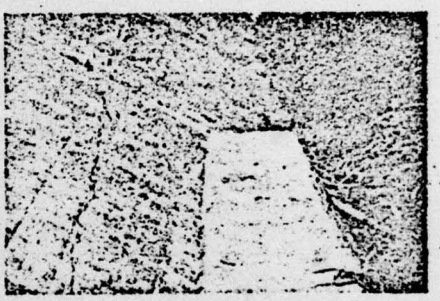
写真 - 6.4 裏のり工法線方向のクラック

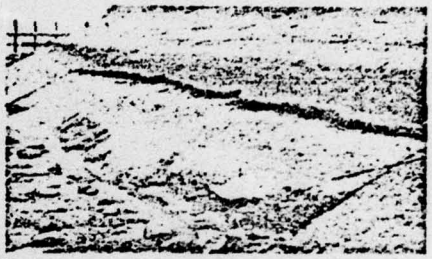
写真－6.6 表のり工下部の打継目に生じた角欠け

Photo 6.6 - Angular Break Tha Developed at th Lower Section o Face Spread

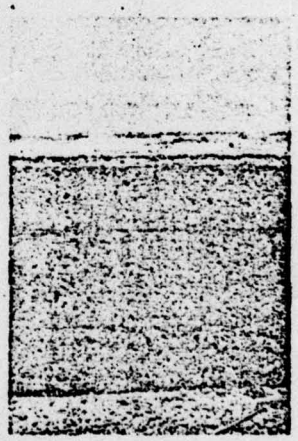
写真－6.8 表のり工全面にわたる断面方向クラック

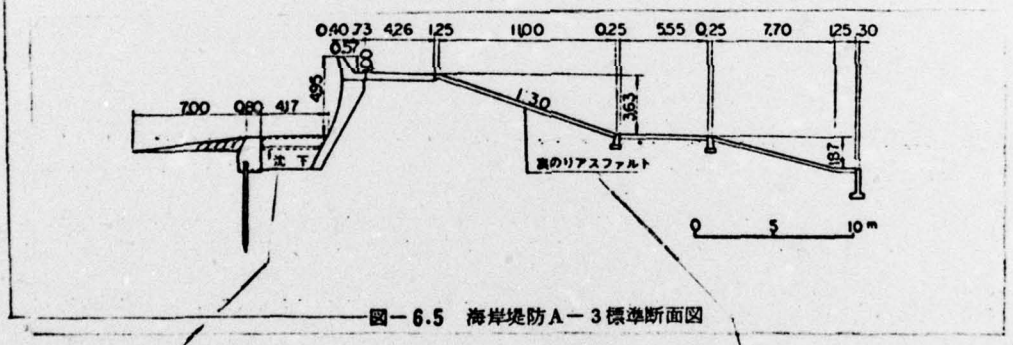
Chart 6.5 - Cross-section Sketch of Embankment A-3

This embankment is located at the mouth of Yahagi Gawa with a beach to the front, but is encountering, it is believed, relatively heavy action of the waves. Both the face spread and the foundation steps are constructed of concrete and the front and rear spreads are provided with asphalt concrete coverings. In one section of the asphalt-concrete coverings, there is a crack, but no other deteriorations, such as exposure, cave-in, etc., were observed. Due to insufficient coverings, exposure of ferro-concretes was observed in the face spread armor and parapet sections. Sinking of the foundation steps was also noted. Reinforced bedding has been constructed of rip-rap concrete to fill up any air gaps.

Weep holes were observed near the bedding anchor as localized holes. These holes, it is believed, were caused by the shift in embankment soil from the permeation of rain water or from the change in the water level of the rear "shio asobi" [literally, "tidal play"].

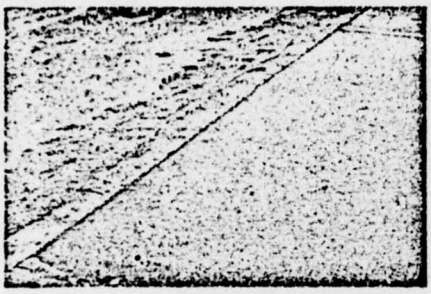
Photo 6.10 - Small Step Slab Sinking of Reinforced Concrete Section

写真-6.10 根固部の小段スラブの沈下

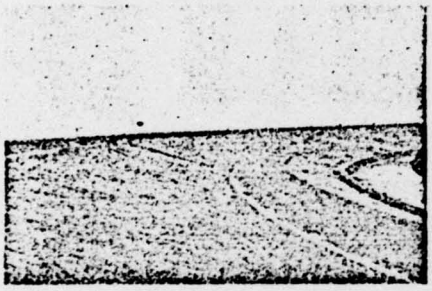
Photo 6.11 - Exposure of Ferro-Concrete of Wave Deflector

写真-6.11 波返し工の鉄筋の露出

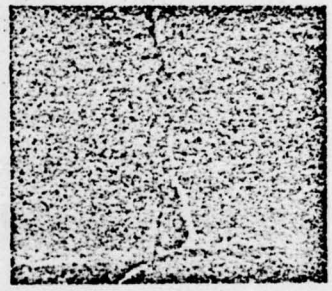
写真-6.13 裏のり工のクラック

Photo 6.13 - Crack of Rear Spread

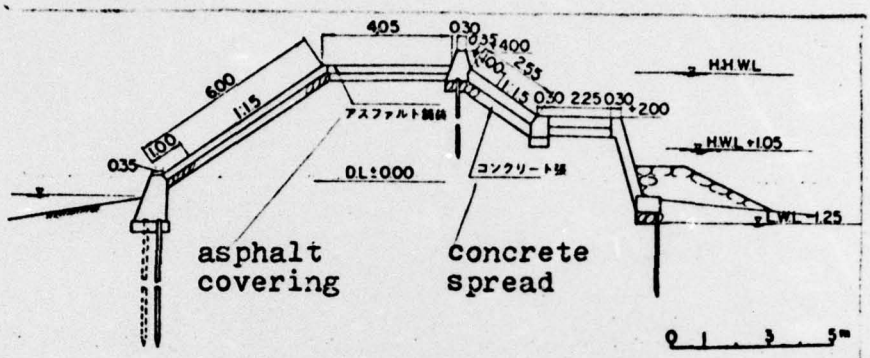
Chart 6.6 - Standard Cross-section Sketch of Coastal Embankment A-4

This embankment faces the waterway that passes through Teratsu Harbor and thus, is not encountering any direct action of the waves. It was constructed atop an old masonry rip-rap after Typhoon No 13. The face spread is provided with small steps and is supported by reinforced bedding. The crown is covered with asphalt concrete. A concrete block cave-in was observed in the step section of the face spread; grass is growing at the ground site. The even slope rear spread is provided with a concrete armor, but a vertical aberration was observed at the vertical ground site. Grass is also growing at this site. The back is a "shio asobi" [tidal play?] area. The aforementioned Aichi survey report stated that a 1-cm air gap was found below the face spread armor.

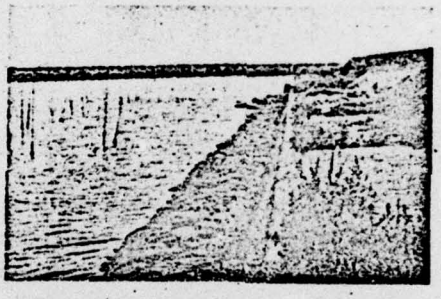
写真－6.14 表のり工および根固工の状況

Photo 6.14 - Conditions of Face Spread and Reinforced Bedding

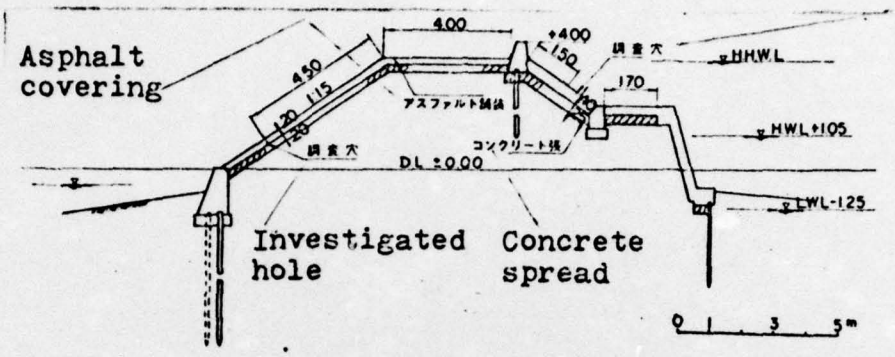
Chart 6.7 - Standard Cross-section Sketch of Embankment A-5

This embankment is located much farther inside than embankment A-4 and is constructed about the same as A-4, structurally. The concrete block of the upper step section of the face spread showed a cave-in (similar to A-4); a 5-cm or more vertical aberration of the vertical ground site was also observed. According to the Aichi survey report, about a 3-cm air gaps were observed beneath the face spread armor.

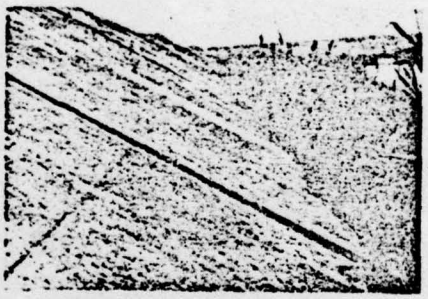
写真 - 6.16 裏のり工のはらみ

Photo 6.16 - Exposed Face Spread

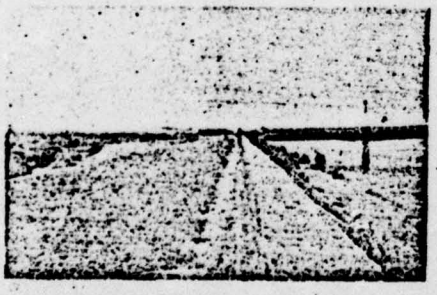
写真 - 6.17 波返し工法線の変形

Photo 6.17 - Normal Line Contour Change of Wave Deflector

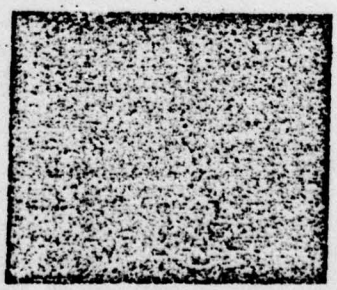
写真 - 6.18
表のり工に生じた法線直角方向クラック

Photo 6.18 - Normal Line Right Angle Crack That Developed in Face Spread
