4. TITLE (and Subtitle): APPARENT WASTING INDEX OF EMBANKMENTS,	5. TYPE OF REPORT & PERIOD COVERED
	6. PERFORMING ORG. REPORT NUMBER: Technical Note, No. 149

7. AUTHOR(s): Furudoi, Teruaki / Iguchi, Motoharu	8. CONTRACT OR GRANT NUMBER(s)
9. PERFORMING ORGANIZATION NAME AND ADDRESS: The Port and Harbor Research Institute, Ministry of Transportation, Tokyo, Japan	10. PROGRAM ELEMENT, PROJECT, TASK AREA & WORK UNIT NUMBERS

11. CONTROLLING OFFICE NAME AND ADDRESS: Department of the Army, Coastal Engineering Research Center, Kingman Building, Fort Belvoir, VA 22060	12. REPORT DATE: December 1976

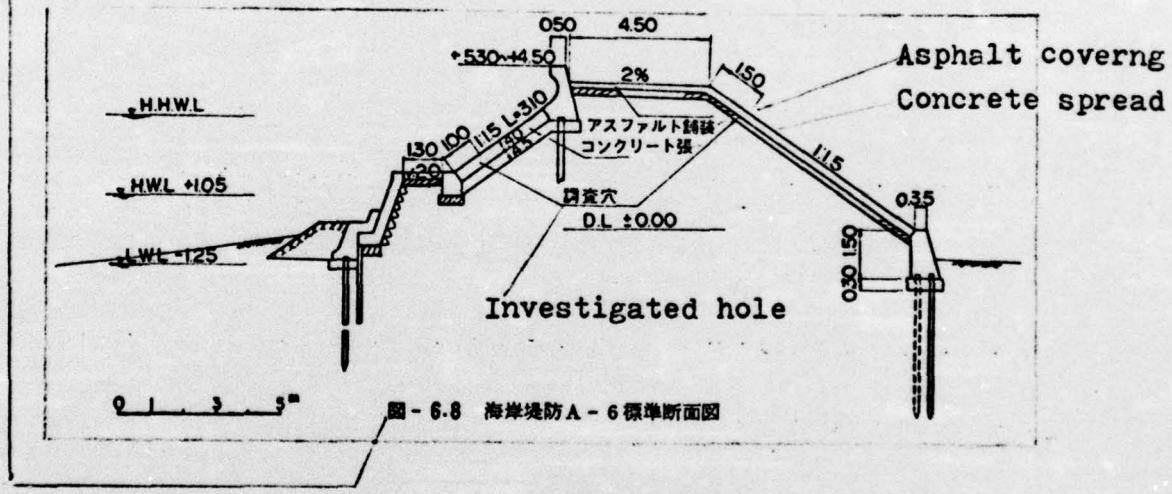
Chart 6.8 - Standard Cross-section Sketch of Coastal Embankment A-6

This embankment is located in an area pinched in by the waterway and Okuda: Nitta. No strong action of the waves, it is believed, is being faced by this embankment. The face spread is provided with small steps and the whole front is supported by reinforced bedding; external observation shows no unusual change in the whole face spread. The crown is covered with asphalt concrete and also shows no deterioration. The rear spread shows some exposure but is provided with concrete armor; few cracks were observed in the rear spread and a patch of growing grass was observed near its connection with the bedding anchor. According to the Aichi survey report, about a 1cm air gap was observed beneath the face spread armor.

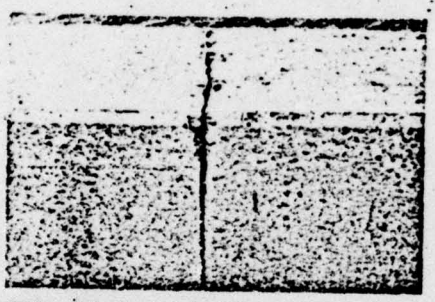
写真-6.21
波返し工の目地の間隙（目地板が脱けたもの）

Photo 6.21 - Opening at the Ground Site of Wave Deflector (breach of ground site block)

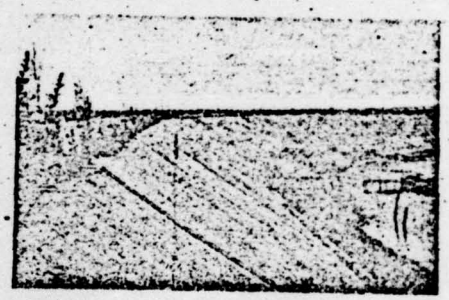
写真-6.22 裏のり工および根留工の状況

Photo 6.22 - Conditions of Rear Spread and Bedding Anchor

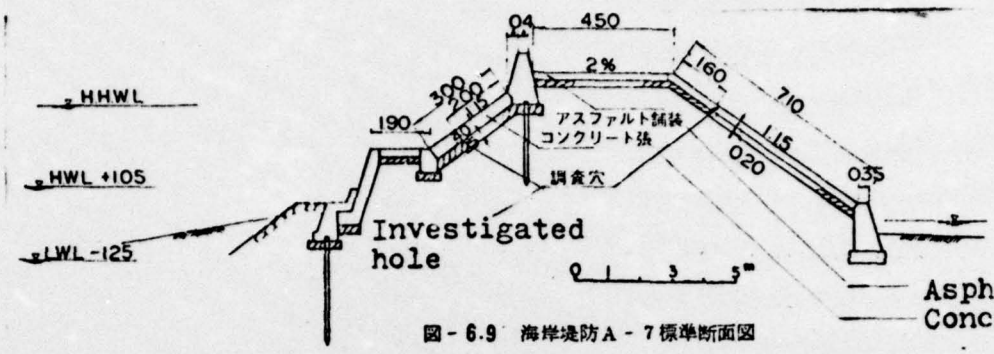
Chart 6.9 - Standard Cross-section Sketch of Embankment A-7

The cross-section of this embankment is almost the same as A-6 but this embankment has a concrete block cave-in block in the step section of the face spread and its reinforced bedding to the front showed scattering near the sluice. The latter development is believed to have been caused by the conversion of waves resulting from the breakwater located on the western side of the sluice. At the vertical and horizontal ground sites of the rear spread armor, big breaks and vertical aberrations were observed. Thick growing grass was observed near the pile joint of the bedding anchor as well on the crown. According to the Aichi survey report, a 2 cm air gap was observed beneath the face spread armor.

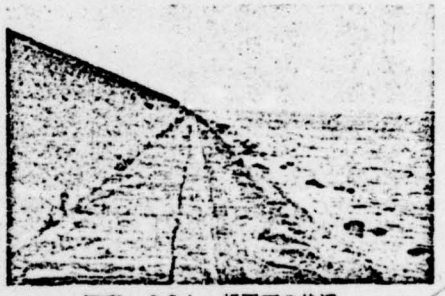
写真 - 6.24 根固工の状況

Photo 6.24 - Condition of Reinforced Bedding

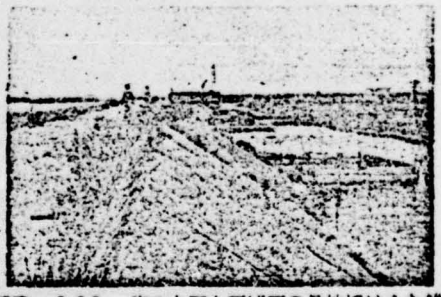
写真 - 6.26 裏のり工と天ば工の目地にはえた雑草

Photo 6.26 - Mixed Grass Growing at the Ground Site of Rear Spread an Crown

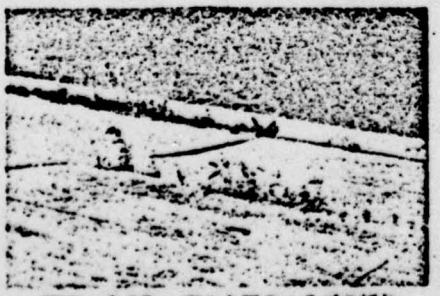
写真 - 6.27 裏のり工のスラブの折れ

Photo 6.27 - Rear Spread Slab Break

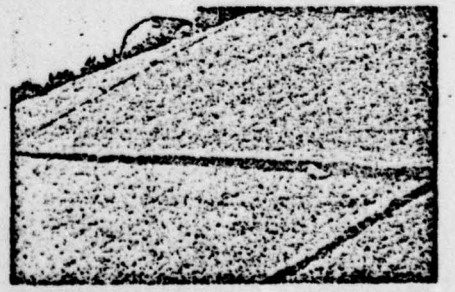
写真 - 6.28 裏のり工スラブの移動による段差

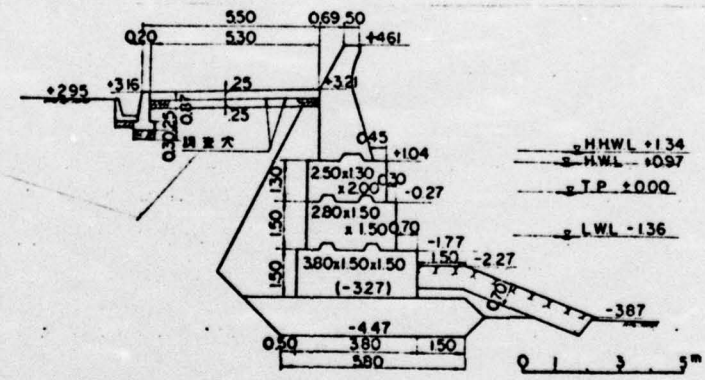
Chart 6.10 - Standard Cross-section Sketch of Embankment/Sea Wall A-8

This is a 3-level sea wall structure with a parapet constructed on the top and a reclaimed ground to the rear. The apron was an asphalt-concrete covering that was employed as a roadway. This covering was removed because of 5-6 cm sinking and a big air hole was discovered below. It was assumed that the cause for this development was the soil erosion from the ground site of the front block. The discovery led to the removal of the whole covering to repack the soil below and to recover the whole blocks with concrete reinforced by use of cords. A year after this renovation work, however, the reinforced coverings with cord began to chip off, leading to the sinking of the coverings. Present plan calls for the placement of sheet pilings to correct the above situation. The reinforced bedding to the front appears to be in good condition, showing no shifting of any kind despite the fact that it has been in existence for about 10 years since its construction.

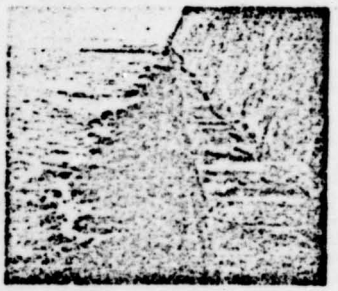
写真 - 6.32　表のり下部の鉄筋の露出

Photo 6.32 - Exposed Ferro-concrete of Lower Section of Face Spread

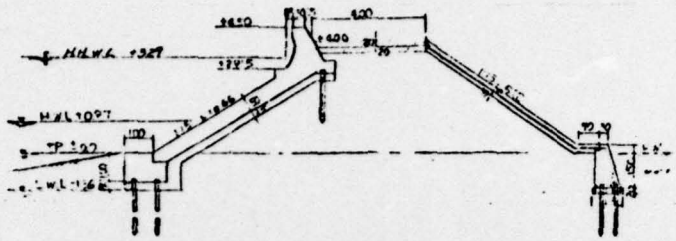
Chart 6.11 - Cross-section Sketch of Coastal Embankment A-9

This embankment is located deep inside the Mikawa Wan in a location where the terrain serves as a barrier against any serious action of the waves. Extensive reclamation work is being undertaken to the front to indicate that in due course of time, this embankment will be facing quiet sea water to the front. Almost no deterioration was observed in the originally constructed reinforced bedding. The face spread armor, however, did show a horizontal direction concrete abrasion near the end of the armor as well as angular breaks and cracks (part of the larger cracks of the spread have been repaired by concrete mending). The rear spread armor also showed a break at the vertical ground site and at the pile joint of the bedding anchor and an erosion of the soil at the shoulder; a number of cracks were also observed in the rear spread. This embankment was not listed as one of the weep-hole sites in the Aichi survey report, but was a suspect site. For this reason, grout pouring work has been carried out so far.

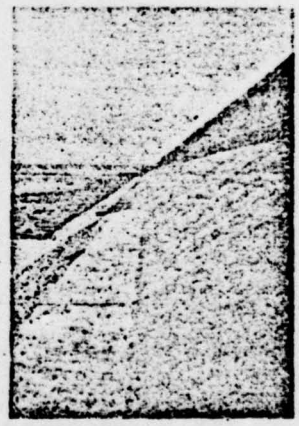
写真 - 6.37
表のり下部の腹付けコンクリート

Photo 6.37 - Added Concrete At the Center Section of the Lower Part of Face Spread

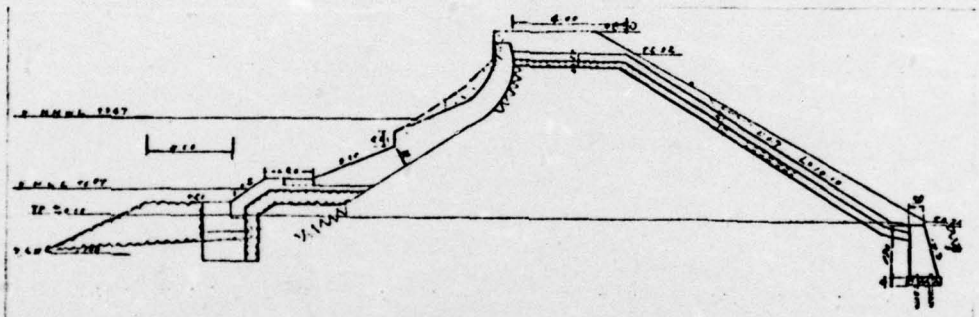
Chart 6.12 - Standard Cross-section Sketch of Coastal Embankment A-10

This is a three-side concrete armor embankment that was constructed over a foundation that a masonry embankment stood before it was destroyed by Typhoon No 13. With the exception of few cracks, the face spread appears almost the same since its completion, but a soil erosion near the shoulder, breach with the bedding anchor near the pile joint, and a crack near the center armor were observed in the rear spread.

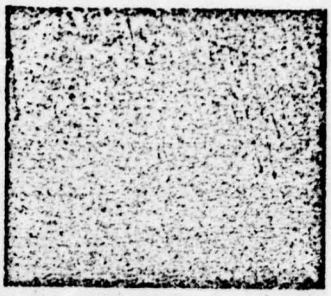
写真 - 6.41　表のりの法線直角方向クラック

Photo 6.41 - Normal Line Right Angle Crack of Face Spread

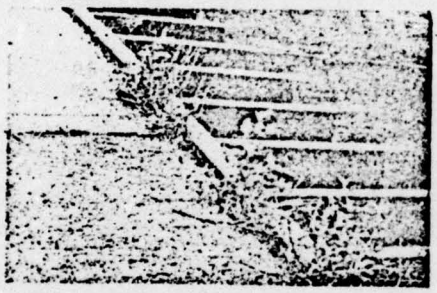
写真 - 6.42　天ば工の沈下による段差

Photo 6.42 - Level Difference Caused by Sinking of Crown

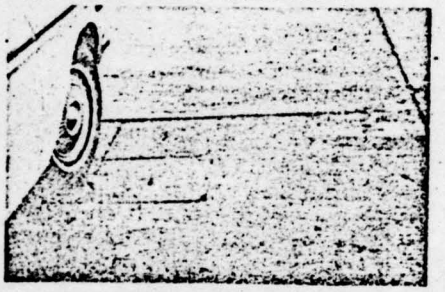
写真 - 6.43　天ば工のマンホール

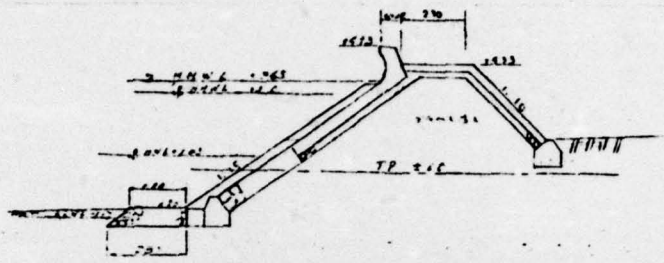
Chart 6.13.- Standard Cross-section Sketch of Coastal Emgankment A-11

Angular breaks and abrasion were observed in the face spread armor near the work site, but concrete repair work had been performed on severe breaks. Generally speaking, the mixture of concrete seemed rather poor, but except for the above deteriorations, no other serious breakdown was noted. Because of fairly high back base, the rear spread profile was very low in comparison. The rear spread showed some exposure but no crack or unusual change. In the Aichi survey, no weep hole or air gap was found, but spread concrete had been employed to repair the upper part of the face spread where many cracks had developed, and grout for the lower part. This embankment was restored after Typhoon No 13 and its face spread armor is only about 30 cm thick.

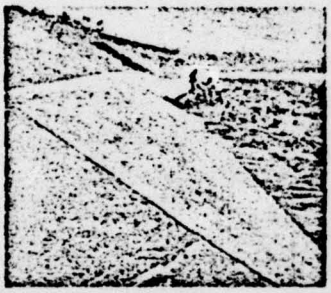
写真- 6.44 全景（腹付けコンクリート）

Photo 6.44 - General View Repaired Cross-section Concrete)
