TECHNICAL REPORT NO. 6-570

DURABILITY AND BEHAVIOR OF PRESTRESSED CONCRETE BEAMS

Report 4

POSTTENSIONED CONCRETE BEAM INVESTIGATION WITH LABORATORY TESTS FROM JUNE 1961 TO SEPTEMBER 1975

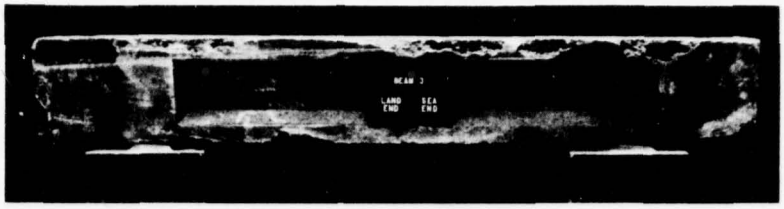
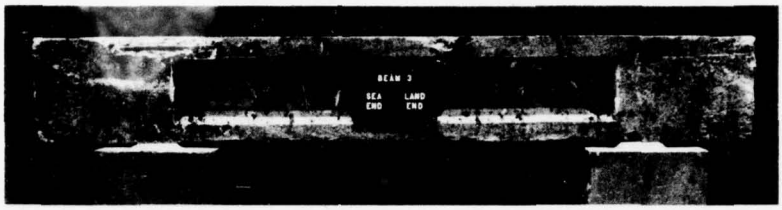
Figure 3. As-received condition of beam 3

33. The as-received condition of beam 3 is shown in Figure 3. Concrete had spalled from the conventional reinforcement in several

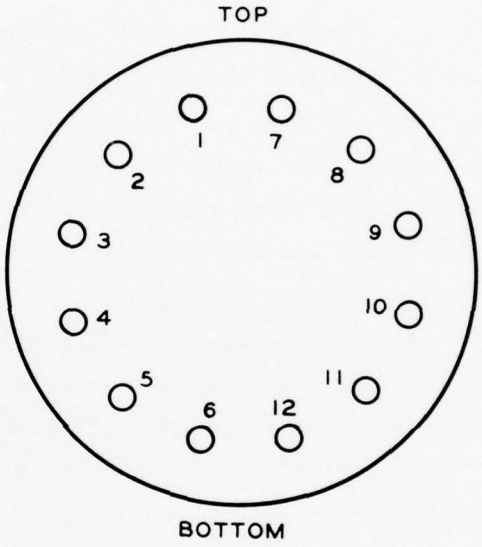
Figure 4. Landward end anchorage, beam 3

35. The strands protruding from the end anchorage of beam 3 were arranged in a circular fashion. For purposes of identification, the strands were numbered as shown in Figure 4 (view from landward end).

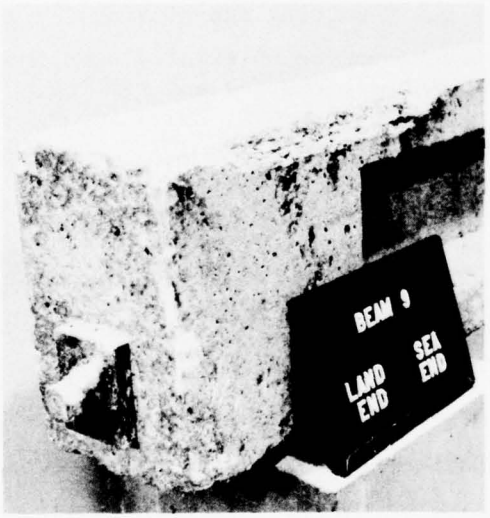
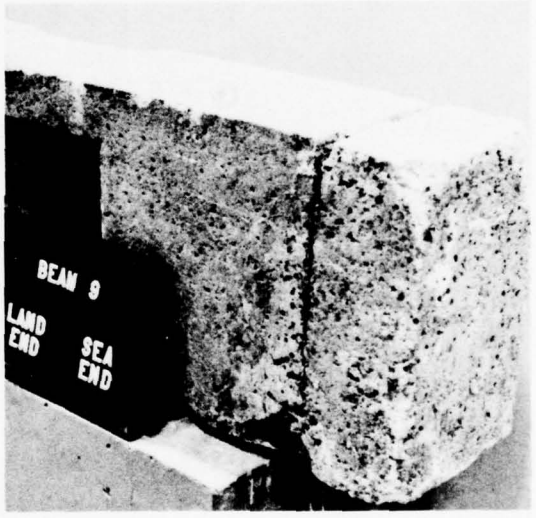
Figure 5. As-received condition of beam 9

The concrete cover had spalled from much of the conventional reinforcement exposing it to the corrosive environment. The end anchorage protection cap (Figure 5d) of the seaward end remained intact but was chipped and damaged at the joint. Figure 5c shows the condition of the

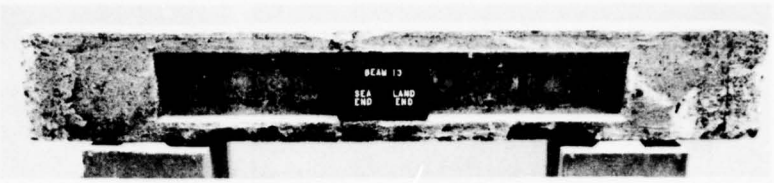
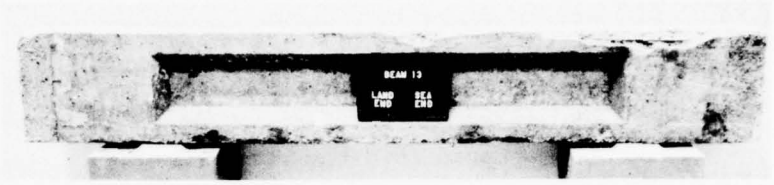
Figure 6. As-received condition of beam 13

58. The as-received condition of beam 13 is shown in Figure 6. Concrete had spalled from the conventional reinforcement at the bottom of the beam. There was one large spalled area at the top of the seaward end of this beam. The concrete caps used as end anchorage protection were only slightly damaged at the corners; otherwise, they were not damaged. Both end anchorage protective caps, at the time they were returned to the WES, had developed cracks between the caps and the actual beam (Figure 6c and d).

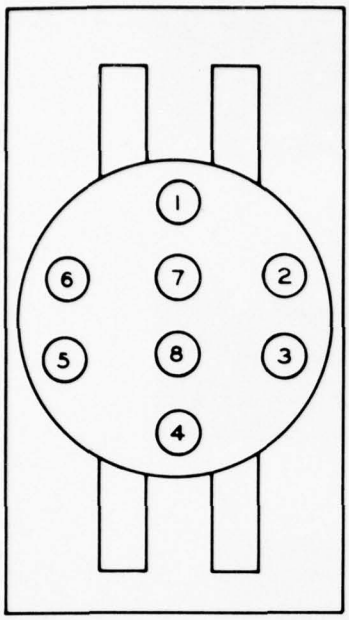
Figure 7. Landward end anchorage, beam 13

60. The strands of the tendon in beam 13 were arranged as shown in Figure 7. For purposes of identification, they were numbered as shown (view from landward end).

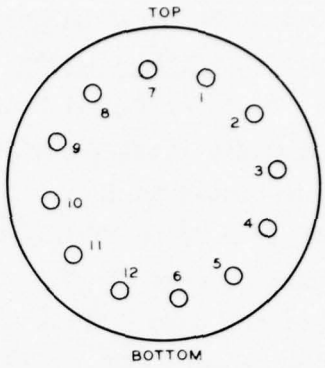
Figure 10. Strand numbering, beam 19

88. The strands of the tendon in beam 19 were arranged in a circular fashion. For purposes of identification, the strands were numbered as shown in Figure 10 (looking from the landward end).

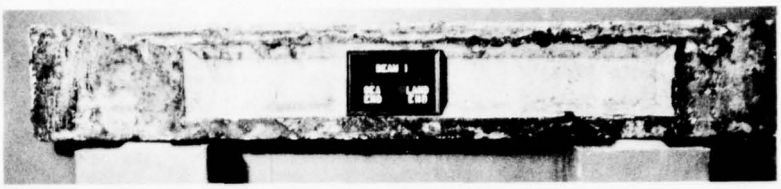
107. The as-received condition of beam 1 after the bituminous membrane had been removed is shown in Figure 13. Some of the concrete had spalled from the top edges of the beam exposing the conventional reinforcement at the seaward end on one side (Figure 13b) and along most of the top edge on the other (Figure 13a). Both end protective caps were still intact and did not show excessive wear.

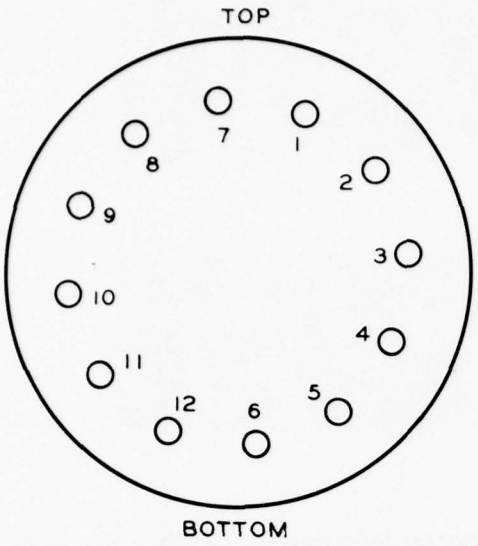
Figure 14. Landward end anchorage, beam 1

coated the strands. All the strands were heavily corroded, and using the nomemclature in Figure 14, the steel strands were corroded as follows:

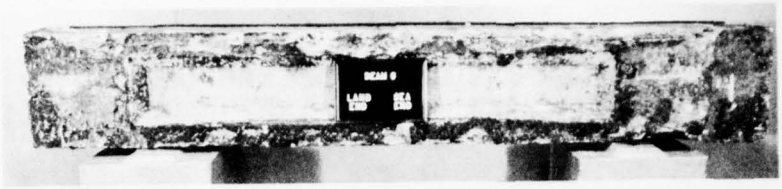
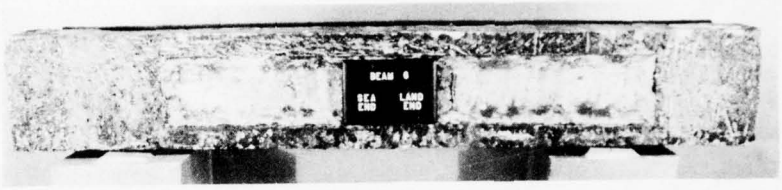
118. The as-received condition of beam 6 after the removal of the protective bituminous membrane is shown in Figure 15. Comparison of the two sides shows that spalling occurred only on one side at the top edge of the beam. Figures 15c and 15d show the conditions of the landward and seaward end protective caps.

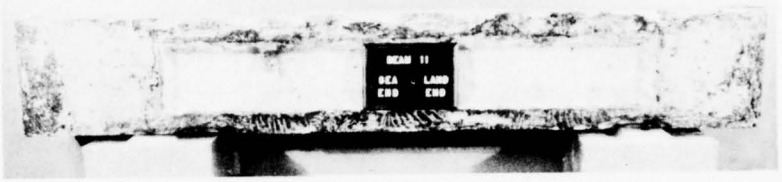
129. The as-received condition of beam 11 is shown in Figure 16. The concrete had spalled from the top edges on both sides of the beam and from one side at the bottom, exposing the conventional reinforcement to saltwater attack. The beam had a protective end cap at the seaward end and a plug over a flush end anchorage at the landward end. Both types of end protection were in excellent shape at the time of inspection.

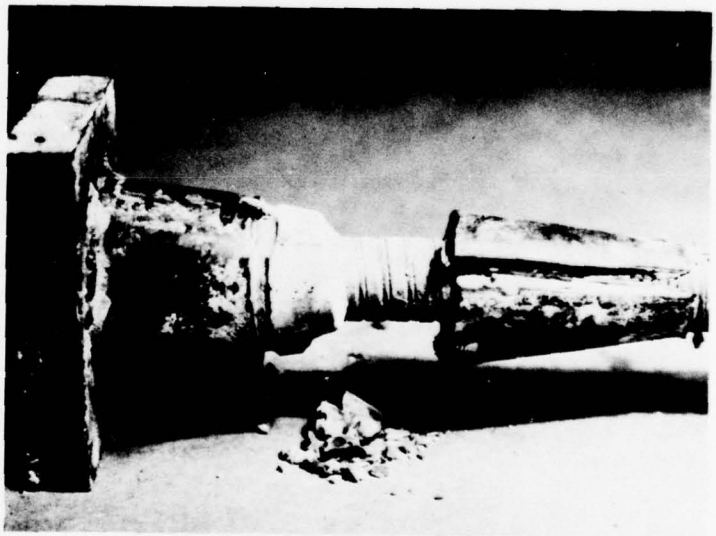
Photo 4. Grout in the landward end housing of beam 9 leaving cavity between housing and conduit

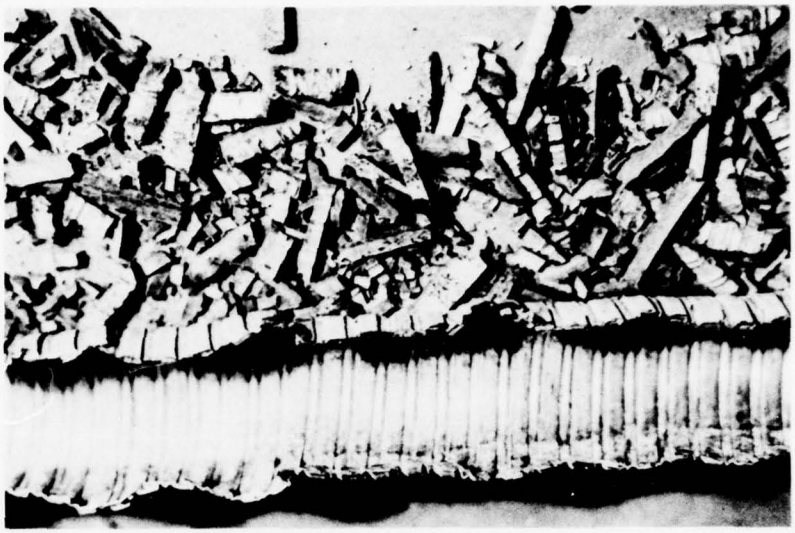
Photo 5. Grout from the landward end of conduit in beam 9

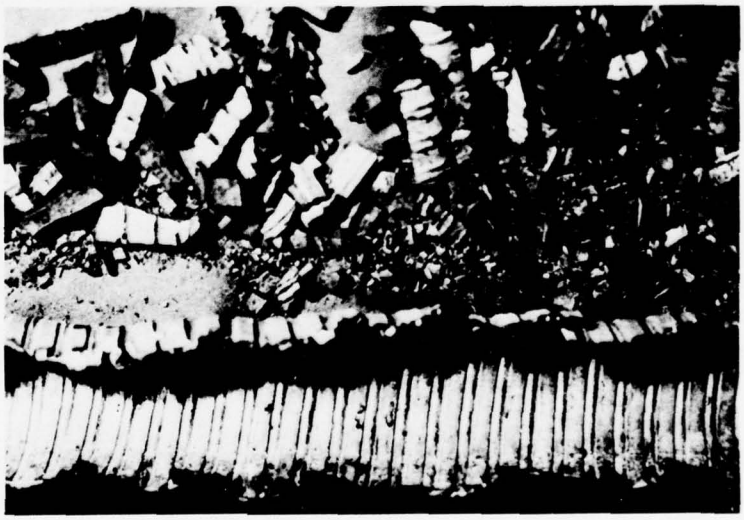
was not very substantial. Also, when the bar was placed inside the conduit and grouted, the longitudinal axis of the posttensioning rod was slightly above that of the conduit throughout the length of the beam. This made the grout cover at the top much thinner than that at the bottom, as reflected by the crack pattern of the grout. At the top, the pieces of grout broke into tiny thin pieces, while at the bottom they were thicker and more elongated (Photo 6). At the surface of the posttensioned bar, the grout was rust-stained to match the surface of the bar. Small pitting-type rust stains appeared on the grout which were similar to the pitting on the bar.

Photo 6. Grout pieces from bottom of conduit in beam 9 thicker and more elongated than those from top of conduit due to thicker grout cover on bottom

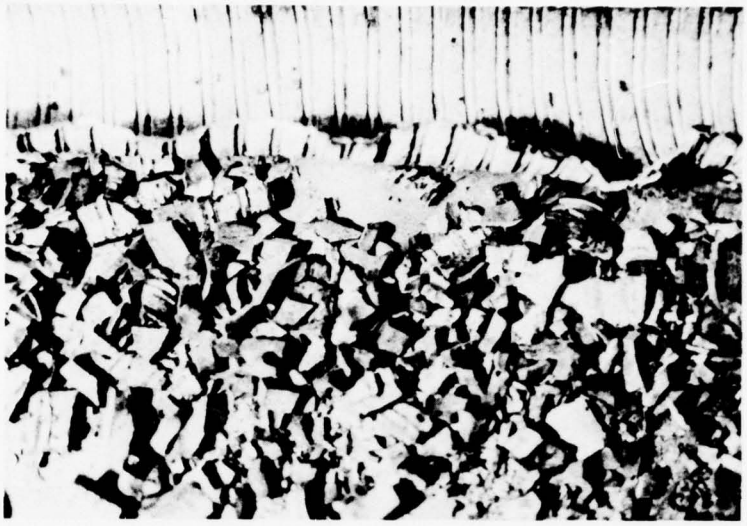
Photo 7. Central section of bottom of conduit in beam 9 and its pieces of grout

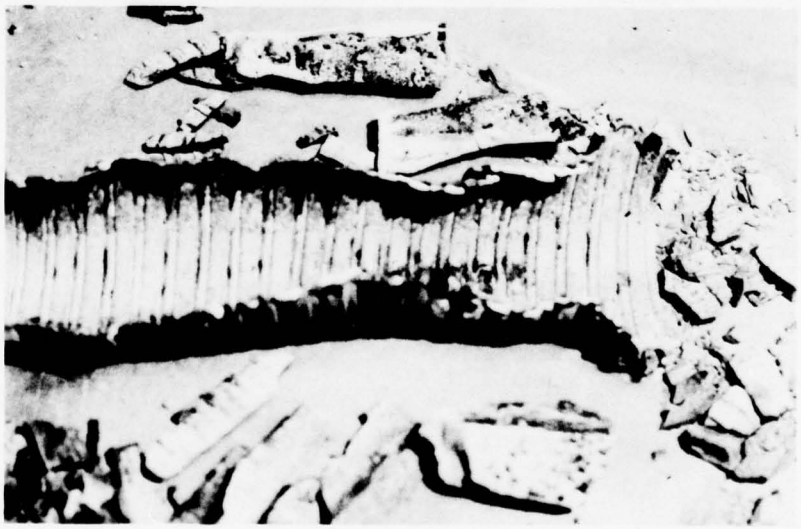
Photo 8. Seaward end of conduit in beam 9 at the funnel housing and an isolated patch of heavy rust

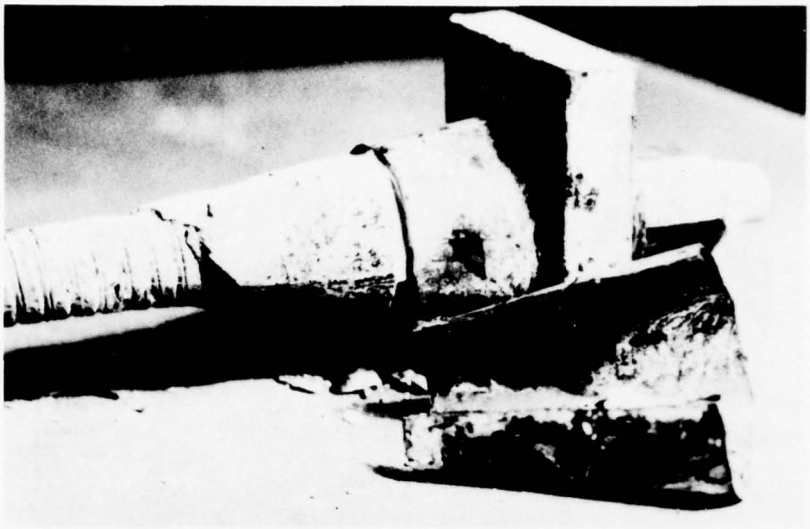
Photo 9. Condition of the seaward end anchor of beam 9

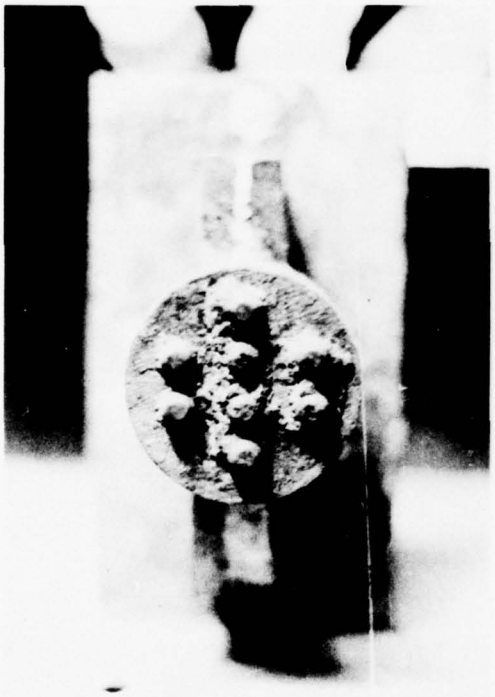
Photo 10. Grout around the ends of strands in beam 13 discolored by rust

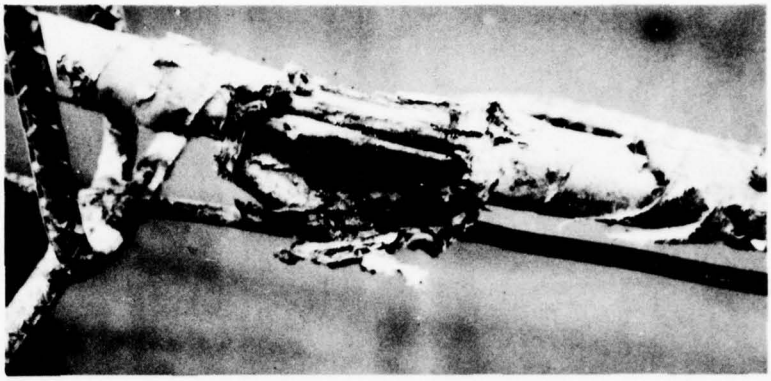
Photo 12. Paper-type wrapping in beam 13 torn, exposing grease and strands

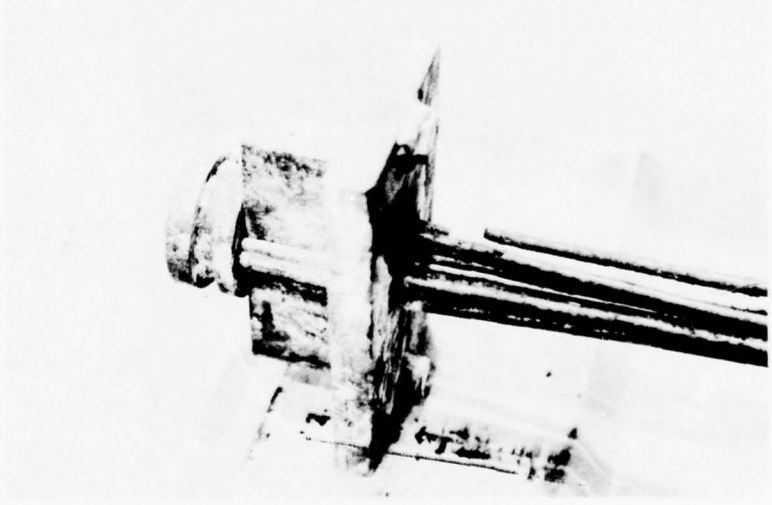
Photo 14. Strand in beam 13 so badly rusted that it broke about 5/8 in. from inside face of the end anchorage

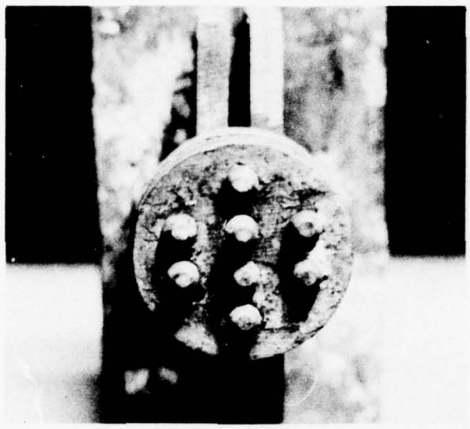
Photo 15. Heavy rusting to round anchor plate on outside face of the seaward end of beam 13

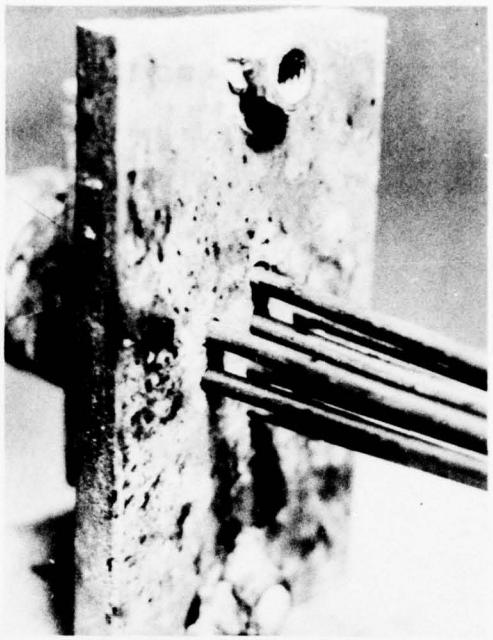
Photo 16. Inside face of the seaward anchorage of beam 13 exhibiting tarnishing and pitting

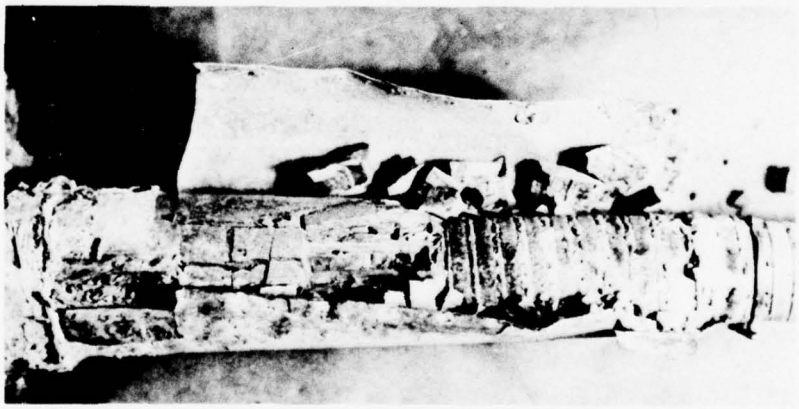
Photo 20. In beam 15, portion of conduit at the landward end that was heavily rusted with tiny pitting rust spots

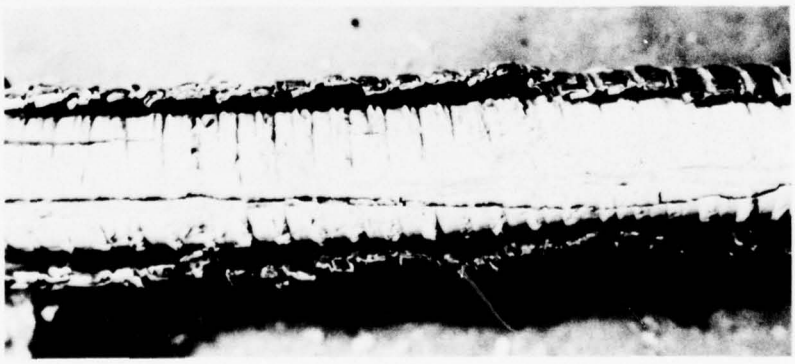
Photo 23. Grout at the seaward end in beam 15 just after conduit was opened. Note longitudinal crack, relieving the remaining stress in the steel

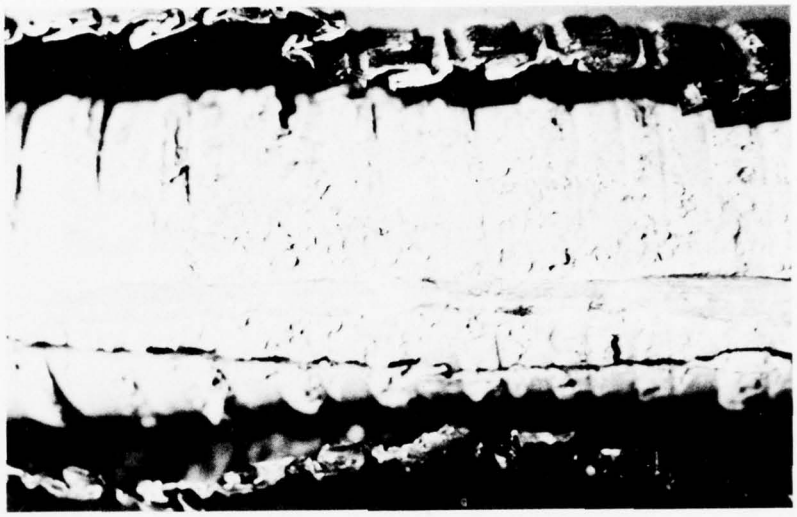
Photo 24. Detail of Photo 23 showing laitance and air voids in the grout

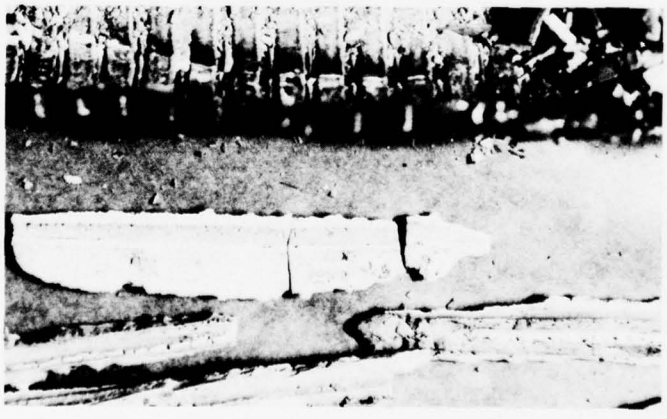
Photo 28. Grout from conduit at the seaward end of beam 15. Note milky white powder (calcium carbonate) covering grout and area of conduit from which the grout was taken

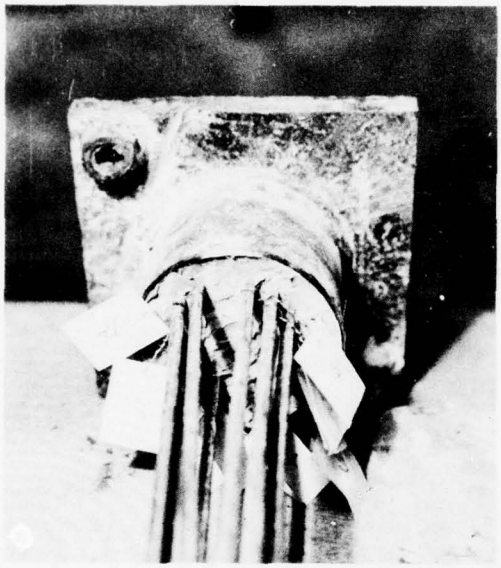
Photo 31. Grout beneath the seaward end funnel housing of beam 19 with less than 30 percent coverage of rust

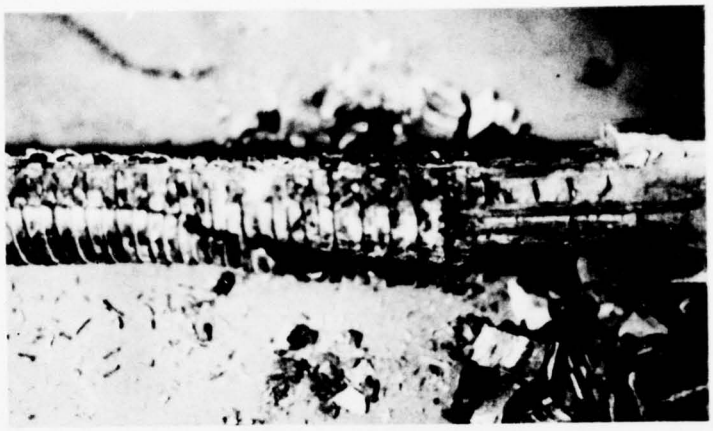
Photo 32. Heavily rust-stained grout beneath conduit at the seaward end of beam 19

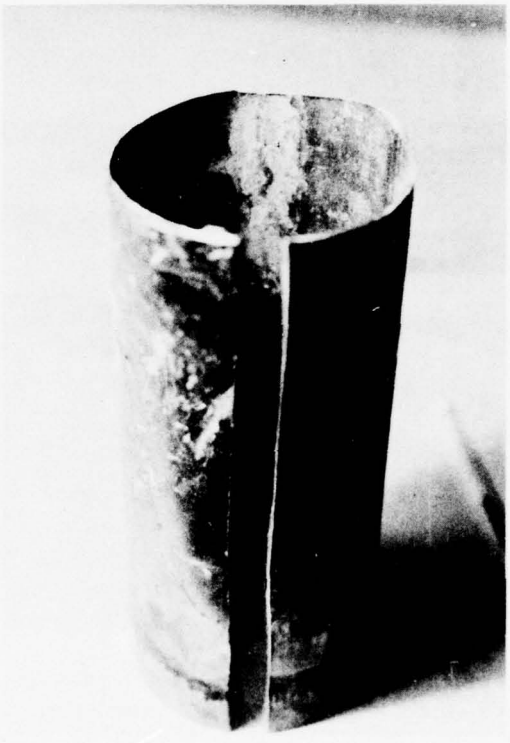
Photo 35. Rust on inside of the landward end funnel housing of beam 19

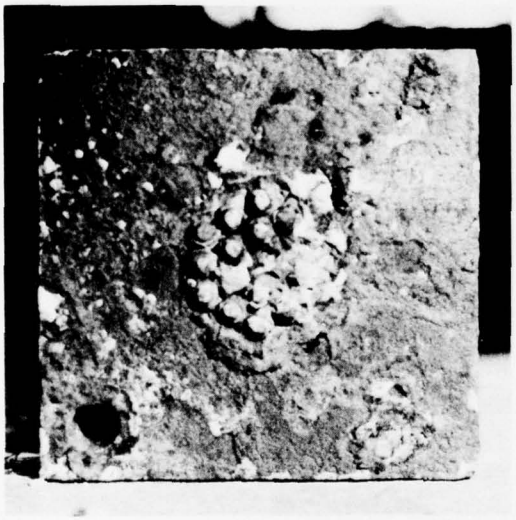
Photo 37. Heavy rust on outside face of the seaward anchorage and strands in beam 19

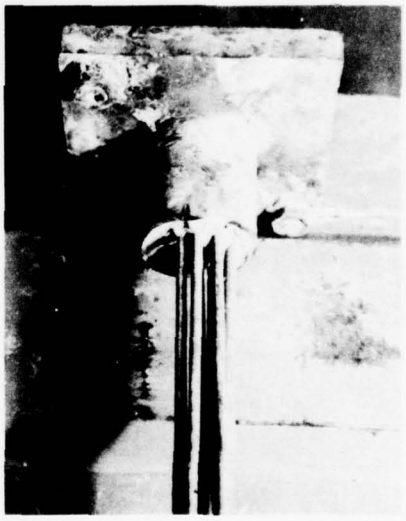
Photo 38. Inside face of the seaward end anchorage plate in beam 19. Note heavy tarnishing and moderate pitting but no rust

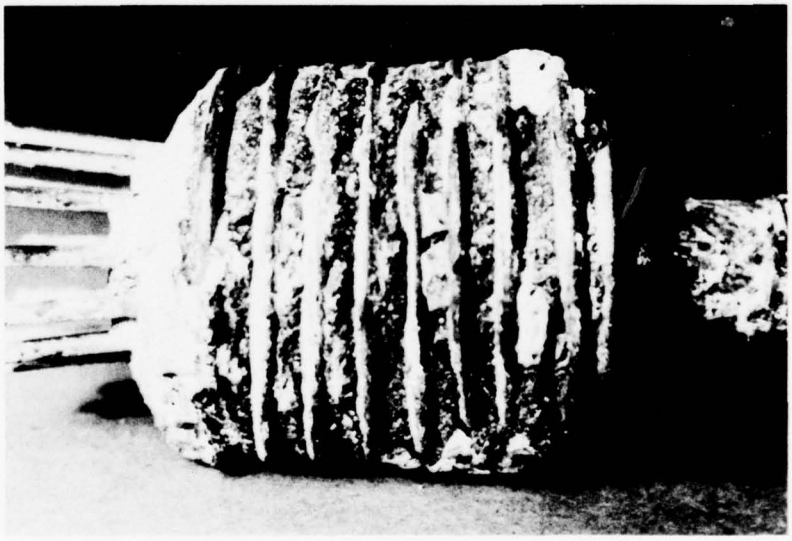
Photo 44. Landward end anchorage of beam 6. Note cement bonded to steel coils and tarnishing on coils but no rusting

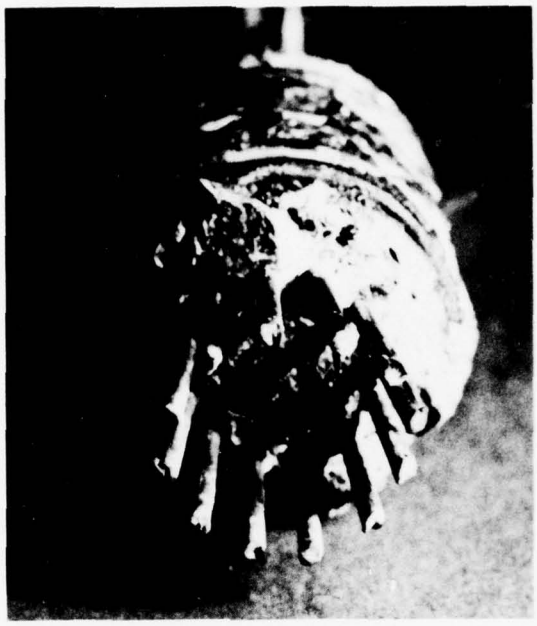
Photo 45. Strands extending 1-1/4 in. from the landward end anchorage of beam 6 completely free of rust

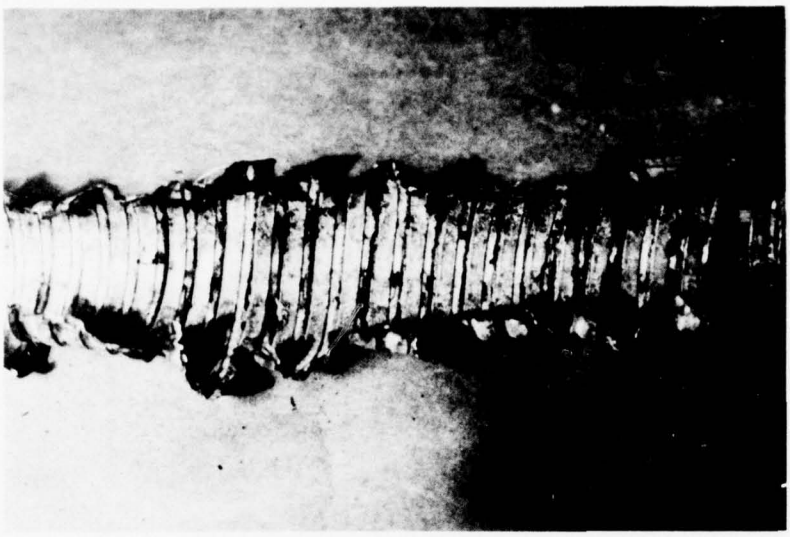
Photo 49. Inside of midsection of conduit in beam 6. Note rust on joints heavier and unrusted surface less lustrous than at ends (Photo 48)

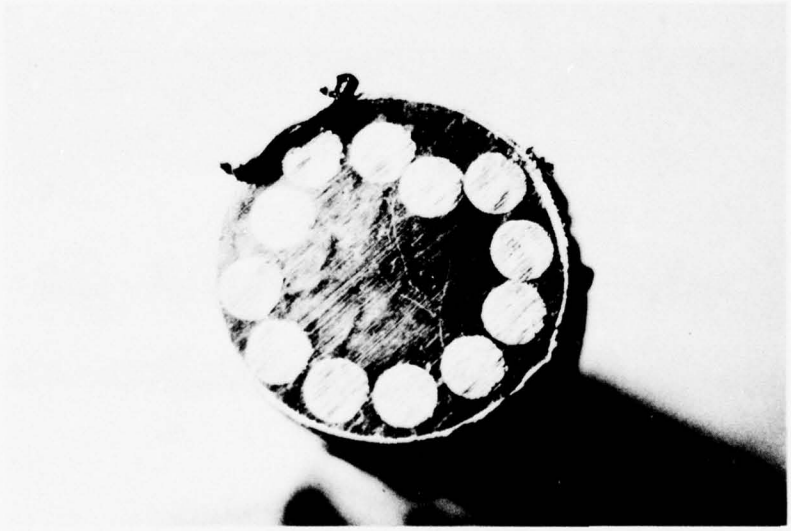
Photo 50. Landward end of conduit in beam 6 immediately after it was cut from conduit. Note closeness of individual strands to outside of conduit and contact of some strands with other strands and inside of the conduit

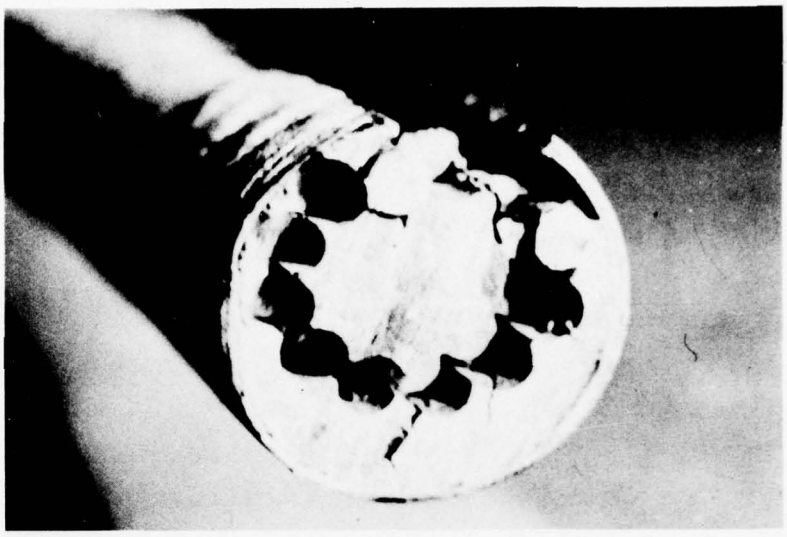
Photo 51. Strands at the seaward end of conduit in beam 6 after conduit was cut lengthwise. Note that 3 of the 12 strands did not shorten when the grout-steel bond failed

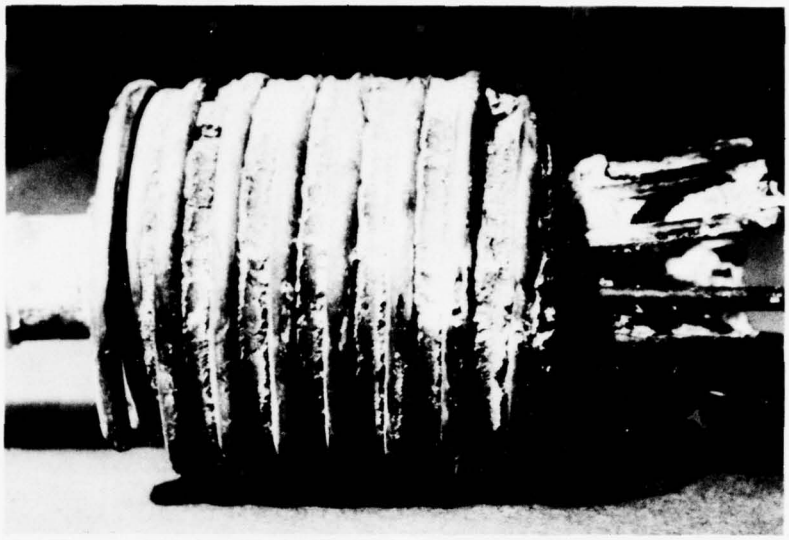
Photo 53. Steel coils of the seaward end anchorage of beam 6 lightly rusted at some spots and lustrous and unpitted in other areas

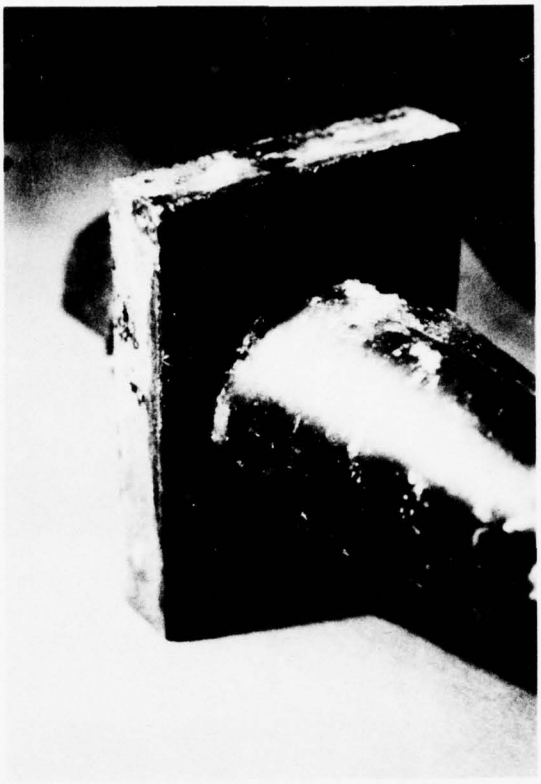
Photo 57. Inside face of the landward end anchorage plate of beam 11 not rusted but heavily tarnished

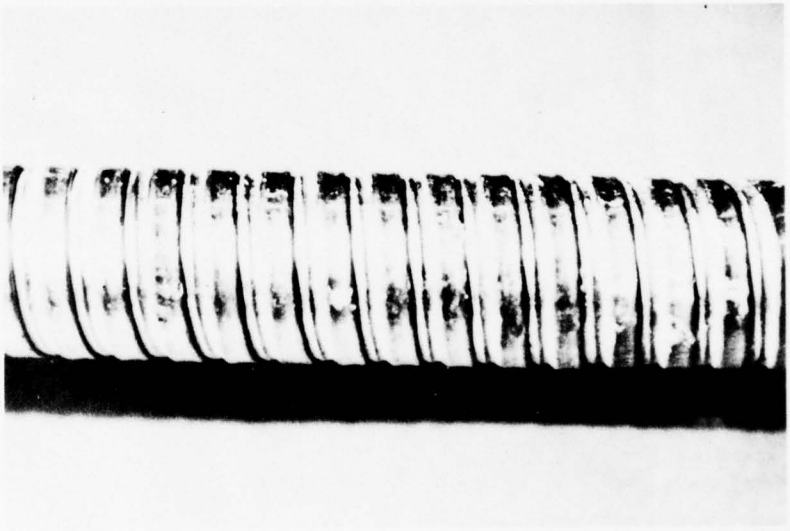
Photo 58. Highly lustrous condition of the conduit of beam 11, showing no rust and lack of any cement bonded to the surface of the metal

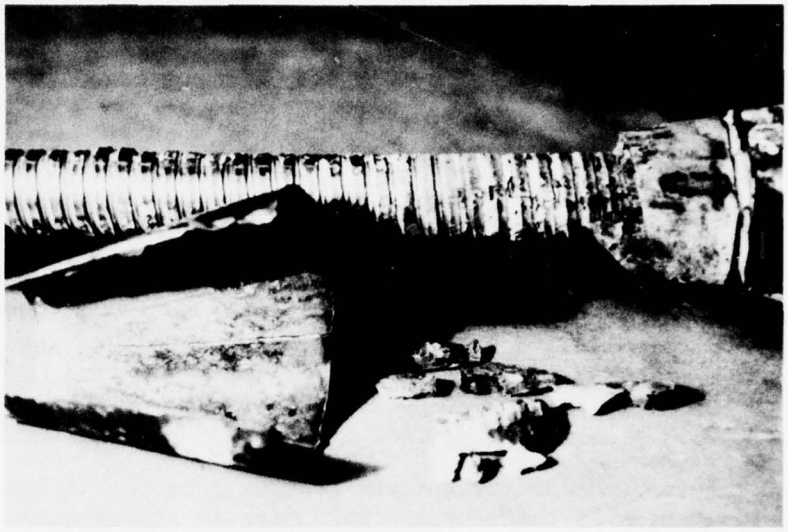
Photo 59. Rust on the bottoms of the funnel housing and conduit of beam 11 and pieces of grout that penetrated into the funnel housing

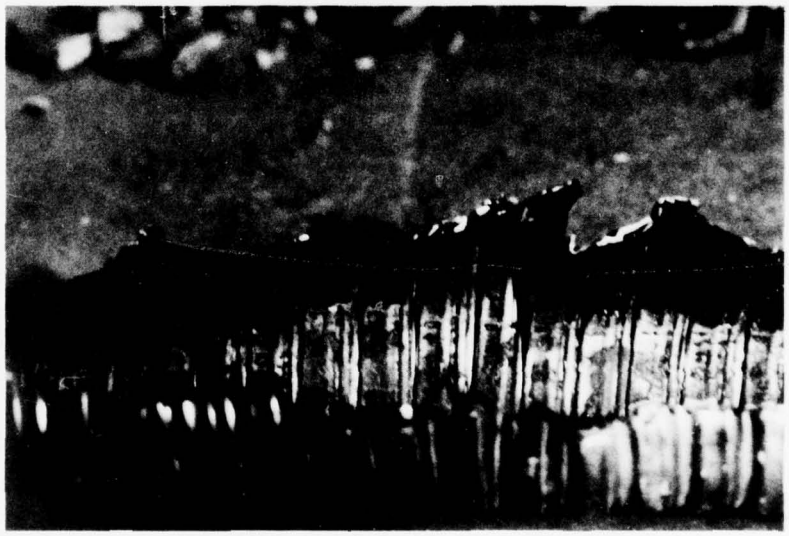
Photo 60. Bottom half of conduit in beam 11. Note border areas on both sides of 1-in.-wide strip of rust

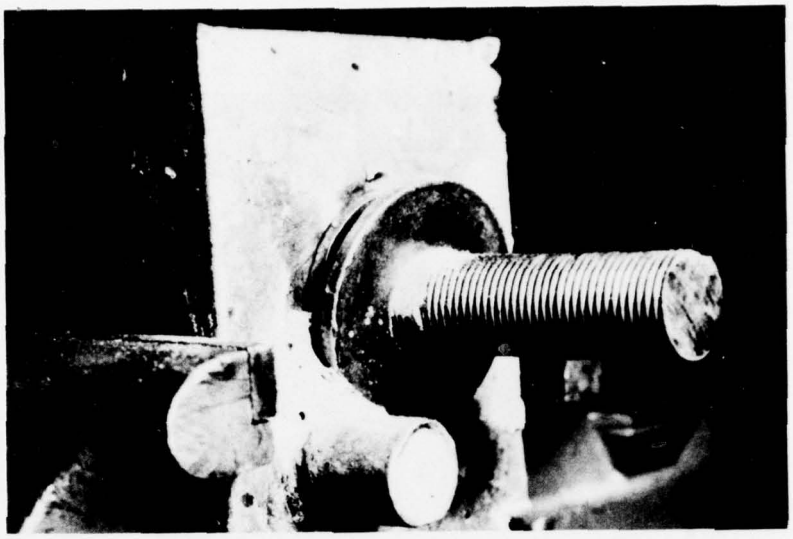
Photo 61. Rust on threads where grout from inside conduit in beam 11 came through the holes in the seaward end anchorage plate and washers. Note outside face of plate lightly rusted at top and free of rust at bottom

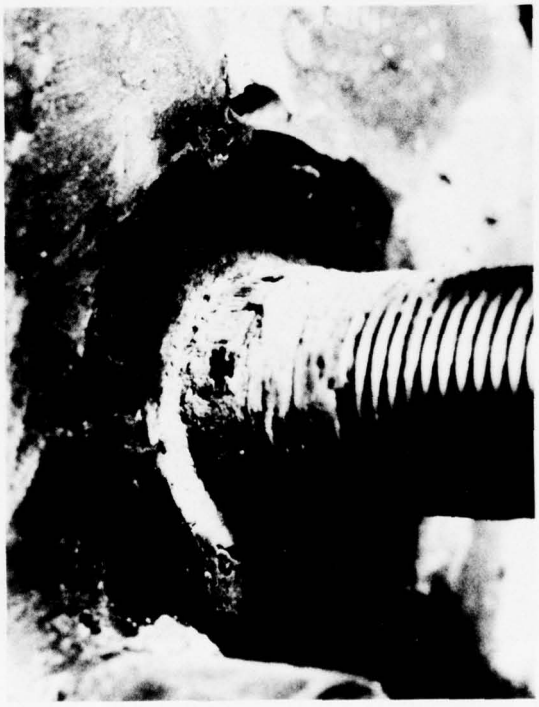
Photo 62. Detail of the seaward end anchorage plate in beam 11 not very rusted except at hole

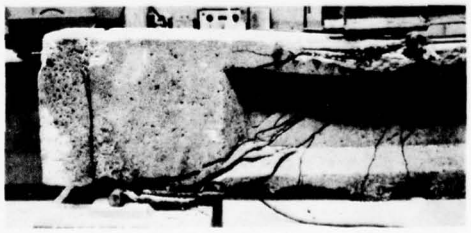
Photo A4. Failure condition of beam 9

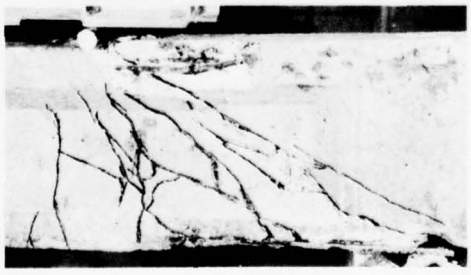
Photo A8. Failure condition of beam 15

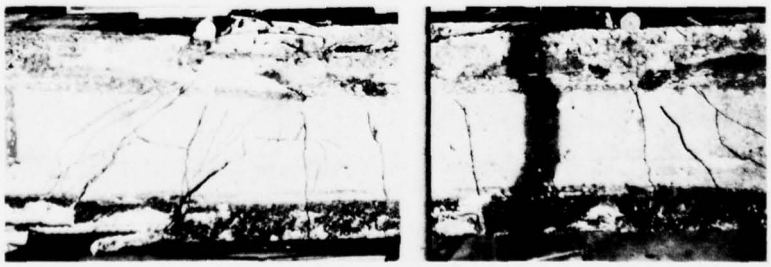
Photo A12. Failure condition of beam 6

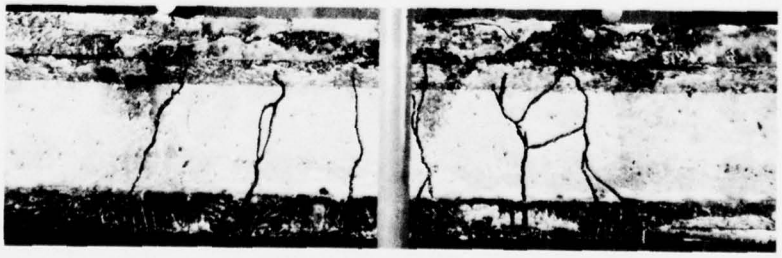
Photo A14. Failure condition of beam 11

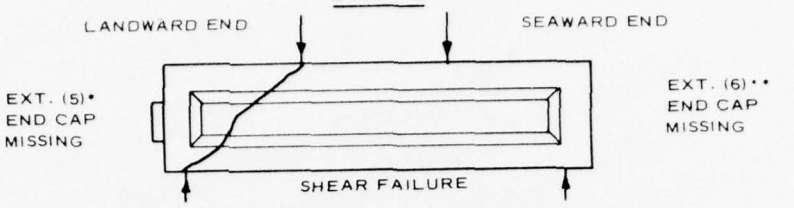
BEAM 19

EXTERNAL ANCHORAGE, JOINT TREATED WITH RETARDING AGENT, NO REINFORCEMENT, AIR-ENTRAINED CONCRETE

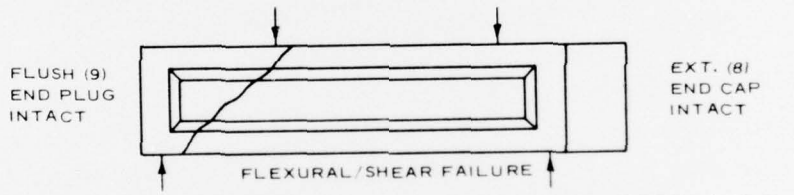
BEAM 6

FLUSH ANCHORAGE PLUG, NO JOINT TREATMENT, SAND-CEMENT MORTAR, NO REINFORCEMENT

EXTERNAL ANCHORAGE, EPOXY CONCRETE WITH REINFORCEMENT

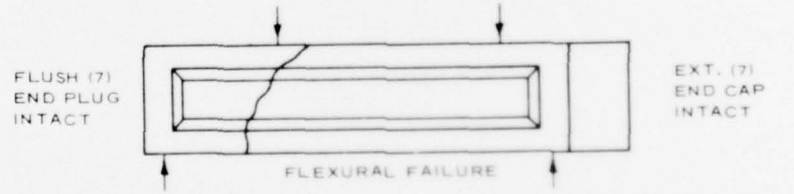
BEAM 11

FLUSH ANCHORAGE PLUG, EPOXY CONCRETE WITHOUT REINFORCEMENT
