REPORT NO. CG-D-5-77

LIGHTWEIGHT LOW DRAG FAST WATER BUOYS

December 1976

FINAL REPORT

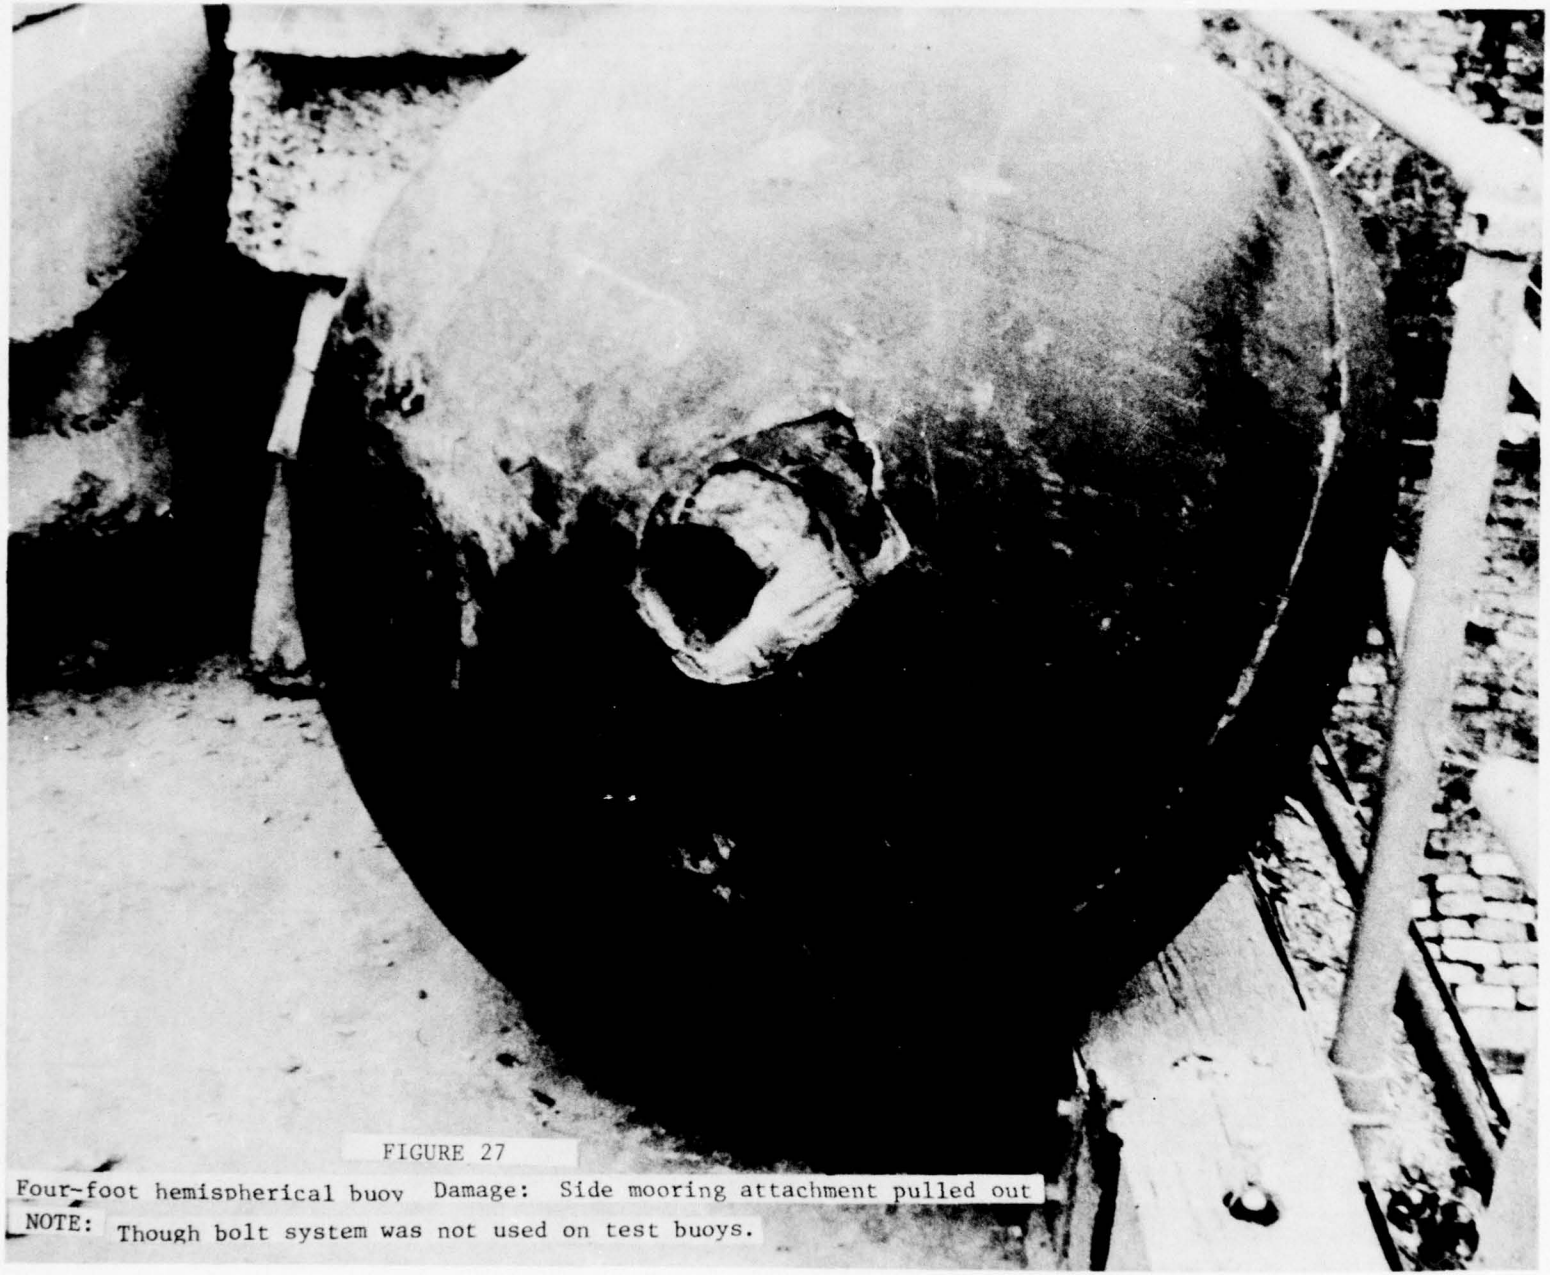
FIGURE 27

3. Mooring Strength: During the field evaluations, frequent failures of the mooring eye were experienced, caused by the mooring eye pulling out of the hull (Figure 27). It was apparent from these failures that the method of anchoring the mooring eye in the hull was not adequate in the hemispherical test hulls. Instead of plastic reinforcing pads at the point of mooring eye attachment, a through-bolt design was necessary to provide adequate mooring eye durability and strength.

Four-foot hemispherical buoy Damage: Side mooring attachment pulled out

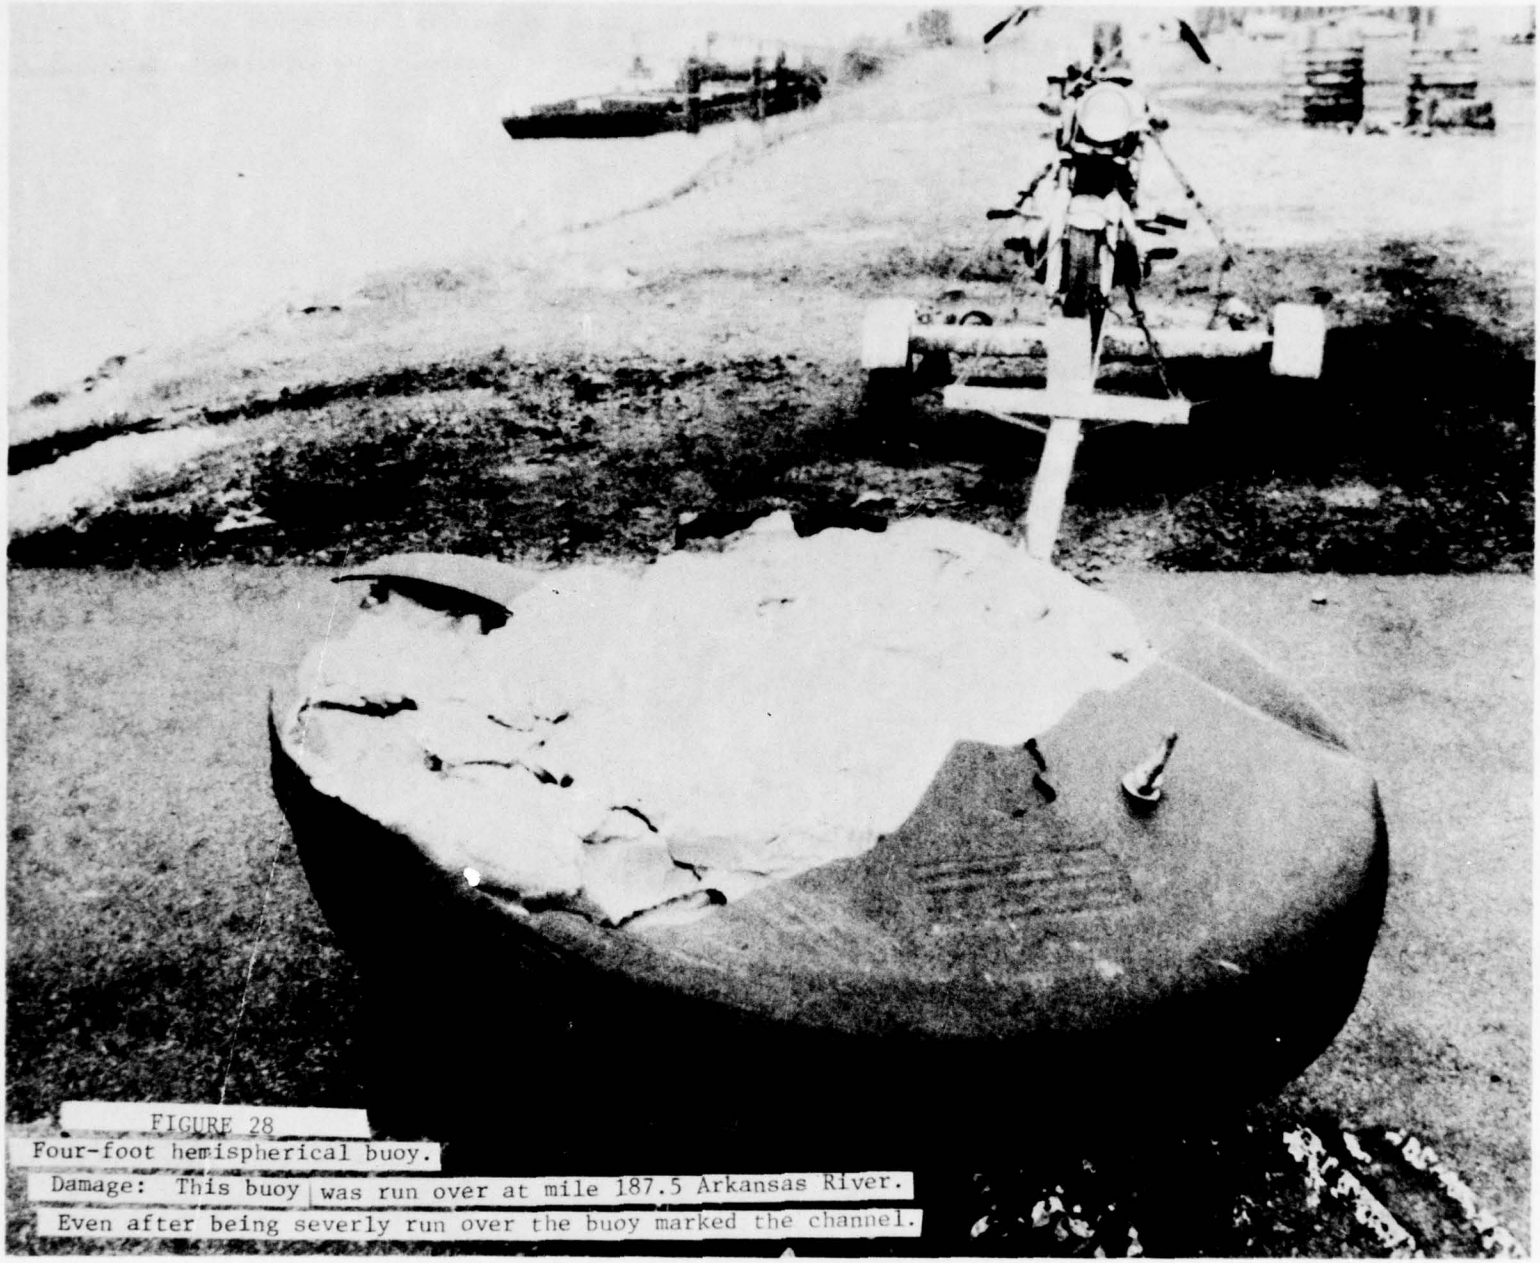
4. Hull Material: The ABS plastic was not an acceptable hull material. Damage sustained by the buoys proved the plastic to be quite brittle, and the hull would crack and break away in pieces upon impact (Figure 28). ABS plastic was also sensitive to temperature changes; as the temperature dropped, the brittleness of the plastic increased. While minor cracks and holes in the hull could be repaired by field personnel using PVC glue, commonly experienced large holes caused by the shattering of the brittle hull were beyond the capability of field personnel to repair. As a result, most damaged hulls had to be scrapped.

FIGURE 28
Four-foot hemispherical buoy.
Damage: This buoy was run over at mile 187.5 Arkansas River.
Even after being severly run over the buoy marked the channel.

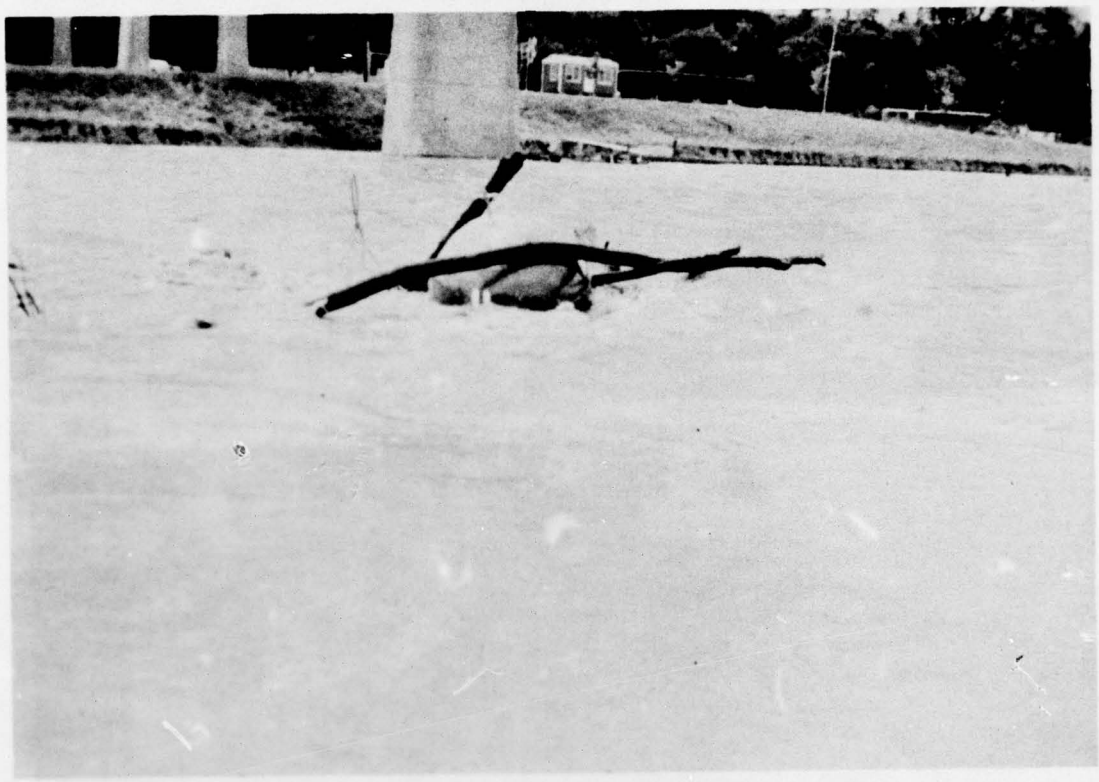
FIGURE 30 - ACCUMULATION OF LARGE DEBRIS AGAINST BUOY HULL

2. The larger types of debris, which consist of waterlogged tree trunks, branches, and stumps, collide with the buoy, and will occasionally catch and become lodged against the buoy hull (Figure 30). The effects of these collisions are hull damage and mooring failure.

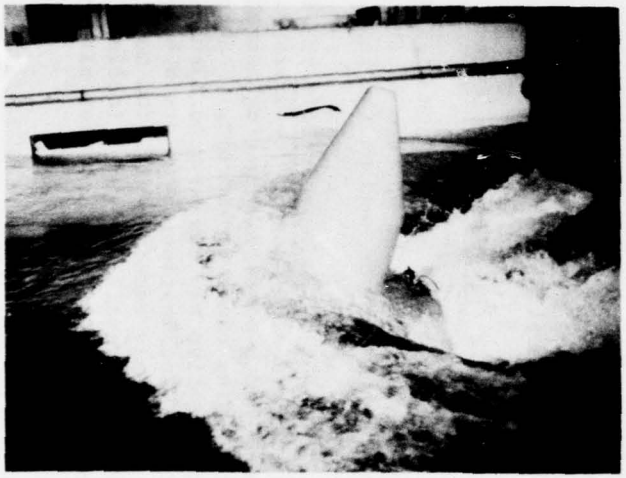
1. Buoy Stability: Early in the evaluation, it became apparent that the buoy, without ballast, was not stable. In calm water, the buoy, moored at the 35° mooring eye, would roll over if disturbed, and would not right itself until the current velocity approached three miles per hour (Figure 42). As the velocity increased, the hull submerged at five miles per hour and capsized at six miles per hour. Again, the buoy would not self right until the current returned to three miles per hour. The instability in slack water could be solved by using the 10° mooring eye, but as currents increased, the buoy would assume an unacceptable aft trim.

FOUR-FOOT PROTOTYPE IN CALM WATER, ROLLED OVER.
THE CAUSE OF INSTABILITY WAS LACK OF BALLAST.

A ballast weight of about 30 pounds cured the defect, and the design of the buoy was modified to permit the addition of concrete in the bottom of the hull. This added about $10 to the cost of each buoy.
