construction
engineering
research
laboratory

SPECIAL REPORT E-107
June 1977

RADIO FREQUENCY SHIELDING TESTS OF SYSTEM TECHNOLOGY TEST FACILITY AT MECK ISLAND, MARSHALL ISLANDS

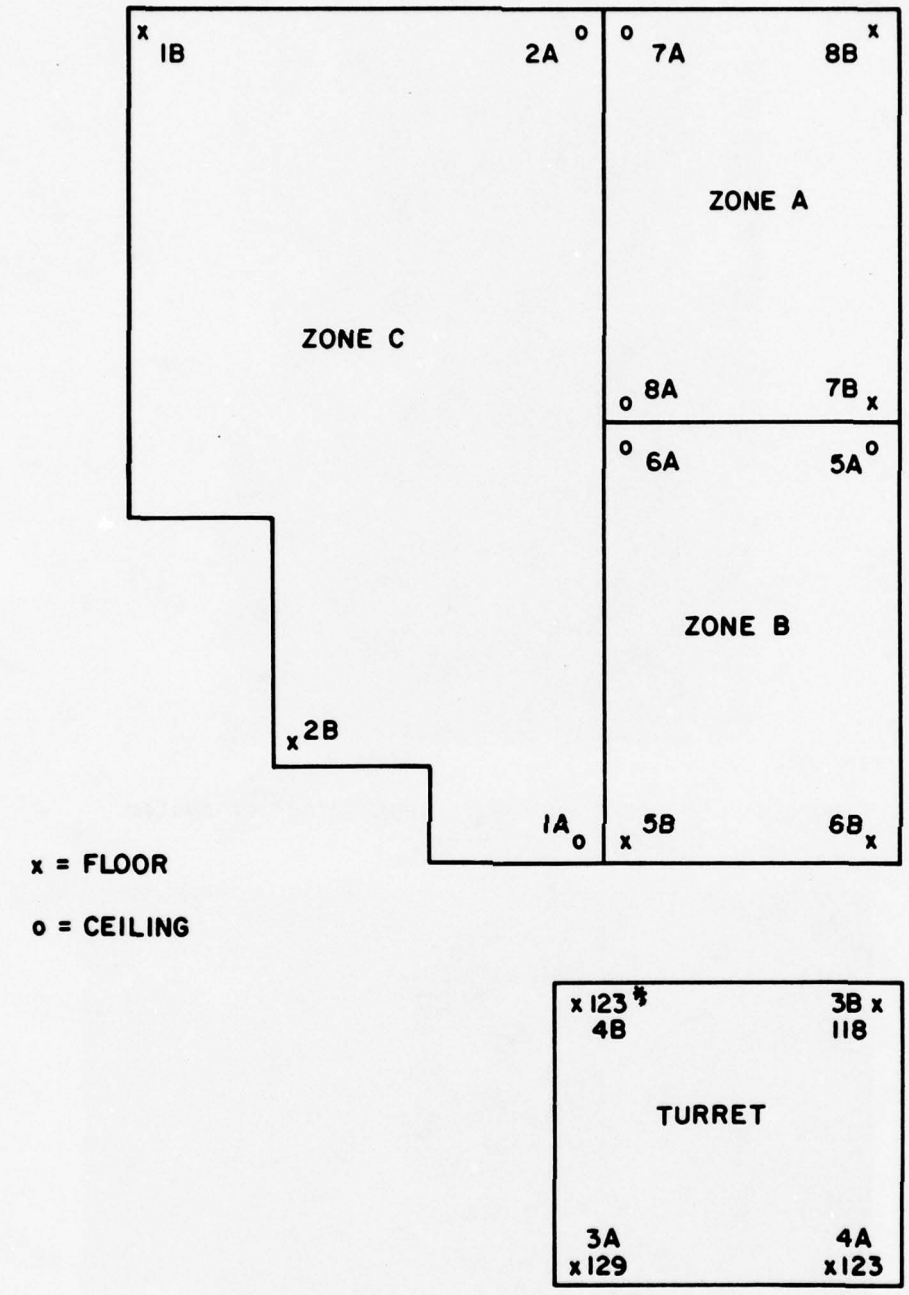
Figure 1. Floor plan. Dark lines are shielding zone boundaries; zone D is outside the building.

Figure 1 is the ground floor plan showing the various shielding zones of the STTF. The second floor or turret is located essentially above room 109 and is also in shielding Zone A. Tables 1 and 2 list the shielding requirements for the zones, which result from continuous welded 11-gauge steel liner plates on all zone boundaries. RF shielded doors allow personnel and equipment to pass between the zones. Test connections to external points on each shielding zone were provided (Figure 2) to permit direct application of RF test signals to the shielded structure. These signals provided the excitation for RF

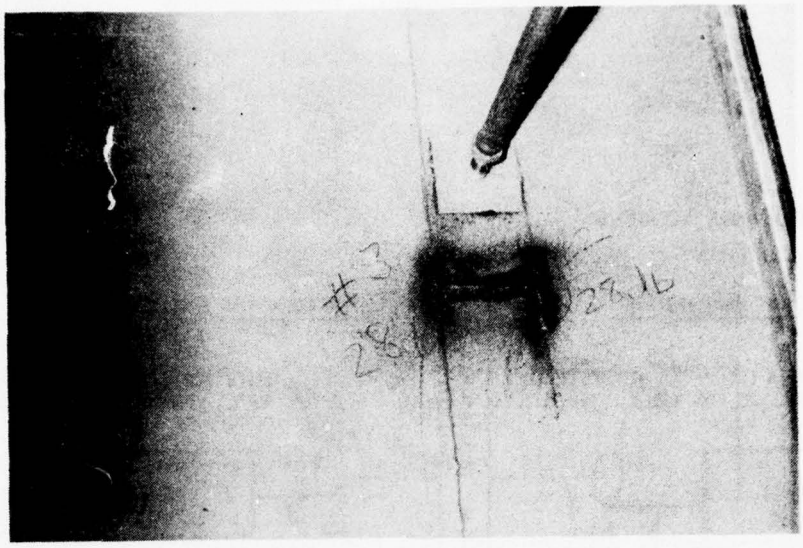
Leaks were found on the mounting of the welded panel doors in rooms 109 and 110 in Zone A, and the floors in area 103 and room 115 in Zone C. The leaks found by the sniffer tests were marked, repaired by rewelding the defects, and retested until no leakage was detected. Figures 5 and 6 show repairs on the floor liner in room 115 and the lower corner of the large panel door in room 110, respectively. Figure 6 also shows some of the perforated metal sound insulation mentioned earlier.

Figure 5. Repaired leaks on floor, room 115.

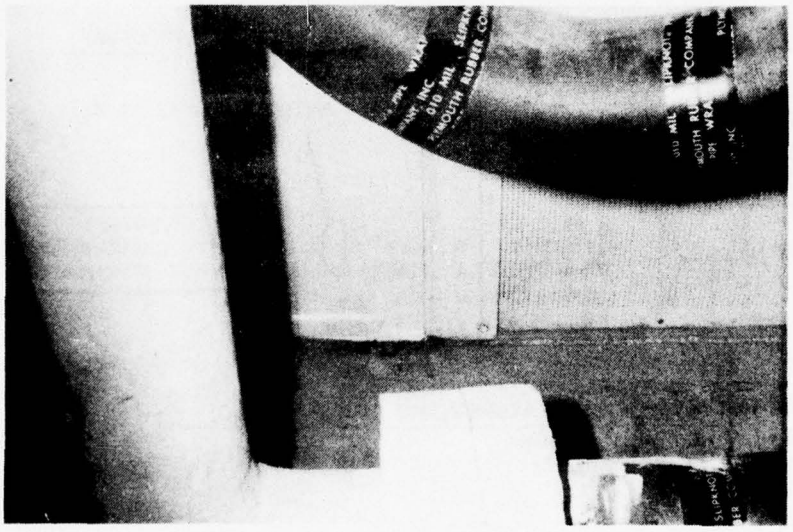
Figure 6. Repaired leak on panel door, room 110.

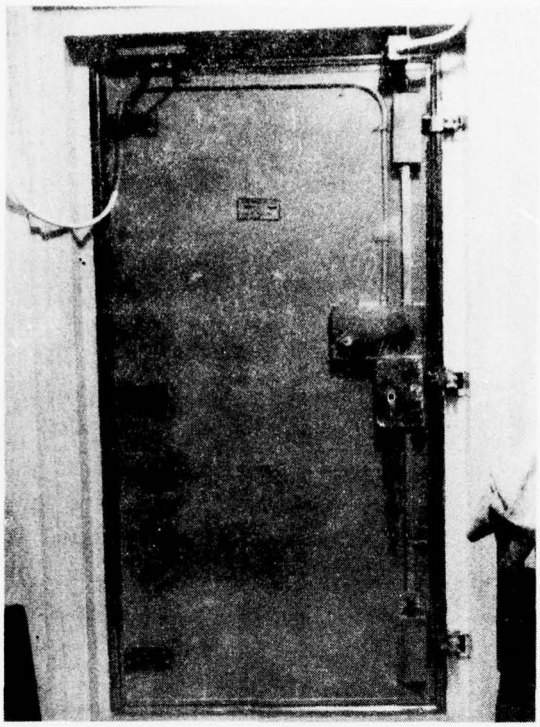
The fingerstock on door 111 (interior) had deteriorated considerably through normal use by 2 October 1976 (Figure 13). This door receives considerable use, and maintenance will be necessary for it to retain satisfactory shielding performance.

Figure 13. Damaged fingerstock, RF shielded door 111 (interior).

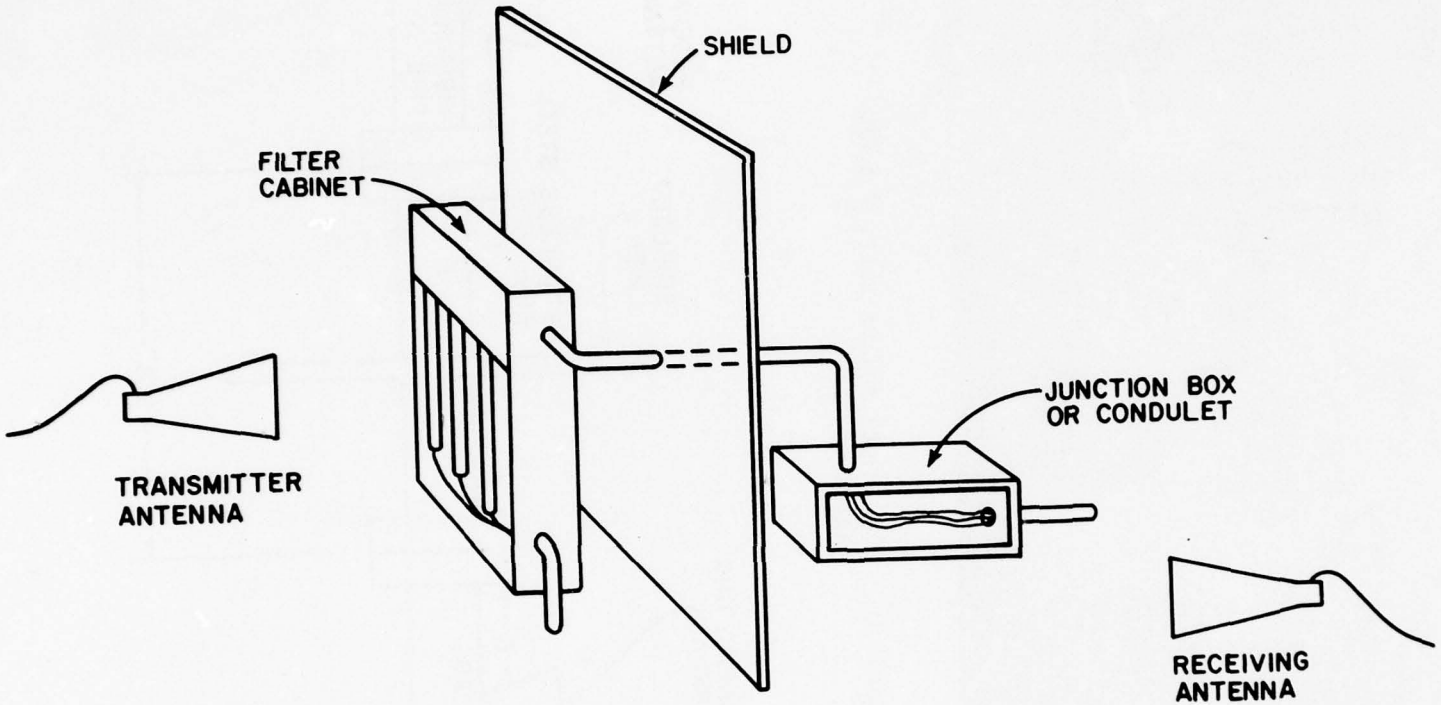
Figure 14. Electrical filter illumination test.

The electrical filters were subjected to a test developed by the White Sands Missile Range (WSMR) Facilities Acceptance Test (FACT) team for tests at the SAFEGUARD Ballistic Missile Defense site in North Dakota. Figure 14 illustrates the test setup. The filter cabinet covers are constructed so that the input and output sides of the filter can be uncovered separately. The test consists of radiating the input side of the filters with RF energy (Figure 15). The first opening in the conduit system (condulet, junction box, etc.) on the opposite side of the shielding liner (output side of the filter) is opened, and the signal level at this point is measured. Antenna spacing for both the radiating and receiving antennas is 1 ft (0.3 m). Although filter tests at the SAFEGUARD facility were performed at all the frequencies used in the door tests, the WSMR test crew felt that the only significant tests were at 200 kHz and S-band. The 200-kHz test would determine if the filters and related conduit hardware were installed properly, while the S-band test would be the main determinant of the quality of the filter. CERL laboratory testing during the SAFEGUARD program supported the conclusion that tests at these two frequencies would be adequate to determine the shielding performance of the filter installation. CERL tests at the STTF included 100 MHz, mainly to determine if other unfiltered wires penetrated the shield.

In addition to the RFI tests, the electrical filters were inspected for conformance to the installation specification and good installation practices. No installation deficiencies were noted.

If the electrical filters are replaced with a different type of filter in order to obtain satisfactory line voltage drop characteristics, additional illumination tests will be necessary to determine whether or not the installed filters have satisfactory RF characteristics.

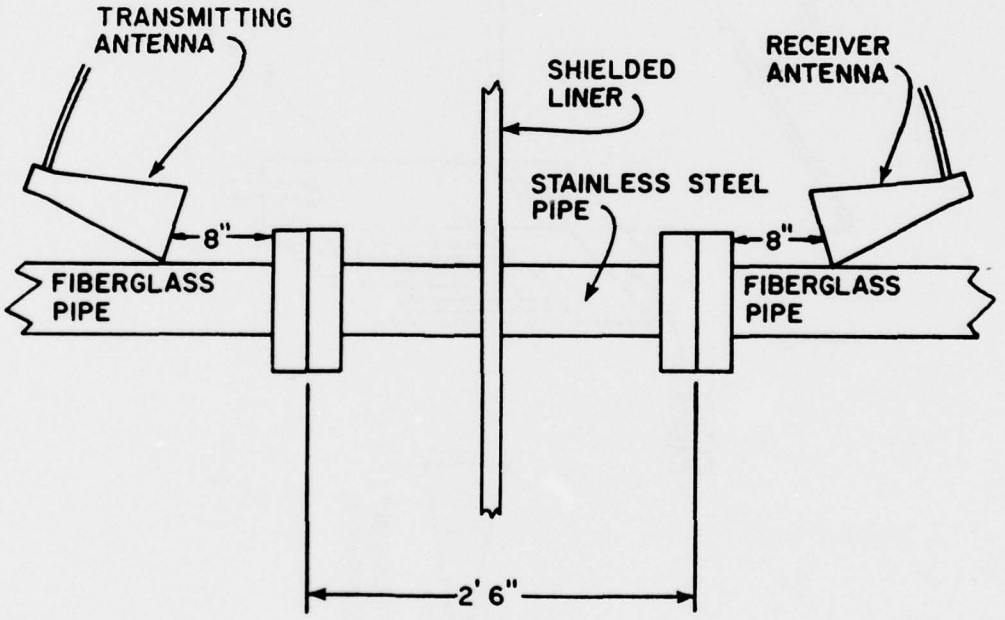
Figure 16. Pipe filter test setup.

The purified water system consists of fiberglass pipe (6-in. [152.4 mm] diameter) except where the system passes through the shielded liner between rooms 110 and 111. At this point, both the supply and return pipes have a 2 1/2 ft (0.7 m) section of stainless steel pipe (Figure 16). An RF honeycomb filter was installed in each of these pipes using conductive epoxy.

For testing, the antennas were positioned as shown in Figure 16. The transmitting horns were wired in place (Figure 17), and the receiving horns were positioned for maximum signal. The RF tests on the pipes were made at two frequencies--2.5 and 7 GHz, since the other test frequencies were well below the cutoff frequency for 6-in. (152.4 mm) round waveguide. Table 9 shows the test results, and Appendix F contains the data sheets for the tests. The RF filters were found in another part of the system after pressurization tests in which some of the field-fabricated fiberglass pipe joints failed. The conductive epoxy used to attach the filters did not hold the filters and appeared not to have hardened.

Waveguide-below-cutoff filters are necessary for the required interzone shield in 6-in. (152 mm) pipes which are used in the purified water system. The conductive epoxy originally used to install these filters does not provide a satisfactory physical bond and may provide an unsatisfactory electrical bond. It is therefore recommended that such filters be silver-soldered in place, as proposed by the Resident Engineer. With proper installation, a retest should not be necessary; however, if any other RF illumination tests are conducted at the STTF, it is recommended that these filters also be tested.

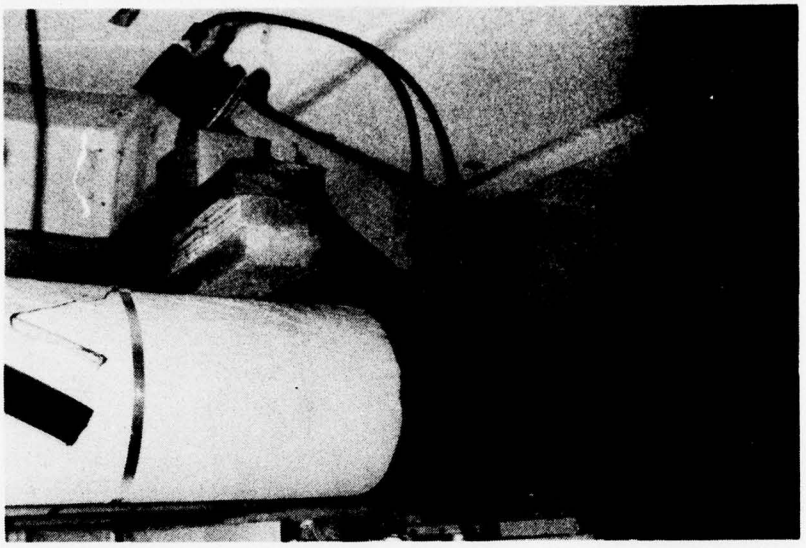
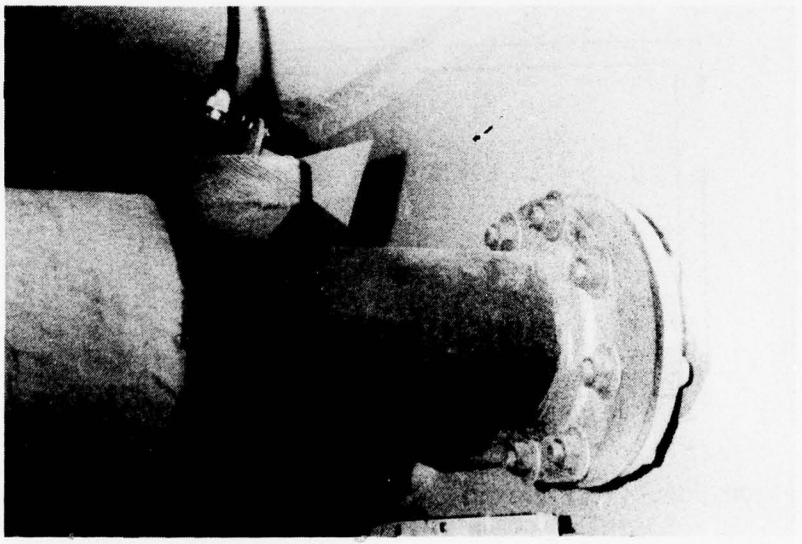
Figure 17. Pipe filter illumination test.

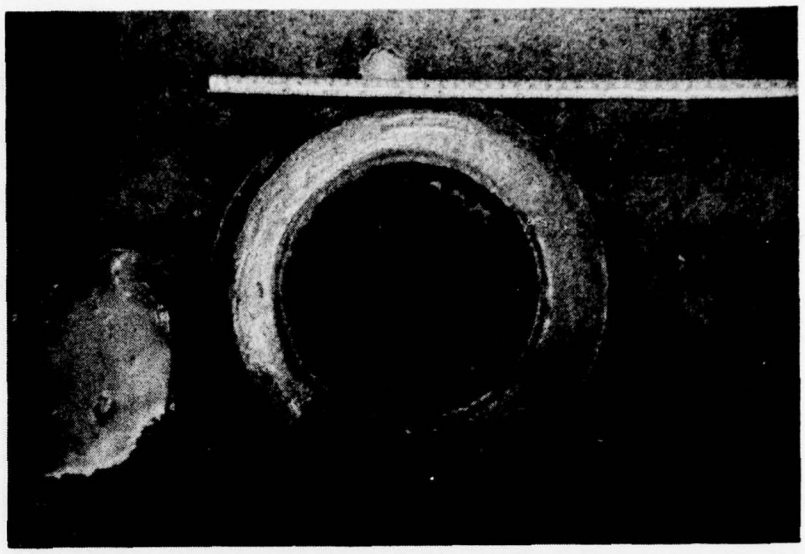
6. Special RF filter floor drains consisting of circular brass blocks with a number of drilled holes (Figure 18) were installed. These drains were welded to the floor shielding liner plate. Since testing these installations by illumination was not possible, they were visually and RF sniffer-inspected. No defects were found.

Figure 18. Brass floor drain filter welded in place.

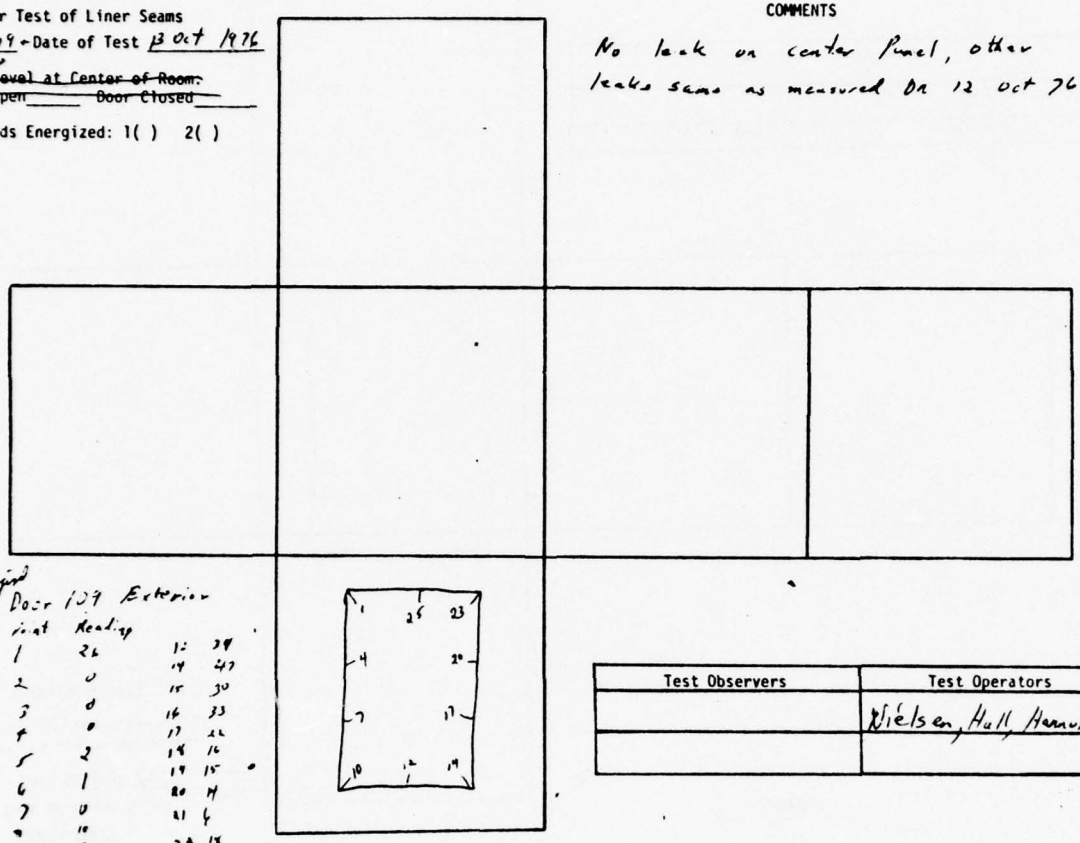
Door 109 Exterior

Door 109 (exterior) also did not meet the 40-dB requirement at 1 kHz. Considerable effort was expended cleaning and drying the fingerstock and the door's knife edge; however, no improvement in shielding effectiveness was obtained. Problems with the door may be due to the relatively large temperature gradient to which it was subjected; the building's air conditioning kept the interior temperature at 60°F (16°C). The rubber seal on the door did not prevent considerable condensation from existing on the bottom of the door and frame system at all times. No corrosion was evident on the gold-plated fingerstock for this door. However, slight corrosion was visible in the mounting channel for the fingerstock located on the door frame. The contractor was not willing to remove the fingerstock for cleaning this surface, since there was no spare gold-plated fingerstock at the site, and the fingerstock is subject to breakage during removal and installation. Since it was not feasible for the CERL test team to remain at the site until additional fingerstock could be procured, the following was recommended:

Additional sniffer tests were conducted on doors 109 (exterior) and 201 (exterior) to provide a limited comparison between illumination test data and sniffer test results. The data sheets for the sniffer tests for Rooms 109 (12 and 13 October) and 201 (13 October) in Appendix B (pp 57-59, 71) give the results of these tests. Spot checks of door 125 (exterior) showed considerably lower leakage (0 to 15 dB) than that of 109 (exterior) and 201 (exterior). Door 125 (exterior) had passed the RF attenuation test earlier, and visual inspection indicated that the fingerstock was in good condition. The data are too limited to draw significant conclusions; however, they do indicate that the sniffer may be a useful tool for door inspection.

1. Upon receipt of additional gold-plated fingerstock, the existing fingerstock should be removed, and the channel in the door frame thoroughly cleaned to remove any oxidation or corrosion.

3. The fingerstock should be cleaned with a solvent and checked for corrosion or damage and replaced in the channel.

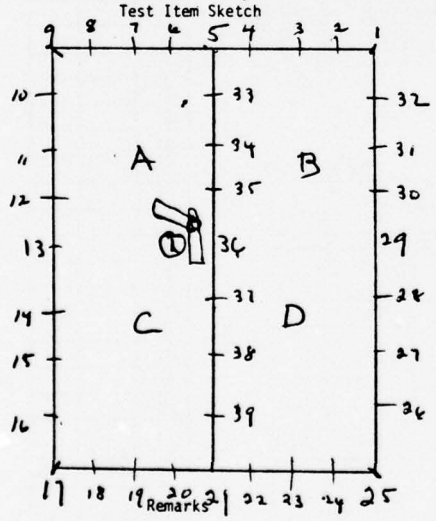
Door picture from outside Building.

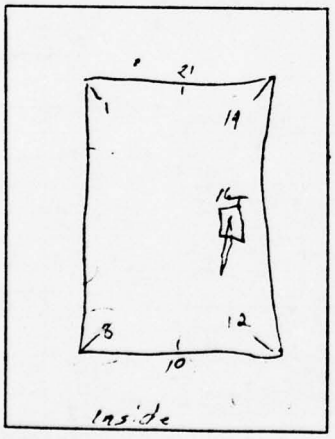
Attenuation db		
Reqd	75	75
Meas.	60	51

Fingerstock missing in corner with AR

Backside of Door has Fingerstock missing

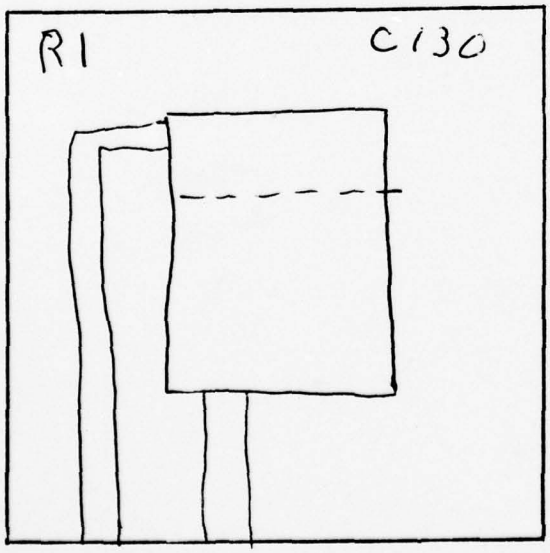
ELECTRICAL FILTER R1
Room 111

Frequency	200 kHz	100 mHz	2.5 gHz
Ref 1	-5	80	80
Meas Lvl	>90	~~<~~ 0	<0
Ref 2	-5	~~>~~ 80	80
Reqd Attn	20DB	48DB	48DB
Meas Attn	>85DB	>80	>80DB

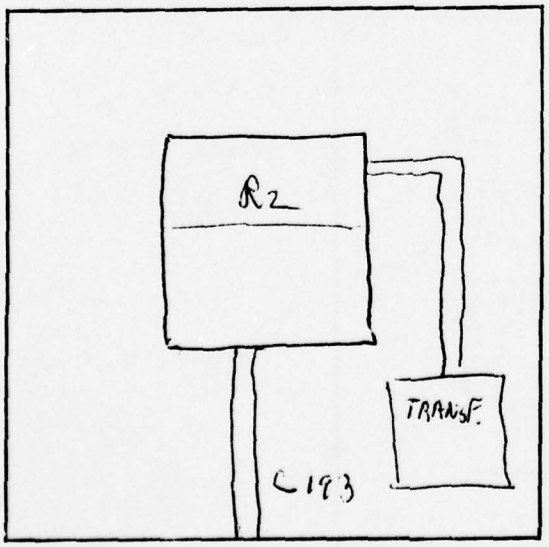
ELECTRICAL FILTER R2
ROOM 111

Frequency	200 kHz	100 mHz	2.5 gHz
Ref 1	-5	80	80
Meas Lvl	>90	<0	<0
Ref 2	-5	80	80
Reqd Attn	20 DB	48DB	48DB
Meas Attn	>85DB	>80DB	>80DB

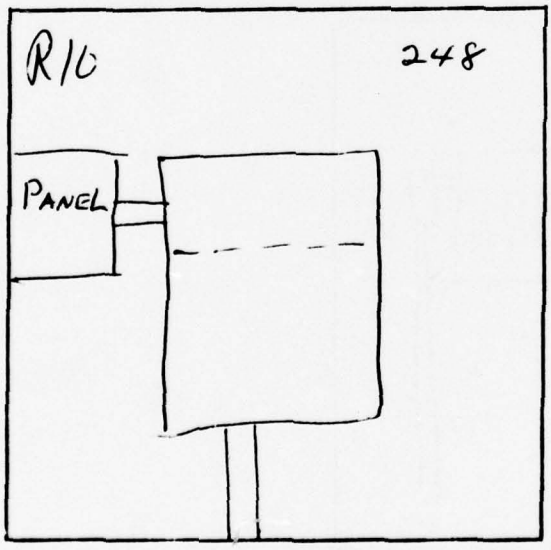
ELECTRICAL FILTER R10
Room 111

Frequency	200 kHz	100 mHz	2.5 gHz
Ref 1	-3	80	80
Meas Lvl	-90	60	60
Ref 2	-3	>80	>80
Reqd Attn			
Meas Attn	87	>80	>80

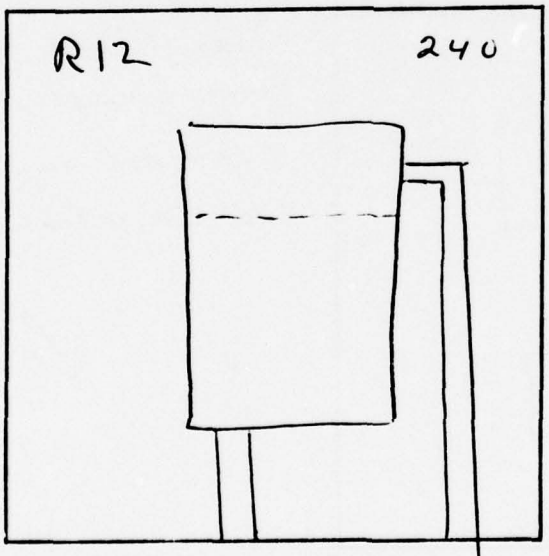
ELECTRICAL FILTER R12
ROOM 111

Frequency	200 kHz	100 mHz	2.5 gHz
Ref 1	-5	80	80
Meas Lvl	∠-90	∠0	∠0
Ref 2	-5	80	80
Reqd Attn			
Meas Attn	>85	>80	>80

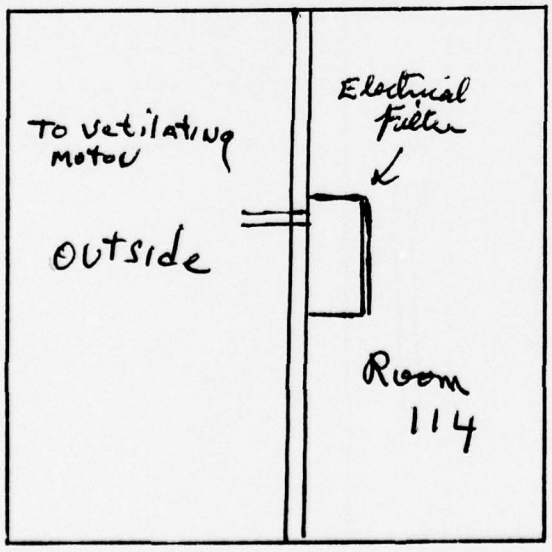
Electrical Filter R22
Room 114 South wall to Outside
September 11, 1976

Frequency	200 kHz	100 mHz	2.5 gHz
Ref 1	-2	70	70
Meas Lvl	∠-90	∠0	∠0
Ref 2	-2	70	70
Reqd Attn			
Meas Attn	>88	>70	>70

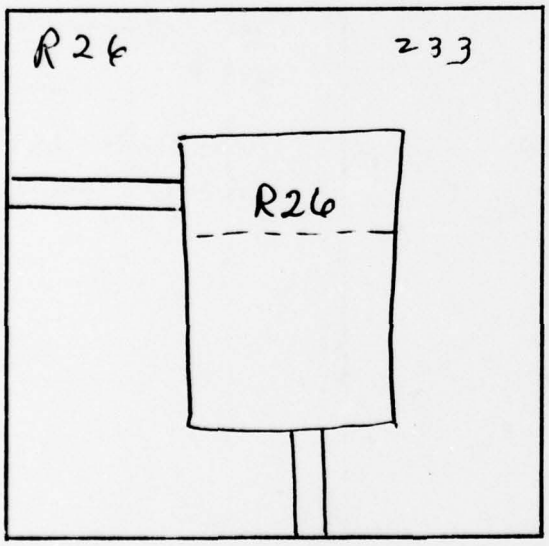
ELECTRICAL FILTER R26
ROOM 111

Frequency	200 kHz	100 mHz	2.5 gHz
Ref 1	-5	80	80
Meas Lvl	<-90	<0	<0
Ref 2	-5	80	80
Reqd Attn			8
Meas Attn	785	780	780
