AD-A045 489 VOUGHT CORP DALLAS TEX F/G 11/6
STUDY TO IDENTIFY STRESS CORROSION PRONE PARTS ON THE TA-7C AIR--ETC(U)
OCT 77 O H COOK N62269-76-C-0353
UNCLASSIFIED 2-53400/7R-3428 NL

(6) 4. TITLE (and Subtitle): STUDY TO IDENTIFY STRESS CORROSION PRONE PARTS ON THE TA-7C AIRCRAFT

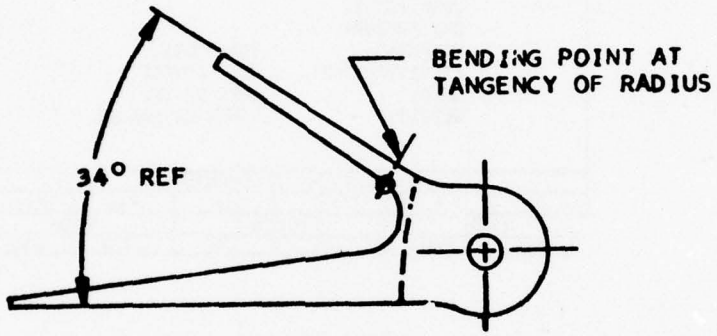
The failure listed as number 1 is in the Outboard Flap Slot Door. P/N 215-70194 (made from CVC10041-36 or -38 shown in Figure 7) failed by SCC in the lugs starting in the I.D. of the bore. This is a hinge where trouble was frequent and attributed to rigging. A small preload tolerance condition prevailed in that a high preload caused SCC and insufficient preload created gapping, which caused overload failures. Infrequent fatigue failures appeared to be associated with a stress condition following SCC failures in other lugs.

Examination of the rating system used for the other product forms would have left this part under 50 in rating. The additional "pull down" approach does not indicate a problem. Unfortunately a stress evaluation would only highlight the pressed fit bushing. The rigging related stresses are not visible to the drawing reviewer.

Because of the failure history, this part was changed to 7075-T73511 from 7075-T6511. Higher stresses were then acceptable with the higher SCC threshold of the T73511 temper. The overload and fatigue failures related to the problem also have not recurred.

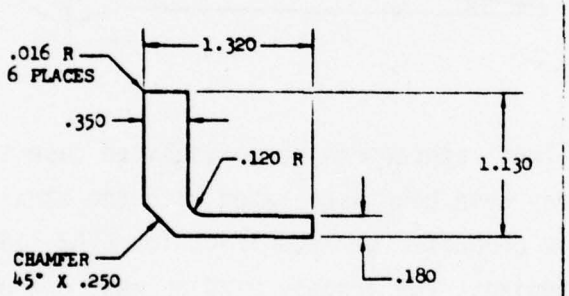
PART NUMBER:	CVC10002-68
REF PART NUMBER:	
CODE IDENT:	
DIE NUMBER:	
MATERIAL:	7075-T6511
AREA:	.542 SQ IN.
WEIGHT:	.0542 LB PER IN.

The failuires numbered 3 and 4 are the Catapult Longeron Splice P/N 215-30420 made from CVC10020-29 or CVC10002-68 shown in Figure 9, and the Catapult Longeron P/N 218-30081 made from CVC10060-11 (a 7" x 2.75" rectangular shape). These failures were associated with discrepancies in shimming and an inadequate attachment design. This situation has been corrected. A stress study of this part from the drawings concluded that the stress was low in this assembly.

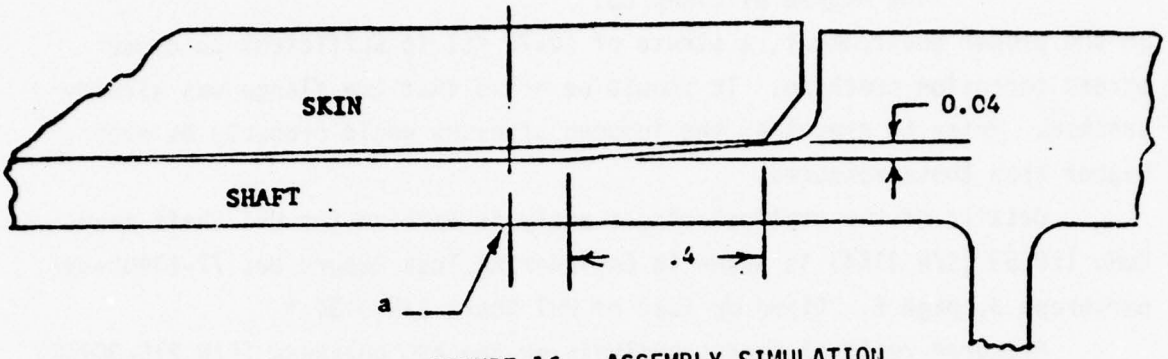
FIGURE 16. ASSEMBLY SIMULATION

A most revealing study was made on the UHT Shaft from BuNo 159659. Radiographic inspection revealed two cracks in the flange between fastener holes. Disassembly confirmed two cracks. The findings of this investigation are summarized as follows:

1. The part was examined visually and was found to have an undercut on the surface of the flange containing the two cracks. A dimensional analysis was performed and it was determined that the thickness tapered approximately .04 inch from the forward edge aft to a point .4 inch from the fillet radius and then tapered back up to the tangent of the radius. The radius was also found to be out-of-tolerance.

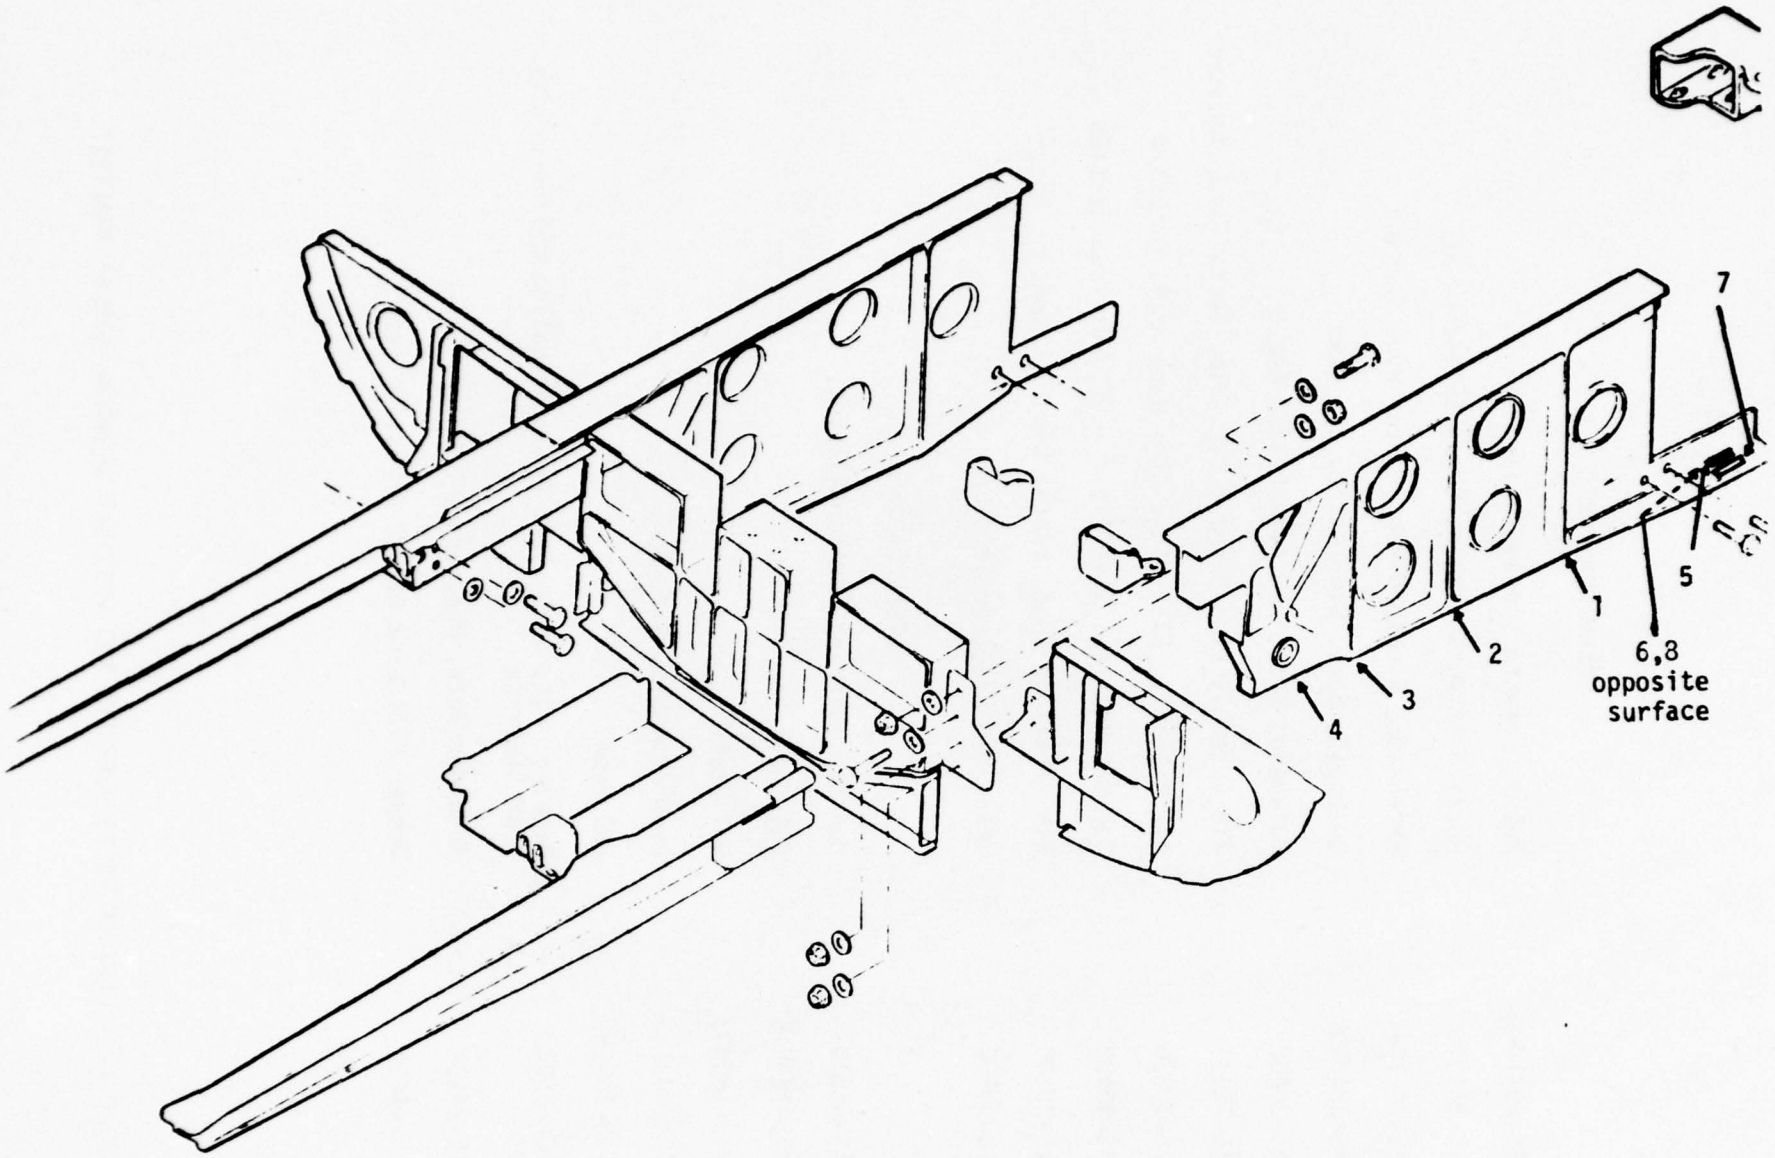
FIGURE 12. 218-30507 KEEL FITTING.

Nine aluminum and nine steel parts were chosen for consideration for analysis. Of the aluminum parts, the 218-30507 keel fitting (Figure 12) and the 215-30402 bulkhead fitting (FIgures 13, 14) were selected as being representative. Of the steel parts, the CV15-160516 UHT horn, the 215-60210 UHT box and CV15-160033 UHT shaft were selected as being representative (Figure 15). The parts considered are shown in Figure 11.

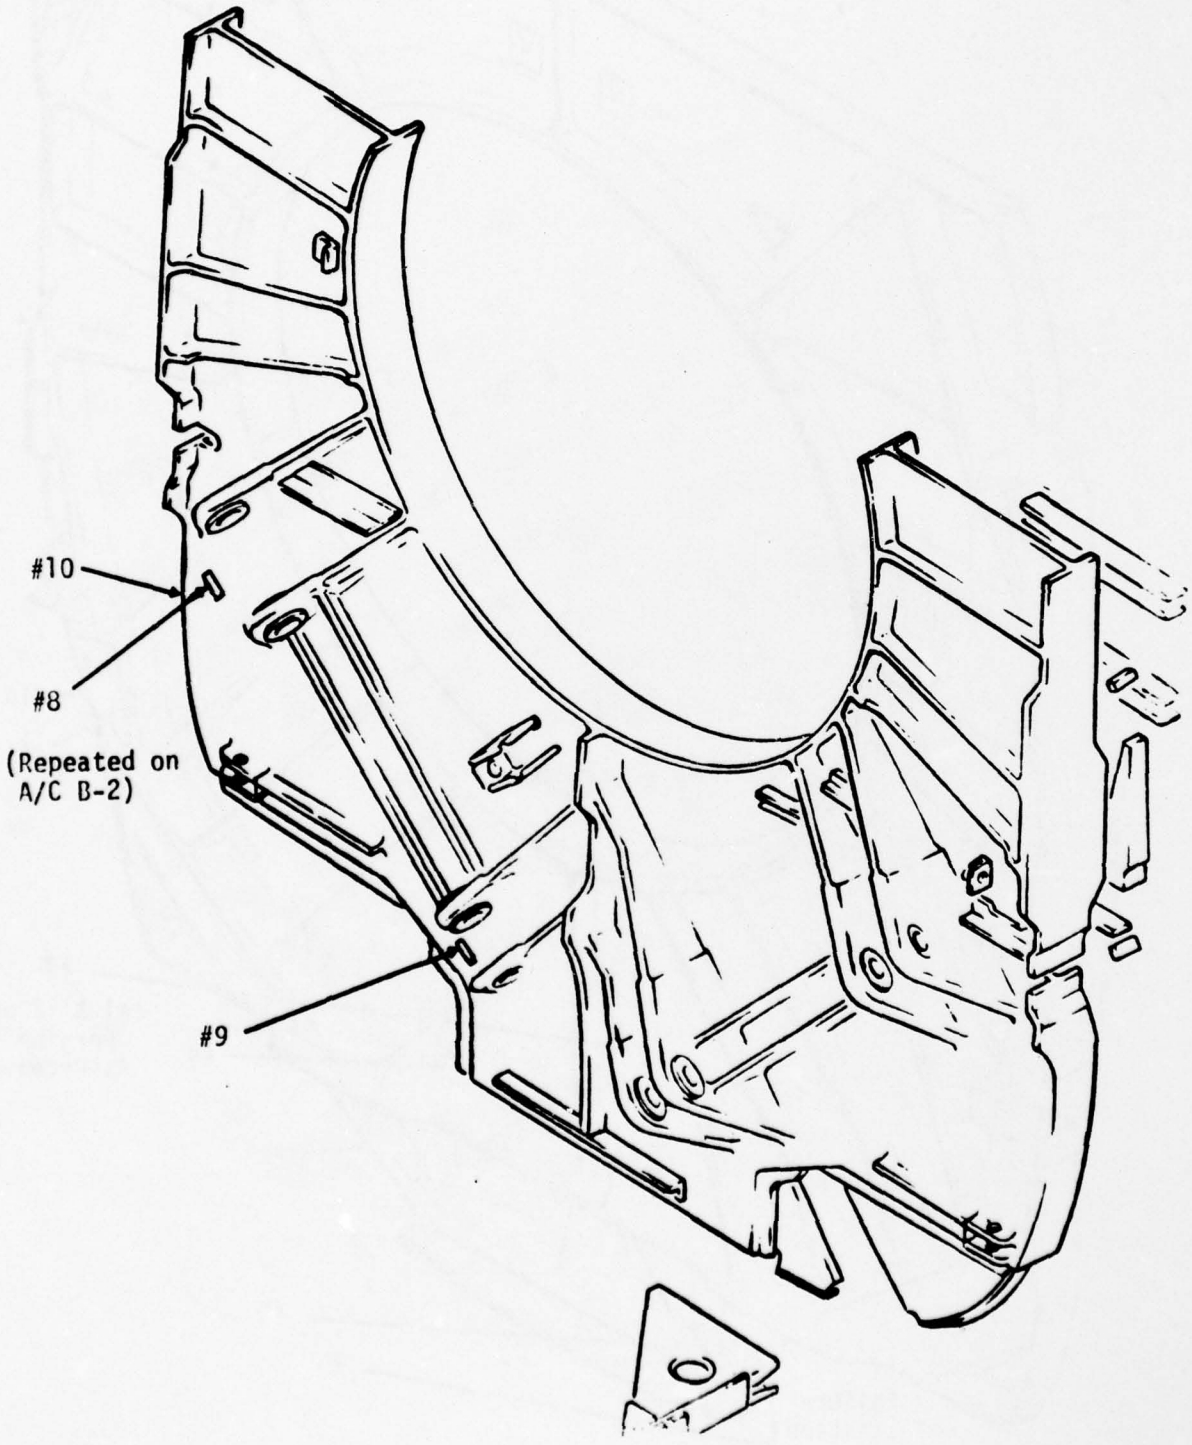
FIGURE 13. 215-30402 BULKHEAD FITTING FORWARD SIDE, AS MACHINED.

Reading number 8 on the forward side as machined was -24,300, and as assembled -36,450. The reading on the aft side at number 11 opposite number 8 shows a +15,525 reading as machined. It is felt that the higher tensile stress can be expected as was seen on the compressive side after assembly. Although this is not at the failure shown by the circle on the aft side (Figure 14) it does indicate high stresses are present before the effect of air loads are added.

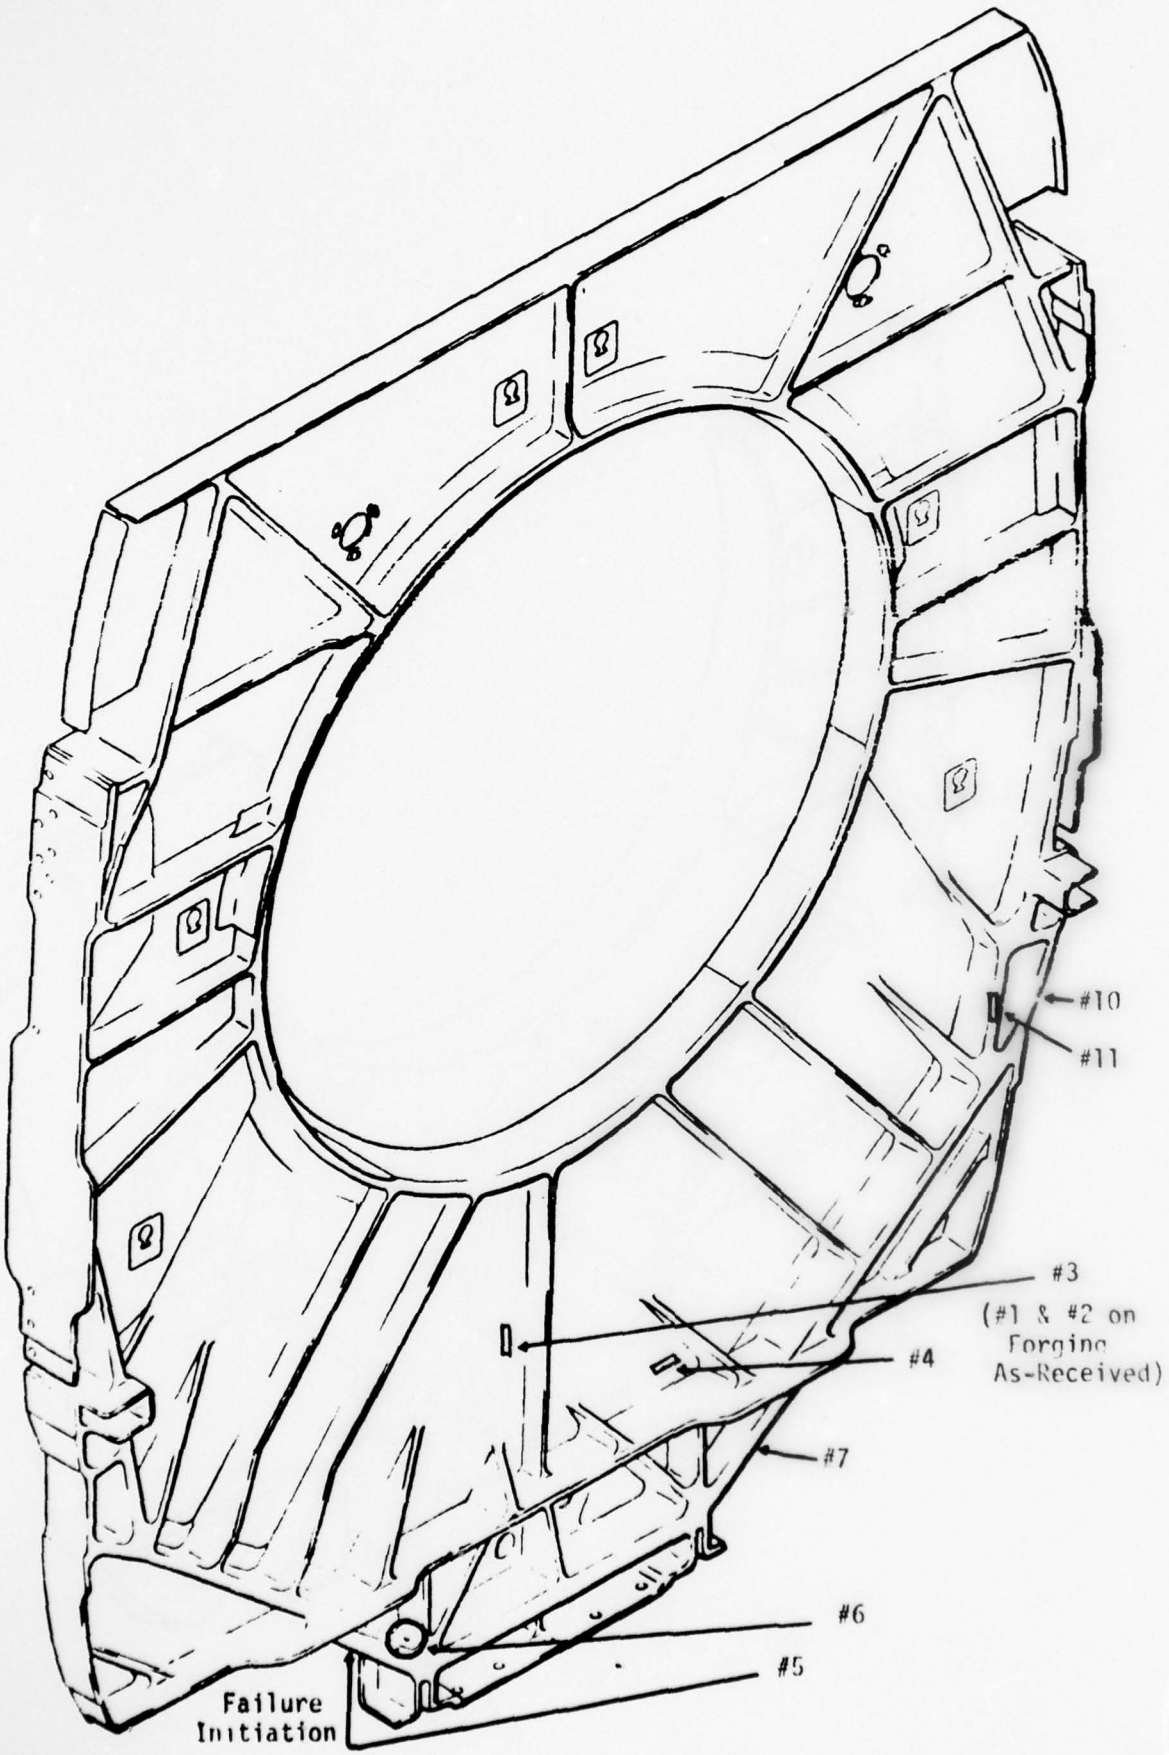
FIGURE 14. 215-30402 BULKHEAD, AFT SIDE, AS-MACHINED.

Measured residual stress analysis on the 490 bulkhead (P/N 215-30402) could not be effectively correlated with analyzed stresses in the failure location due to the Rigaku machine size. The failure location is shown by a circle on the aft side (Figure 14, Section 4.1).

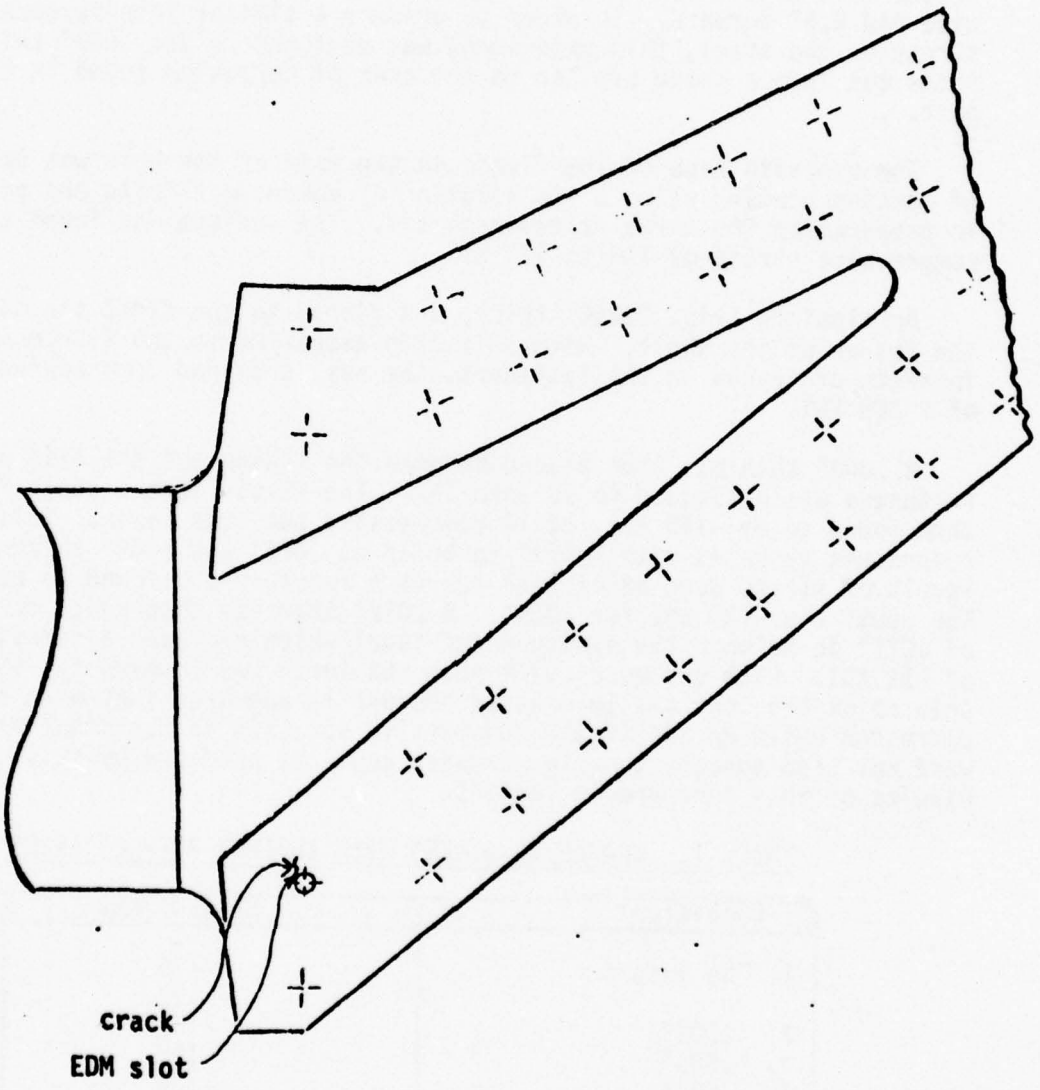
FIGURE 1. LOCATION OF HOLE IN LOWER FLANGE IN WHICH CRACK WAS INITIATED.

With this stress being exerted on the hole, and after applying wax to mask off all the part except the area immediately around the hole, the part was placed in the salt spray cabinet for 72 hours.

After this exposure, the surface near the slot was carefully inspected using a 30X glass. There was no evidence of a crack at this time. The pin was then pressed into the hole 0.1" more, or a total of 0.003" interference. In three hours, the surface was inspected again and found to have a crack approximately 0.250" long. The part was then submitted to Quality Control for NDI to verify the crack and for their use in developing an x-ray technique for field use.

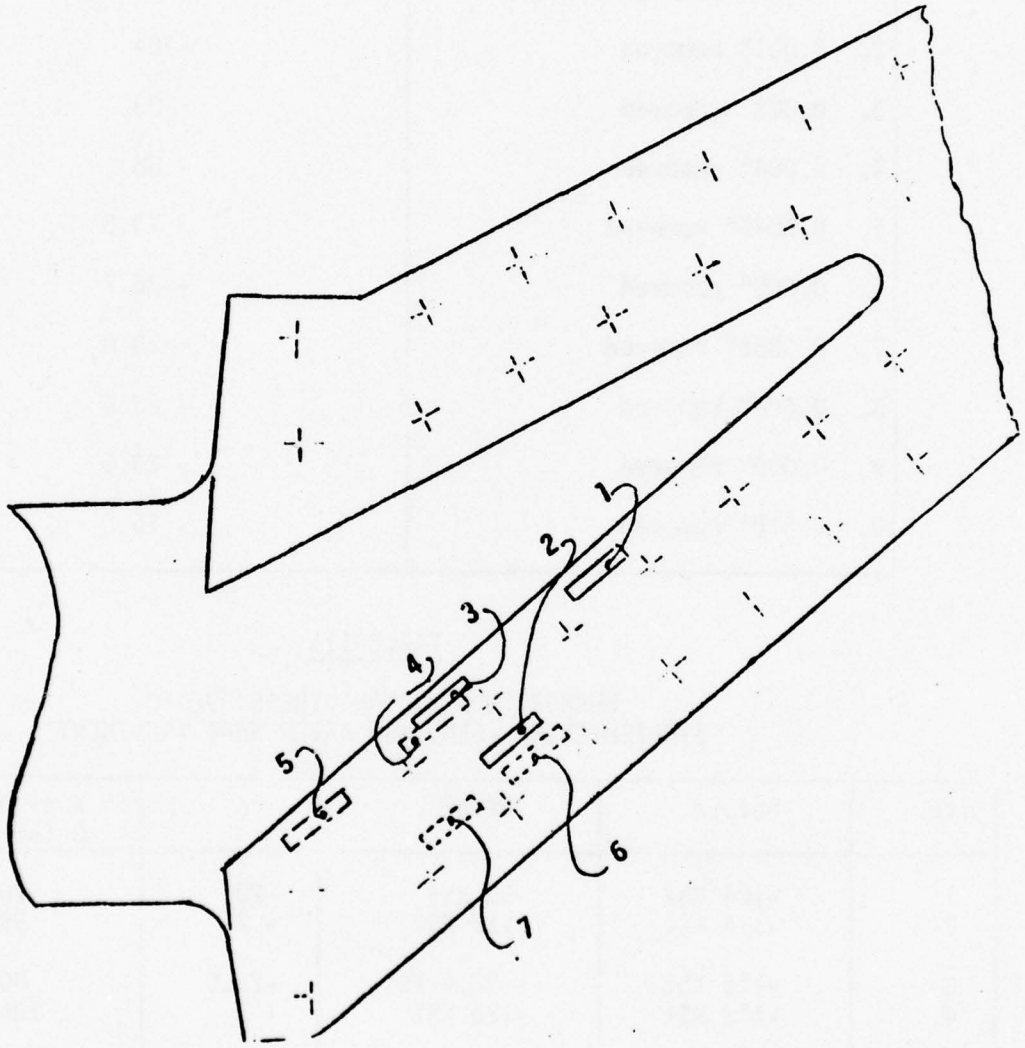
FIGURE 2

The thickness of the flange was determined using sheet metal micrometers before and after each successive step. This was found to be inaccurate and a more accurate method was incorporated at the final step which involved spring loaded calipers and a 0.100" gauge block. Results of this test are in Table II and Figure 2.

* Note: Readings 6 and 7 were made using ψ angles of 40° to 60°. While the actual residual stress may be inaccurate, it is believed the difference in before and after may be relied upon.

1, 2, 3 - Upper flange, upper surface.
4, 5, - Lower flange, lower surface.
6, 7, - Upper flange, lower surface (6 opposite 2).

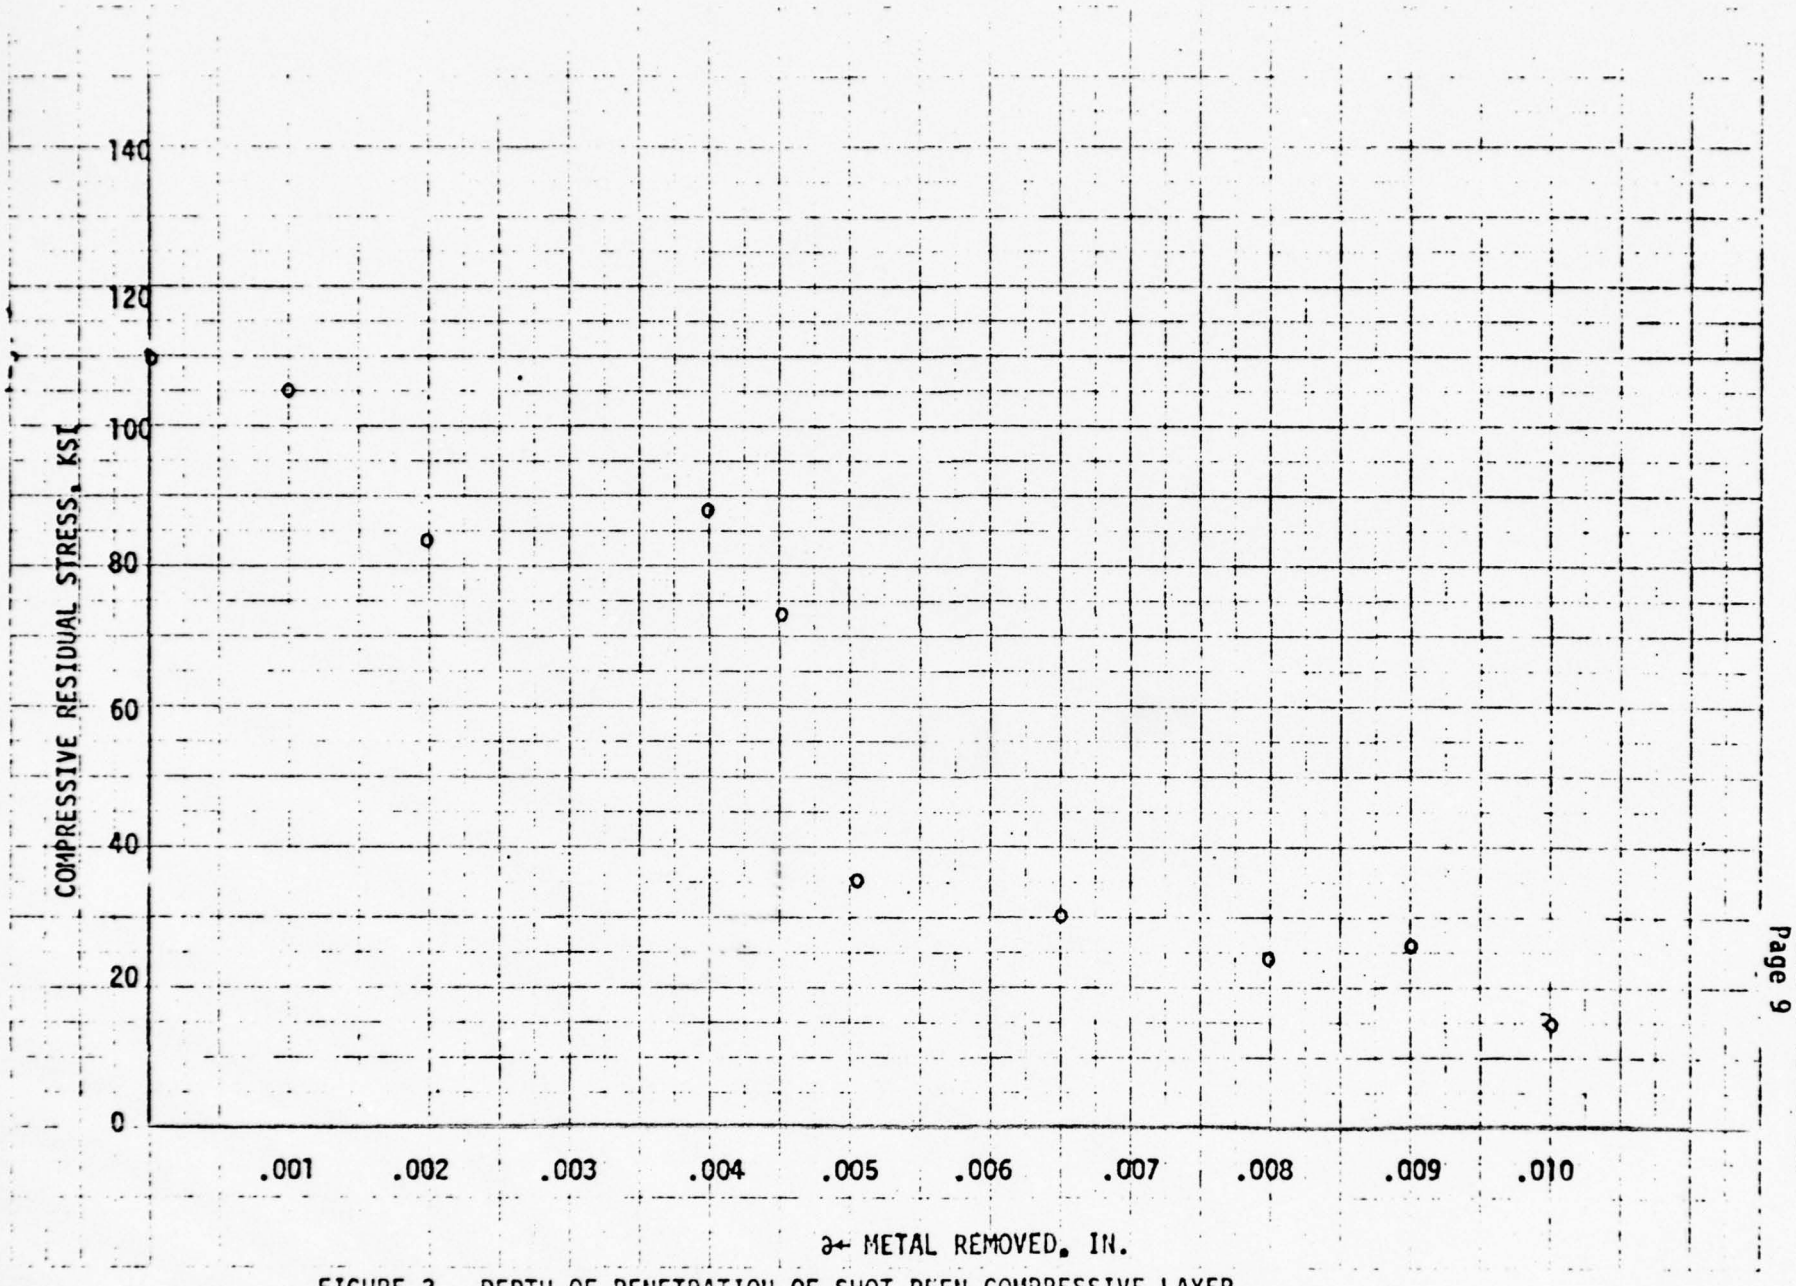
FIGURE 3. DEPTH OF PENETRATION OF SHOT PEEN COMPRESSIVE LAYER
