SS EDMUND FITZGERALD; SINKING IN LAKE SUPERIOR

ON 10 NOVEMBER 1975 WITH LOSS OF LIFE

U.S. COAST GUARD
MARINE BOARD OF INVESTIGATION REPORT

REPORT NO. USCG 16732/64216

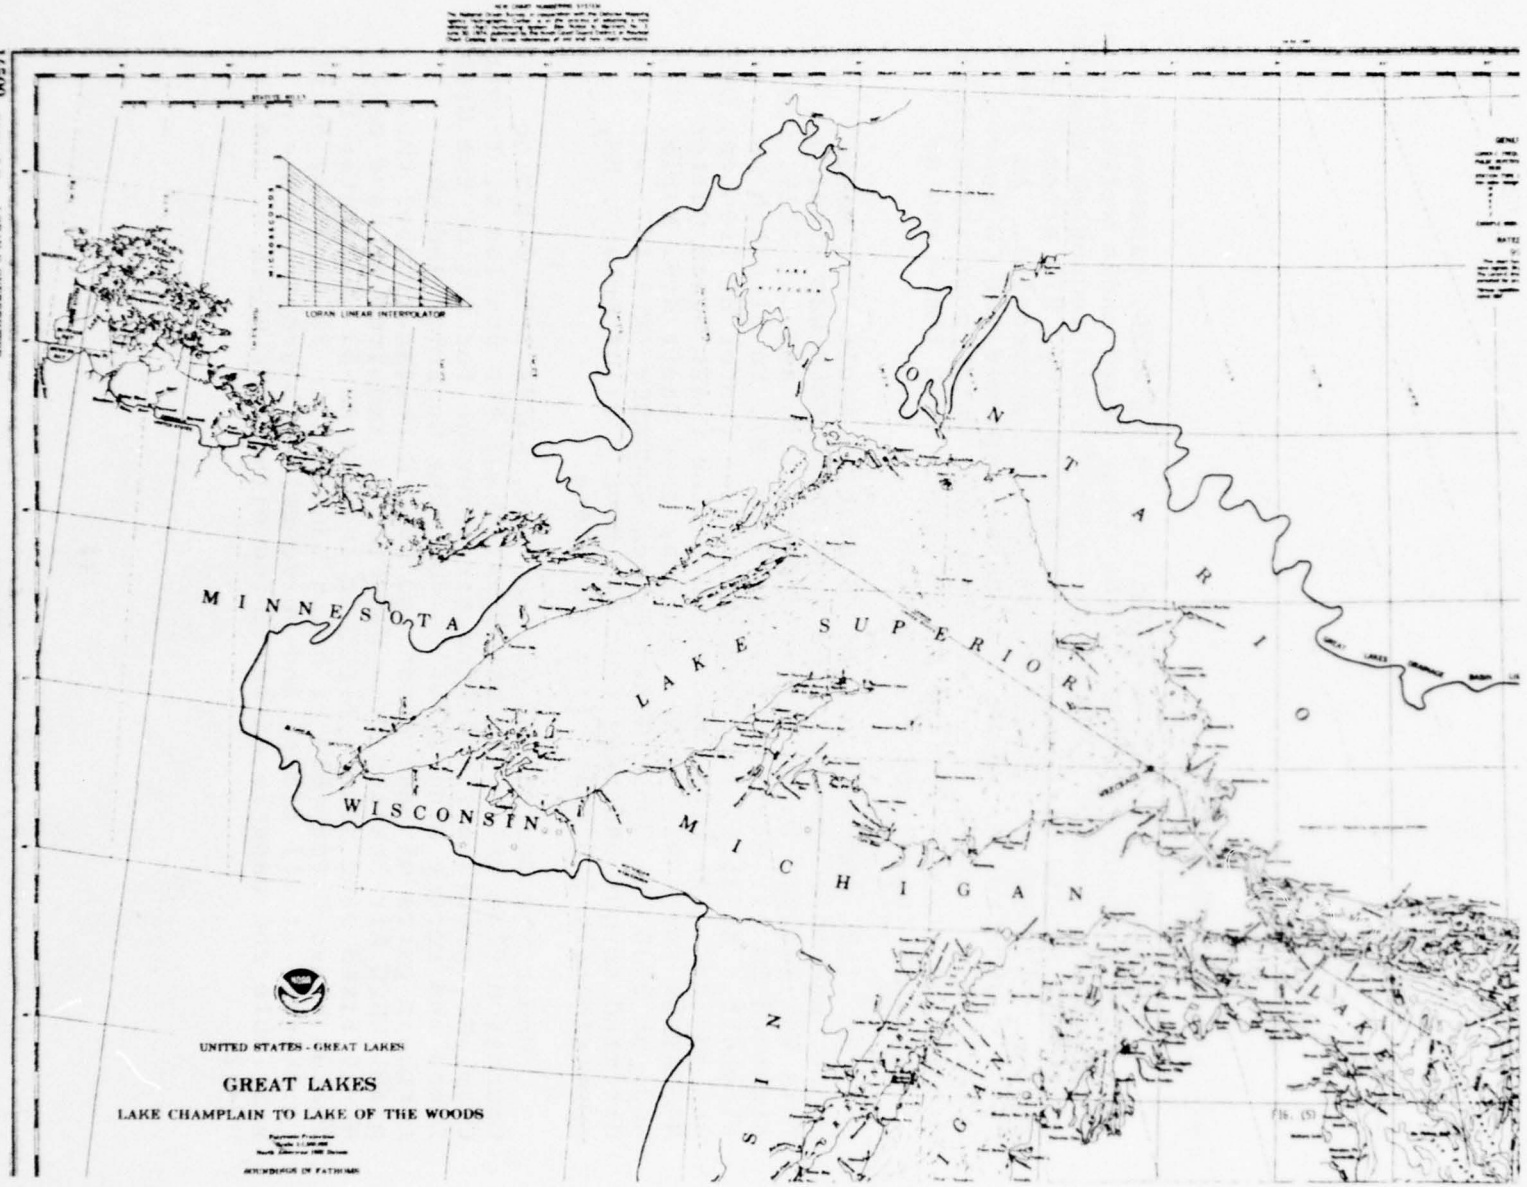
Coast Guard Group Sault Ste. Marie logged a call from the ARTHUR M. ANDERSON on Channel 22 at 2032 in which CAPT Cooper said, "I am very concerned with the welfare of the Steamer EDMUND FITZGERALD. He was right in front of us experiencing a little difficulty. He was taking on a small amount of water and none of the upbound ships have passed him. I can see no lights as before and don't have him on radar. I just hope he didn't take a nose dive." This is the first recorded call from ANDERSON and the station log makes no mention of a broadcast concerning a lost 16-foot boat.

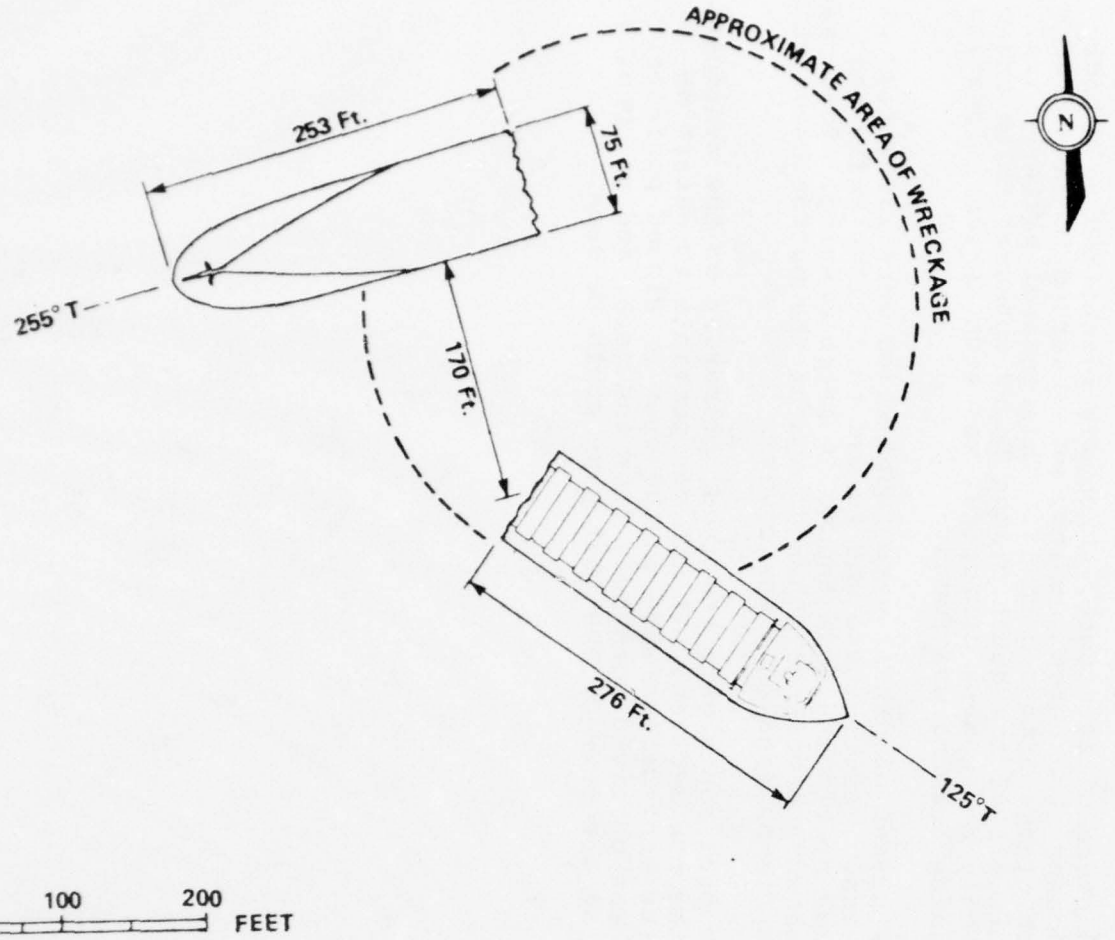
The stern section is upside down, inclined approximately 10°. All of the bottom plating and the side shell plating which is visible above the mud line is intact. The separation is estimated to be at frame 155, which would correspond to the after end of hatch No. 18. At the separation, approximately 12 to 15 feet of the hull extends above the mud. At the after end, the overhead of the Spar Deck, i.e., the underside of the Poop Deck, is lying approximately even with the mud level. The aft superstructure is buried in the mud. The rudder and propeller are clearly visible and undamaged. The rudder appears to be at the midships position. There is no hole or rupture in the exposed stern section of the hull other than at the separation.

One dent was found slightly to port of centerline, approximately 50 feet forward of the rudder post. A large inward dent, which appears to be a buckle, was found on the starboard side of the stern section at a position approximately 20 feet from the separation, extending vertically from the mud line to the turn of the bilge and across the hull for 10 or 15 feet. There was no breach of the hull at either dent. At the separation on the starboard side, the plating is twisted outward from the hull, while on the port side, the plating is, in general, twisted inward.
